**2 MANDALA PARADE, CASTLE HILL
(DORAN DRIVE PRECINCT)
PRE-DILAPIDATION REPORT
Of Sydney Metro and Hills Shire Council Assets
DEICORP PROJECTS SHOWGROUND
PTY LTD.**

Job No. 200124.3
07/07/2021

ACE Structural Services Pty Ltd

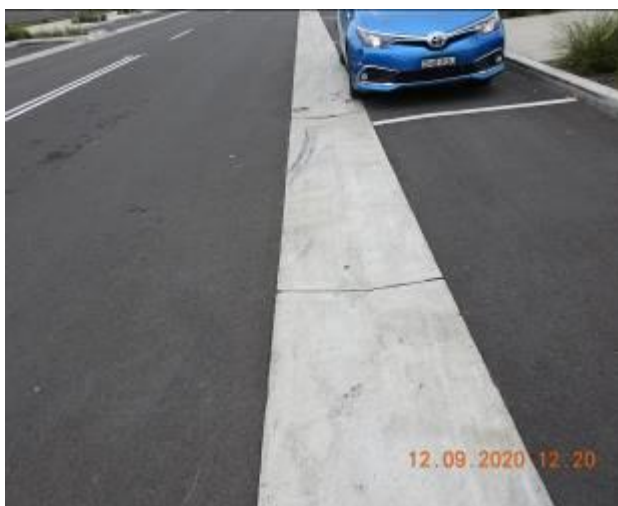
Figure 985 – General condition of gutter heading South

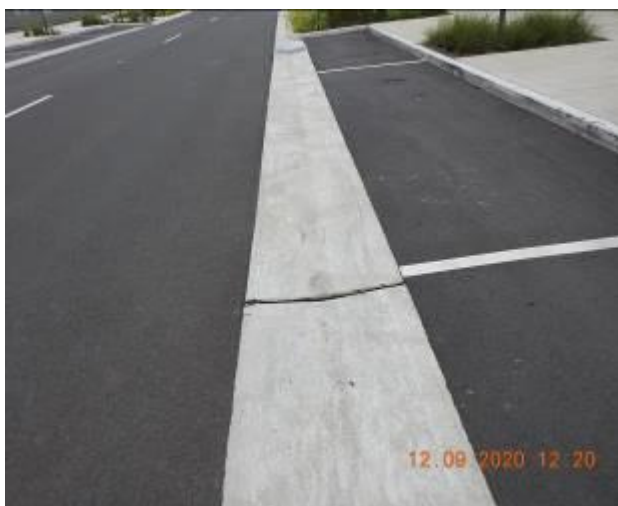
Figure 987 – Loss of material through gutter

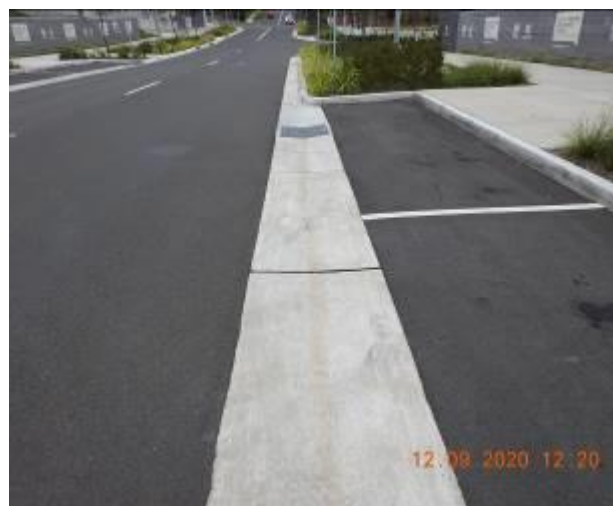
Figure 988 – General condition of gutter

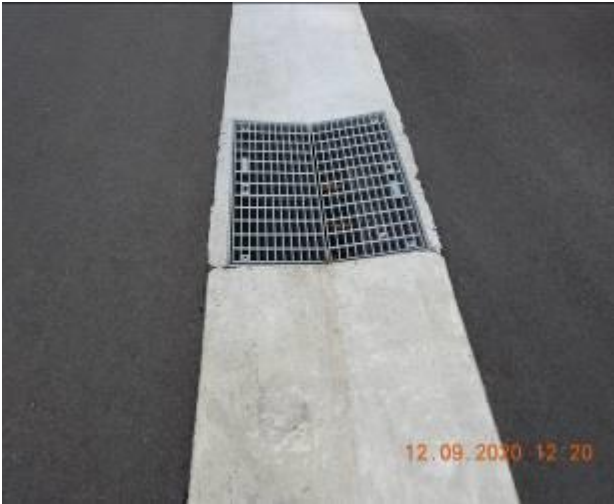
Figure 989 – Loss of material through gutter/General condition of stormwater inlet pit

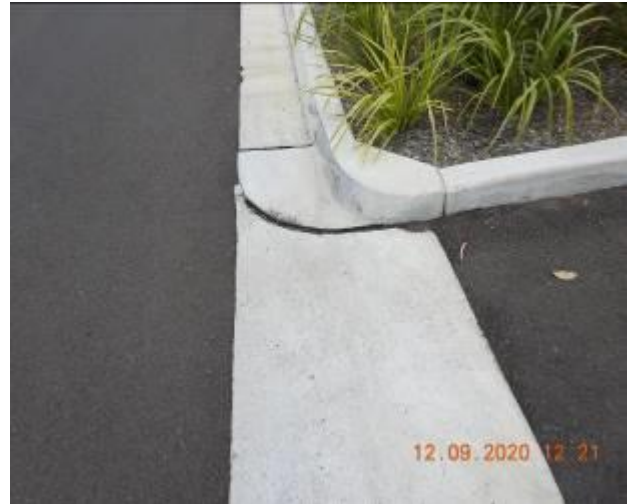
Figure 990 – Loss of material through gutter

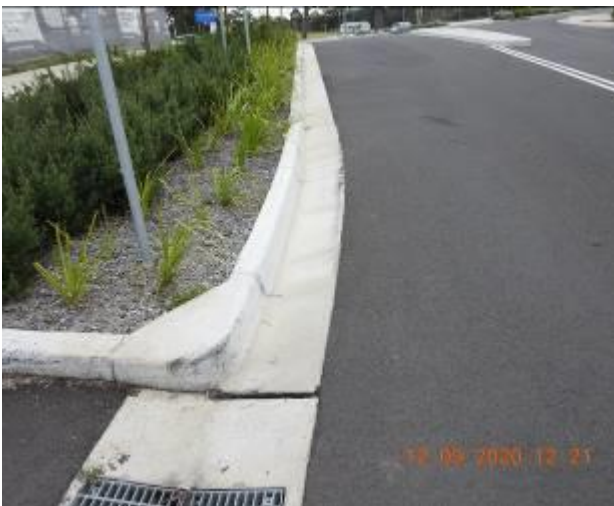
Figure 991 – Loss of material through gutter

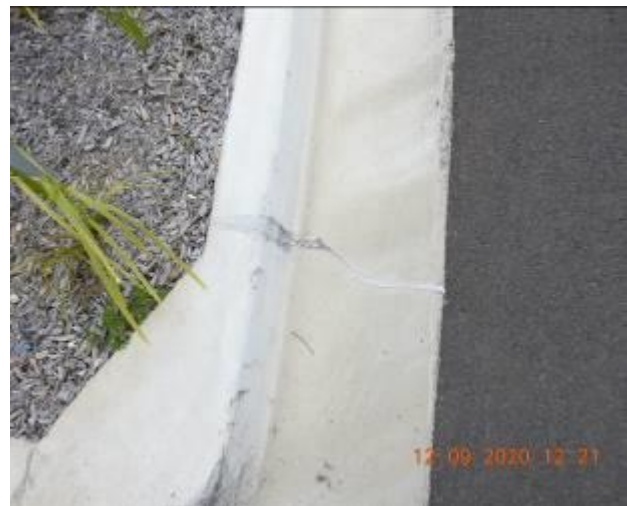
Figure 992 – General condition of kerb and gutter heading North

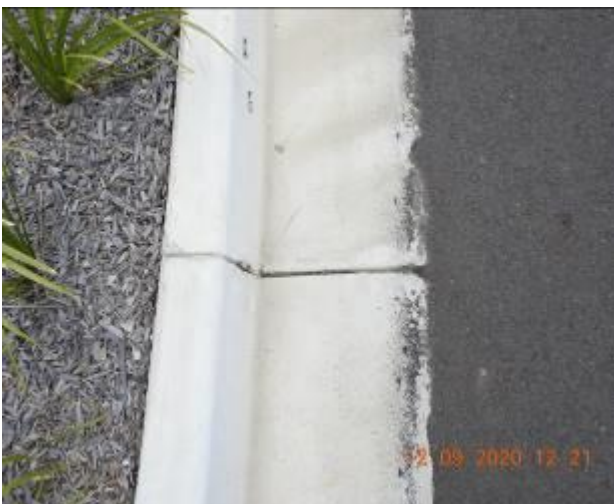
Figure 993 – Evidence of patchwork and crack propagation through kerb and gutter

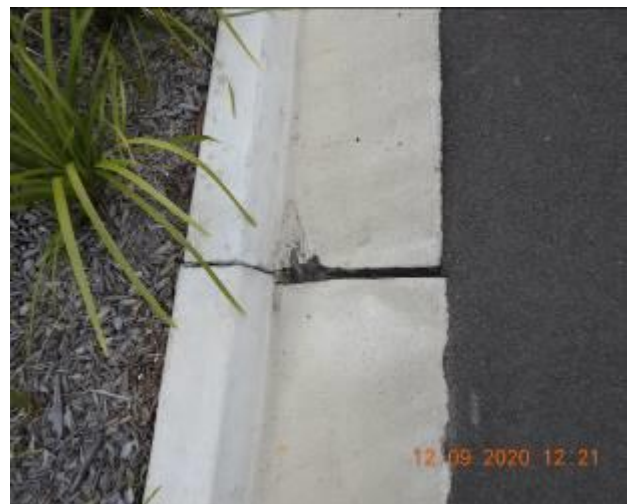
Figure 994 – Crack propagation and loss of material through kerb and gutter

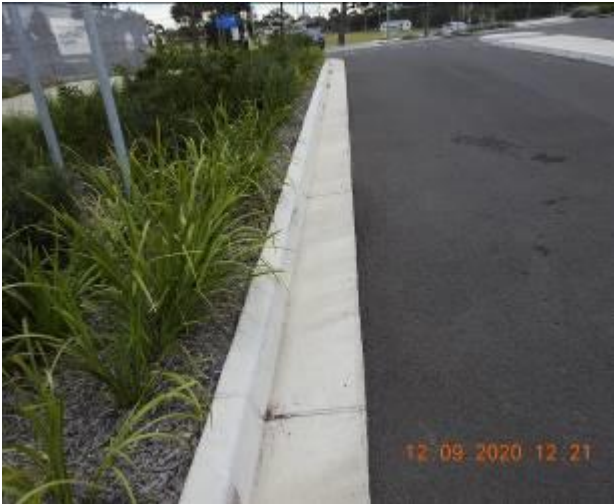
Figure 995 – Loss of material through kerb

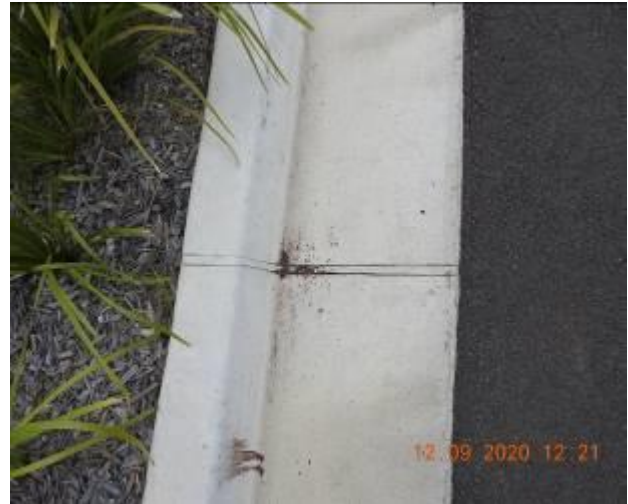
Figure 996 – General condition of kerb and gutter

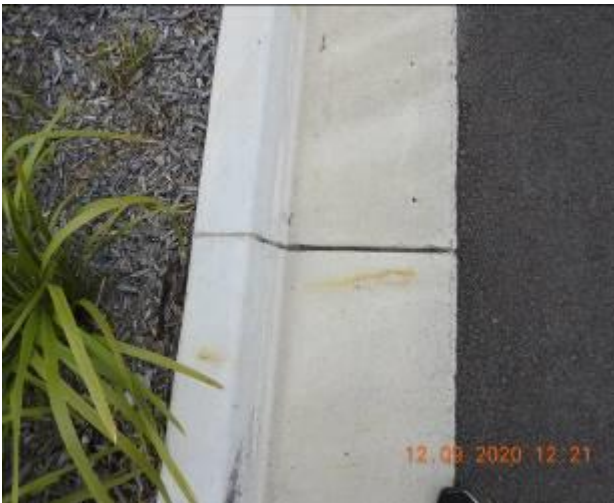
Figure 997 – Crack propagation and loss of material through kerb and gutter

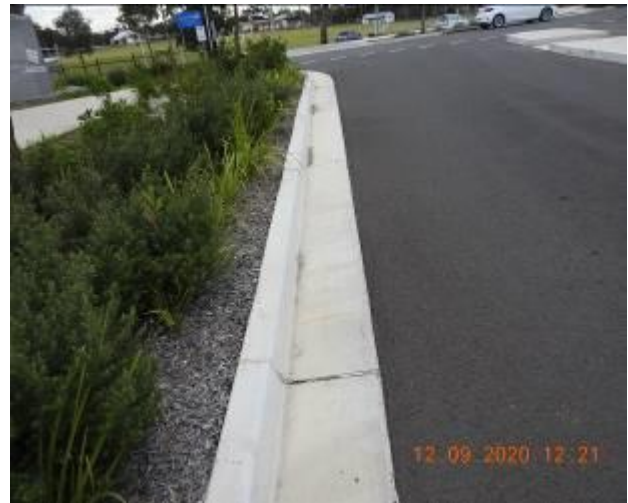
Figure 998 – Crack propagation and loss of material through kerb and gutter

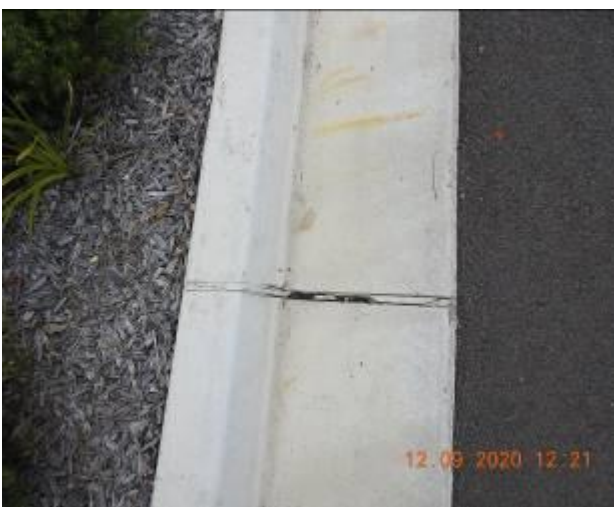
Figure 999 – General condition of kerb and gutter

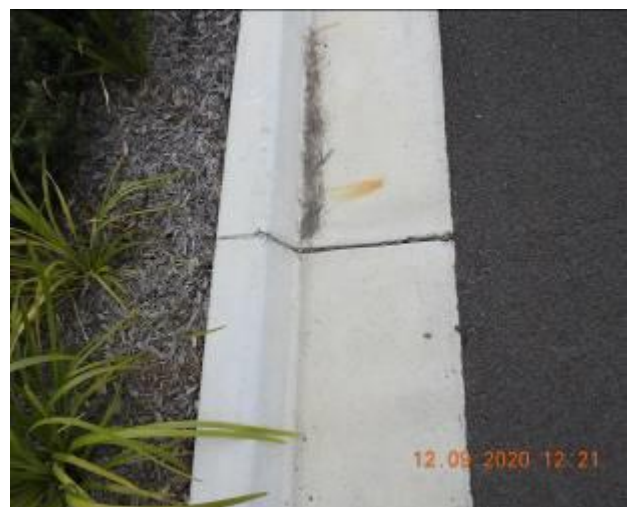
Figure 1000 – Crack propagation and loss of material through kerb and gutter

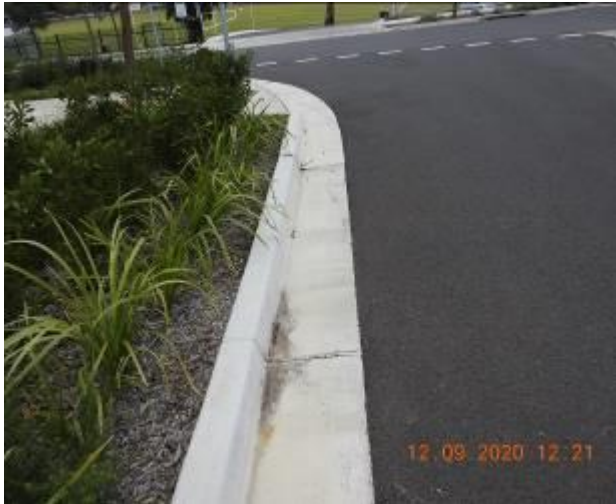
Figure 1001 – Crack propagation and loss of material through kerb and gutter

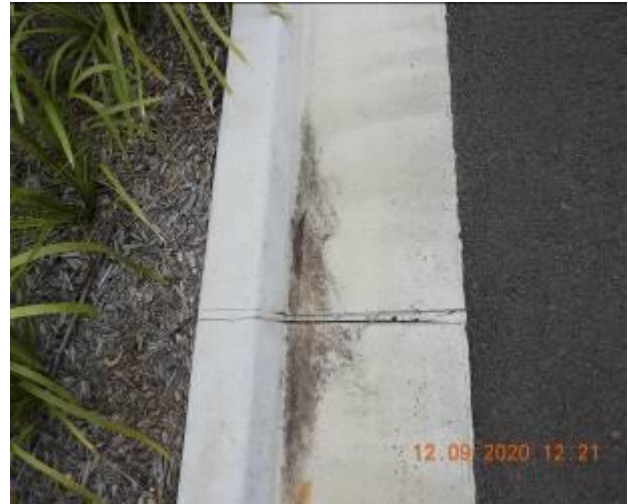
Figure 1002 – General condition of kerb and gutter

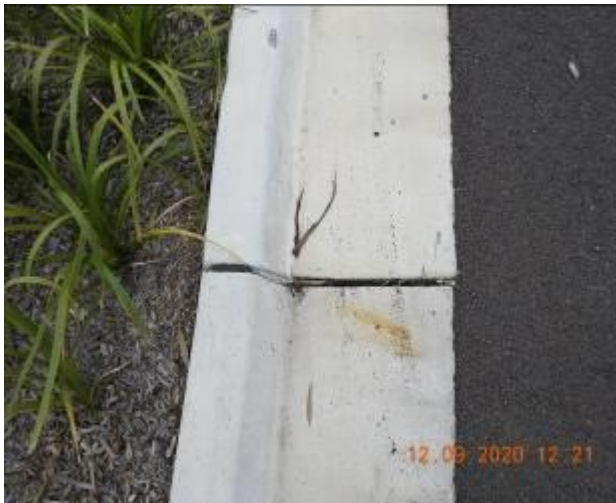
Figure 1003 – Crack propagation and loss of material through kerb and gutter

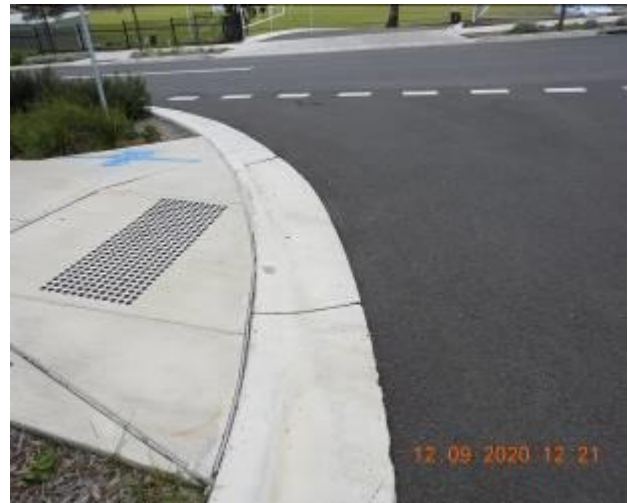
Figure 1004 – Loss of material through kerb and gutter

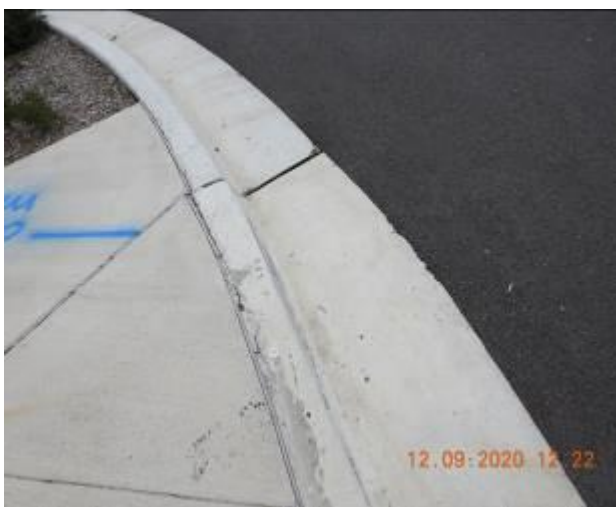
Figure 1005 – General condition of layback and gutter

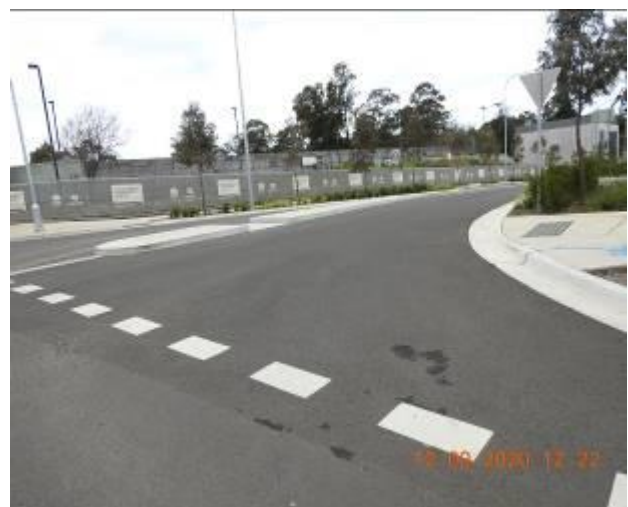
Figure 1006 – Crack propagation and loss of material through kerb and gutter

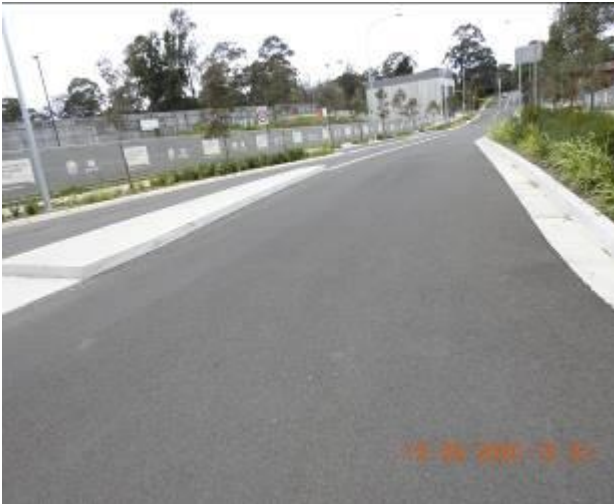
Figure 1007 –General condition of road surface heading South

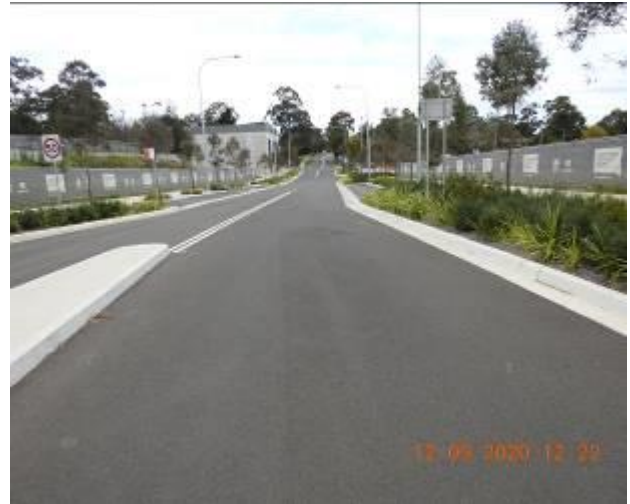
Figure 1008 – General condition of road surface

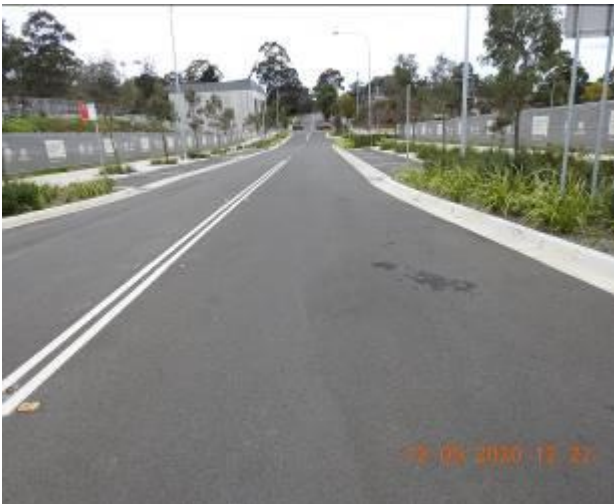
Figure 1010 – General condition of road surface

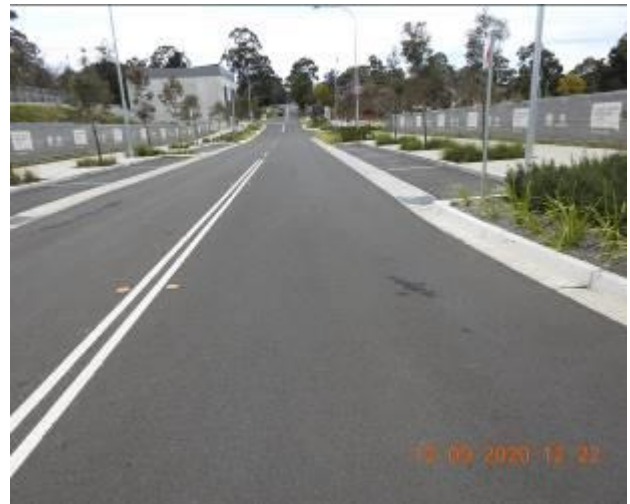
Figure 1011 – General condition of road surface

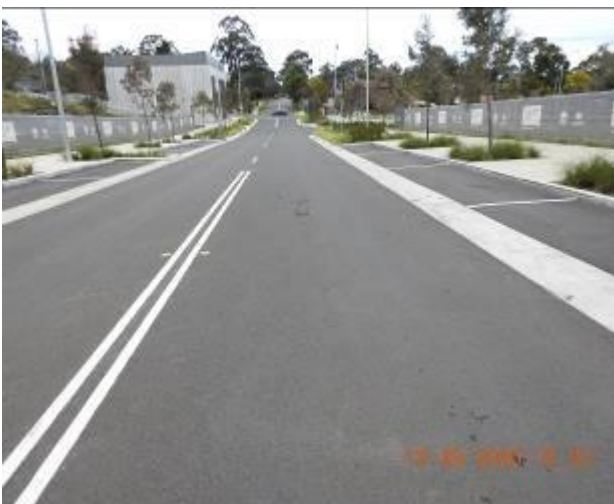
Figure 1012 – General condition of road surface

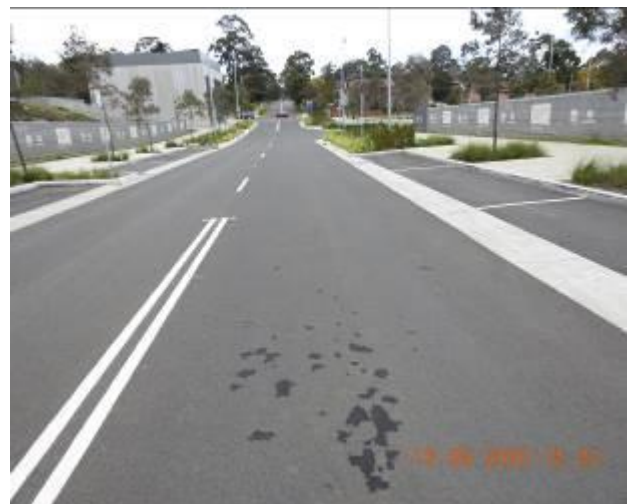
Figure 1013 – General condition of road surface

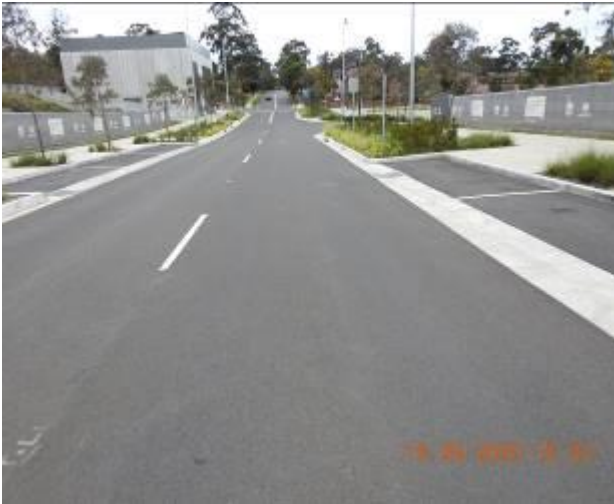
Figure 1014 – General condition of road surface

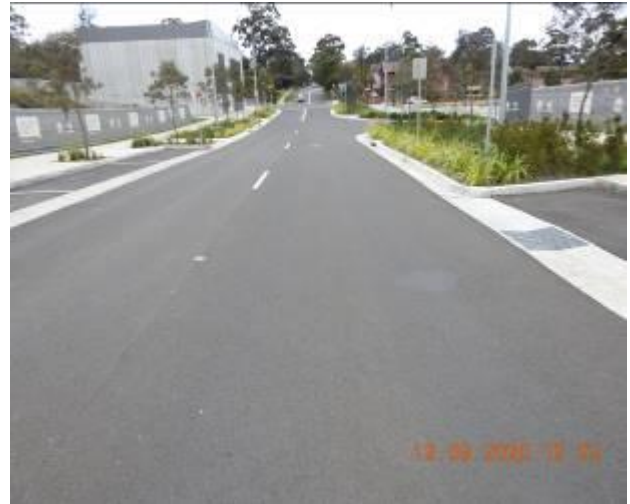
Figure 1015 – General condition of road surface

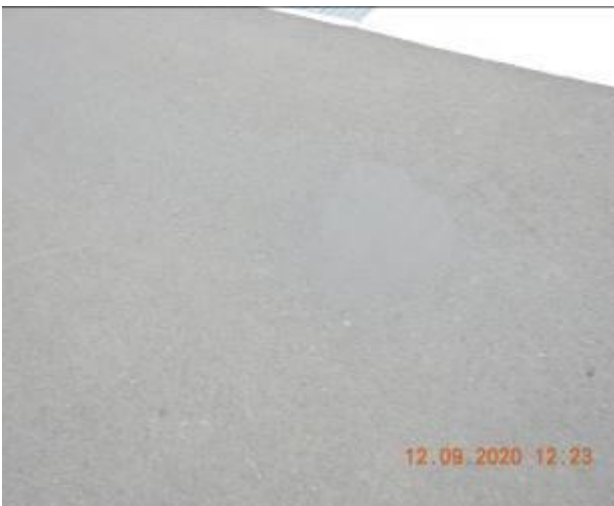
Figure 1016 – Evidence of patchwork through road surface

The road surface of Andalusian Way at the time of the inspection was in a good condition with evidence of patchwork.

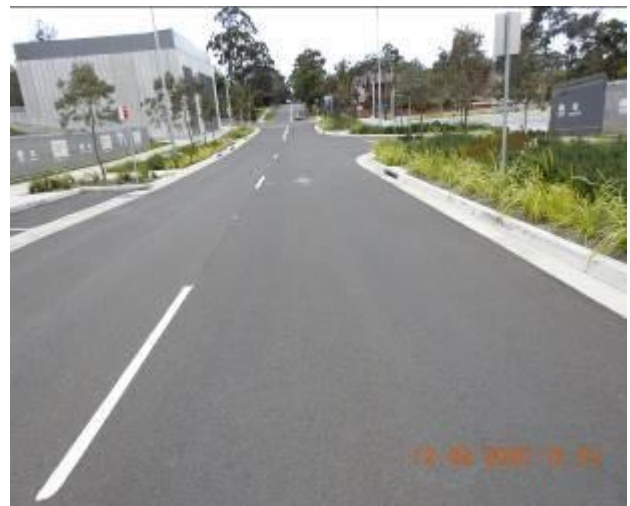
Figure 1017 – General condition of road surface

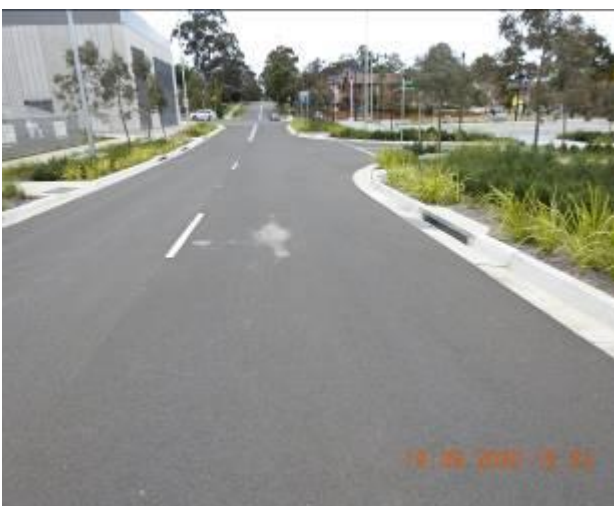
Figure 1018 – General condition of road surface

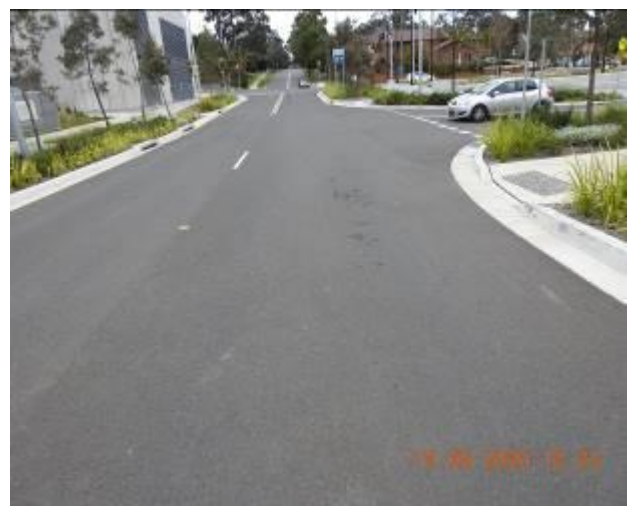
Figure 1019 – General condition of road surface

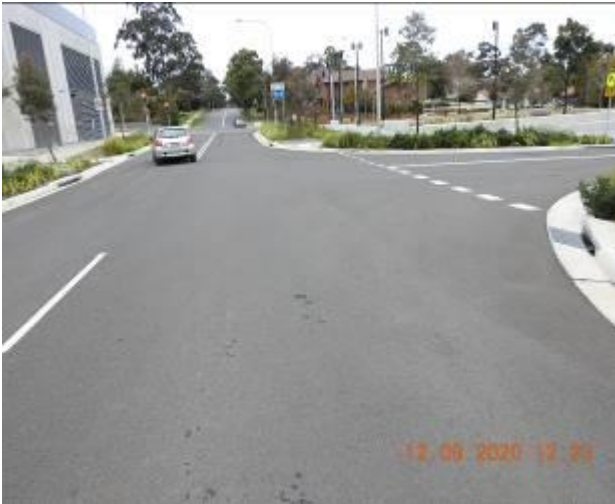
Figure 1020 – General condition of road surface

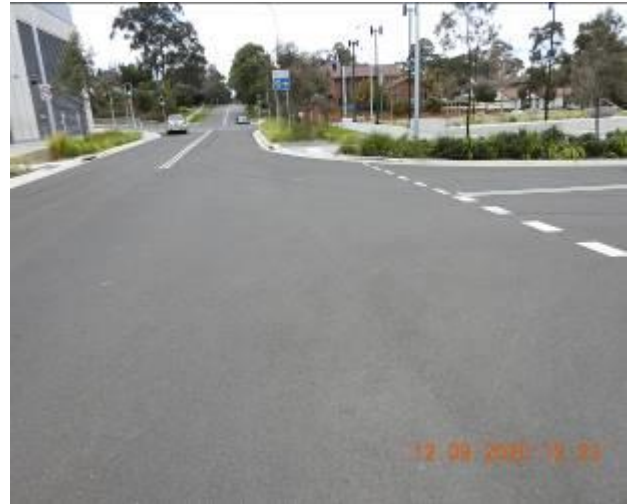
Figure 1021 – General condition of road surface

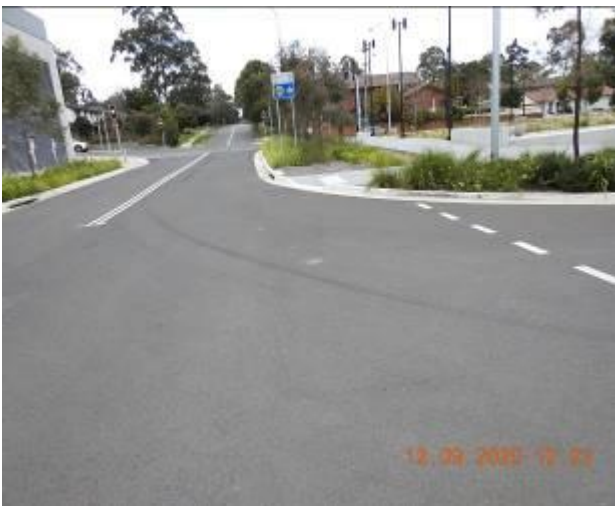
Figure 1022 – General condition of road surface

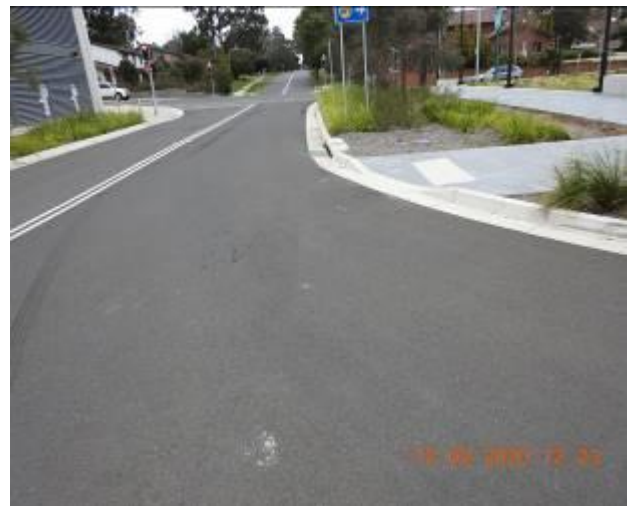
Figure 1023 – General condition of road surface

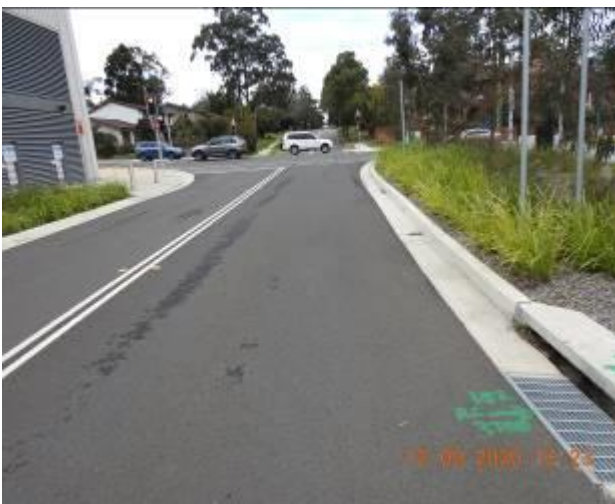
Figure 1024 – General condition of road surface

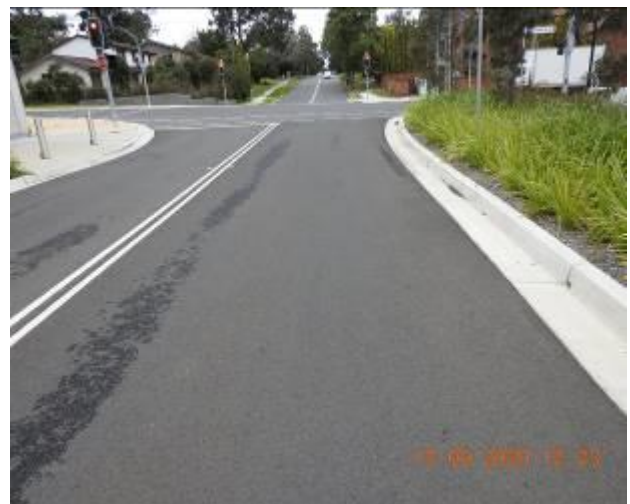
Figure 1025 – General condition of road surface

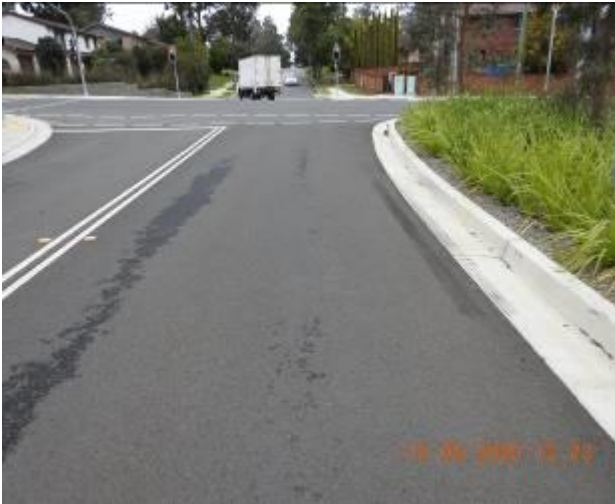
Figure 1026 – General condition of road surface

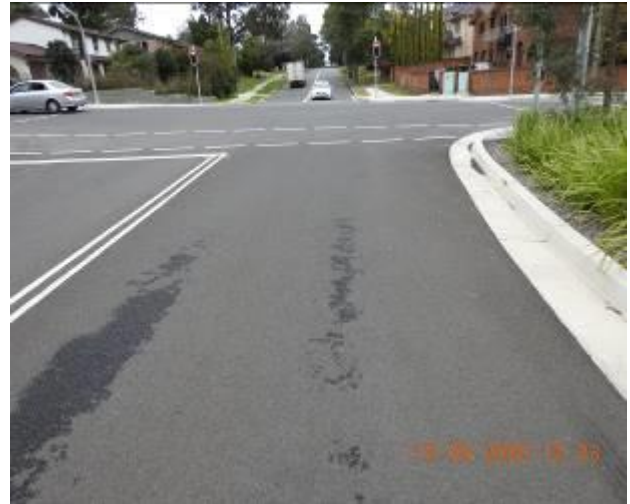
Figure 1027 – General condition of road surface

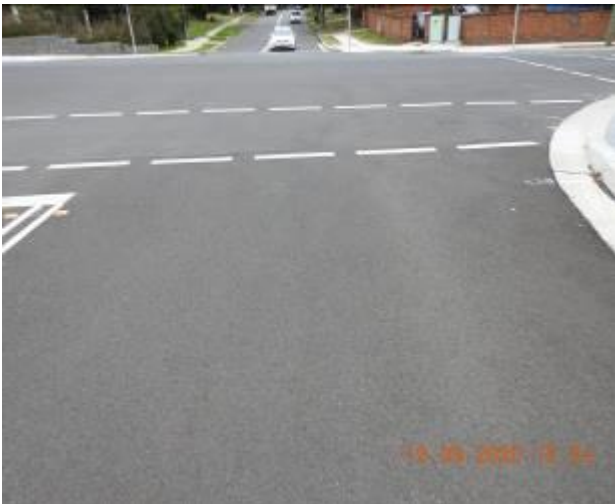
Figure 1028 – General condition of road surface

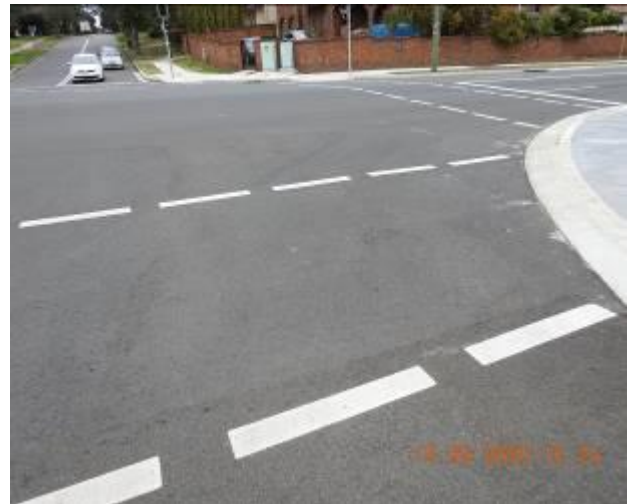
Figure 1029 – General condition of road surface

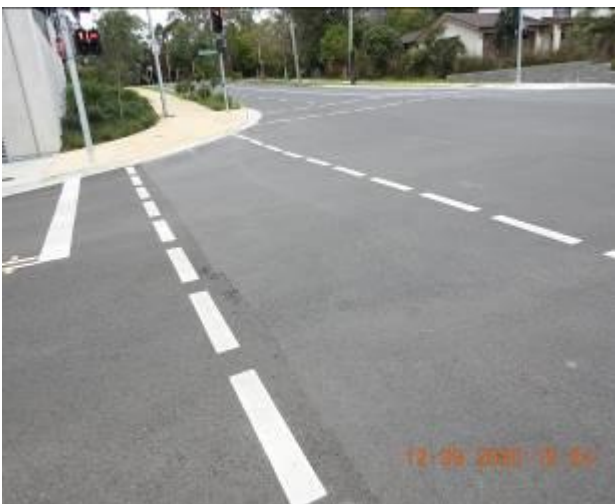
Figure 1030 – General condition of road surface

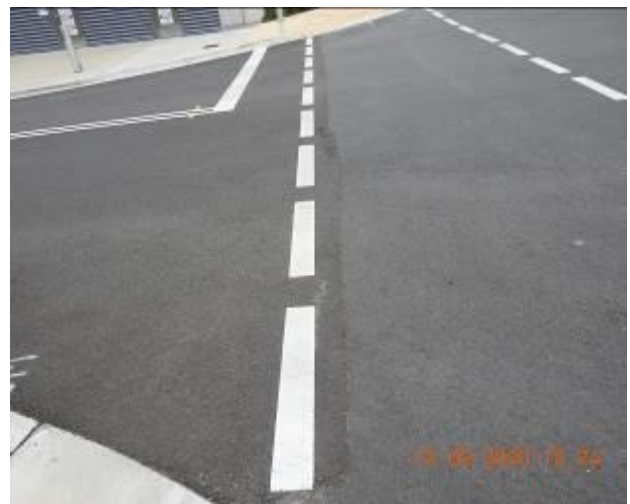
Figure 1031 – General condition of road surface

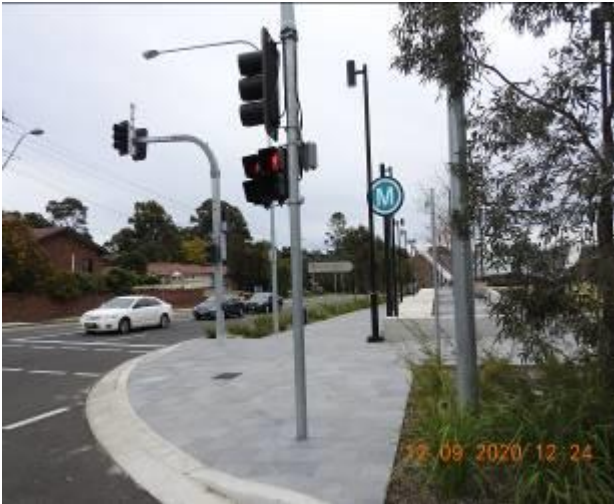
Figure 1032 – General condition of traffic light

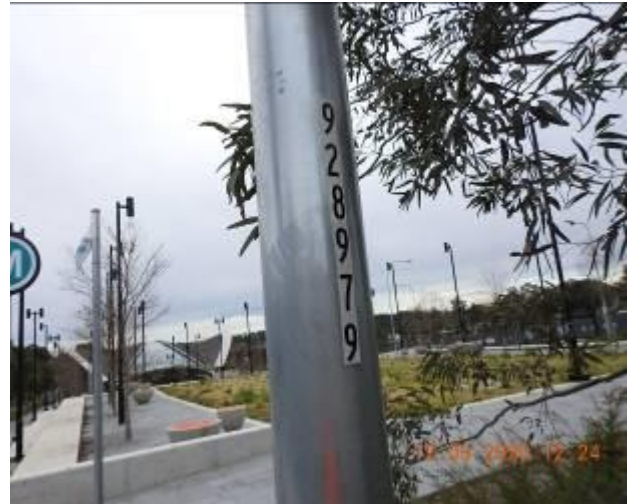
Figure 1033 – General condition of lamp post
Identification No. 928979

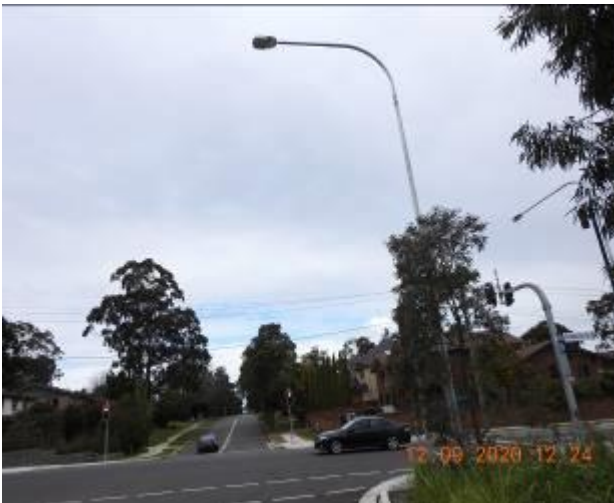
Figure 1034 – General condition of lamp post
Identification No. 928979 and plantation

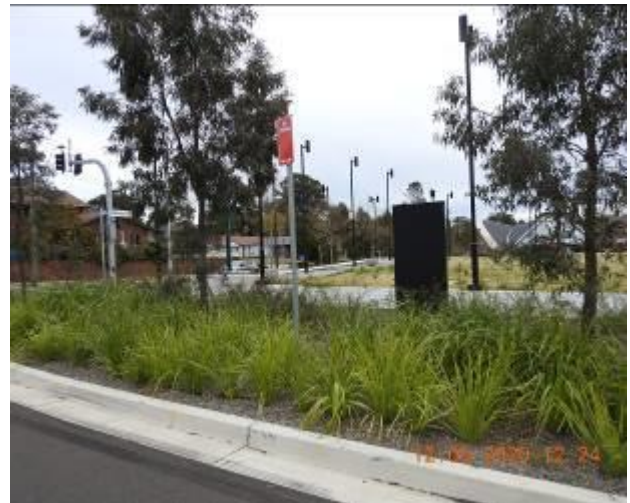
Figure 1035 – General condition of street signs and
plantation

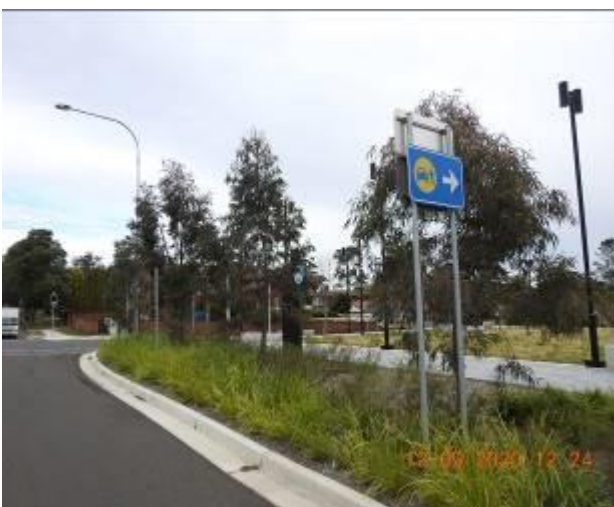
Figure 1036 – General condition of street signs and
plantation

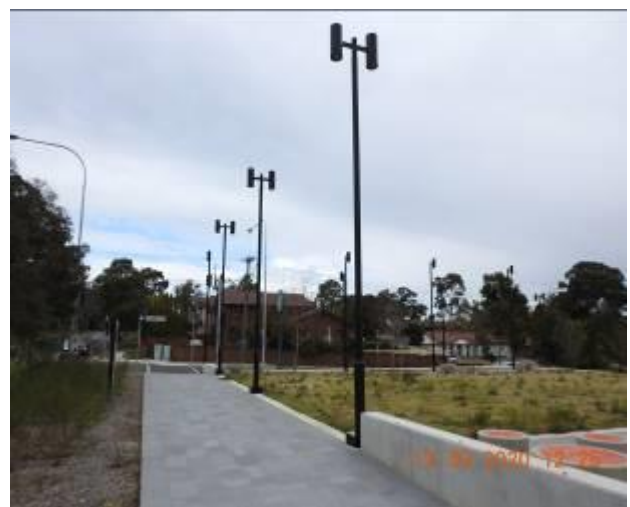
Figure 1037 – General condition of showground lamp
posts

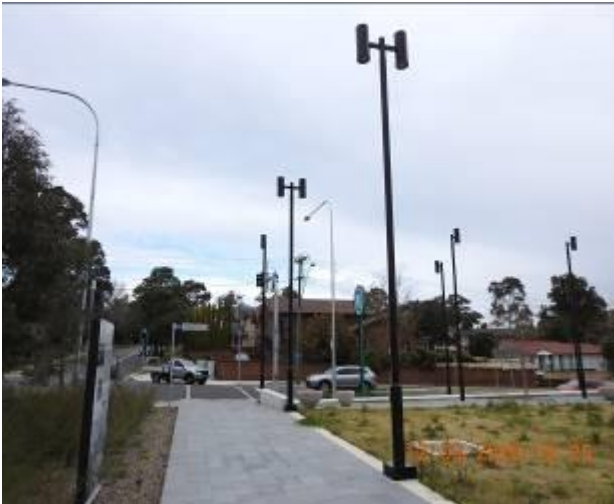
Figure 1038 – General condition of showground lamp posts

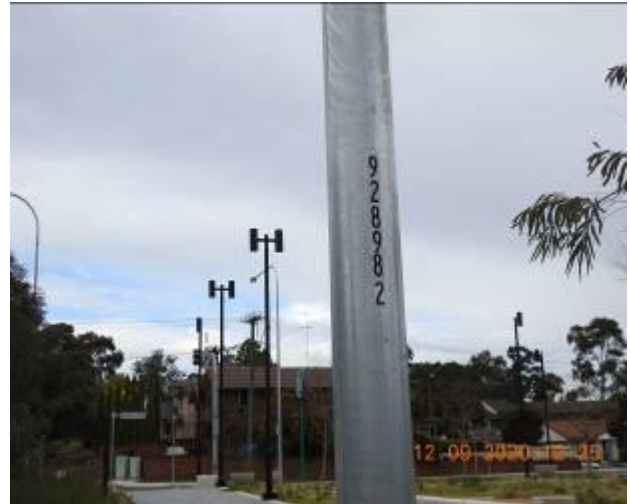
Figure 1039 – General condition of lamp post Identification No. 928982

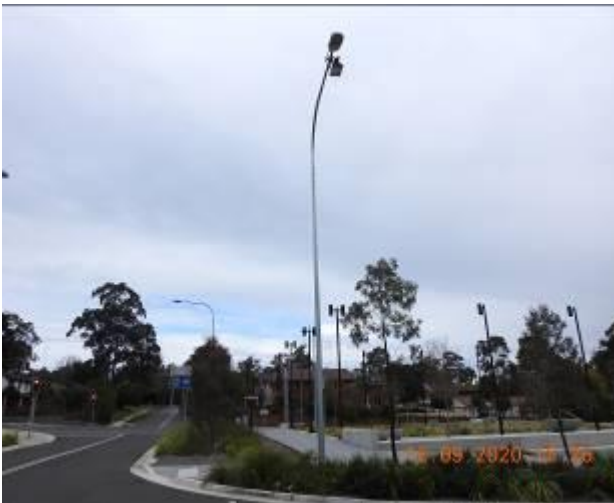
Figure 1040 – General condition of lamp post Identification No. 928982 and plantation

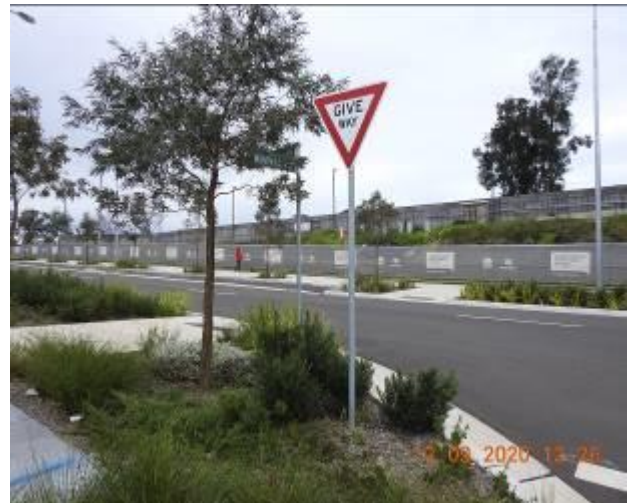
Figure 1041 – General condition of street sign and plantation

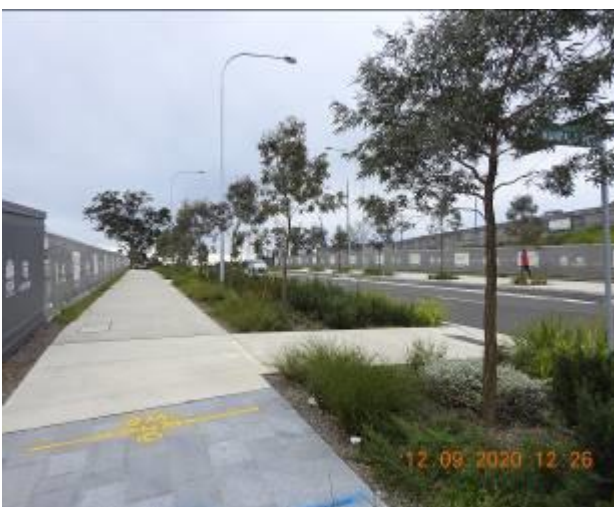
Figure 1042 – General condition of plantations

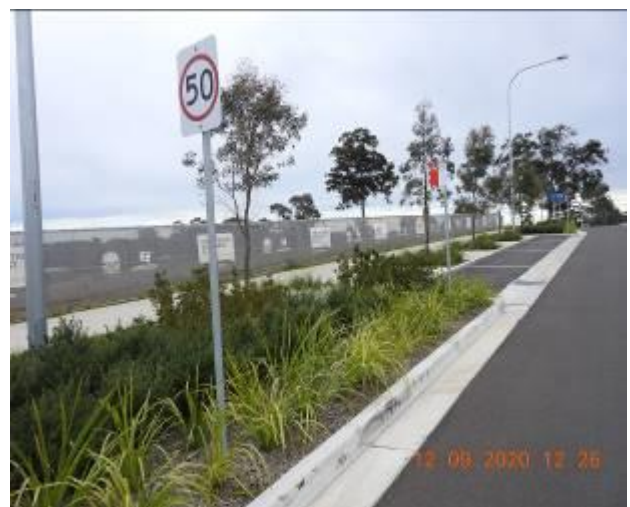
Figure 1043 – General condition of street signs and plantations

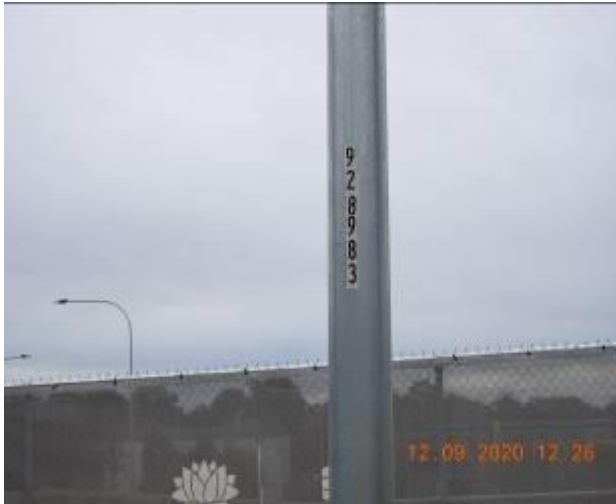
Figure 1044 – General condition of lamp post identification No 928983

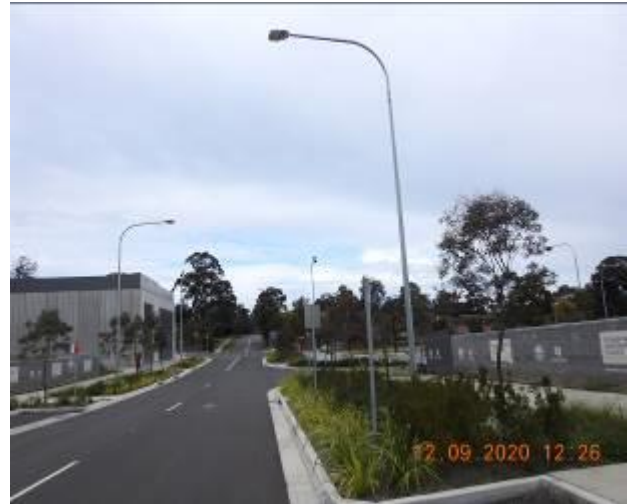
Figure 1045 – General condition of lamp post identification No 928983

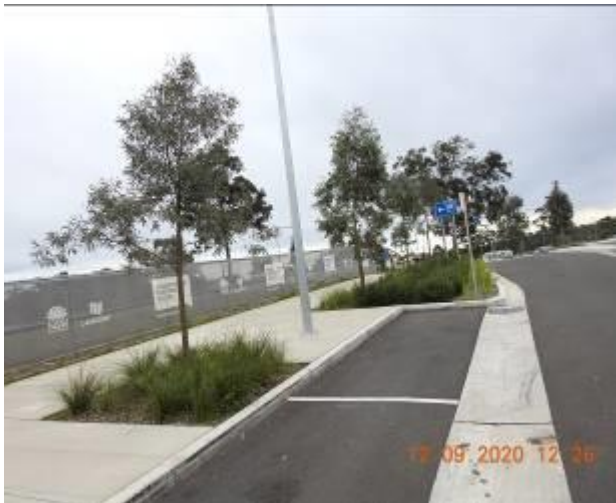
Figure 1046 – General condition of plantations

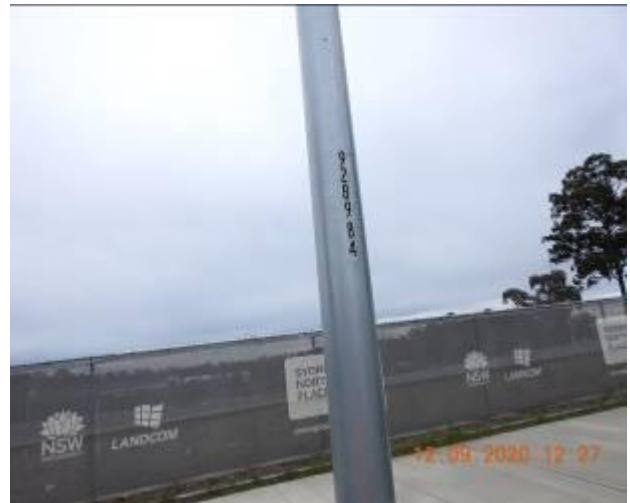
Figure 1047 – General condition of lamp post Identification No. 928984

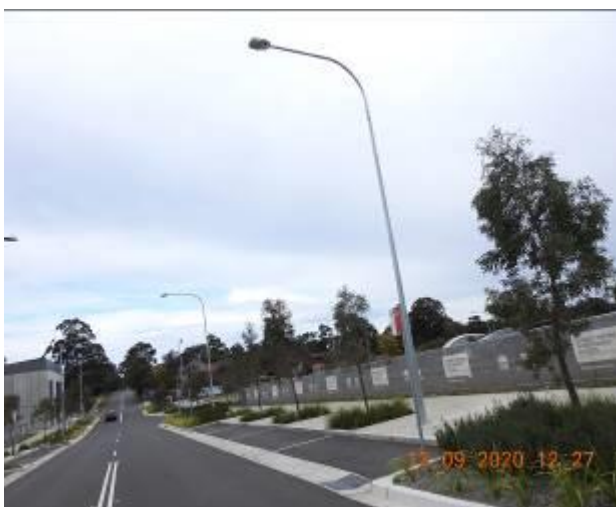
Figure 1048 – General condition of lamp post Identification No. 928984 and plantations

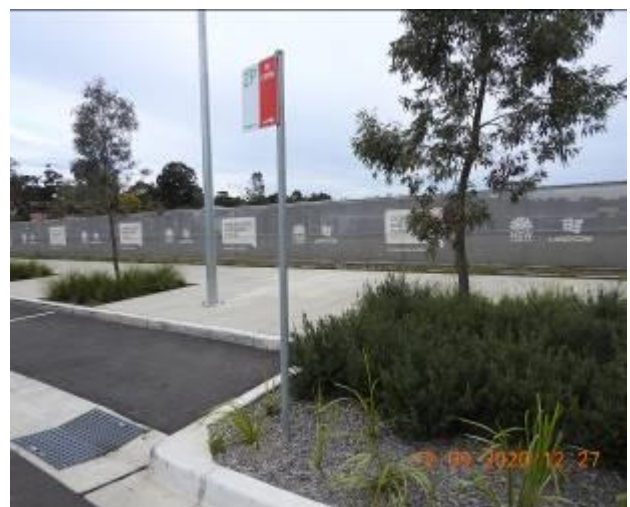
Figure 1049 – General condition of street sign

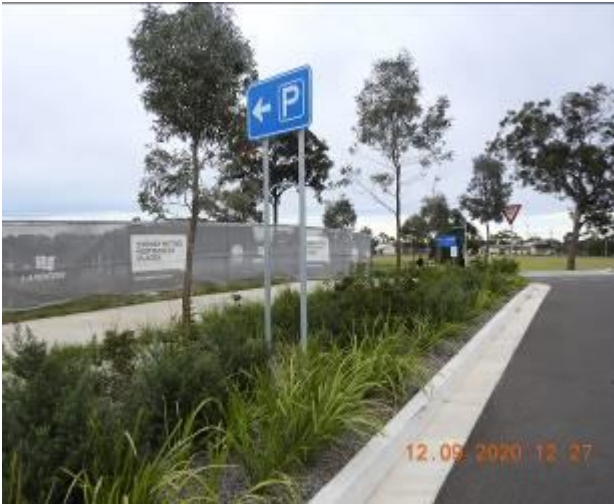
Figure 1050 – General condition of street sign and plantations

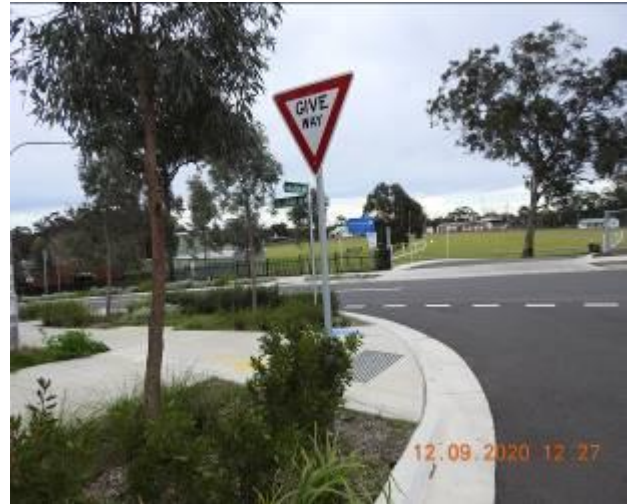
Figure 1051 – General condition of street sign

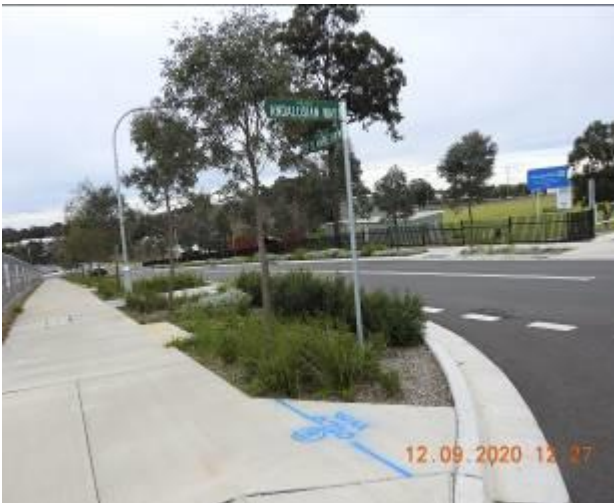
Figure 1052 – General condition of street sign and plantation

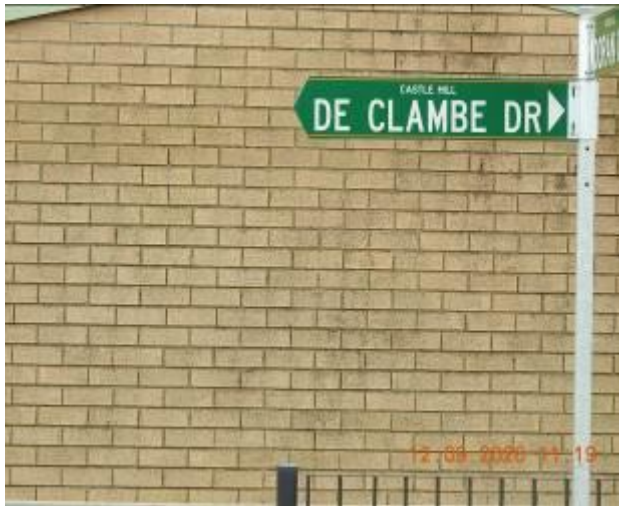
Figure 1053 – The following images display the condition of De Clambe Drive

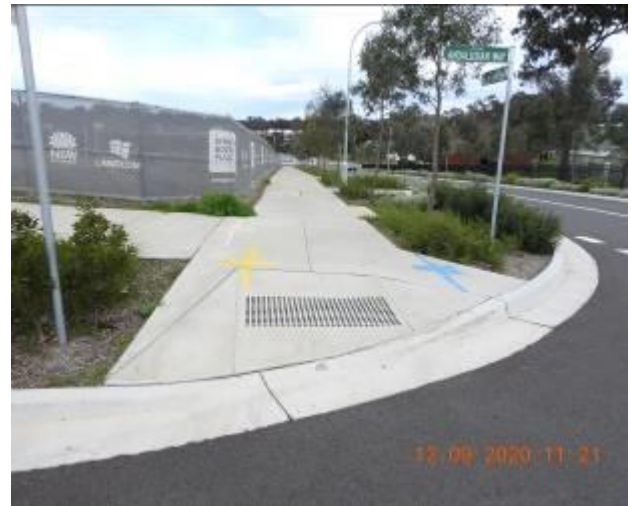
Figure 1054 – General condition of footpath pavement heading West

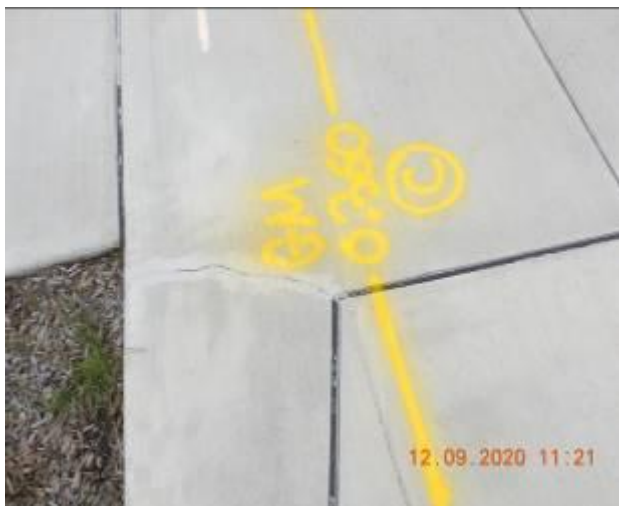
Figure 1055 – Crack propagation and loss of material through footpath pavement

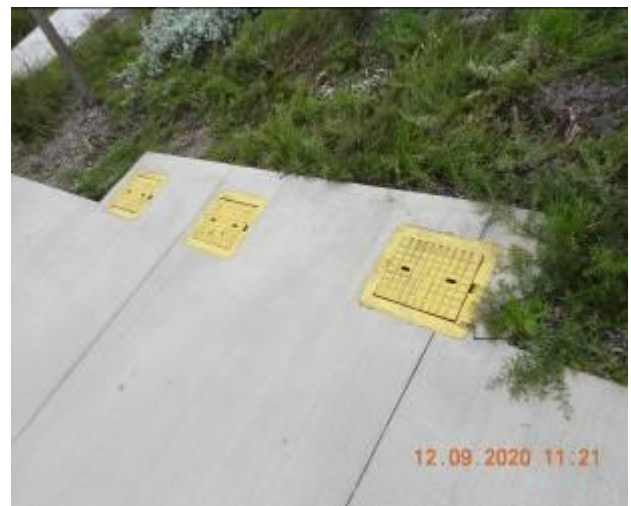
Figure 1056 – General condition of service pits
