**2 MANDALA PARADE, CASTLE HILL
(DORAN DRIVE PRECINCT)
PRE-DILAPIDATION REPORT
Of Sydney Metro and Hills Shire Council Assets
DEICORP PROJECTS SHOWGROUND
PTY LTD.**

Job No. 200124.3
07/07/2021

ACE Structural Services Pty Ltd

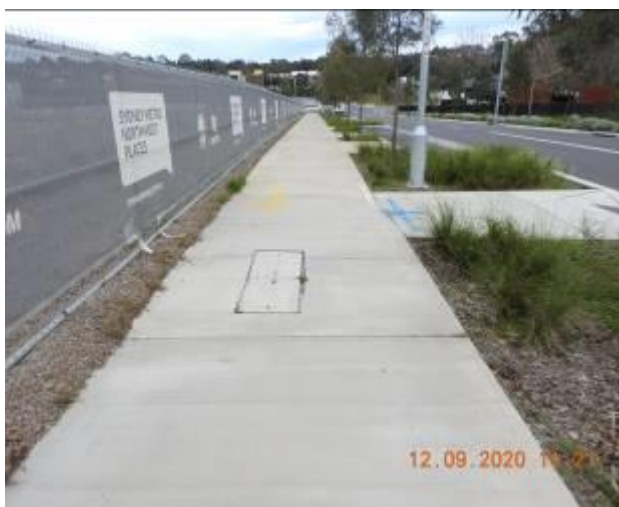
Figure 1057 – General condition of footpath pavement

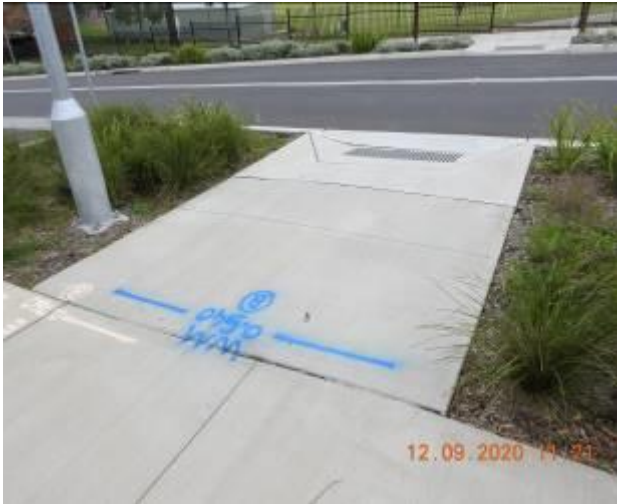
Figure 1059 – General condition of footpath pavement

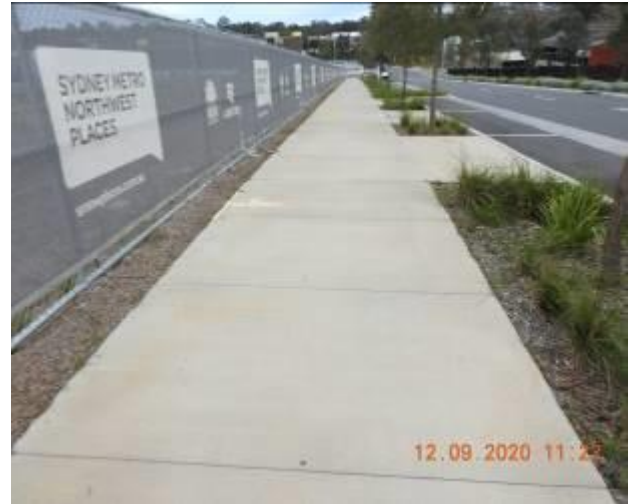
Figure 1060 – General condition of footpath pavement

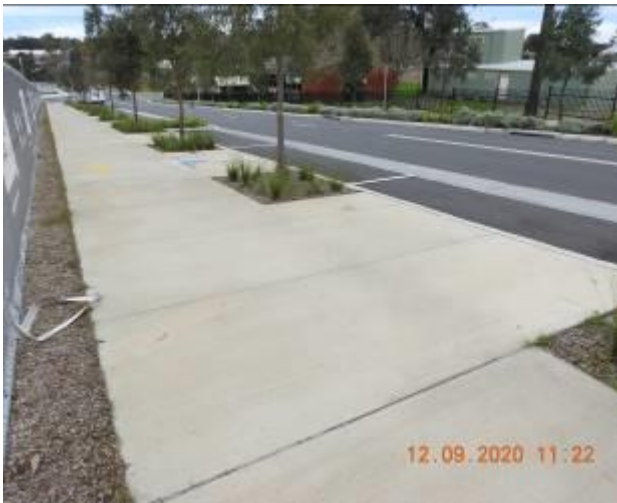
Figure 1061 – General condition of footpath pavement

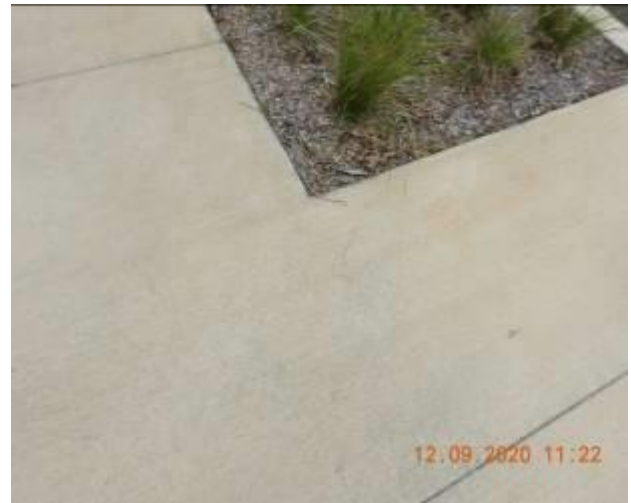
Figure 1062 – Hairline crack propagation through footpath pavement

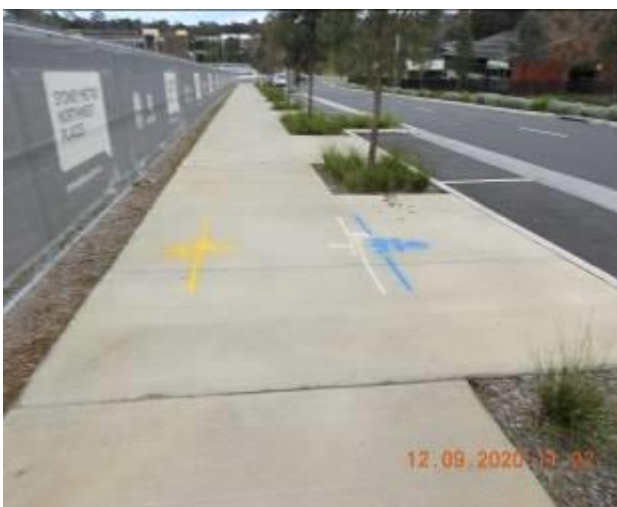
Figure 1063 – General condition of footpath pavement

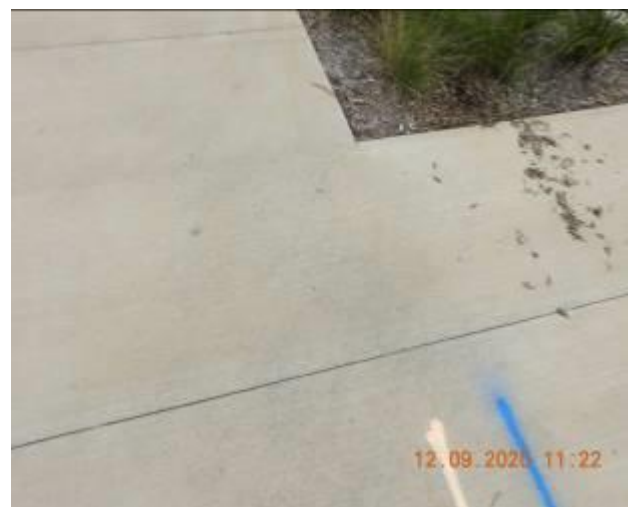
Figure 1064 – Hairline crack propagation through footpath pavement

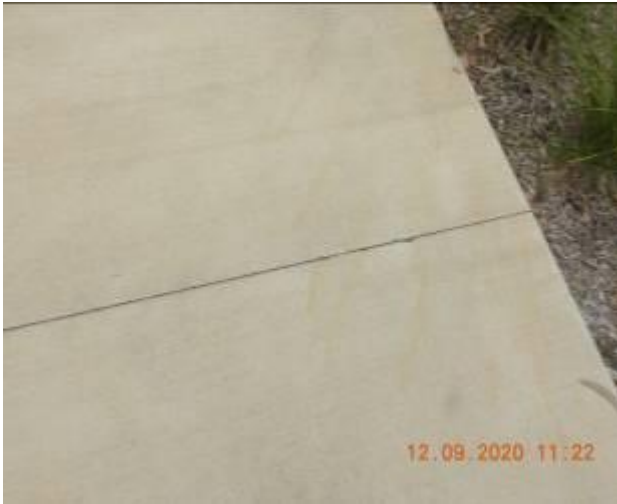
Figure 1065 – Loss of material through footpath pavement

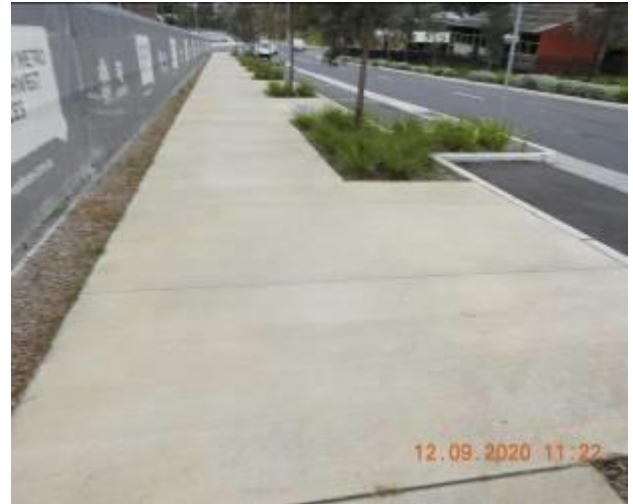
Figure 1066 – General condition of footpath pavement

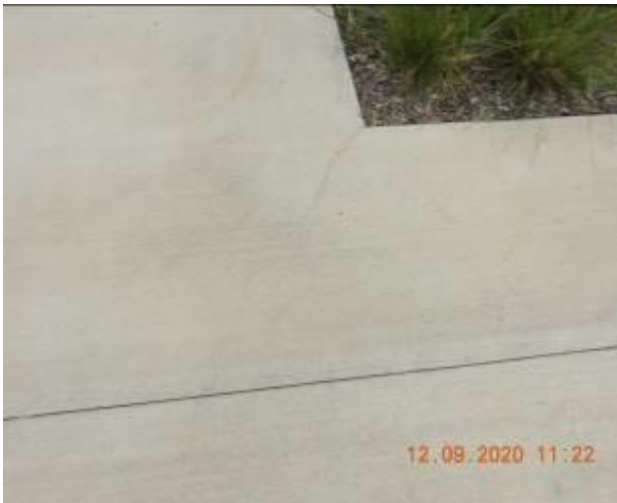
Figure 1067 – Hairline crack propagation through footpath pavement

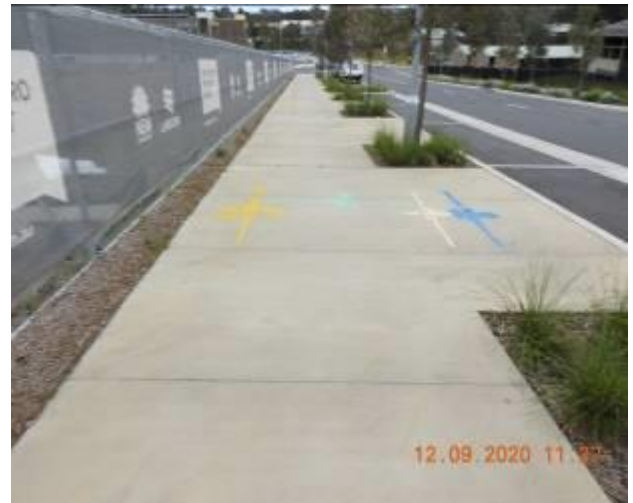
Figure 1068 – General condition of footpath pavement

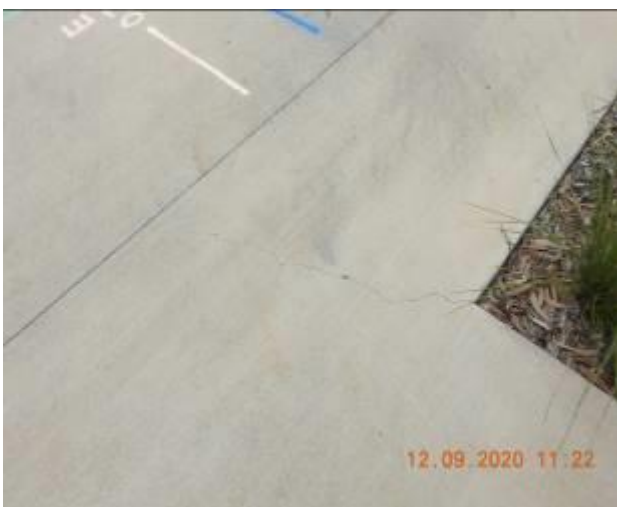
Figure 1069 – Crack propagation through footpath pavement

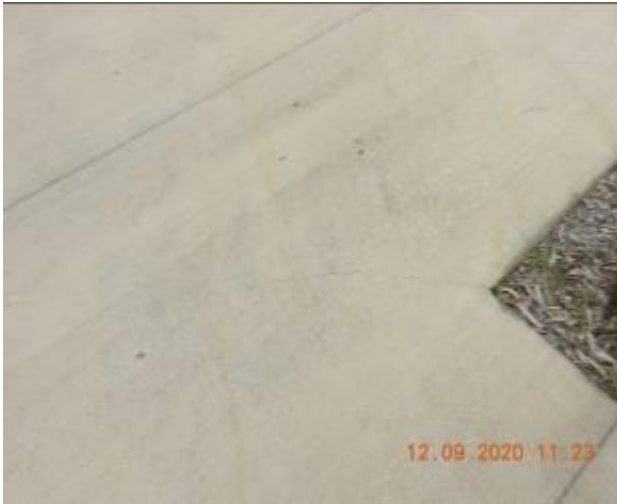
Figure 1071 – Crack propagation through footpath pavement

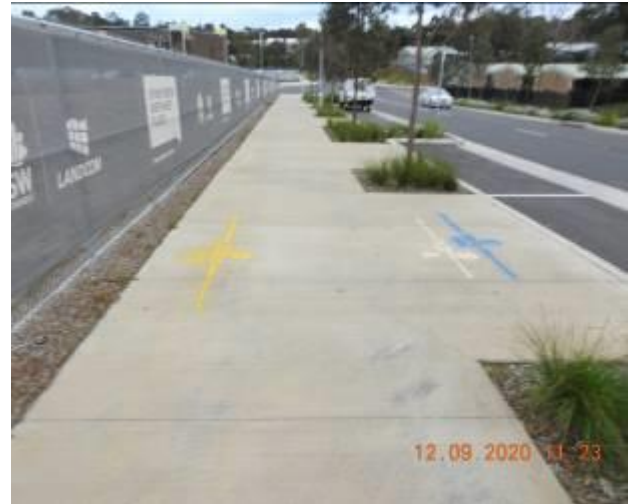
Figure 1072 – General condition of footpath pavement

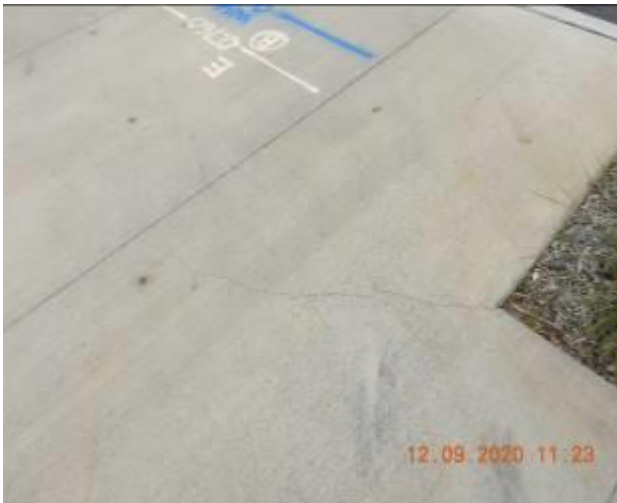
Figure 1073 – Crack propagation through footpath pavement

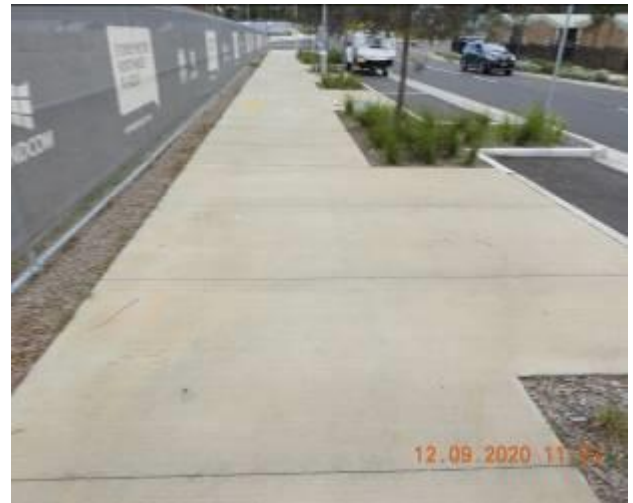
Figure 1074 – General condition of footpath pavement

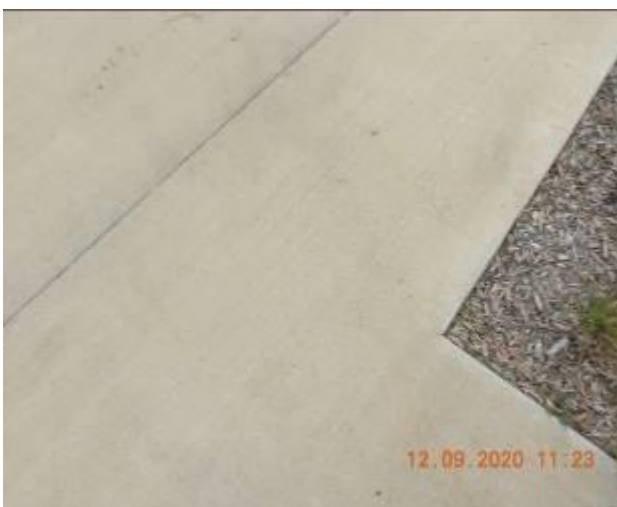
Figure 1075 – Hairline crack propagation through footpath pavement

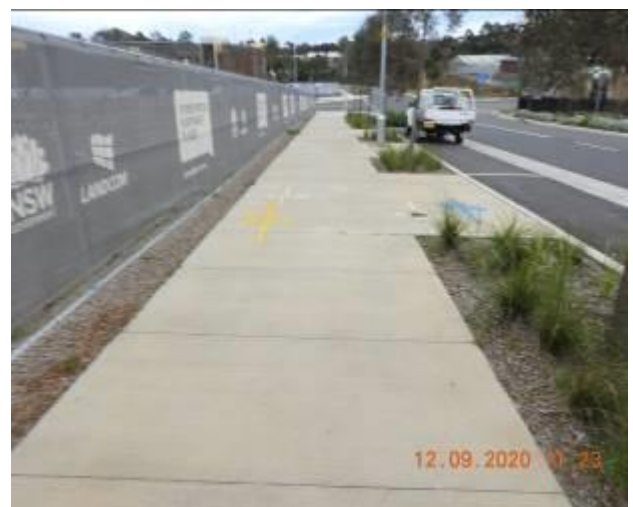
Figure 1076 – General condition of footpath pavement

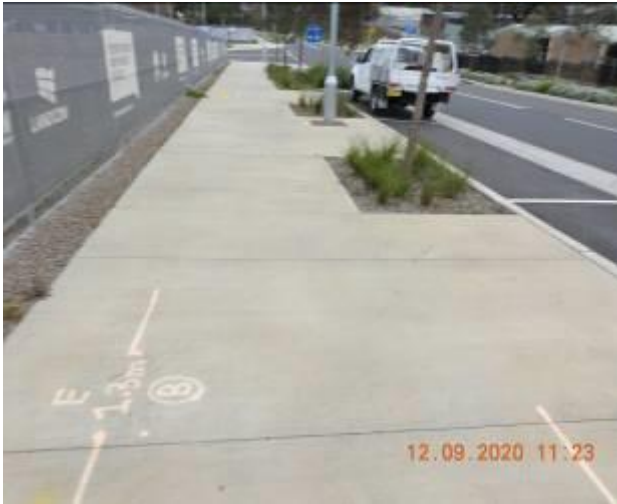
Figure 1077 – General condition of footpath pavement

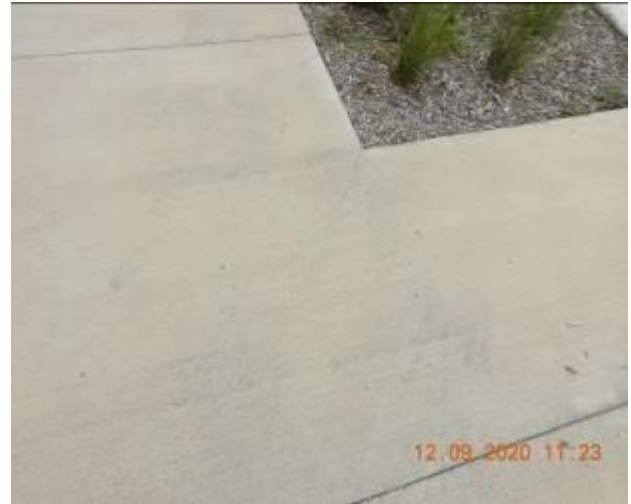
Figure 1078 – Crack propagation through footpath pavement

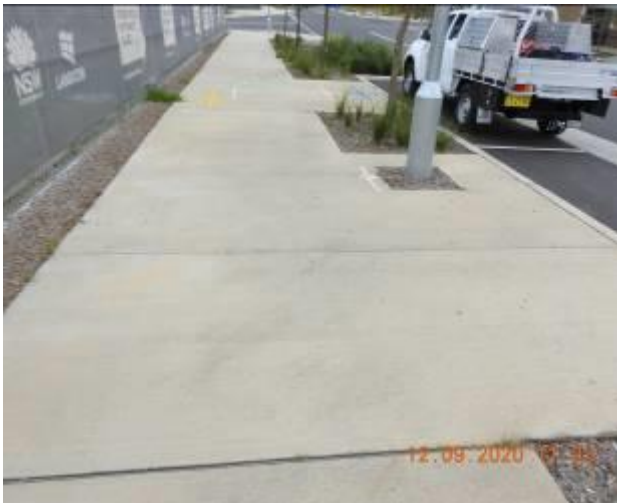
Figure 1079 – General condition of footpath pavement

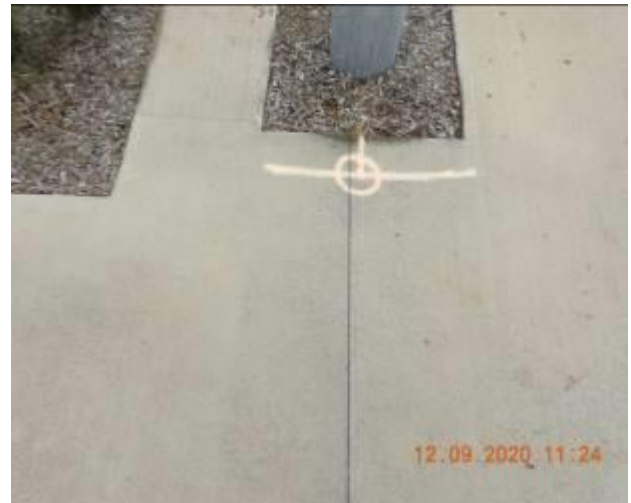
Figure 1080 – Crack propagation and loss of material through footpath pavement

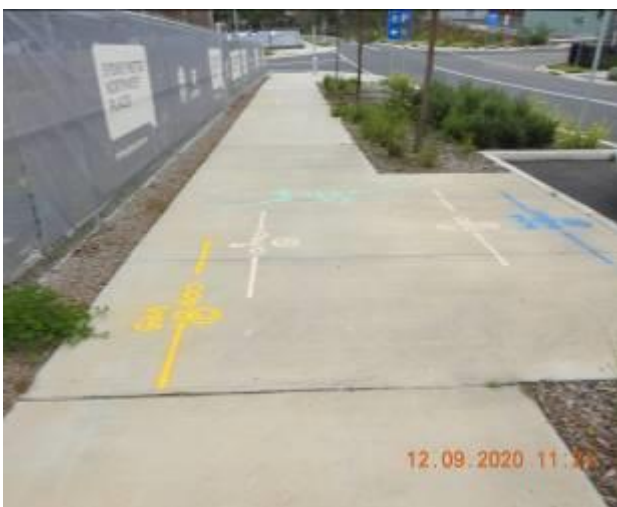
Figure 1081 – General condition of footpath pavement

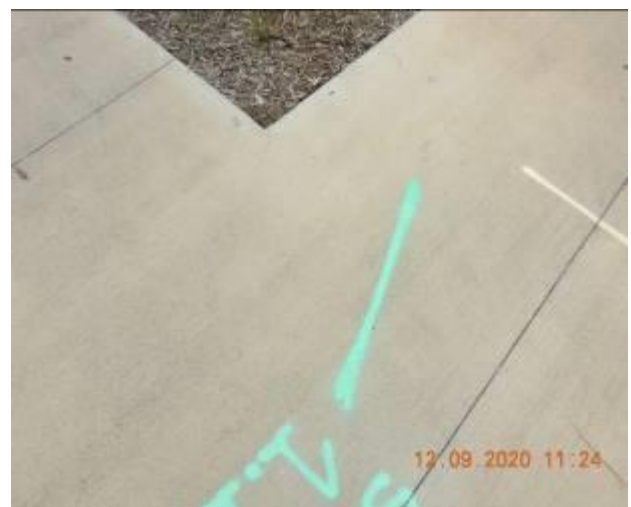
Figure 1082 – Crack propagation through footpath pavement

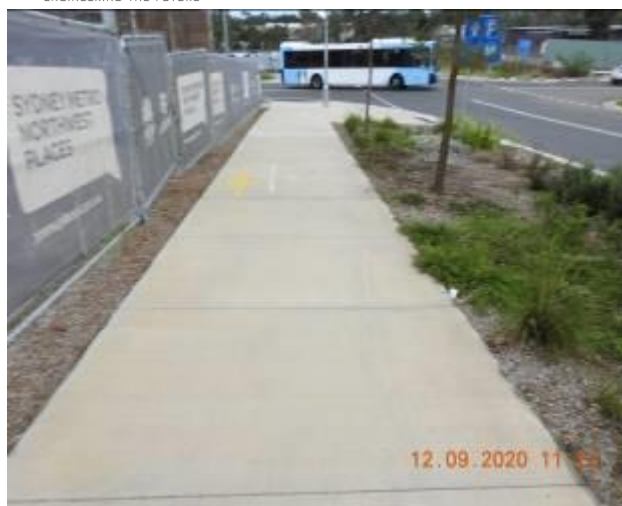
Figure 1083 – General condition of footpath pavement

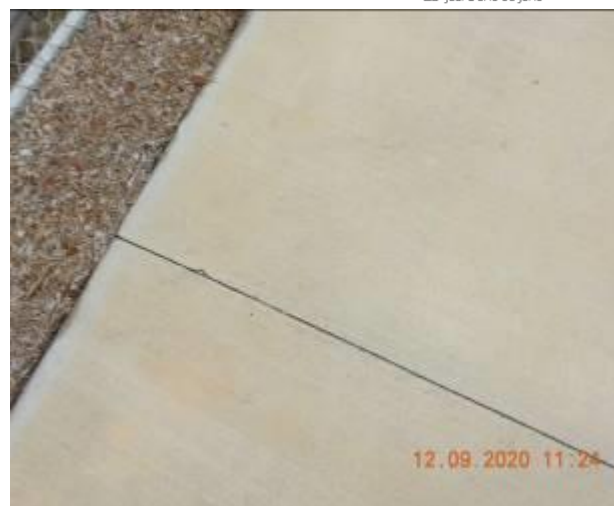
Figure 1084 – Loss of material through footpath pavement

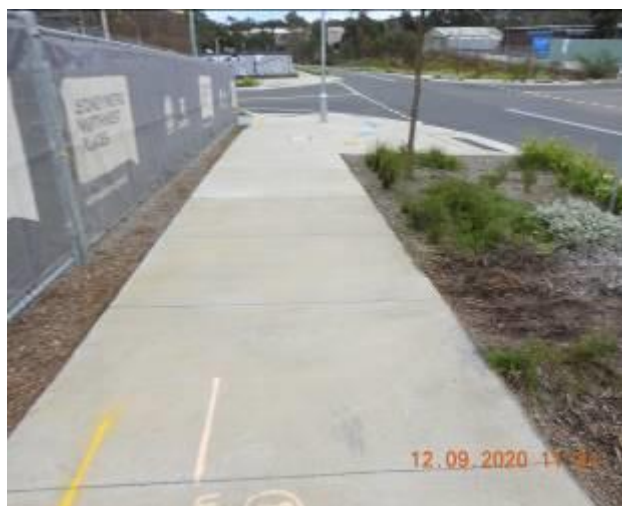
Figure 1085 – General condition of footpath pavement

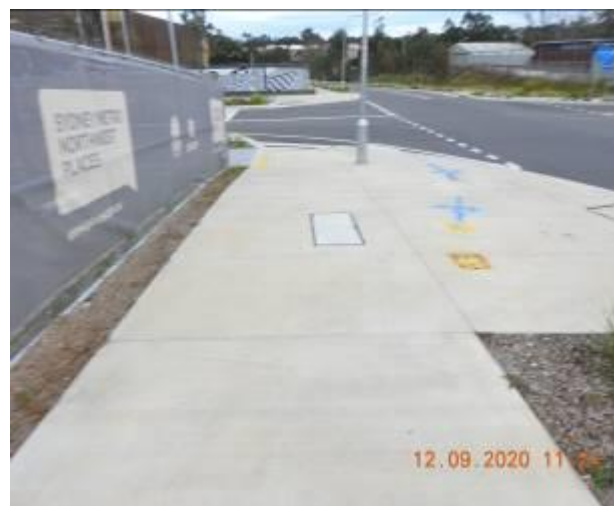
Figure 1086 – General condition of footpath pavement

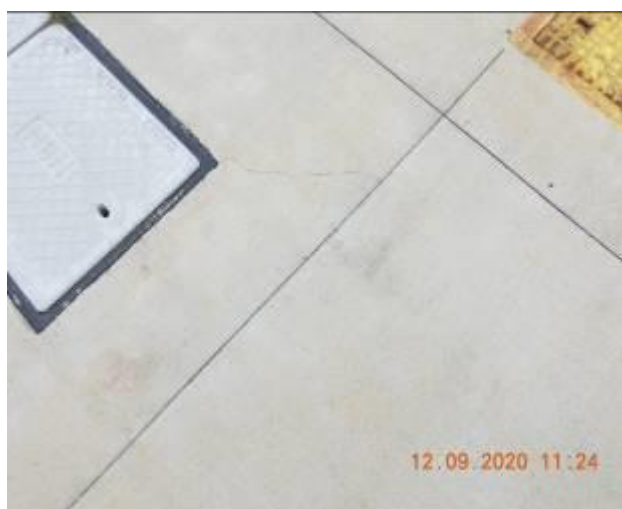
Figure 1087 – Crack propagation and loss of material through footpath pavement

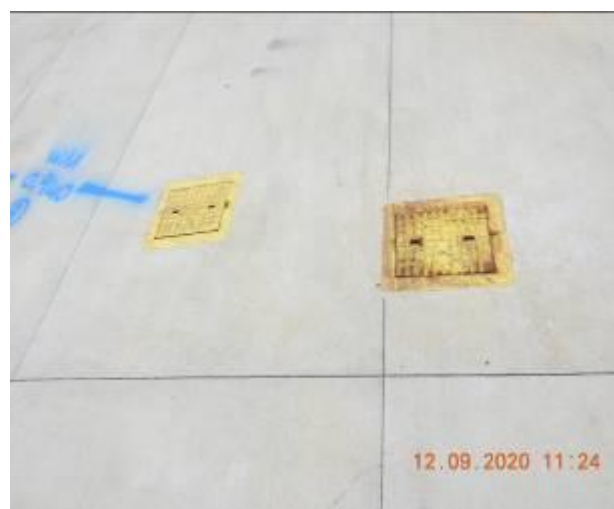
Figure 1088 – General condition of service pit

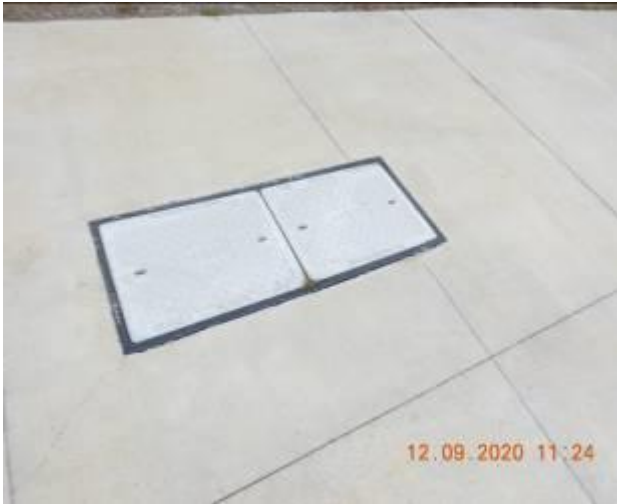
Figure 1089 – General condition of service pit

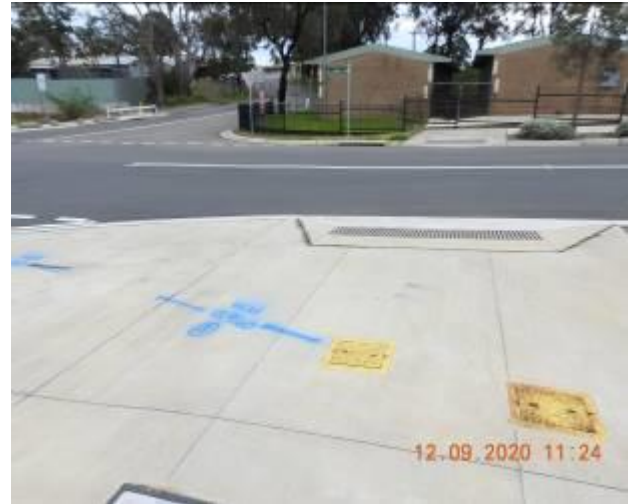
Figure 1090 – General condition of service pit

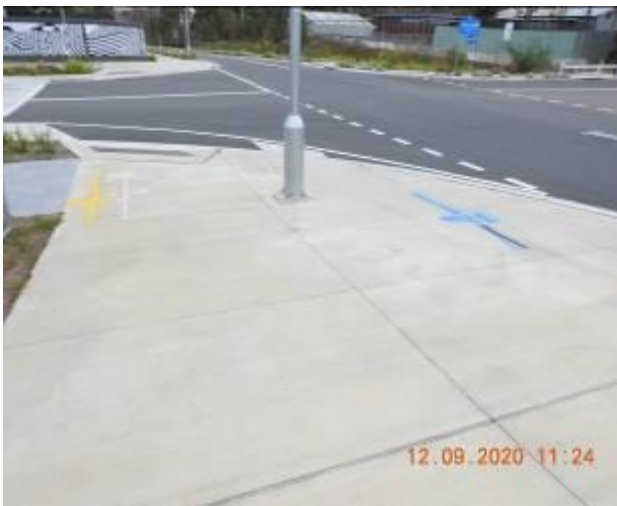
Figure 1091 – General condition of footpath pavement

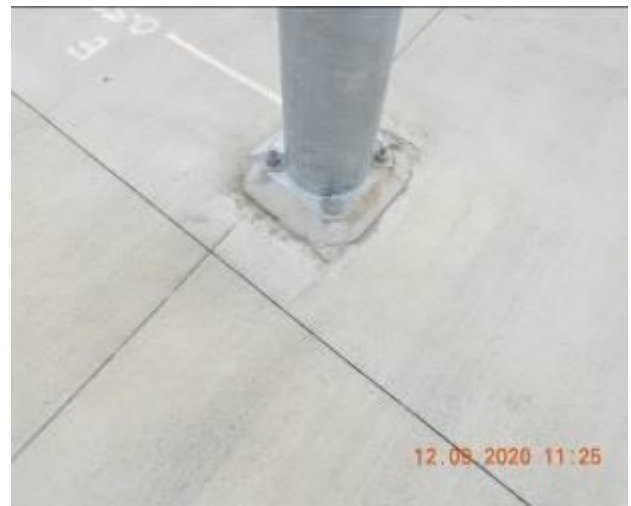
Figure 1092 – Crack propagation and loss of material through lamp post foundation

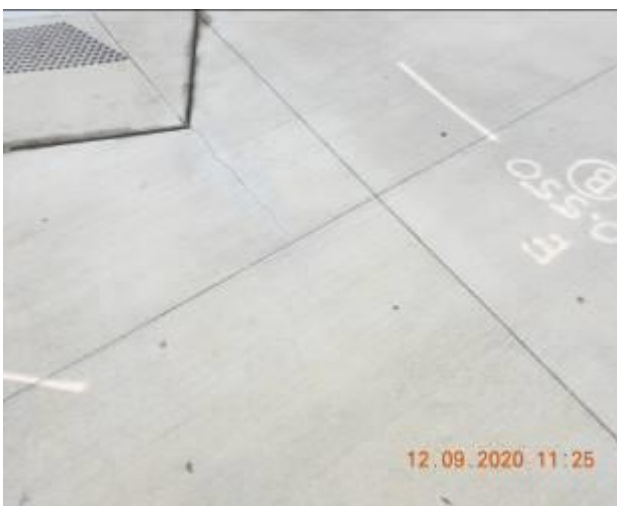
Figure 1093 – Crack propagation and loss of material through footpath pavement

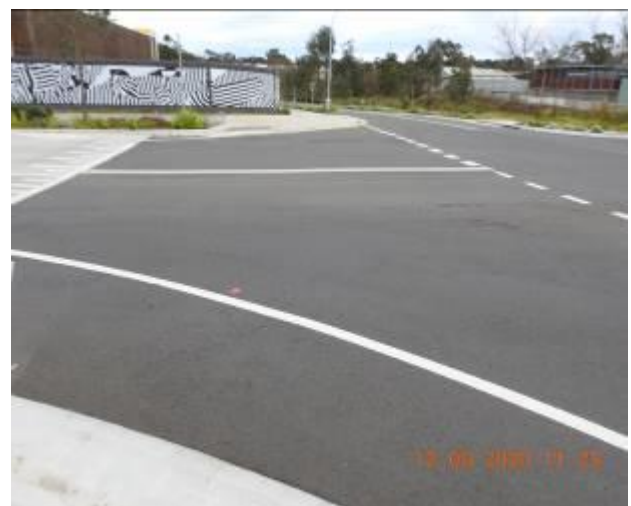
Figure 1094 – General condition of footpath pavement

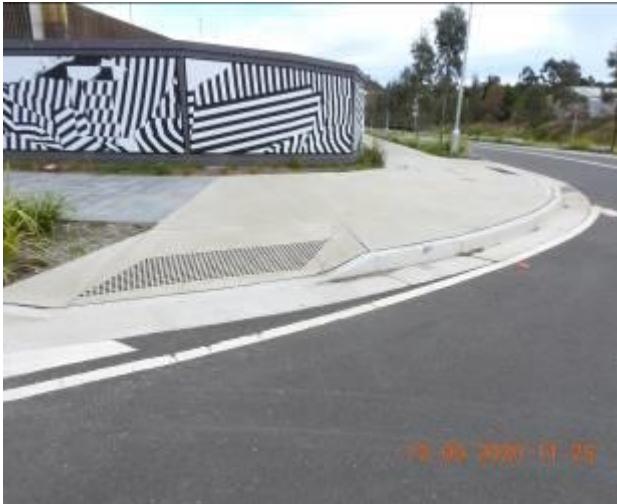
Figure 1095 – General condition of footpath pavement

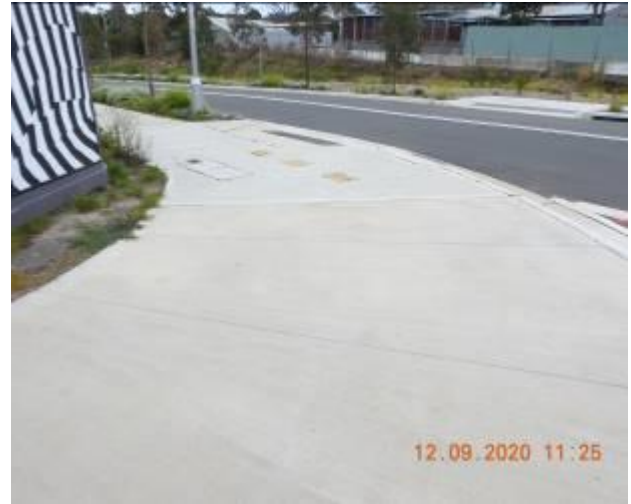
Figure 1096 – General condition of footpath pavement

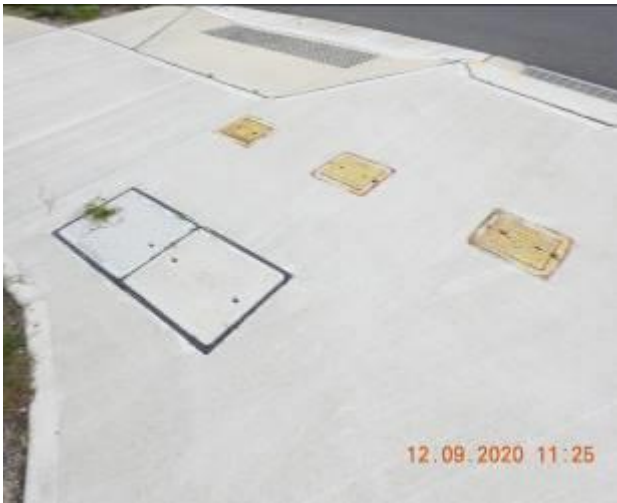
Figure 1097 – General condition of service pits

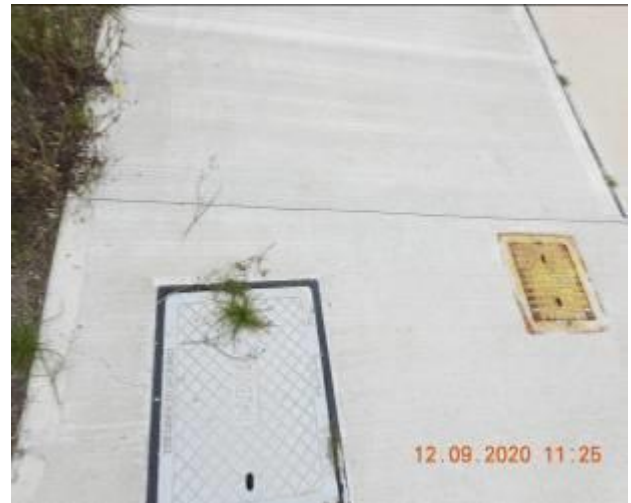
Figure 1098 – Crack propagation through footpath pavement

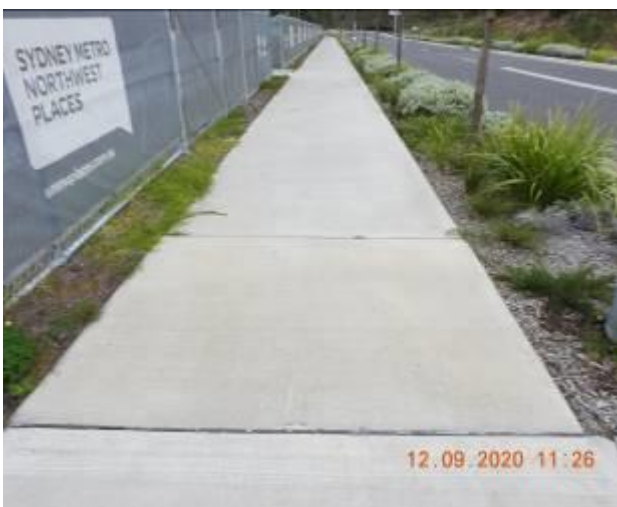
Figure 1099 – General condition of footpath pavement

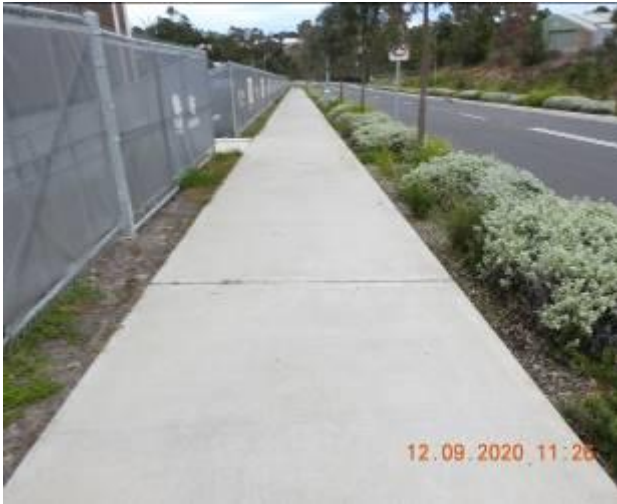
Figure 1101 – General condition of footpath pavement

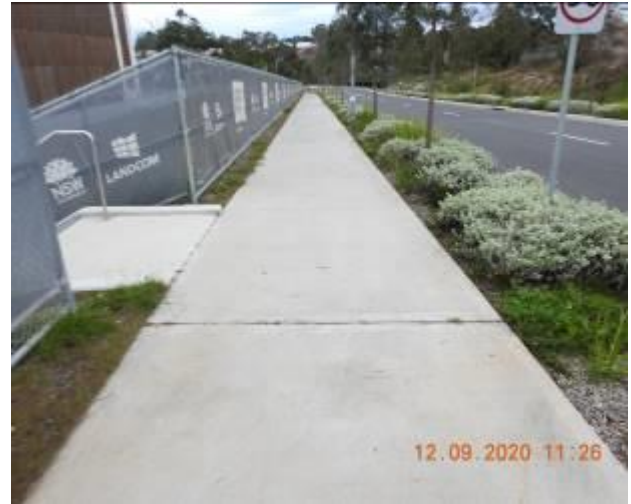
Figure 1102 – General condition of footpath pavement

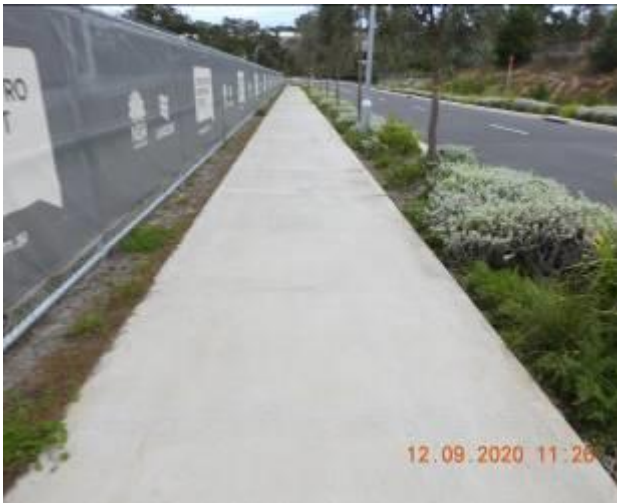
Figure 1103 – General condition of footpath pavement

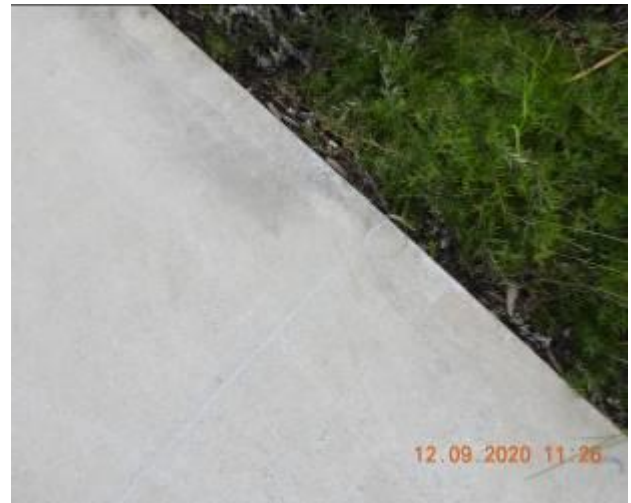
Figure 1104 – Crack propagation through footpath pavement

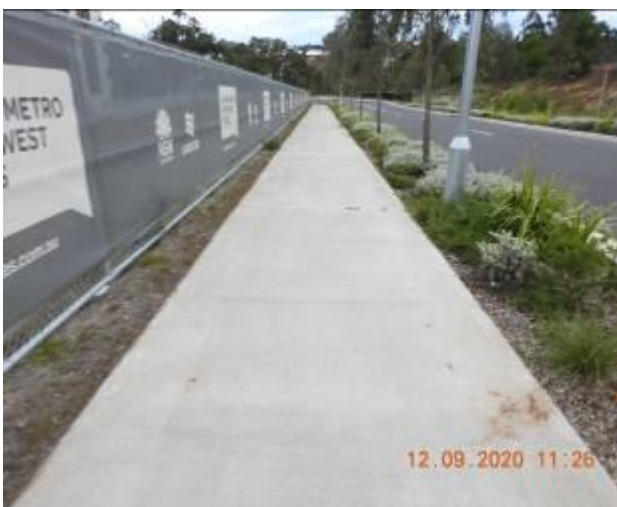
Figure 1105 – General condition of footpath pavement

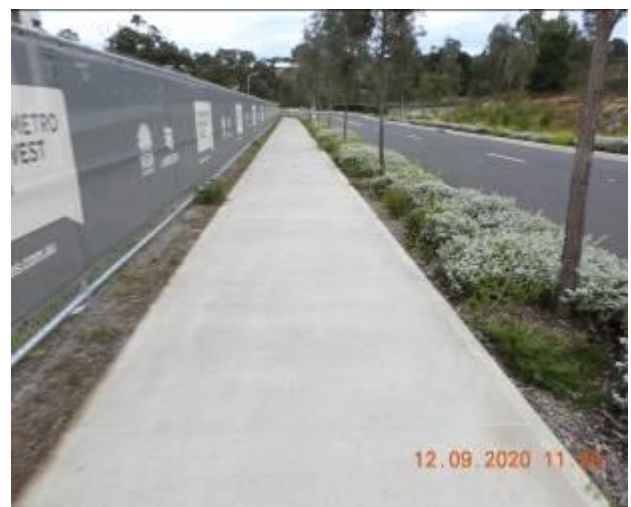
Figure 1106 – General condition of footpath pavement

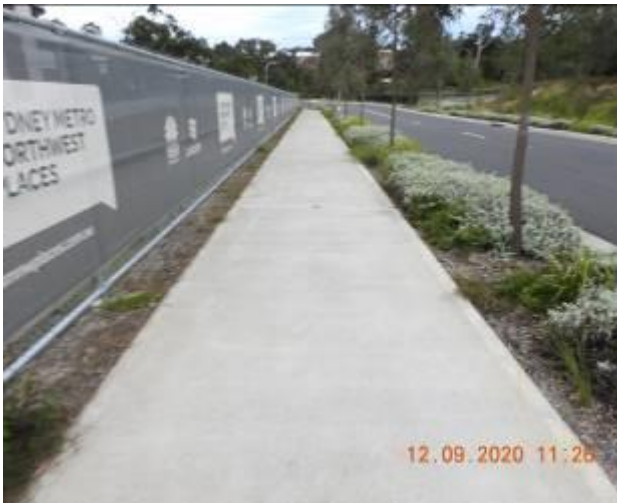
Figure 1107 – General condition of footpath pavement

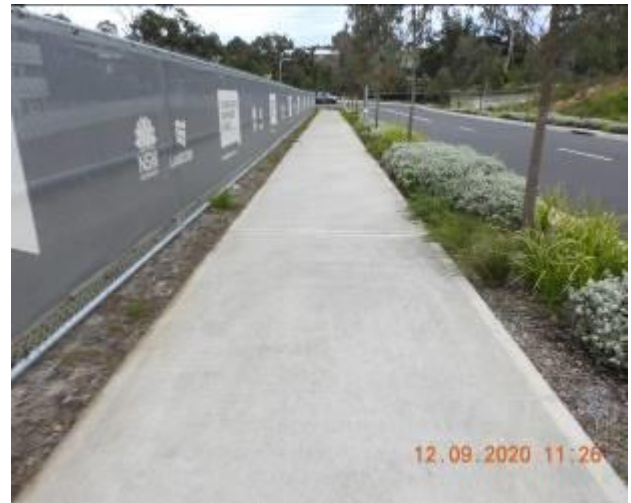
Figure 1108 – General condition of footpath pavement

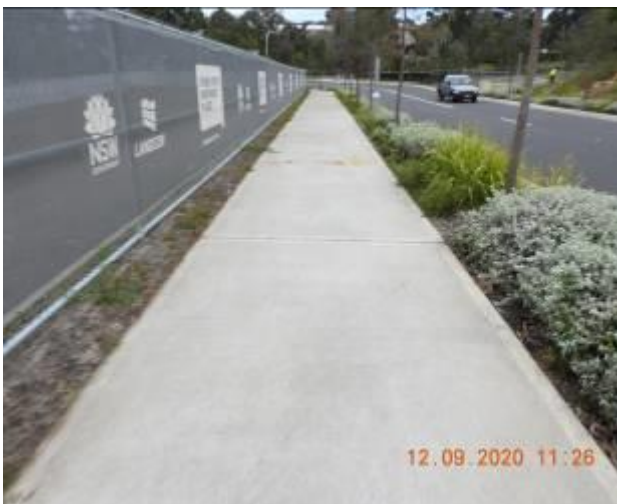
Figure 1109 – General condition of footpath pavement

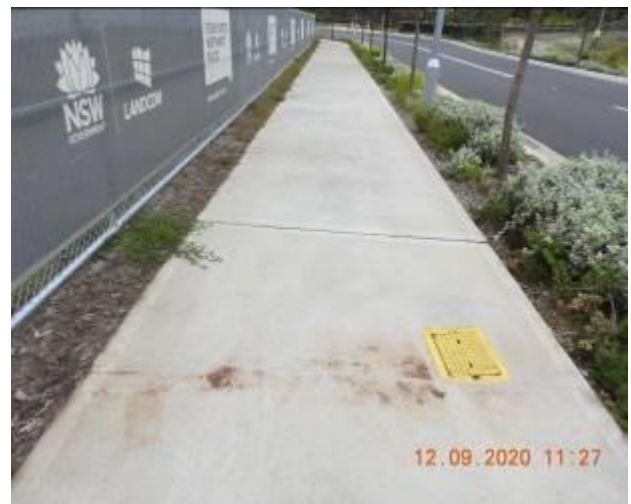
Figure 1110 – General condition of service pit

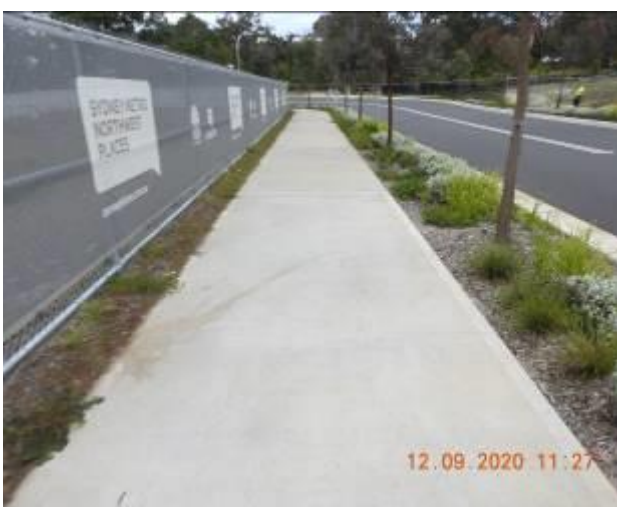
Figure 1111 – General condition of footpath pavement

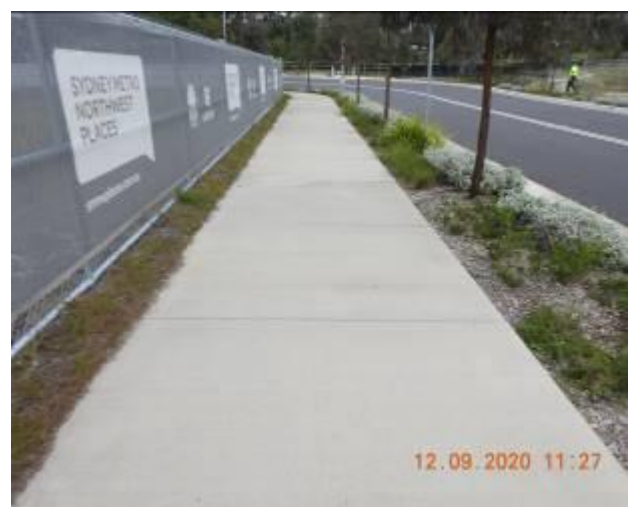
Figure 1112 – General condition of footpath pavement

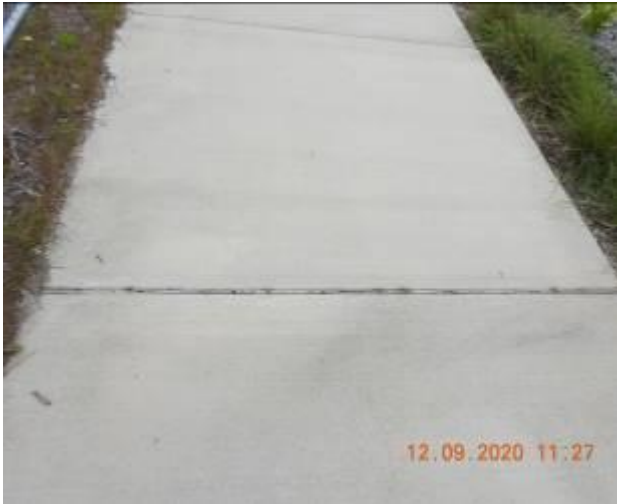
Figure 1113 – Loss of material through footpath pavement

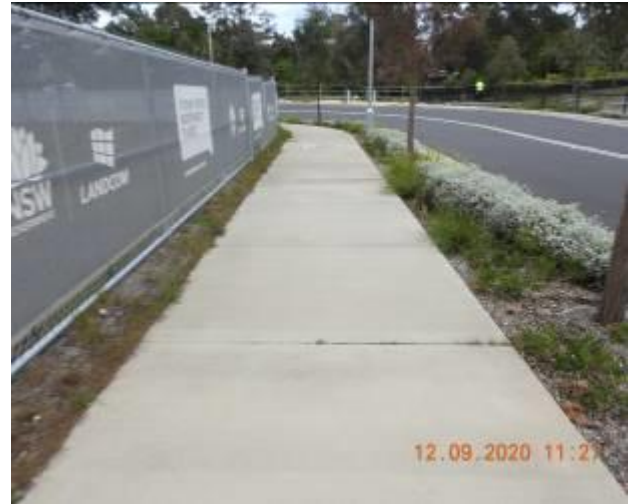
Figure 1114 – General condition of footpath pavement

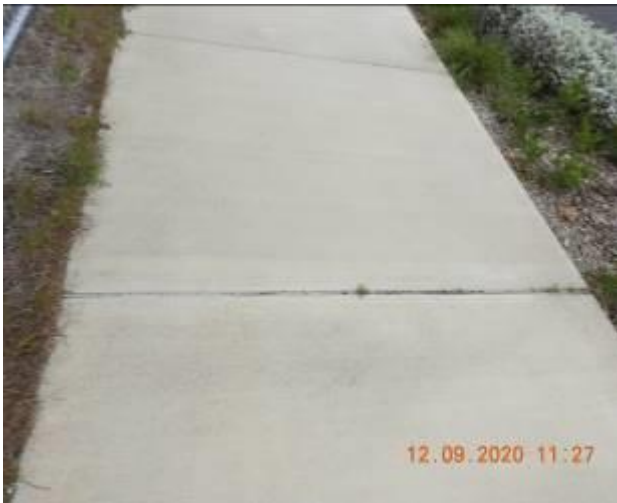
Figure 1115 – Loss of material through footpath pavement

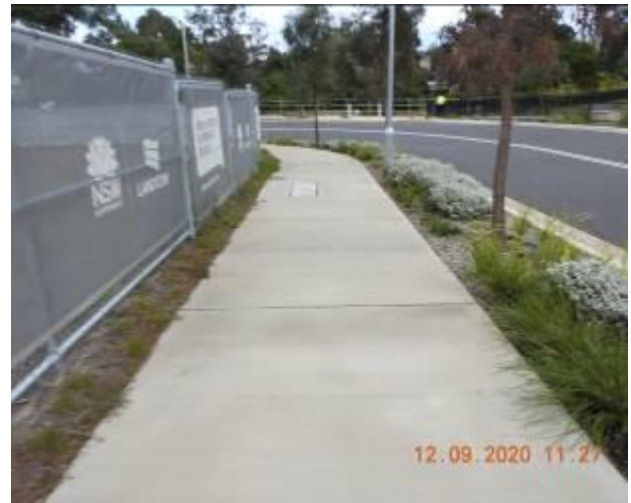
Figure 1116 – General condition of footpath pavement

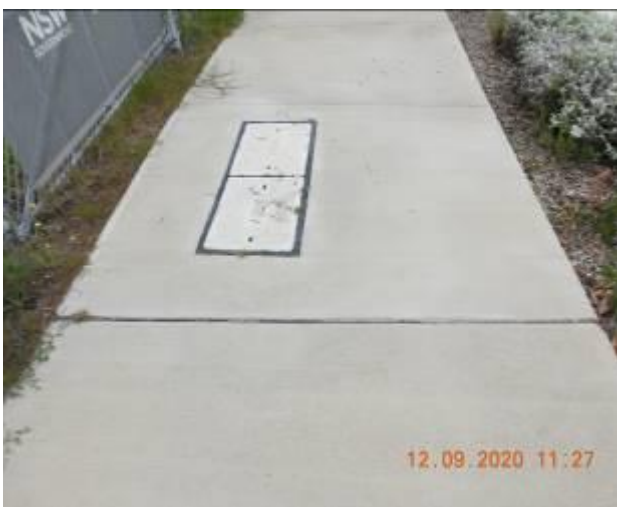
Figure 1117 – General condition of service pit

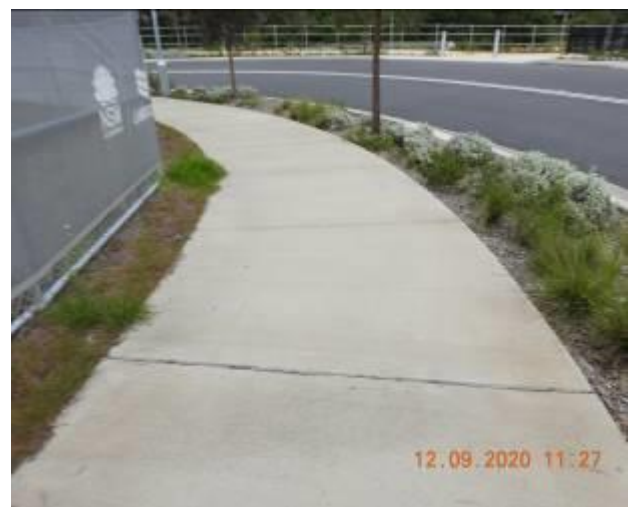
Figure 1118 – General condition of footpath pavement

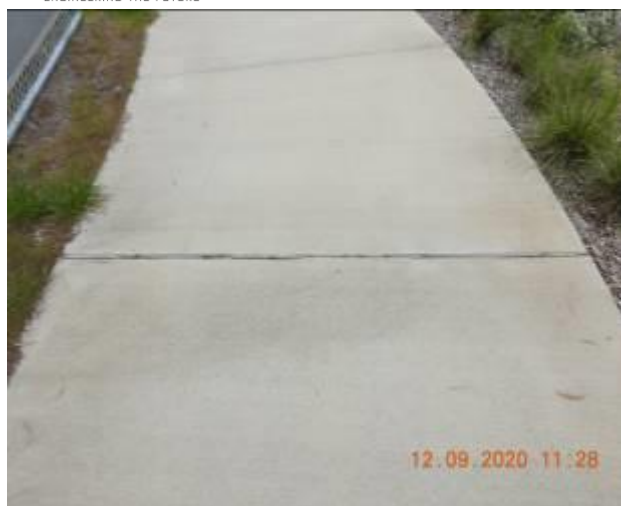
Figure 1119 – Crack propagation and loss of material through footpath pavement

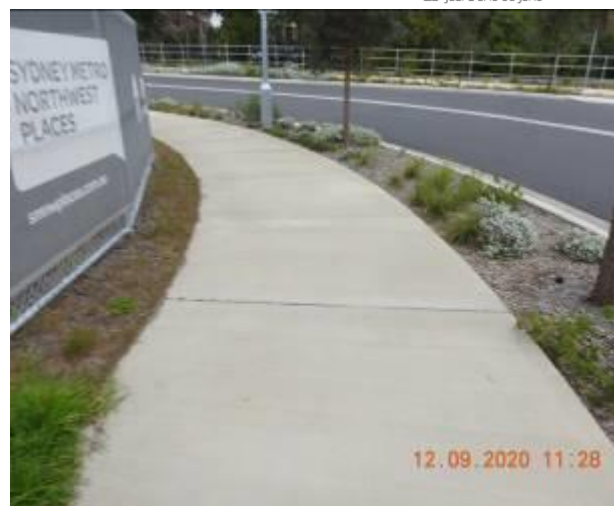
Figure 1120 – General condition of footpath pavement

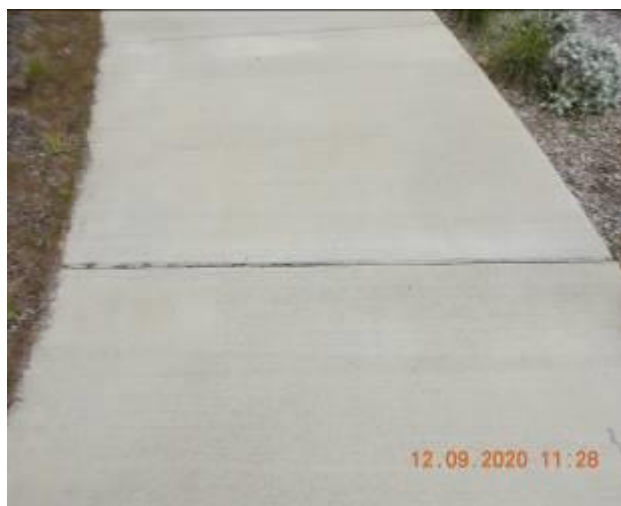
Figure 1121 – Crack propagation and loss of material through footpath pavement

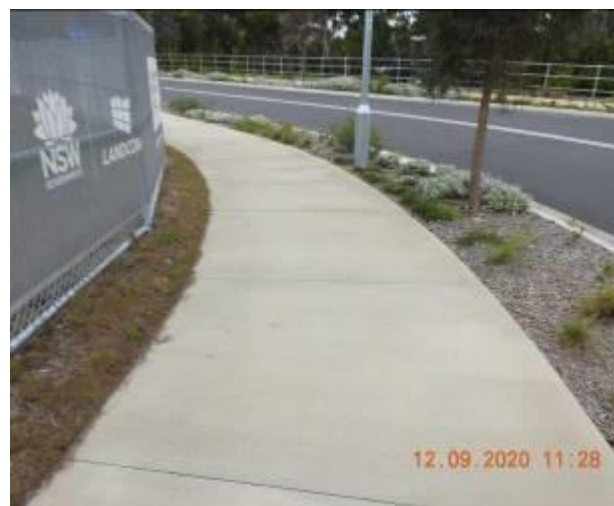
Figure 1122 – General condition of footpath pavement heading South

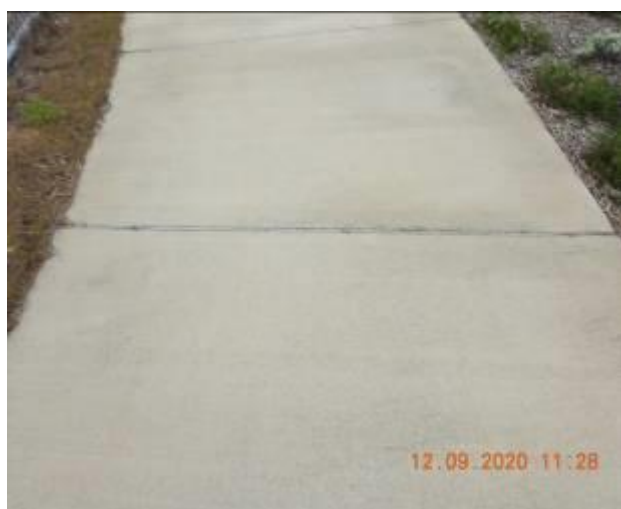
Figure 1123 – Loss of material through footpath pavement

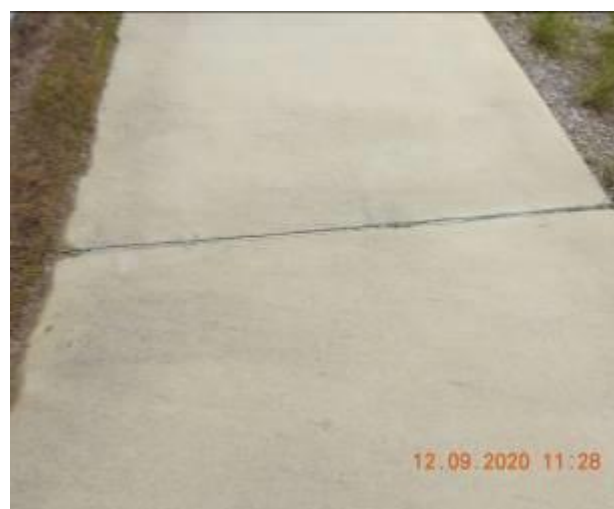
Figure 1124 – Loss of material through footpath pavement

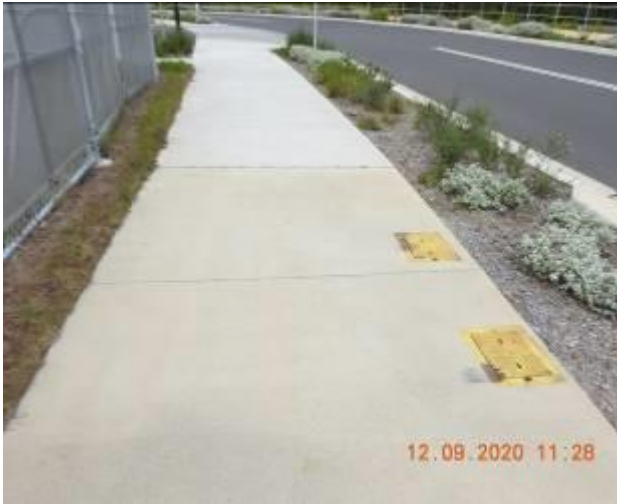
Figure 1125 – General condition of footpath pavement/General condition of service pit

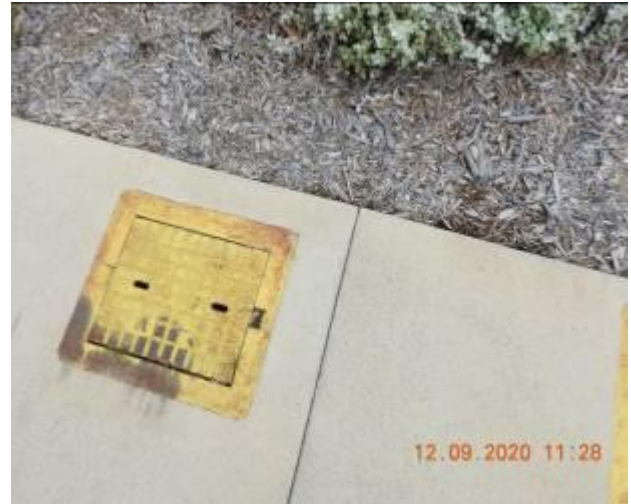
Figure 1126 – Crack propagation through footpath pavement

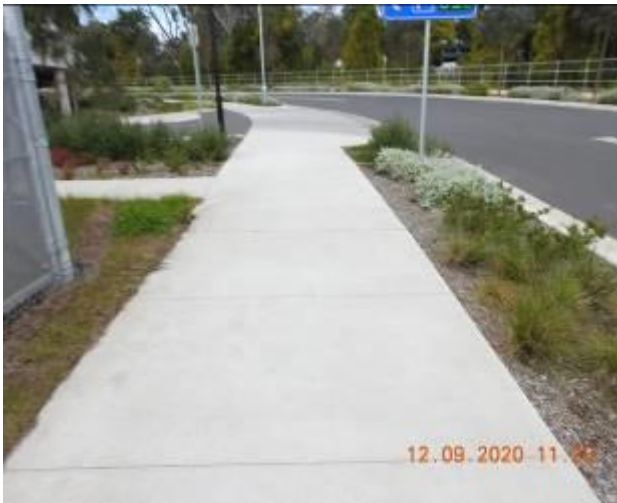
Figure 1127 – General condition of footpath pavement

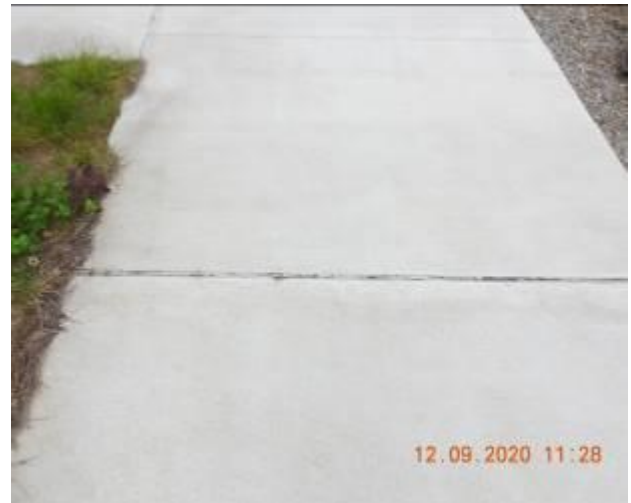
Figure 1128 – Loss of material through footpath pavement

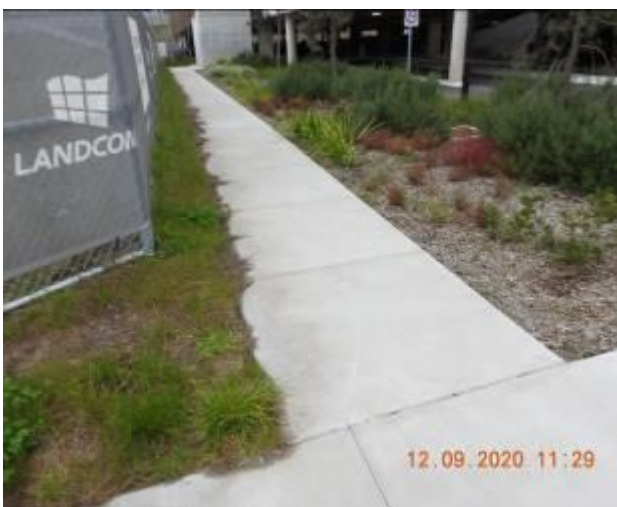
Figure 1129 – General condition of footpath pavement
