**2 MANDALA PARADE, CASTLE HILL
(DORAN DRIVE PRECINCT)
PRE-DILAPIDATION REPORT
Of Sydney Metro and Hills Shire Council Assets
DEICORP PROJECTS SHOWGROUND
PTY LTD.**

Job No. 200124.3
07/07/2021

ACE Structural Services Pty Ltd

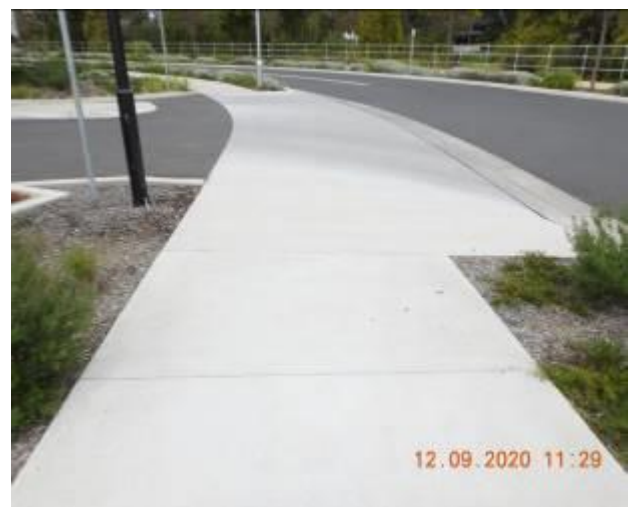
Figure 1130 – General condition of footpath pavement

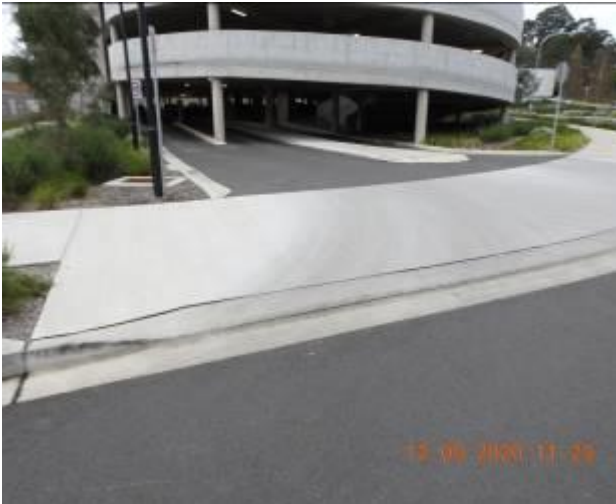
Figure 1131 – General condition of driveway pavement

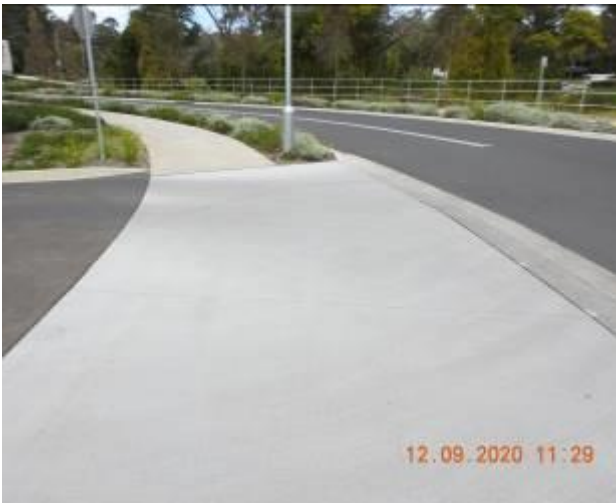
Figure 1132 – Crack propagation and loss of material through driveway pavement

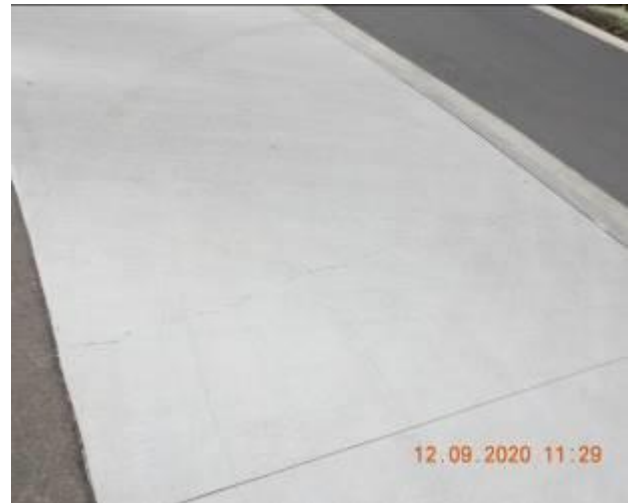
Figure 1133 – General condition of driveway pavement

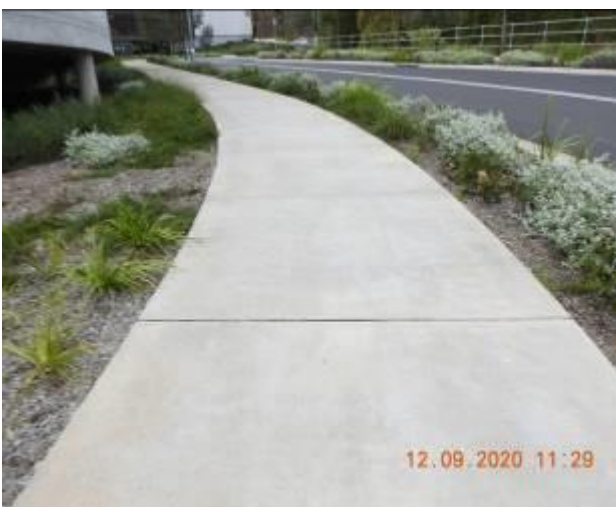
Figure 1134 – Crack propagation and loss of material through driveway pavement

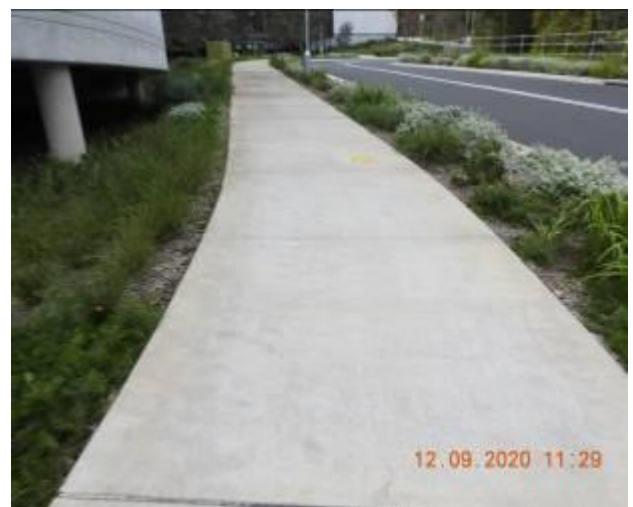
Figure 1135 – General condition of footpath pavement

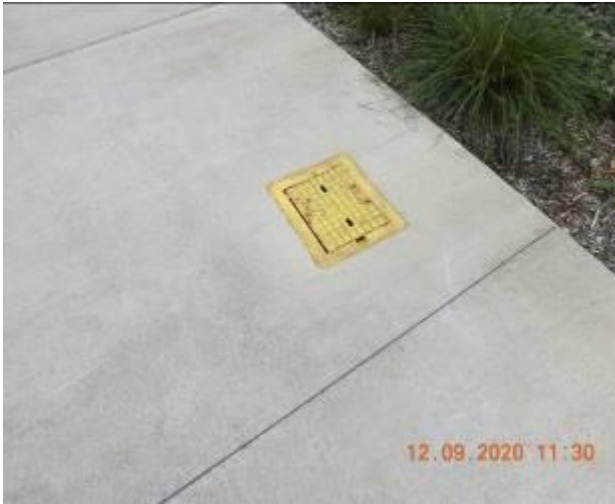
Figure 1136 – General condition of footpath pavement

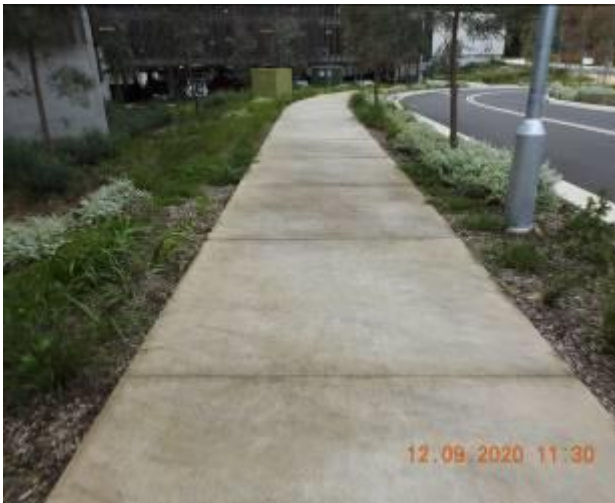
Figure 1138 – General condition of footpath pavement

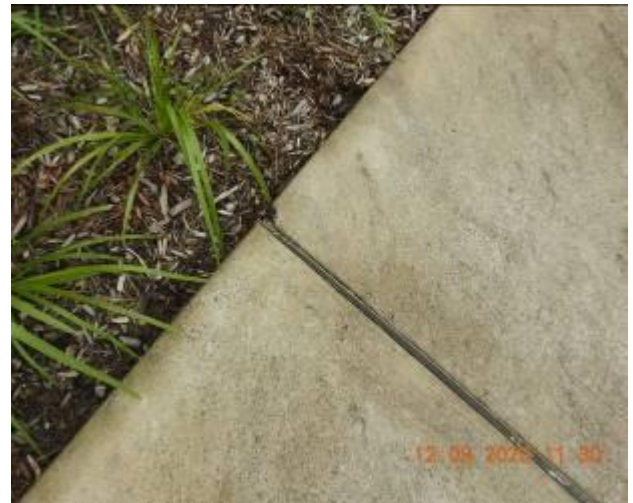
Figure 1139 – General condition of footpath pavement

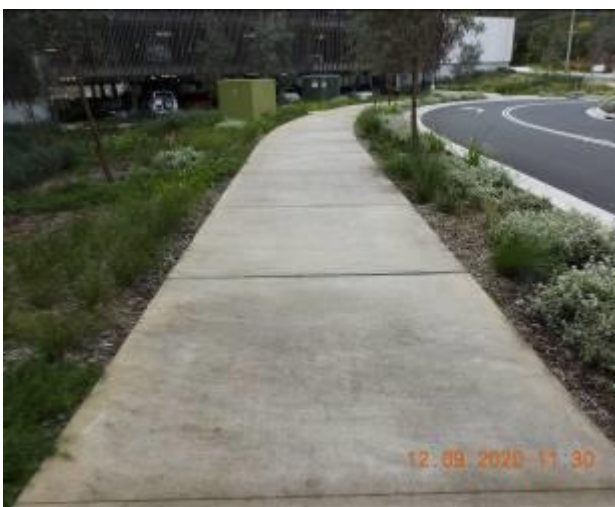
Figure 1140 – Loss of material through footpath pavement

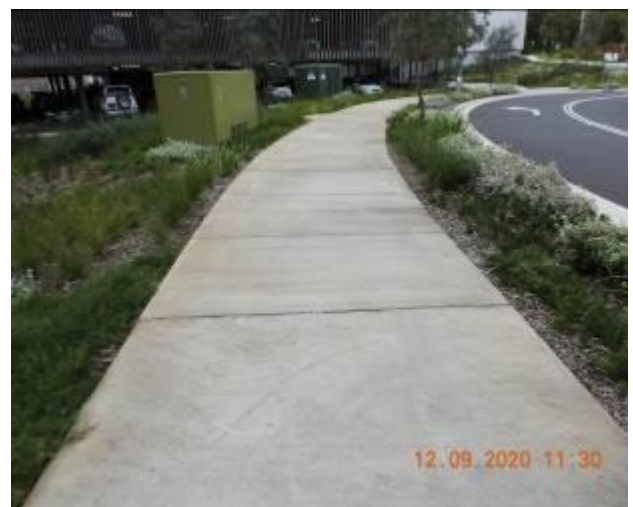
Figure 1141 – General condition of footpath pavement

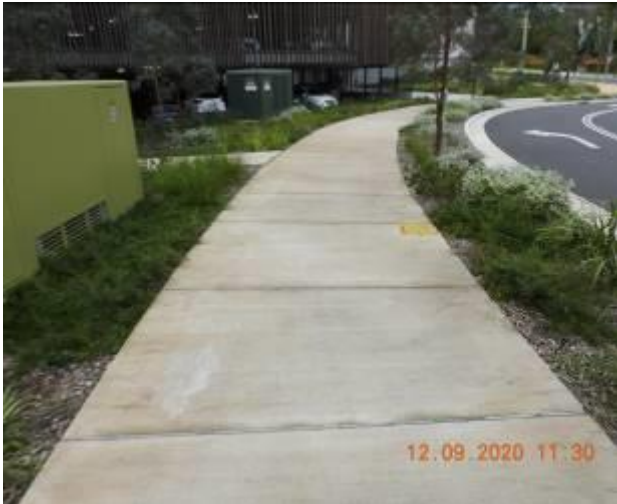
Figure 1142 – General condition of footpath pavement

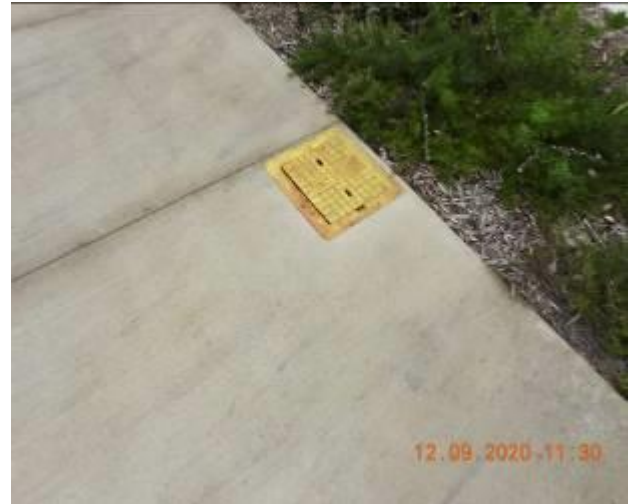
Figure 1143 – Loss of material through footpath pavement

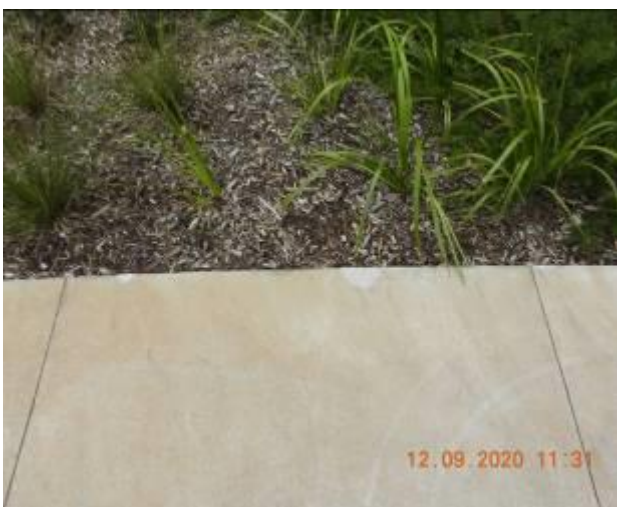
Figure 1146 – General condition of footpath pavement

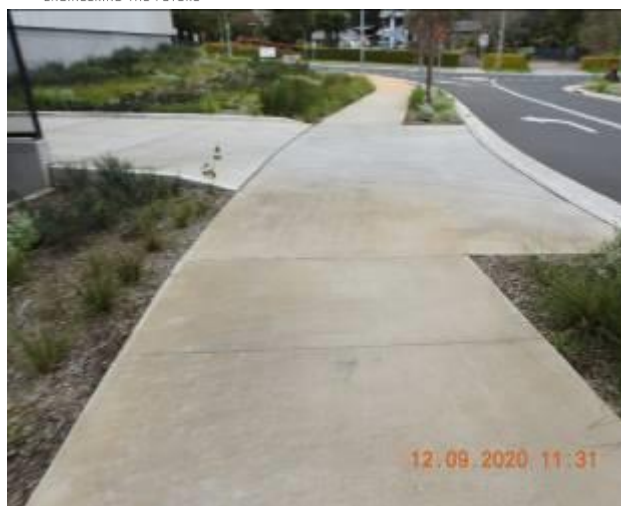
Figure 1148 – General condition of footpath pavement

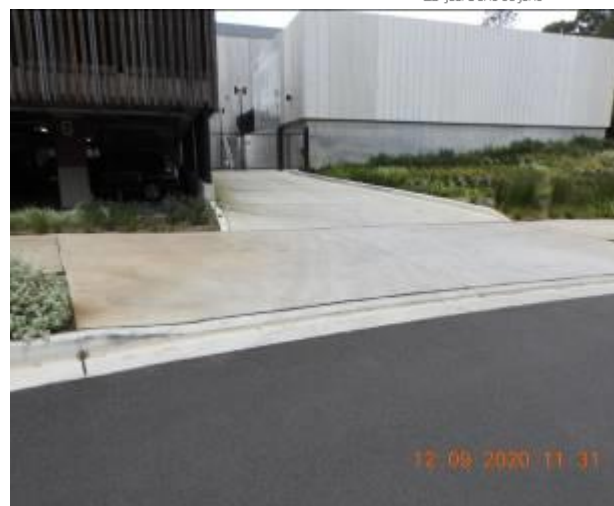
Figure 1149 – General condition of footpath pavement

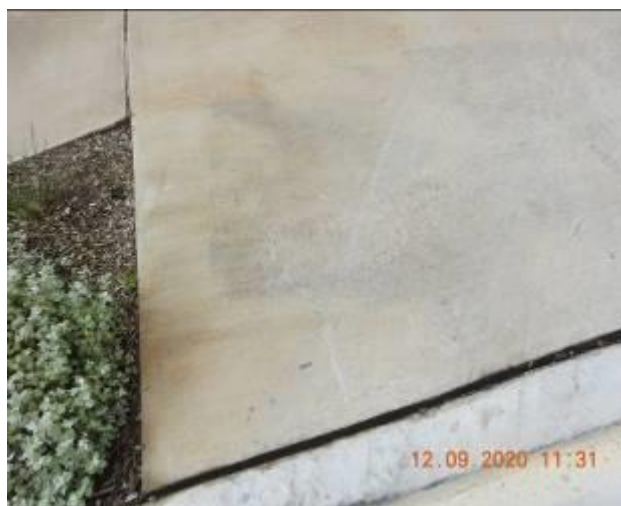
Figure 1150 – General condition of driveway pavement

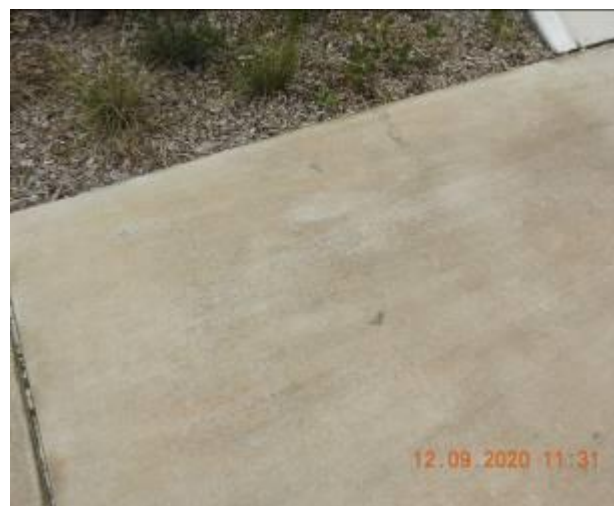
Figure 1151 – Loss of material through driveway pavement

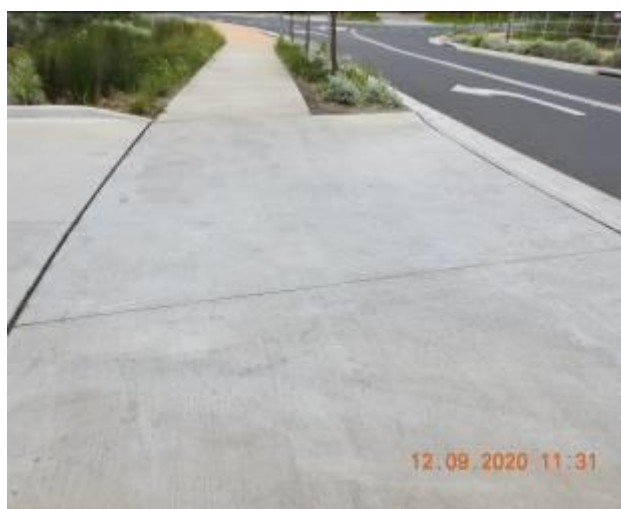
Figure 1152 – Loss of material through driveway pavement

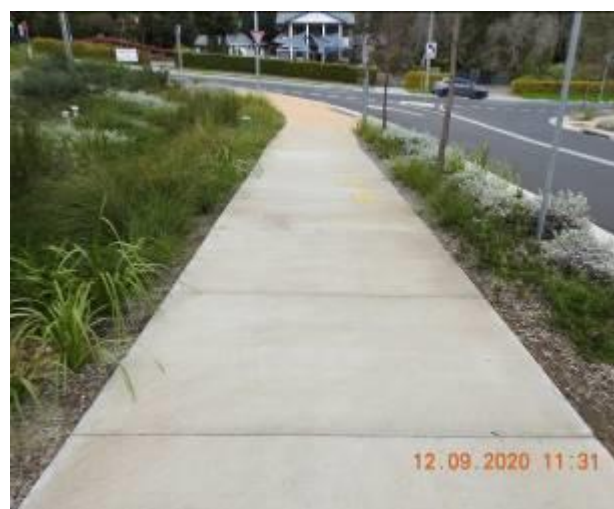
Figure 1153 – General condition of driveway pavement

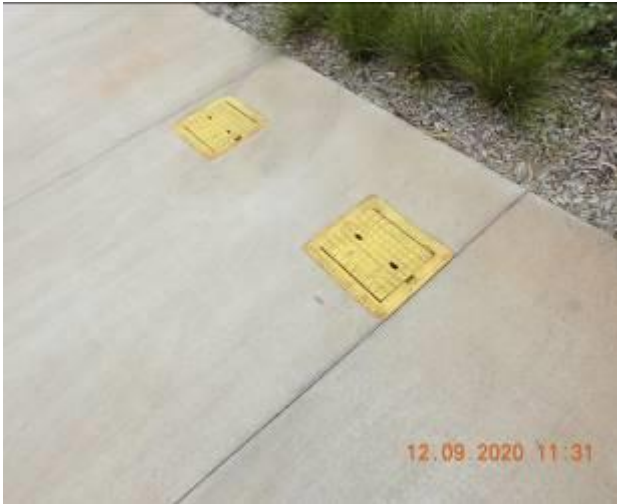
Figure 1154 – Loss of material through footpath pavement

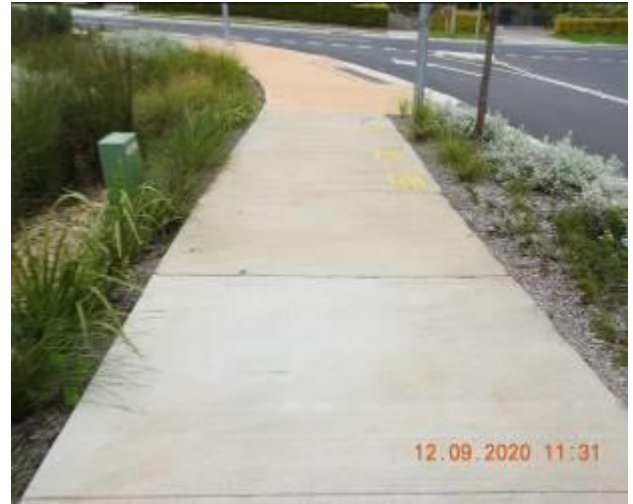
Figure 1155 – General condition of service pit

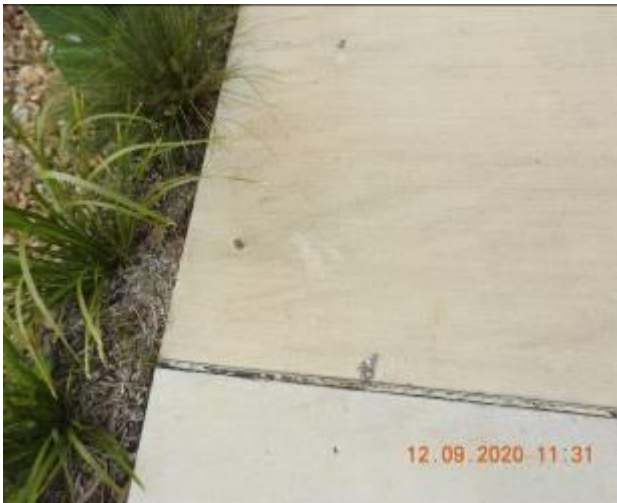
Figure 1156 – General condition of footpath pavement

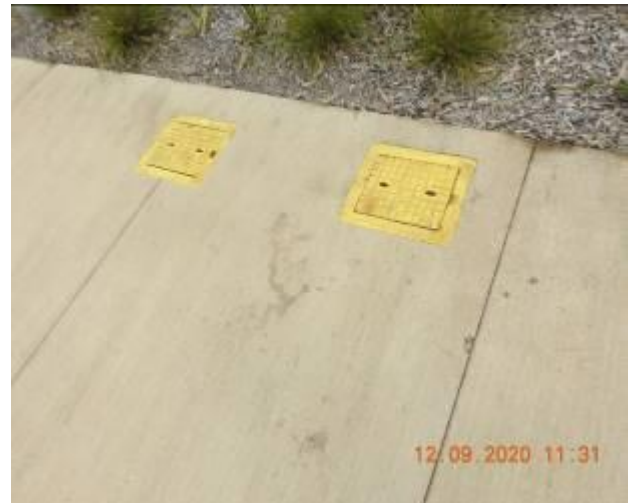
Figure 1157 – Loss of material through footpath pavement

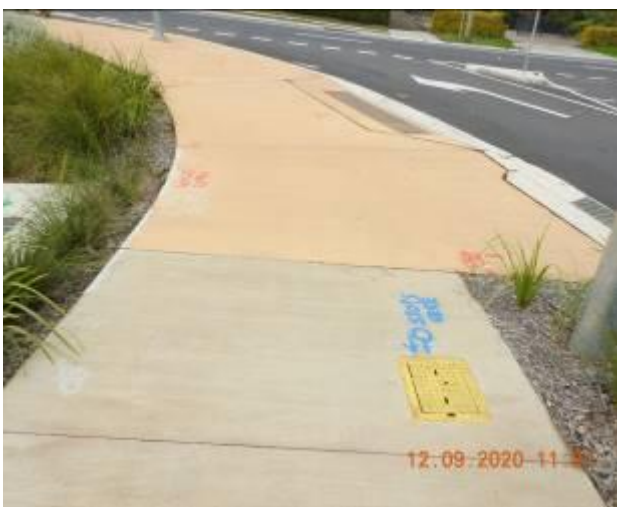
Figure 1158 – General condition of service pit/ Loss of material through footpath pavement

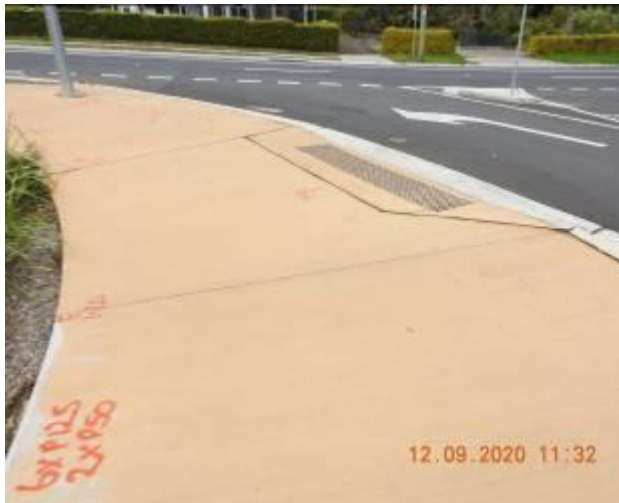
Figure 1160 – Loss of material through footpath pavement

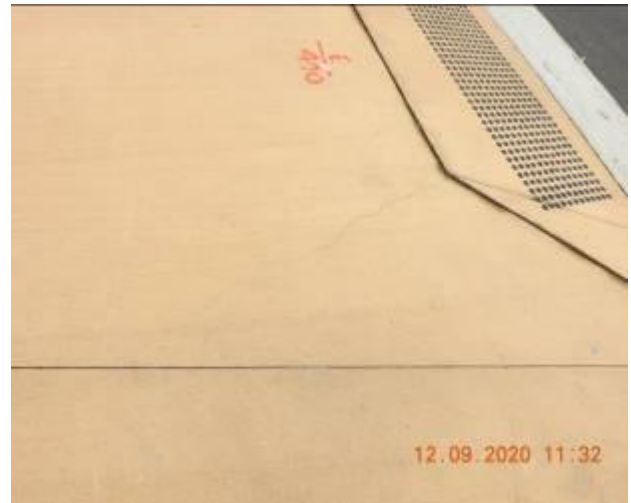
Figure 1161 – General condition of footpath pavement

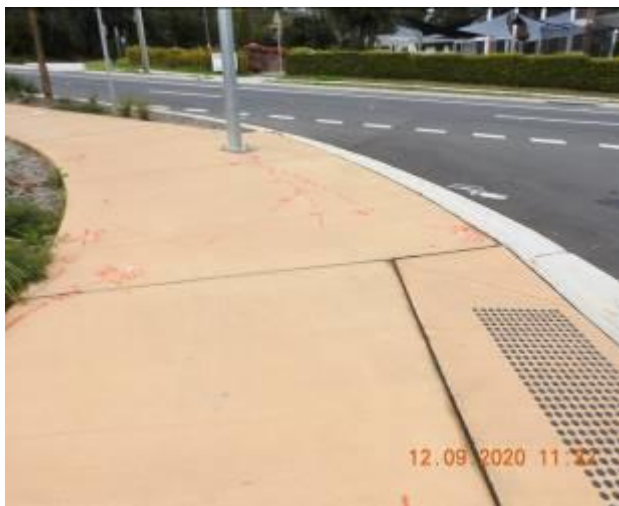
Figure 1162 – Crack propagation through footpath pavement

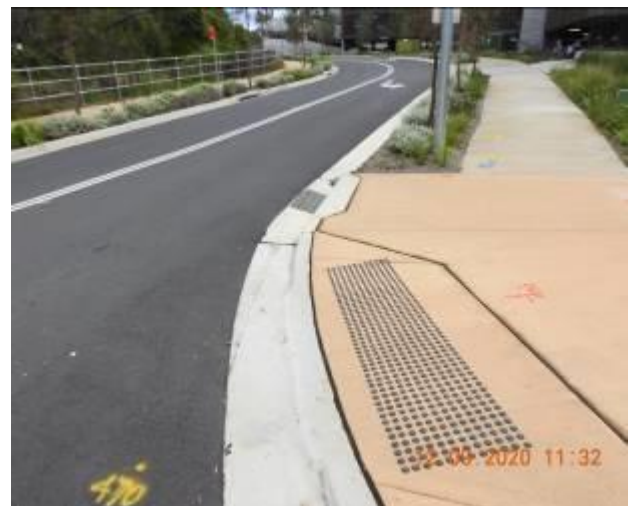
Figure 1163 – General condition of footpath pavement

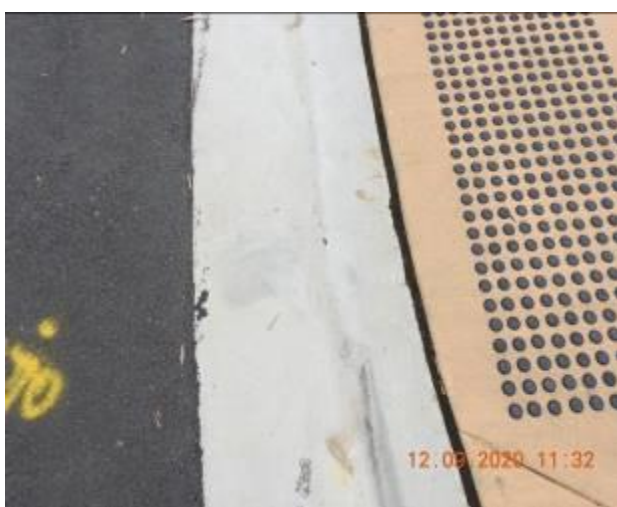
Figure 1164 – General condition of kerbs and gutter heading North

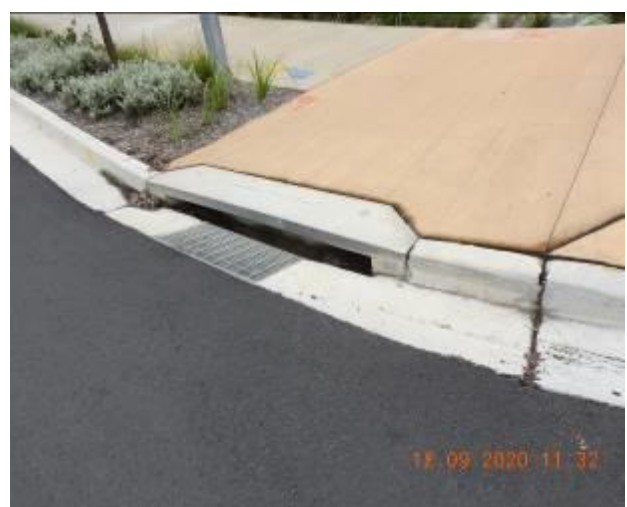
Figure 1165 – Crack propagation through layback and gutter

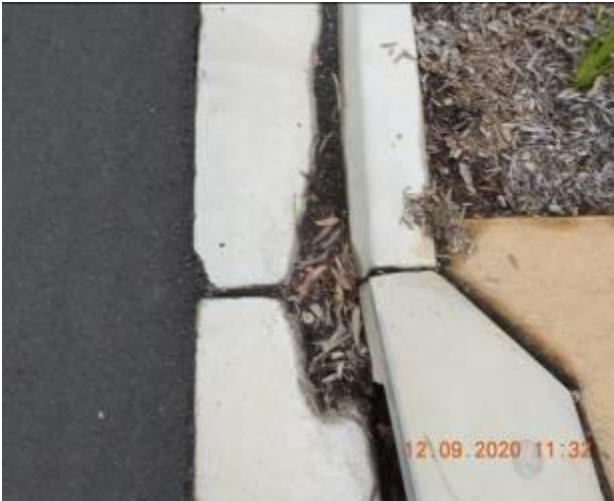
Figure 1166 – General condition of stormwater inlet pit/Evidence of patchwork through kerb

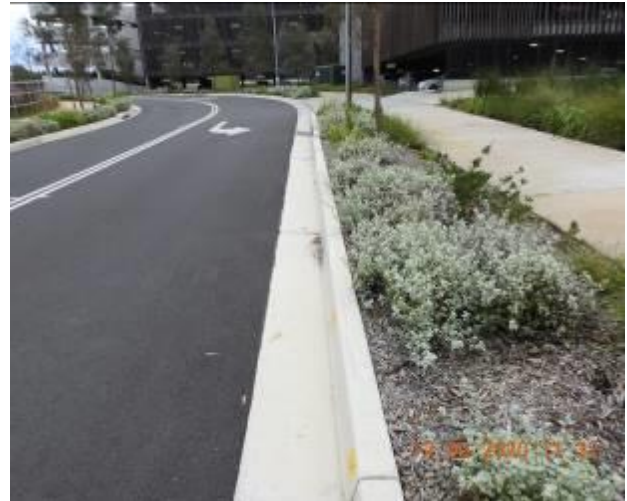
Figure 1167 – Loss of material through kerbs and gutter

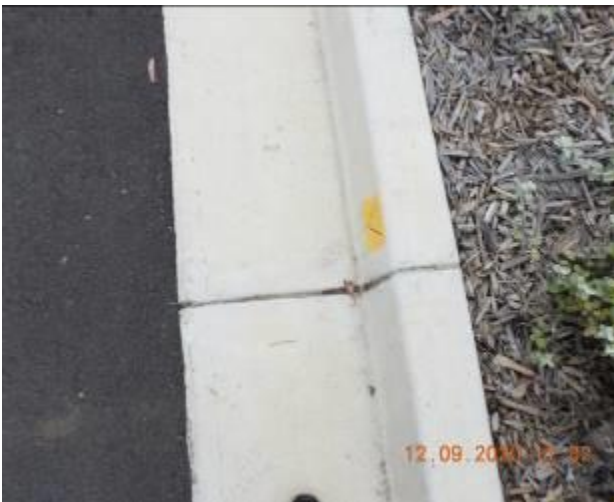
Figure 1168 – General condition of kerbs and gutter

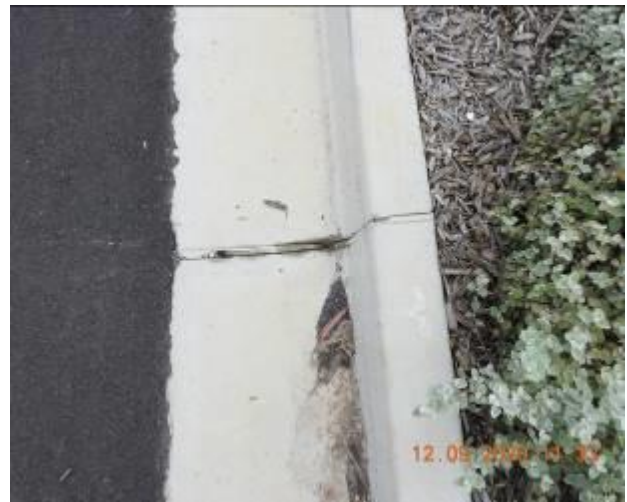
Figure 1169 – Crack propagation and loss of material through kerbs and gutter

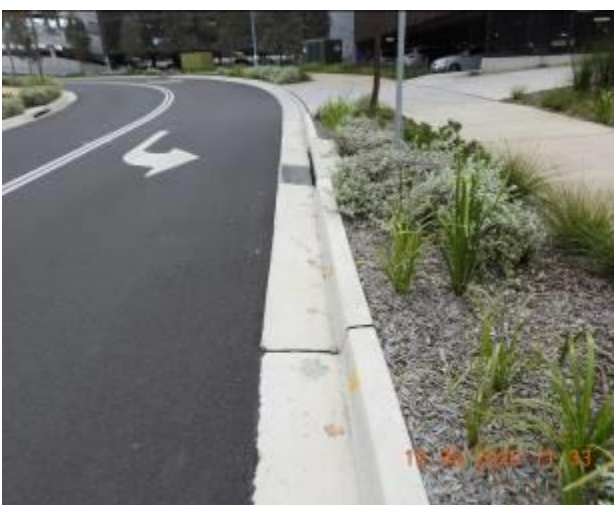
Figure 1170 – Crack propagation and loss of material through kerbs and gutter

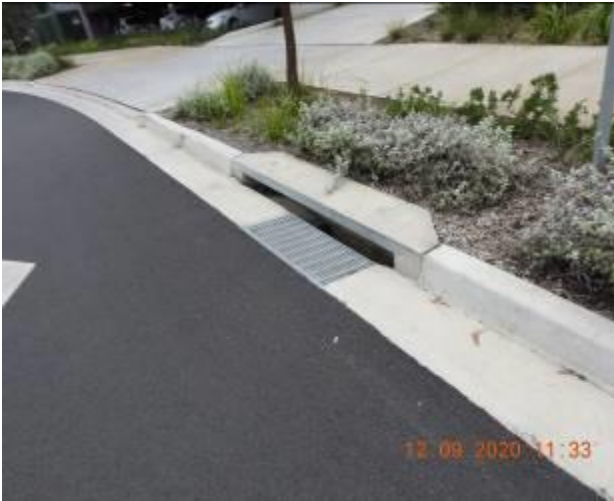
Figure 1172 – Loss of material through kerbs and gutter

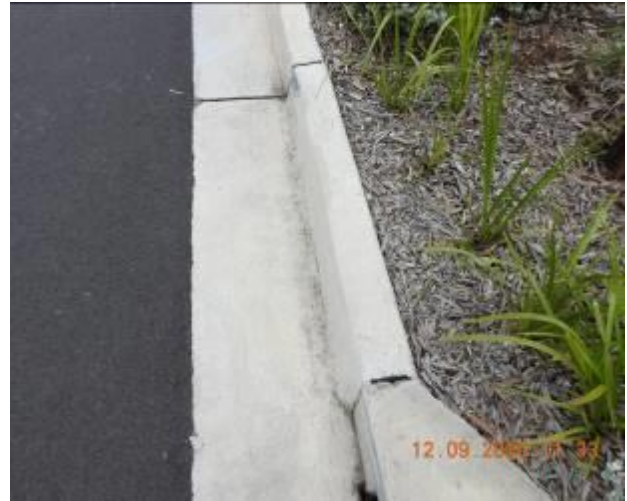
Figure 1173 – General condition of stormwater inlet pit/ Loss of material through kerb

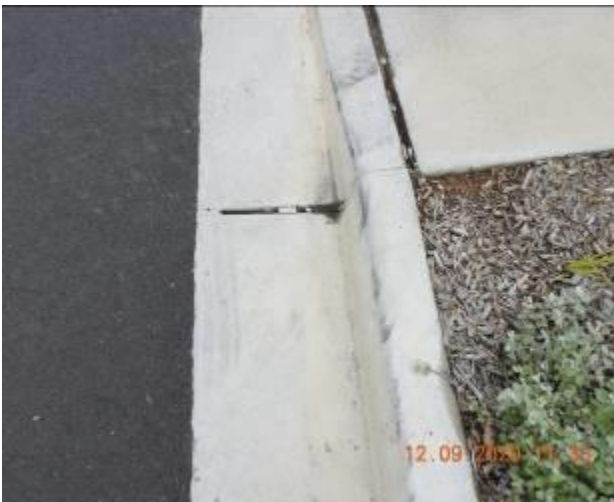
Figure 1175 – Crack propagation and loss of material through kerbs and gutter

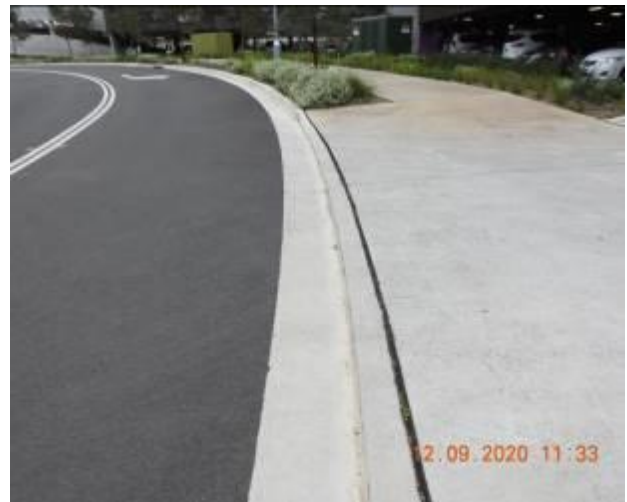
Figure 1176 – General condition of layback and gutter

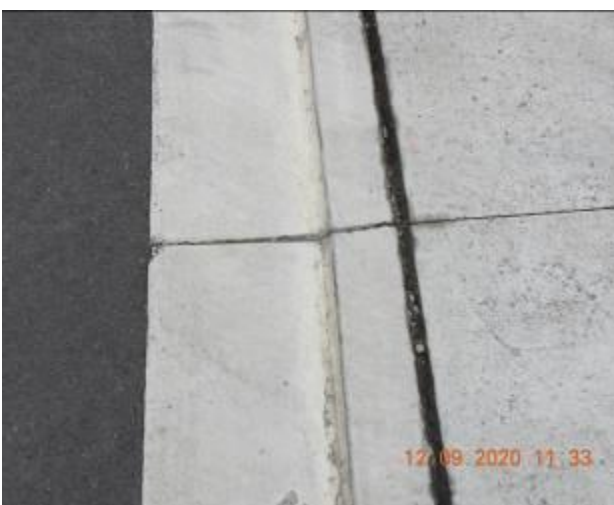
Figure 1177 – Loss of material through layback and gutter

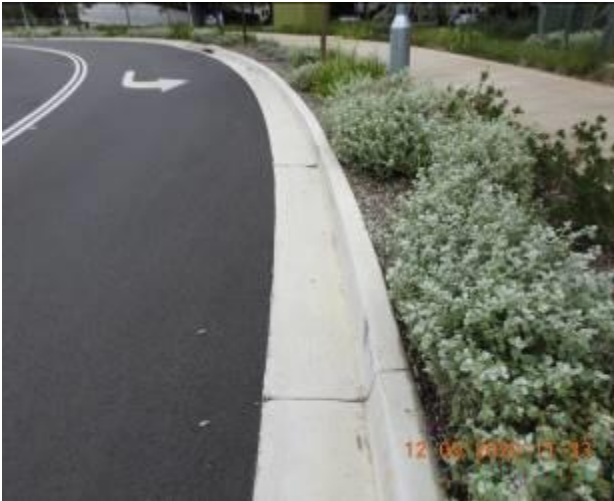
Figure 1179 – General condition of kerb and gutter

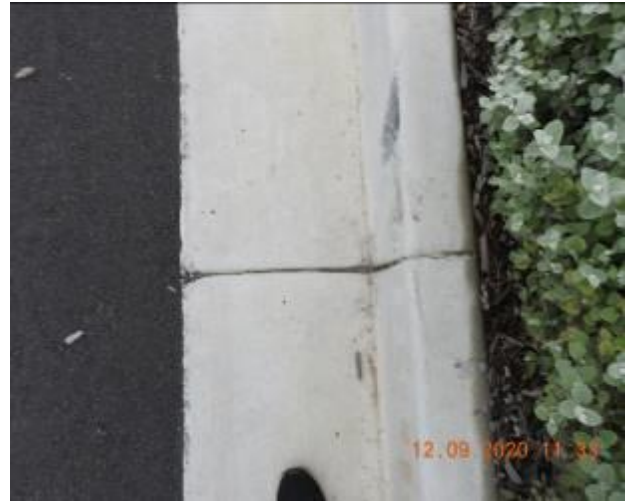
Figure 1180 – Crack propagation and loss of material through kerb and gutter

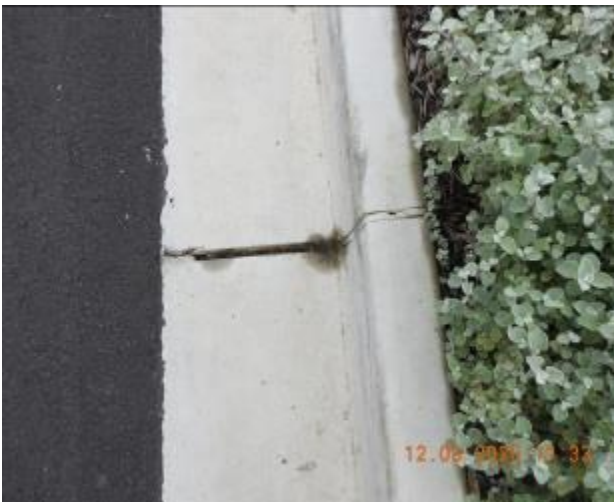
Figure 1181 – Crack propagation and loss of material through kerb and gutter

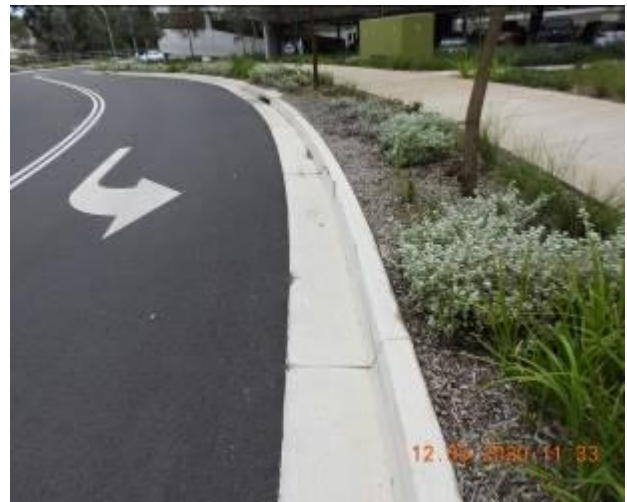
Figure 1182 – General condition of kerb and gutter

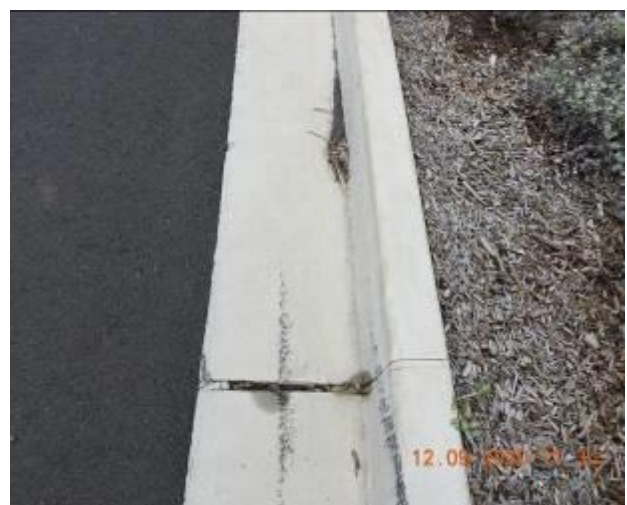
Figure 1184 – Crack propagation and loss of material through kerb and gutter

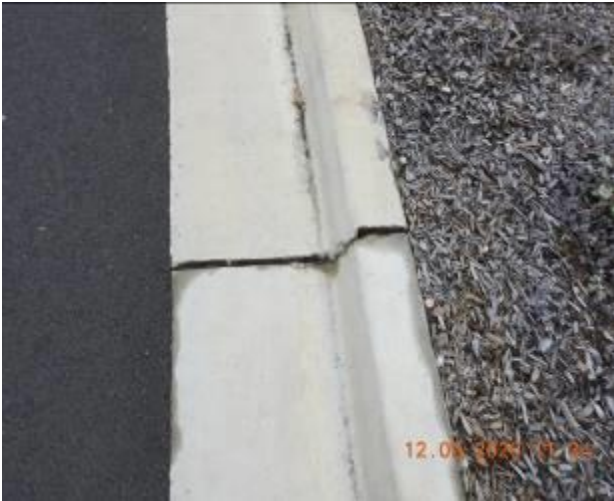
Figure 1185 – Loss of material through kerb and gutter

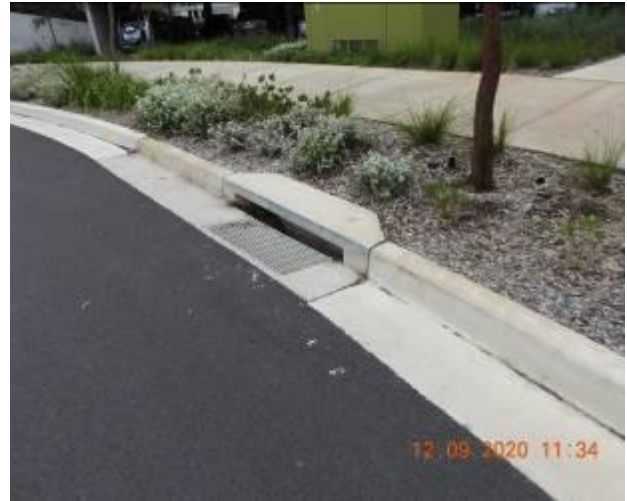
Figure 1186 – General condition of stormwater inlet pit/ Loss of material through kerb

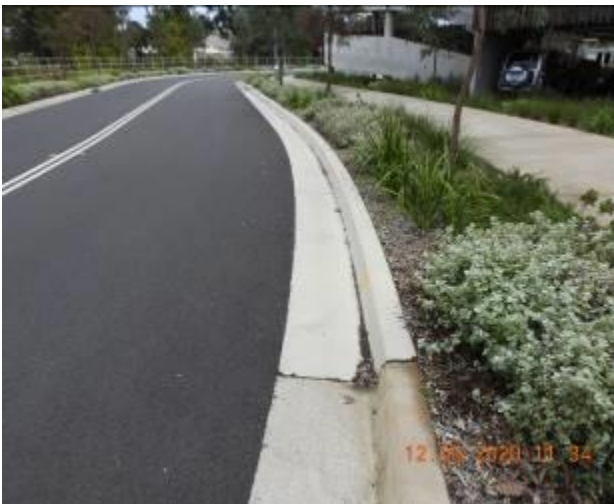
Figure 1187 – General condition of kerb and gutter

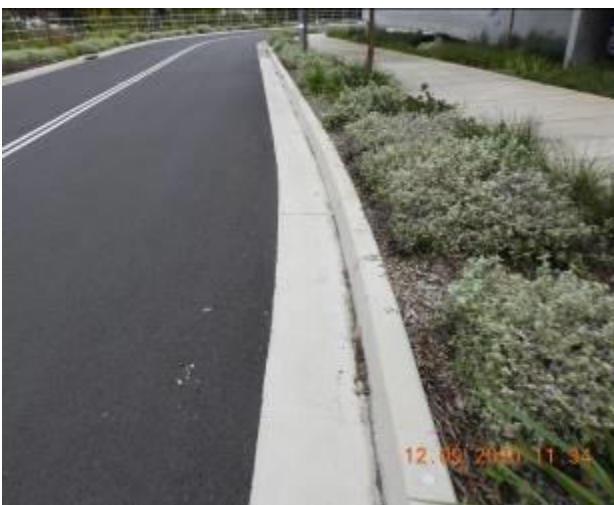
Figure 1189 – General condition of kerb and gutter

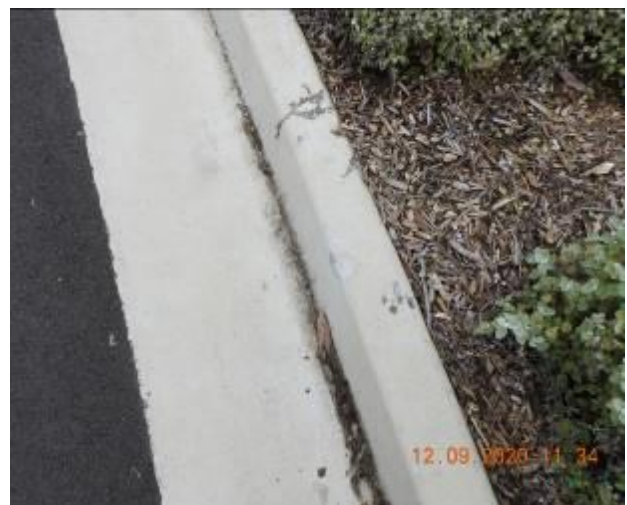
Figure 1190 – Evidence of patchwork through kerb

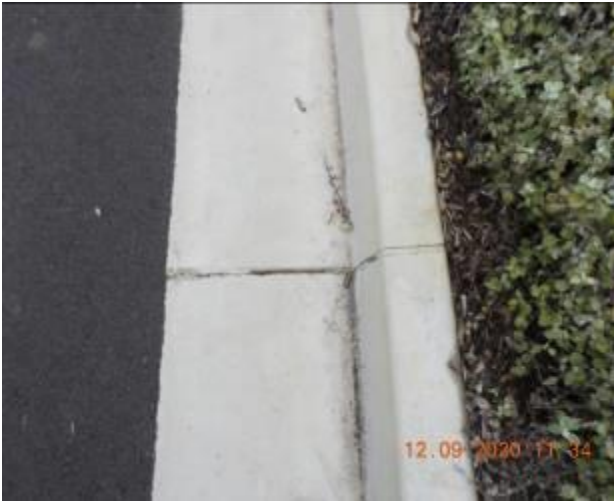
Figure 1191 – Loss of material through kerb and gutter

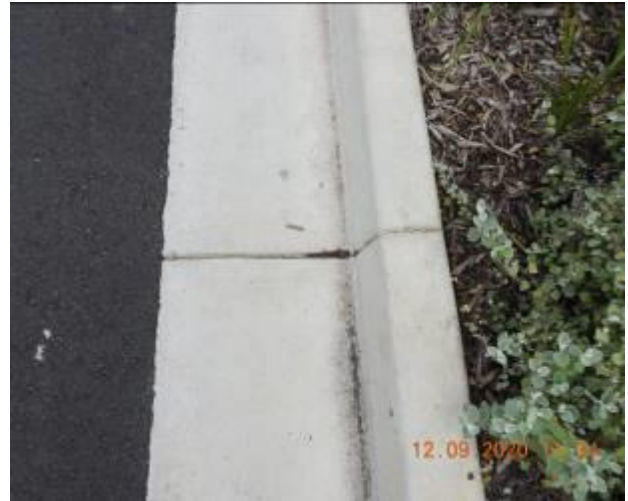
Figure 1192 – Crack propagation and loss of material through kerb and gutter

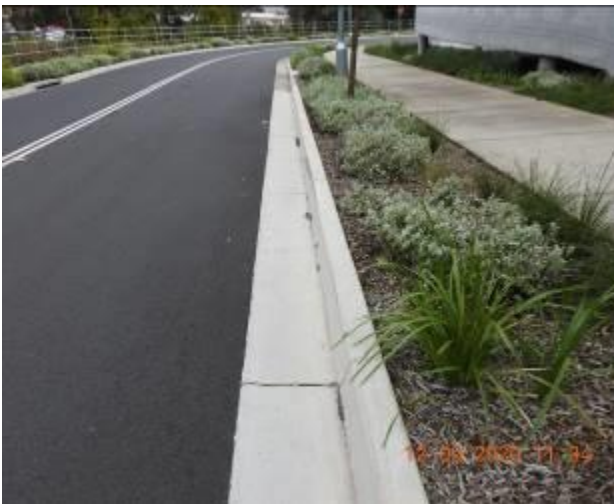
Figure 1193 – General condition of kerb and gutter

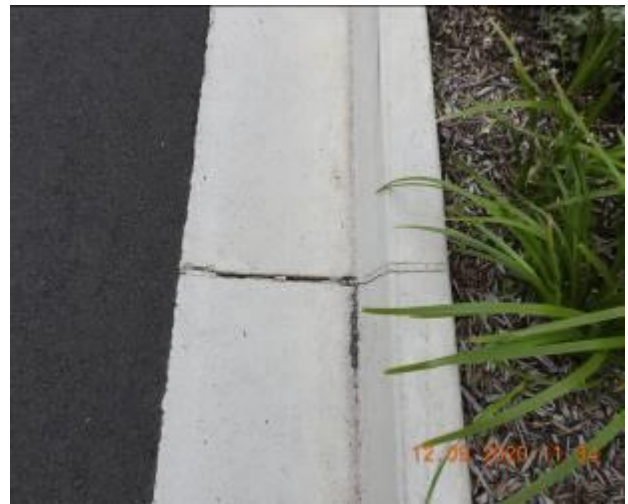
Figure 1194 – Loss of material through kerb and gutter

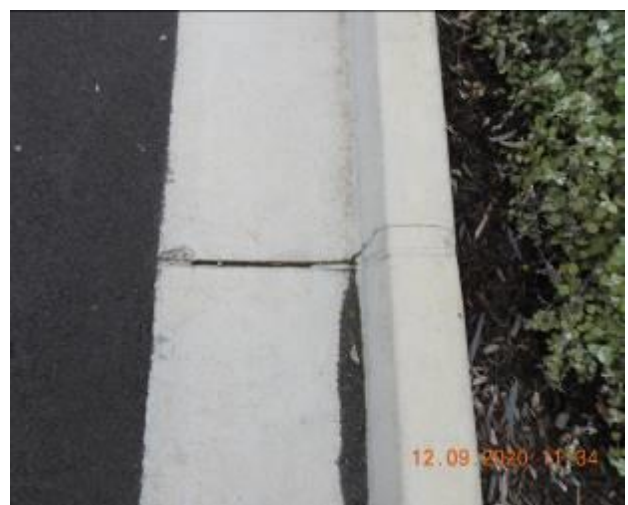
Figure 1196 – Crack propagation and loss of material through kerb and gutter

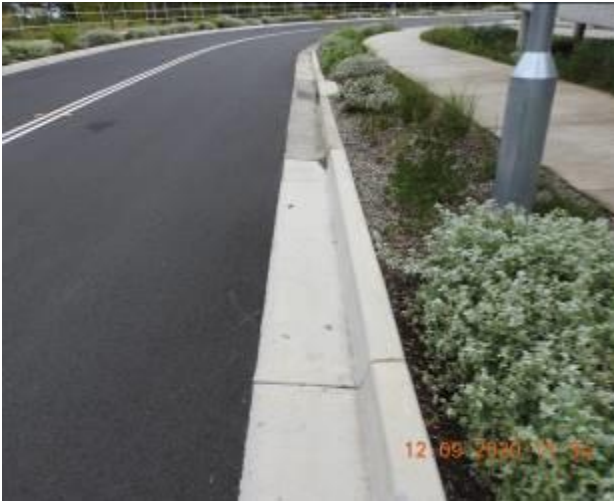
Figure 1197 – General condition of kerb and gutter

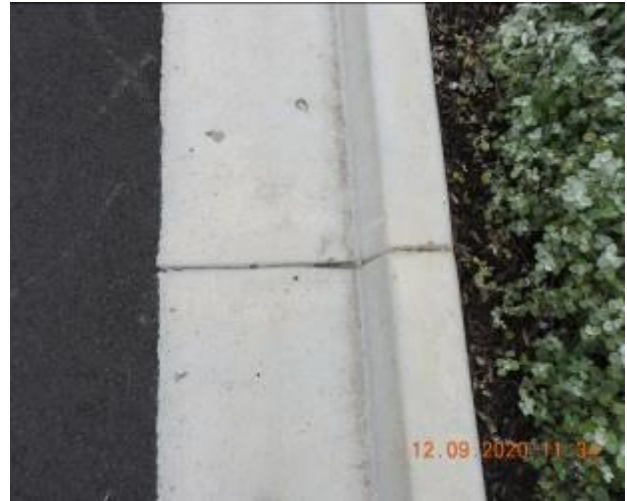
Figure 1198 – Crack propagation and loss of material through kerb and gutter

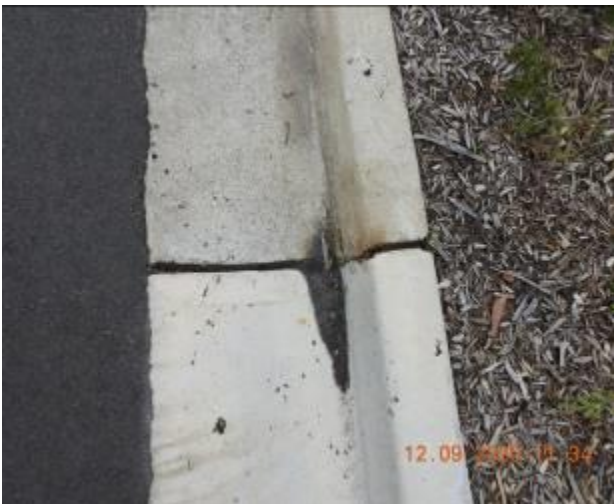
Figure 1199 – Loss of material through kerb and gutter

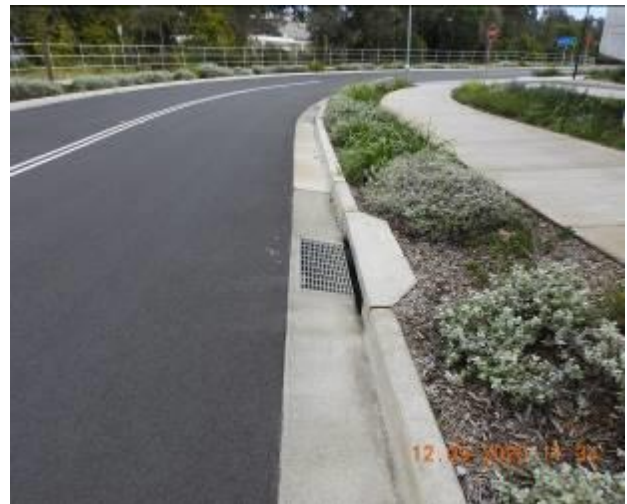
Figure 1200 – General condition of kerb and gutter

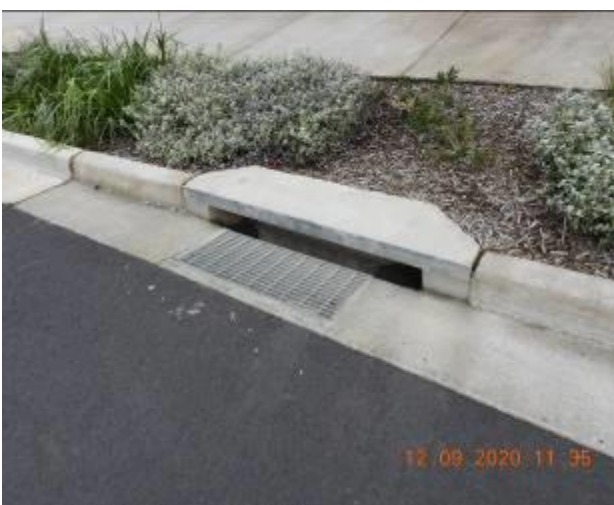
Figure 1201 – General condition of stormwater inlet pit

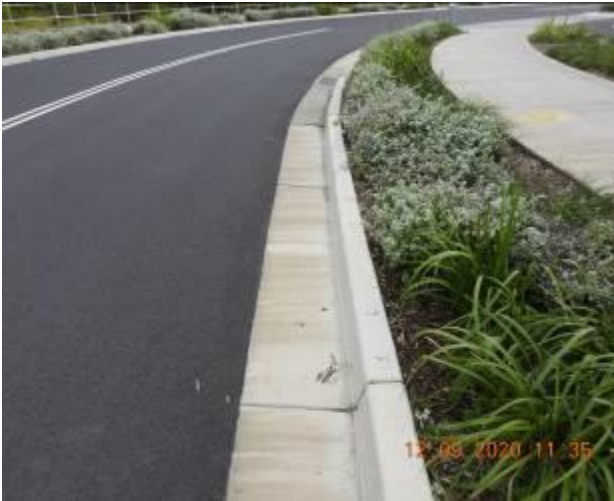
Figure 1203 – General condition of kerb and gutter

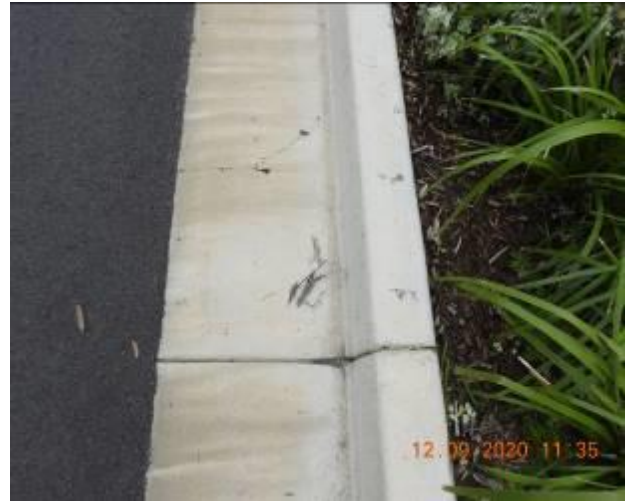
Figure 1204 – Crack propagation and loss of material through kerb and gutter

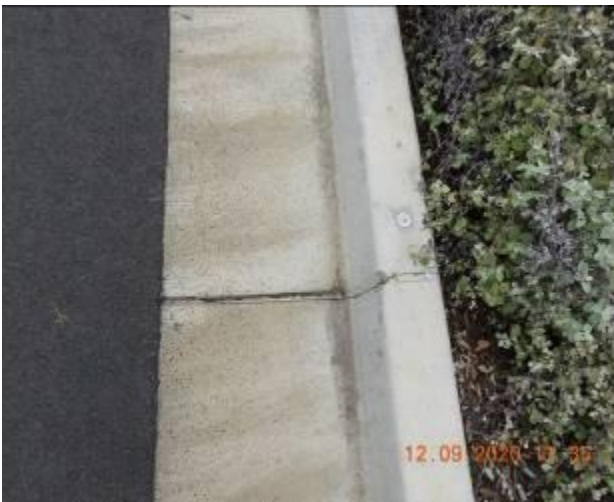
Figure 1205 – Crack propagation and loss of material through kerb and gutter

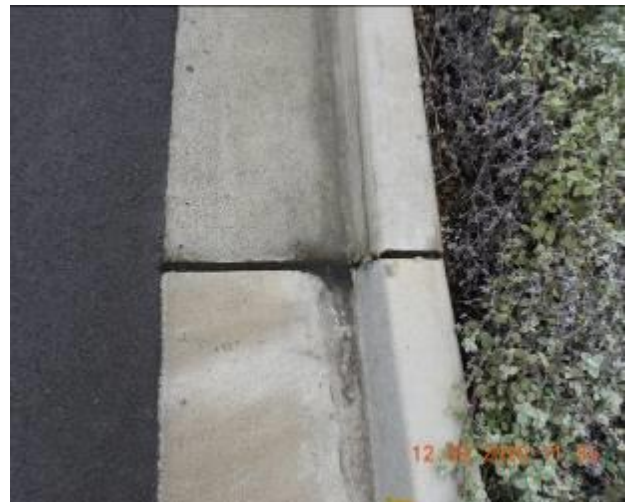
Figure 1206 – Loss of material through kerb and gutter

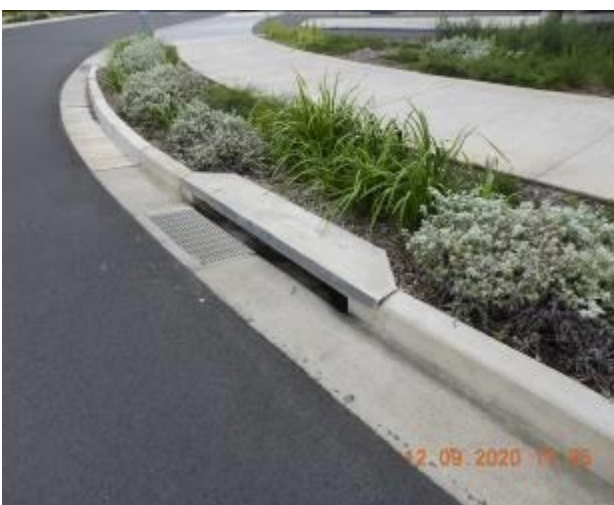
Figure 1207 – General condition of stormwater inlet pit

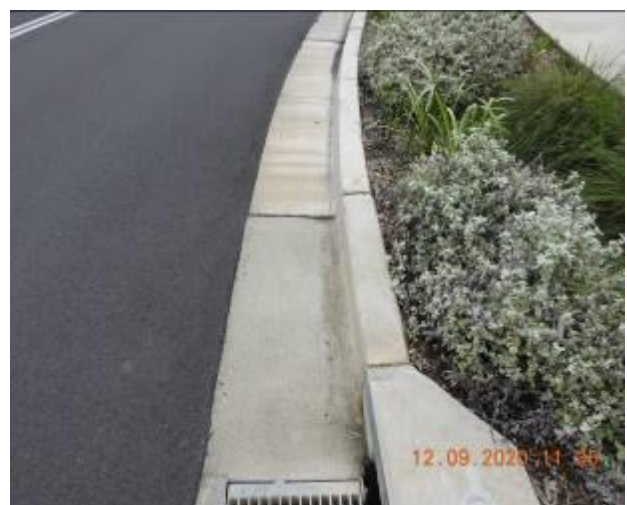
Figure 1208 – Loss of material through kerb

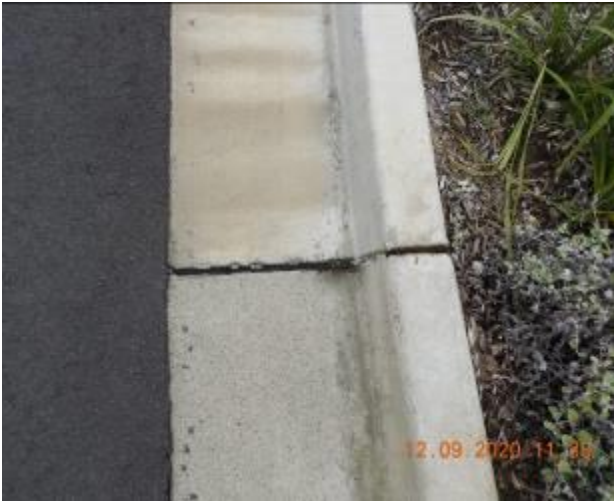
Figure 1209 – Crack propagation and loss of material through kerb and gutter

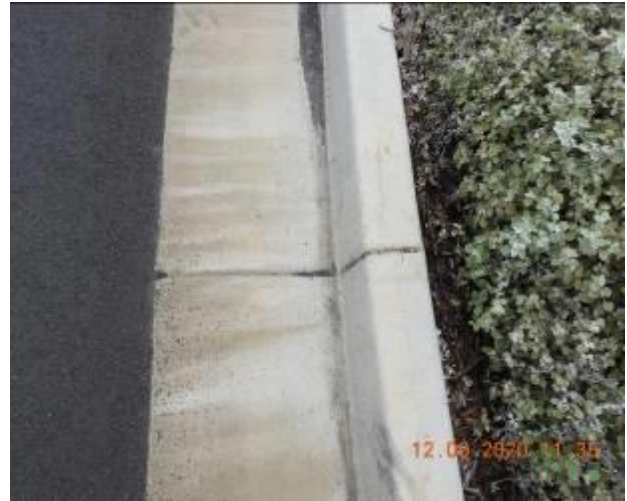
Figure 1210 – Crack propagation and loss of material through kerb

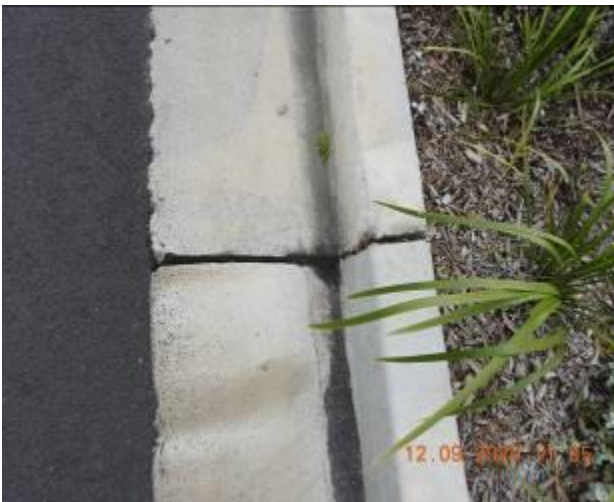
Figure 1211 – Loss of material through kerb
