**2 MANDALA PARADE, CASTLE HILL
(DORAN DRIVE PRECINCT)
PRE-DILAPIDATION REPORT
Of Sydney Metro and Hills Shire Council Assets
DEICORP PROJECTS SHOWGROUND
PTY LTD.**

Job No. 200124.3
07/07/2021

ACE Structural Services Pty Ltd

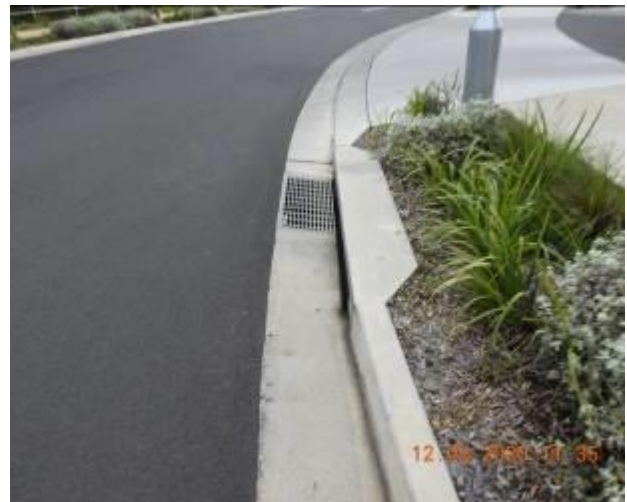
Figure 1212 – General condition of kerb and gutter

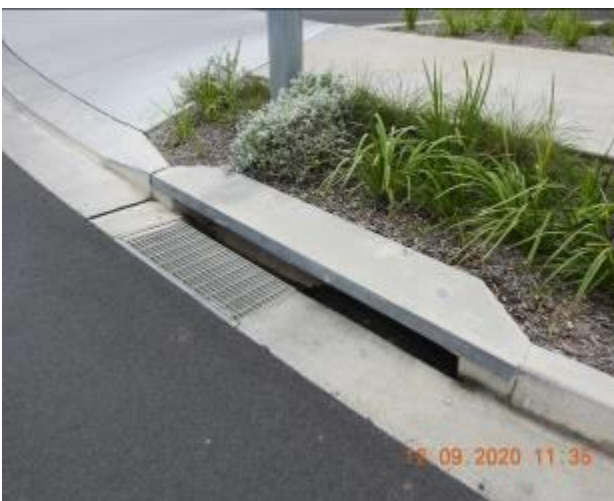
Figure 1213 – General condition of stormwater inlet pit/ Loss of material through kerb and gutter

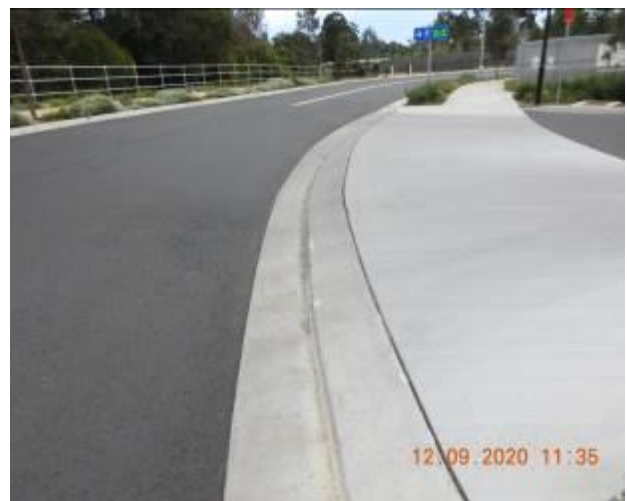
Figure 1214 – General condition of layback and gutter

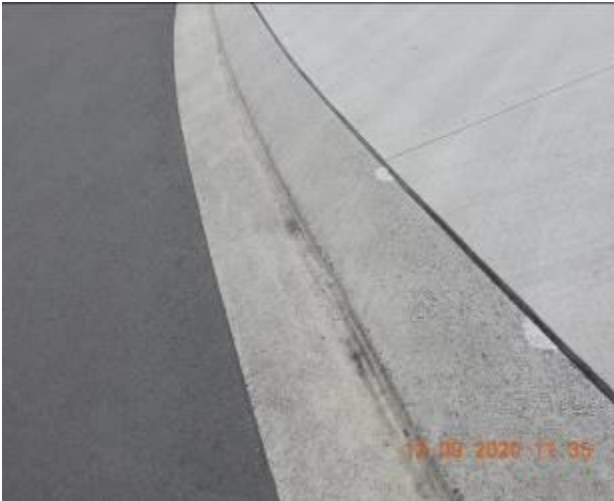
Figure 1215 – Evidence of patchwork through layback

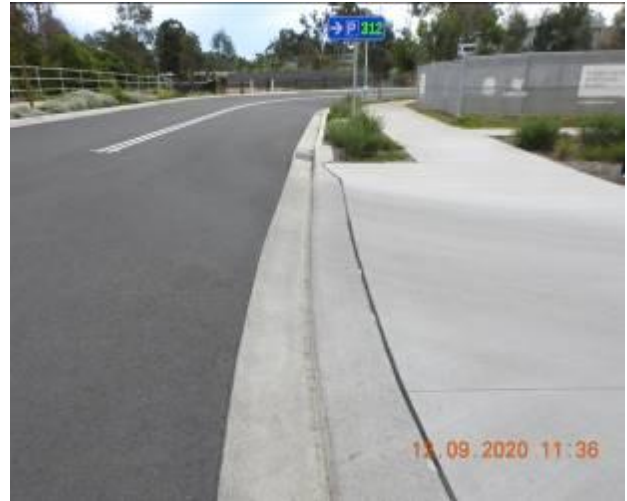
Figure 1216 – General condition of layback and gutter

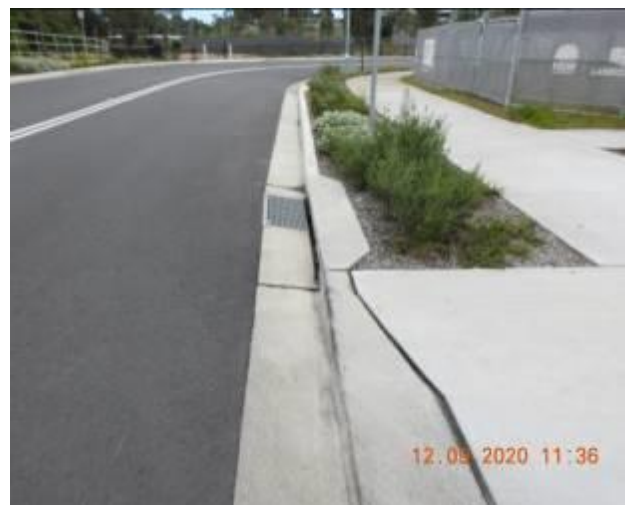
Figure 1218 – General condition of layback and gutter

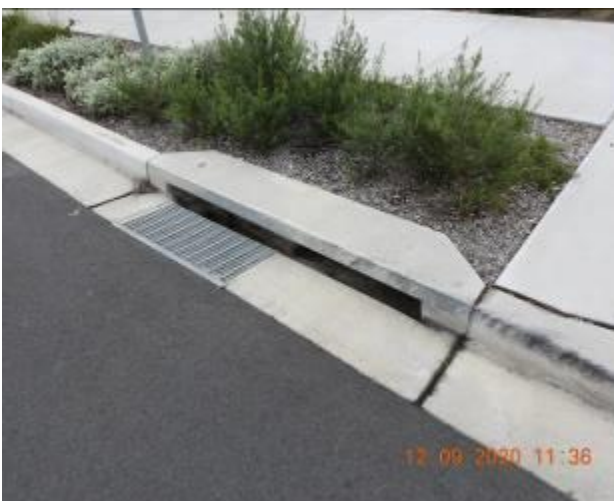
Figure 1219 – General condition of stormwater inlet pit

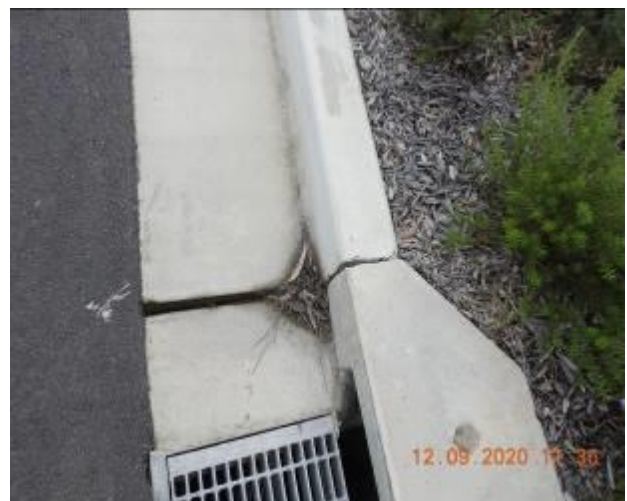
Figure 1220 – Loss of material through kerb

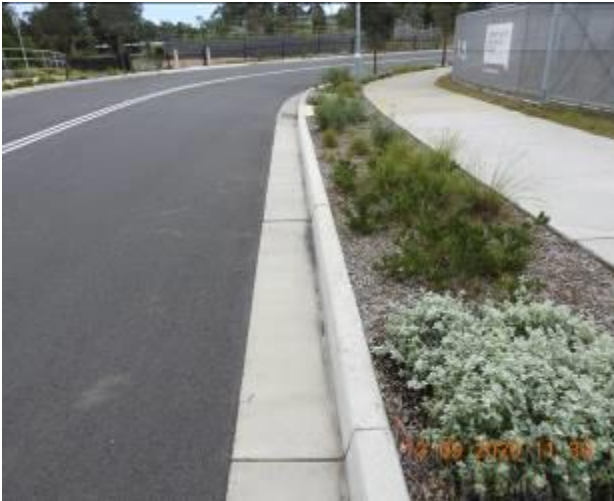
Figure 1221 – General condition of kerb and gutter

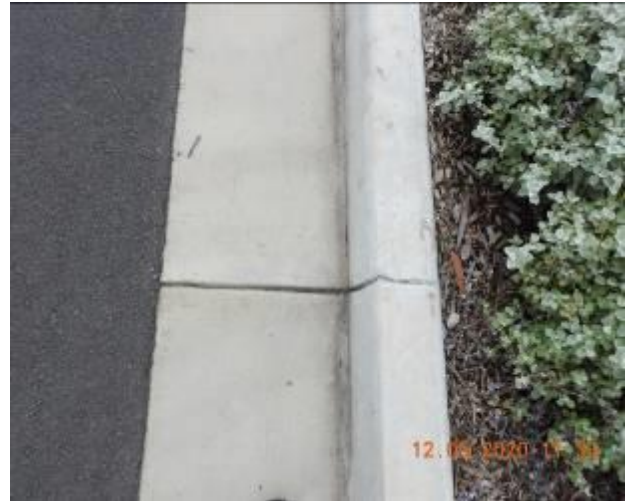
Figure 1222 – Crack propagation and loss of material through kerb and gutter

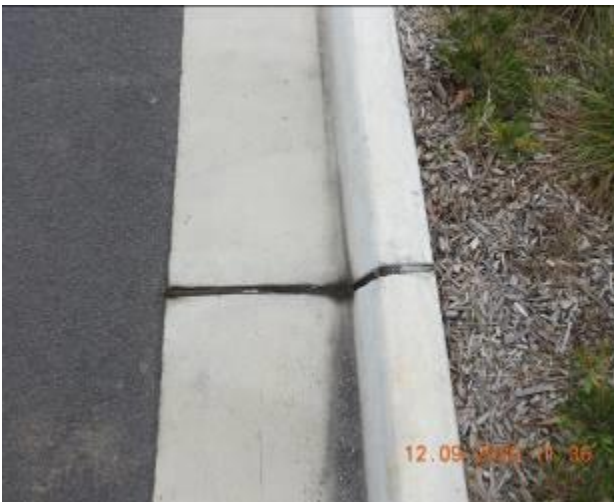
Figure 1223 – Crack propagation and loss of material through kerb and gutter

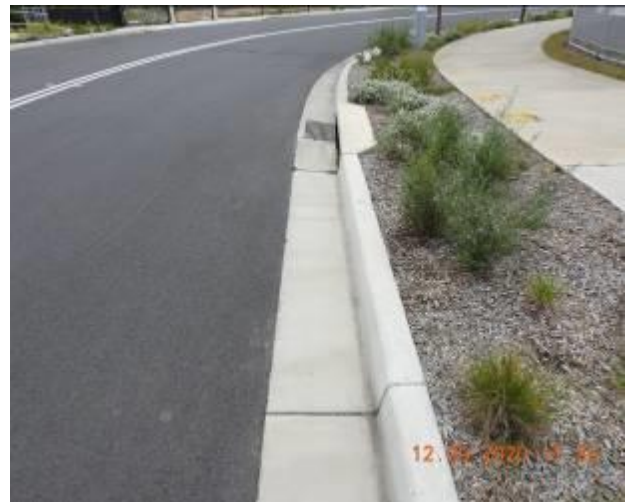
Figure 1224 –General condition of kerb and gutter

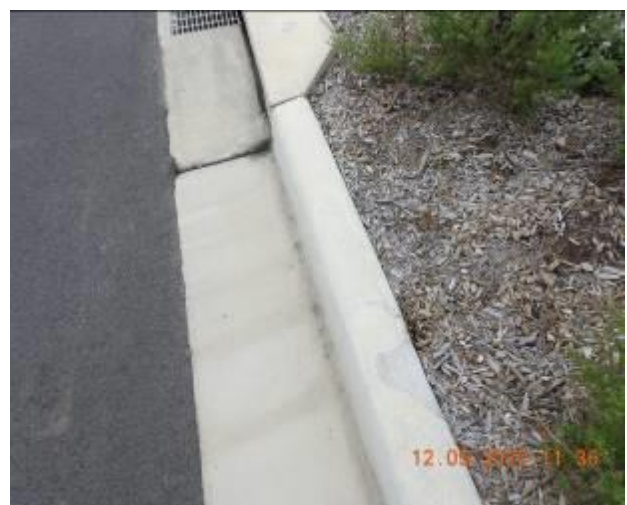
Figure 1226 – Evidence of patchwork and loss of material through kerb and gutter

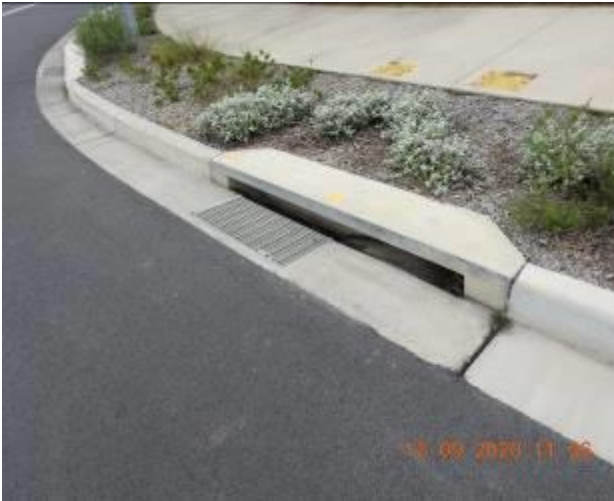
Figure 1227 – General condition of stormwater inlet pit

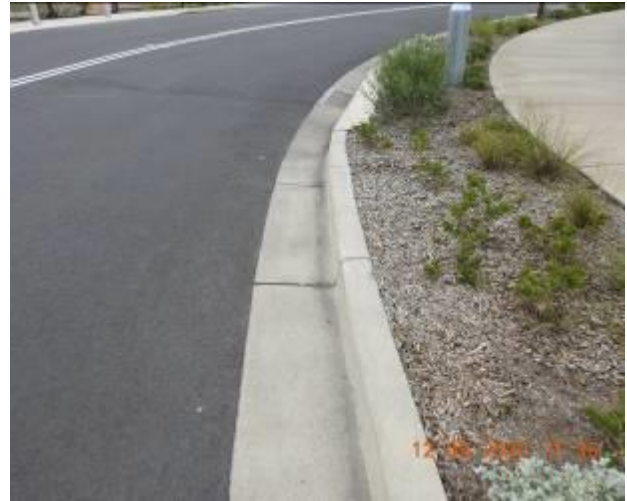
Figure 1228 – General condition of kerb and gutter

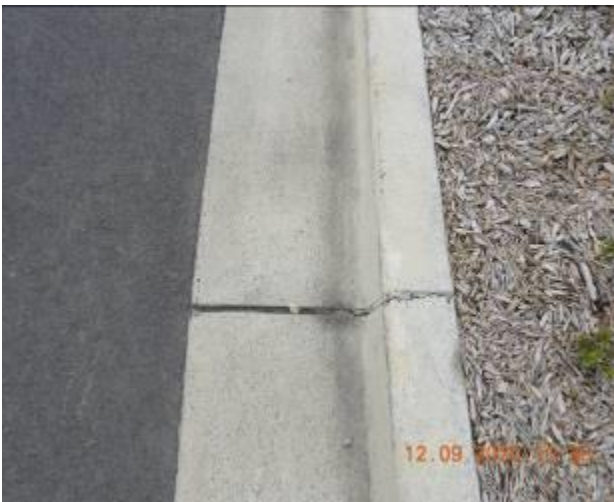
Figure 1229 – Crack propagation and loss of material through kerb and gutter

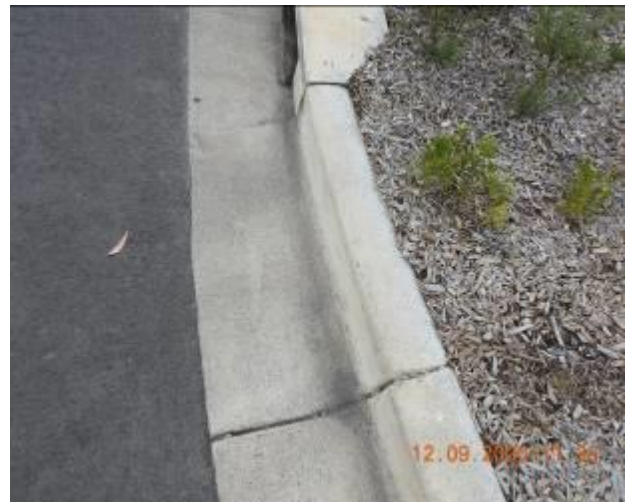
Figure 1230 – Loss of material through kerb and gutter

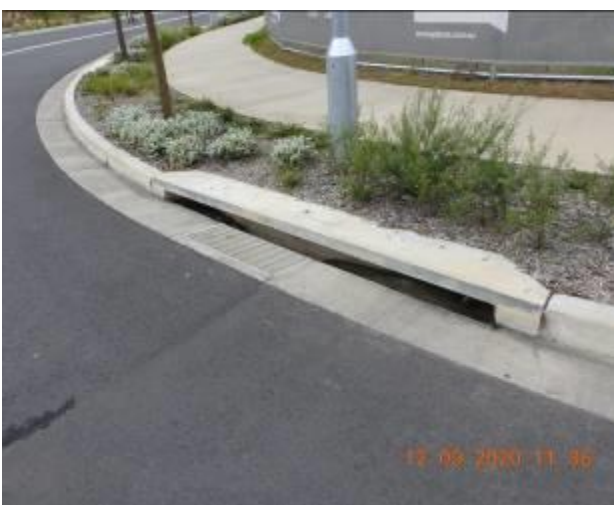
Figure 1231 – General condition of stormwater inlet pit/Crack propagation and loss of material through kerb and gutter

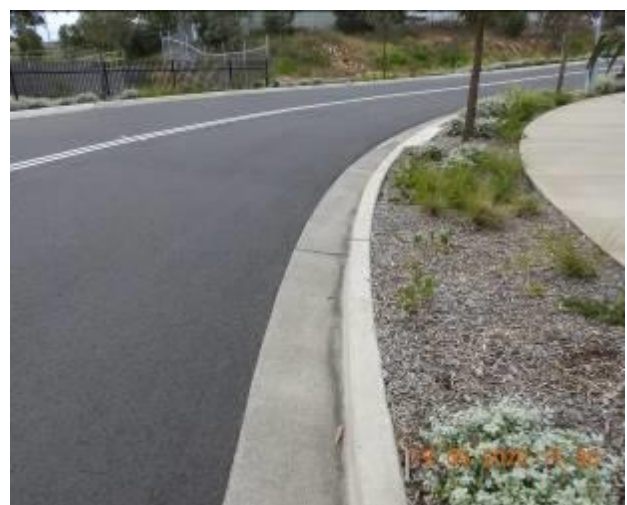
Figure 1232 – General condition of kerb and gutter

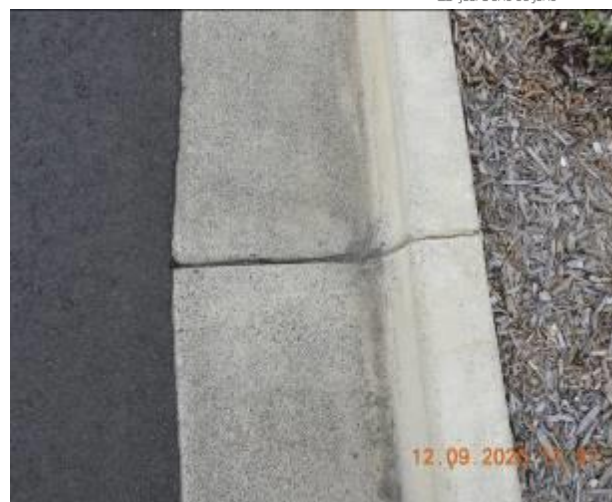
Figure 1234 – Crack propagation and loss of material through kerb and gutter

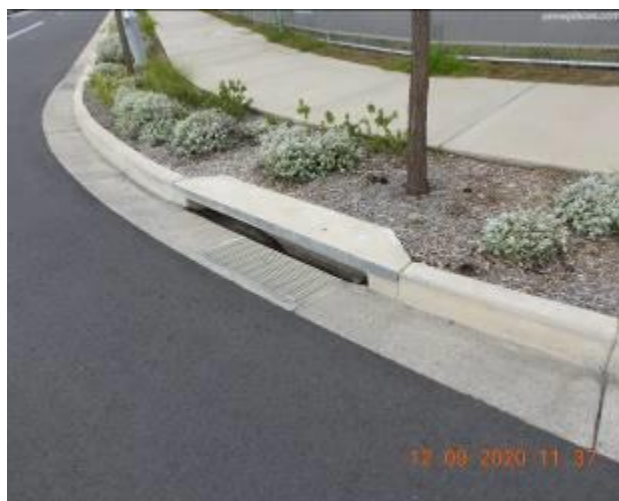
Figure 1235 – Crack propagation and loss of material through kerb and gutter/General condition of stormwater inlet pit

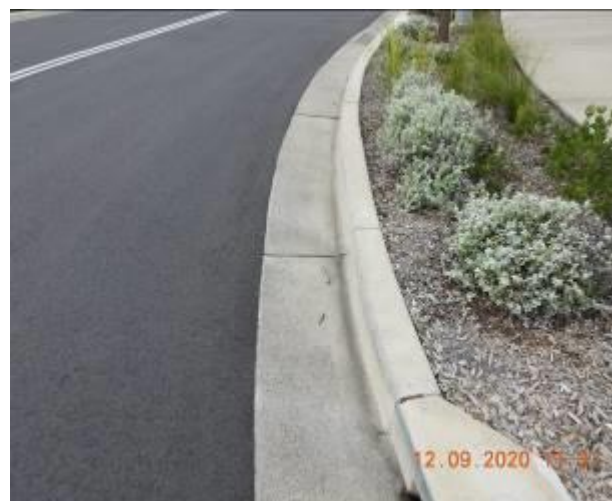
Figure 1236 –General condition of kerb and gutter heading East

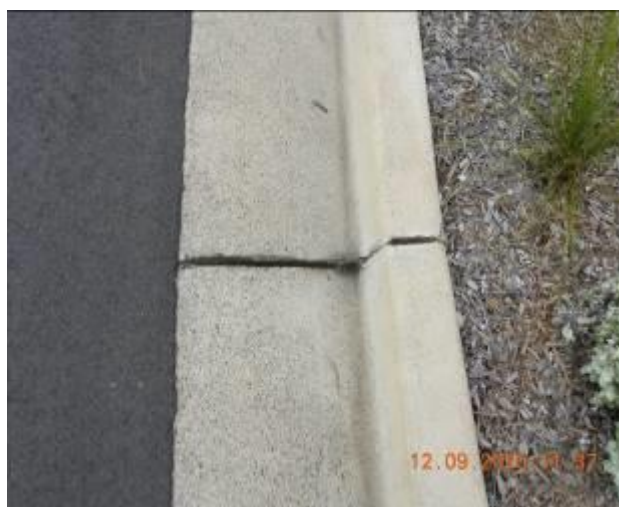
Figure 1237 – Crack propagation and loss of material through kerb and gutter

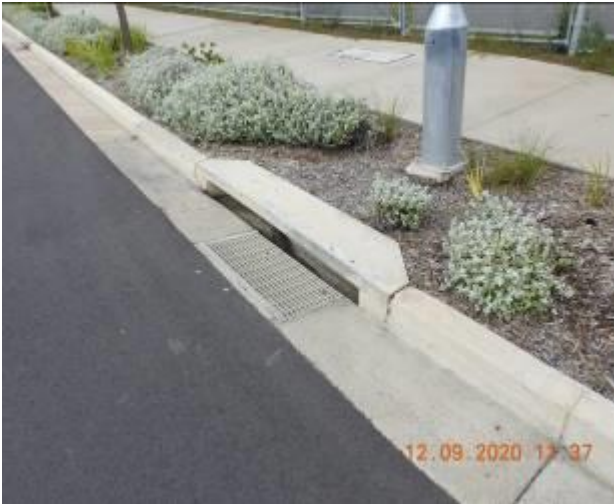
Figure 1239 – General condition of stormwater inlet pit /Loss of material through kerb

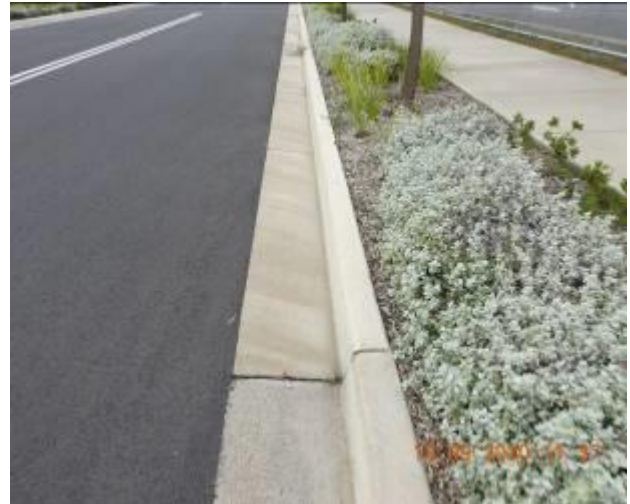
Figure 1240 – General condition of kerb and gutter

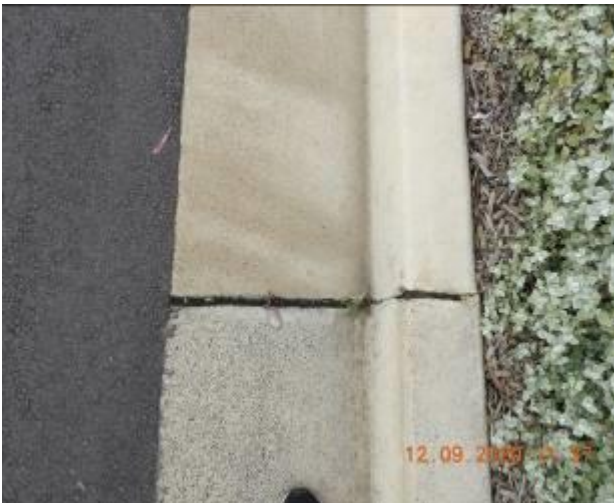
Figure 1241 – Crack propagation and loss of material through kerb and gutter

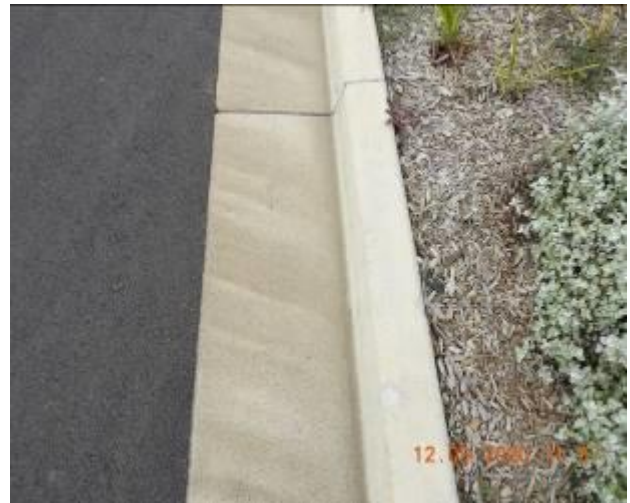
Figure 1242 – Evidence of patchwork through kerb

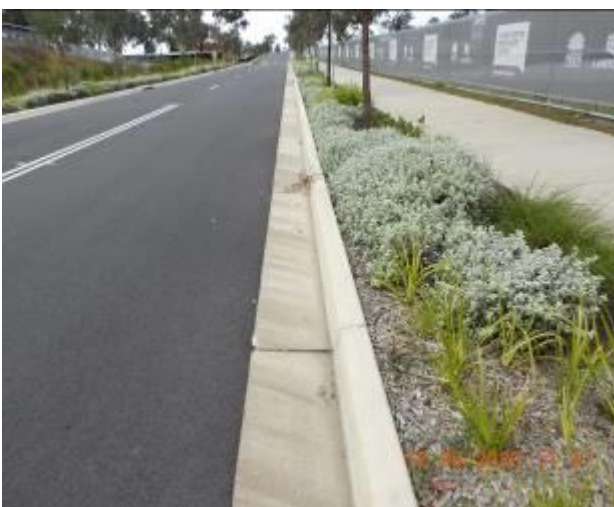
Figure 1243 – General condition of kerb and gutter

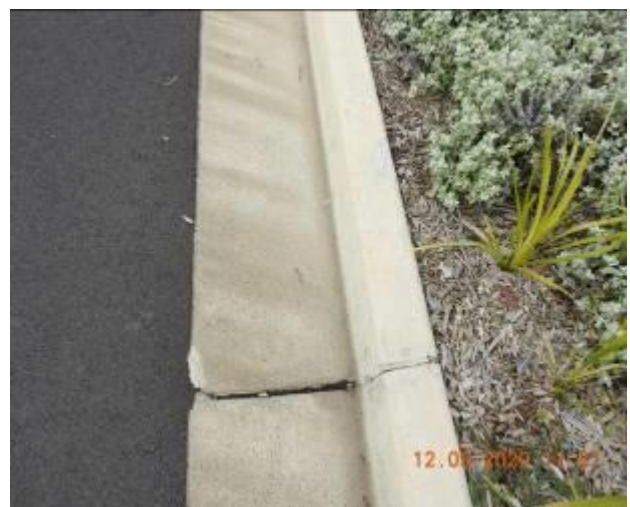
Figure 1244 – Crack propagation and loss of material through kerb and gutter

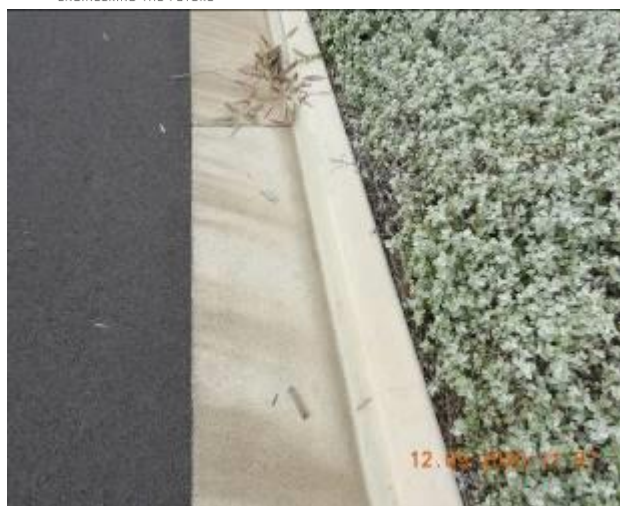
Figure 1245 – Crack propagation through kerb

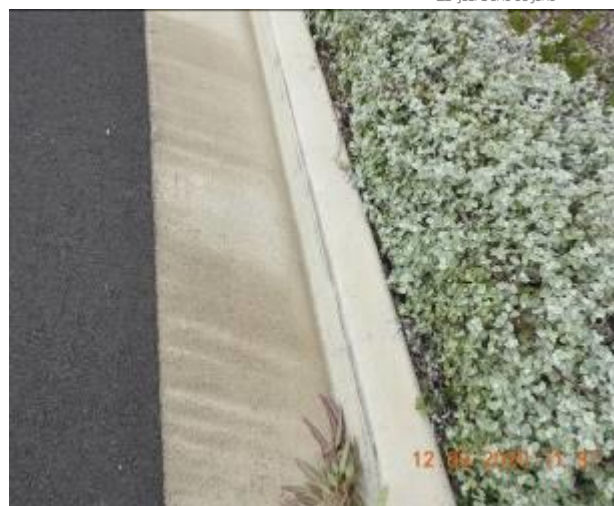
Figure 1246 – Crack propagation through kerb

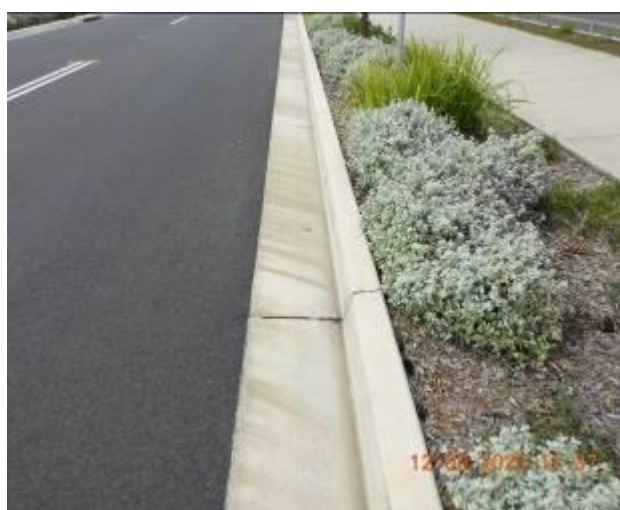
Figure 1247 – General condition of kerb and gutter

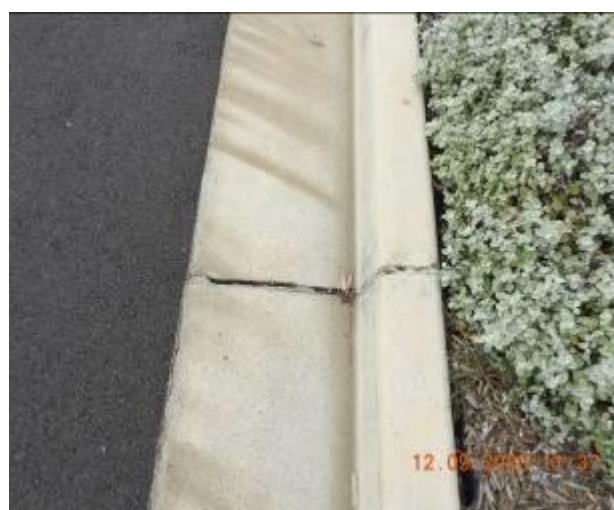
Figure 1248 – Crack propagation and loss of material through kerb and gutter

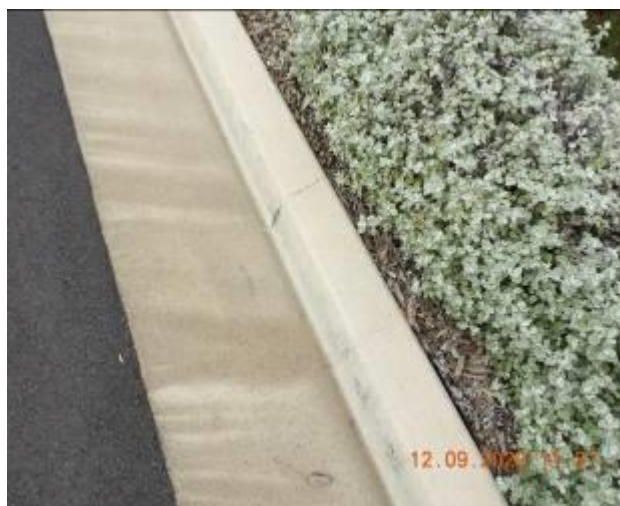
Figure 1249 – Crack propagation and loss of material through kerb and gutter

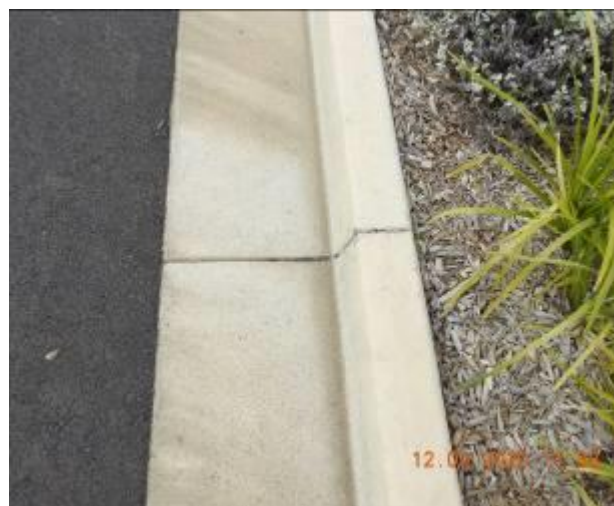
Figure 1250 – Crack propagation and loss of material through kerb and gutter

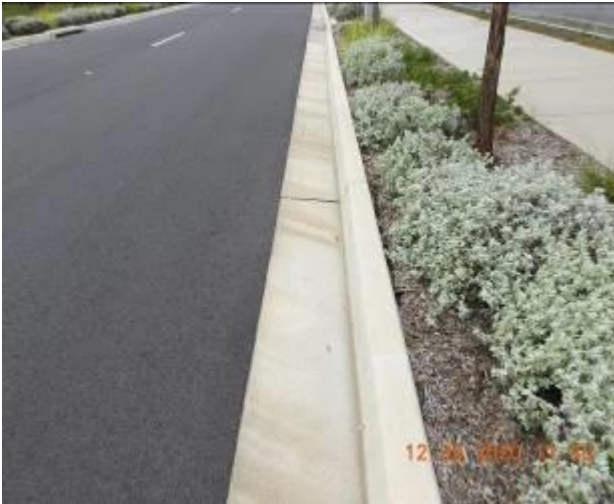
Figure 1251 – General condition of kerb and gutter

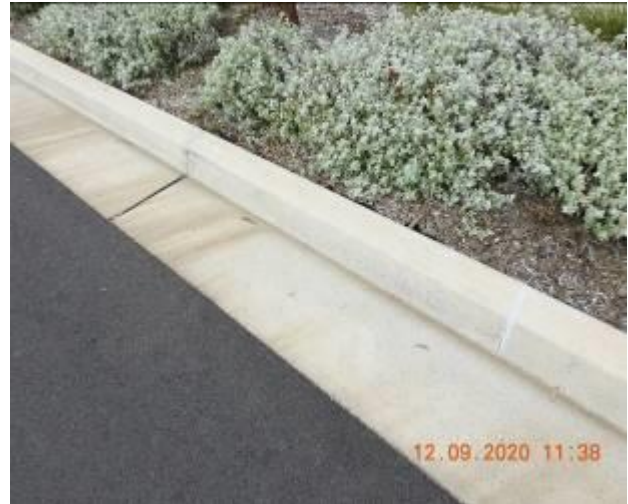
Figure 1252 – Hairline crack propagation through kerb

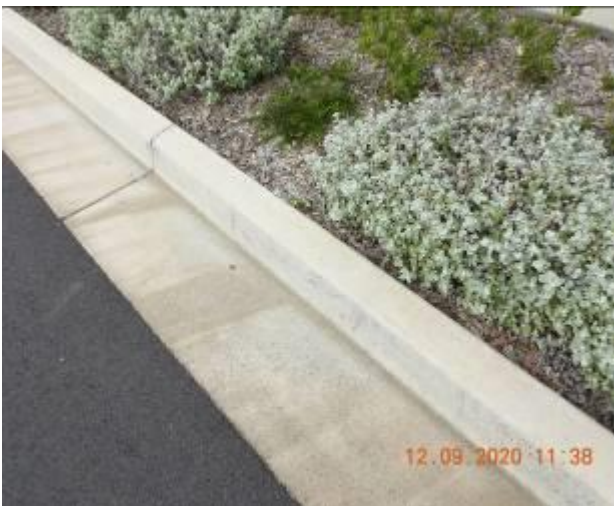
Figure 1253 – Hairline crack propagation through kerb

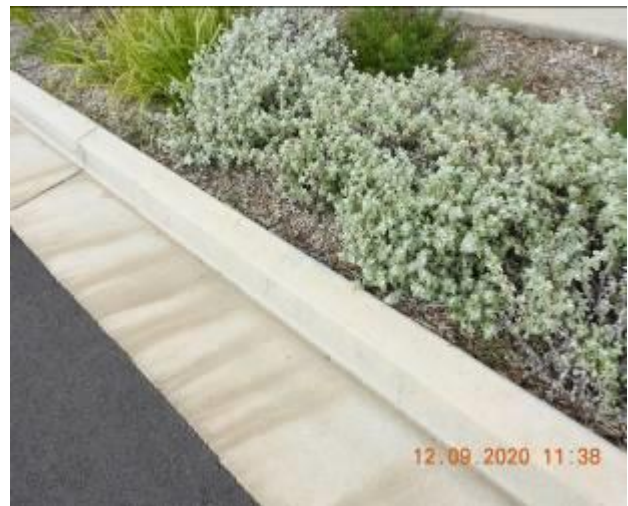
Figure 1254 – Hairline crack propagation through kerb

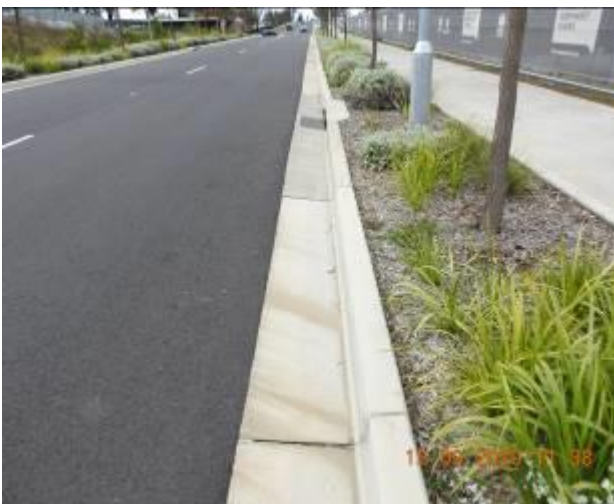
Figure 1255 – General condition of kerb and gutter

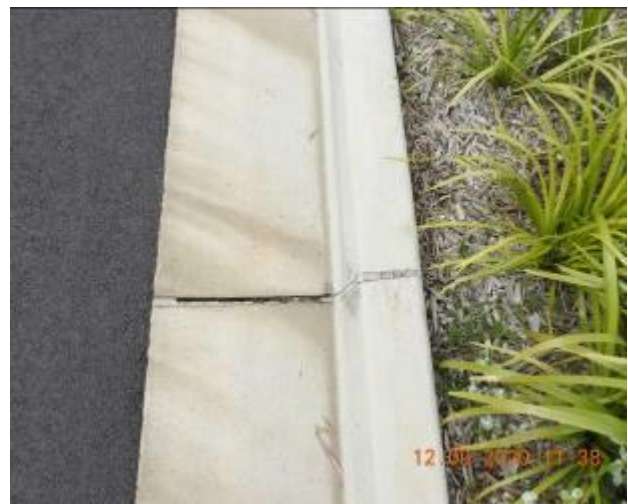
Figure 1256 – Loss of material through kerb and gutter

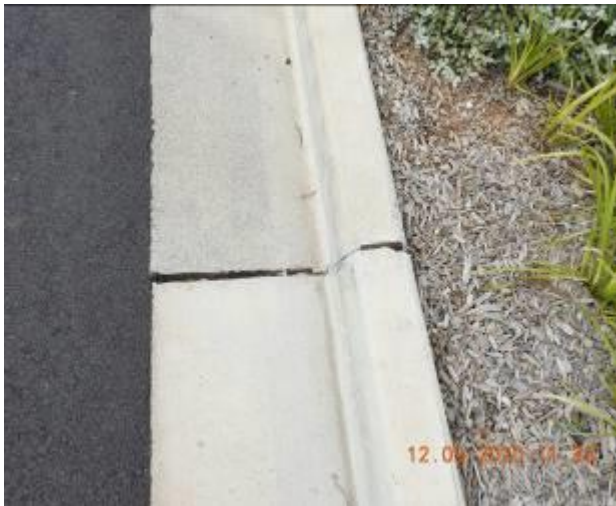
Figure 1257 – Loss of material through curb and gutter

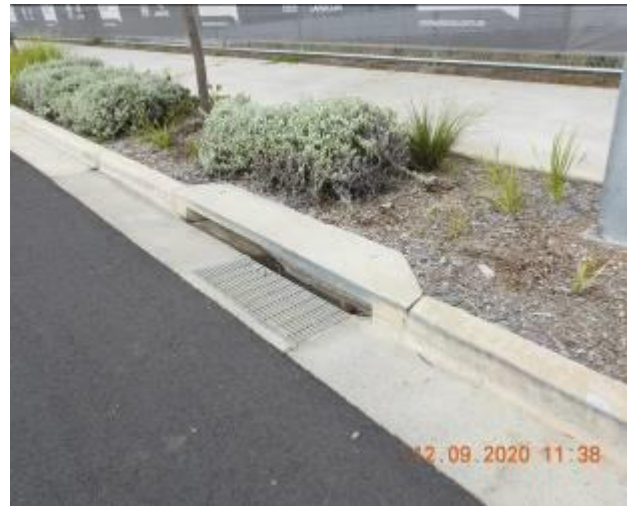
Figure 1258 – General condition of stormwater inlet pit/Loss of material through curb

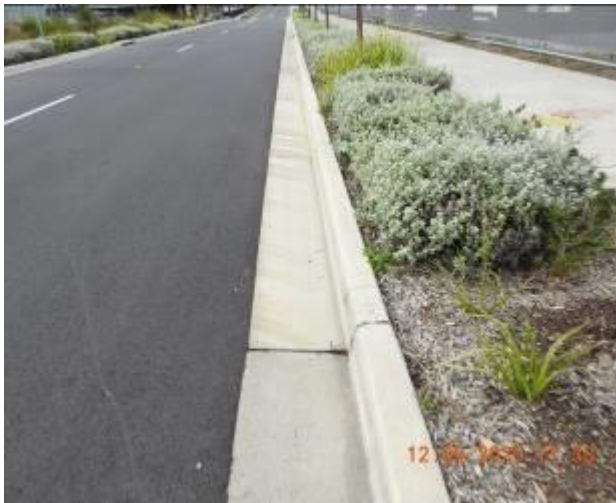
Figure 1259 – General condition of curb and gutter

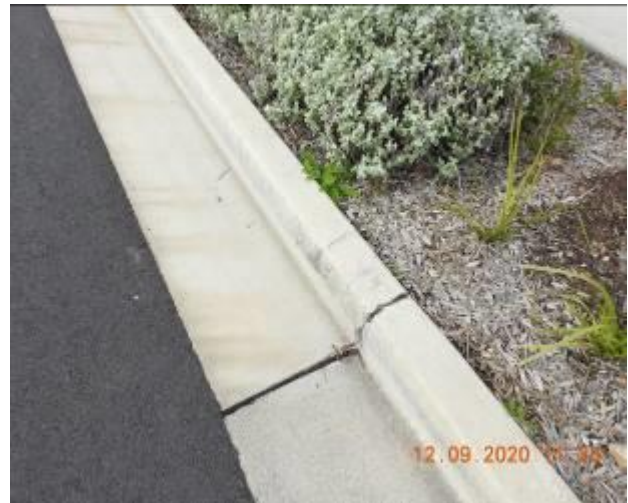
Figure 1260 – Crack propagation and loss of material through curb and gutter

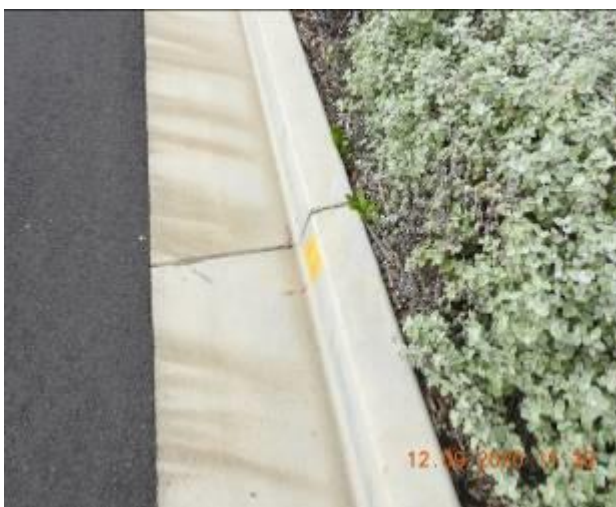
Figure 1261 – Crack propagation and loss of material through curb and gutter

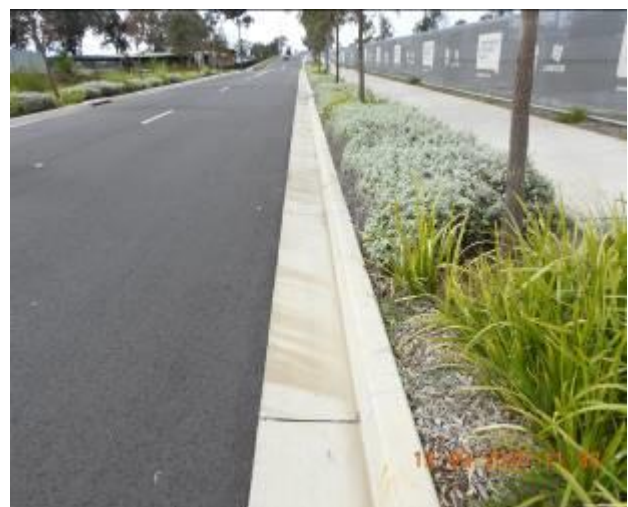
Figure 1262 – General condition of curb and gutter

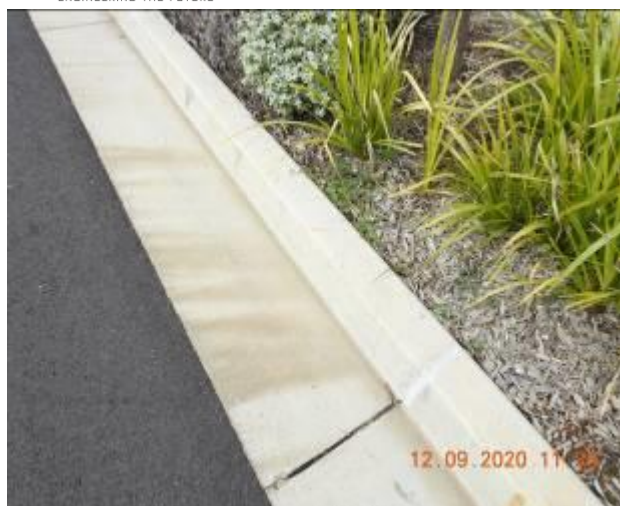
Figure 1263 – Hairline crack propagation through kerb

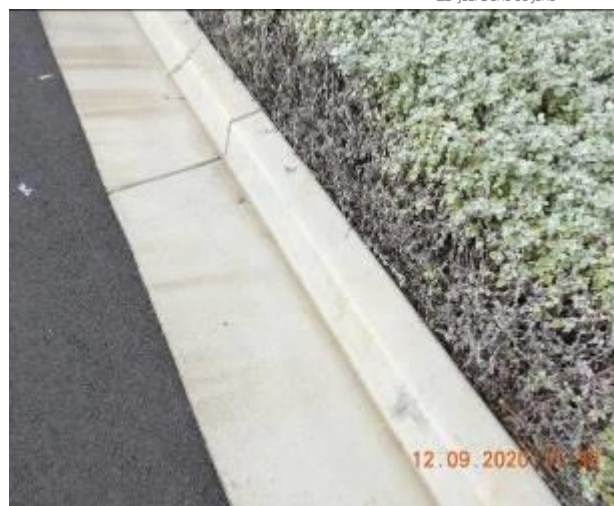
Figure 1264 – Crack propagation through kerb

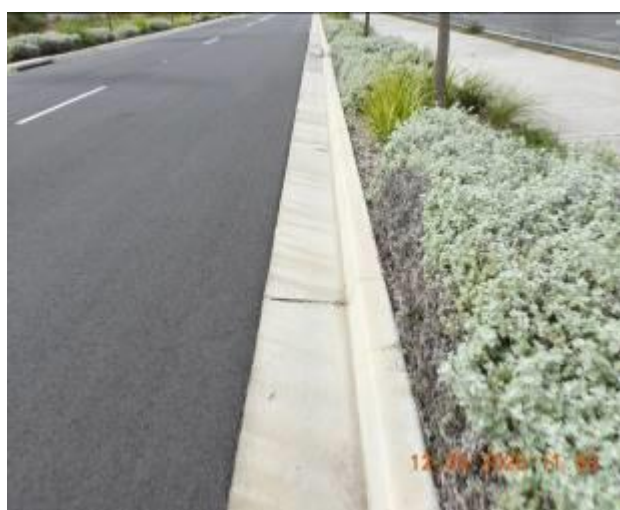
Figure 1265 – General condition of kerb and gutter

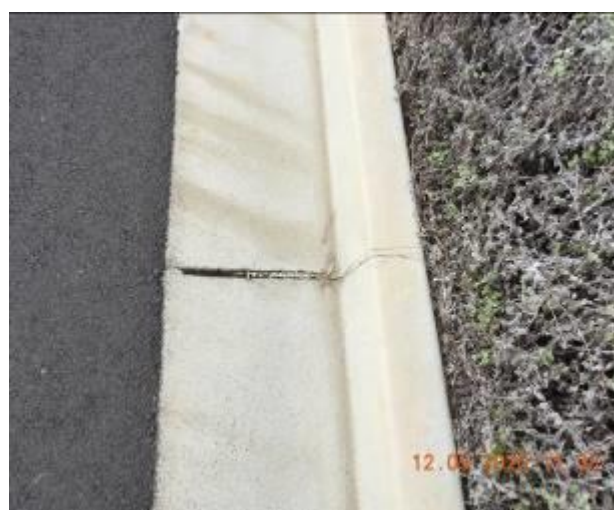
Figure 1266 – Crack propagation and loss of material through kerb and gutter

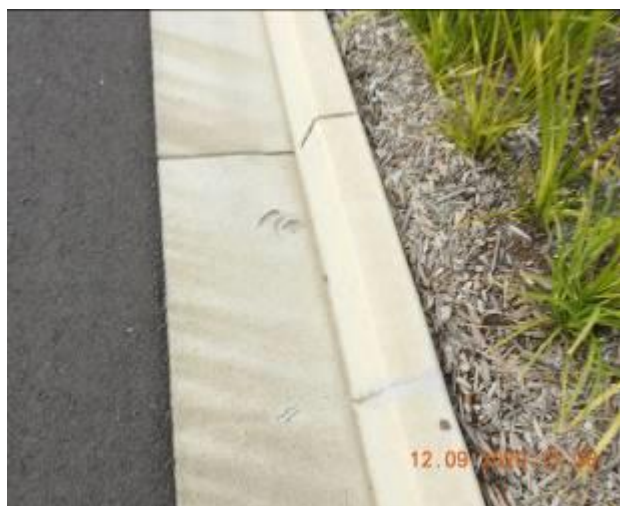
Figure 1267 – Crack propagation and loss of material through kerb and gutter

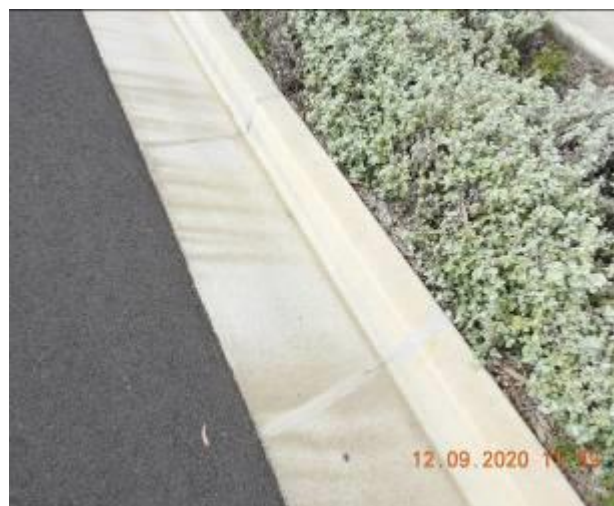
Figure 1268 – Crack propagation and loss of material through kerb and gutter

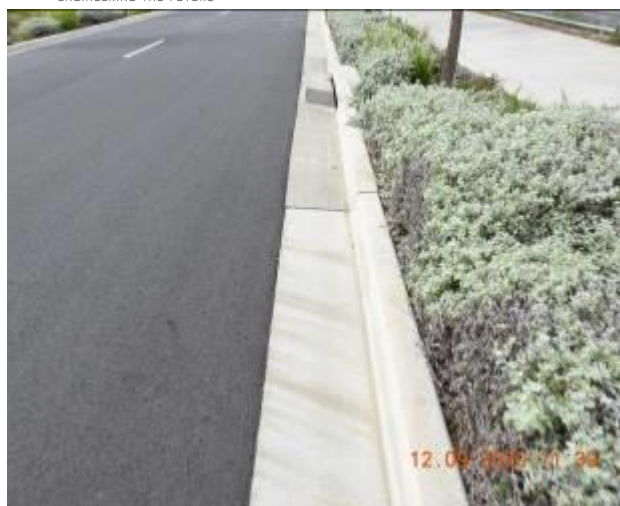
Figure 1269 – General condition of kerb and gutter

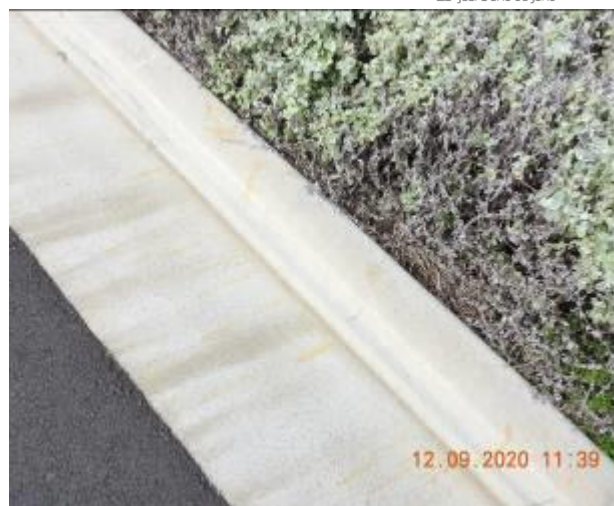
Figure 1270 – Hairline crack propagation through kerb

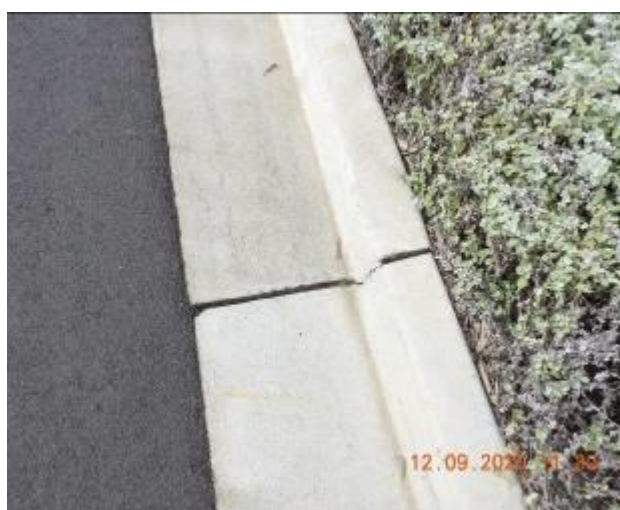
Figure 1271 – Loss of material through kerb and gutter

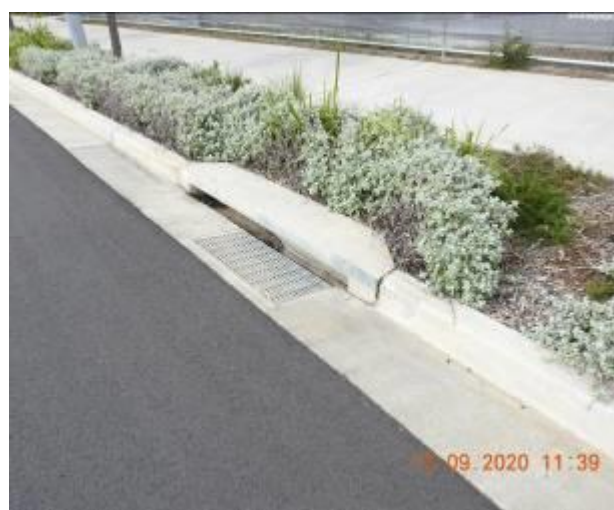
Figure 1272 – General condition of stormwater inlet pit/ Loss of material through kerb

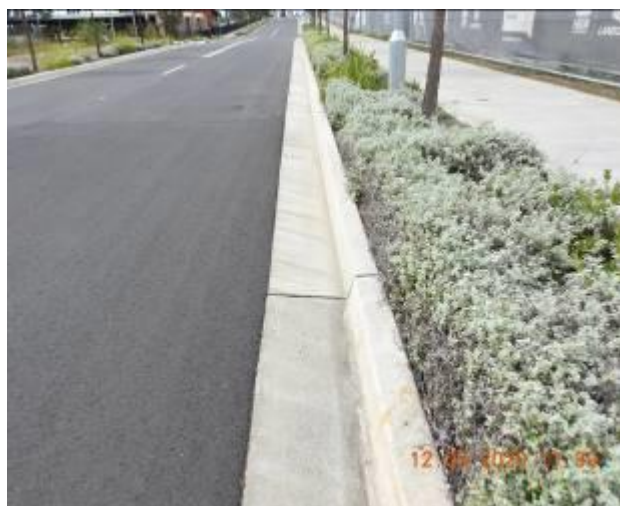
Figure 1273 – General condition of kerb and gutter

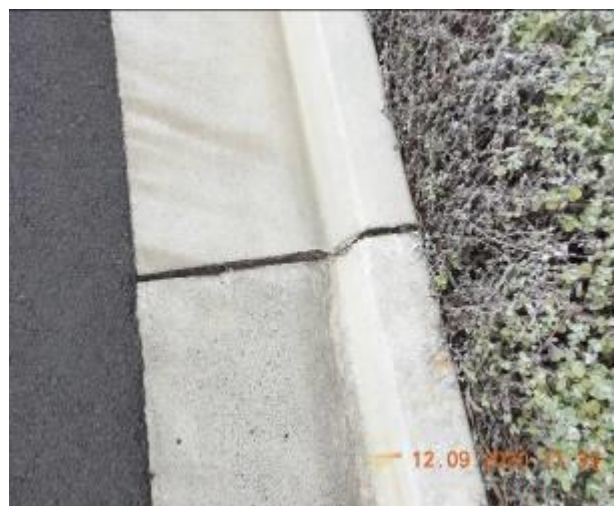
Figure 1274 – Loss of material through kerb and gutter

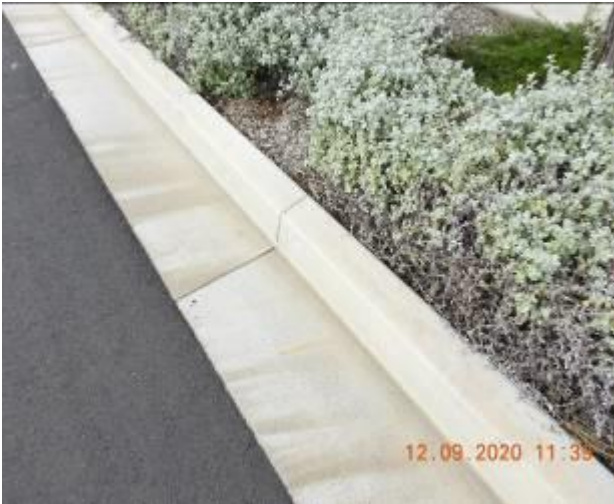
Figure 1275 – Crack propagation and loss of material through kerb and gutter

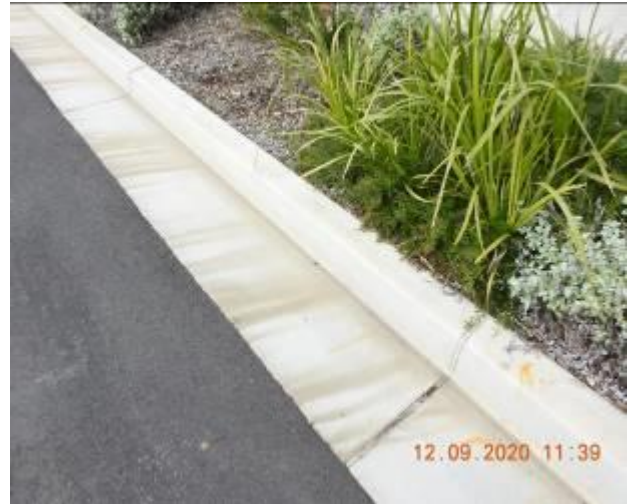
Figure 1276 – Loss of material through gutter

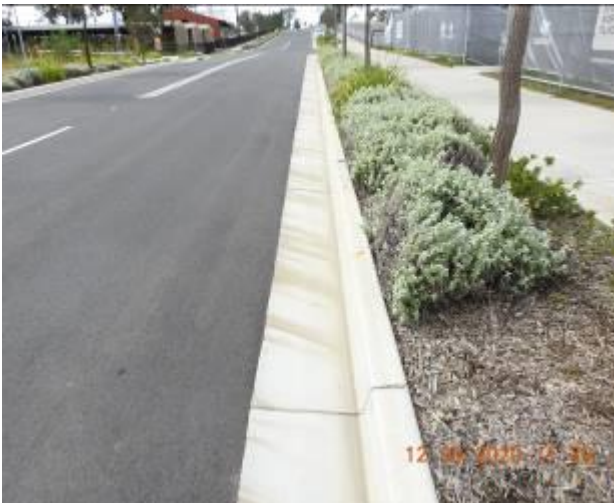
Figure 1277 – General condition of kerb and gutter

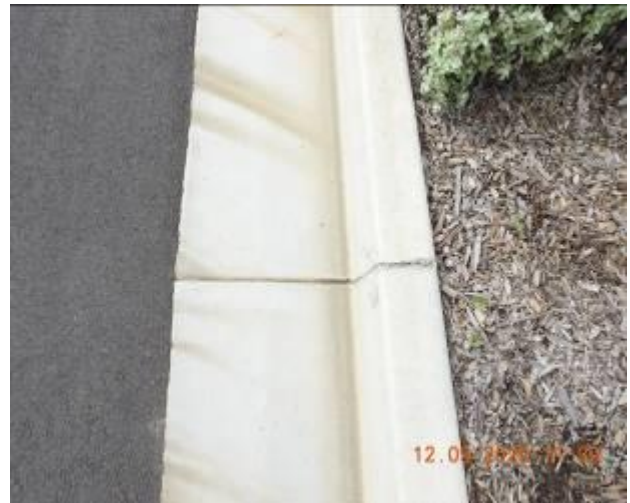
Figure 1278 – Crack propagation and loss of material through kerb and gutter

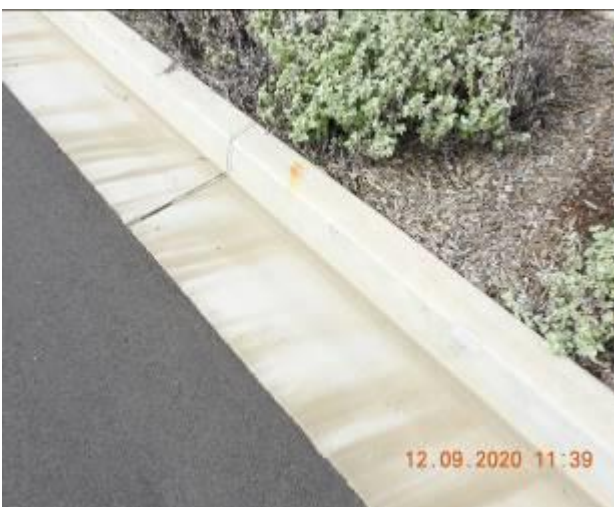
Figure 1279 – Evidence of patchwork and loss of material through kerb and gutter

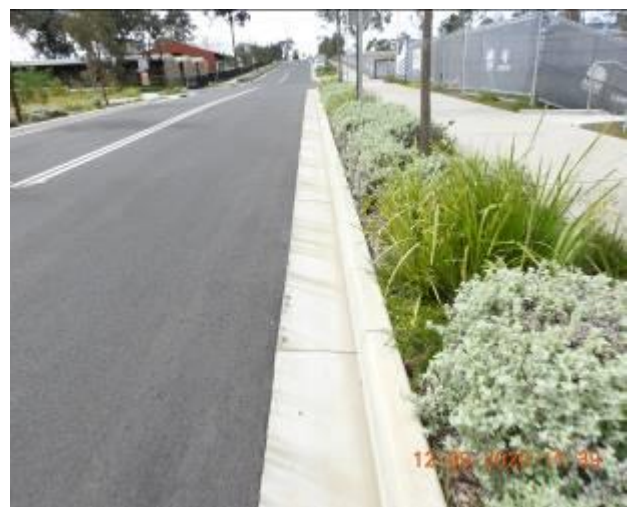
Figure 1280 – General condition of kerb and gutter

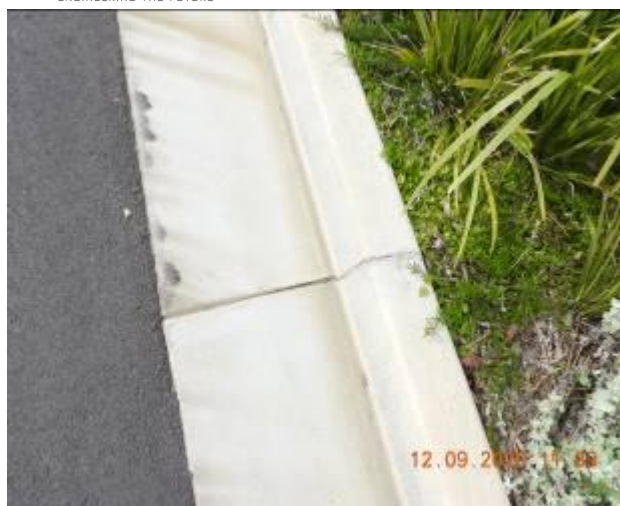
Figure 1281 – Crack propagation and loss of material through kerb and gutter

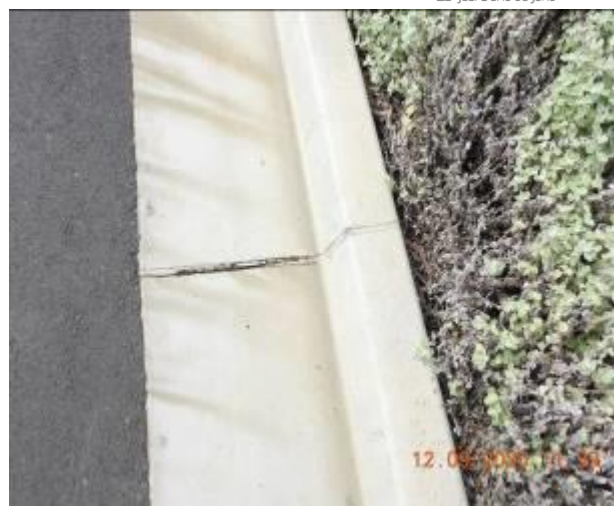
Figure 1282 – Crack propagation and loss of material through kerb and gutter

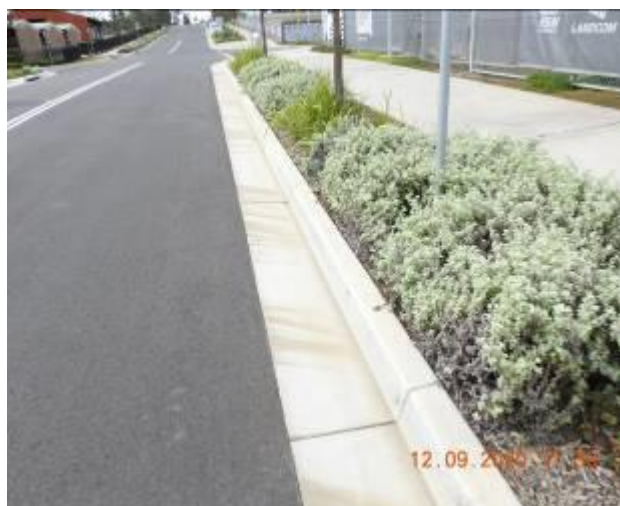
Figure 1283 – General condition of kerb and gutter

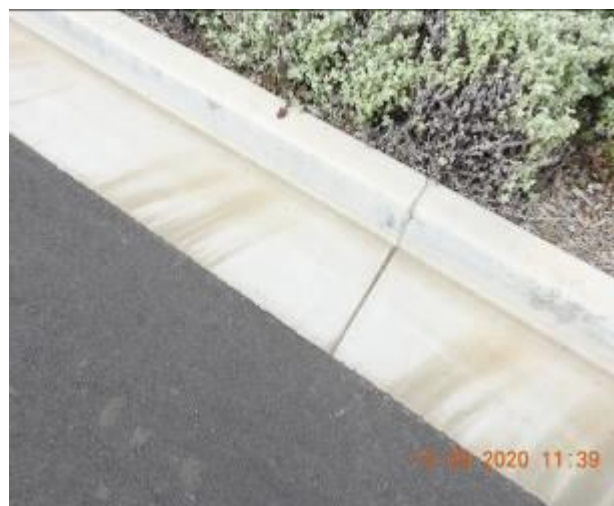
Figure 1284 – Crack propagation and loss of material through kerb and gutter

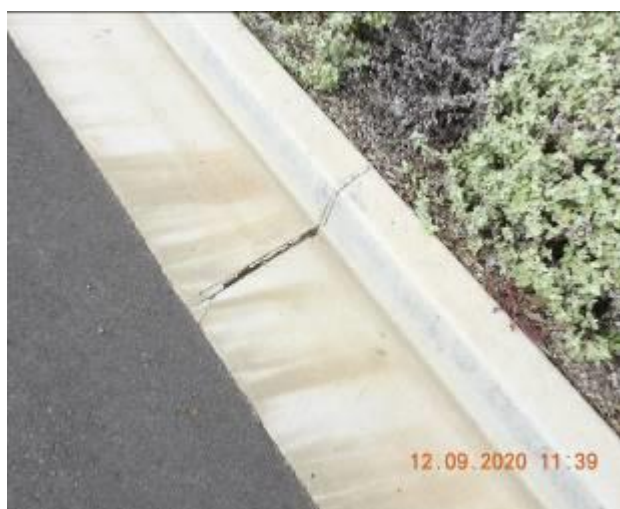
Figure 1285 – Loss of material through kerb and gutter
