**2 MANDALA PARADE, CASTLE HILL
(DORAN DRIVE PRECINCT)
PRE-DILAPIDATION REPORT
Of Sydney Metro and Hills Shire Council Assets
DEICORP PROJECTS SHOWGROUND
PTY LTD.**

Job No. 200124.3
07/07/2021

ACE Structural Services Pty Ltd

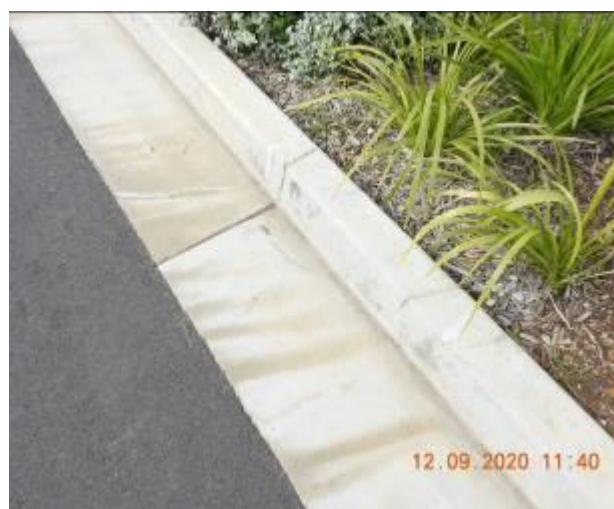
Figure 1286 – Crack propagation and loss of material through kerb and gutter

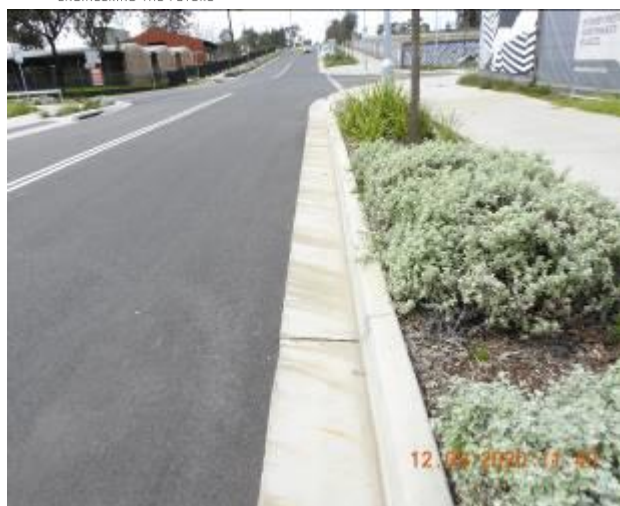
Figure 1287 – General condition of kerb and gutter

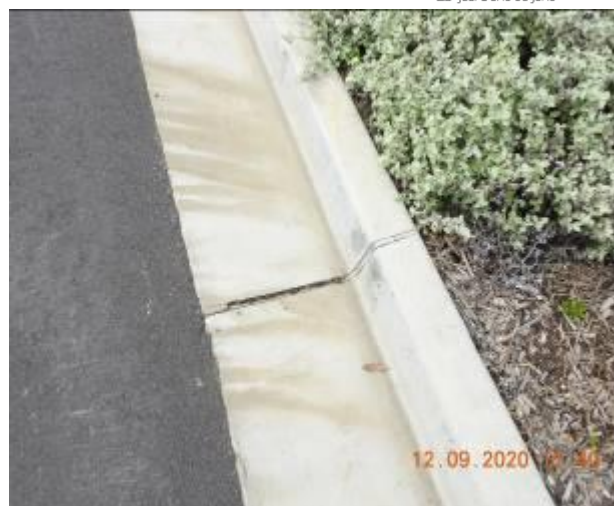
Figure 1288 – Crack propagation and loss of material through kerb and gutter

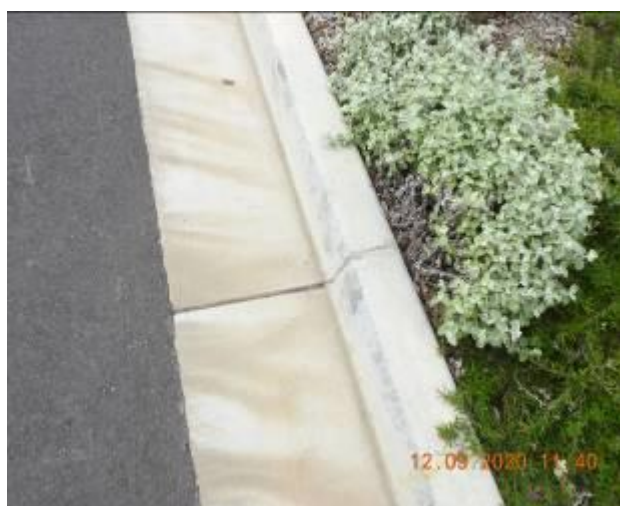
Figure 1289 – Crack propagation and loss of material through kerb and gutter

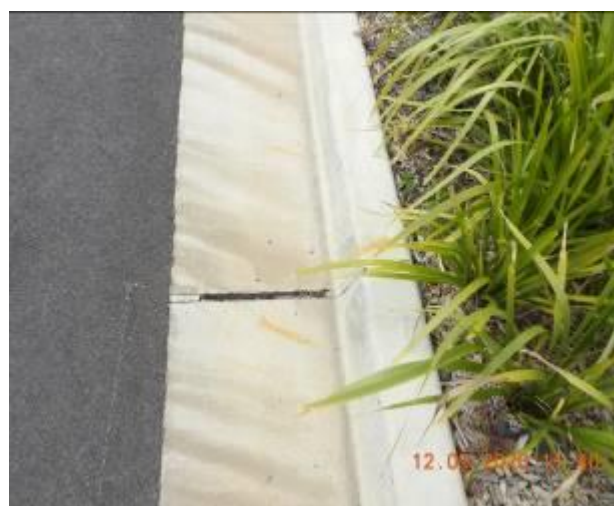
Figure 1290 – Loss of material through kerb and gutter

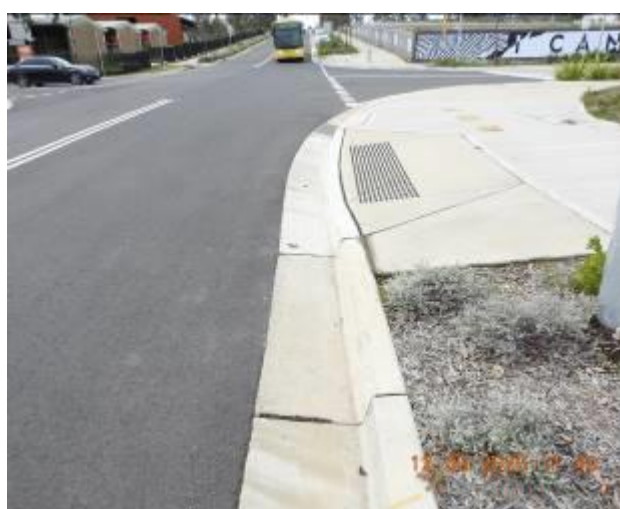
Figure 1291 – General condition of kerb and gutter

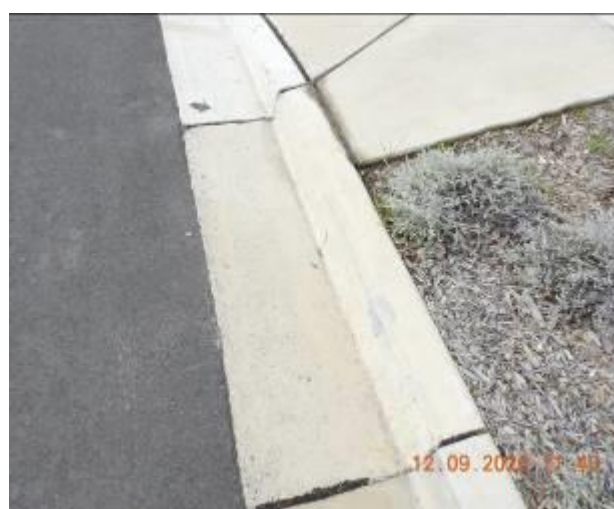
Figure 1292 – Evidence of patchwork and loss of material through kerb and gutter

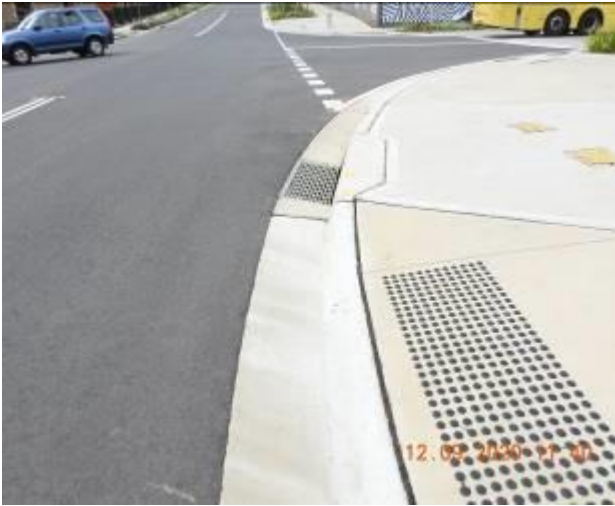
Figure 1293 – General condition of layback and gutter

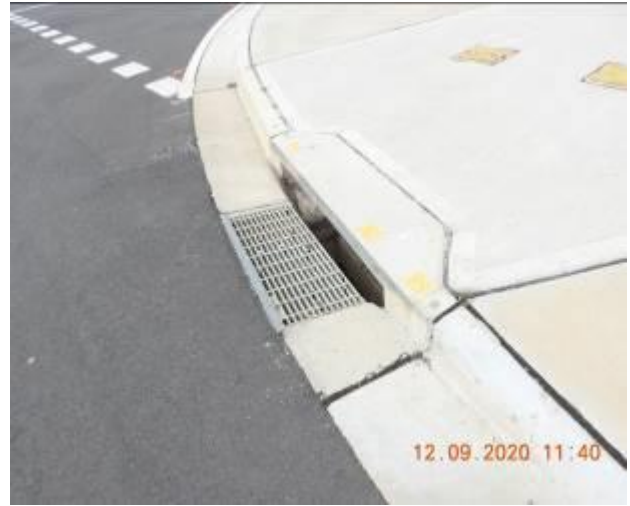
Figure 1294 – General condition of stormwater inlet pit/Crack propagation and loss of material through kerb and gutter

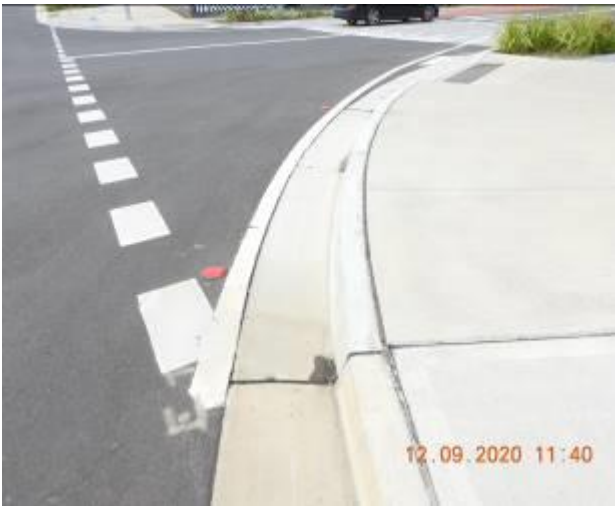
Figure 1295 – General condition of kerb and gutter

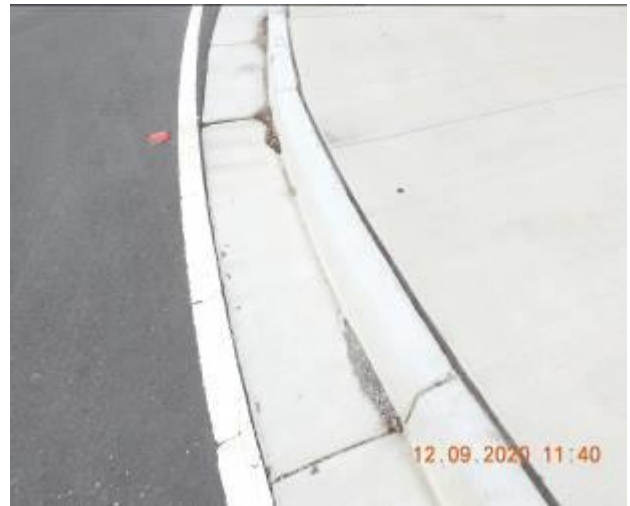
Figure 1296 – Crack propagation and loss of material through kerb and gutter

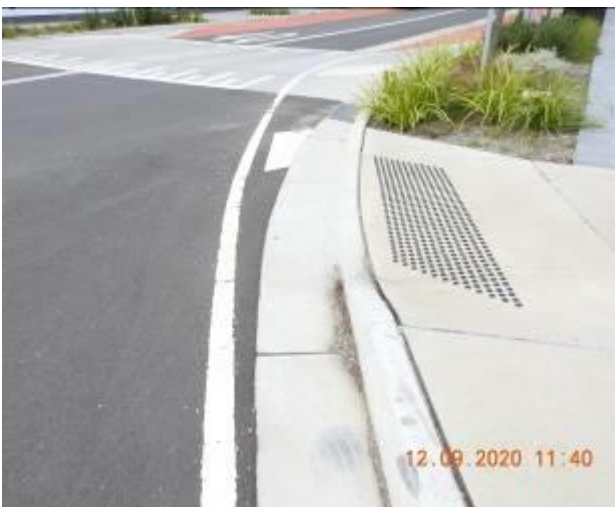
Figure 1297 – General condition of kerb and gutter

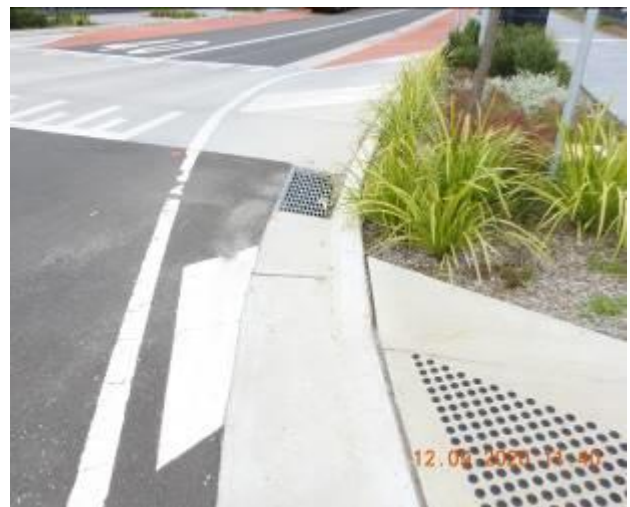
Figure 1298 – General condition of kerb and gutter

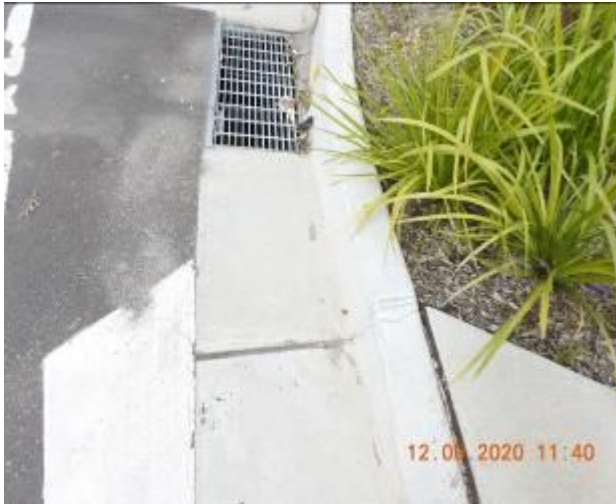
Figure 1299 – Crack propagation through kerb

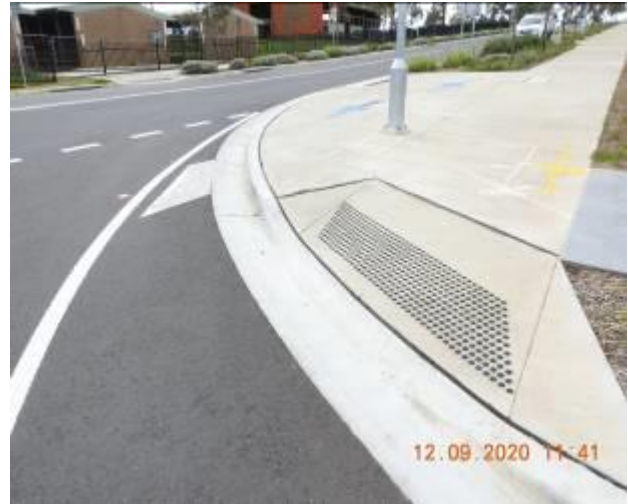
Figure 1300 – General condition of layback and gutter

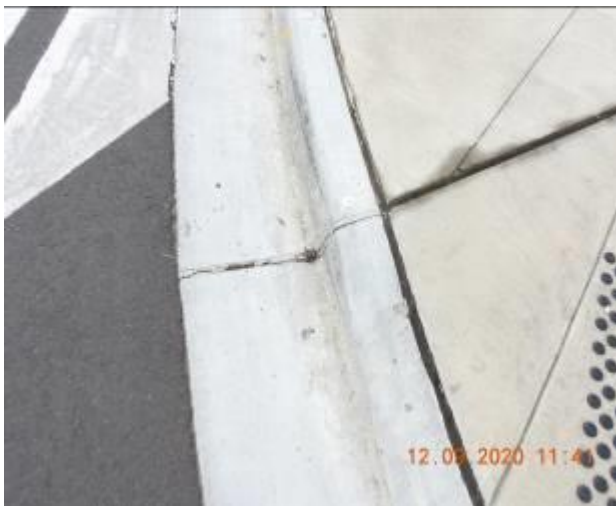
Figure 1301 – Crack propagation and loss of material through kerb and gutter

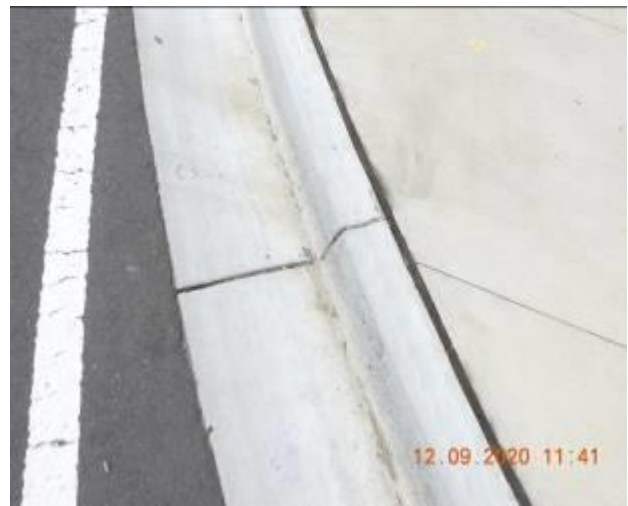
Figure 1302 – Crack propagation and loss of material through kerb

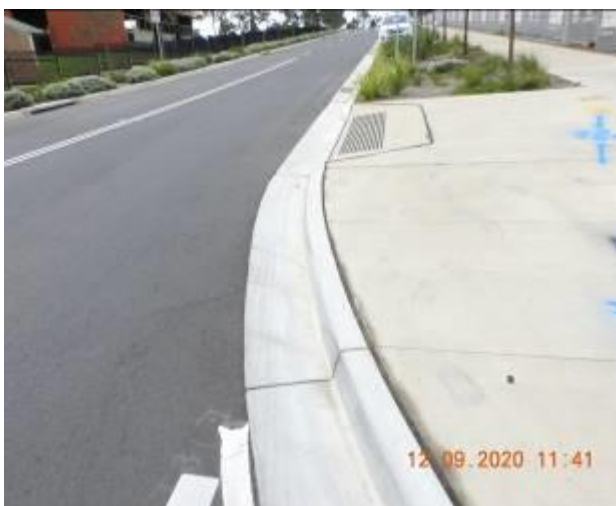
Figure 1303 – General condition of kerb and gutter

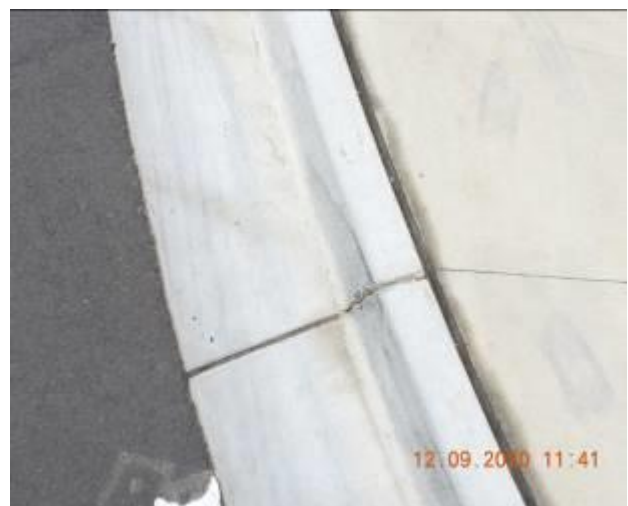
Figure 1304 – Crack propagation and loss of material through kerb

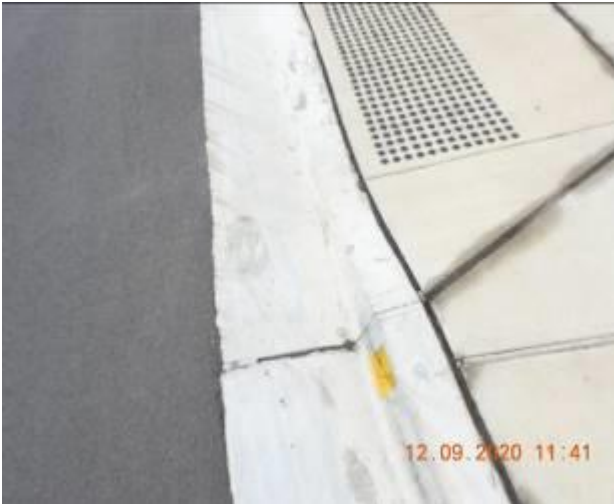
Figure 1305 – Crack propagation and loss of material through kerb and gutter

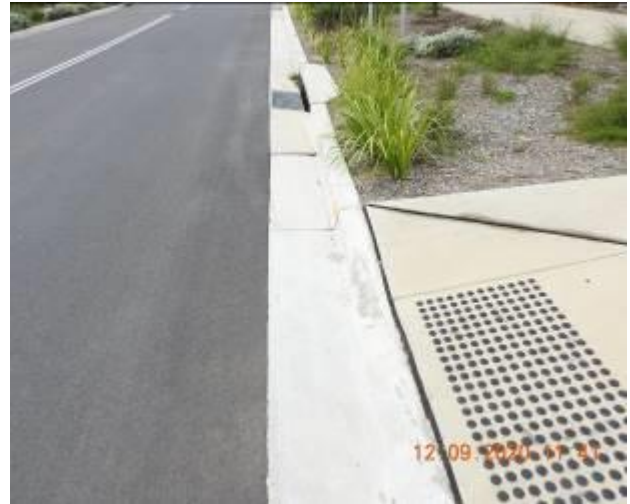
Figure 1306 – General condition of layback and gutter

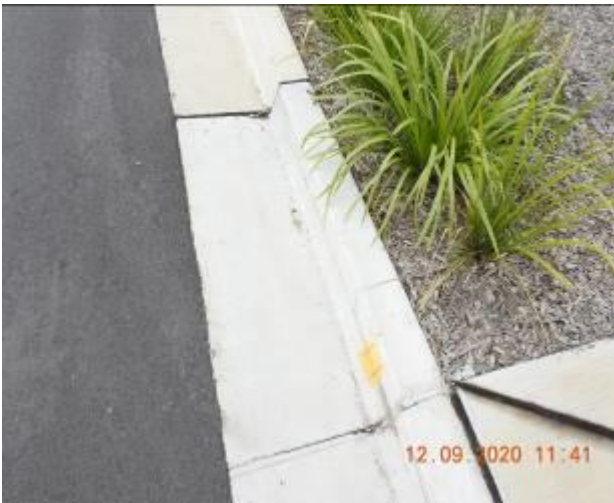
Figure 1307 – Crack propagation and loss of material through kerb and gutter

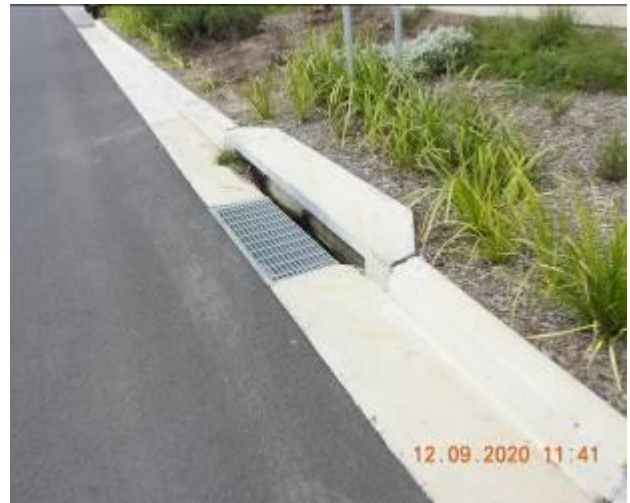
Figure 1308 – General condition of stormwater inlet pit/ Loss of material through kerb

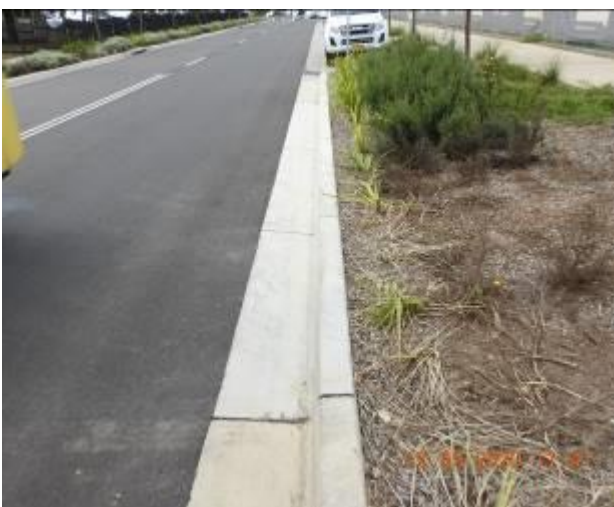
Figure 1309 – General condition of kerb and gutter

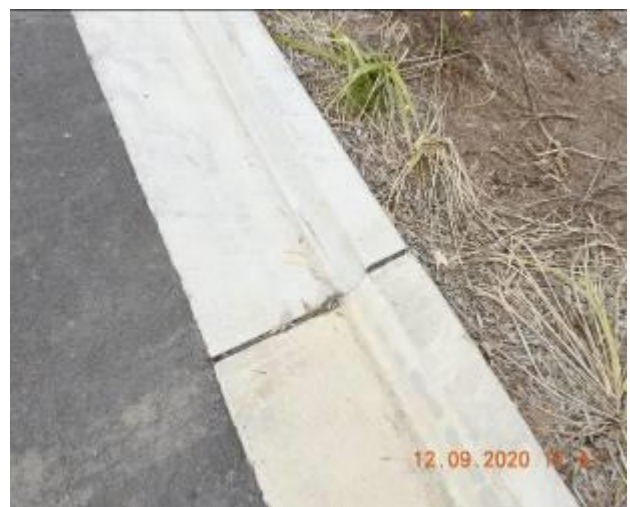
Figure 1310 – Loss of material through kerb and gutter

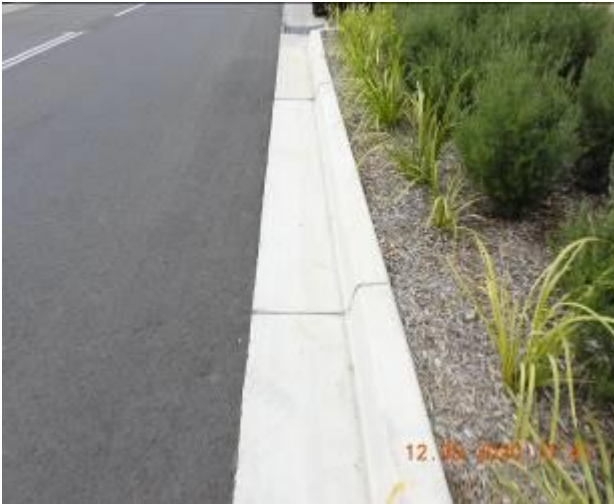
Figure 1311 – General condition of kerb and gutter

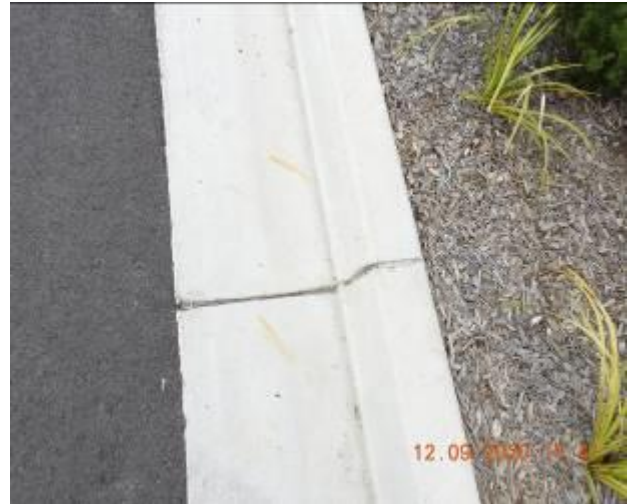
Figure 1312 – Crack propagation and loss of material through kerb and gutter

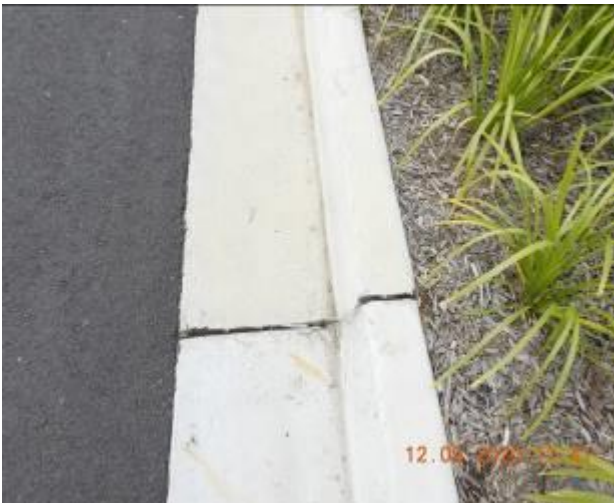
Figure 1313 – Crack propagation and loss of material through kerb and gutter

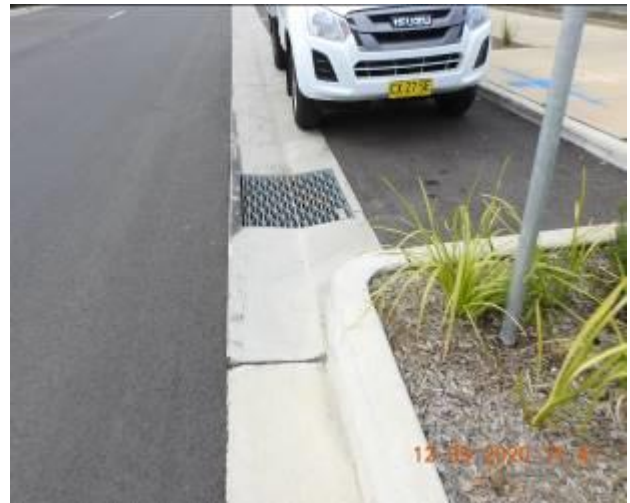
Figure 1314 – Loss of material through gutter

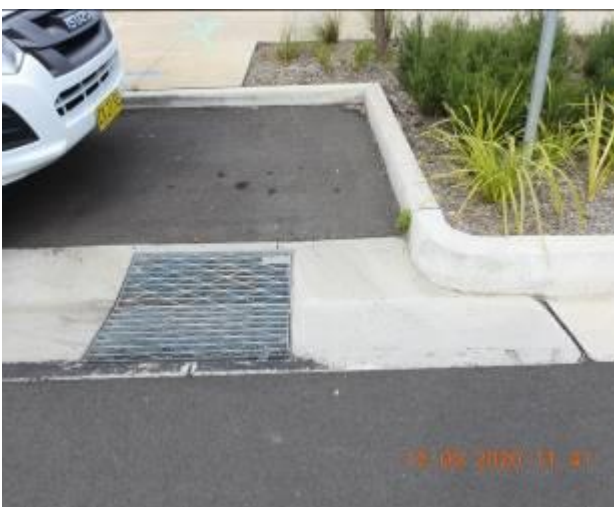
Figure 1315 – General condition of kerb and gutter

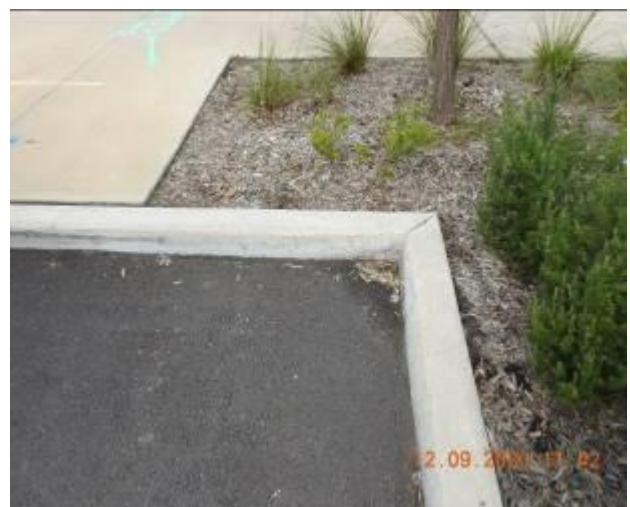
Figure 1316 – General condition of kerb

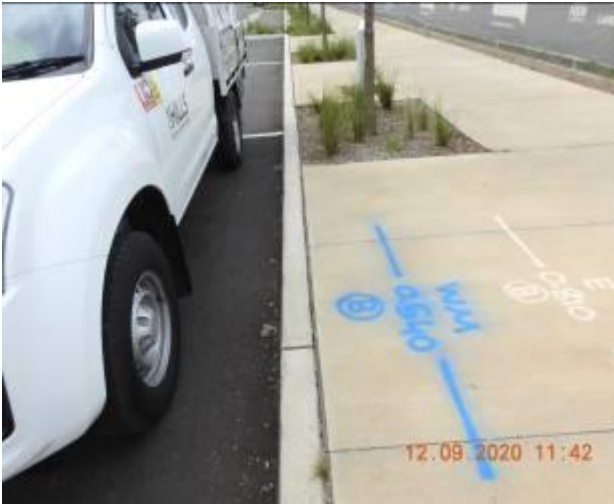
Figure 1317 – General condition of kerb

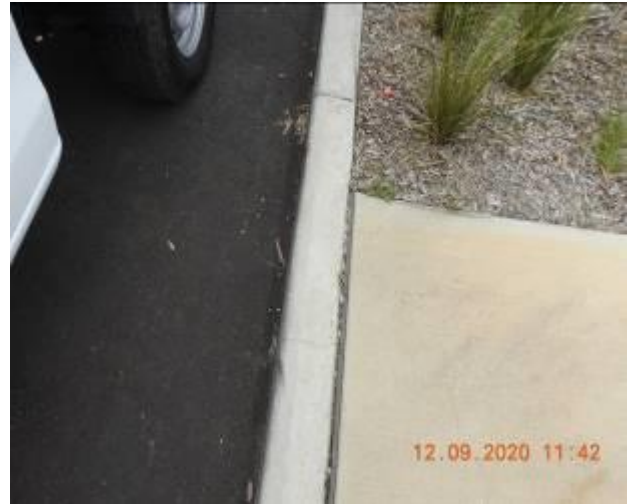
Figure 1318 – Crack propagation through kerb

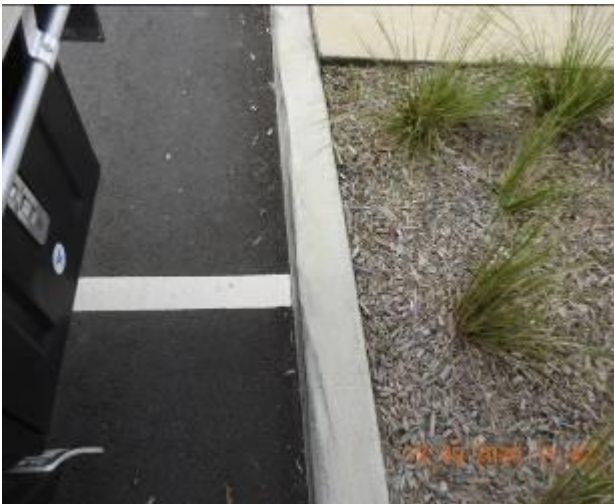
Figure 1319 – Crack propagation through kerb

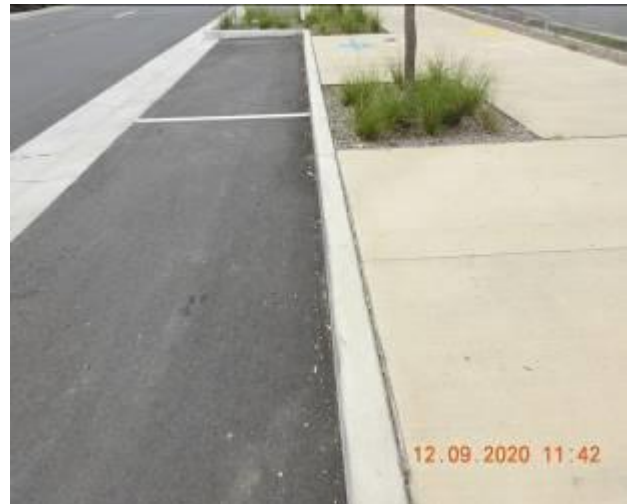
Figure 1320 – General condition of kerb

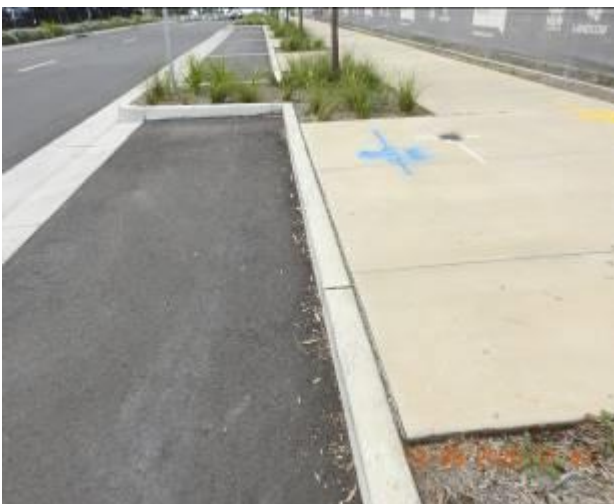
Figure 1321 – General condition of kerb

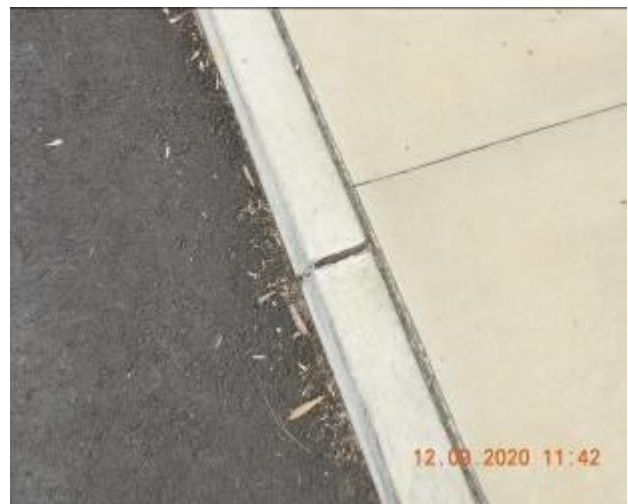
Figure 1322 – Loss of material through kerb

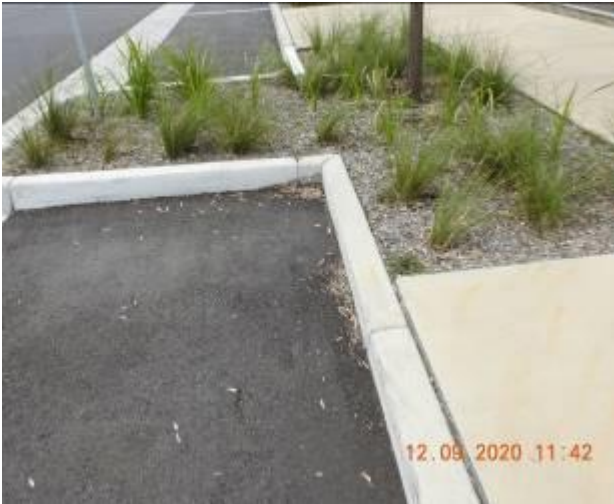
Figure 1323 – General condition of kerb

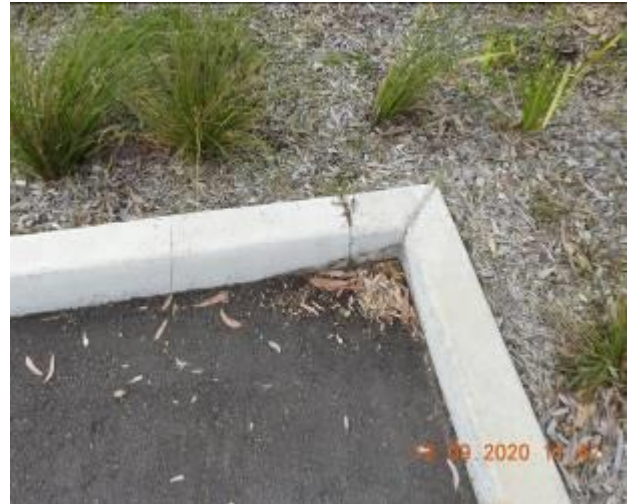
Figure 1324 – Crack propagation and loss of material through kerb

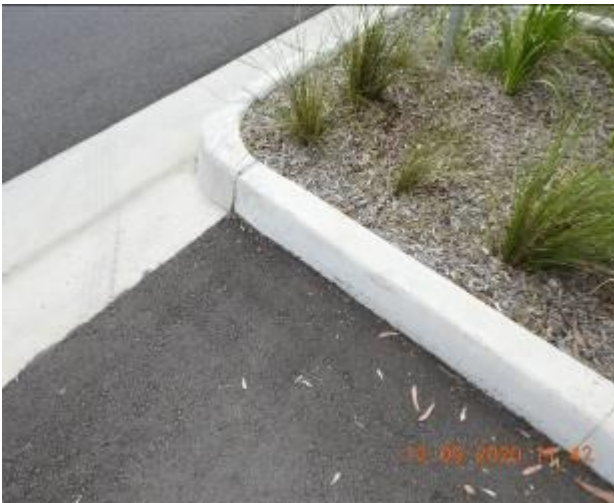
Figure 1325 – Loss of material through kerb

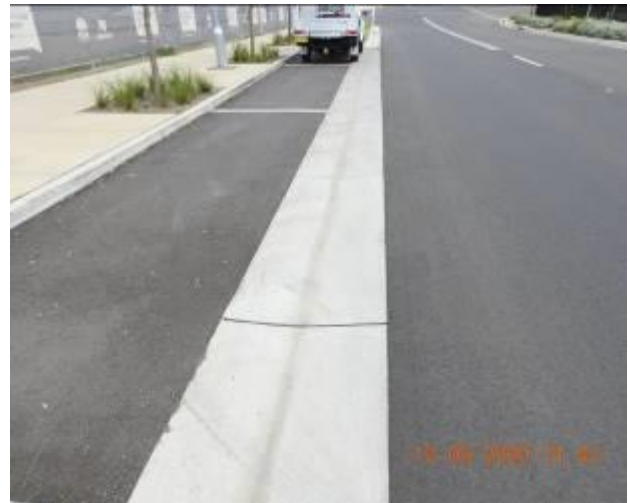
Figure 1326 – General condition of gutter heading West

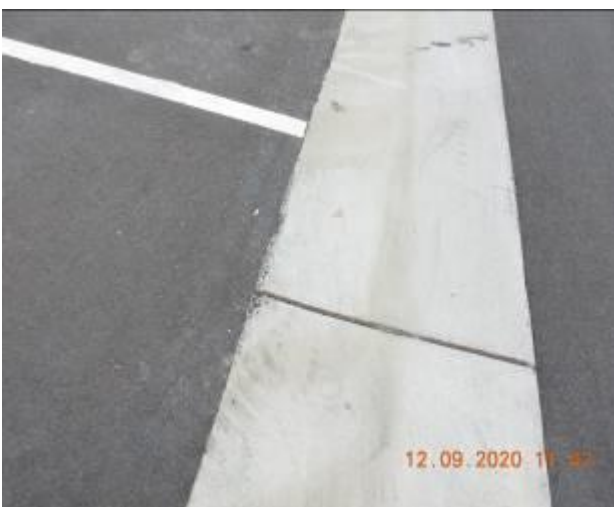
Figure 1327 – Loss of material through gutter

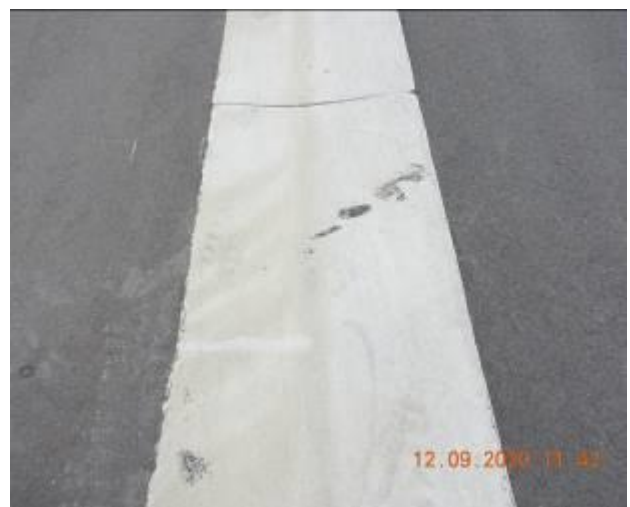
Figure 1328 – Evidence of patchwork, crack propagation and loss of material through gutter

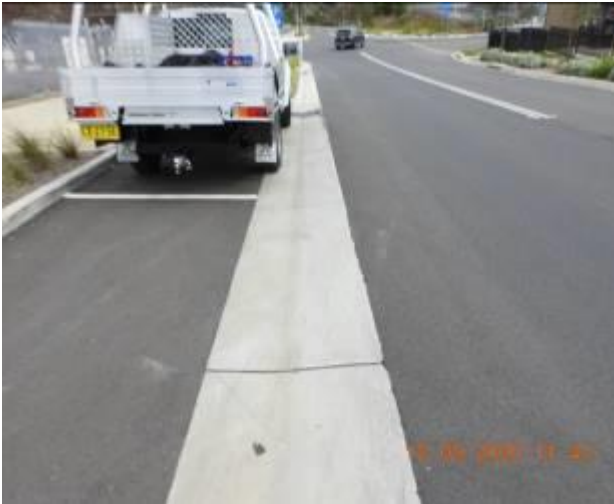
Figure 1329 – General condition of gutter

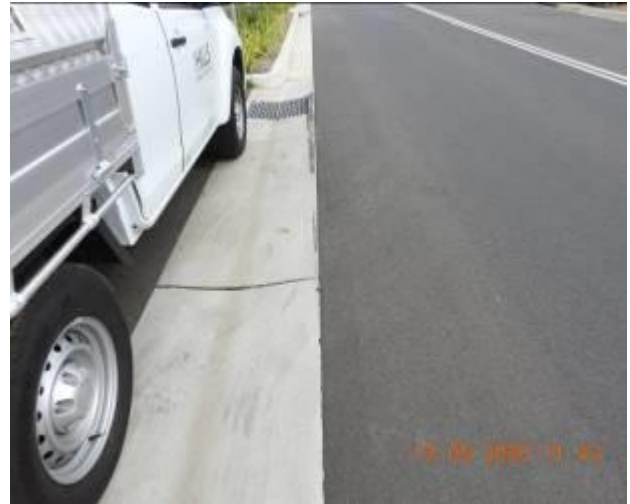
Figure 1330 – General condition of gutter

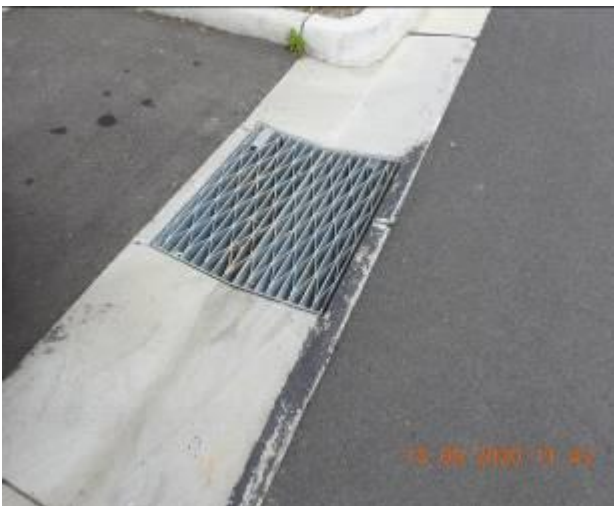
Figure 1331 – General condition of stormwater inlet pit

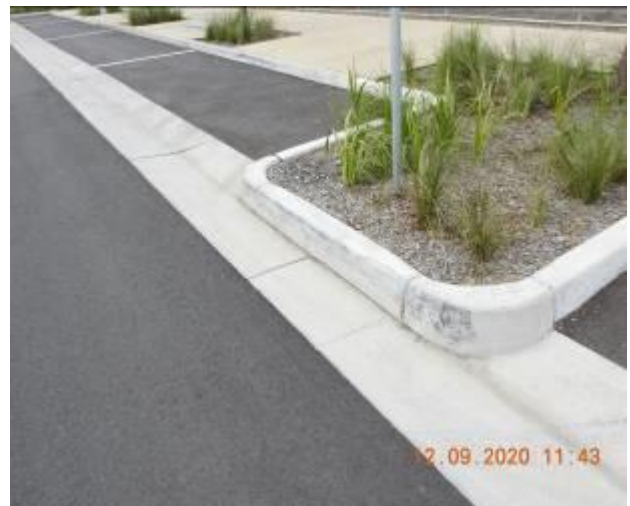
Figure 1332 – General condition of kerb and gutter heading East

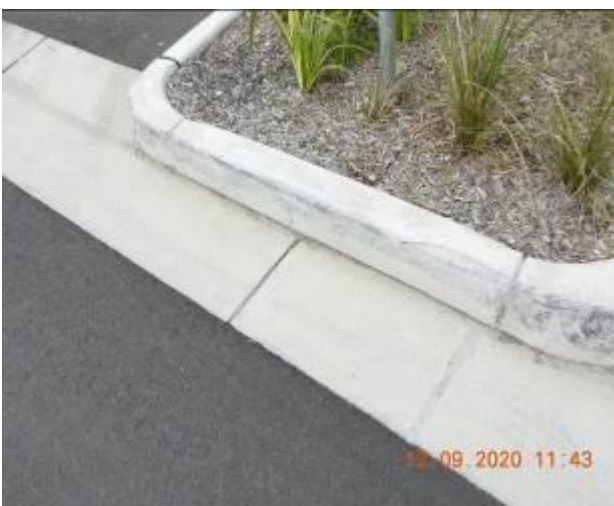
Figure 1333 – Crack propagation through kerb

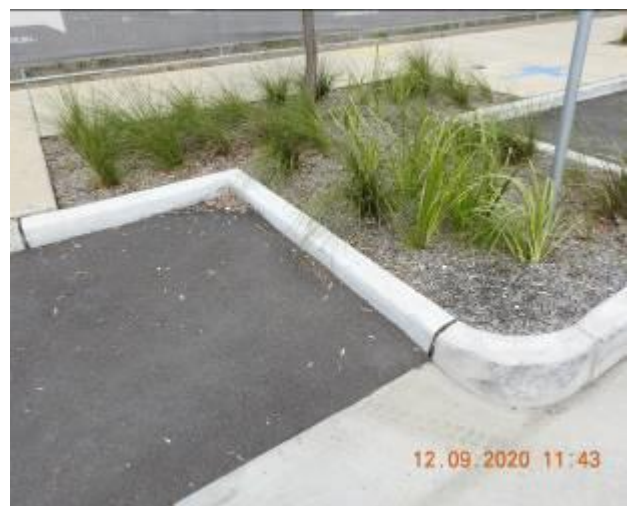
Figure 1334 – General condition of kerb

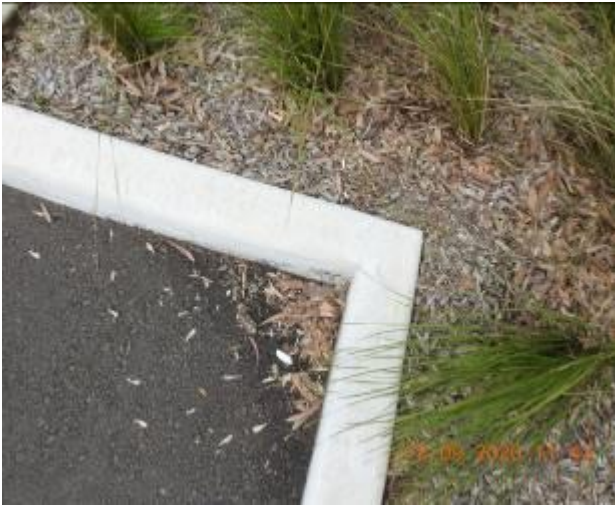
Figure 1335 – Crack propagation through kerb

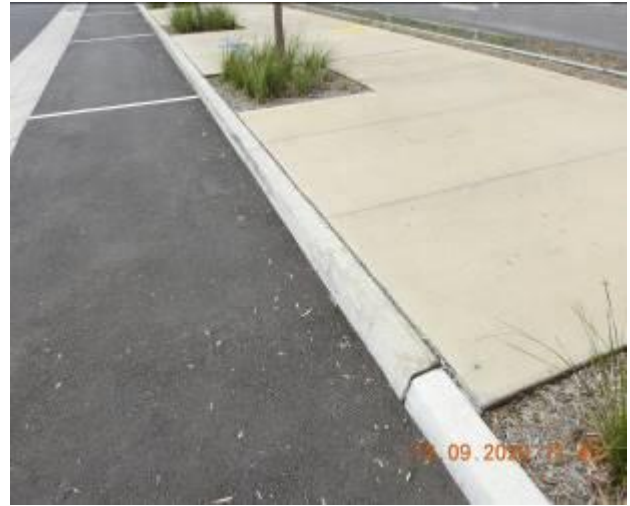
Figure 1336 – Loss of material through kerb

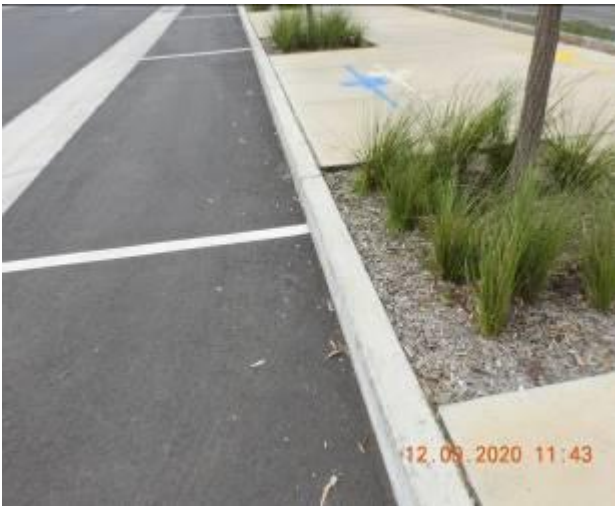
Figure 1337 – General condition of kerb

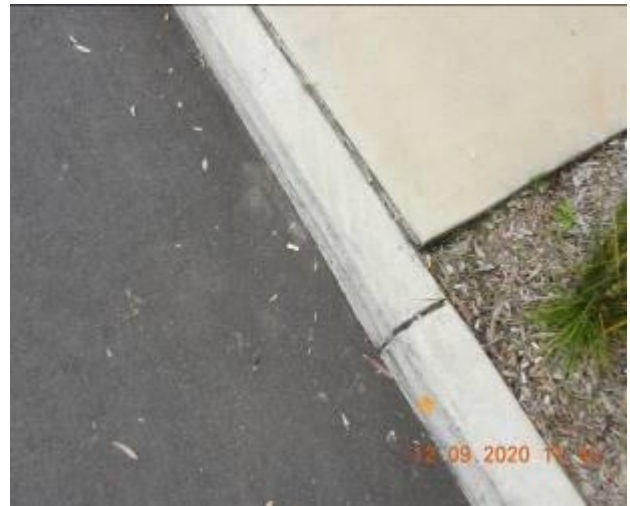
Figure 1338 – Loss of material through kerb

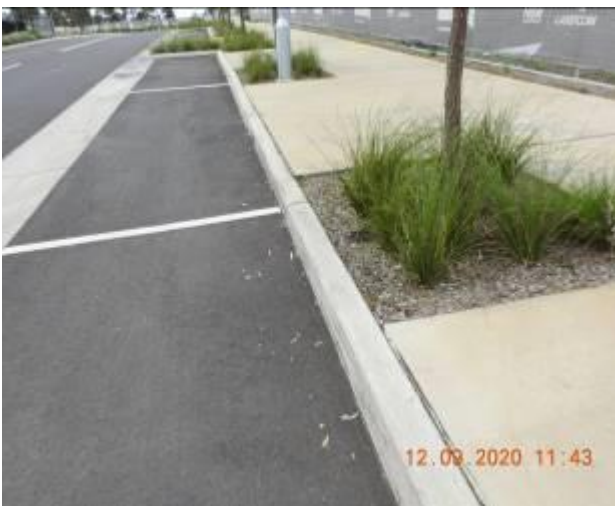
Figure 1339 – General condition of kerb

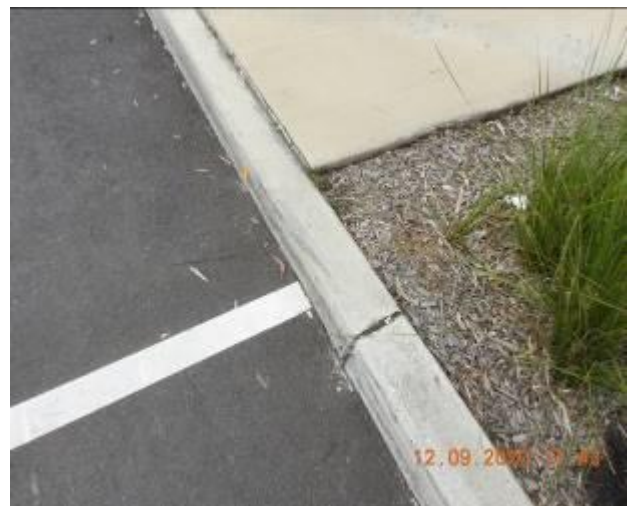
Figure 1340 – Loss of material through kerb

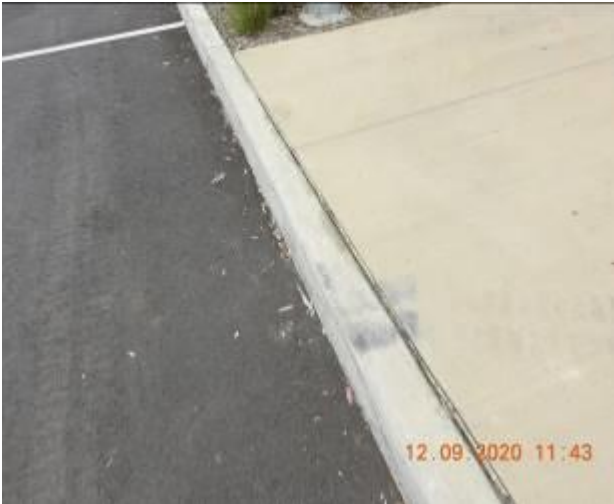
Figure 1341 – General condition of kerb

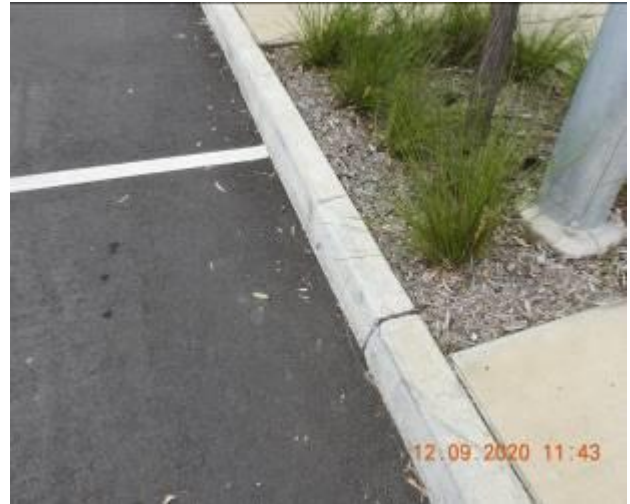
Figure 1342 – Loss of material through kerb

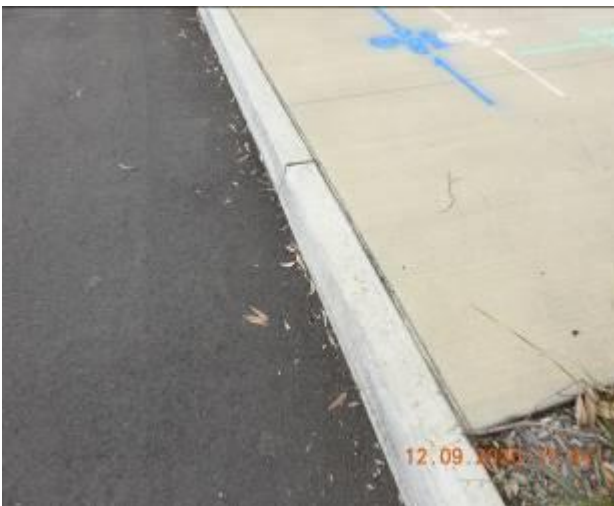
Figure 1343 – Loss of material through kerb

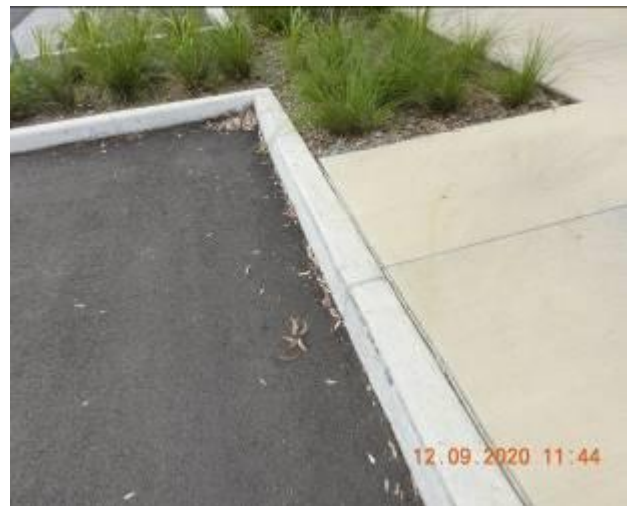
Figure 1344 – General condition of kerb

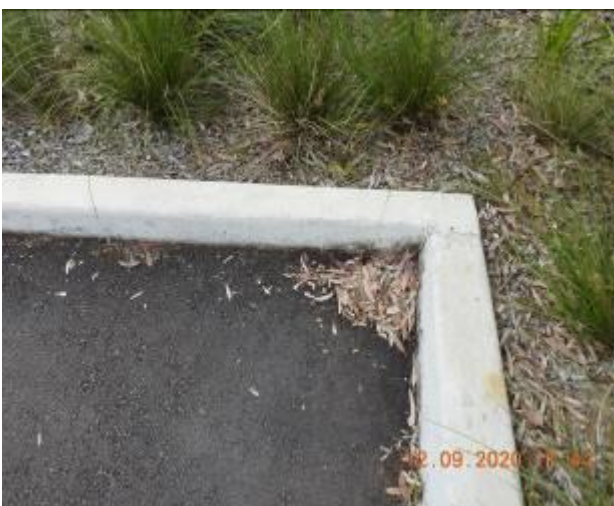
Figure 1345 – Crack propagation and loss of material through kerb

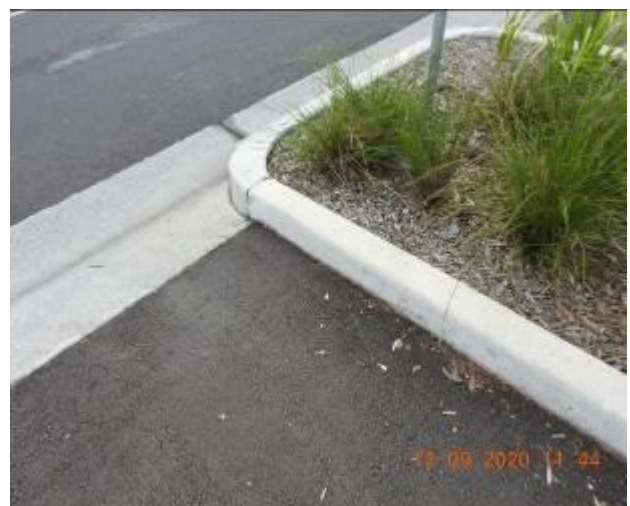
Figure 1346 – General condition of kerb

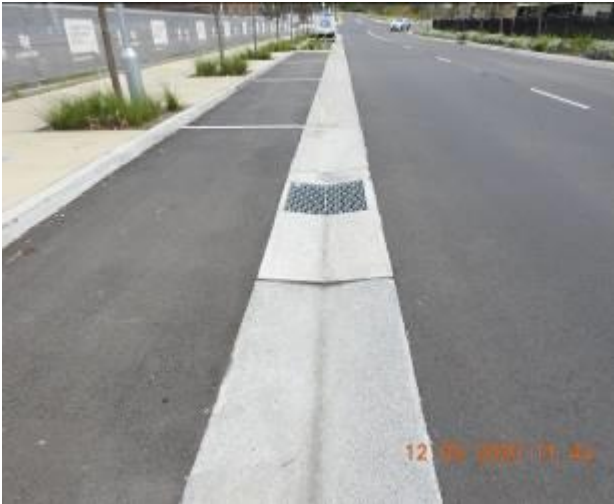
Figure 1347 – General condition of gutter heading West

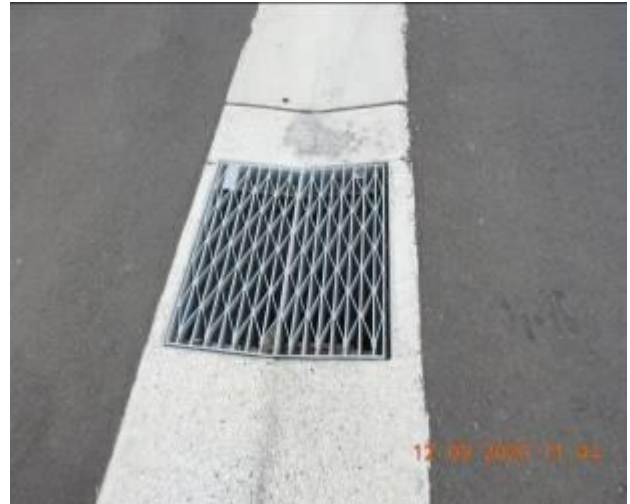
Figure 1348 – Crack propagation and loss of material through gutter/General condition of stormwater inlet pit

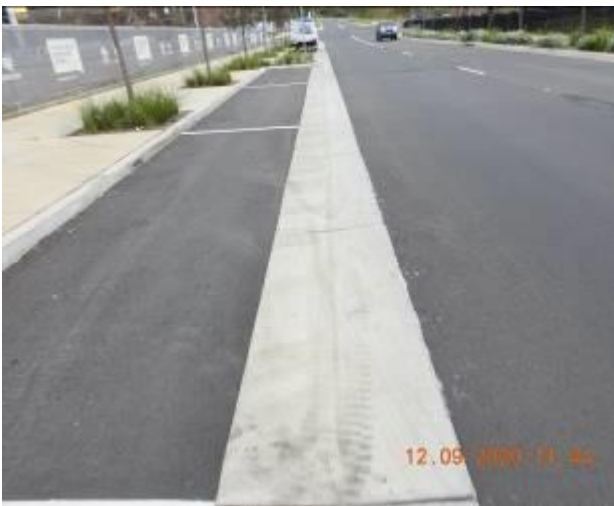
Figure 1349 – General condition of gutter

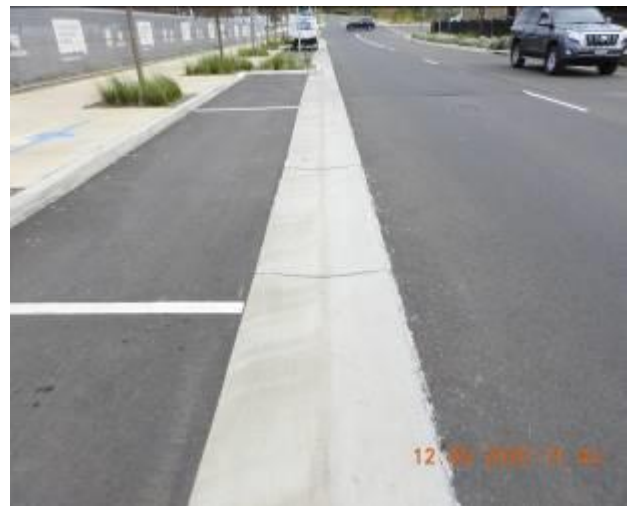
Figure 1350 – General condition of gutter

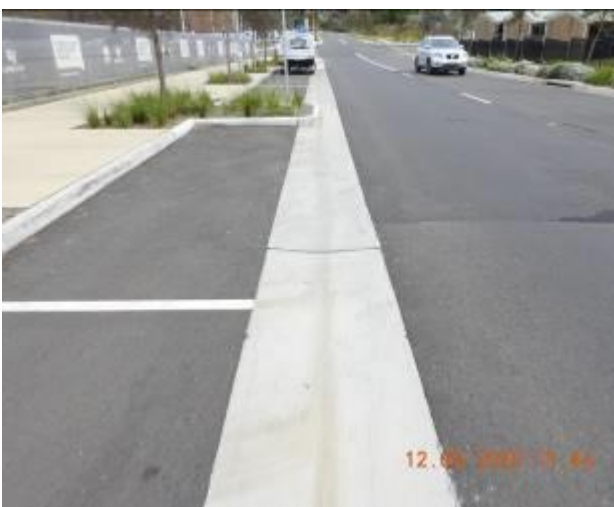
Figure 1351 – General condition of gutter

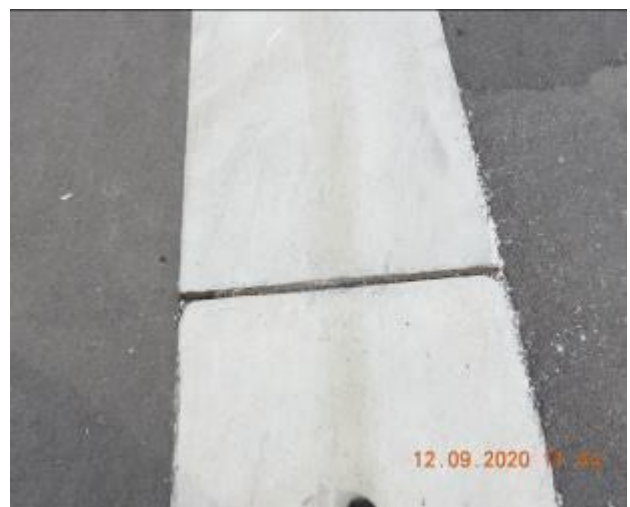
Figure 1352 – Loss of material through gutter

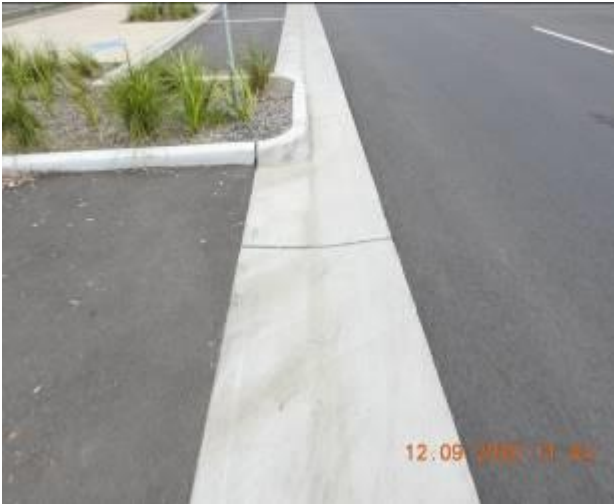
Figure 1353 – General condition of gutter

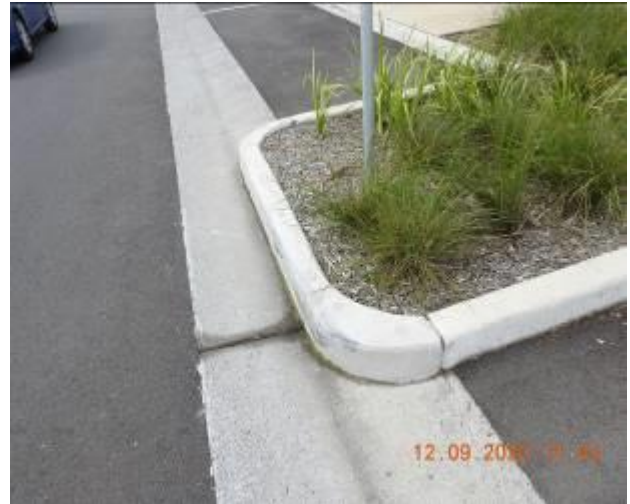
Figure 1354 – General condition of kerb and gutter heading East

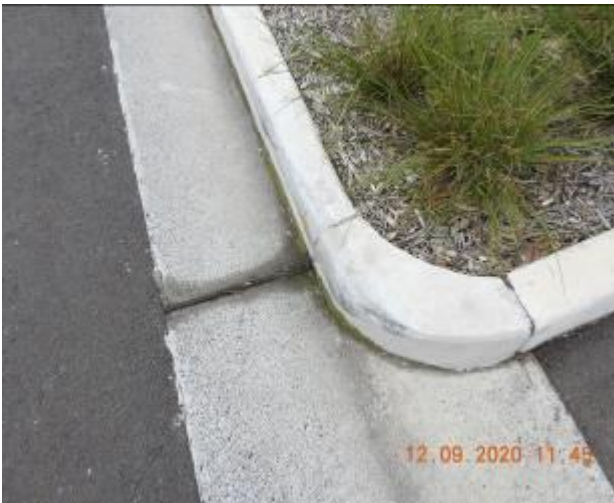
Figure 1355 – Evidence of patchwork, crack propagation and loss of material through kerb and gutter
