**2 MANDALA PARADE, CASTLE HILL
(DORAN DRIVE PRECINCT)
PRE-DILAPIDATION REPORT
Of Sydney Metro and Hills Shire Council Assets
DEICORP PROJECTS SHOWGROUND
PTY LTD.**

Job No. 200124.3
07/07/2021

ACE Structural Services Pty Ltd

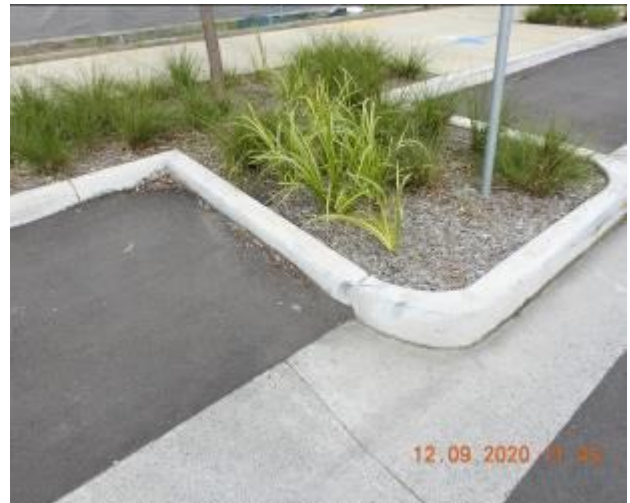
Figure 1356 – General condition of kerb

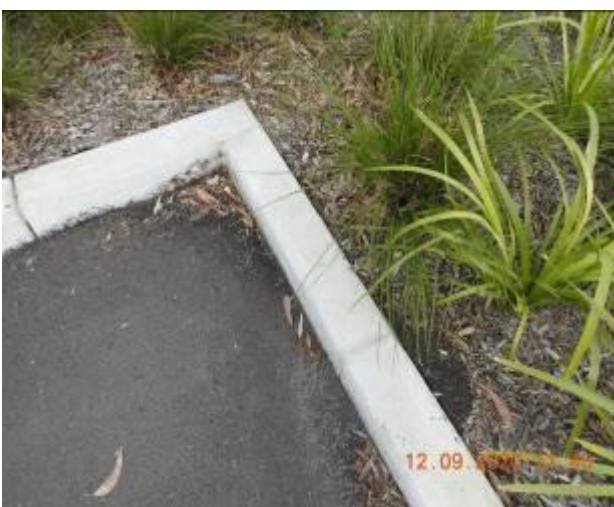
Figure 1357 – Evidence of patchwork through kerb

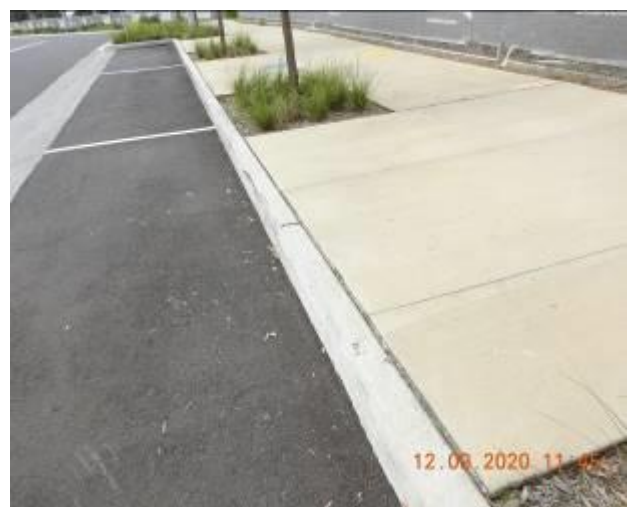
Figure 1358 – General condition of kerb

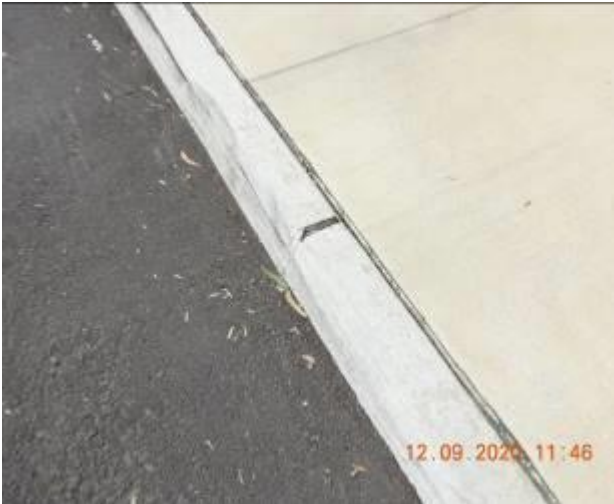
Figure 1359 – Loss of material through kerb

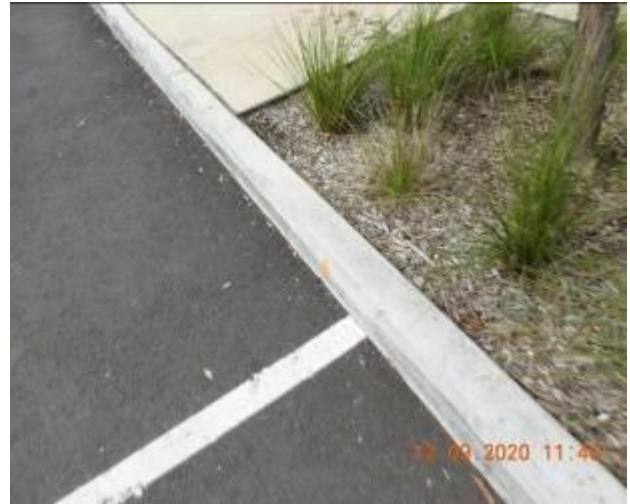
Figure 1360 – Crack propagation through kerb

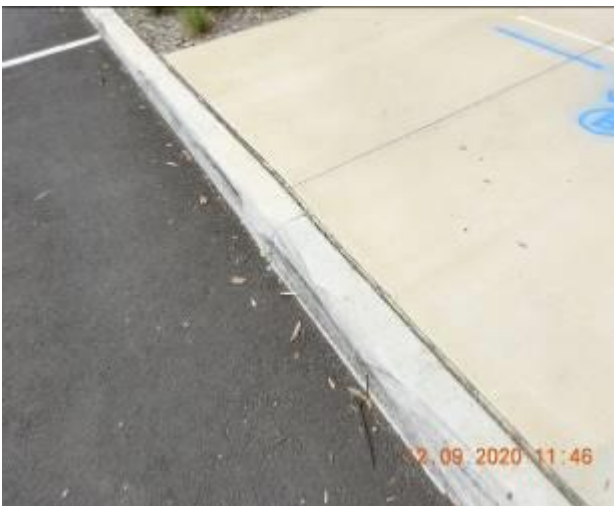
Figure 1361 – Crack propagation and loss of material through kerb

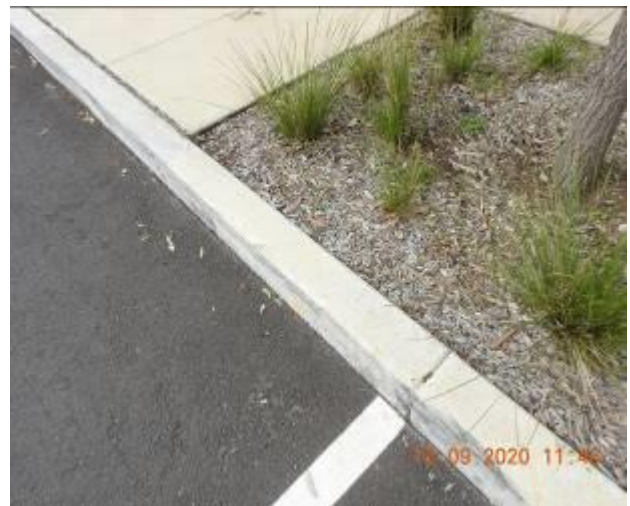
Figure 1362 – Loss of material through kerb

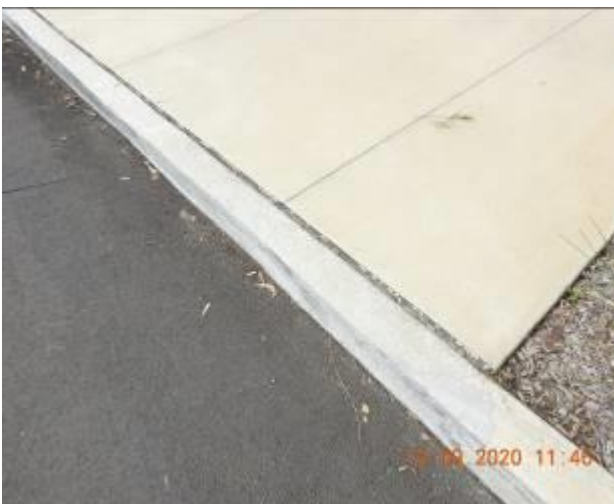
Figure 1363 – Evidence of patchwork through kerb

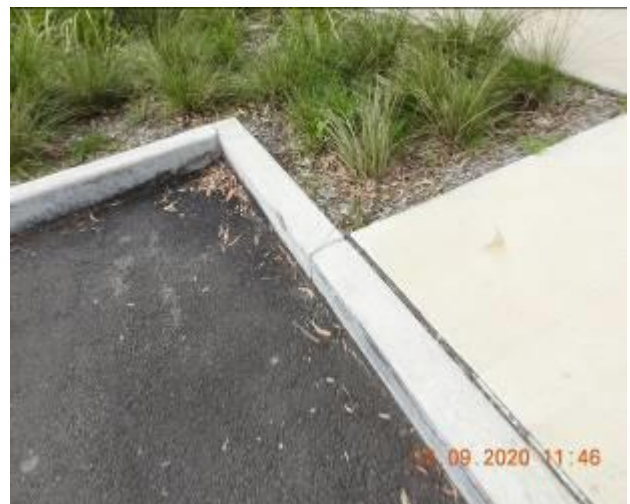
Figure 1364 – General condition of kerb

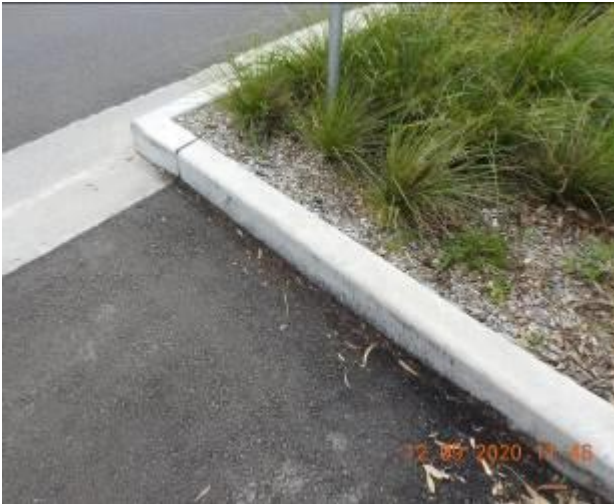
Figure 1365 – General condition of kerb

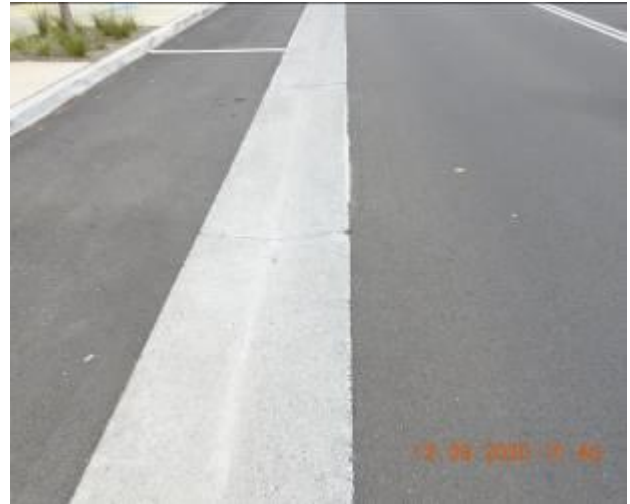
Figure 1366 – General condition of gutter heading West

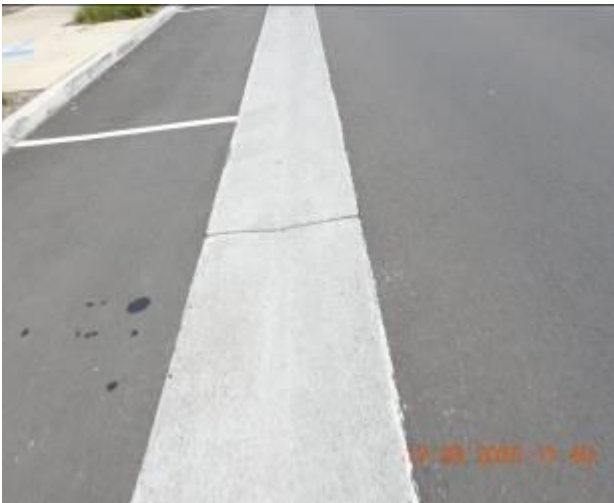
Figure 1367 – Crack propagation and loss of material through gutter

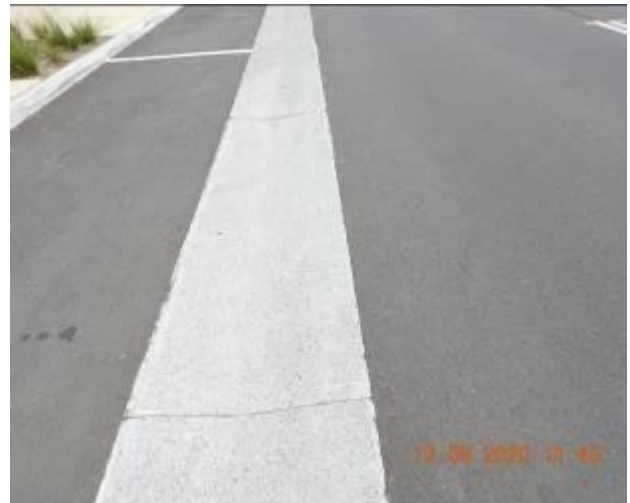
Figure 1368 – General condition of gutter

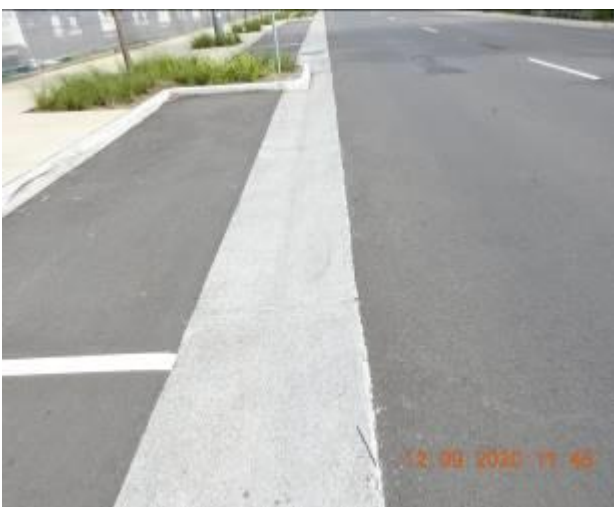
Figure 1369 – General condition of gutter

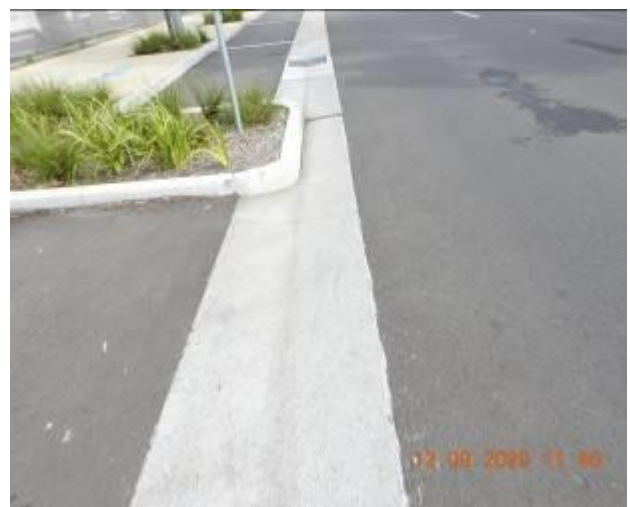
Figure 1370 – General condition of gutter

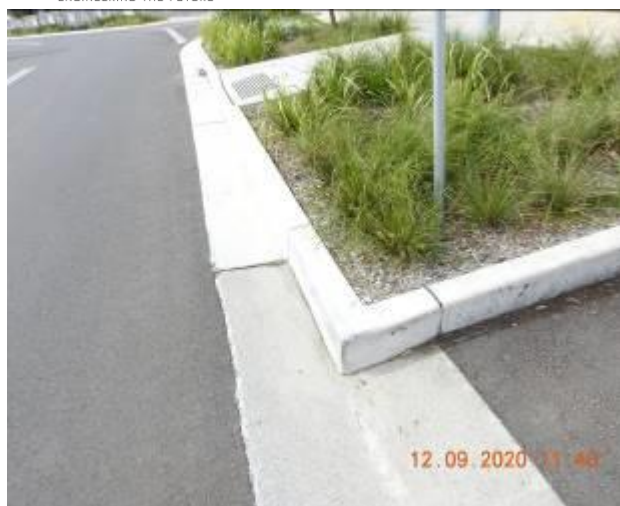
Figure 1371 – General condition of kerb and gutter heading East

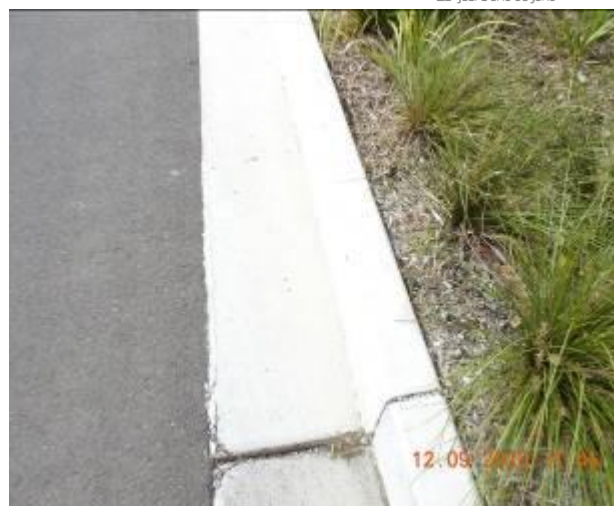
Figure 1372 – Crack propagation and loss of material through kerb and gutter

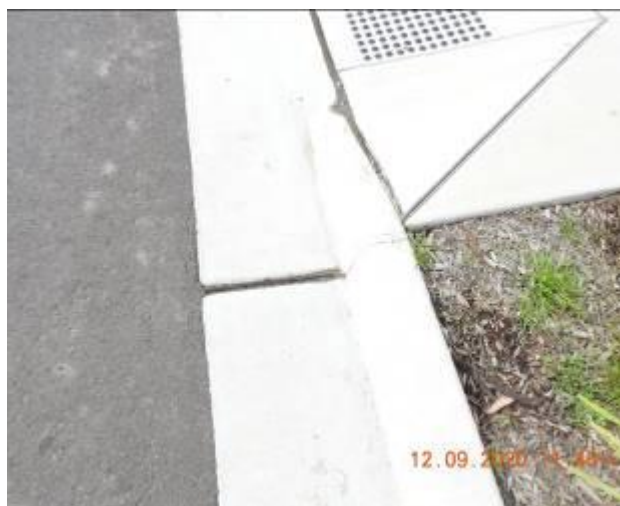
Figure 1373 – Crack propagation and loss of material through kerb and gutter

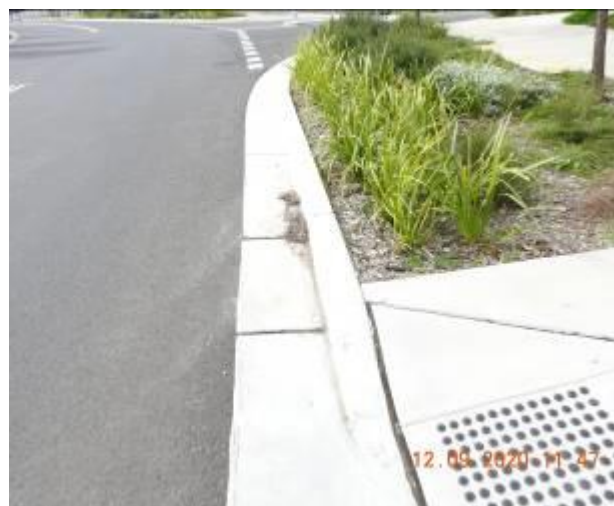
Figure 1374 – General condition of kerb and gutter

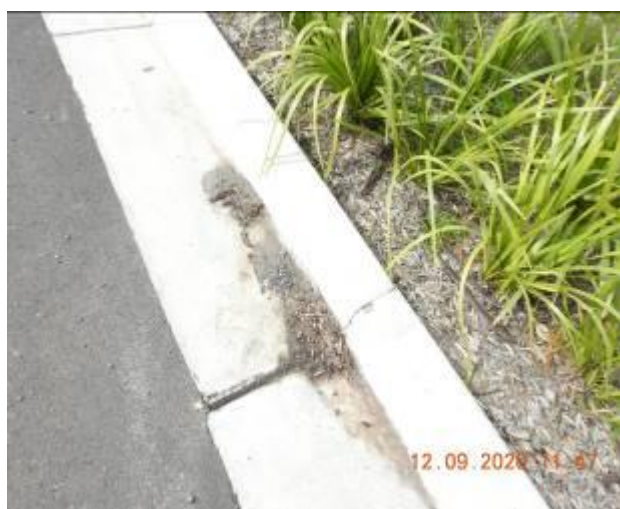
Figure 1375 – Crack propagation and loss of material through kerb and gutter

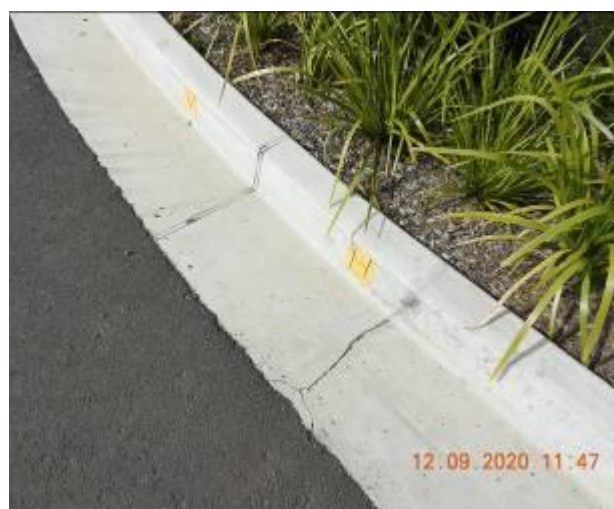
Figure 1376 – Crack propagation and loss of material through kerb and gutter

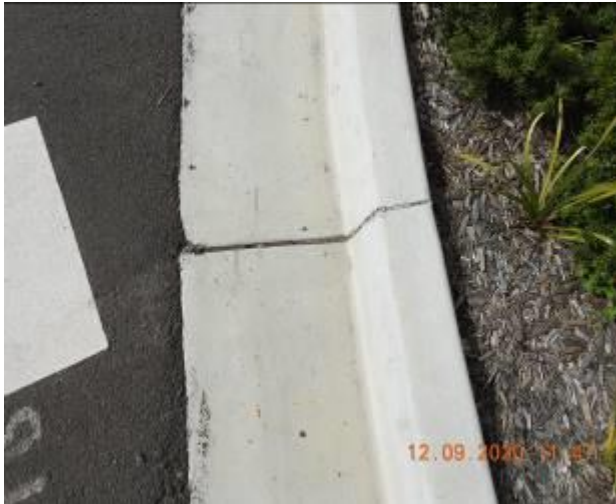
Figure 1377 – Crack propagation and loss of material through kerb and gutter

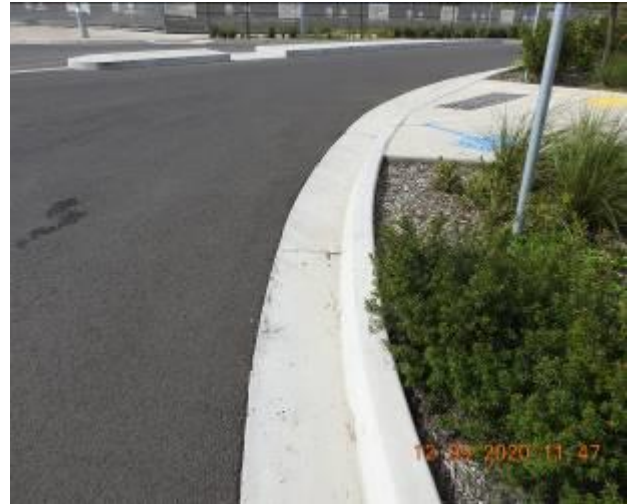
Figure 1378 – Crack propagation and loss of material through gutter

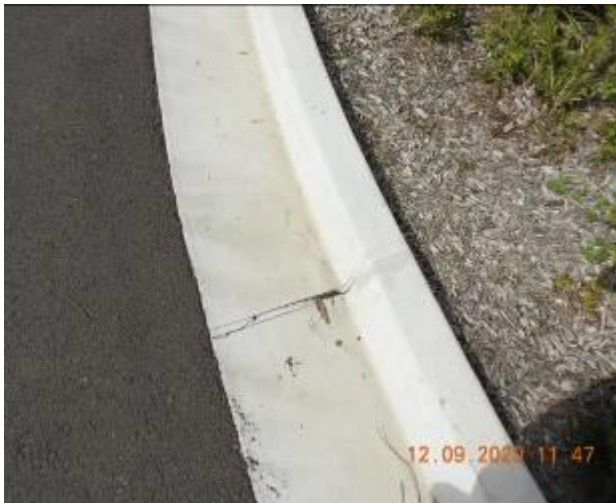
Figure 1379 – Crack propagation and loss of material through kerb and gutter

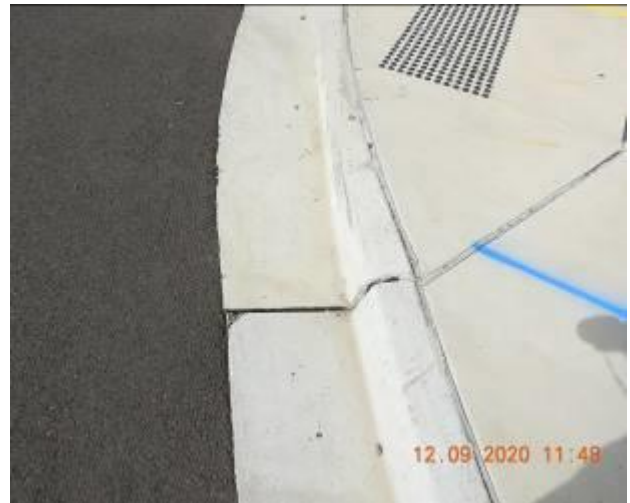
Figure 1380 – Crack propagation and loss of material through kerb and gutter

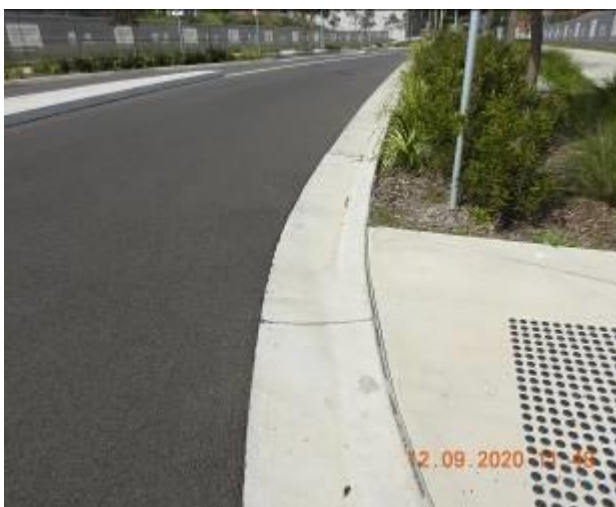
Figure 1381 – General condition of kerb and gutter

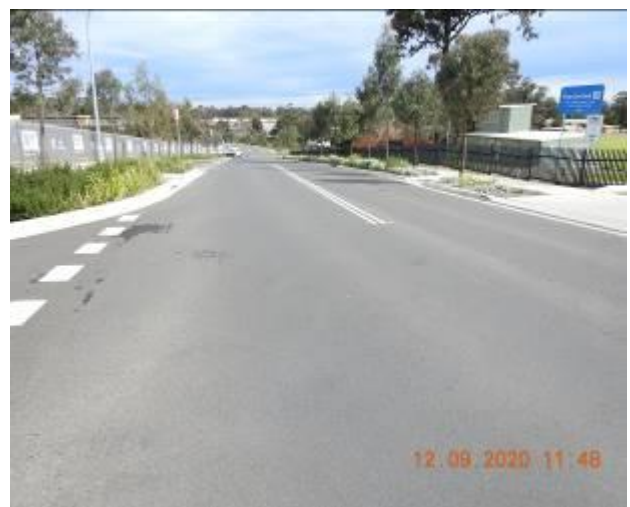
Figure 1382 –General condition of road surface heading West

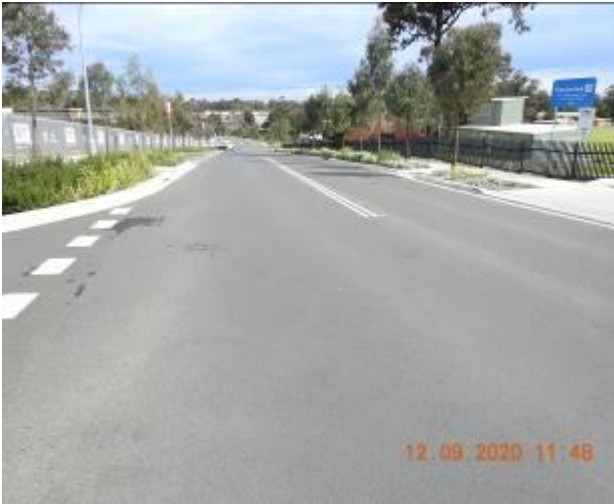
Figure 1383 – General condition of road surface

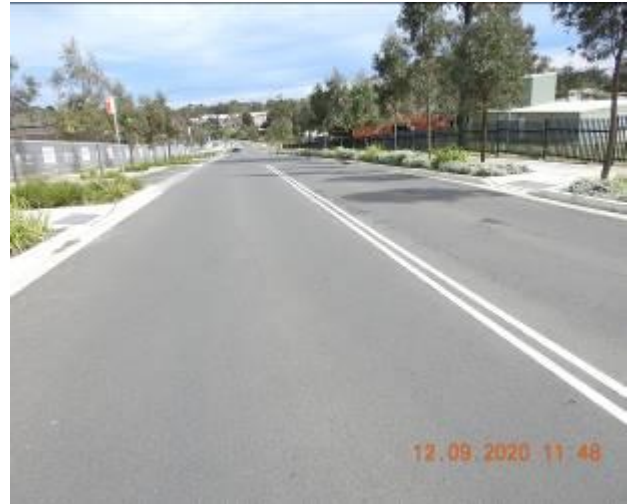
Figure 1384 – General condition of road surface

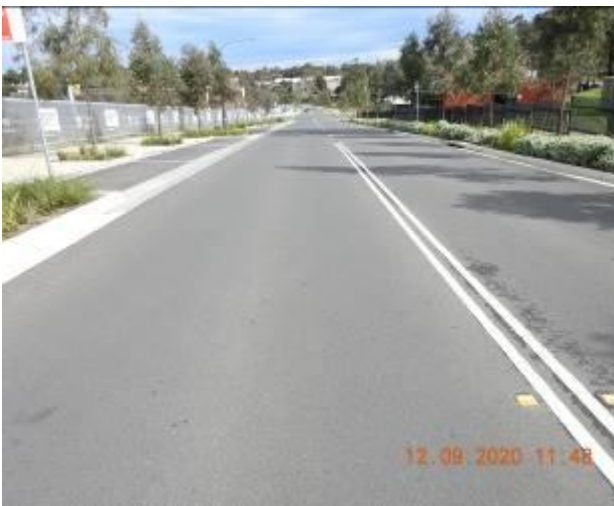
Figure 1385 – General condition of road surface

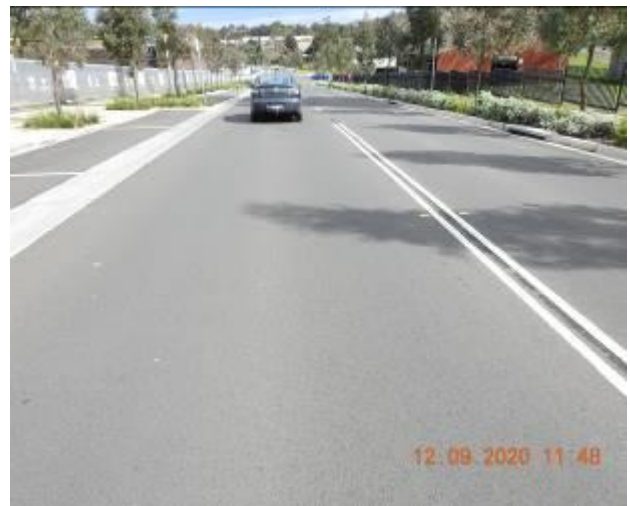
Figure 1386 – General condition of road surface

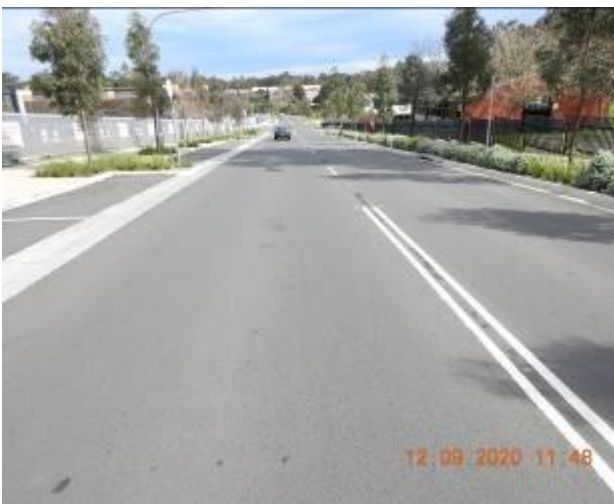
Figure 1387 – Evidence of patchwork through road surface

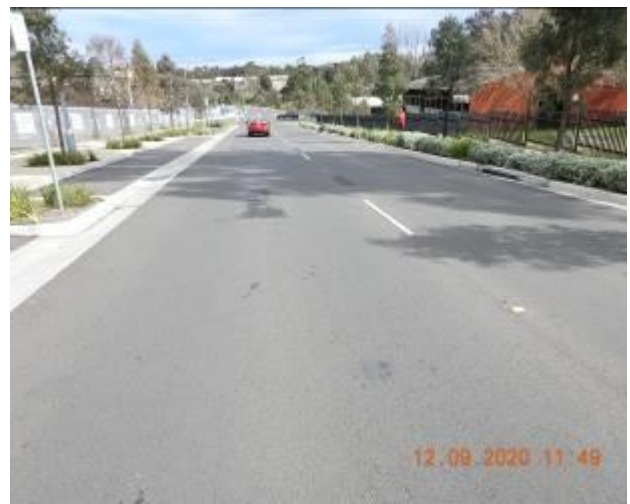
Figure 1388 – Evidence of patchwork through road surface

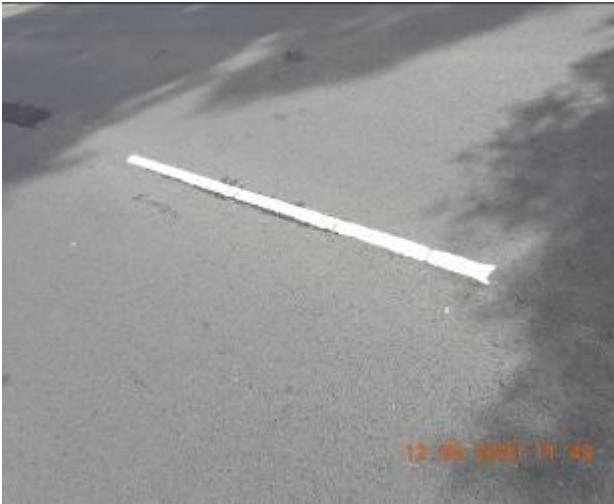
Figure 1389 – Crack propagation and loss of material through road surface

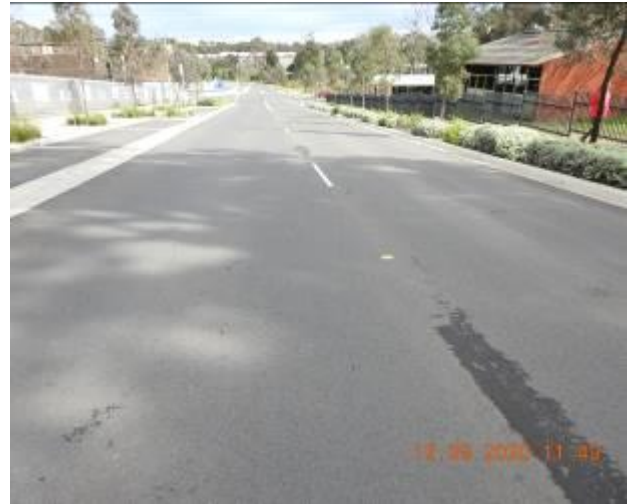
Figure 1390 – General condition of road surface

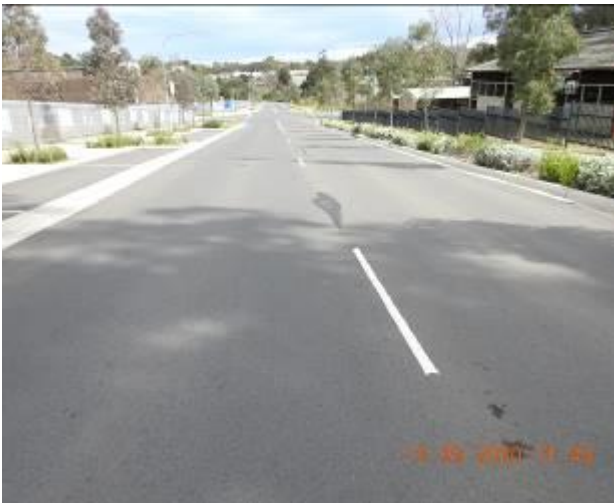
Figure 1391 – General condition of road surface

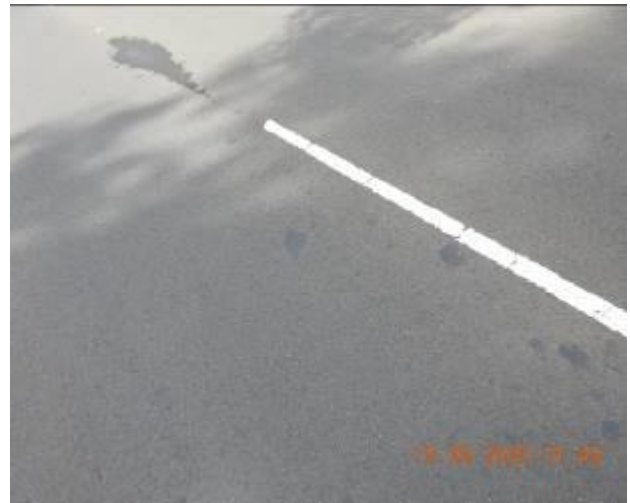
Figure 1392 – Evidence of patchwork through road surface

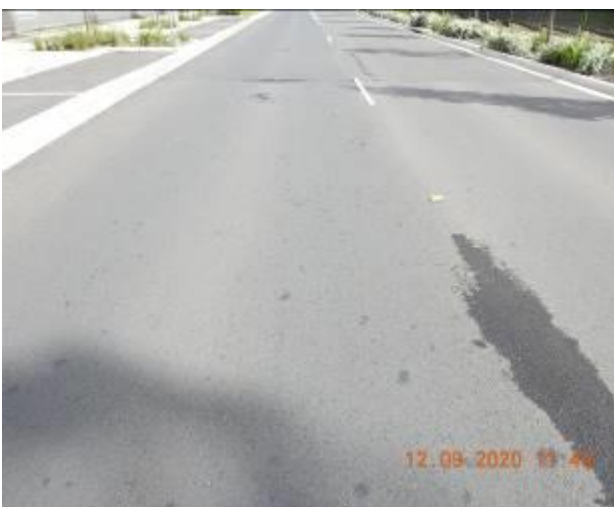
Figure 1393 – Evidence of patchwork through road surface

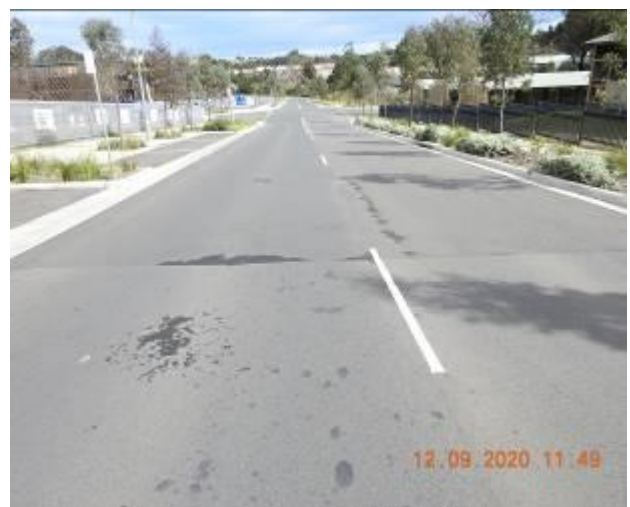
Figure 1394 – Evidence of patchwork through road surface

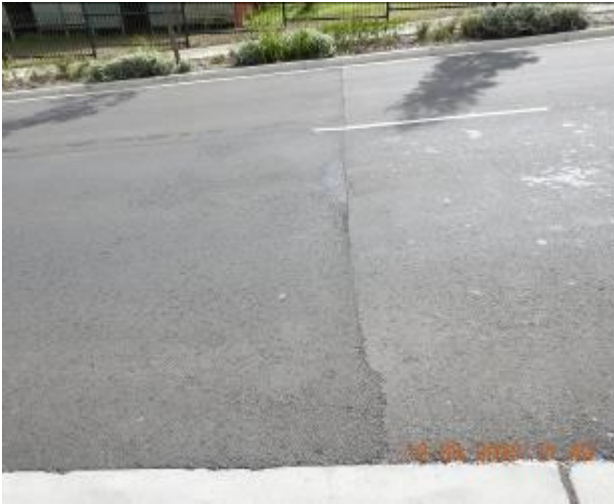
Figure 1395 – Loss of material and evidence of patchwork through road surface

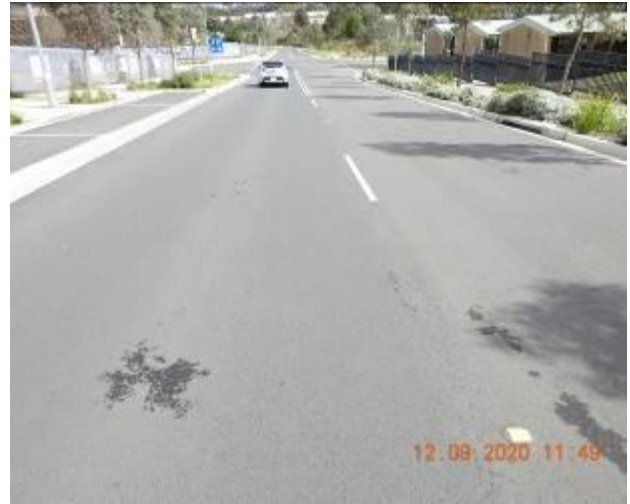
Figure 1396 – Loss of material through road surface

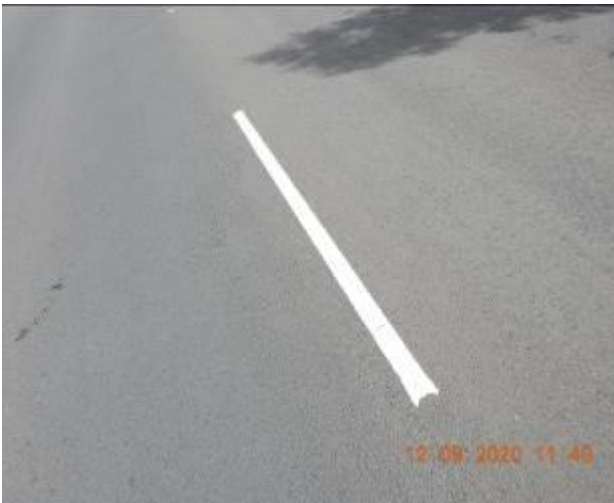
Figure 1397 – Crack propagation and loss of material through road surface

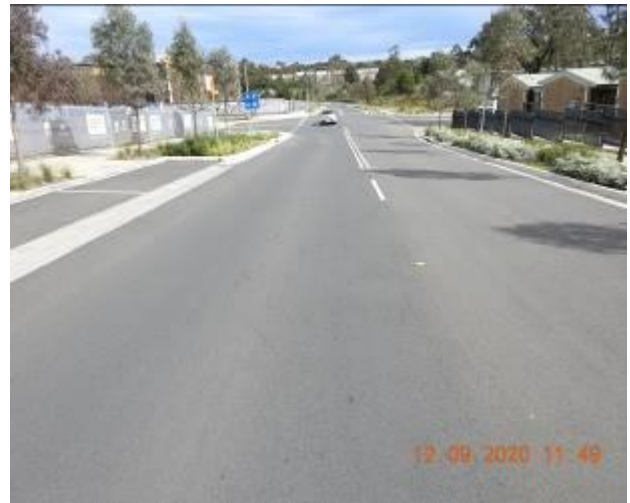
Figure 1398 – General condition of road surface

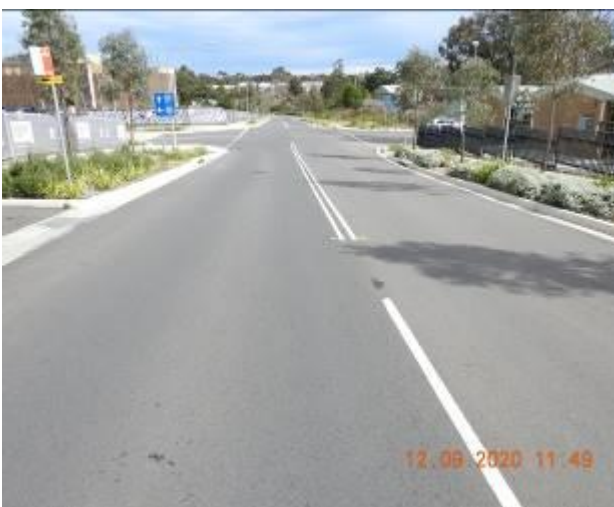
Figure 1399 – General condition of road surface

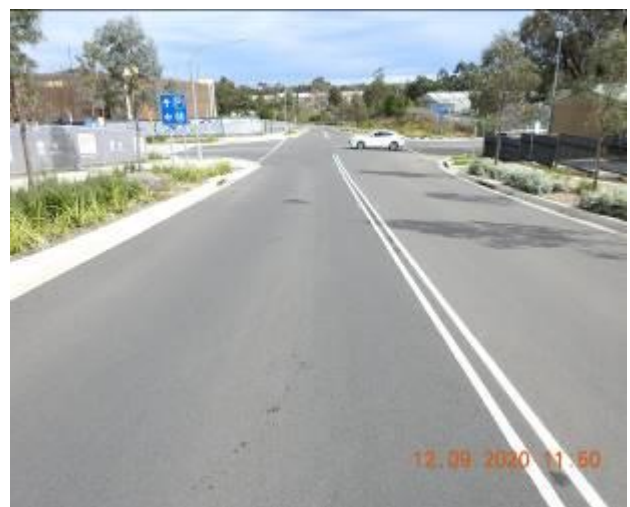
Figure 1400 – General condition of road surface

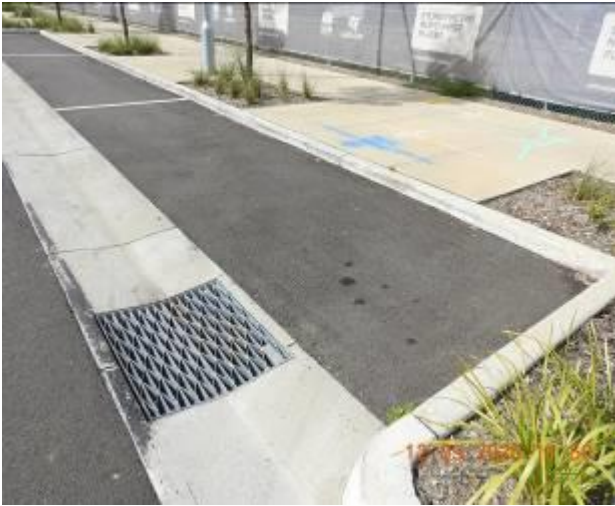
Figure 1401 – General condition of road surface heading East

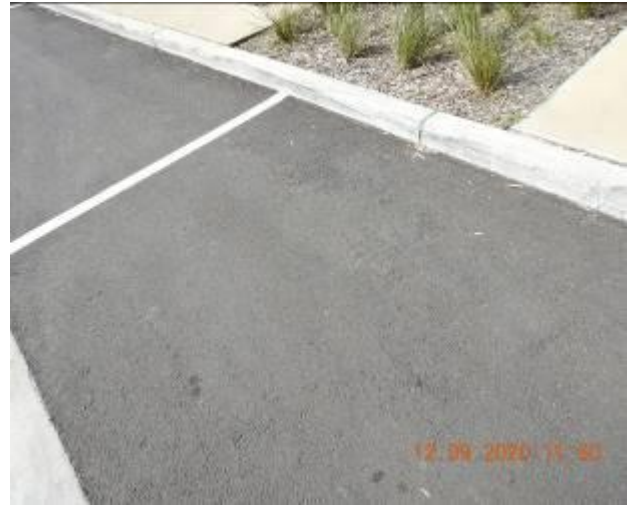
Figure 1402 – General condition of road surface

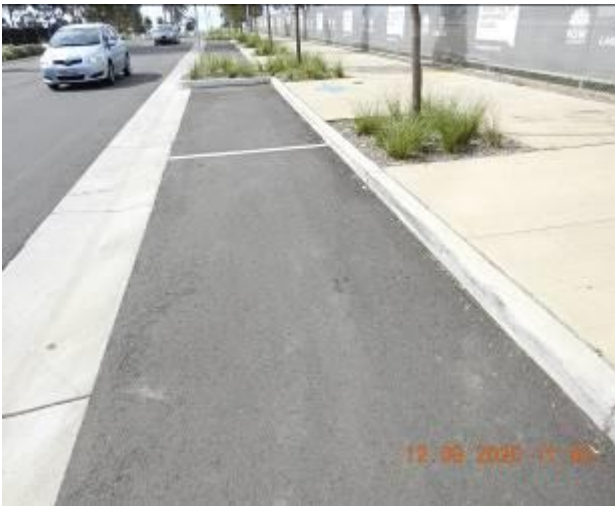
Figure 1403 – General condition of road surface

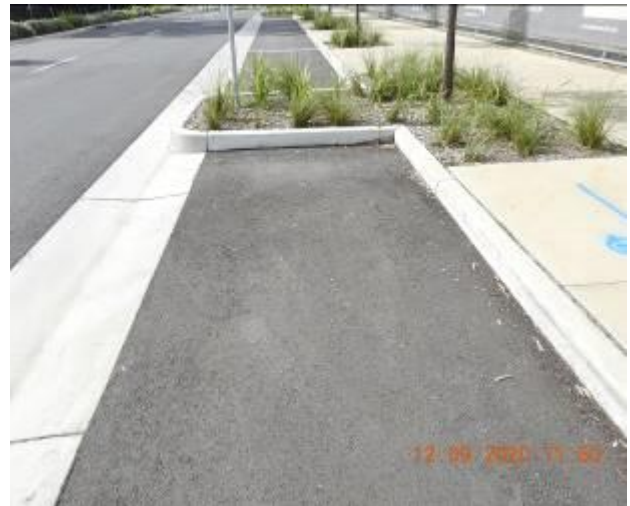
Figure 1404 – General condition of road surface

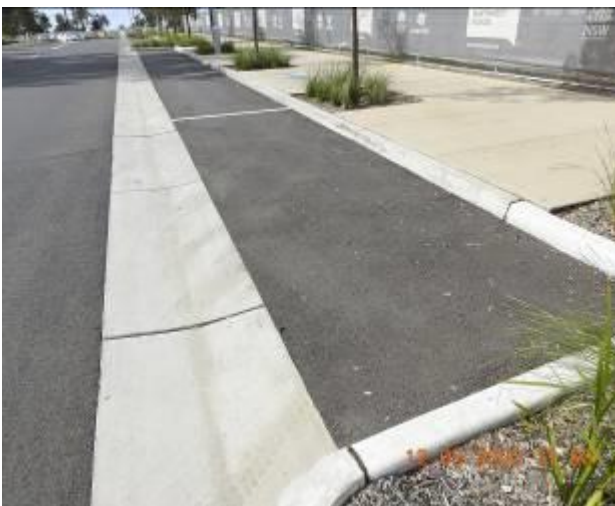
Figure 1405 – General condition of road surface

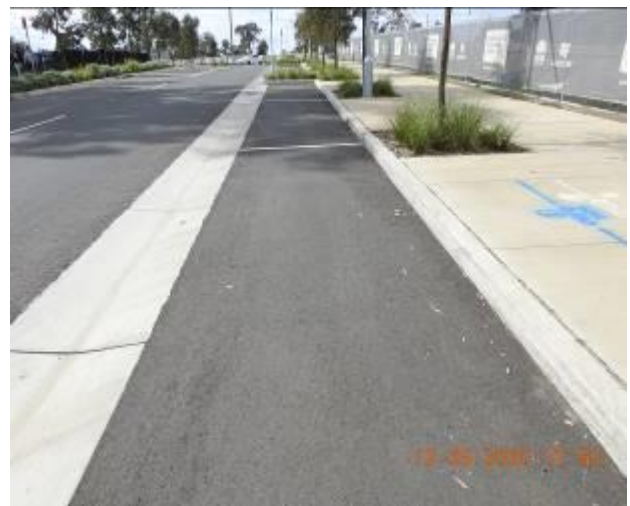
Figure 1406 – General condition of road surface

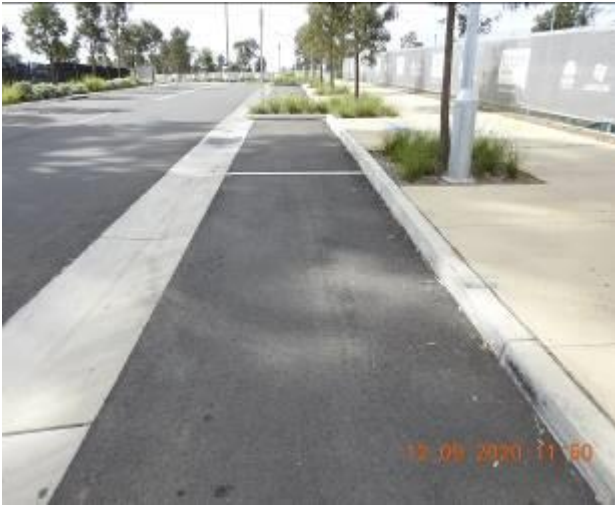
Figure 1407 – General condition of road surface

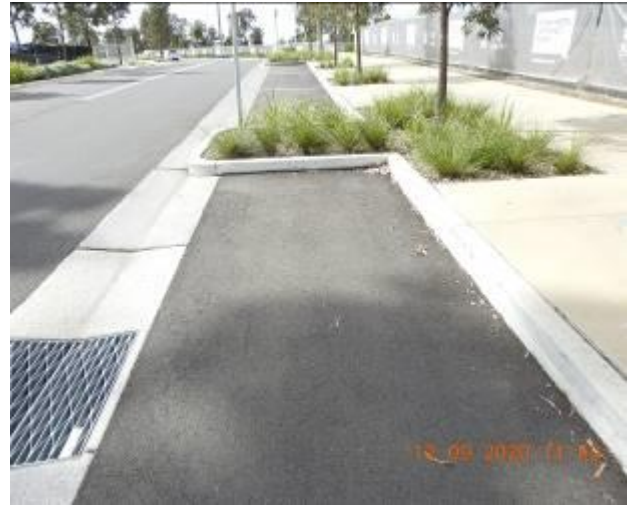
Figure 1408 – General condition of road surface

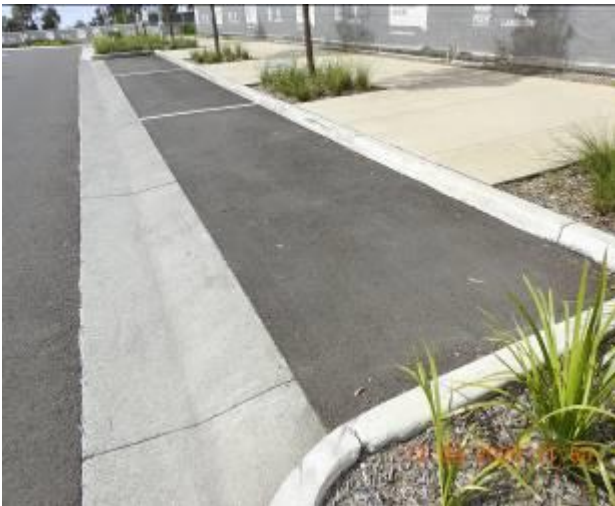
Figure 1409 – General condition of road surface

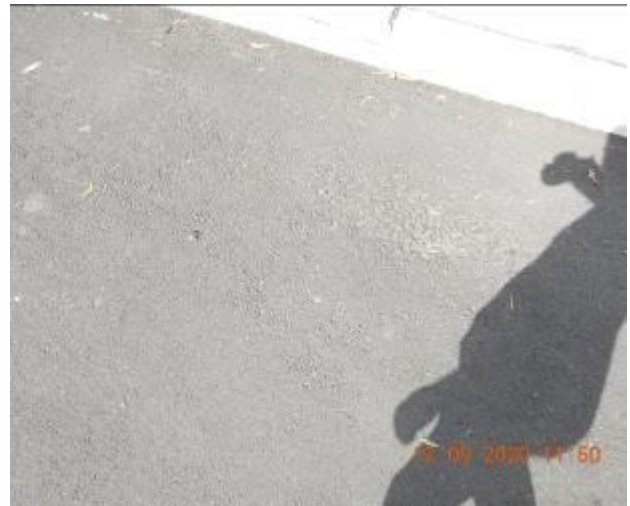
Figure 1410 – Loss of material through road surface

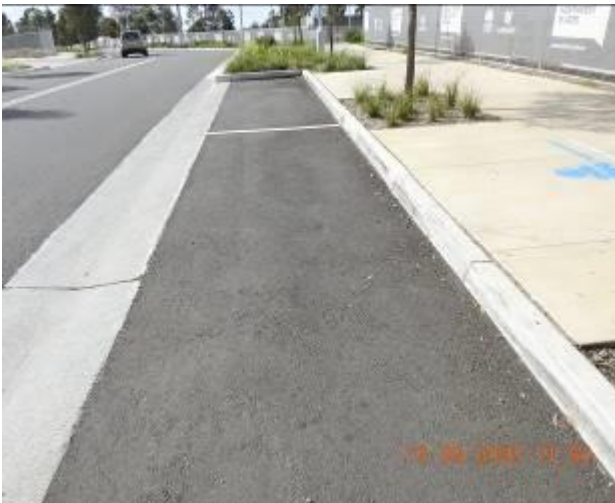
Figure 1411 – General condition of road surface

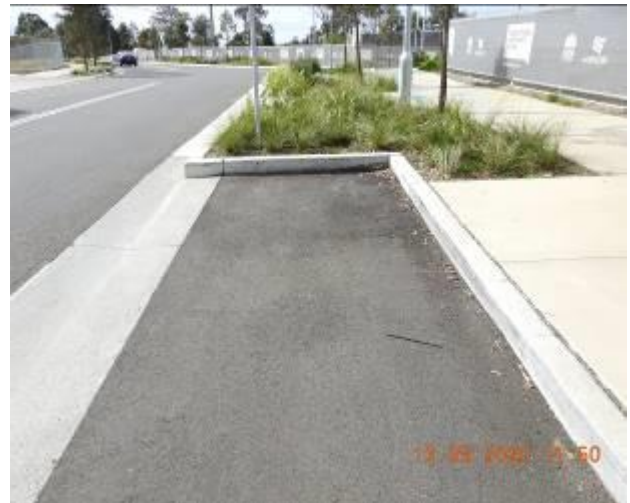
Figure 1412 – General condition of road surface

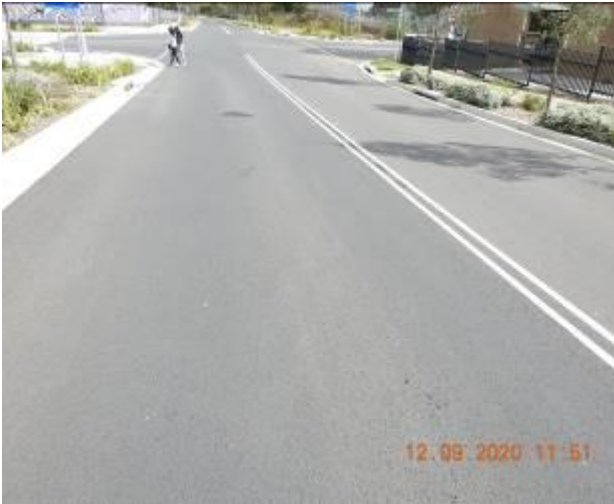
Figure 1413 – General condition of road surface heading West

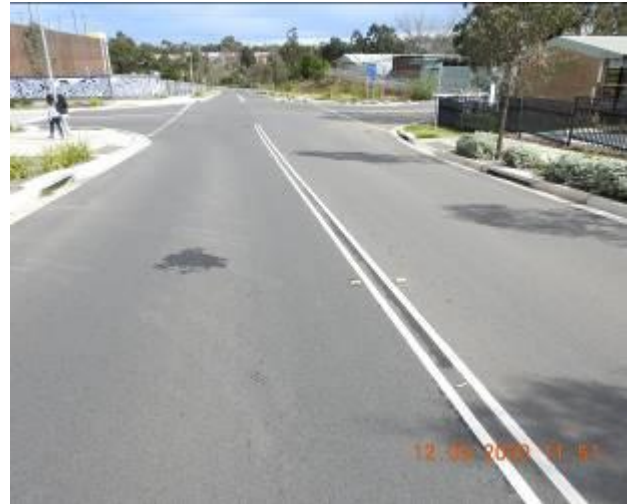
Figure 1414 – General condition of road surface

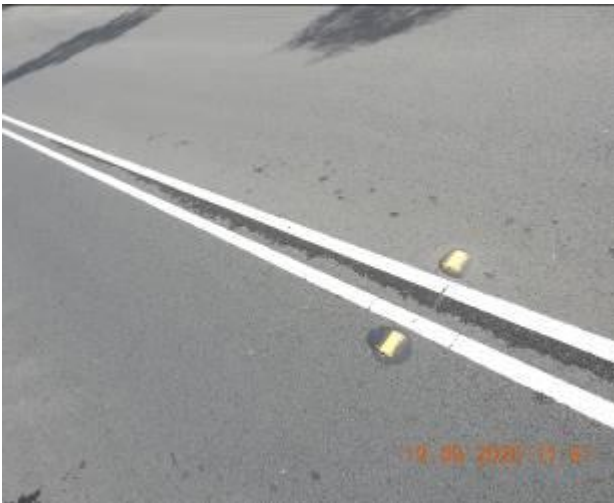
Figure 1415 – Evidence of patchwork, crack propagation and loss of material through road surface

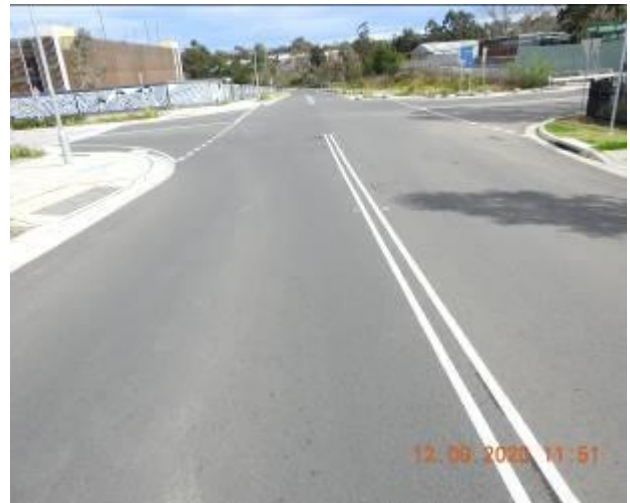
Figure 1416 – General condition of road surface

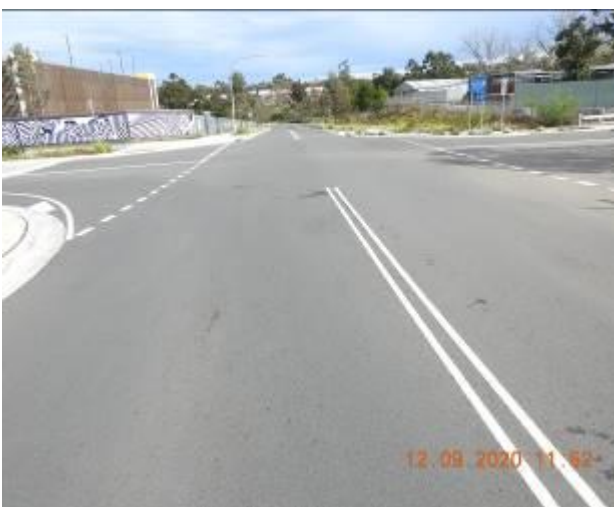
Figure 1417 – General condition of road surface

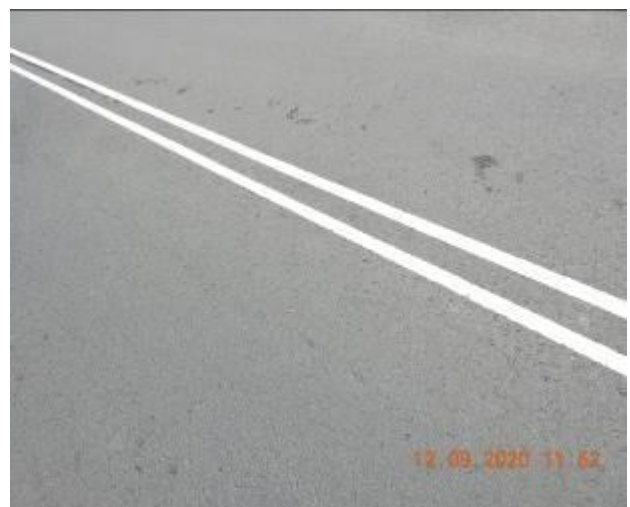
Figure 1418 – Crack propagation and loss of material through road surface

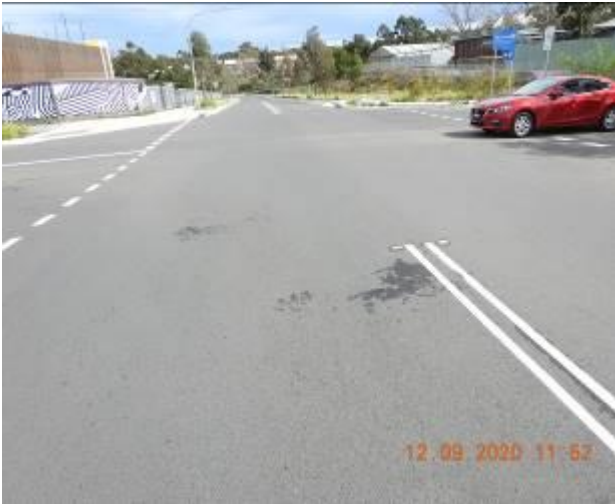
Figure 1419 – General condition of road surface

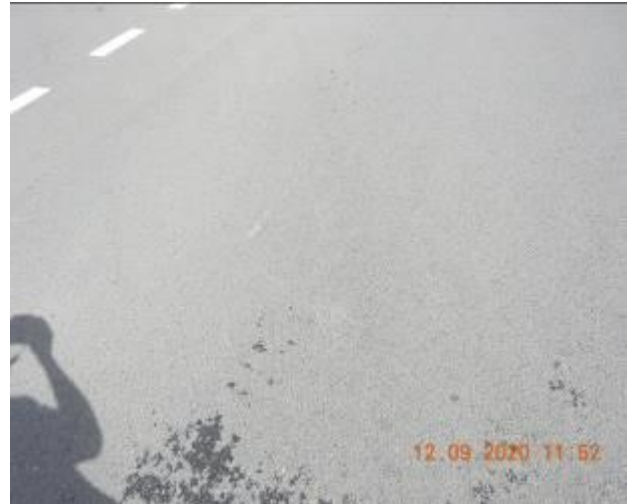
Figure 1420 – Loss of material through road surface

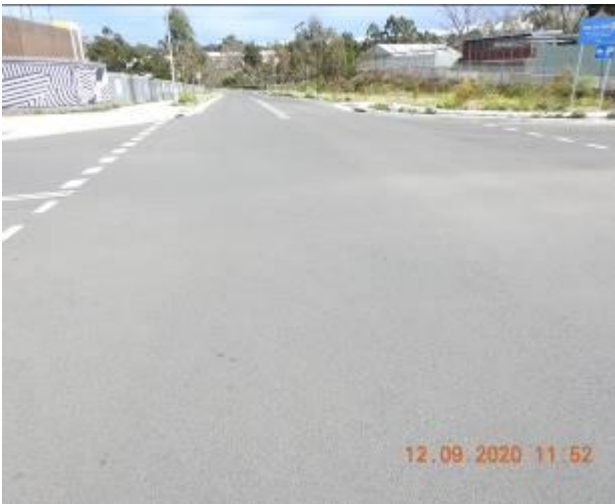
Figure 1421 – General condition of road surface

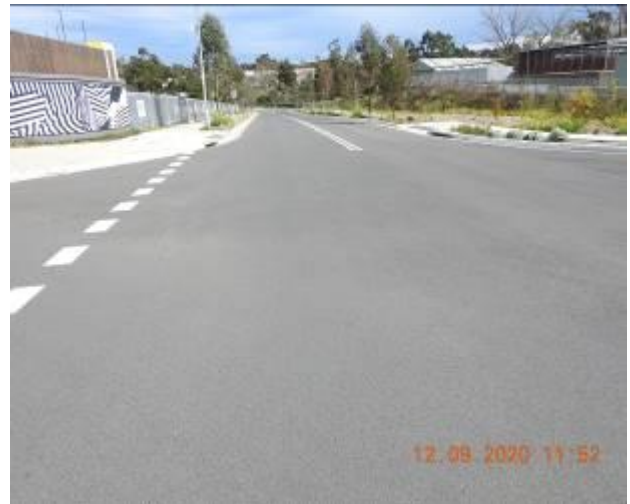
Figure 1422 – General condition of road surface

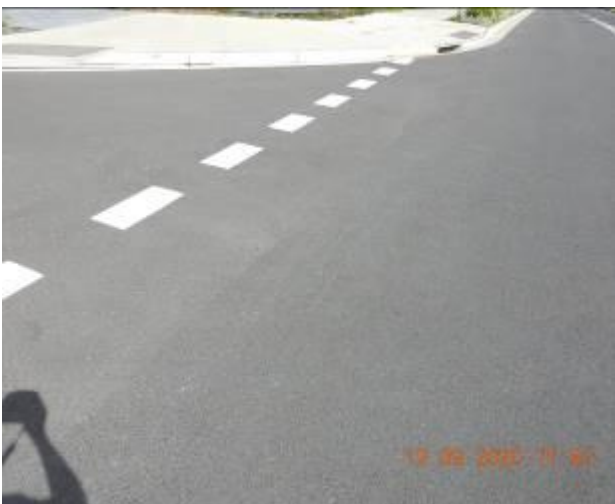
Figure 1423 – Crack propagation through road surface

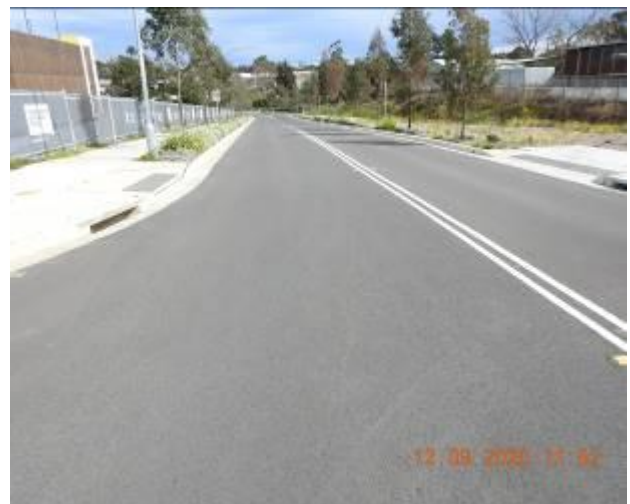
Figure 1424 – General condition of road surface

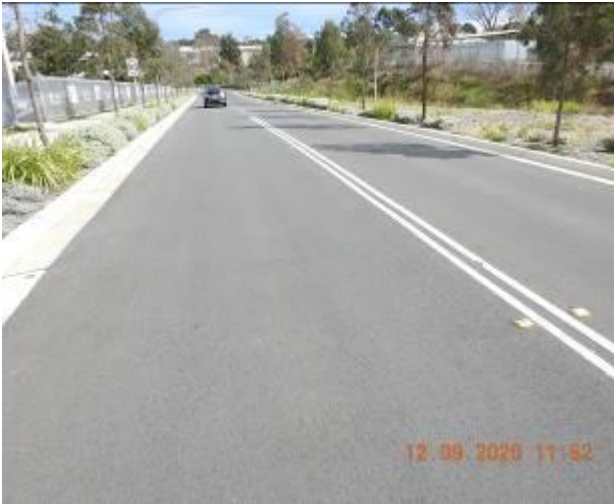
Figure 1425 – General condition of road surface
