**2 MANDALA PARADE, CASTLE HILL
(DORAN DRIVE PRECINCT)
PRE-DILAPIDATION REPORT
Of Sydney Metro and Hills Shire Council Assets
DEICORP PROJECTS SHOWGROUND
PTY LTD.**

Job No. 200124.3
07/07/2021

ACE Structural Services Pty Ltd

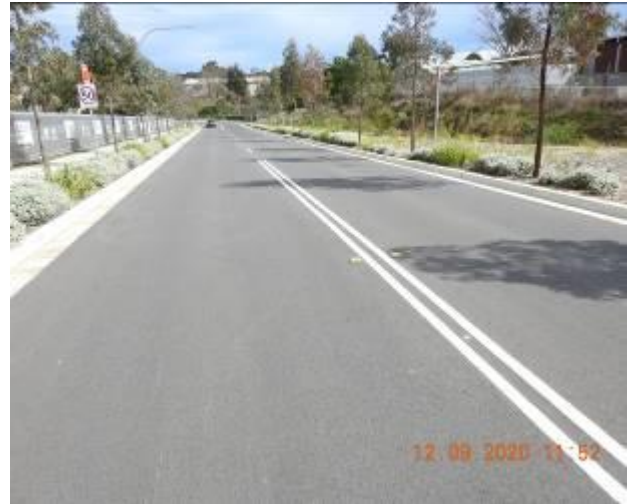
Figure 1426 – General condition of road surface

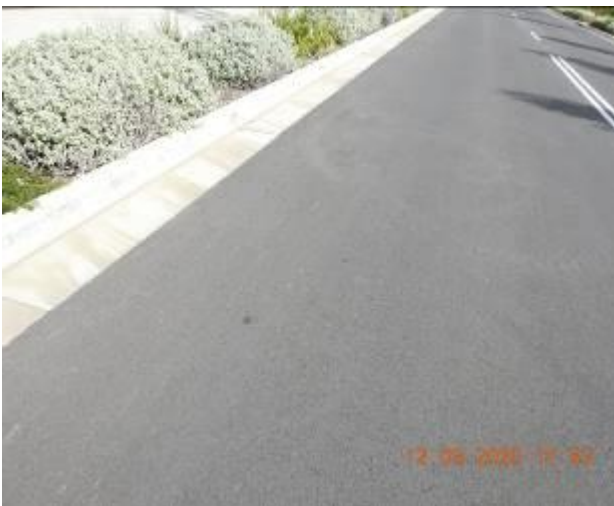
Figure 1427 – General condition of road surface

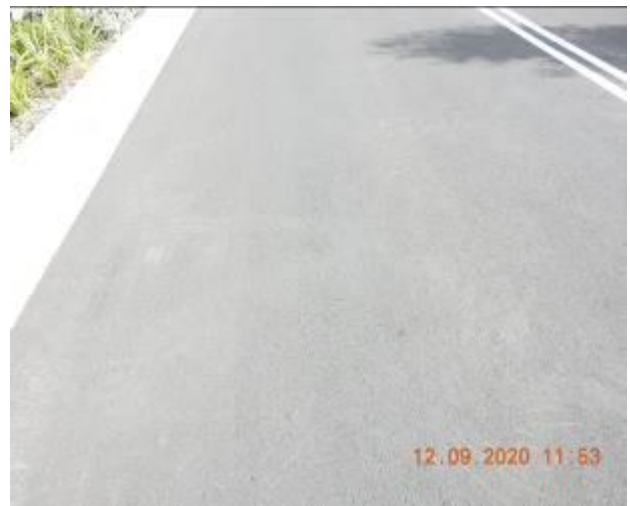
Figure 1428 – General condition of road surface

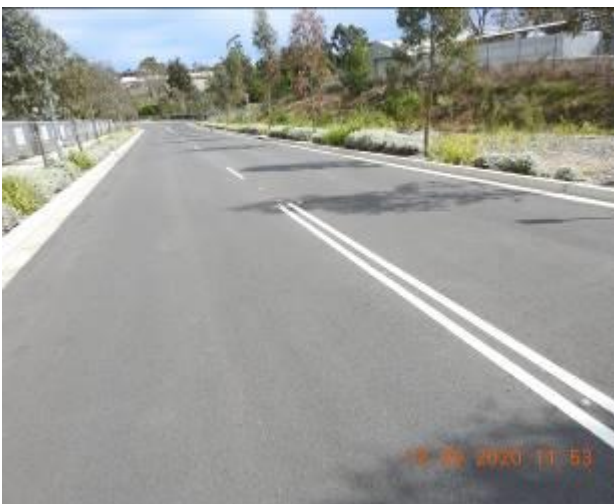
Figure 1429 – General condition of road surface

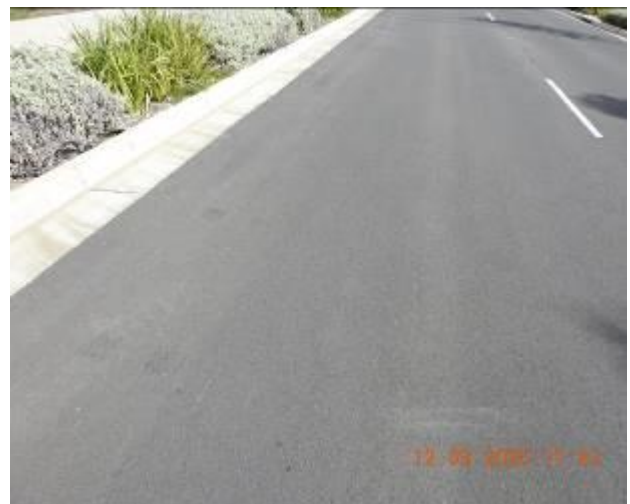
Figure 1430 – General condition of road surface

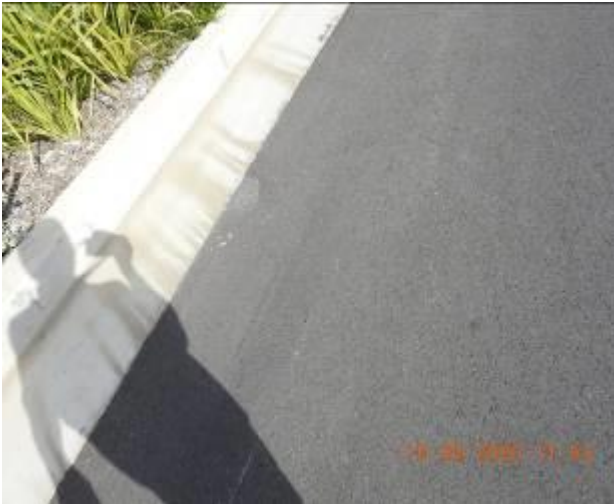
Figure 1431 – Evidence of patchwork through road surface

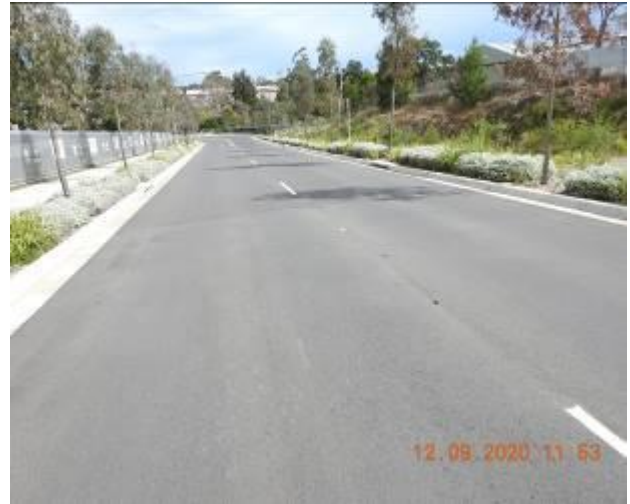
Figure 1432 – General condition of road surface

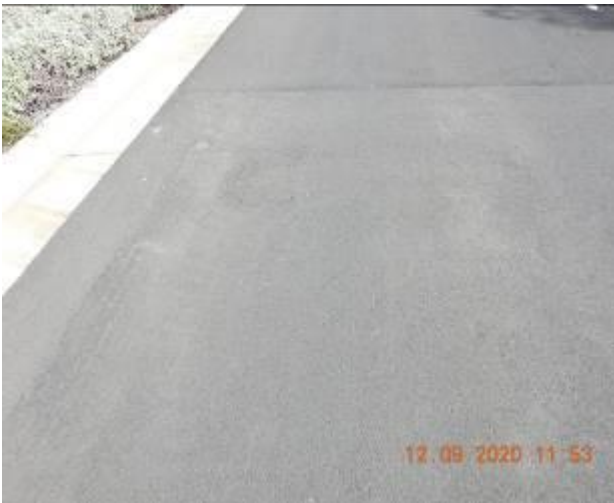
Figure 1433 – Loss of material through road surface

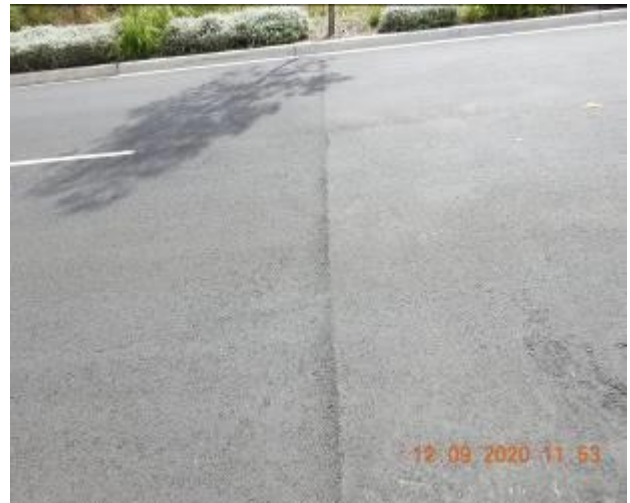
Figure 1434 – Evidence of patchwork through road surface

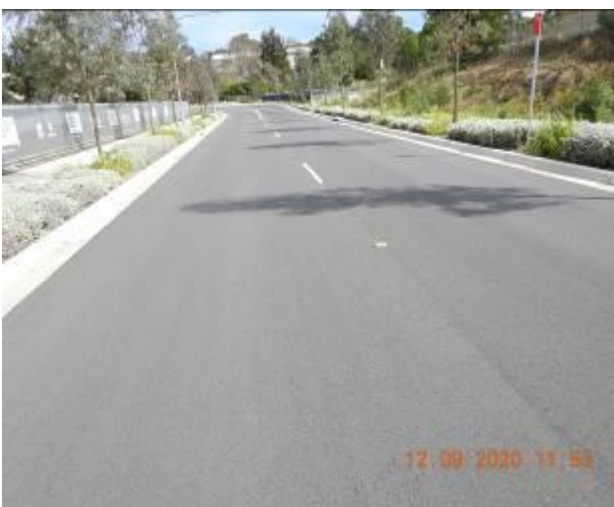
Figure 1435 – General condition of road surface

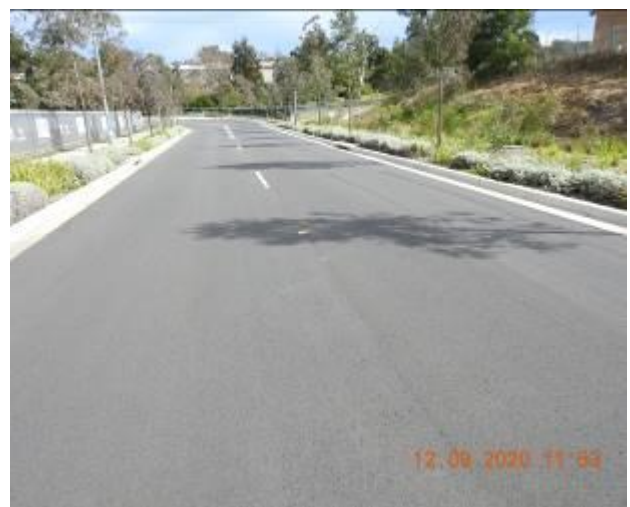
Figure 1436 – General condition of road surface

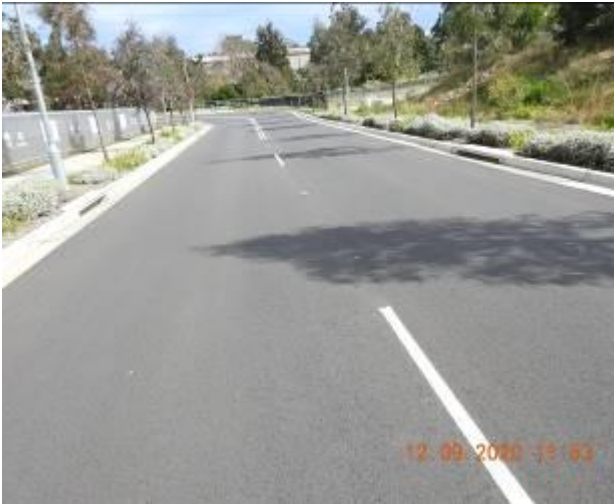
Figure 1437 – General condition of road surface

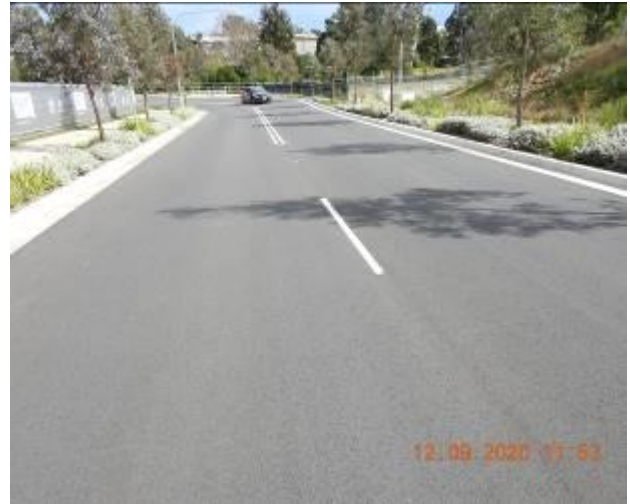
Figure 1438 – General condition of road surface

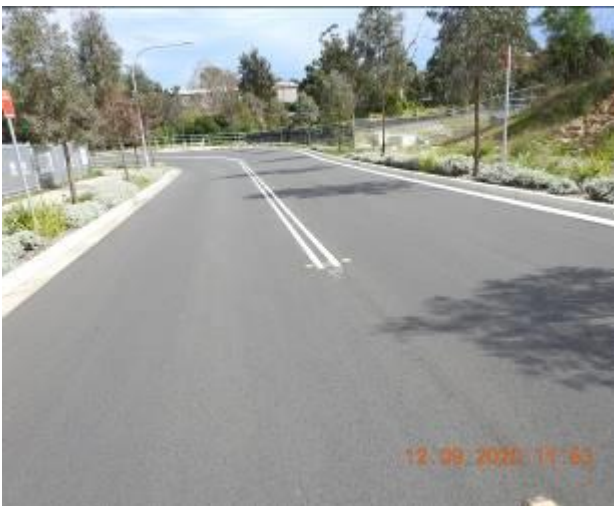
Figure 1439 – General condition of road surface

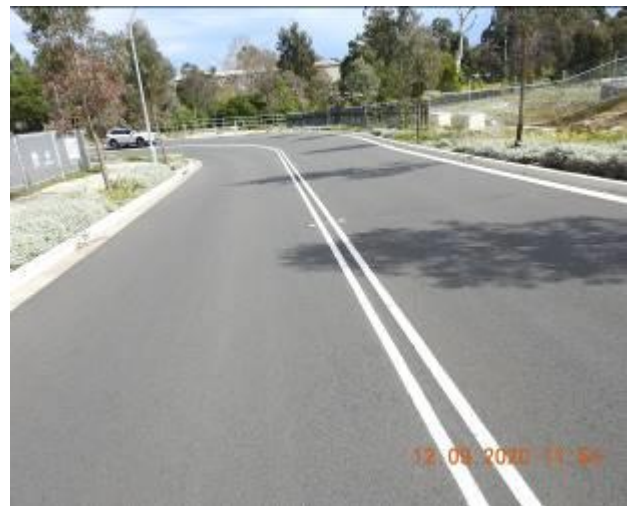
Figure 1440 – General condition of road surface

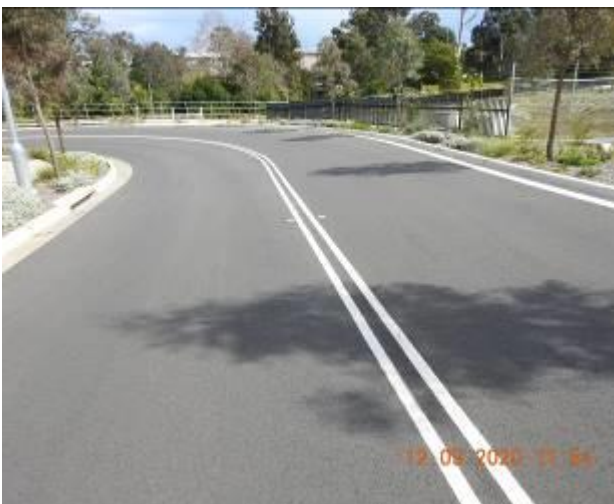
Figure 1441 – General condition of road surface

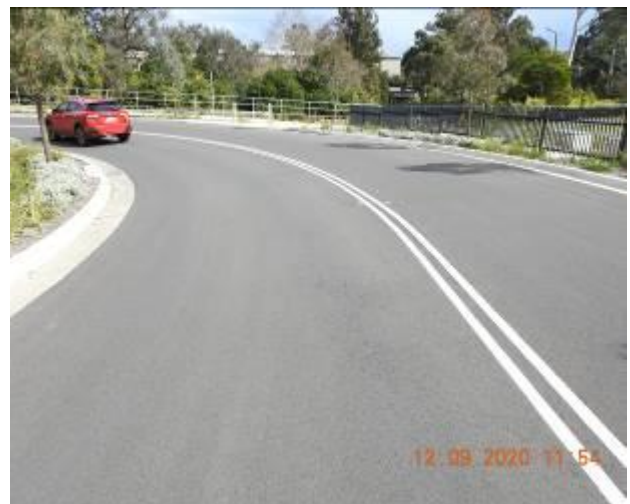
Figure 1442 – General condition of road surface

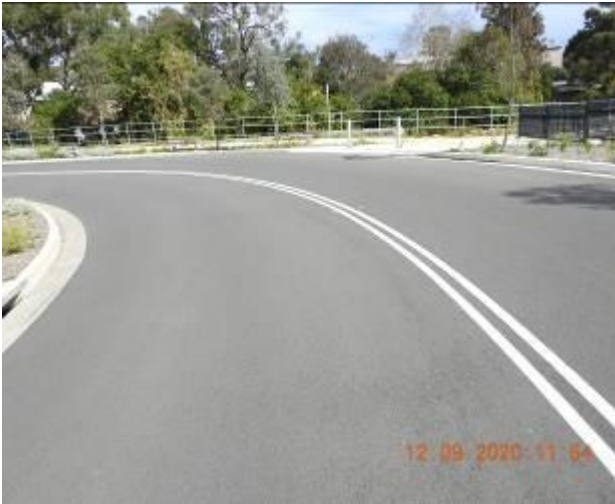
Figure 1443 – General condition of road surface

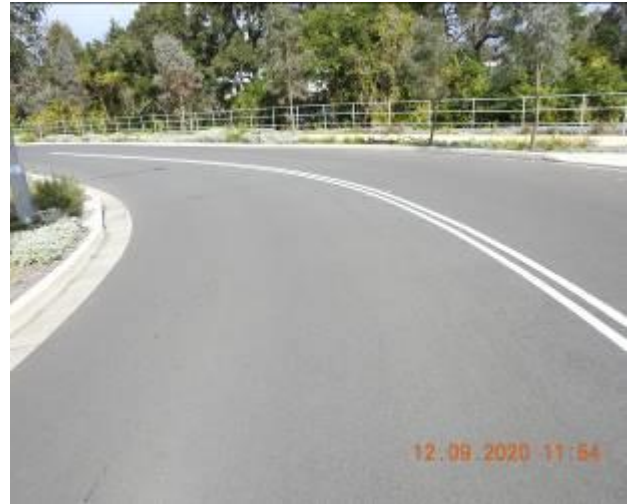
Figure 1444 – General condition of road surface heading South

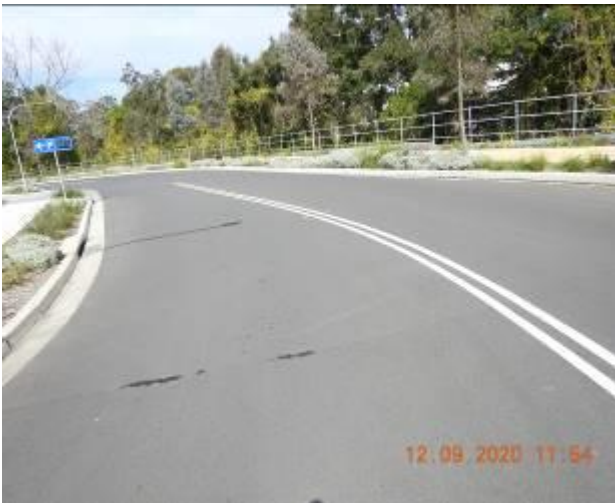
Figure 1445 – Evidence of patchwork through road surface

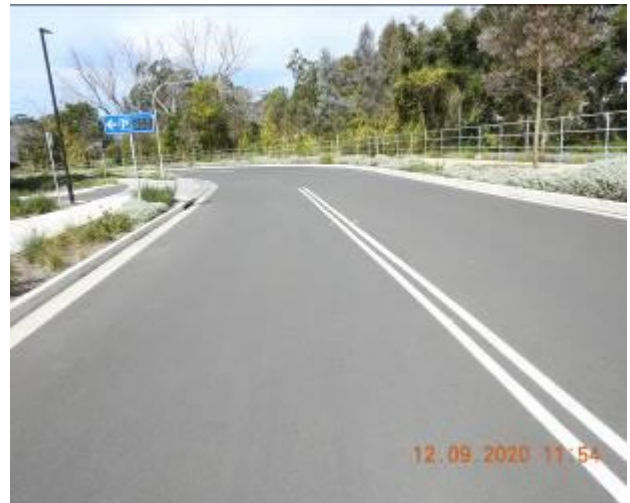
Figure 1446 – General condition of road surface

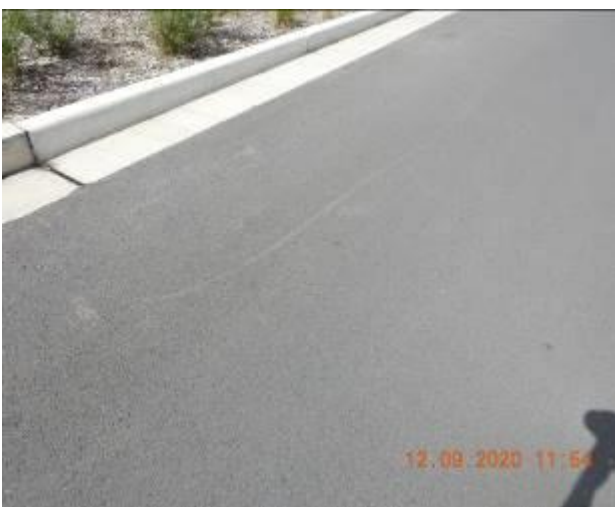
Figure 1447 – Loss of material through road surface

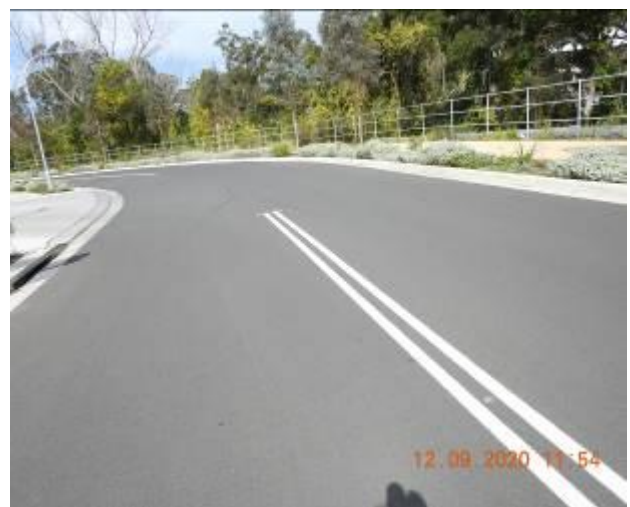
Figure 1448 – General condition of road surface

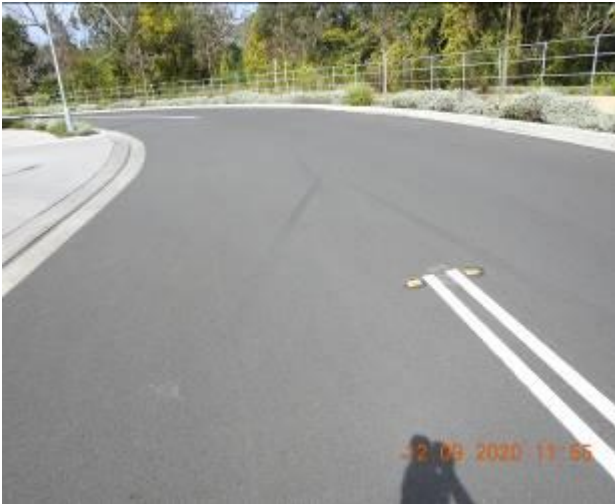
Figure 1449 – General condition of road surface

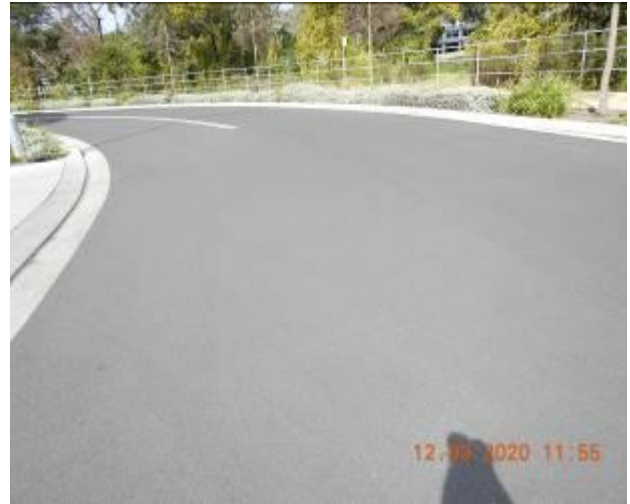
Figure 1450 – General condition of road surface

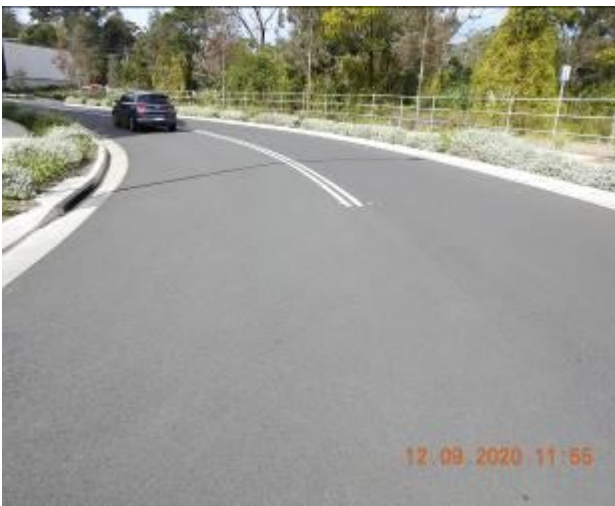
Figure 1451 – General condition of road surface

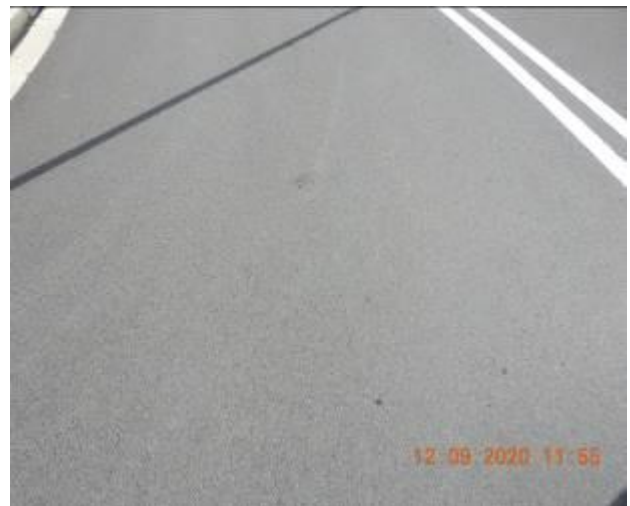
Figure 1452 – Loss of material through road surface

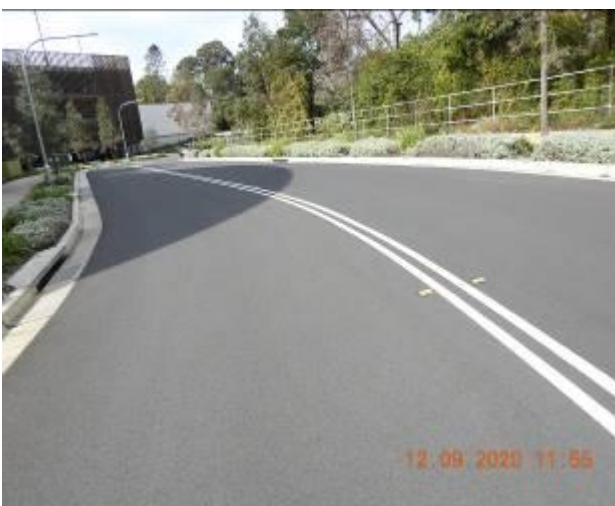
Figure 1453 – General condition of road surface

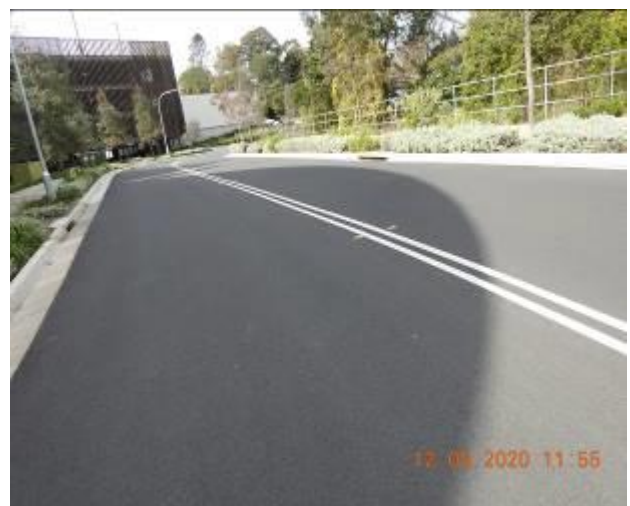
Figure 1454 – General condition of road surface

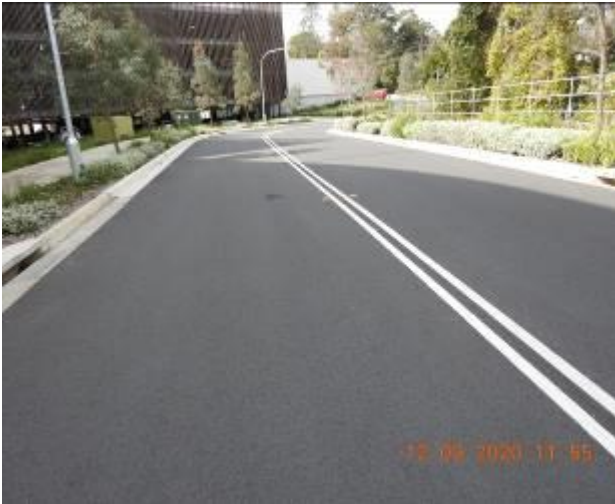
Figure 1455 – General condition of road surface

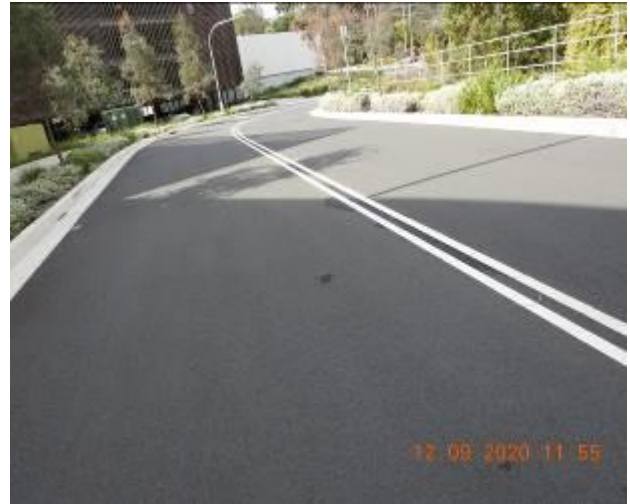
Figure 1456 – Evidence of patchwork through road surface

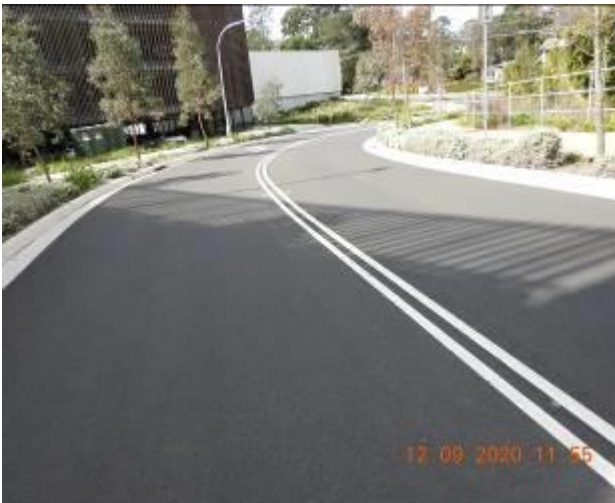
Figure 1457 – General condition of road surface

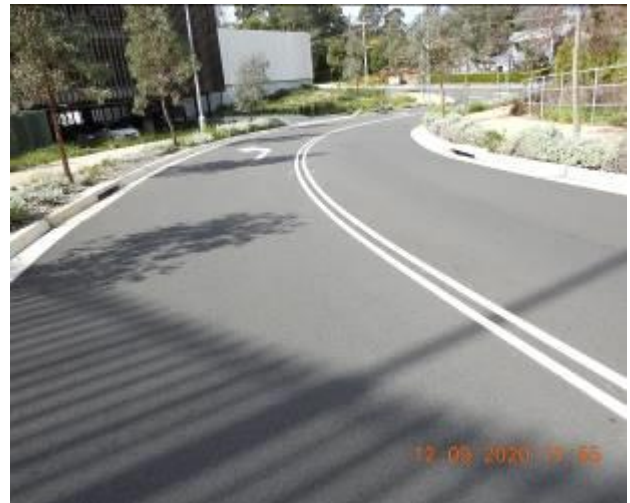
Figure 1458 – General condition of road surface

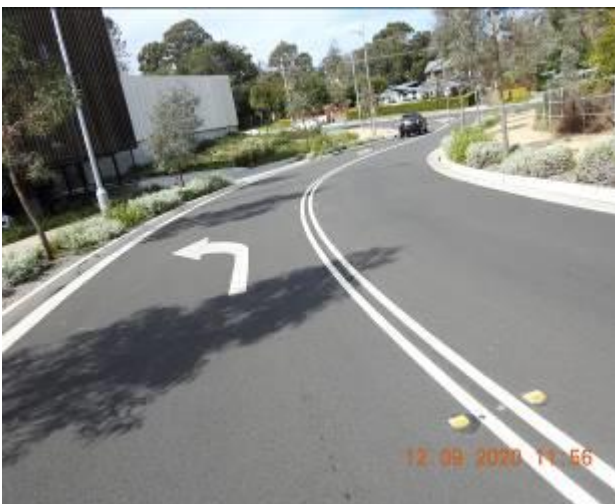
Figure 1459 – Loss of material through road surface

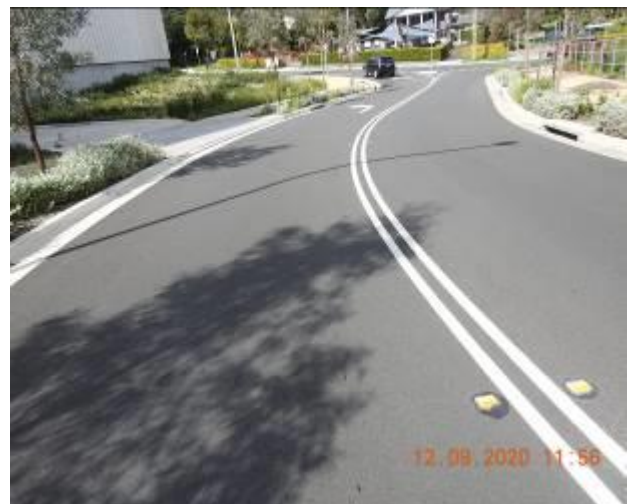
Figure 1460 – General condition of road surface

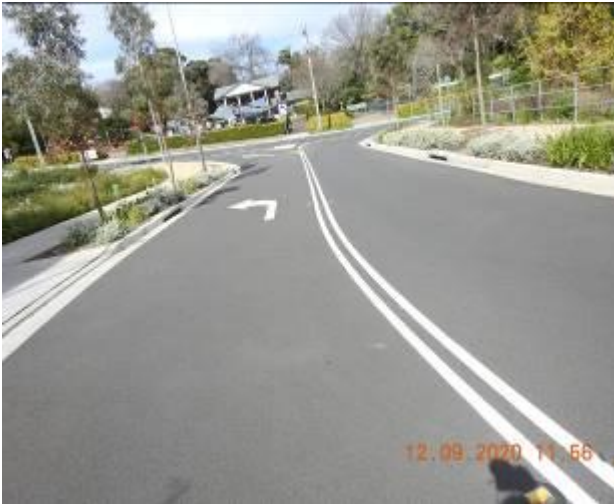
Figure 1461 – General condition of road surface

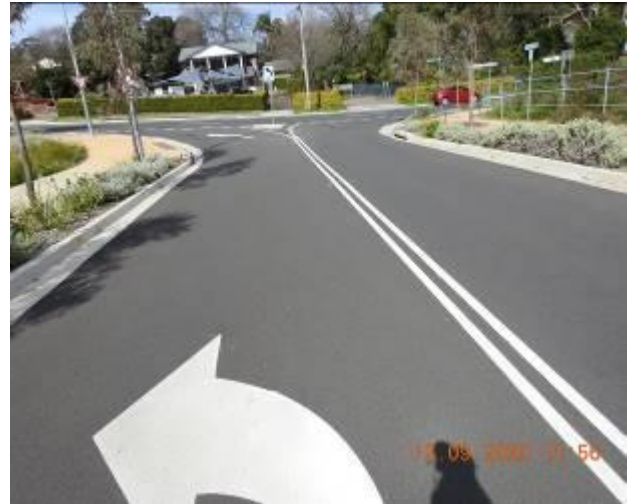
Figure 1462 – General condition of road surface

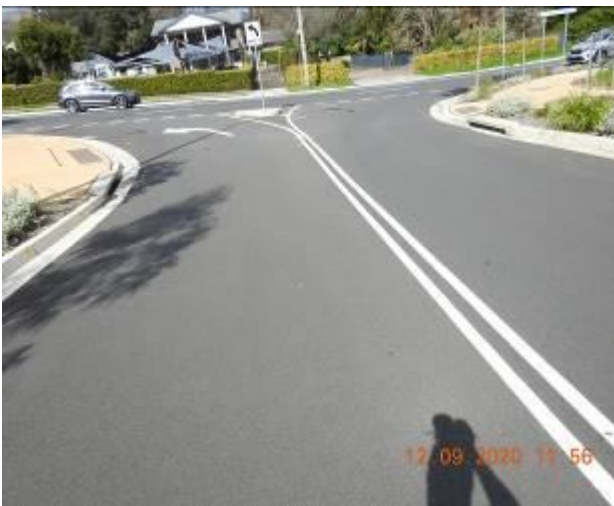
Figure 1463 – General condition of road surface

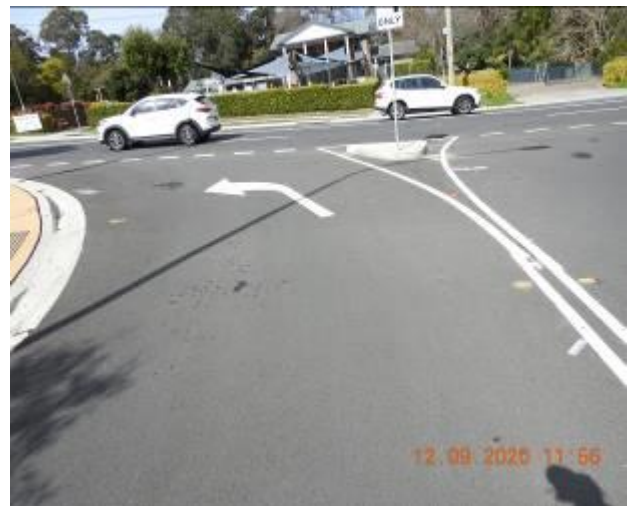
Figure 1464 – General condition of road surface

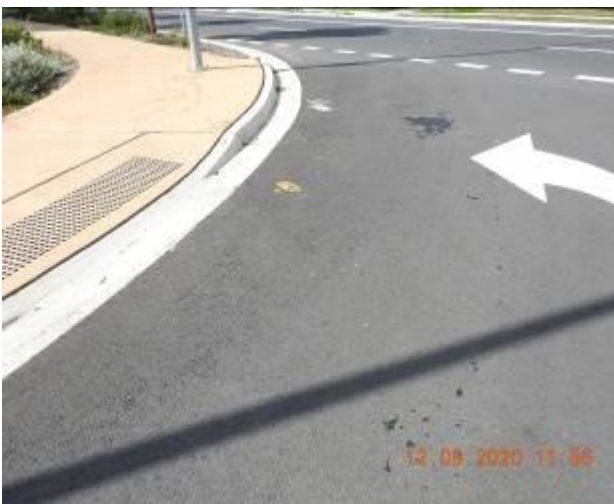
Figure 1465 – General condition of road surface

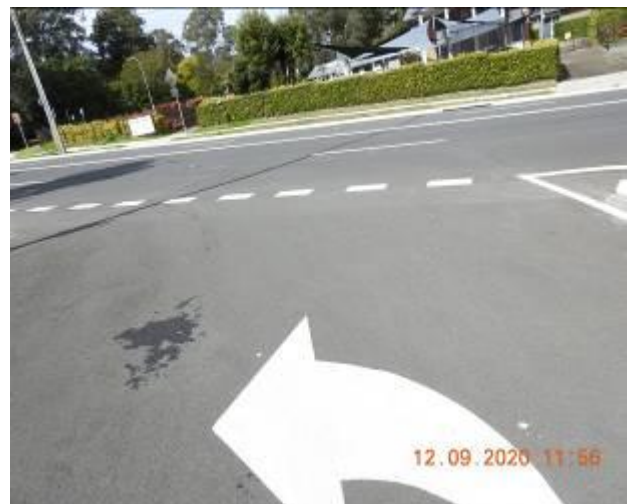
Figure 1466 – General condition of road surface

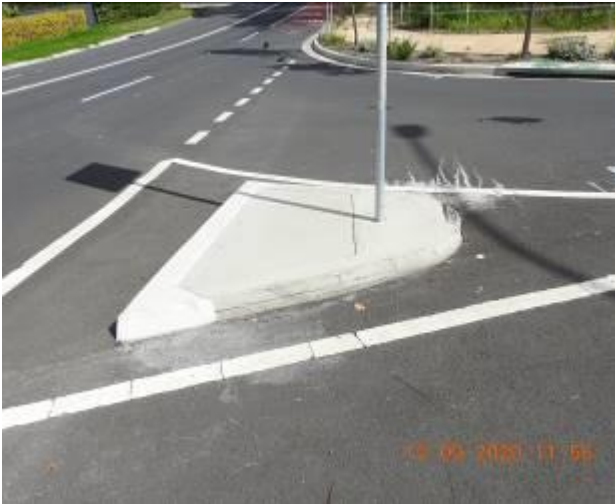
Figure 1467 – General condition of traffic island

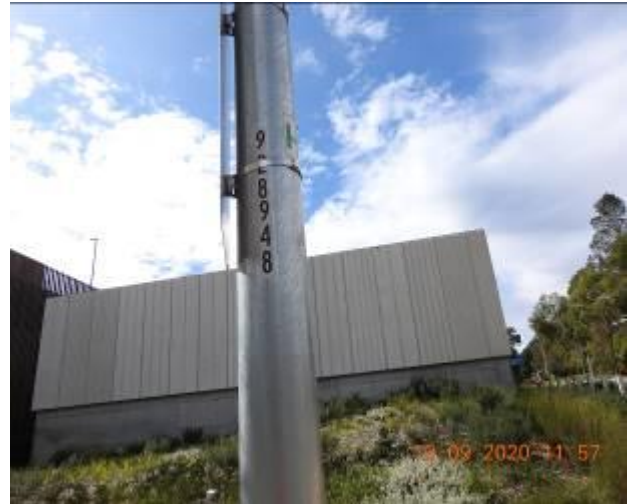
Figure 1468 – General condition of lamp post Identification No. 928948 heading North

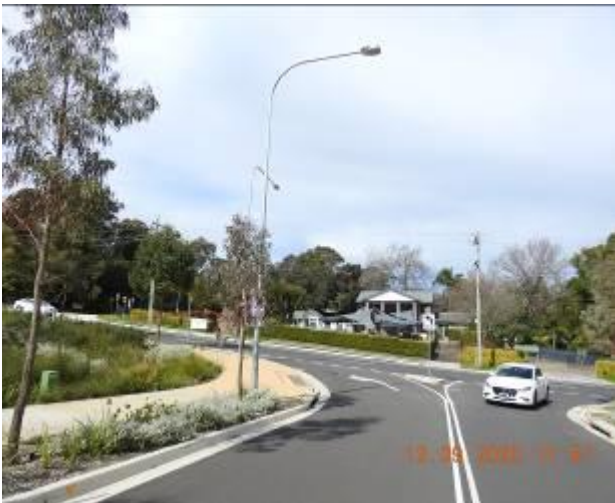
Figure 1469 – General condition of lamp post Identification No. 928948 and plantations

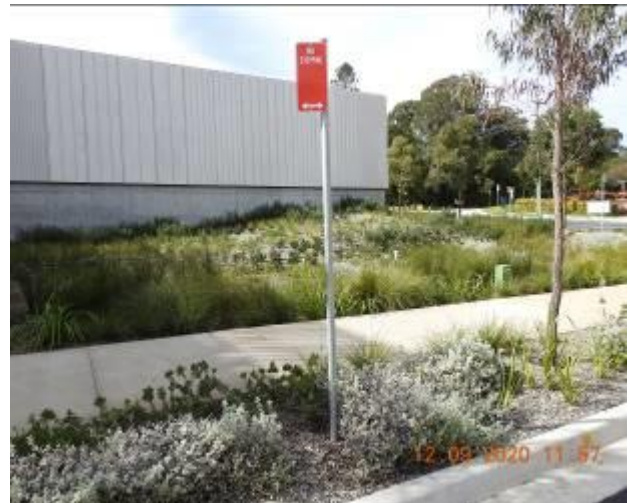
Figure 1470 – General condition of street sign

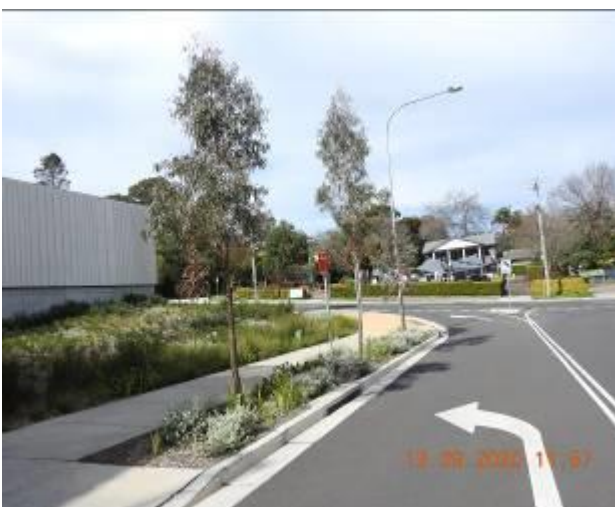
Figure 1471 – General condition of plantations

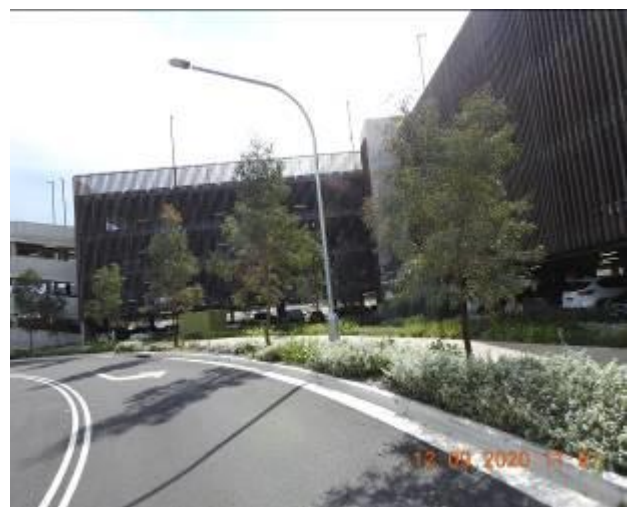
Figure 1472 – General condition of plantations

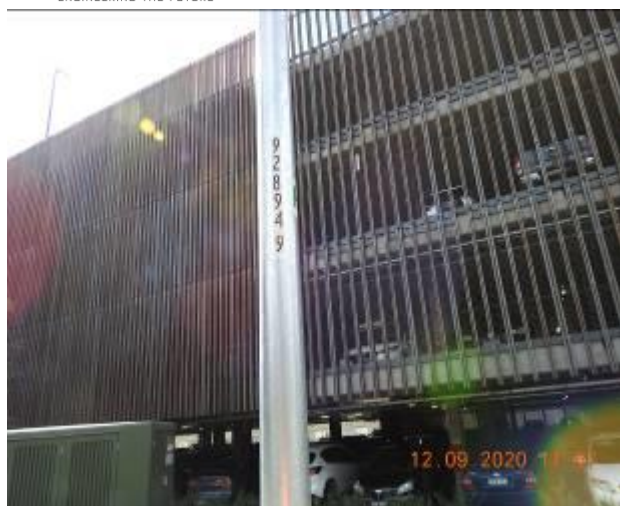
Figure 1473 – General condition of lamp post
Identification No. 928949

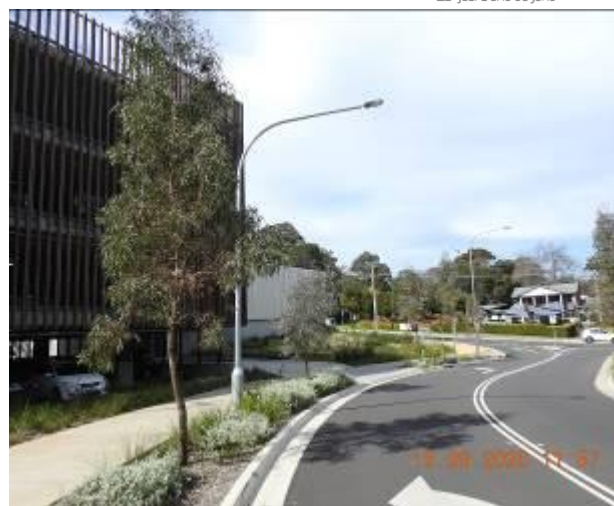
Figure 1474 – General condition of lamp post
Identification No. 928949 and plantations

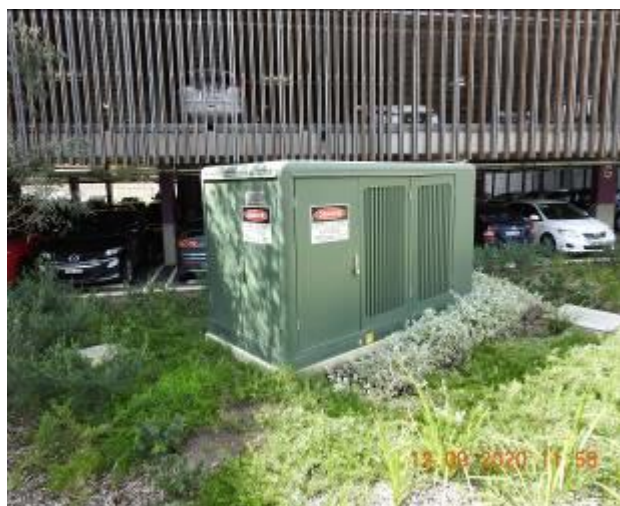
Figure 1475 – General condition of electricity box

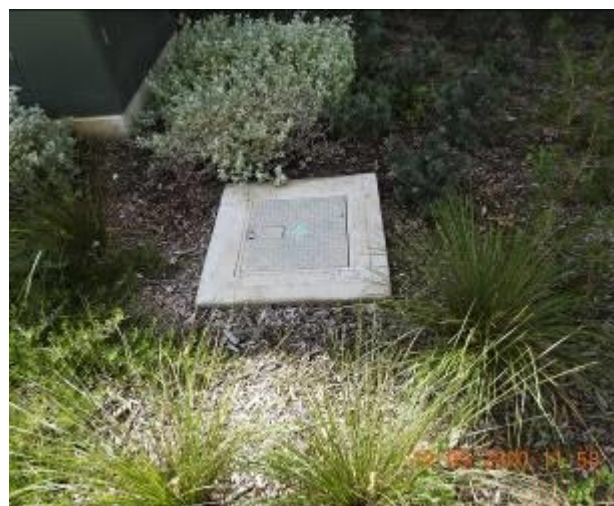
Figure 1476 – General condition of service pit

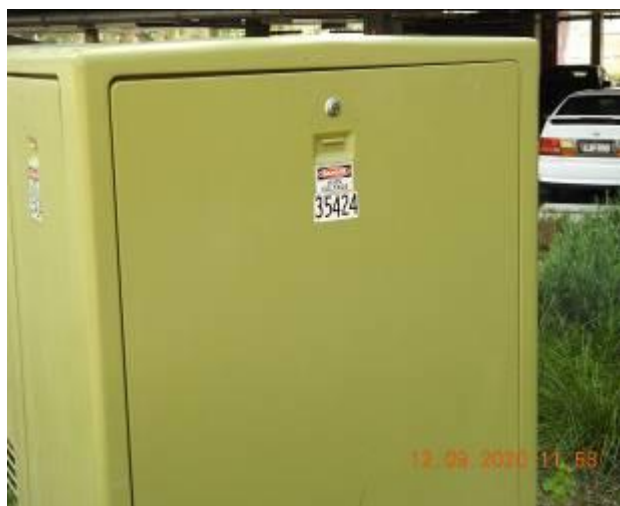
Figure 1477 – General condition of electricity
substation Identification No. 35424

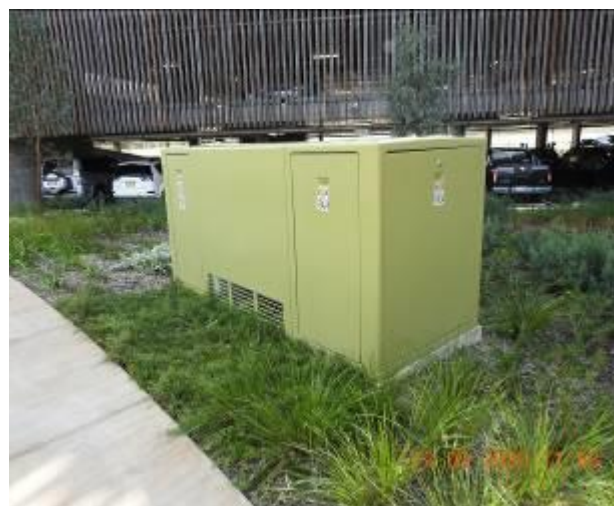
Figure 1478 – General condition of electricity
substation Identification No. 35424

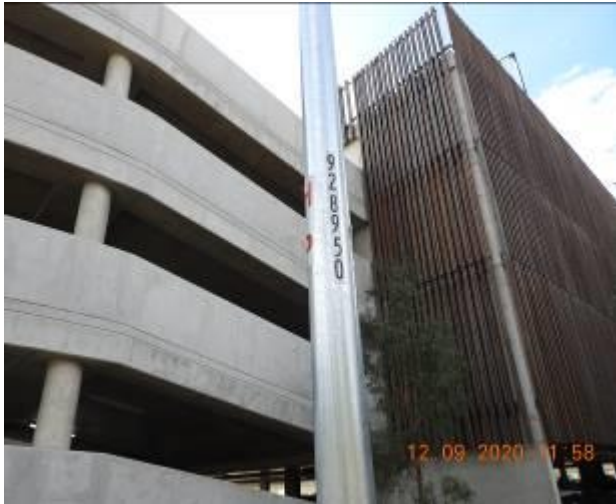
Figure 1479 – General condition of lamp post Identification No. 928950

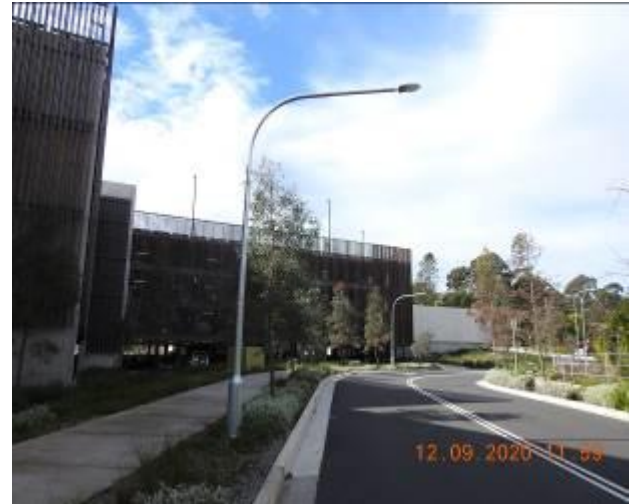
Figure 1480 – General condition of lamp post Identification No. 928950 and plantations

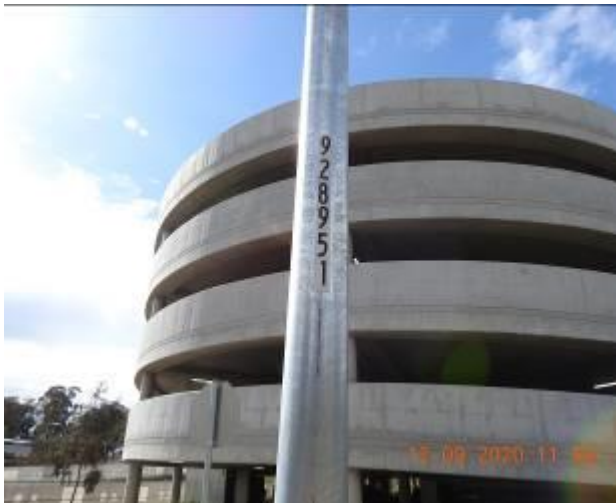
Figure 1481 – General condition of lamp post Identification No. 928951

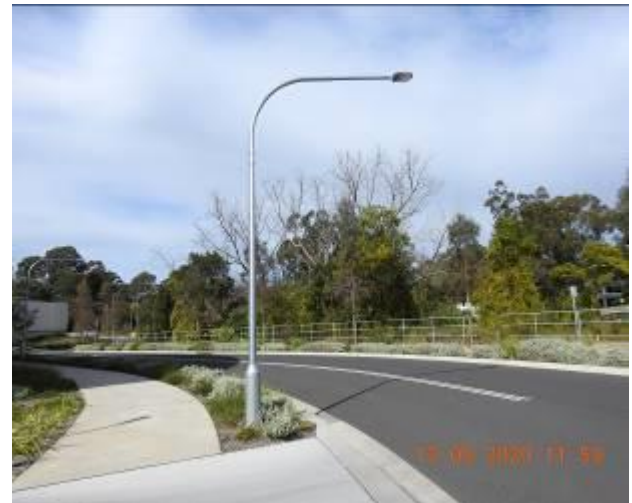
Figure 1482 – General condition of lamp post Identification No. 928951

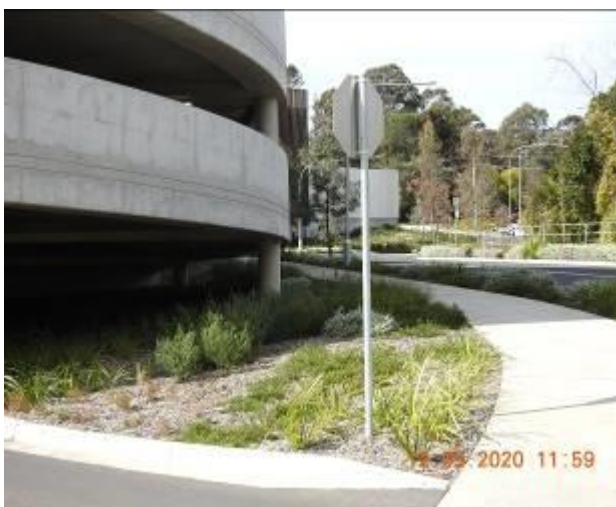
Figure 1483 – General condition of street sign

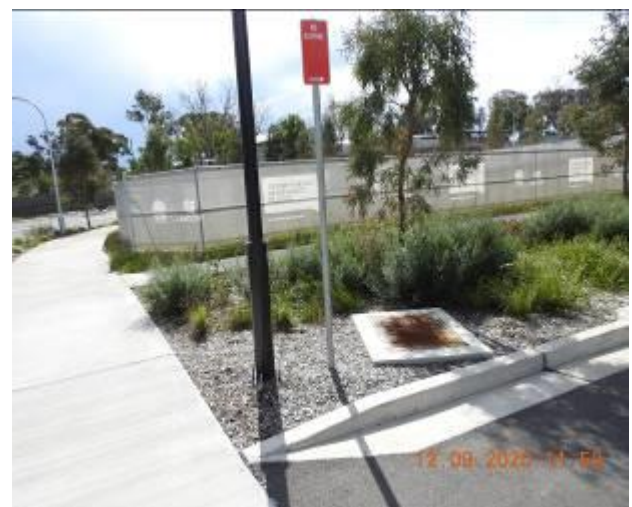
Figure 1484 – General condition of street sign

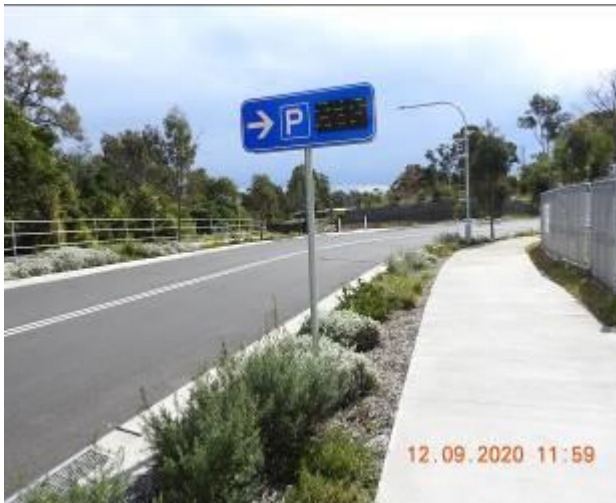
Figure 1485 – General condition of street sign

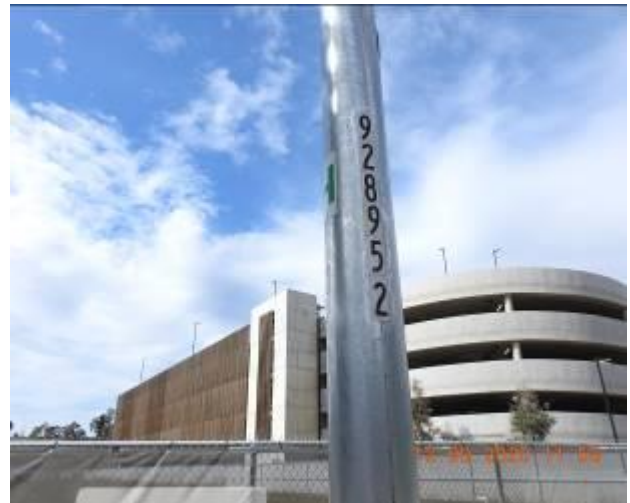
Figure 1486 – General condition of lamp post Identification No. 928952

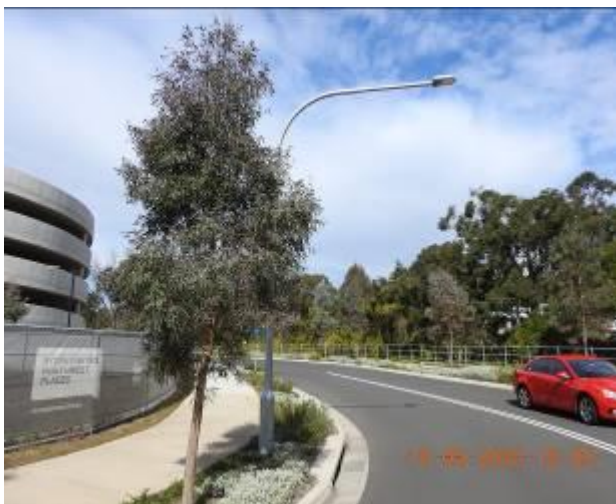
Figure 1487 – General condition of lamp post Identification No. 928952 and plantation

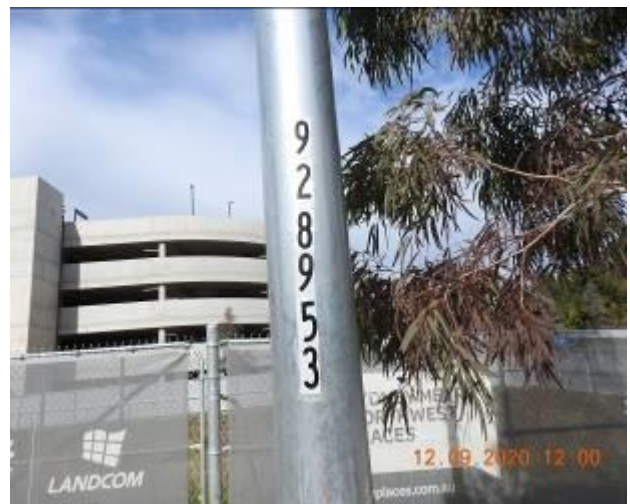
Figure 1488 – General condition of lamp post Identification No. 928953 heading East

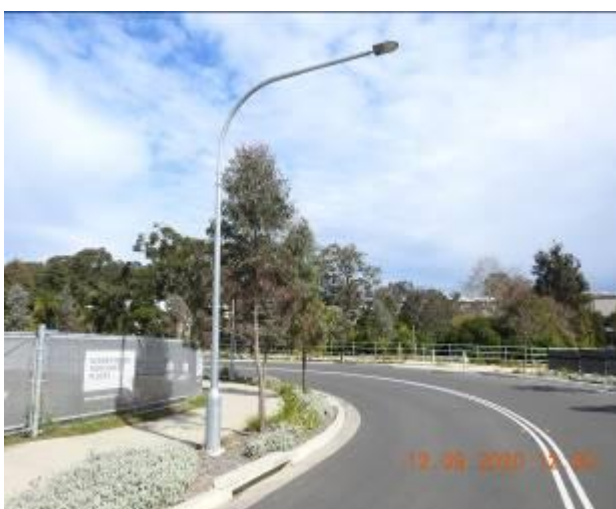
Figure 1489 – General condition of lamp post Identification No. 928953 and plantations

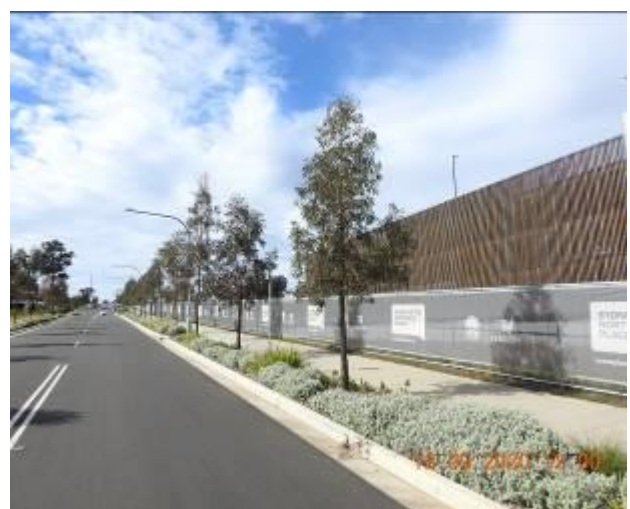
Figure 1490 – General condition of plantations

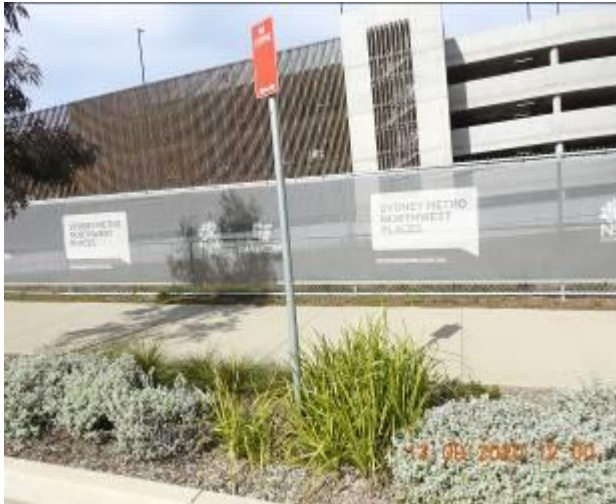
Figure 1491 – General condition of street sign

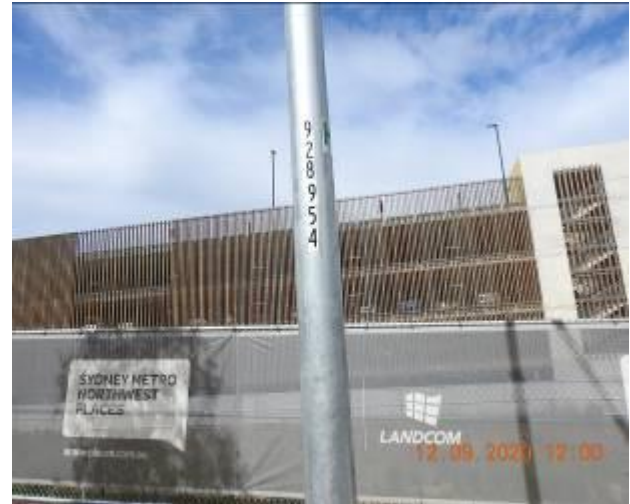
Figure 1492 – General condition of lamp post
Identification No. 928954

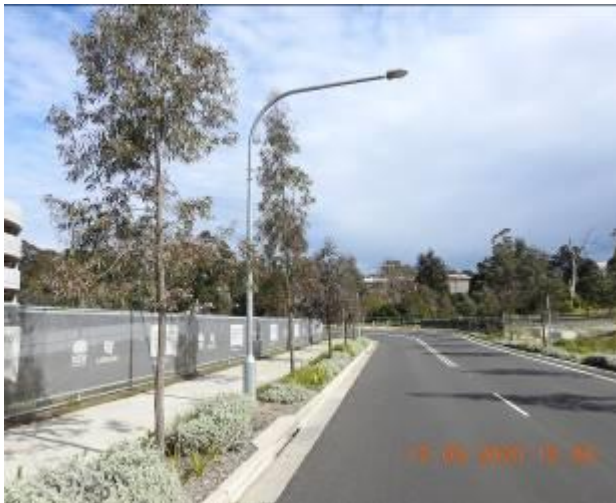
Figure 1493 – General condition of lamp post
Identification No. 928954 and plantations

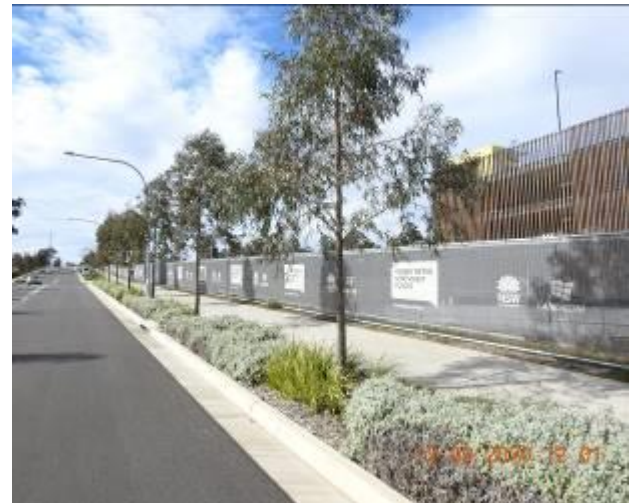
Figure 1494 – General condition of plantations

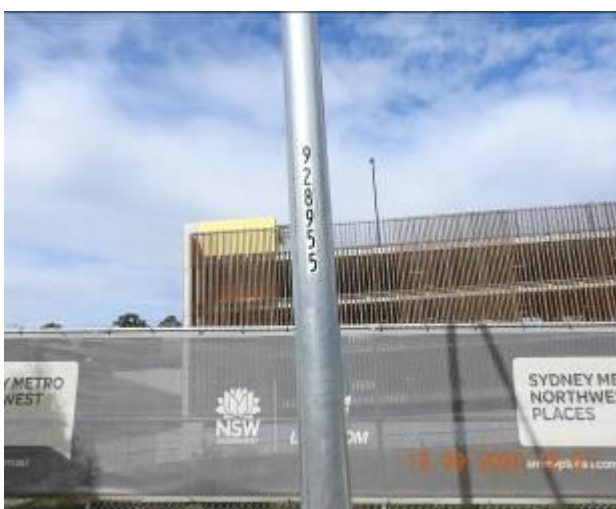
Figure 1495 – General condition of lamp post
Identification No. 928955
