**2 MANDALA PARADE, CASTLE HILL
(DORAN DRIVE PRECINCT)
PRE-DILAPIDATION REPORT
Of Sydney Metro and Hills Shire Council Assets
DEICORP PROJECTS SHOWGROUND
PTY LTD.**

Job No. 200124.3
07/07/2021

ACE Structural Services Pty Ltd

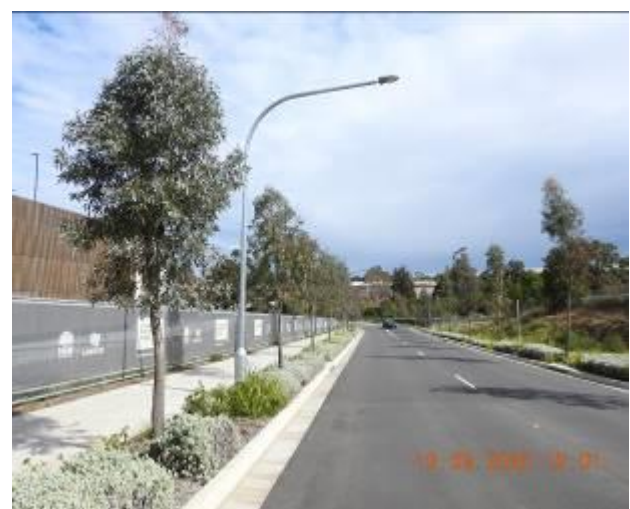
Figure 1496 – General condition of lamp post
Identification No. 928955

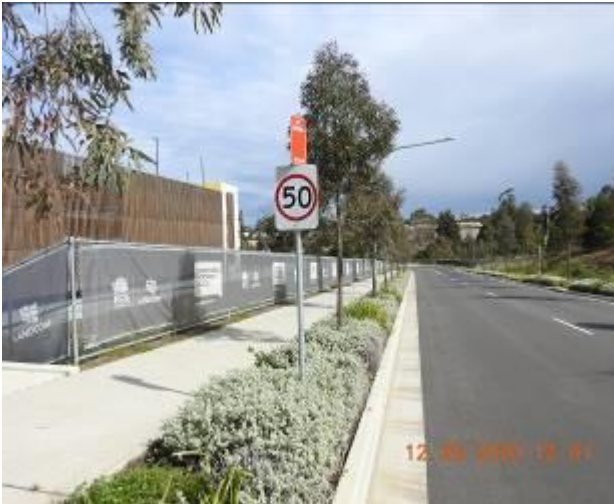
Figure 1497 – General condition of street signs

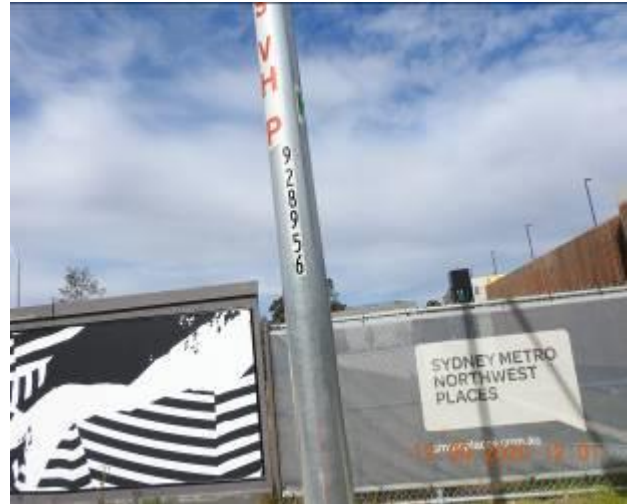
Figure 1498 – General condition of lamp post
Identification No. 928956

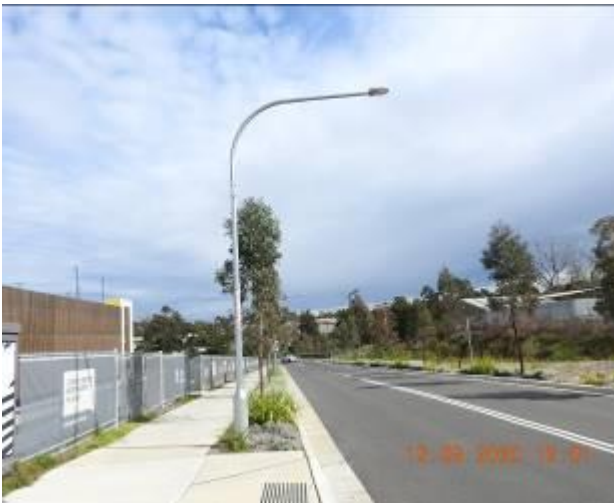
Figure 1499 – General condition of lamp post
Identification No. 928956 and plantations

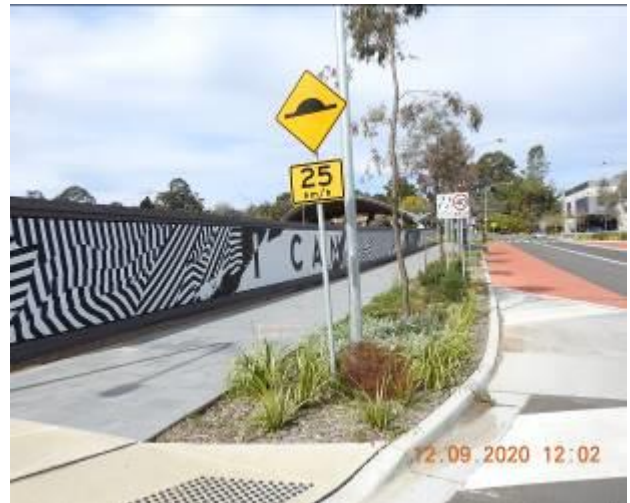
Figure 1500 – General condition of street sign

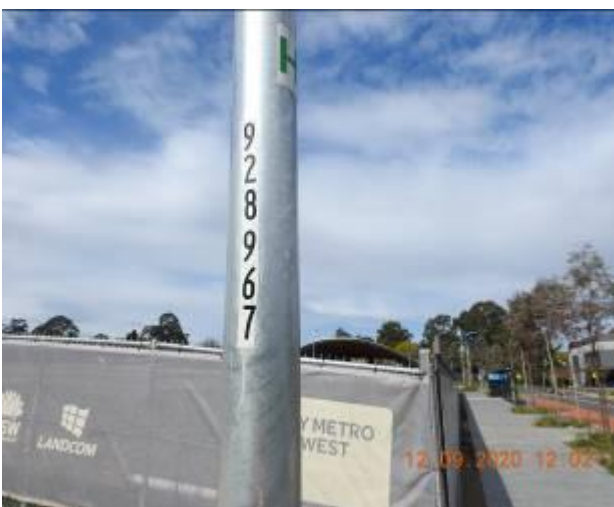
Figure 1501 – General condition of lamp post
Identification No. 928957

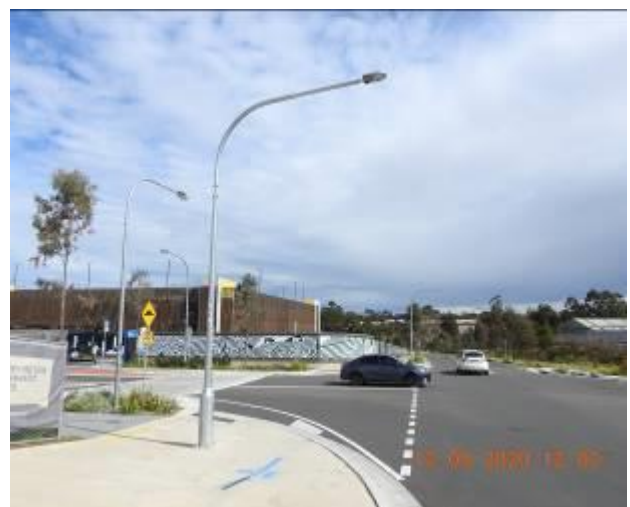
Figure 1502 – General condition of lamp post
Identification No. 928957

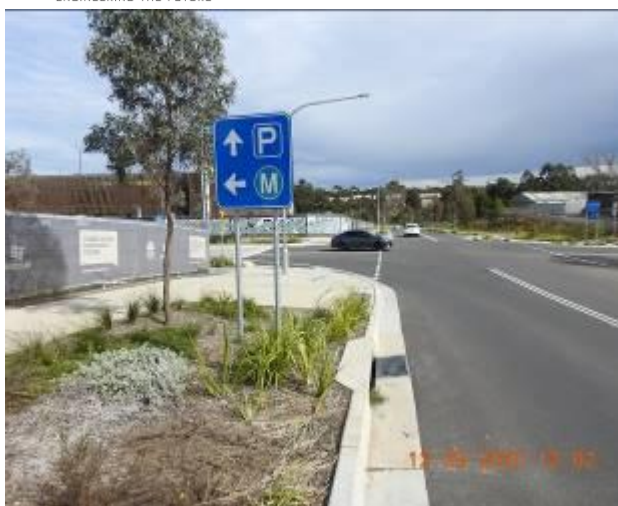
Figure 1503 – General condition of street sign and plantation

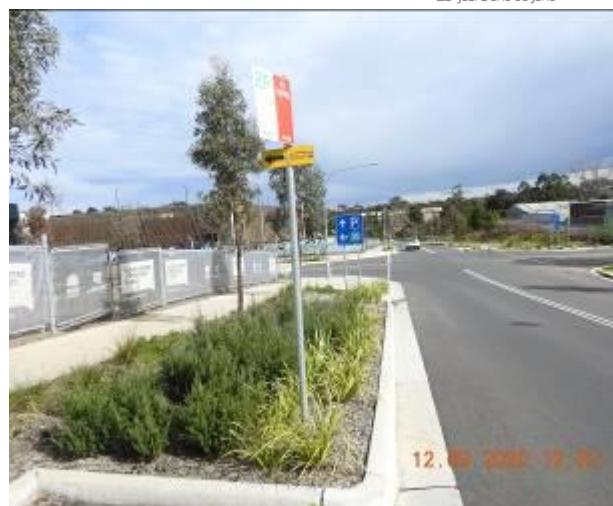
Figure 1504 – General condition of street sign and plantation

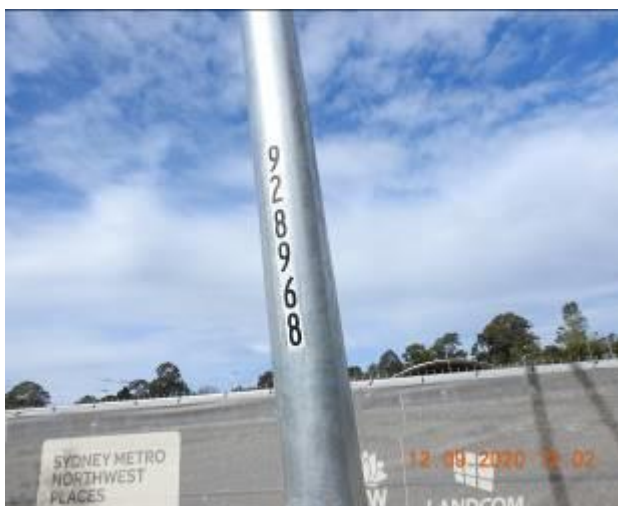
Figure 1505 – General condition of lamp post Identification No. 928958

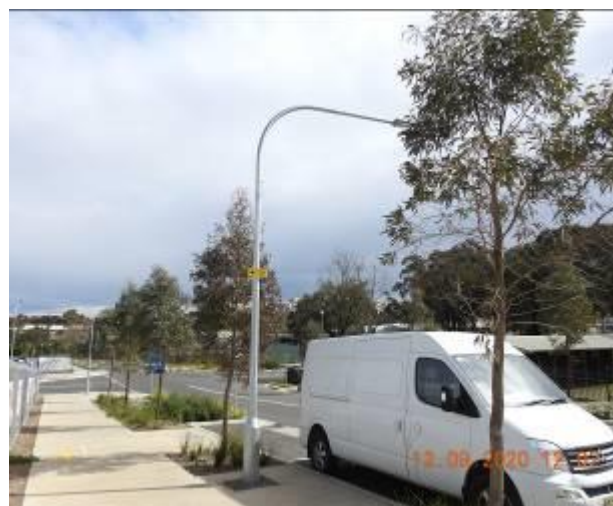
Figure 1506 – General condition of lamp post Identification No. 928958

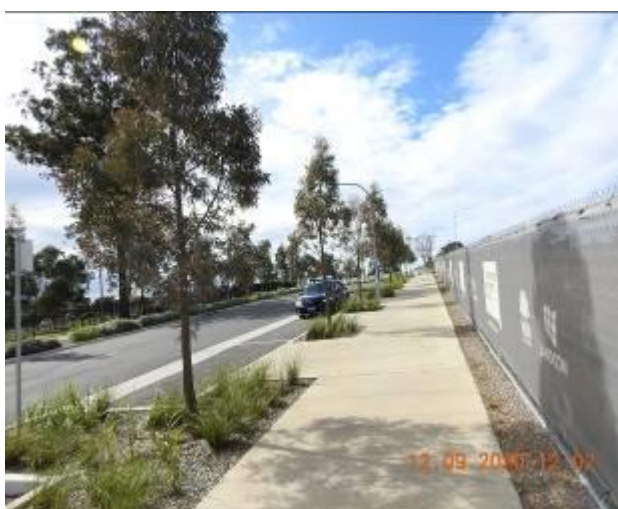
Figure 1507 – General condition of plantation

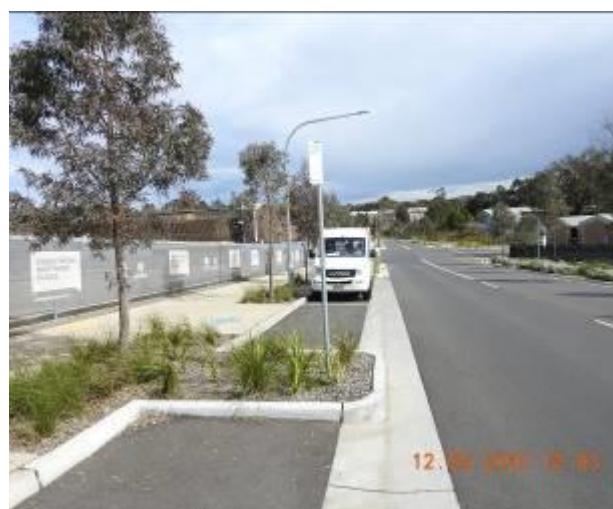
Figure 1508 – General condition of street sign and plantation

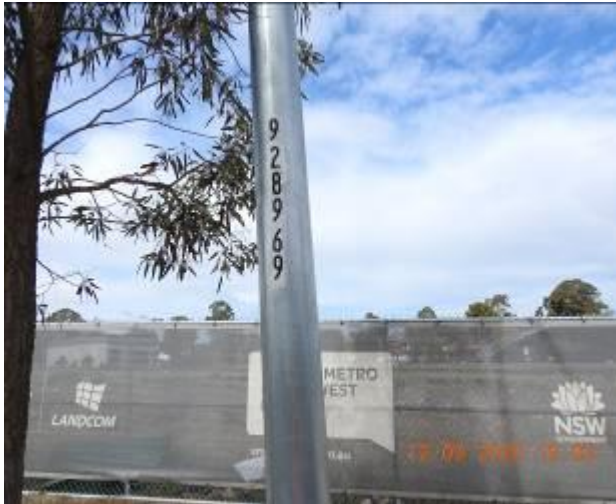
Figure 1509 – General condition of lamp post
Identification No. 928969

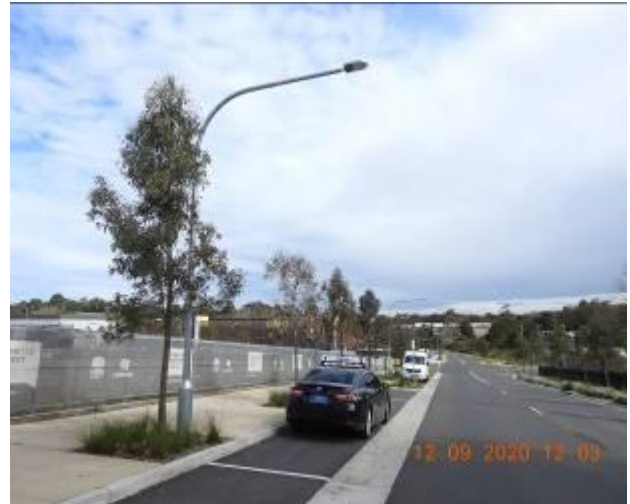
Figure 1510 – General condition of lamp post
Identification No. 928969

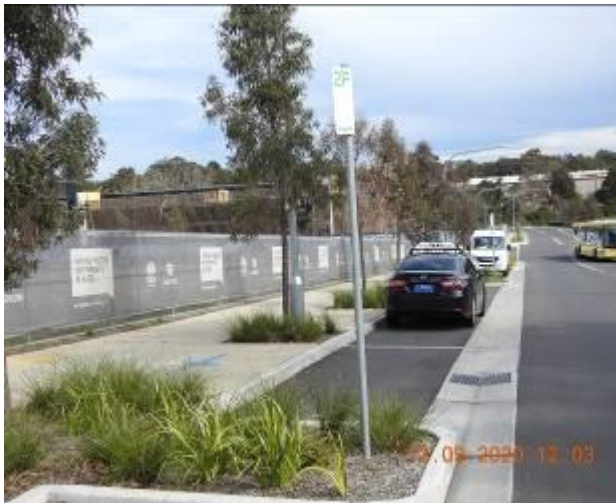
Figure 1511 – General condition of street sign and
plantation

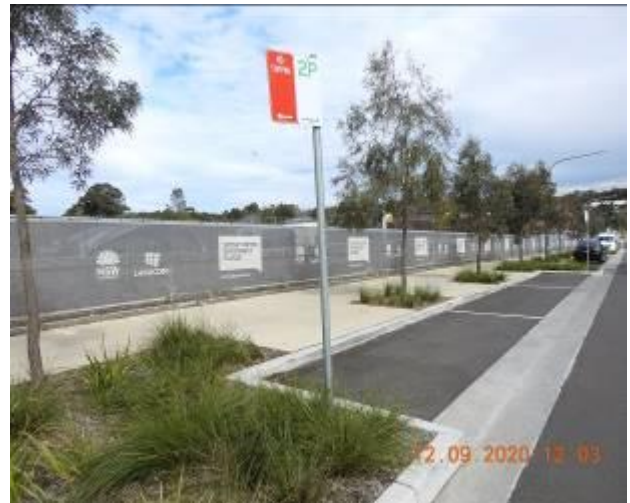
Figure 1512 – General condition of street sign

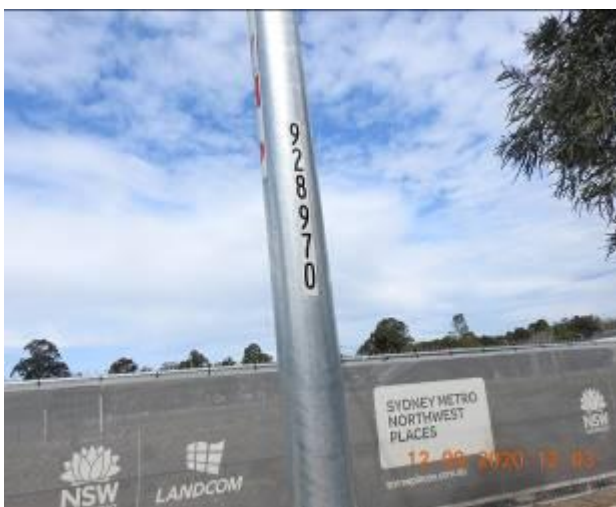
Figure 1513 – General condition of lamp post
Identification No. 928970

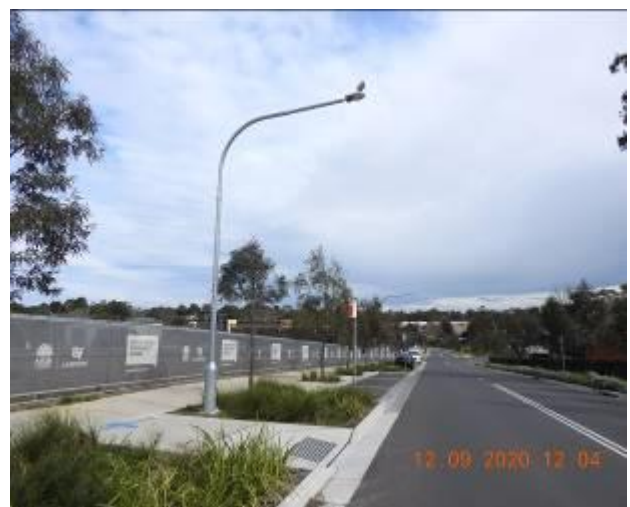
Figure 1514 – General condition of lamp post
Identification No. 928970

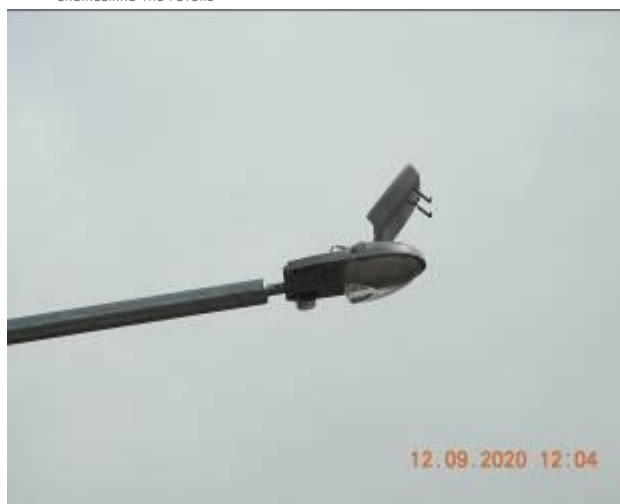
Figure 1515 – Physical damage through lamp post
Identification No. 928970

The condition of the lamp posts, plantation, electricity boxes, stormwater inlet pits, street signs and service pits were also inspected and were determined to be in a reasonable condition. Evidence of cracking and material loss was observed through the service pit pavement. Furthermore, physical damage was also observed through the lamp post.

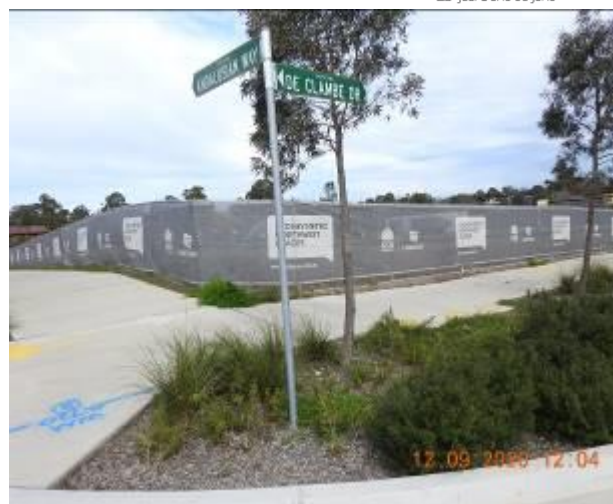
Figure 1516 – General condition of street sign and
plantation

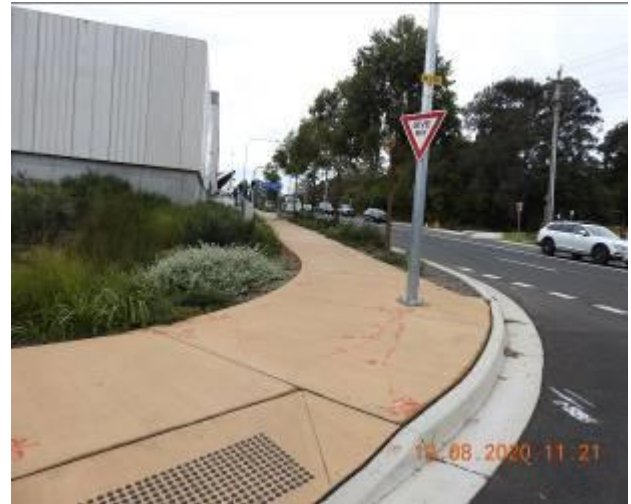
Figure 1518 – General condition of footpath pavement heading East

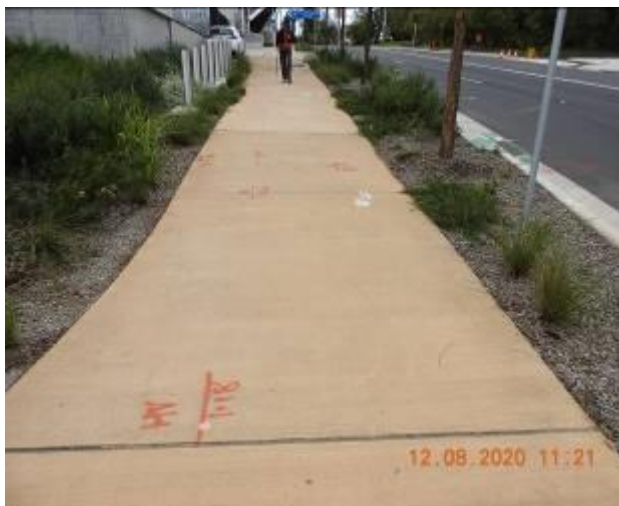
Figure 1519 – General condition of footpath pavement

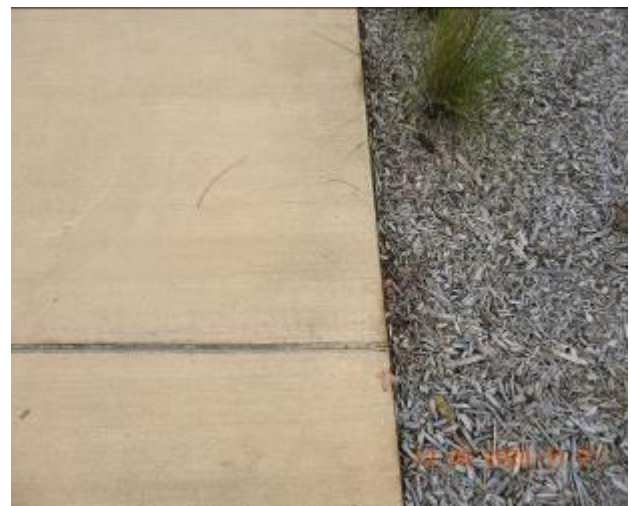
Figure 1520 – Loss of material through footpath pavement

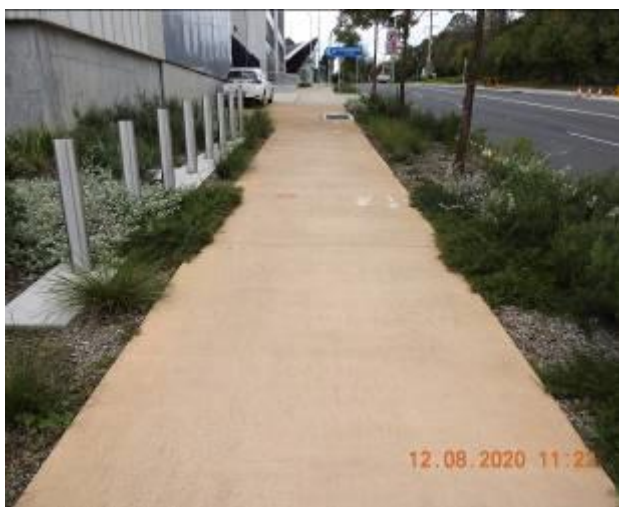
Figure 1521 – General condition of footpath pavement

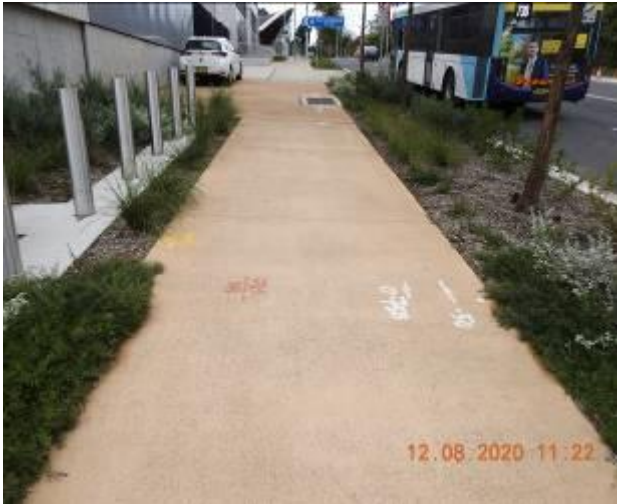
Figure 1523 – General condition of footpath pavement

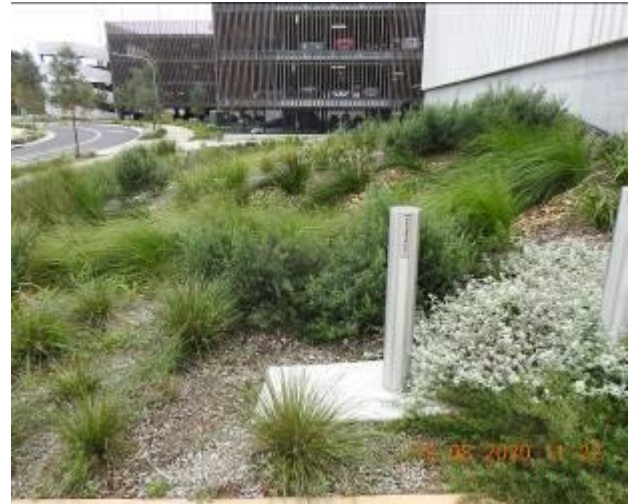
Figure 1524 – General condition of nature strip

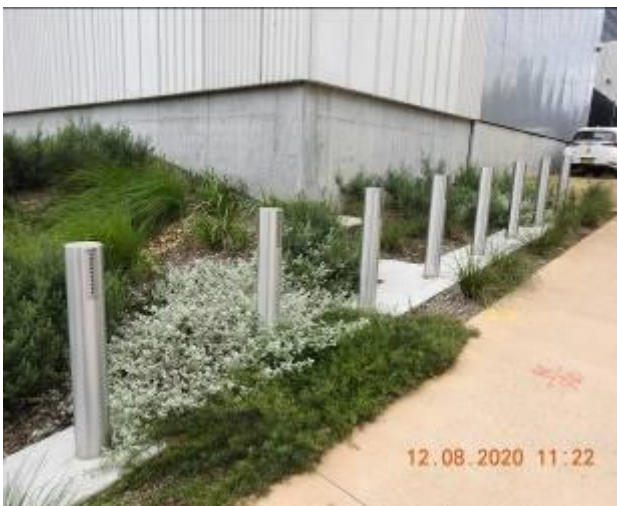
Figure 1525 – General condition of nature strip

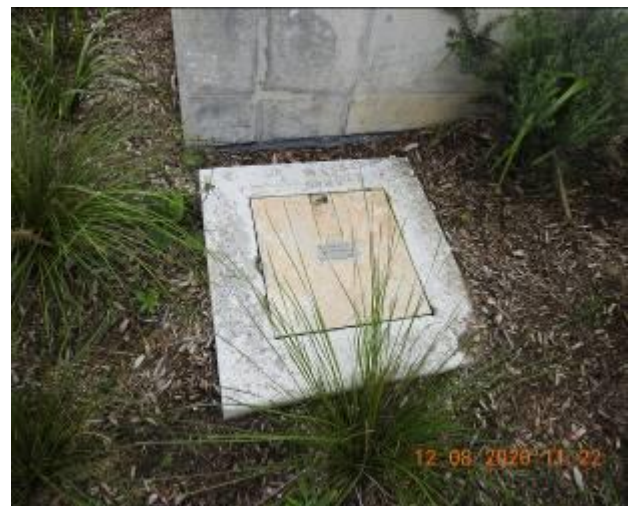
Figure 1526 – Loss of material through service pit pavement

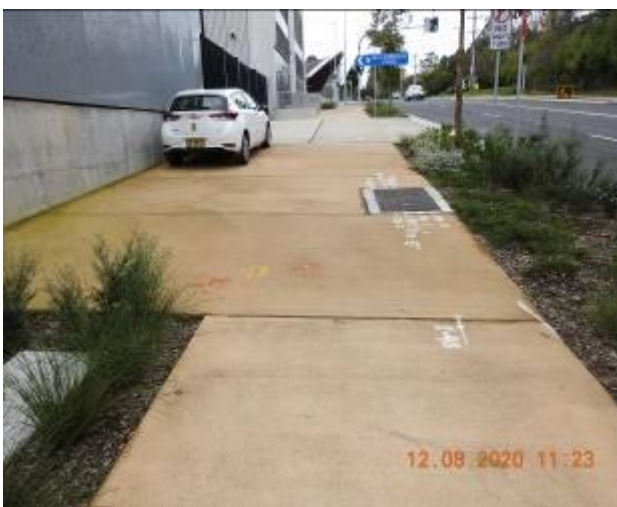
Figure 1527 – General condition of footpath pavement

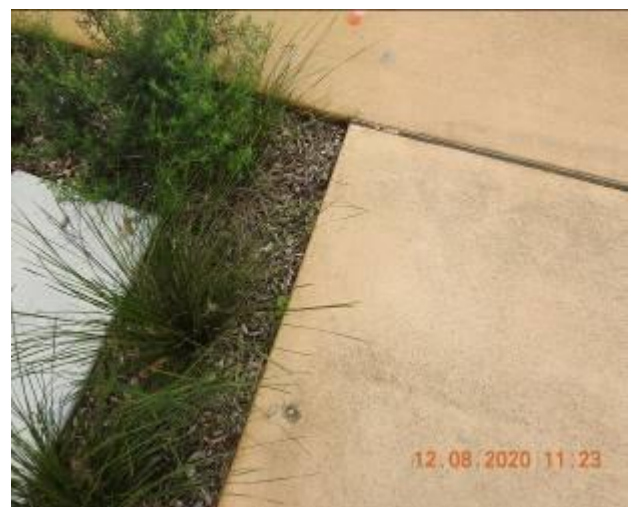
Figure 1528 – Loss of material through footpath pavement

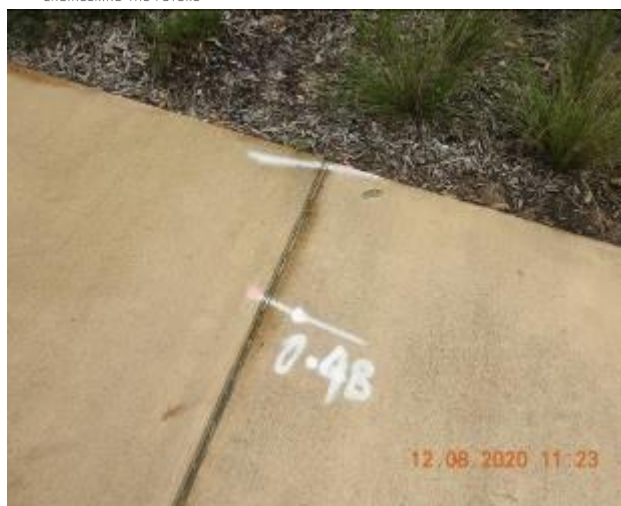
Figure 1529 – Loss of material through footpath pavement

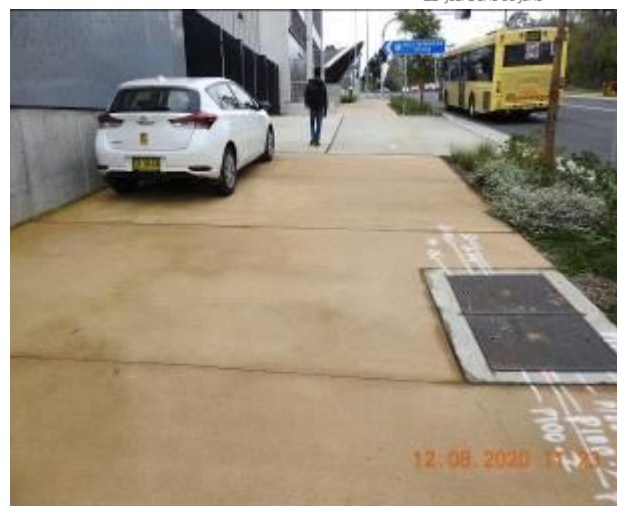
Figure 1530 – General condition of footpath pavement

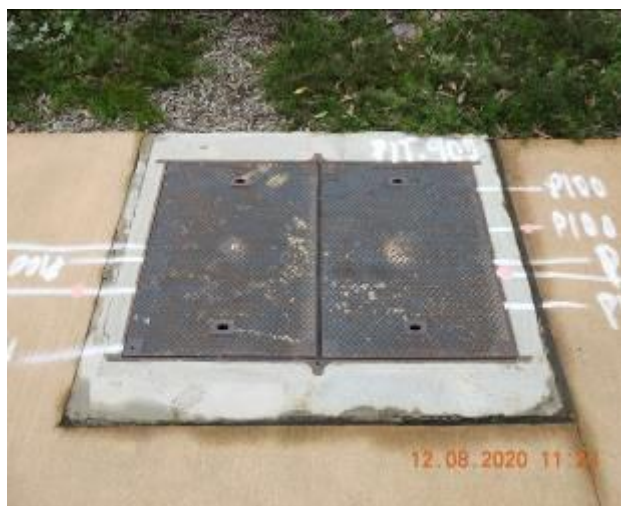
Figure 1531 – Crack propagation and loss of material through service pit pavement

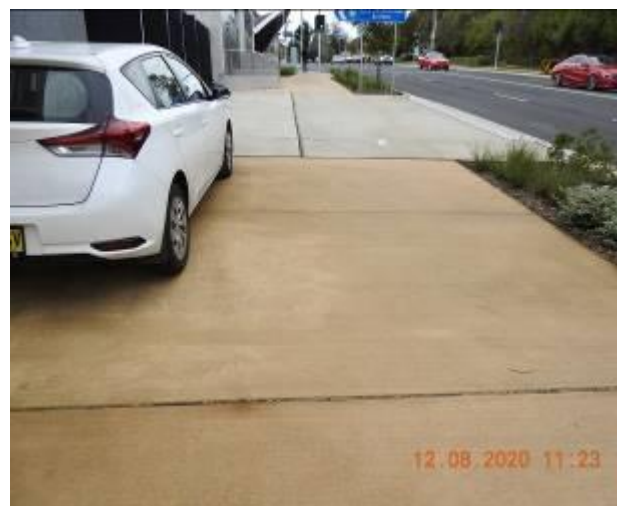
Figure 1532 – General condition of footpath pavement

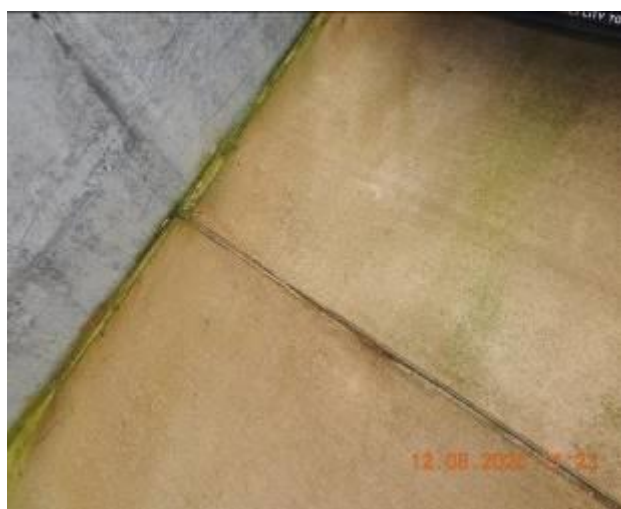
Figure 1533 – Crack propagation and loss of material through footpath pavement

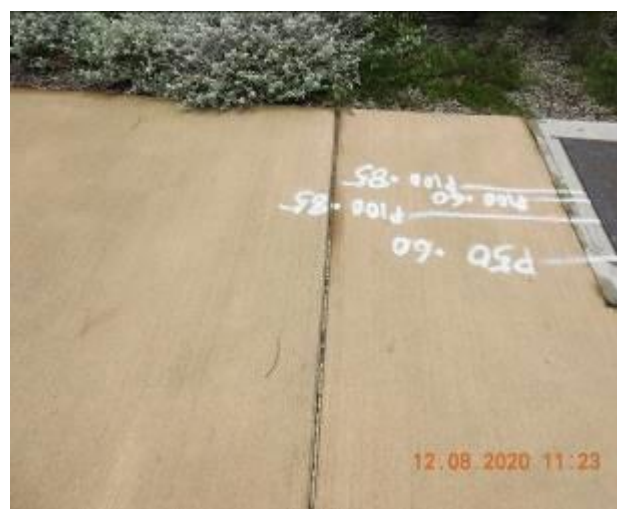
Figure 1534 – Crack propagation and loss of material through footpath pavement

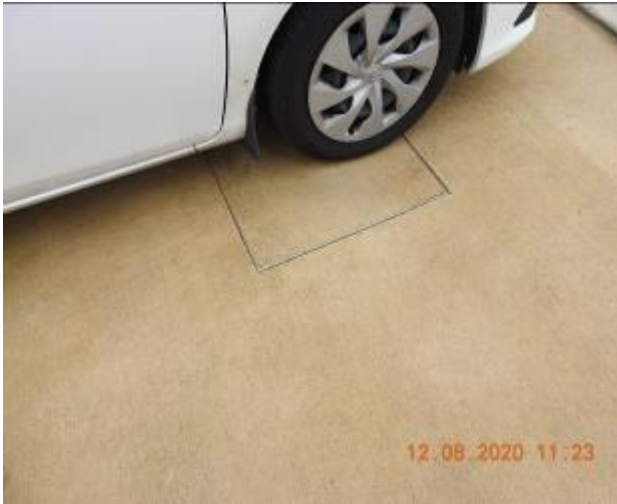
Figure 1535 – General condition of service pit/Crack propagation through footpath pavement

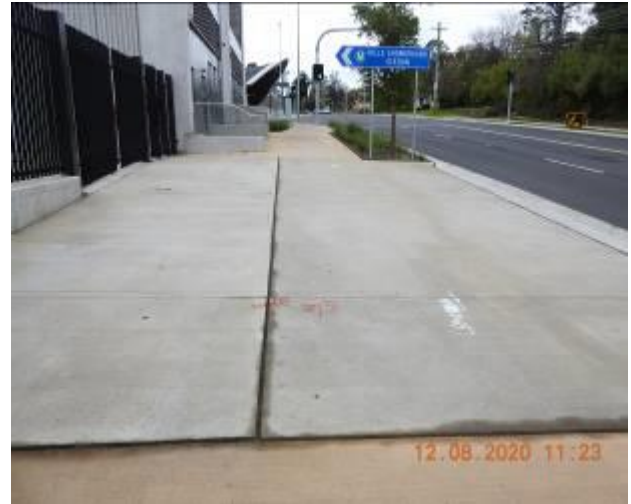
Figure 1536 – General condition of footpath pavement

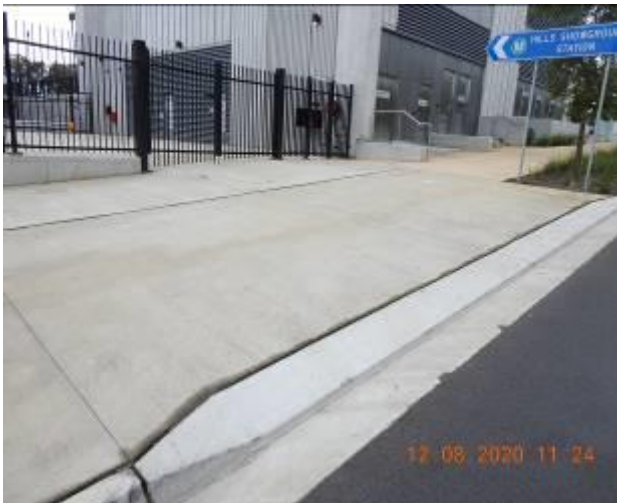
Figure 1537 – General condition of driveway pavement

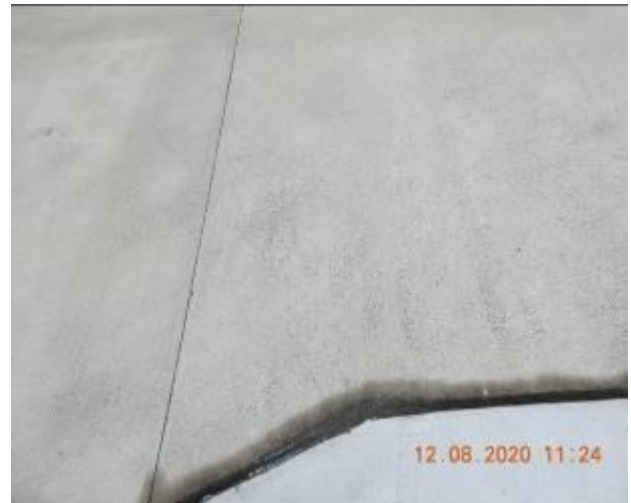
Figure 1538 – Crack propagation and loss of material through driveway pavement

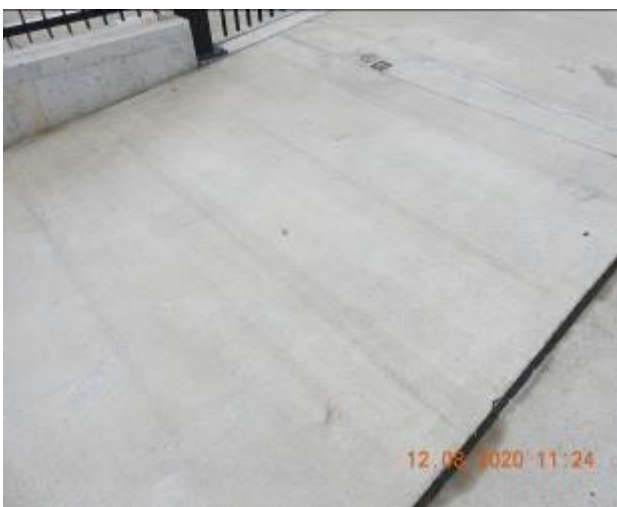
Figure 1539 – Loss of material through driveway pavement

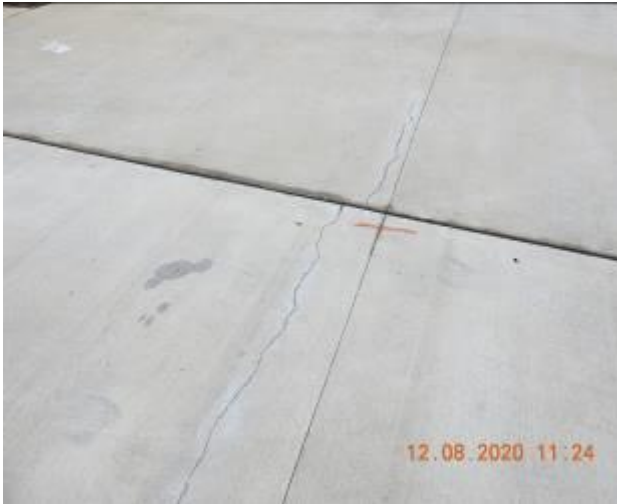
Figure 1541 – Crack propagation and loss of material through driveway pavement

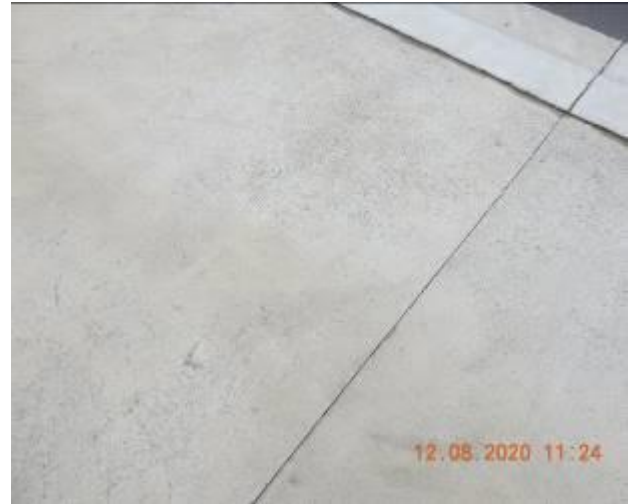
Figure 1542 – Loss of material through driveway pavement

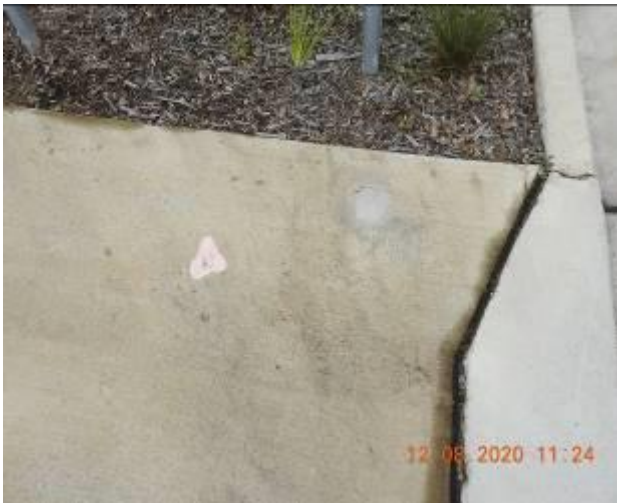
Figure 1543 – Evidence of patchwork through driveway pavement

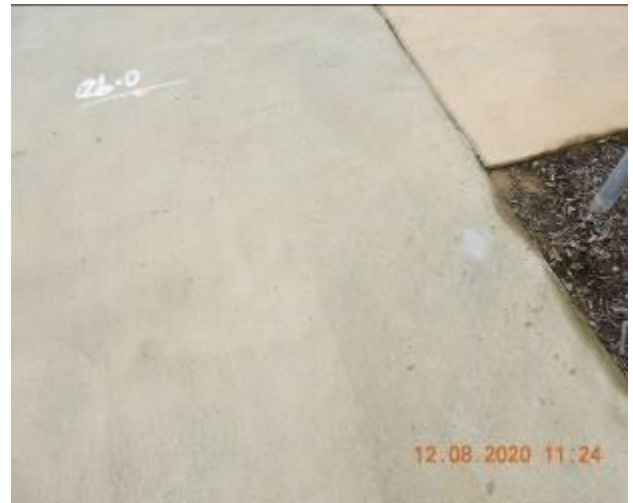
Figure 1544 – Evidence of patchwork through driveway pavement

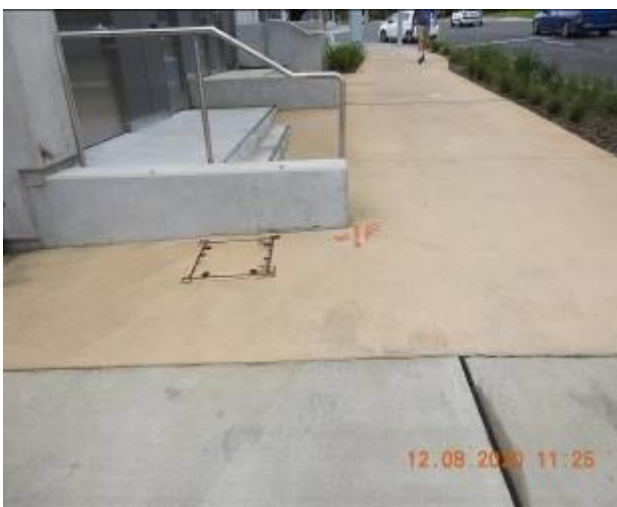
Figure 1545 – General condition of footpath pavement

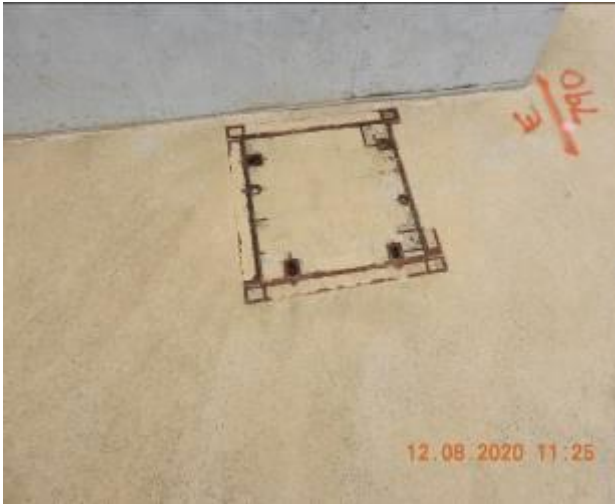
Figure 1547 – Loss of material through service pit pavement

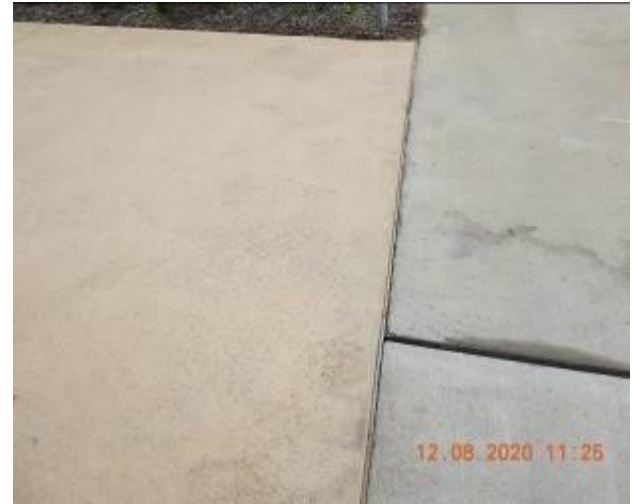
Figure 1548 – Loss of material through footpath pavement

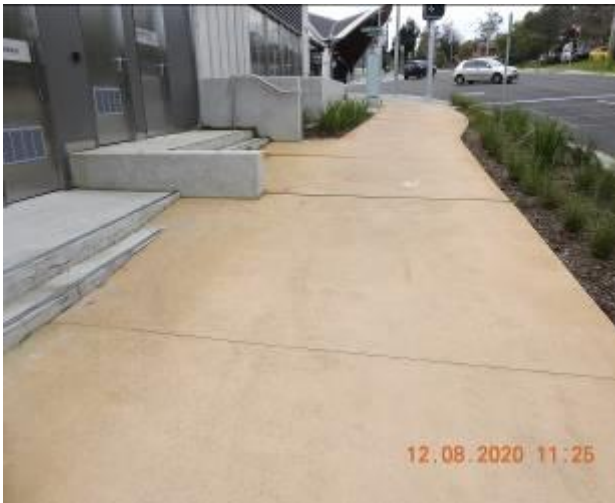
Figure 1549 – General condition of footpath pavement

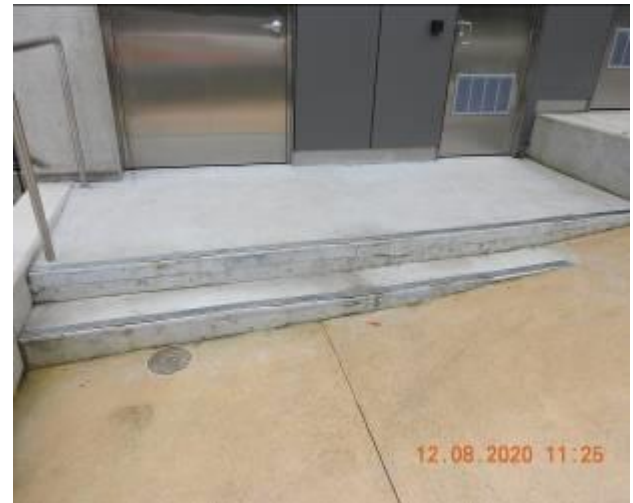
Figure 1550 – General condition of steps pavement

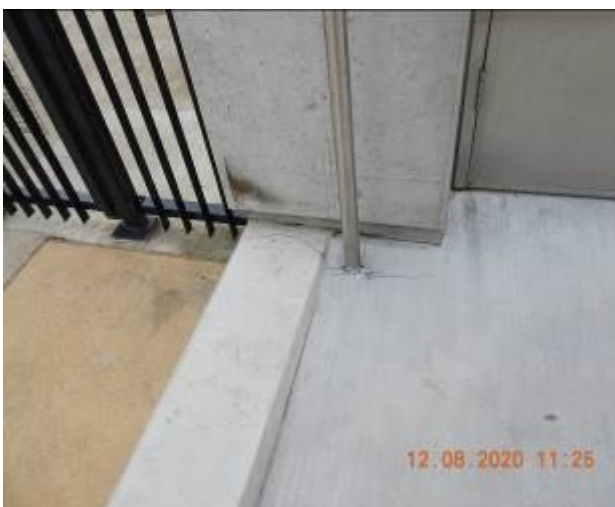
Figure 1551 – Crack propagation and loss of material through steps pavement

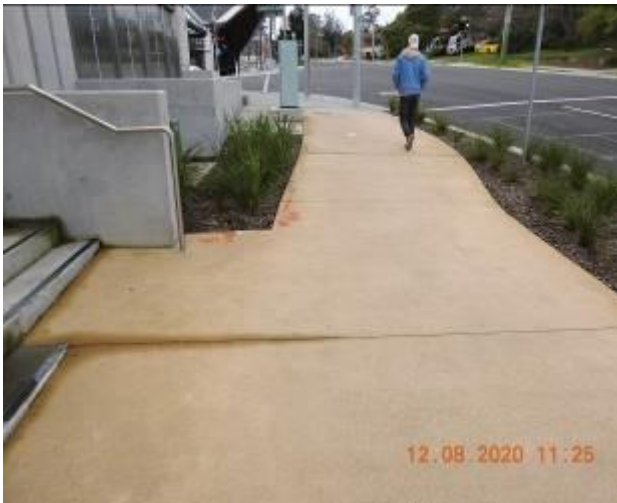
Figure 1553 – General condition of footpath pavement

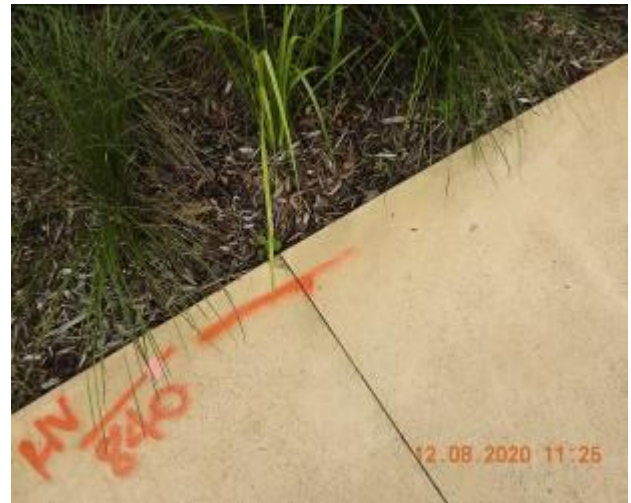
Figure 1554 – Loss of material through footpath pavement

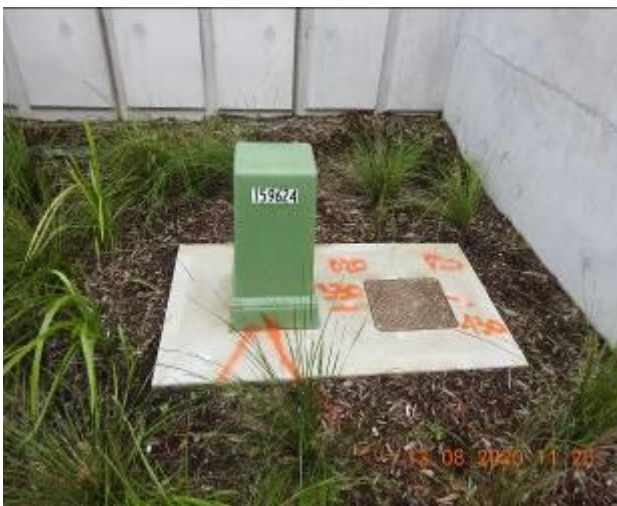
Figure 1555 – General condition of service pit and Electricity Box Identification No. 159624

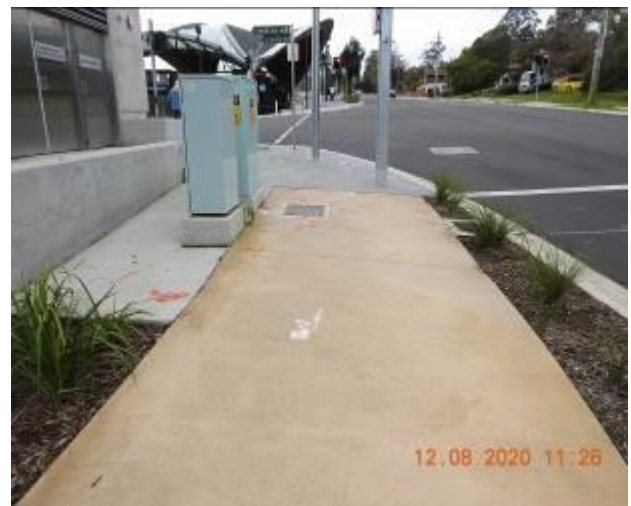
Figure 1556 – General condition of footpath pavement

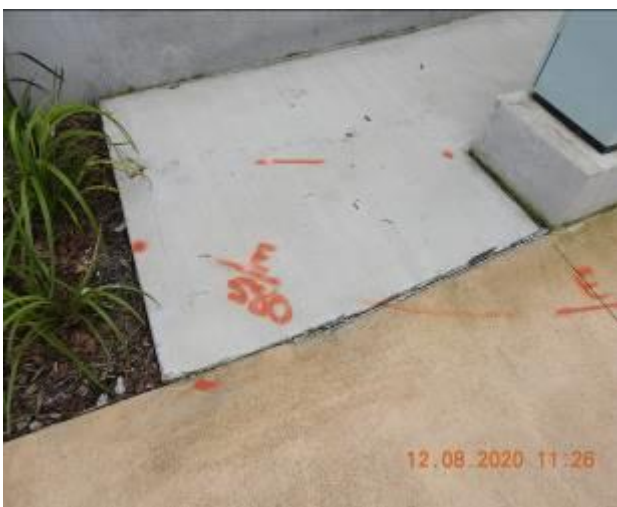
Figure 1557 – Crack propagation and loss of material through footpath pavement

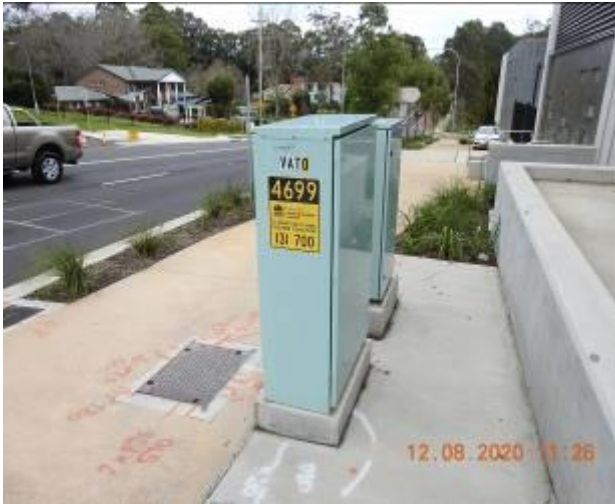
Figure 1559 – General condition of Service Boxes Identification No. 4699

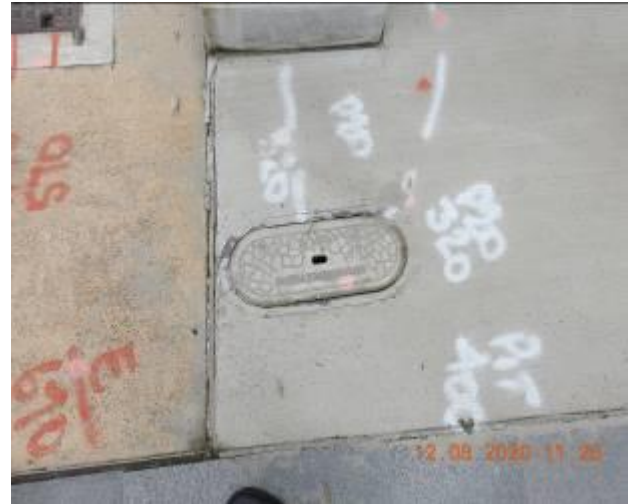
Figure 1560 – Crack propagation and loss of material through service pit pavement

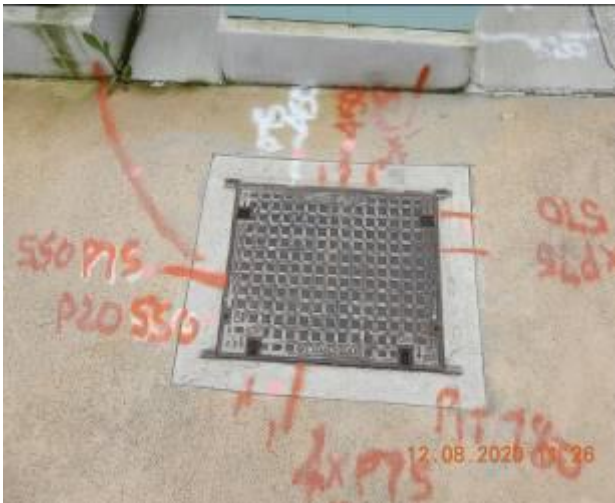
Figure 1561 – General condition of service pit

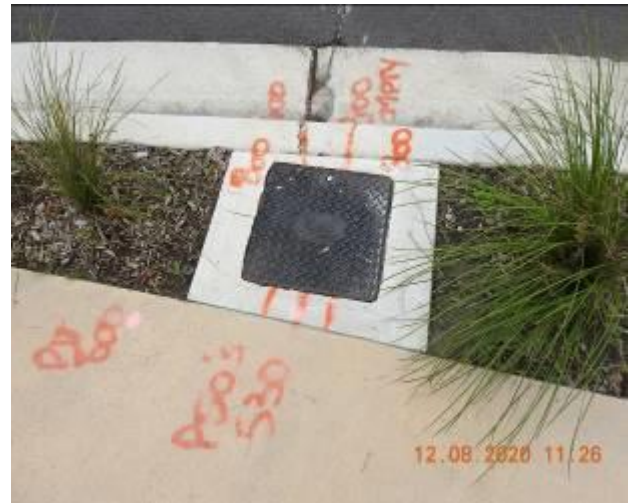
Figure 1562 – Crack propagation and loss of material through service pit pavement

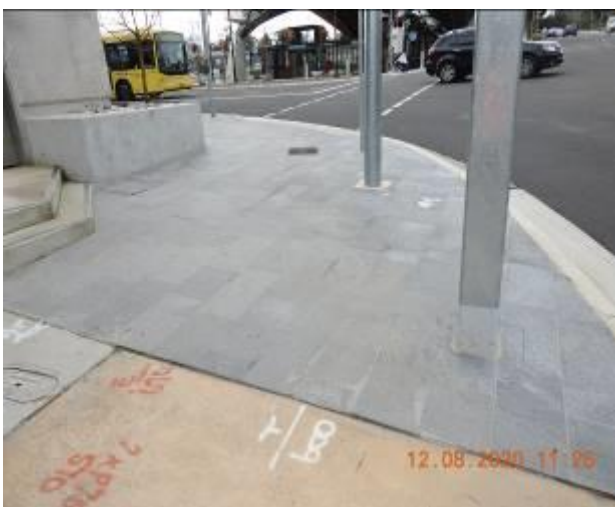
Figure 1563 – Loss of material through footpath pavement

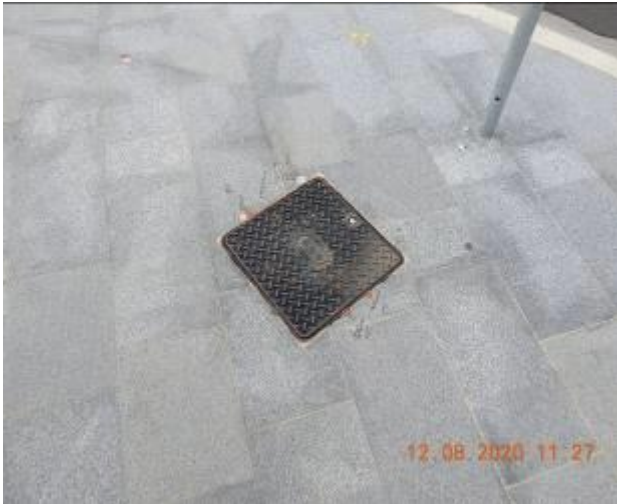
Figure 1565 – General condition of service pit

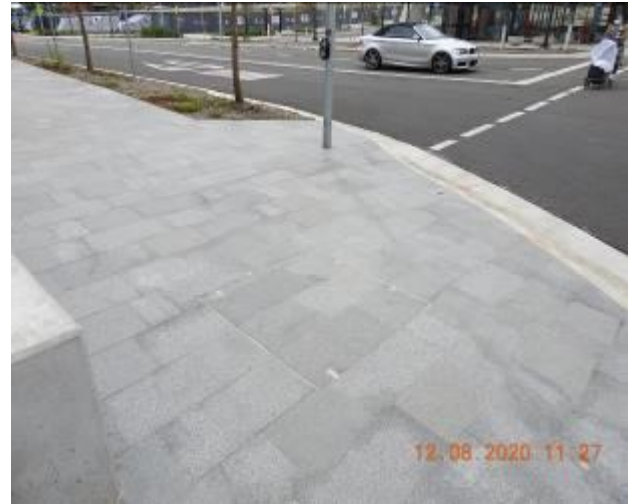
Figure 1566 – General condition of footpath pavement

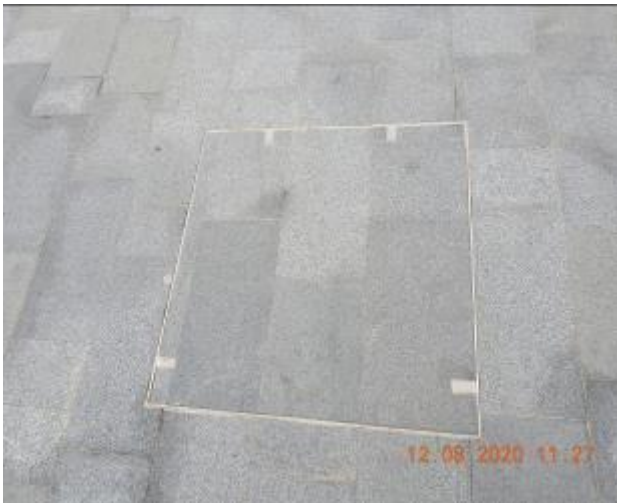
Figure 1567 – General condition of service pit

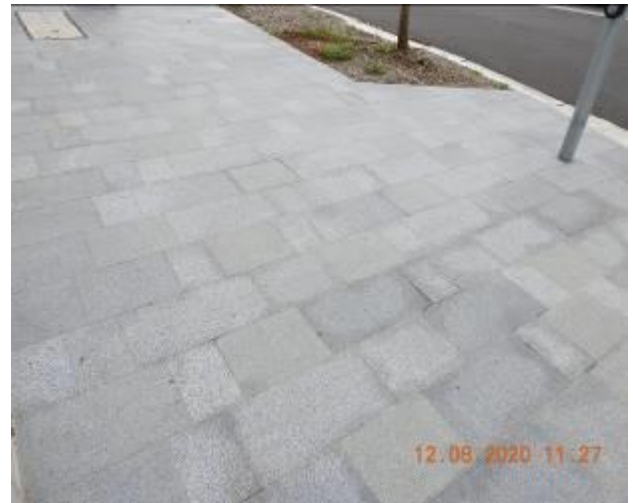
Figure 1568 – Loss of material through footpath pavement

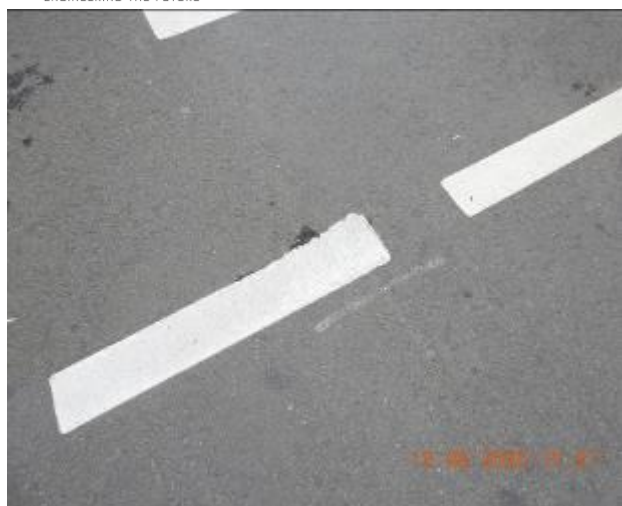
Figure 1571 – Loss of material through walkway pavement

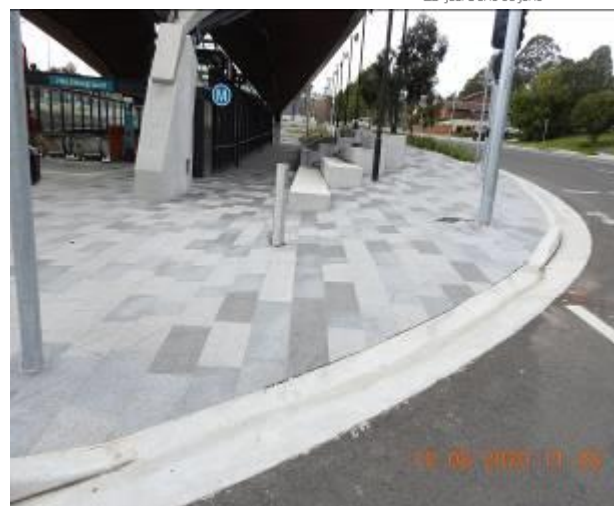
Figure 1572 – General condition of footpath pavement

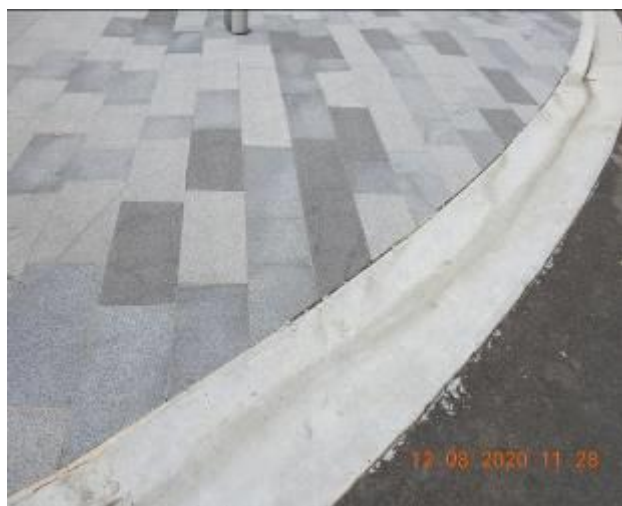
Figure 1573 – Crack propagation and loss of material through footpath pavement
