**2 MANDALA PARADE, CASTLE HILL
(DORAN DRIVE PRECINCT)
PRE-DILAPIDATION REPORT
Of Sydney Metro and Hills Shire Council Assets
DEICORP PROJECTS SHOWGROUND
PTY LTD.**

Job No. 200124.3
07/07/2021

ACE Structural Services Pty Ltd

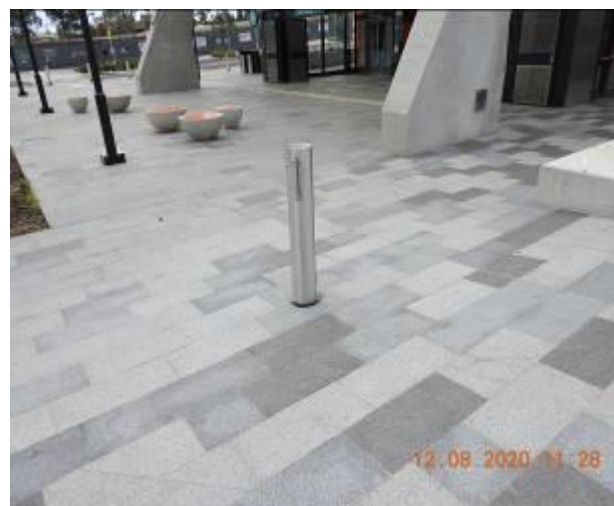
Figure 1574 – General condition of footpath pavement

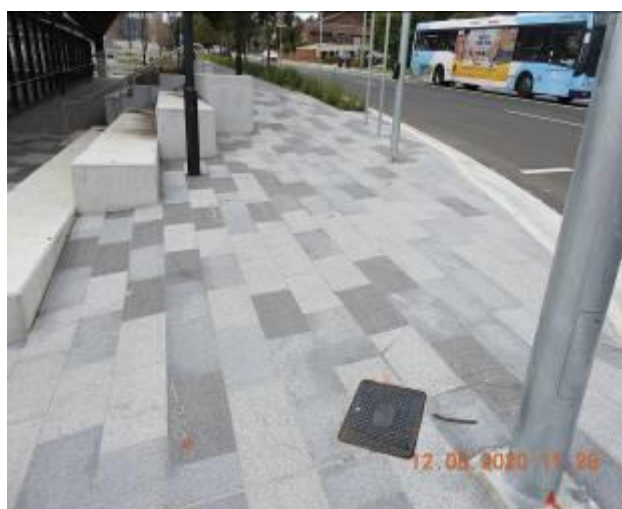
Figure 1575 – Loss of material through footpath pavement

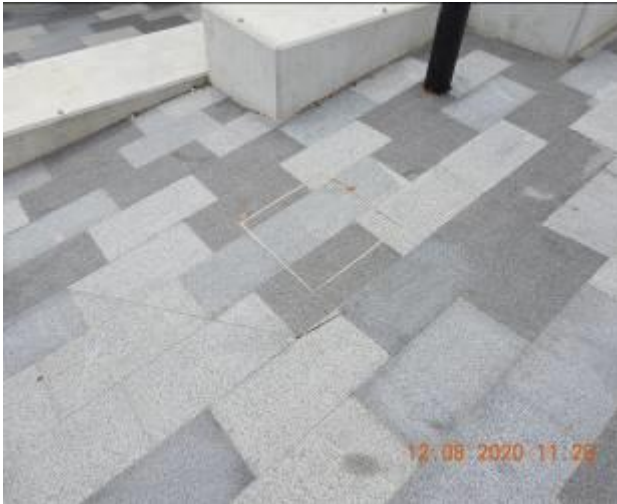
Figure 1577 – General condition of service pit/ Loss of material through footpath pavement

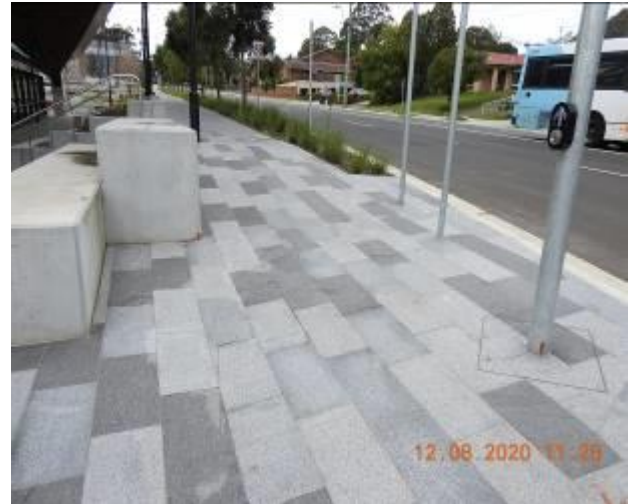
Figure 1578 – General condition of footpath pavement

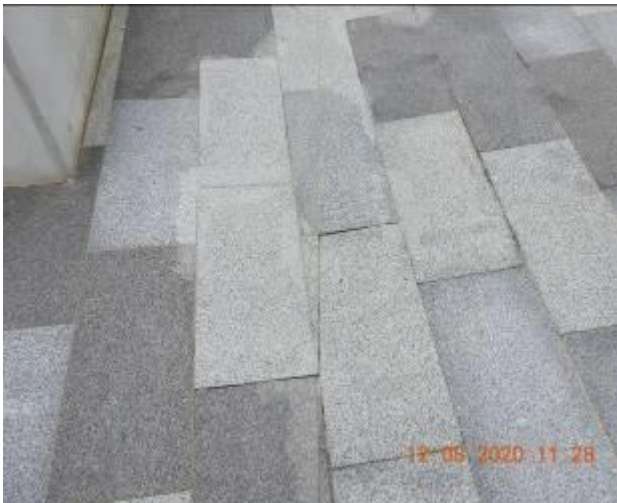
Figure 1579 – Crack propagation and loss of material through footpath pavement

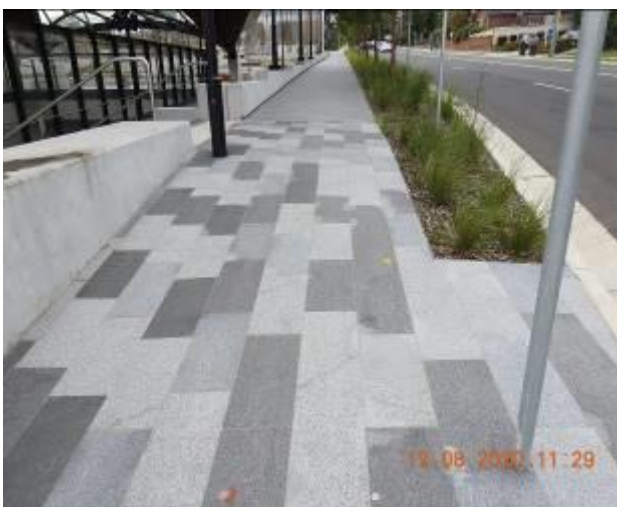
Figure 1580 – Crack propagation and loss of material through footpath pavement

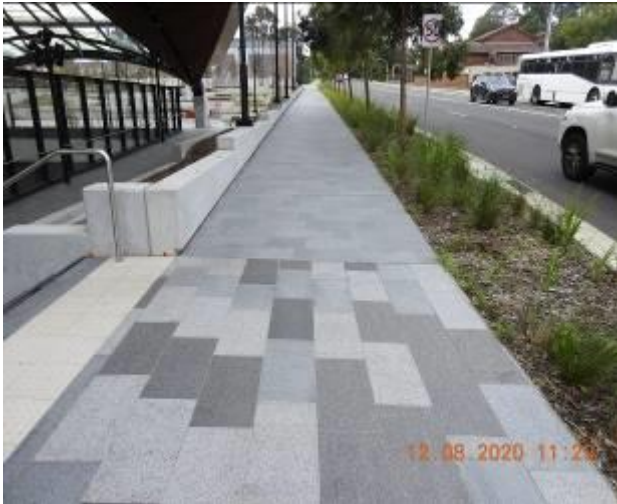
Figure 1582 – Hairline crack propagation through footpath pavement

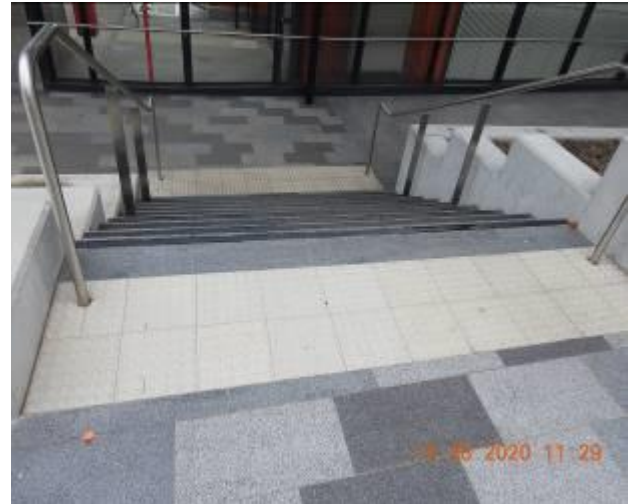
Figure 1583 – General condition of footpath pavement

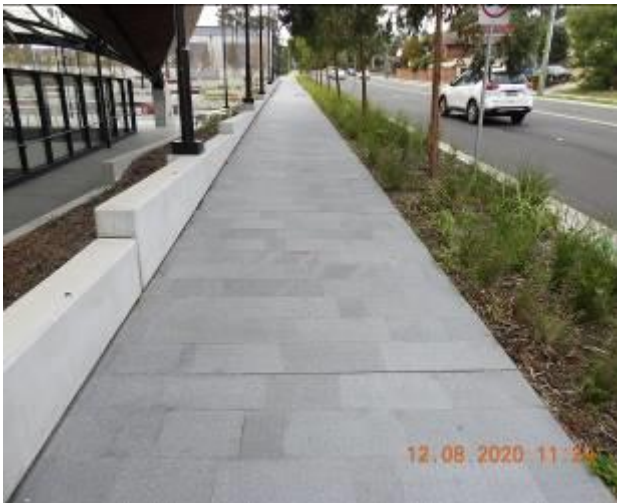
Figure 1584 – General condition of footpath pavement

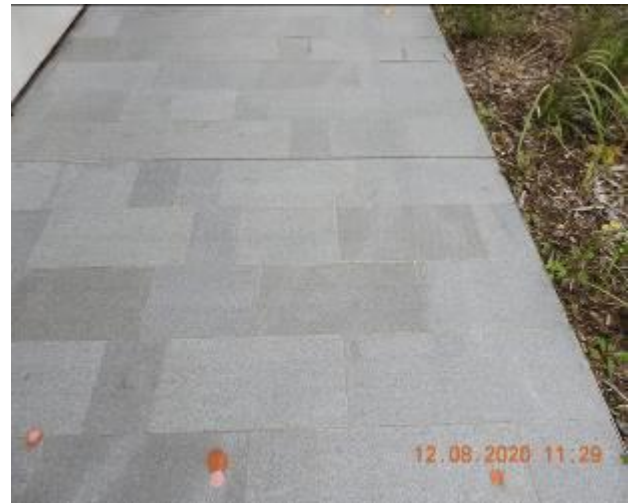
Figure 1585 – Loss of material through footpath pavement

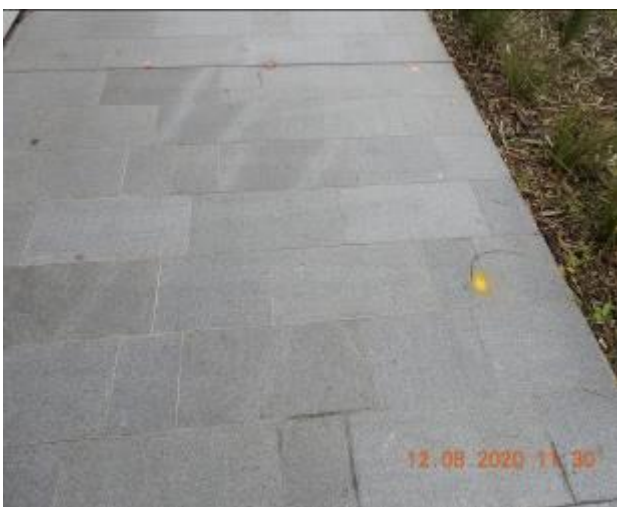
Figure 1586 – Efflorescence and hairline crack propagation through footpath pavement

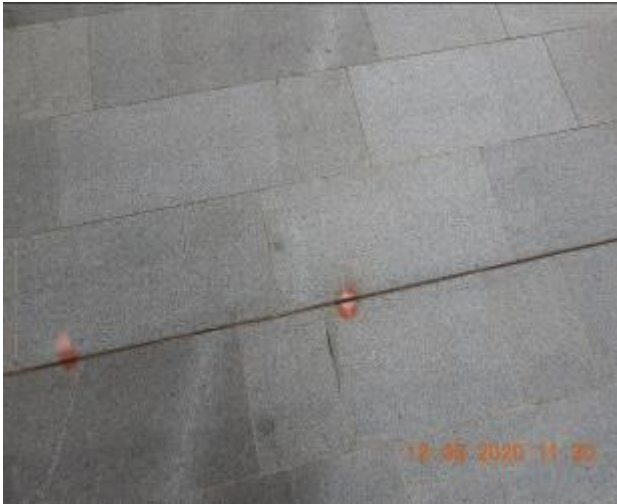
Figure 1588 – General condition of footpath pavement

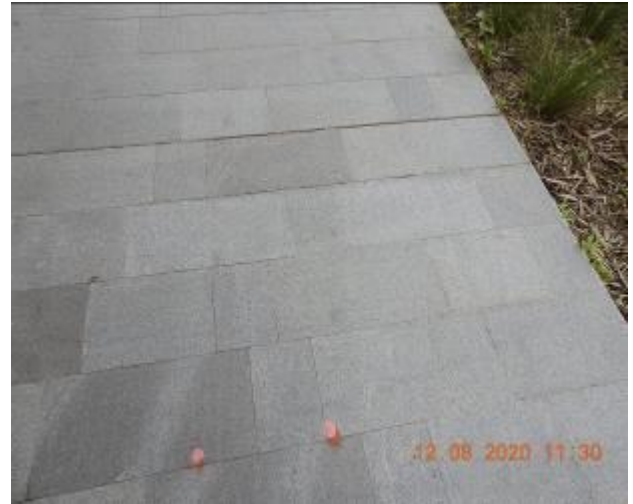
Figure 1589 – Loss of material through footpath pavement

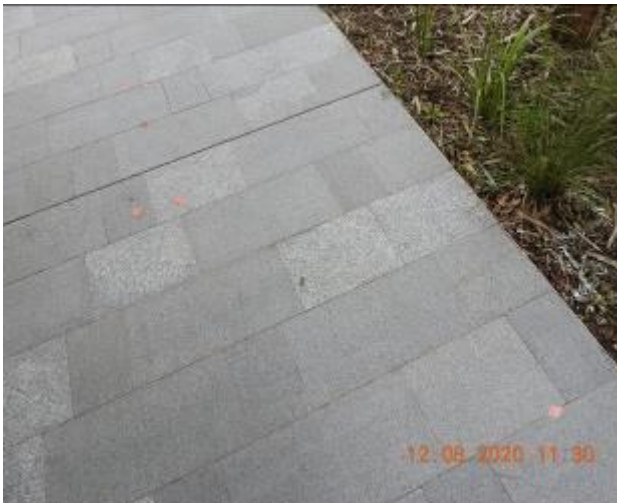
Figure 1590 – Crack propagation and loss of material through footpath pavement

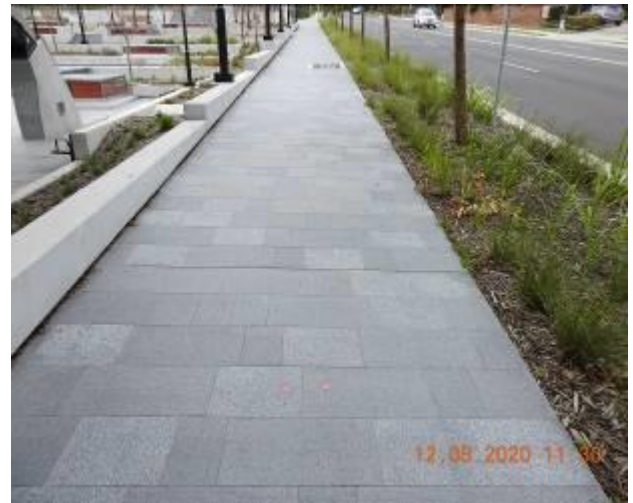
Figure 1591 – Loss of material through footpath pavement

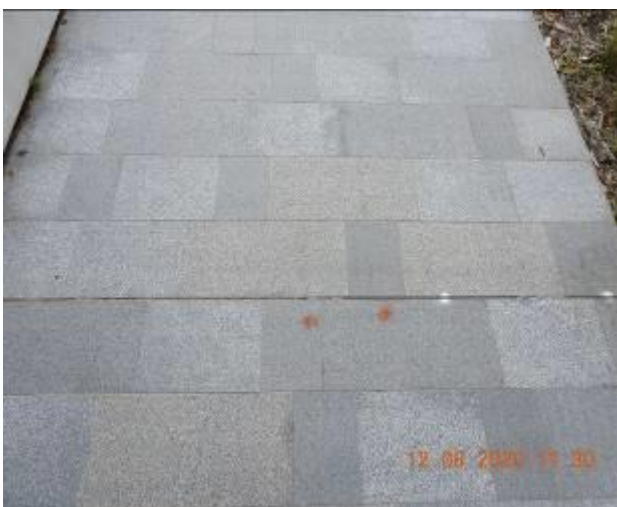
Figure 1592 – General condition of footpath pavement

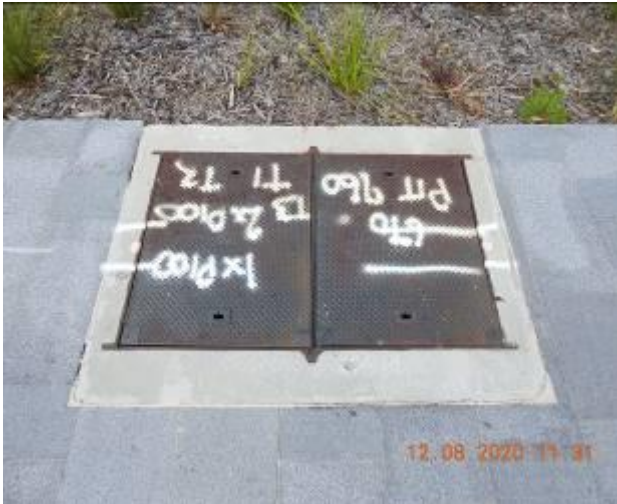
Figure 1594 – General condition of footpath pavement

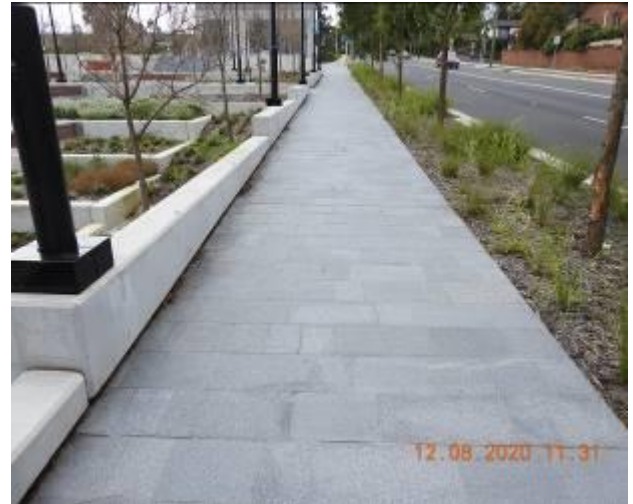
Figure 1595 – Crack propagation and loss of material through service pit pavement

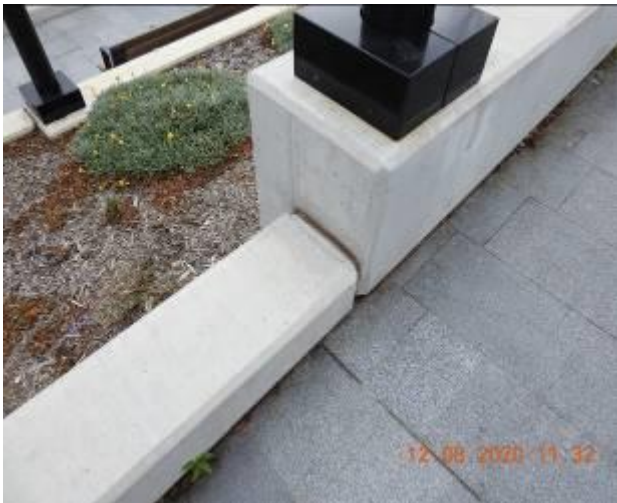
Figure 1596 – General condition of footpath pavement

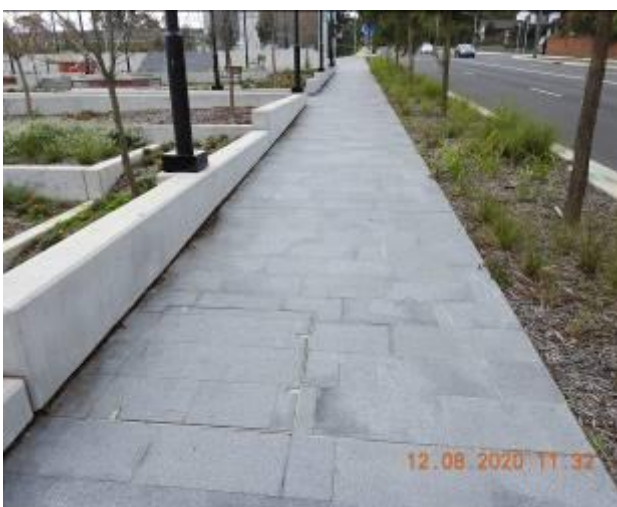
Figure 1598 – Efflorescence, hairline crack propagation and loss of material through footpath pavement

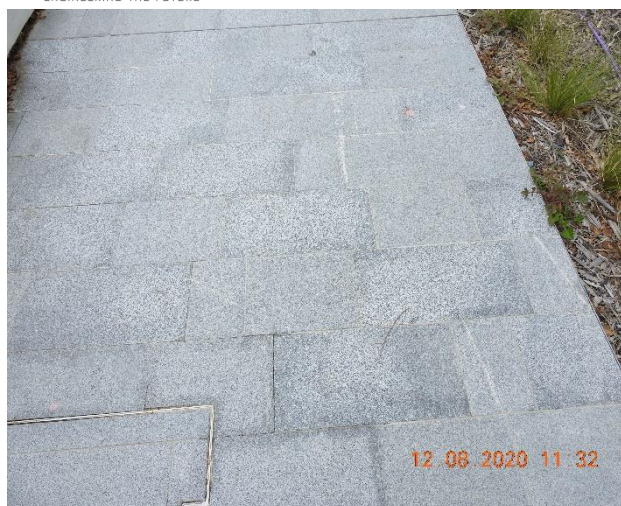
Figure 1600 – Loss of material through service pit pavement

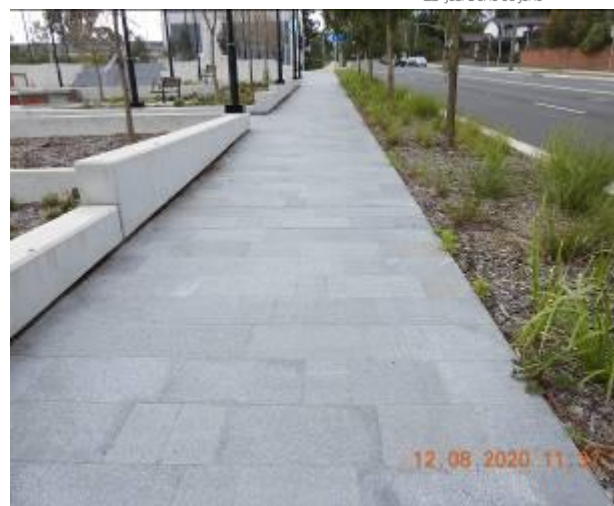
Figure 1601 – Hairline crack propagation and loss of material through footpath pavement

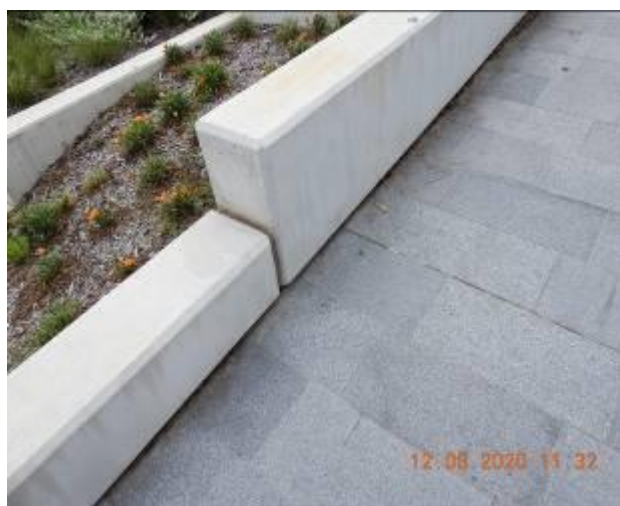
Figure 1602 – General condition of footpath pavement

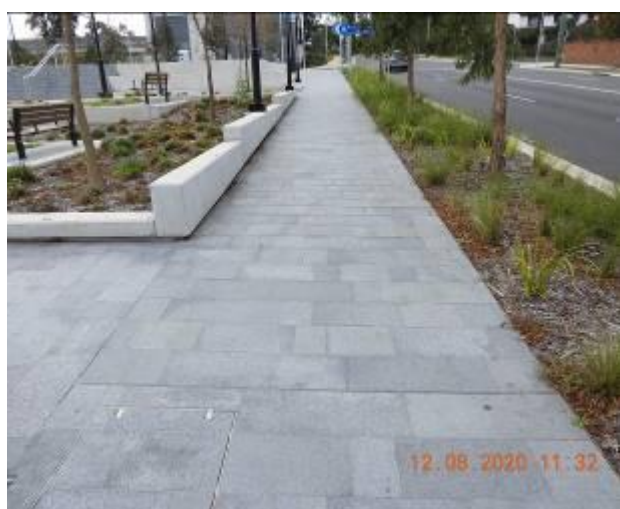
Figure 1604 – Hairline crack propagation through footpath pavement

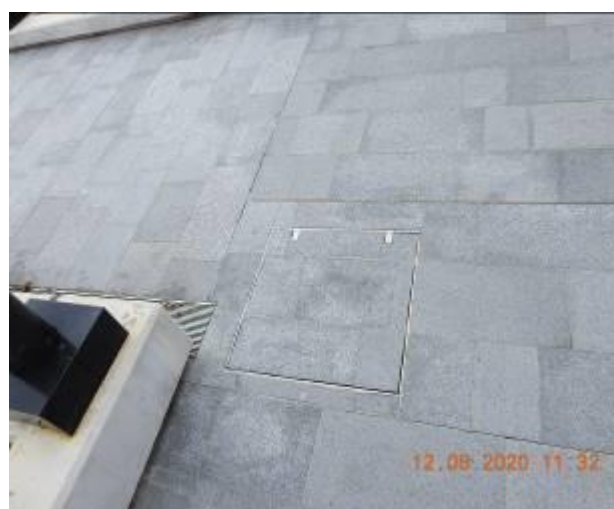
Figure 1605 – General condition of footpath pavement

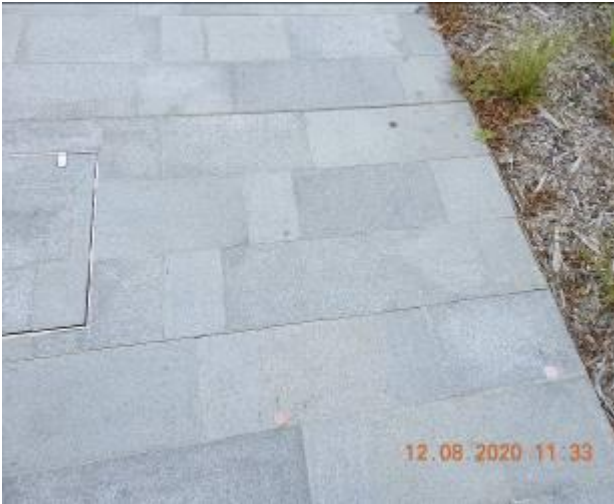
Figure 1606 – Loss of material through service pit pavement/Crack propagation and loss of material through footpath pavement

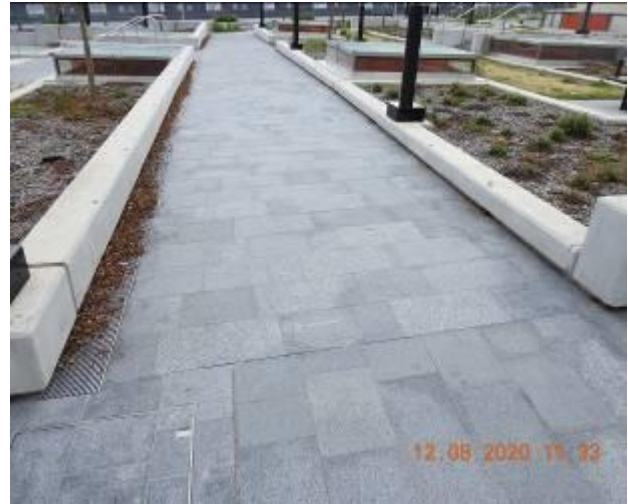
Figure 1607 – Crack propagation and loss of material through footpath pavement

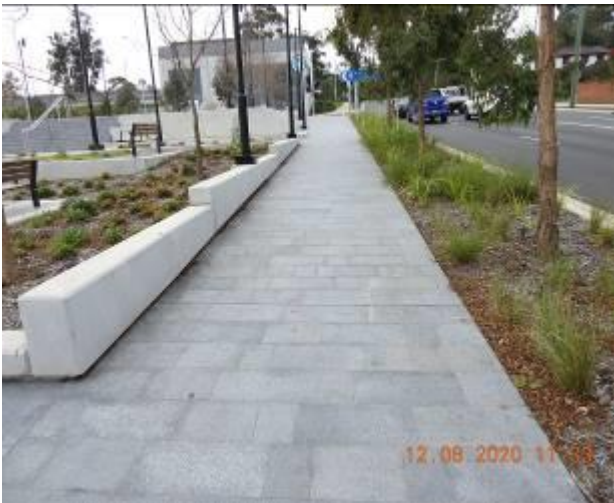
Figure 1608 – Crack propagation and loss of material through footpath pavement

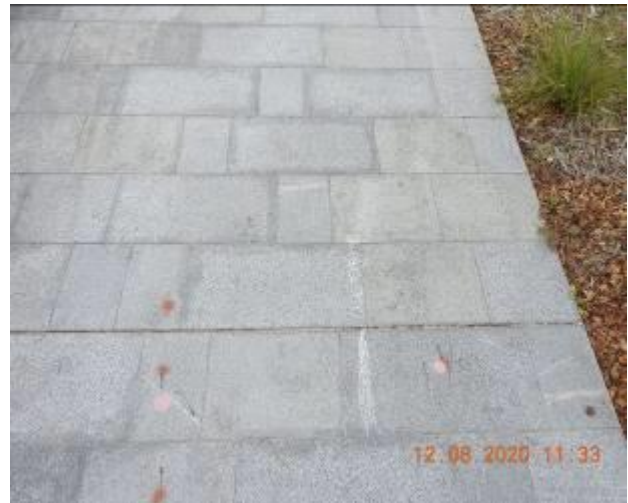
Figure 1609 – General condition of footpath pavement

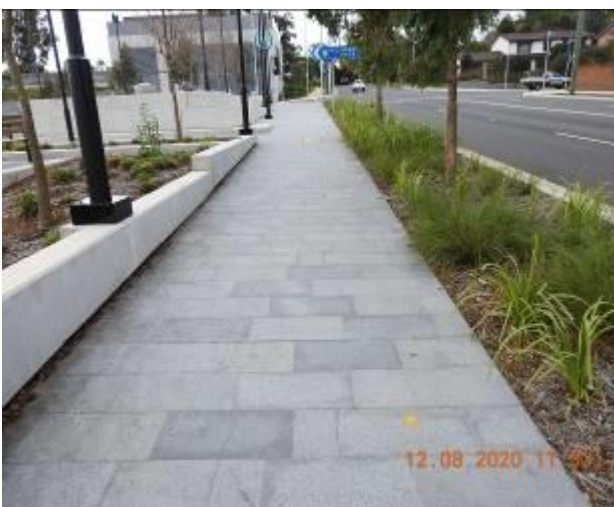
Figure 1610 – Efflorescence and hairline crack propagation through footpath pavement

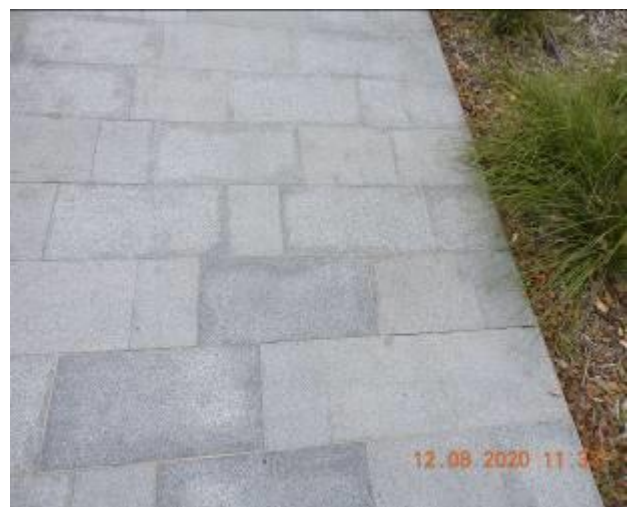
Figure 1611 – General condition of footpath pavement

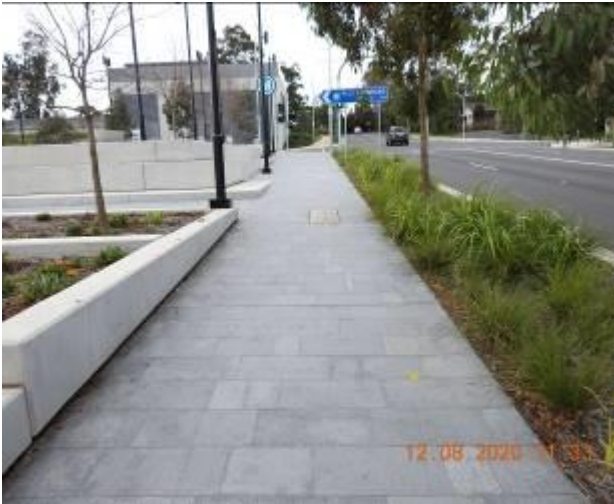
Figure 1612 – Crack propagation and loss of material through footpath pavement

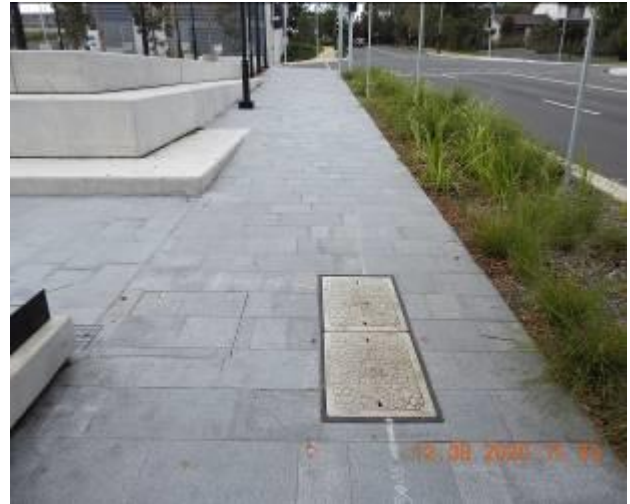
Figure 1613 – General condition of footpath pavement

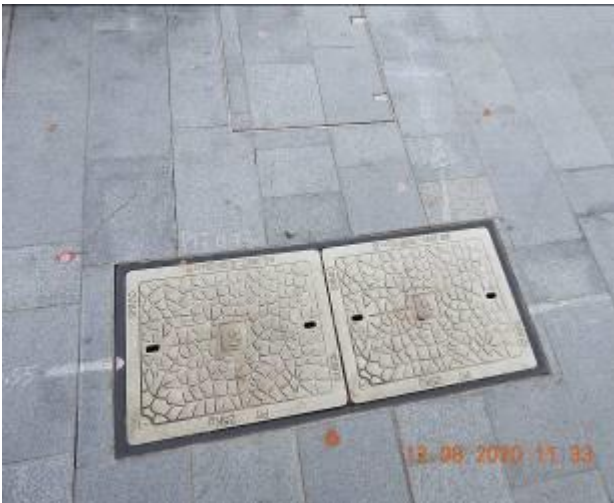
Figure 1614 – General condition of footpath pavement

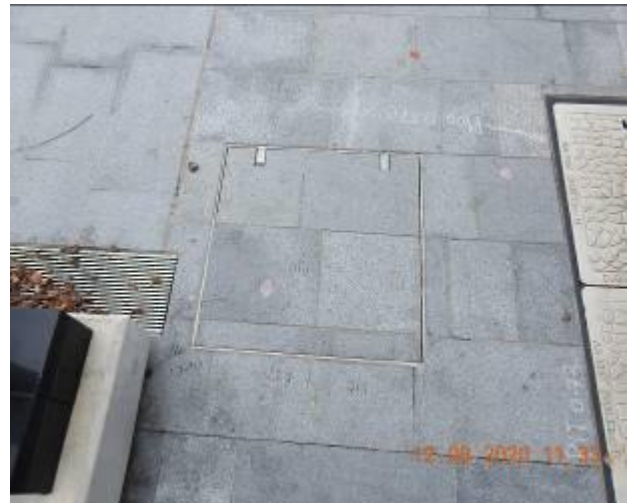
Figure 1615 – General condition of service pit

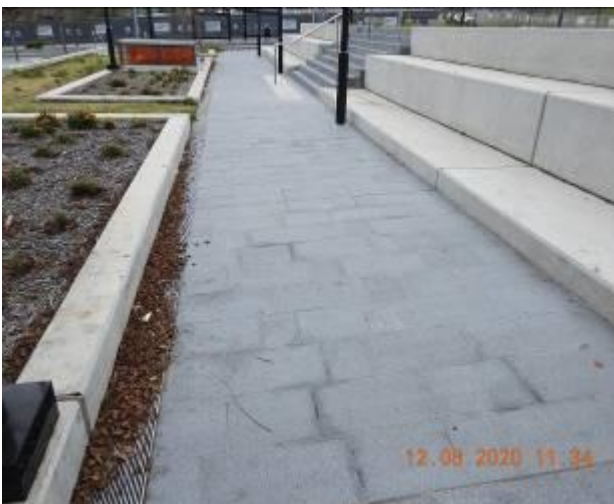
Figure 1616 – Loss of material through service pit

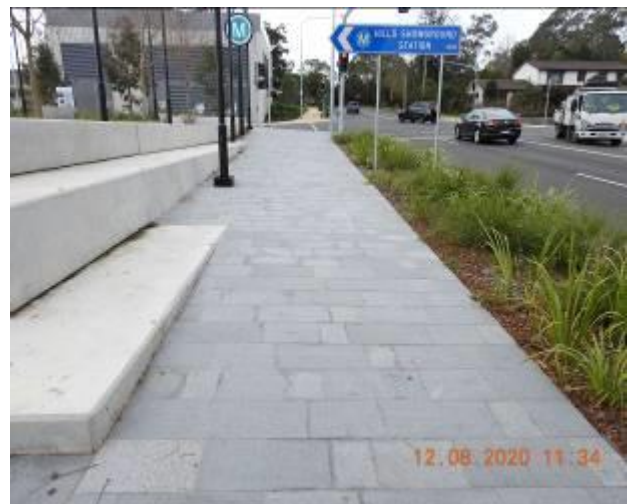
Figure 1617 – Loss of material through showground footpath pavement

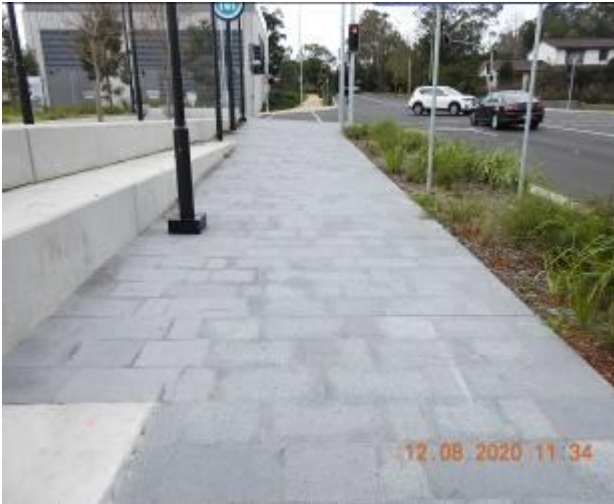
Figure 1618 – Efflorescence and hairline crack propagation through footpath pavement

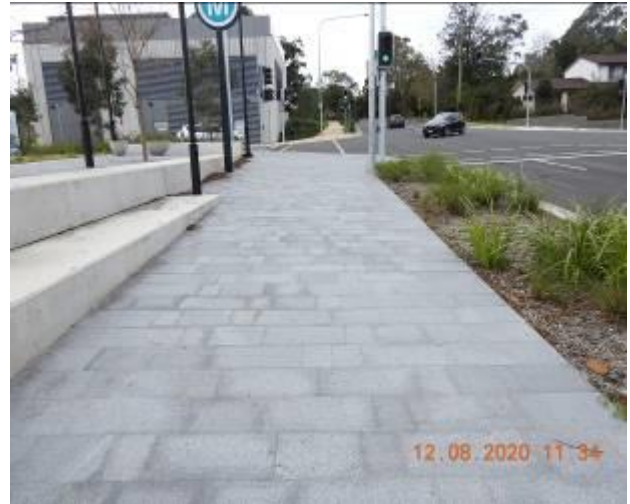
Figure 1619 – Hairline crack propagation through footpath pavement

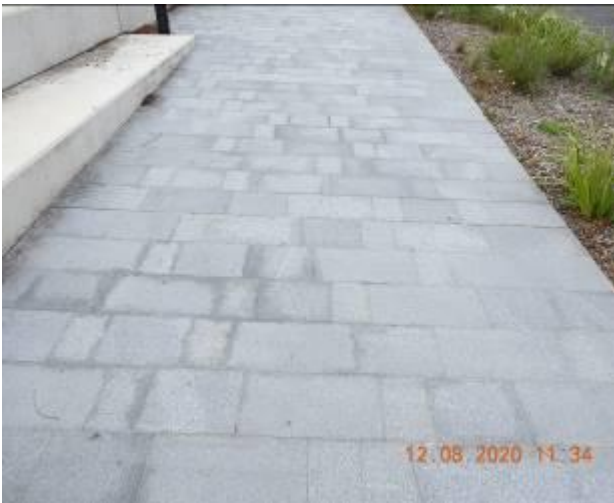
Figure 1620 – Hairline crack propagation through footpath pavement

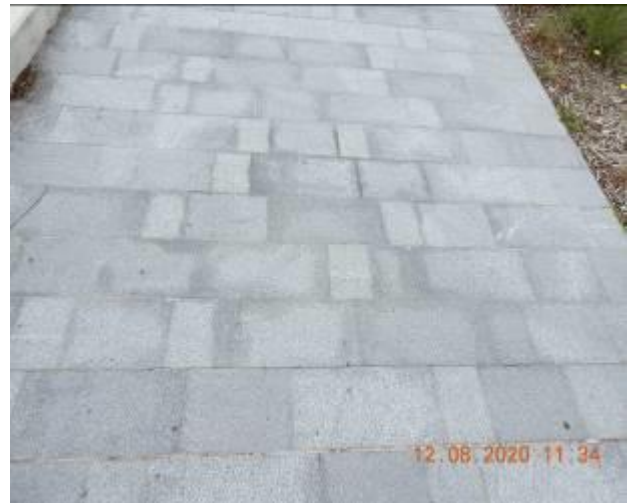
Figure 1621 – Hairline crack propagation through footpath pavement

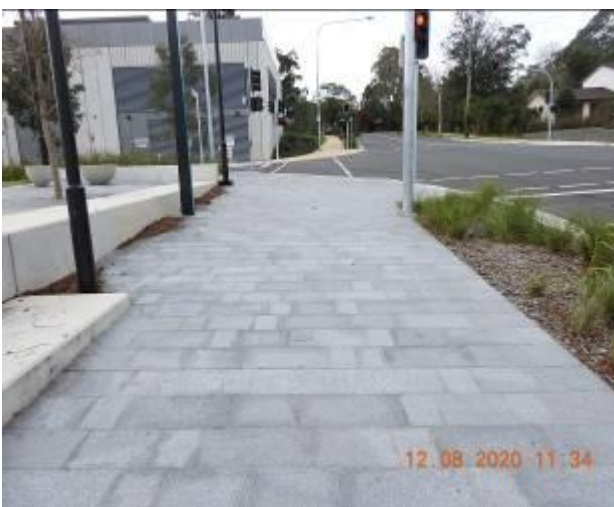
Figure 1622 – Crack propagation and loss of material through footpath pavement

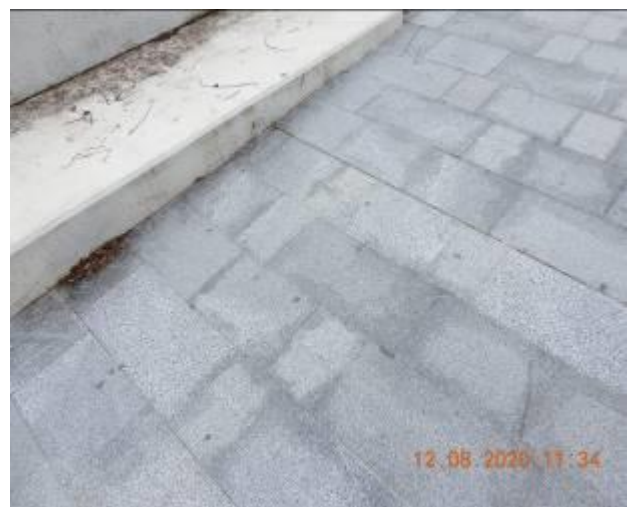
Figure 1624 – Crack propagation and loss of material through footpath pavement

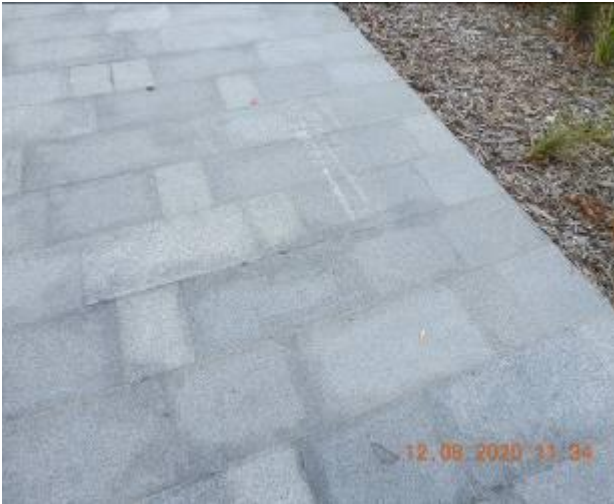
Figure 1625 – Hairline crack propagation through footpath pavement

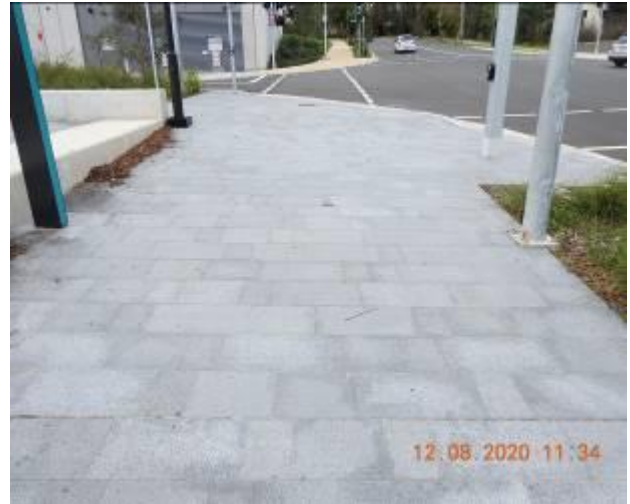
Figure 1626 – Hairline crack propagation through footpath pavement

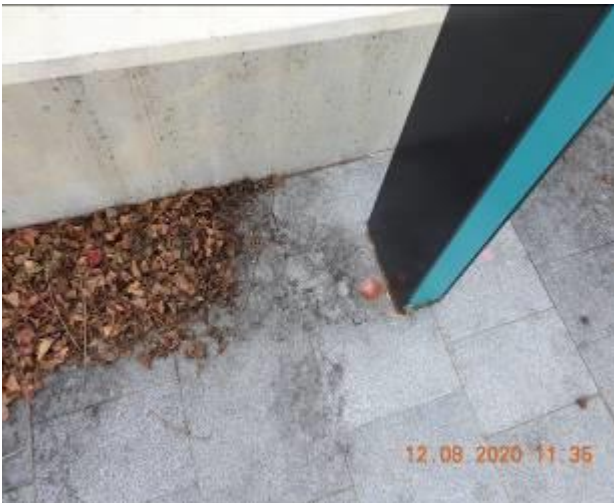
Figure 1627 – Crack propagation and loss of material through footpath pavement

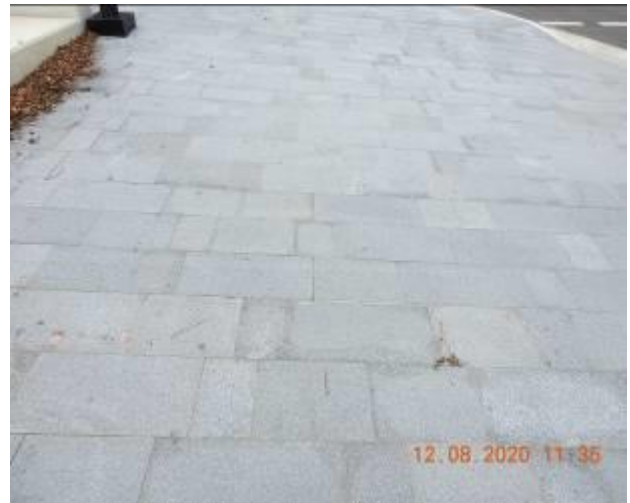
Figure 1628 – Crack propagation and loss of material through footpath pavement

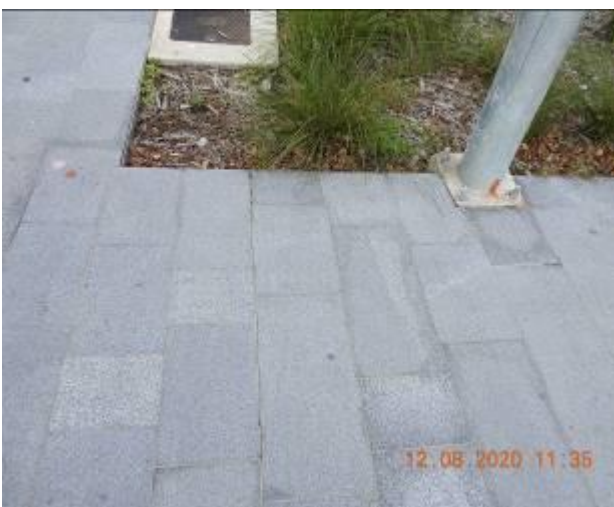
Figure 1629 – Crack propagation and loss of material through footpath pavement

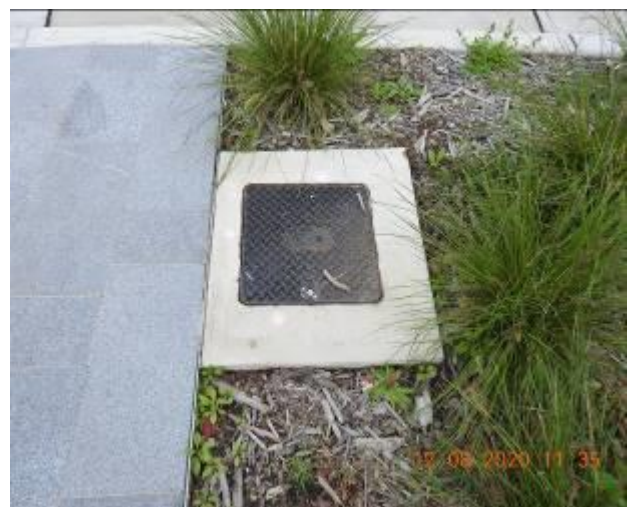
Figure 1630 – Loss of material through service pit pavement

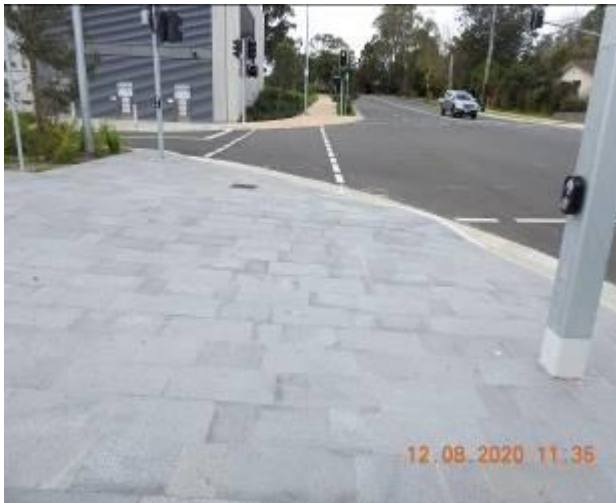
Figure 1631 – General condition of footpath pavement

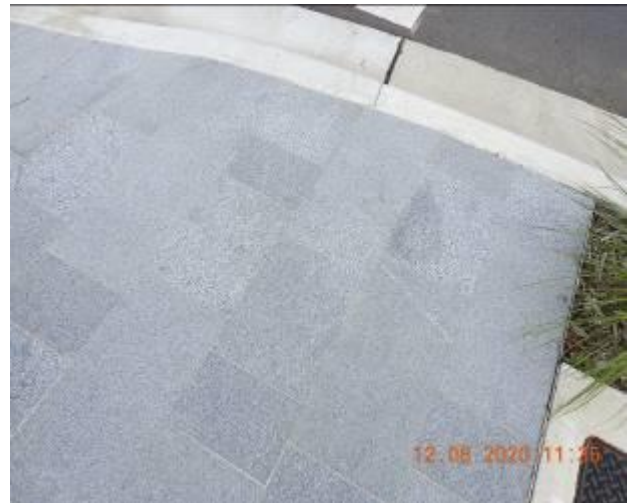
Figure 1632 – Hairline crack propagation through footpath pavement

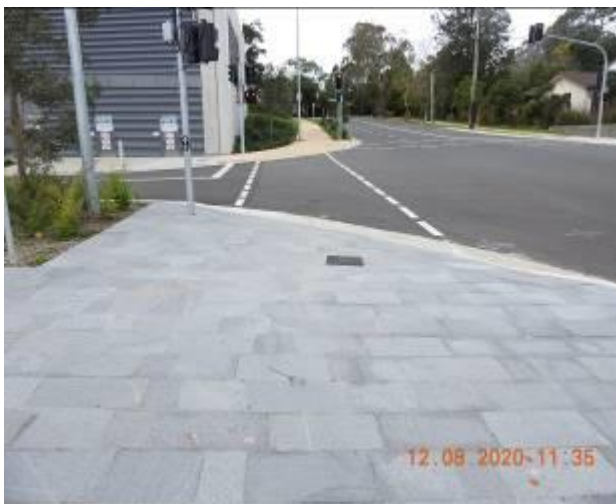
Figure 1633 – Hairline crack propagation through footpath pavement

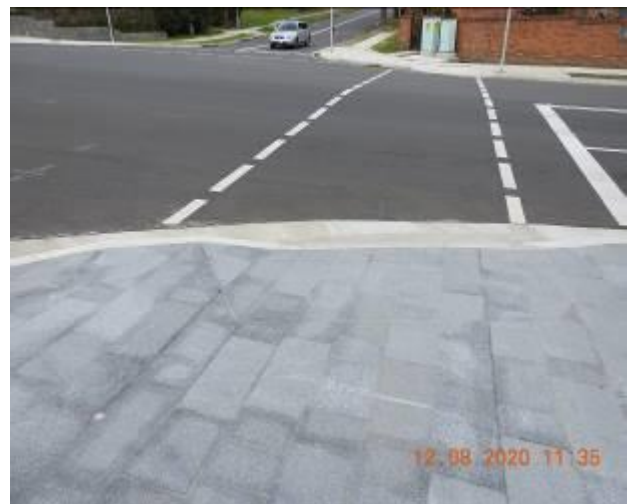
Figure 1634 – Hairline crack propagation through footpath pavement

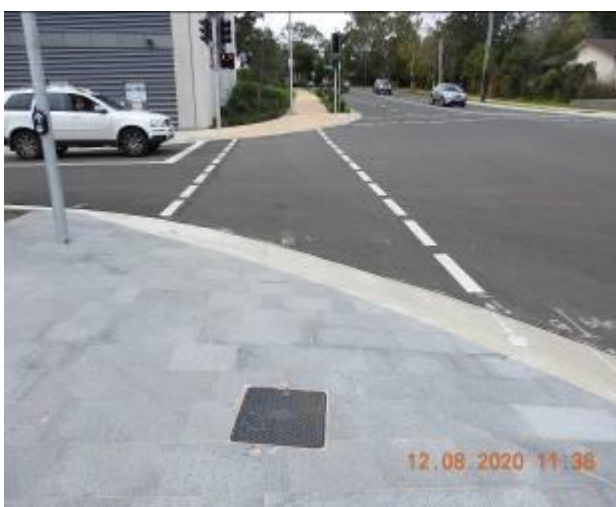
Figure 1635 – Hairline crack propagation through footpath pavement

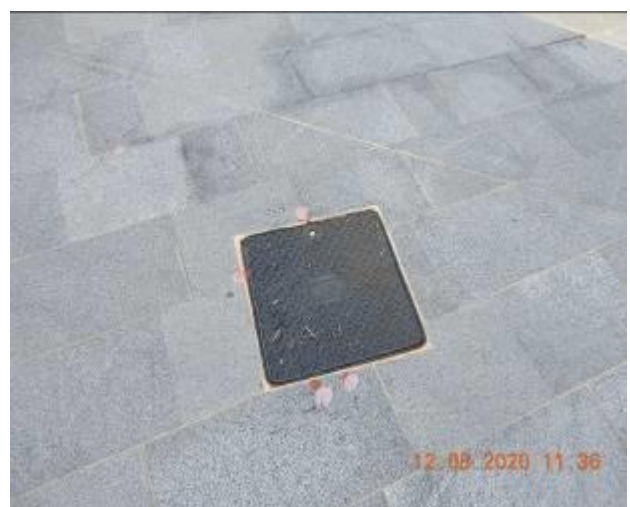
Figure 1636 – General condition of service pit/
Hairline crack propagation through footpath pavement

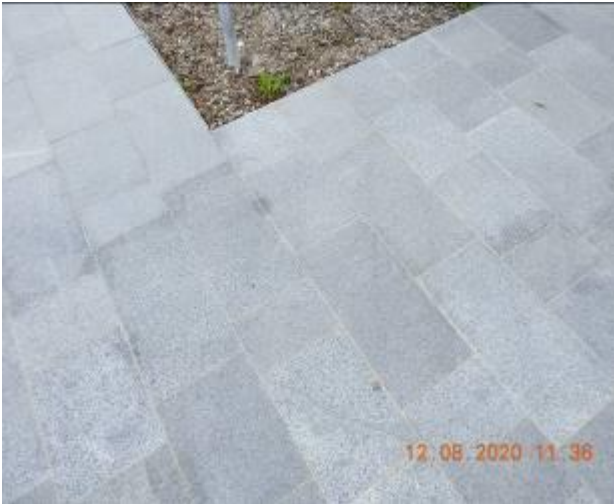
Figure 1637 – Hairline crack propagation through footpath pavement

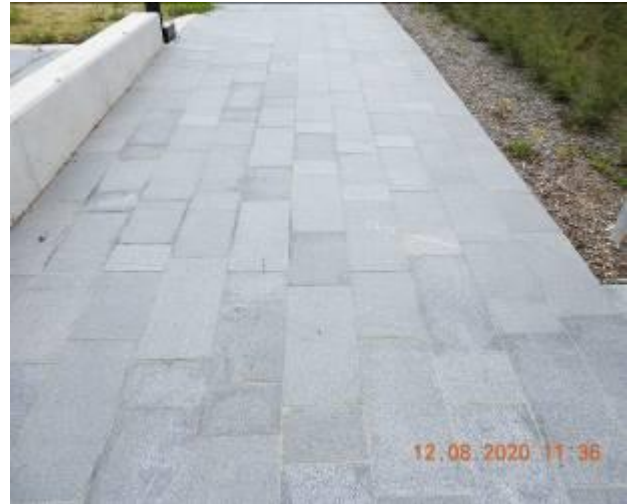
Figure 1638 – Hairline crack propagation through footpath pavement

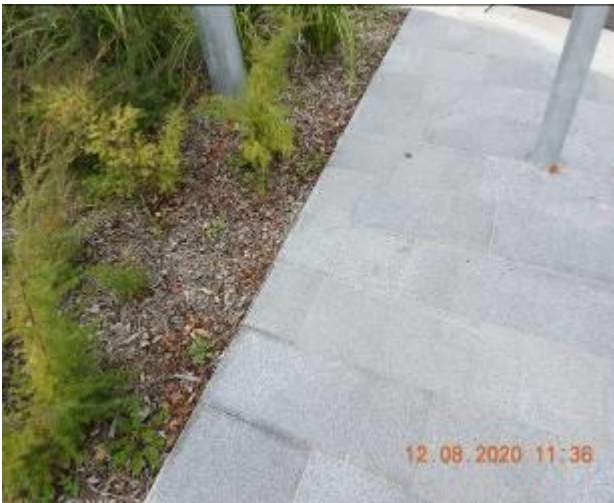
Figure 1639 – Hairline crack propagation and loss of material through footpath pavement

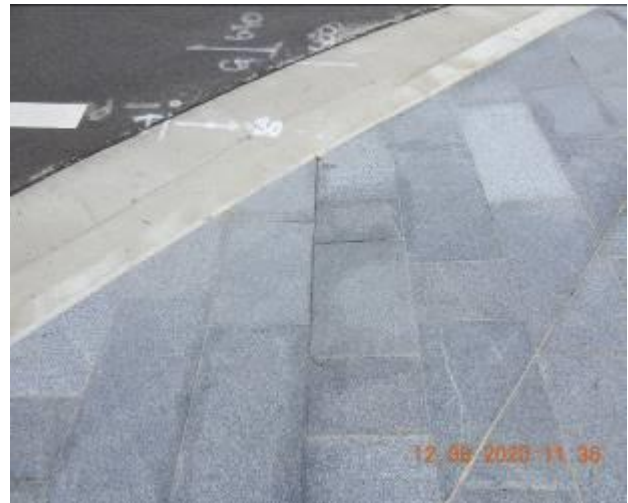
Figure 1640 – Crack propagation and loss of material through footpath pavement

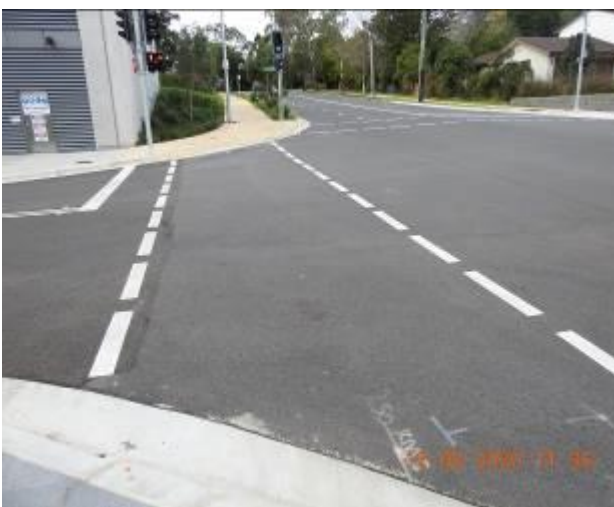
Figure 1641 – General condition of road surface

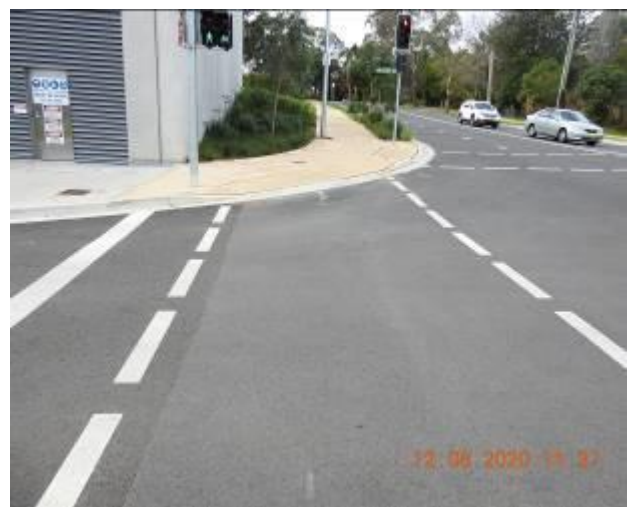
Figure 1642 – General condition of road surface

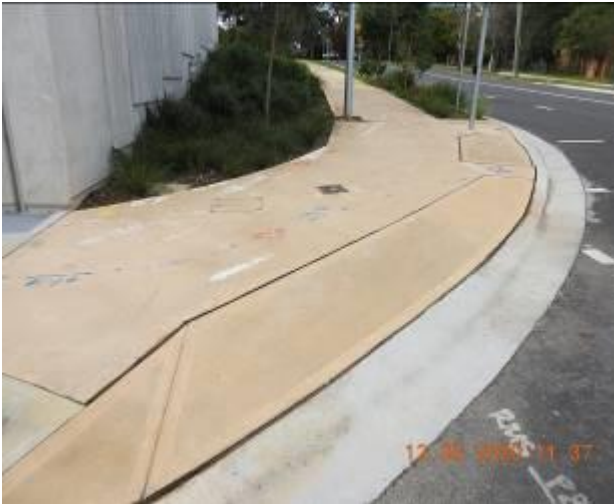
Figure 1643 – General condition of footpath pavement

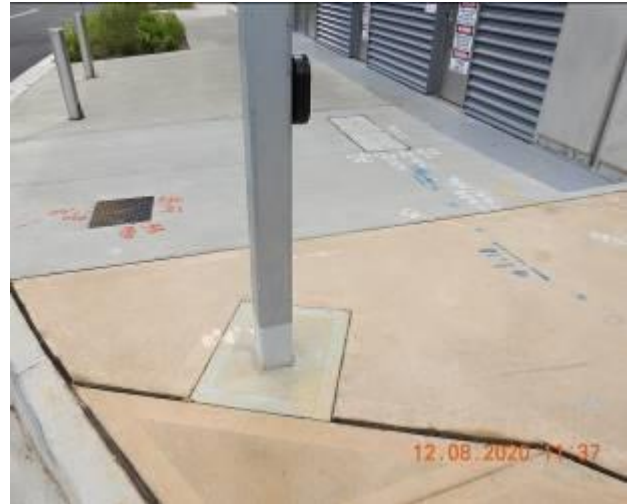
Figure 1644 – General condition of footpath pavement

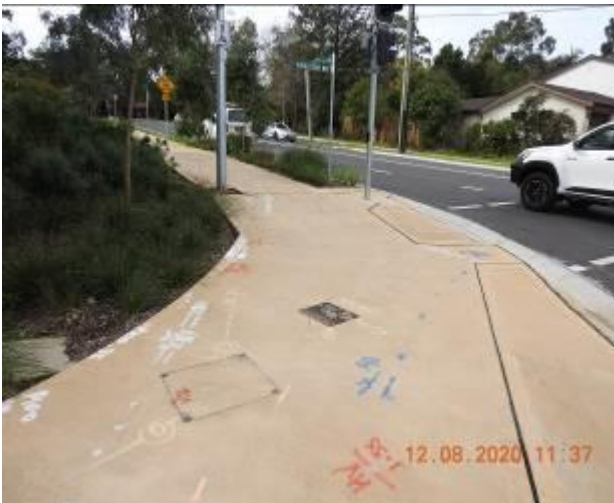
Figure 1645 – General condition of footpath pavement

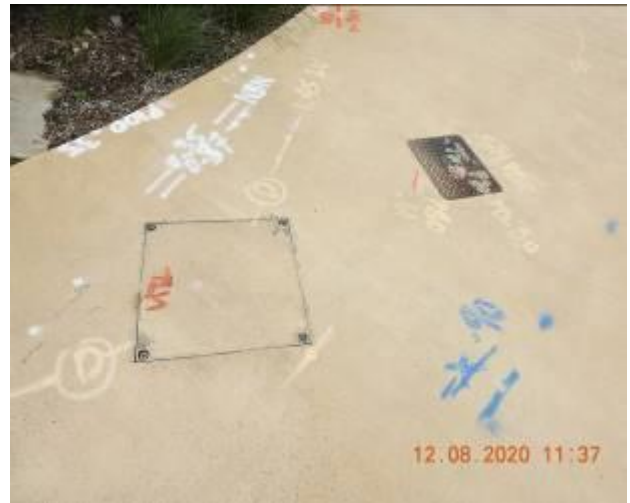
Figure 1646 – General condition of service pits/ Crack propagation through footpath pavement

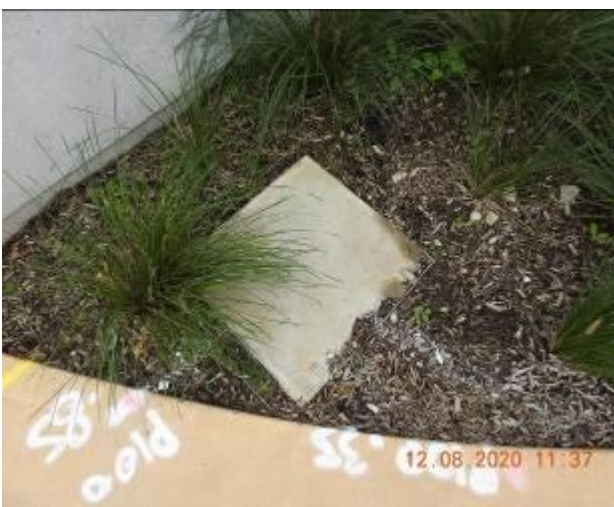
Figure 1647 – Crack propagation and loss of material through service pit pavement

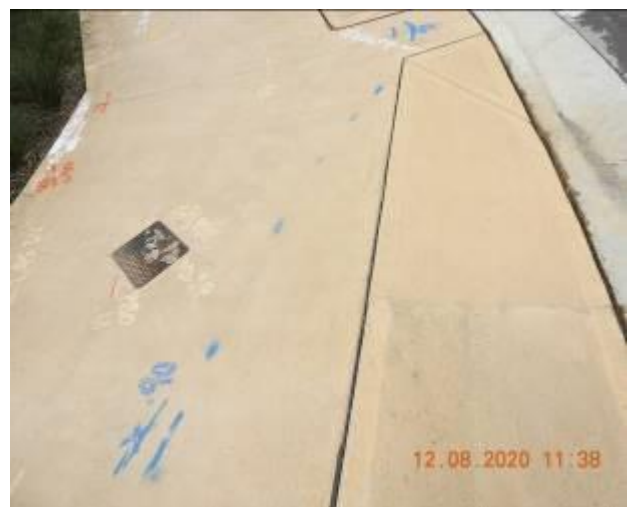
Figure 1648 – Crack propagation through footpath pavement

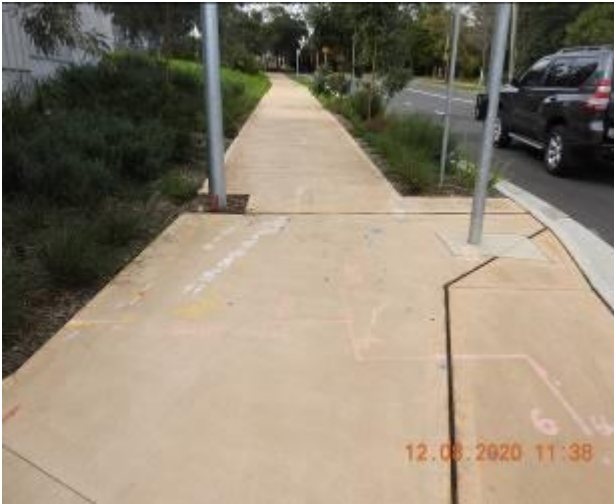
Figure 1649 – General condition of Crack propagation through footpath pavement

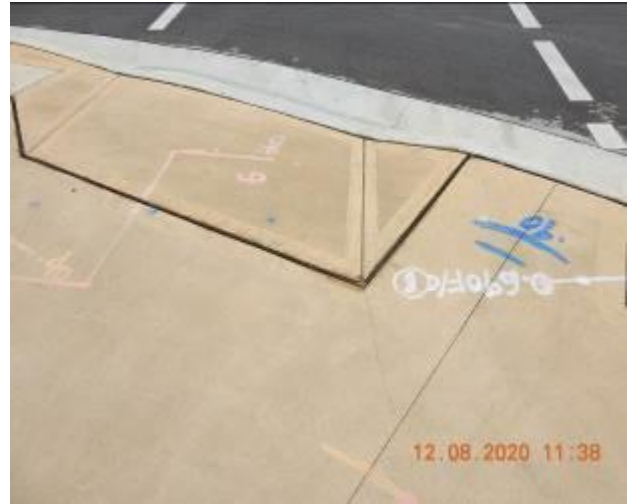
Figure 1650 – Crack propagation and loss of material through footpath pavement
