**2 MANDALA PARADE, CASTLE HILL
(DORAN DRIVE PRECINCT)
PRE-DILAPIDATION REPORT
Of Sydney Metro and Hills Shire Council Assets
DEICORP PROJECTS SHOWGROUND
PTY LTD.**

Job No. 200124.3
07/07/2021

ACE Structural Services Pty Ltd

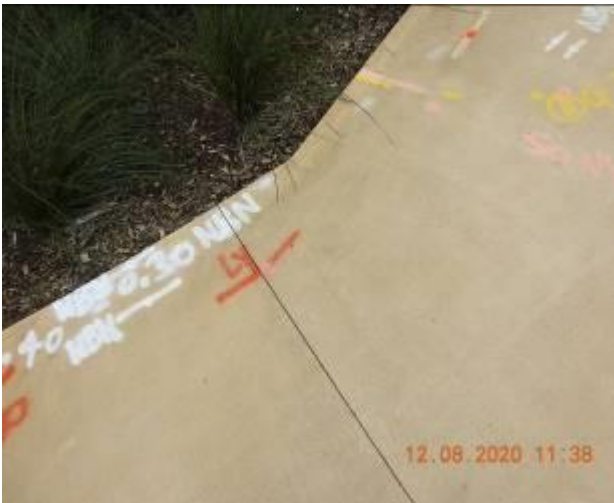
Figure 1651 – Separation through footpath pavement

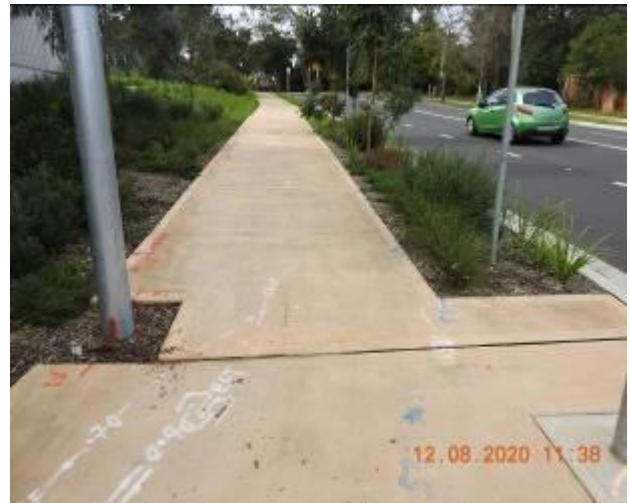
Figure 1652 – General condition of footpath pavement

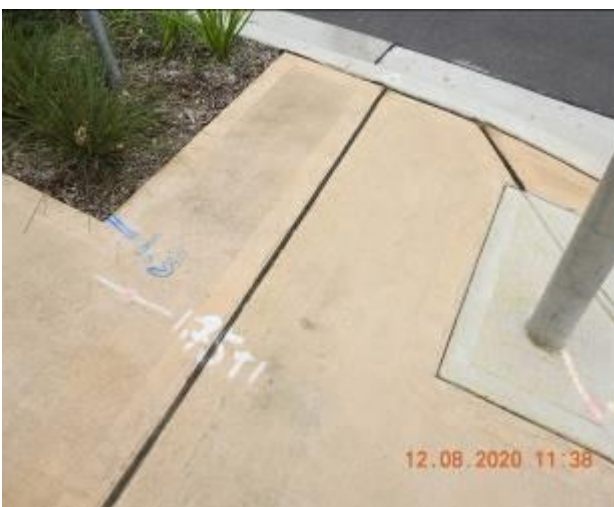
Figure 1653 – Crack propagation and loss of material through footpath pavement

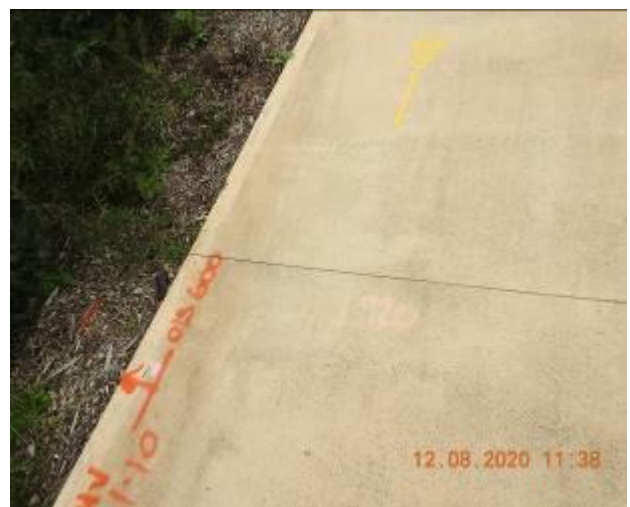
Figure 1654 – Separation through footpath pavement

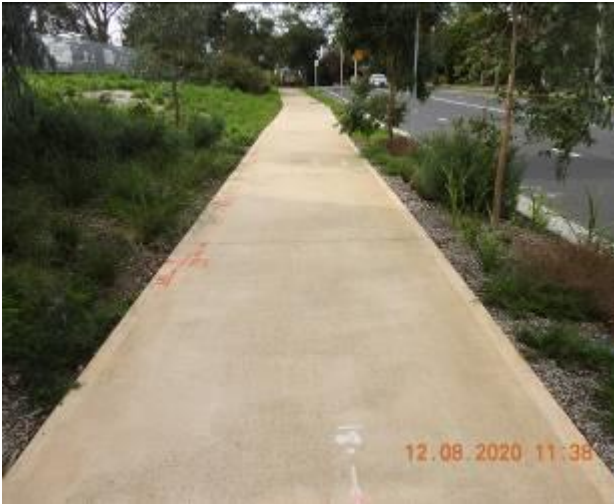
Figure 1655 – General condition of footpath pavement

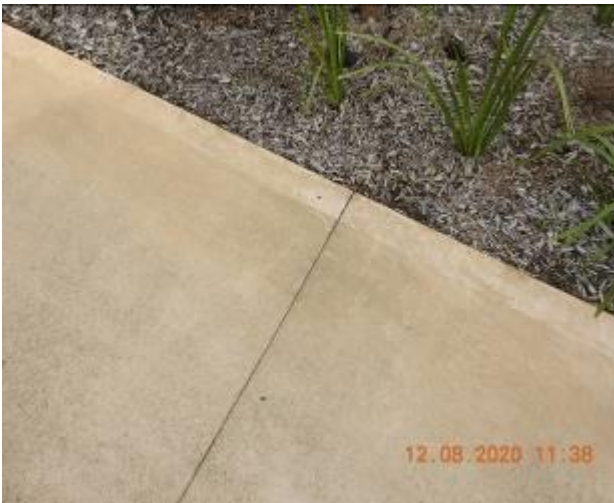
Figure 1657 – Separation through footpath pavement

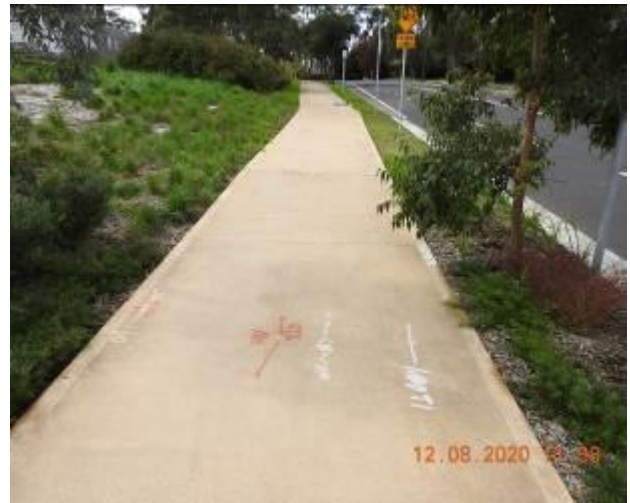
Figure 1658 – General condition of footpath pavement

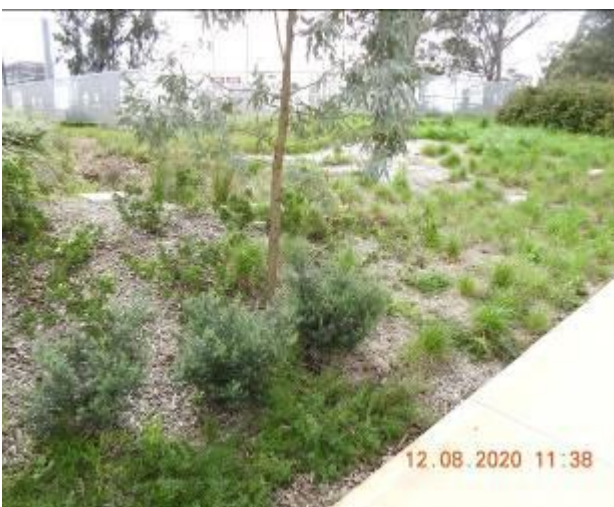
Figure 1659 – General condition of nature strip

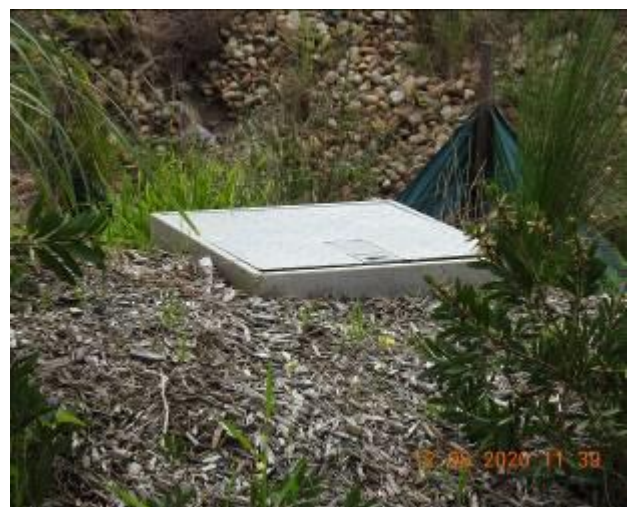
Figure 1660 – Loss of material through service pit pavement

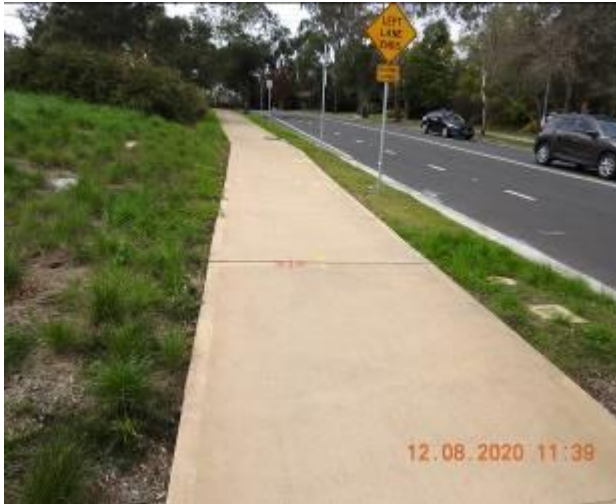
Figure 1661 – General condition of footpath pavement

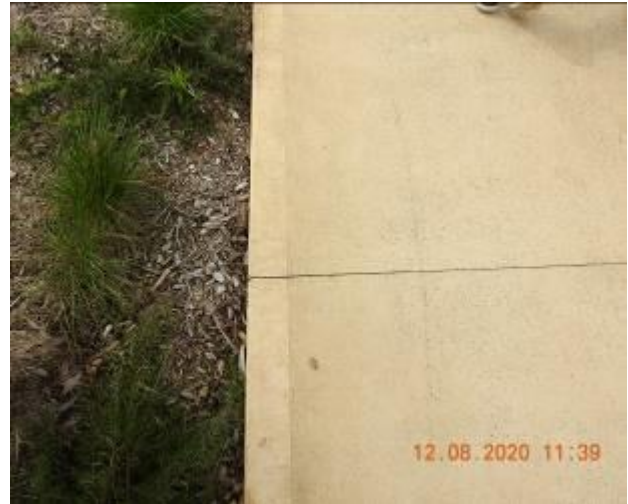
Figure 1662 – Loss of material through footpath pavement

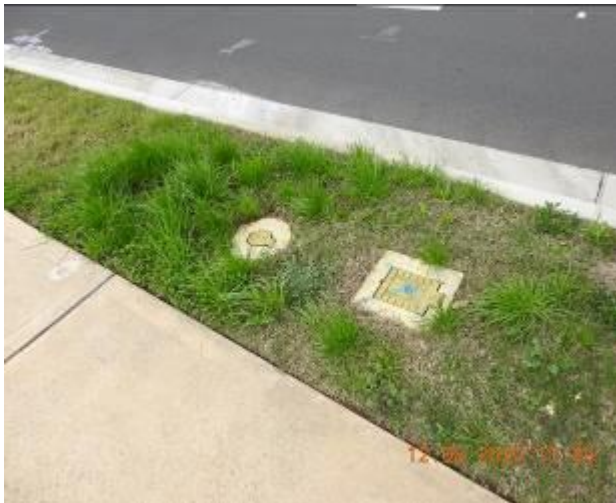
Figure 1663 – General condition of service pits

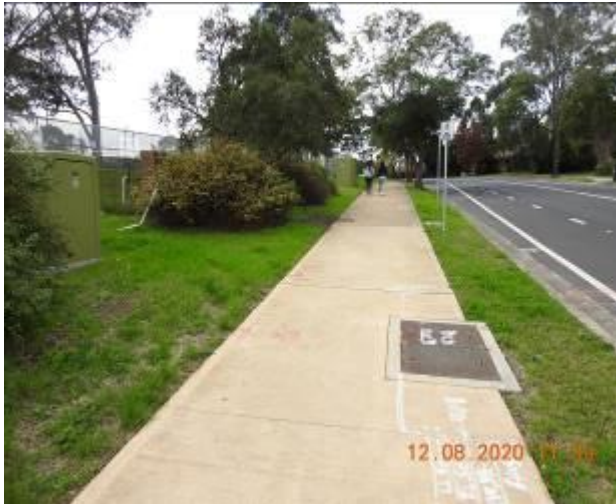
Figure 1666 – Loss of material through footpath pavement

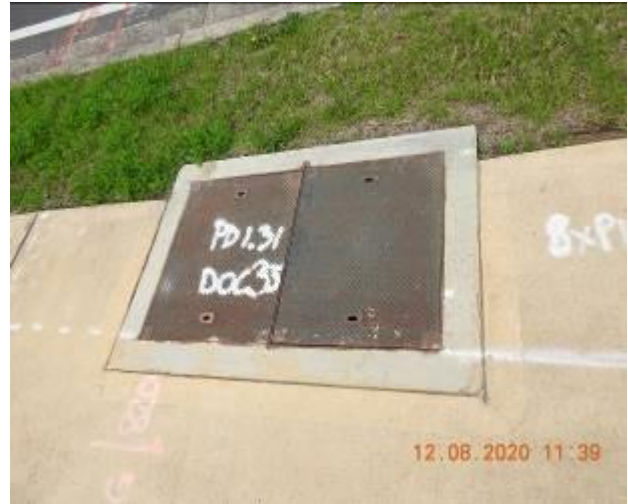
Figure 1667 – General condition of footpath pavement

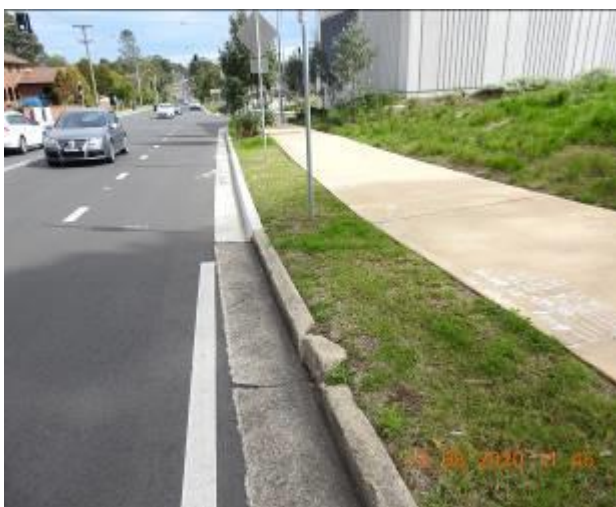
Figure 1670 – General condition of footpath pavement

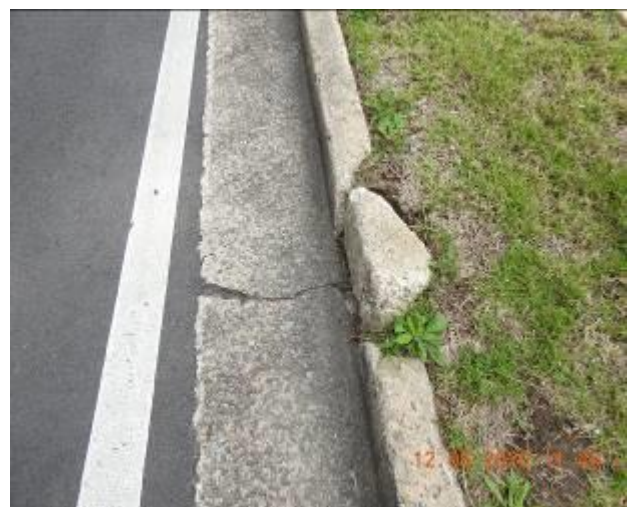
Figure 1671 – General condition of kerb and gutter heading West

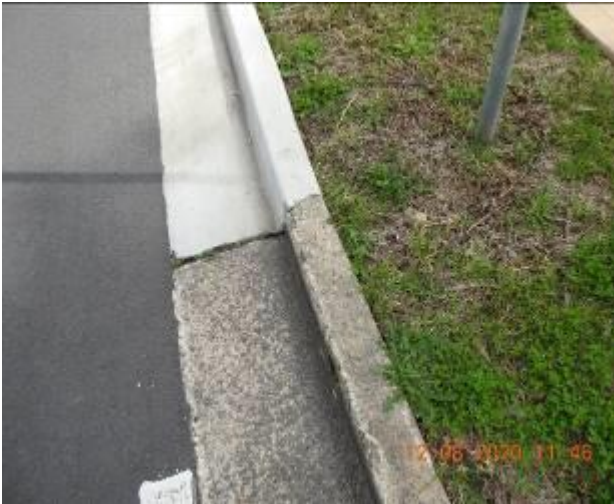
Figure 1672 – Crack propagation and loss of material through kerb and gutter

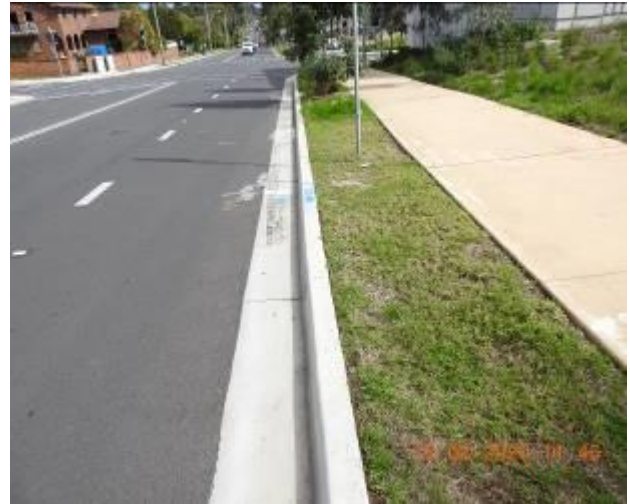
Figure 1673 – Loss of material through kerb and gutter

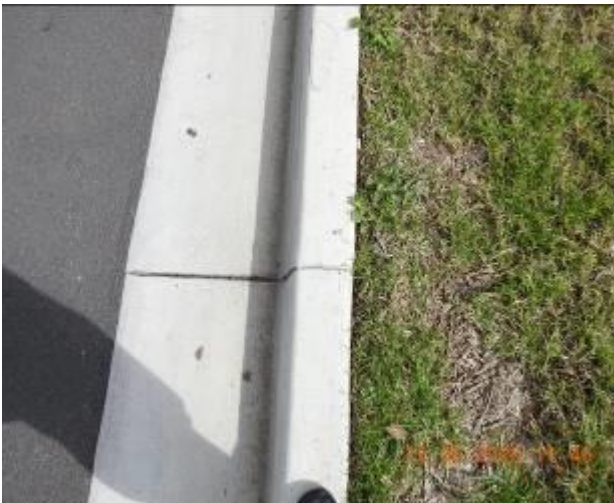
Figure 1674 – General condition of kerb and gutter

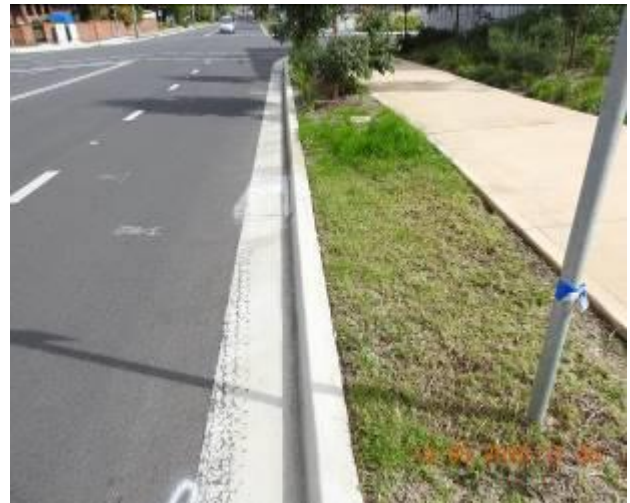
Figure 1675 – Crack propagation and loss of material through kerb and gutter

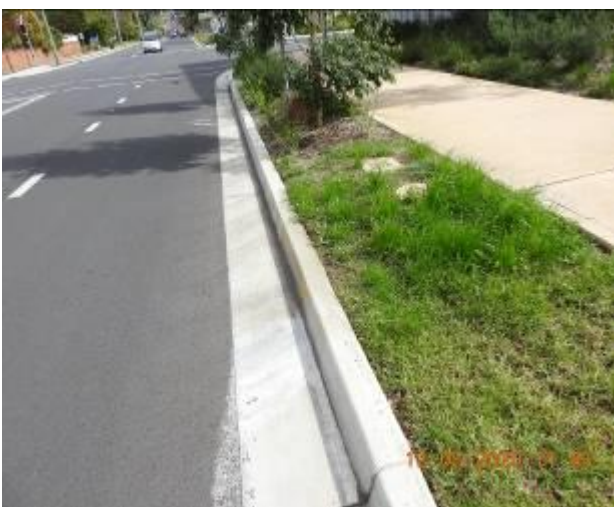
Figure 1676 – General condition of kerb and gutter

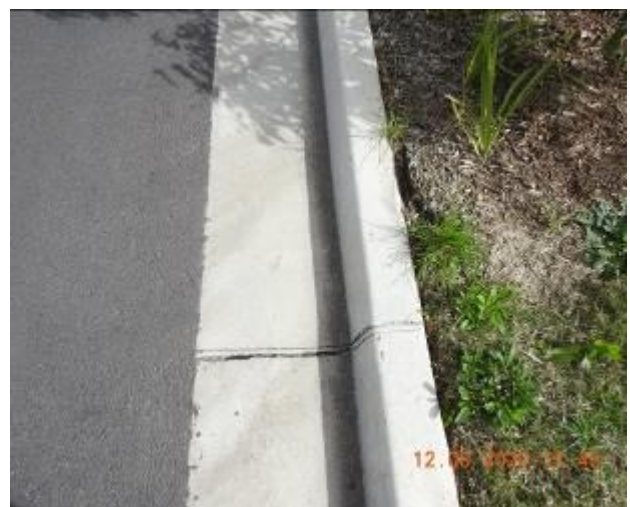
Figure 1677 – General condition of kerb and gutter

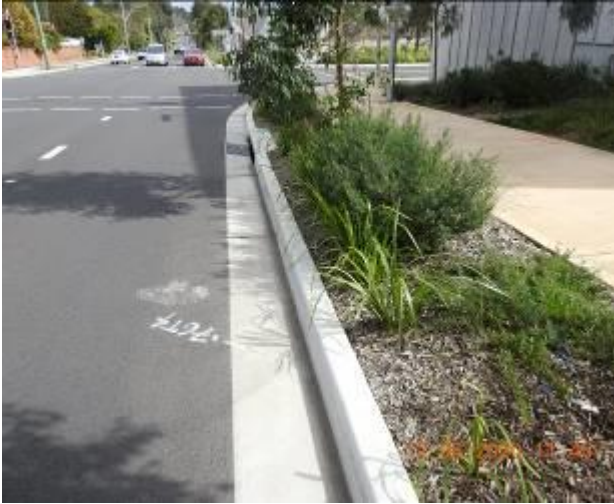
Figure 1678 – Crack propagation and loss of material through kerb and gutter

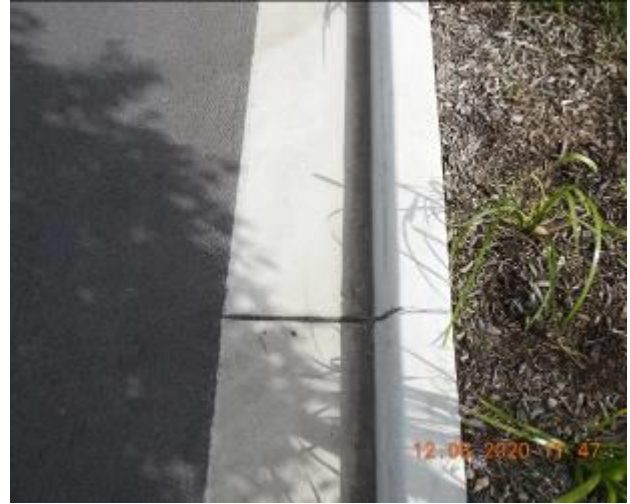
Figure 1679 – General condition of kerb and gutter

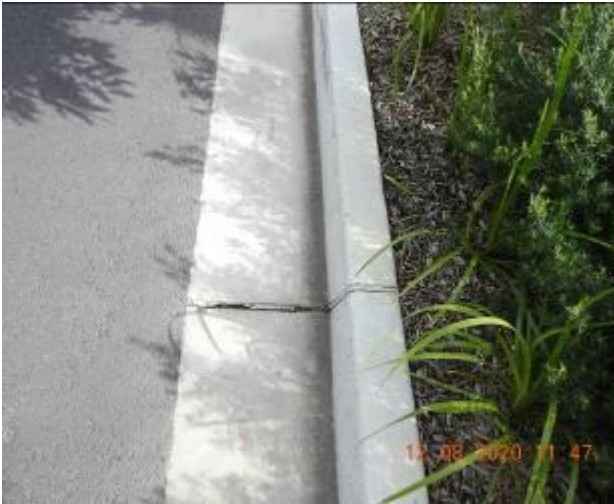
Figure 1680 – Crack propagation and loss of material through kerb and gutter

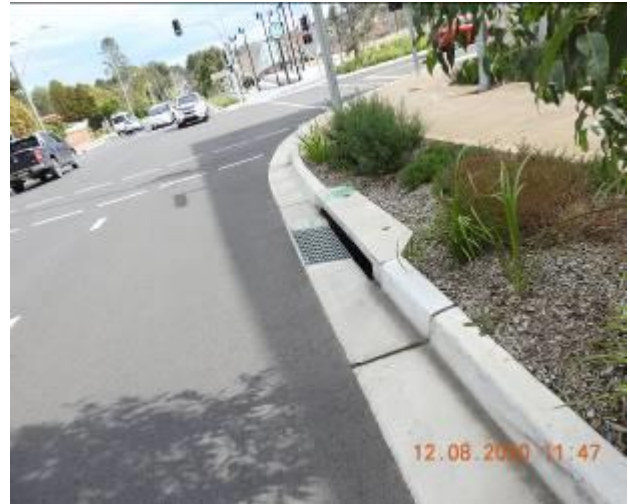
Figure 1681 – Crack propagation and loss of material through kerb and gutter

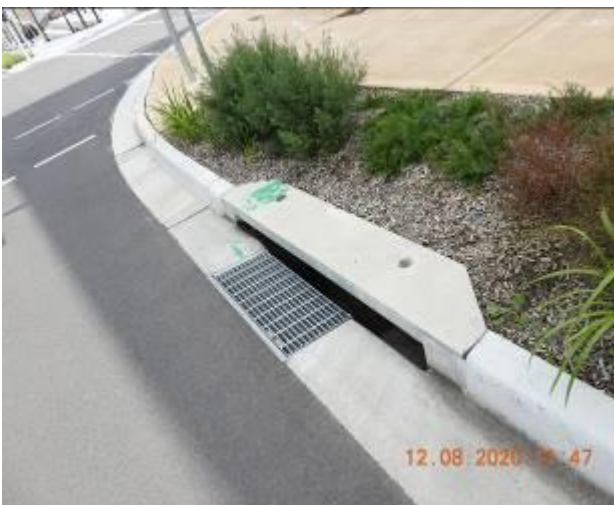
Figure 1682 – General condition of kerb and gutter

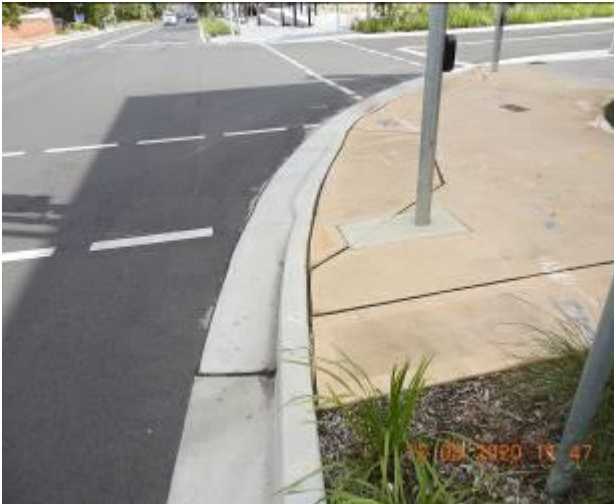
Figure 1684 – Loss of material through kerb and gutter

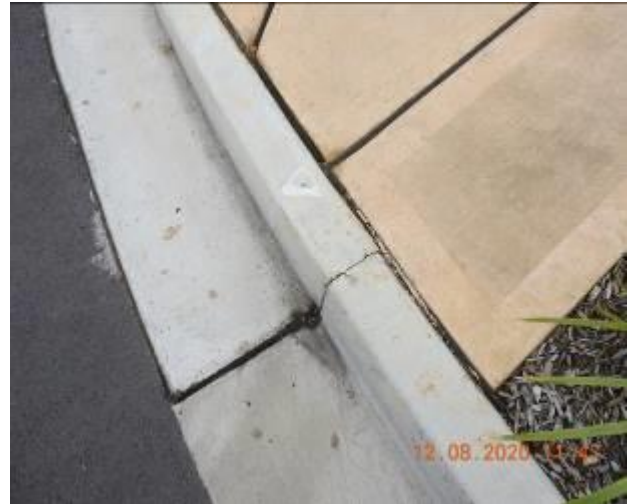
Figure 1685 – General condition of kerb and gutter

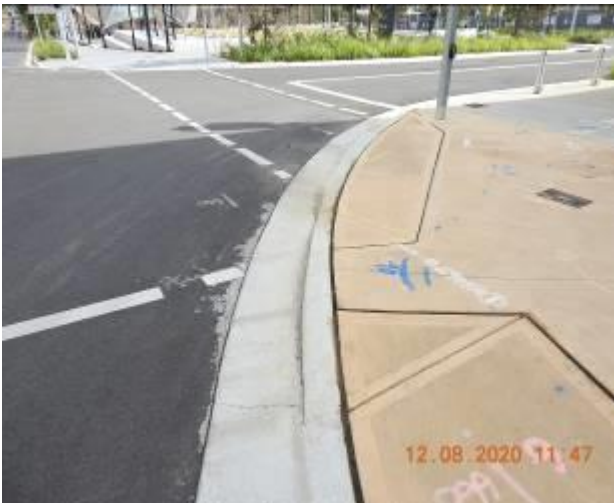
Figure 1686 – Crack propagation and loss of material through kerb and gutter

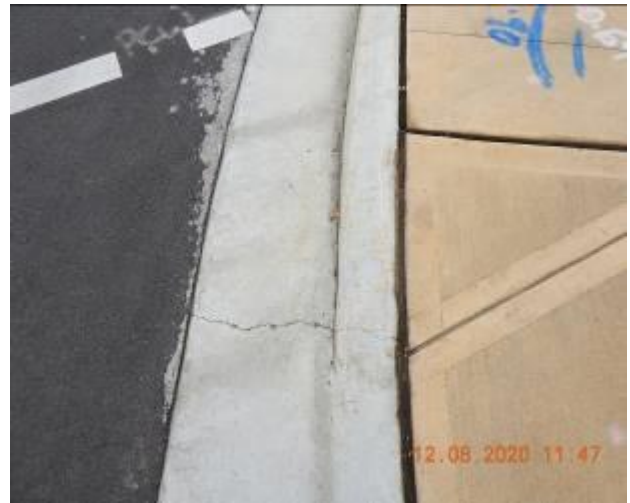
Figure 1687 – General condition of kerb and gutter

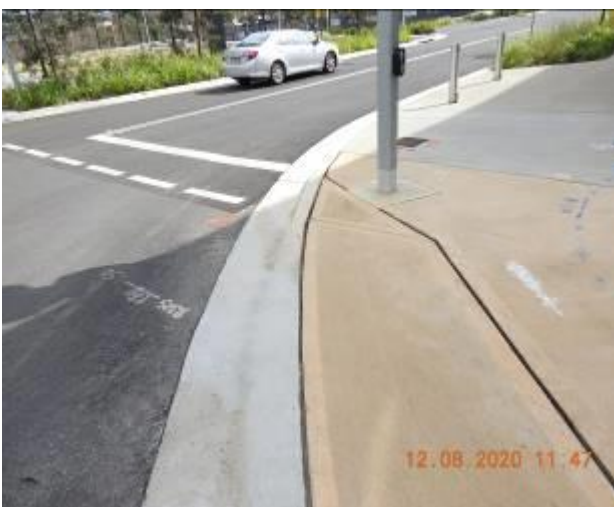
Figure 1688 – Crack propagation and loss of material through layback and gutter

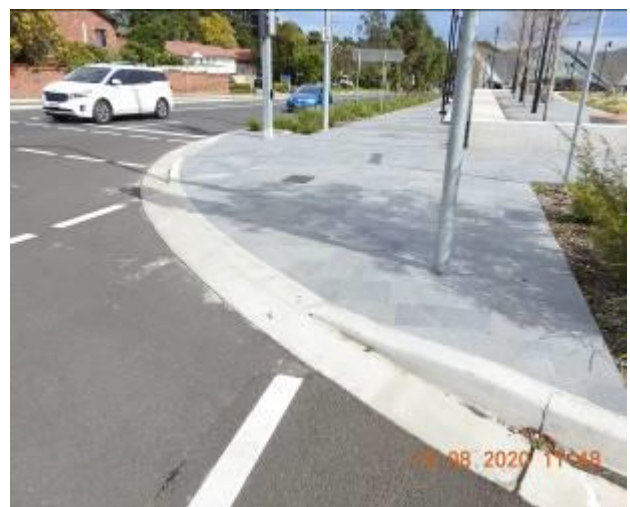
Figure 1689 – General condition of kerb and gutter

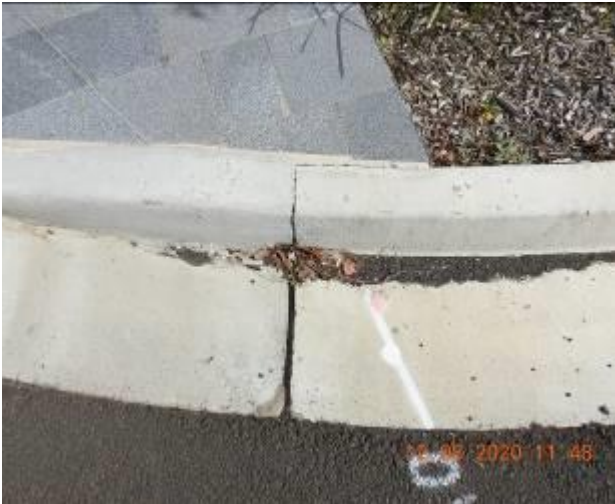
Figure 1690 – General condition of kerb and gutter heading West

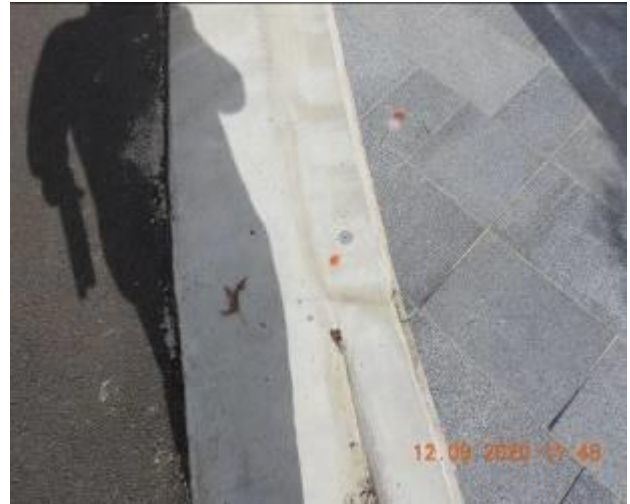
Figure 1691 – Loss of material through kerb and evidence of patchwork through gutter

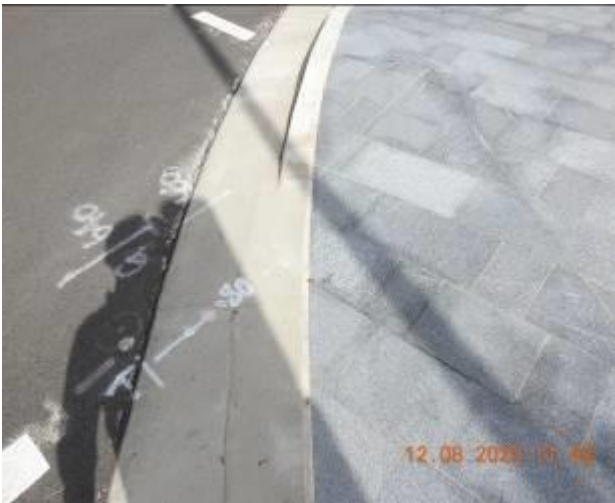
Figure 1692 – Crack propagation through layback and gutter

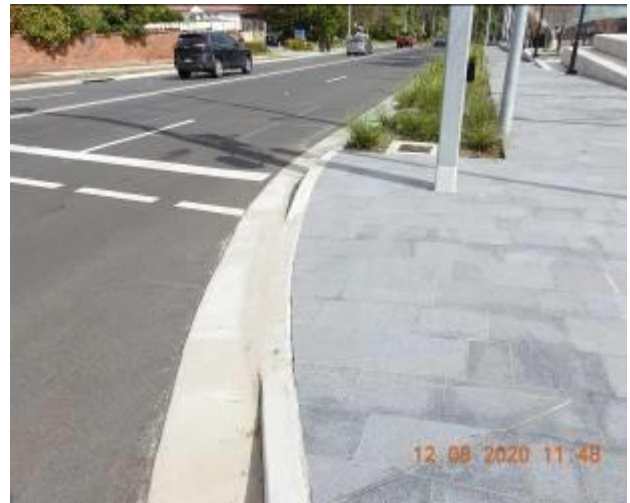
Figure 1693 – Crack propagation through layback and gutter

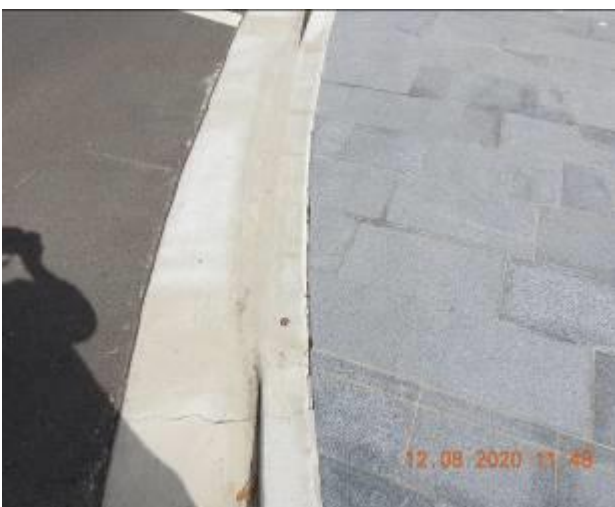
Figure 1694 – General condition of kerb and gutter

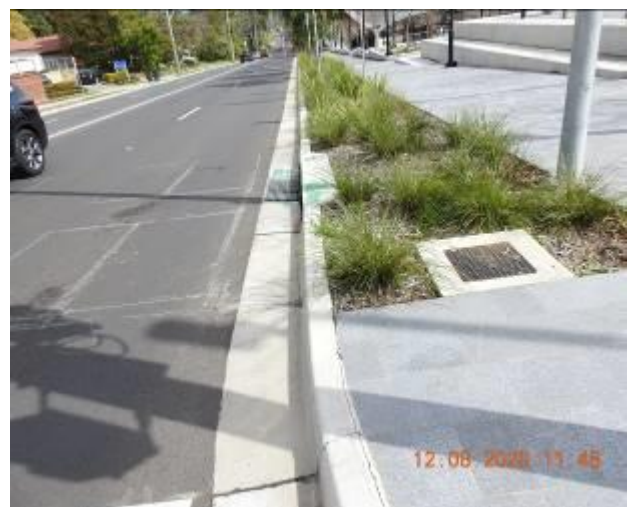
Figure 1695 – Crack propagation and loss of material through layback and gutter

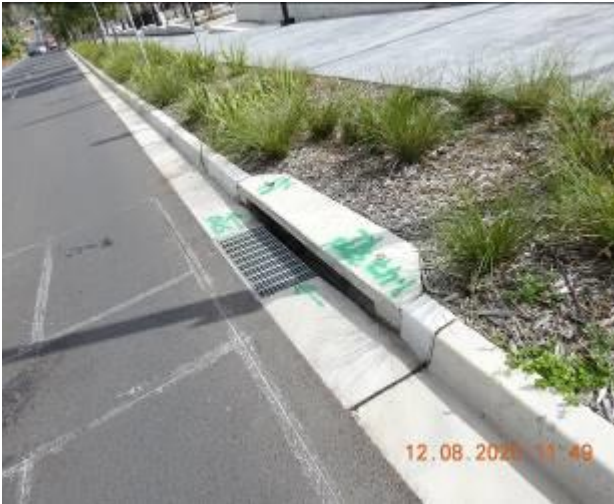
Figure 1696 – General condition of kerb and gutter

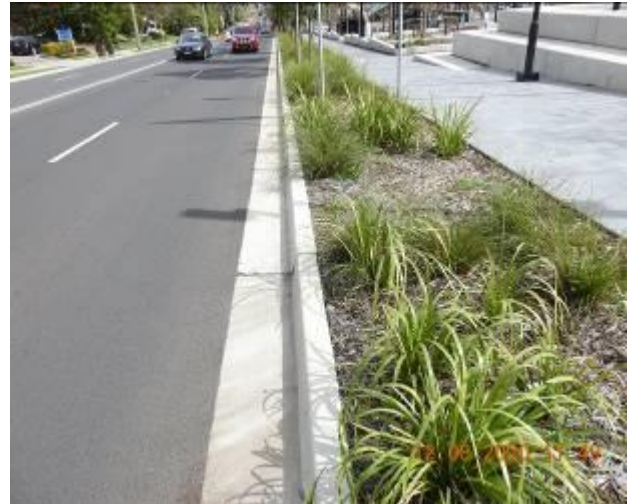
Figure 1697 – General condition of stormwater inlet pit/Loss of material through kerb

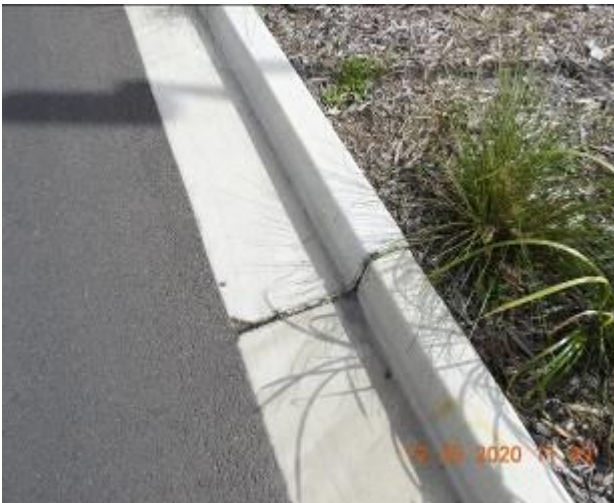
Figure 1698 – General condition of kerb and gutter

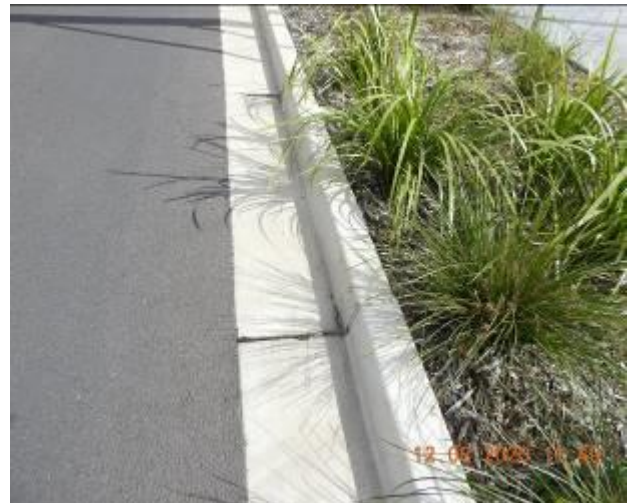
Figure 1699 – Loss of material through kerb and gutter

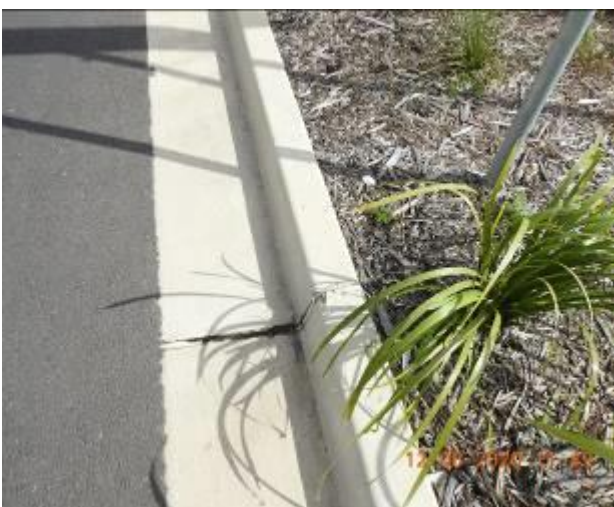
Figure 1700 – Loss of material through kerb and gutter

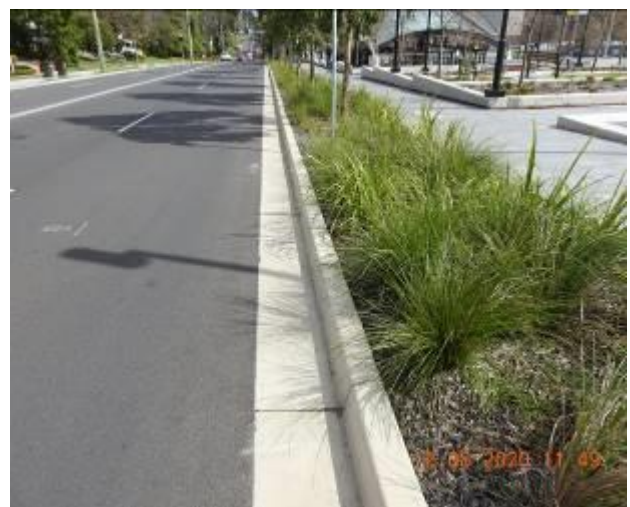
Figure 1701 – Loss of material through kerb and gutter

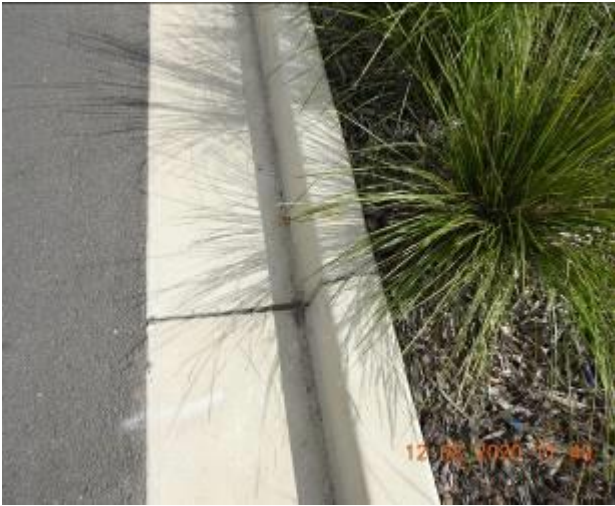
Figure 1702 – General condition of kerb and gutter

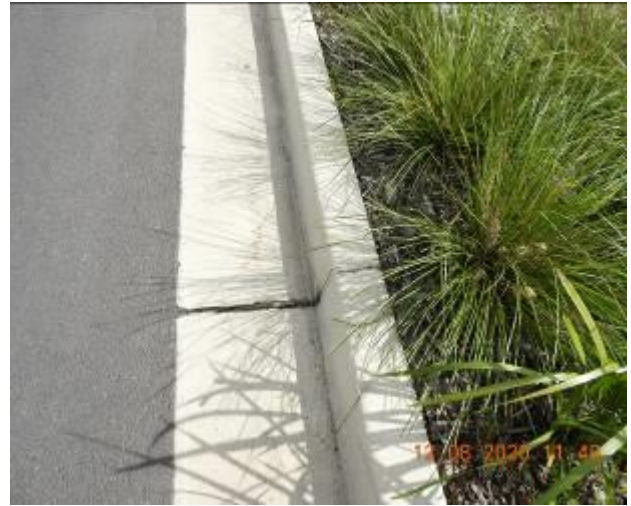
Figure 1703 – Crack propagation and loss of material through kerb and gutter

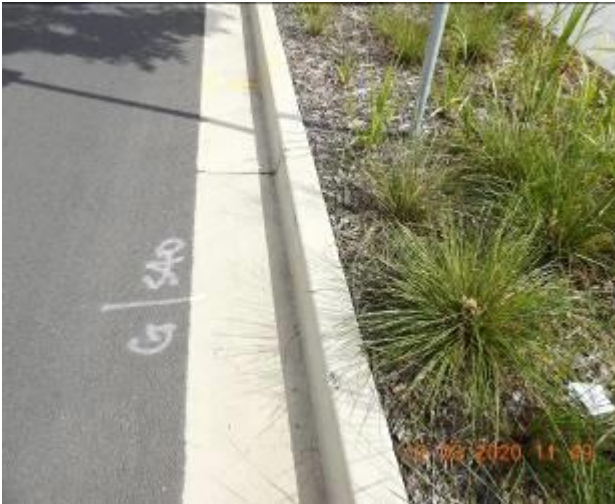
Figure 1704 – Crack propagation and loss of material through kerb and gutter

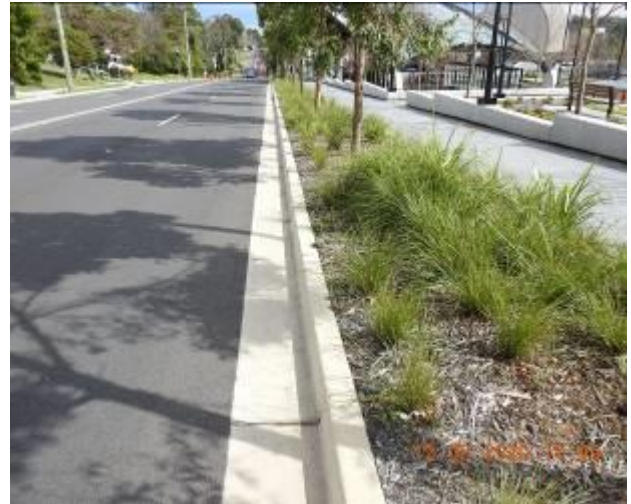
Figure 1705 – Loss of material through kerb

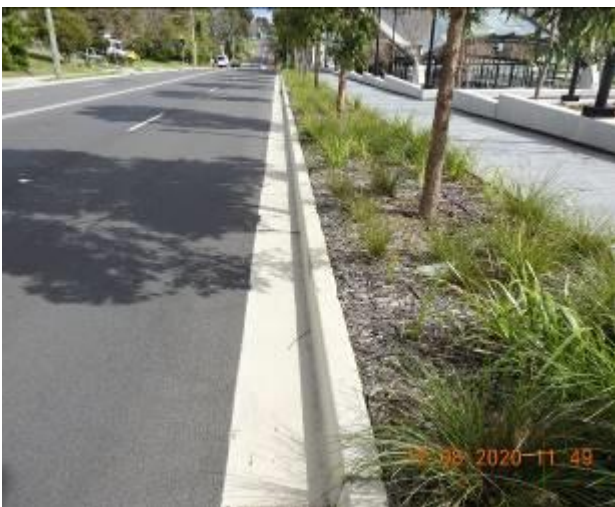
Figure 1706 – Loss of material through kerb and gutter

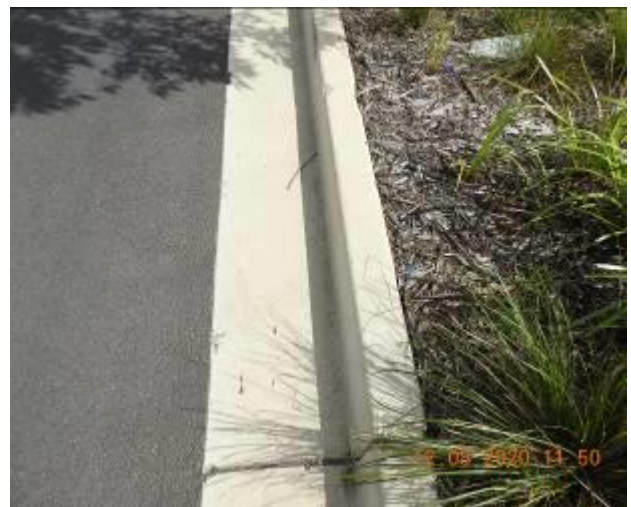
Figure 1707 – Loss of material through kerb

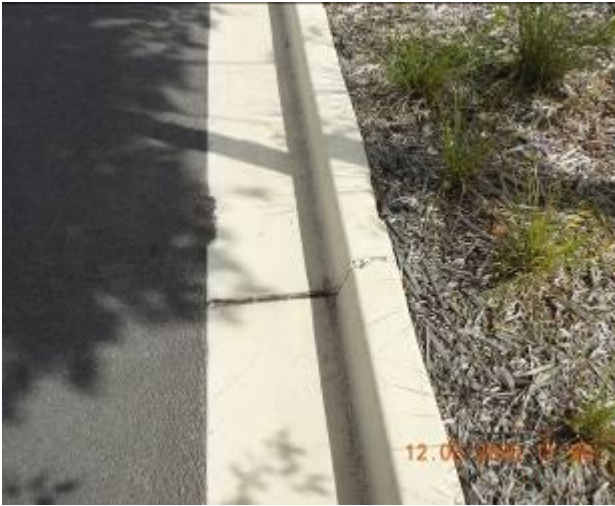
Figure 1708 – Loss of material through kerb and gutter

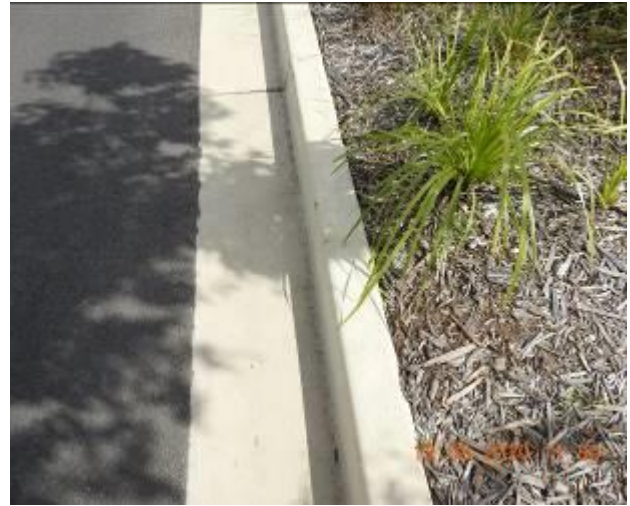
Figure 1709 – Loss of material through kerb and gutter

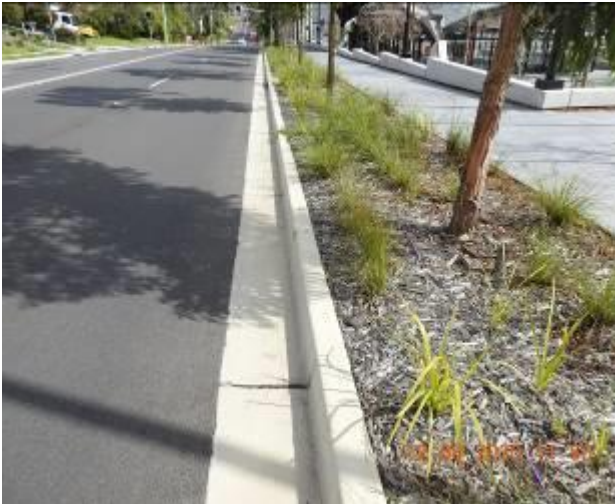
Figure 1710 – Loss of material through kerb and gutter

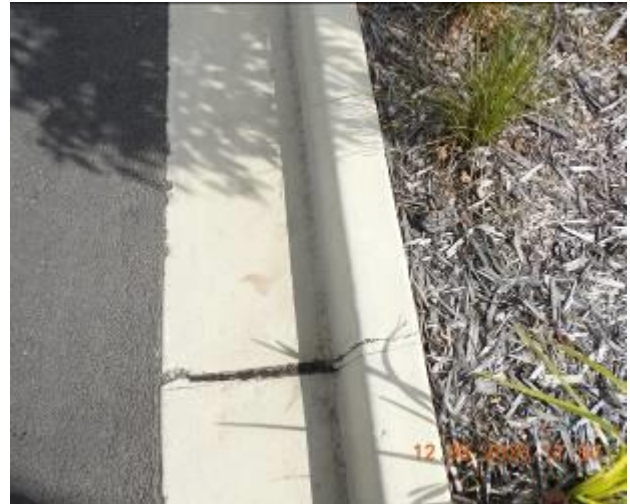
Figure 1711 – General condition of kerb and gutter

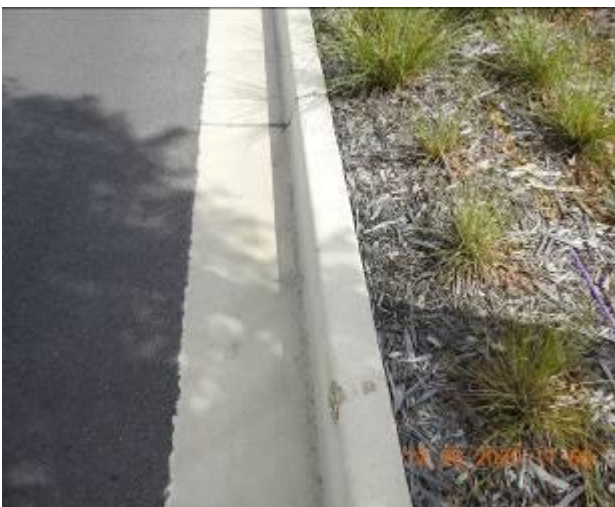
Figure 1712 – Loss of material through kerb and gutter

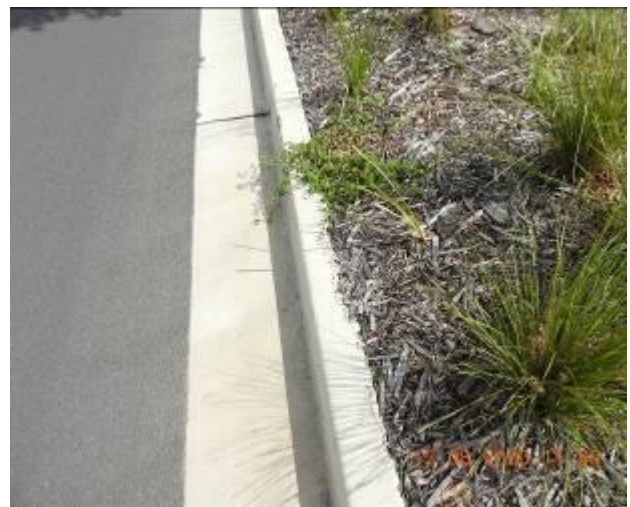
Figure 1713 – Loss of material through gutter

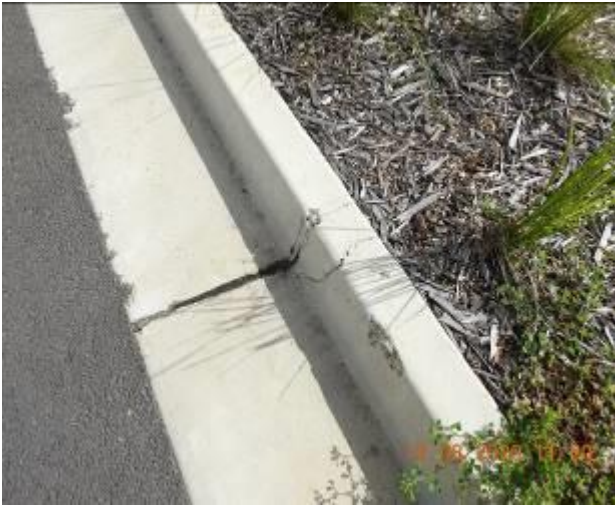
Figure 1714 – Loss of material through gutter

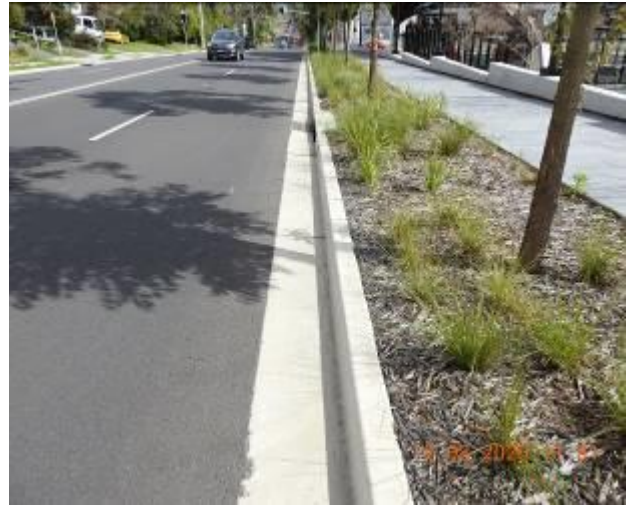
Figure 1715 – Crack propagation and loss of material through gutter

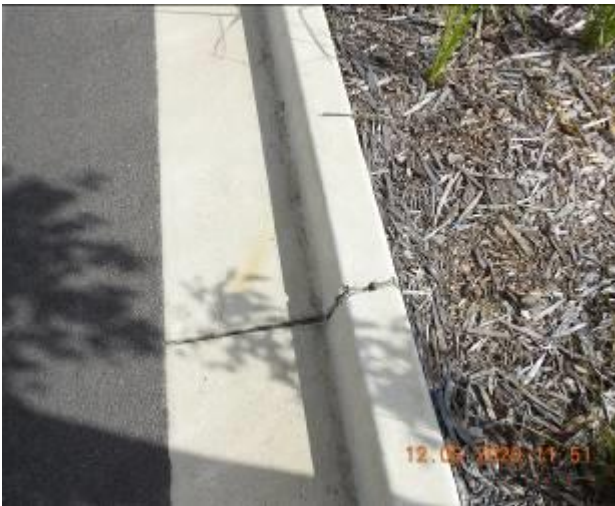
Figure 1716 – General condition of kerb and gutter

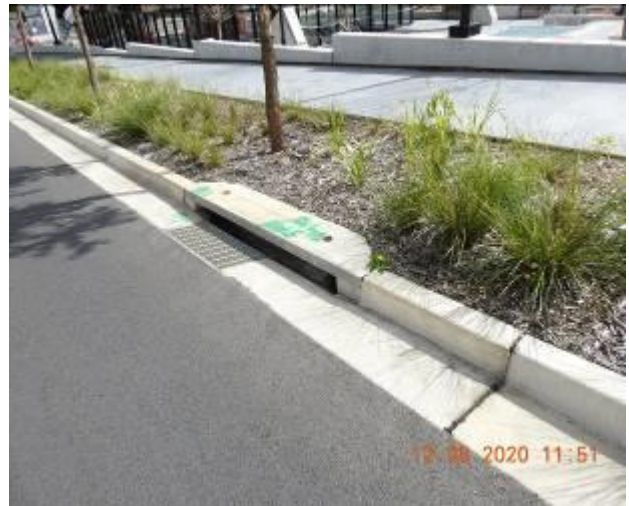
Figure 1717 – Crack propagation and loss of material through kerb and gutter

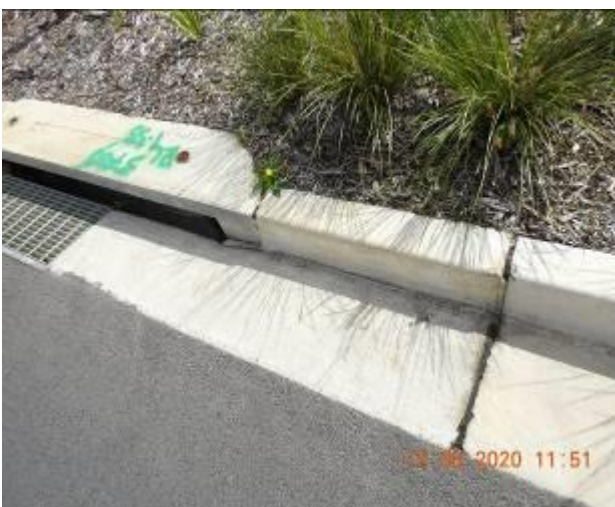
Figure 1718 – General condition of stormwater inlet pit

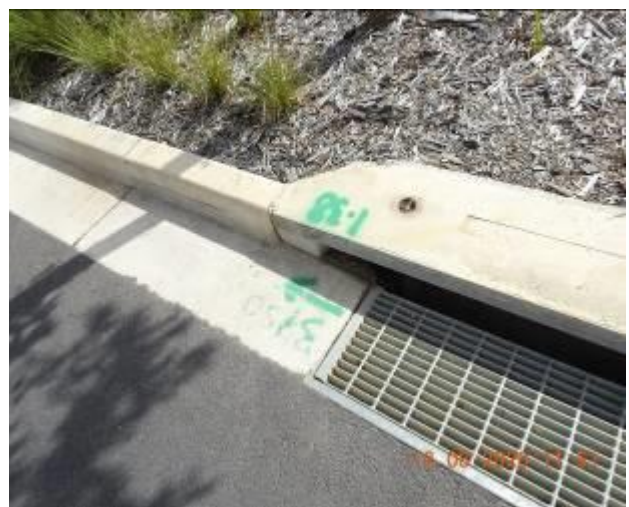
Figure 1719 – Crack propagation and loss of material through kerb and gutter

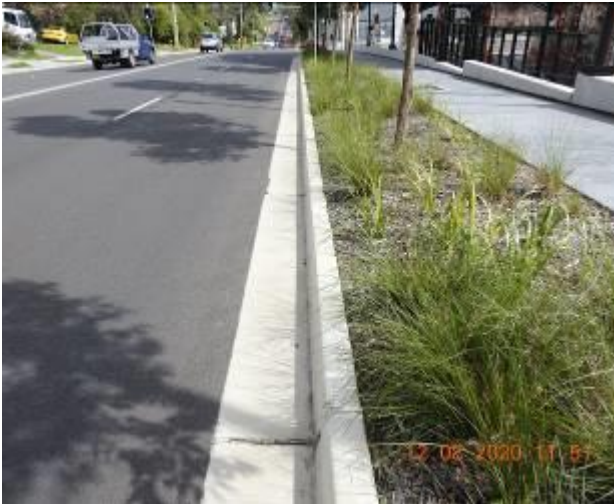
Figure 1720 – Loss of material through kerb

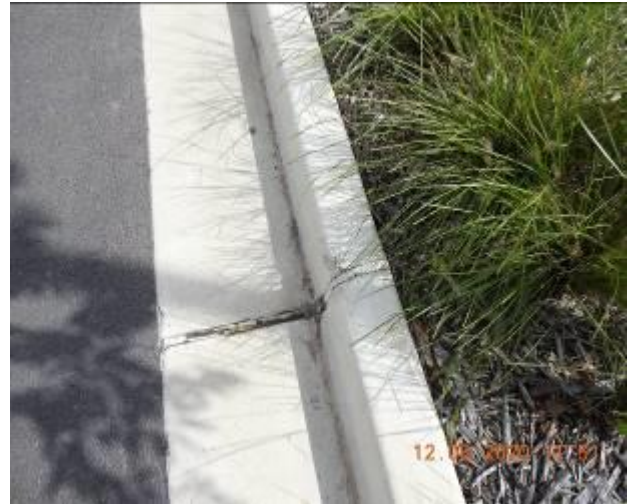
Figure 1721 – General condition of kerb and gutter

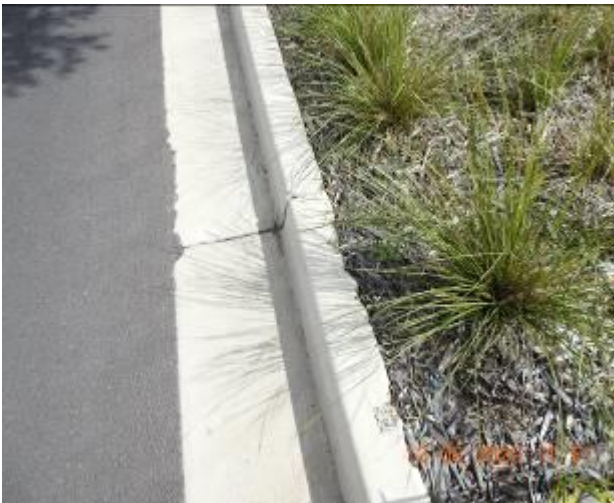
Figure 1722 – Crack propagation and loss of material through kerb and gutter

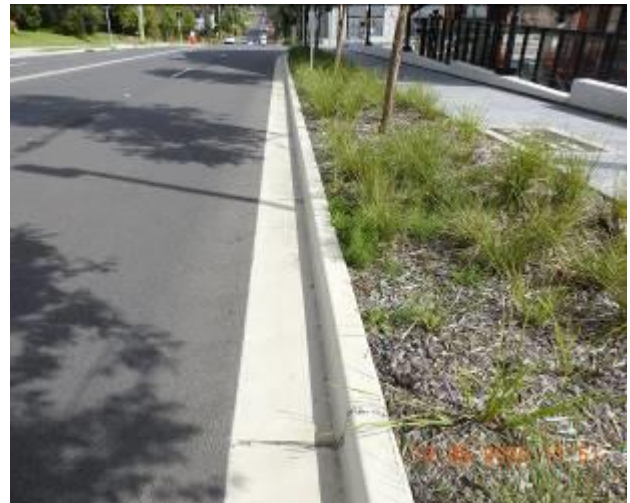
Figure 1723 – Crack propagation and loss of material through kerb and gutter

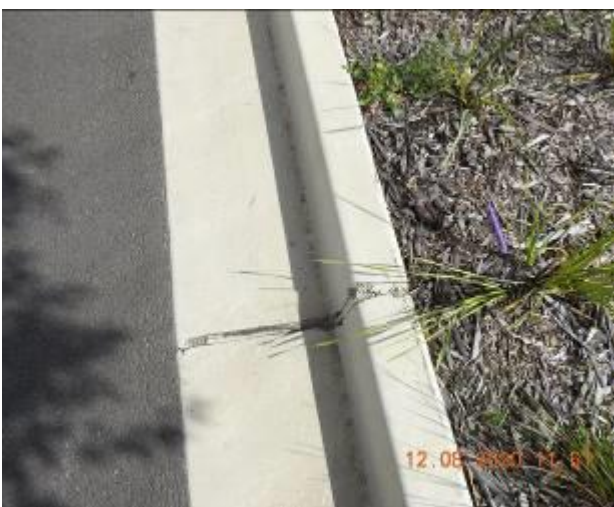
Figure 1724 – General condition of kerb and gutter

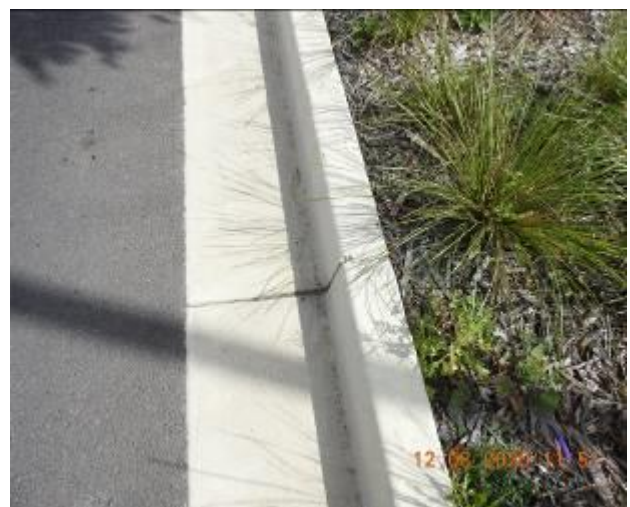
Figure 1725 – Crack propagation and loss of material through kerb and gutter

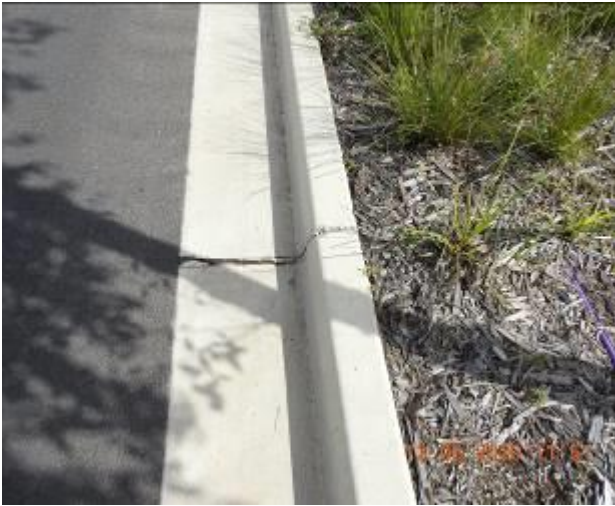
Figure 1726 – Crack propagation and loss of material through kerb and gutter
