**2 MANDALA PARADE, CASTLE HILL
(DORAN DRIVE PRECINCT)
PRE-DILAPIDATION REPORT
Of Sydney Metro and Hills Shire Council Assets
DEICORP PROJECTS SHOWGROUND
PTY LTD.**

Job No. 200124.3
07/07/2021

ACE Structural Services Pty Ltd

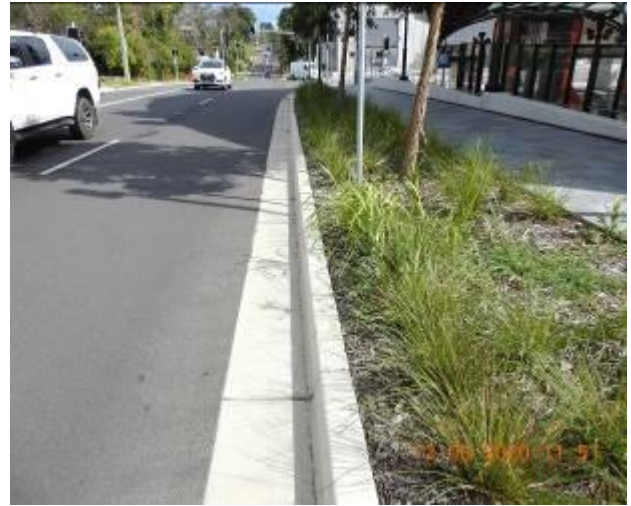
Figure 1727 – Crack propagation and loss of material through kerb and gutter

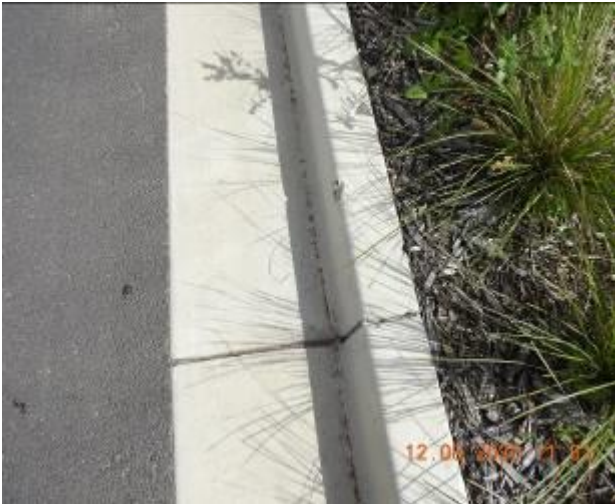
Figure 1728 – General condition of kerb and gutter

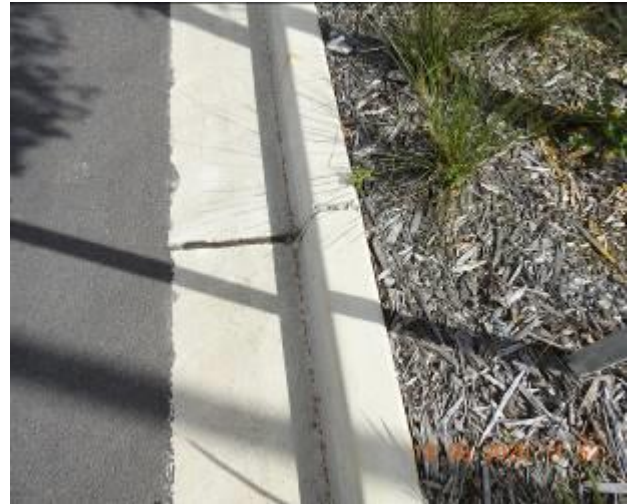
Figure 1729 – Crack propagation and loss of material through kerb and gutter

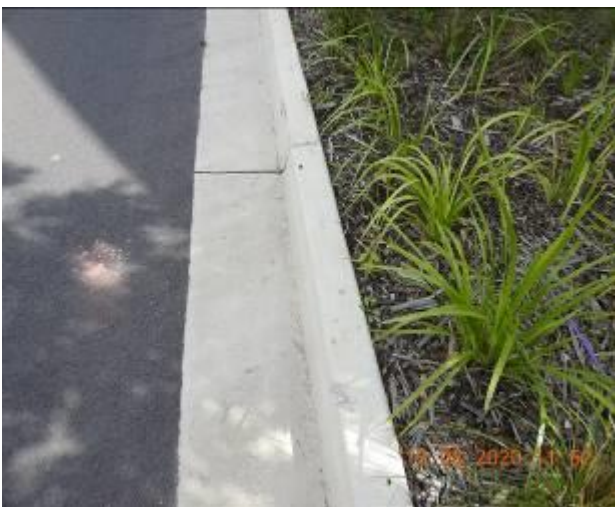
Figure 1730 – Crack propagation and loss of material through kerb and gutter

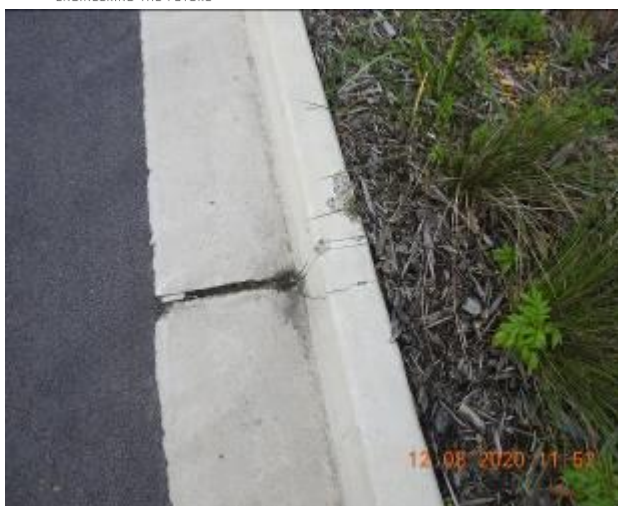
Figure 1732 – General condition of kerb and gutter

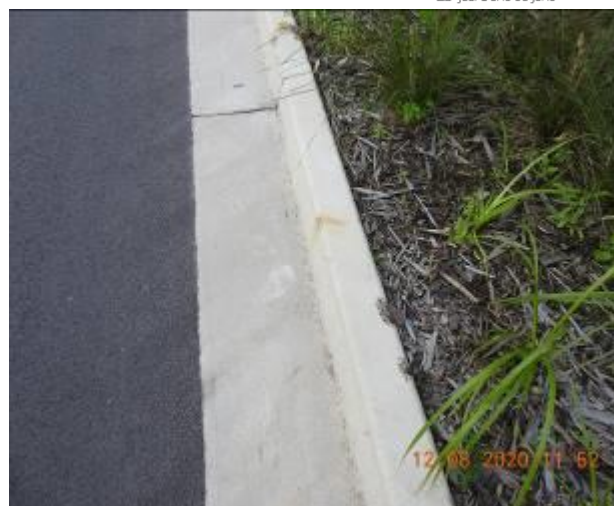
Figure 1733 – Crack propagation and loss of material through kerb and gutter

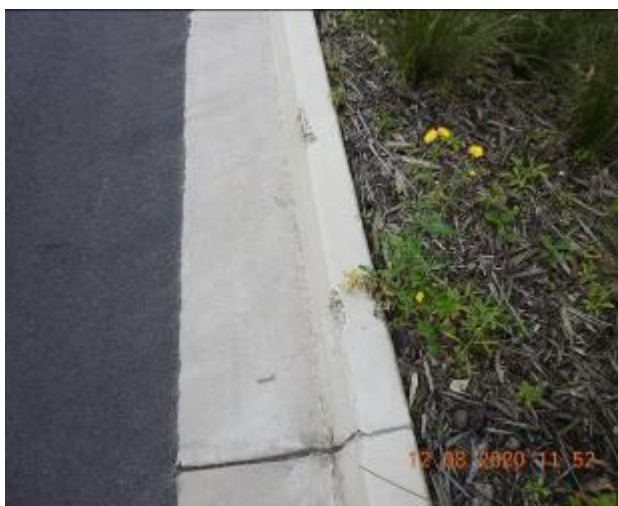
Figure 1734 – Loss of material through kerb

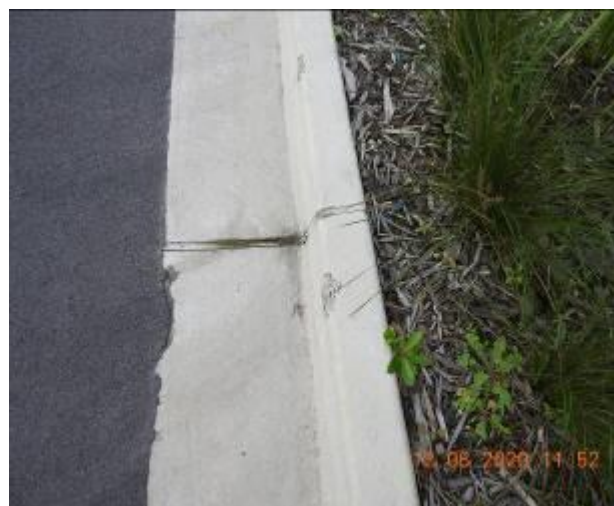
Figure 1735 – Crack propagation and loss of material through kerb

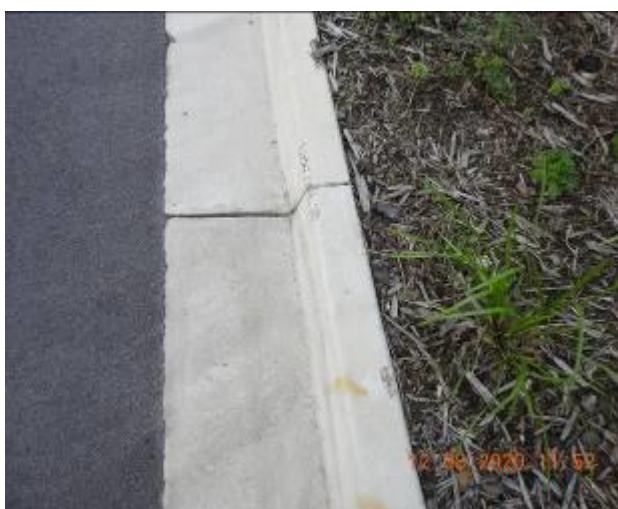
Figure 1736 – Crack propagation and loss of material through kerb and gutter

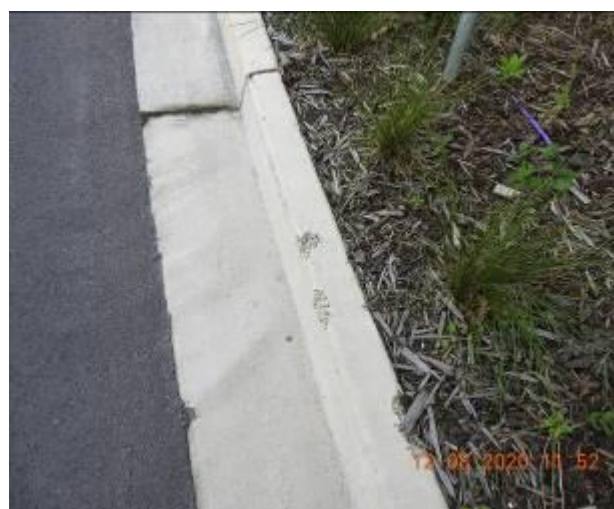
Figure 1737 – Loss of material through kerb

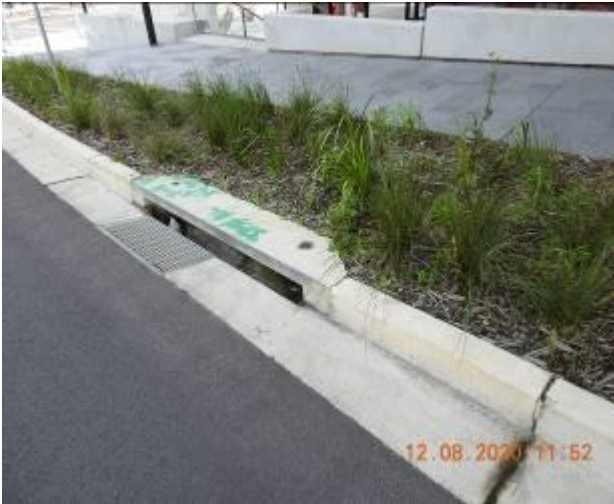
Figure 1738 – Loss of material through kerb and gutter

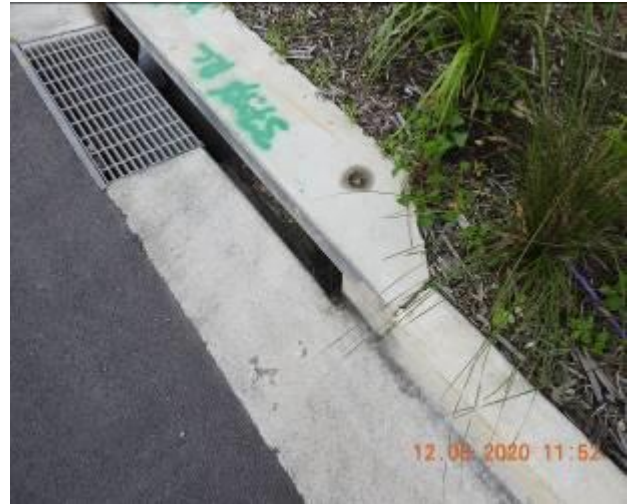
Figure 1739 – General condition of stormwater inlet pit

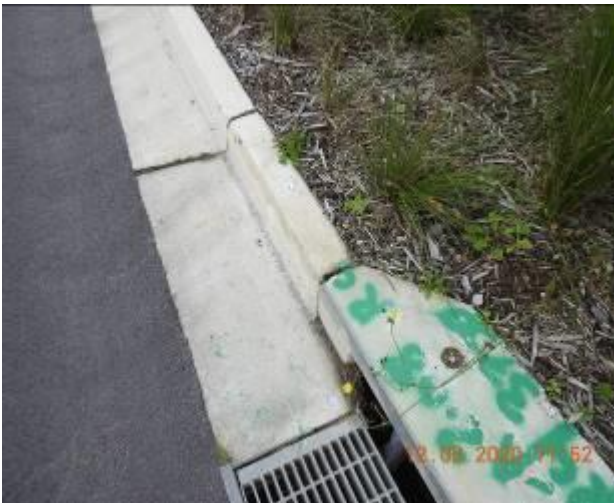
Figure 1740 – Loss of material through kerb

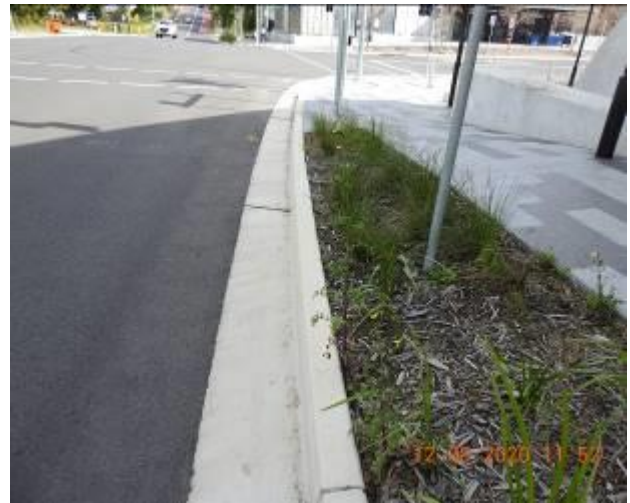
Figure 1741 – Crack propagation and loss of material through kerb

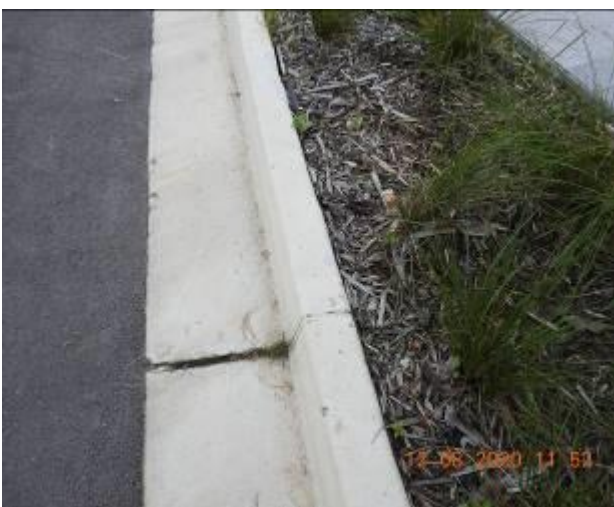
Figure 1742 – General condition of kerb and gutter

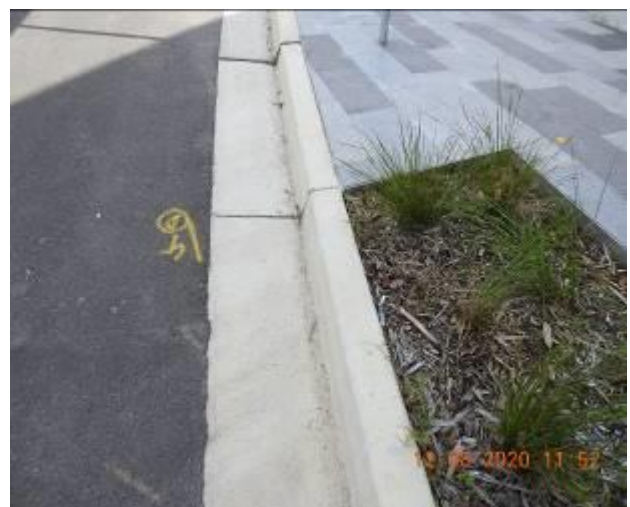
Figure 1743 – Crack propagation and loss of material through kerb and gutter

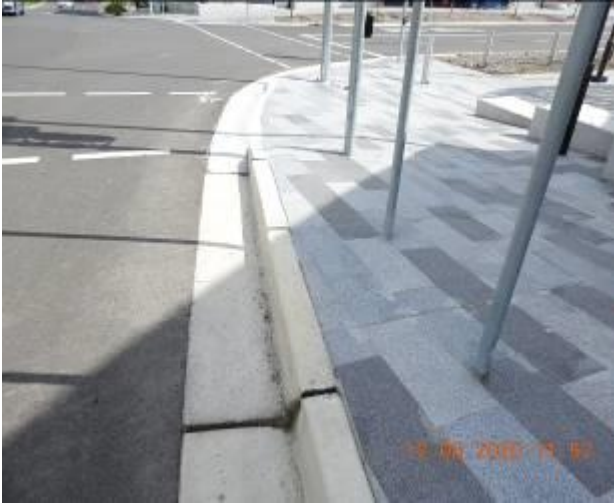
Figure 1745 – General condition of kerb and gutter

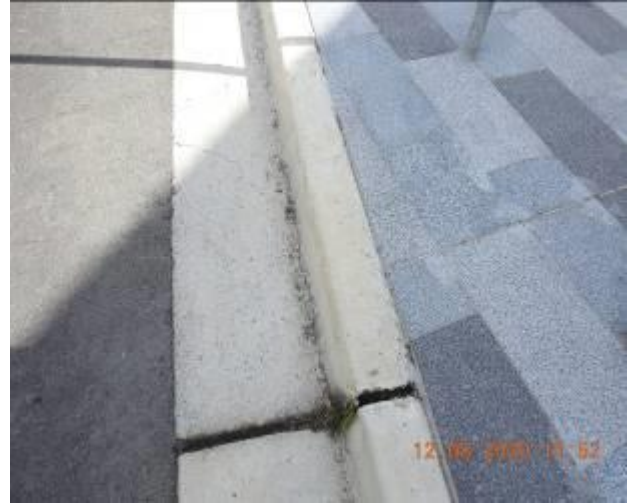
Figure 1746 – Crack propagation and loss of material through kerb and gutter

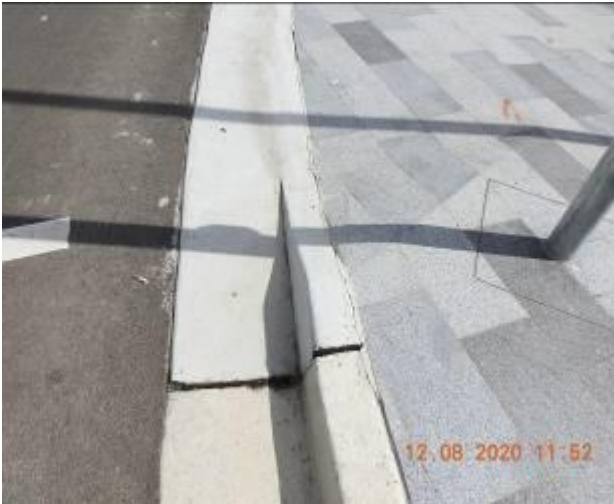
Figure 1747 – Crack propagation and loss of material through kerb and gutter

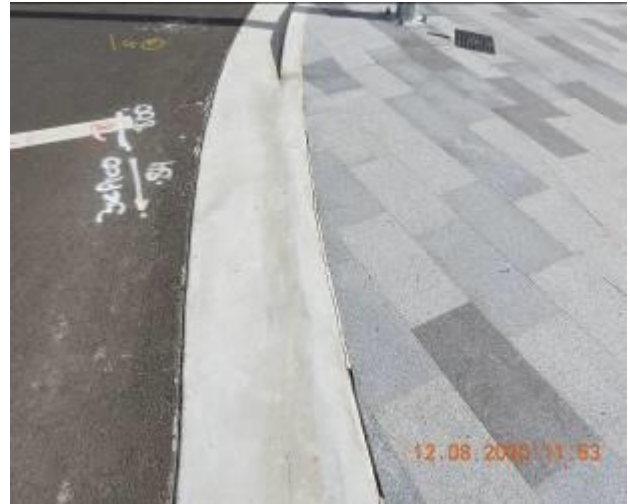
Figure 1748 – Loss of material through layback

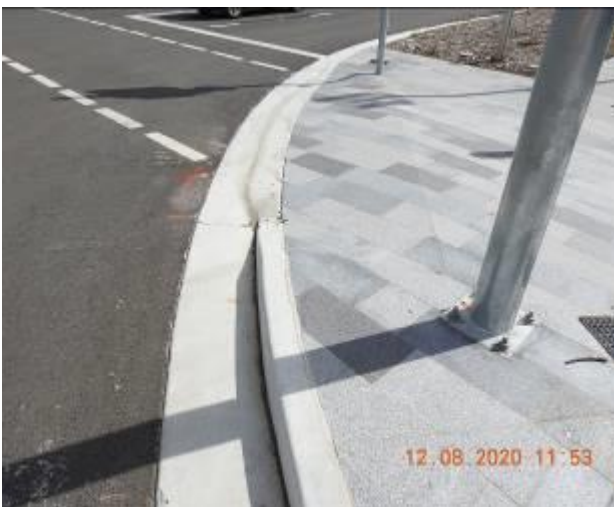
Figure 1749 – General condition of kerb and gutter

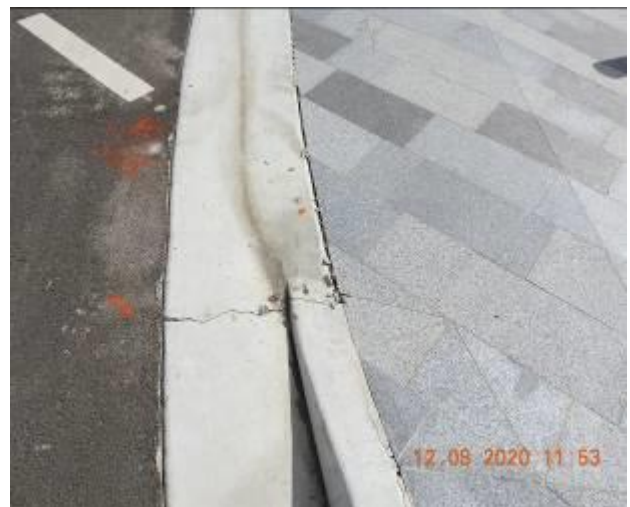
Figure 1750 – Crack propagation and loss of material through layback and gutter

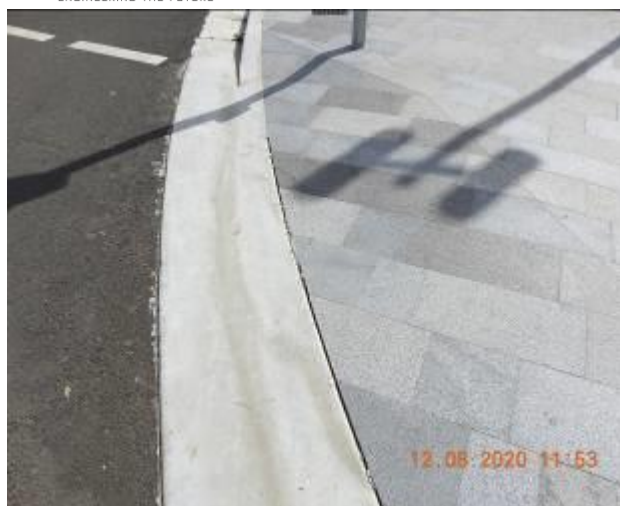
Figure 1751 – Loss of material through layback

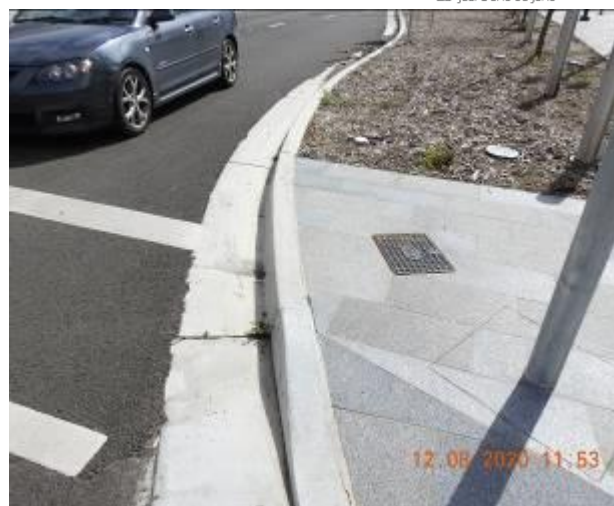
Figure 1752 – General condition of kerb and gutter

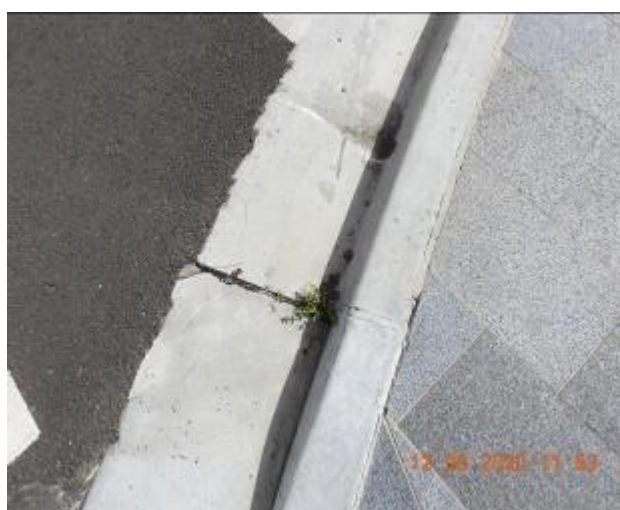
Figure 1753 – Evidence of patchwork and loss of material through kerb and gutter

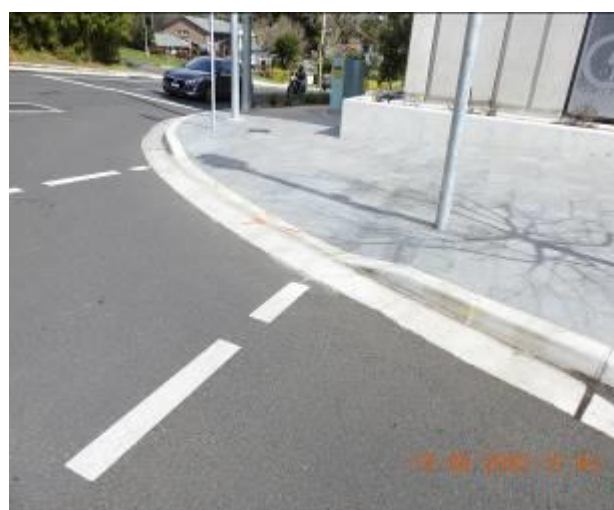
Figure 1754 – General condition of kerb and gutter

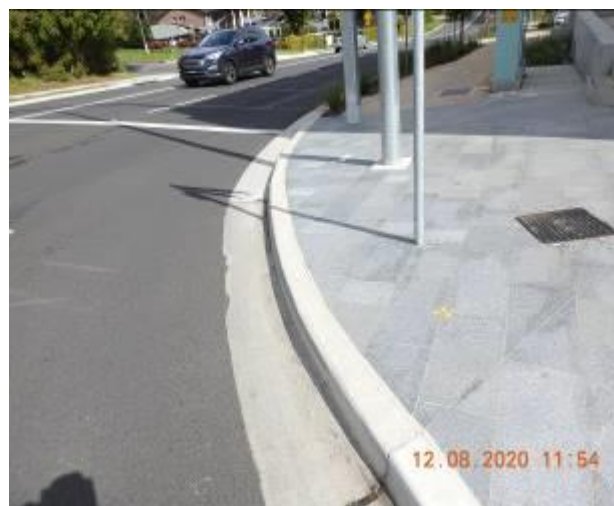
Figure 1756 – General condition of kerb and gutter heading West

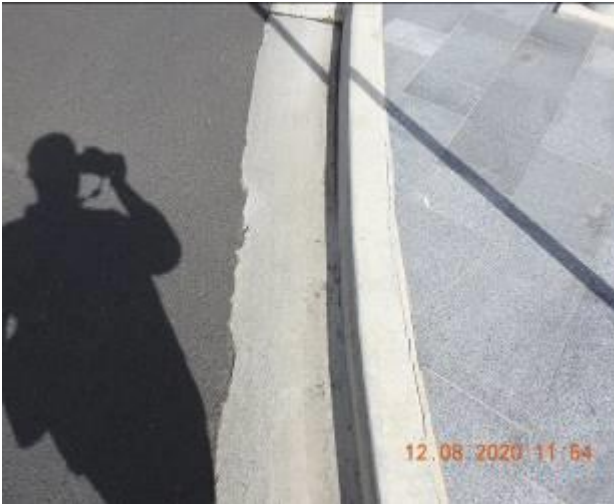
Figure 1757 – Loss of material through kerb and gutter

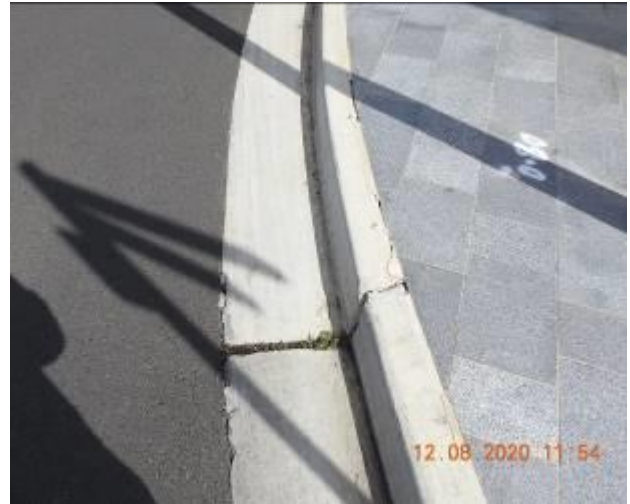
Figure 1758 – Crack propagation and loss of material through kerb and gutter

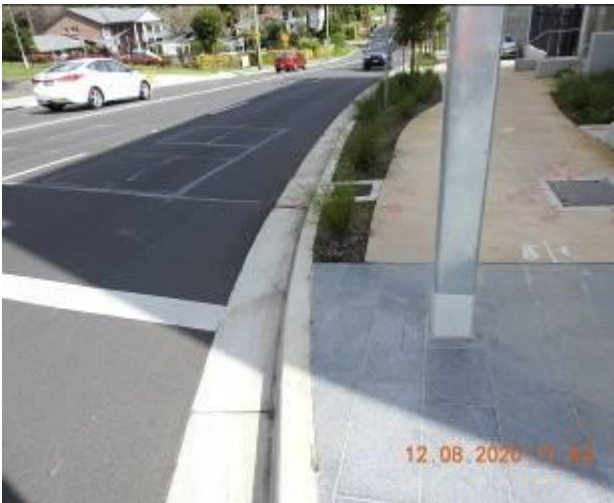
Figure 1759 – General condition of kerb and gutter

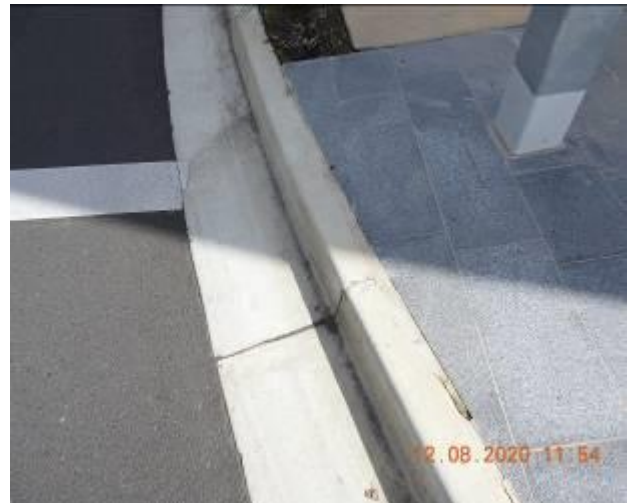
Figure 1760 – Crack propagation and loss of material through kerb

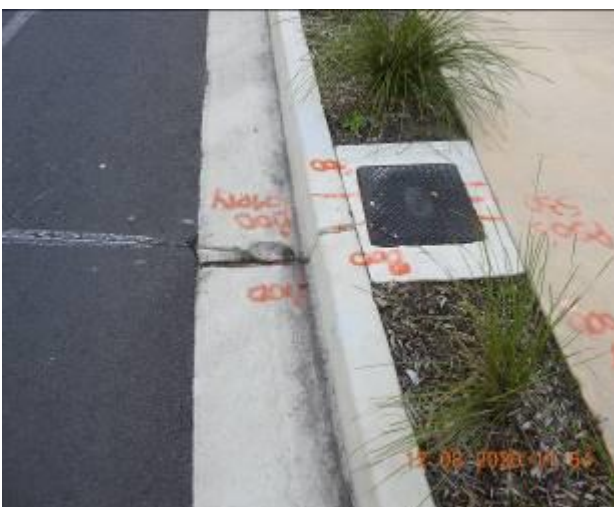
Figure 1761 – Evidence of patchwork through gutter and Loss of material through kerb and gutter

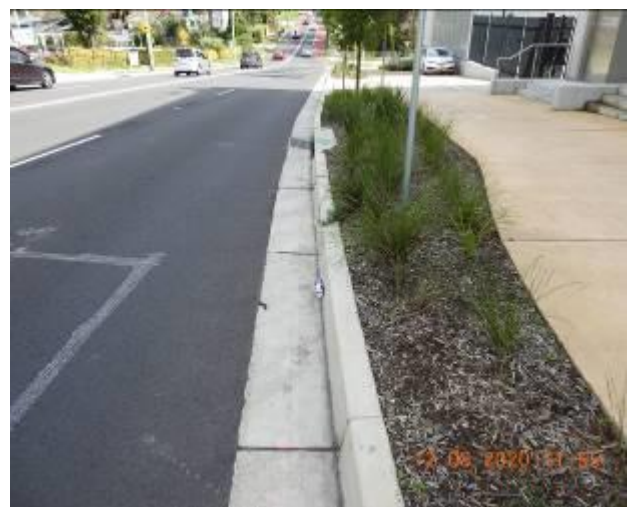
Figure 1762 – General condition of kerb and gutter

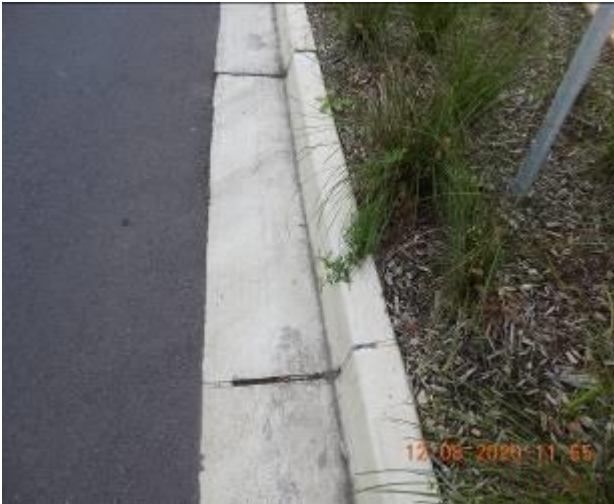
Figure 1763 – Crack propagation and loss of material through kerb and gutter

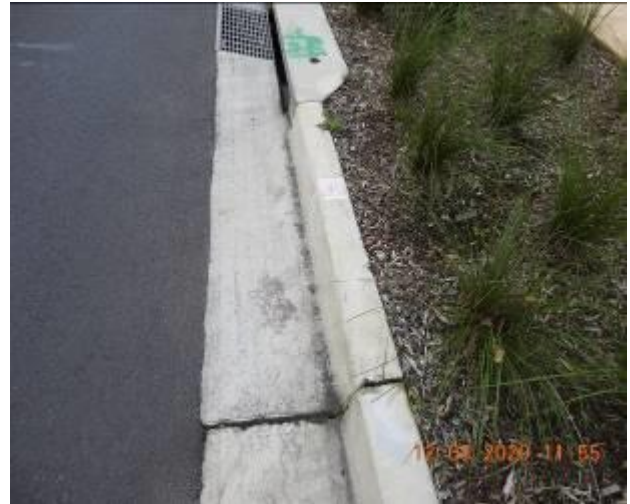
Figure 1764 – Loss of material through kerb and gutter

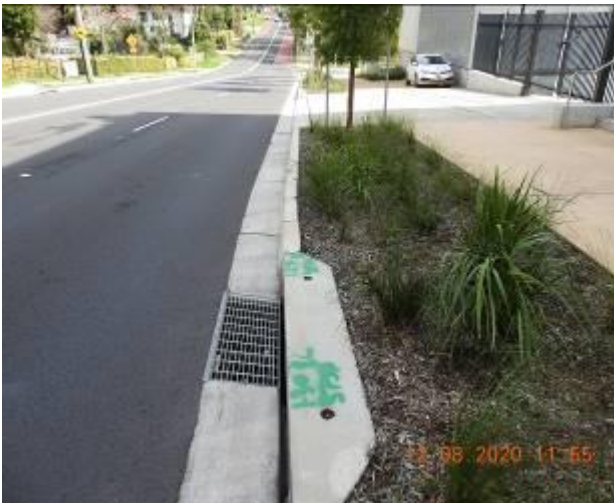
Figure 1765 – General condition of kerb and gutter

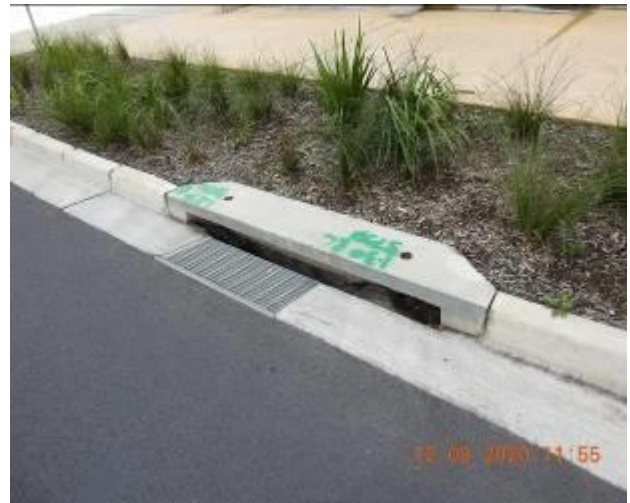
Figure 1766 – General condition of stormwater inlet pit

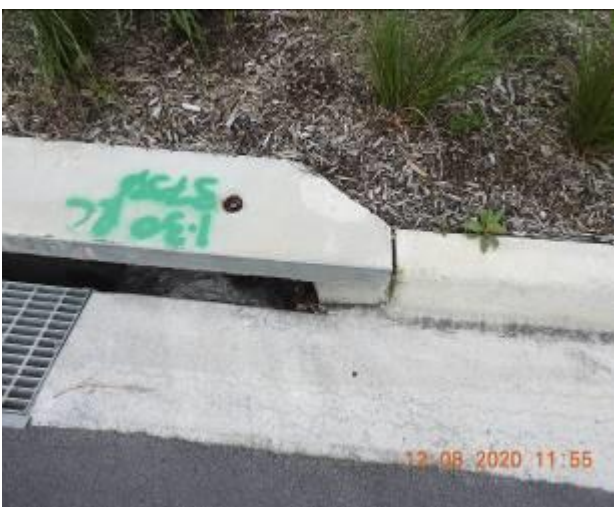
Figure 1767 – Loss of material through kerb

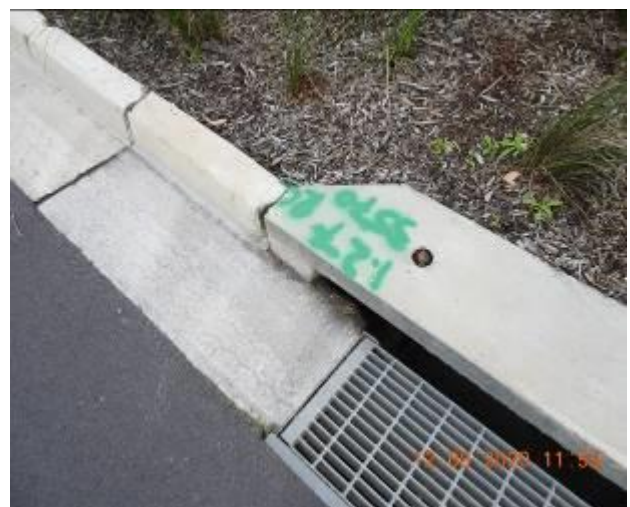
Figure 1768 – Loss of material through kerb and gutter

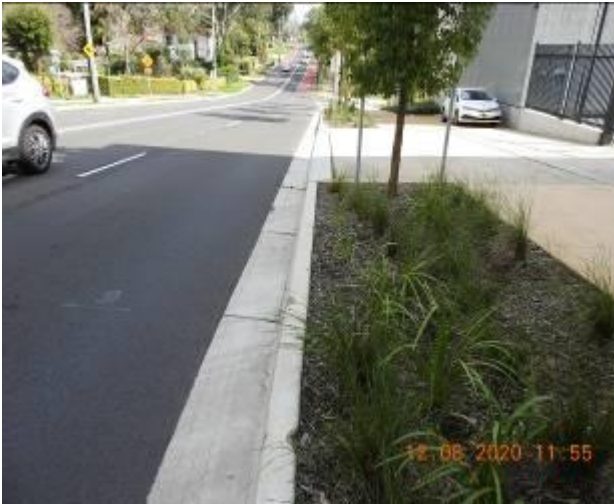
Figure 1769 – General condition of kerb and gutter

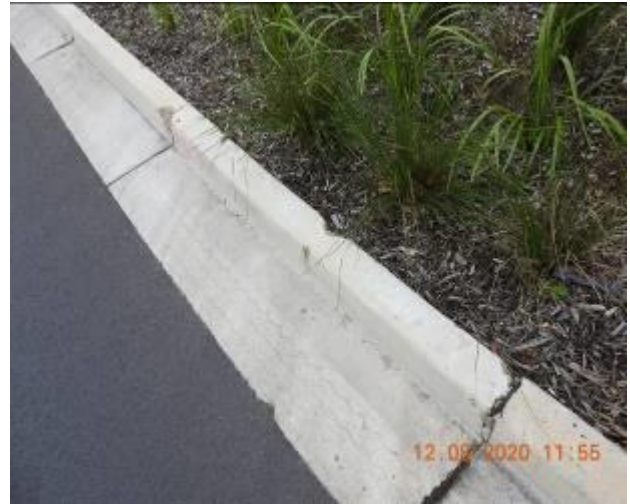
Figure 1770 – Loss of material through kerb and gutter

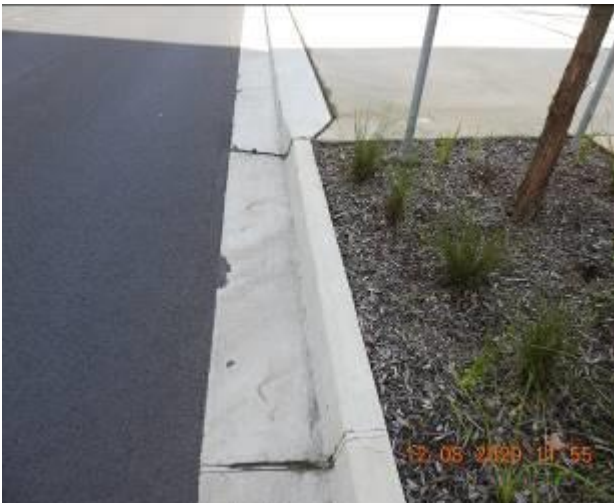
Figure 1771 – Crack propagation and loss of material through kerb and gutter

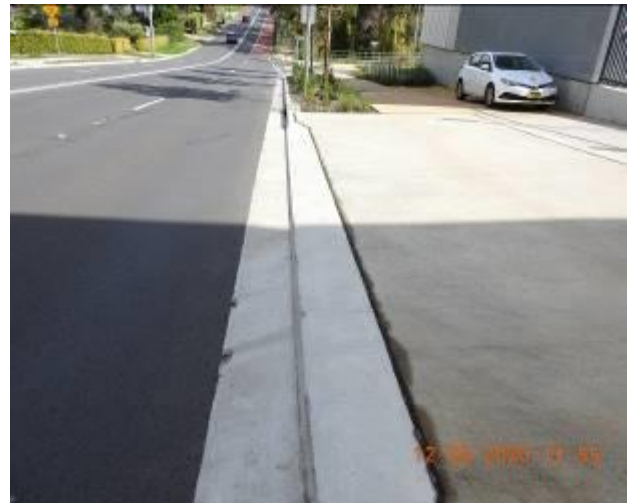
Figure 1772 – General condition of layback and gutter

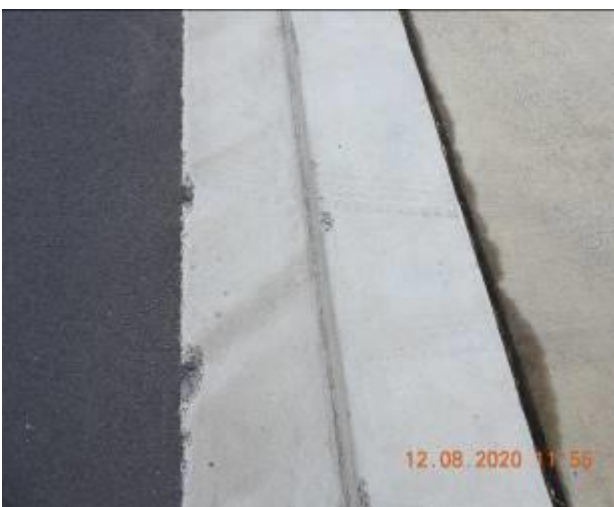
Figure 1773 – Loss of material through layback and gutter

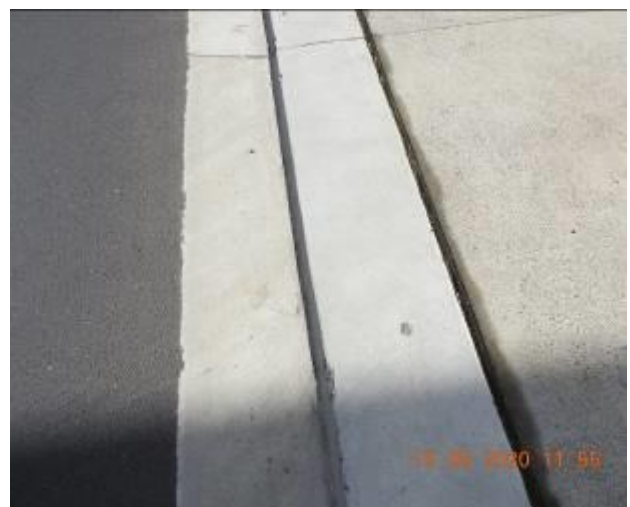
Figure 1774 – Loss of material through layback

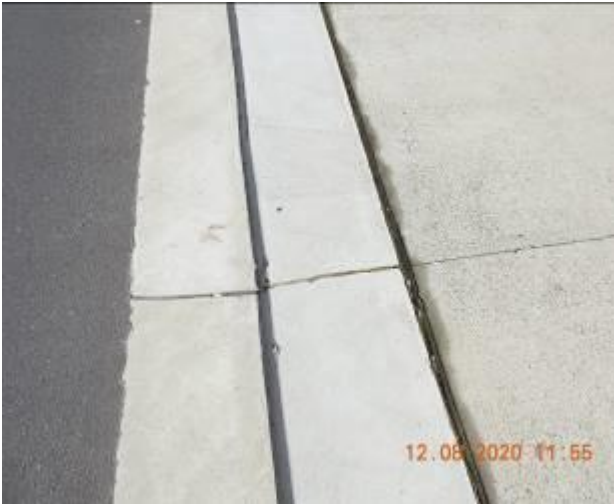
Figure 1775 – Loss of material through layback

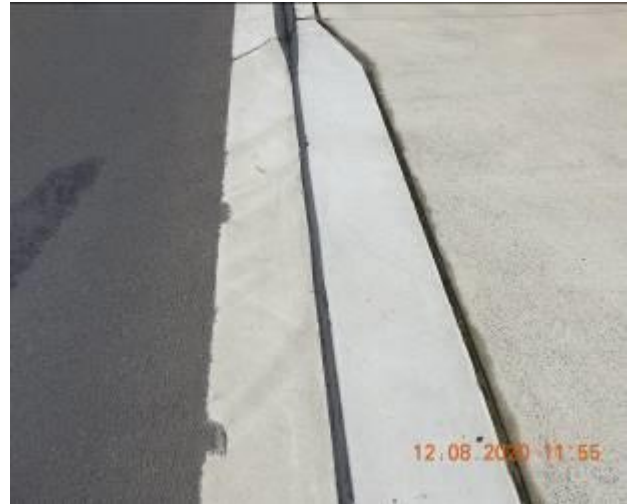
Figure 1776 – Loss of material through layback and gutter

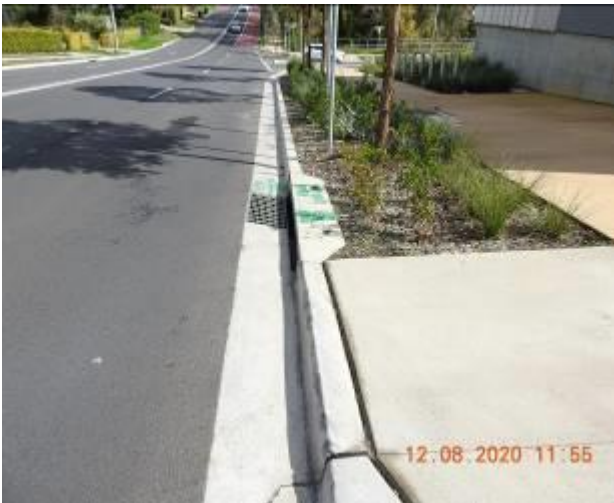
Figure 1777 – General condition of kerb and gutter

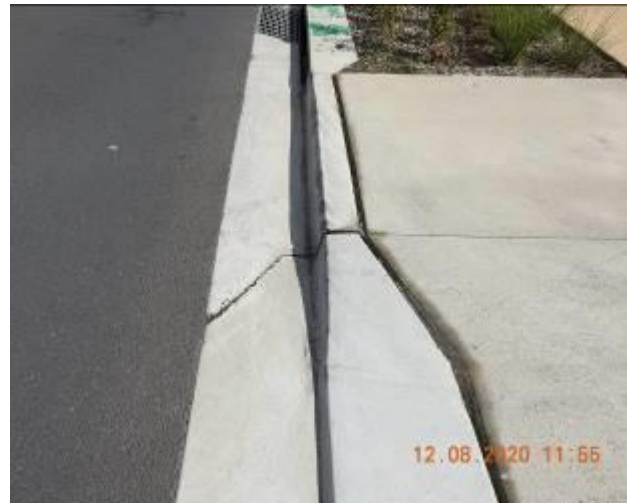
Figure 1778 – Loss of material through kerb and gutter

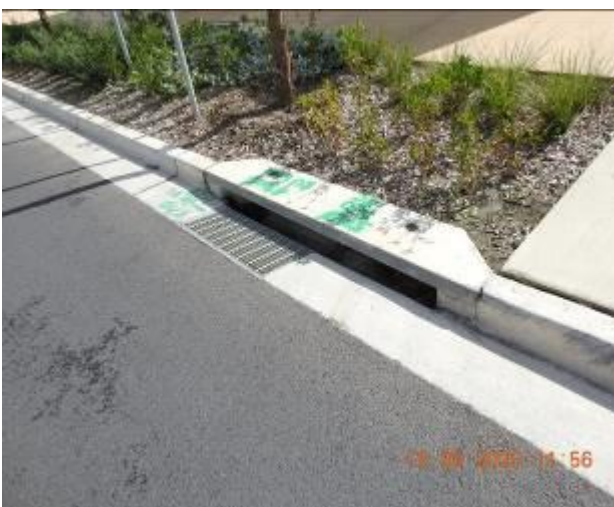
Figure 1779 – General condition of stormwater inlet pit

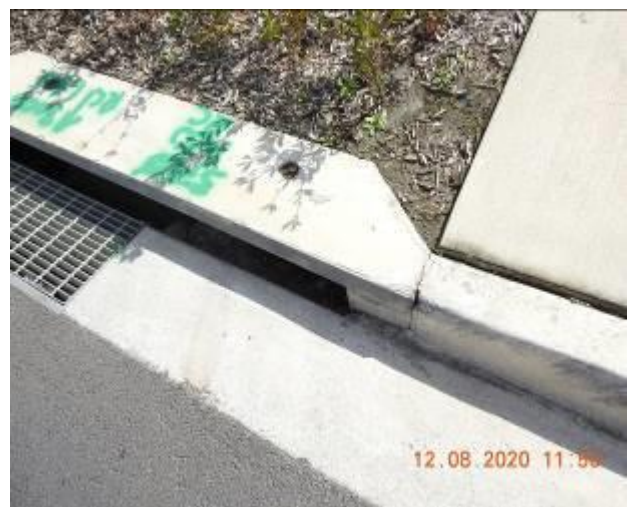
Figure 1780 – Crack propagation and loss of material through curb

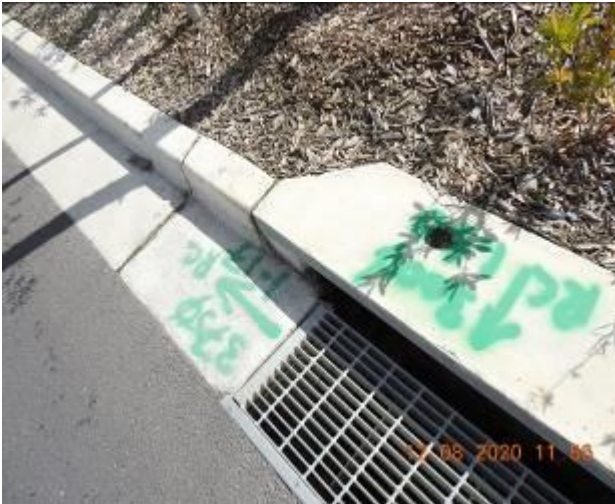
Figure 1781 – Crack propagation and loss of material through kerb

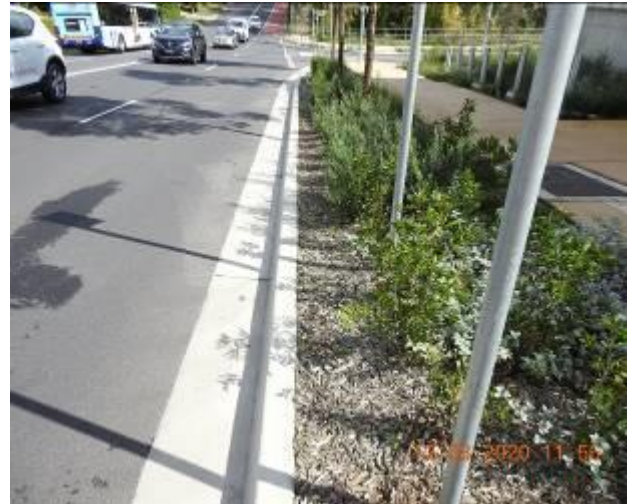
Figure 1782 – General condition of kerb and gutter

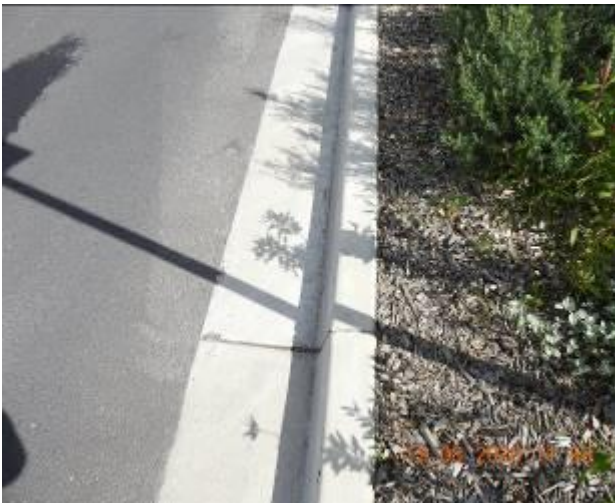
Figure 1783 – Loss of material through kerb and gutter

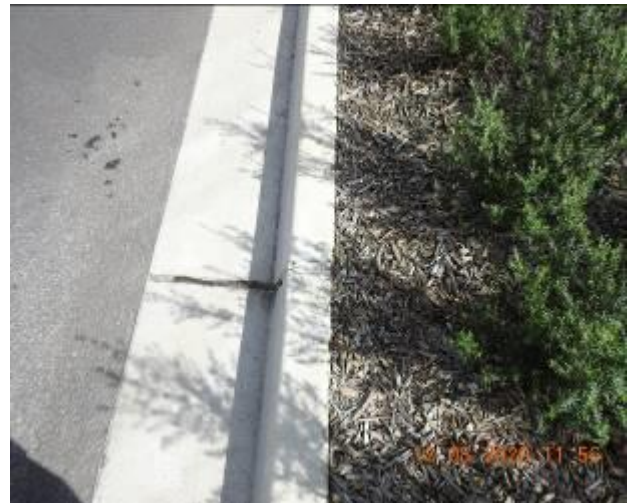
Figure 1784 – Crack propagation and loss of material through kerb and gutter

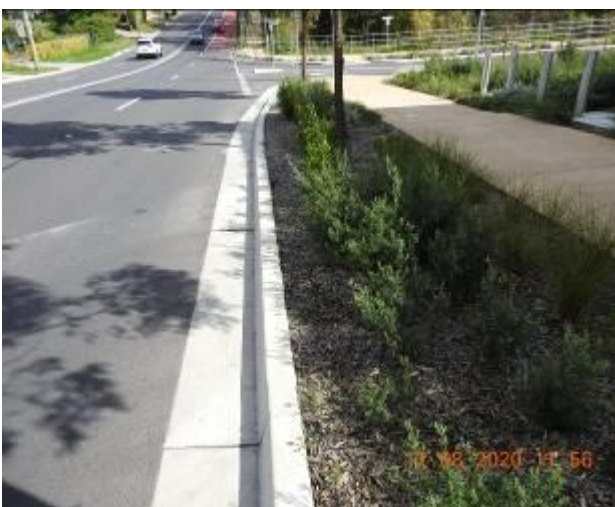
Figure 1785 – General condition of kerb and gutter

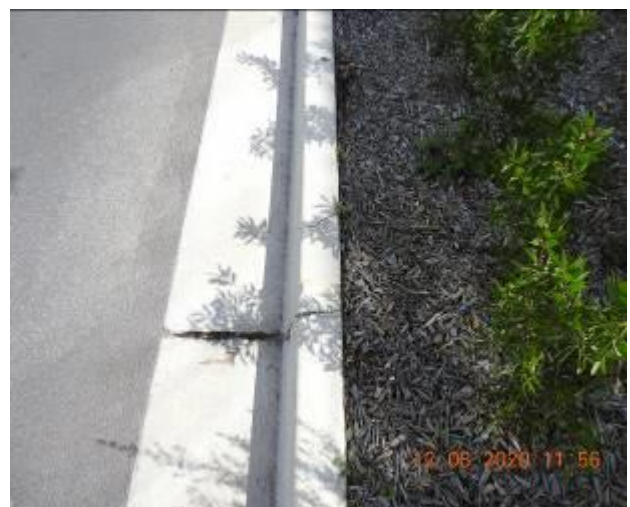
Figure 1786 – Crack propagation and loss of material through kerb and gutter

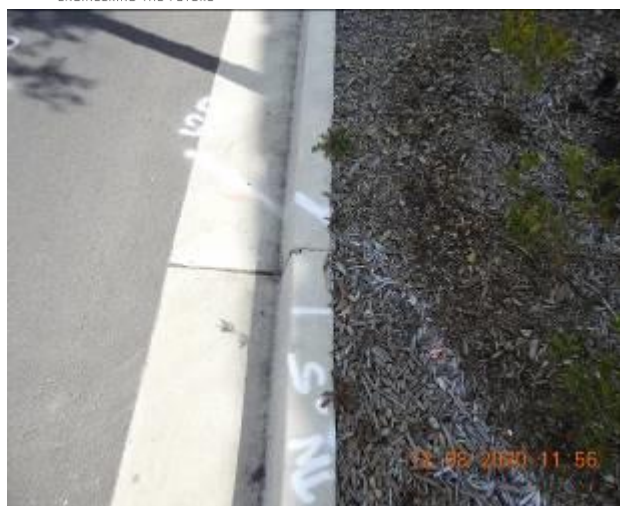
Figure 1787 – Crack propagation and loss of material through kerb and gutter

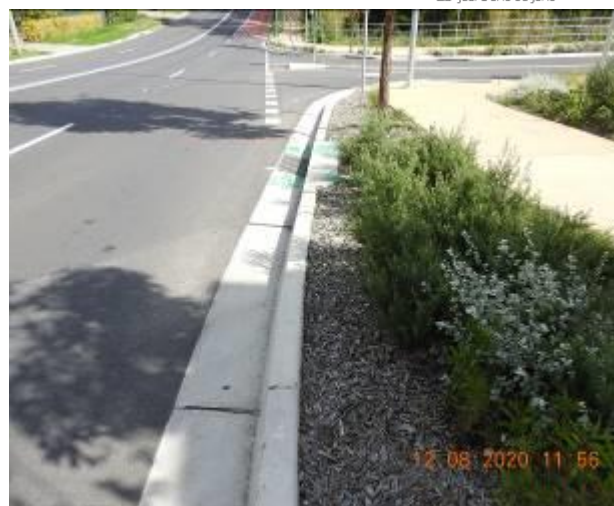
Figure 1788 – General condition of kerb and gutter

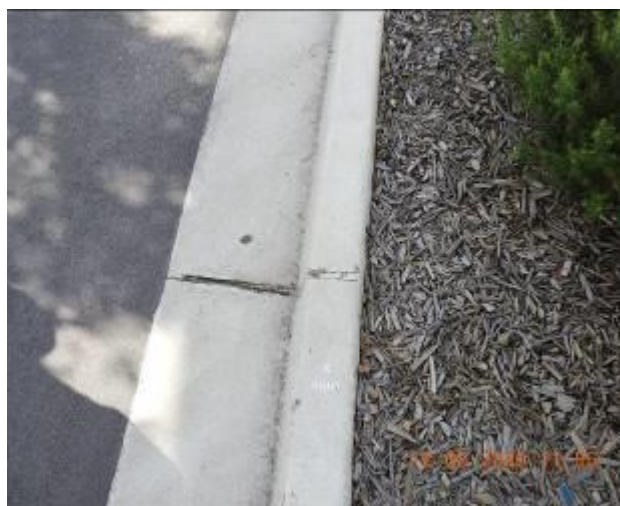
Figure 1789 – Crack propagation and loss of material through kerb and gutter

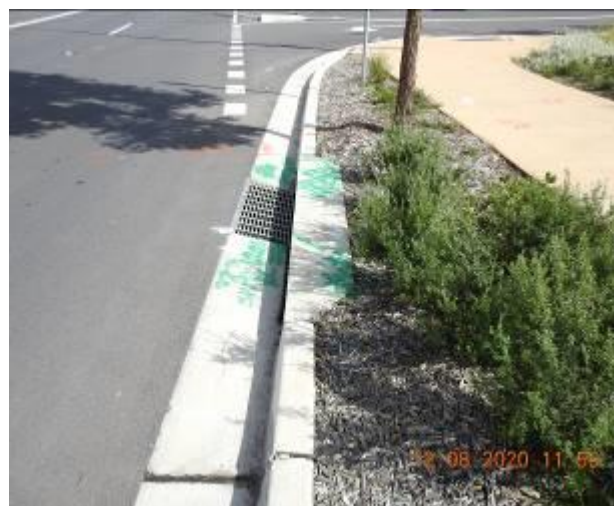
Figure 1790 – General condition of kerb and gutter

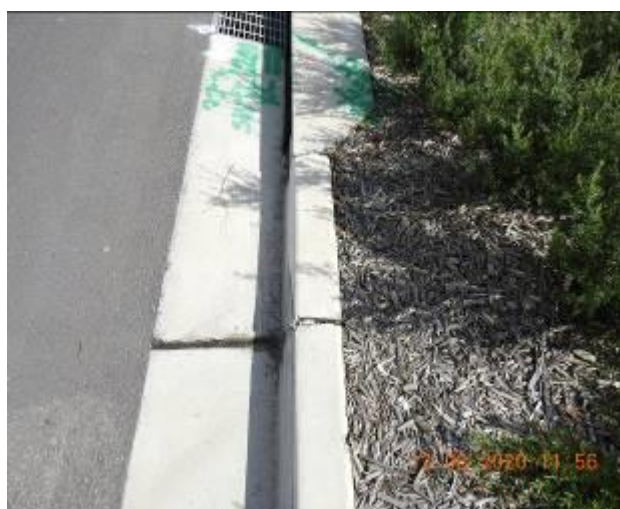
Figure 1791 – Loss of material through kerb and gutter

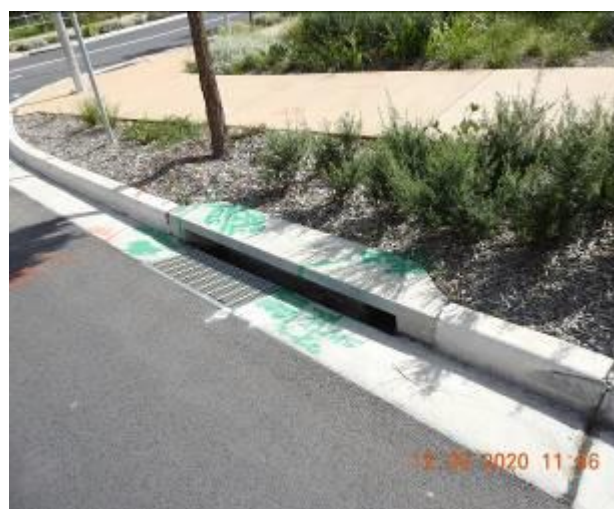
Figure 1792 – General condition of stormwater inlet pit

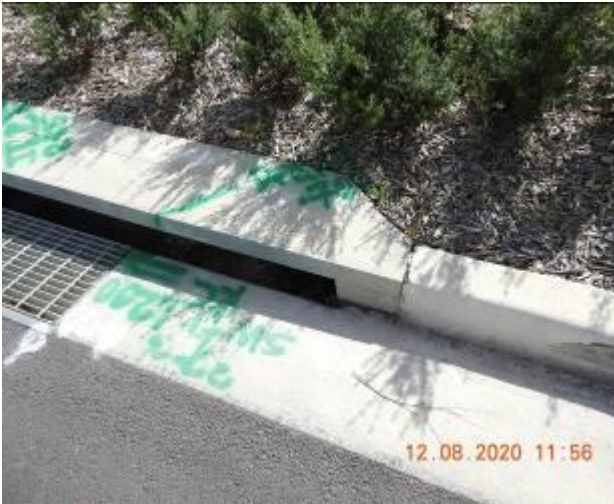
Figure 1793 – Loss of material through kerb

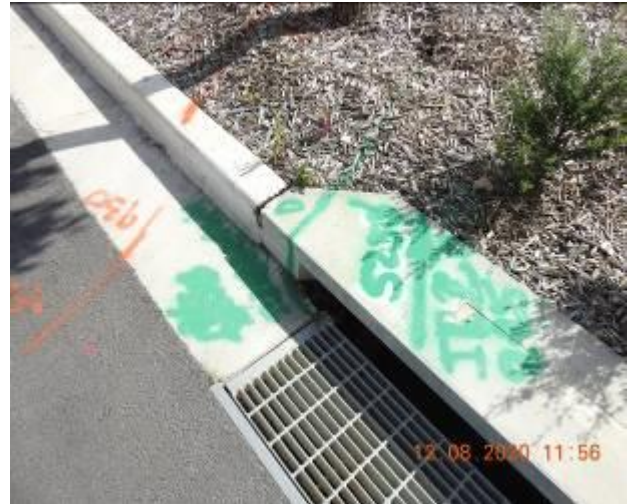
Figure 1794 – Loss of material through kerb

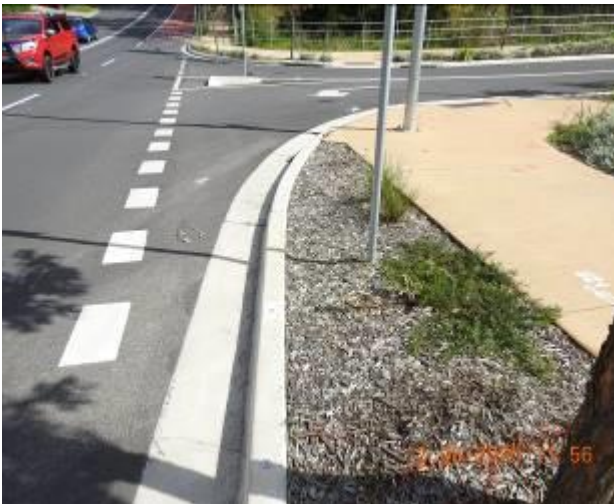
Figure 1795 – General condition of kerb and gutter

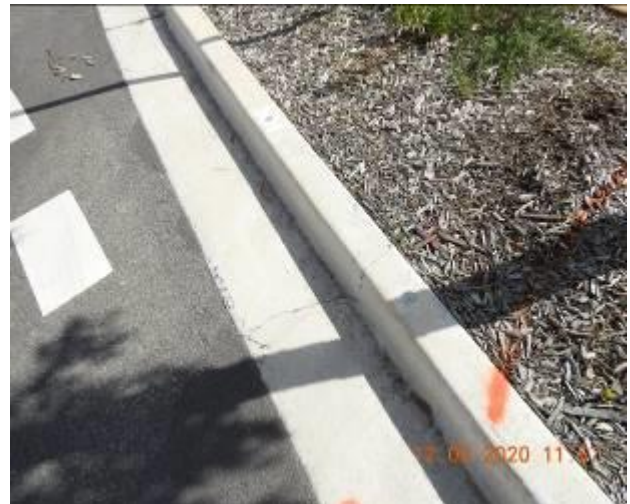
Figure 1796 – Crack propagation and loss of material through kerb and gutter

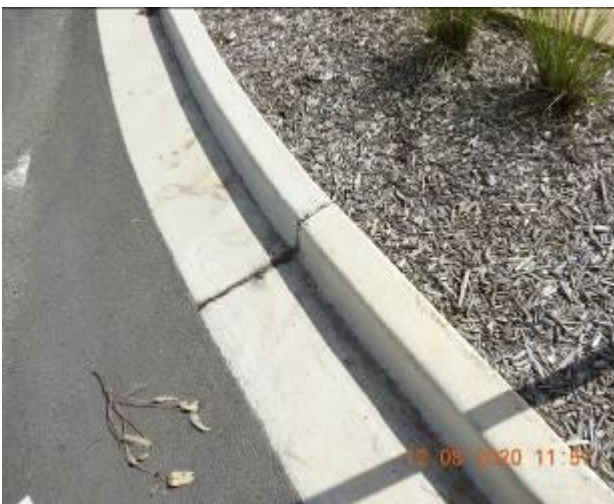
Figure 1797 – Loss of material through kerb

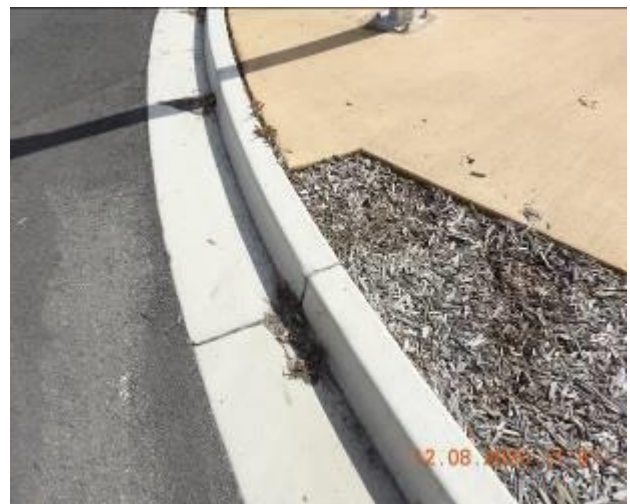
Figure 1798 – Crack propagation and loss of material through kerb

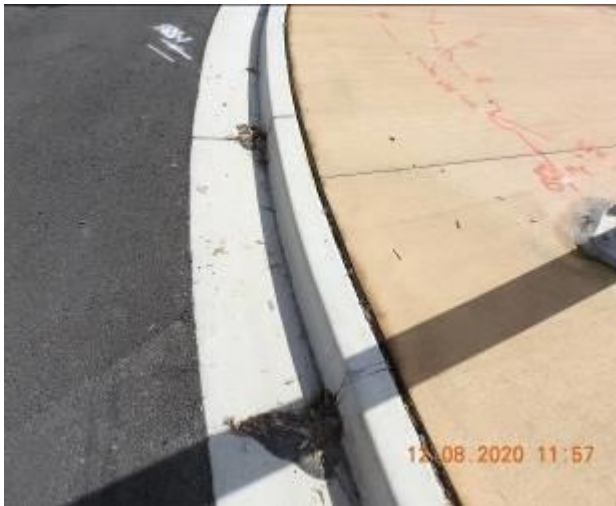
Figure 1799 – Evidence of patchwork, crack propagation and loss of material through kerb
