**2 MANDALA PARADE, CASTLE HILL
(DORAN DRIVE PRECINCT)
PRE-DILAPIDATION REPORT
Of Sydney Metro and Hills Shire Council Assets
DEICORP PROJECTS SHOWGROUND
PTY LTD.**

Job No. 200124.3
07/07/2021

ACE Structural Services Pty Ltd

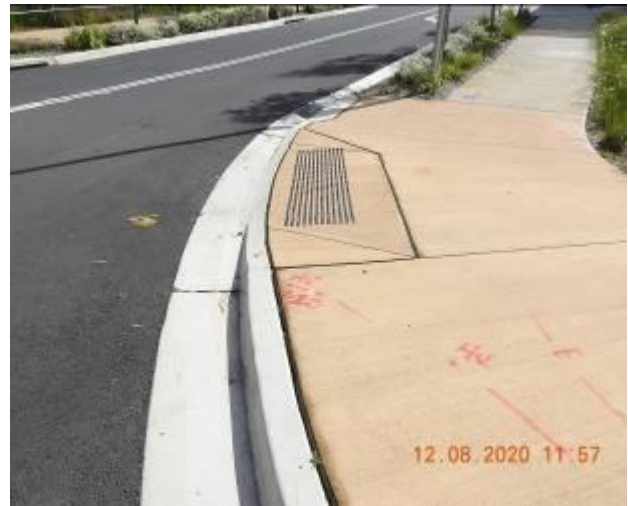
Figure 1800 – General condition of kerb and gutter

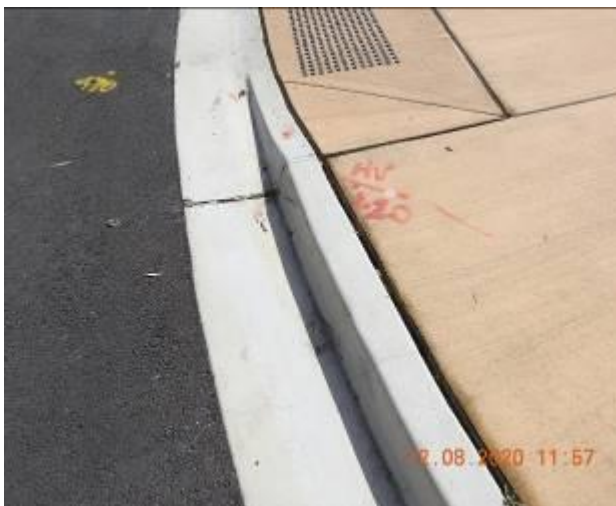
Figure 1801 – Crack propagation through kerb and gutter

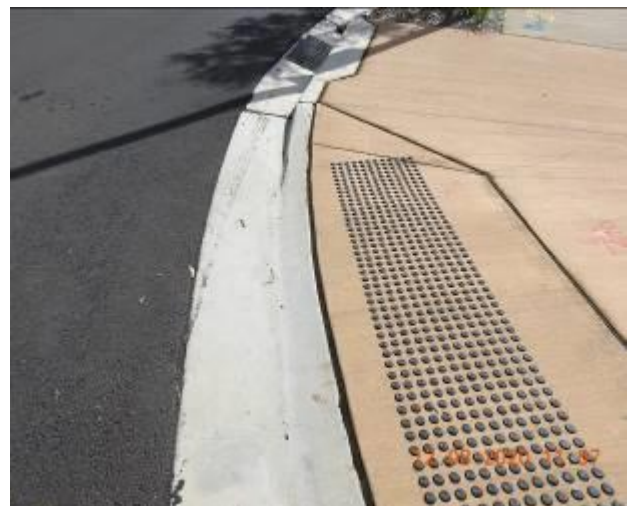
Figure 1802 – Crack propagation through layback and gutter

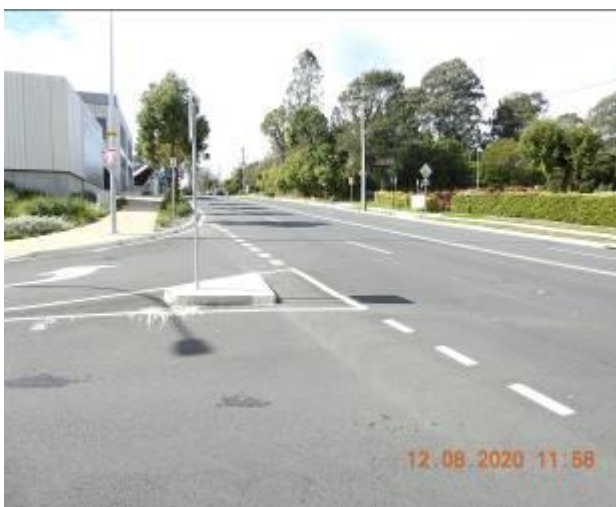
Figure 1803 – General condition of road surface heading East

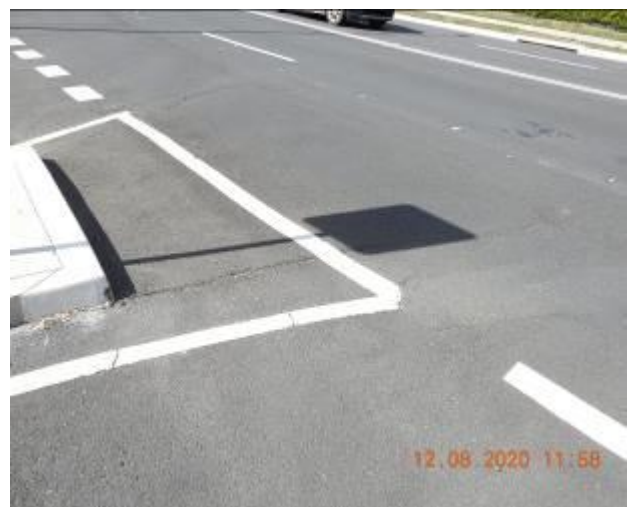
Figure 1804 – Crack propagation and loss of material through road surface

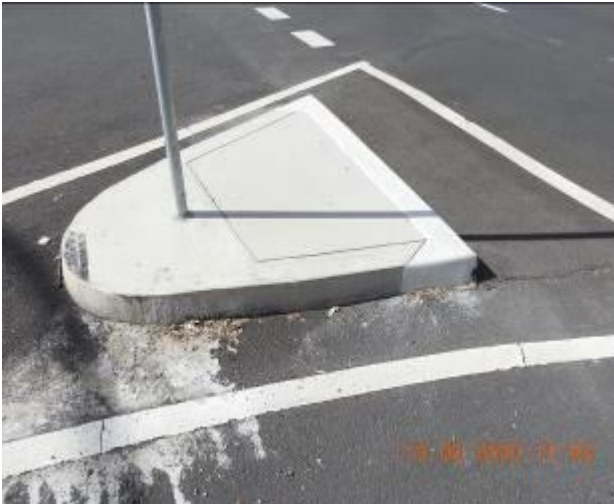
Figure 1805 – General condition of traffic island

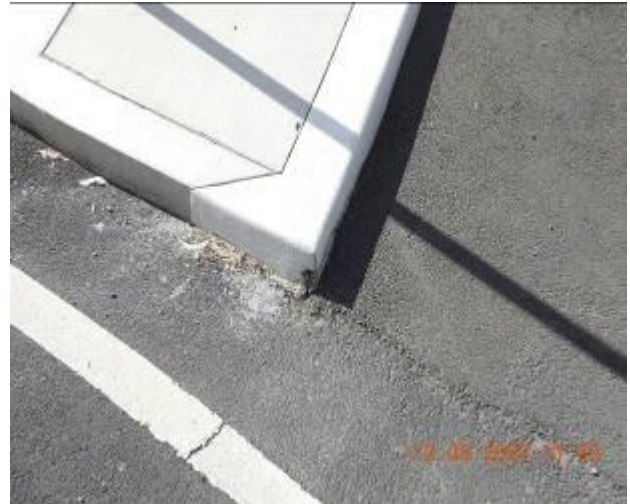
Figure 1806 – Loss of material through traffic island pavement

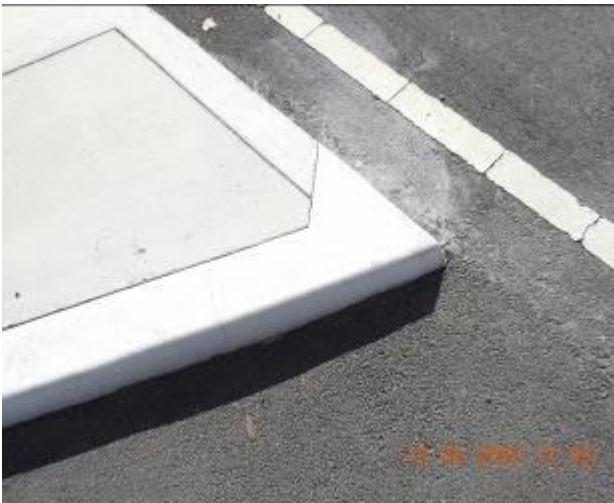
Figure 1807 – Crack propagation through traffic island pavement

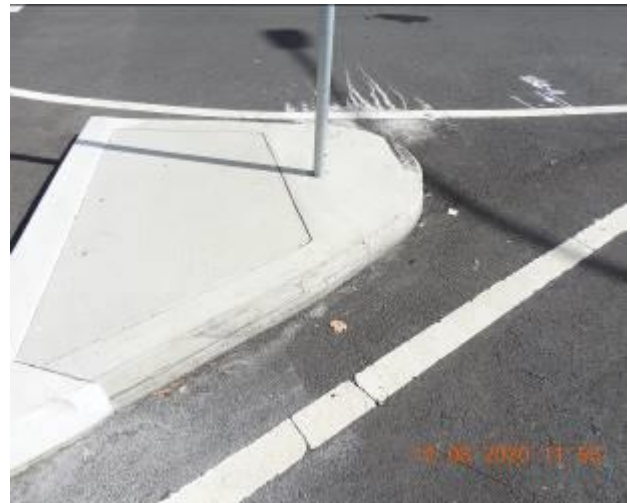
Figure 1808 – Loss of material through traffic island pavement/Crack propagation and loss of material through road surface

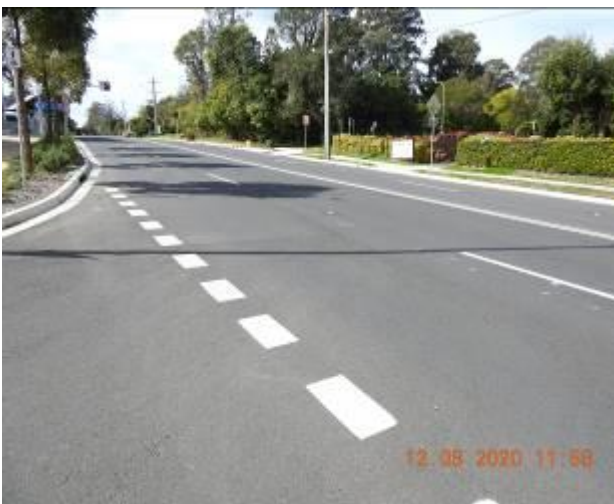
Figure 1809 – General condition of road surface

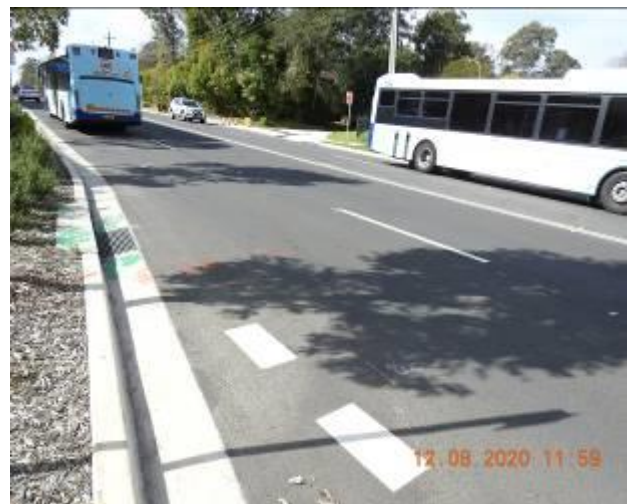
Figure 1810 – General condition of road surface

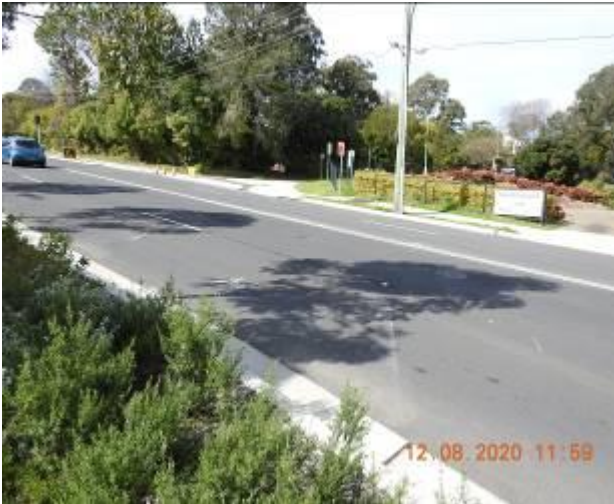
Figure 1811 – General condition of road surface

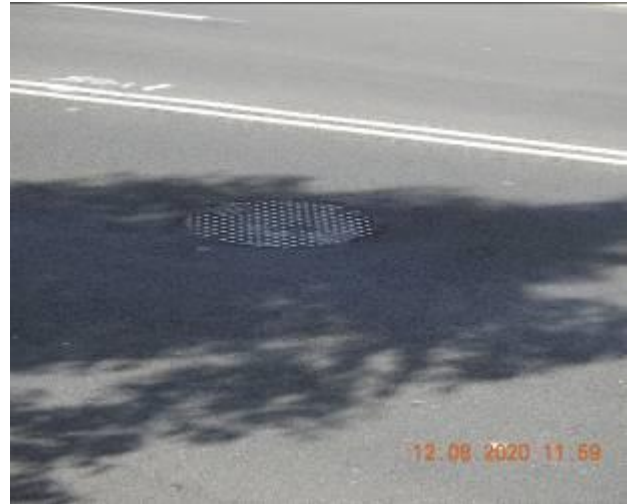
Figure 1812 – General condition of service pit

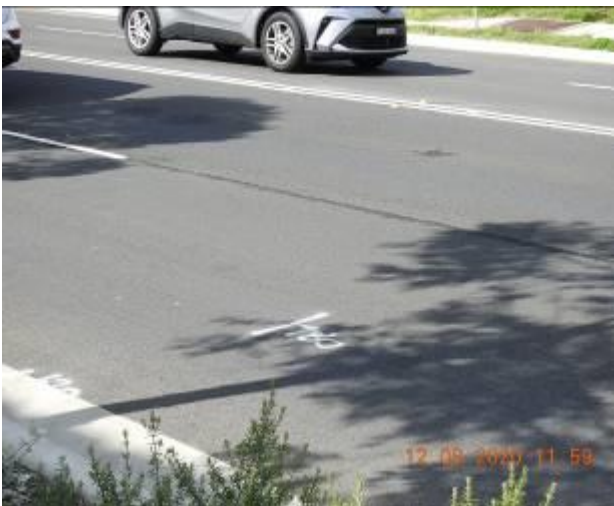
Figure 1813 – General condition of road surface

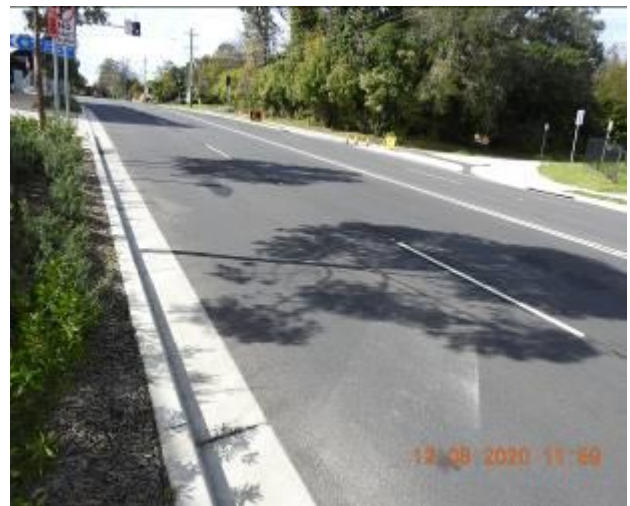
Figure 1814 – Loss of material through road surface

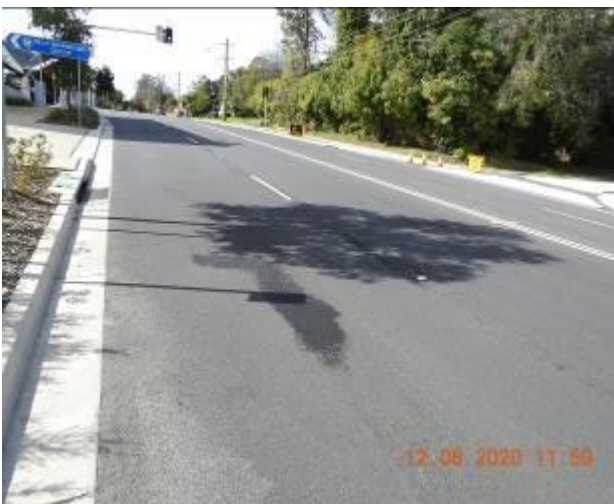
Figure 1815 – General condition of road surface

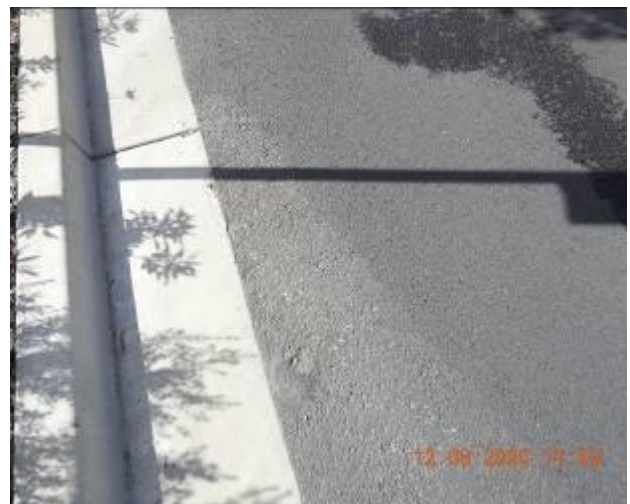
Figure 1816 – Evidence of patchwork through road surface

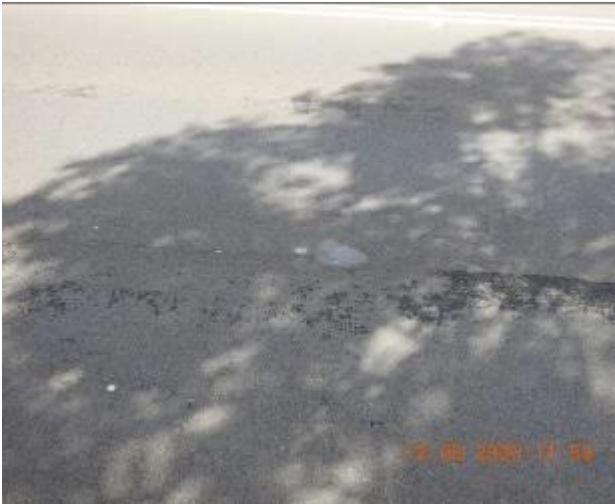
Figure 1817 – Evidence of patchwork through road surface

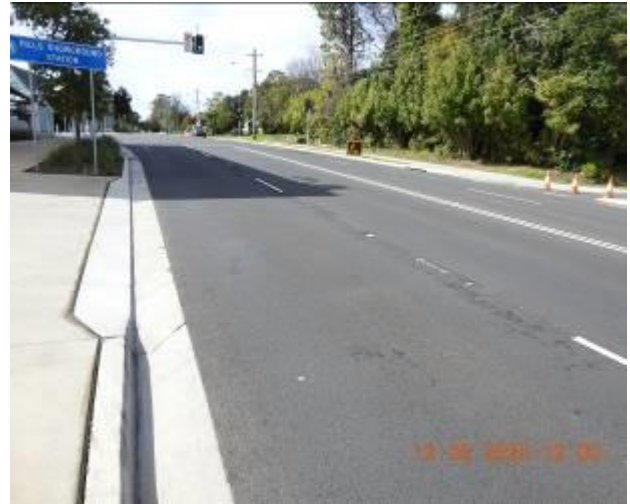
Figure 1818 – General condition of road surface

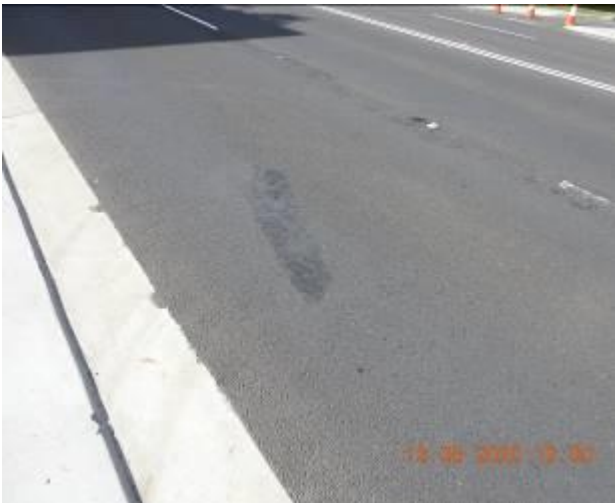
Figure 1819 – Evidence of patchwork through road surface

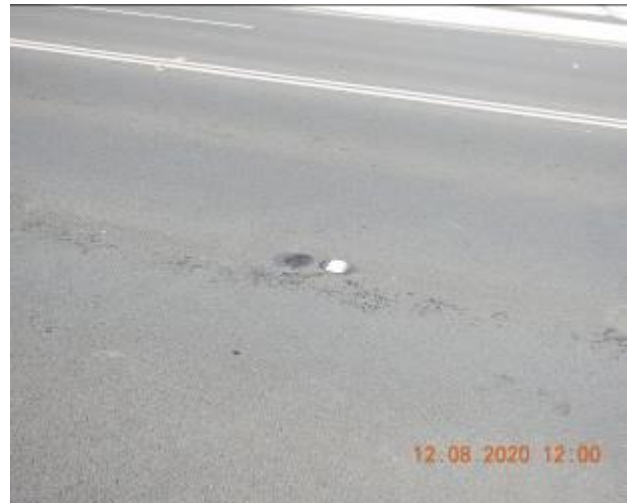
Figure 1820 – Evidence of patchwork through road surface

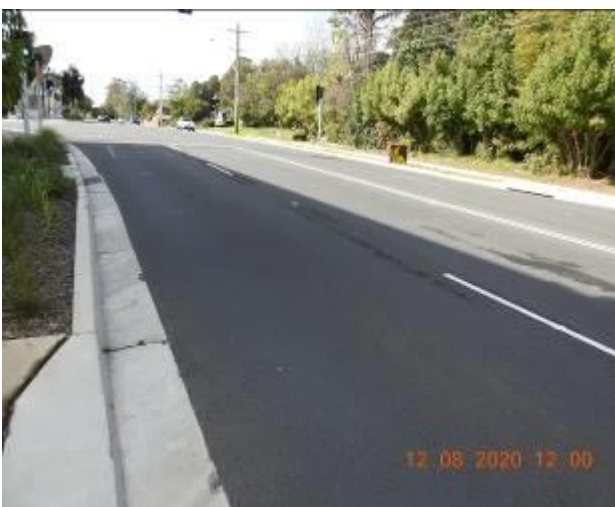
Figure 1821 – General condition of road surface

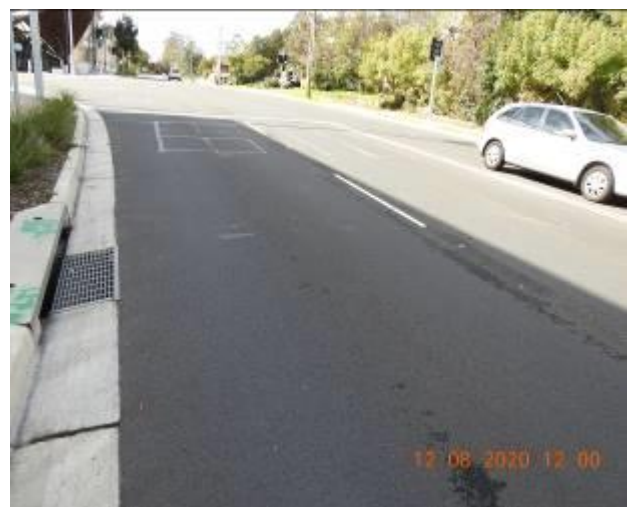
Figure 1822 – General condition of road surface

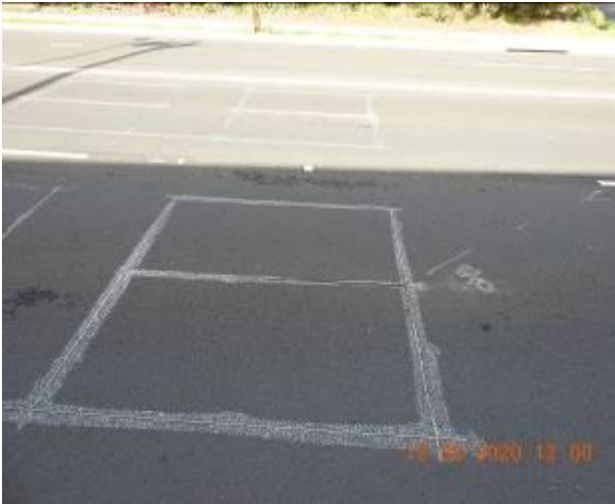
Figure 1823 – Loss of material and evidence of patchwork through road surface

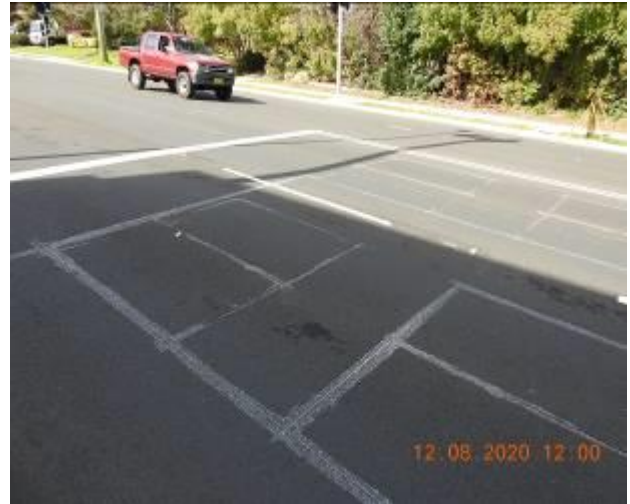
Figure 1824 – Loss of material and evidence of patchwork through road surface

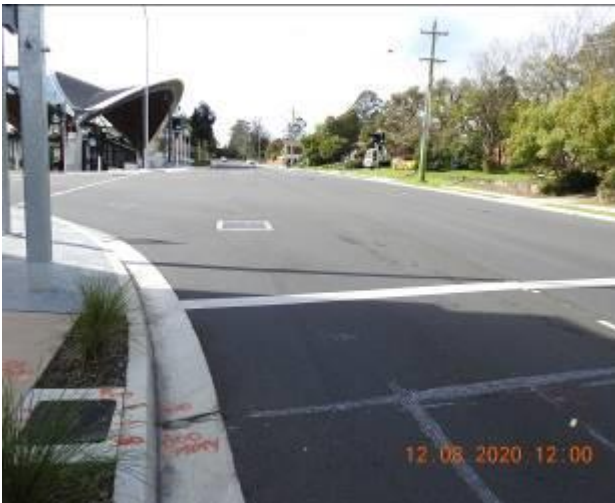
Figure 1825 – Loss of material and evidence of patchwork through road surface

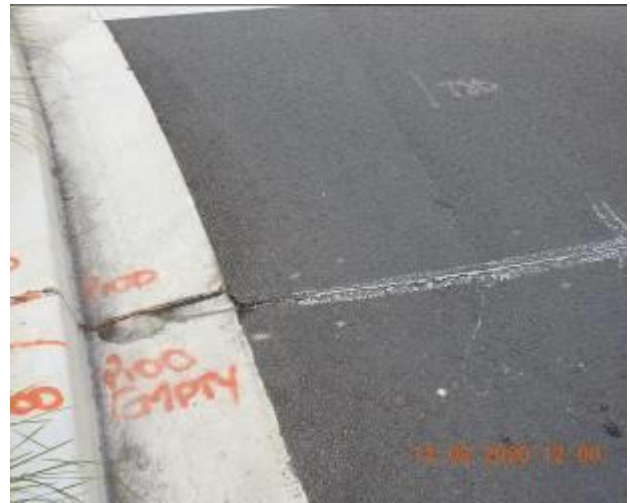
Figure 1826 – Loss of material through road surface

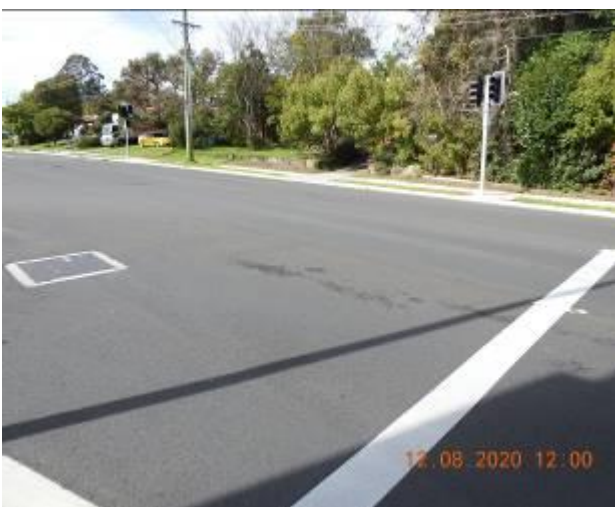
Figure 1827 – General condition of road surface

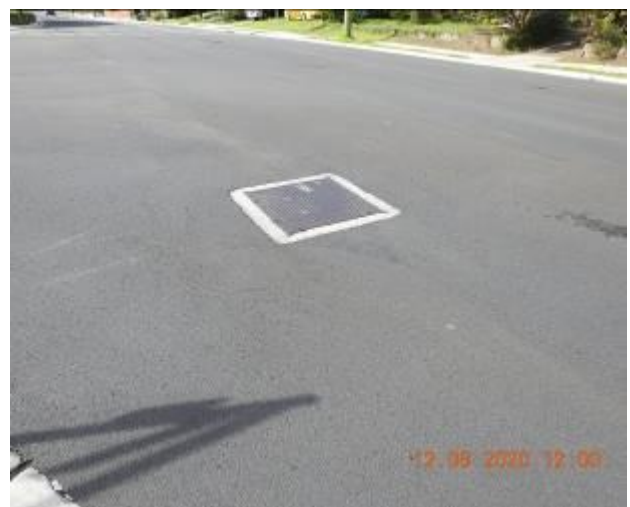
Figure 1828 – Crack propagation and loss of material through service pit

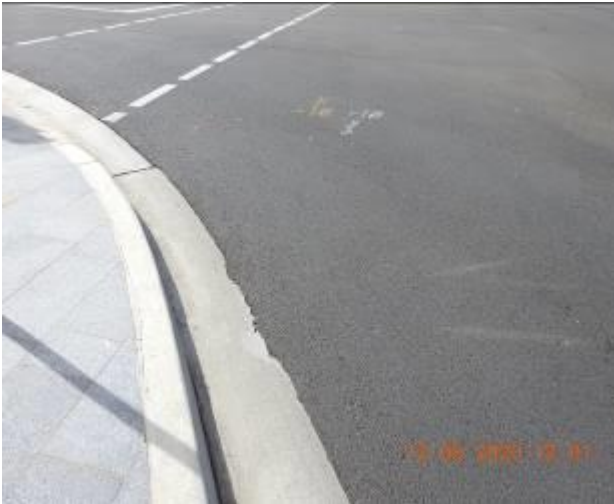
Figure 1829 – Loss of material through road surface

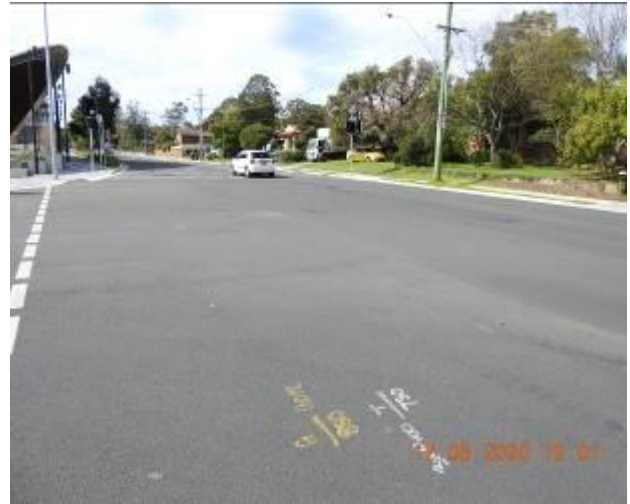
Figure 1830 – General condition of road surface

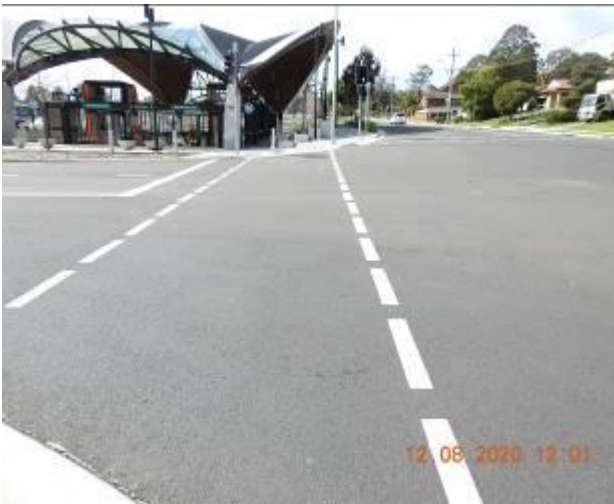
Figure 1831 – General condition of road surface

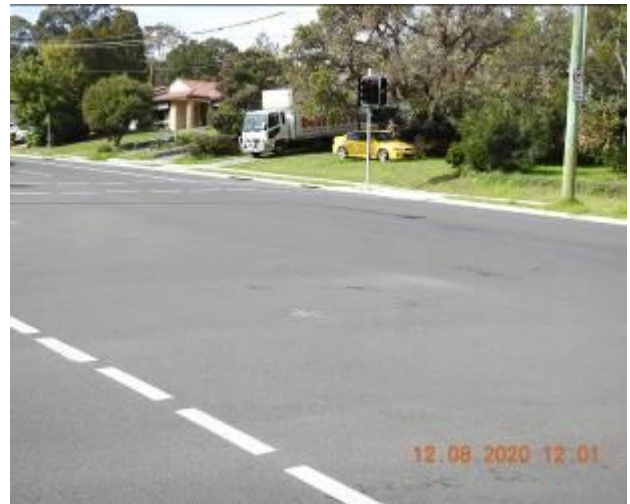
Figure 1832 – General condition of road surface

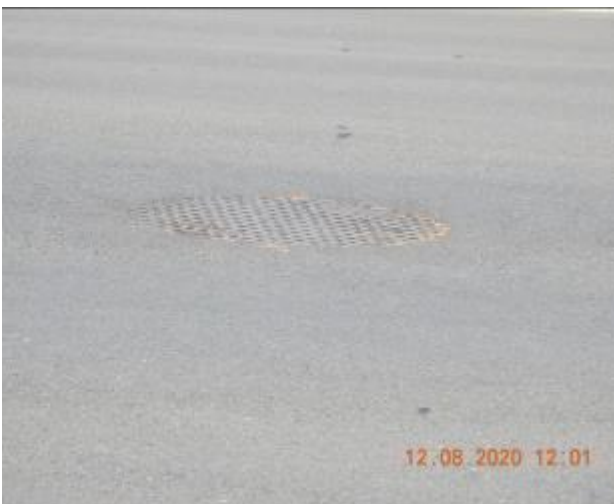
Figure 1833 – General condition of service pit

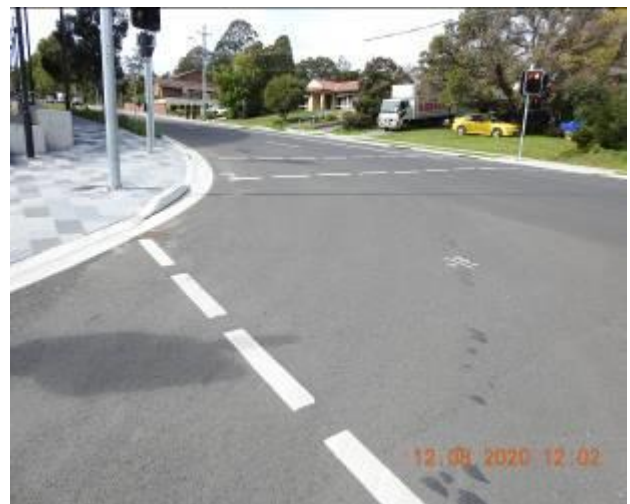
Figure 1834 – Evidence of patchwork through road surface

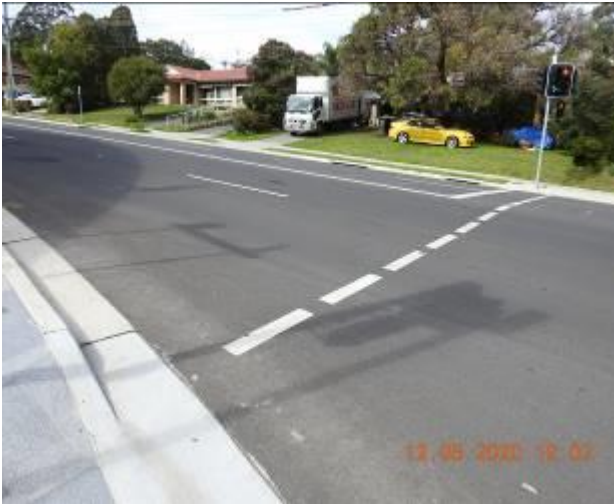
Figure 1835 – Evidence of patchwork through road surface

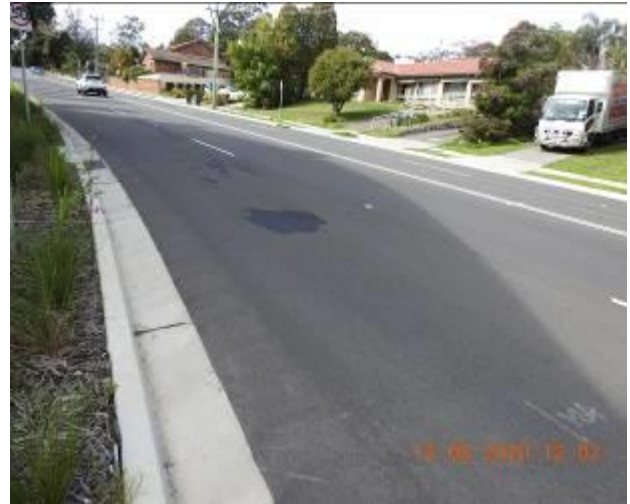
Figure 1836 – General condition of road surface

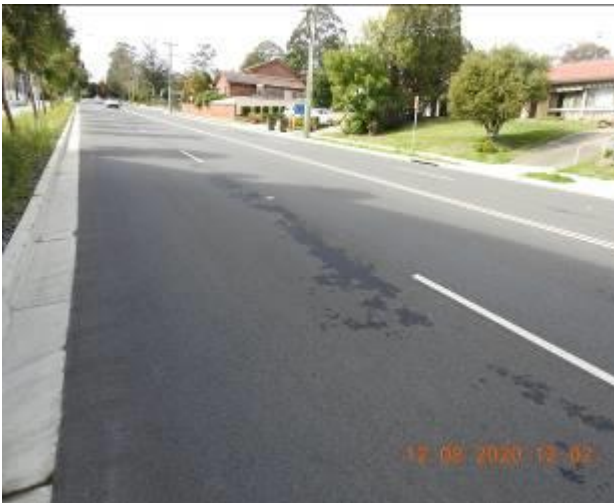
Figure 1837 – General condition of road surface

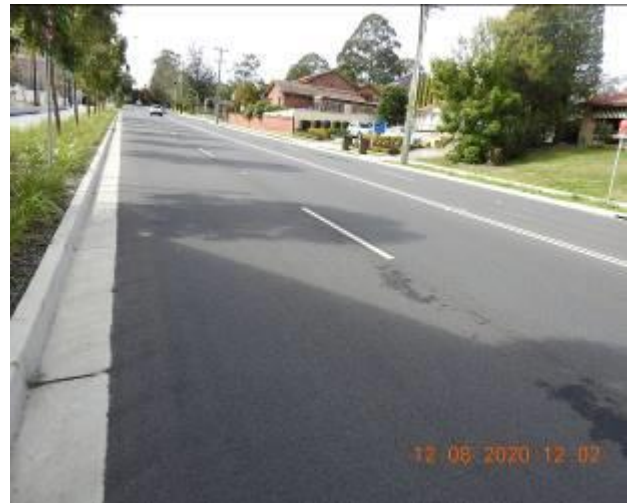
Figure 1838 – General condition of road surface

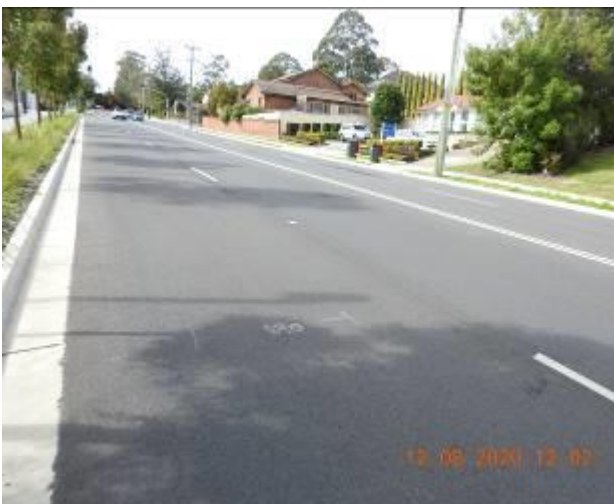
Figure 1839 – General condition of road surface

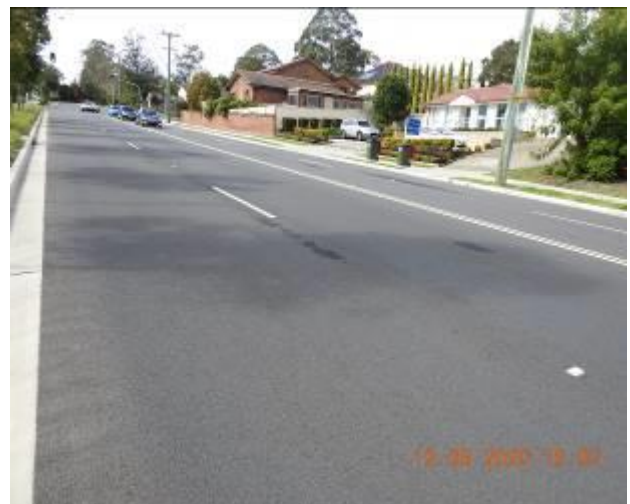
Figure 1840 – General condition of road surface

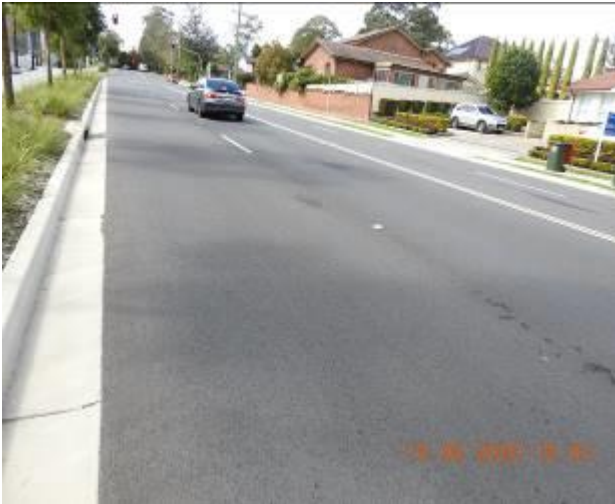
Figure 1841 – General condition of road surface

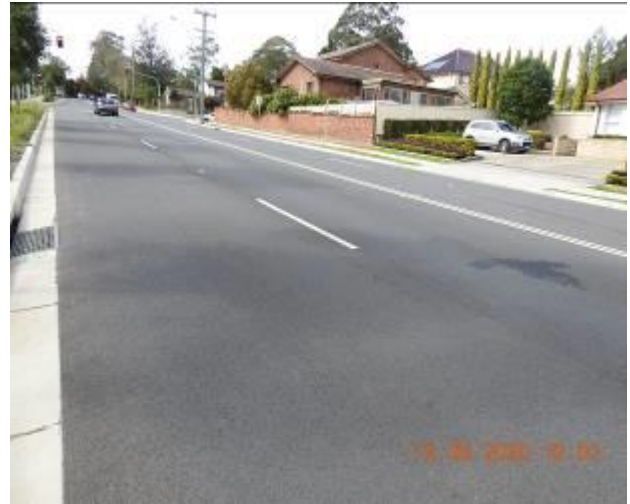
Figure 1842 – General condition of road surface

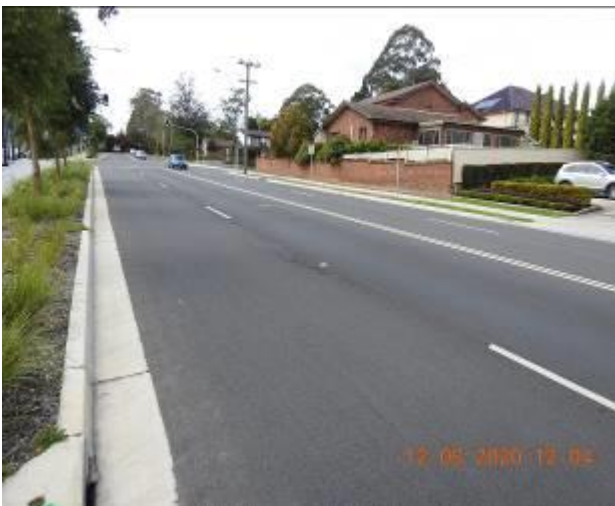
Figure 1843 – General condition of road surface

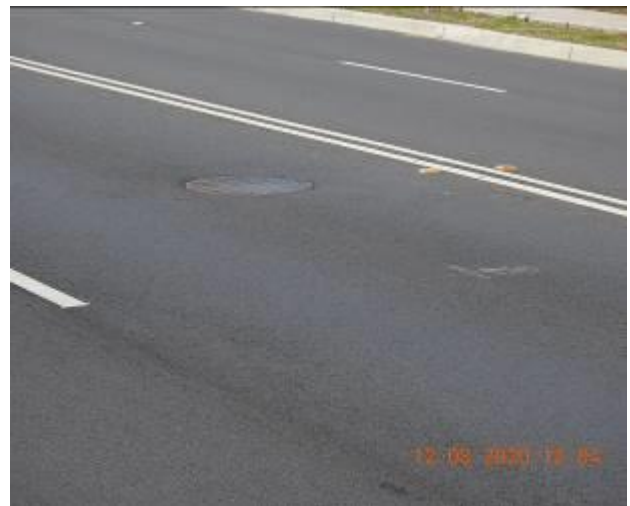
Figure 1844 – General condition of service pit

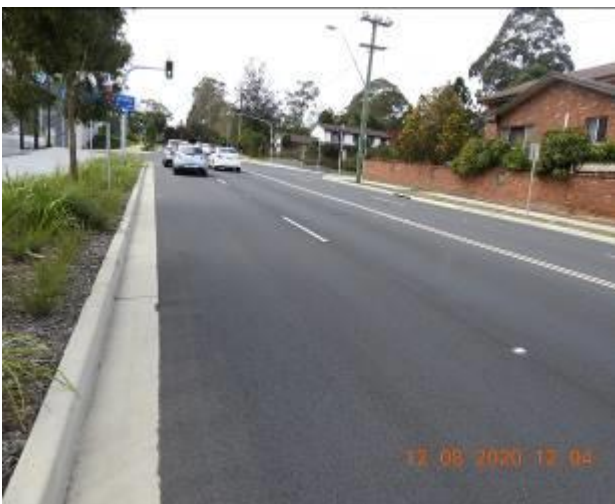
Figure 1845 – General condition of road surface

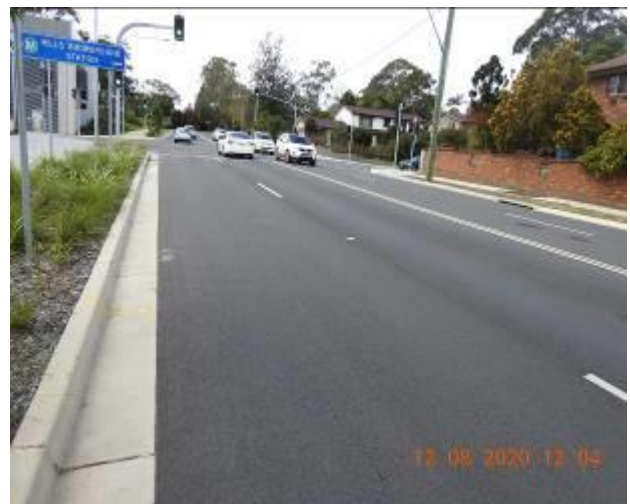
Figure 1846 – General condition of road surface

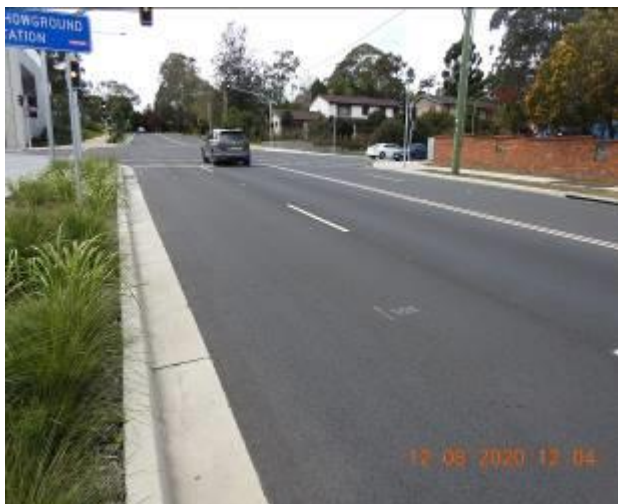
Figure 1847 – General condition of road surface

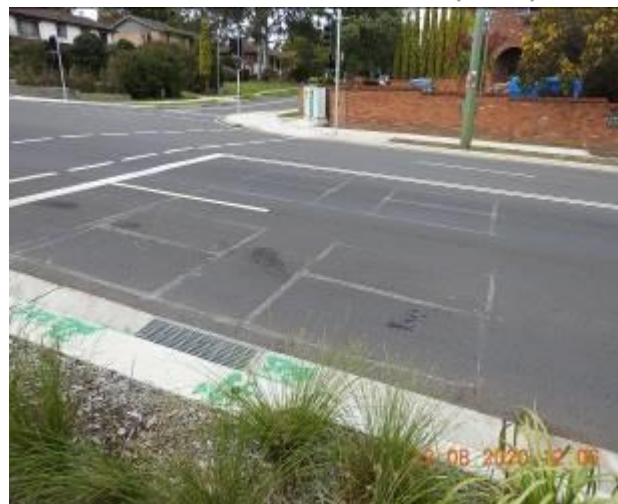
Figure 1848 – Evidence of patchwork and loss of material through road surface

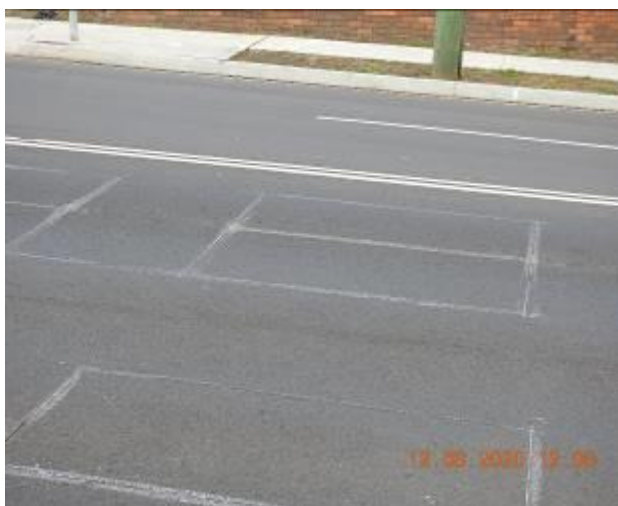
Figure 1849 – Evidence of patchwork and loss of material through road surface

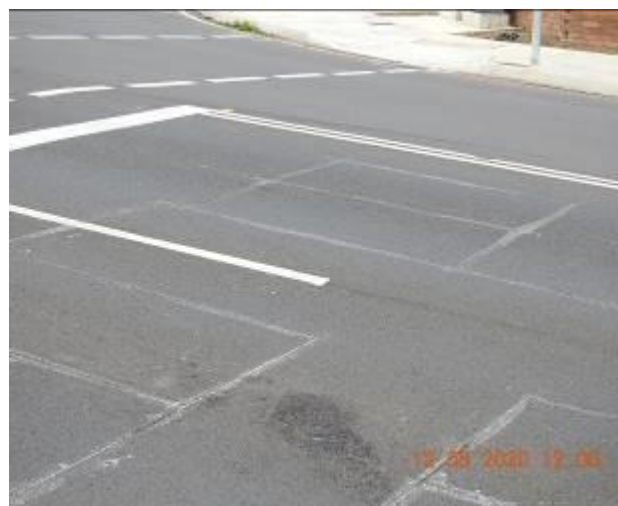
Figure 1850 – Evidence of patchwork and loss of material through road surface

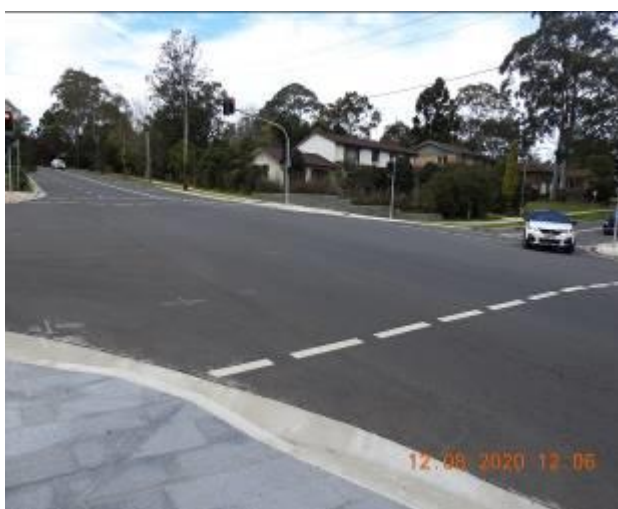
Figure 1851 – Loss of material through road surface

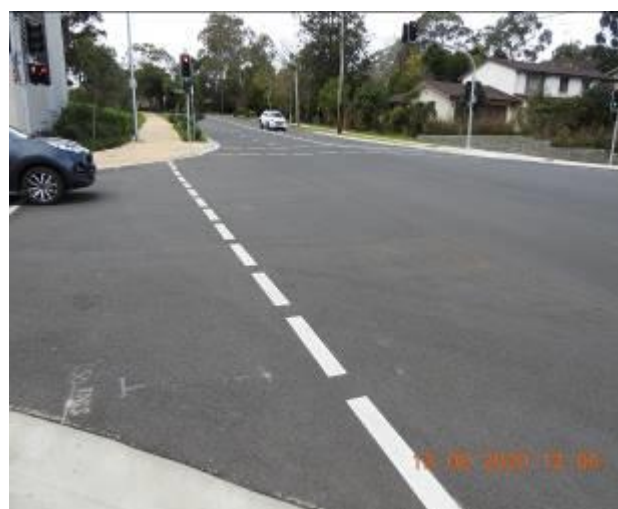
Figure 1852 – Loss of material through road surface

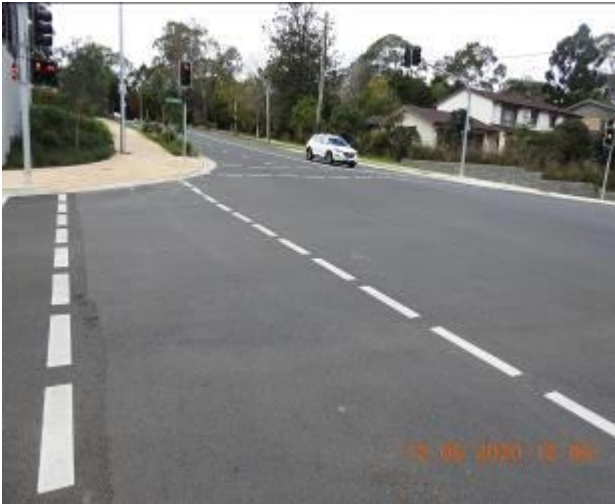
Figure 1853 – General condition of road surface

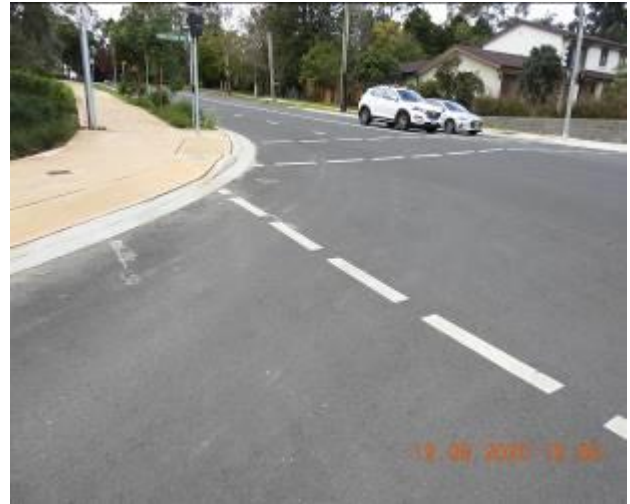
Figure 1854 – General condition of road surface

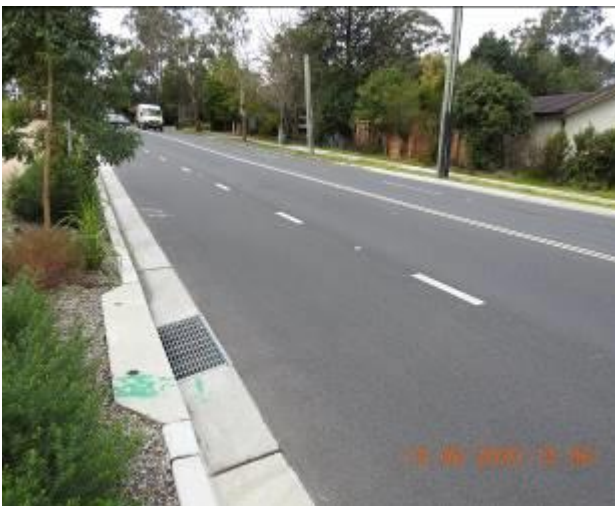
Figure 1855 – General condition of road surface

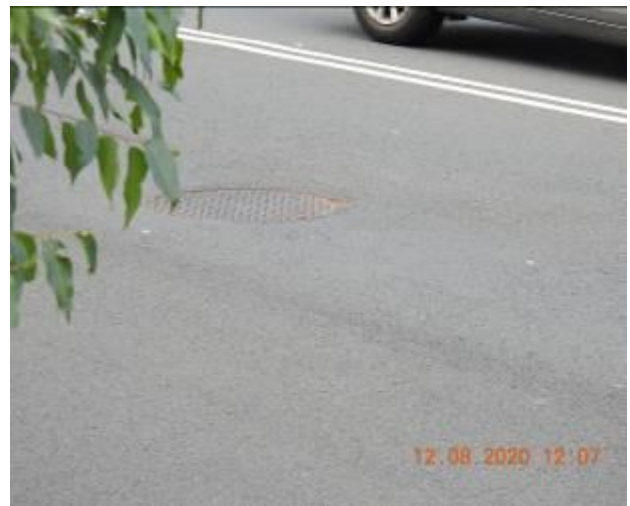
Figure 1856 – General condition of service pit

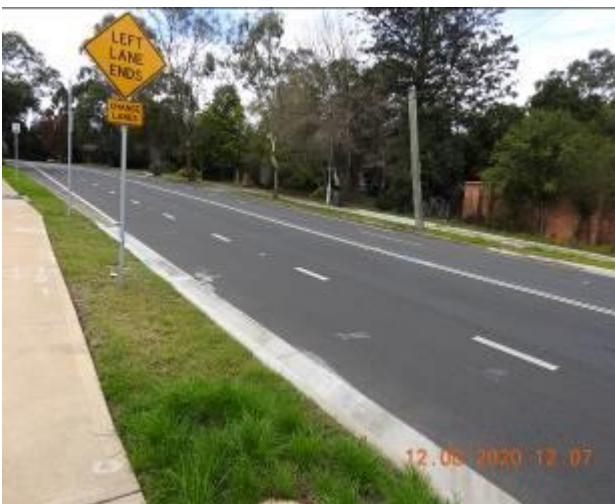
Figure 1857 – General condition of road surface

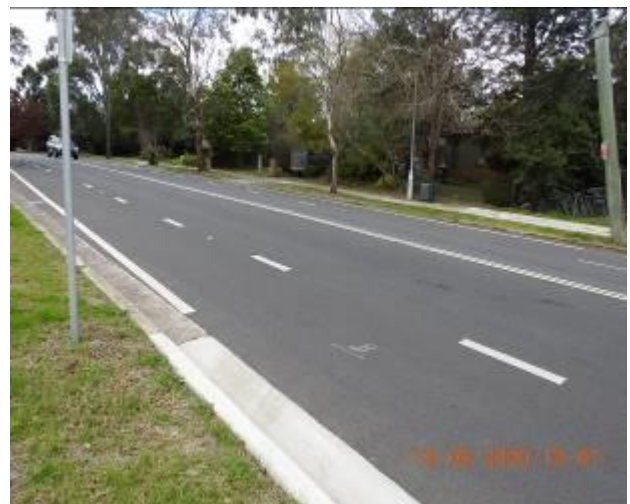
Figure 1858 – General condition of road surface

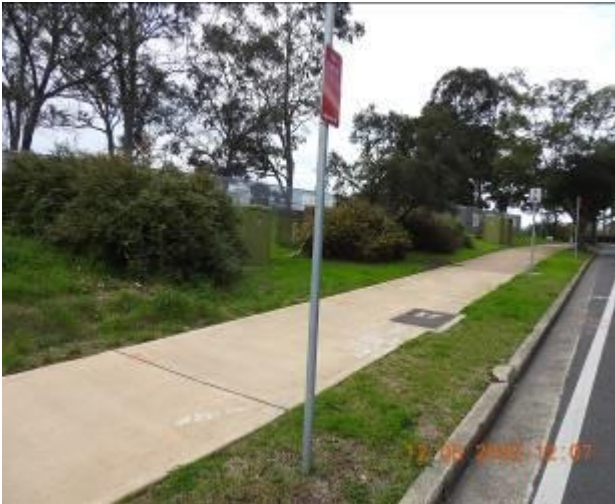
Figure 1859 – General condition of street sign heading West

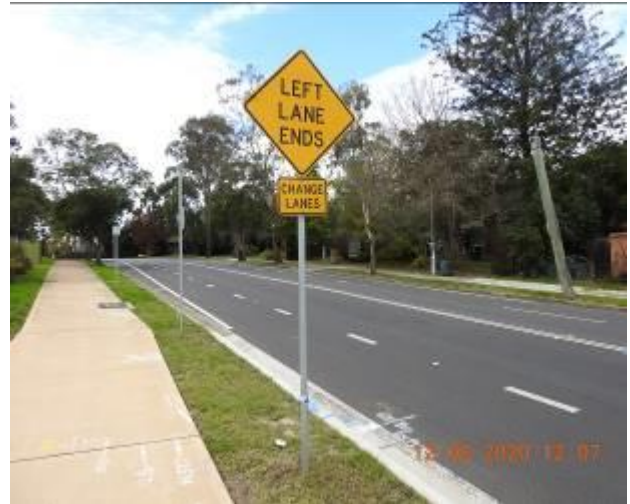
Figure 1860 – General condition of street sign

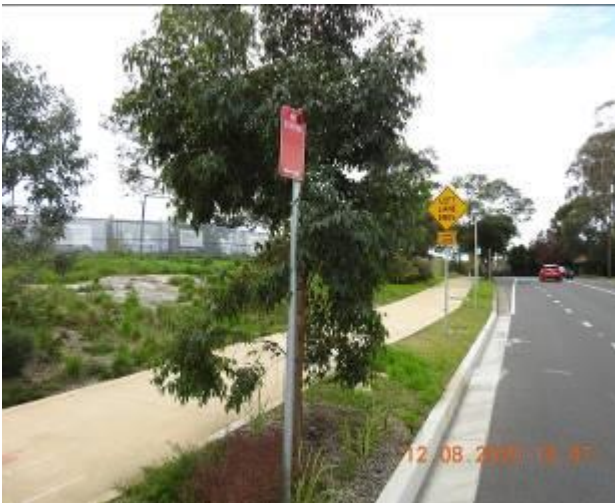
Figure 1861 – General condition of street sign and plantation

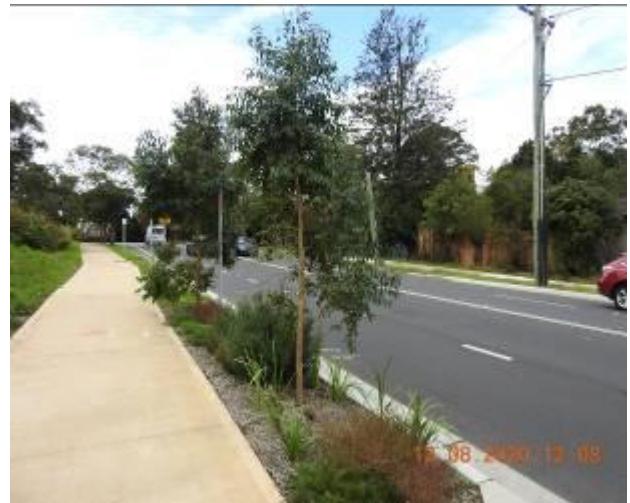
Figure 1862 – General condition of plantations

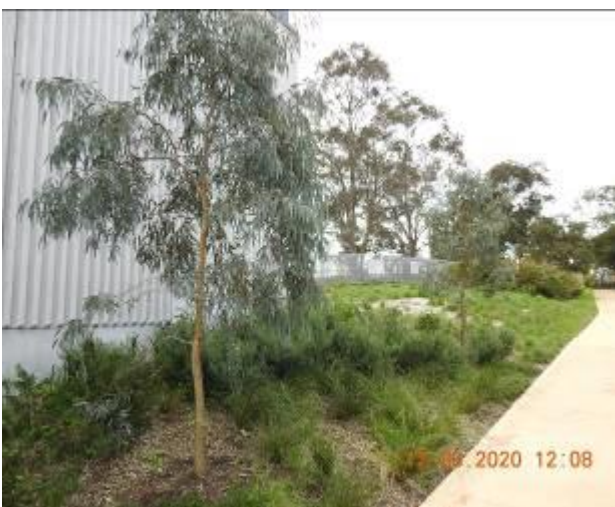
Figure 1863 – General condition of plantations

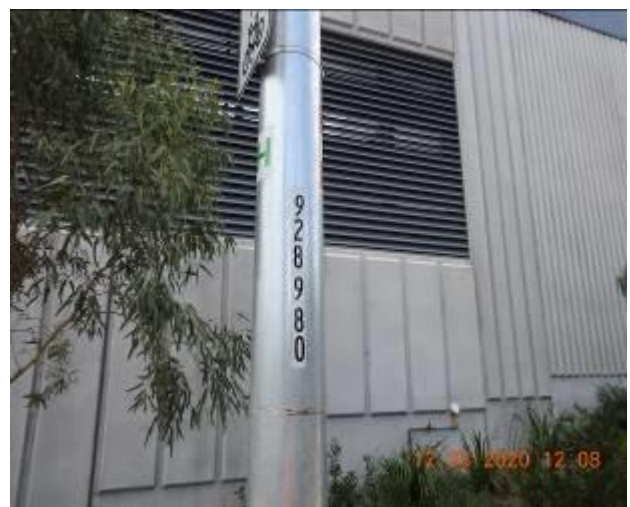
Figure 1864 – General condition of lamp post
Identification No. 928980

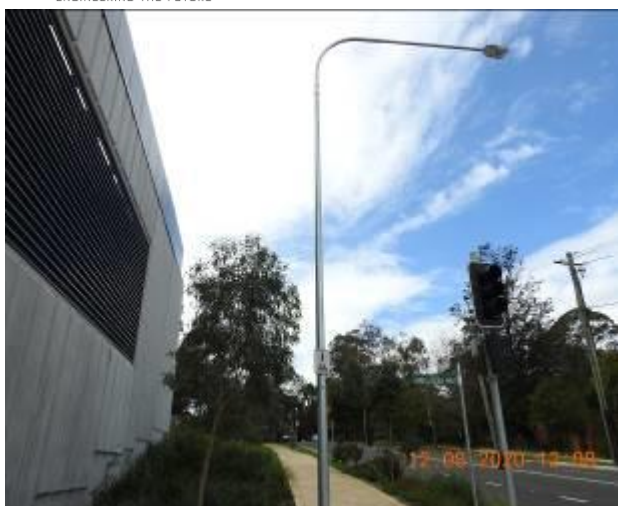
Figure 1865 – General condition of lamp post
Identification No. 928980

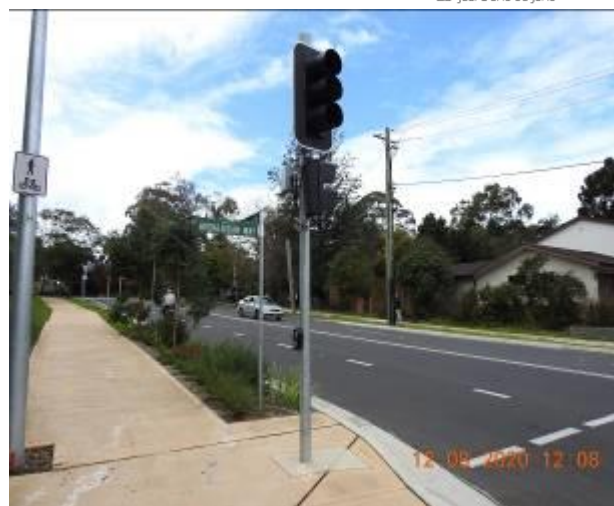
Figure 1866 – General condition of traffic light

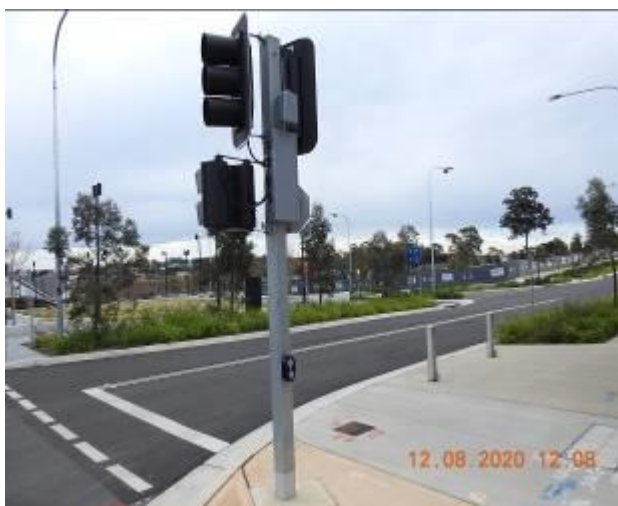
Figure 1867 – General condition of traffic light and
safety bollards

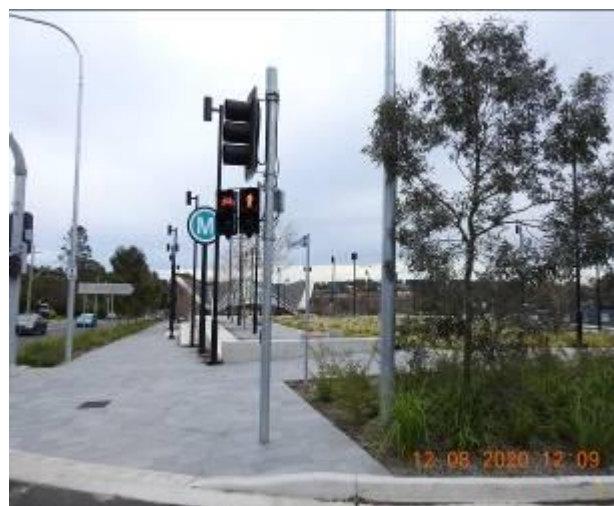
Figure 1868 – General condition of traffic light

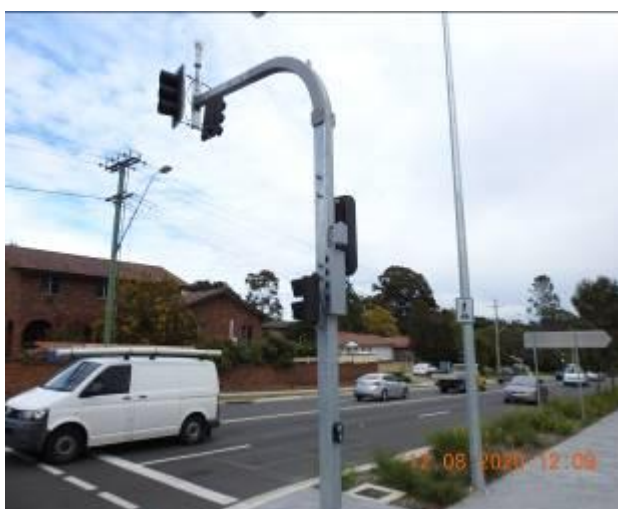
Figure 1869 – General condition of traffic light
