**2 MANDALA PARADE, CASTLE HILL
(DORAN DRIVE PRECINCT)
PRE-DILAPIDATION REPORT
Of Sydney Metro and Hills Shire Council Assets
DEICORP PROJECTS SHOWGROUND
PTY LTD.**

Job No. 200124.3
07/07/2021

ACE Structural Services Pty Ltd

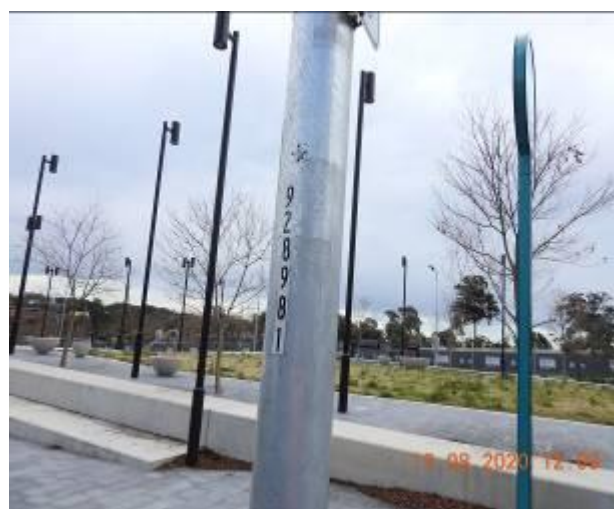
Figure 1870 – General condition of lamp post
Identification No. 928981

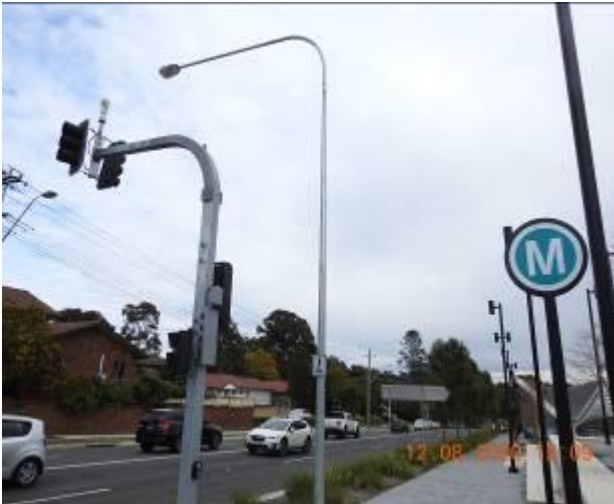
Figure 1871 – General condition of lamp post
Identification No. 928981

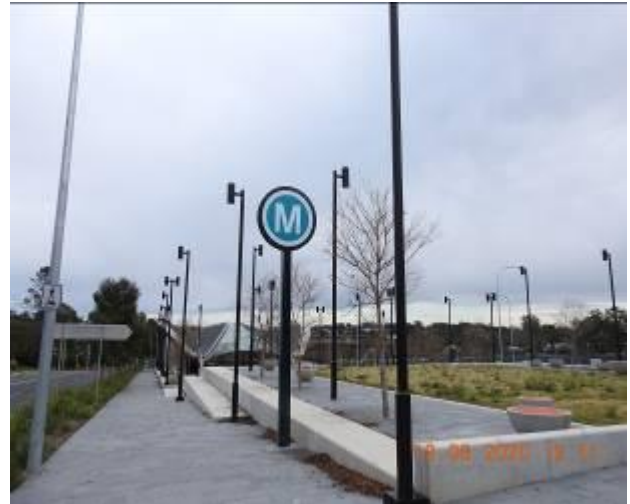
Figure 1872 – General condition of showground lamp posts

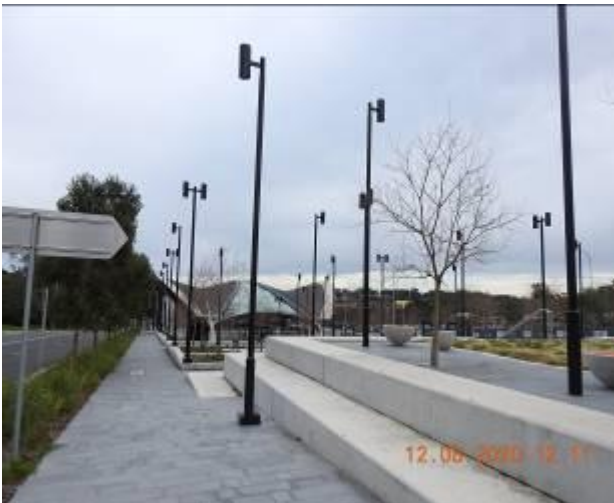
Figure 1873 – General condition of showground lamp posts

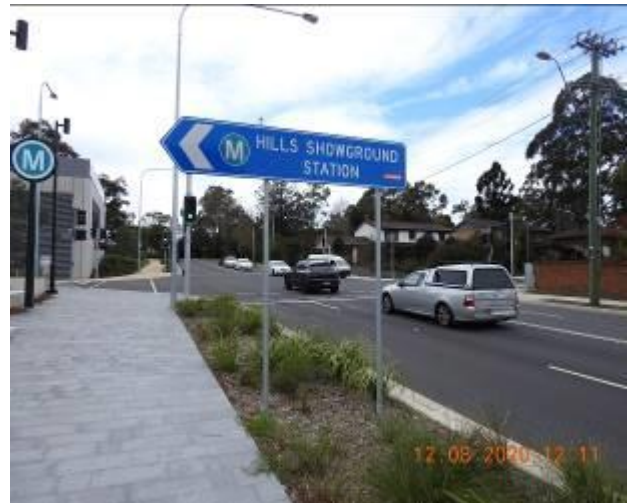
Figure 1874 – General condition of street sign

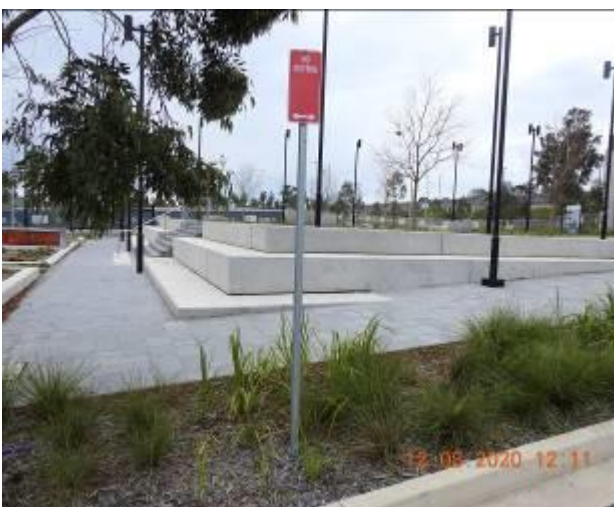
Figure 1875 – General condition of street sign

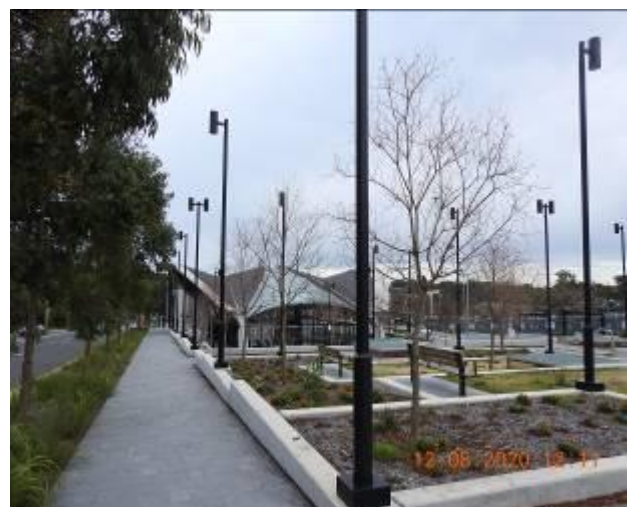
Figure 1876 – General condition of showground lamp posts

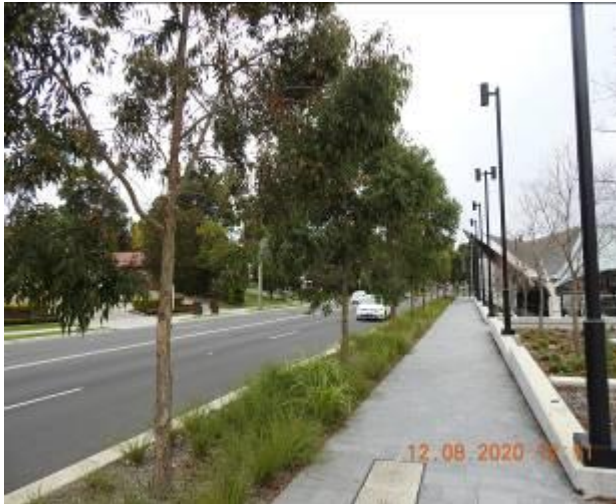
Figure 1877 – General condition of plantations

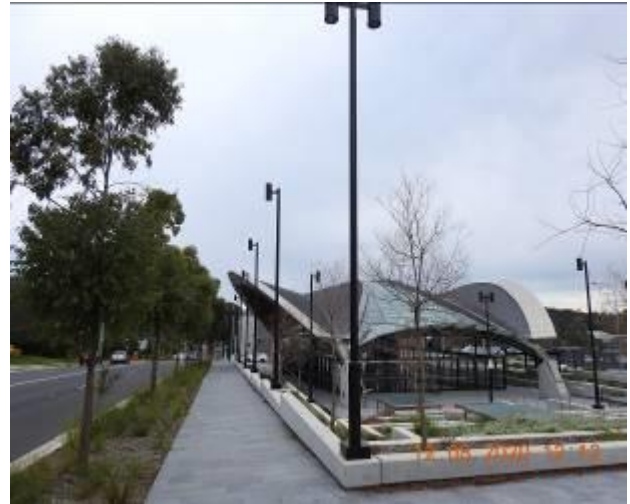
Figure 1878 – General condition of showground lamp posts and plantations

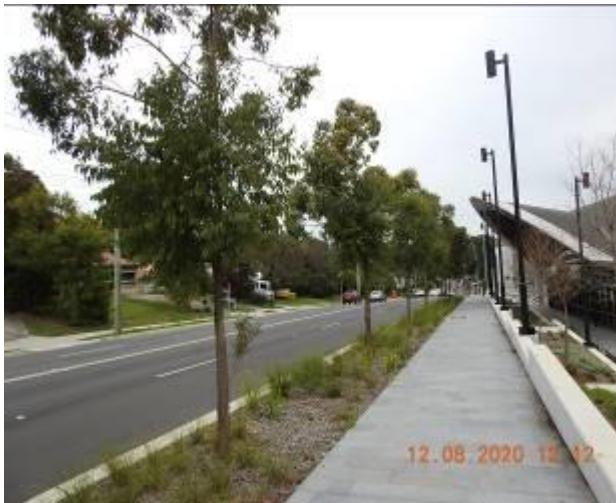
Figure 1879 – General condition of showground lamp posts and plantations

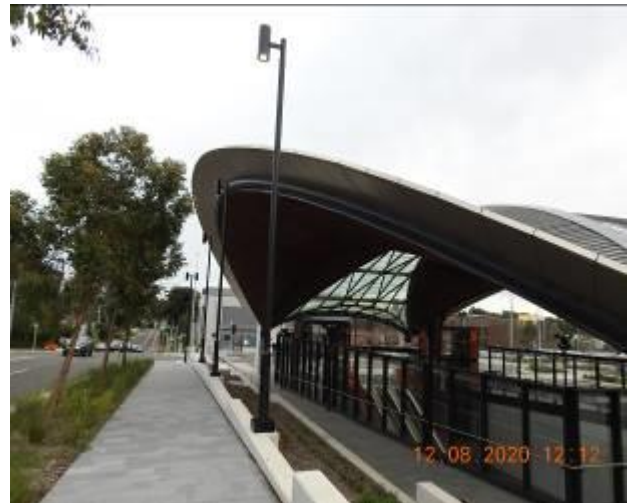
Figure 1880 – General condition of showground lamp posts and plantations

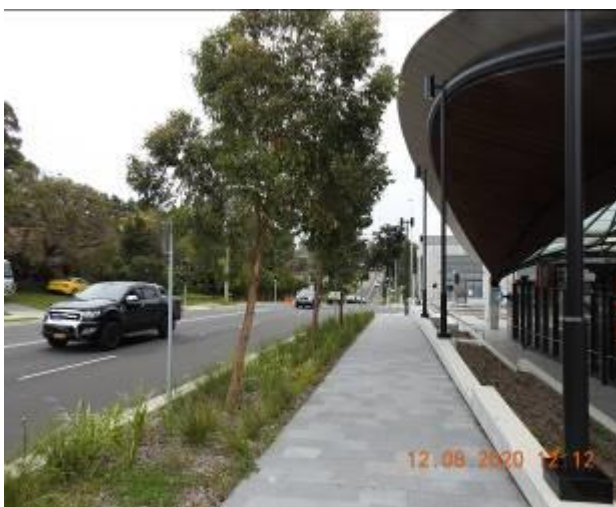
Figure 1881 – General condition of showground lamp posts and plantations

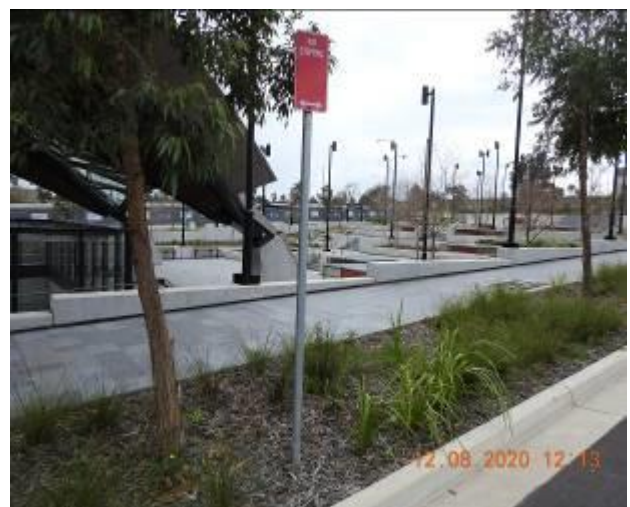
Figure 1882 – General condition of street sign

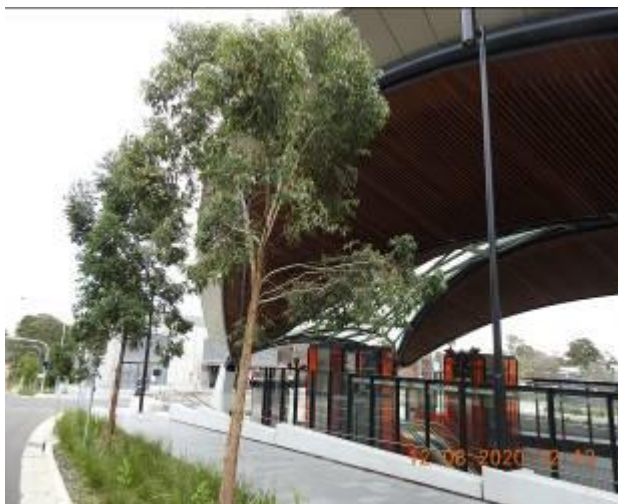
Figure 1883 – General condition of showground lamp posts and plantations

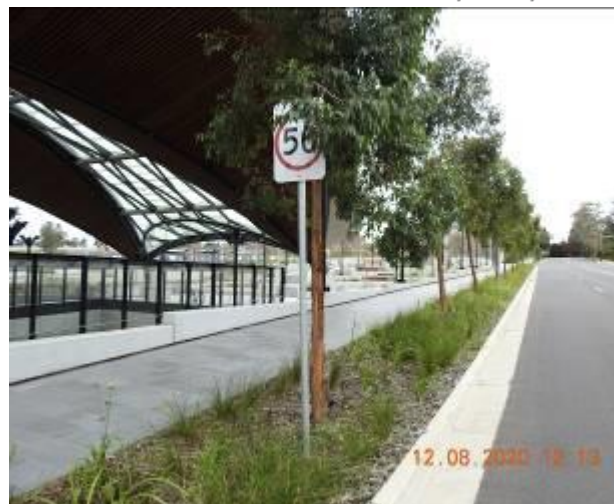
Figure 1884 – General condition of street sign and plantations

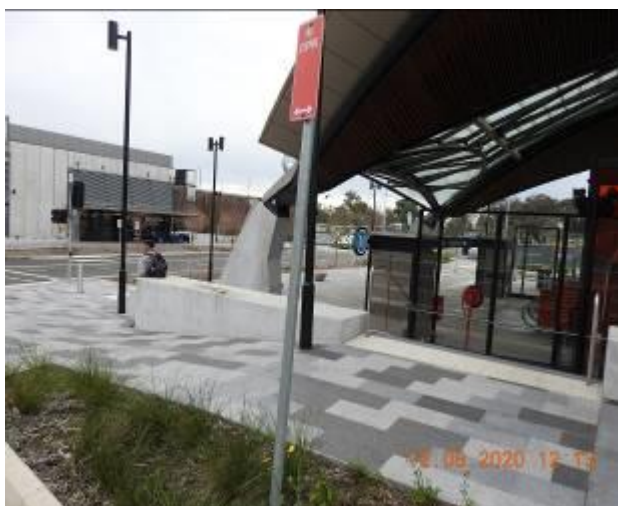
Figure 1885 – General condition of street sign

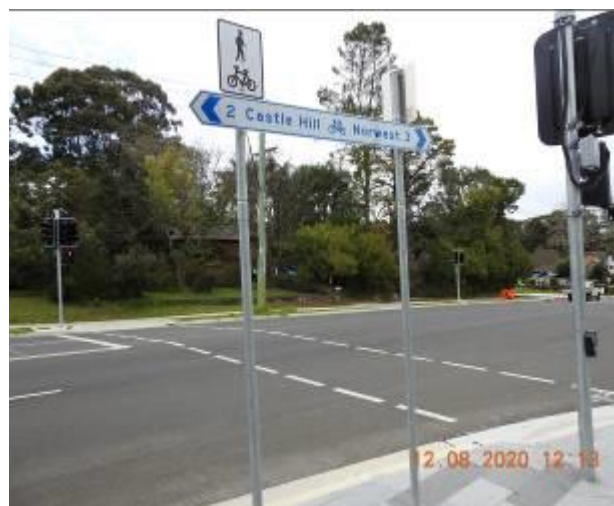
Figure 1886 – General condition of street signs

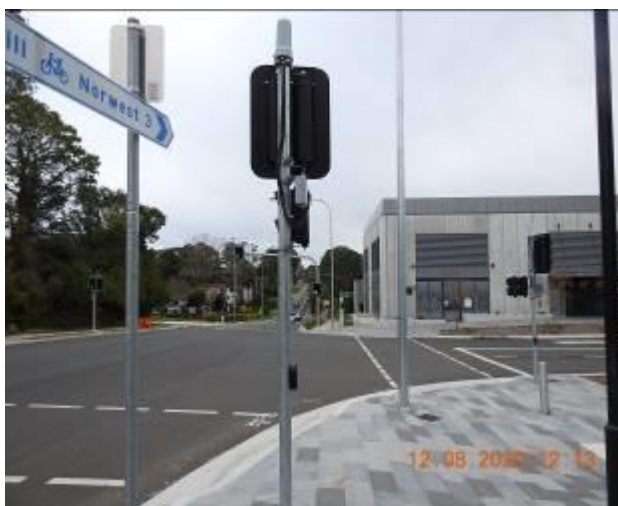
Figure 1887 – General condition of traffic light

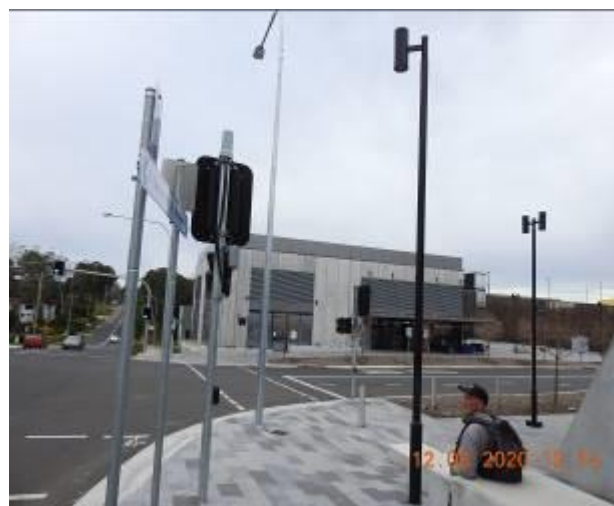
Figure 1888 – General condition of street signs, lamp post and traffic light

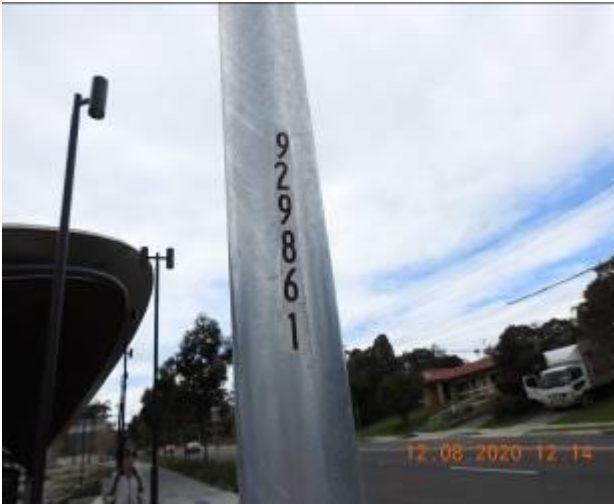
Figure 1889 – General condition of lamp post
Identification No. 929861

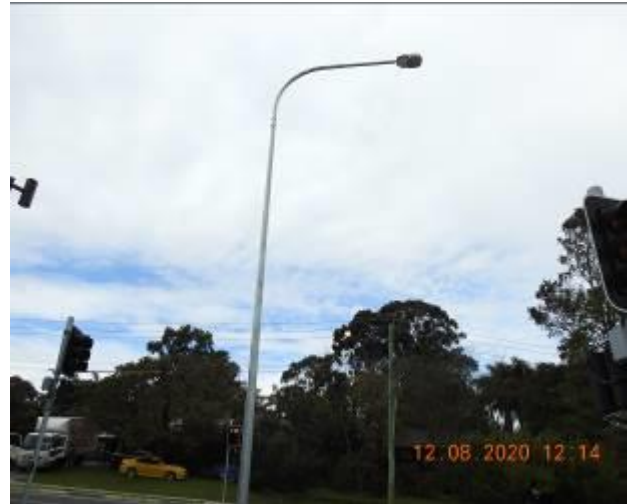
Figure 1890 – General condition of lamp post
Identification No. 929861

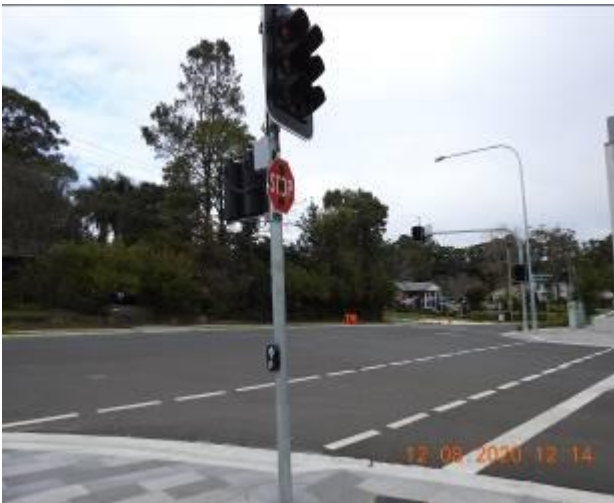
Figure 1891 – General condition of traffic light

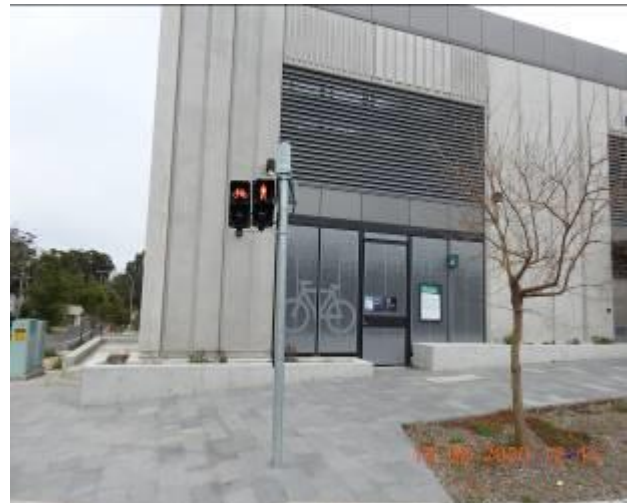
Figure 1892 – General condition of traffic light

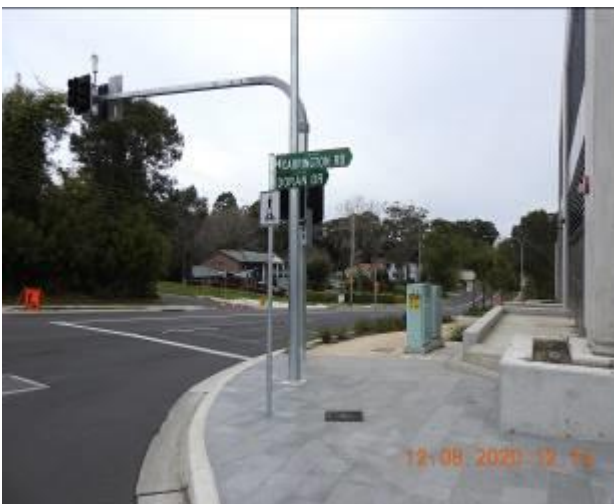
Figure 1893 – General condition of street signs and
traffic light

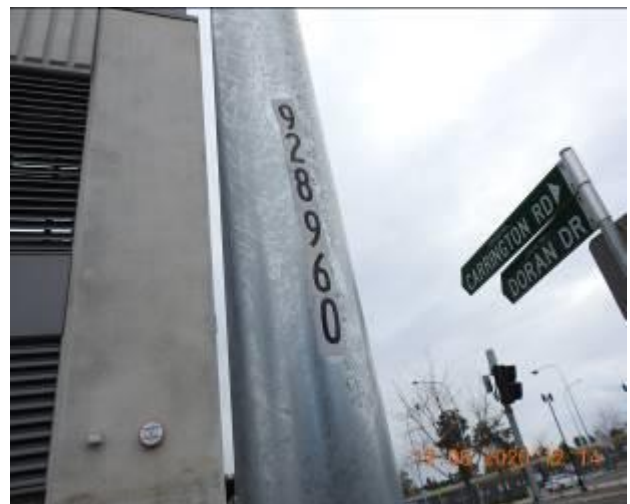
Figure 1894 – General condition of lamp post
Identification No. 928960

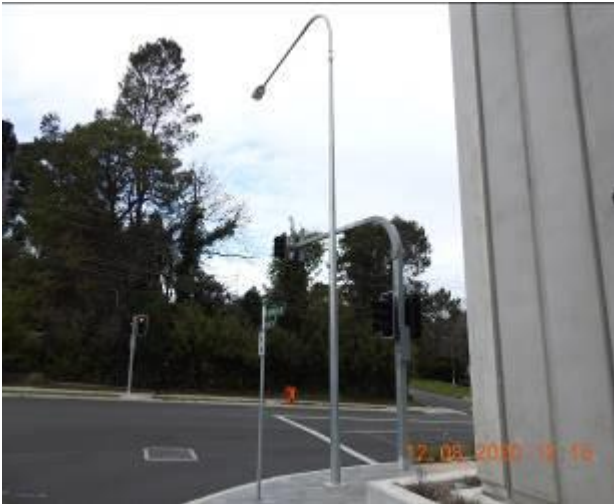
Figure 1895 – General condition of lamp post Identification No. 928960 and Traffic Light

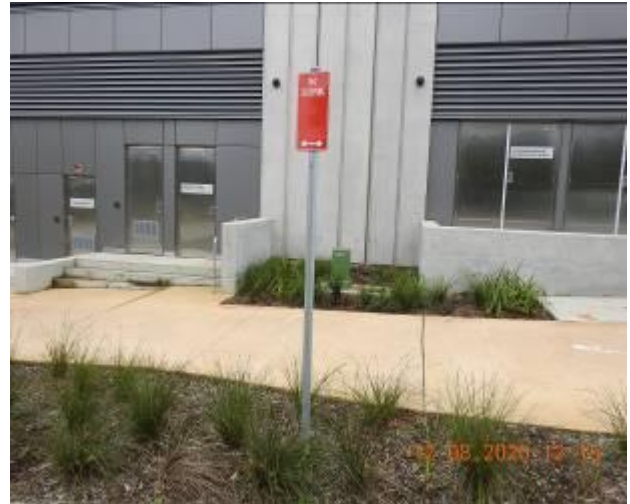
Figure 1896 – General condition of Street Sign

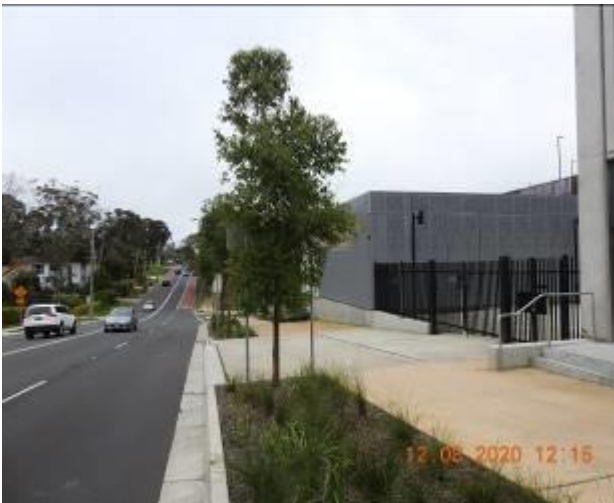
Figure 1897 – General condition of plantations

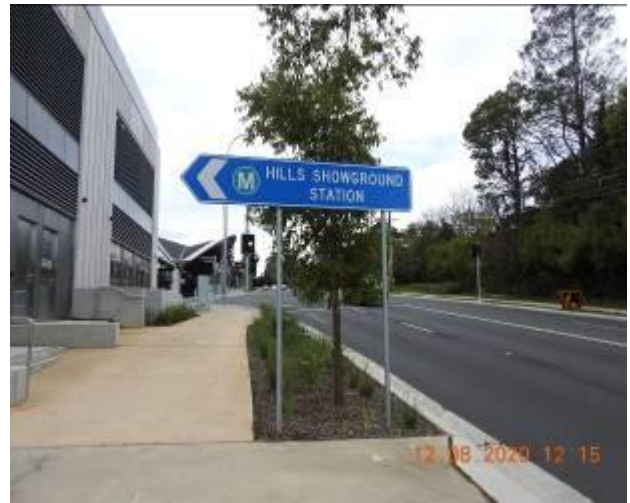
Figure 1898 – General condition of street sign

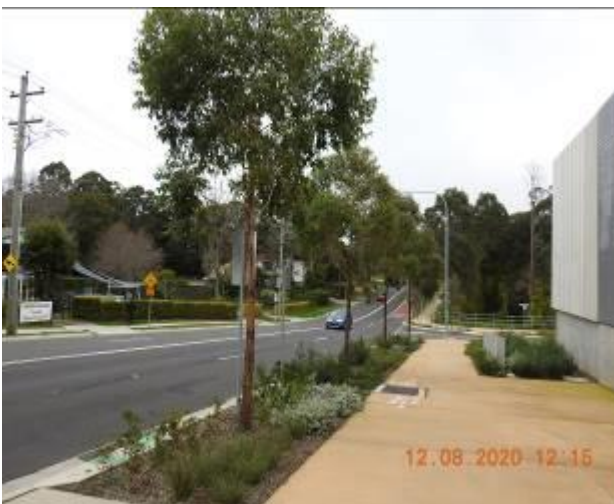
Figure 1899 – General condition of plantations

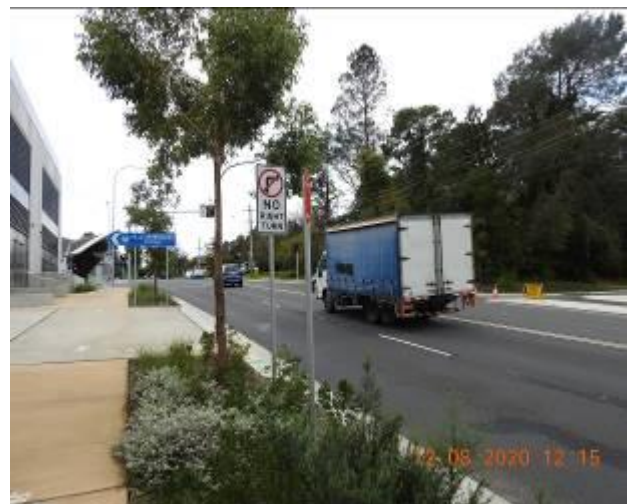
Figure 1900 – General condition of Street Signs

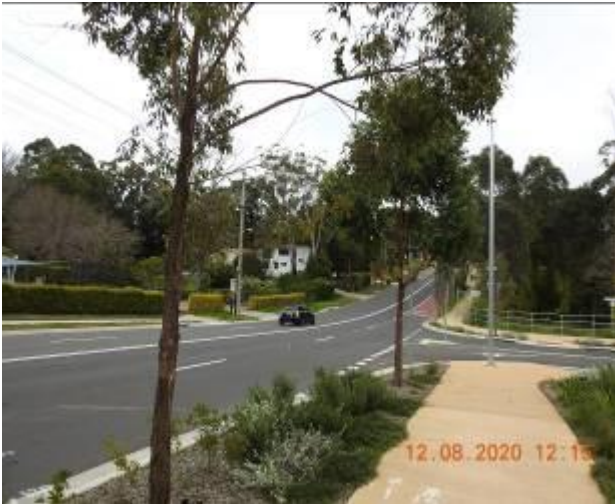
Figure 1901 – General condition of Plantations

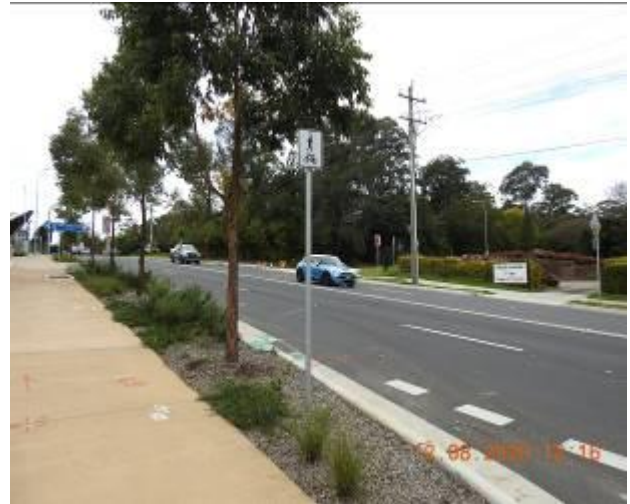
Figure 1902 – General condition of Street Sign and Plantations

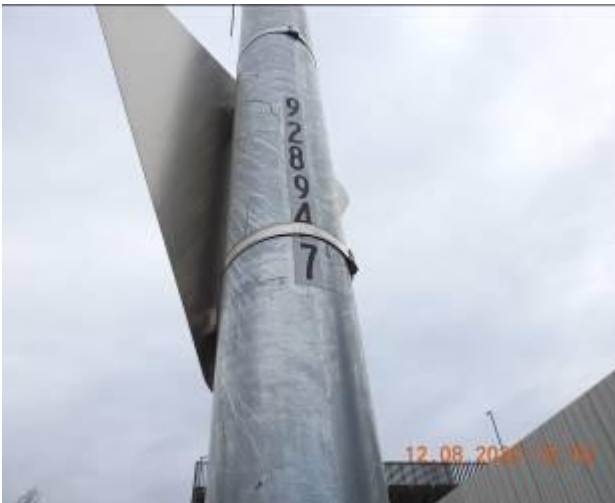
Figure 1903 – General condition of Lamp Post Identification No. 928947

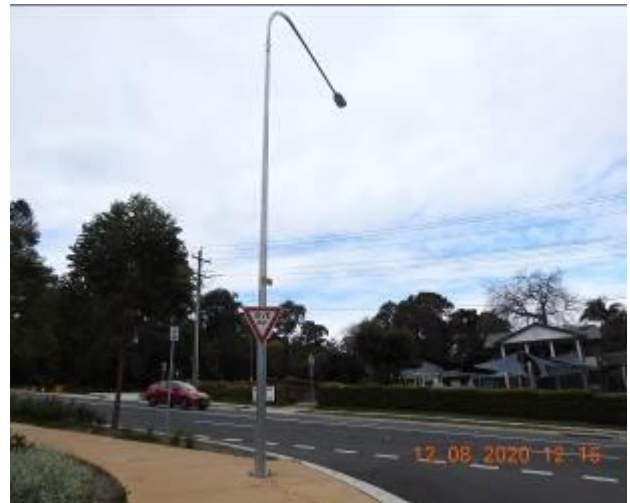
Figure 1904 – General condition of Lamp Post Identification No. 928947

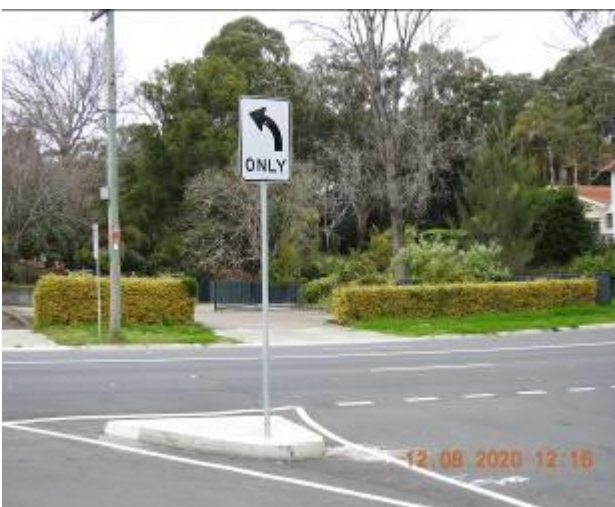
Figure 1905 – General condition of street sign

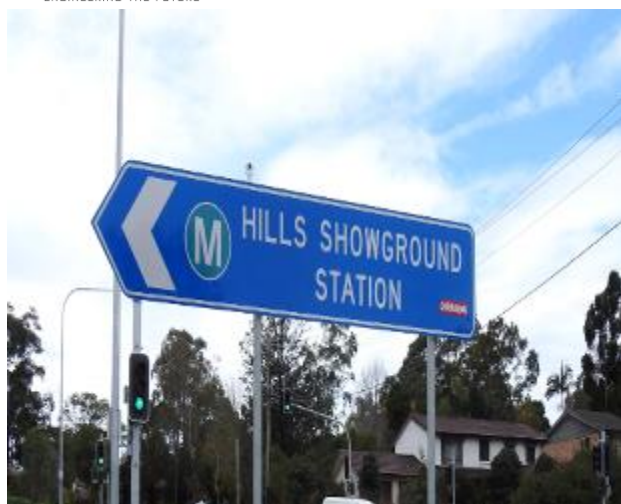
Figure 1906 – The following images display the external condition of Hills Showground Station

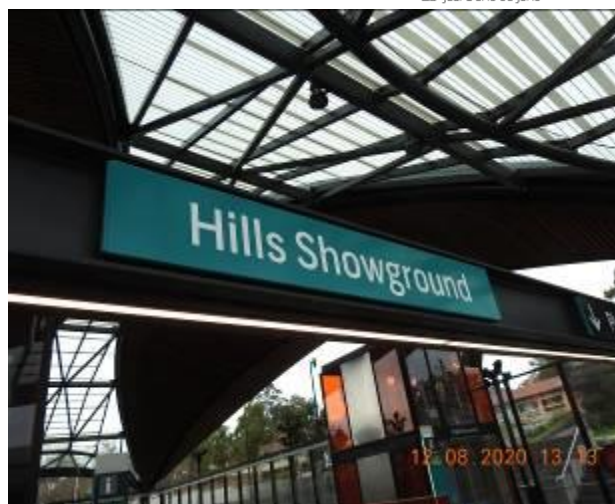
Figure 1907 – General condition of Hills Showground Station

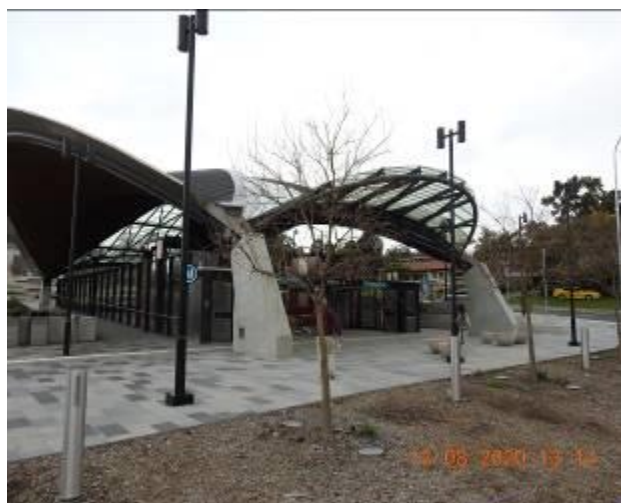
Figure 1908 – General condition of Western façade

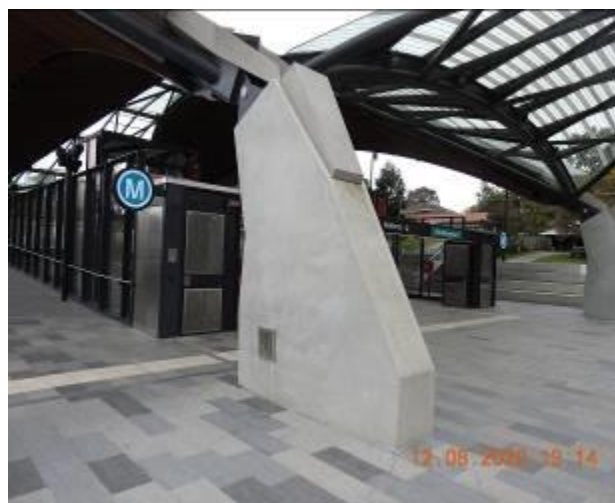
Figure 1909 – General condition of external wall

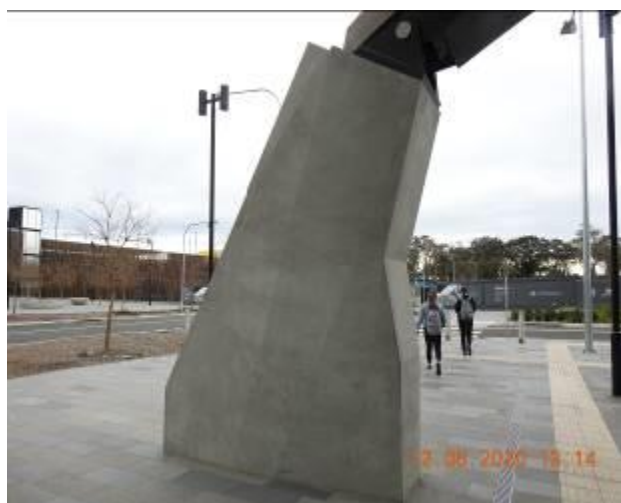
Figure 1910 – General condition of external wall

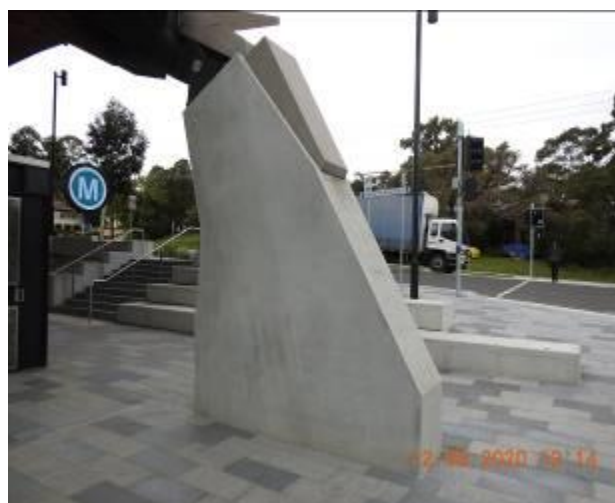
Figure 1911 – General condition of external wall

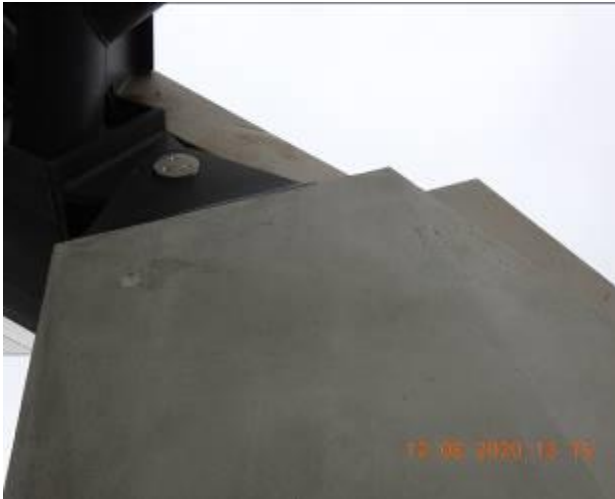
Figure 1912 – Evidence of patchwork through external wall

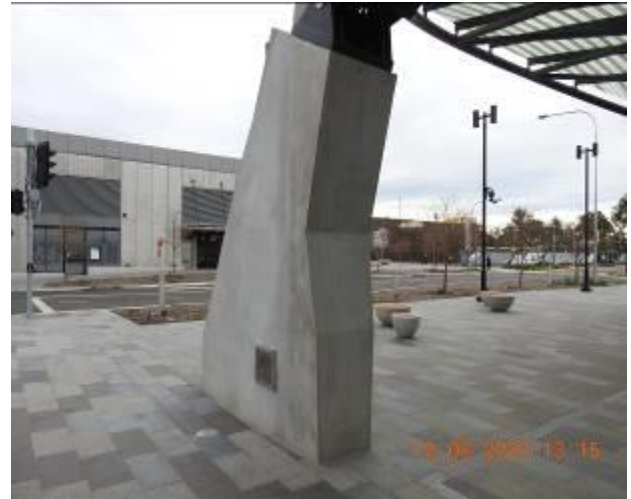
Figure 1913 – General condition of external wall

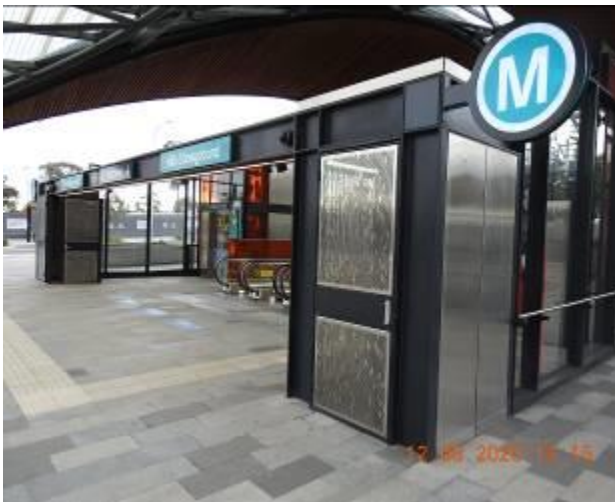
Figure 1914 – General condition of Hills Showground main entrance

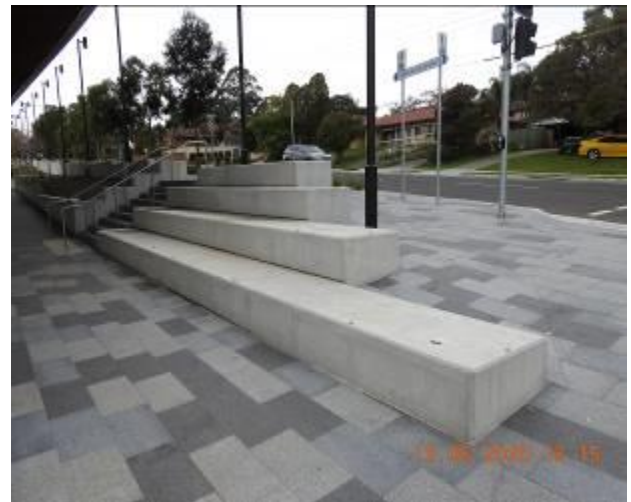
Figure 1915 – General condition of retaining wall

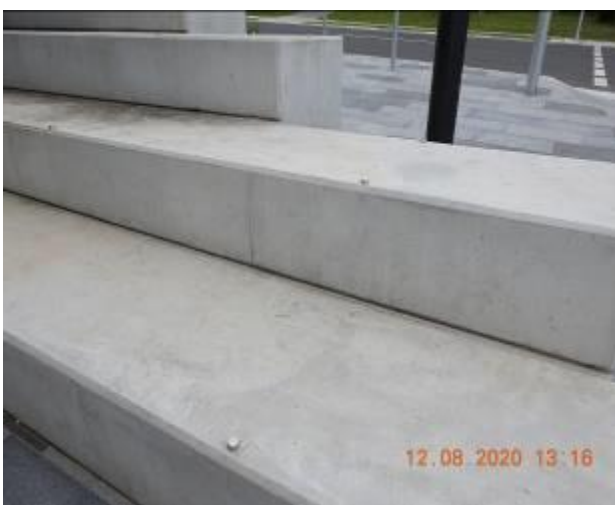
Figure 1916 – Crack propagation and loss of material through retaining wall

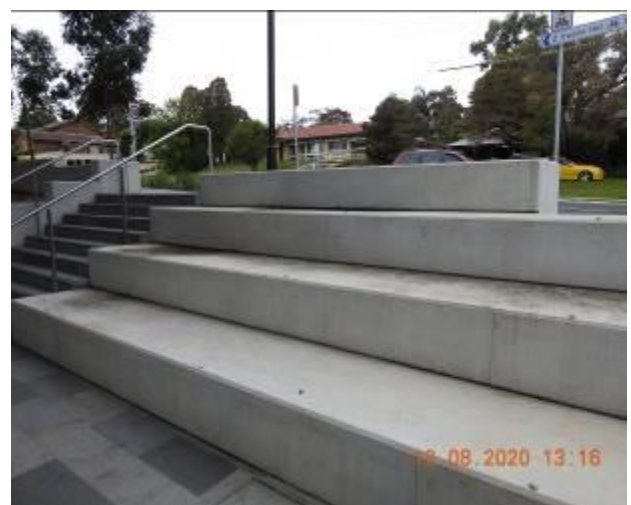
Figure 1917 – General condition of retaining wall

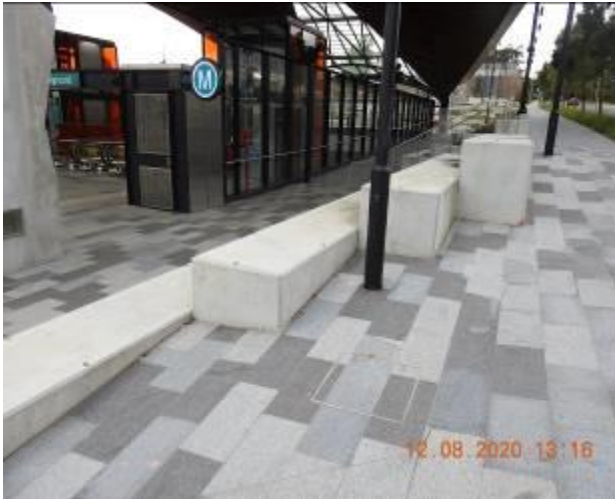
Figure 1918 – General condition of retaining wall

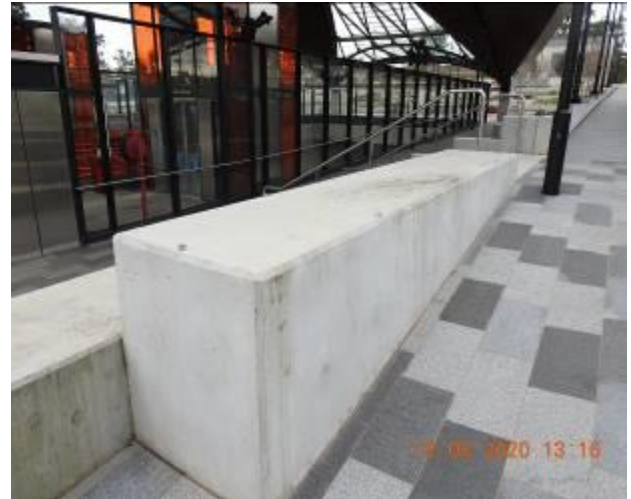
Figure 1919 – General condition of retaining wall

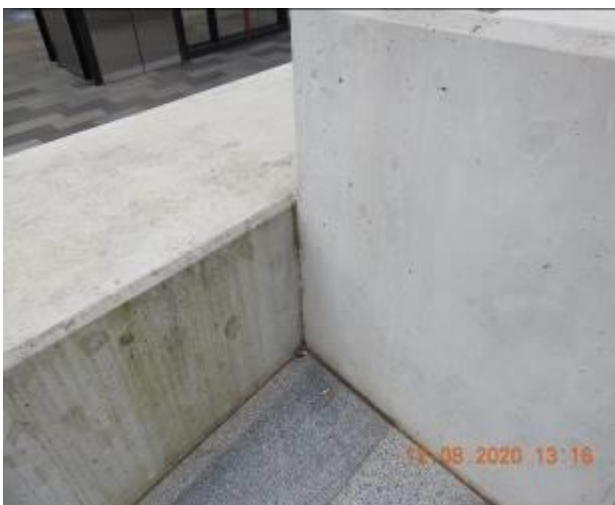
Figure 1920 – Crack propagation and loss of material through retaining wall

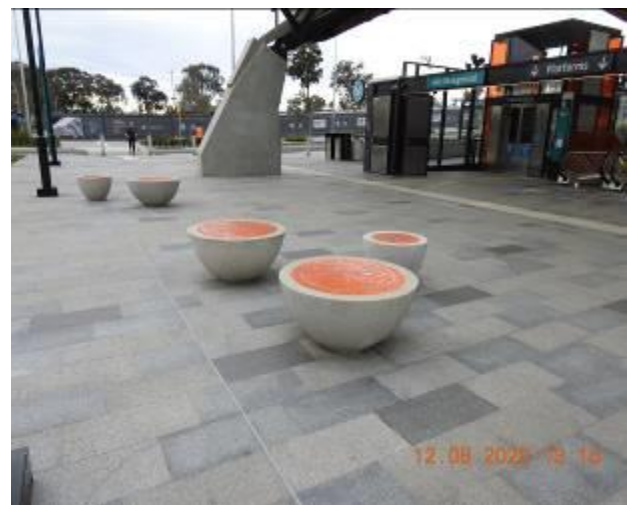
Figure 1921 – General condition of Western façade pavement

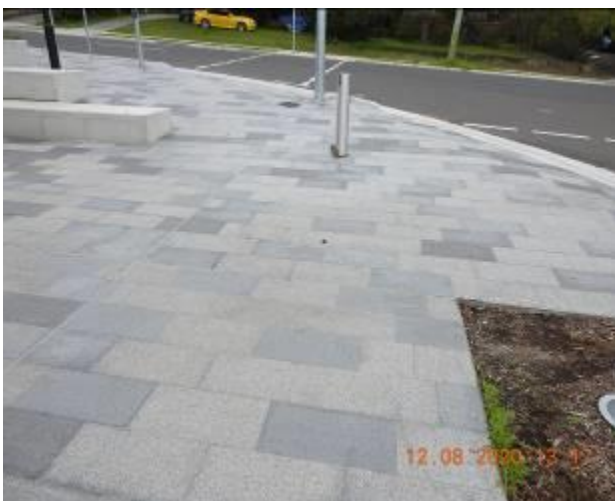
Figure 1922 – General condition of floor tiles

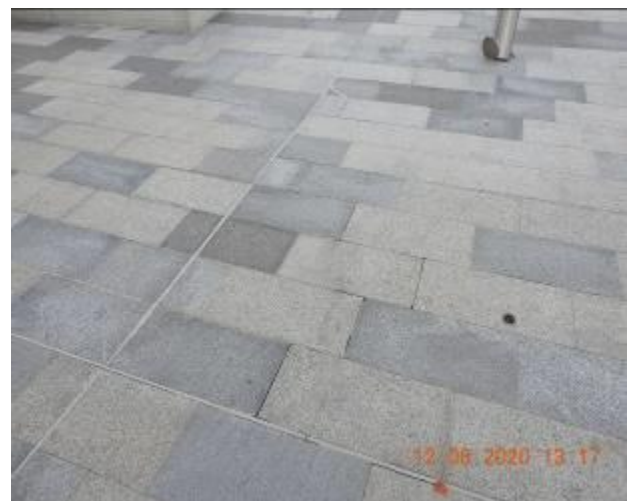
Figure 1923 – Crack propagation and loss of material through floor tiles

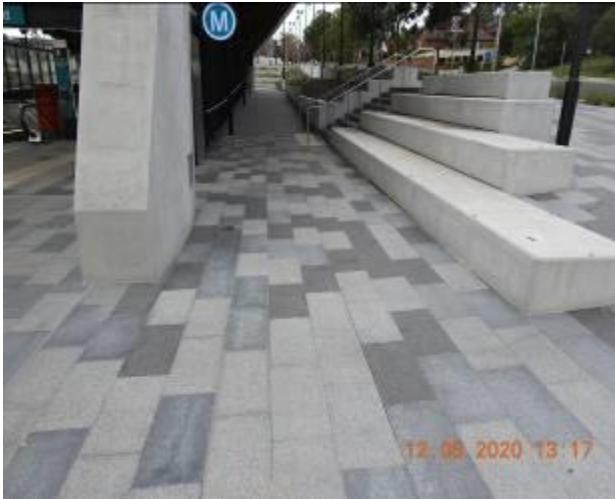
Figure 1924 – General condition of floor tiles

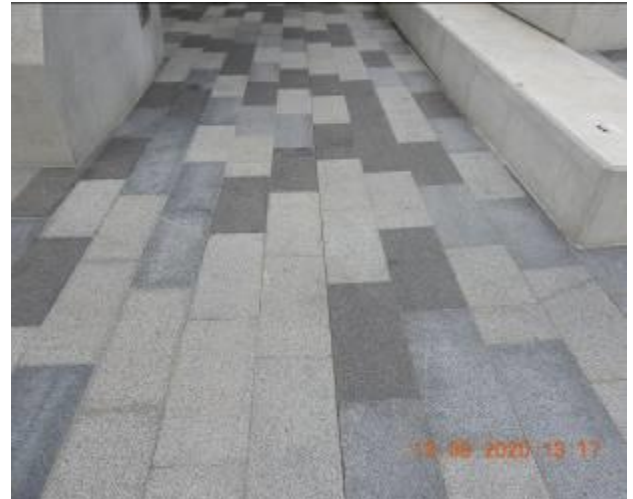
Figure 1925 – Crack propagation and loss of material through floor tiles

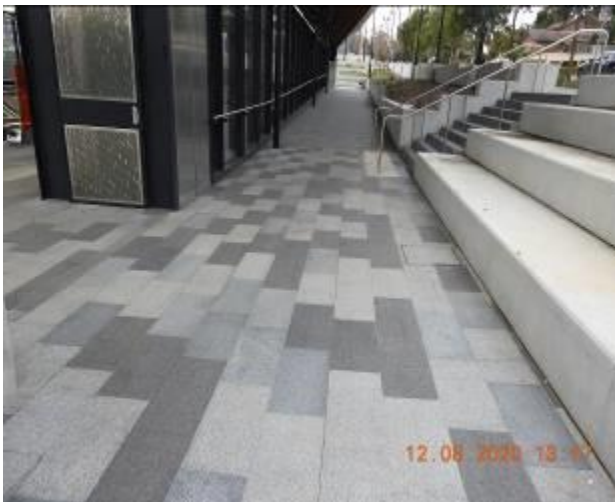
Figure 1926 – Crack propagation and loss of material through floor tiles

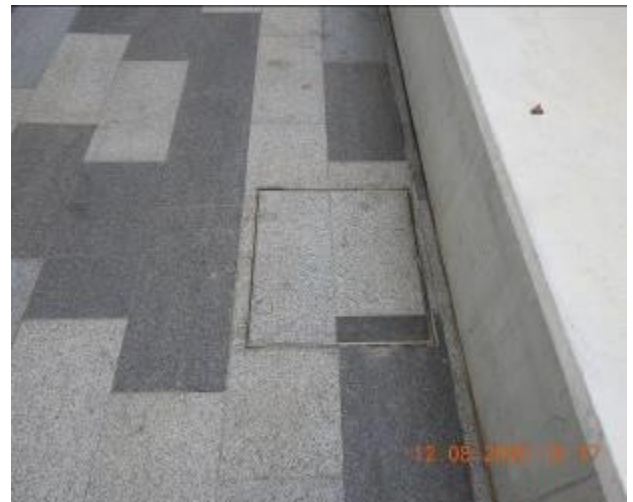
Figure 1927 – General condition of service pit

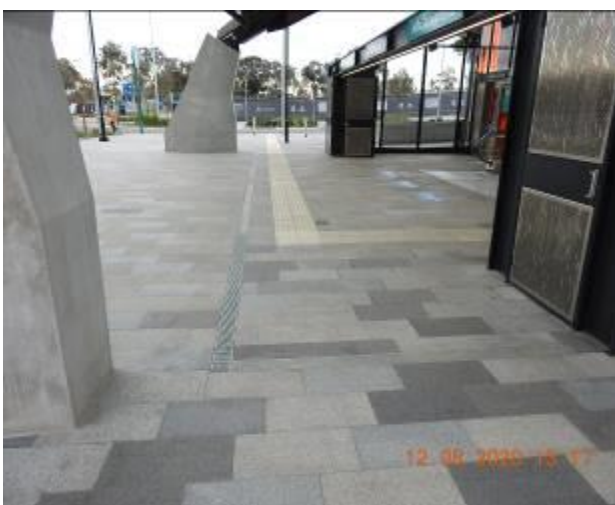
Figure 1928 – General condition of floor tiles

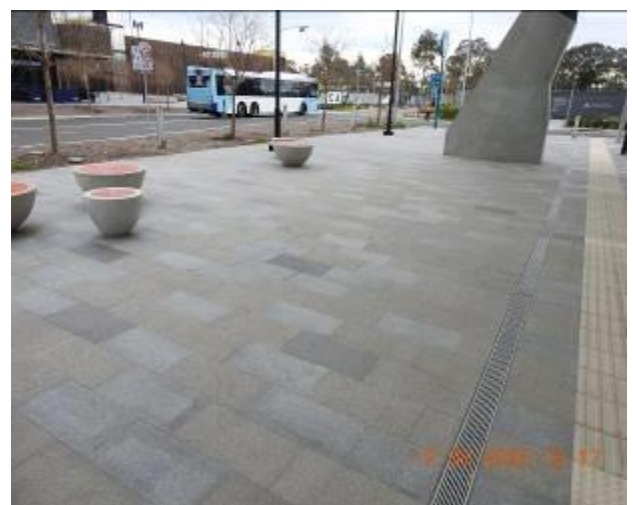
Figure 1929 – General condition of floor tiles

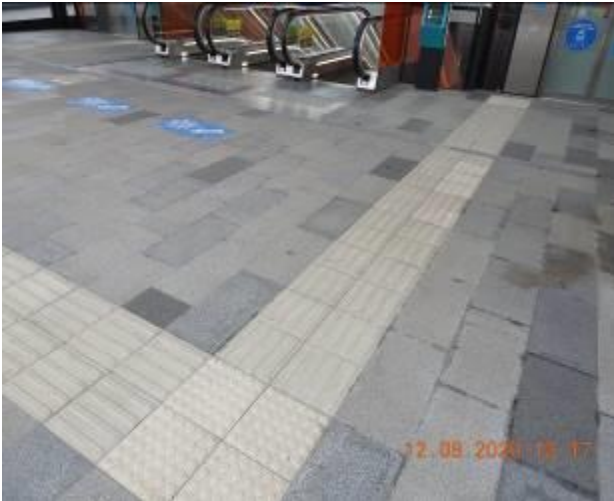
Figure 1930 – General condition of floor tiles

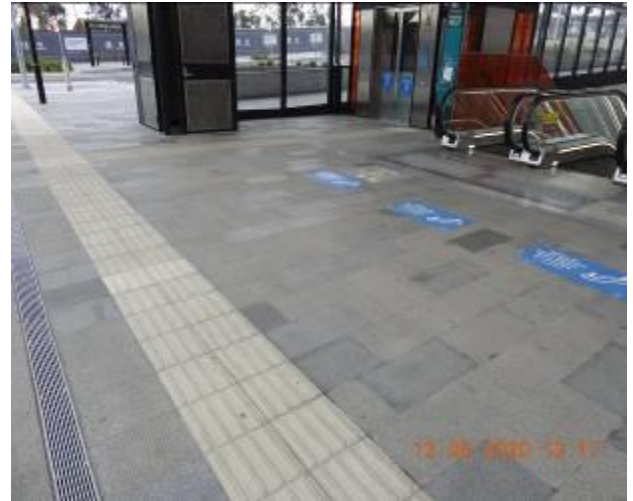
Figure 1931 – General condition of floor tiles

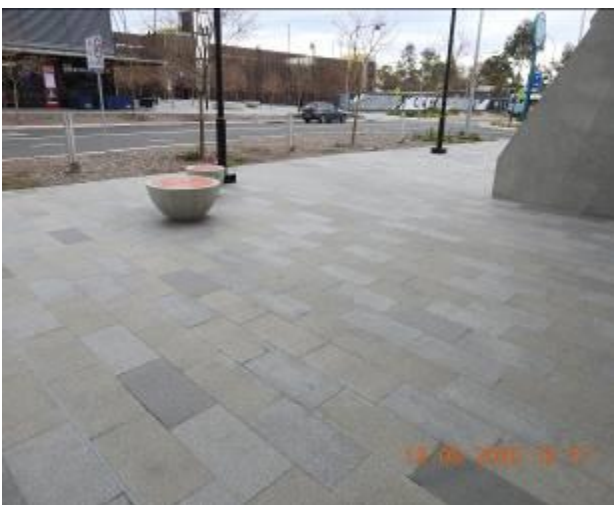
Figure 1932 – General condition of floor tiles

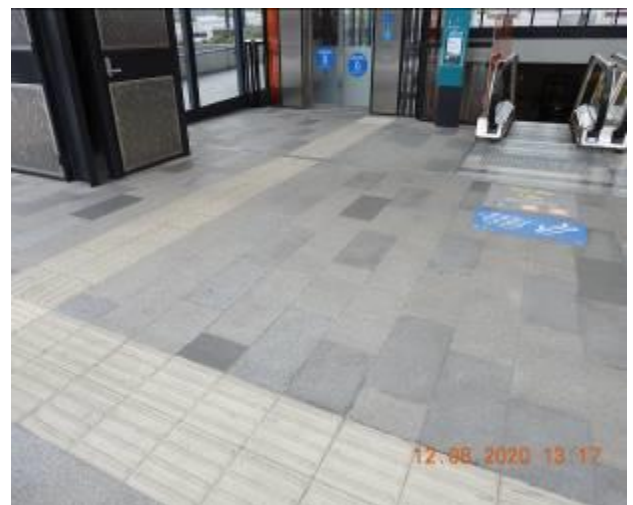
Figure 1933 – General condition of floor tiles

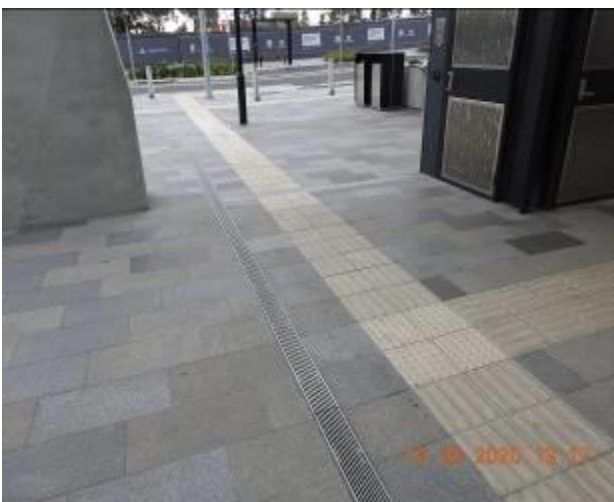
Figure 1934 – General condition of floor tiles

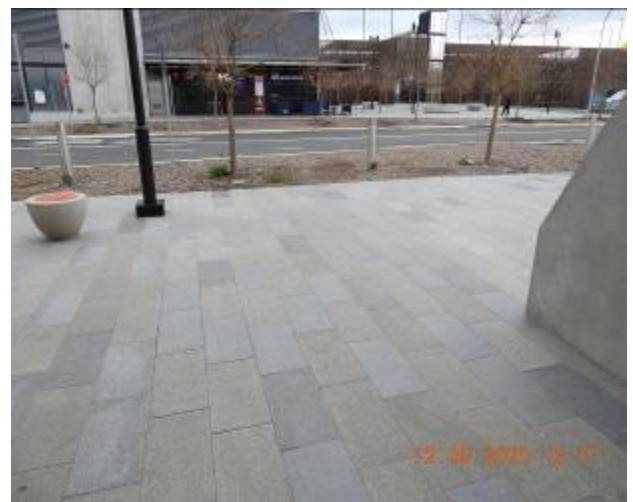
Figure 1935 – General condition of floor tiles

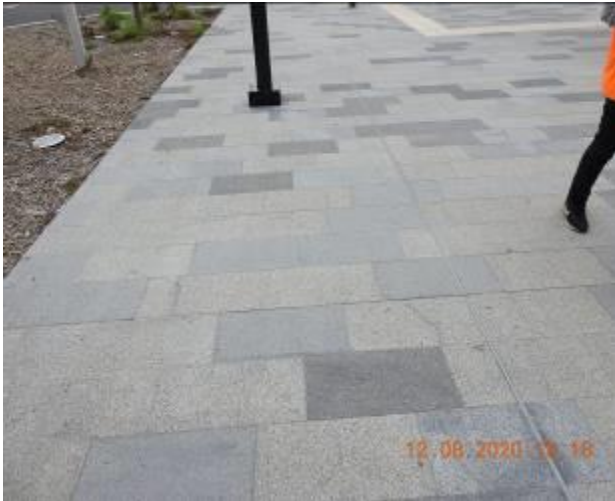
Figure 1936 – Loss of material through floor tiles

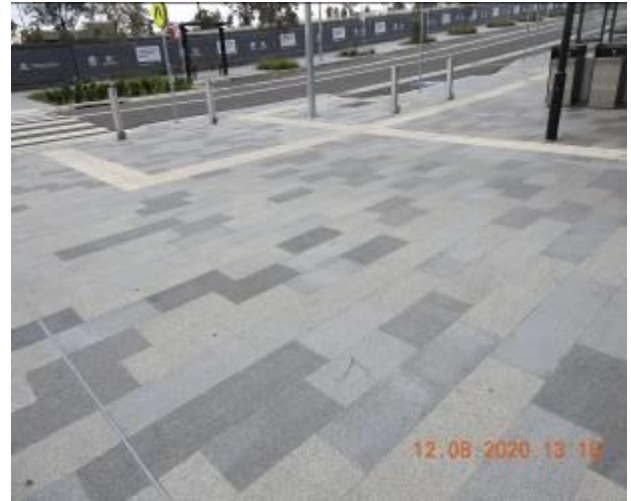
Figure 1937 – Crack propagation through floor tiles

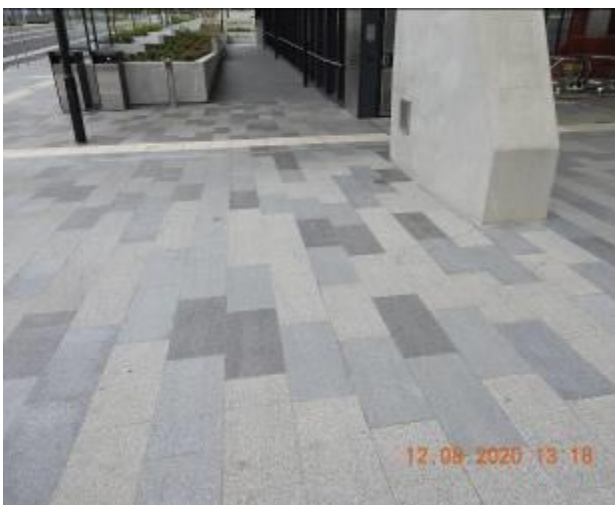
Figure 1938 – Loss of material through floor tiles

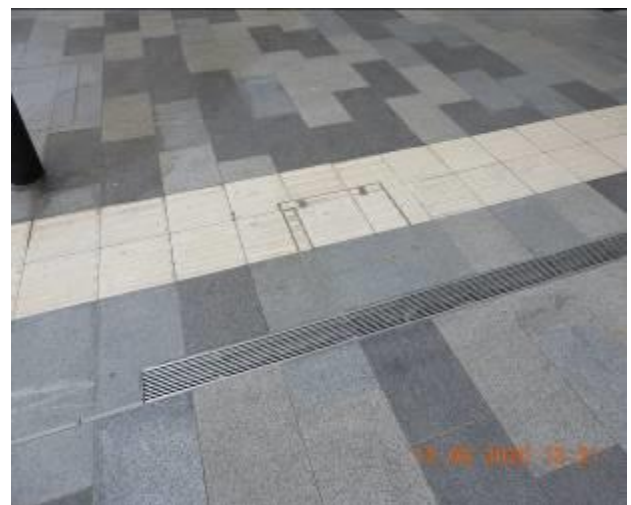
Figure 1939 – General condition of service pit
