**2 MANDALA PARADE, CASTLE HILL
(DORAN DRIVE PRECINCT)
PRE-DILAPIDATION REPORT
Of Sydney Metro and Hills Shire Council Assets
DEICORP PROJECTS SHOWGROUND
PTY LTD.**

Job No. 200124.3
07/07/2021

ACE Structural Services Pty Ltd

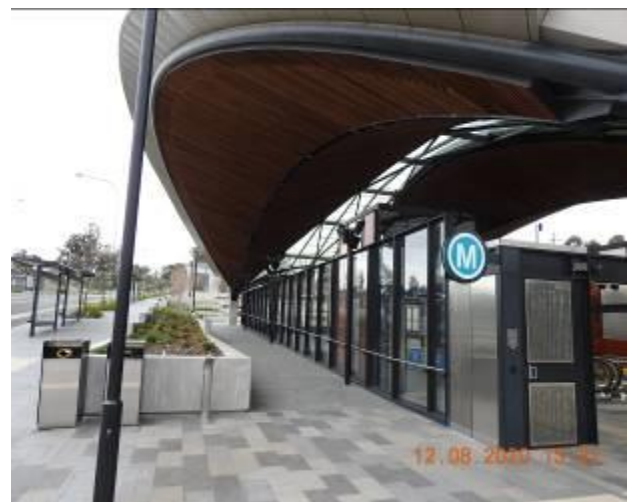
Figure 1941 – General condition of Northern façade

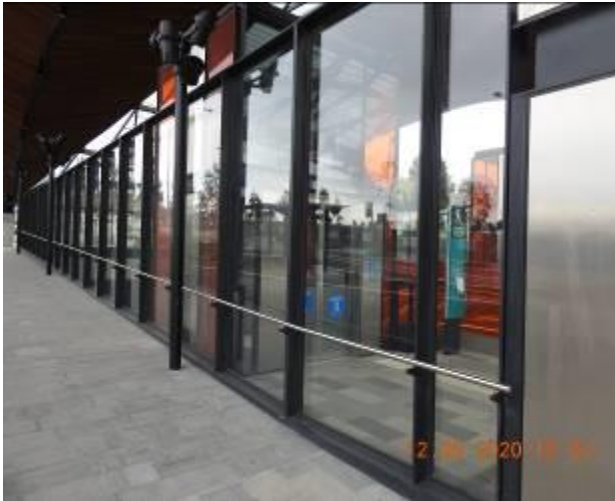
Figure 1942 – General condition of external glass wall

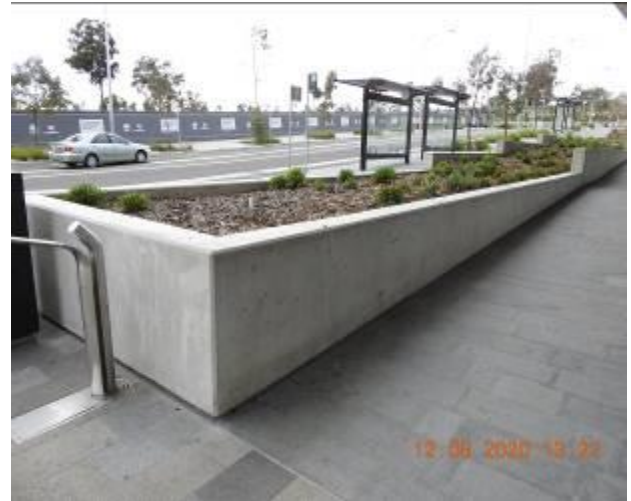
Figure 1943 – General condition of retaining wall

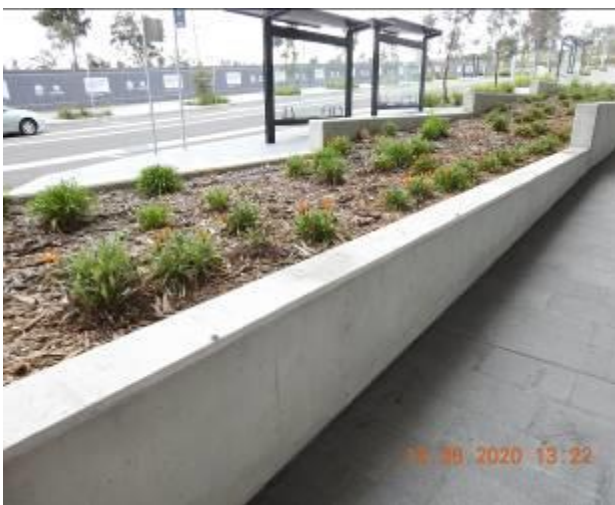
Figure 1944 – General condition of retaining wall

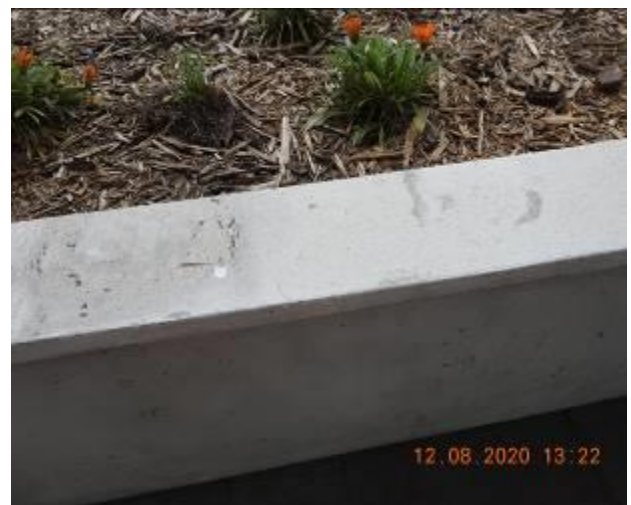
Figure 1945 – Crack propagation and loss of material through retaining wall

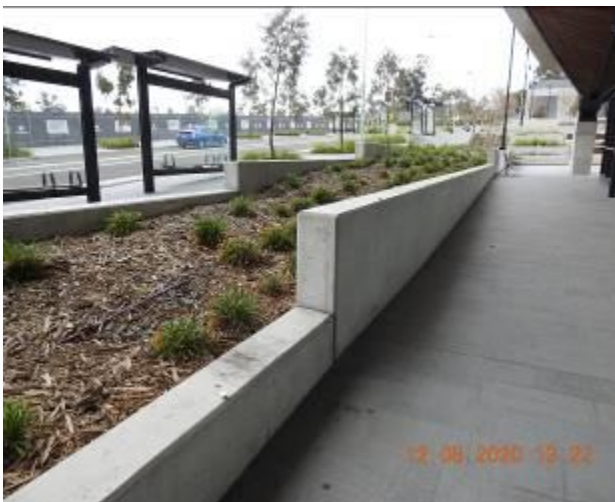
Figure 1946 – General condition of retaining wall

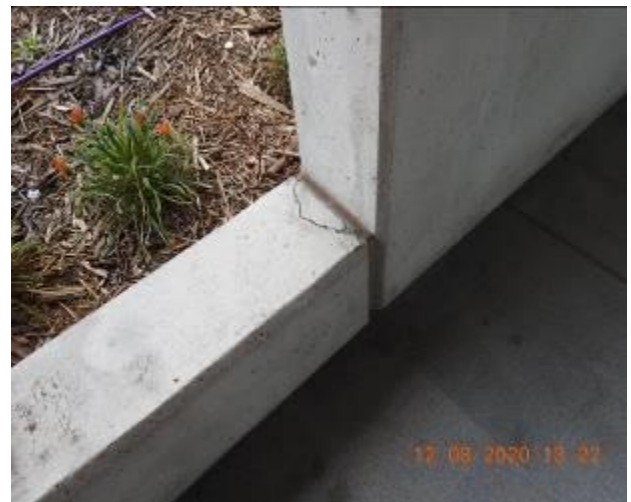
Figure 1947 – Crack propagation and loss of material through retaining wall

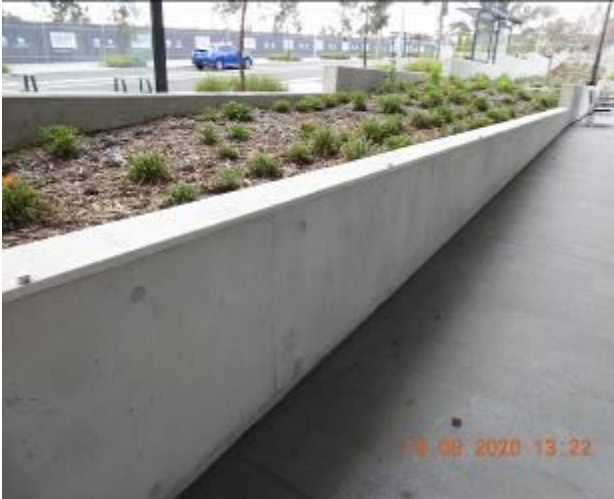
Figure 1948 – General condition of retaining wall

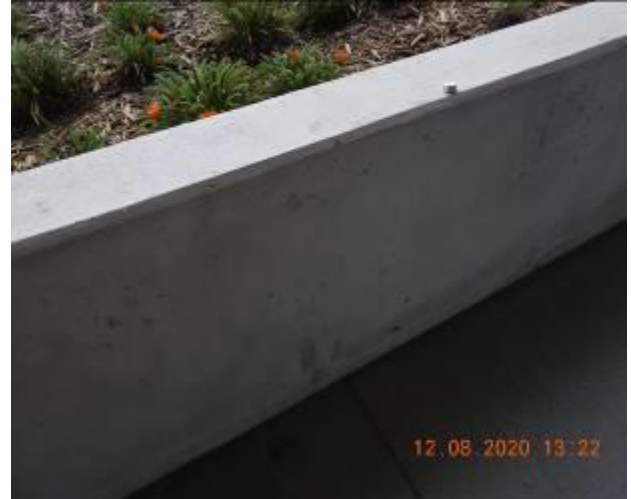
Figure 1949 – Crack propagation through retaining wall

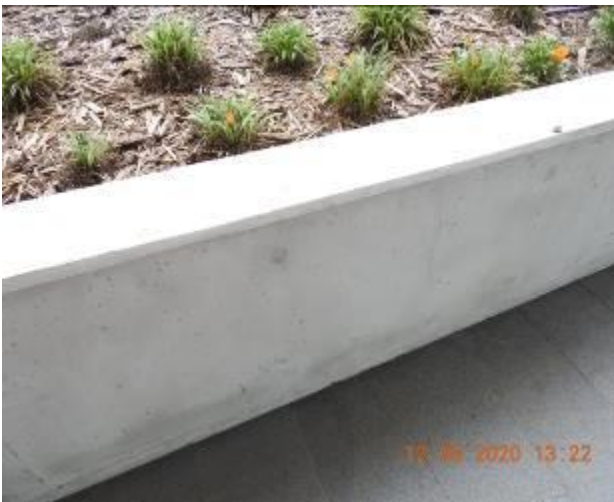
Figure 1950 – Crack propagation through retaining wall

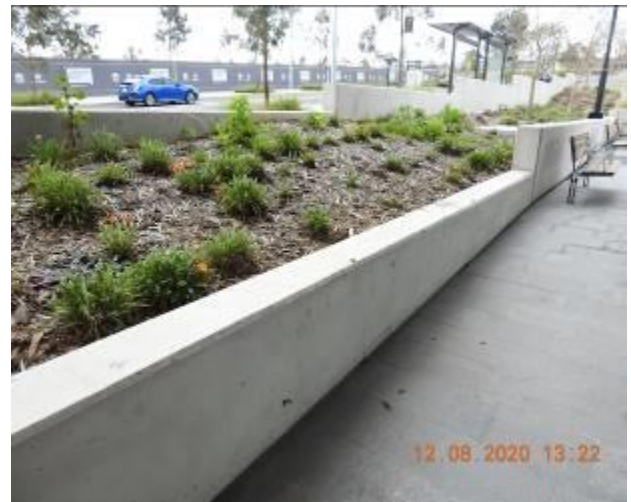
Figure 1951 – General condition of retaining wall

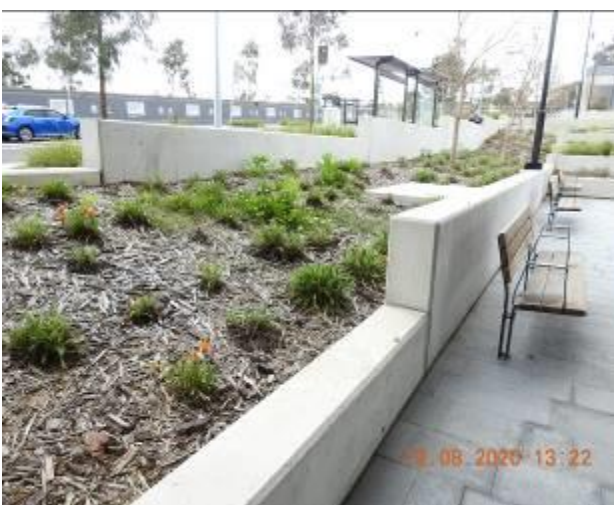
Figure 1952 – General condition of retaining wall

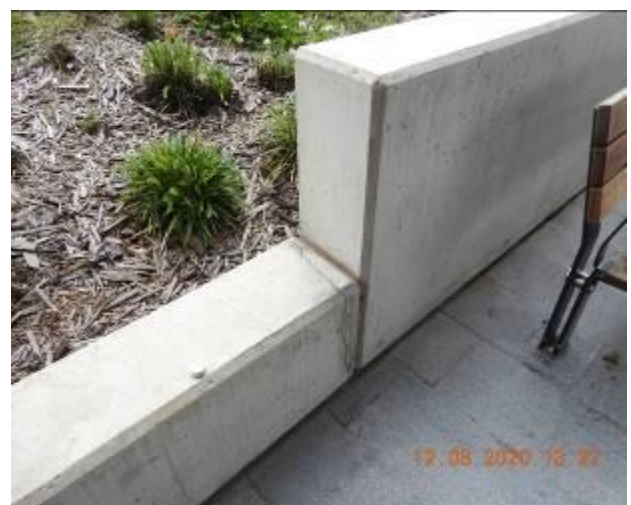
Figure 1953 – Crack propagation and loss of material through retaining wall

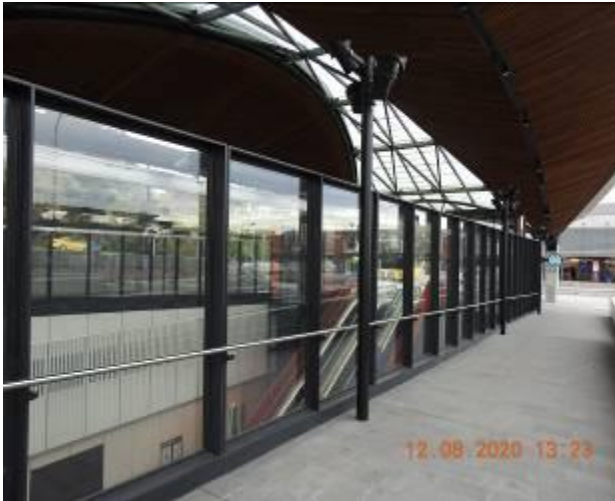
Figure 1954 – General condition of external glass wall

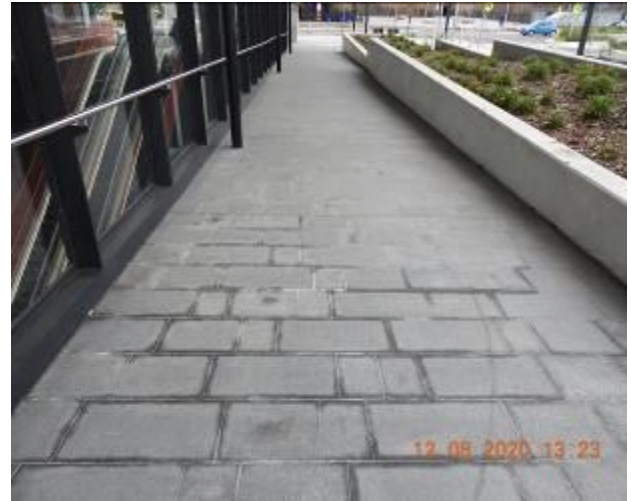
Figure 1955 – General condition of floor tiles

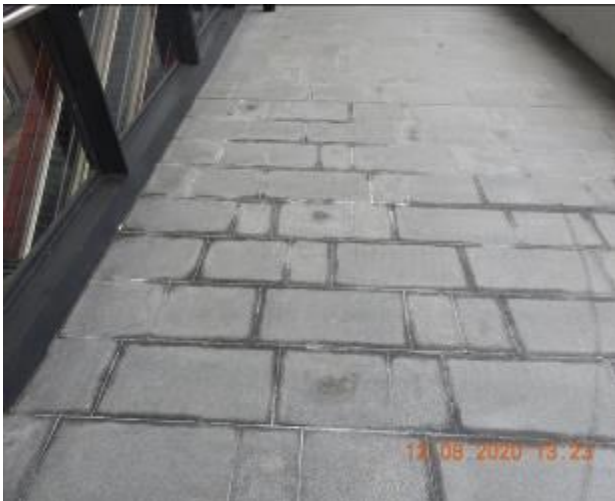
Figure 1956 – Efflorescence, crack propagation and loss of material through floor tiles

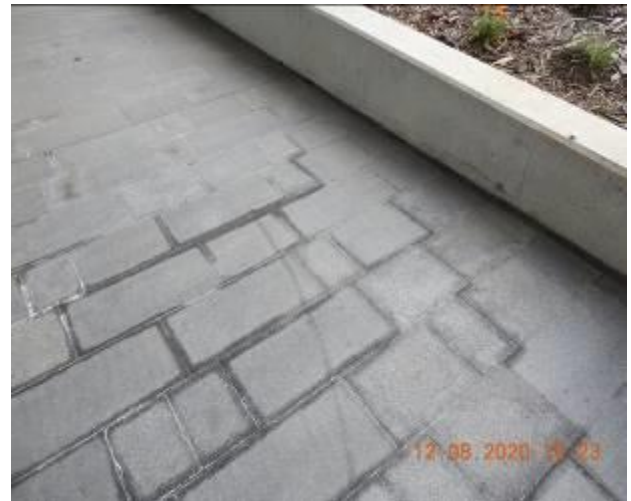
Figure 1957 – Efflorescence, crack propagation and loss of material through floor tiles

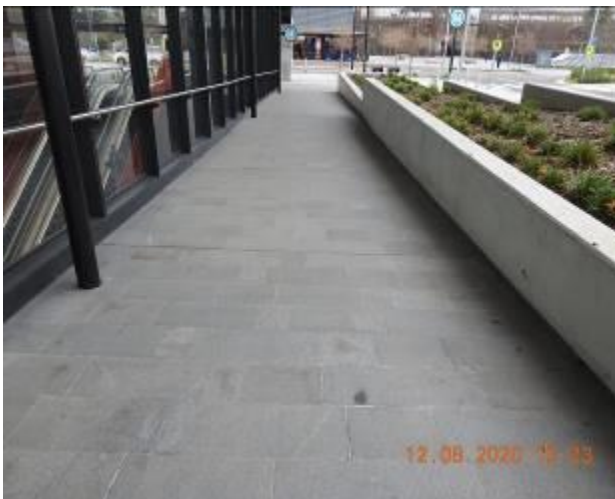
Figure 1958 – Efflorescence through floor tiles

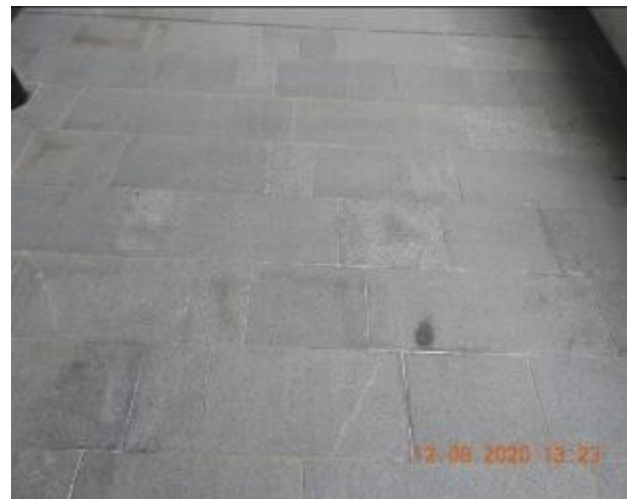
Figure 1959 – Efflorescence and hairline crack propagation through floor tiles

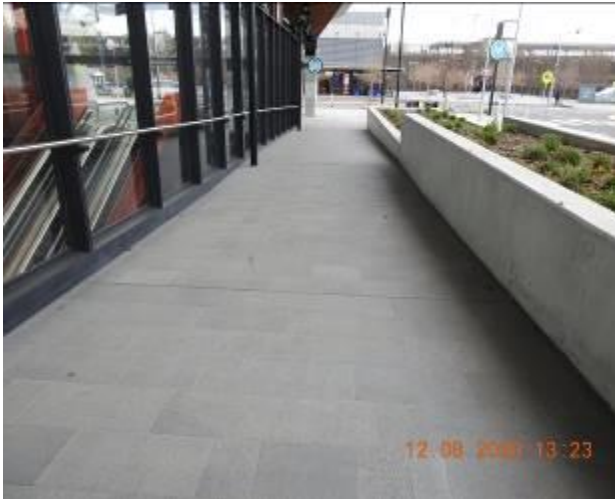
Figure 1960 – General condition of floor tiles

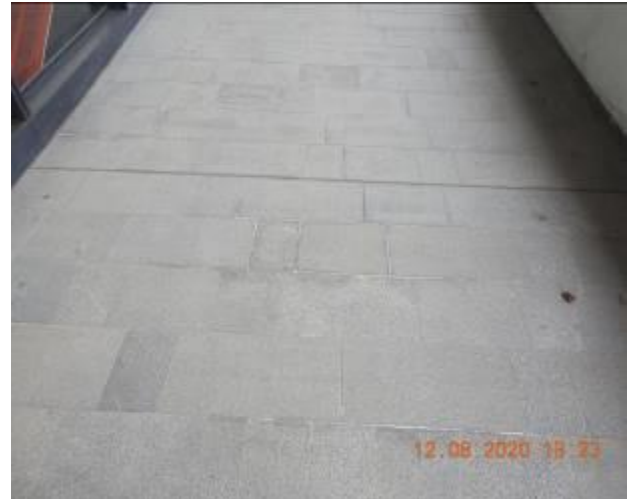
Figure 1961 – Efflorescence through floor tiles

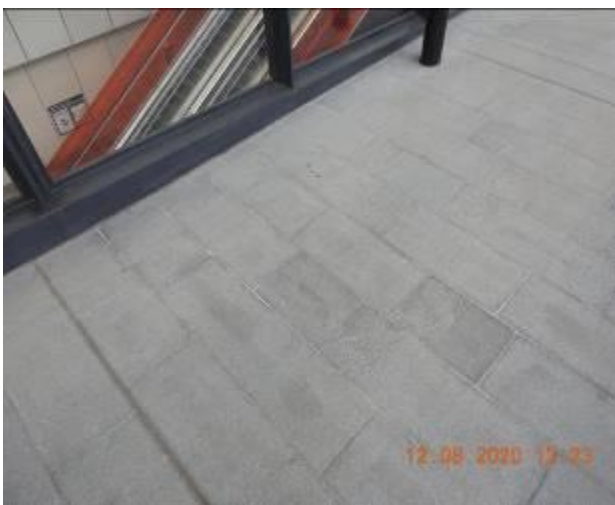
Figure 1962 – Efflorescence through floor tiles

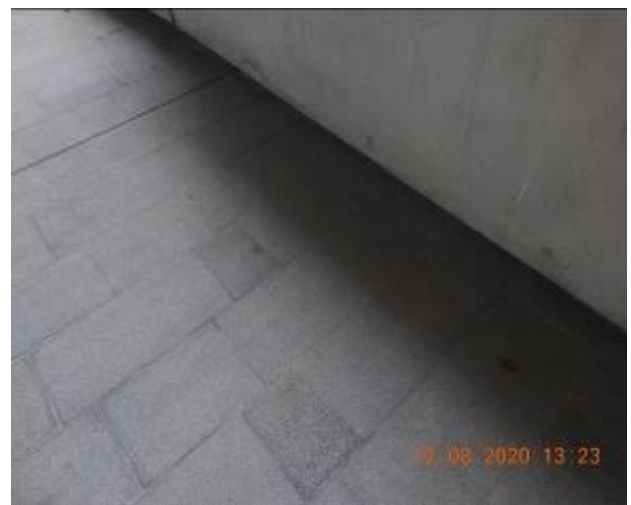
Figure 1963 – Efflorescence through floor tiles

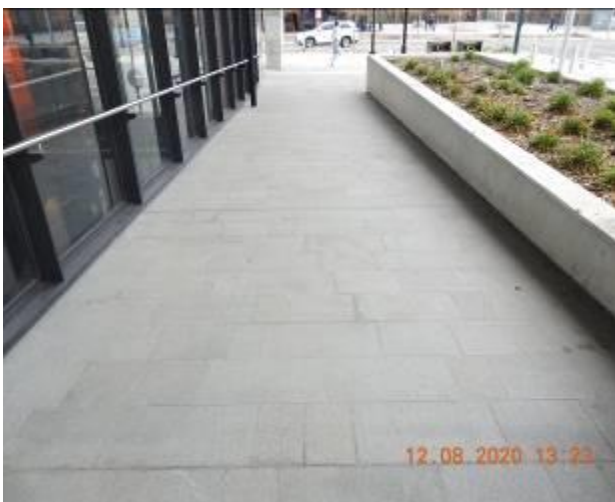
Figure 1964 – General condition of floor tiles

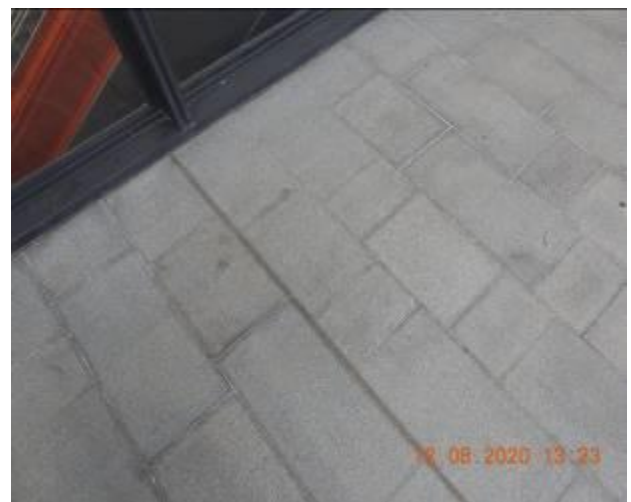
Figure 1965 – Efflorescence through floor tiles

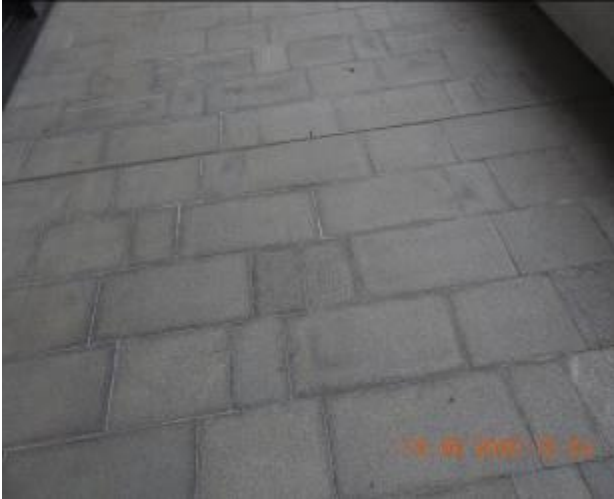
Figure 1966 – Efflorescence through floor tiles

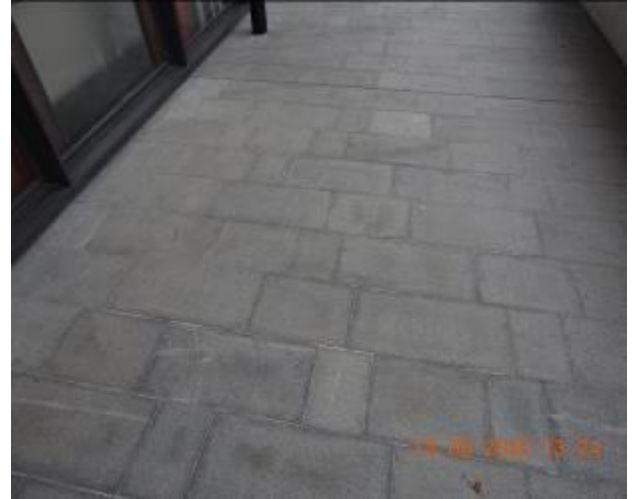
Figure 1967 – Efflorescence and hairline crack propagation through floor tiles

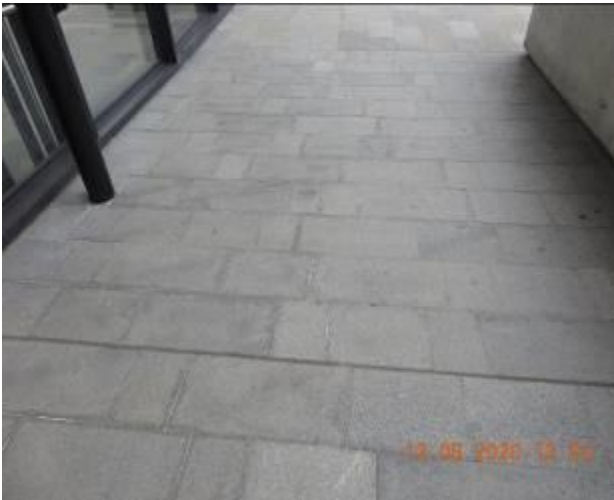
Figure 1968 – Efflorescence through floor tiles

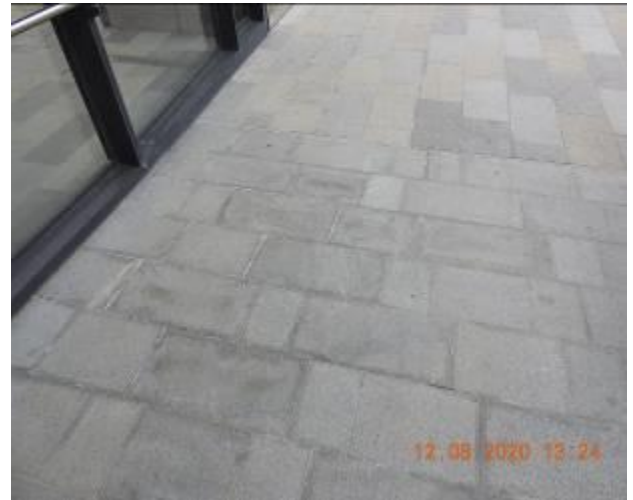
Figure 1969 – Efflorescence and loss of material through floor tiles

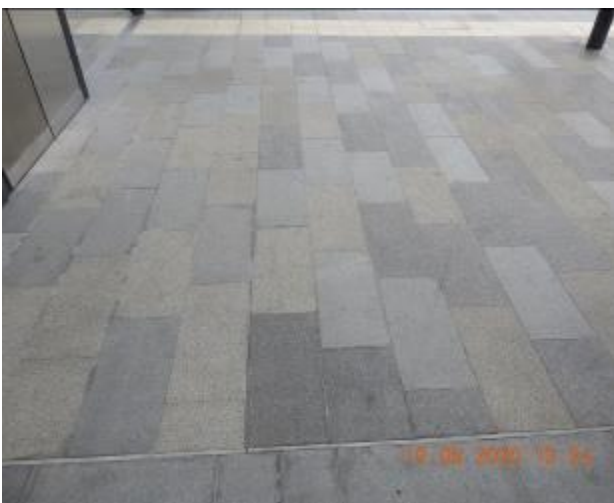
Figure 1970 – General condition of floor tiles

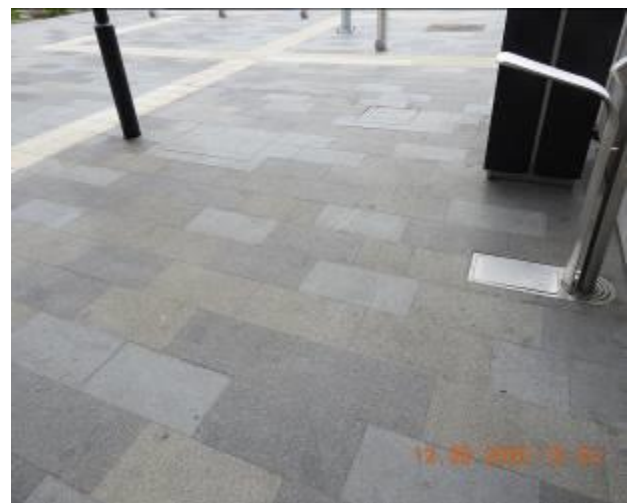
Figure 1971 – General condition of floor tiles

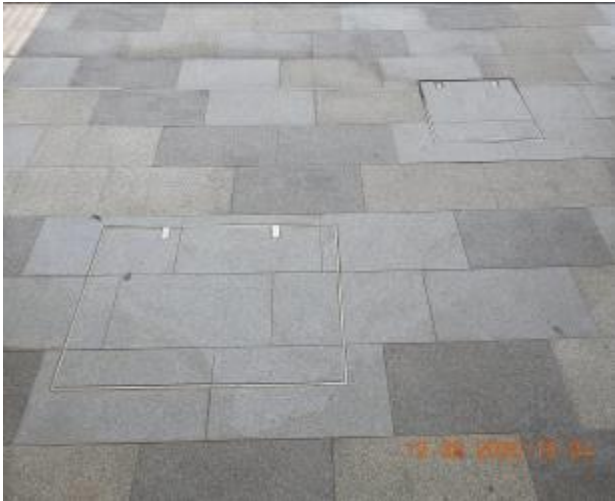
Figure 1972 – General condition of service pit

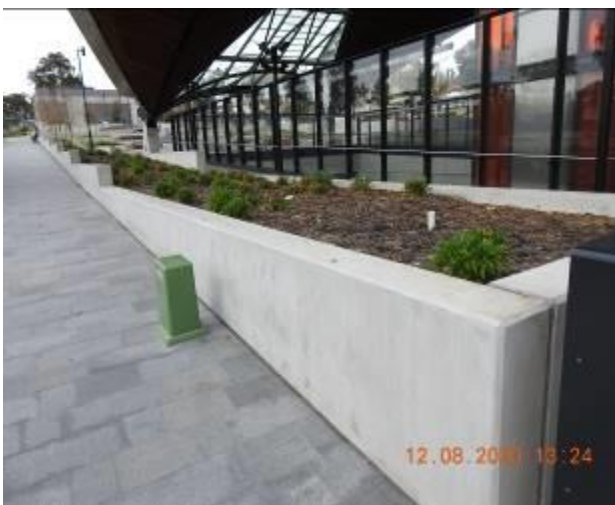
Figure 1974 – General condition of retaining wall

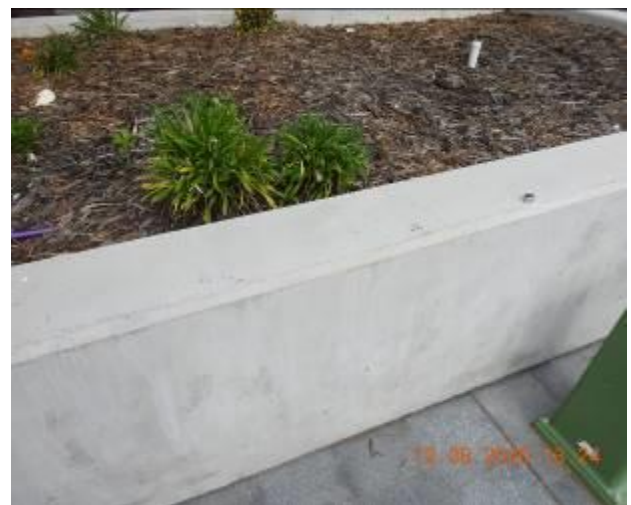
Figure 1975 – Crack propagation through retaining wall

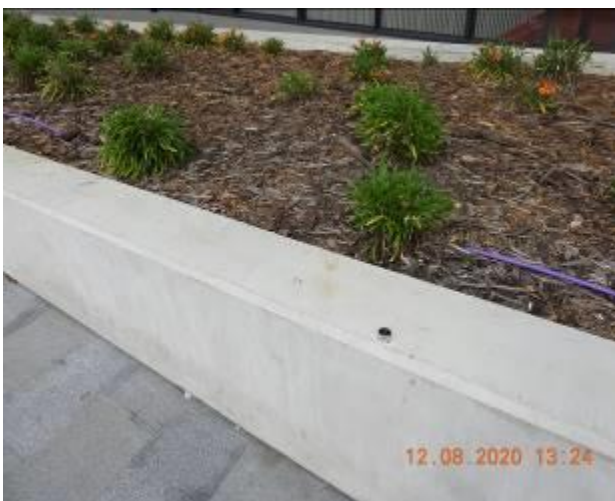
Figure 1976 – Crack propagation through retaining wall

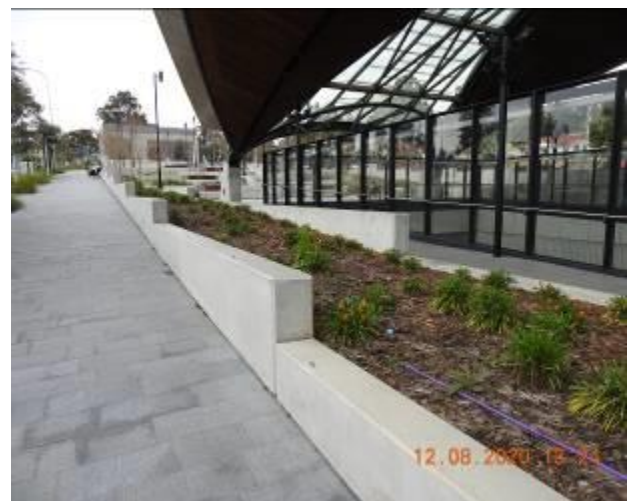
Figure 1977 – General condition of retaining wall

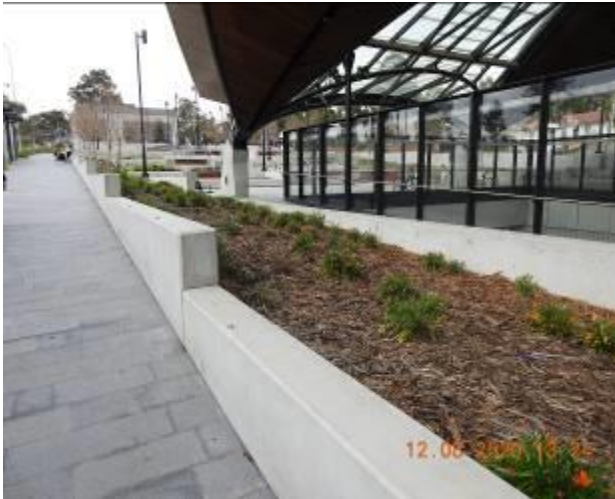
Figure 1978 – General condition of retaining wall

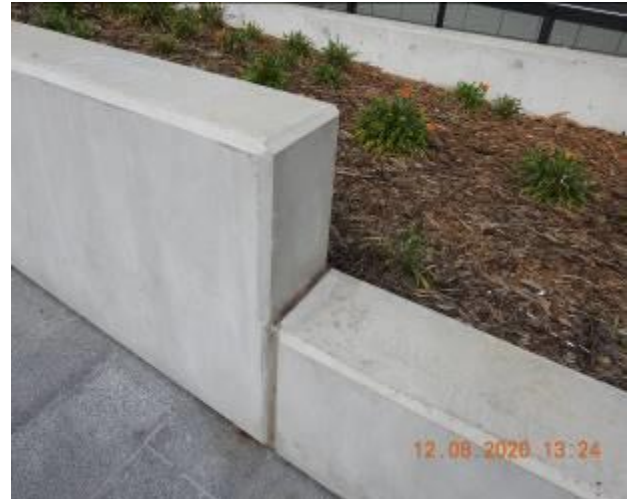
Figure 1979 – Crack propagation and loss of material through retaining wall

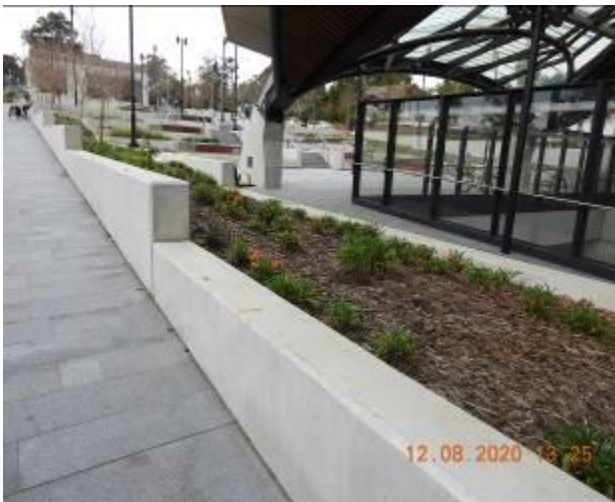
Figure 1980 – Crack propagation through retaining wall

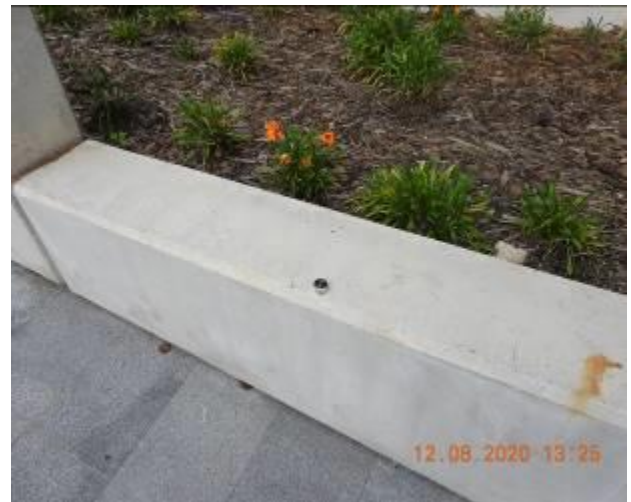
Figure 1981 – Loss of material through retaining wall

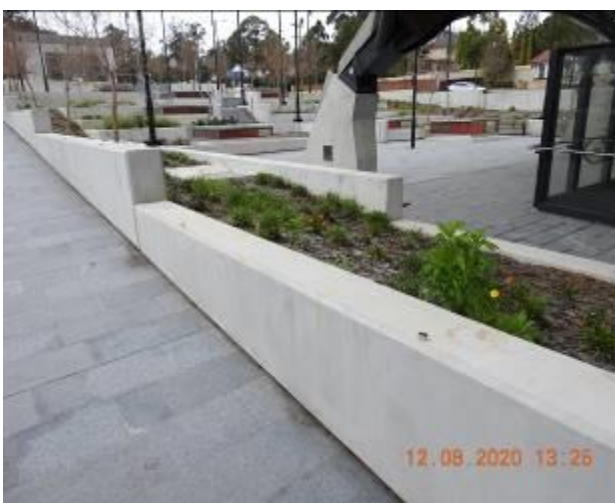
Figure 1982 – General condition of retaining wall

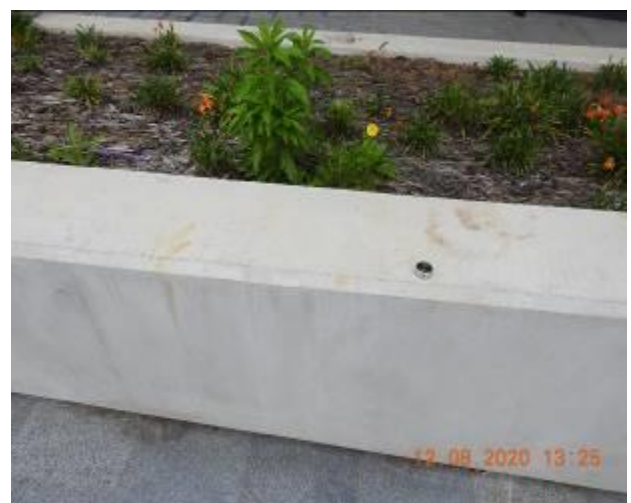
Figure 1983 – Crack propagation through retaining wall

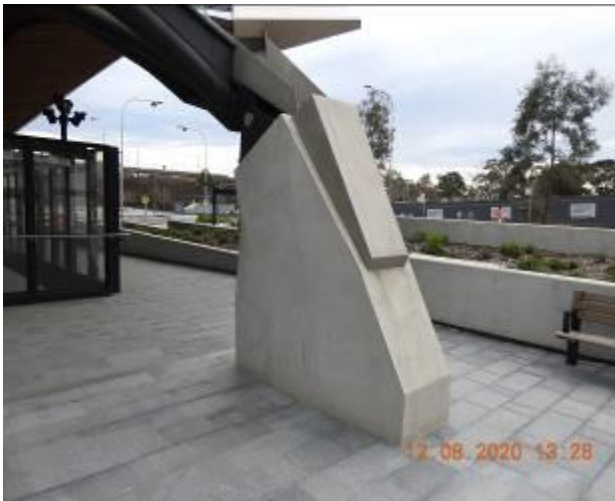
Figure 1985 – General condition of Eastern façade

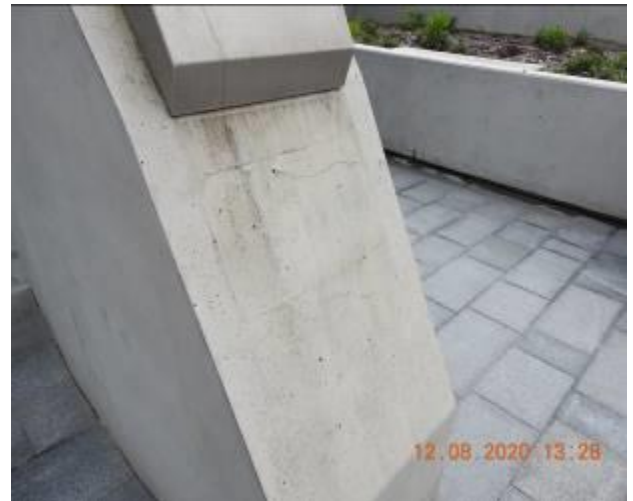
Figure 1986 – General condition of external wall

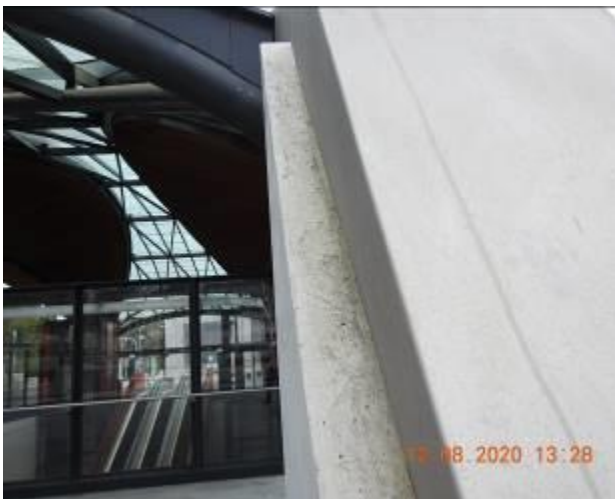
Figure 1987 – Crack propagation and loss of material through external wall

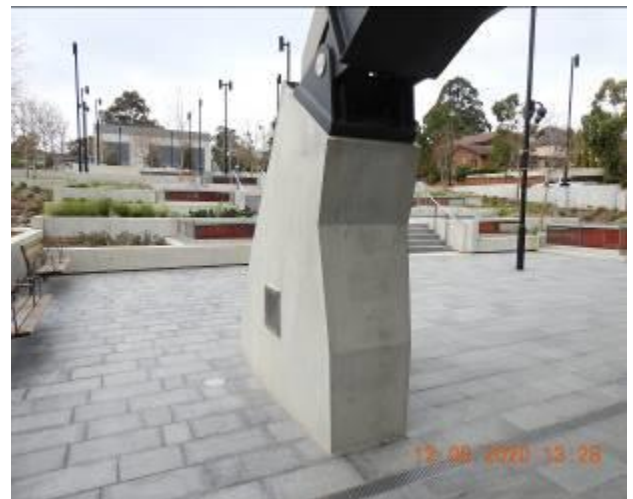
Figure 1988 – Hairline crack propagation and loss of material through external wall

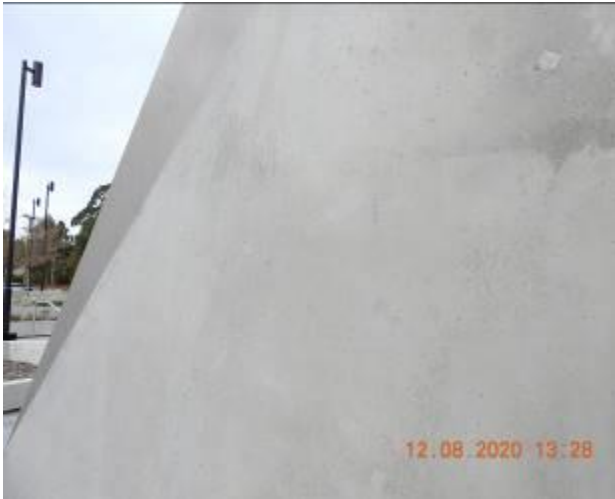
Figure 1989 – General condition of external wall

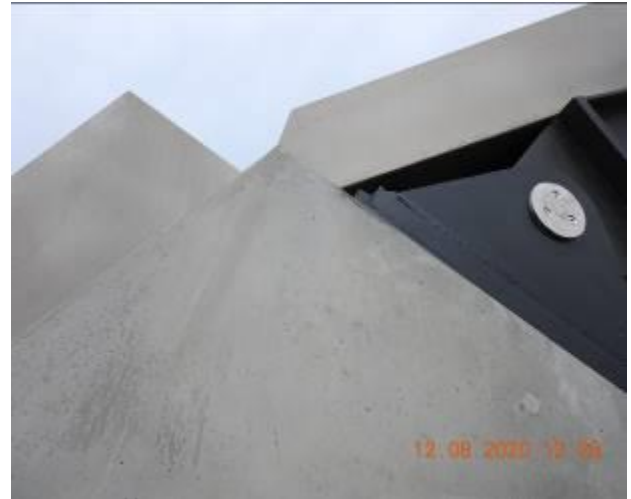
Figure 1990 – Hairline crack propagation through external wall

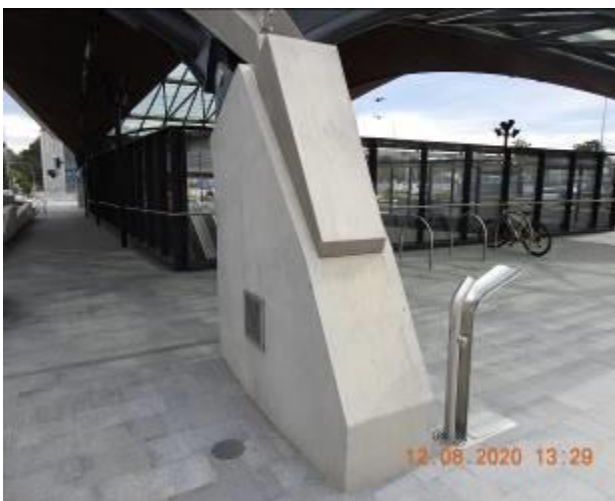
Figure 1993 – General condition of external wall

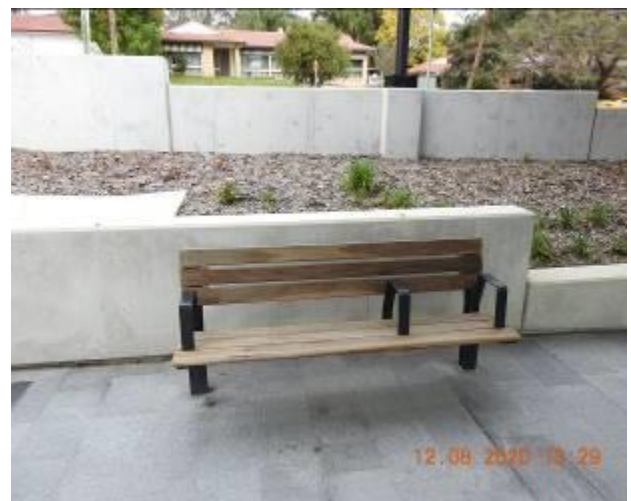
Figure 1994 – General condition of external wall

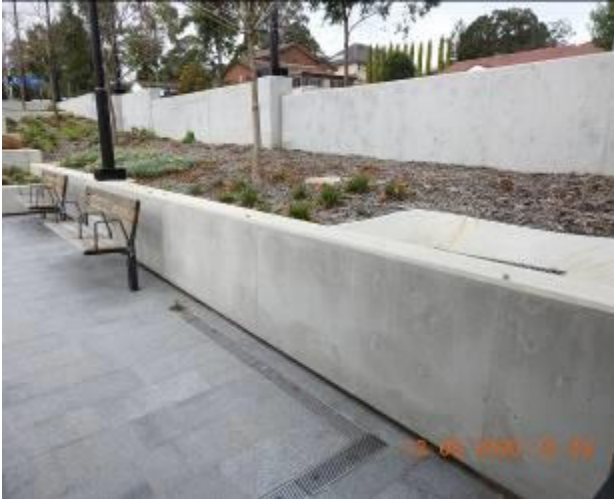
Figure 1995 – General condition of retaining wall

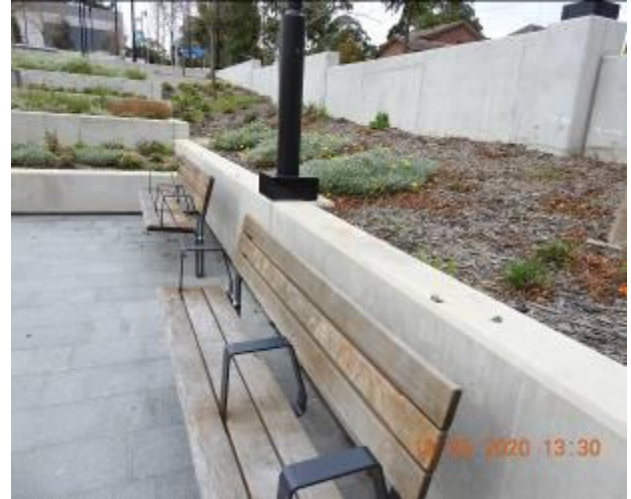
Figure 1996 – General condition of retaining wall

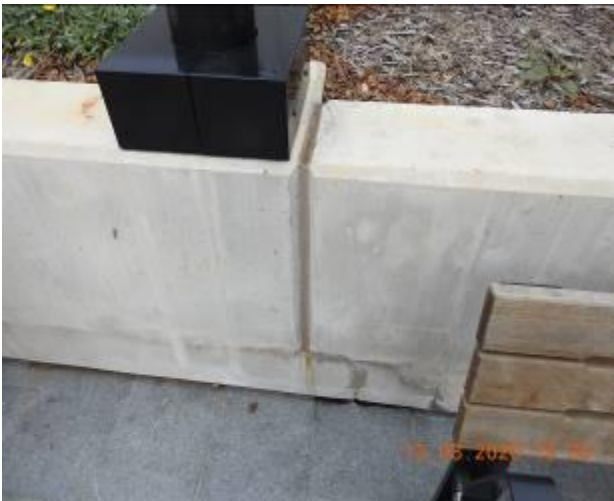
Figure 1997 – General condition of retaining wall

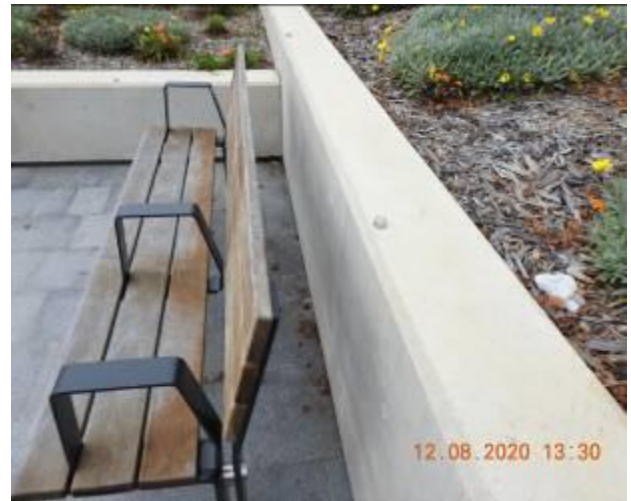
Figure 1998 – Crack propagation and loss of material through retaining wall

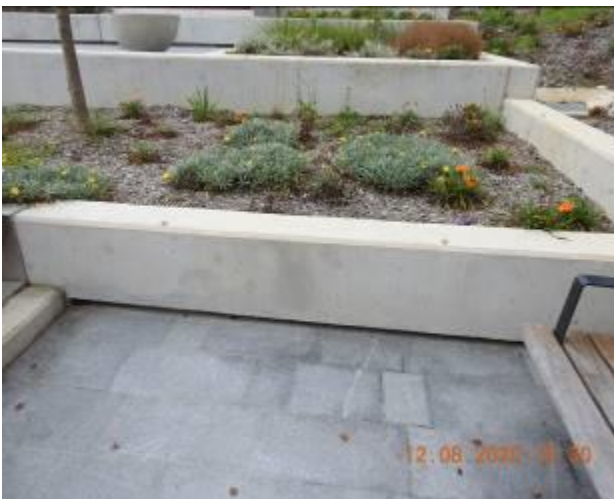
Figure 1999 – General condition of retaining wall

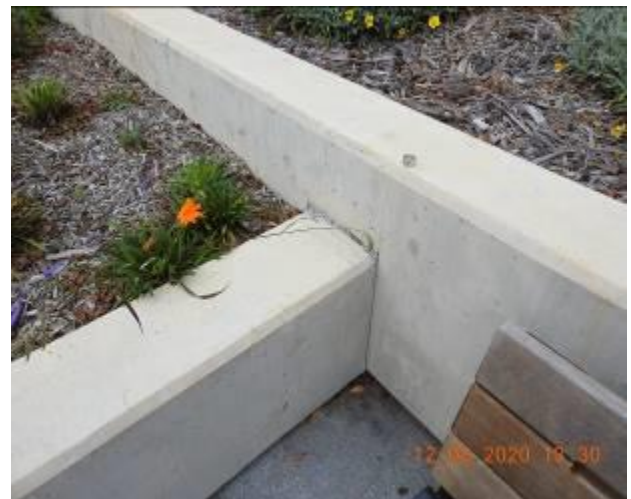
Figure 2000 – General condition of retaining wall

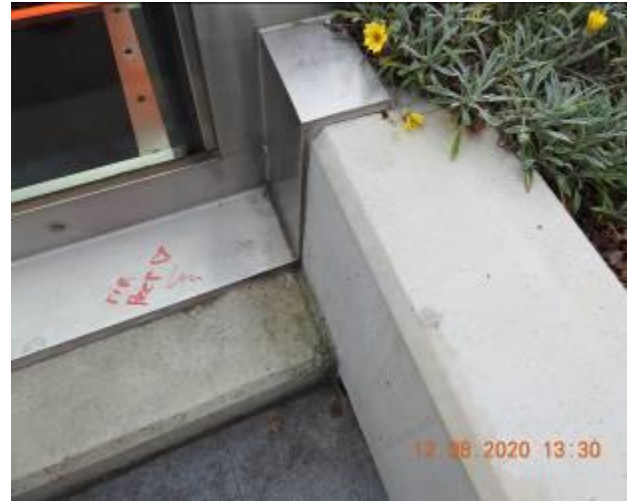
Figure 2002 – General condition of retaining wall

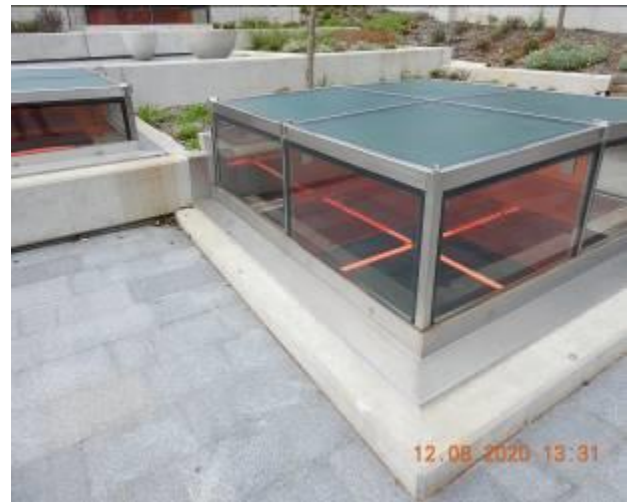
Figure 2004 – General condition of retaining wall

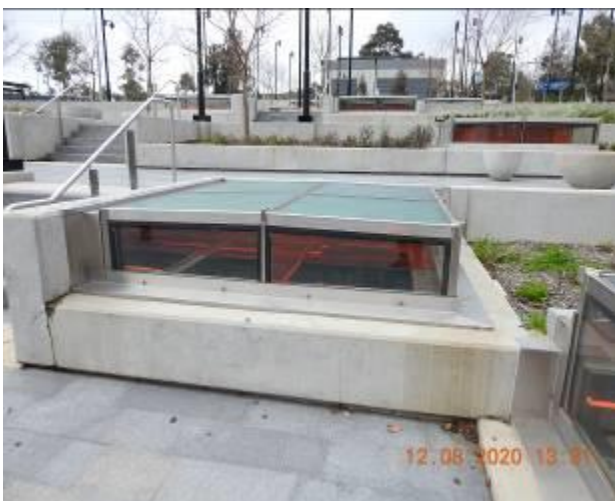
Figure 2005 – General condition of retaining wall

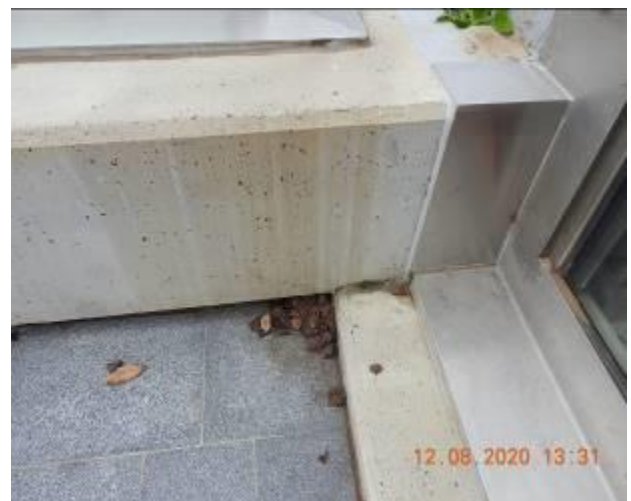
Figure 2006 – General condition of retaining wall

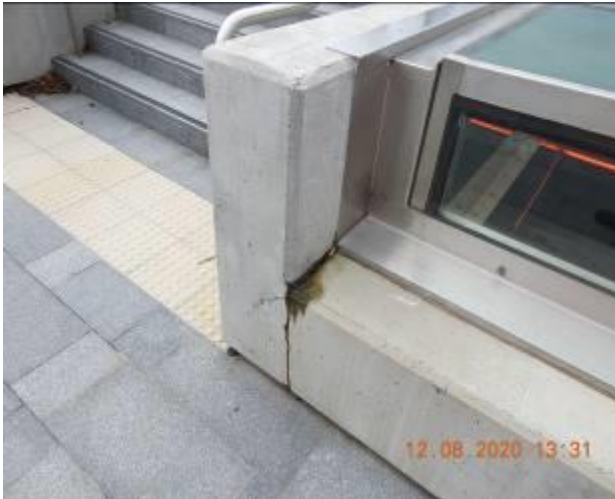
Figure 2007 – Loss of material through retaining wall

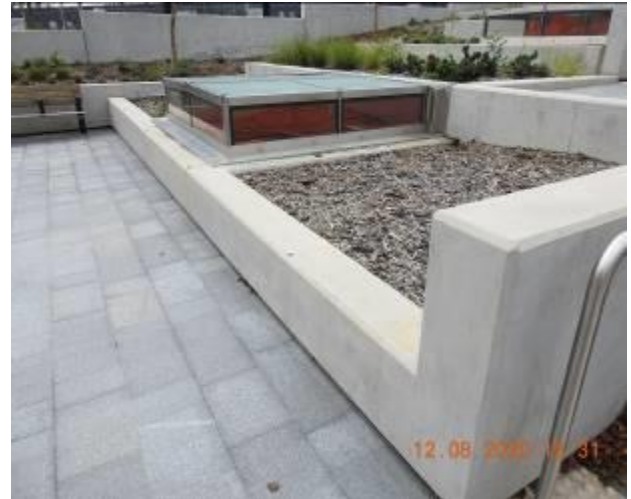
Figure 2008 – Crack propagation through retaining wall

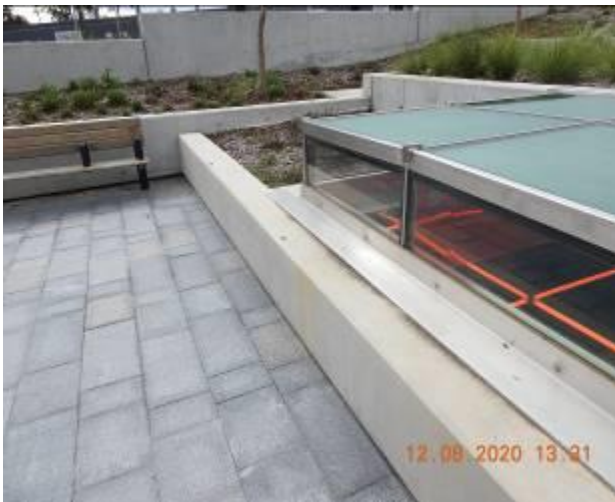
Figure 2009 – General condition of retaining wall

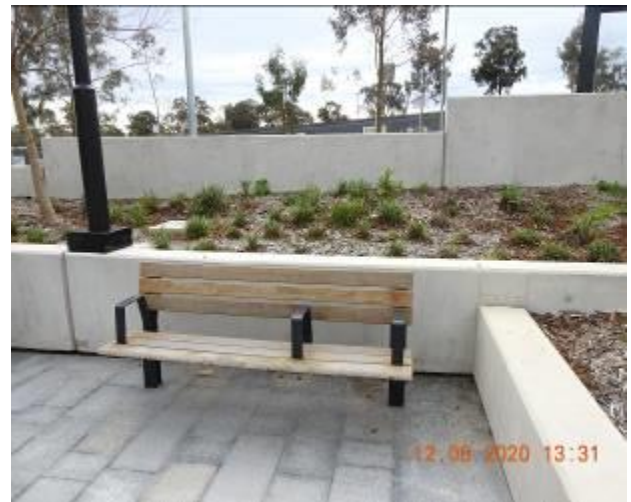
Figure 2100 – General condition of retaining wall

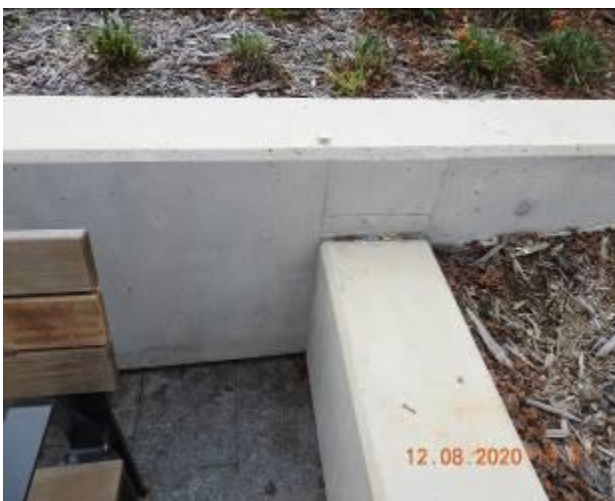
Figure 2011 – General condition of retaining wall

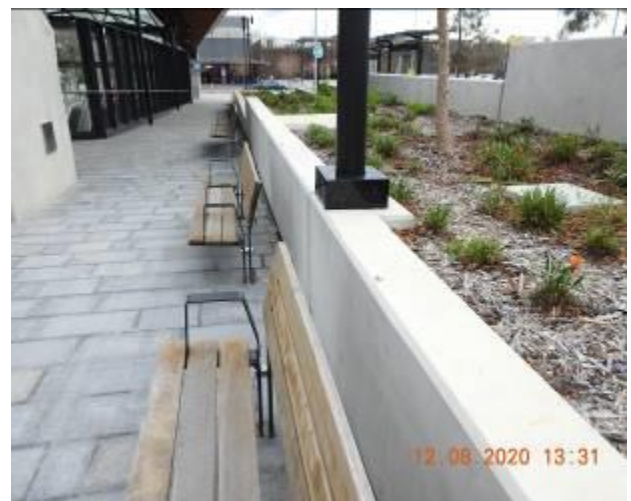
Figure 2012 – Crack propagation and loss of material through retaining wall

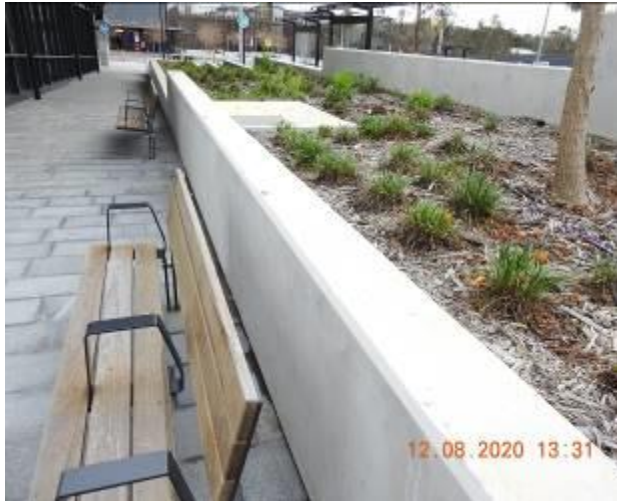
Figure 2013 – General condition of retaining wall

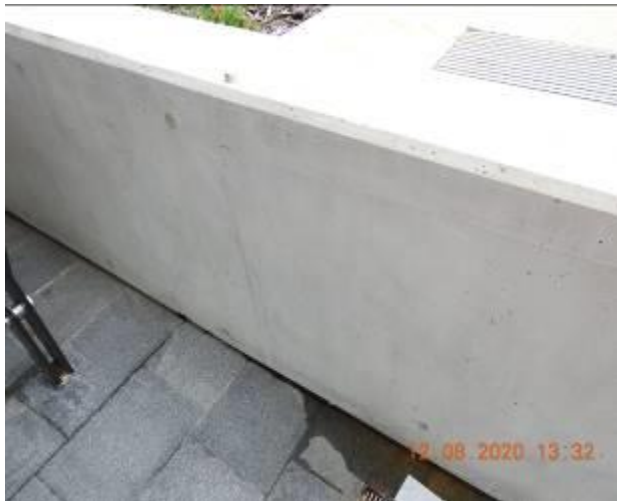
Figure 2014 – General condition of retaining wall

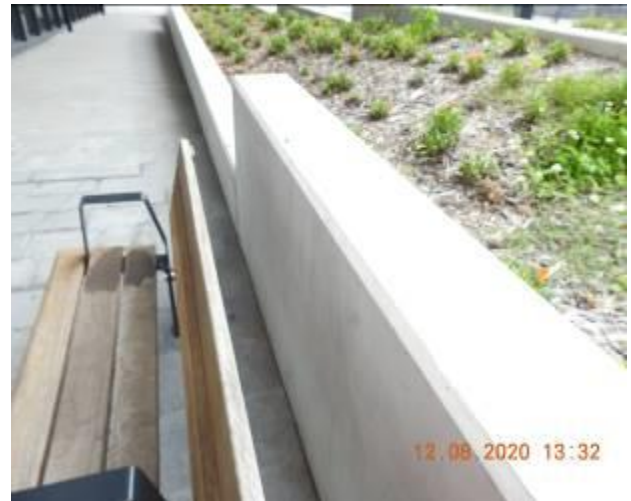
Figure 2015 – General condition of retaining wall

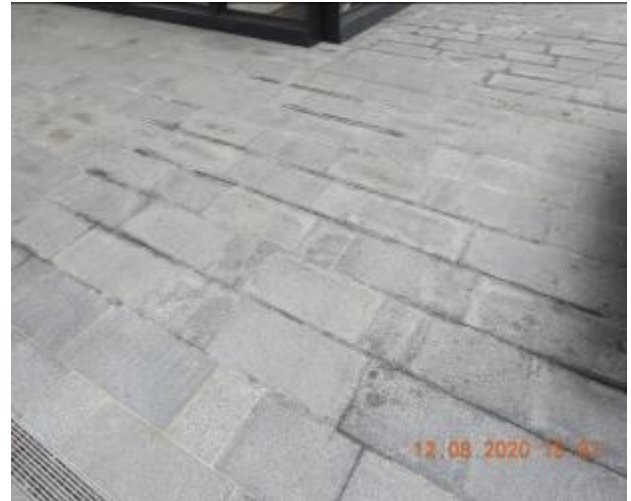
Figure 2020 – General condition of floor tiles
