**2 MANDALA PARADE, CASTLE HILL
(DORAN DRIVE PRECINCT)
PRE-DILAPIDATION REPORT
Of Sydney Metro and Hills Shire Council Assets
DEICORP PROJECTS SHOWGROUND
PTY LTD.**

Job No. 200124.3
07/07/2021

ACE Structural Services Pty Ltd

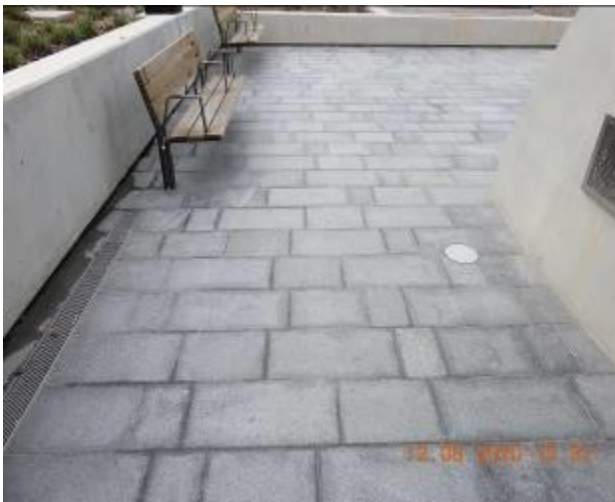
Figure 2021 – Efflorescence and loss of material through floor tiles

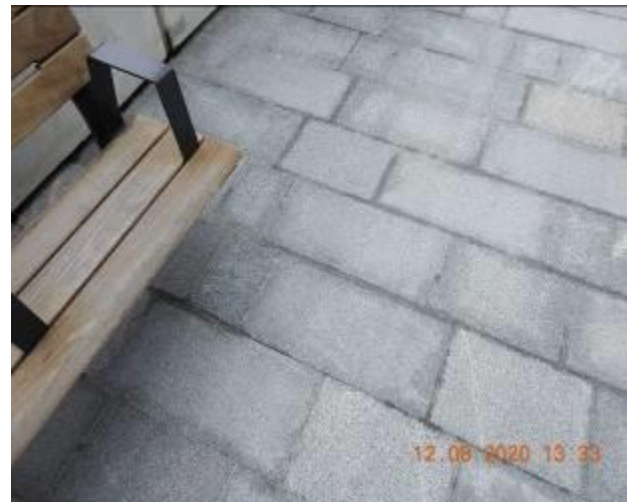
Figure 2022 – General condition of floor tiles

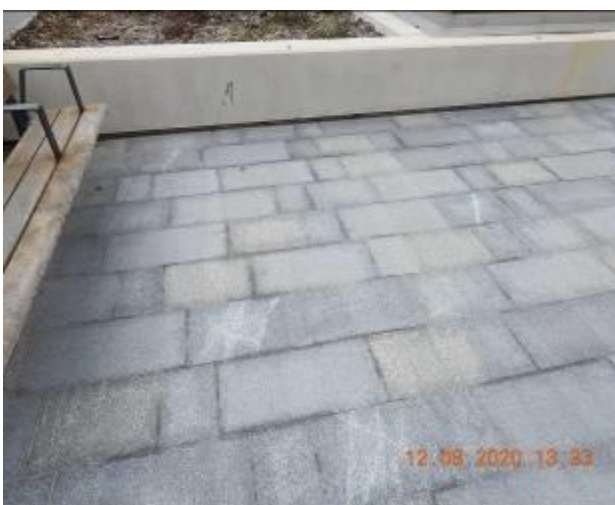
Figure 2023 – Hairline crack propagation and loss of material through floor tiles

It is important to note that multiple cases of hairline cracking, efflorescence and material loss through the floor tiles were observed at the time of inspection.

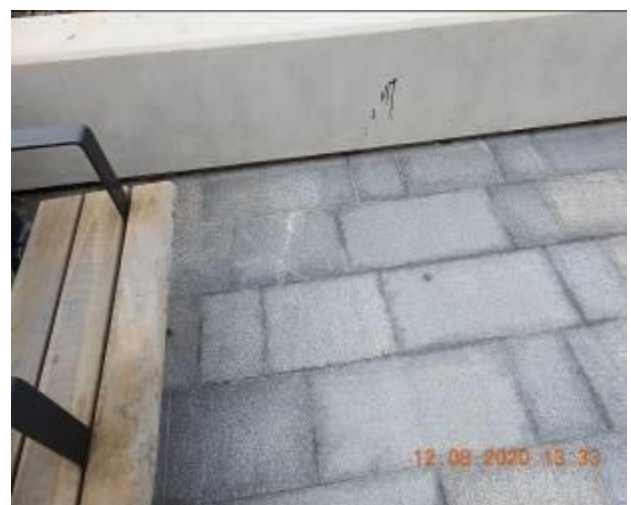
Figure 2024 – Hairline crack propagation through floor tiles

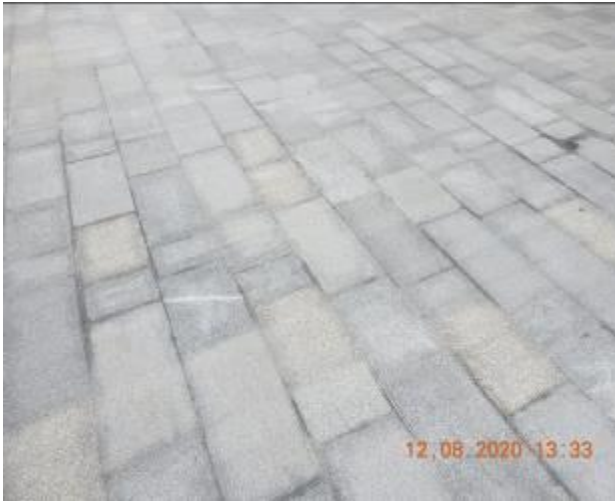
Figure 2025 – Hairline crack propagation through floor tiles

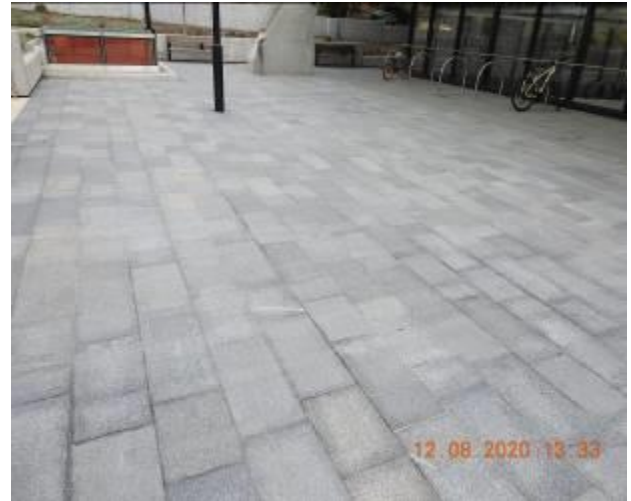
Figure 2026 – Hairline crack propagation and loss of material through floor tiles

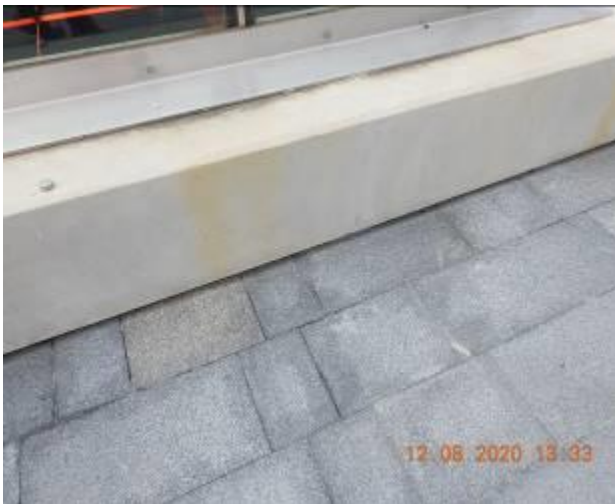
Figure 2027 – Hairline crack propagation and loss of material through floor tiles

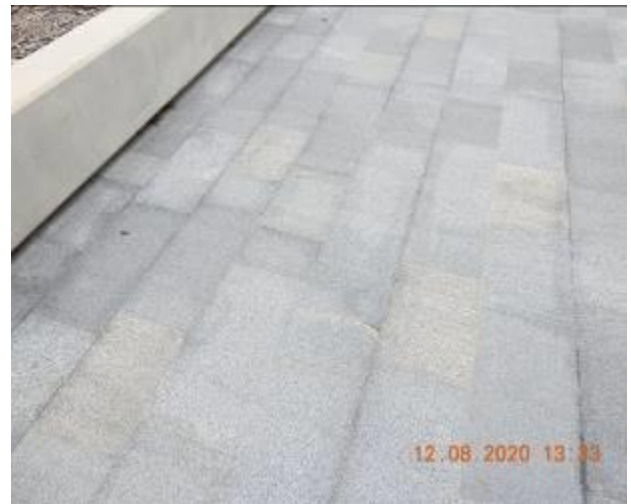
Figure 2028 – Loss of material through floor tiles

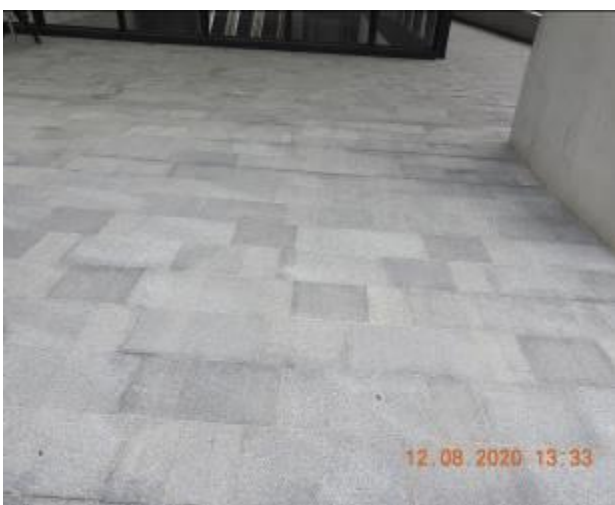
Figure 2029 – Crack propagation and loss of material through floor tiles

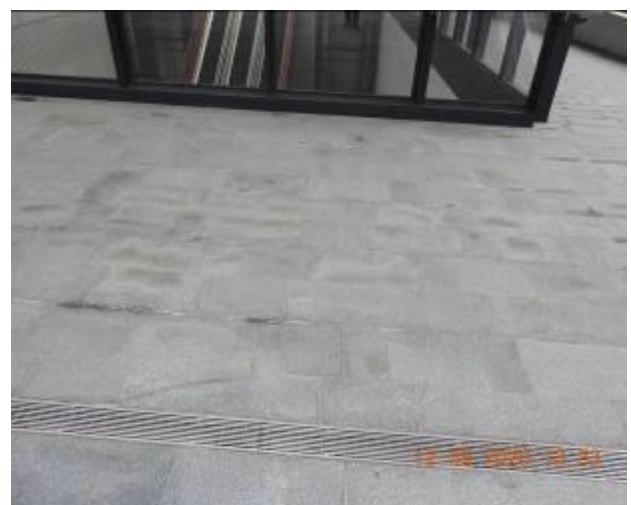
Figure 2030 – Hairline crack propagation through floor tiles

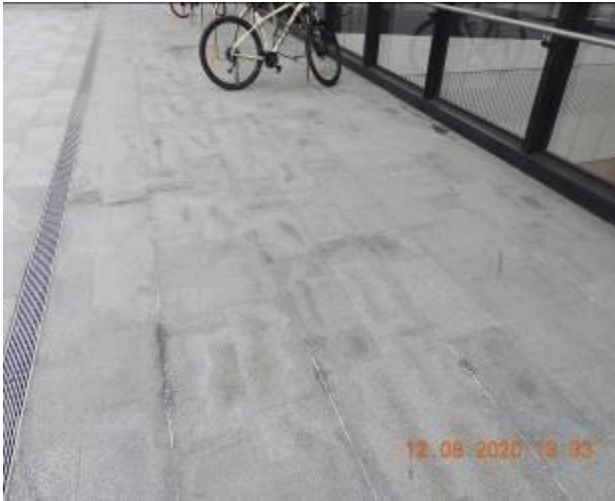
Figure 2031 – Efflorescence and hairline crack propagation through floor tiles

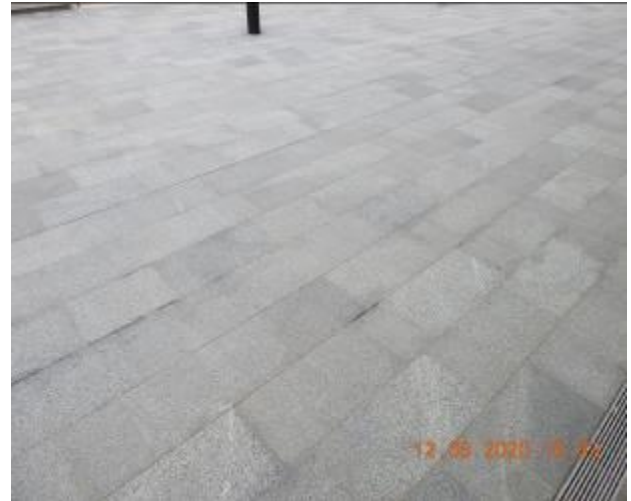
Figure 2032 – Efflorescence and loss of material through floor tiles

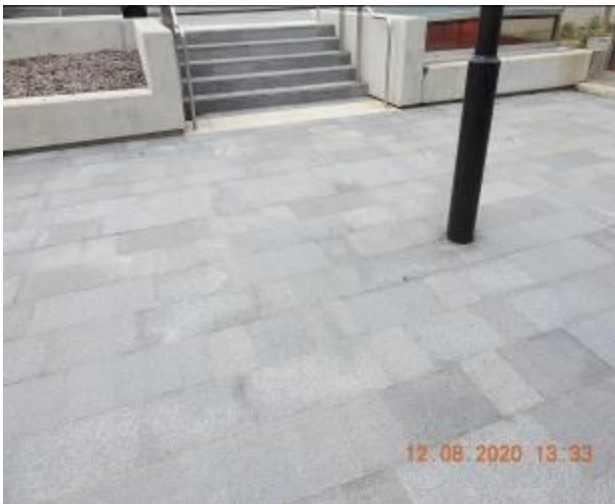
Figure 2033 – Crack propagation through floor tiles

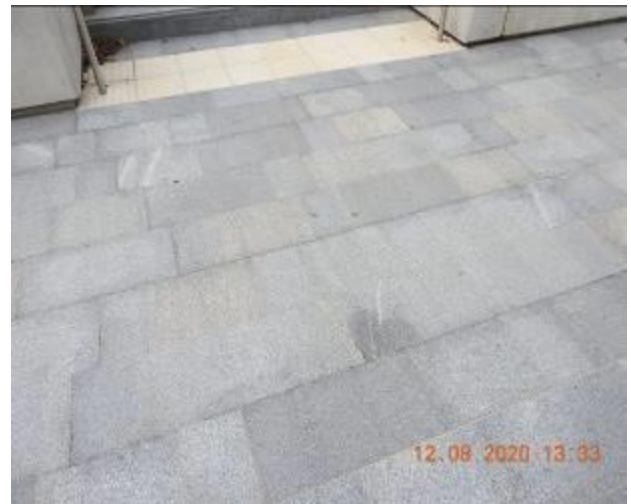
Figure 2034 – General condition of floor tiles

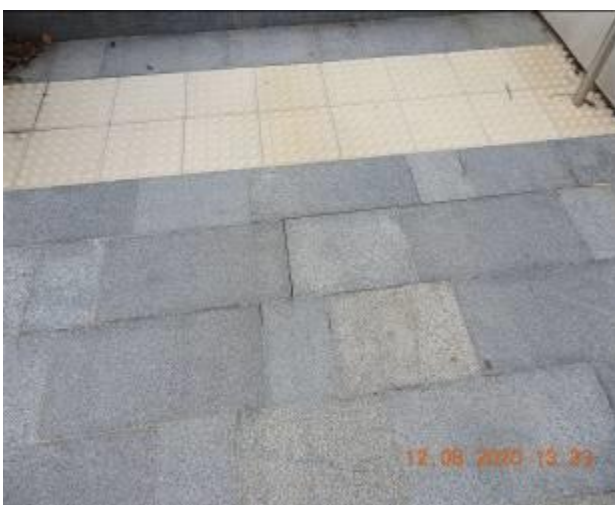
Figure 2035 – Crack propagation and loss of material through floor tiles

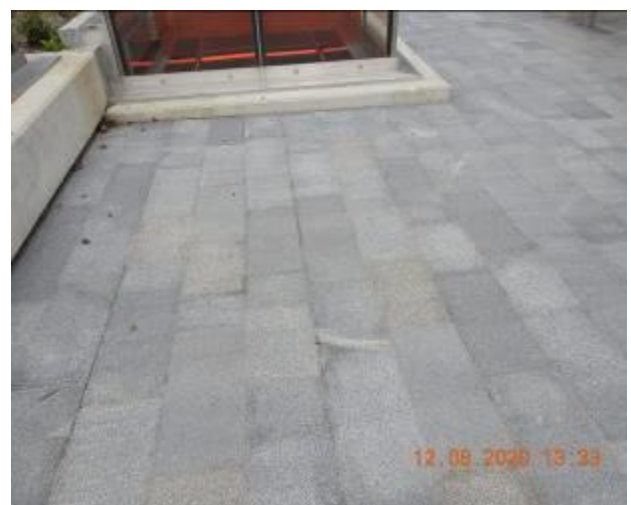
Figure 2036 – Loss of material through floor tiles

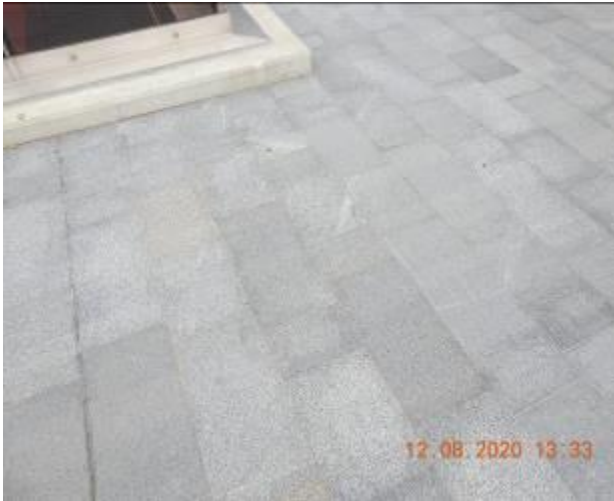
Figure 2037 – Hairline crack propagation through floor tiles

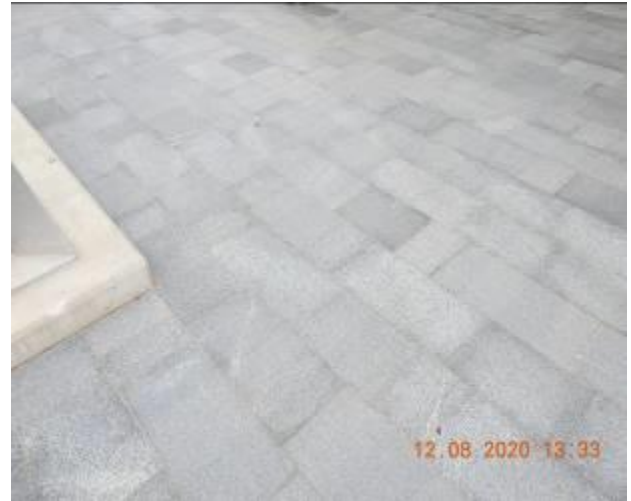
Figure 2038 – Hairline crack propagation through floor tiles

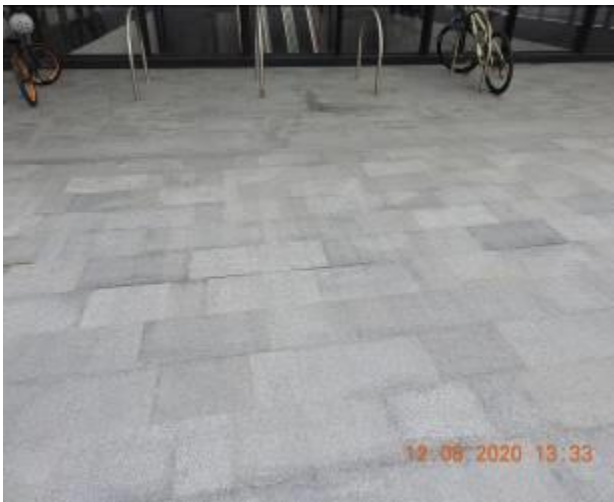
Figure 2039 – Hairline crack propagation through floor tiles

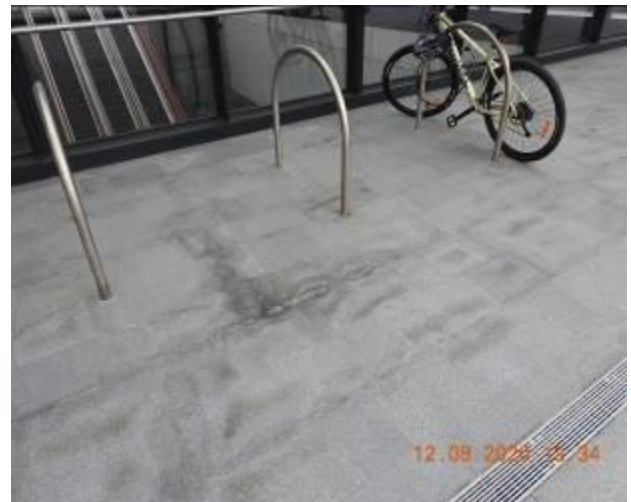
Figure 2040 – General condition of floor tiles

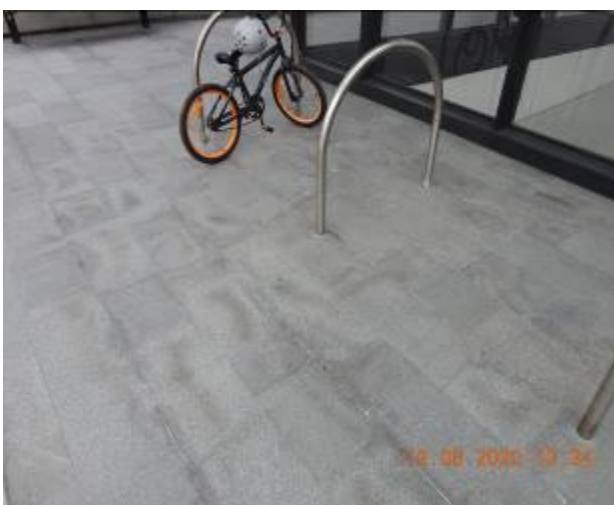
Figure 2041 – Efflorescence, crack propagation and loss of material through floor tiles

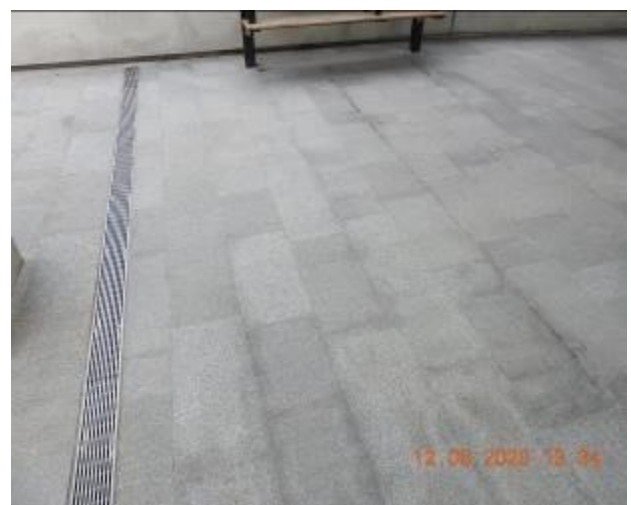
Figure 2042 – Efflorescence, crack propagation and loss of material through floor tiles

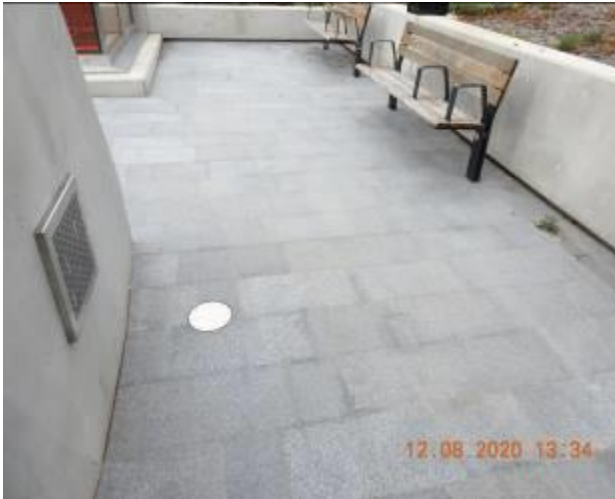
Figure 2043 – General condition of floor tiles

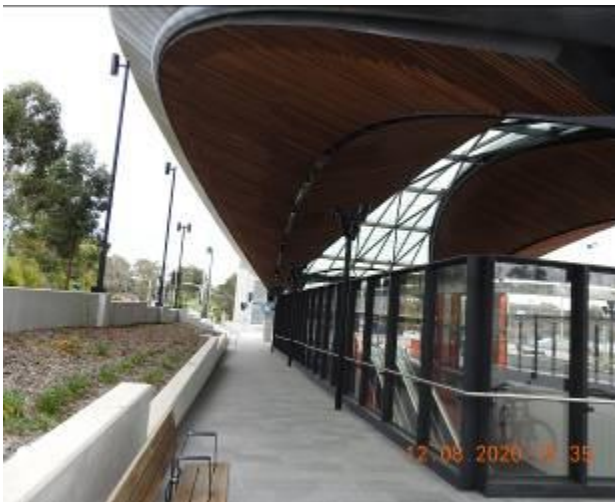
Figure 2045 – General condition of ceiling

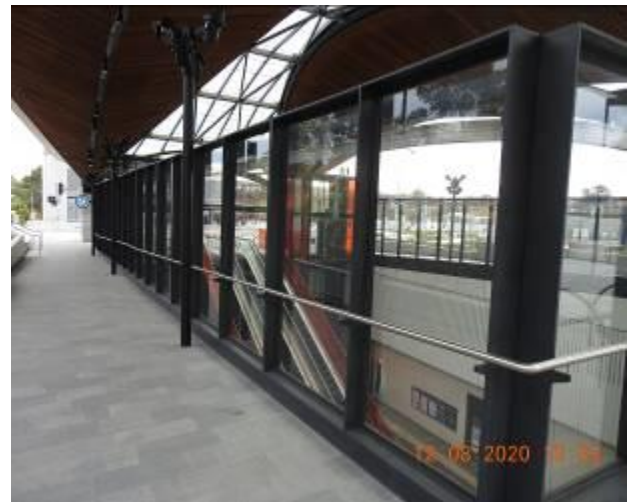
Figure 2046 – The following images display the external condition of Southern façade

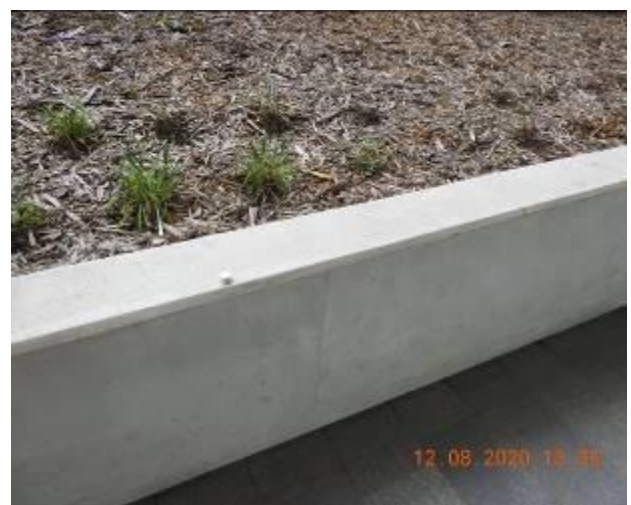
Figure 2048 – General condition of retaining wall

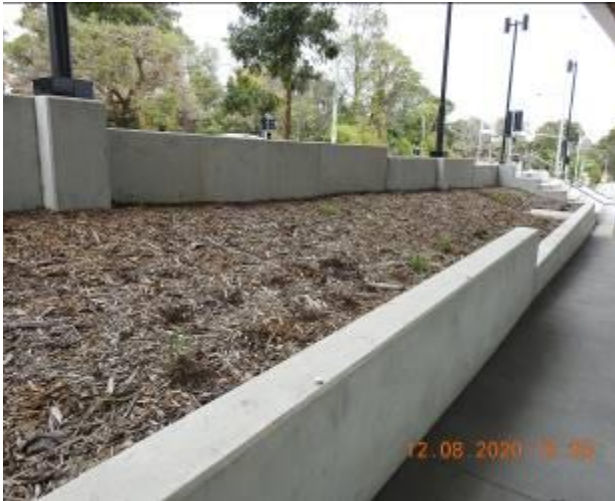
Figure 2049 – Crack propagation through retaining wall

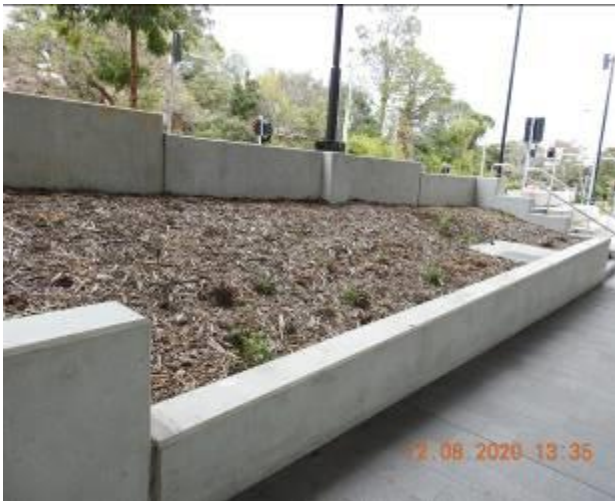
Figure 2050 – General condition of retaining wall

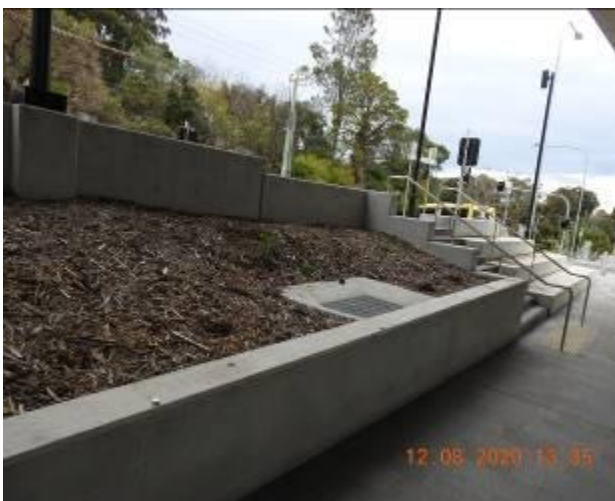
Figure 2052 – General condition of retaining wall

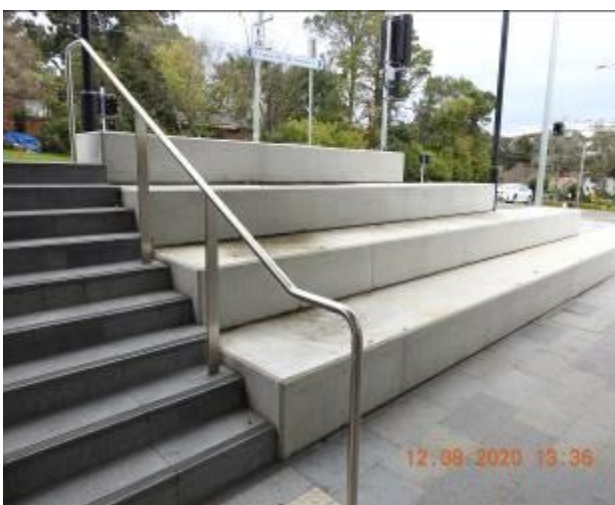
Figure 2059 – General condition of retaining wall

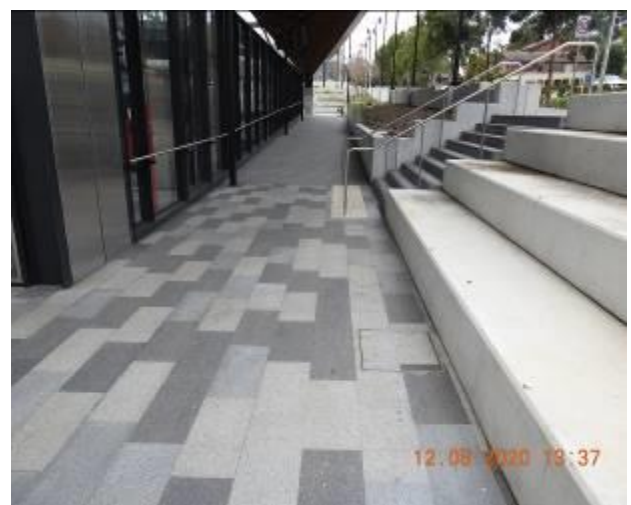
Figure 2060 – General condition of retaining wall

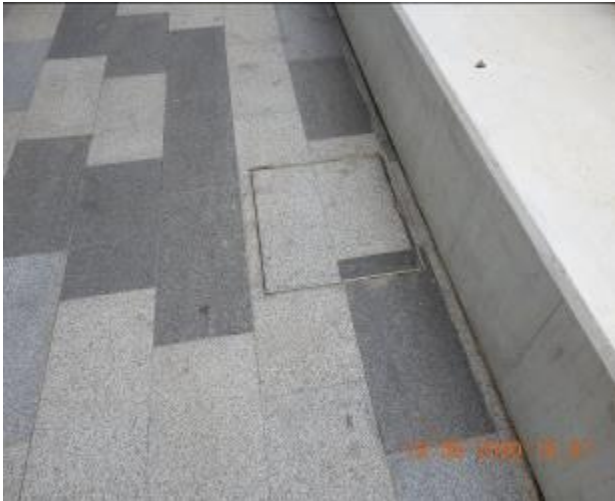
Figure 2061 – General condition of floor tiles

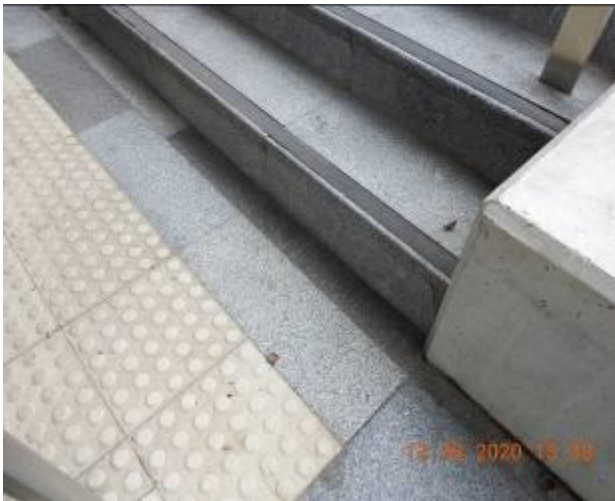
Figure 2064 – Crack propagation and loss of material through floor tiles

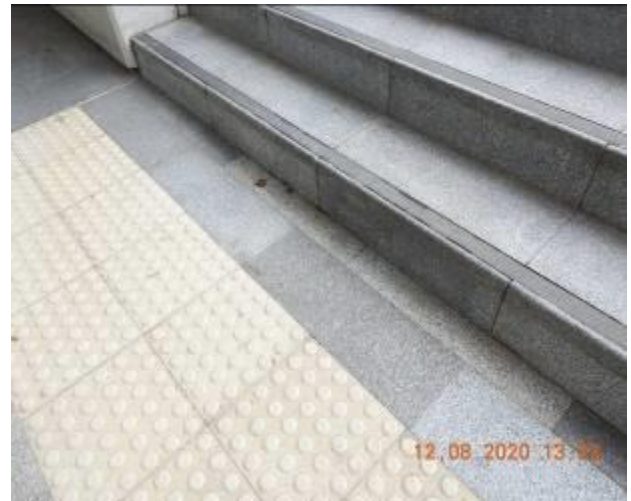
Figure 2065 – Crack propagation and loss of material through floor tiles

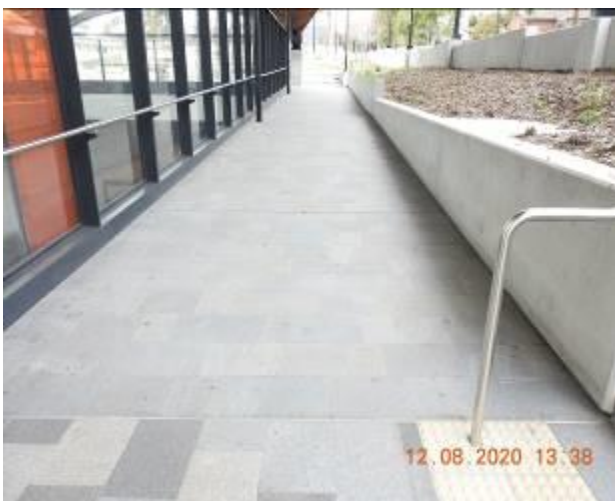
Figure 2066 – General condition of floor tiles

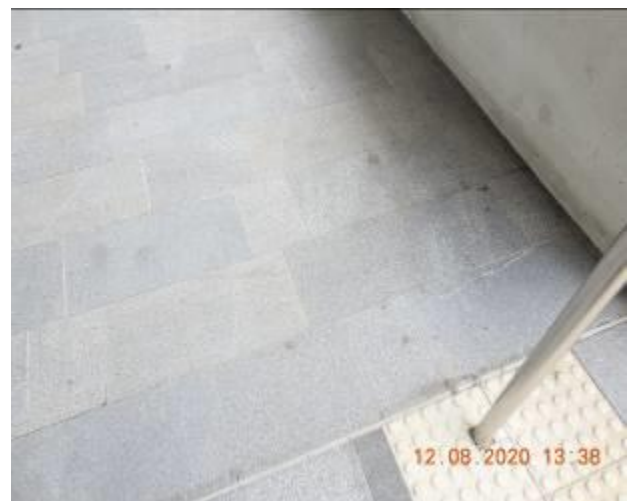
Figure 2067 – Crack propagation through floor tiles

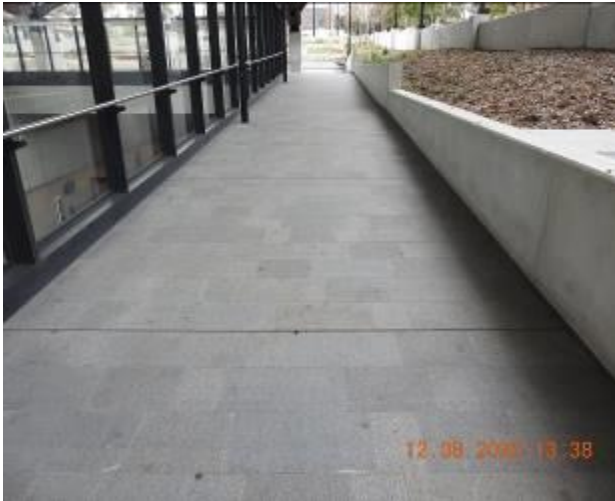
Figure 2068 – Hairline crack propagation through floor tiles

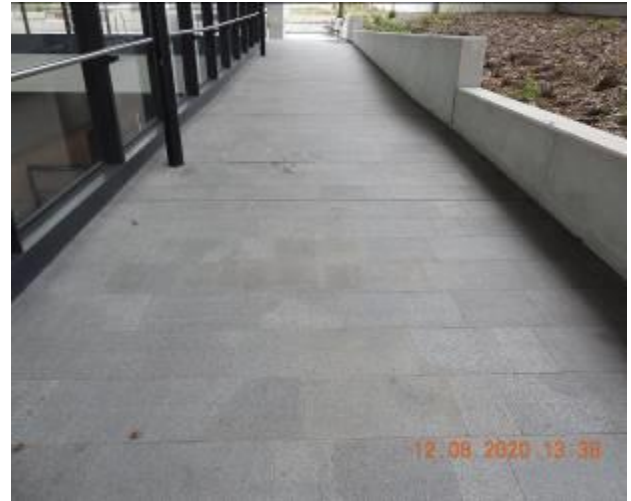
Figure 2069 – Hairline crack propagation through floor tiles

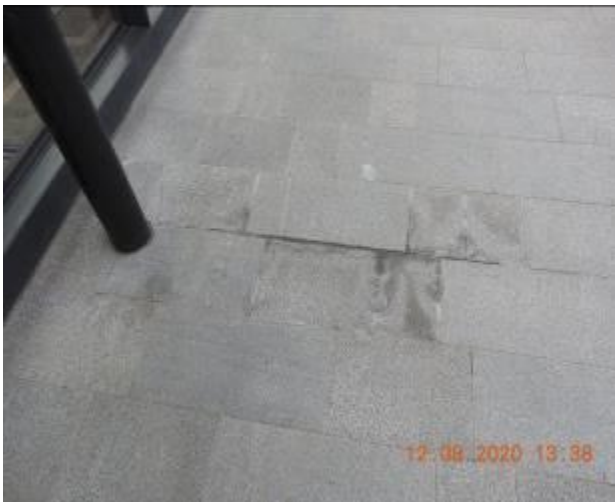
Figure 2070 – Loss of material through floor tiles

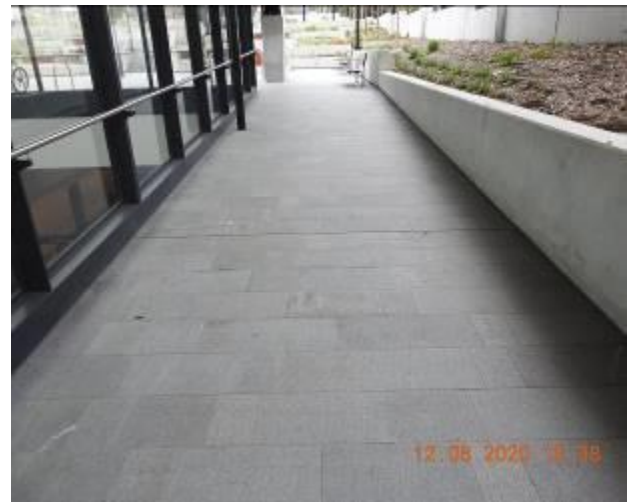
Figure 2071 – General condition of floor tiles

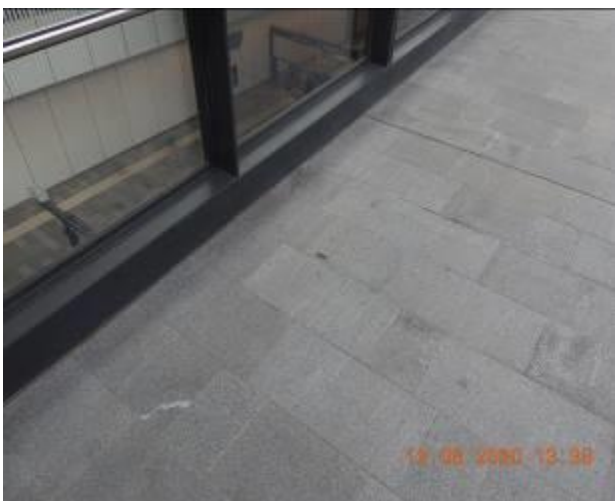
Figure 2072 – Efflorescence and loss of material through floor tiles

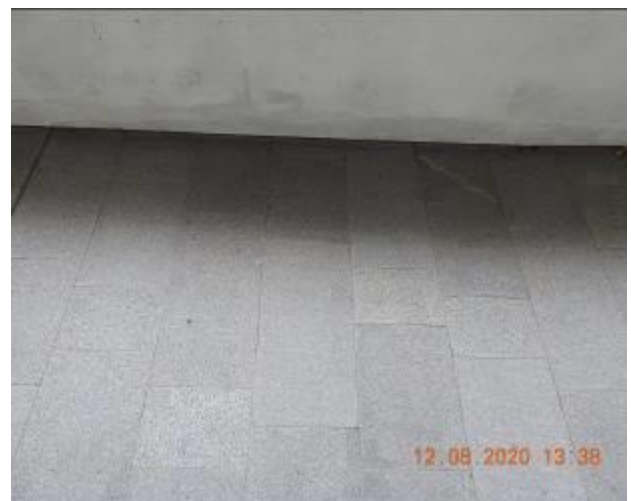
Figure 2073 – Efflorescence, crack propagation and loss of material through floor tiles

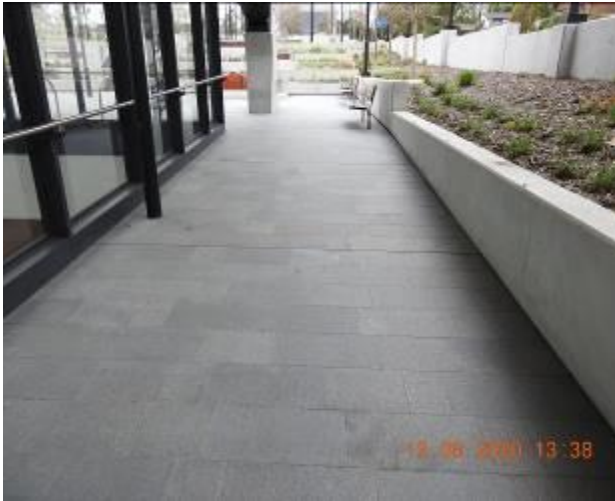
Figure 2074 – General condition of floor tiles

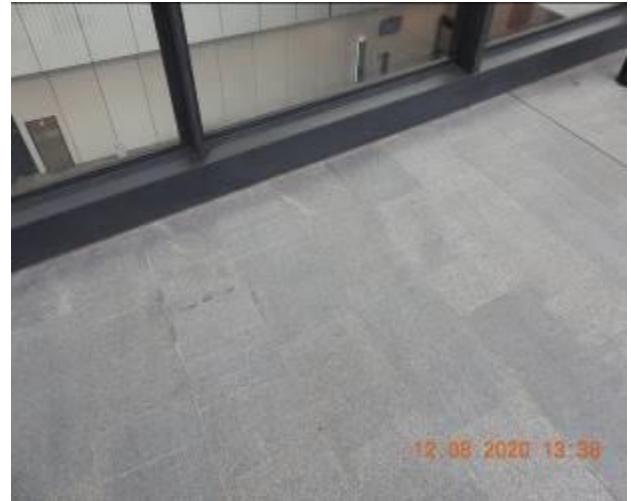
Figure 2075 – Hairline crack propagation through floor tiles

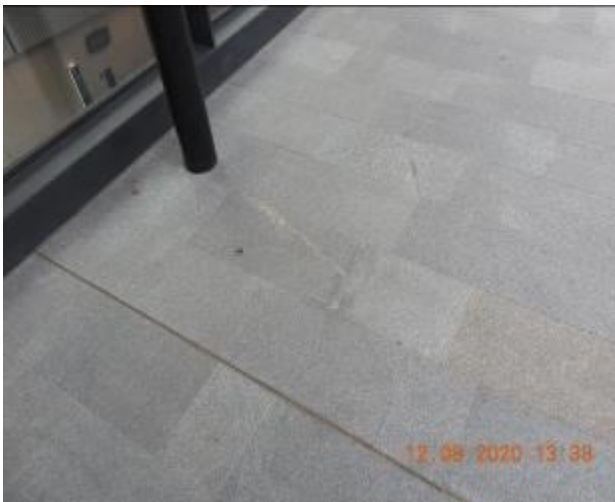
Figure 2076 – Hairline crack propagation through floor tiles

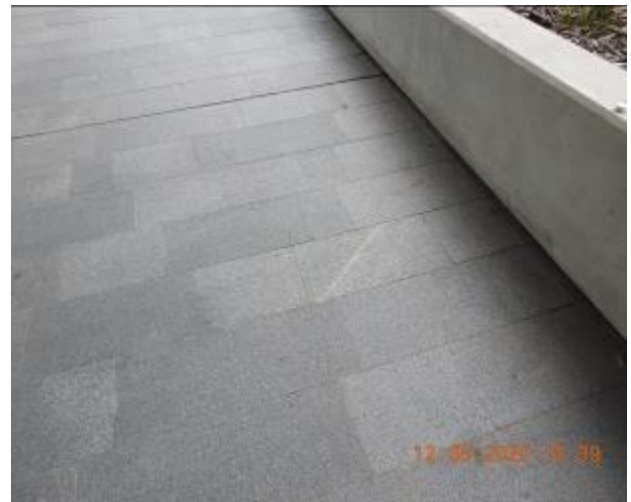
Figure 2077 – Hairline crack propagation through floor tiles

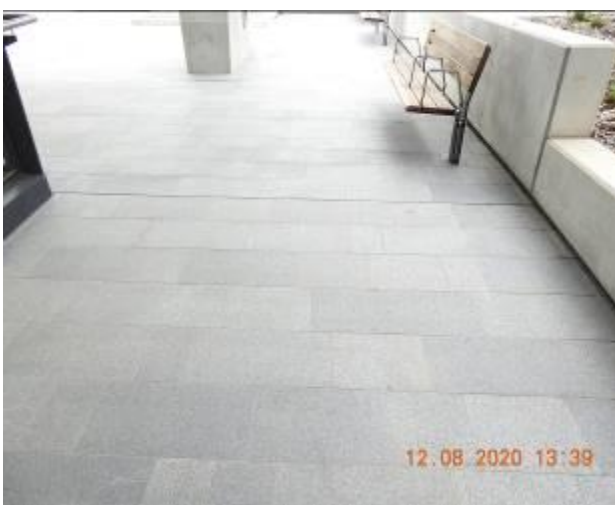
Figure 2078 – Hairline crack propagation through floor tiles

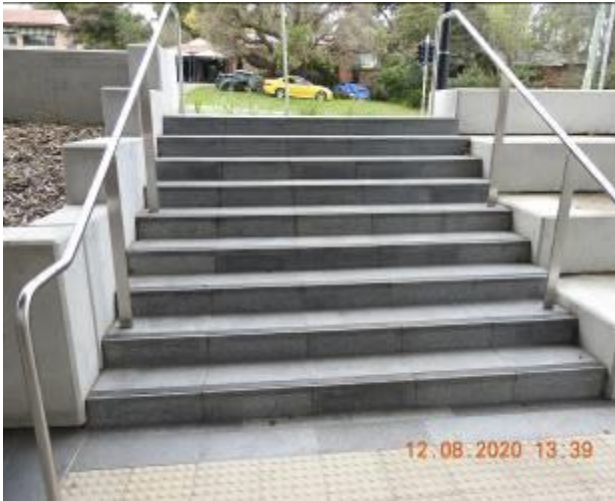
Figure 2080 – General condition of staircase pavement

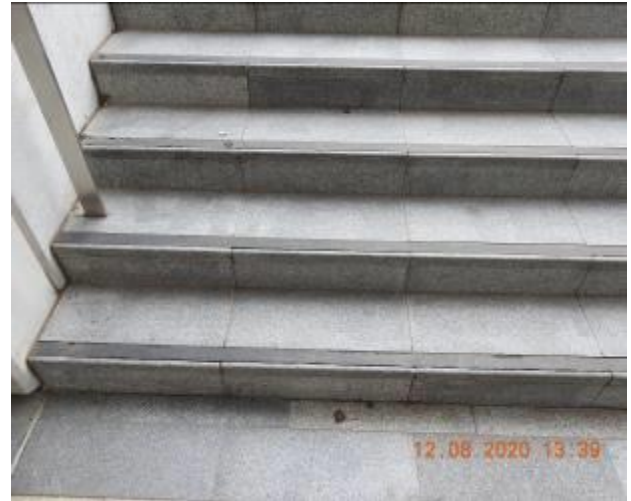
Figure 2081 – Separation through staircase pavement

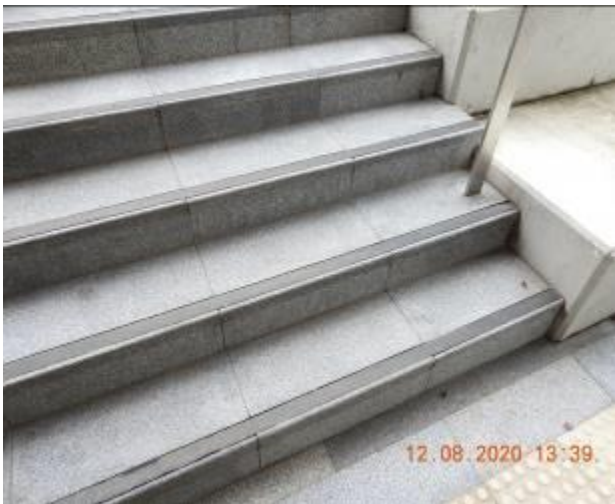
Figure 2082 – Separation through staircase pavement

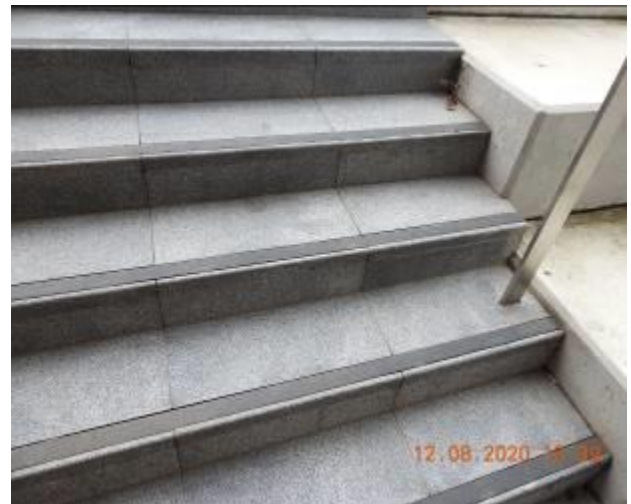
Figure 2083 – Separation through staircase pavement

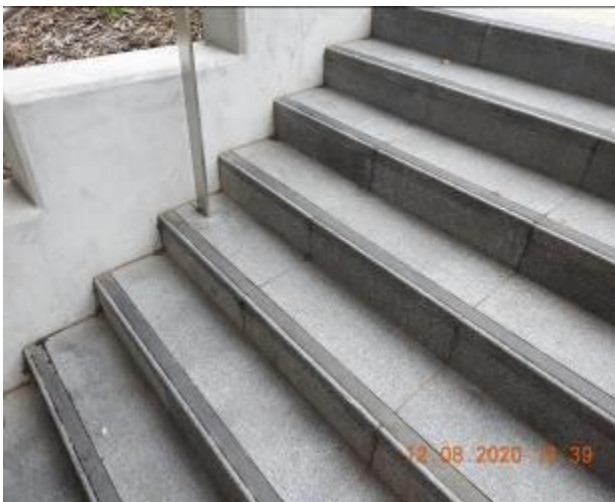
Figure 2084 – Separation through staircase pavement

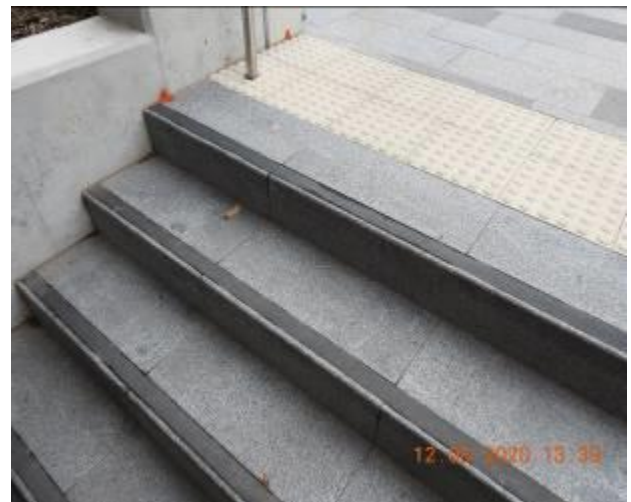
Figure 2085 – Separation through staircase pavement

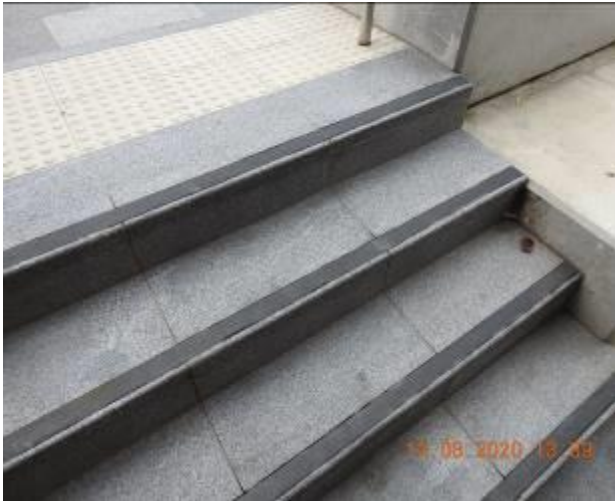
Figure 2086 – Separation through staircase pavement

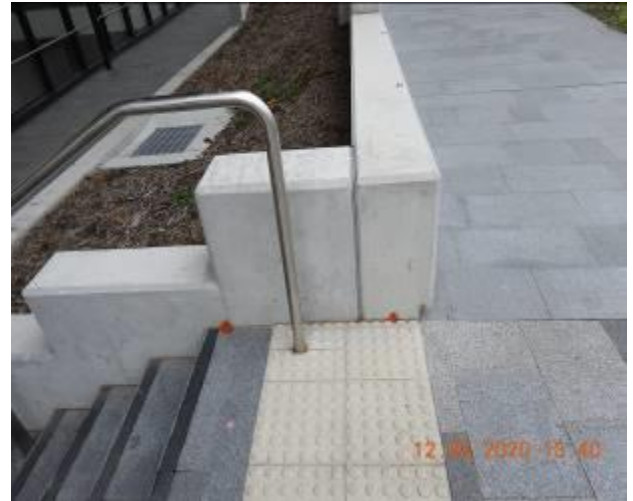
Figure 2087 – General condition of retaining wall

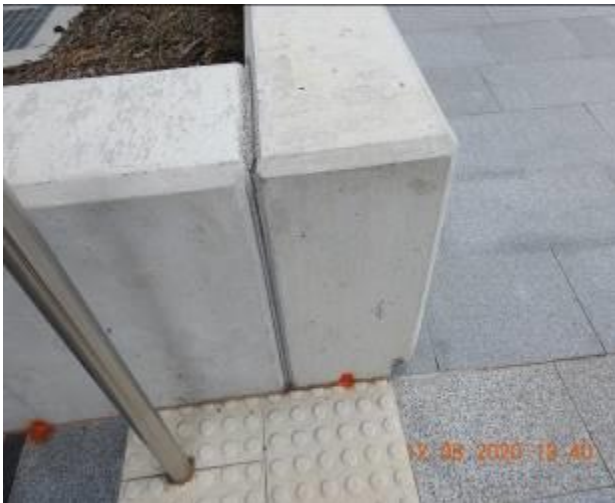
Figure 2088 – Crack propagation through retaining wall

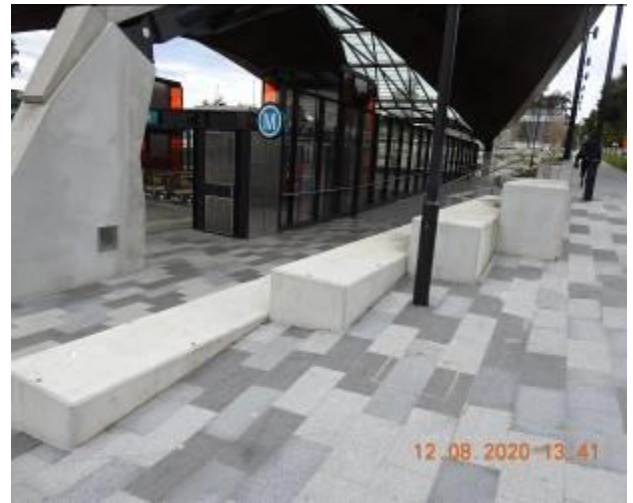
Figure 2089 – General condition of retaining wall

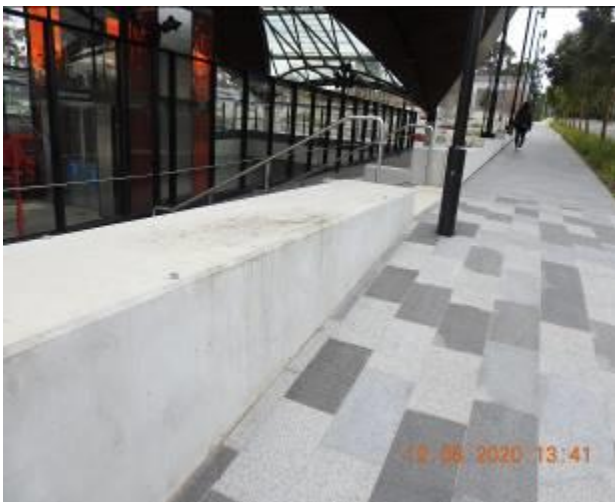
Figure 2090 – General condition of retaining wall

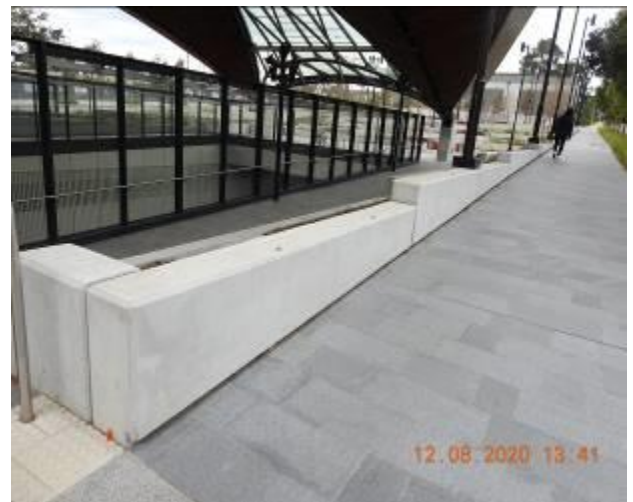
Figure 2091 – General condition of retaining wall

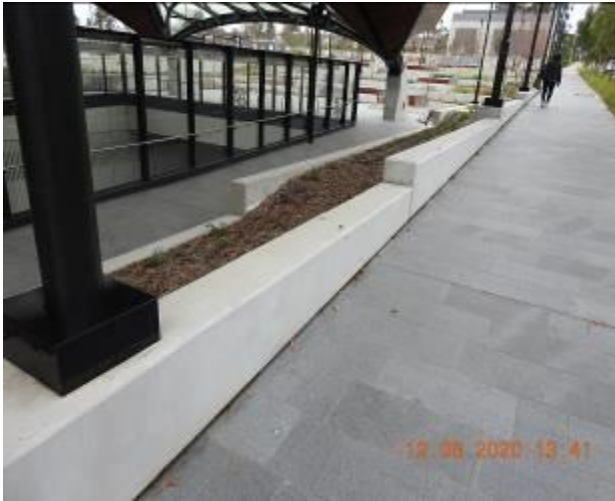
Figure 2092 – General condition of retaining wall

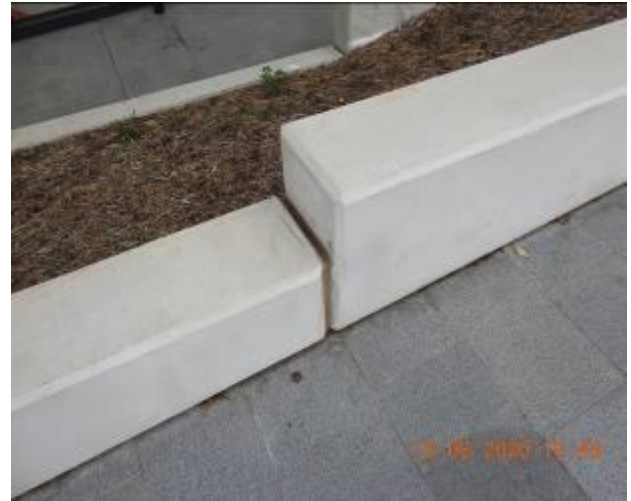
Figure 2093 – Crack propagation and loss of material through retaining wall

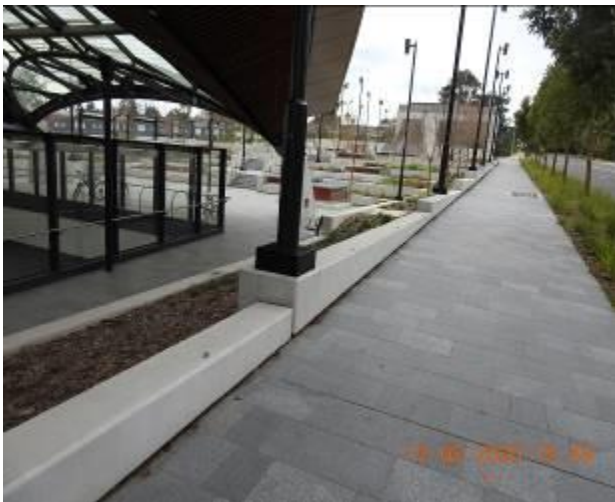
Figure 2094 – General condition of retaining wall

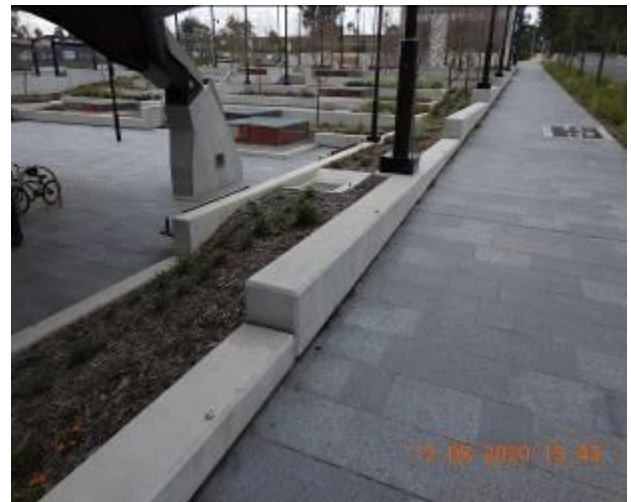
Figure 2095 – General condition of retaining wall

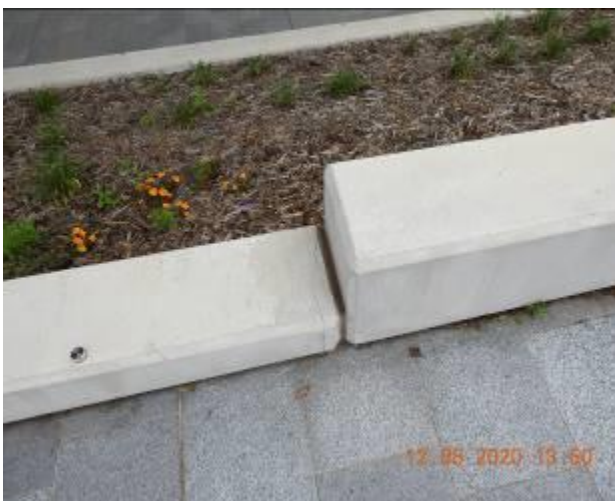
Figure 2096 – Crack propagation through retaining wall

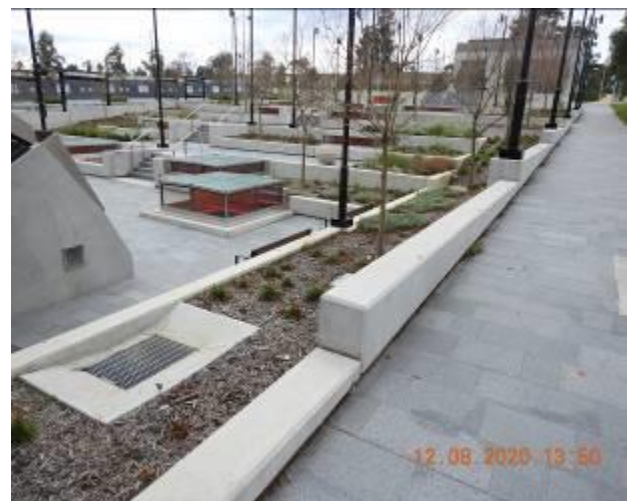
Figure 2097 – General condition of retaining wall

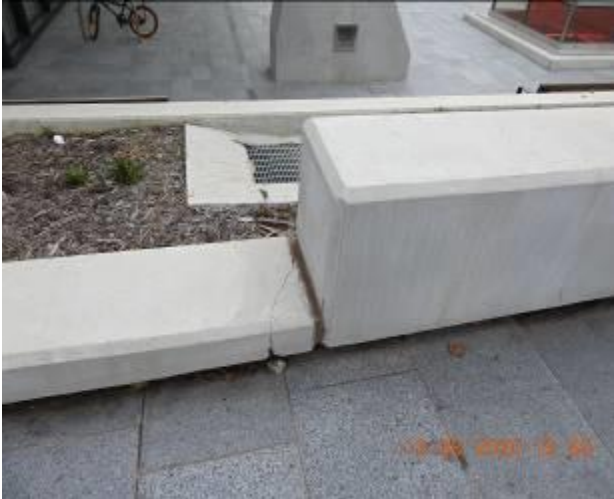
Figure 2098 – Crack propagation and loss of material through retaining wall

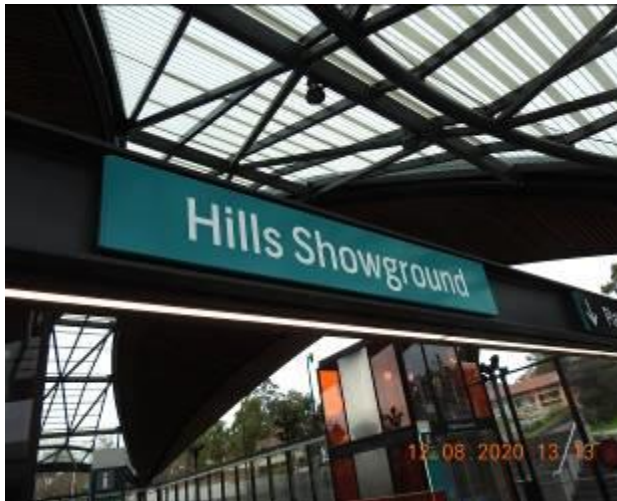
Figure 2099 – The following images display the condition of Hills Showground

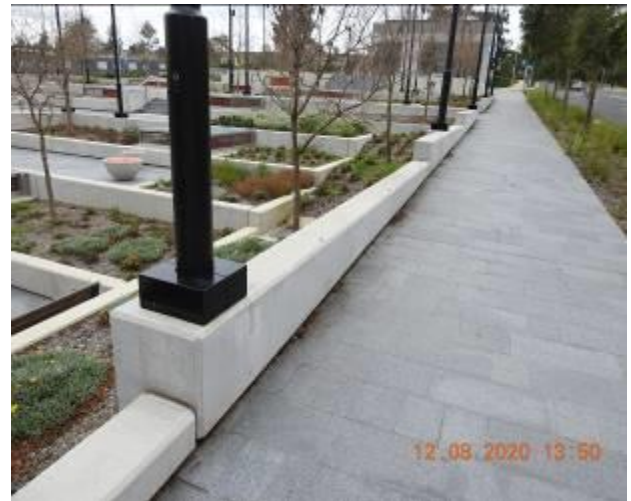
Figure 2100 – General condition of retaining wall

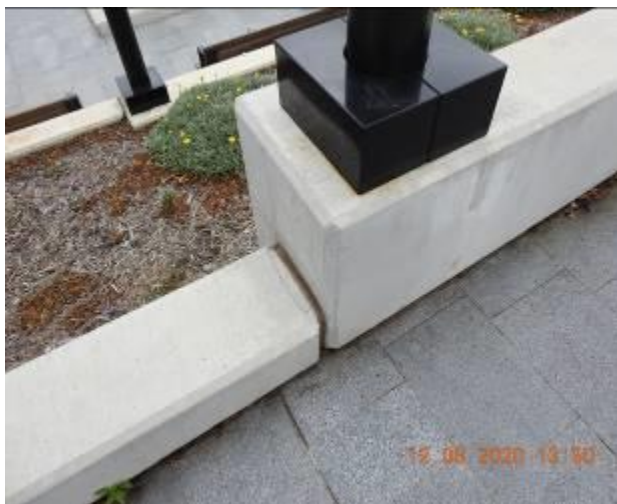
Figure 2101 – Crack propagation and loss of material through retaining wall

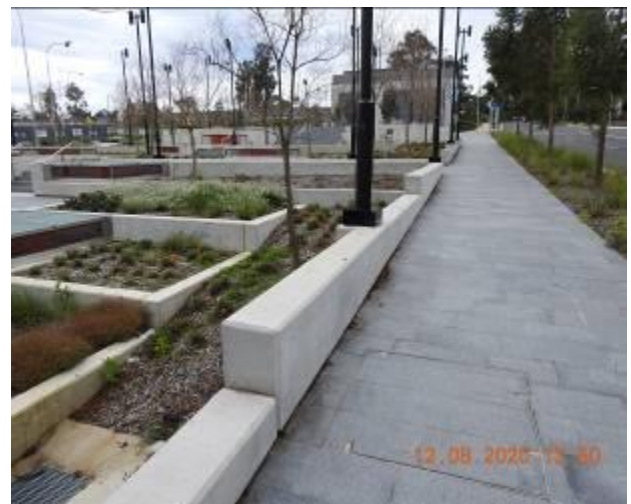
Figure 2102 – General condition of retaining wall
