**2 MANDALA PARADE, CASTLE HILL
(DORAN DRIVE PRECINCT)
PRE-DILAPIDATION REPORT
Of Sydney Metro and Hills Shire Council Assets
DEICORP PROJECTS SHOWGROUND
PTY LTD.**

Job No. 200124.3
07/07/2021

ACE Structural Services Pty Ltd

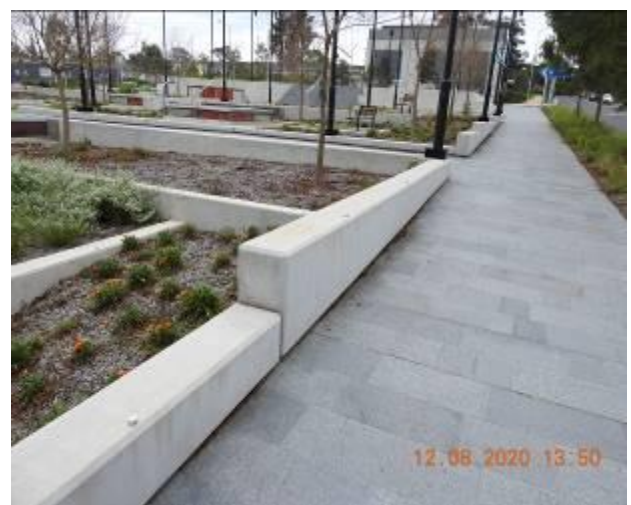
Figure 2103 – Crack propagation through retaining wall

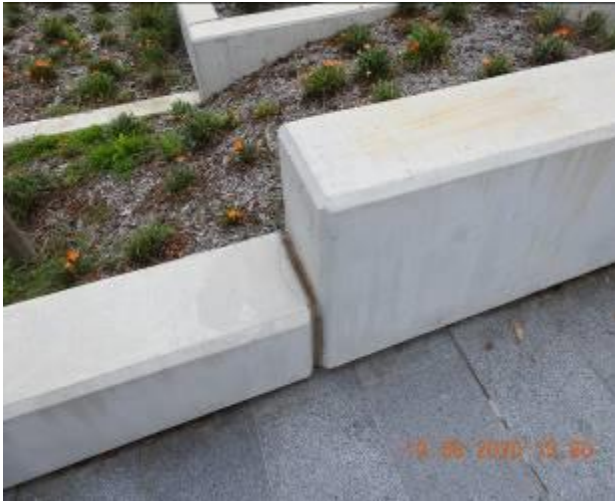
Figure 2104 – General condition of retaining wall

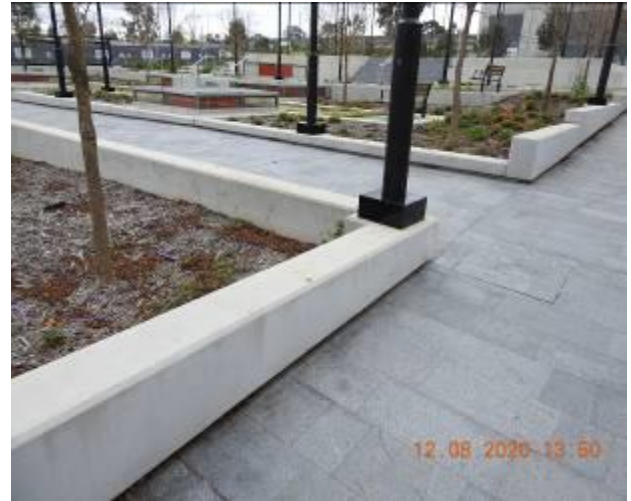
Figure 2105 – Crack propagation through retaining wall

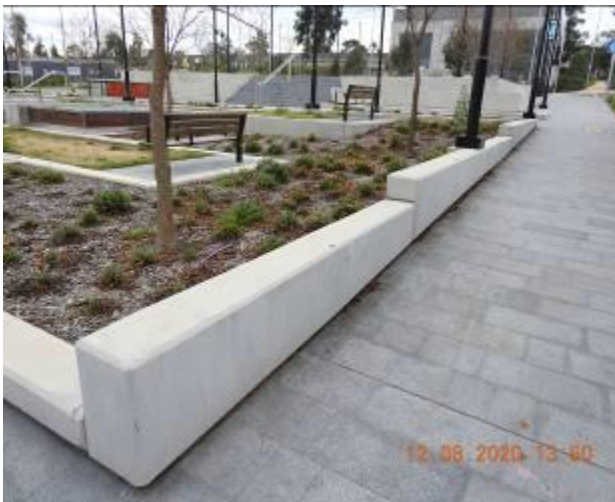
Figure 2106 – General condition of retaining wall

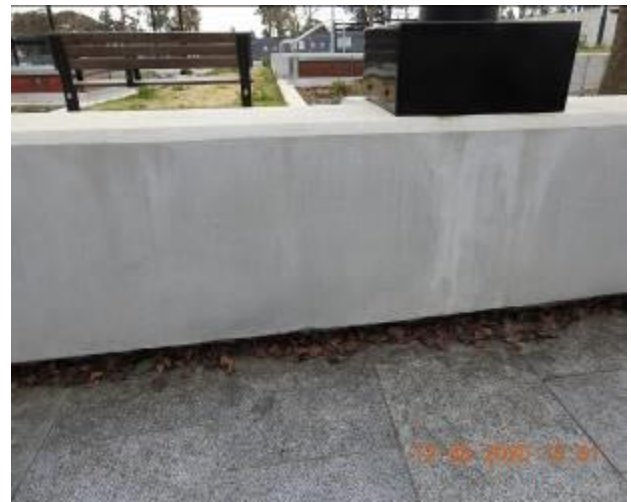
Figure 2107 – General condition of retaining wall

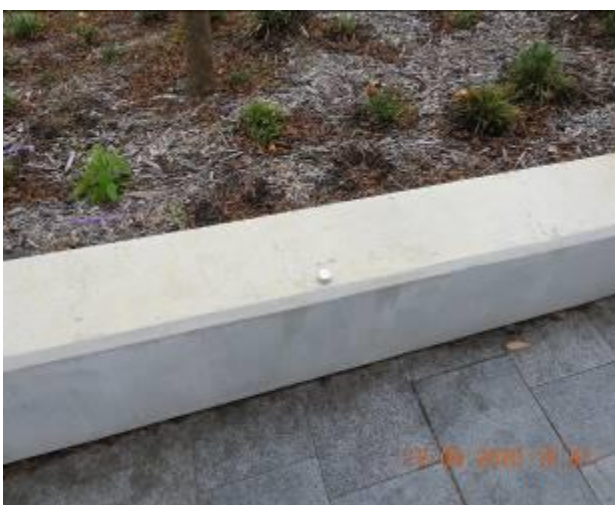
Figure 2108 – Hairline crack propagation through retaining wall

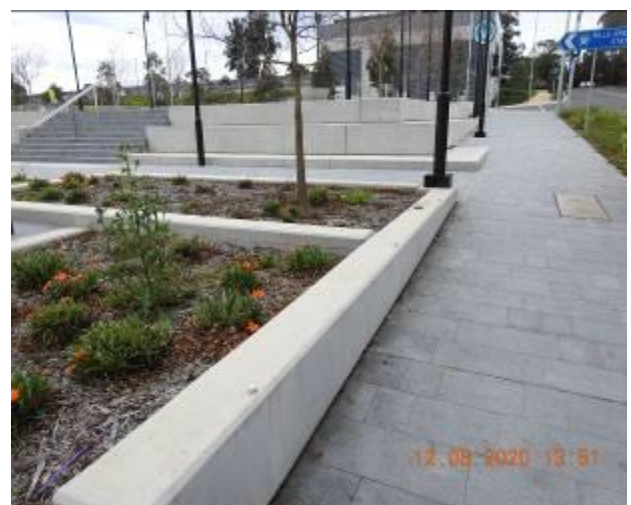
Figure 2109 – Loss of material through retaining wall

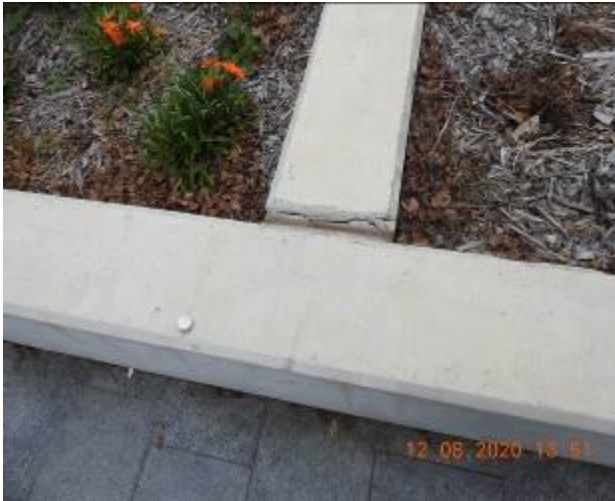
Figure 2110 – General condition of retaining wall

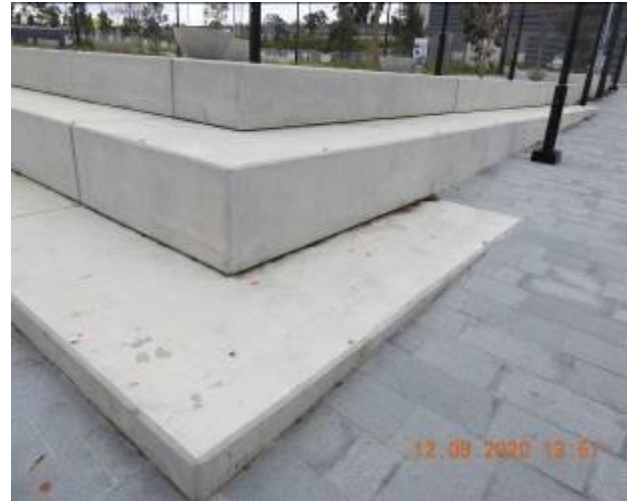
Figure 2111 – Crack propagation and loss of material through retaining wall

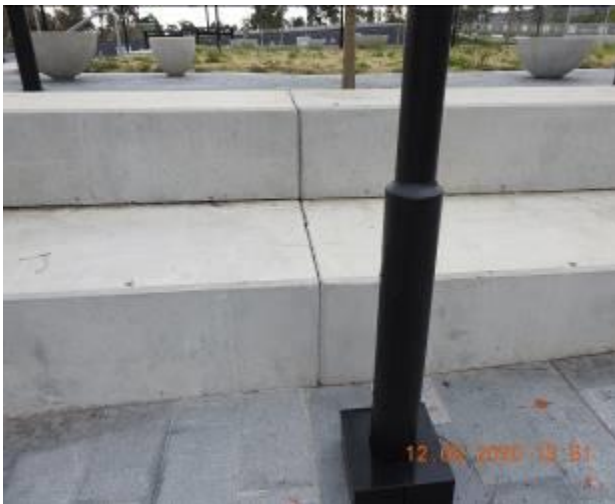
Figure 2112 – General condition of retaining wall

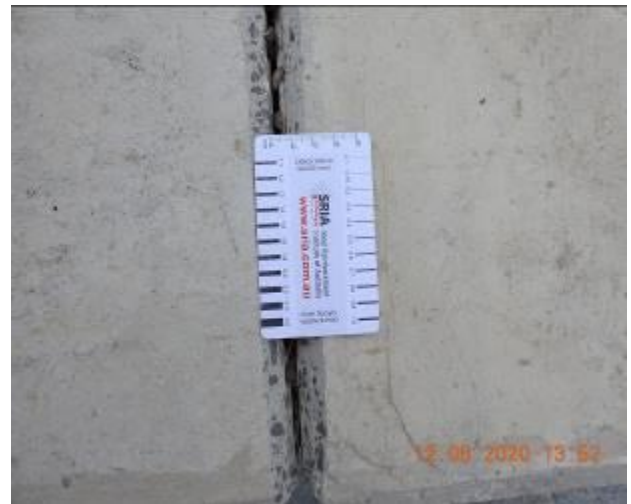
Figure 2113 – Separation through retaining wall

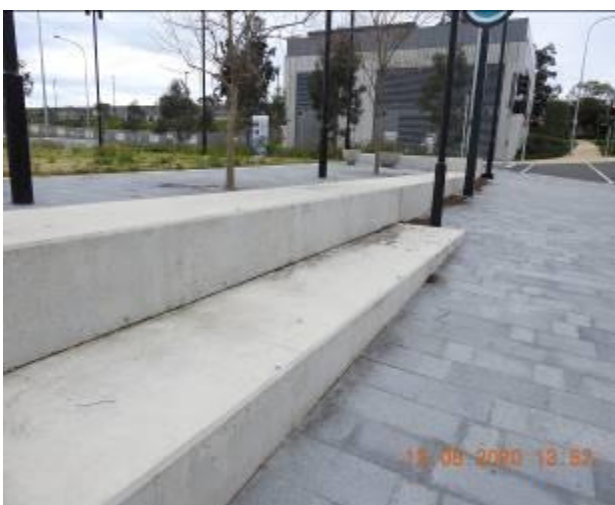
Figure 2114 – Separation through retaining wall
Approx. 3mm in width

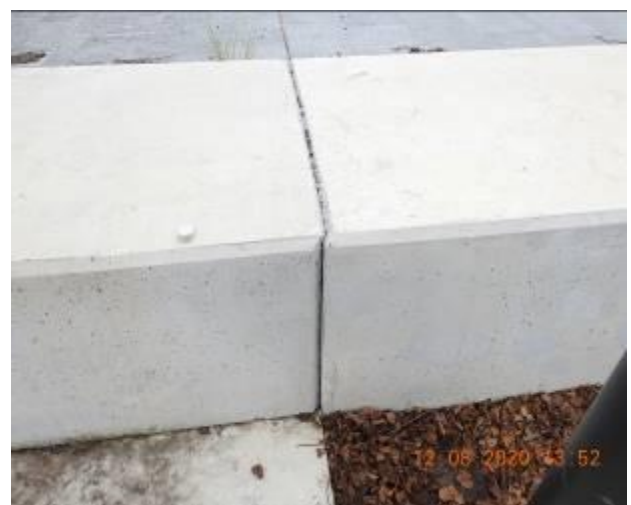
Figure 2115 – General condition of retaining wall

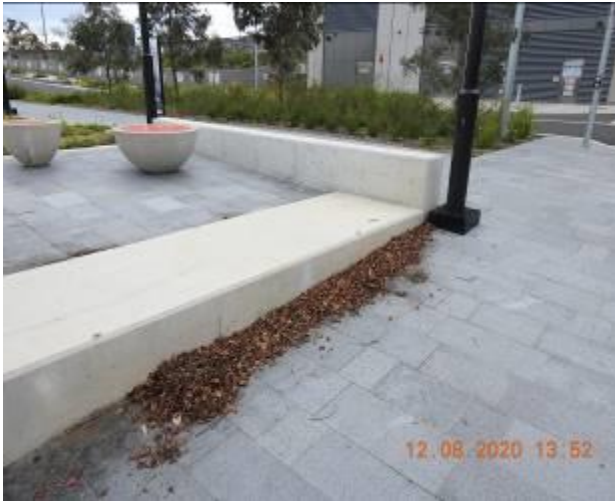
Figure 2116 – Separation through retaining wall

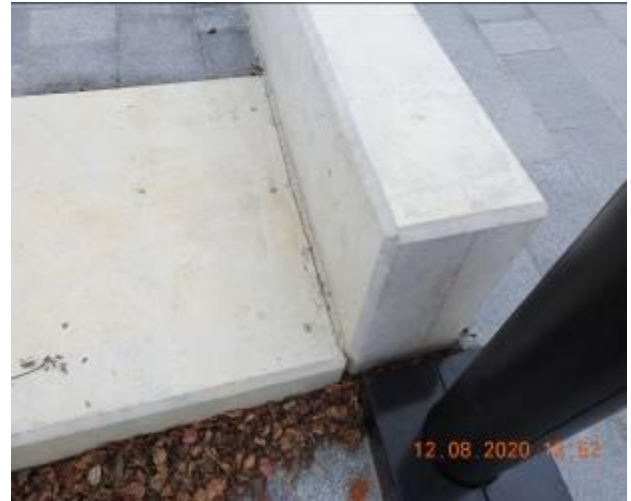
Figure 2117 – General condition of retaining wall

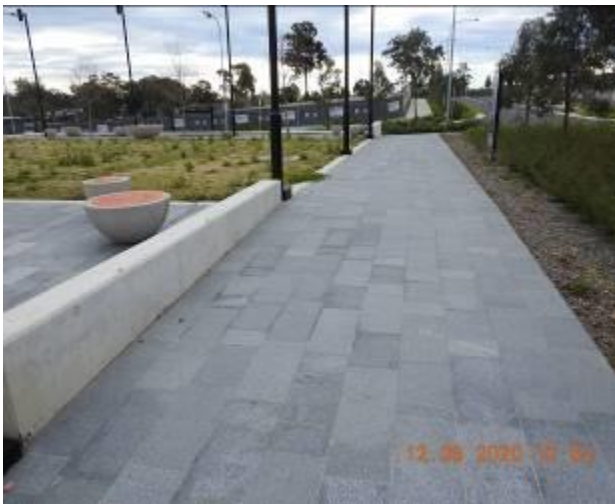
Figure 2118 – Crack propagation and loss of material through retaining wall

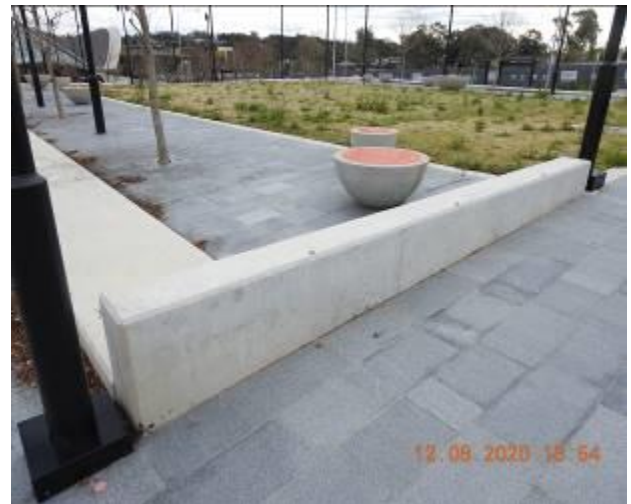
Figure 2119 – General condition of retaining wall

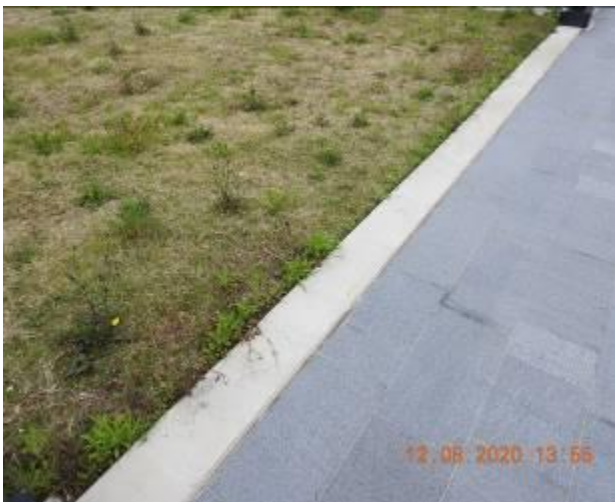
Figure 2120 – General condition of retaining wall

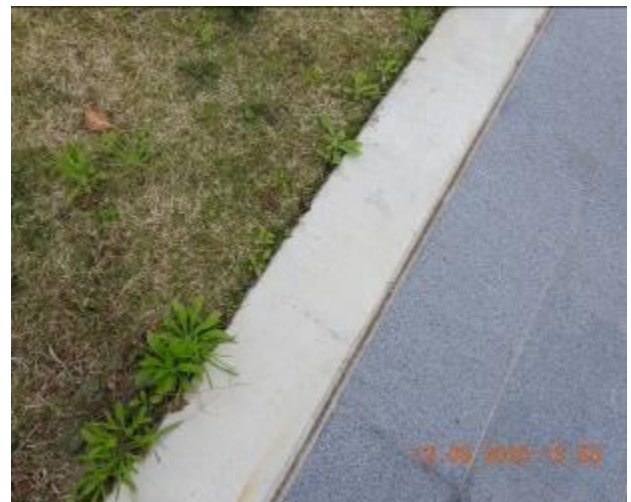
Figure 2121 – General condition of retaining wall

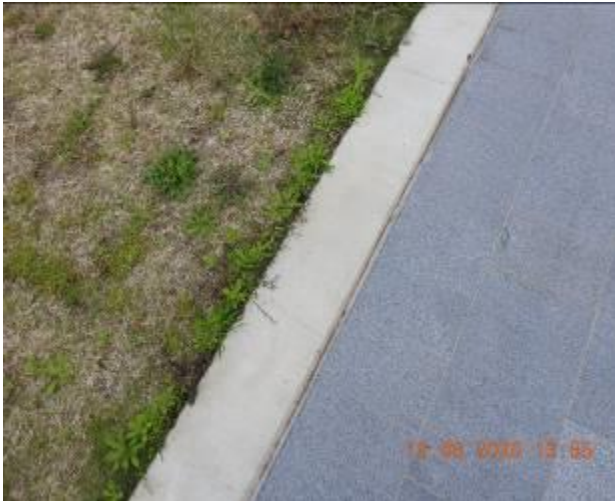
Figure 2122 – Crack propagation through retaining wall

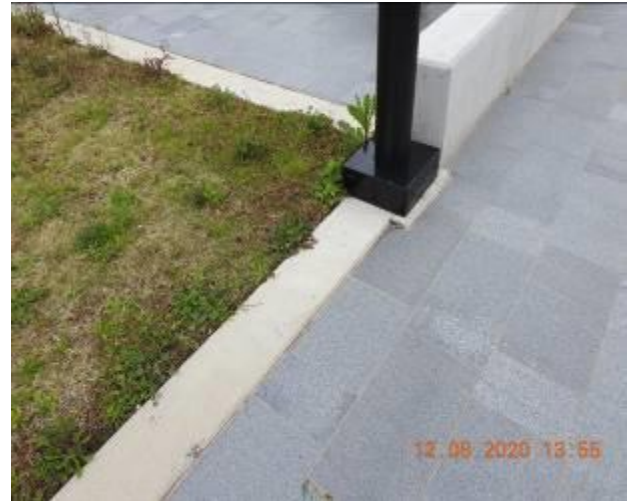
Figure 2123 – Crack propagation through retaining wall

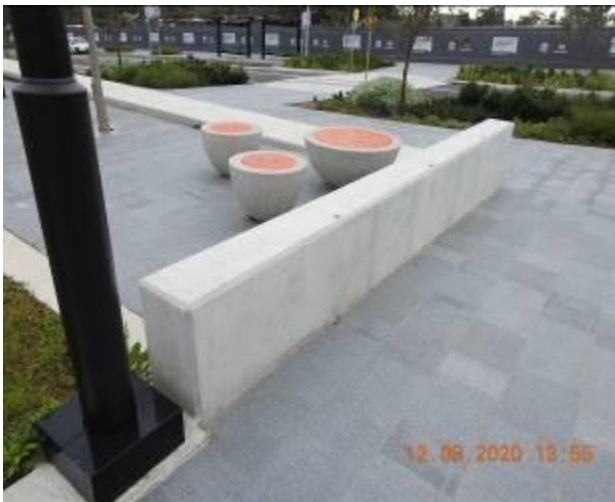
Figure 2124 – Crack propagation through retaining wall

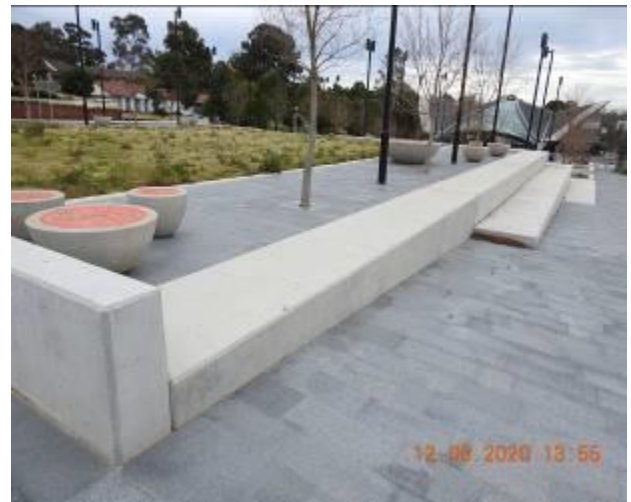
Figure 2125 – General condition of retaining wall

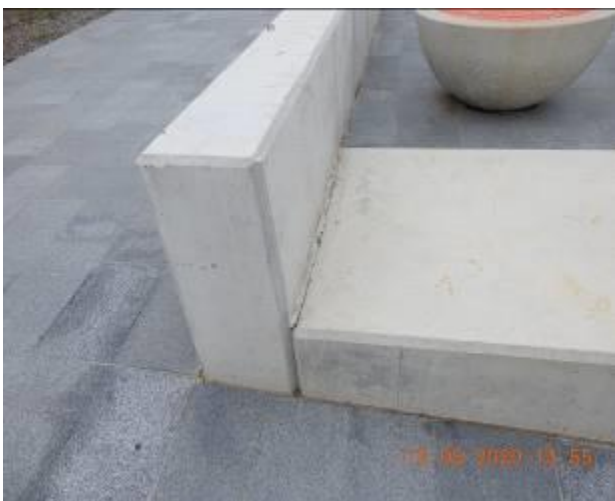
Figure 2126 – General condition of retaining wall

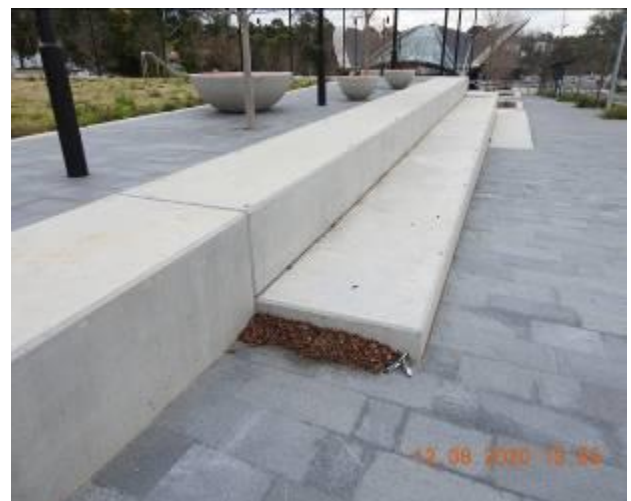
Figure 2127 – Crack propagation and loss of material through retaining wall

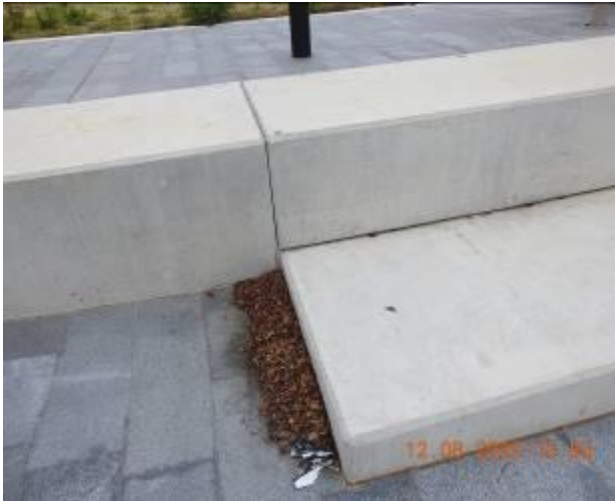
Figure 2128 – General condition of retaining wall

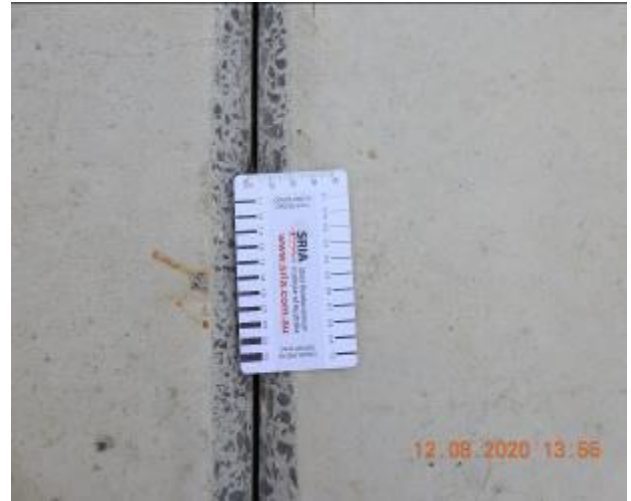
Figure 2129 – Separation through retaining wall

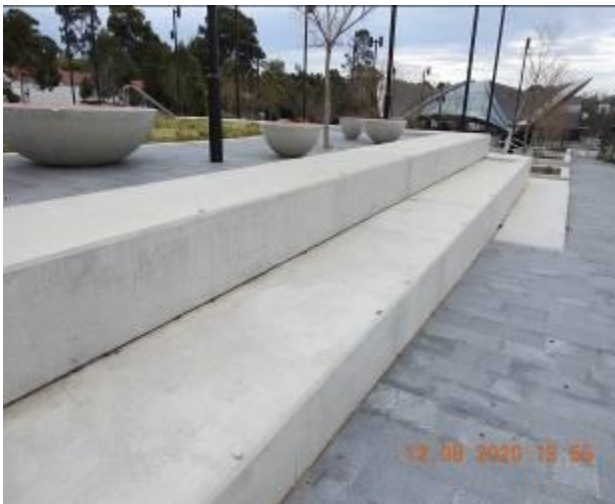
Figure 2130 – Separation through retaining wall
Approx. 3mm in width

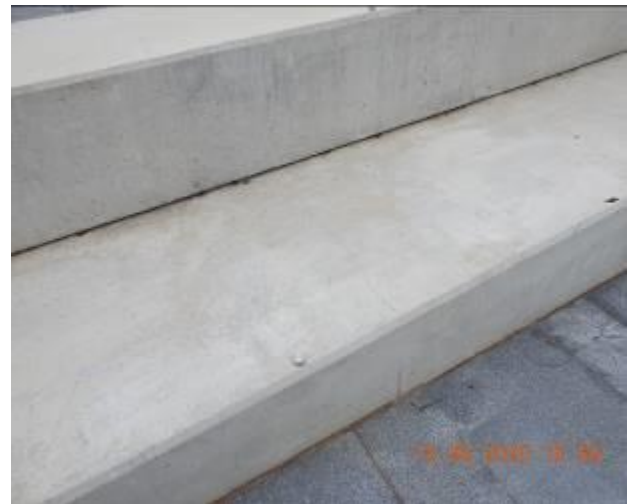
Figure 2131 – General condition of retaining wall

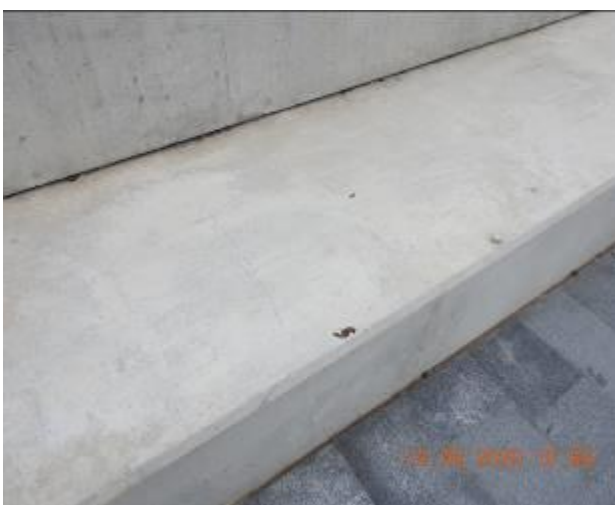
Figure 2132 – Crack propagation through retaining wall

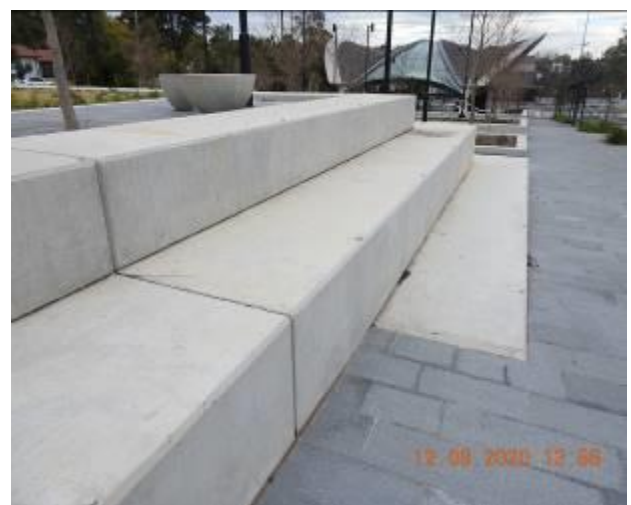
Figure 2133 – Crack propagation through retaining wall

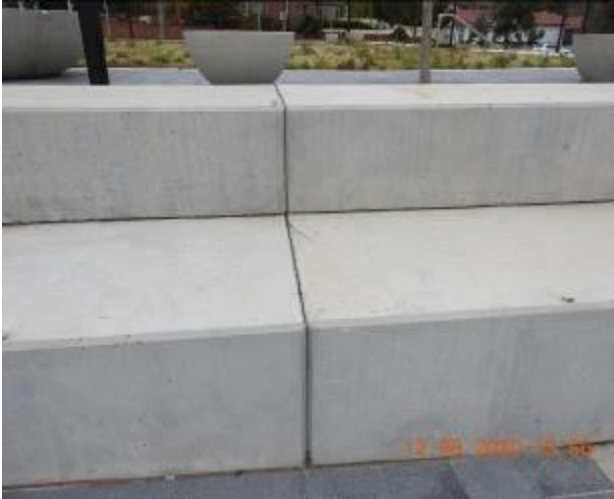
Figure 2134 – General condition of retaining wall

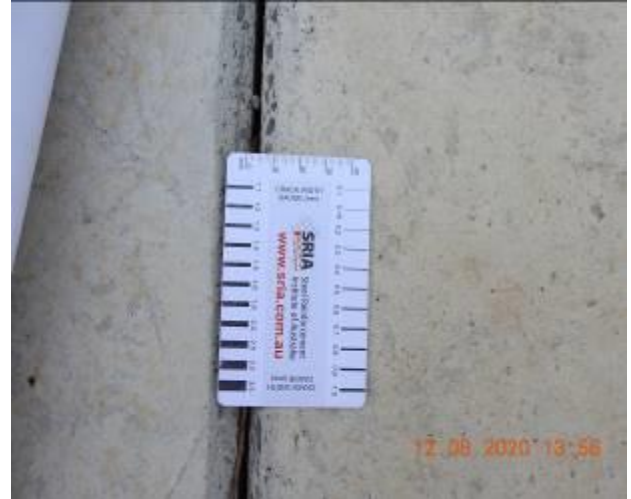
Figure 2135 – Separation through retaining wall

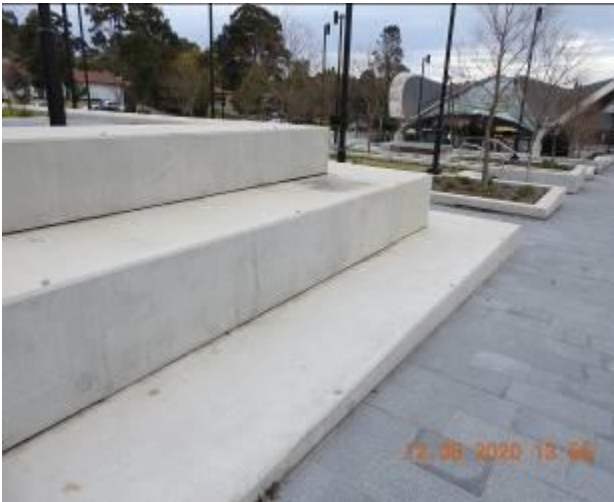
Figure 2136 – Separation through retaining wall
Approx. 4mm in width

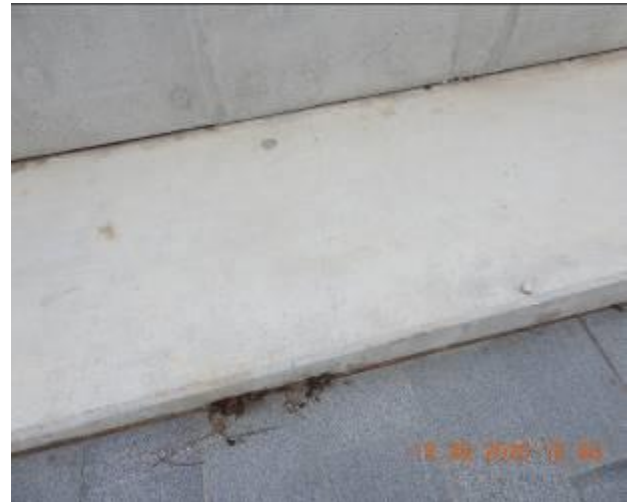
Figure 2137 – General condition of retaining wall

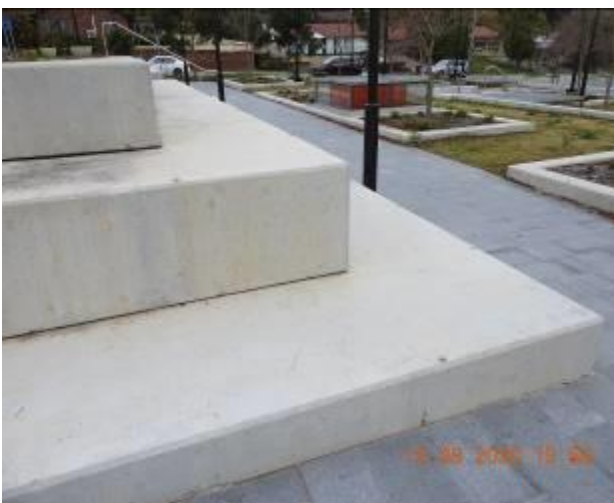
Figure 2138 – Crack propagation through retaining wall

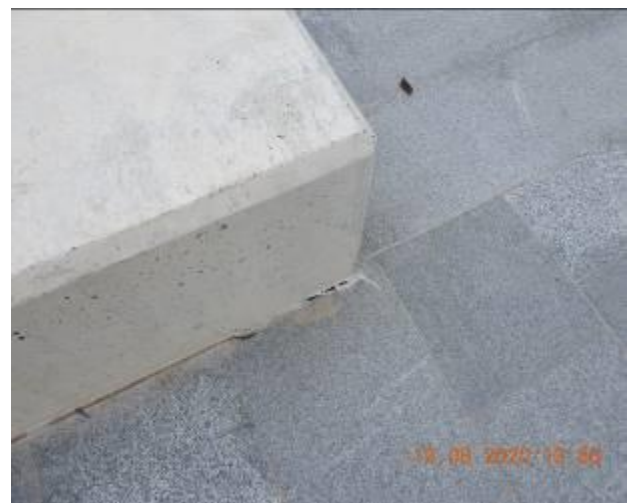
Figure 2139 – General condition of retaining wall

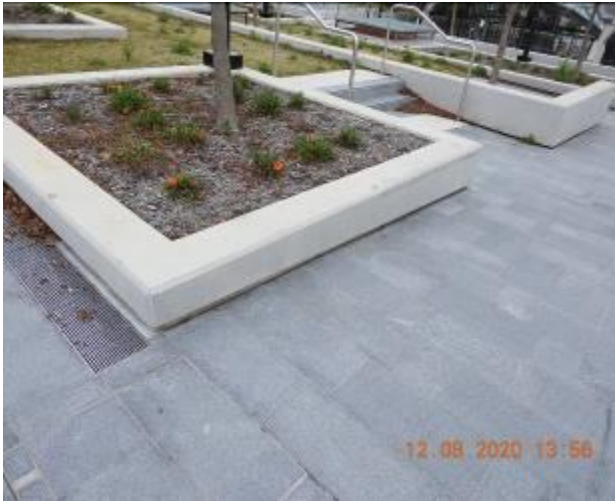
Figure 2140 – Loss of material through retaining wall

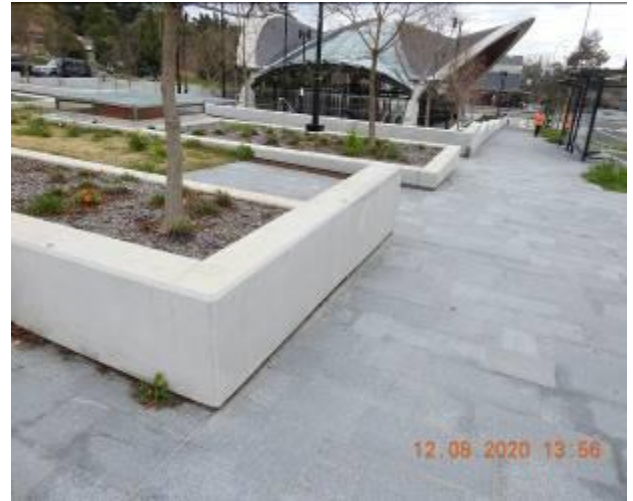
Figure 2141 – General condition of retaining wall

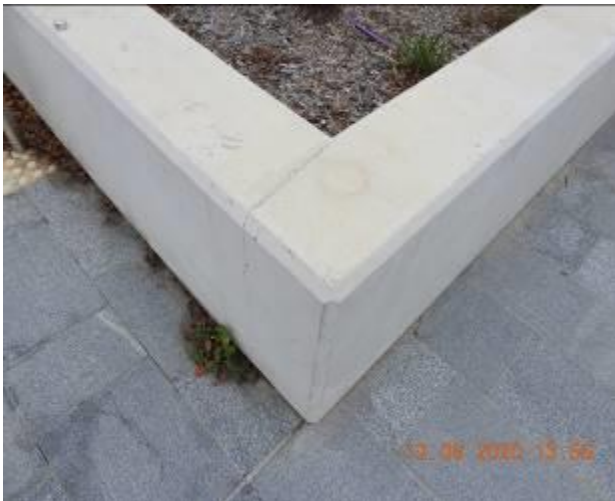
Figure 2143 – Crack propagation through retaining wall

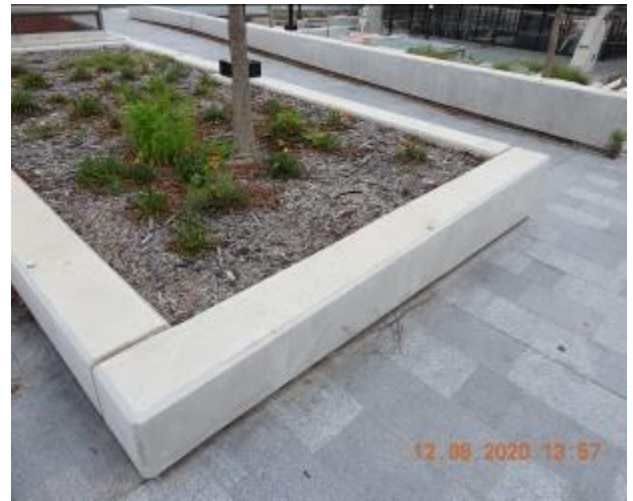
Figure 2144 – General condition of retaining wall

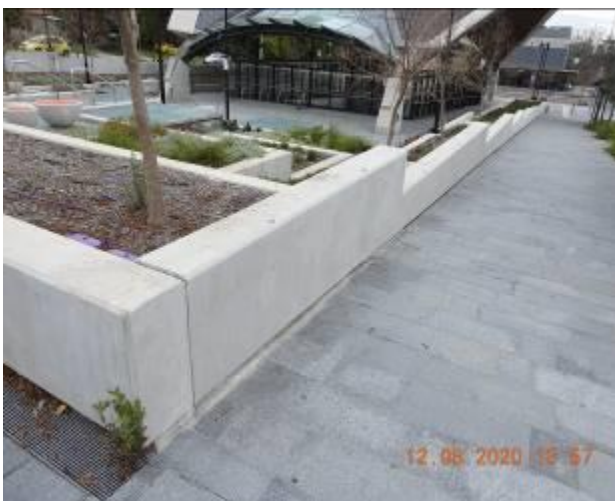
Figure 2145 – General condition of retaining wall

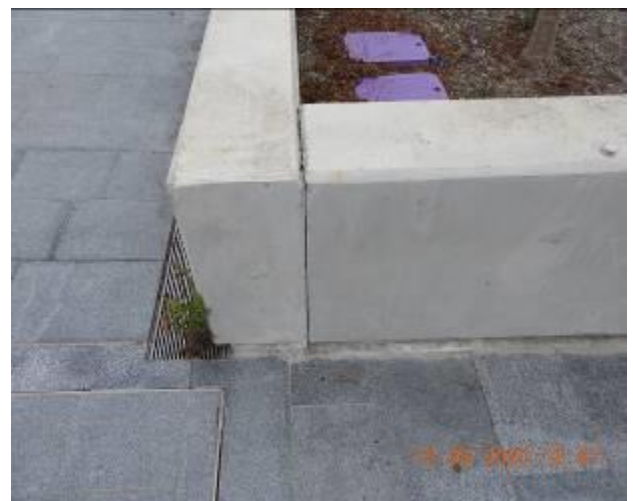
Figure 2146 – Separation through retaining wall

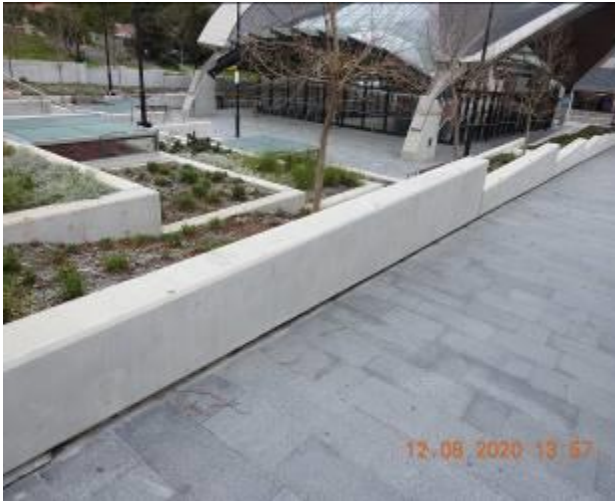
Figure 2147 – General condition of retaining wall

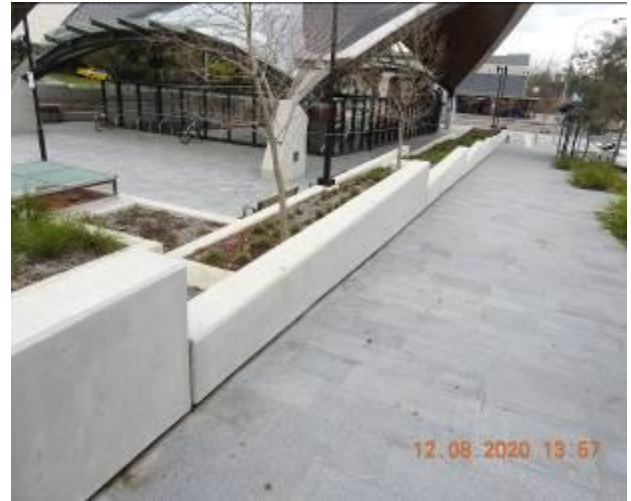
Figure 2148 – General condition of retaining wall

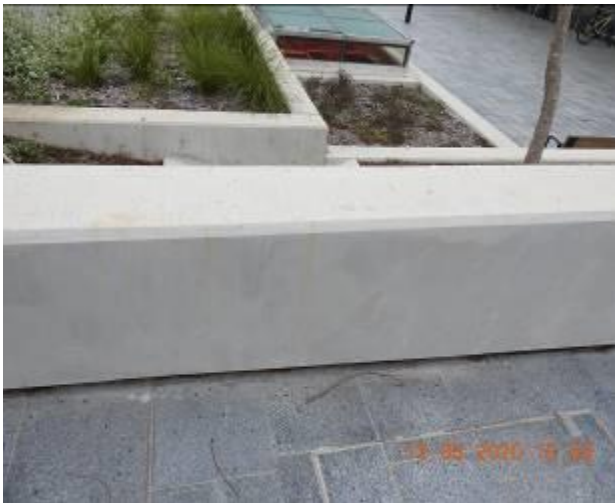
Figure 2149 – Hairline crack propagation through retaining wall

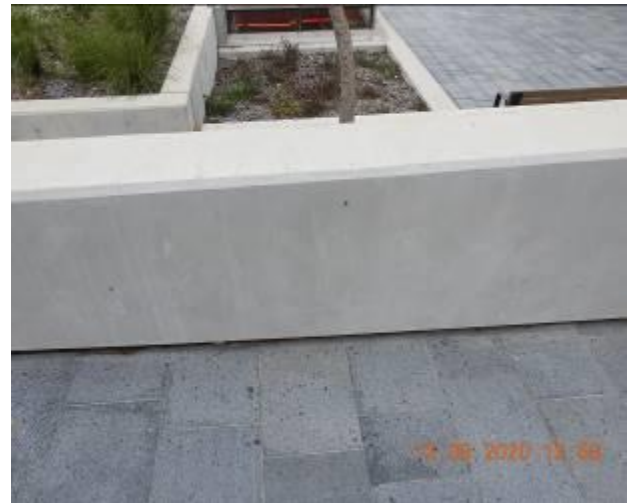
Figure 2150 – Hairline crack propagation through retaining wall

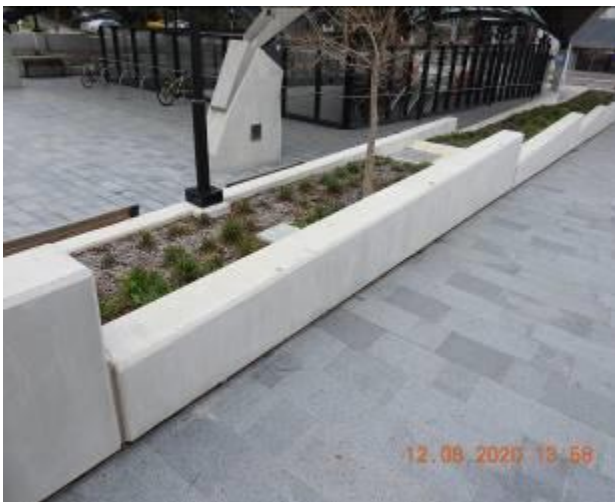
Figure 2151 – General condition of retaining wall

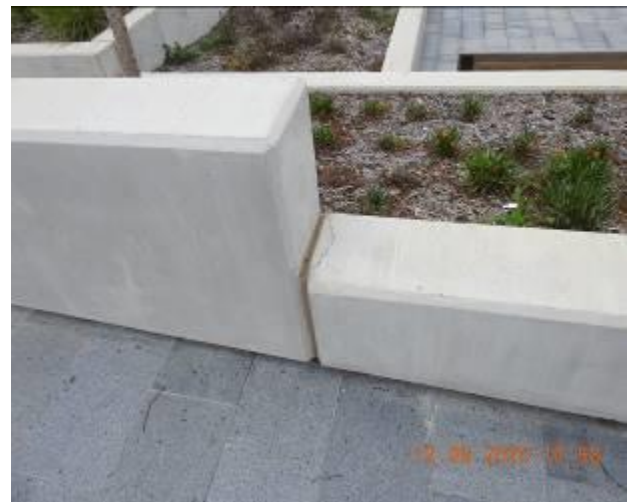
Figure 2152 – Crack propagation and loss of material through retaining wall

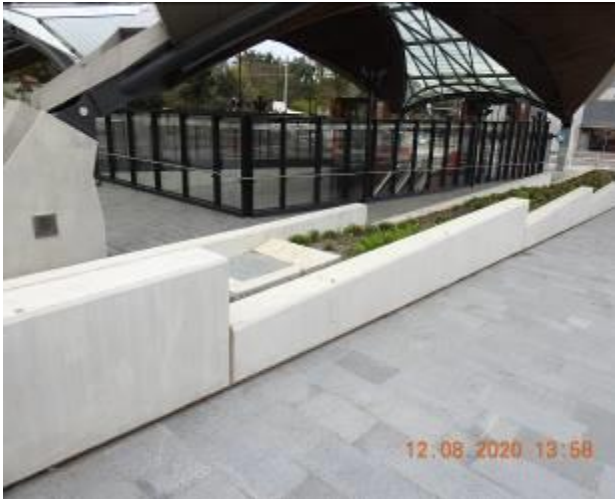
Figure 2153 – General condition of retaining wall

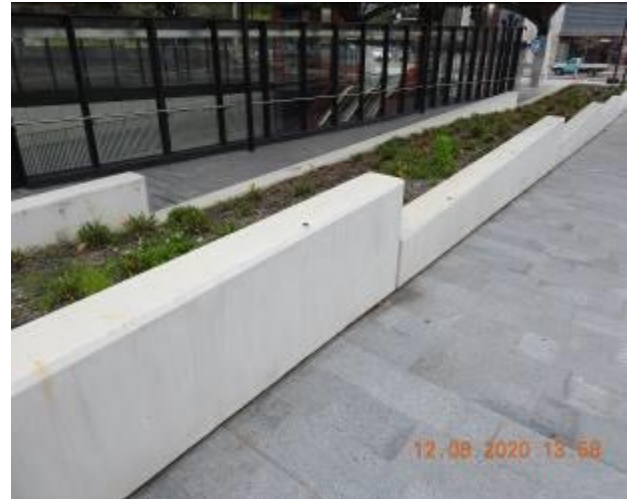
Figure 2154 – General condition of retaining wall

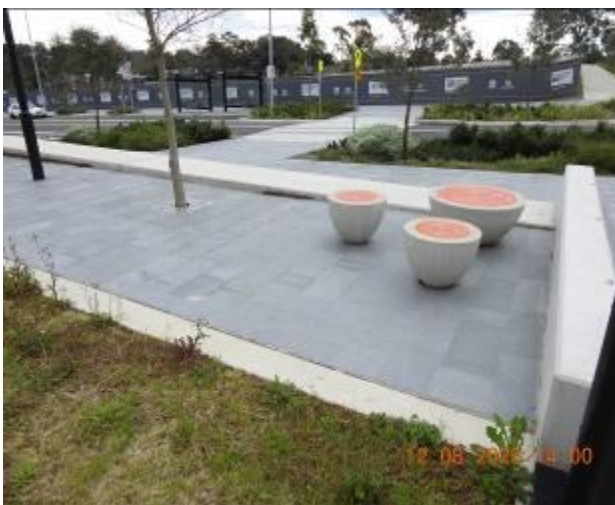
Figure 2155 – General condition of retaining wall

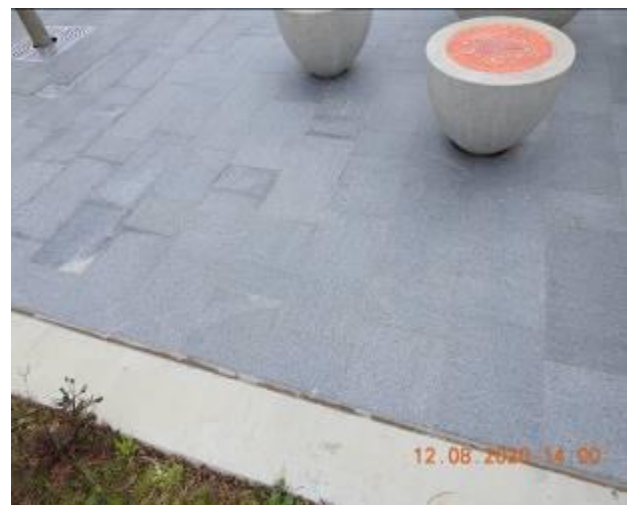
Figure 2156 – Hairline crack propagation and loss of material through walkway floor

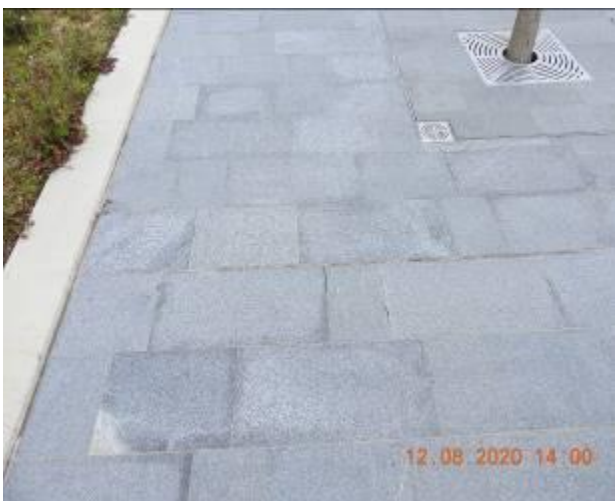
Figure 2157 – Loss of material through walkway floor

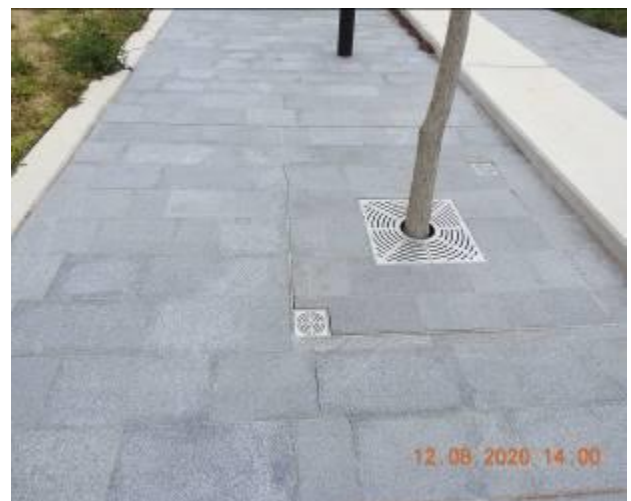
Figure 2158 – Loss of material through walkway floor

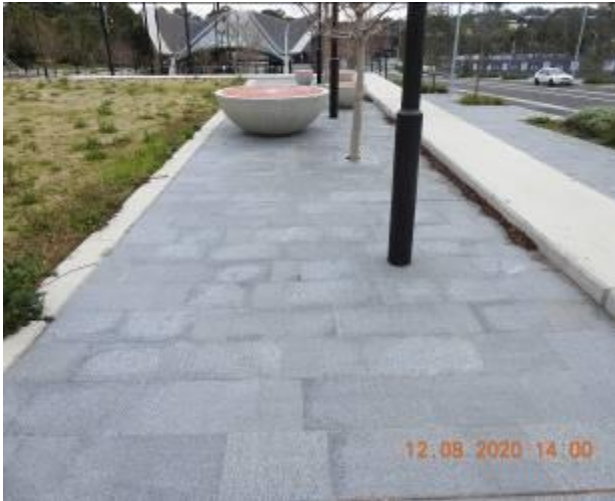
Figure 2159 – Hairline crack propagation through walkway floor

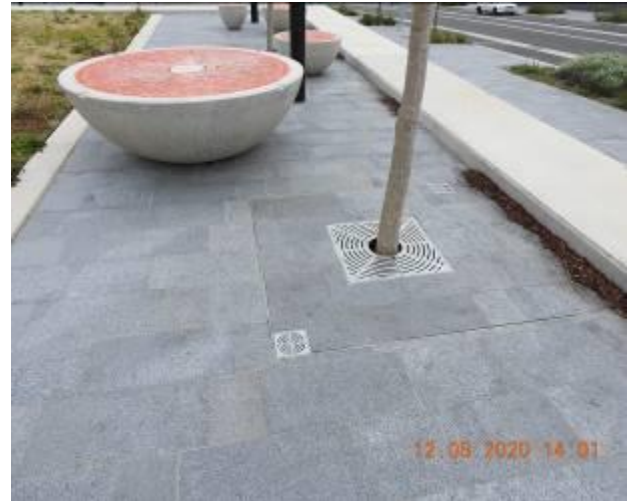
Figure 2160 – Hairline crack propagation through walkway floor

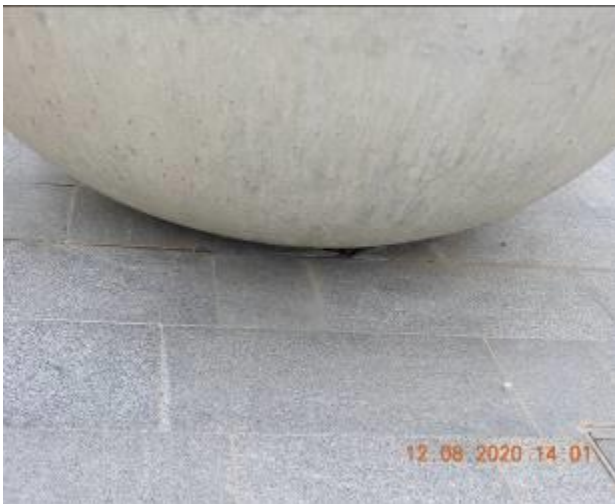
Figure 2161 – Loss of material through walkway floor

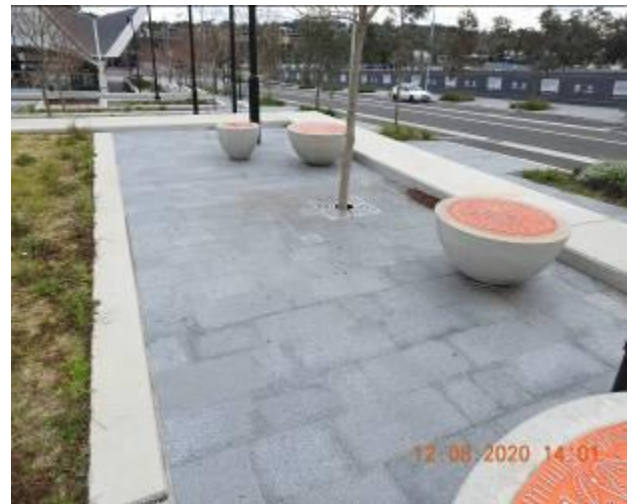
Figure 2162 – General condition of walkway floor

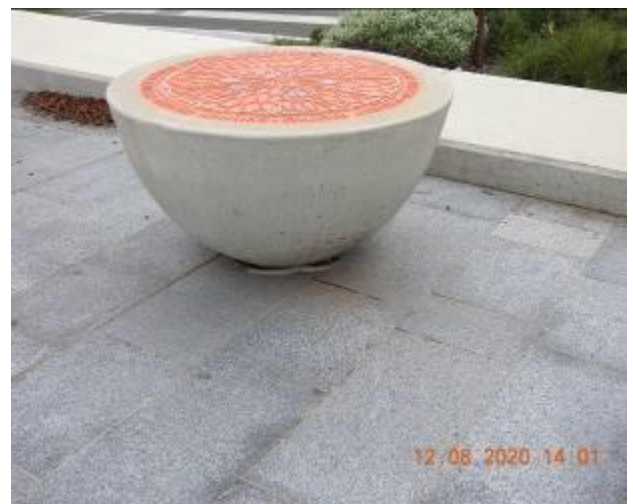
Figure 2164 – Loss of material through walkway floor

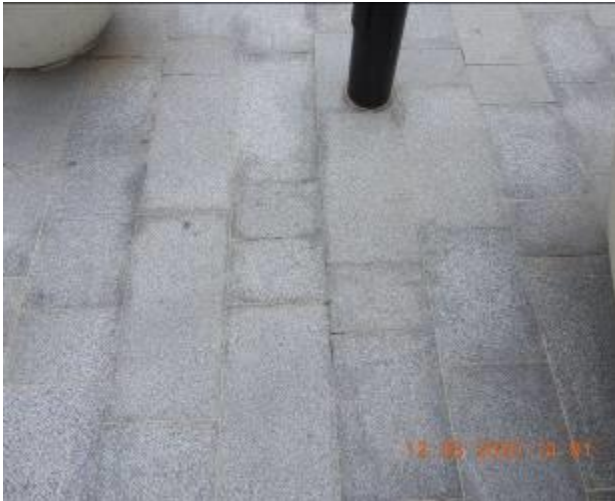
Figure 2165 – Loss of material through walkway floor

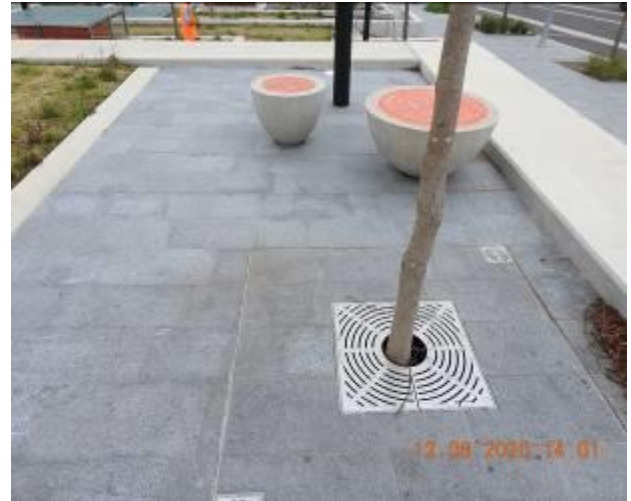
Figure 2166 – General condition of walkway floor

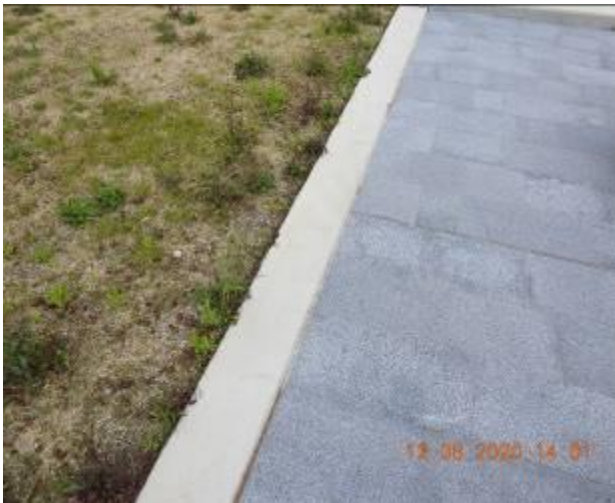
Figure 2167 – Crack propagation through Retaining wall

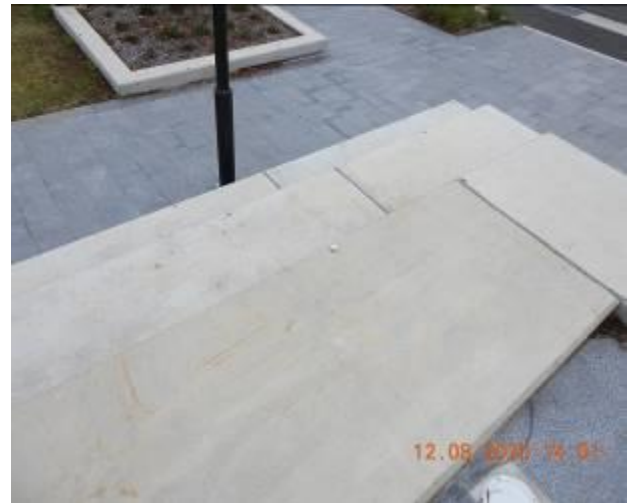
Figure 2168 – General condition of Retaining wall

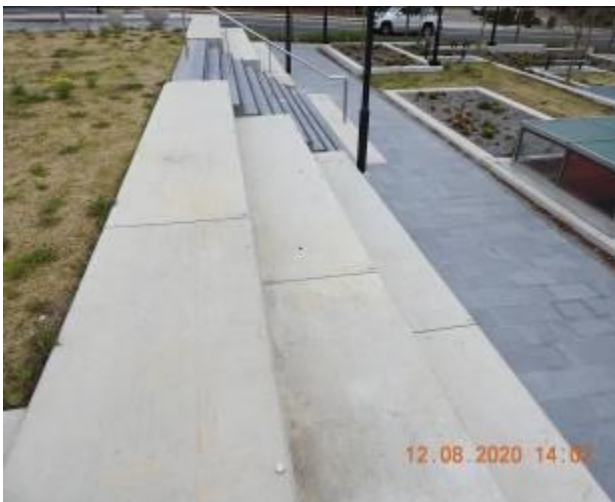
Figure 2169 – General condition of Retaining wall

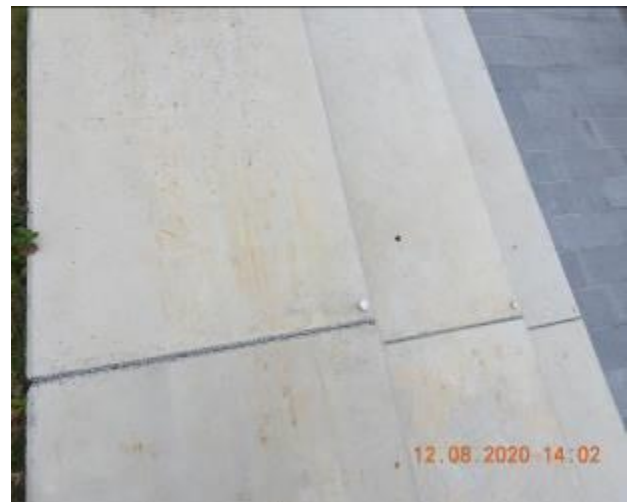
Figure 2170 – Separation through Retaining wall

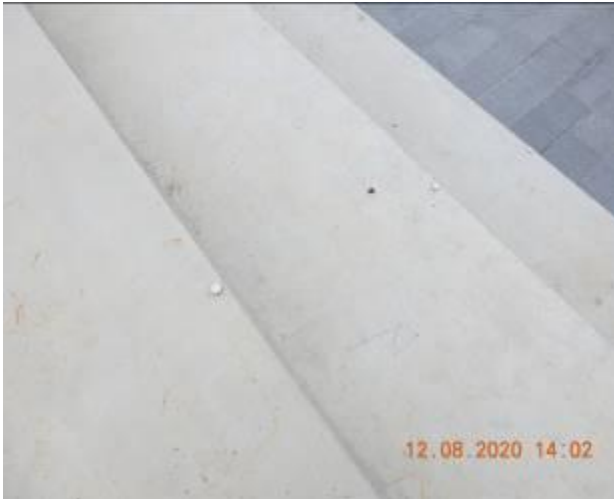
Figure 2171 – Crack propagation through Retaining wall

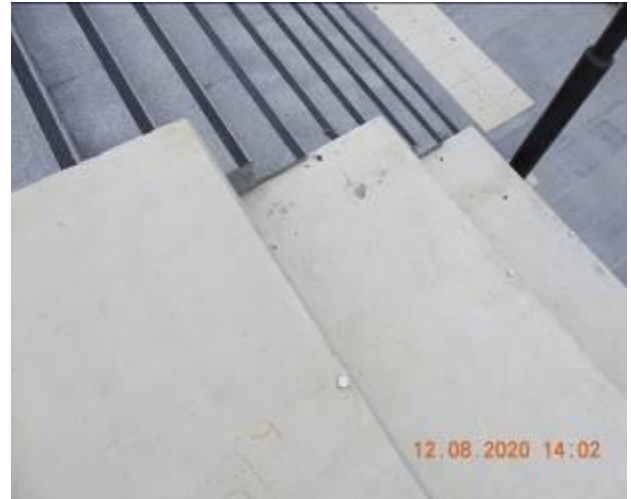
Figure 2172 – Loss of material through Retaining wall

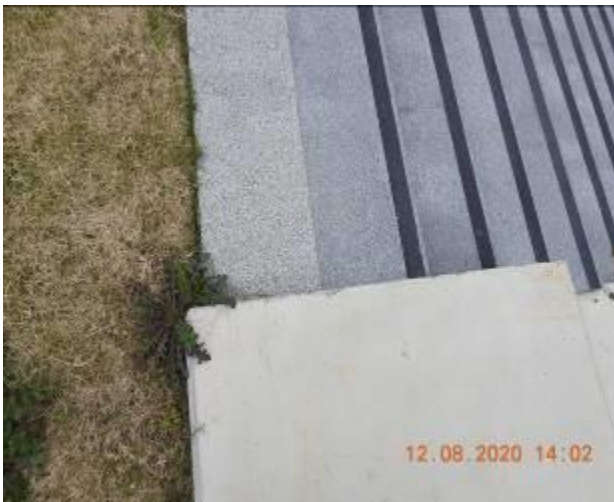
Figure 2173 – Loss of material through retaining

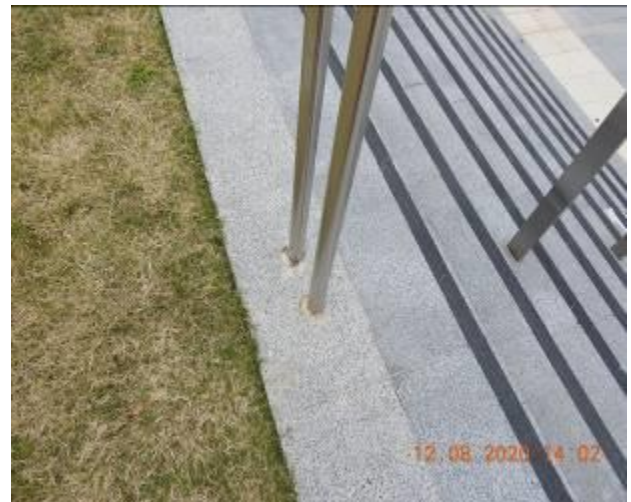
Figure 2174 – Loss of material through retaining
