**2 MANDALA PARADE, CASTLE HILL
(DORAN DRIVE PRECINCT)
PRE-DILAPIDATION REPORT
Of Sydney Metro and Hills Shire Council Assets
DEICORP PROJECTS SHOWGROUND
PTY LTD.**

Job No. 200124.3
07/07/2021

ACE Structural Services Pty Ltd

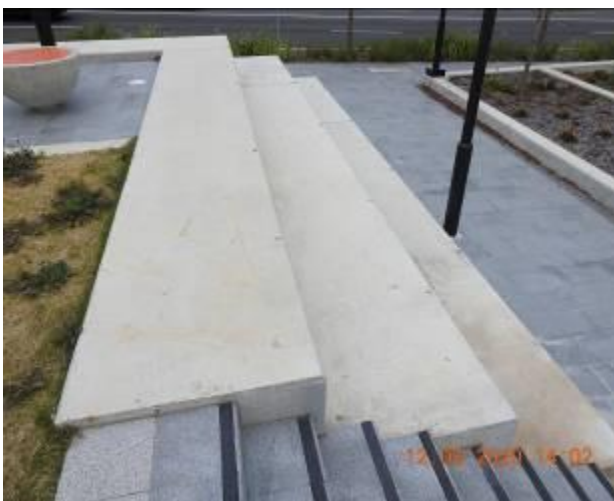
Figure 2175 – General condition of retaining

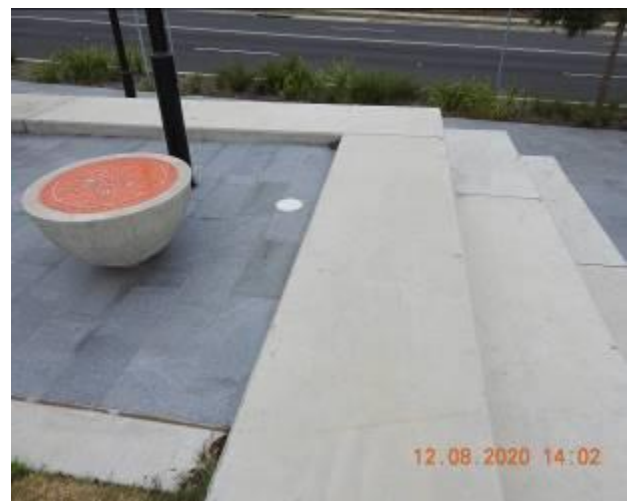
Figure 2176 – General condition of retaining

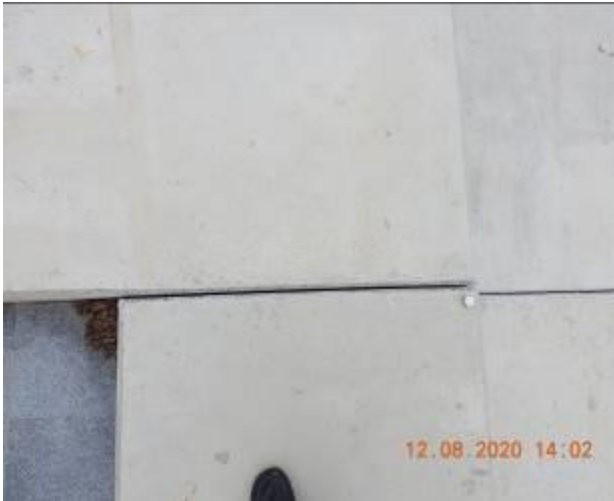
Figure 2177 – Separation through retaining wall

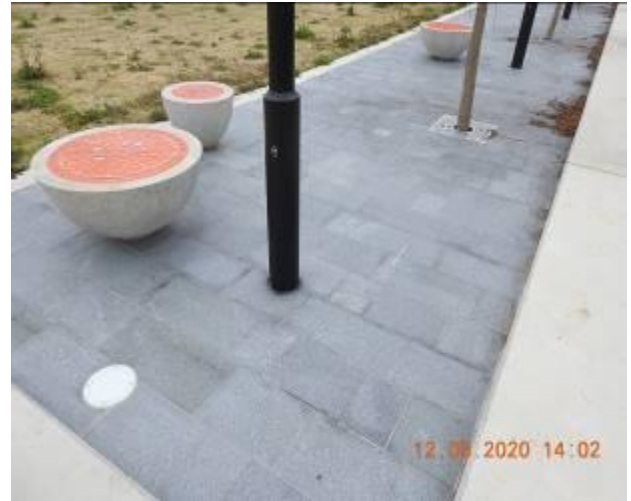
Figure 2178 – Hairline Crack propagation through walkway floor

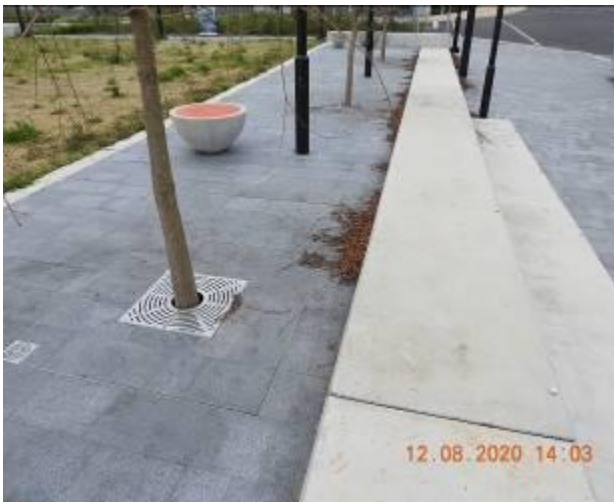
Figure 2179 – General condition of retaining wall

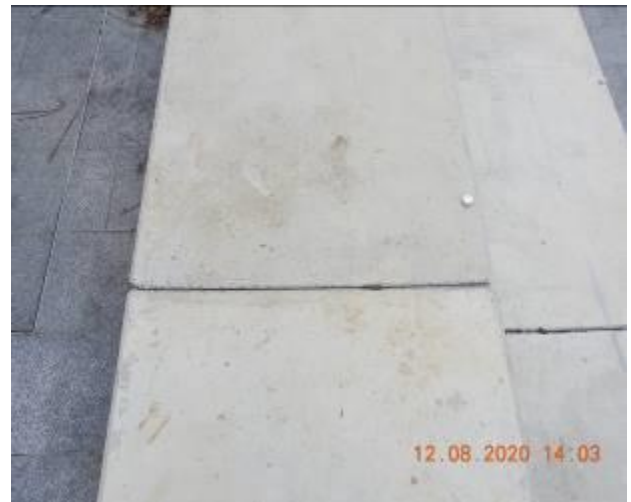
Figure 2180 – Separation through retaining wall

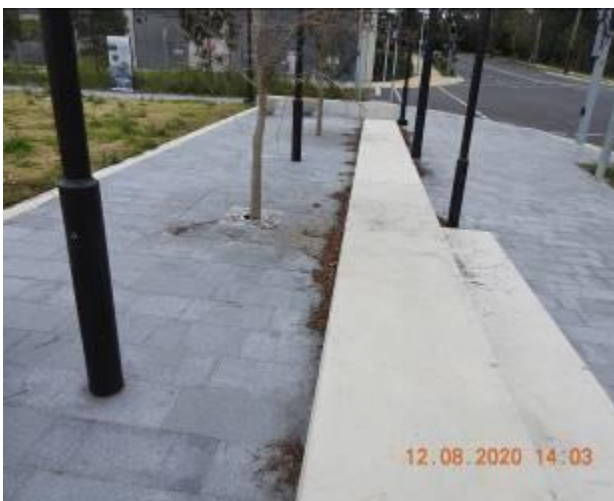
Figure 2181 – General condition of walkway floor

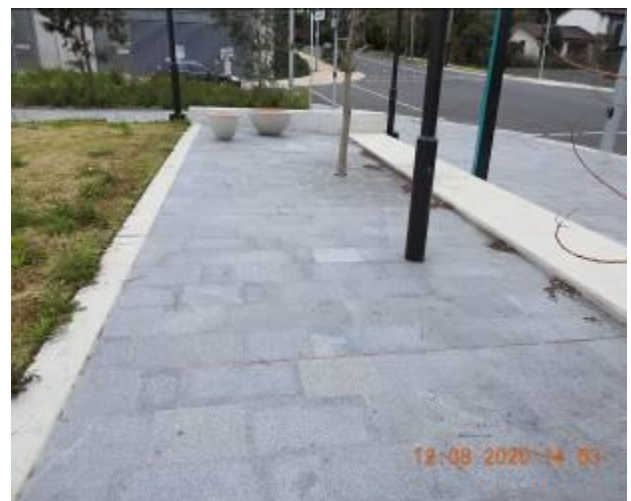
Figure 2182 – General condition of walkway floor

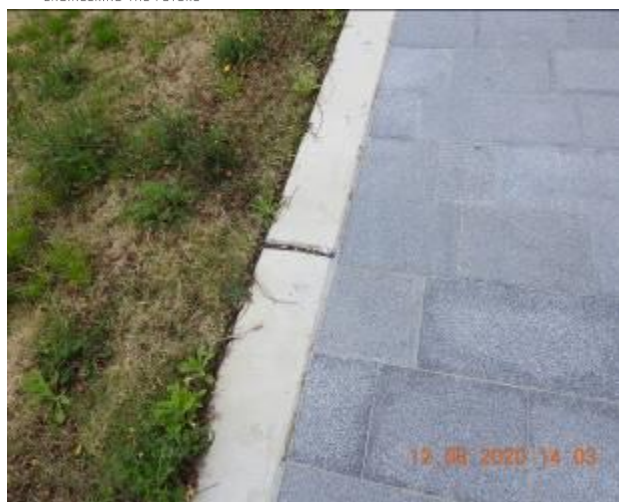
Figure 2183 – Loss of material through retaining wall

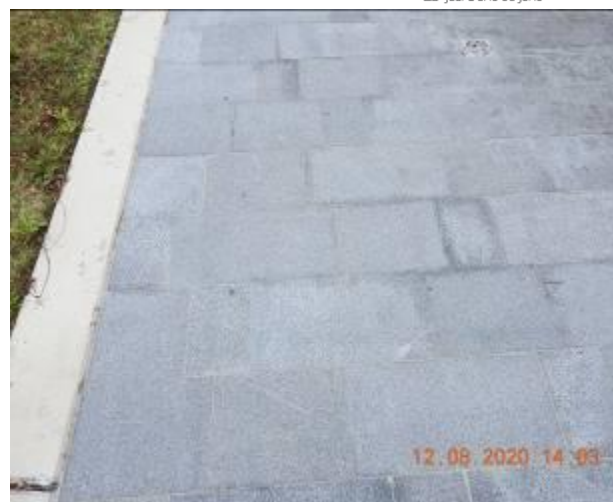
Figure 2184 – Hairline crack propagation through walkway floor

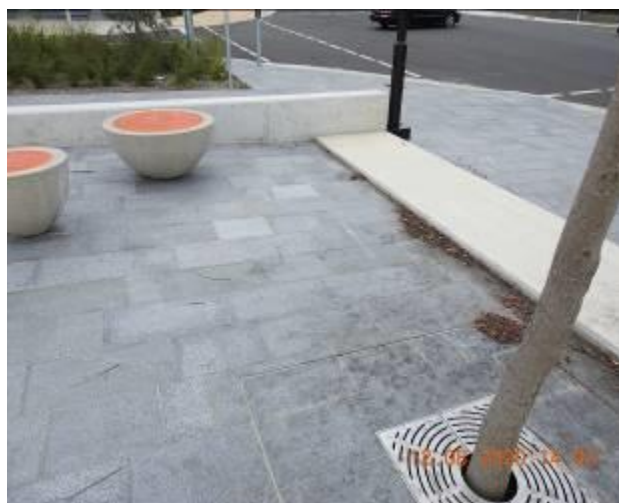
Figure 2185 – Loss of material through walkway floor

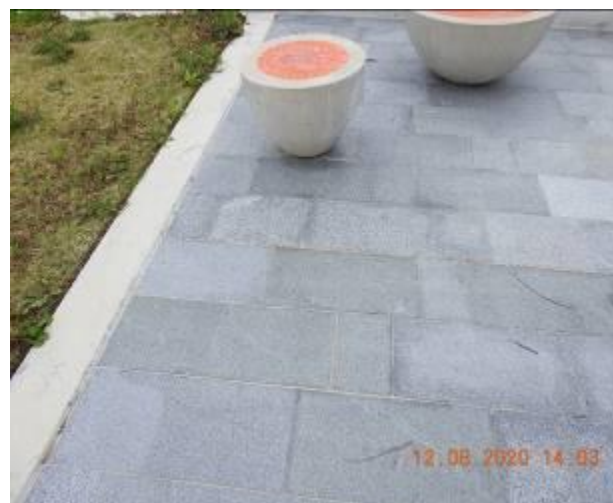
Figure 2186 – Hairline crack propagation through walkway floor

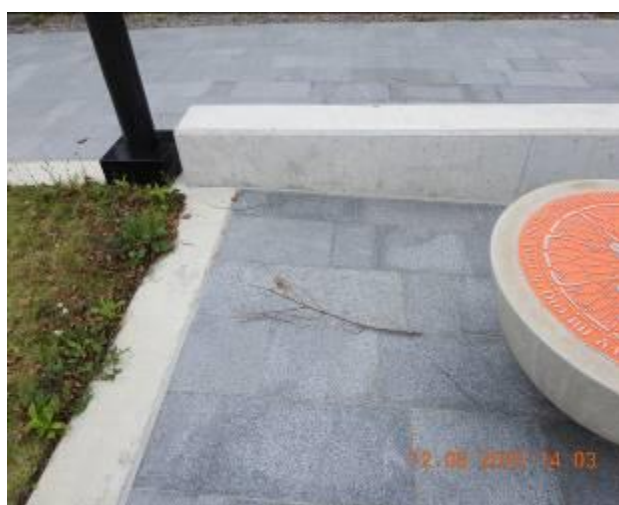
Figure 2187 – Hairline crack propagation through walkway floor

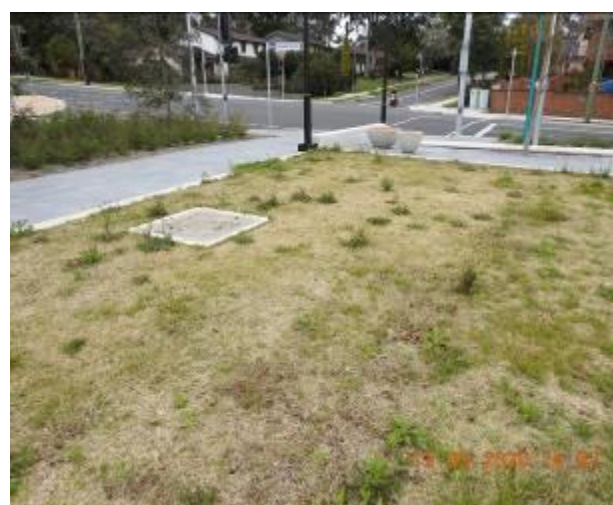
Figure 2188 – General condition of nature strip

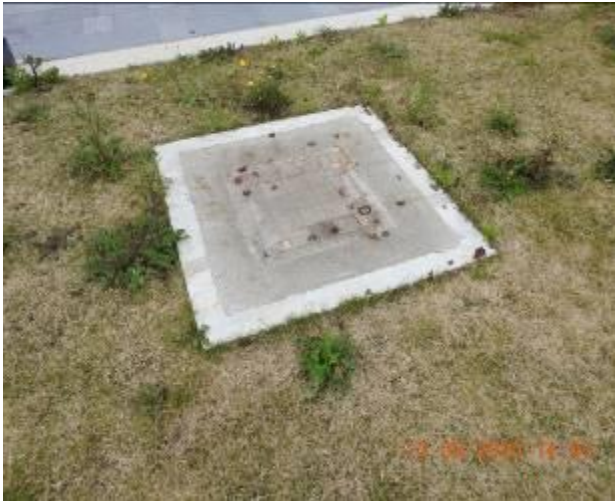
Figure 2189 – Evidence of patchwork through service pit pavement

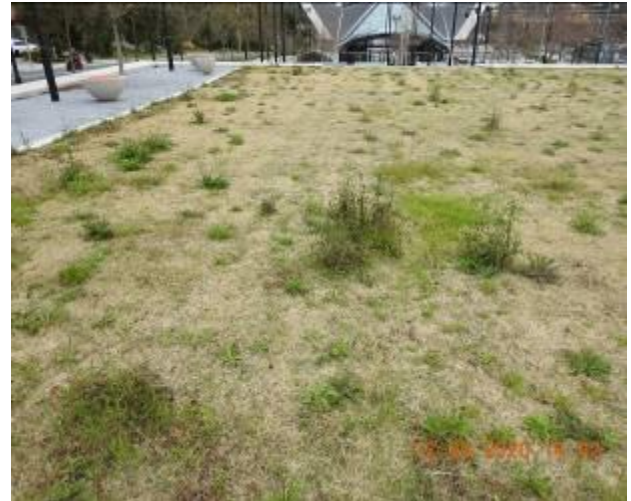
Figure 2190 – General condition of nature strip

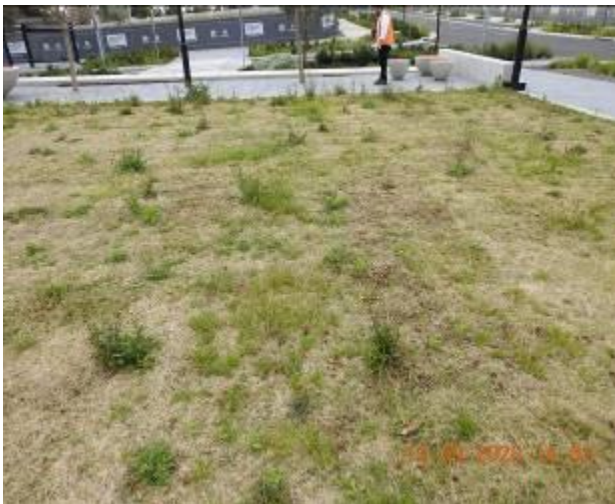
Figure 2191 – General condition of nature strip

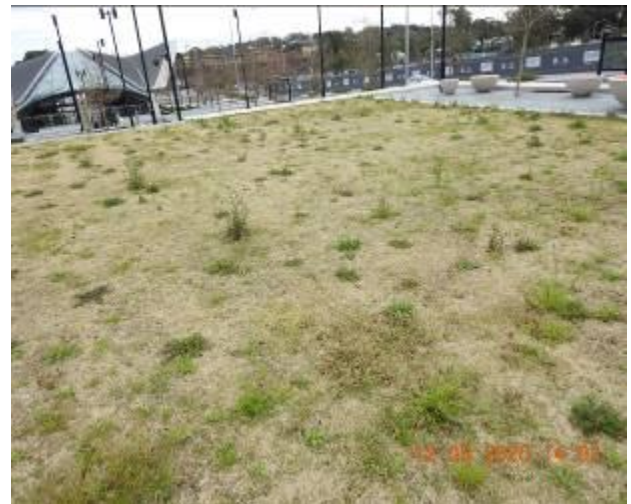
Figure 2192 – General condition of nature strip

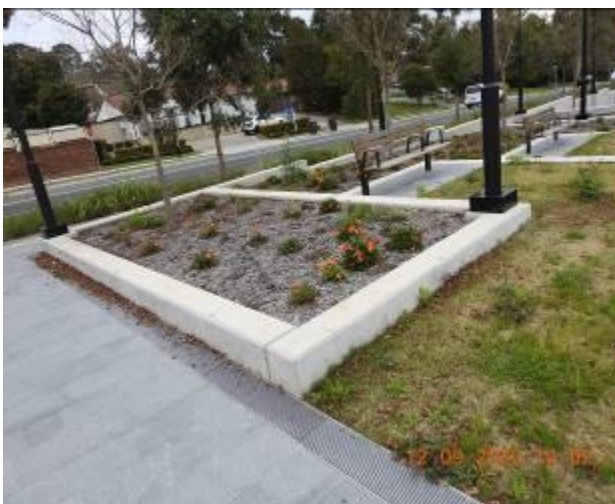
Figure 2193 – General condition of nature strip

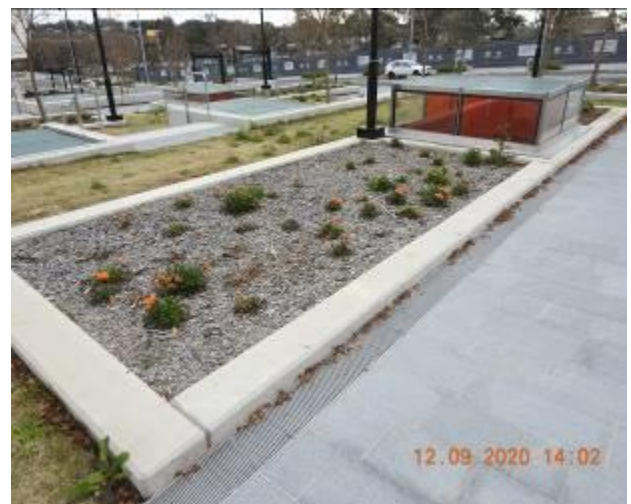
Figure 2194 – General condition of nature strip

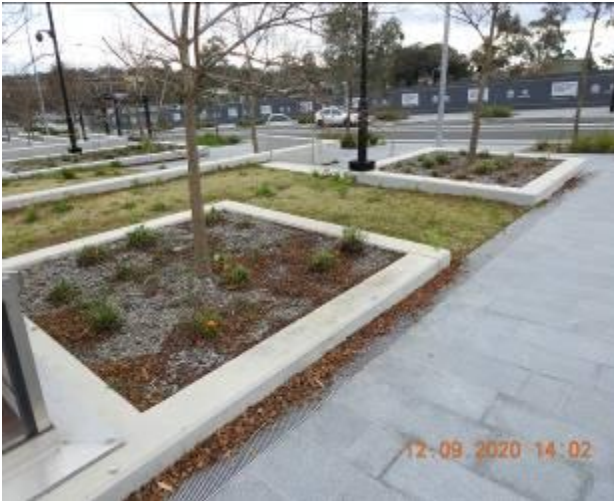
Figure 2195 – General condition of nature strip

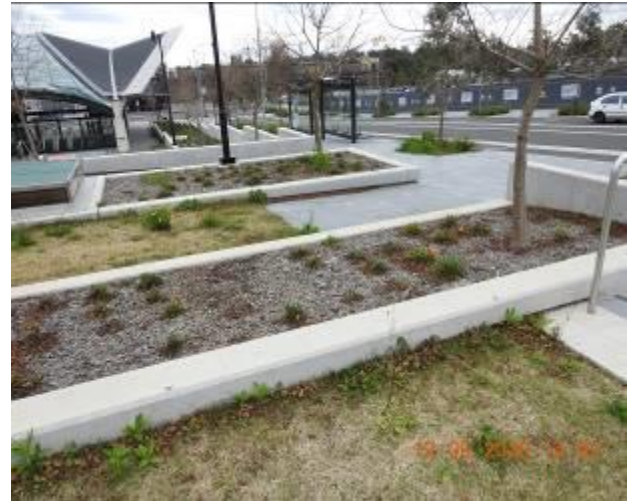
Figure 2196 – General condition of nature strip

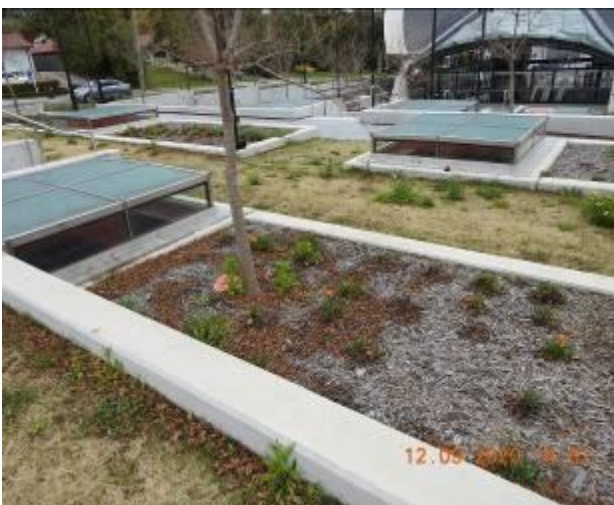
Figure 2197 – General condition of nature strip

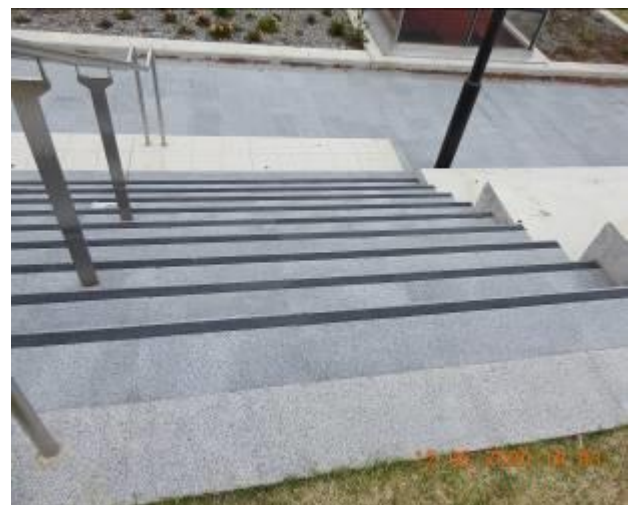
Figure 2198 – General condition of staircase floor

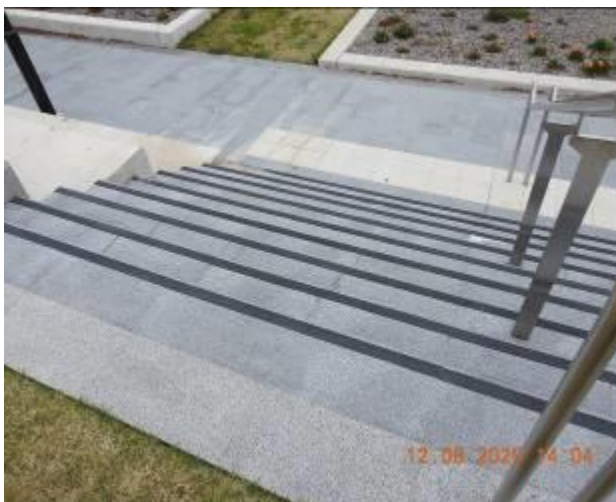
Figure 2199 – General condition of staircase floor

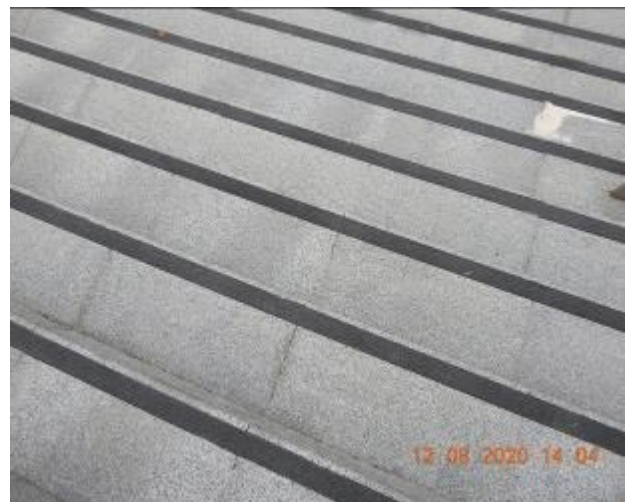
Figure 2200 – Loss of material through staircase floor

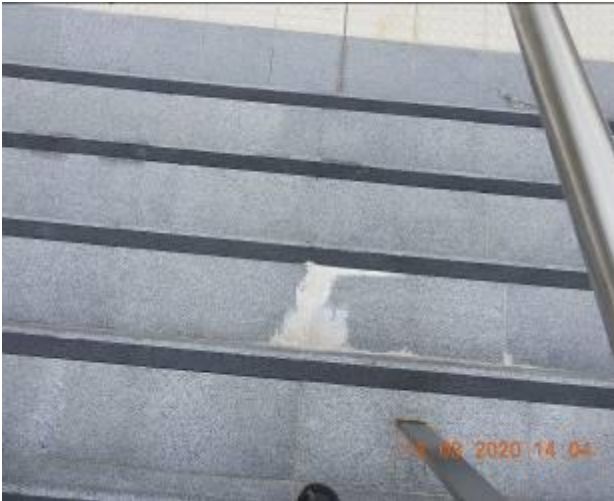
Figure 2201 – Efflorescence through staircase floor

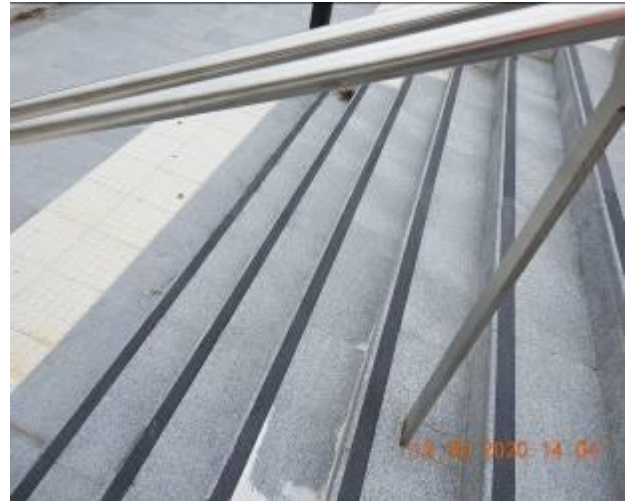
Figure 2202 – General condition of staircase floor

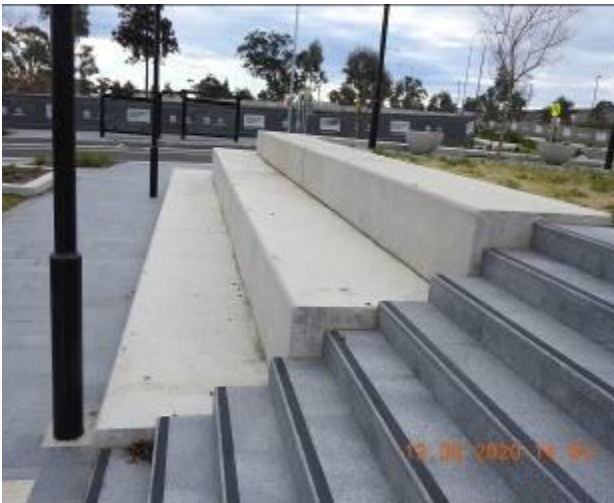
Figure 2203 – General condition of retaining wall

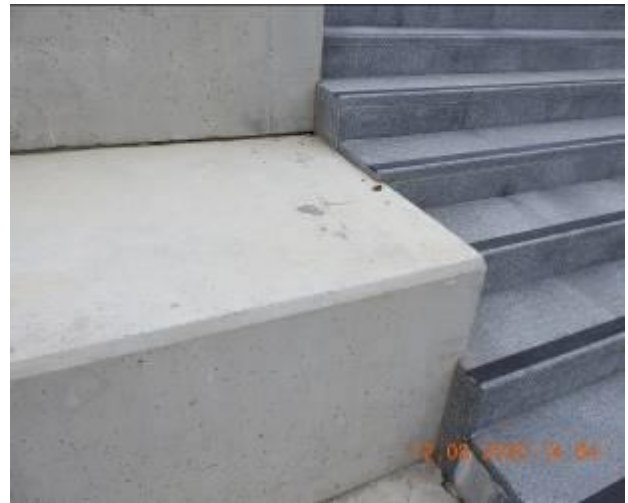
Figure 2204 – Loss of material through retaining wall

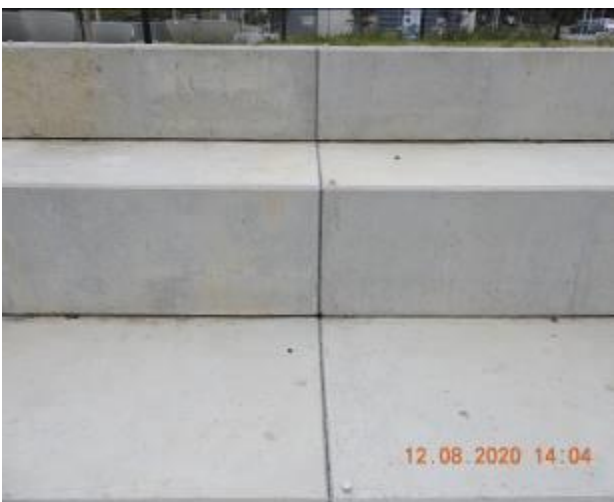
Figure 2205 – Separation through retaining wall

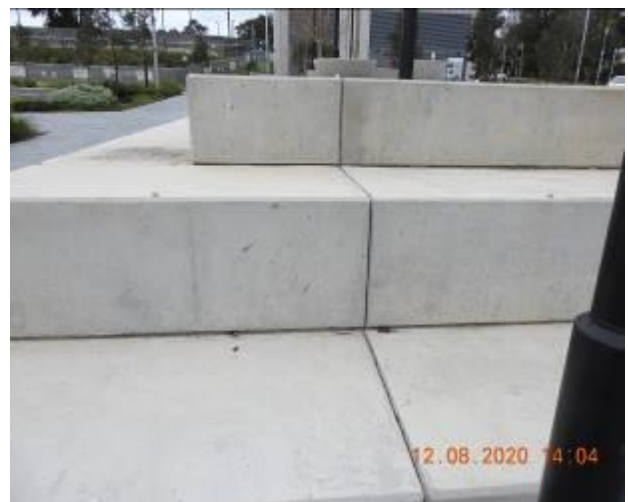
Figure 2206 – Separation through retaining wall

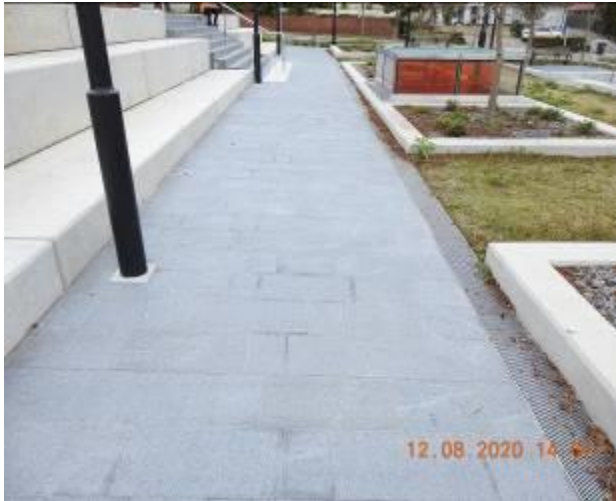
Figure 2207 – Loss of material through walkway floor

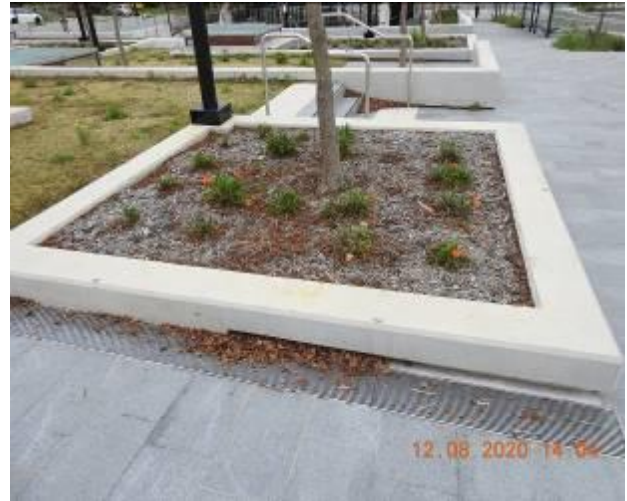
Figure 2208 – General condition of retaining wall

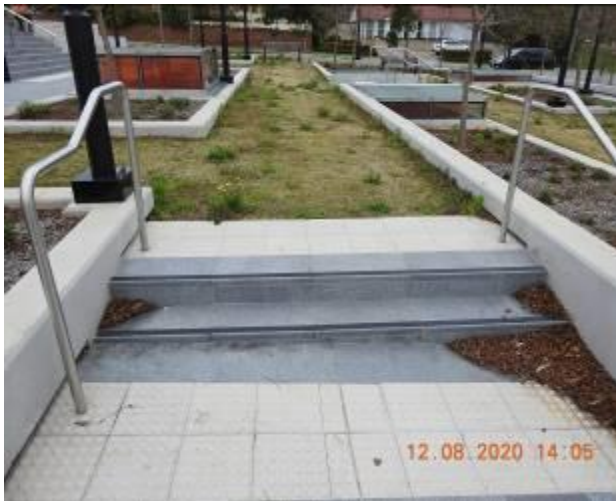
Figure 2209 – General condition of walkway floor

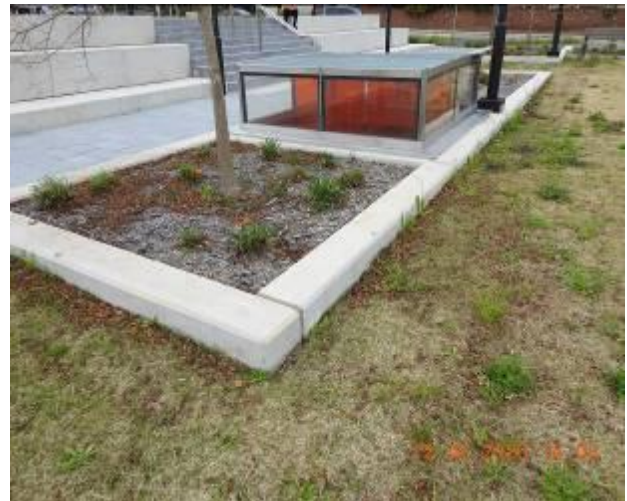
Figure 2210 – General condition of retaining wall

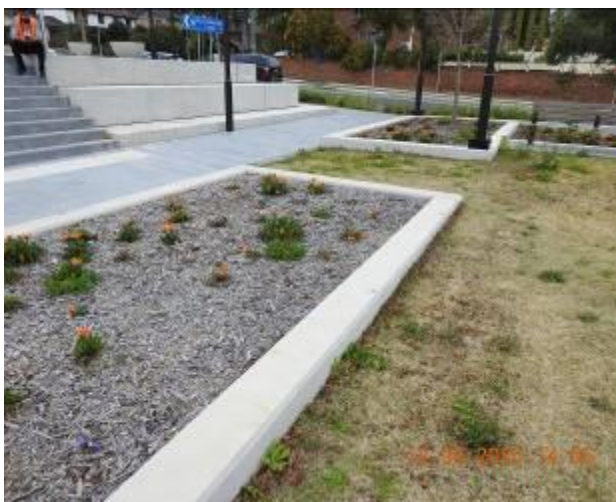
Figure 2211 – General condition of retaining wall

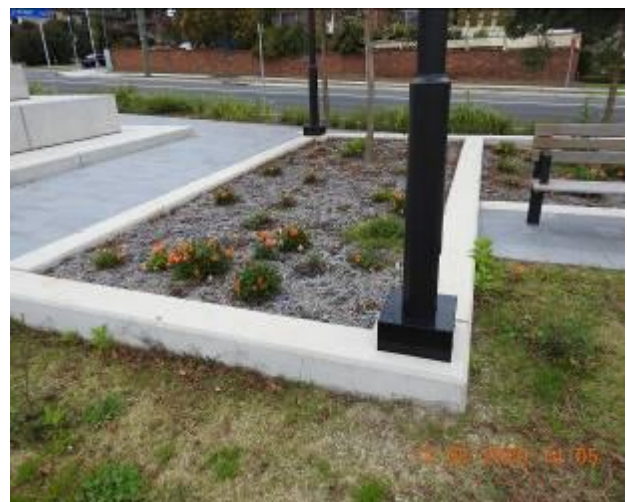
Figure 2212 – General condition of retaining wall

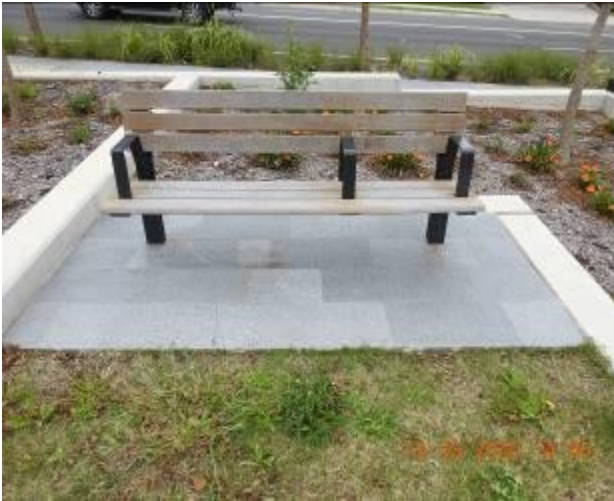
Figure 2213 – General condition of walkway floor

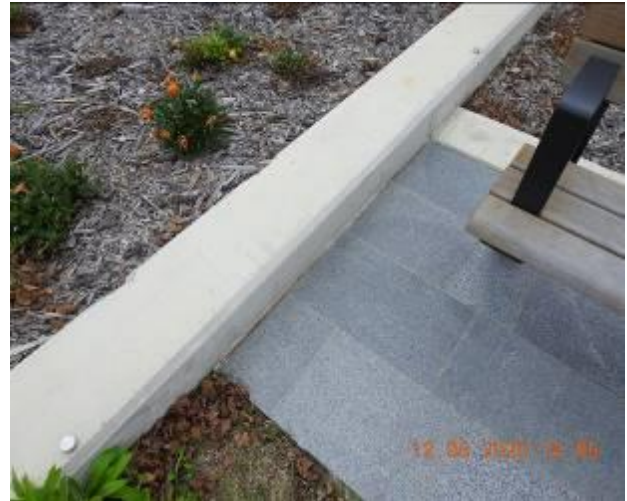
Figure 2214 – Crack propagation and loss of material through retaining wall

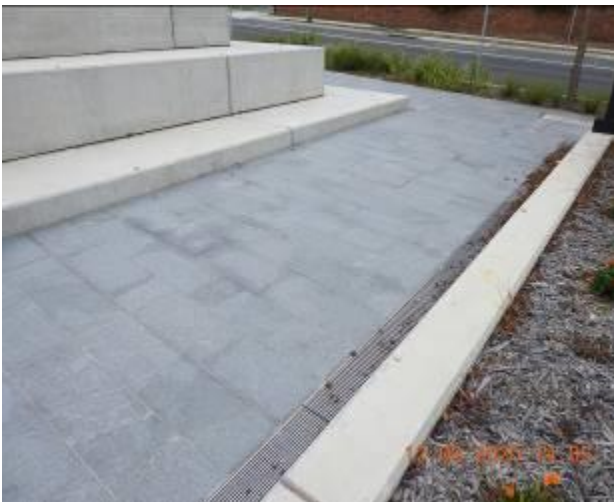
Figure 2215 – General condition of retaining wall

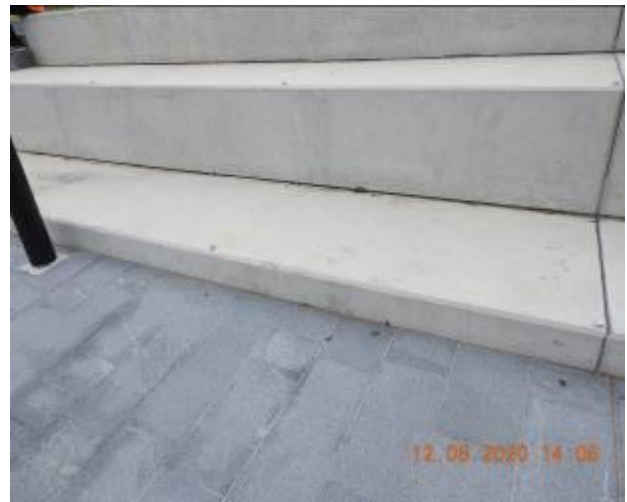
Figure 2216 – General condition of retaining wall

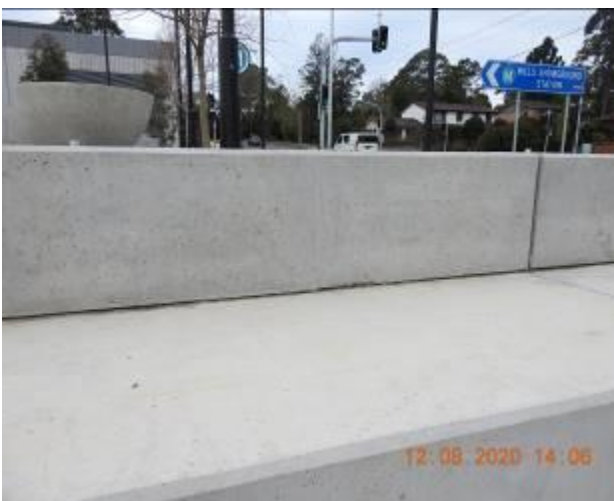
Figure 2217 – Loss of material through retaining wall

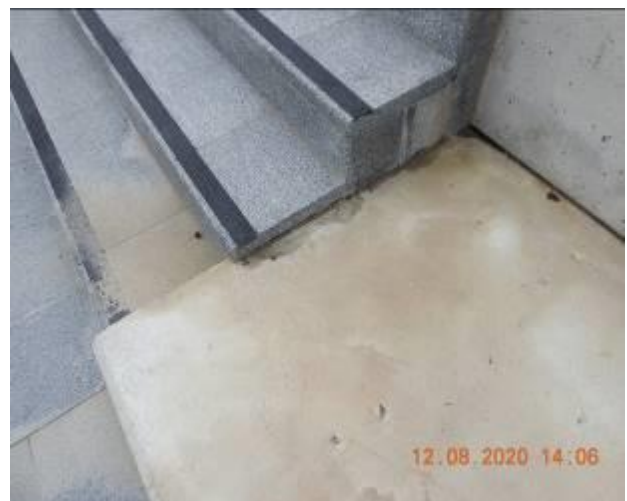
Figure 2218 – Efflorescence through staircase floor

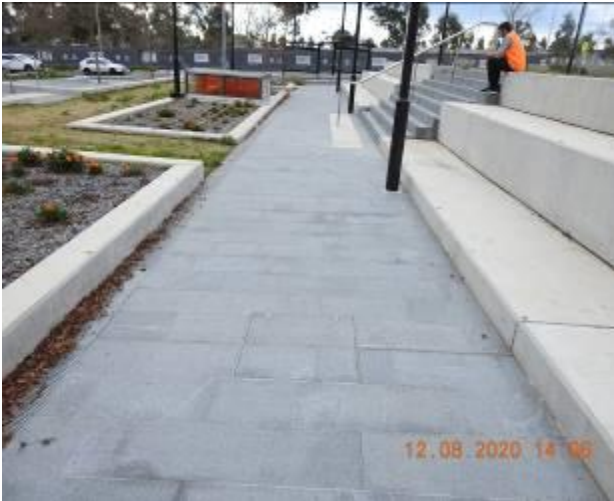
Figure 2219 – General condition of walkway floor

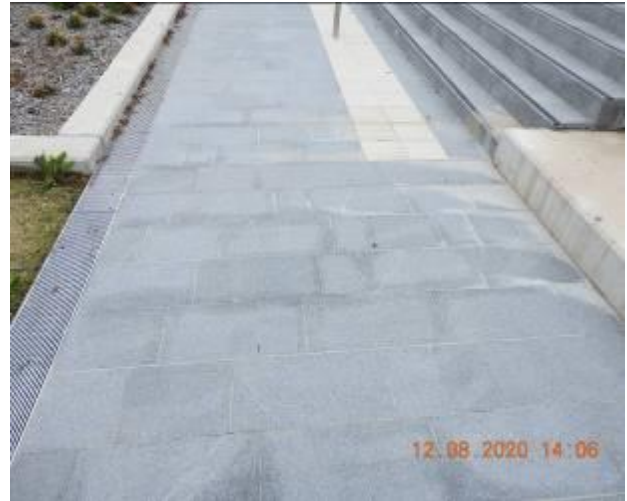
Figure 2220 – Hairline crack propagation through walkway floor

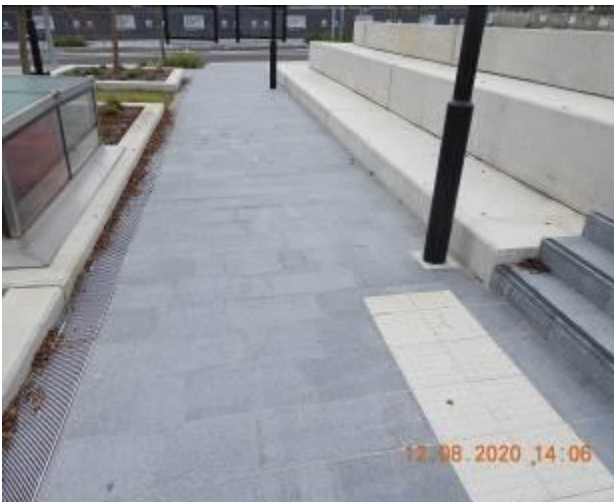
Figure 2221 – Hairline crack propagation through walkway floor

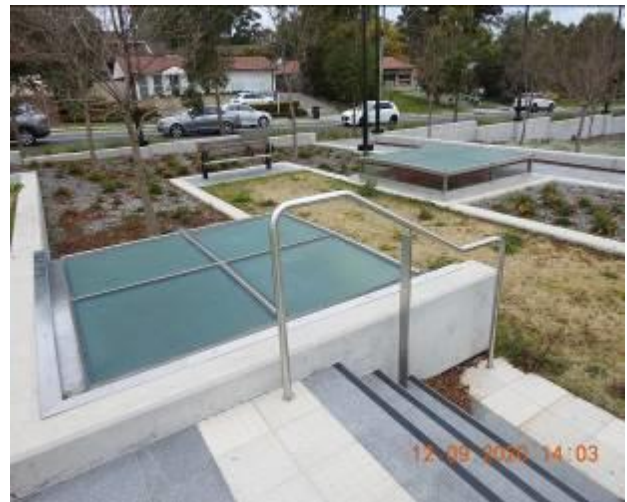
Figure 2222 – General condition of nature strip

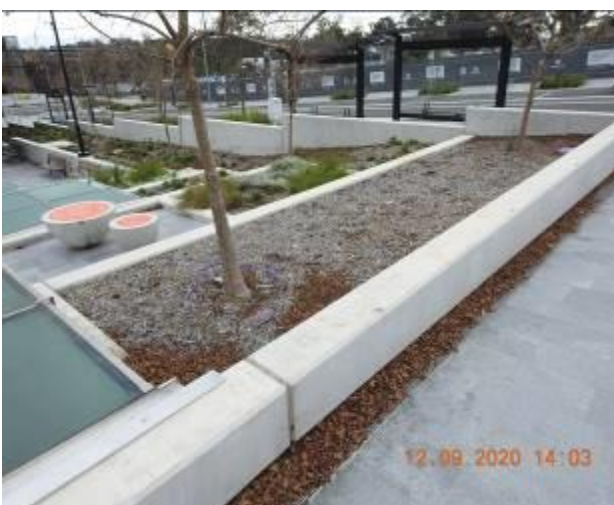
Figure 2223 – General condition of nature strip

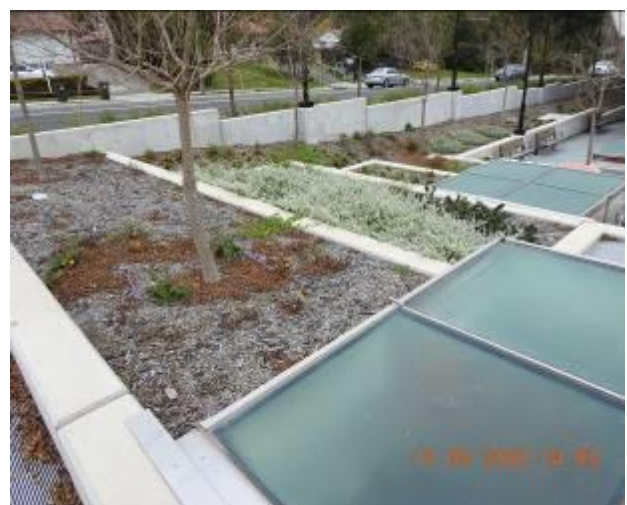
Figure 2224 – General condition of nature strip

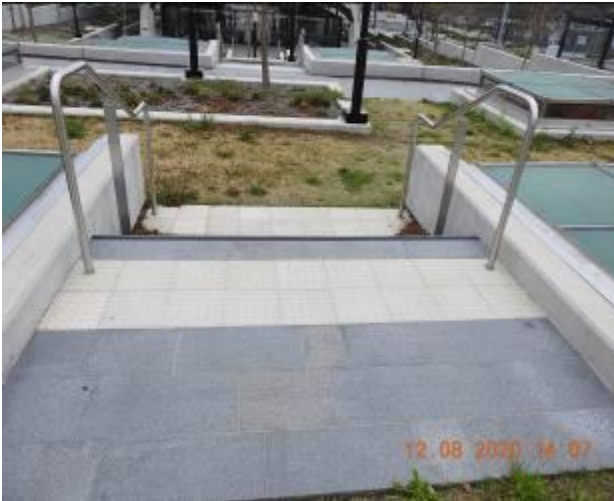
Figure 2225 – Hairline crack propagation through walkway floor

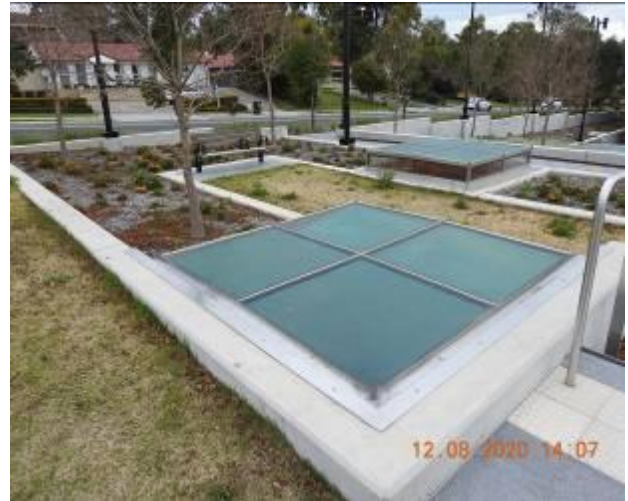
Figure 2226 – General condition of nature strip

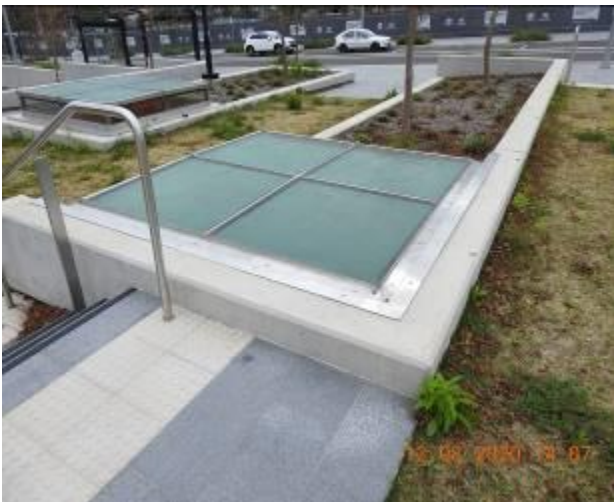
Figure 2227 – General condition of nature strip

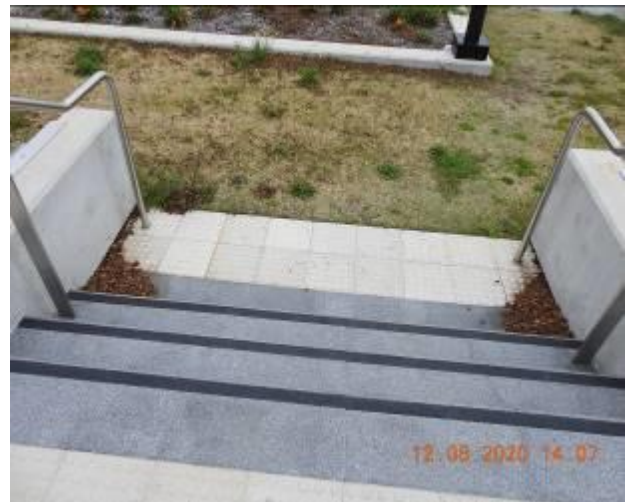
Figure 2228 – General condition of staircase floor

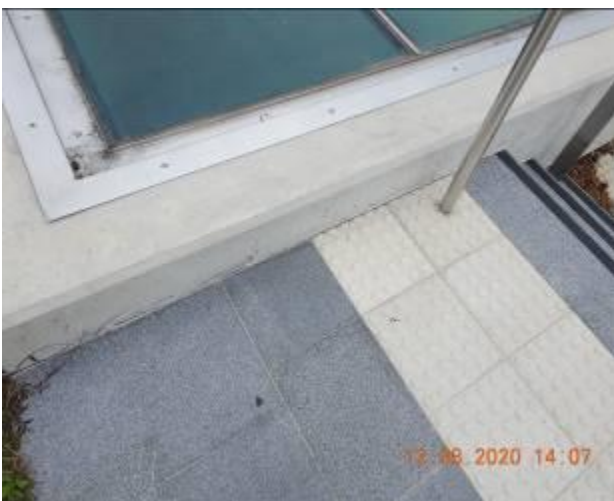
Figure 2229 – Separation through staircase floor

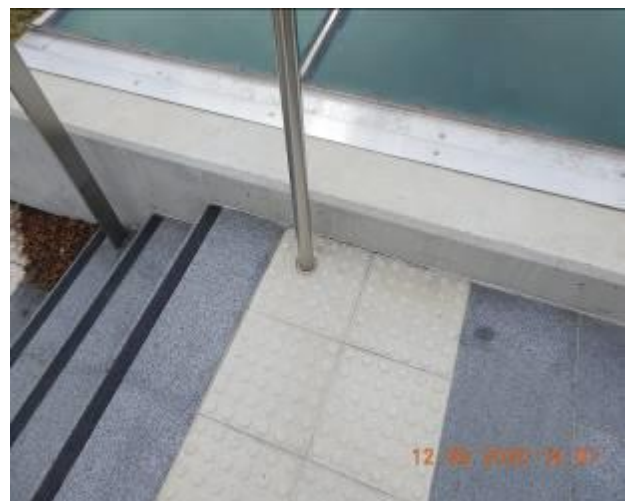
Figure 2230 – Separation through staircase floor

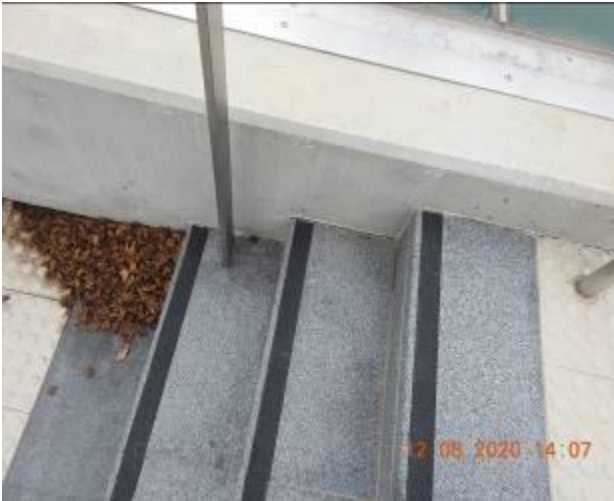
Figure 2231 – Separation through staircase floor

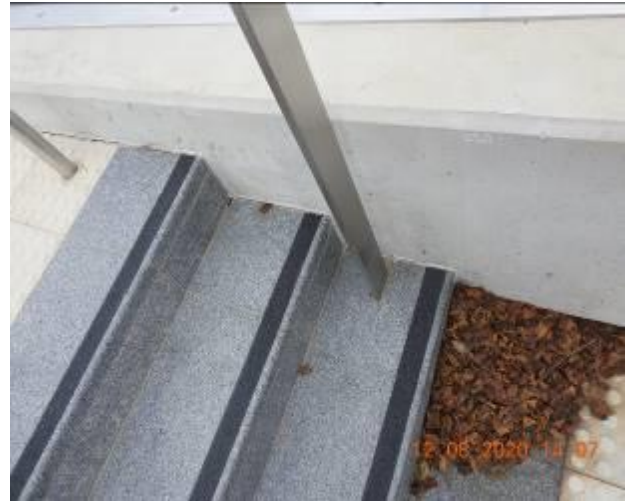
Figure 2232 – Separation through staircase floor

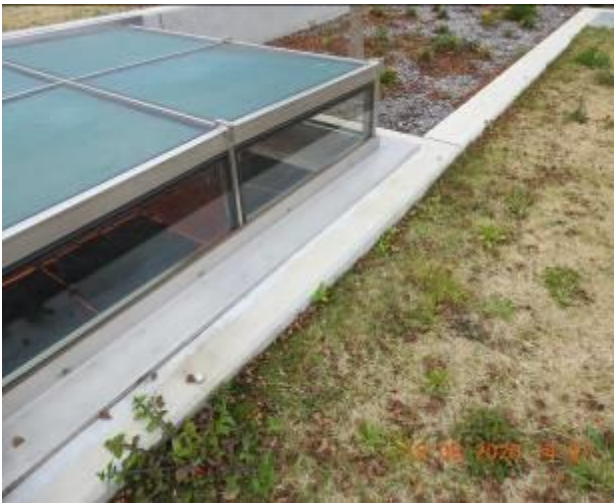
Figure 2233 – General condition of retaining wall

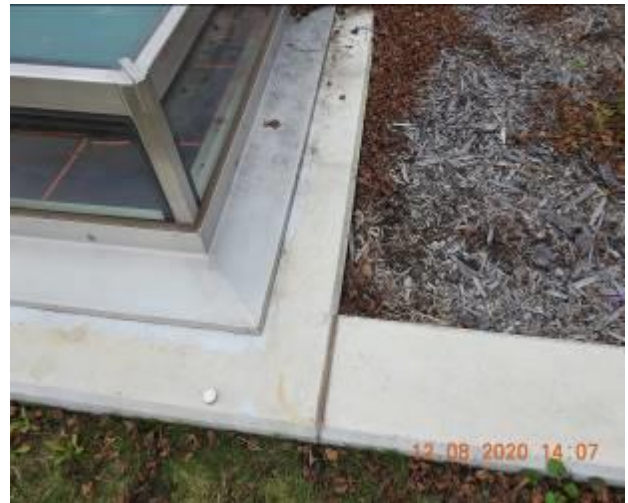
Figure 2234 – Loss of material through retaining wall

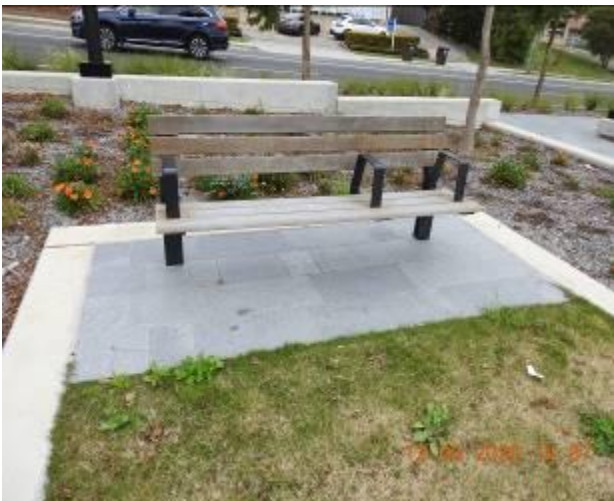
Figure 2235 – General condition of nature strip

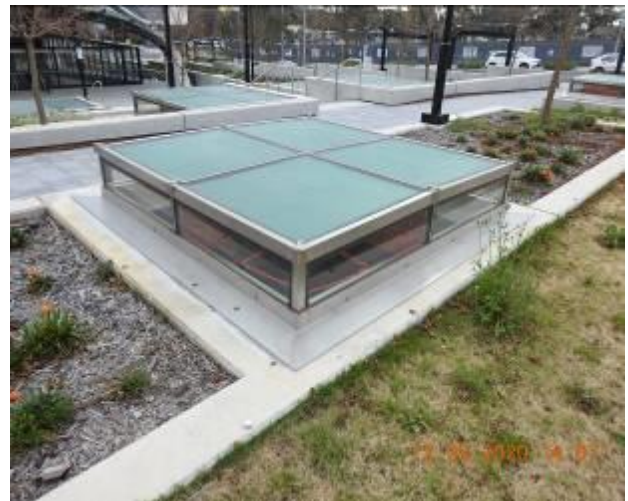
Figure 2236 – General condition of nature strip

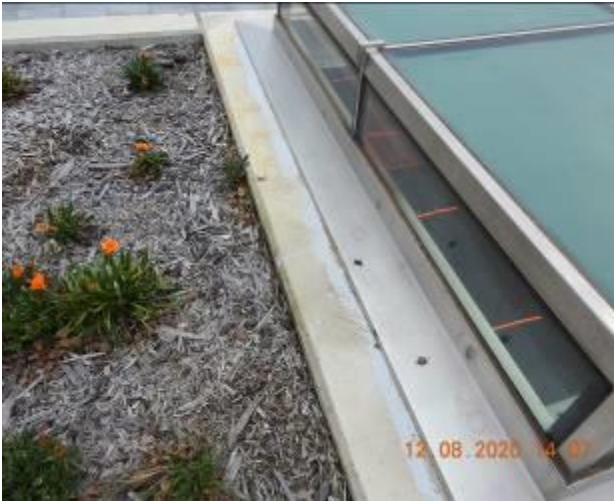
Figure 2237 – General condition of retaining wall

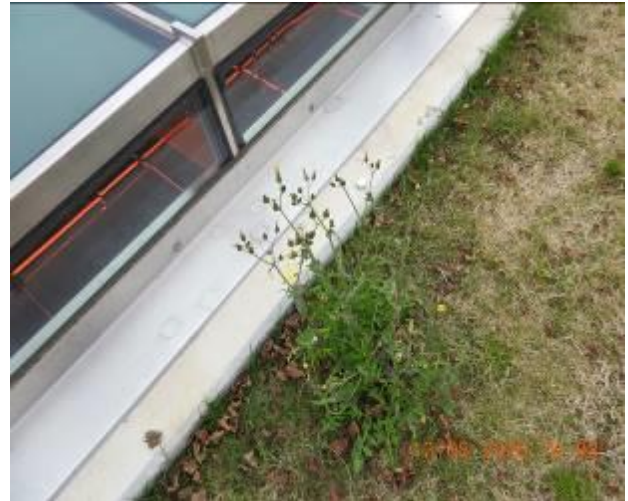
Figure 2238 – General condition of retaining wall

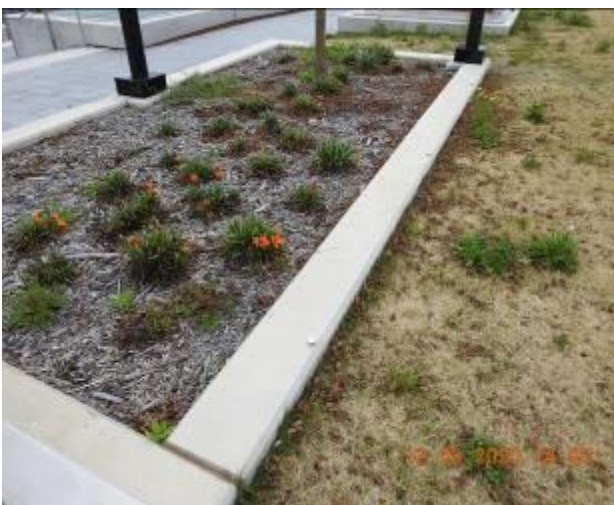
Figure 2239 – General condition of retaining wall

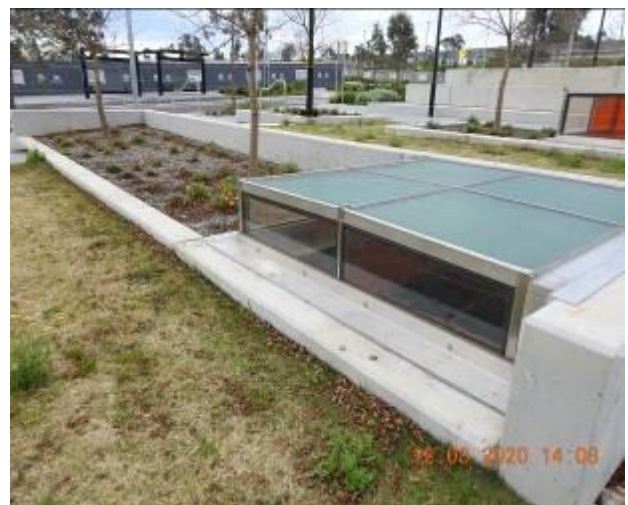
Figure 2240 – General condition of retaining wall

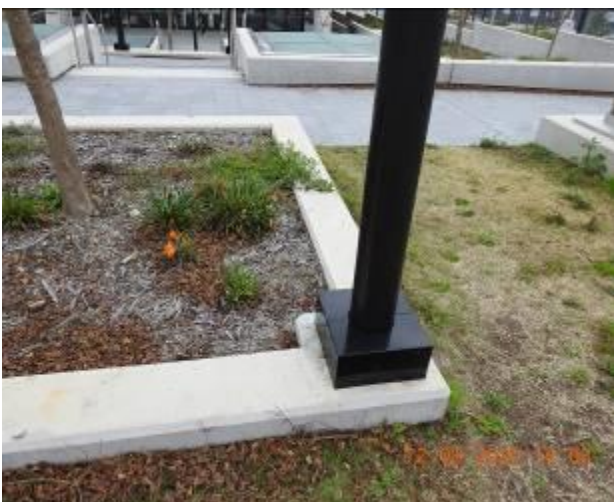
Figure 2241 – General condition of retaining wall

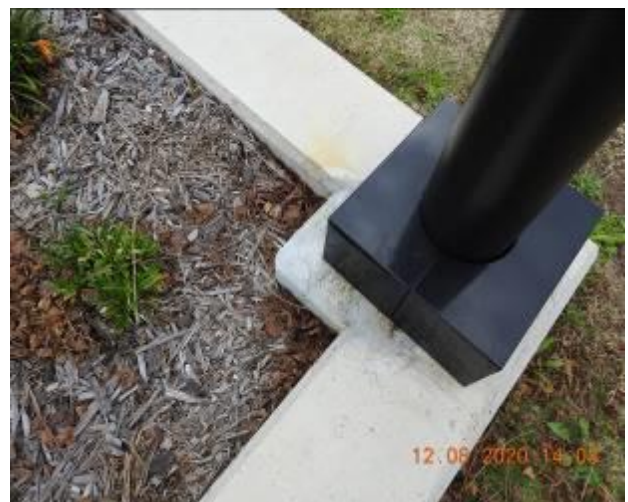
Figure 2242 – Evidence of patchwork and hairline crack propagation through retaining wall

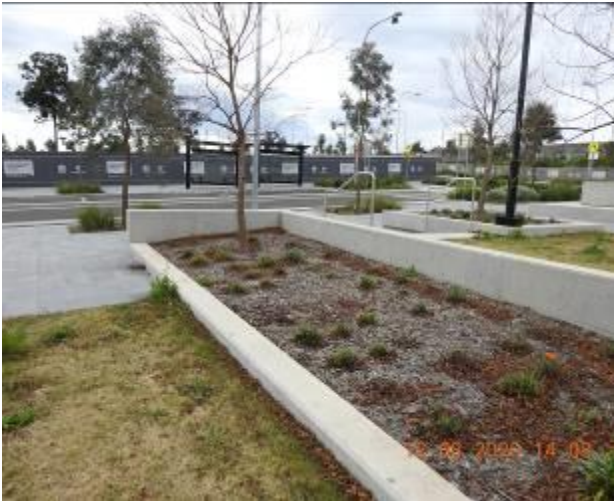
Figure 2243 – General condition of nature strip

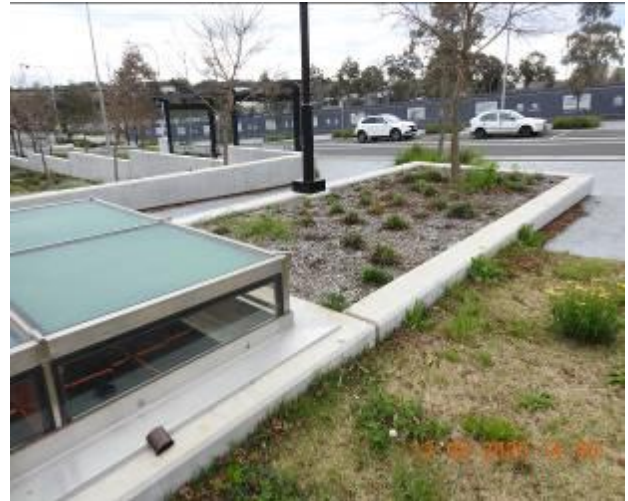
Figure 2244 – General condition of nature strip

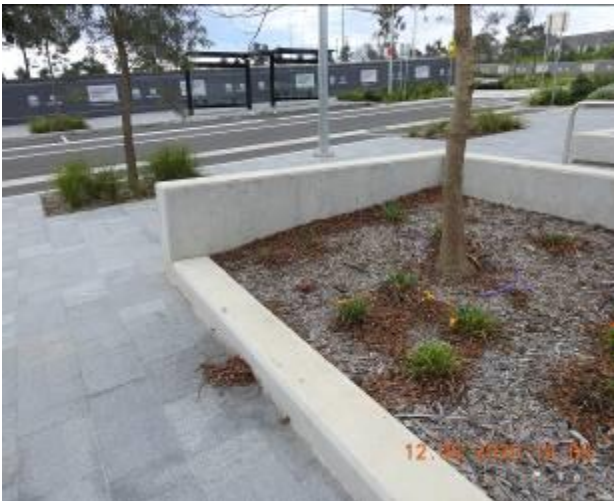
Figure 2245 – General condition of nature strip
