**2 MANDALA PARADE, CASTLE HILL
(DORAN DRIVE PRECINCT)
PRE-DILAPIDATION REPORT
Of Sydney Metro and Hills Shire Council Assets
DEICORP PROJECTS SHOWGROUND
PTY LTD.**

Job No. 200124.3
07/07/2021

ACE Structural Services Pty Ltd

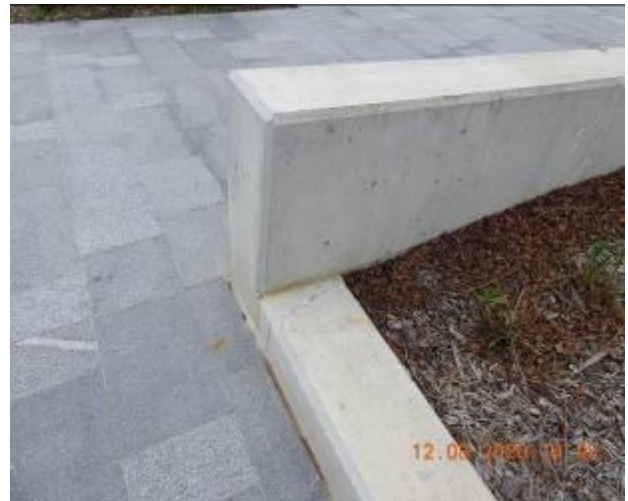
Figure 2246 – Separation through retaining wall

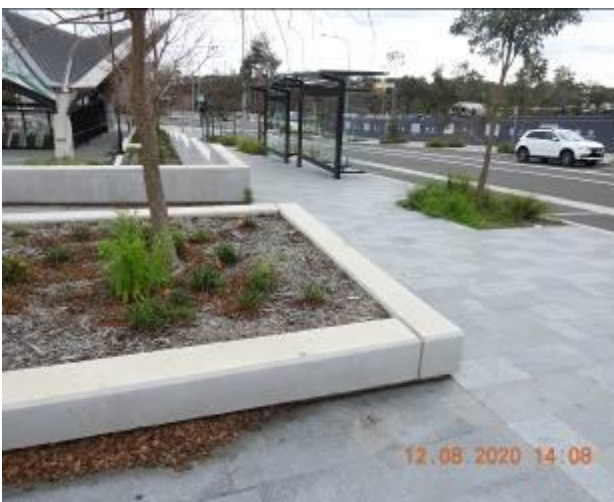
Figure 2247 – General condition of retaining wall

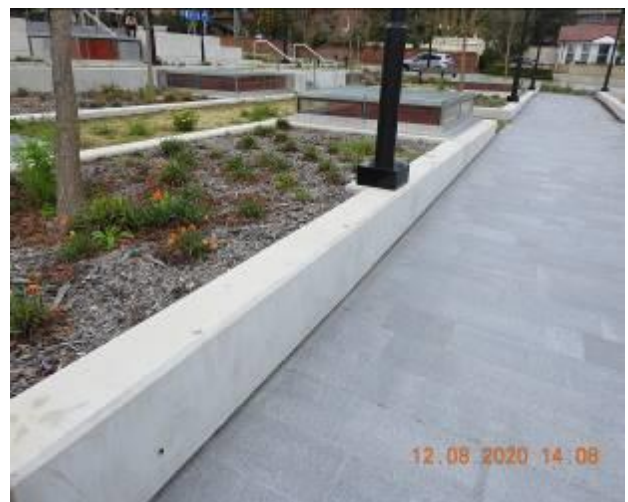
Figure 2248 – General condition of retaining wall

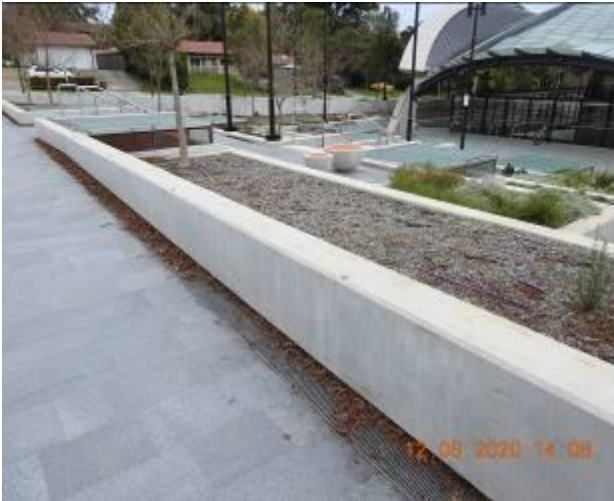
Figure 2249 – General condition of retaining wall

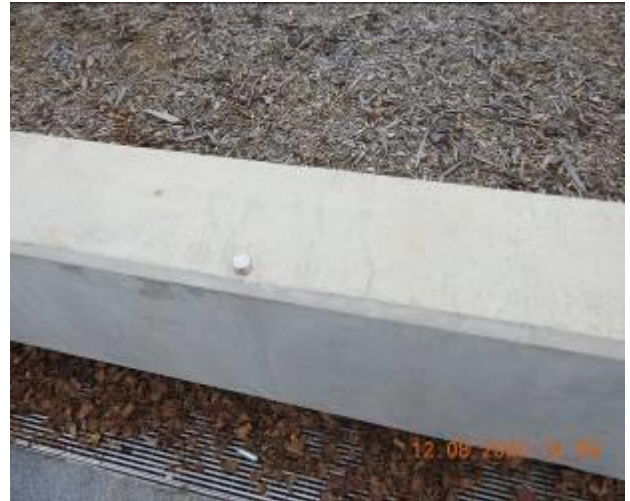
Figure 2250 – Crack propagation through retaining wall

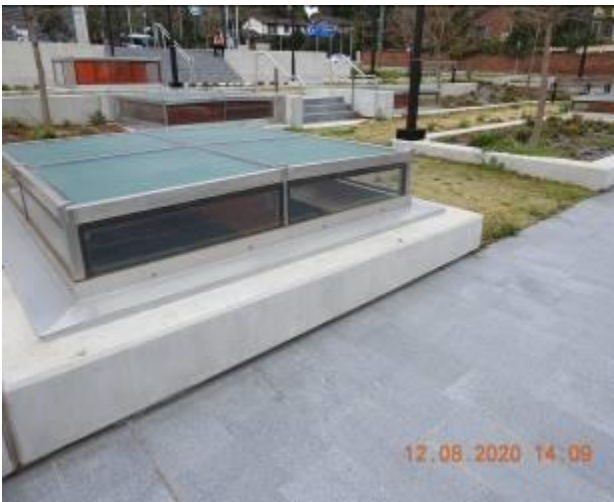
Figure 2251 – General condition of retaining wall

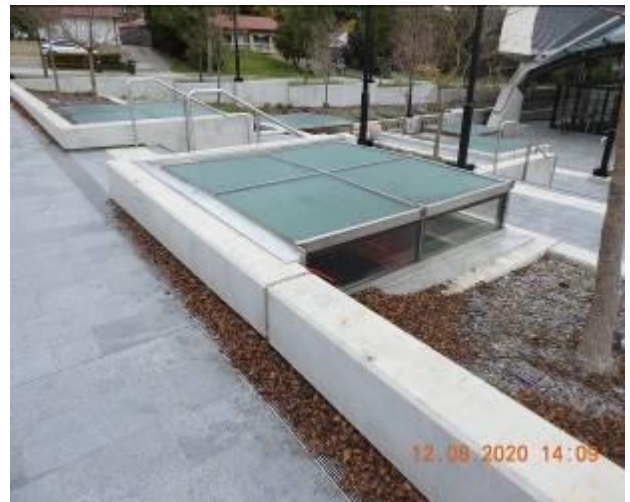
Figure 2252 – General condition of retaining wall

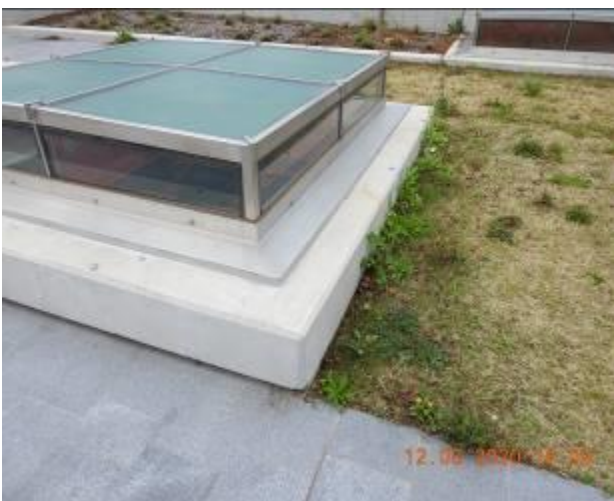
Figure 2253 – General condition of retaining wall

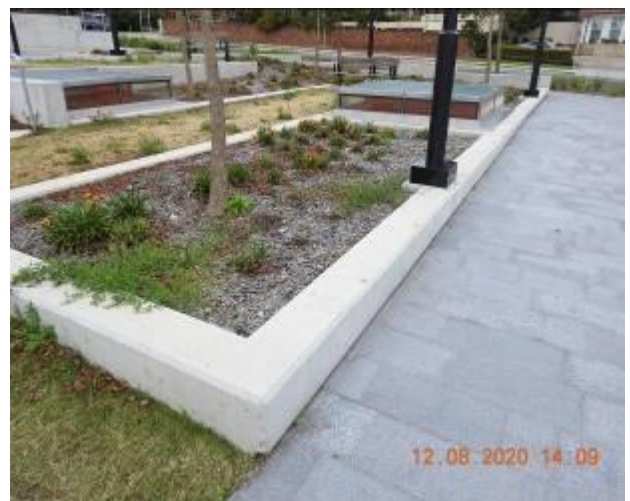
Figure 2254 – General condition of retaining wall

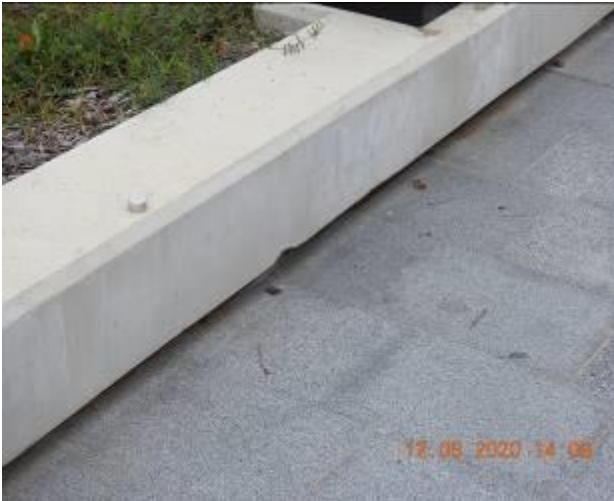
Figure 2255 – Loss of material through retaining wall

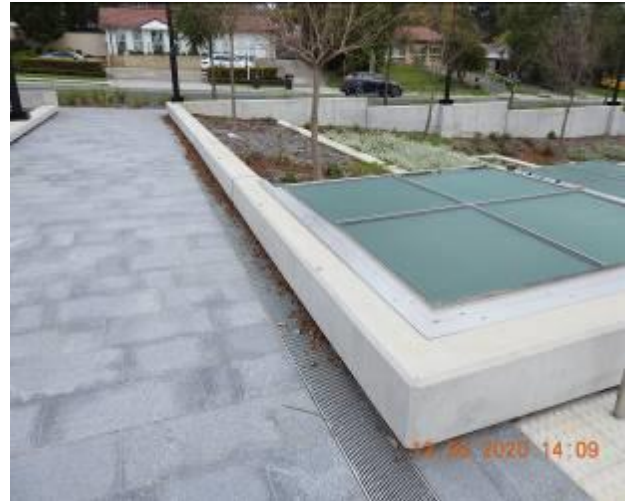
Figure 2256 – General condition of retaining wall

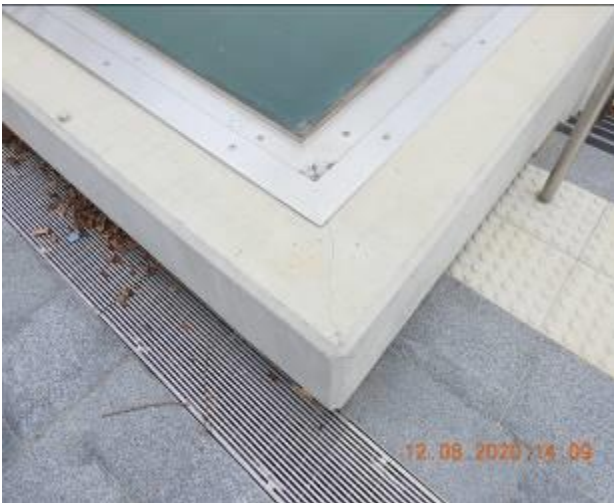
Figure 2257 – Crack propagation through retaining wall

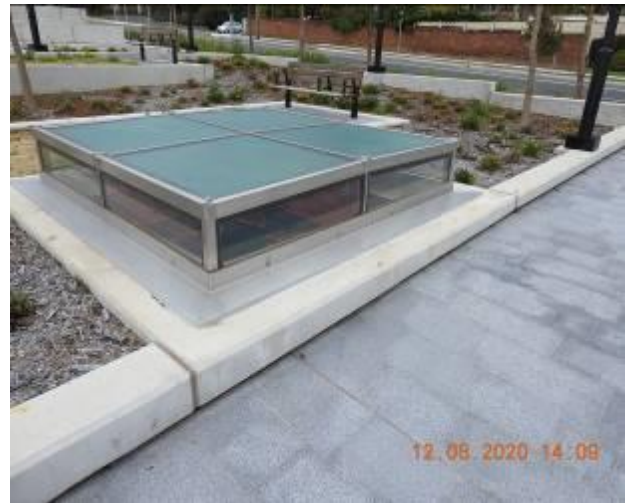
Figure 2258 – General condition of retaining wall

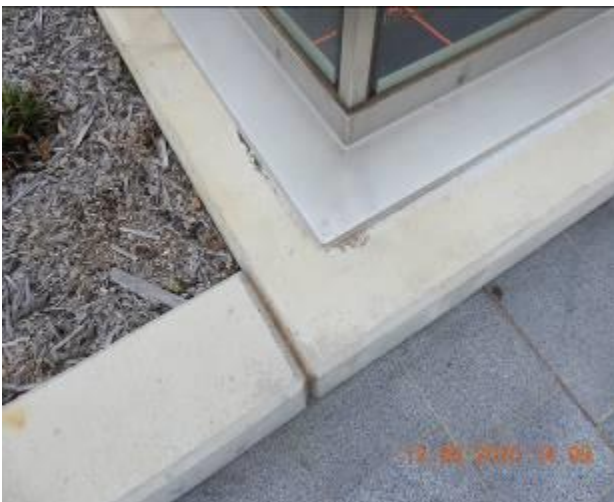
Figure 2259 – Loss of material through retaining wall

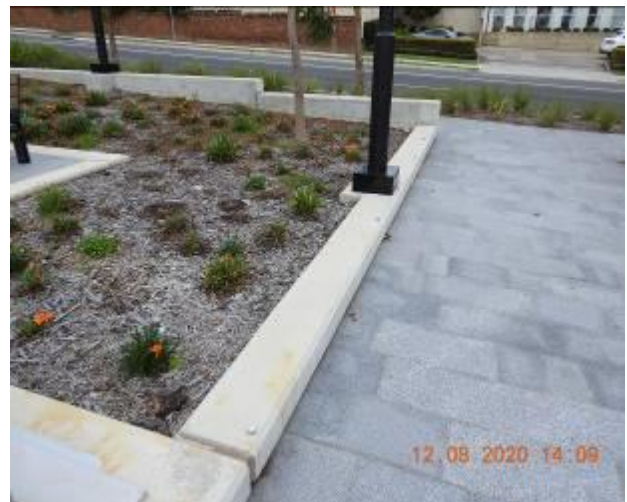
Figure 2260 – General condition of retaining wall

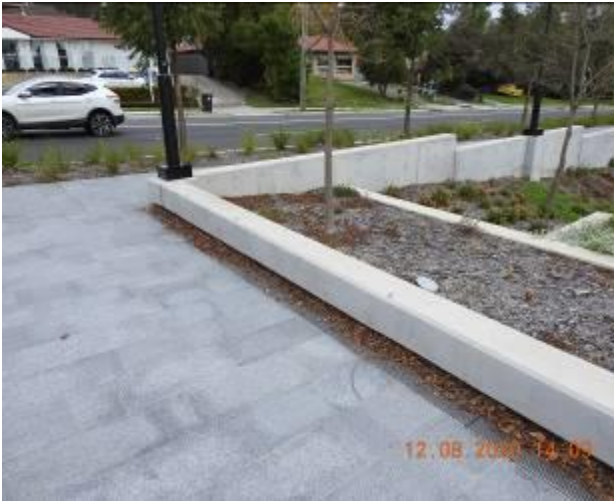
Figure 2261 – General condition of retaining wall

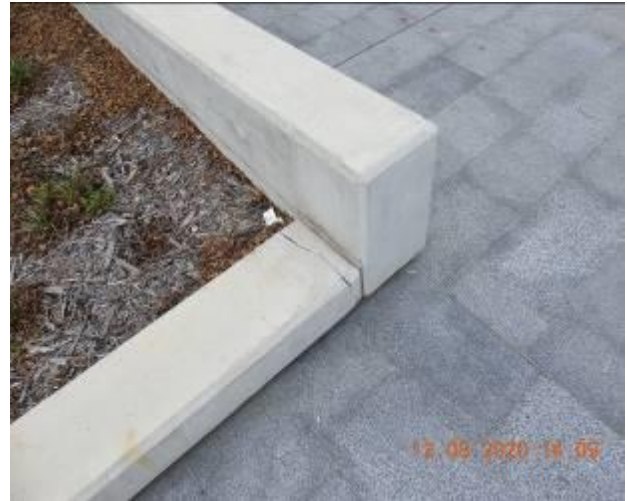
Figure 2262 – Crack propagation and loss of material through retaining wall

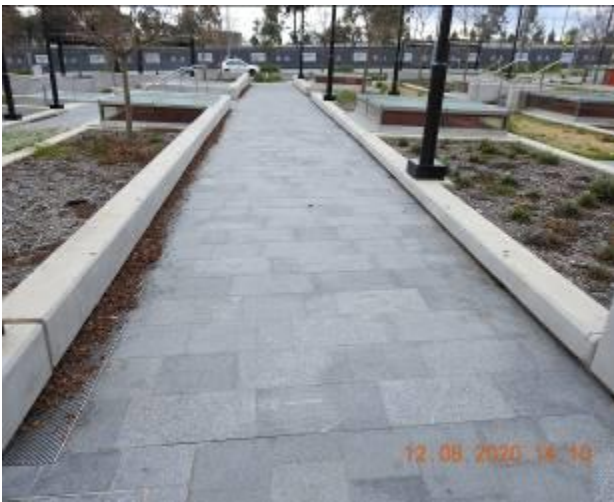
Figure 2263 – General condition of walkway floor

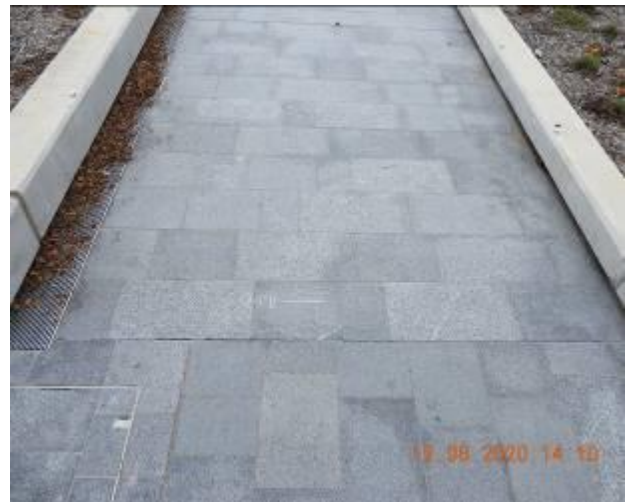
Figure 2264 – Crack propagation and loss of material through walkway floor

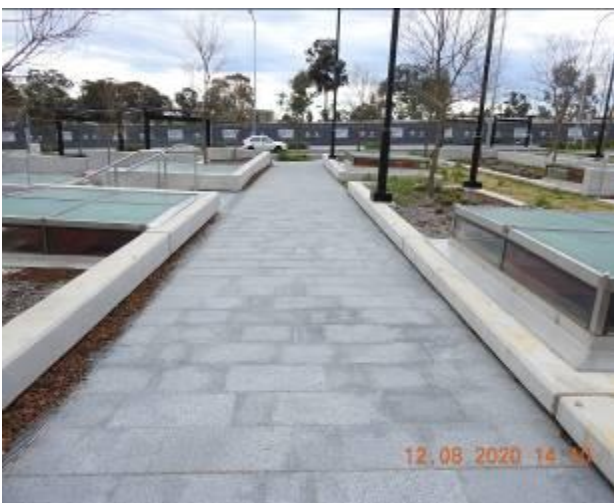
Figure 2265 – Hairline crack propagation through walkway floor

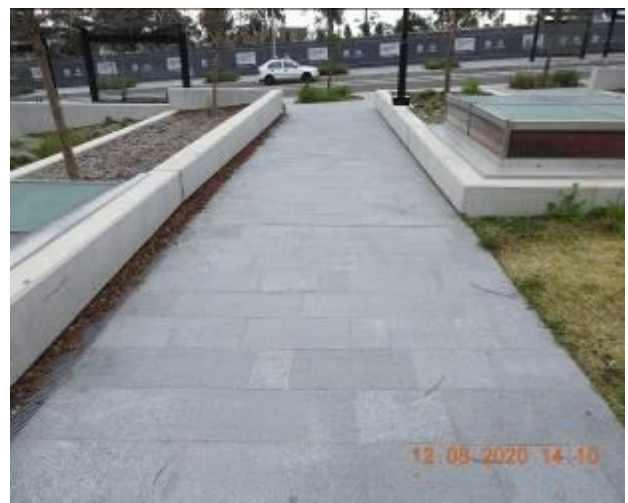
Figure 2266 – Hairline crack propagation through walkway floor

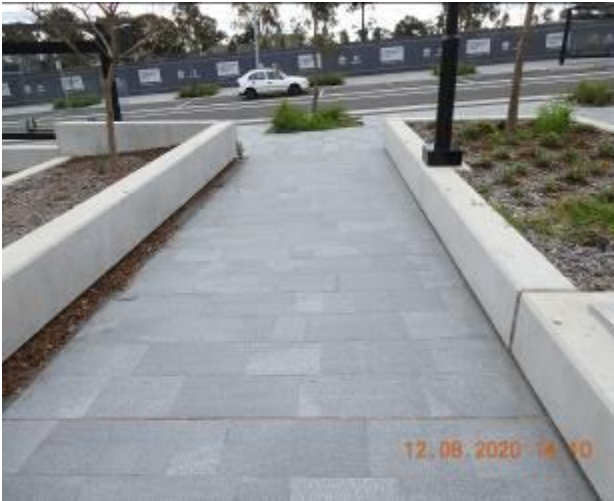
Figure 2267 – Hairline crack propagation through walkway floor

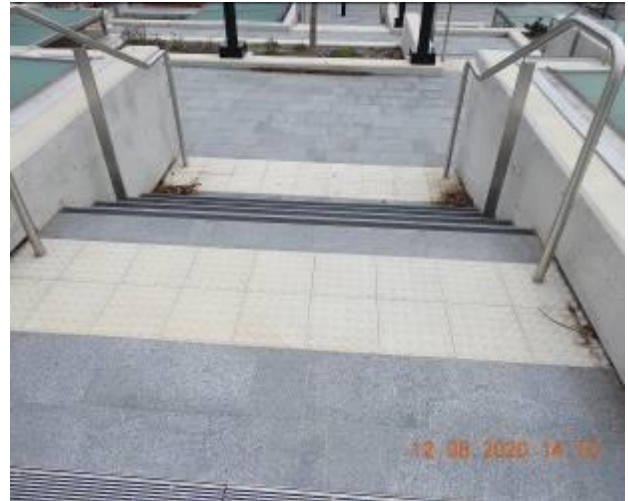
Figure 2268 – General condition of staircase floor

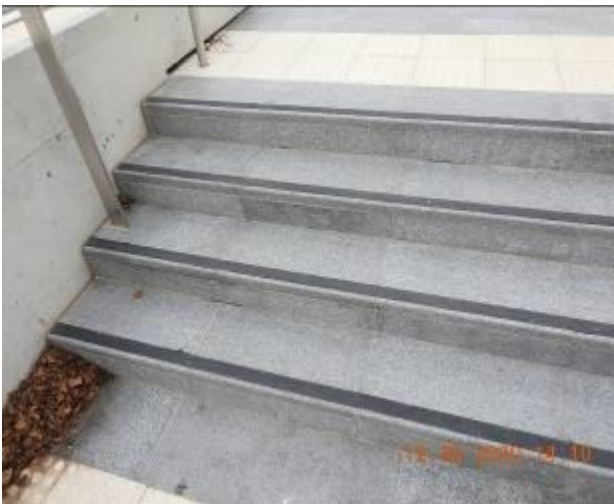
Figure 2269 – Loss of material through staircase floor

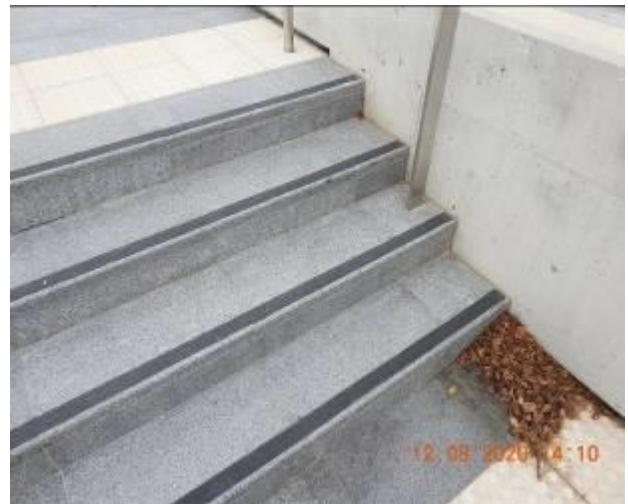
Figure 2270 – Separation through staircase floor

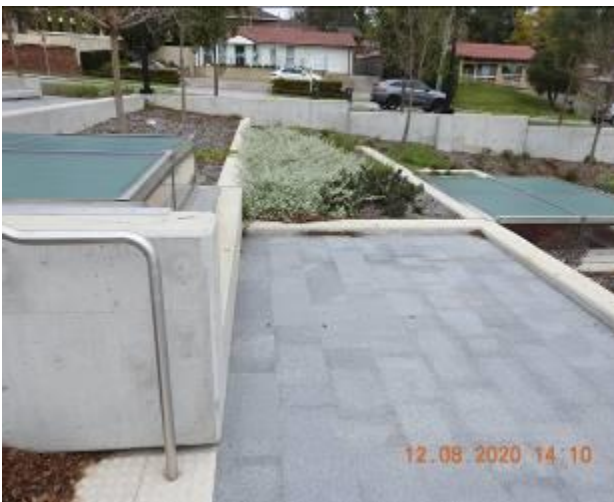
Figure 2271 – General condition of retaining wall

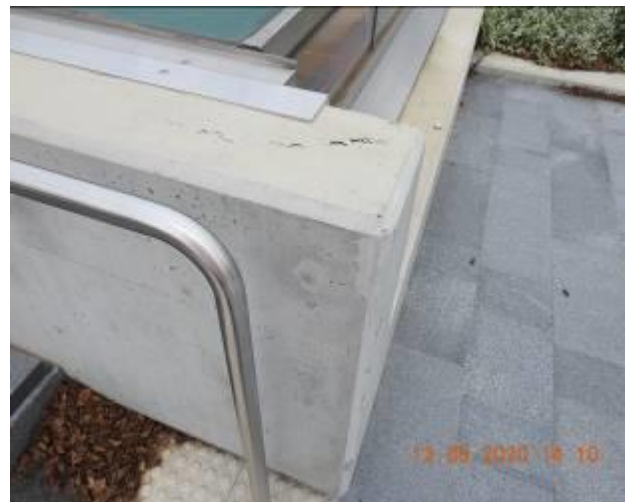
Figure 2272 – Crack propagation and loss of material through retaining wall

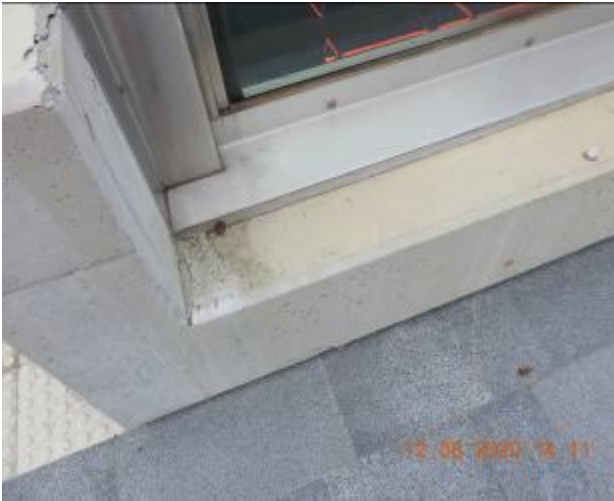
Figure 2273 – Loss of material through retaining wall

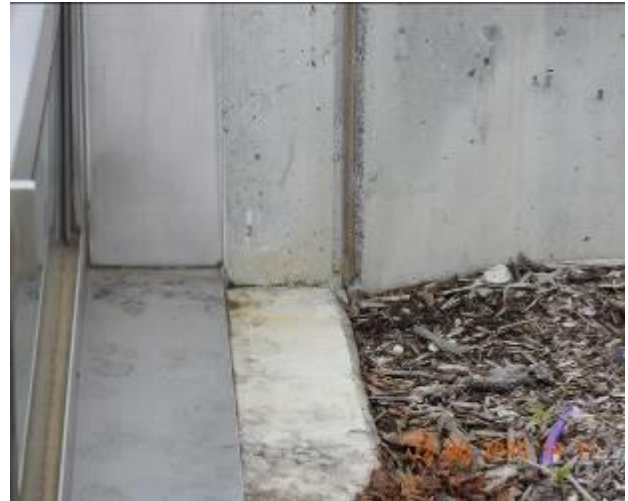
Figure 2274 – Crack propagation and loss of material through retaining wall

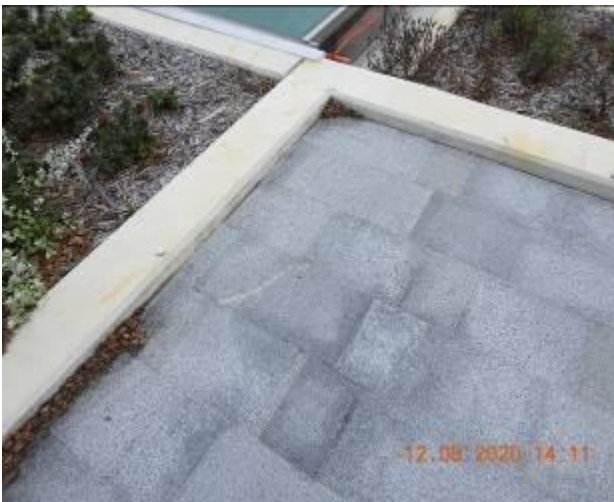
Figure 2275 – Efflorescence and crack propagation through walkway floor and retaining wall

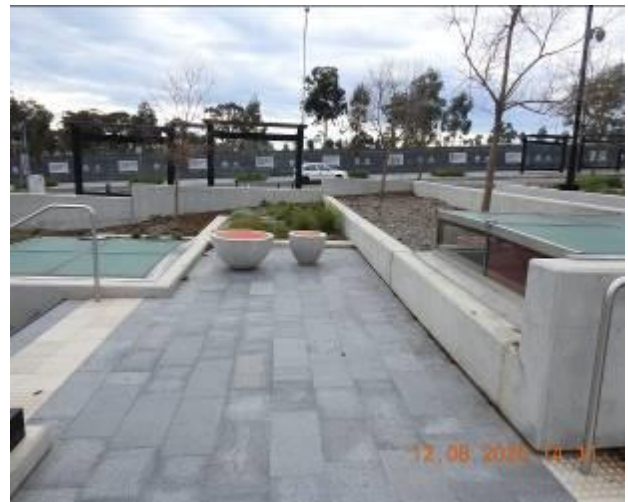
Figure 2276 – General condition of walkway floor

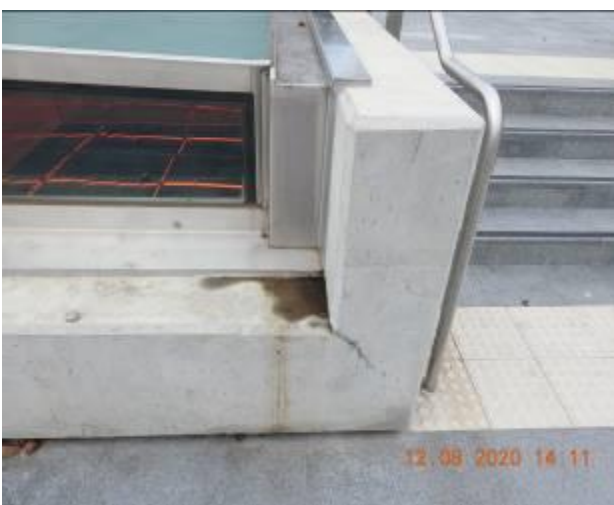
Figure 2277 – Crack propagation through retaining wall

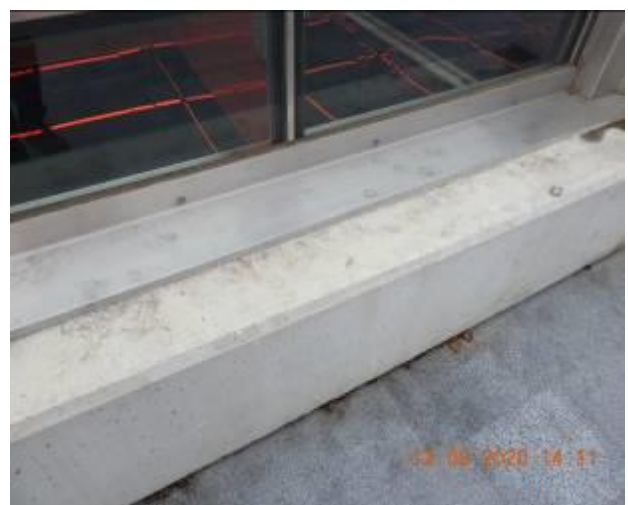
Figure 2278 – Crack propagation through retaining wall

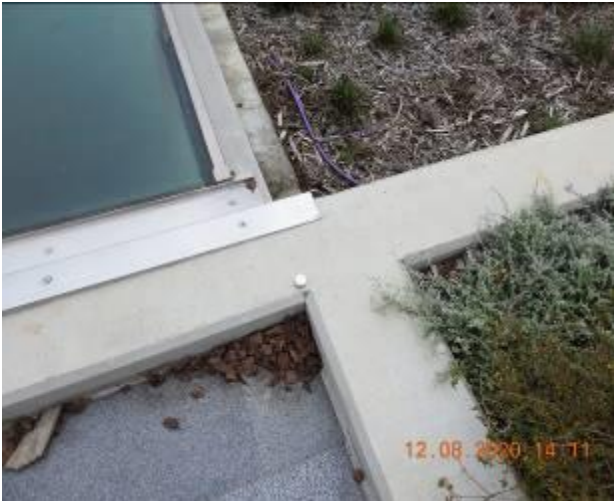
Figure 2279 – Crack propagation and loss of material through retaining wall

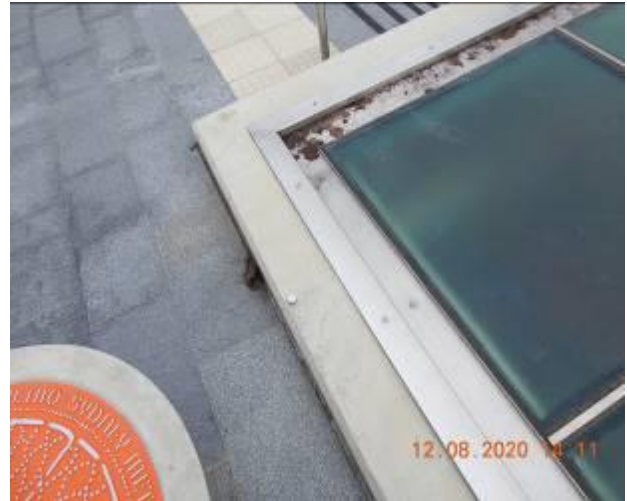
Figure 2280 – General condition of retaining wall

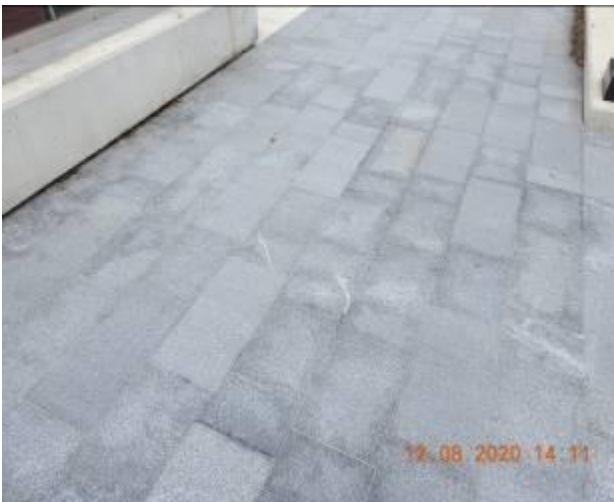
Figure 2281 – Efflorescence and crack propagation through walkway floor

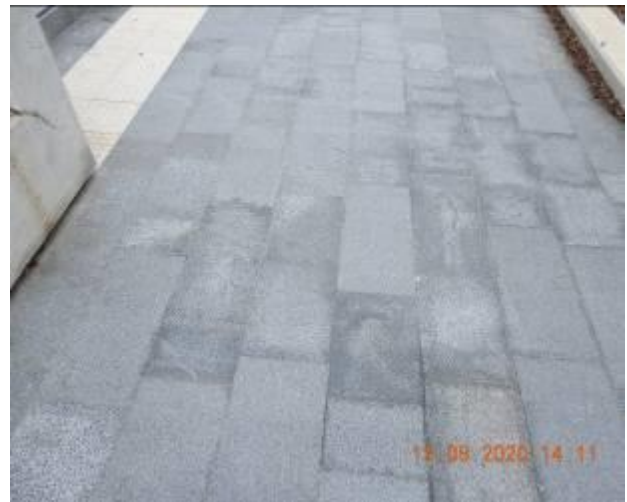
Figure 2282 – Hairline crack propagation through walkway floor

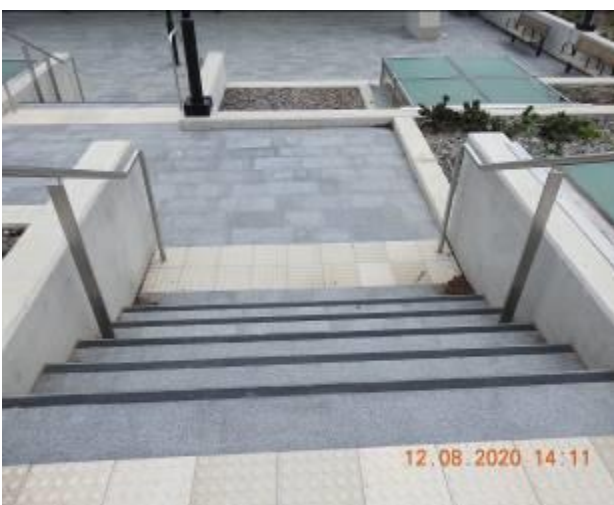
Figure 2283 – General condition of staircase floor

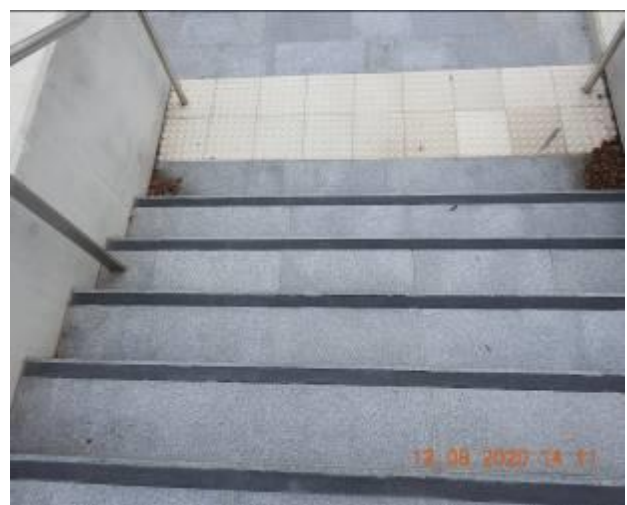
Figure 2284 – Separation through staircase floor

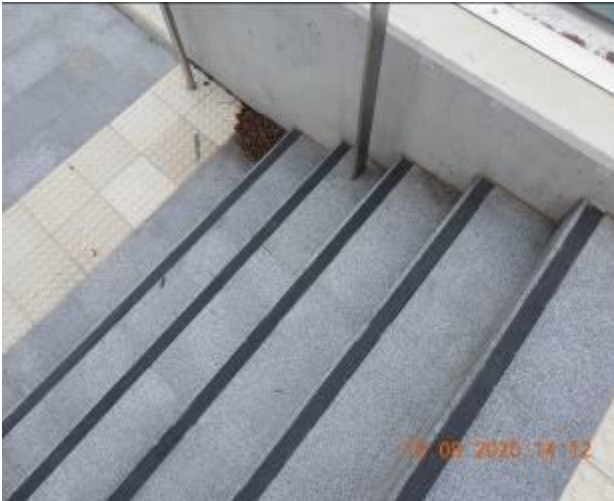
Figure 2285 – Separation through staircase floor

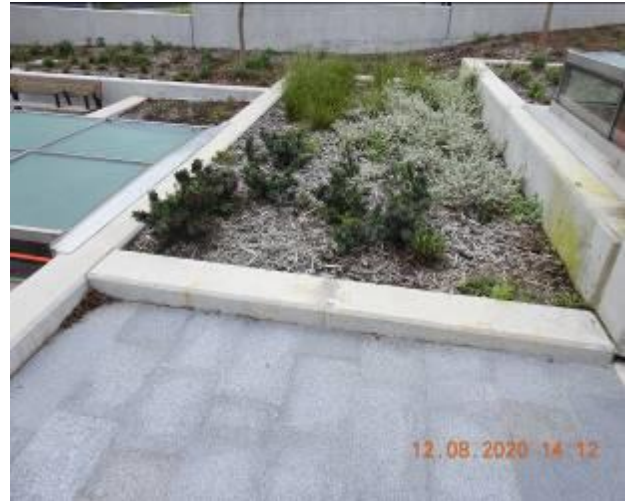
Figure 2286 – General condition of nature strip

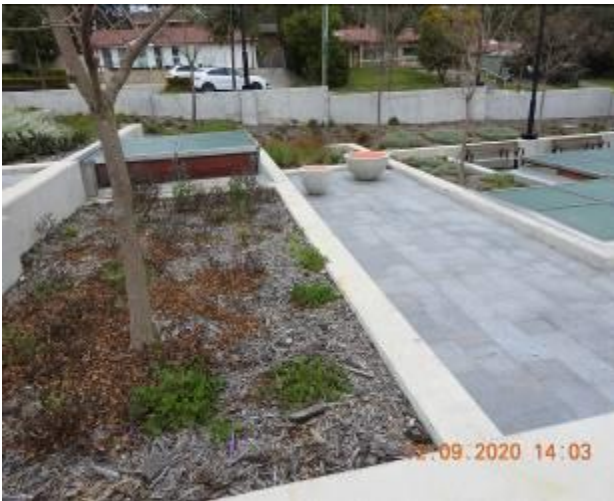
Figure 2287 – General condition of nature strip

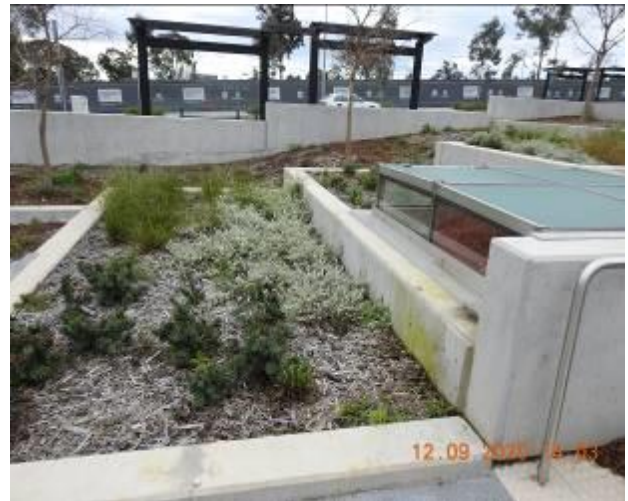
Figure 2288 – General condition of nature strip

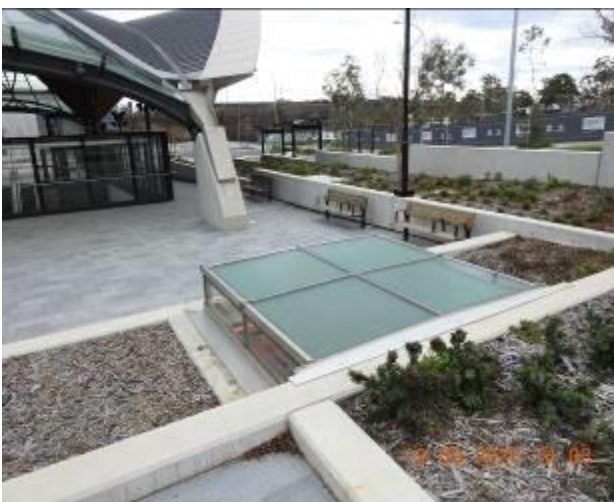
Figure 2289 – General condition of nature strip

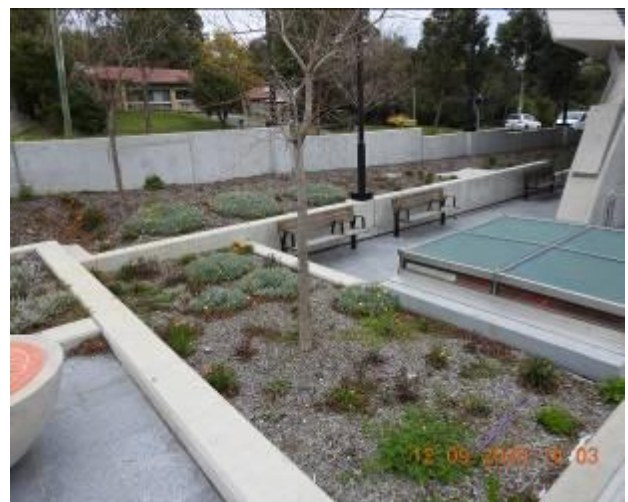
Figure 2290 – General condition of nature strip

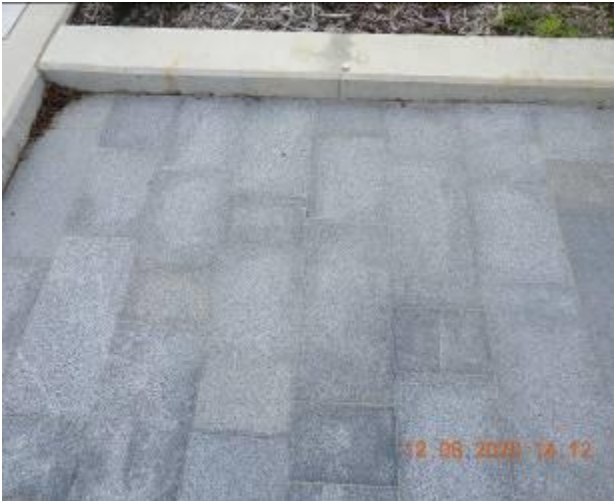
Figure 2291 – Hairline crack propagation and loss of material through walkway floor

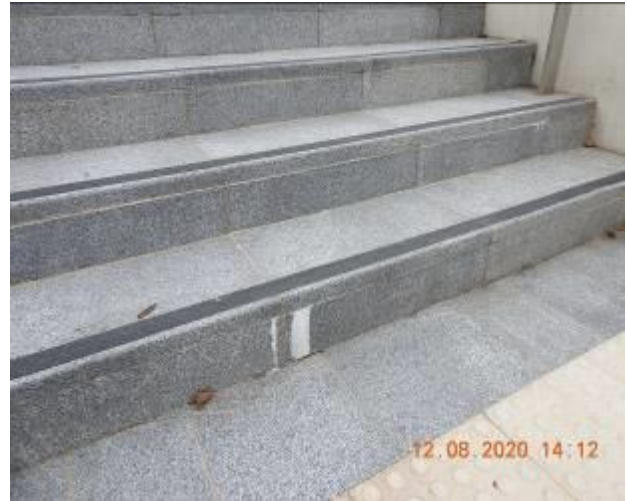
Figure 2292 – Efflorescence, crack propagation and loss of material through staircase floor

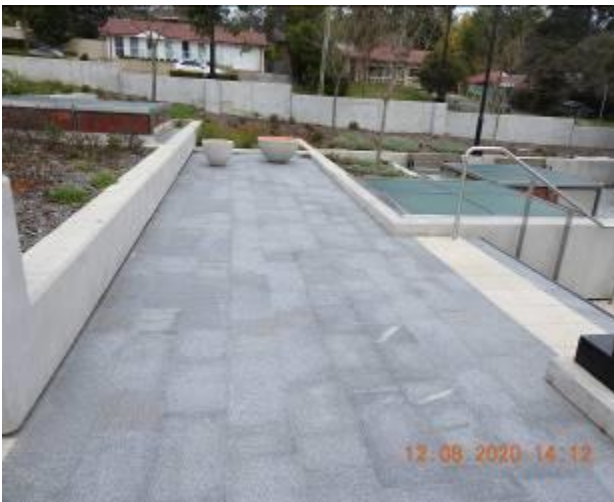
Figure 2293 – General condition of walkway floor

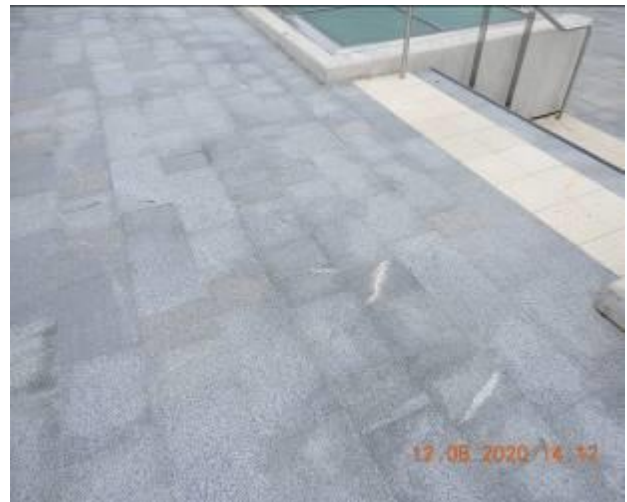
Figure 2294 – Efflorescence and crack propagation through walkway floor

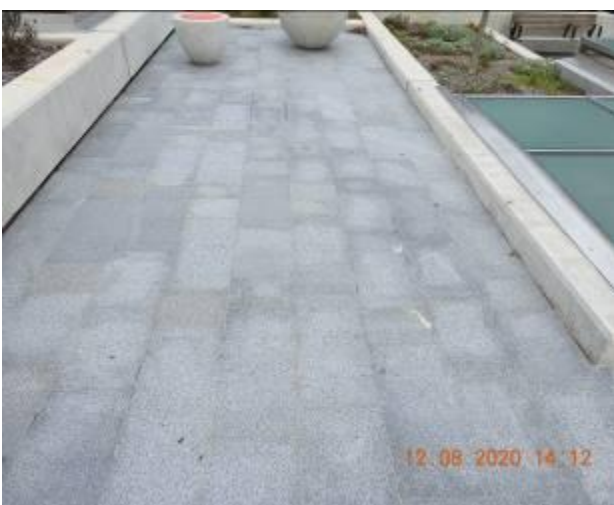
Figure 2295 – Efflorescence and crack propagation through walkway floor

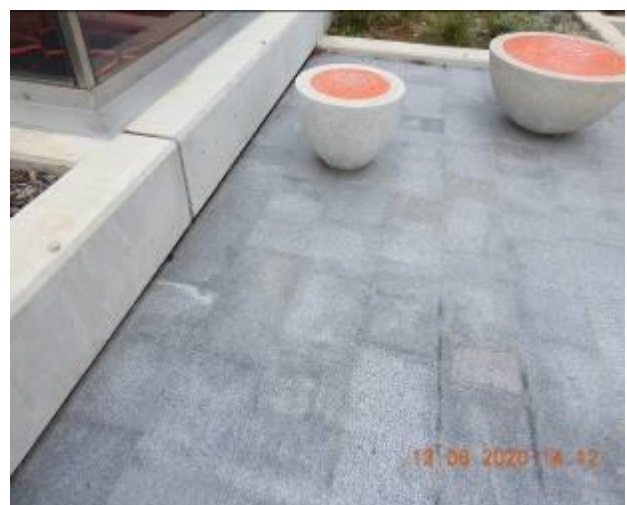
Figure 2296 – Efflorescence and crack propagation through walkway floor

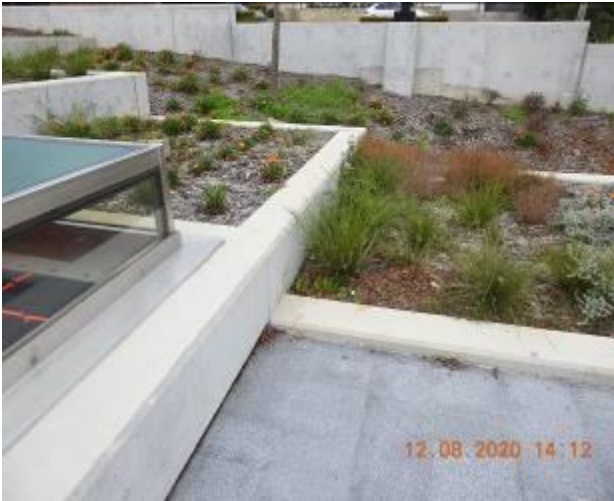
Figure 2297 – General condition of nature strip

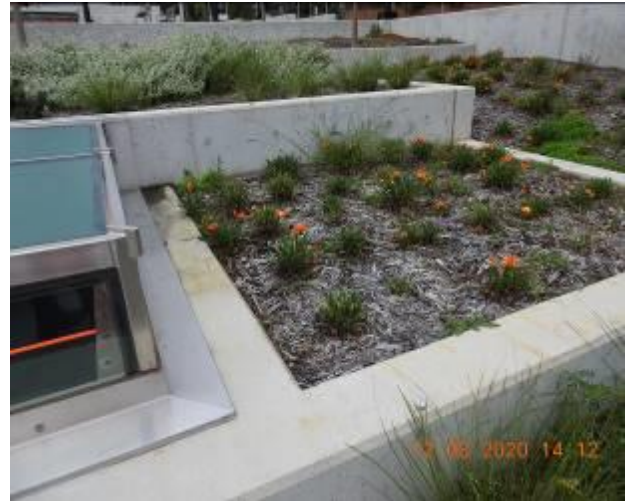
Figure 2298 – General condition of nature strip

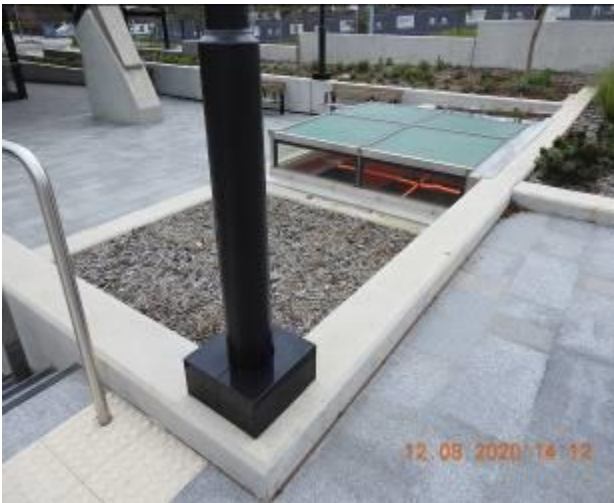
Figure 2299 – General condition of nature strip

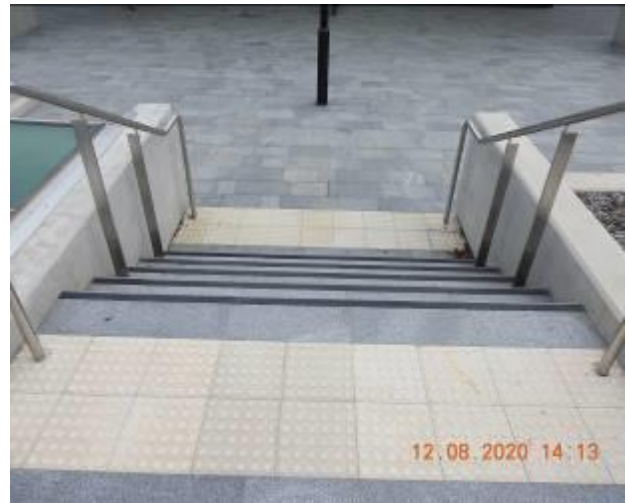
Figure 2300 – General condition of staircase floor

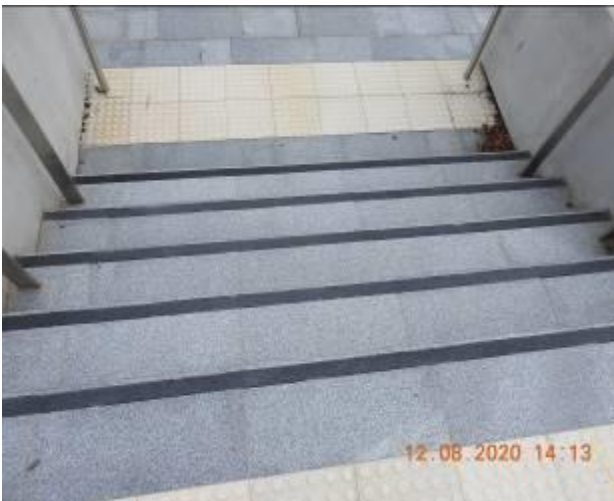
Figure 2301 – Separation through staircase floor

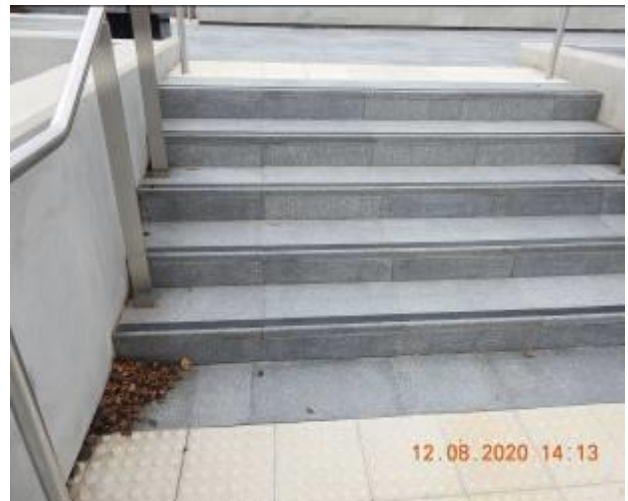
Figure 2302 – Crack propagation and loss of material through staircase floor

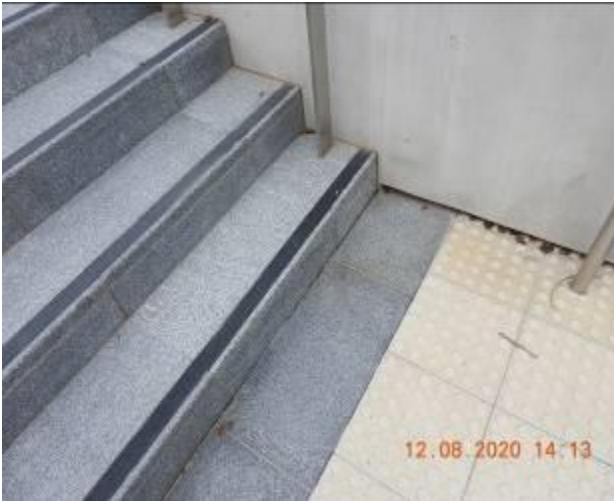
Figure 2303 – Crack propagation and loss of material through staircase floor

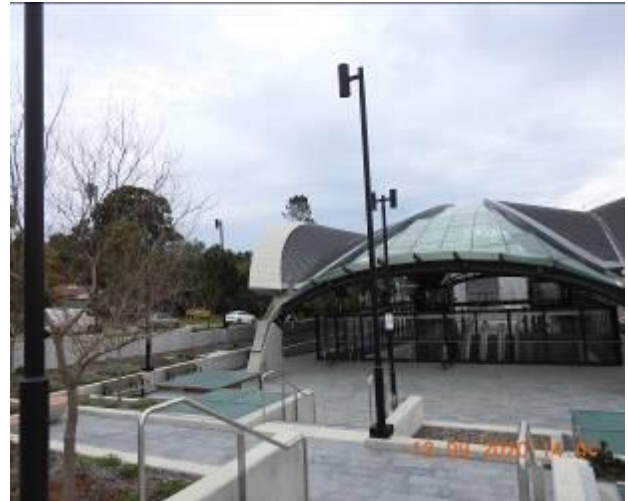
Figure 2304 – General condition of Showground lamp posts and plantations

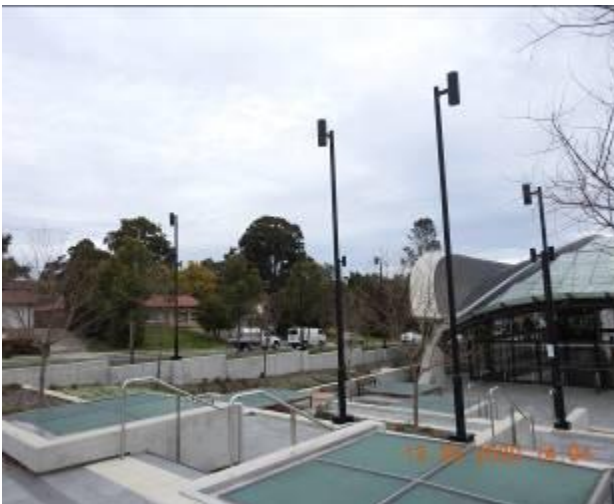
Figure 2305 – General condition of Showground lamp posts and plantations

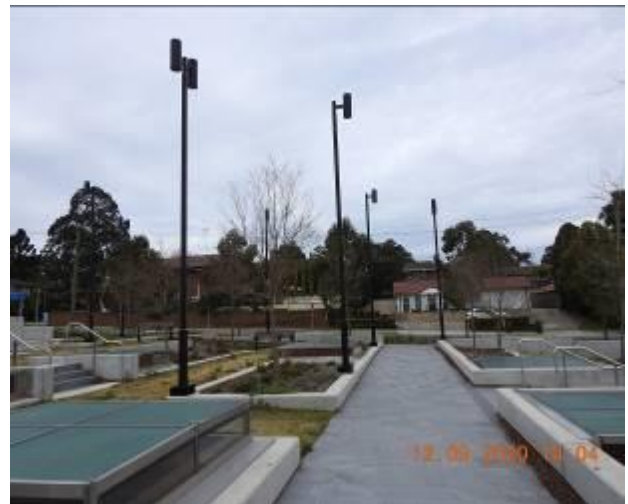
Figure 2306 – General condition of Showground lamp posts and plantations

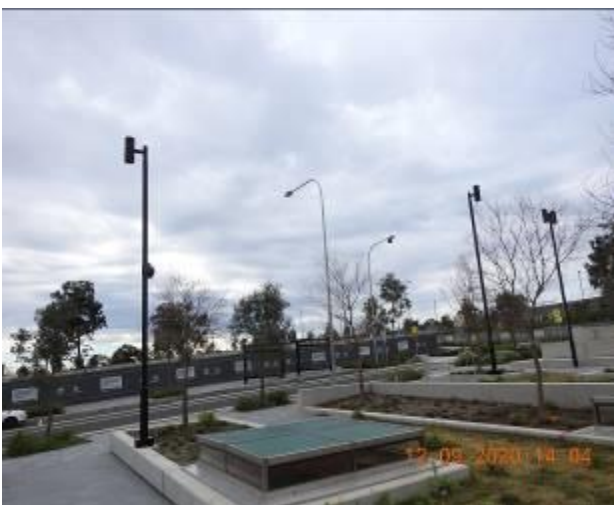
Figure 2307 – General condition of Showground lamp posts and plantations

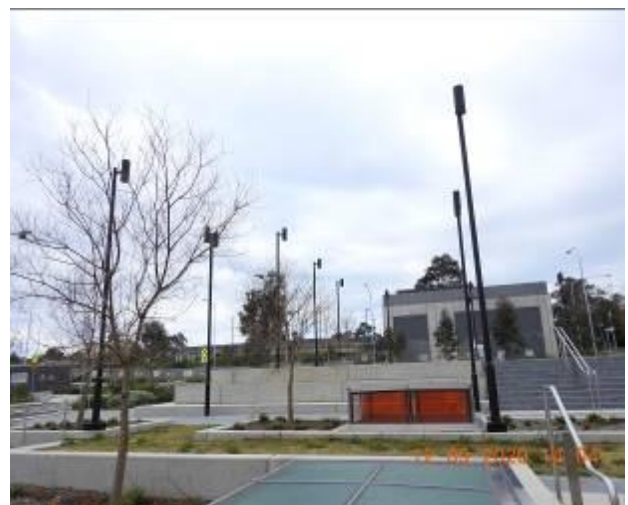
Figure 2308 – General condition of Showground lamp posts and plantations

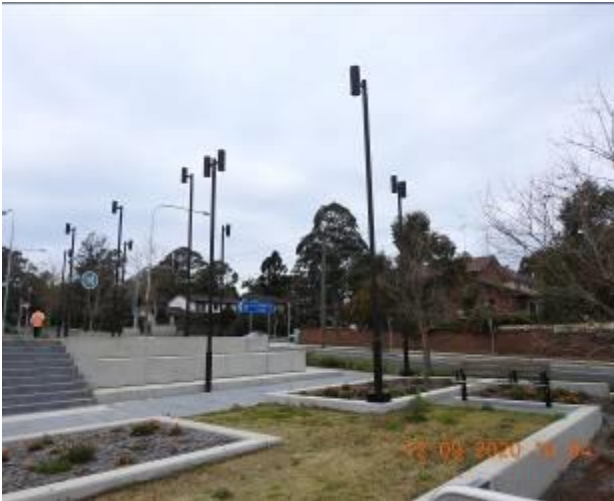
Figure 2309 – General condition of Showground lamp posts and plantations

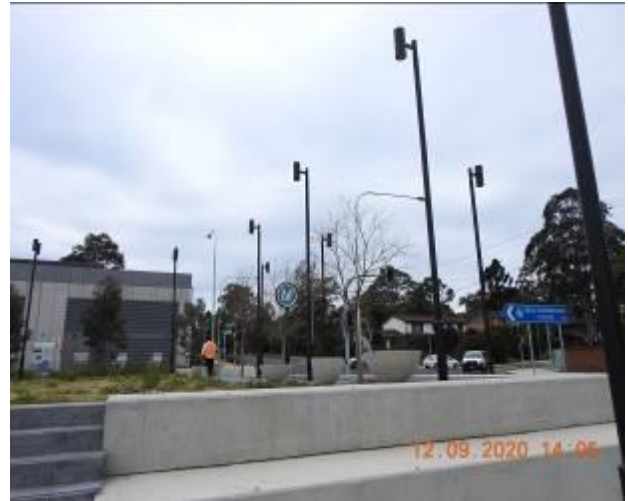
Figure 2310 – General condition of Showground lamp posts and plantations

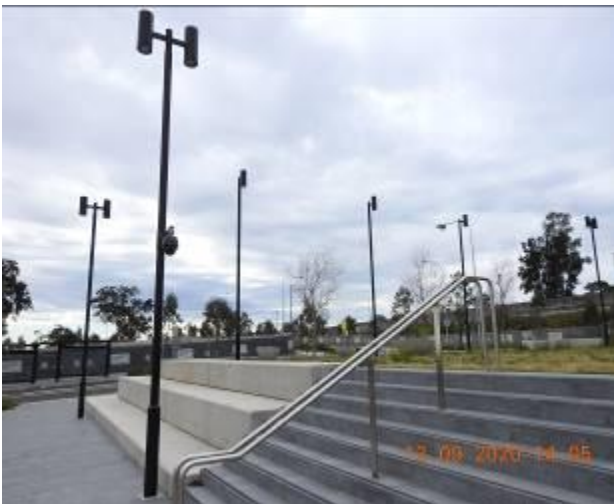
Figure 2311 – General condition of Showground lamp posts, plantations and staircase balustrade

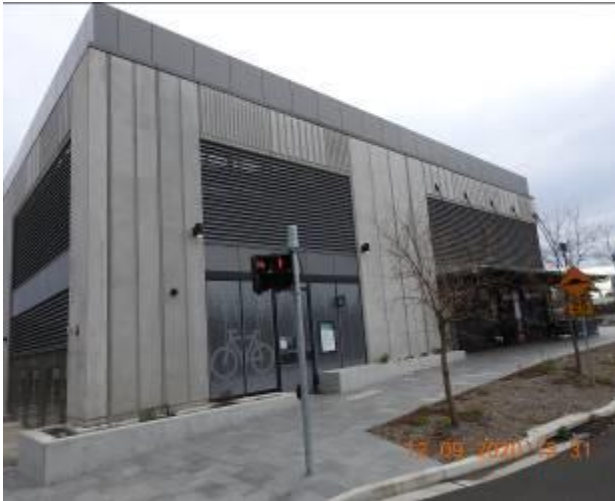
Figure 2313 – General condition of Eastern façade

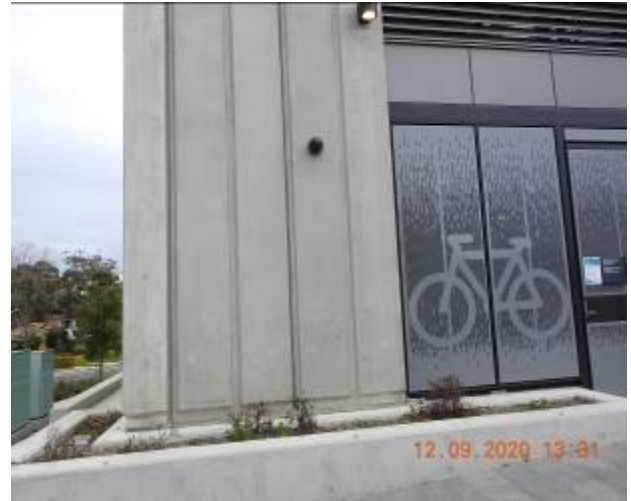
Figure 2314 – Evidence of patchwork through external wall

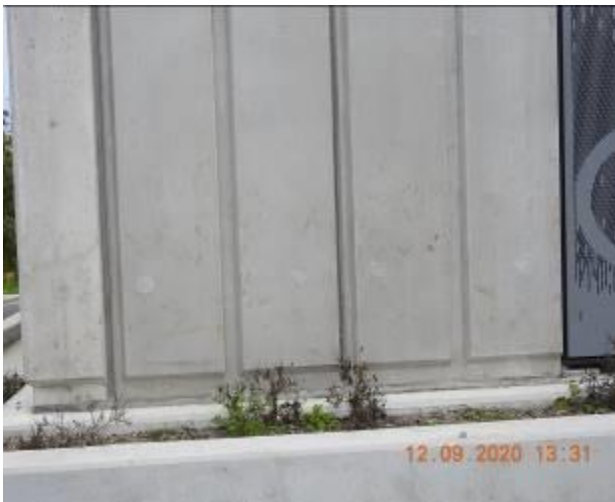
Figure 2315 – General condition of external wall

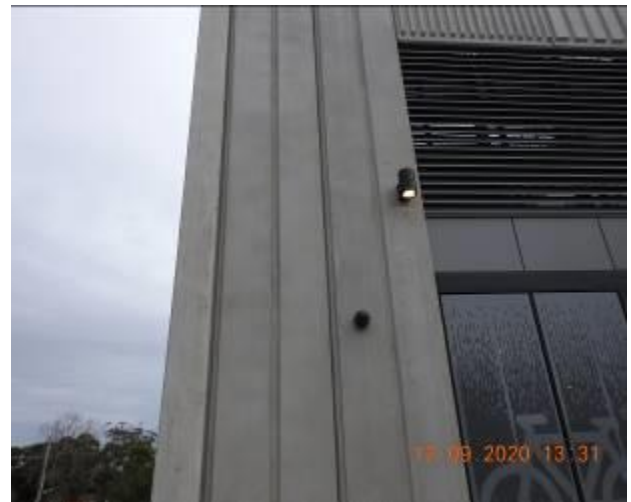
Figure 2316 – Crack propagation through external wall
