**2 MANDALA PARADE, CASTLE HILL
(DORAN DRIVE PRECINCT)
PRE-DILAPIDATION REPORT
Of Sydney Metro and Hills Shire Council Assets
DEICORP PROJECTS SHOWGROUND
PTY LTD.**

Job No. 200124.3
07/07/2021

ACE Structural Services Pty Ltd

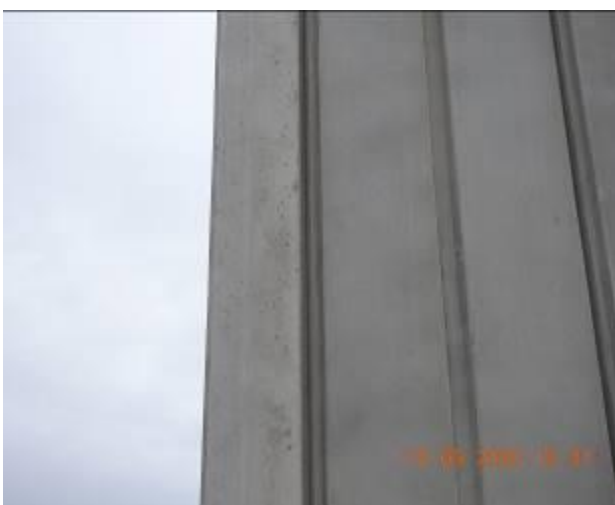
Figure 2317 – General condition of external wall

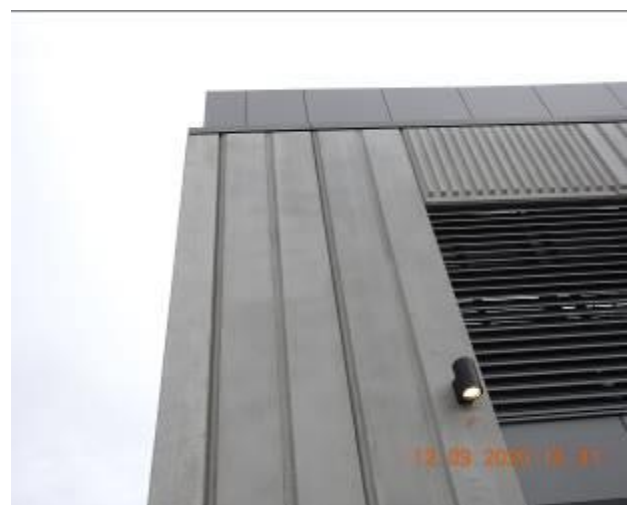
Figure 2318 – Hairline crack propagation through external wall

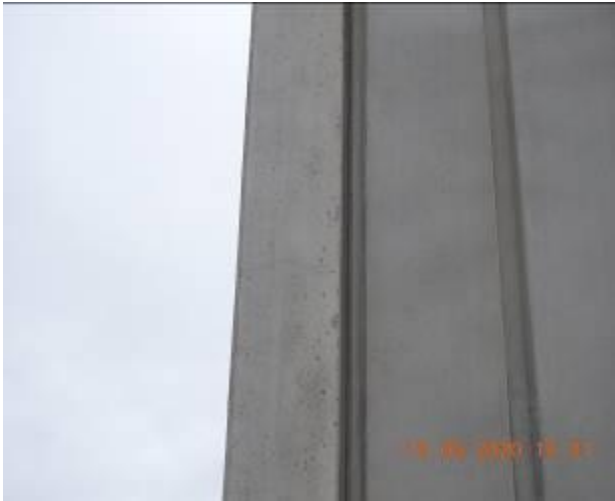
Figure 2319 – Hairline crack propagation through external wall

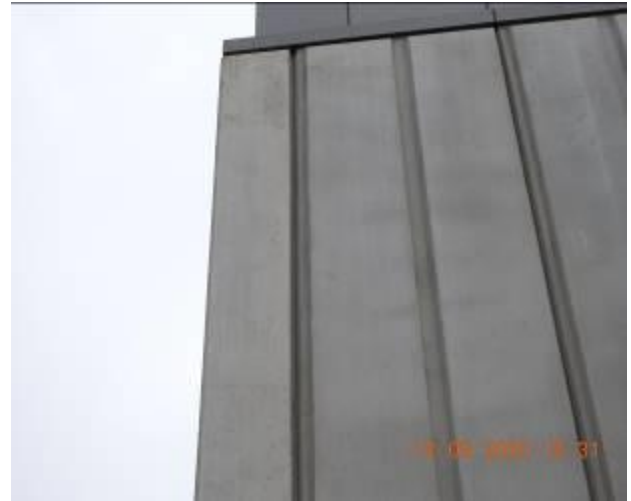
Figure 2320 – General condition of external wall

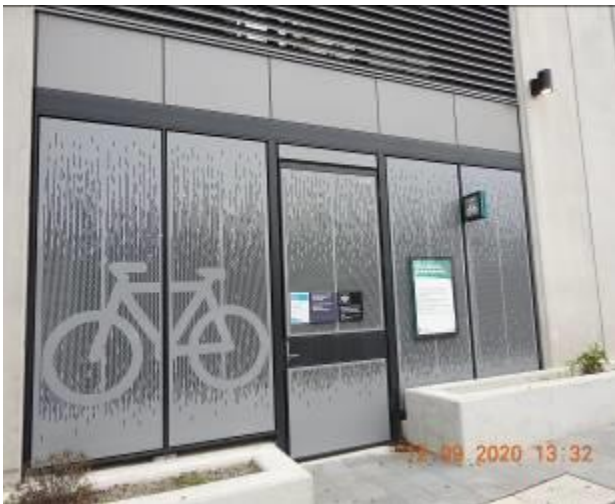
Figure 2321 – General condition of external wall

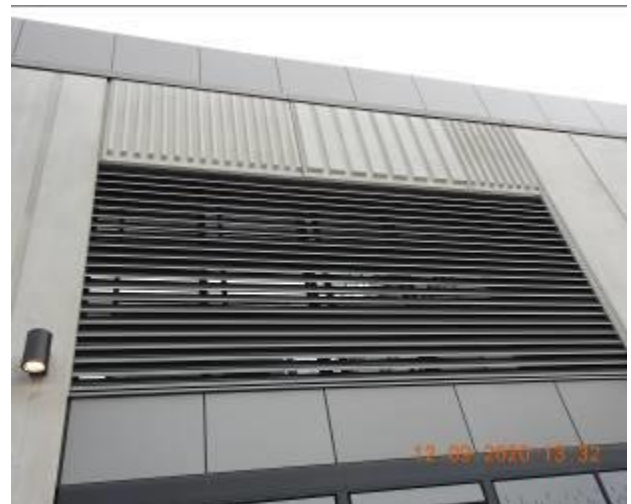
Figure 2322 – General condition of external wall

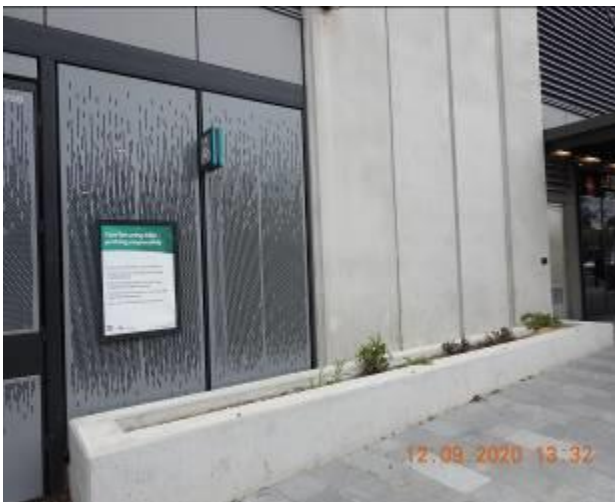
Figure 2323 – Evidence of patchwork through external wall

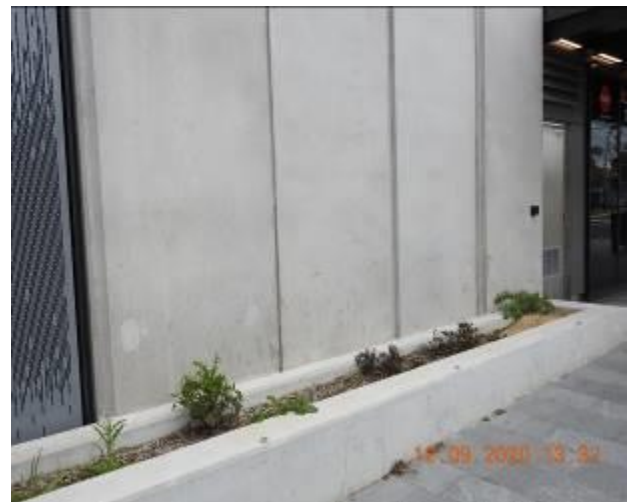
Figure 2324 – General condition of external wall

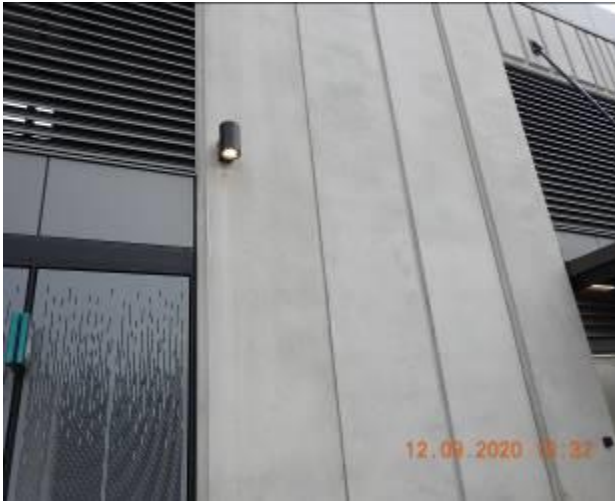
Figure 2325 – Hairline crack propagation through external wall

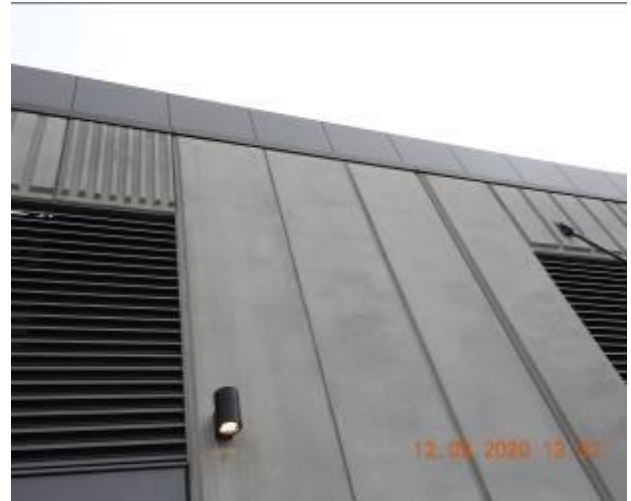
Figure 2326 – General condition of external wall

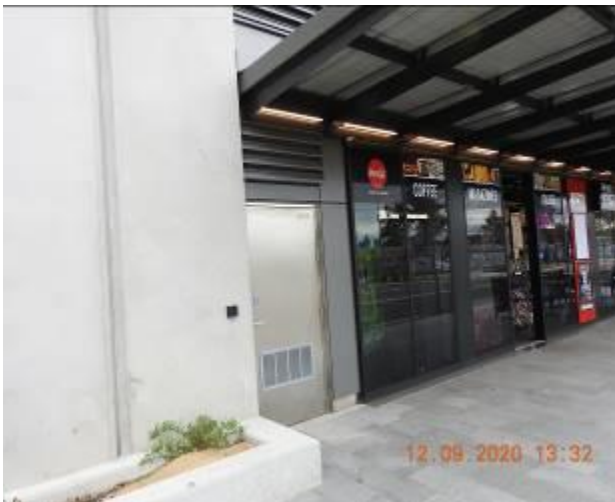
Figure 2327 – Evidence of patchwork through external wall

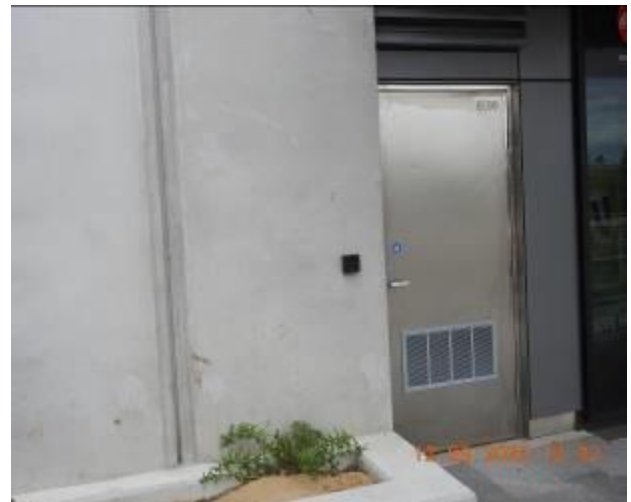
Figure 2328 – General condition of external wall

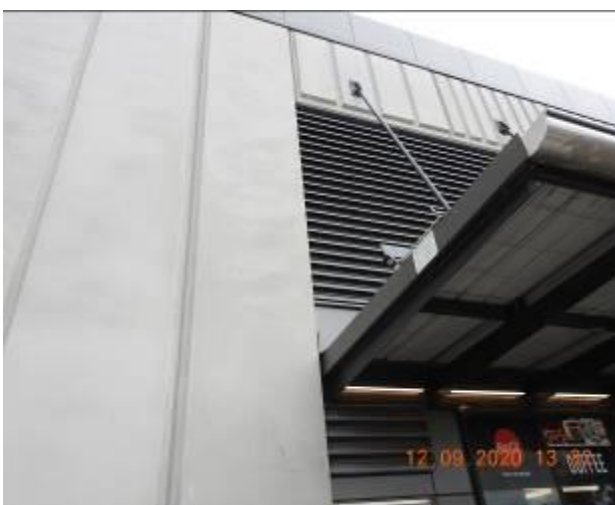
Figure 2329 – General condition of external wall

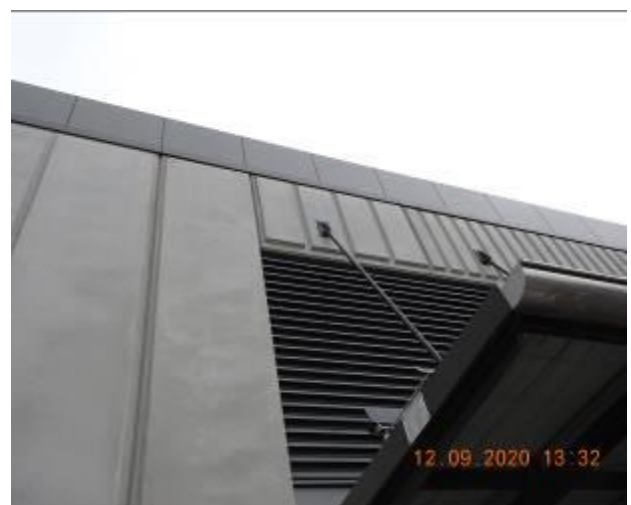
Figure 2330 – General condition of external wall

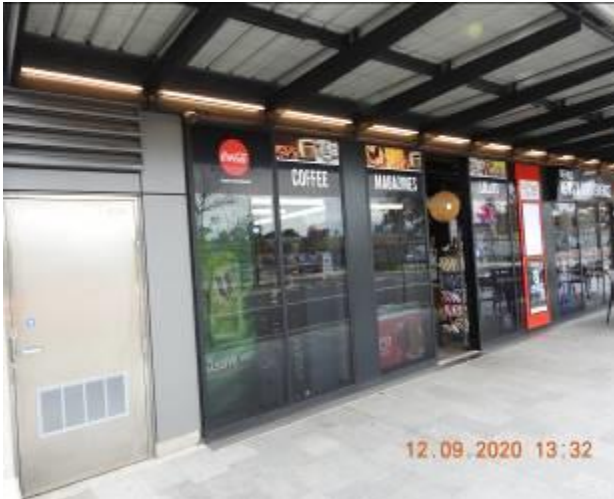
Figure 2331 – General condition of external wall

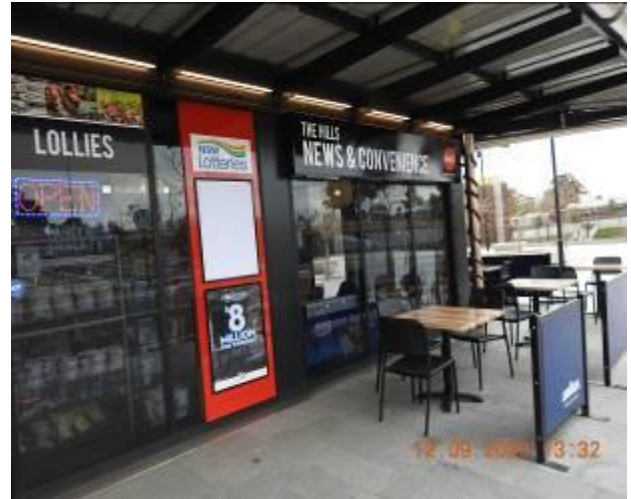
Figure 2332 – General condition of external wall

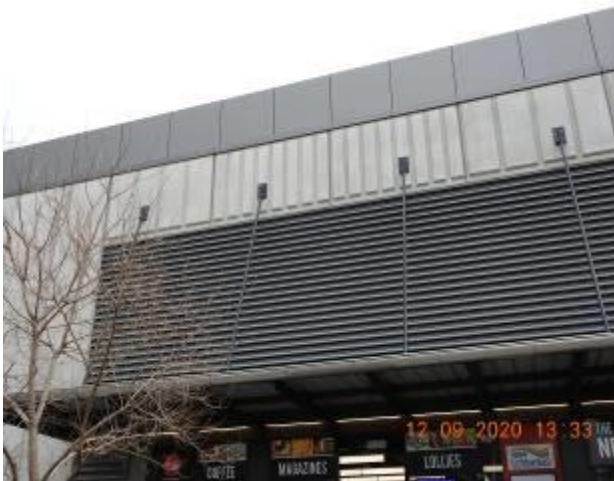
Figure 2333 – General condition of external wall

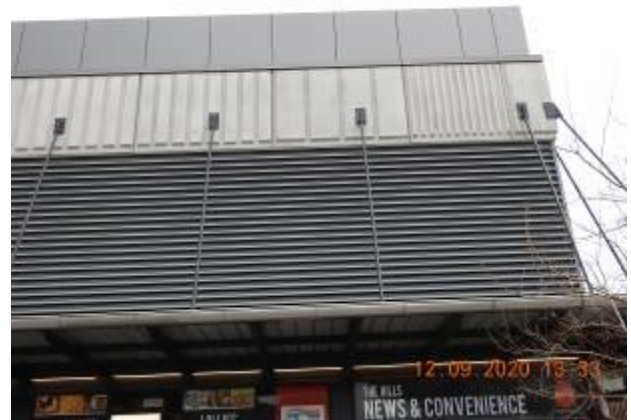
Figure 2334 – General condition of ceiling

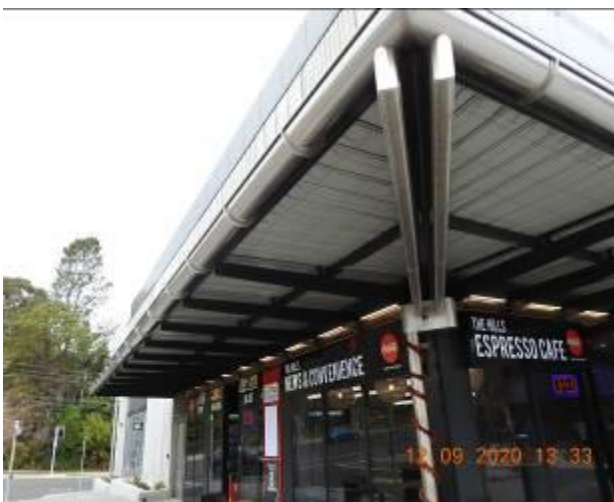
Figure 2335 – General condition of ceiling

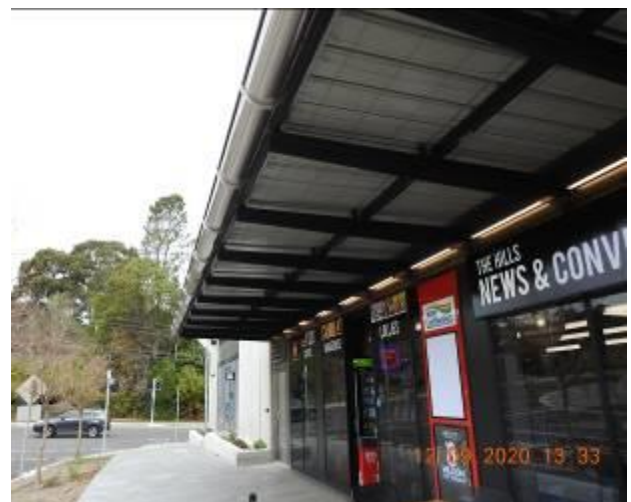
Figure 2336 – General condition of ceiling

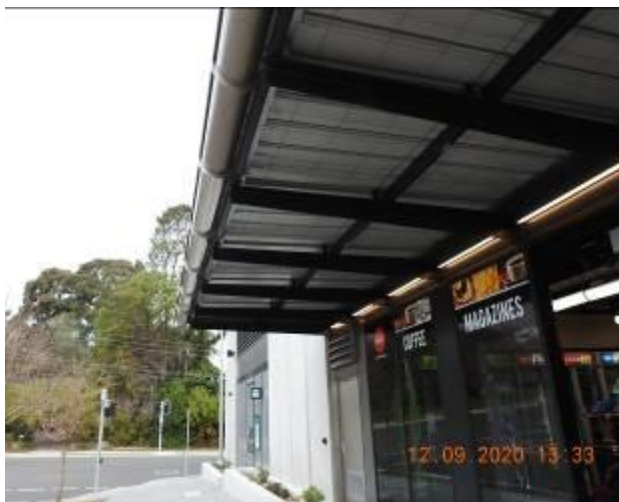
Figure 2337 – General condition of external wall

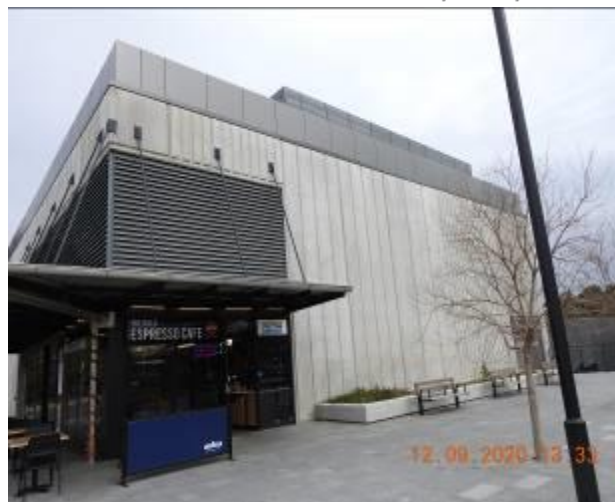
Figure 2338 – General condition of external wall

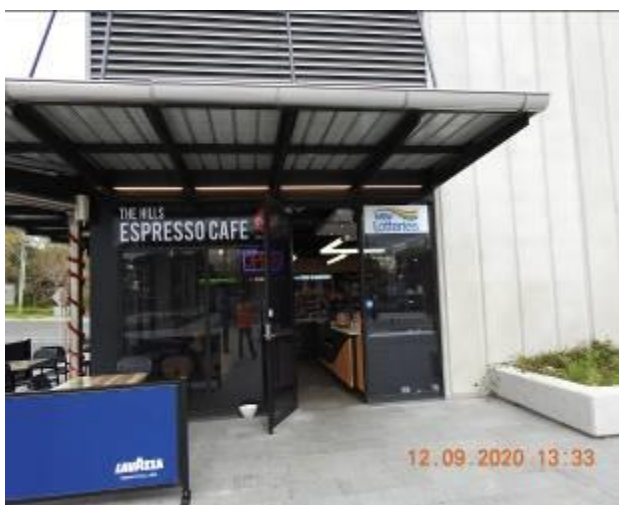
Figure 2339 – General condition of external wall

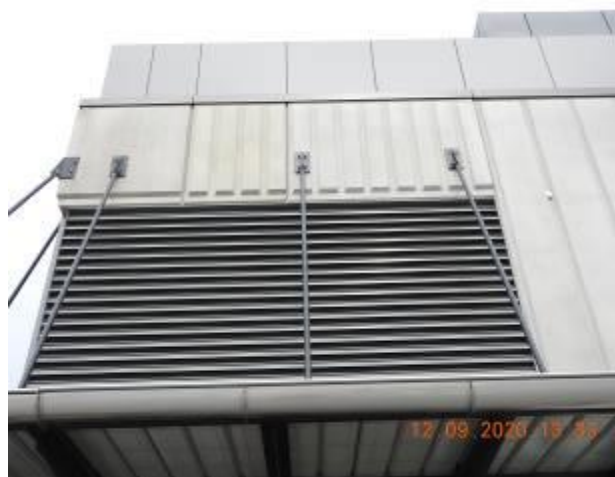
Figure 2340 – General condition of external wall

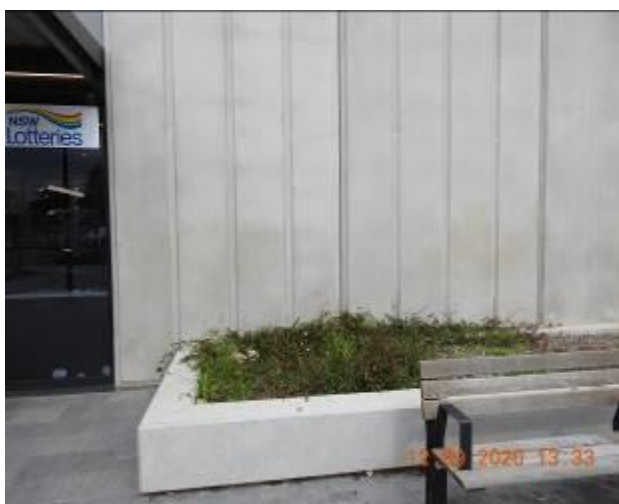
Figure 2341 – Evidence of patchwork through external wall

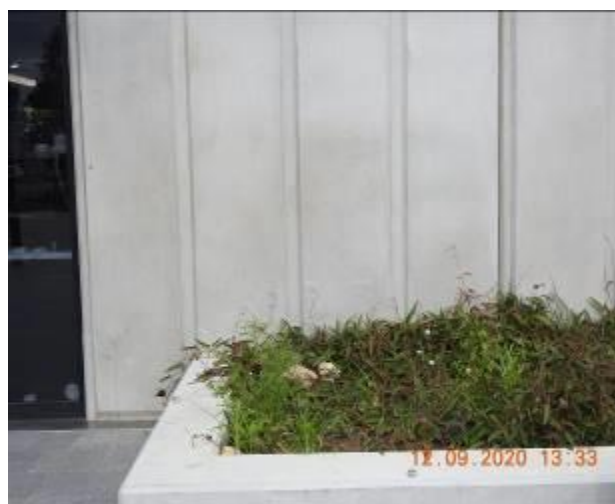
Figure 2342 – General condition of external wall

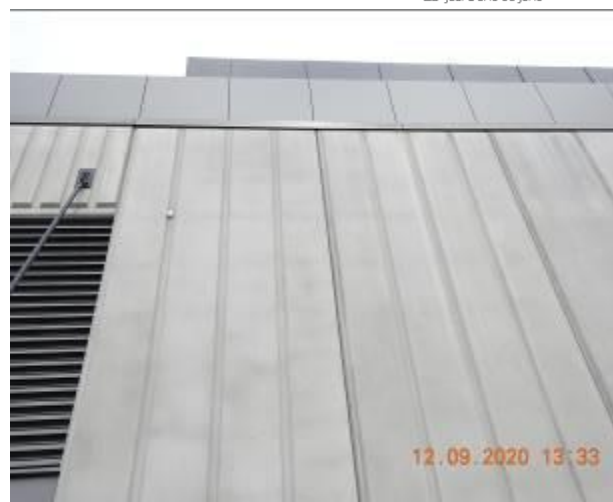
Figure 2343 – General condition of external wall

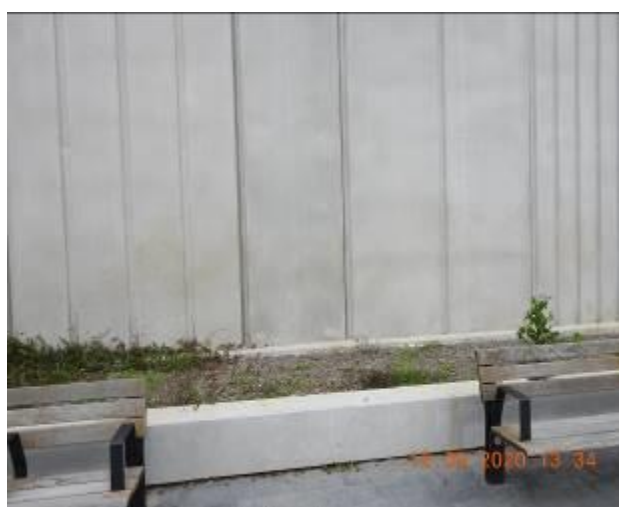
Figure 2344 – General condition of external wall

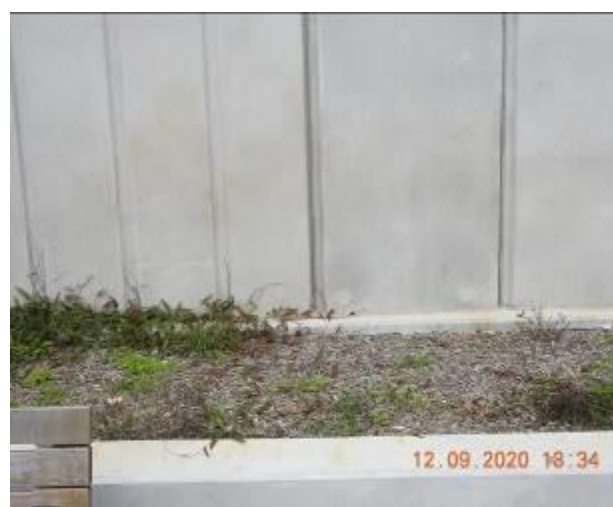
Figure 2345 – Crack propagation and Evidence of patchwork through external wall

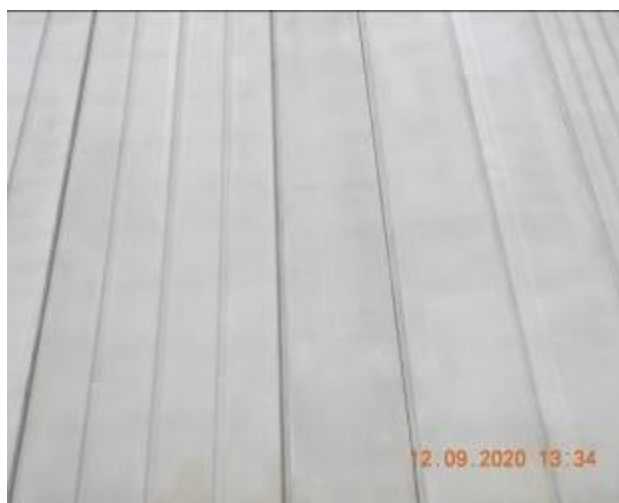
Figure 2346 – Crack propagation through external wall

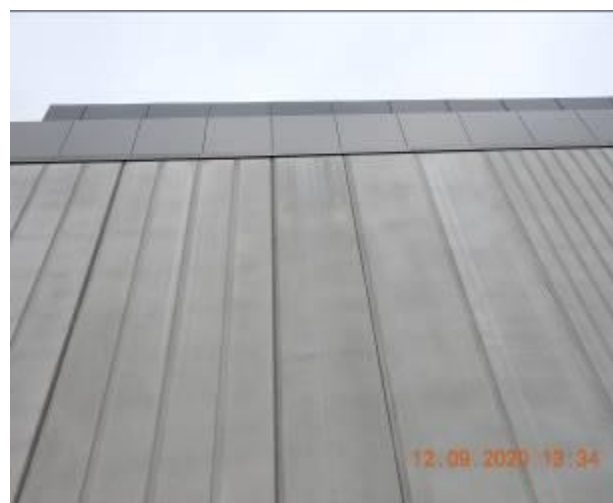
Figure 2347 – Crack propagation and loss of material through external wall

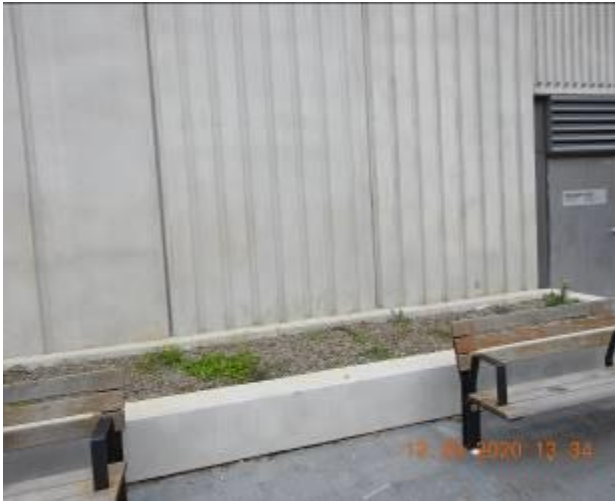
Figure 2348 – General condition of external wall

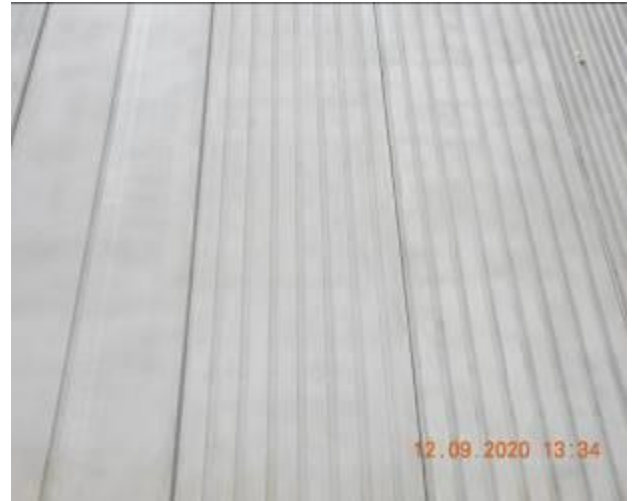
Figure 2349 – General condition of external wall

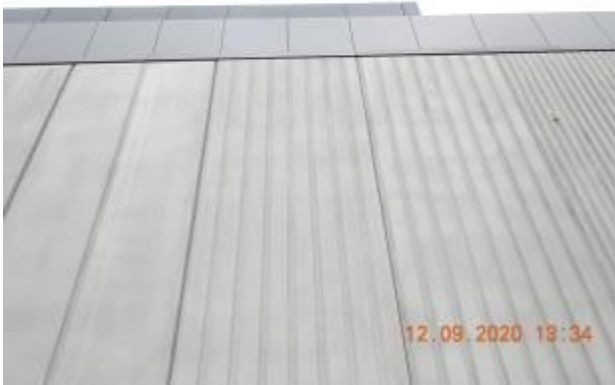
Figure 2350 – General condition of external wall

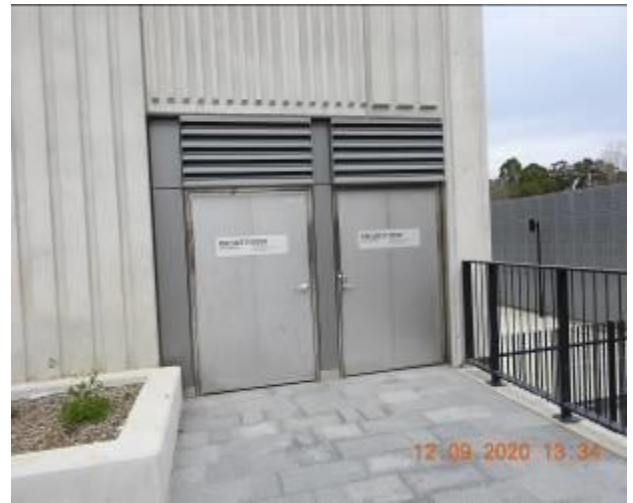
Figure 2351 – General condition of external wall

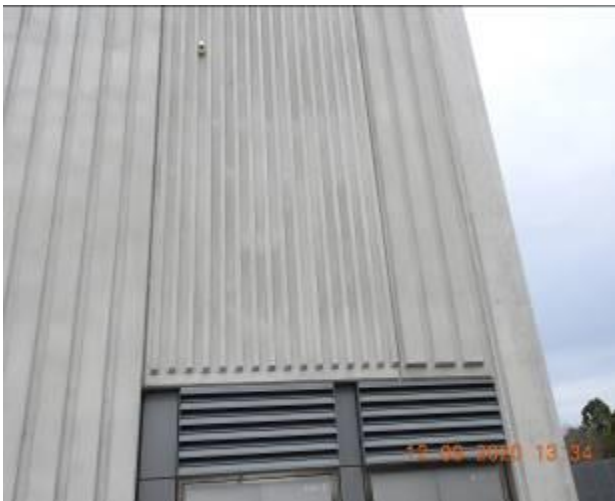
Figure 2352 – Crack propagation through external wall

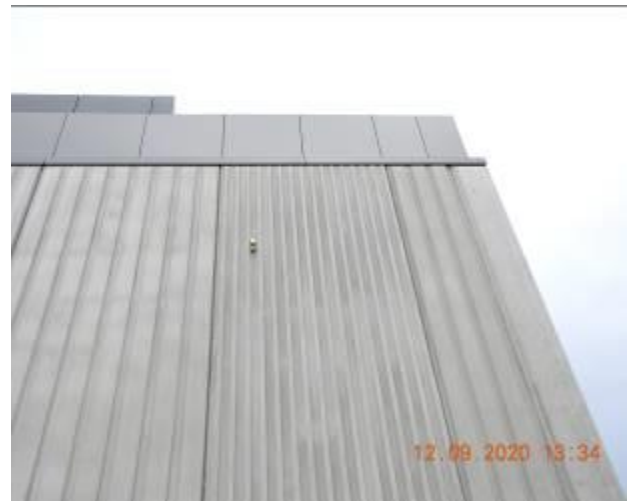
Figure 2353 – Crack propagation through external wall

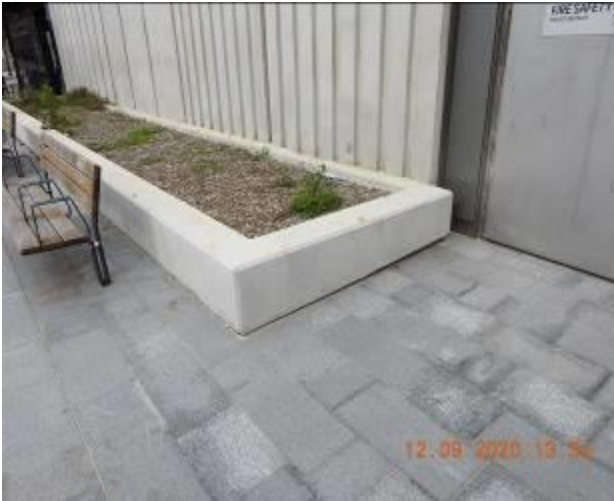
Figure 2354 – General condition of garden bed

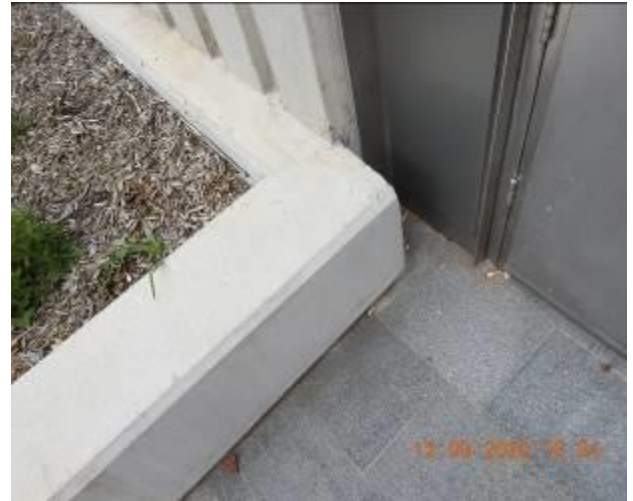
Figure 2355 – Loss of material through retaining wall

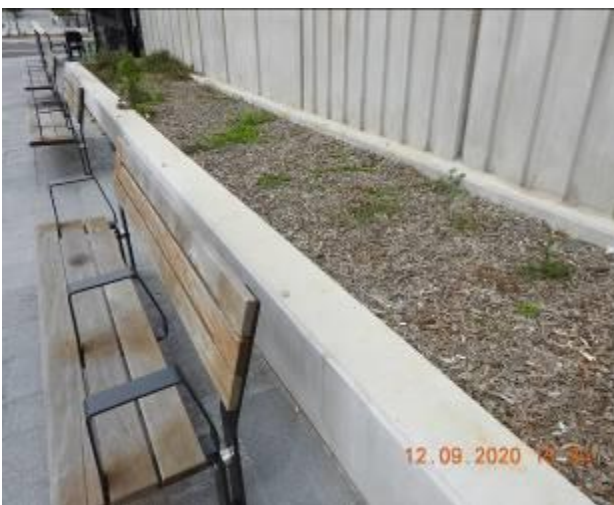
Figure 2356 – General condition of retaining wall

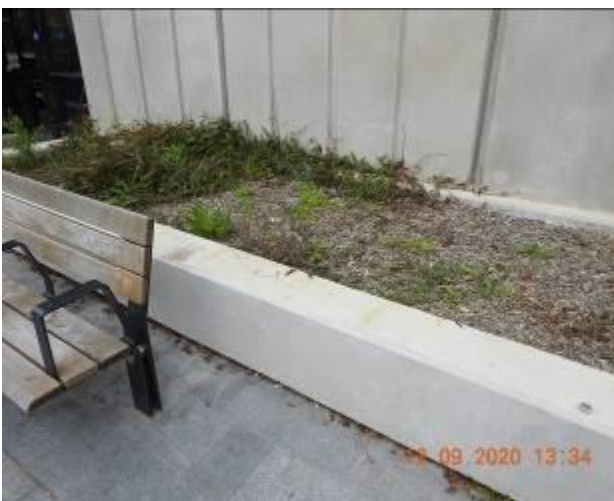
Figure 2358 – General condition of retaining wall

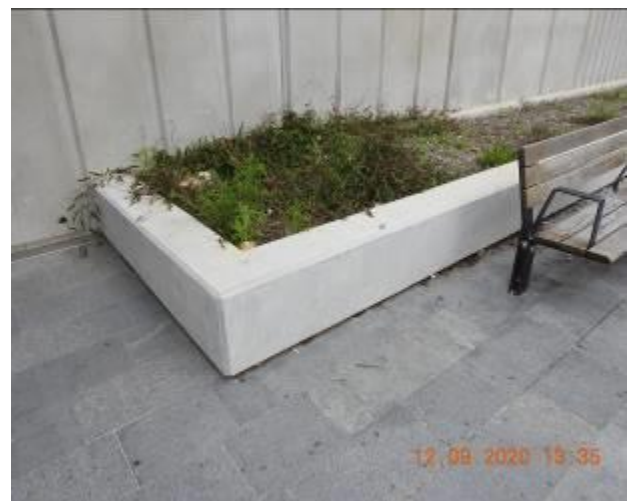
Figure 2359 – General condition of retaining wall

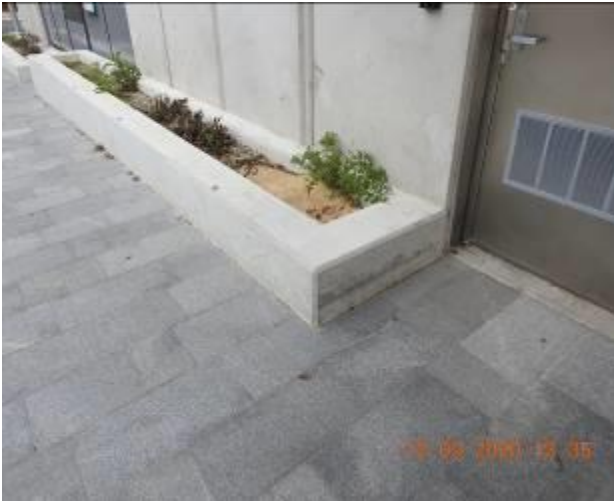
Figure 2360 – Crack propagation and loss of material through retaining wall

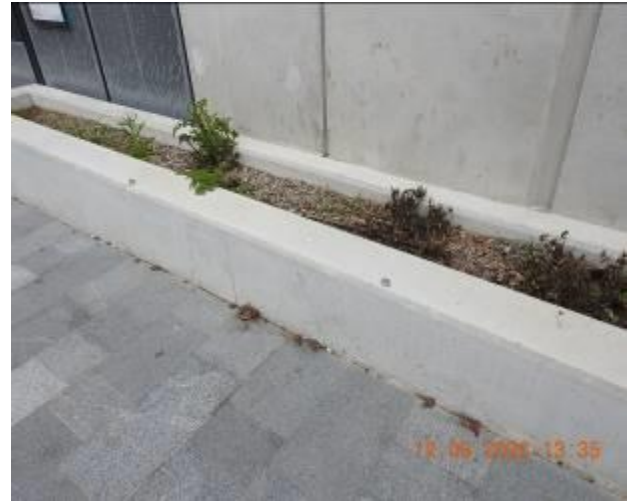
Figure 2361 – Crack propagation through retaining wall

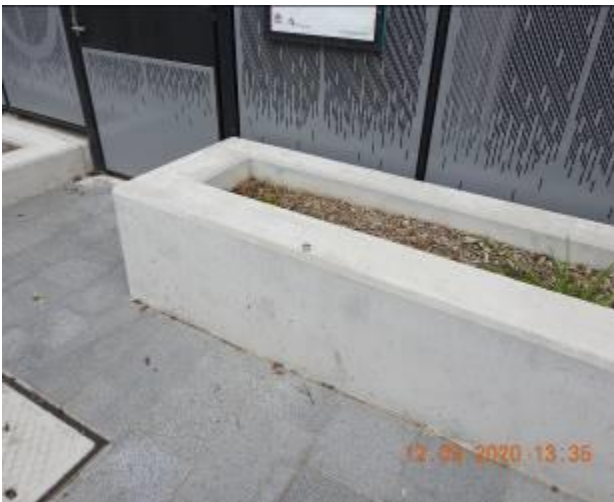
Figure 2362 – General condition of retaining wall

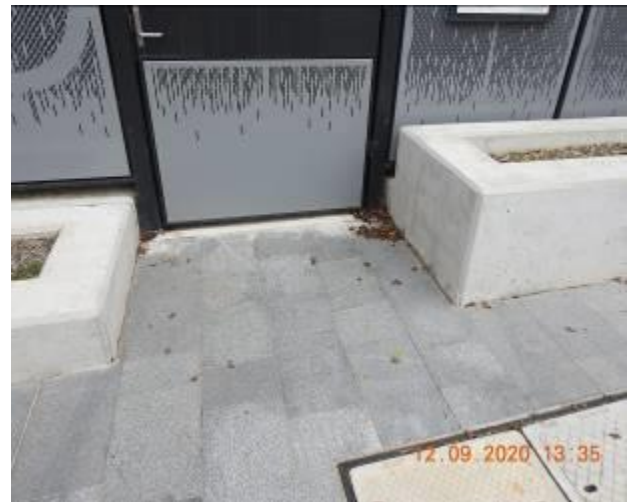
Figure 2363 – Hairline crack propagation through walkway floor

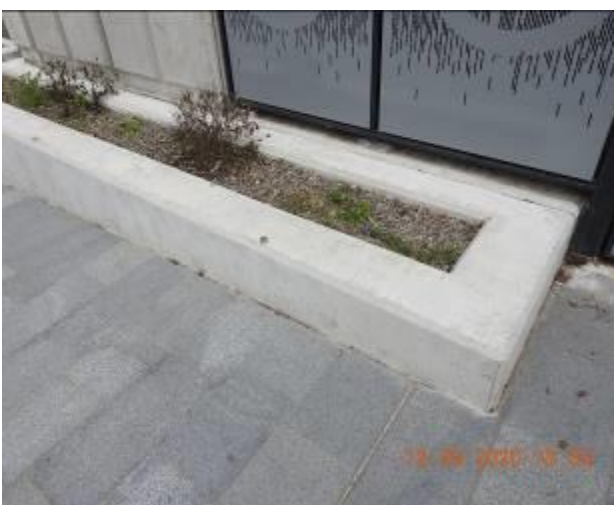
Figure 2364 – Crack propagation and loss of material through retaining wall

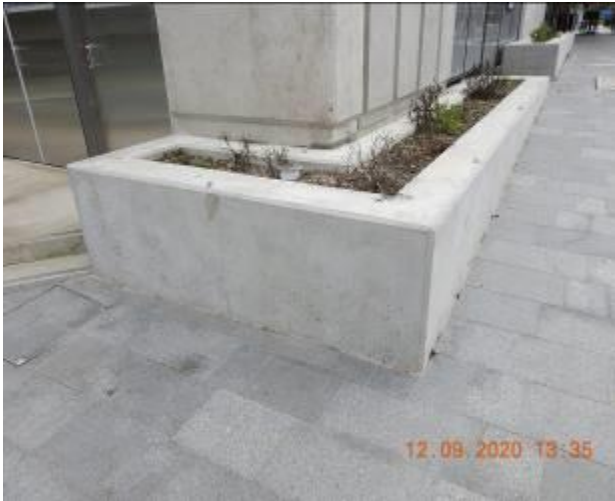
Figure 2366 – Loss of material through external wall

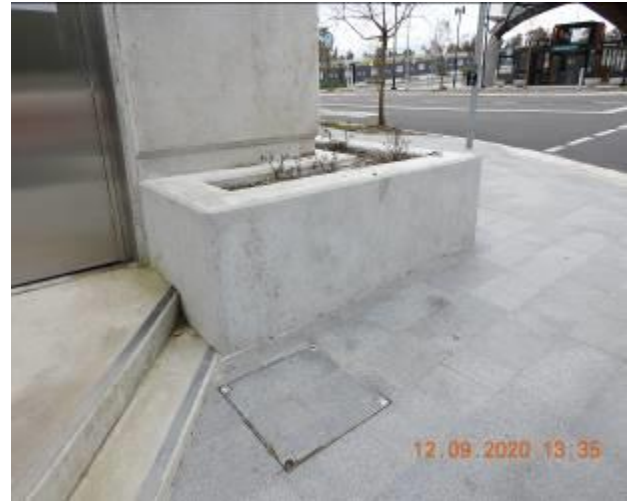
Figure 2367 – General condition of retaining wall

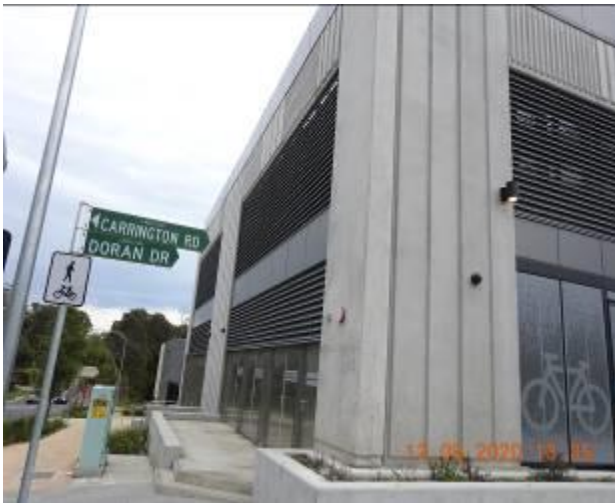
Figure 2368 – General condition of Southern facade

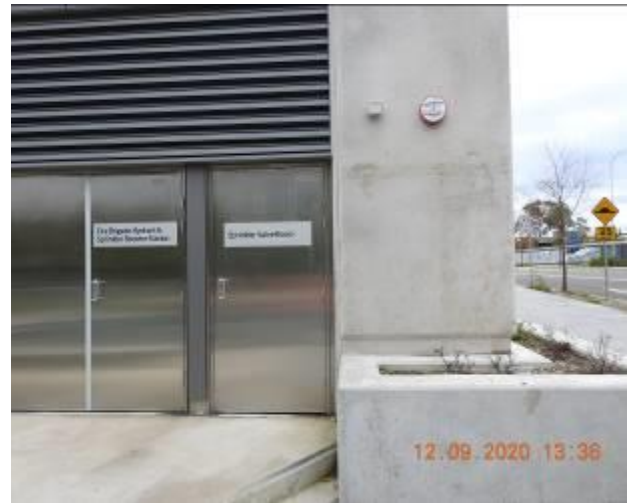
Figure 2369 – General condition of external wall

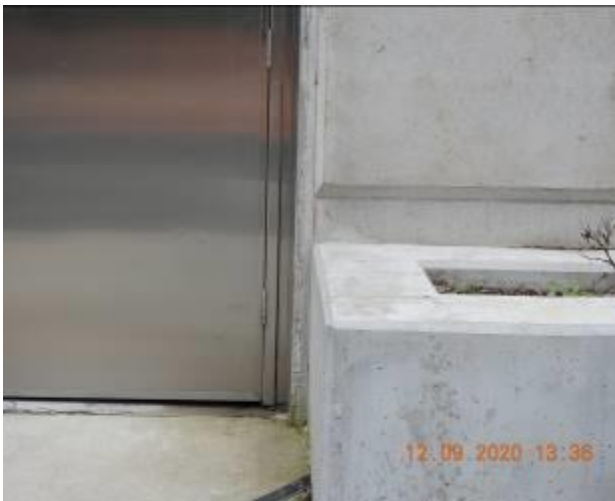
Figure 2370 – Loss of material through external wall

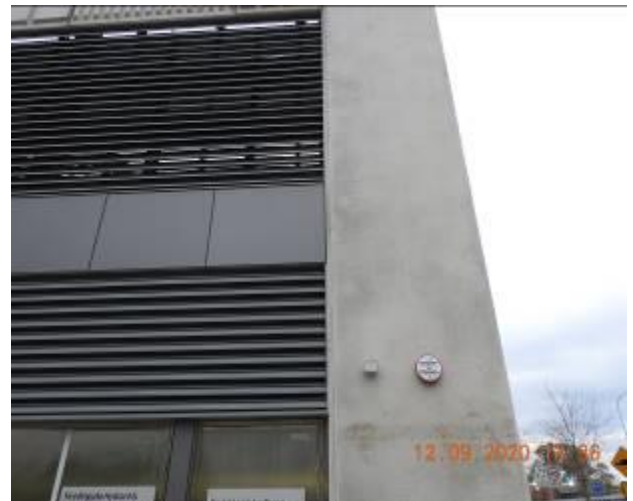
Figure 2371 – General condition of external wall

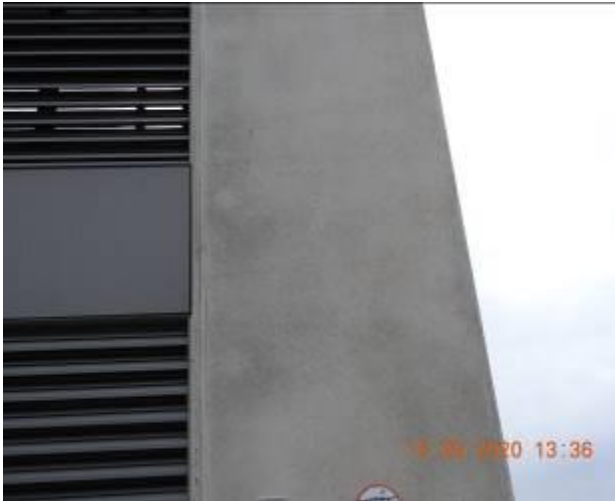
Figure 2372 – Hairline crack propagation through external wall

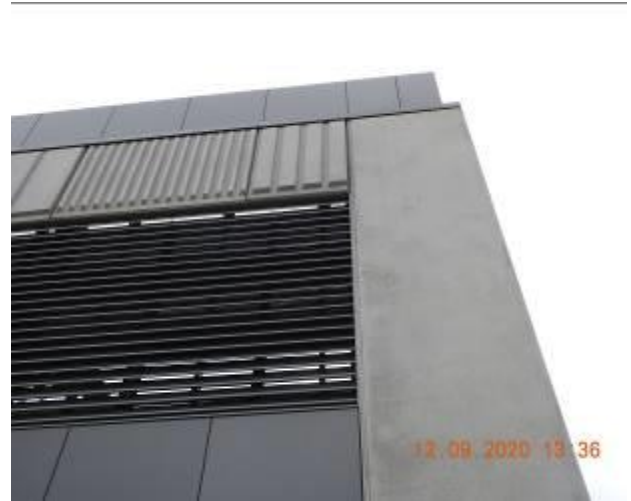
Figure 2373 – General condition of external wall

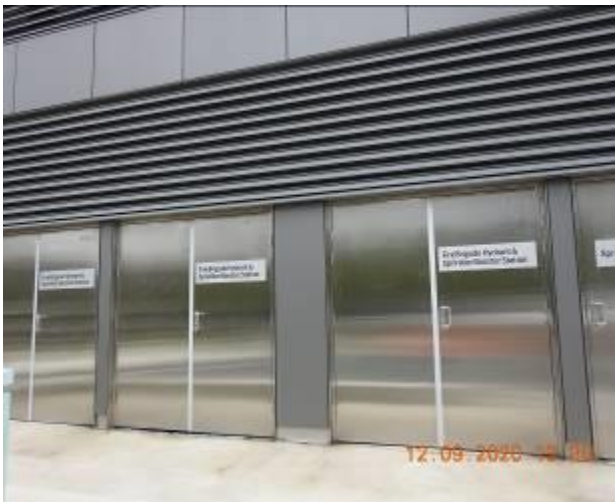
Figure 2374 – General condition of external wall

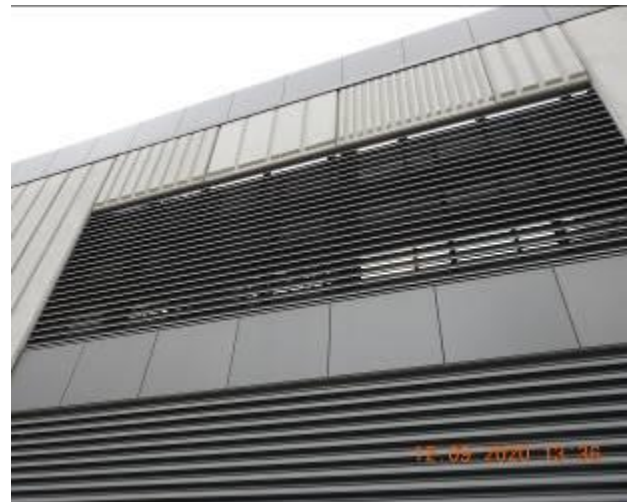
Figure 2375 – Loss of material through external wall

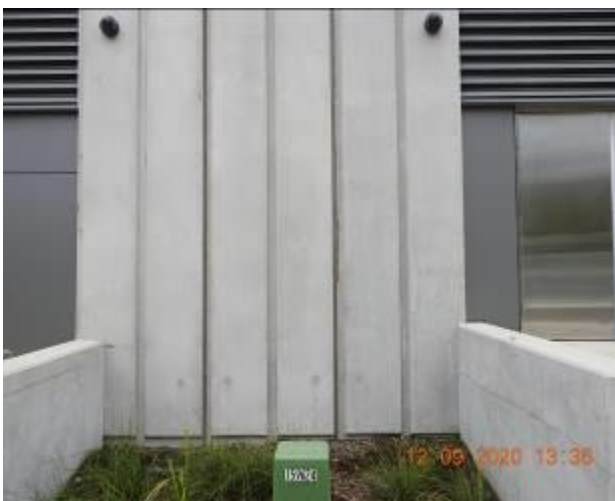
Figure 2376 – Crack propagation and loss of material through external wall

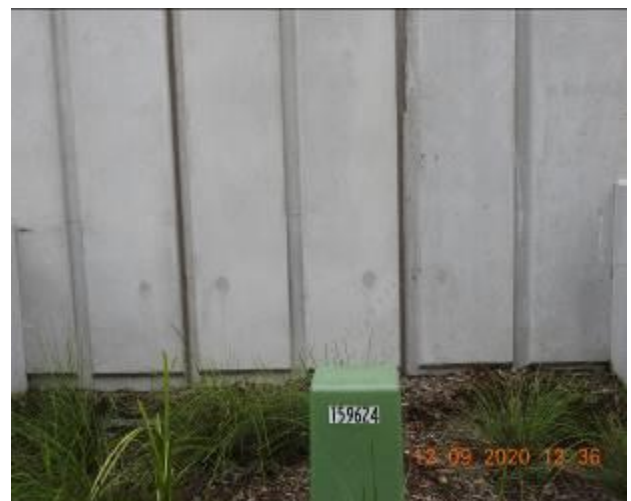
Figure 2377 – Loss of material through external wall

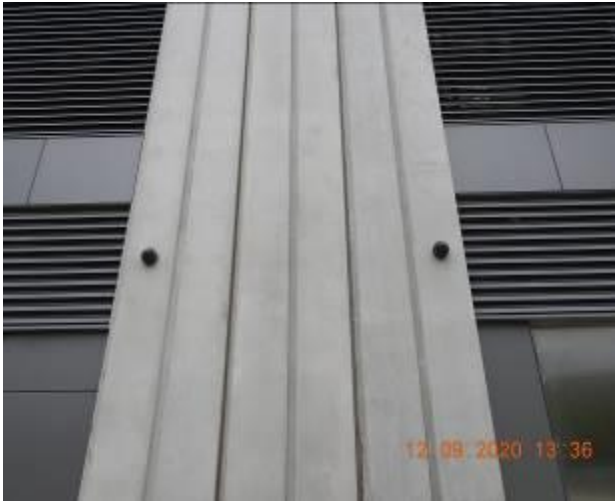
Figure 2378 – Crack propagation and loss of material through external wall

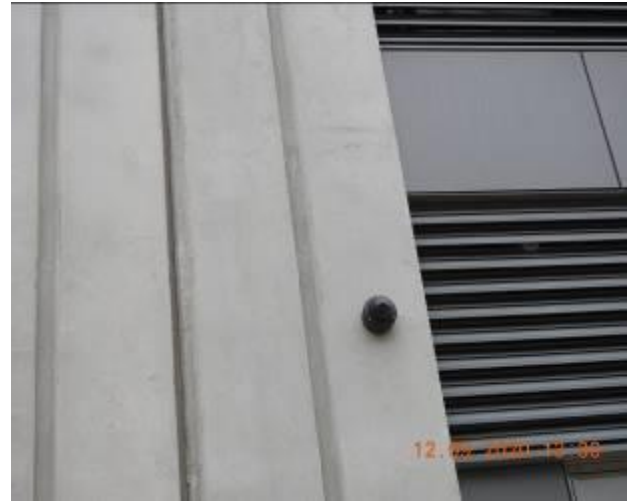
Figure 2379 – Crack propagation and loss of material through external wall

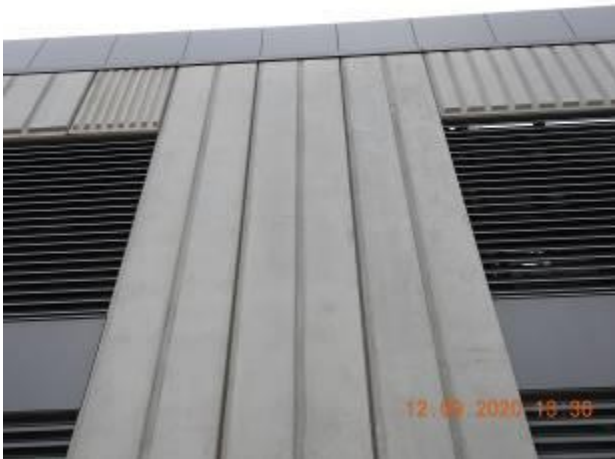
Figure 2380 – Crack propagation and loss of material through external wall

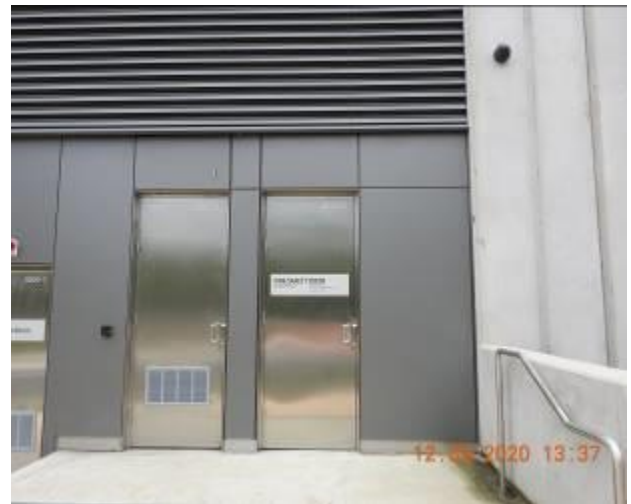
Figure 2381 – General condition of external wall

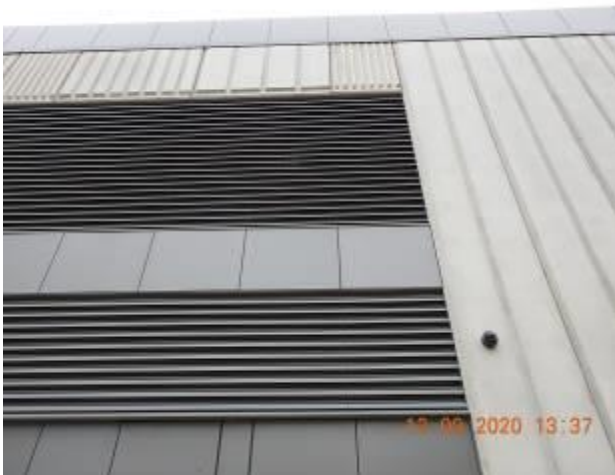
Figure 2382 – General condition of external wall

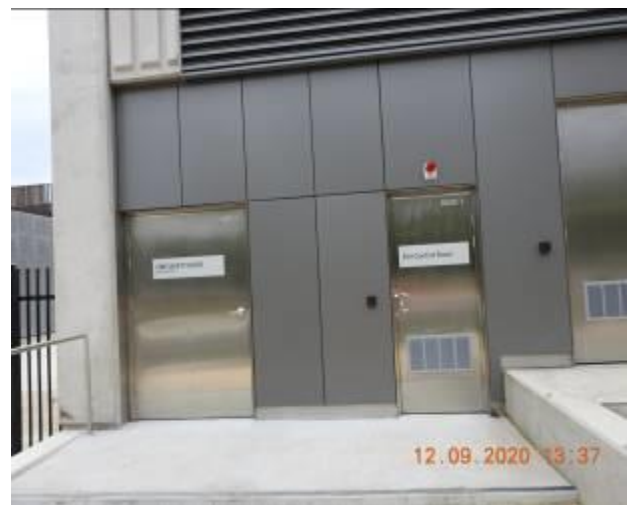
Figure 2383 – General condition of external wall

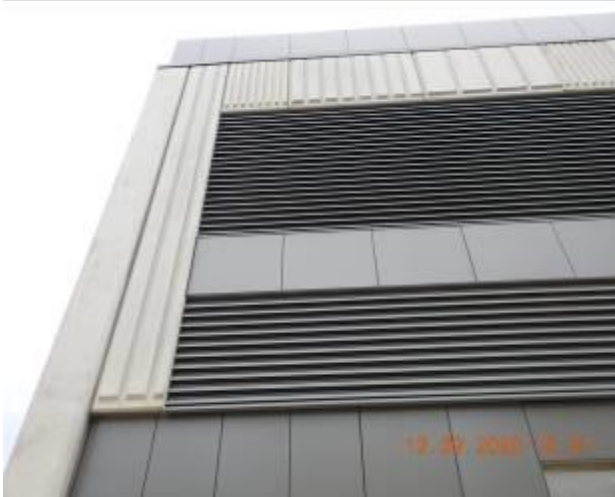
Figure 2384 – General condition of external wall

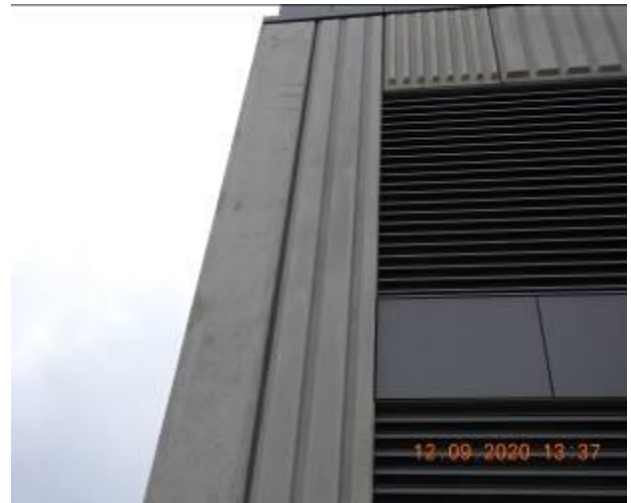
Figure 2385 – Crack propagation through external wall

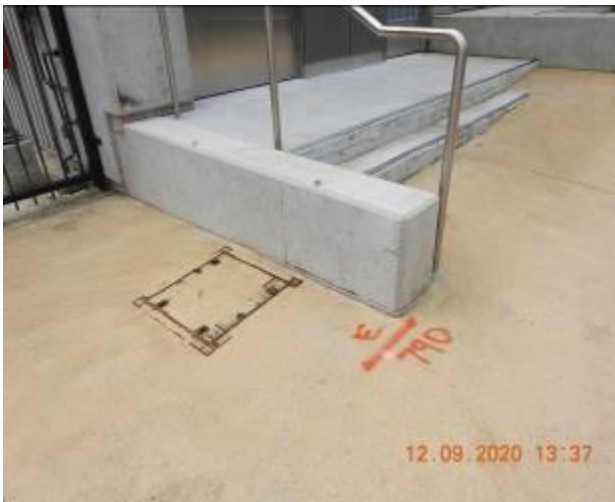
Figure 2386 – General condition of staircase pavement

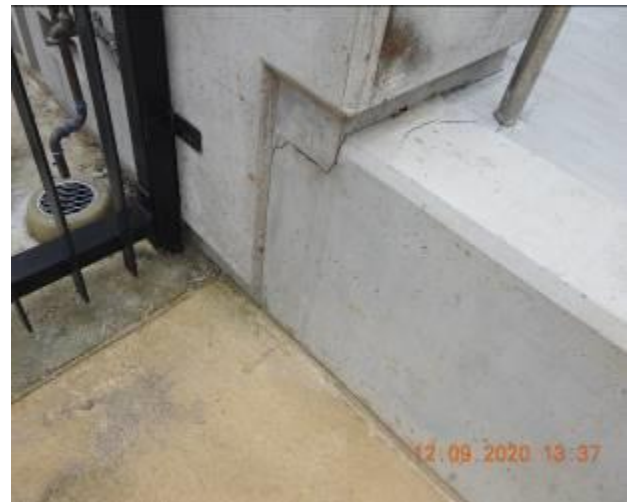
Figure 2387 – Crack propagation and loss of material through staircase pavement

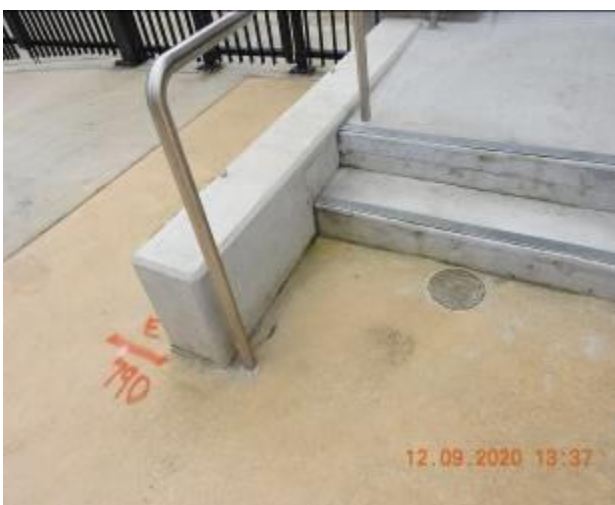
Figure 2388 – General condition of staircase pavement

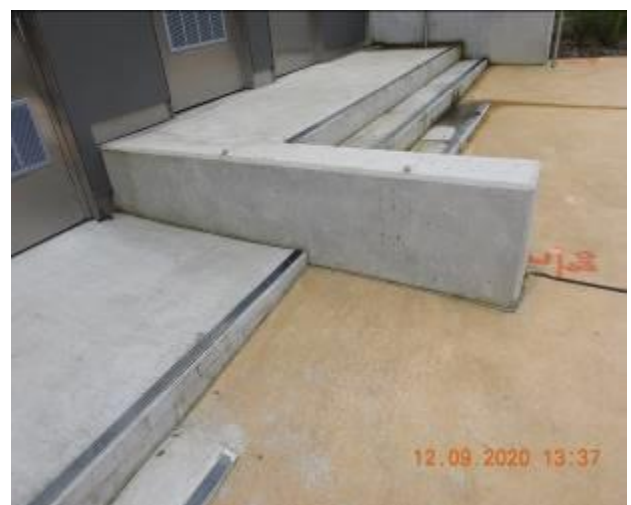
Figure 2389 – General condition of staircase pavement
