**2 MANDALA PARADE, CASTLE HILL
(DORAN DRIVE PRECINCT)
PRE-DILAPIDATION REPORT
Of Sydney Metro and Hills Shire Council Assets
DEICORP PROJECTS SHOWGROUND
PTY LTD.**

Job No. 200124.3
07/07/2021

ACE Structural Services Pty Ltd

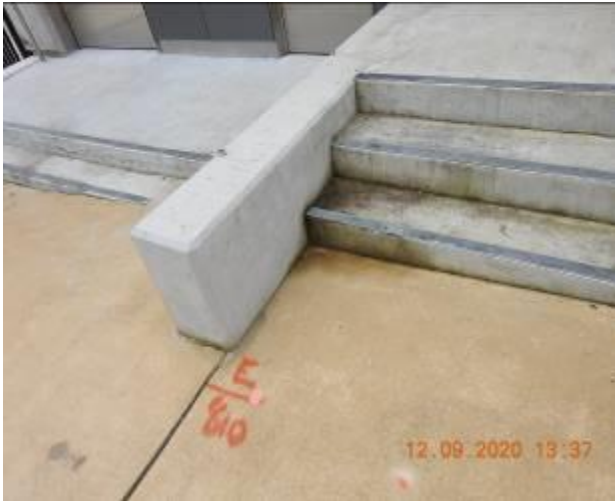
Figure 2390 – Crack propagation and loss of material through staircase pavement

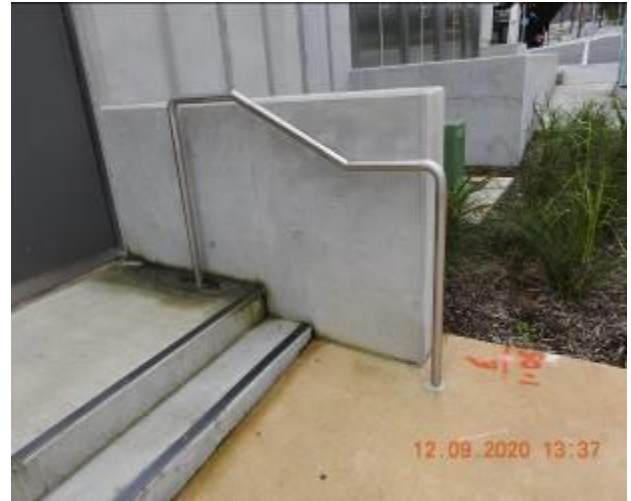
Figure 2391 – General condition of staircase pavement

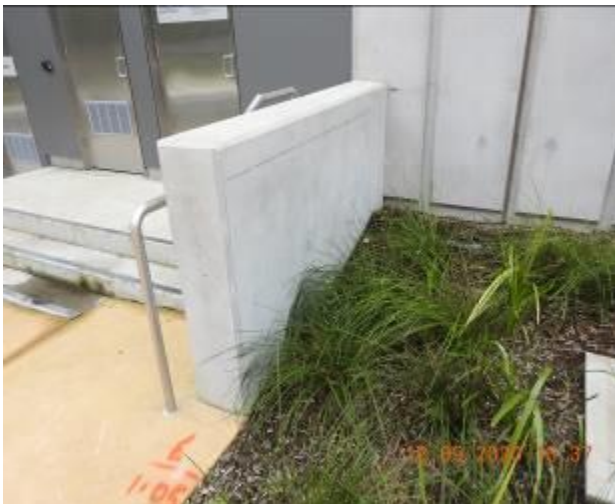
Figure 2392 – General condition of staircase pavement

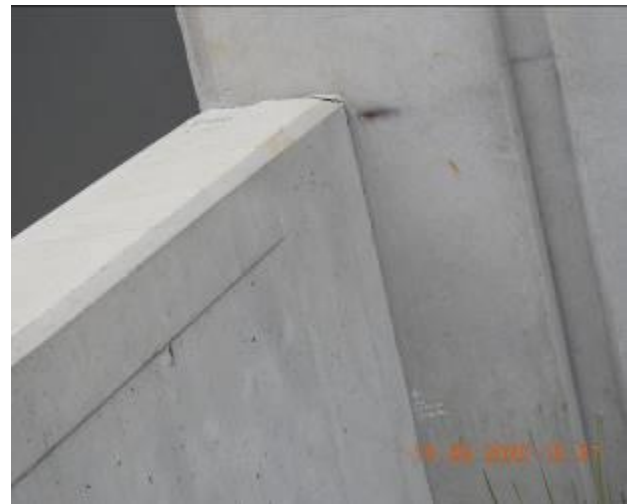
Figure 2393 – Crack propagation and loss of material through retaining wall

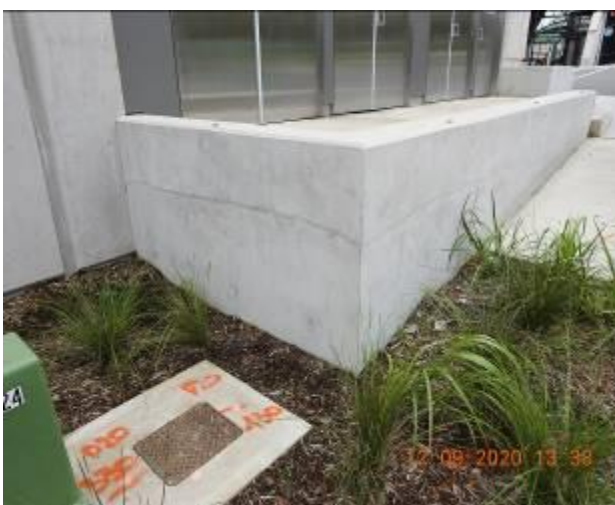
Figure 2394 – Loss of material through retaining wall

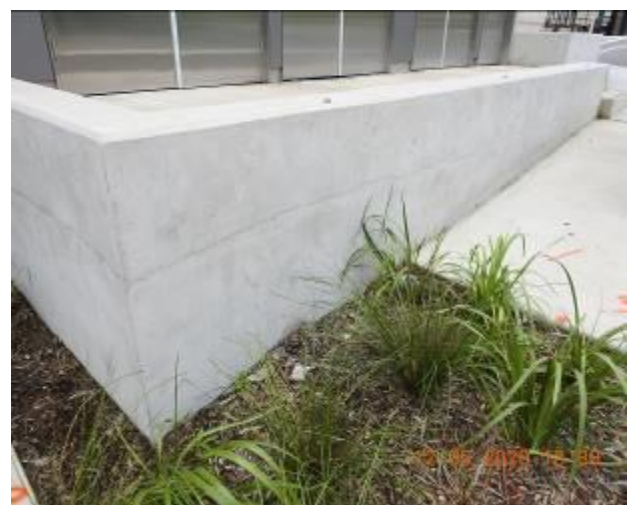
Figure 2395 – Loss of material through retaining wall

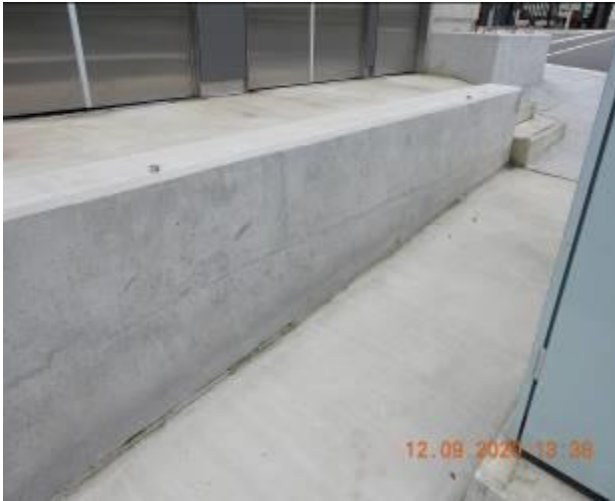
Figure 2396 – Crack propagation through retaining wall

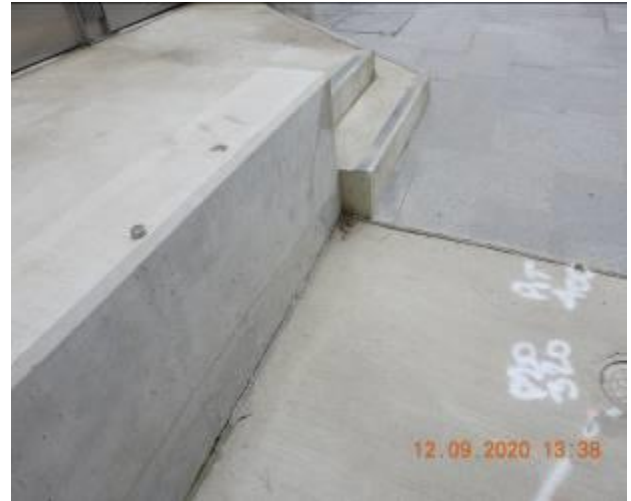
Figure 2397 – Crack propagation and loss of material through retaining wall

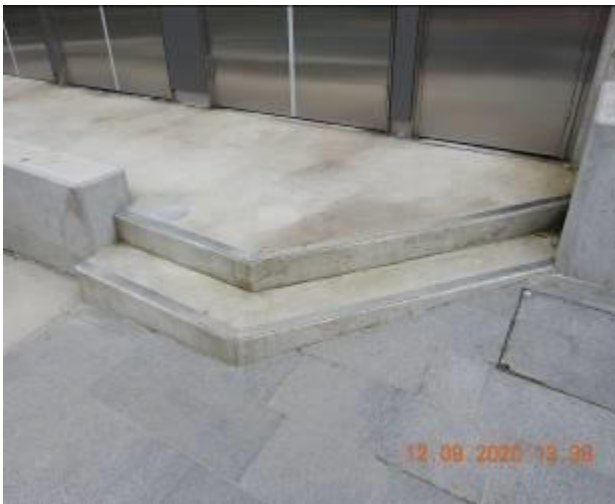
Figure 2398 – General condition of steps

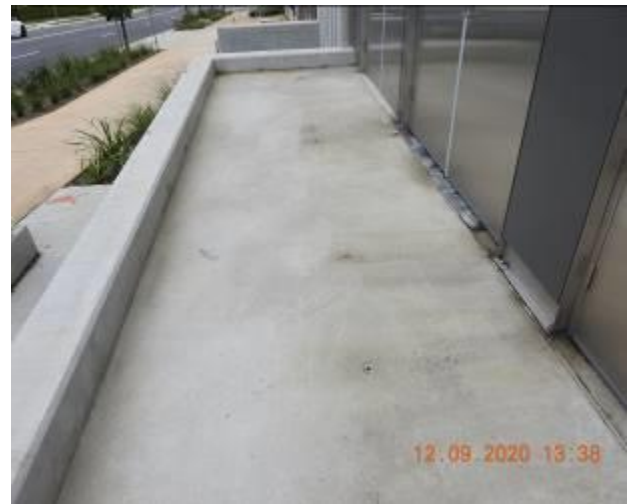
Figure 2399 – General condition of walkway pavement

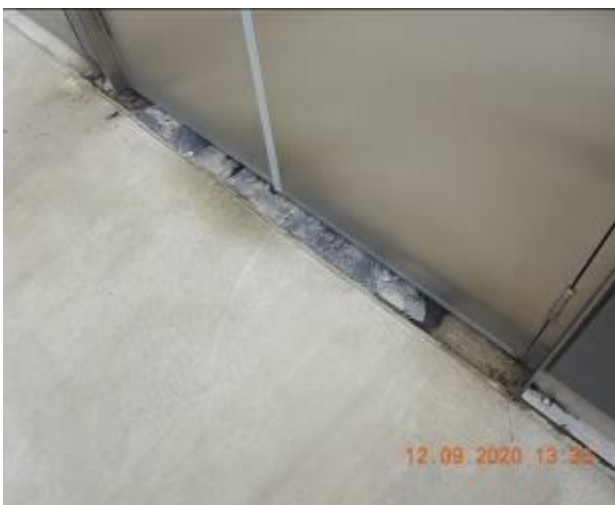
Figure 2400 – Loss of material through walkway pavement

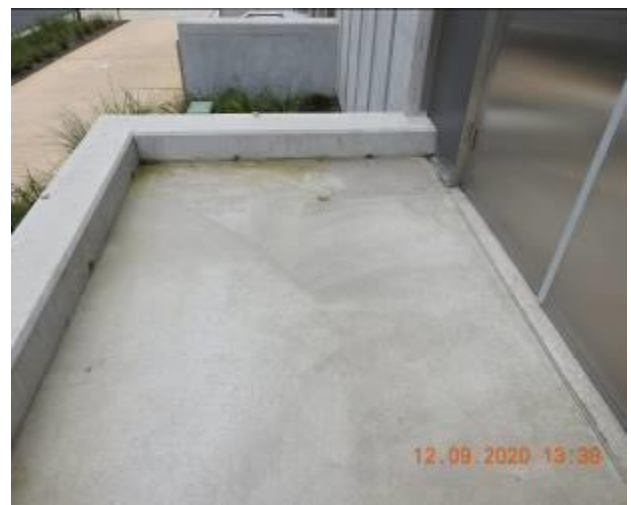
Figure 2401 – General condition of walkway pavement

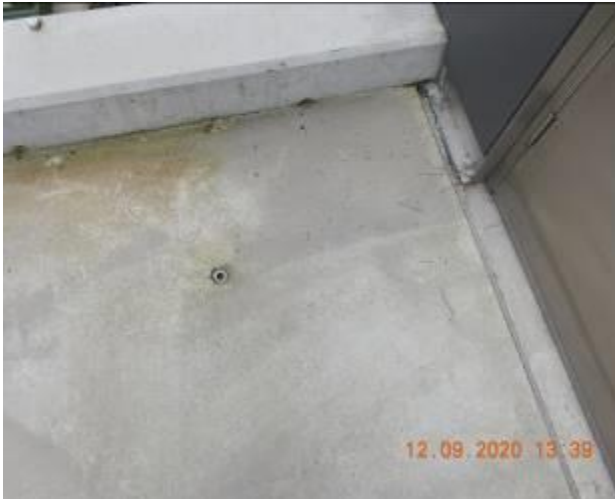
Figure 2402 – Loss of material through walkway pavement

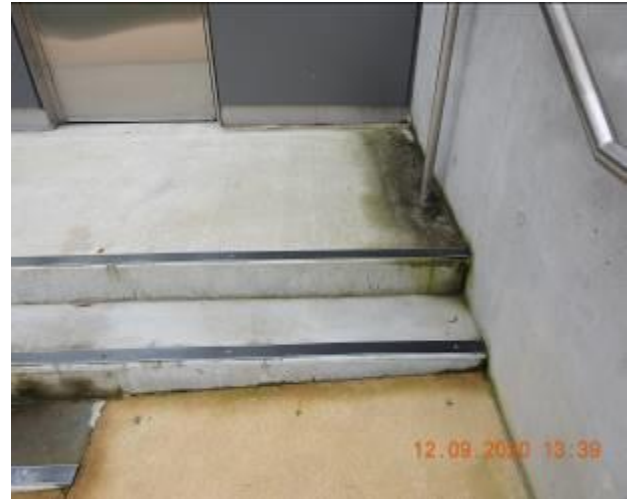
Figure 2403 – Loss of material through steps pavement

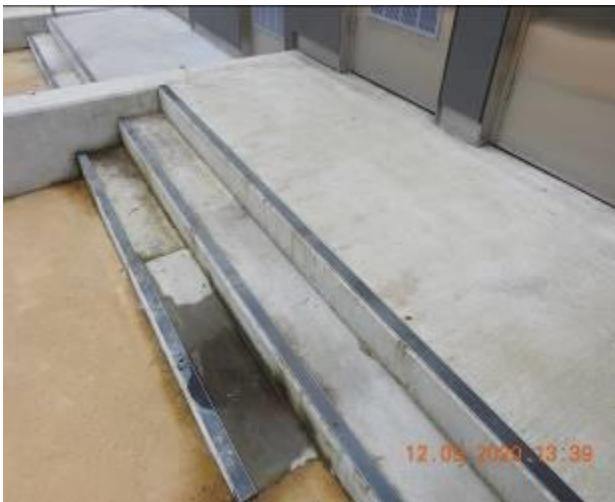
Figure 2404 – Loss of material through steps pavement

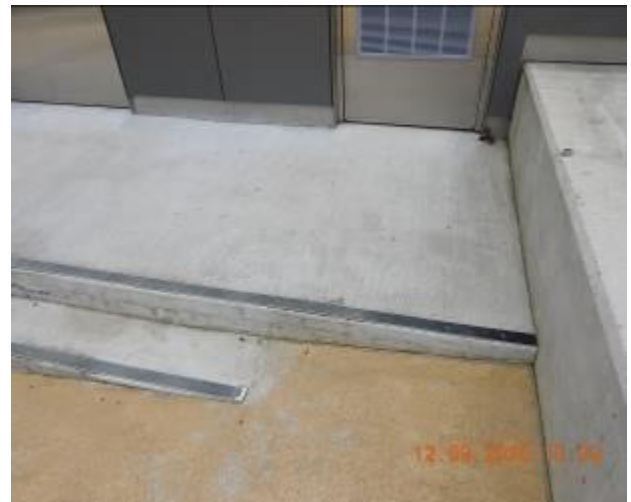
Figure 2405 – Loss of material through steps pavement

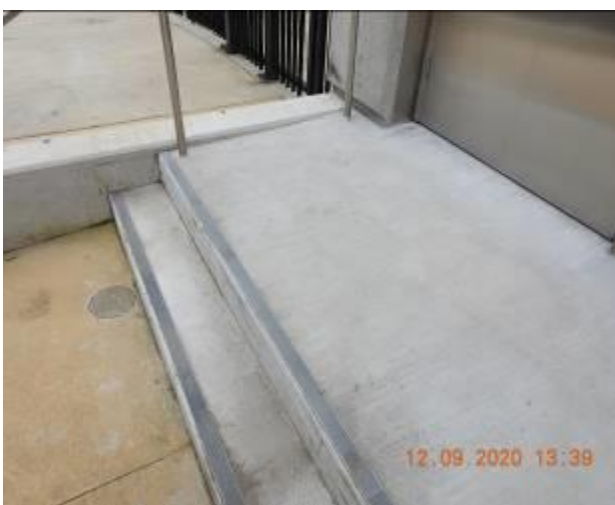
Figure 2406 – General condition of steps pavement

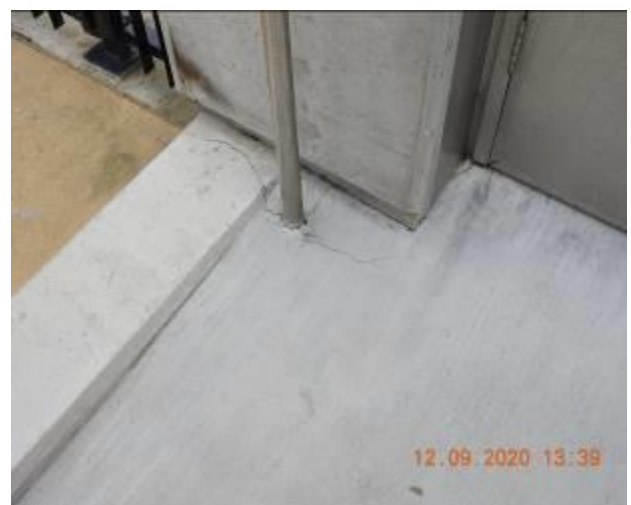
Figure 2407 – Crack propagation and loss of material through steps pavement

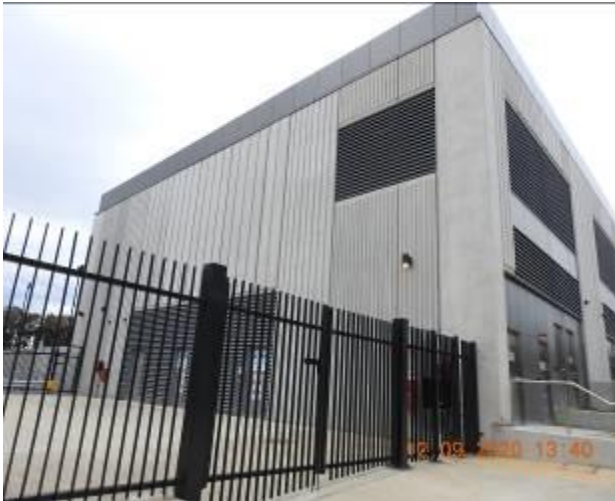
Figure 2408 – General condition of Western facade

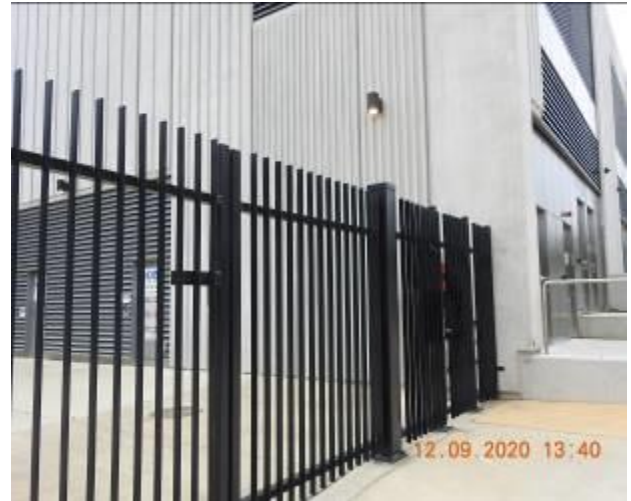
Figure 2409 – General condition of external wall

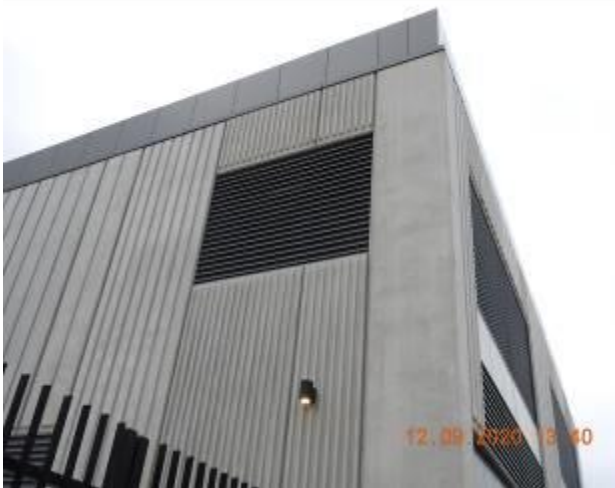
Figure 2410 – General condition of external wall

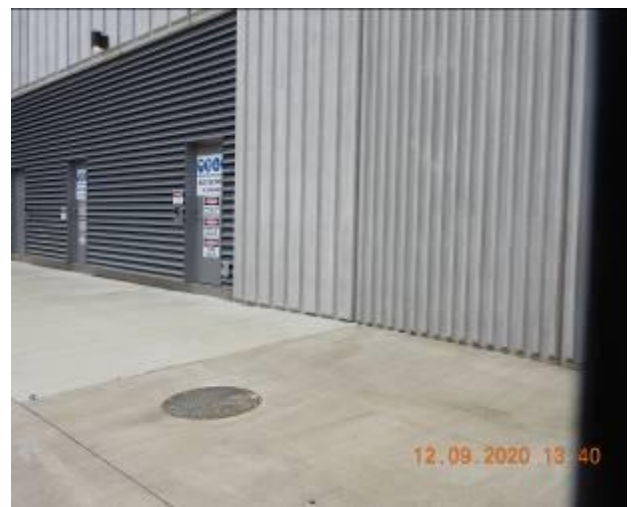
Figure 2411 – General condition of external wall

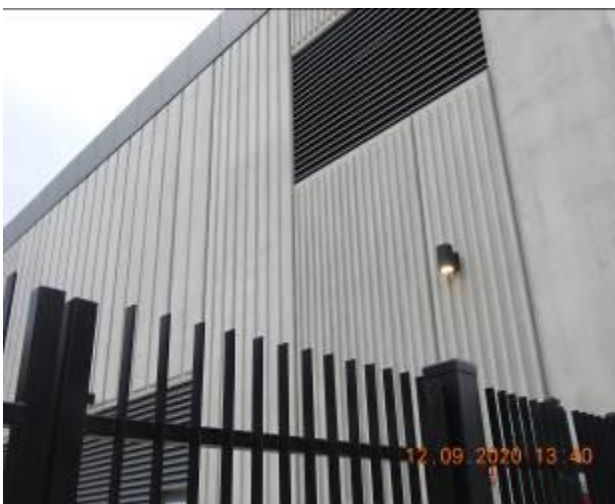
Figure 2412 – General condition of external wall

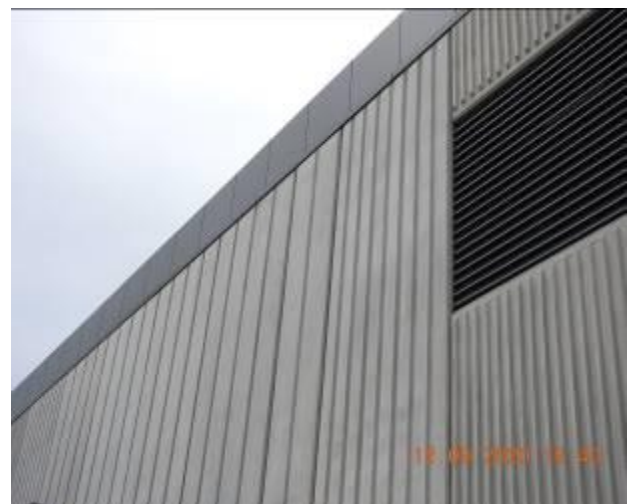
Figure 2413 – General condition of external wall

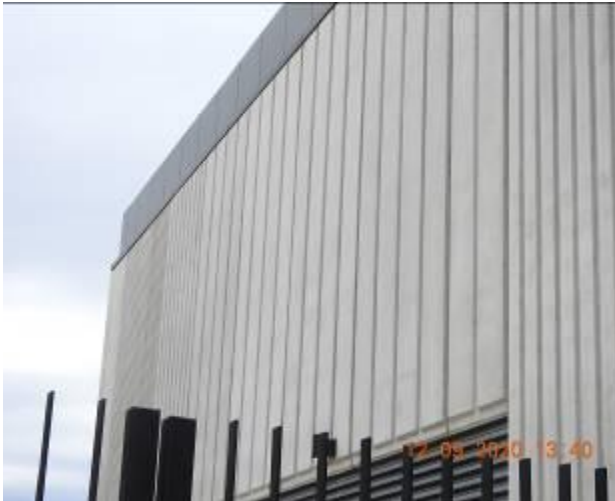
Figure 2414 – General condition of external wall

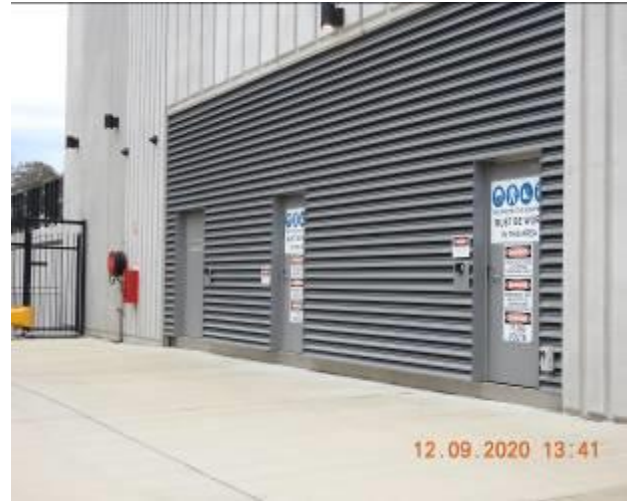
Figure 2415 – General condition of external wall

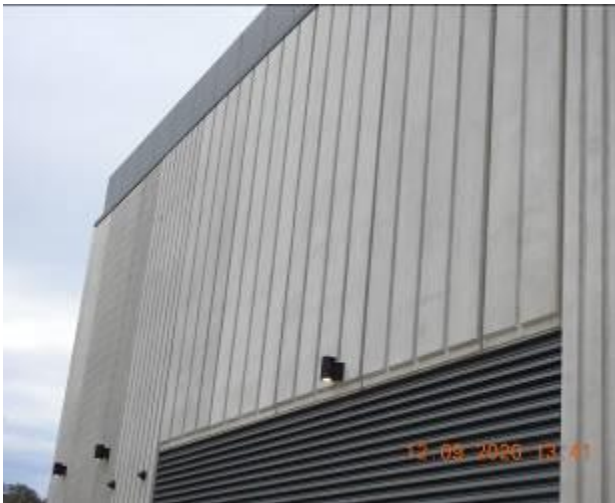
Figure 2416 – General condition of external wall

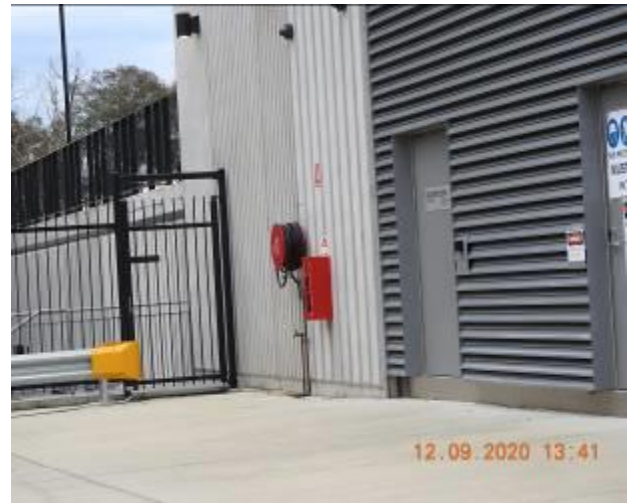
Figure 2417 – General condition of external wall

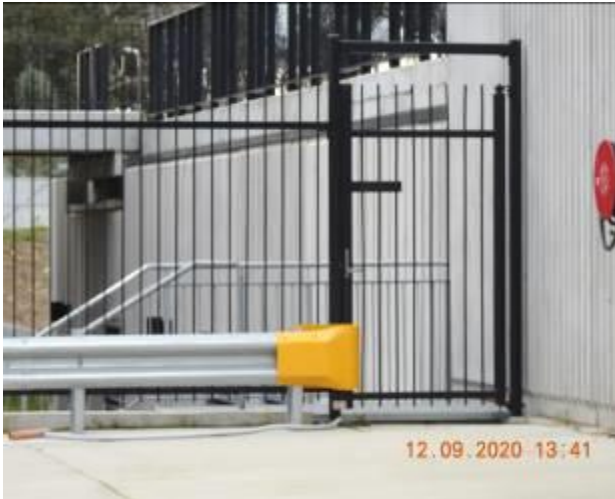
Figure 2420 – General condition of external wall

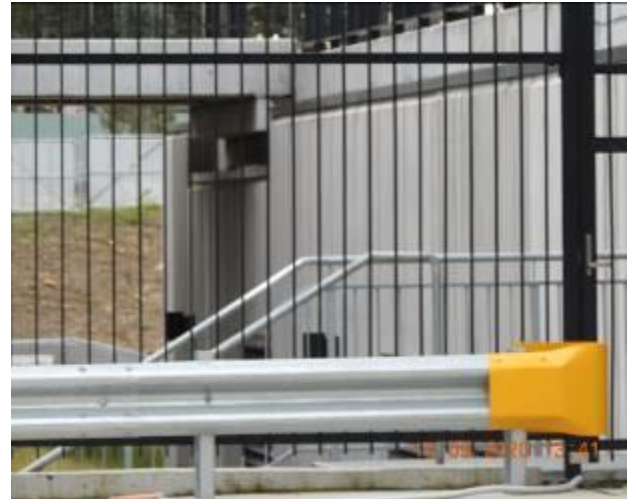
Figure 2421 – General condition of external wall

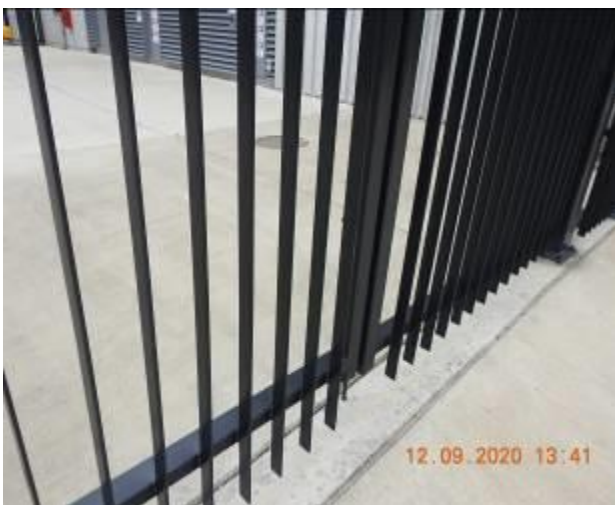
Figure 2422 – General condition of driveway pavement

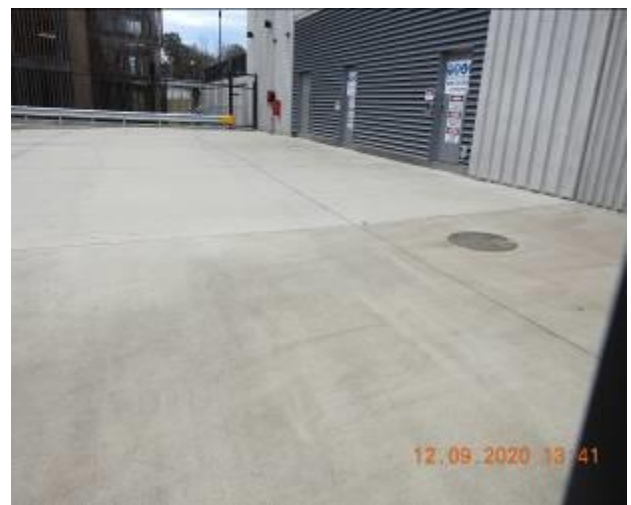
Figure 2423 – General condition of driveway pavement

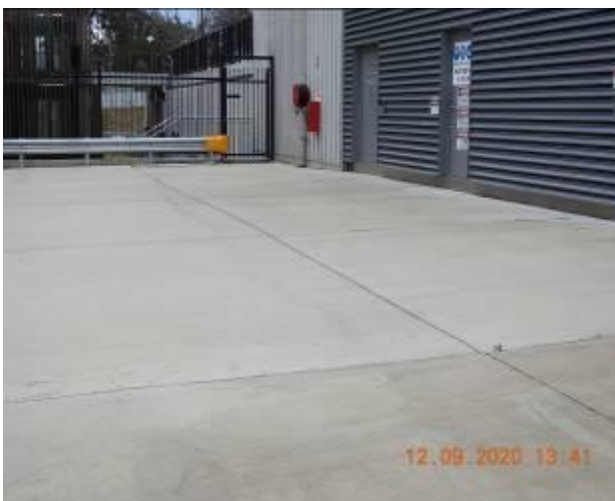
Figure 2424 – General condition of driveway pavement

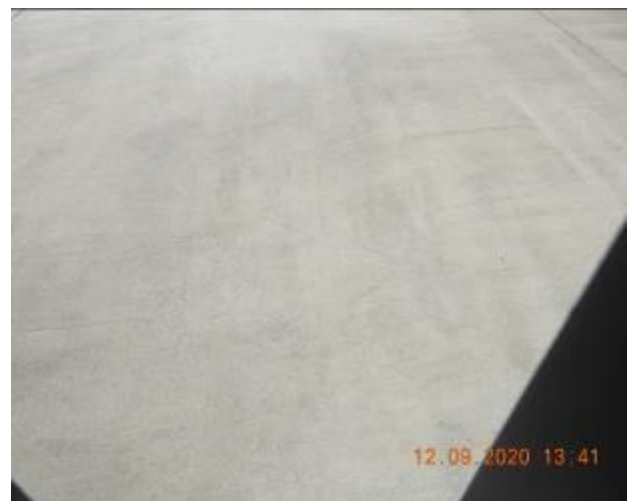
Figure 2425 – General condition of driveway pavement

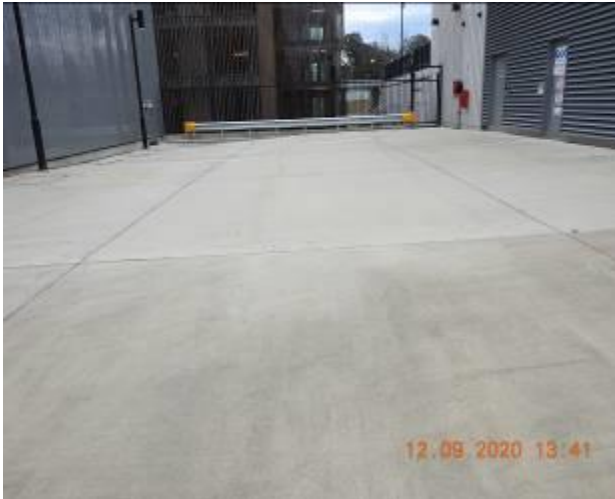
Figure 2426 – General condition of driveway pavement

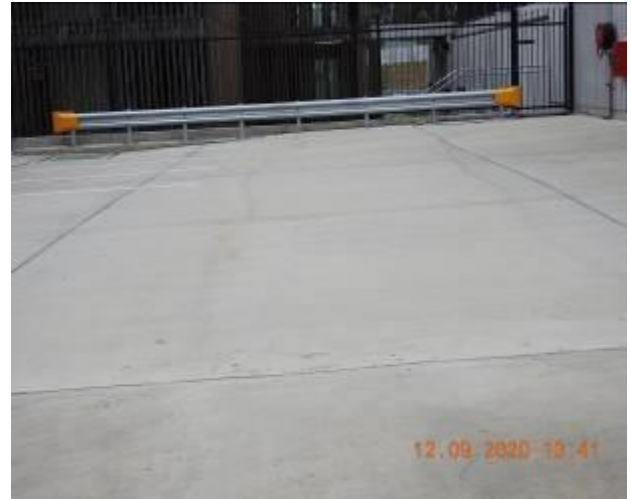
Figure 2427 – General condition of driveway pavement

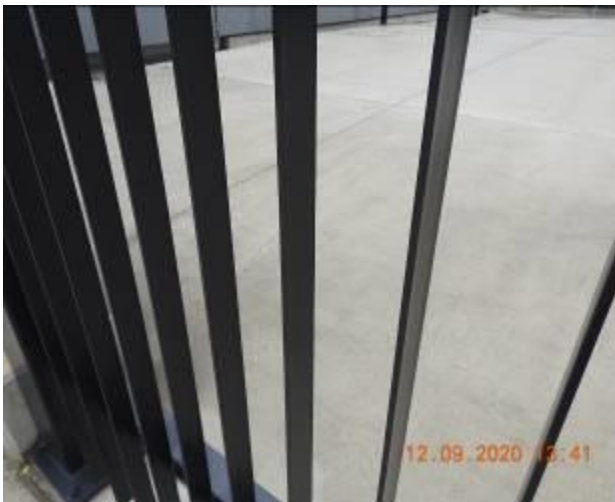
Figure 2428 – Crack propagation through driveway pavement

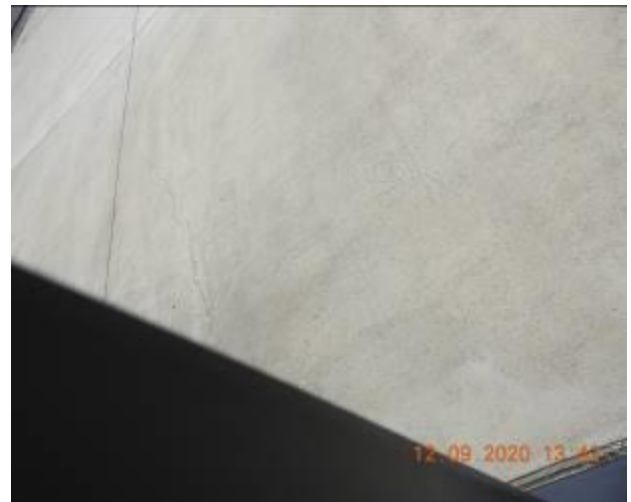
Figure 2429 – Crack propagation through driveway pavement

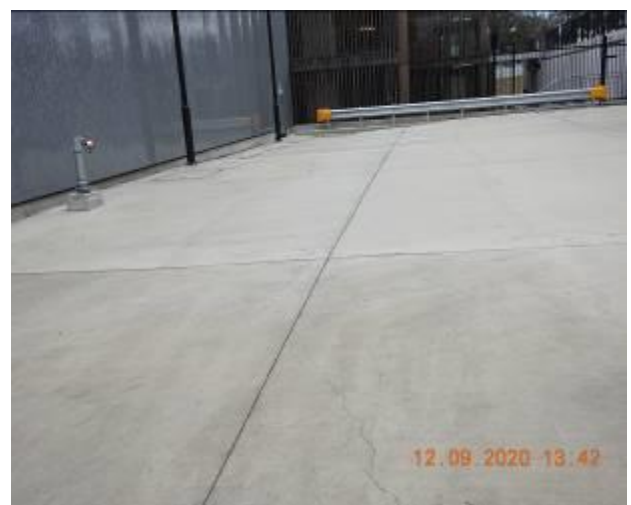
Figure 2431 – Crack propagation through driveway pavement

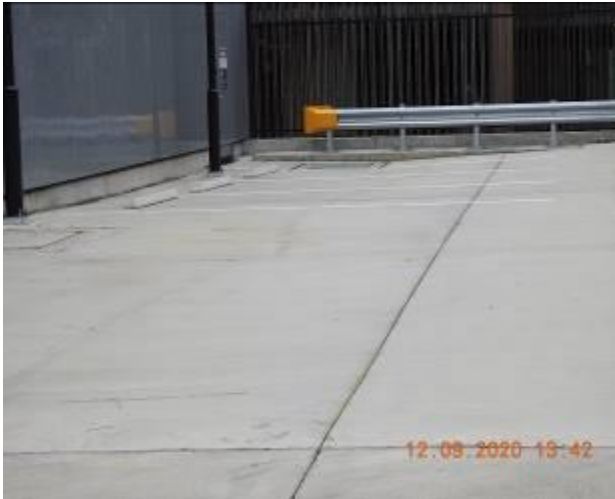
Figure 2432 – General condition of driveway pavement

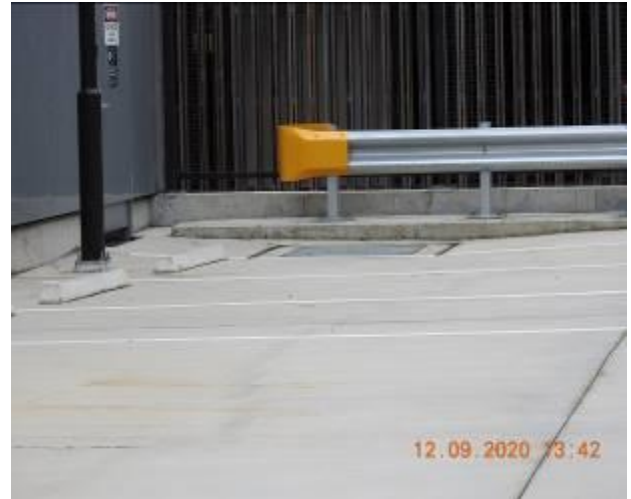
Figure 2433 – General condition of driveway pavement

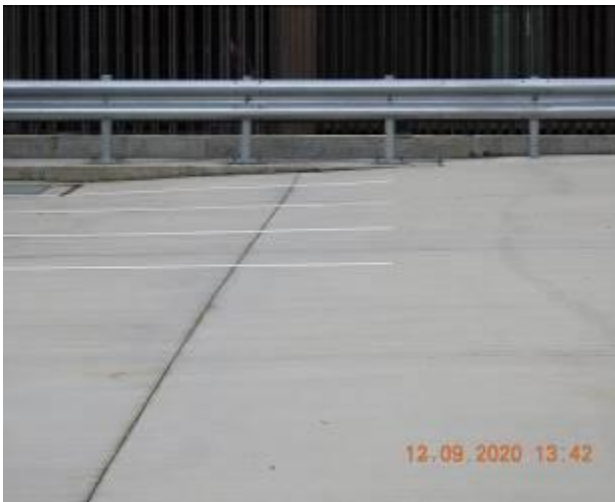
Figure 2434 – General condition of driveway pavement

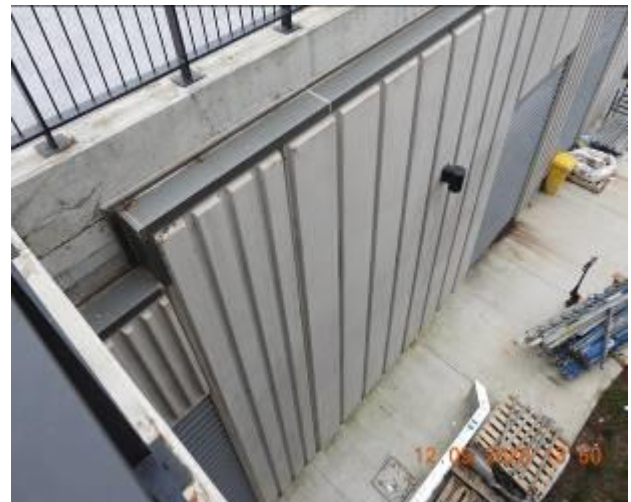
Figure 2435 – General condition of Northern facade

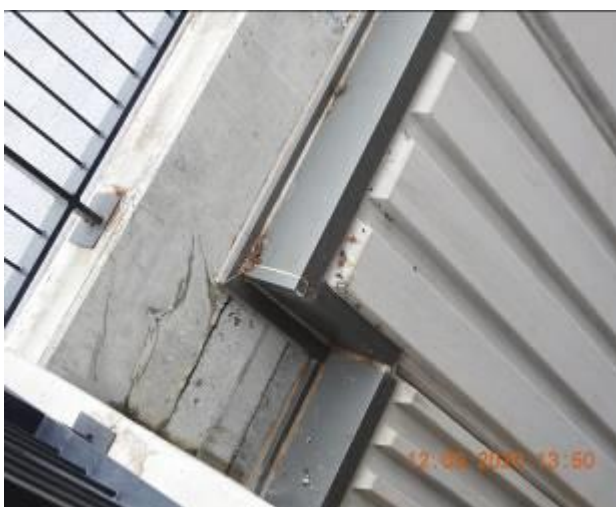
Figure 2436 – Crack propagation and loss of material through external wall

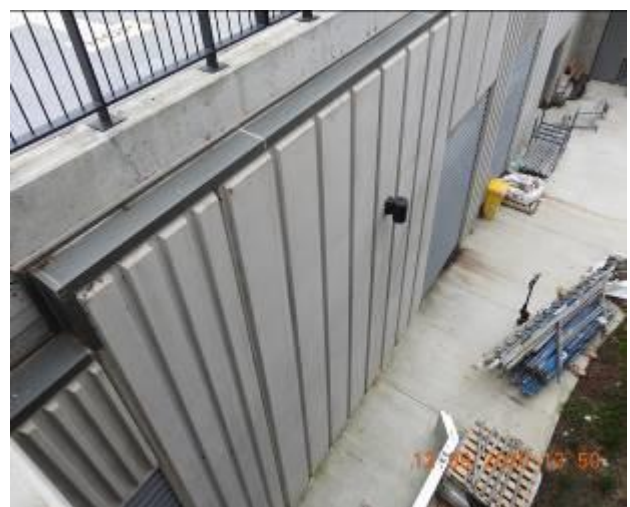
Figure 2437 – General condition of external wall

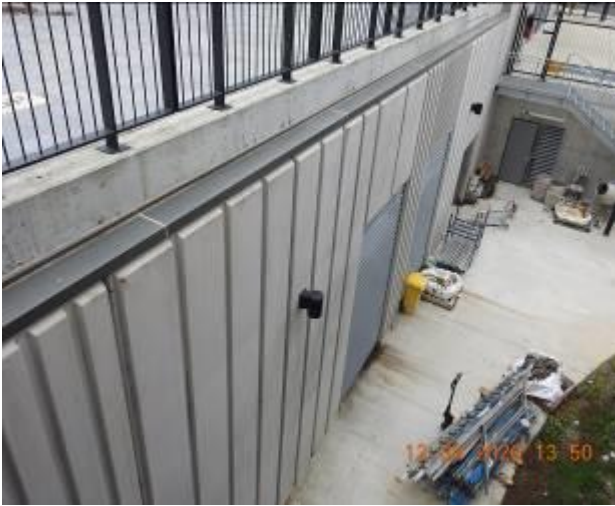
Figure 2438 – General condition of external wall

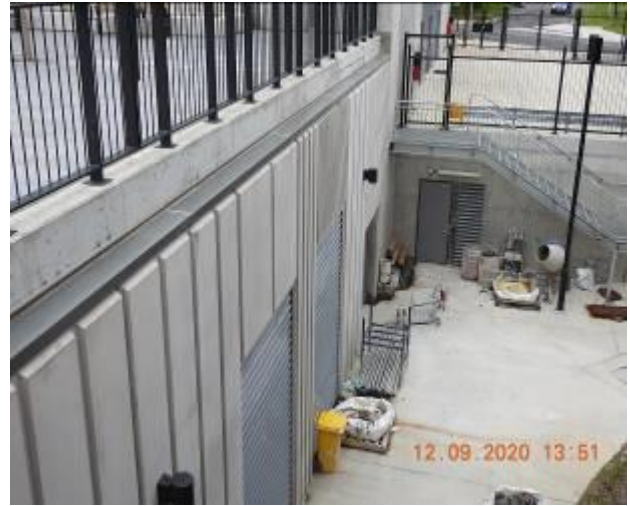
Figure 2439 – General condition of external wall

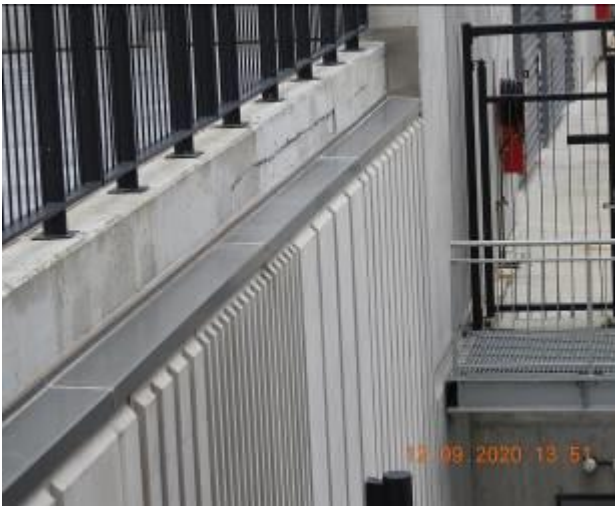
Figure 2440 – Loss of material through external wall

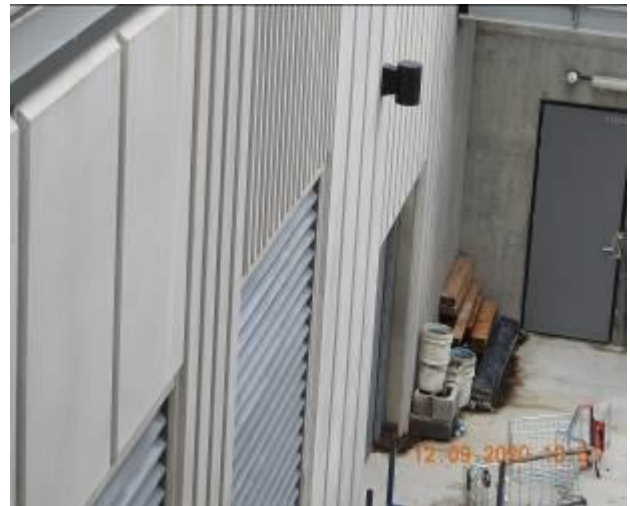
Figure 2441 – General condition of external wall

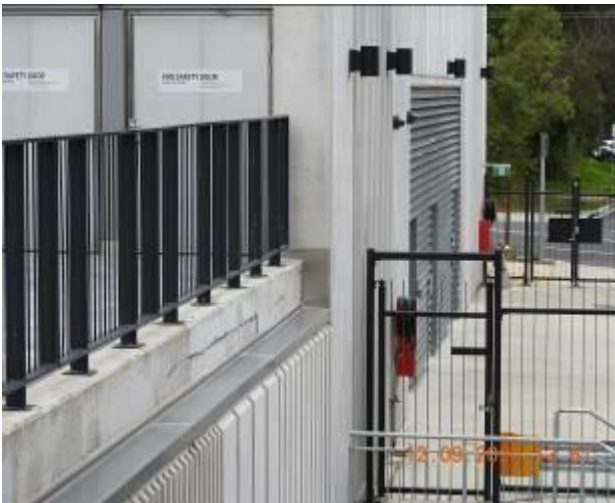
Figure 2442 – Loss of material through external wall

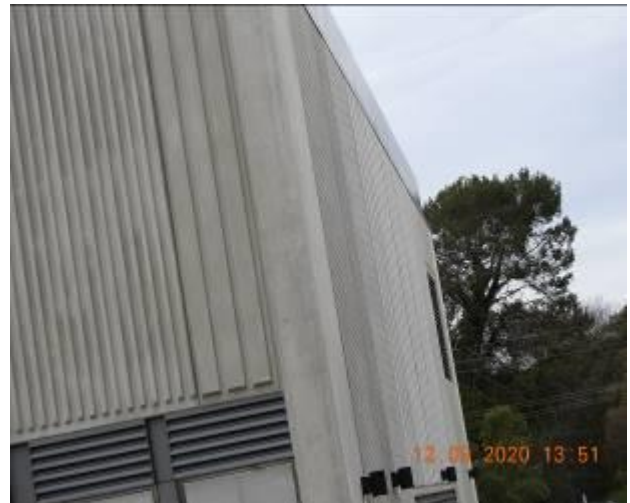
Figure 2443 – General condition of external wall

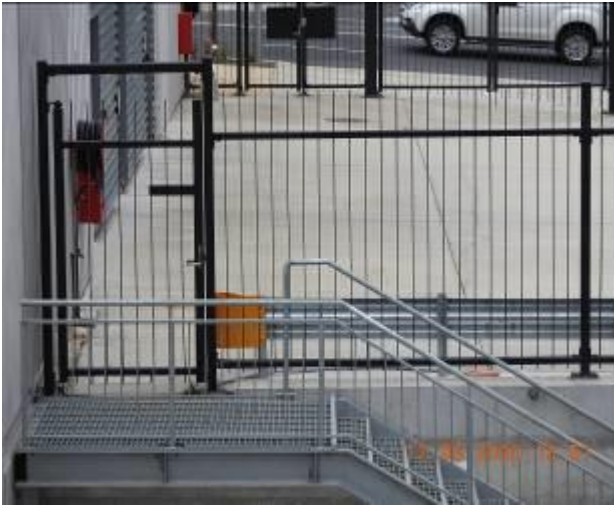
Figure 2444 – General condition of driveway pavement

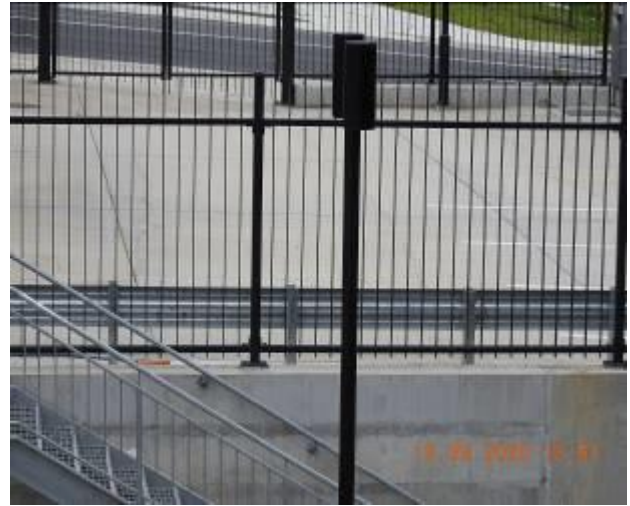
Figure 2445 – General condition of driveway pavement

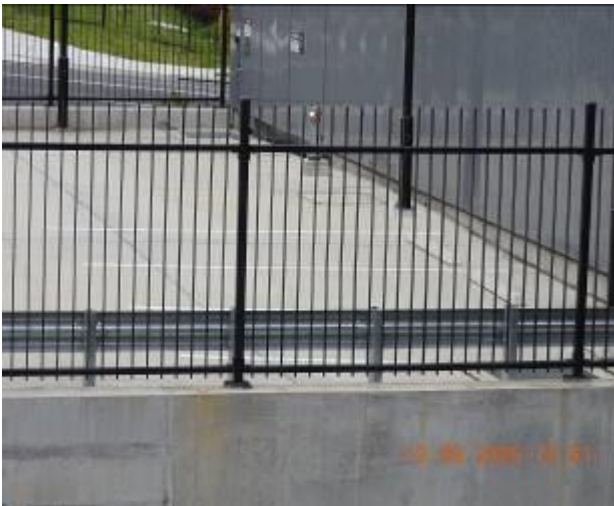
Figure 2446 – General condition of driveway pavement

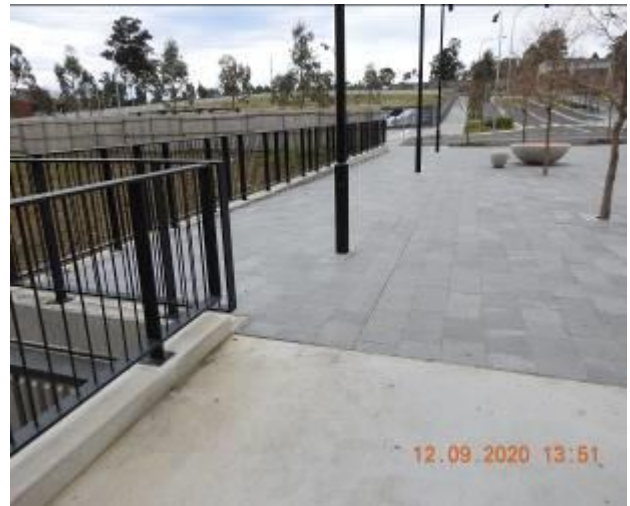
Figure 2447 – General condition of Hills Plaza Outdoor

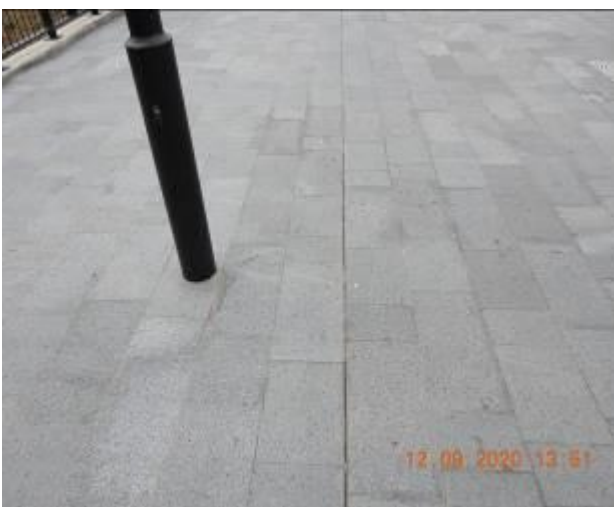
Figure 2448 – General condition of walkway floor

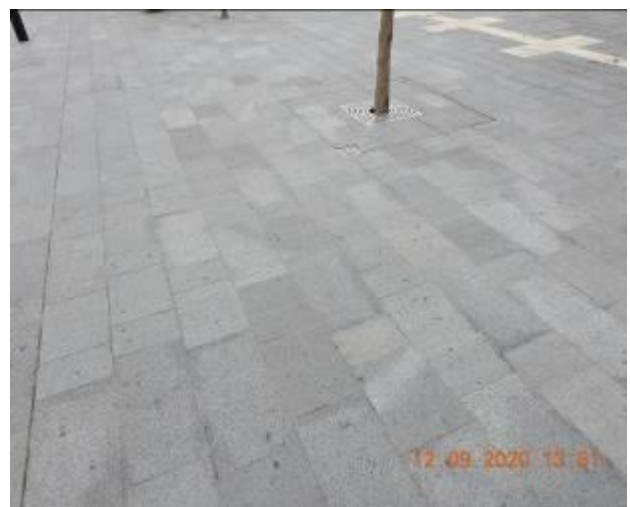
Figure 2449 – Hairline crack propagation through walkway floor

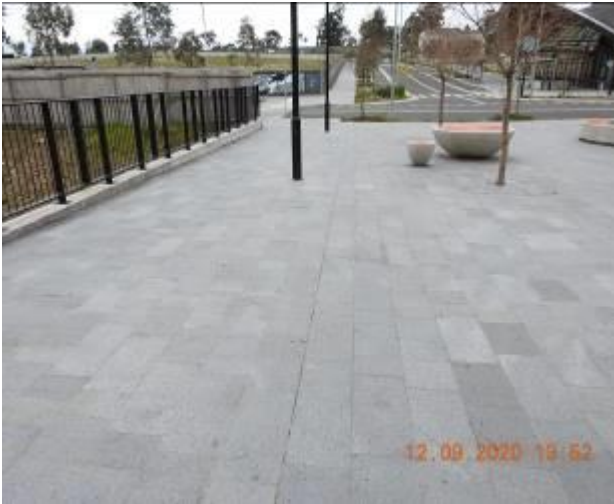
Figure 2450 – Hairline crack propagation through walkway floor

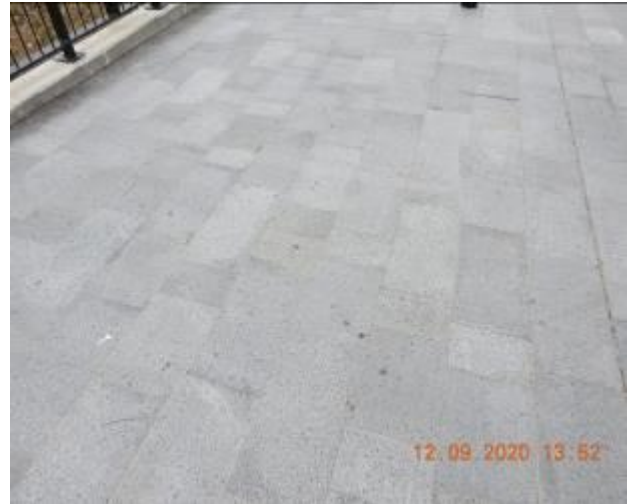
Figure 2451 – Hairline crack propagation through walkway floor

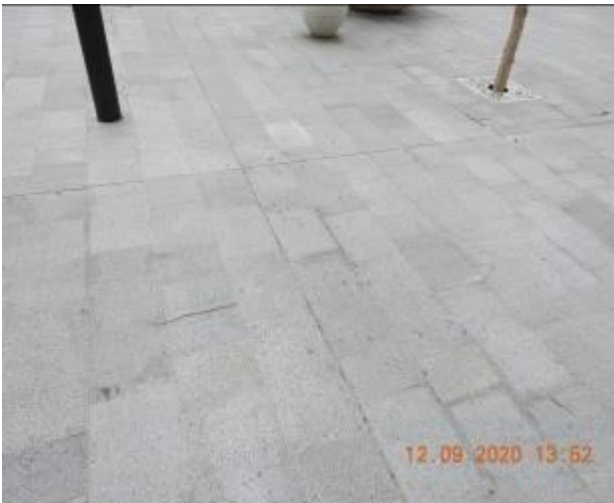
Figure 2452 – Hairline crack propagation through walkway floor

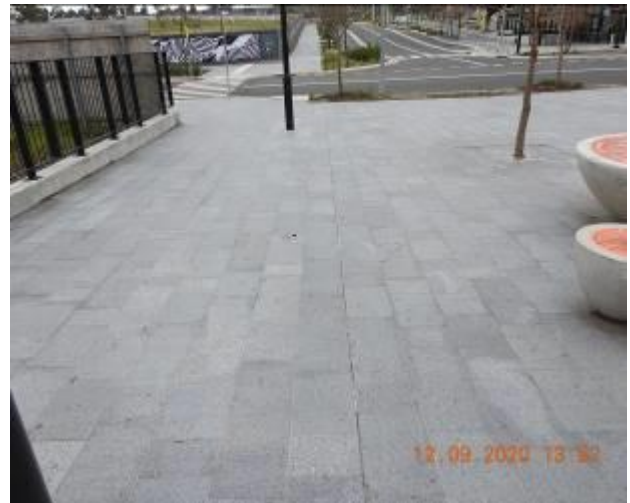
Figure 2453 – Hairline crack propagation through walkway floor

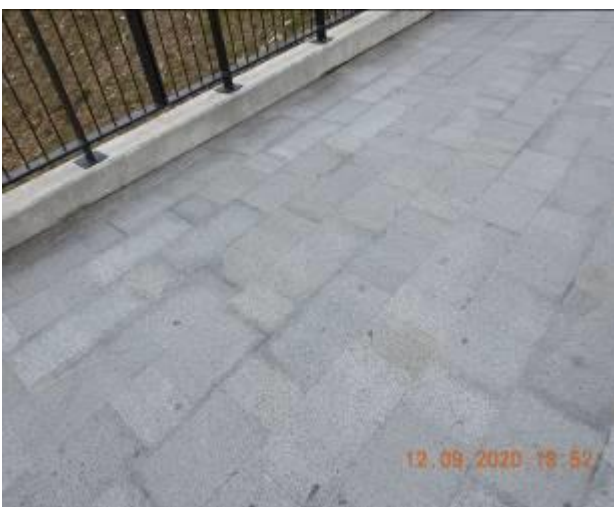
Figure 2454 – Hairline crack propagation through walkway floor

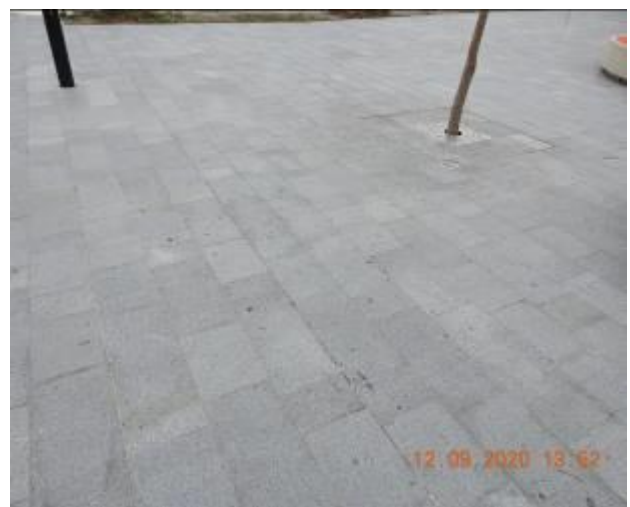
Figure 2455 – Hairline crack propagation through walkway floor

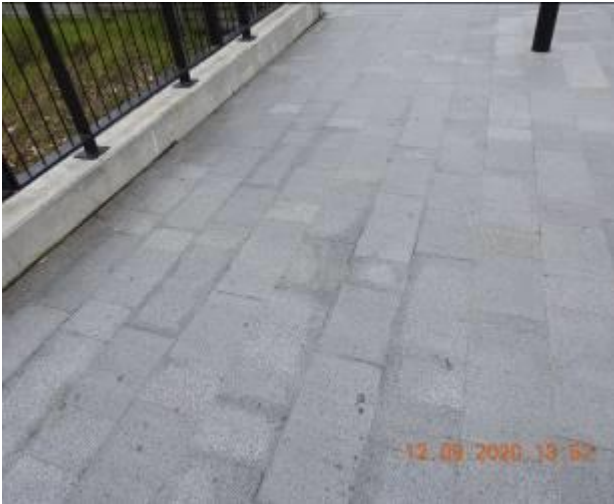
Figure 2456 – Hairline crack propagation through walkway floor

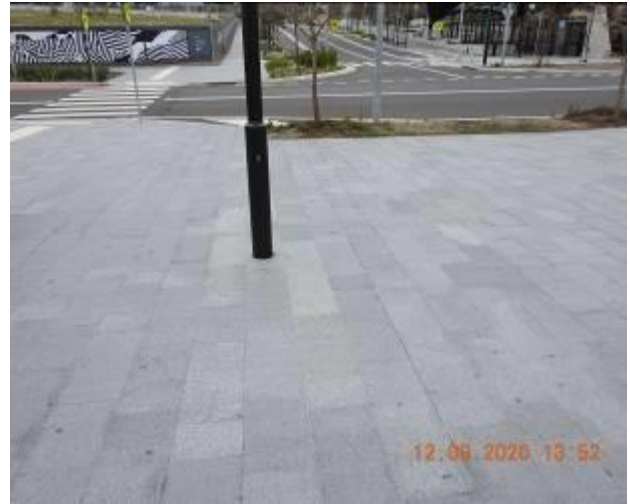
Figure 2457 – General condition of walkway floor

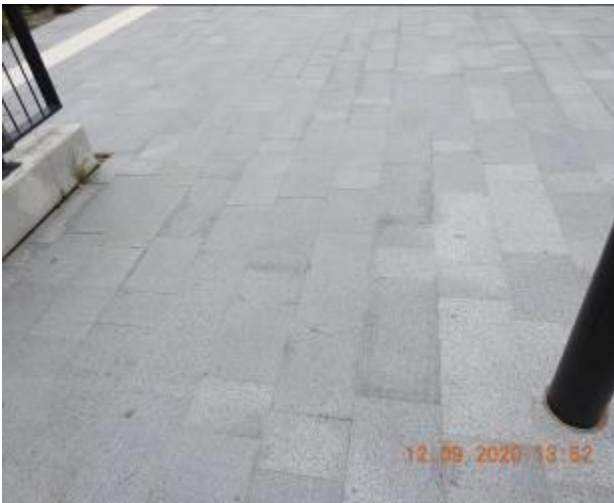
Figure 2458 – Hairline crack propagation through walkway floor

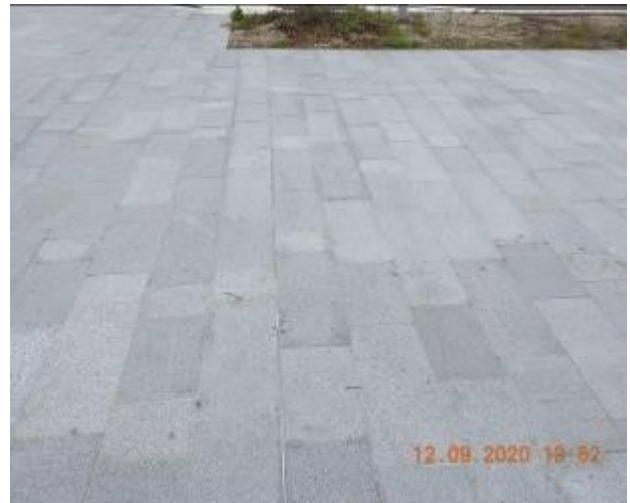
Figure 2459 – Hairline crack propagation through walkway floor

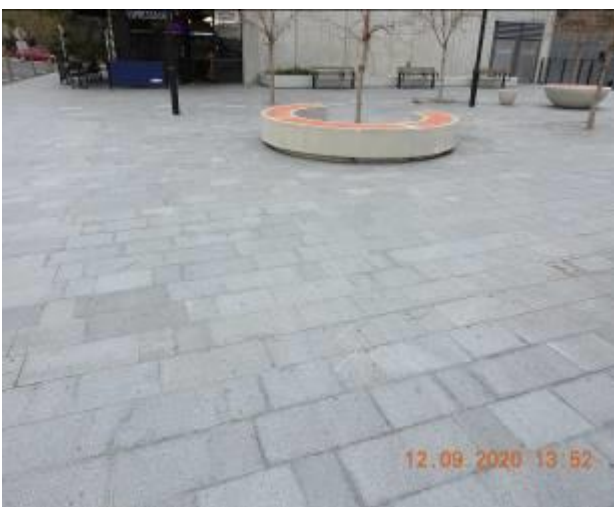
Figure 2460 – General condition of walkway floor

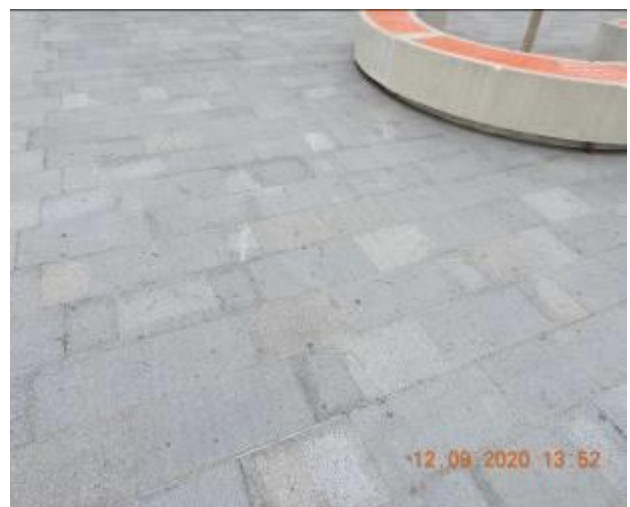
Figure 2461 – Hairline crack propagation through walkway floor

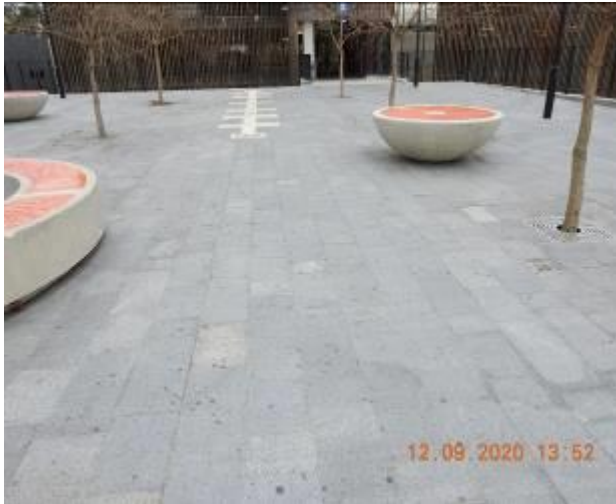
Figure 2462 – General condition of walkway floor
