**2 MANDALA PARADE, CASTLE HILL
(DORAN DRIVE PRECINCT)
PRE-DILAPIDATION REPORT
Of Sydney Metro and Hills Shire Council Assets
DEICORP PROJECTS SHOWGROUND
PTY LTD.**

Job No. 200124.3
07/07/2021

ACE Structural Services Pty Ltd

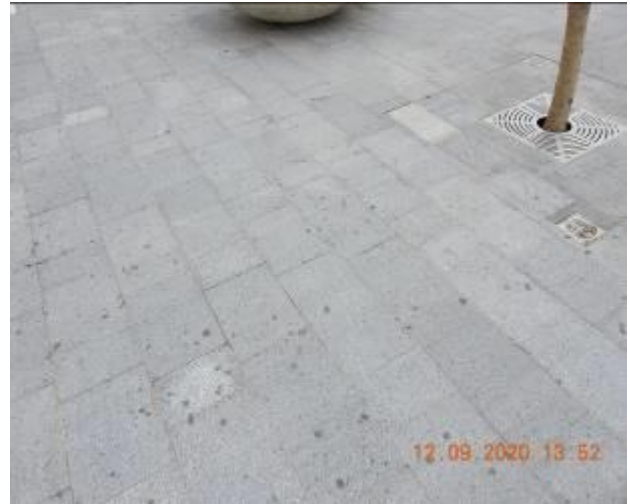
Figure 2463 – Hairline crack propagation through walkway floor

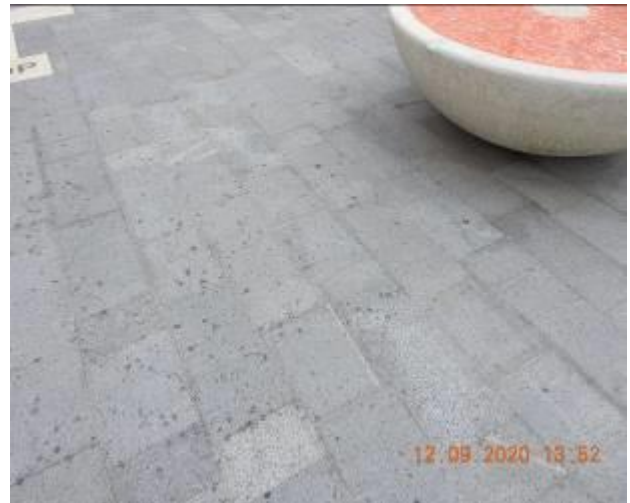
Figure 2464 – Hairline crack propagation through walkway floor

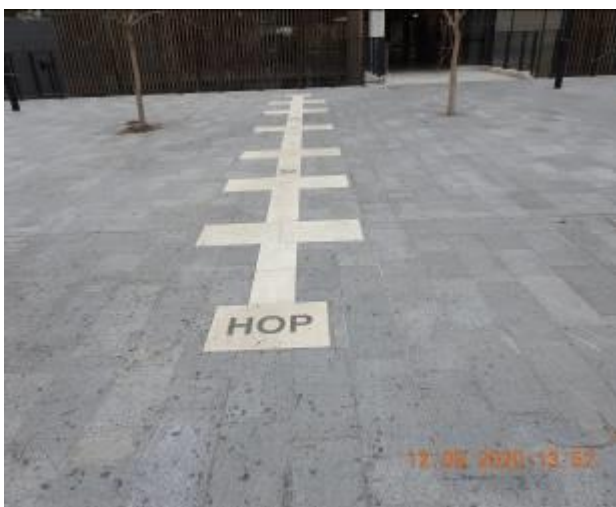
Figure 2465 – Hairline crack propagation through walkway floor

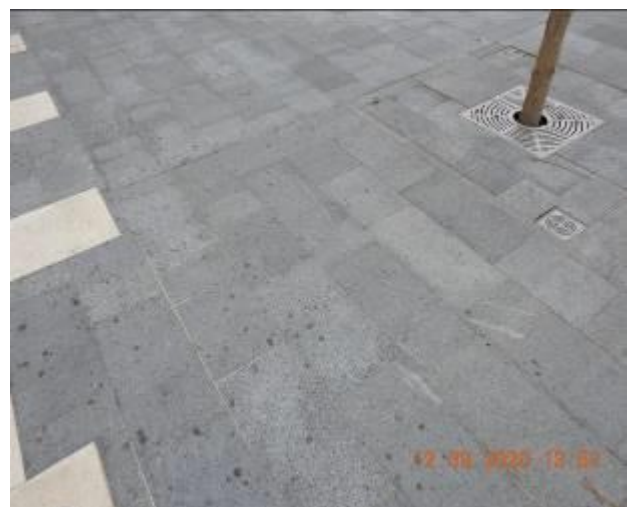
Figure 2466 – General condition of walkway floor

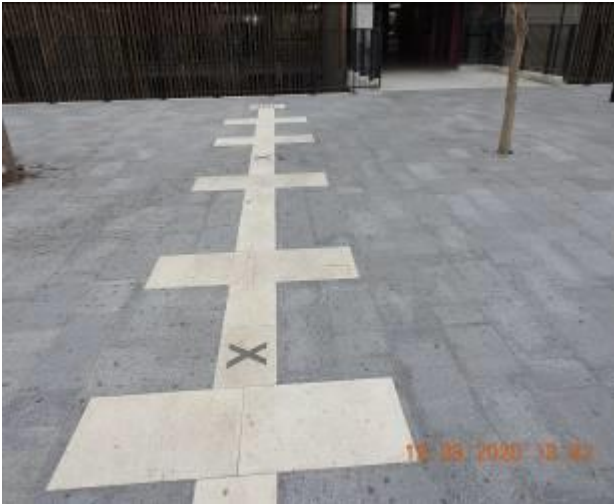
Figure 2467 – Hairline crack propagation through walkway floor

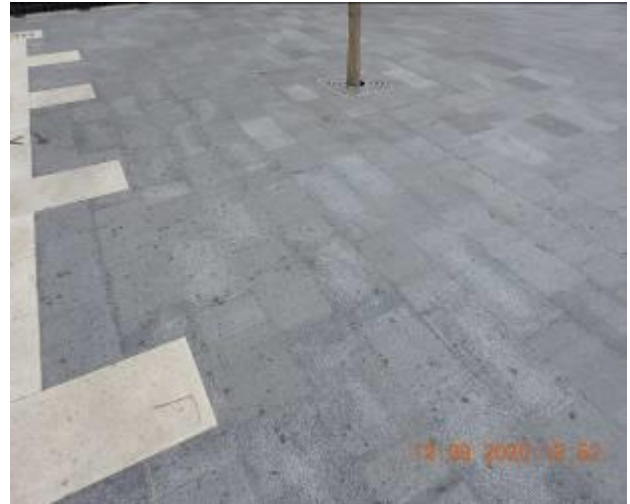
Figure 2468 – Hairline crack propagation through walkway floor

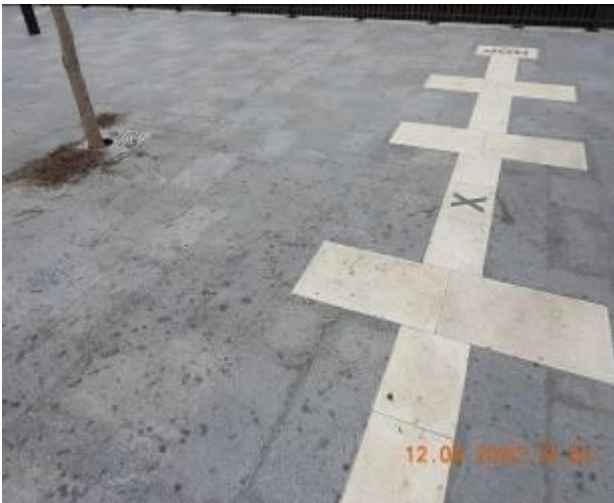
Figure 2469 – Hairline crack propagation through walkway floor

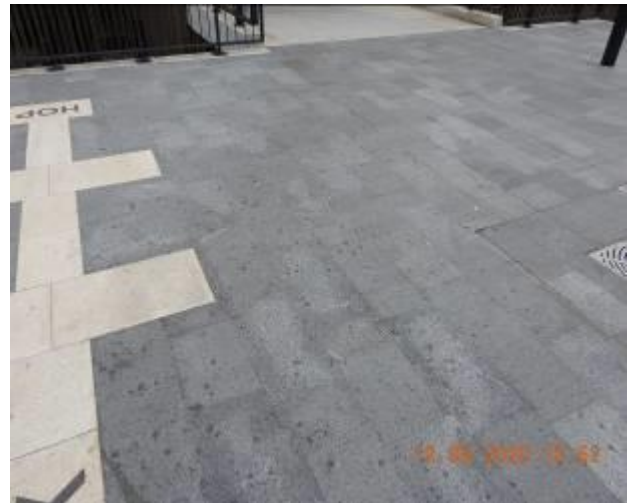
Figure 2470 – Hairline crack propagation through walkway floor

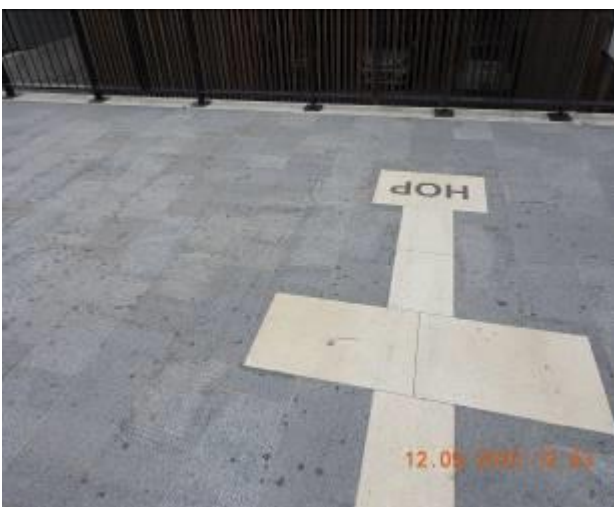
Figure 2471 – Hairline crack propagation through walkway floor

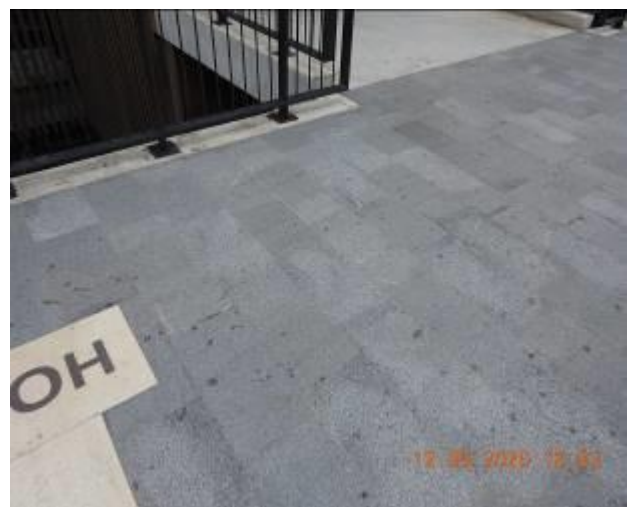
Figure 2472 – Hairline crack propagation through walkway floor

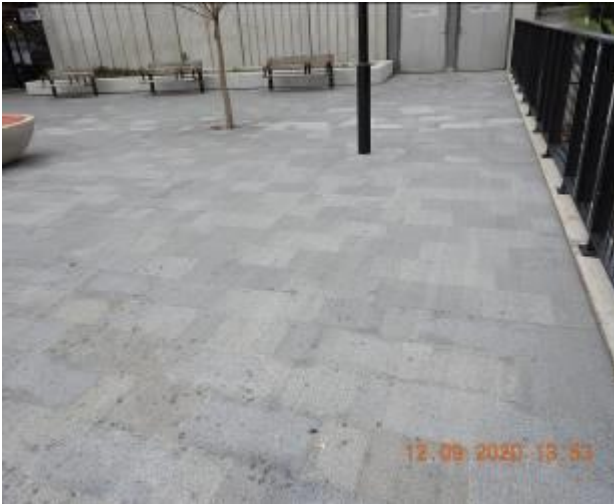
Figure 2473 – Hairline crack propagation through walkway floor

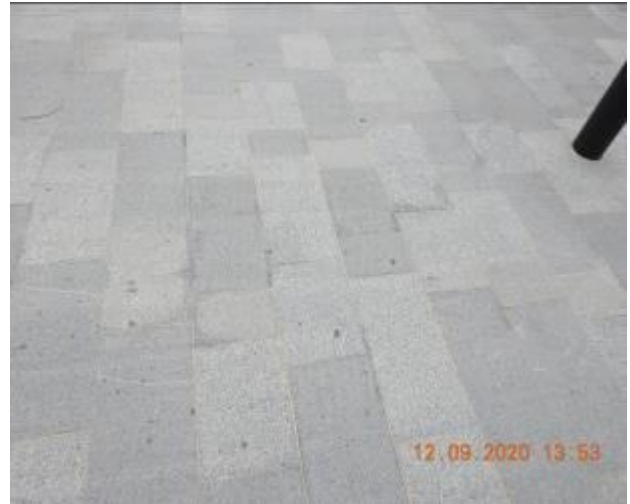
Figure 2474 – General condition of walkway floor

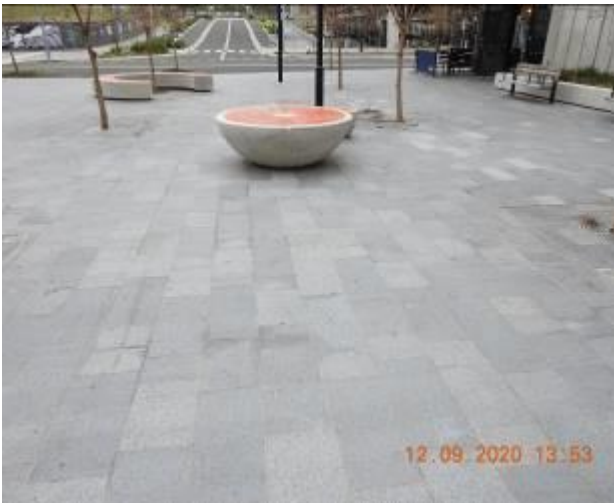
Figure 2475 – Hairline crack propagation through walkway floor

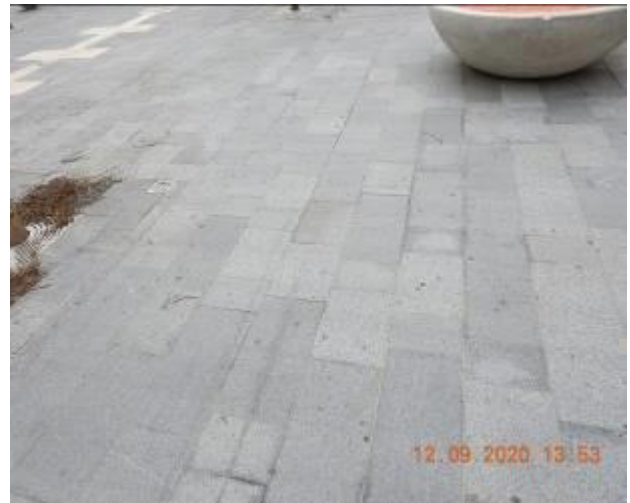
Figure 2476 – Hairline crack propagation through walkway floor

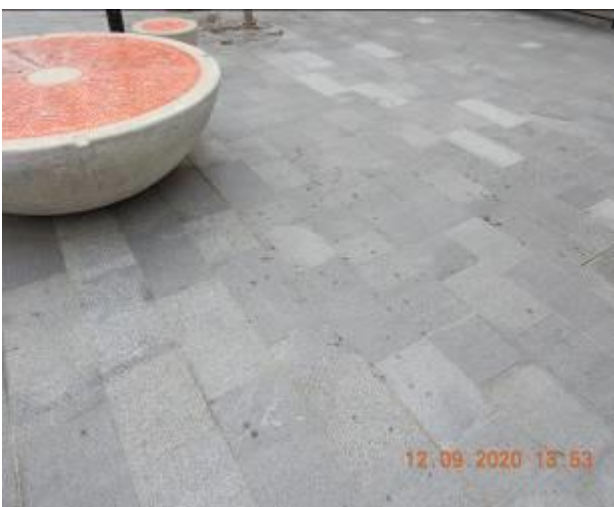
Figure 2477 – Hairline crack propagation through walkway floor

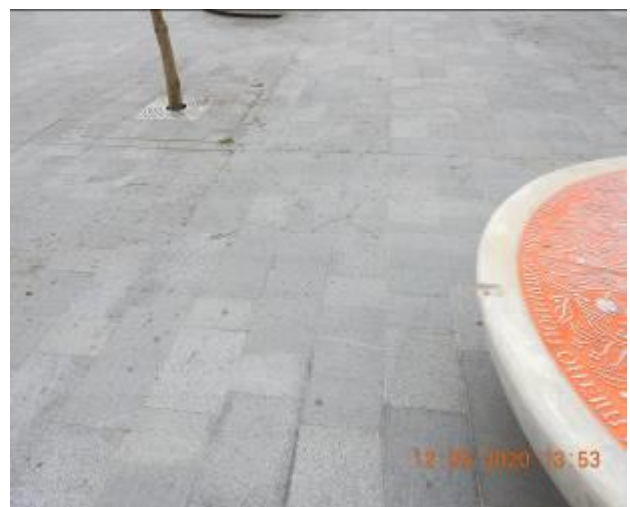
Figure 2478 – Hairline crack propagation through walkway floor

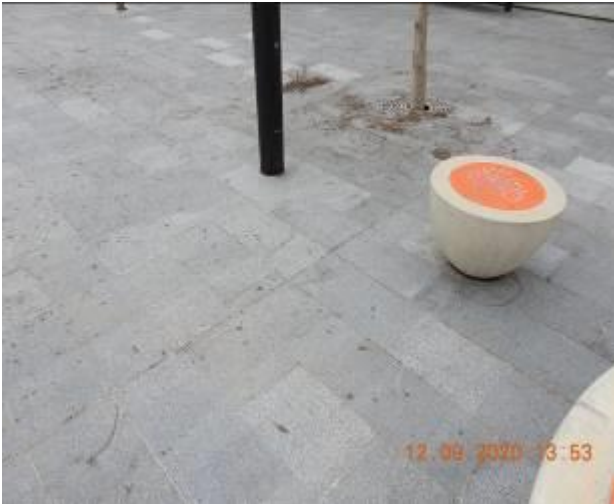
Figure 2479 – Hairline crack propagation through walkway floor

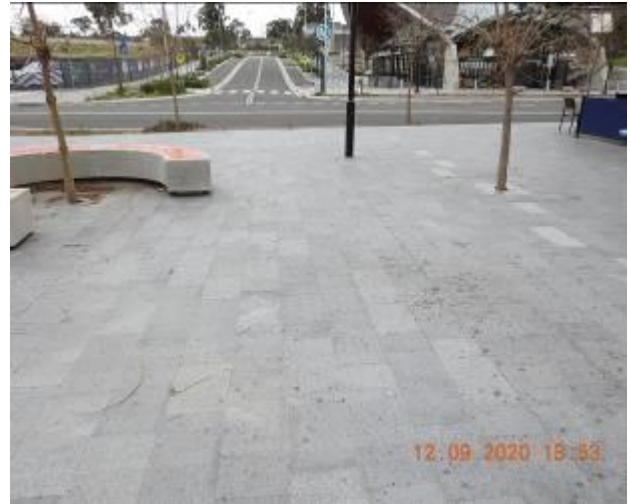
Figure 2480 – Hairline crack propagation through walkway floor

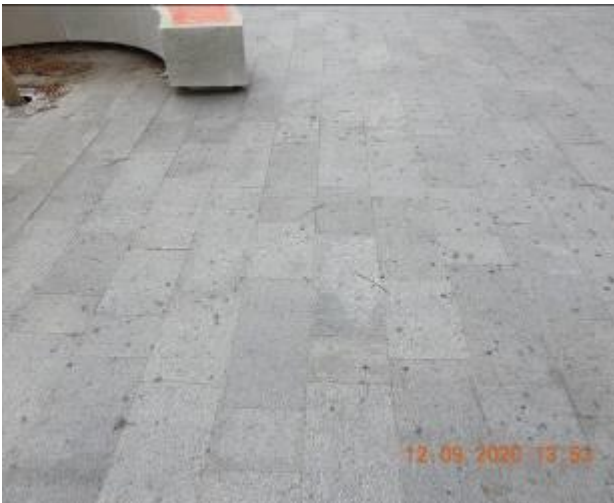
Figure 2481 – Hairline crack propagation through walkway floor

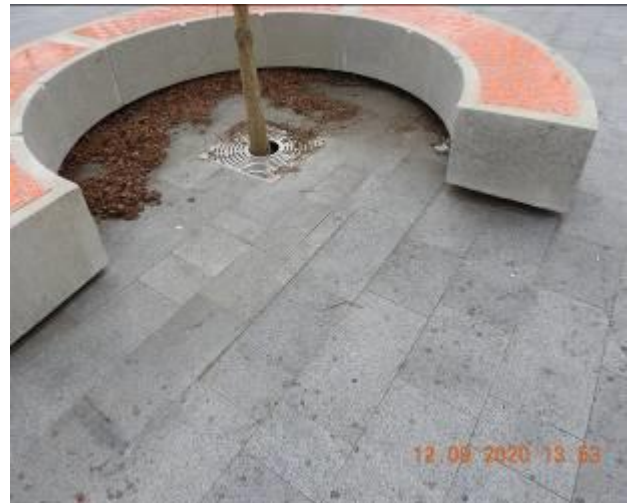
Figure 2482 – Hairline crack propagation through walkway floor

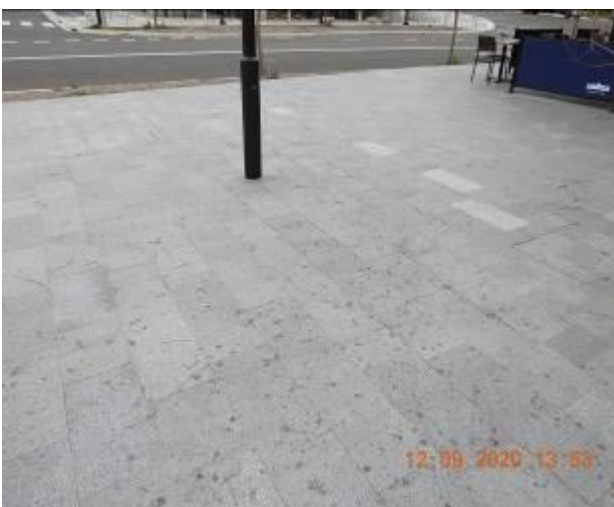
Figure 2483 – Hairline crack propagation through walkway floor

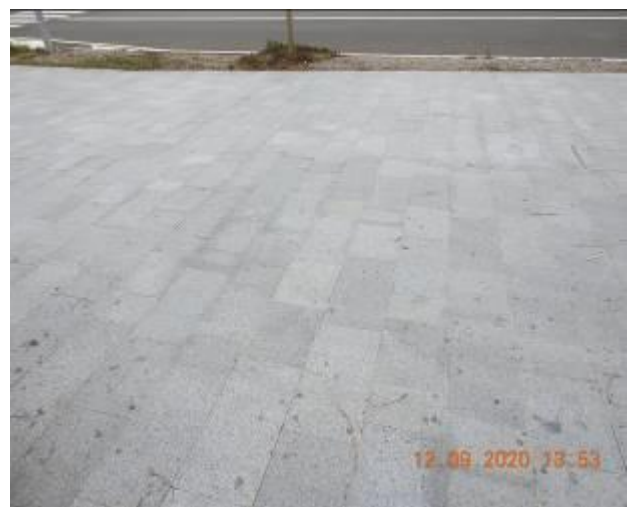
Figure 2484 – Hairline crack propagation through walkway floor

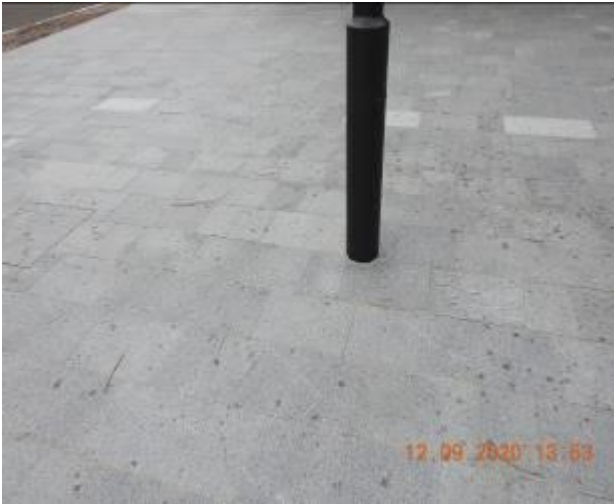
Figure 2485 – Hairline crack propagation through walkway floor

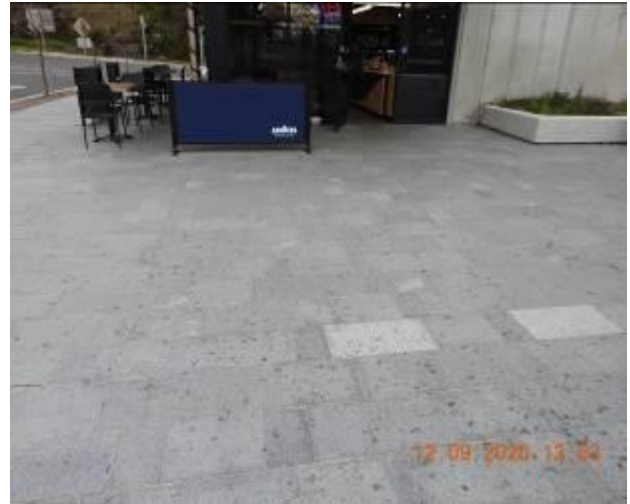
Figure 2486 – Hairline crack propagation through walkway floor

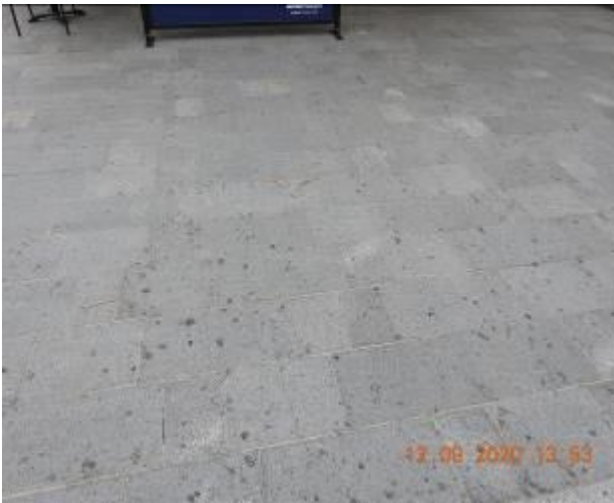
Figure 2487 – Hairline crack propagation through walkway floor

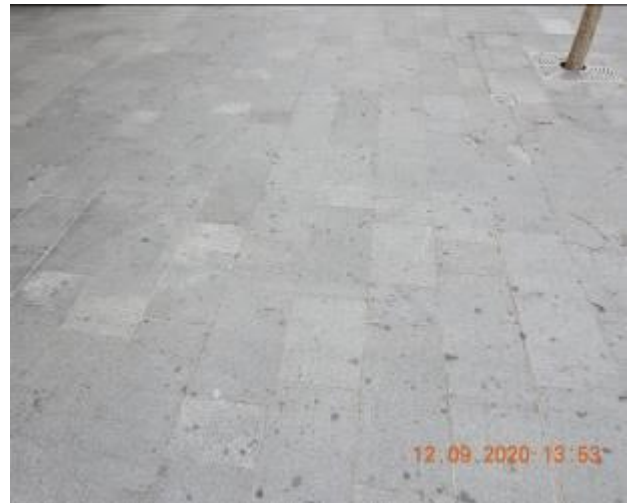
Figure 2488 – Hairline crack propagation through walkway floor

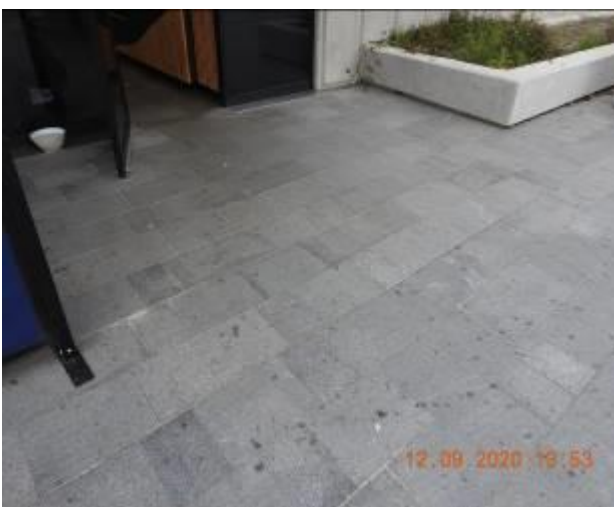
Figure 2489 – Hairline crack propagation through walkway floor

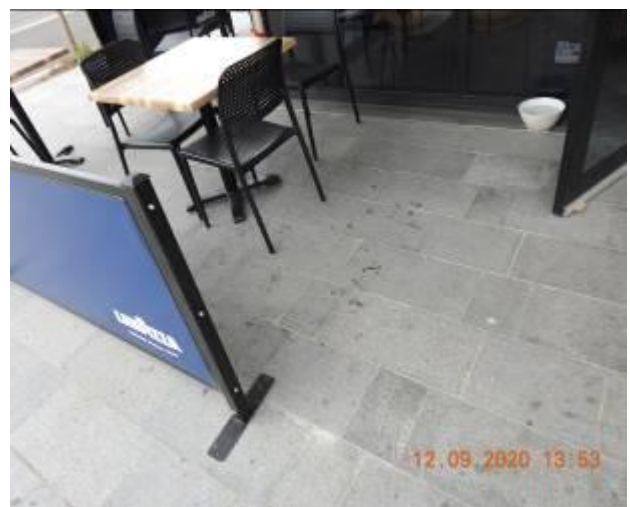
Figure 2490 – Hairline crack propagation through walkway floor

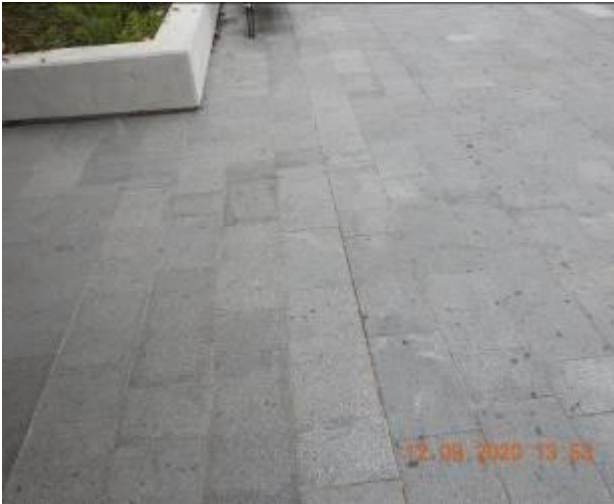
Figure 2491 – Hairline crack propagation through walkway floor

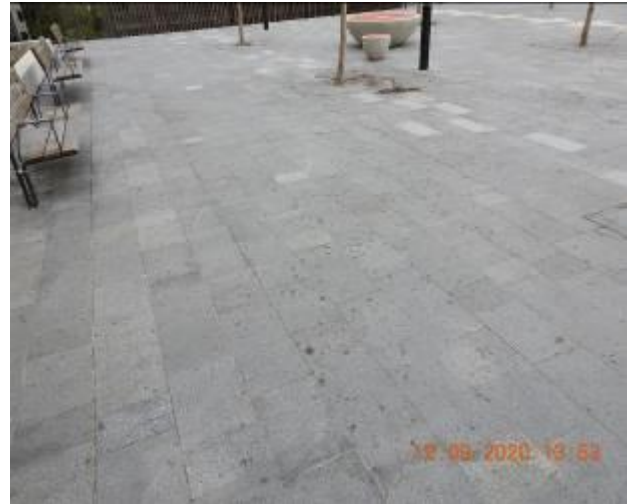
Figure 2492 – Hairline crack propagation through walkway floor

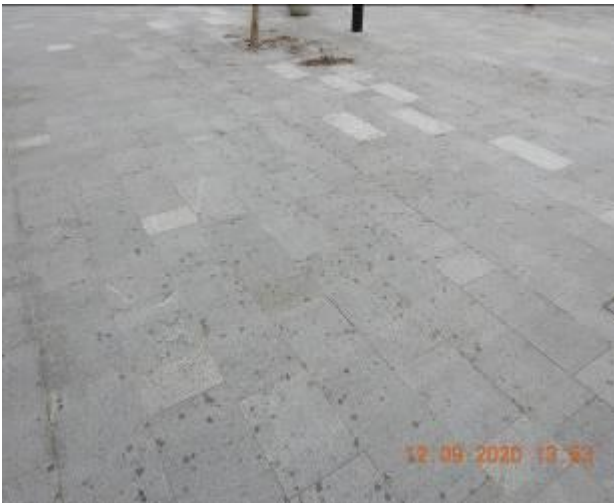
Figure 2493 – Hairline crack propagation through walkway floor

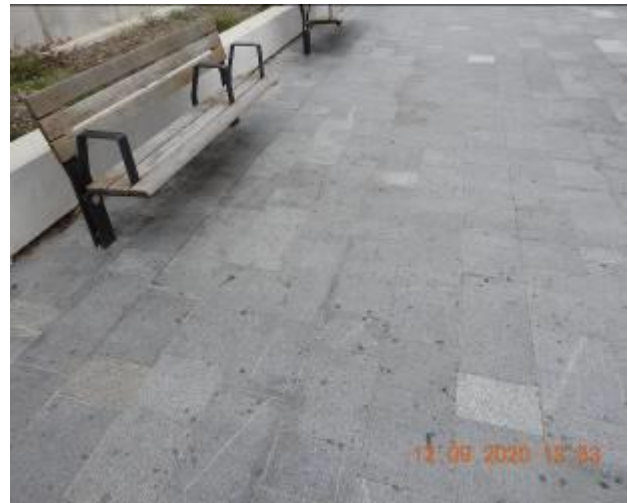
Figure 2494 – Hairline crack propagation through walkway floor

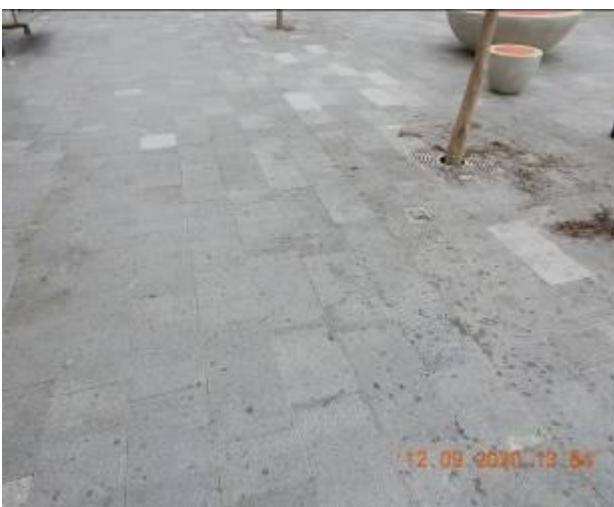
Figure 2495 – Hairline crack propagation through walkway floor

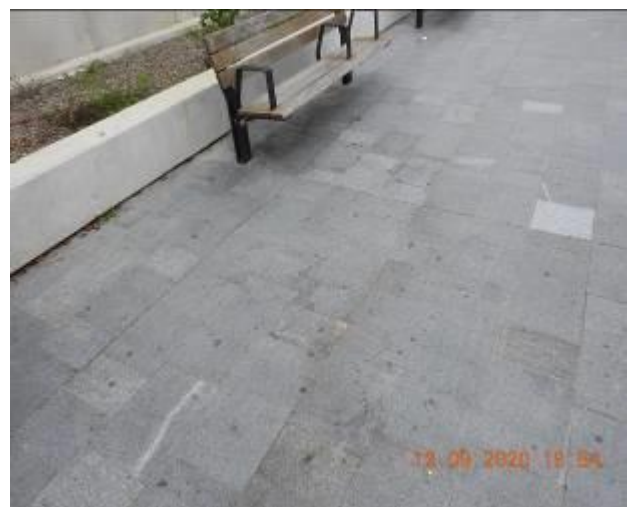
Figure 2496 – Hairline crack propagation through walkway floor

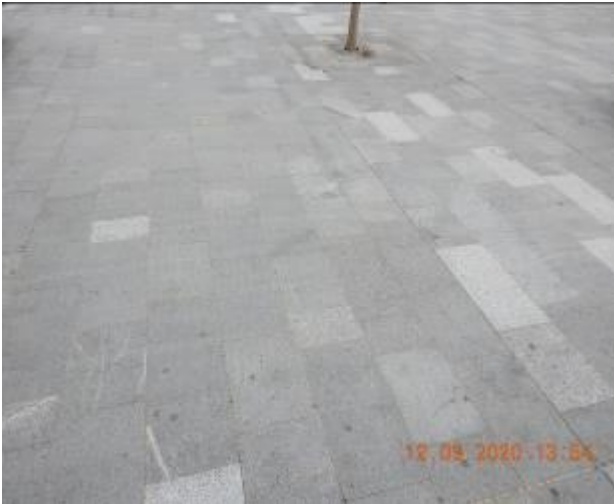
Figure 2497 – Hairline crack propagation through walkway floor

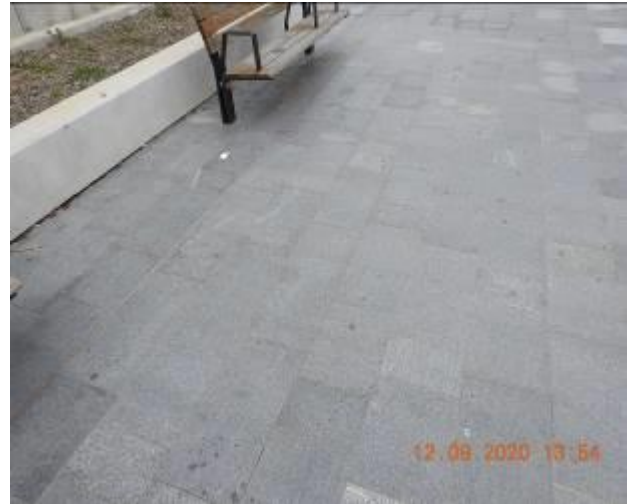
Figure 2498 – Hairline crack propagation through walkway floor

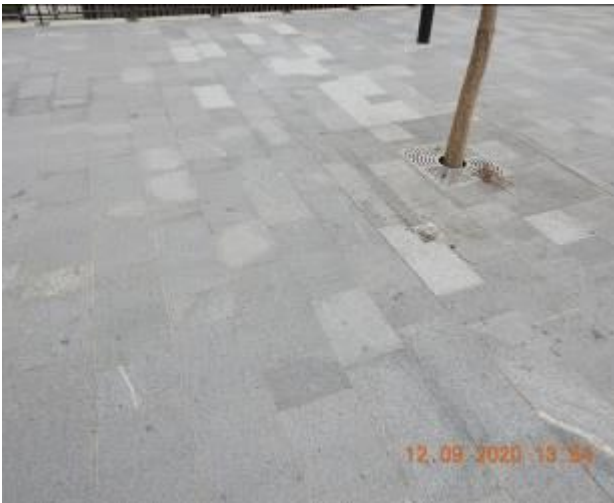
Figure 2499 – Hairline crack propagation through walkway floor

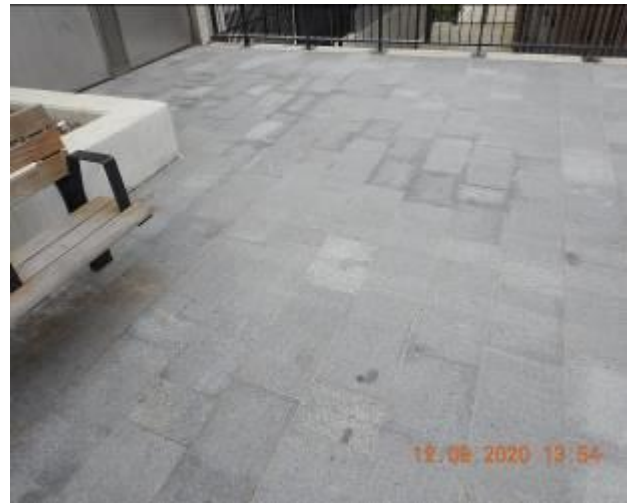
Figure 2500 – Hairline crack propagation through walkway floor

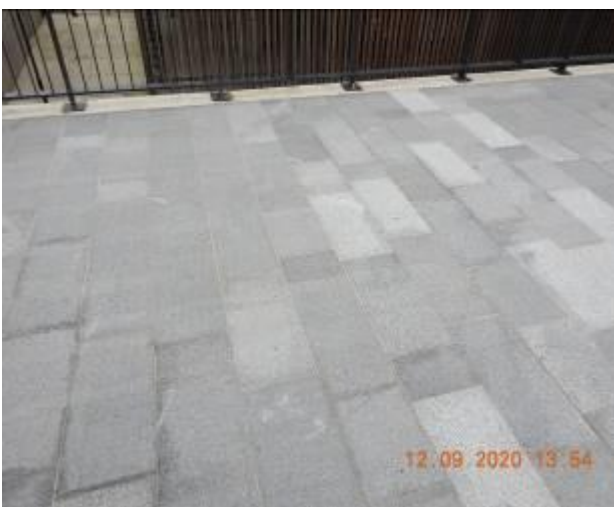
Figure 2501 – Hairline crack propagation through walkway floor

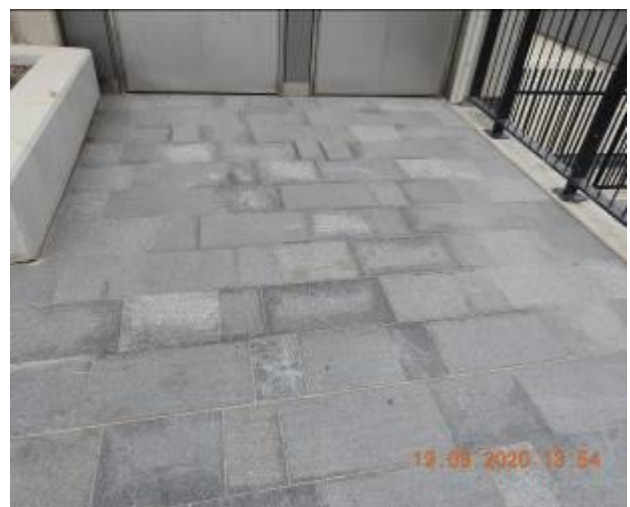
Figure 2502 – Hairline crack propagation through walkway floor

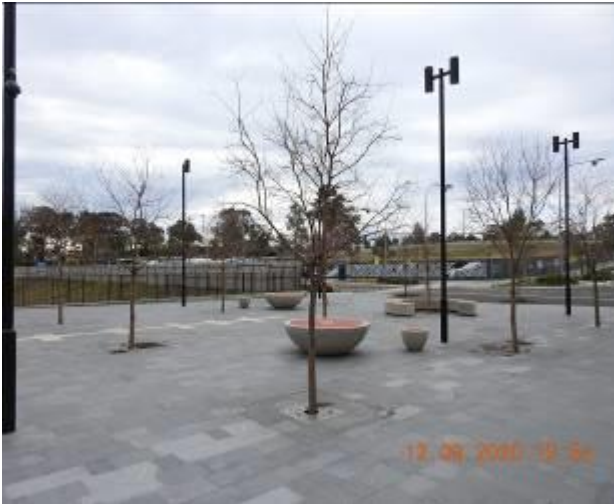
Figure 2504 – General condition of plantations and lamp posts

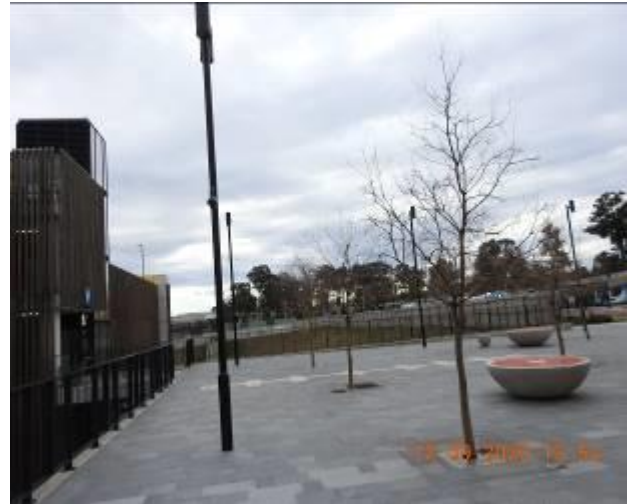
Figure 2505 – General condition of plantations and lamp posts

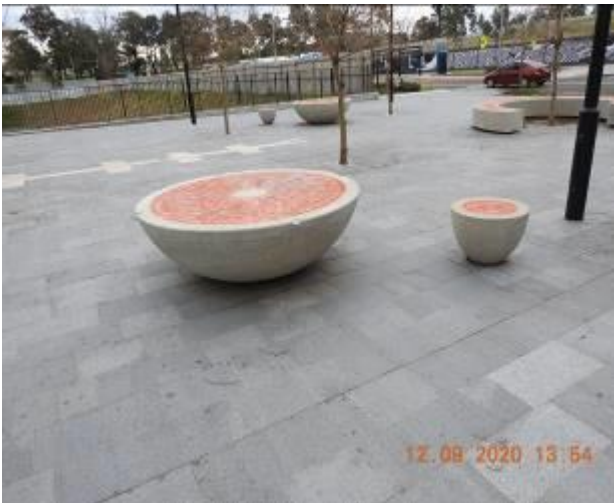
Figure 2506 – General condition of public bench

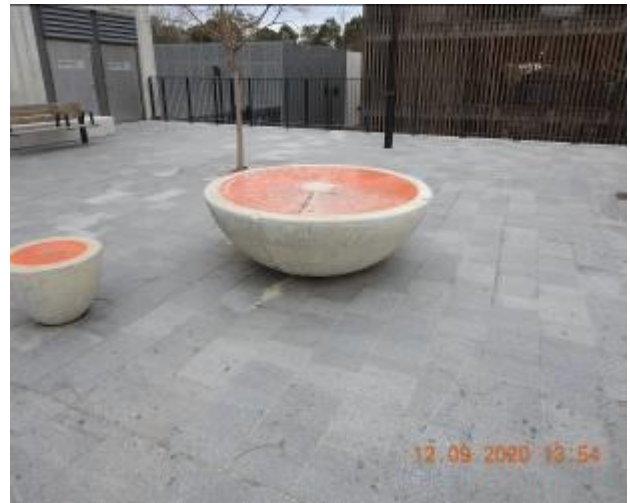
Figure 2507 – General condition of public bench

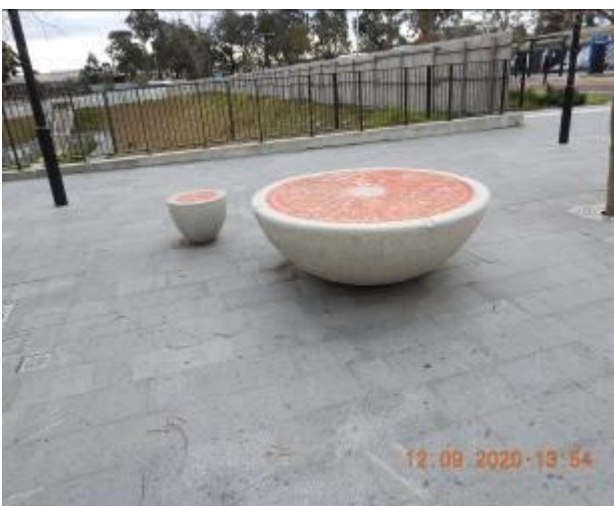
Figure 2508 – General condition of public bench

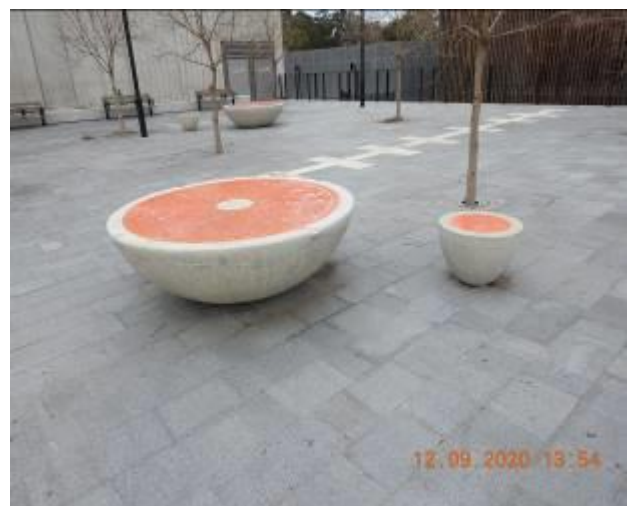
Figure 2509 – General condition of public bench

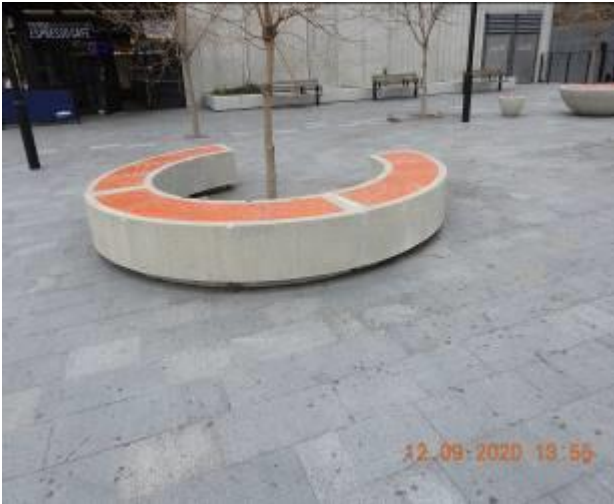
Figure 2510 – General condition of public bench

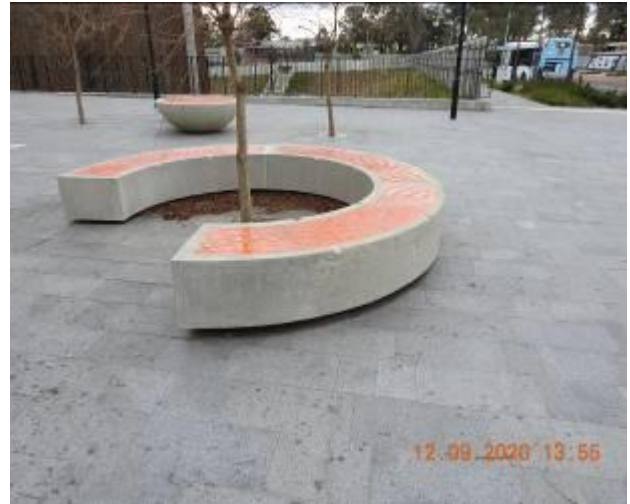
Figure 2511 – General condition of public bench

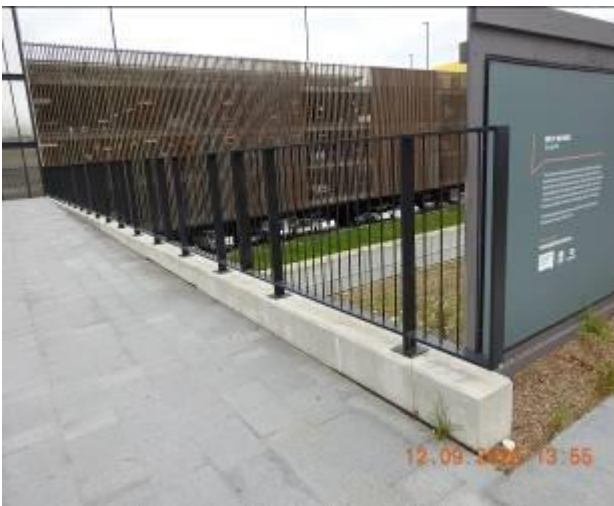
Figure 2512 – General condition of boundary fence/wall

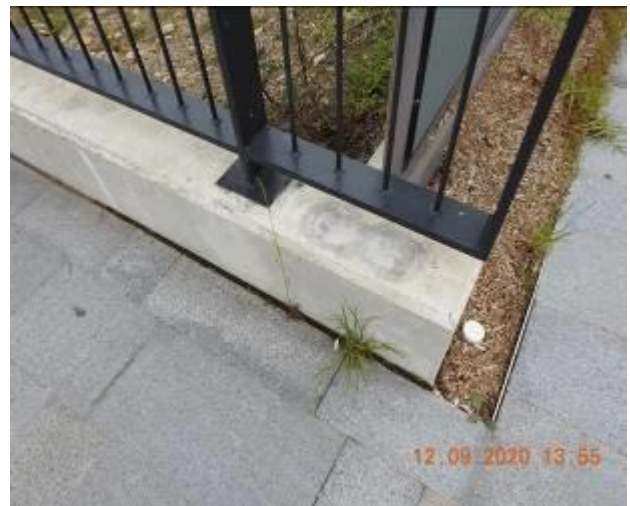
Figure 2513 – Evidence of patchwork through boundary wall

The exterior of the building within the zone of influence was in a reasonable condition with evidence of cracking and material loss through the external walls and surrounding pavement, as well as patchwork through the external walls. There were also cases of hairline cracking and material loss through the retaining walls and boundary walls. Evidence of cracking and material loss was also observed through the driveway pavement.

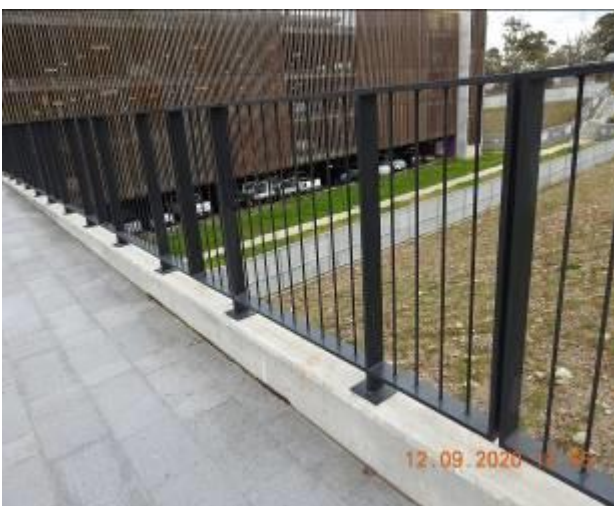
Figure 2514 – General condition of boundary fence/wall

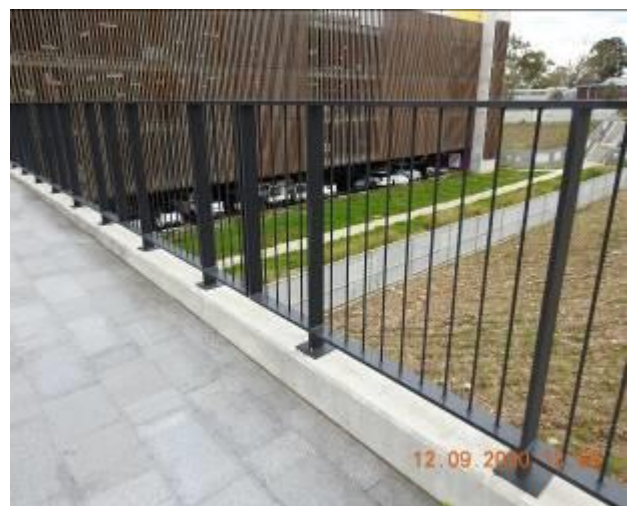
Figure 2515 – General condition of boundary fence/wall

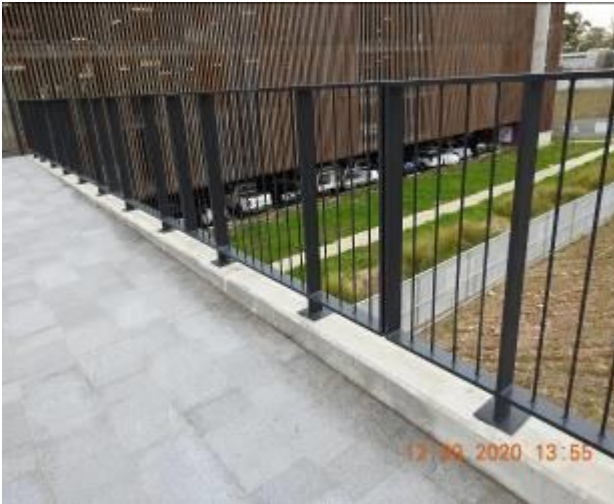
Figure 2516 – General condition of boundary fence/wall

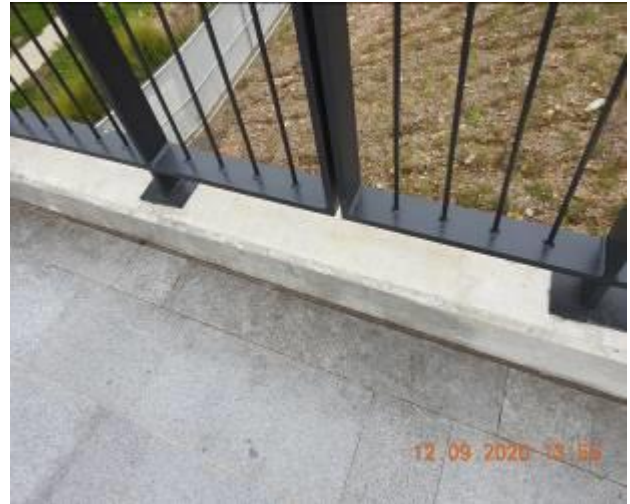
Figure 2517 – Crack propagation through boundary wall

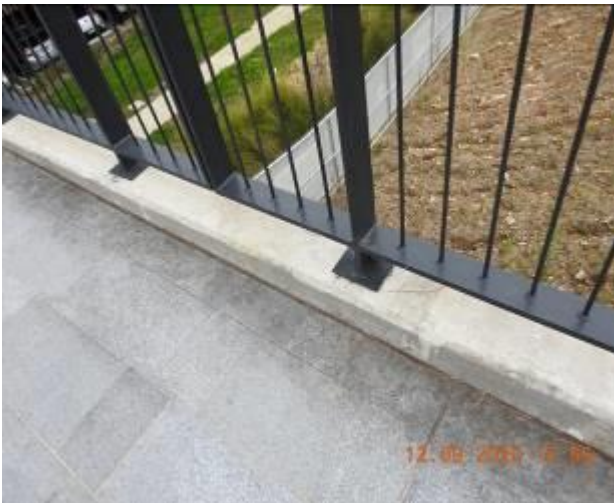
Figure 2518 – Loss of material through boundary wall

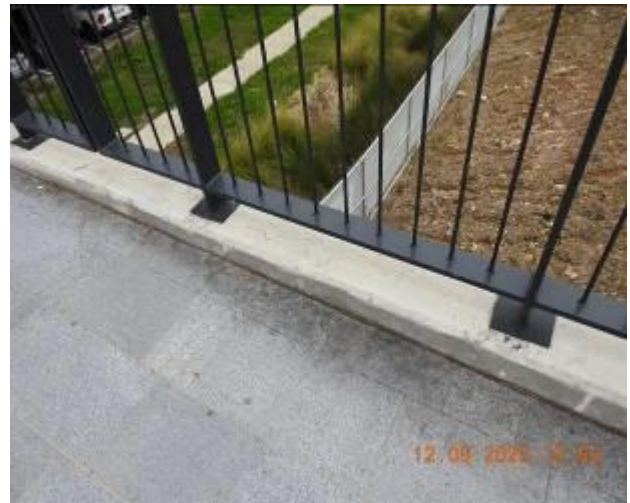
Figure 2519 – Crack propagation and loss of material through boundary wall

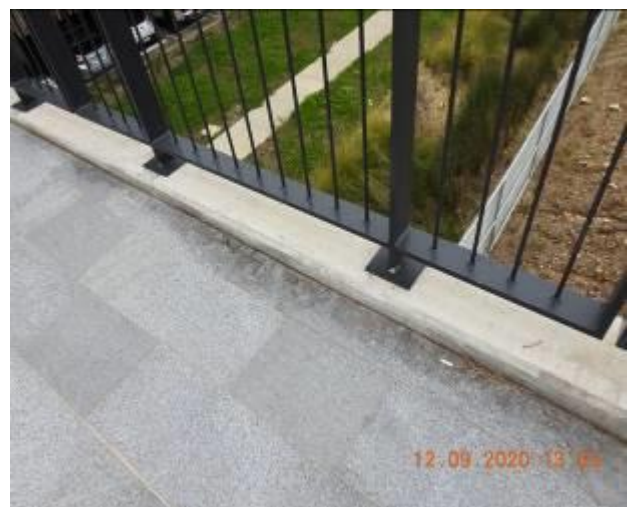
Figure 2521 – Crack propagation through boundary wall

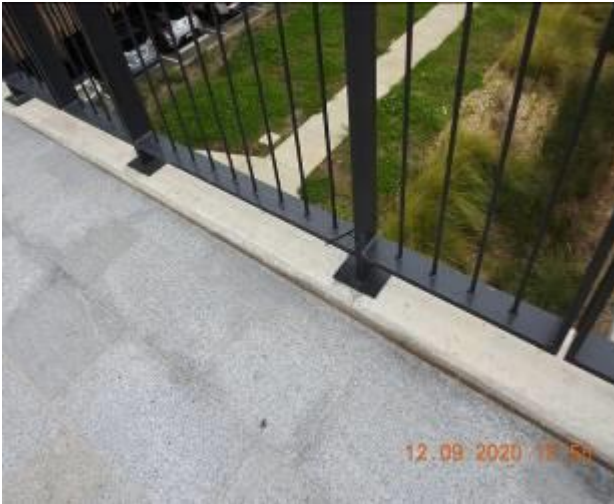
Figure 2522 – Crack propagation through boundary wall

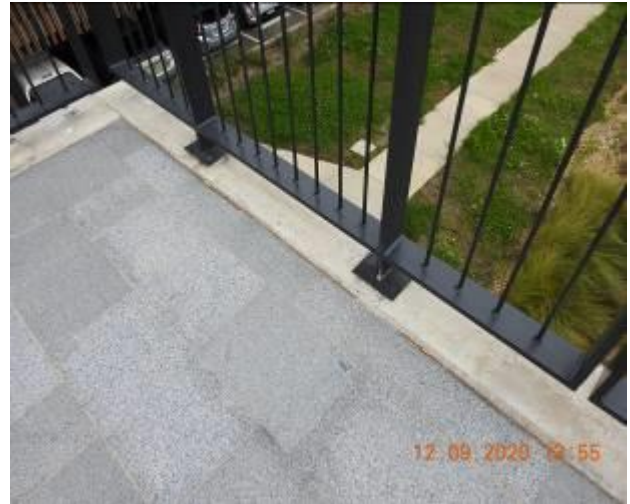
Figure 2523 – Loss of material through boundary wall

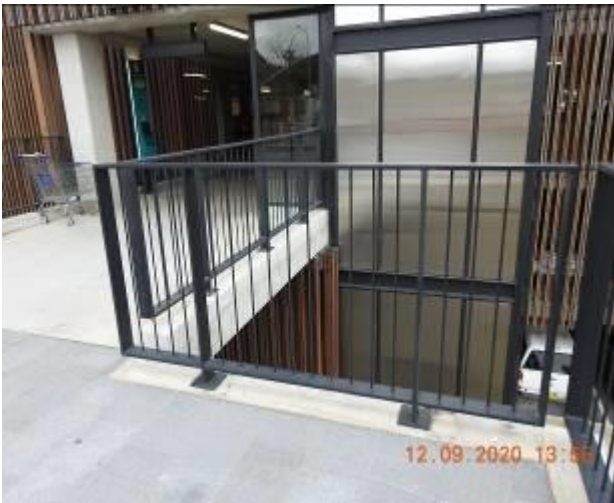
Figure 2524 – General condition of boundary fence

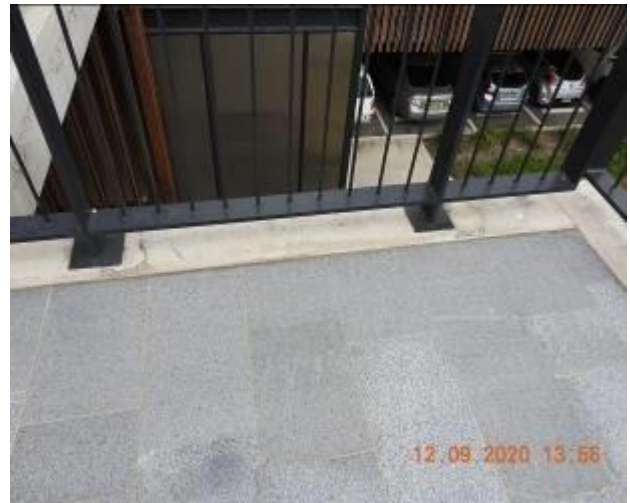
Figure 2525 – Loss of material through boundary wall

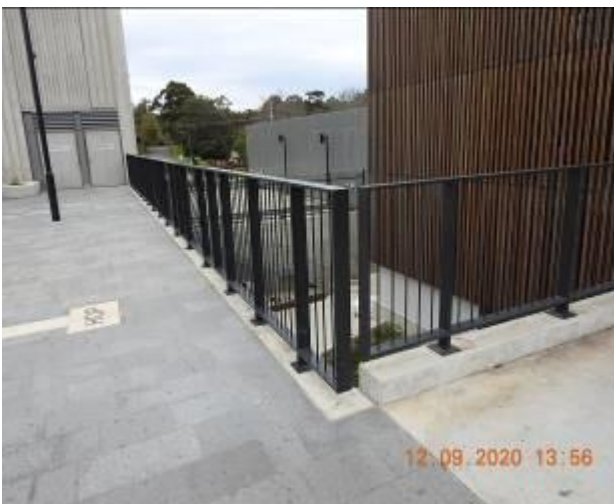
Figure 2526 – General condition of boundary fence

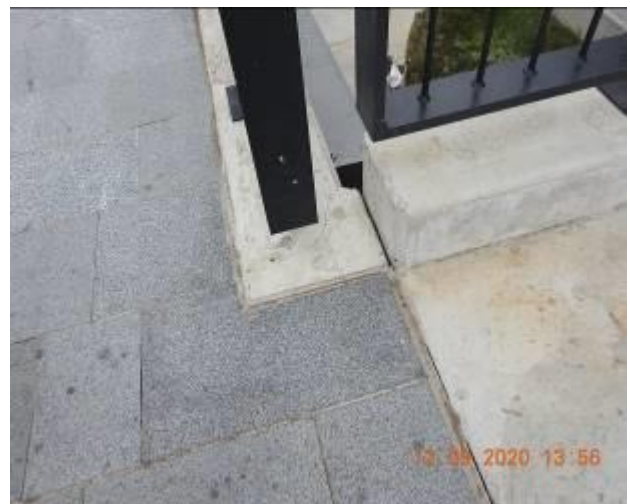
Figure 2527 – Crack propagation through boundary wall

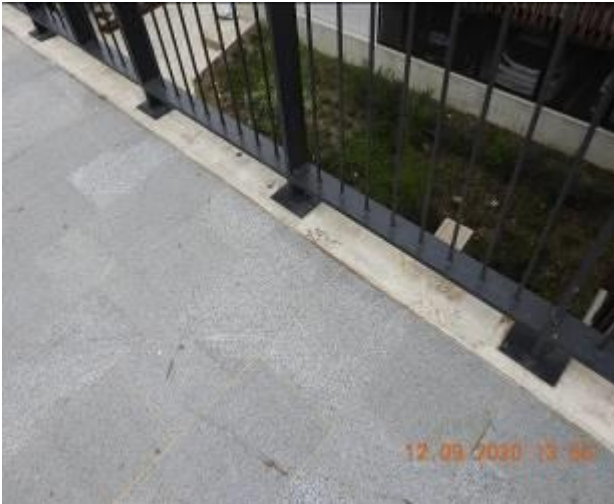
Figure 2528 – Evidence of patchwork through boundary wall

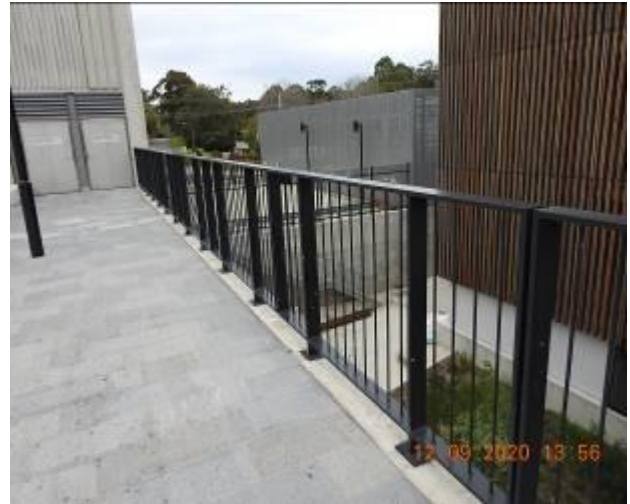
Figure 2529 – General condition of boundary fence/wall

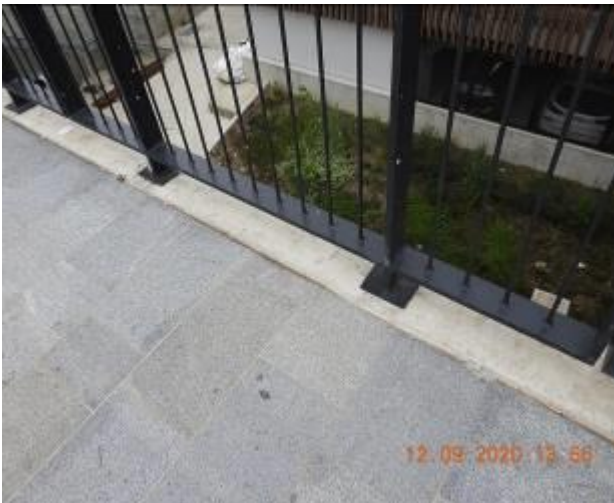
Figure 2530 – Hairline crack propagation through boundary wall

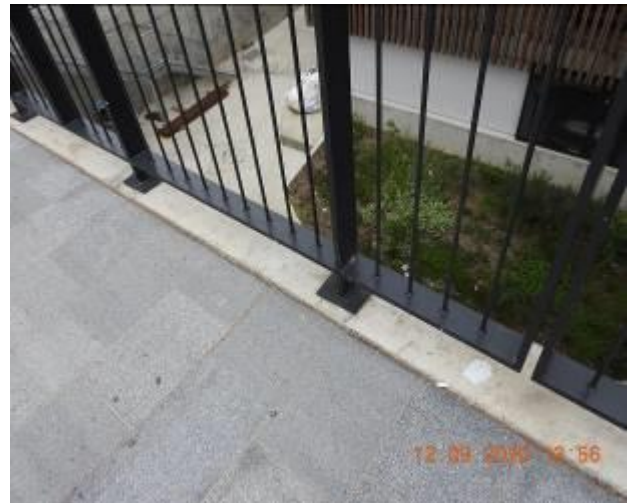
Figure 2531 – Hairline crack propagation through boundary wall

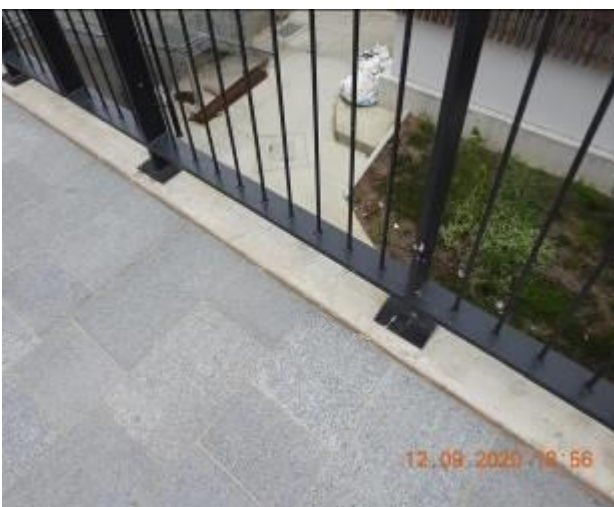
Figure 2532 – Hairline crack propagation through boundary wall

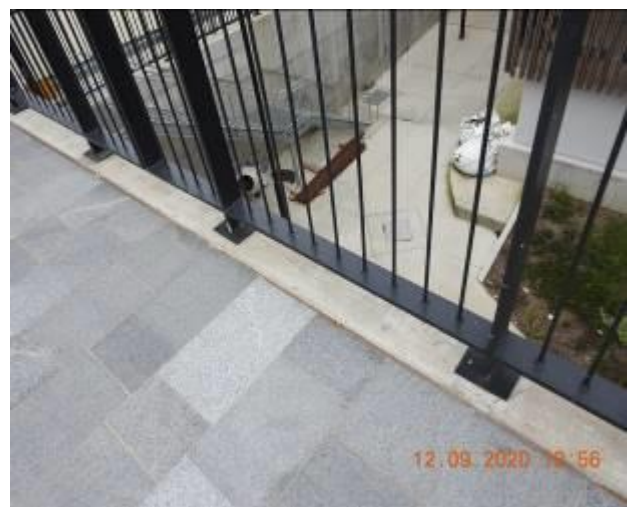
Figure 2533 – Hairline crack propagation through boundary wall

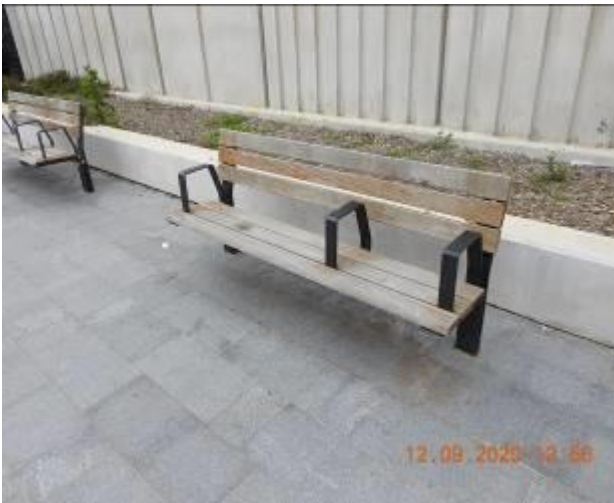
Figure 2536 – General condition of public benches
