**2 MANDALA PARADE, CASTLE HILL
(DORAN DRIVE PRECINCT)
PRE-DILAPIDATION REPORT
Of Sydney Metro and Hills Shire Council Assets
DEICORP PROJECTS SHOWGROUND
PTY LTD.**

Job No. 200124.3
07/07/2021

ACE Structural Services Pty Ltd

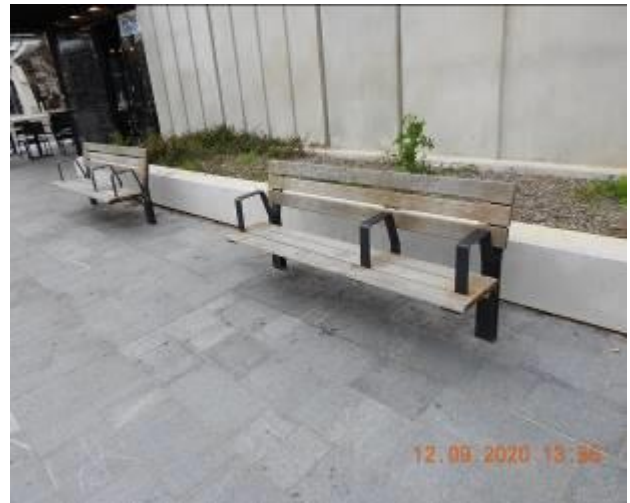
Figure 2537 – General condition of public benches

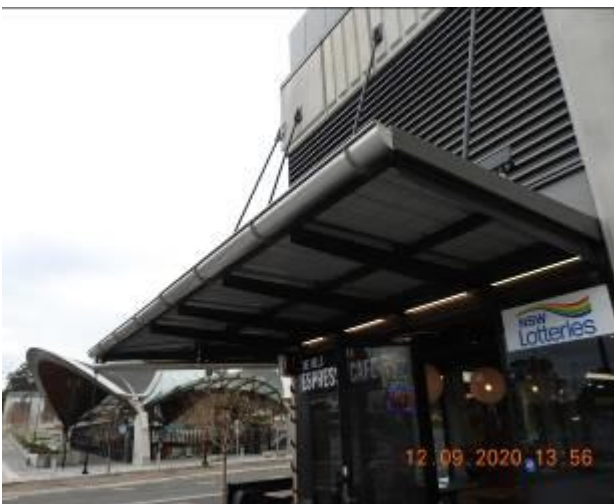
Figure 2538 – General condition of ceiling
