Report on  
Hazardous Building Materials (HBM) Survey

Lot 100 DP1261496, Maitland Street, Muswellbrook,  
NSW

Prepared for  
Pacific Brook Christian School Ltd

Project 91601.01  
July 2021

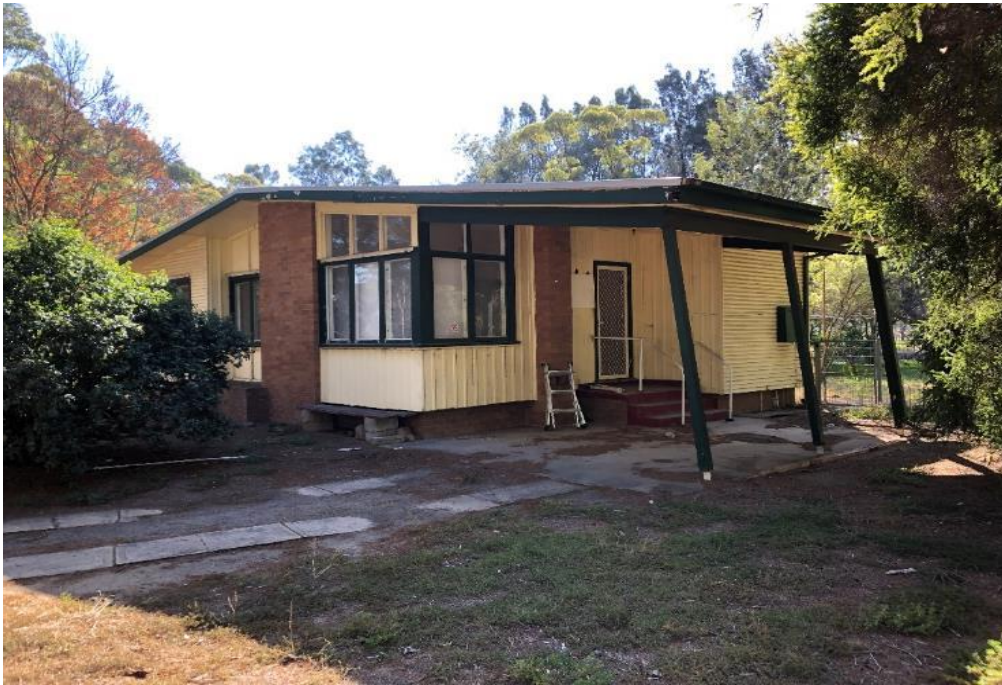
Photograph 1: Building 1 - Timber framed residential dwelling with timber floors and skillion roof

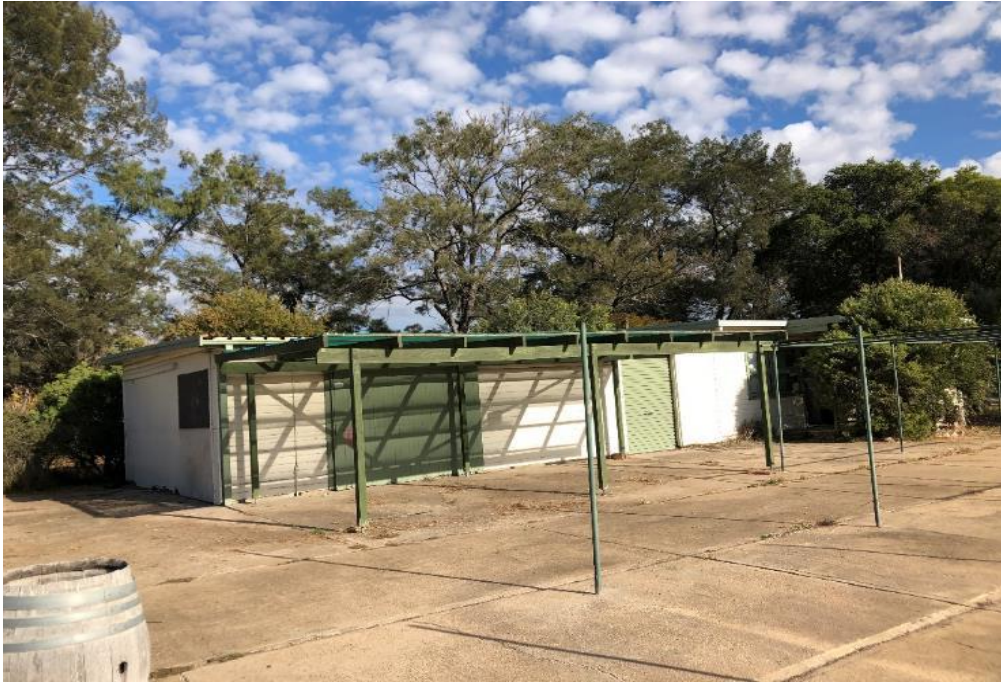
Photograph 35: Front Office.

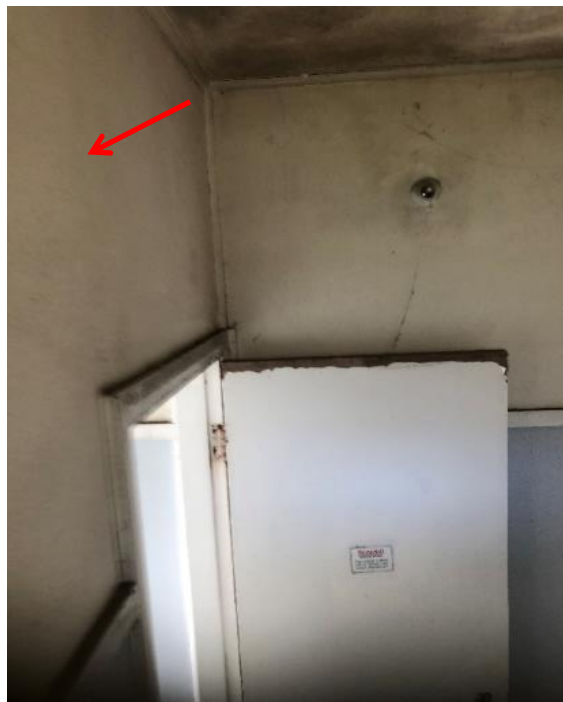
Photograph 40: Front Office, internal, walls to bathroom, fibre cement sheet, asbestos detected by analysis.

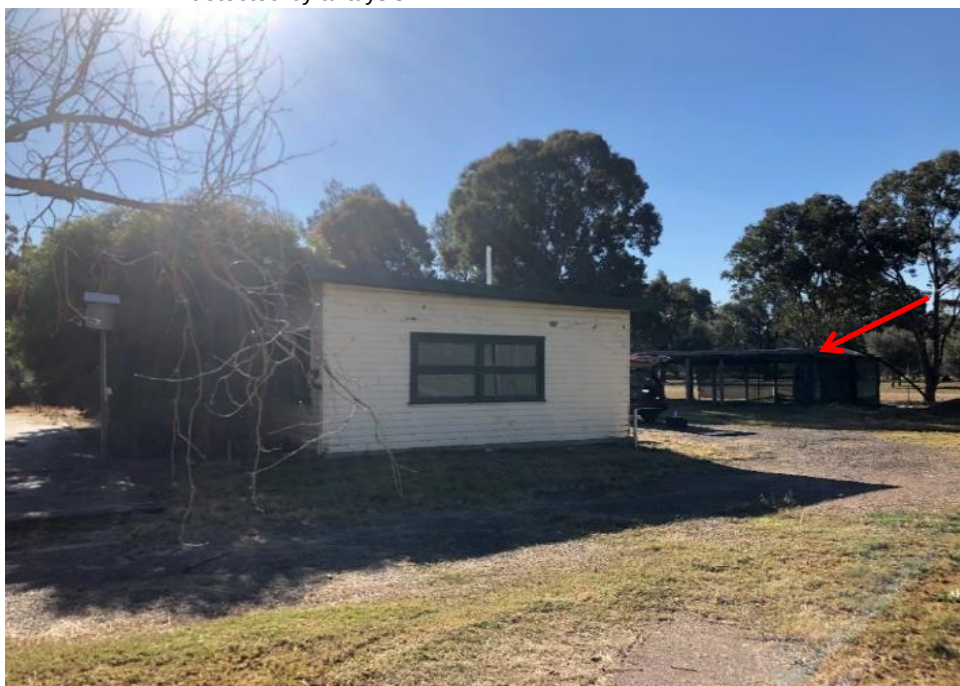
Photograph 48: Shade cloth shed.

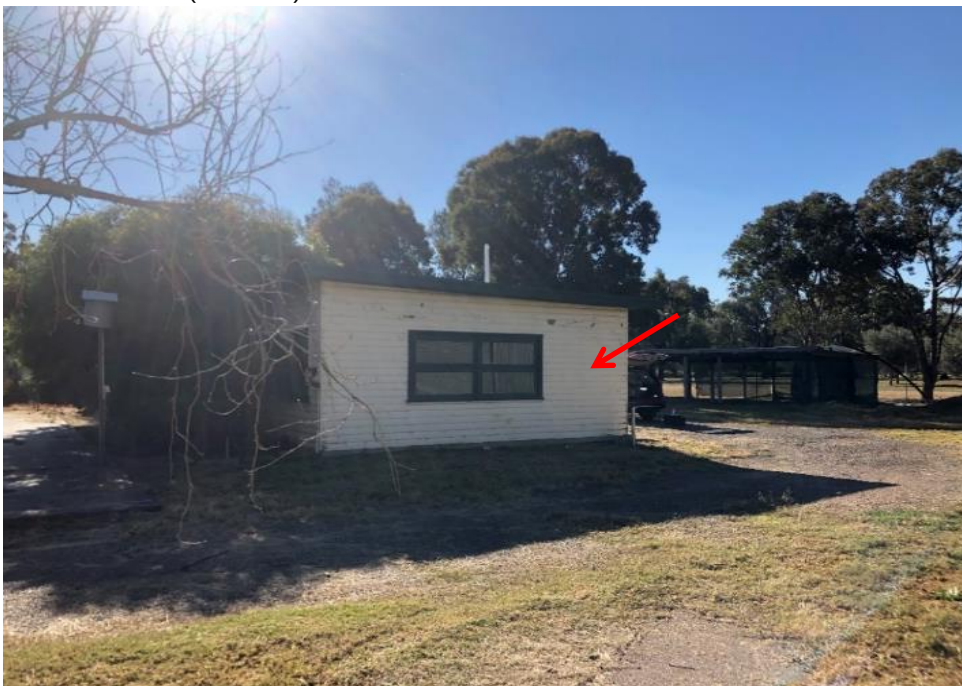
Photograph 50: Building 8 - Rear office and wet rooms

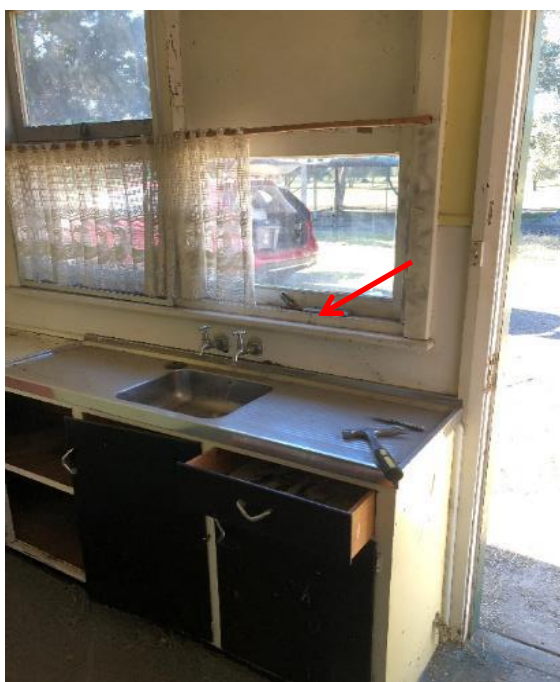
Photograph 56: Rear Office, internal , architraves, white paint, non-lead paint ( $\leq 0.1\%$  lead w/w).

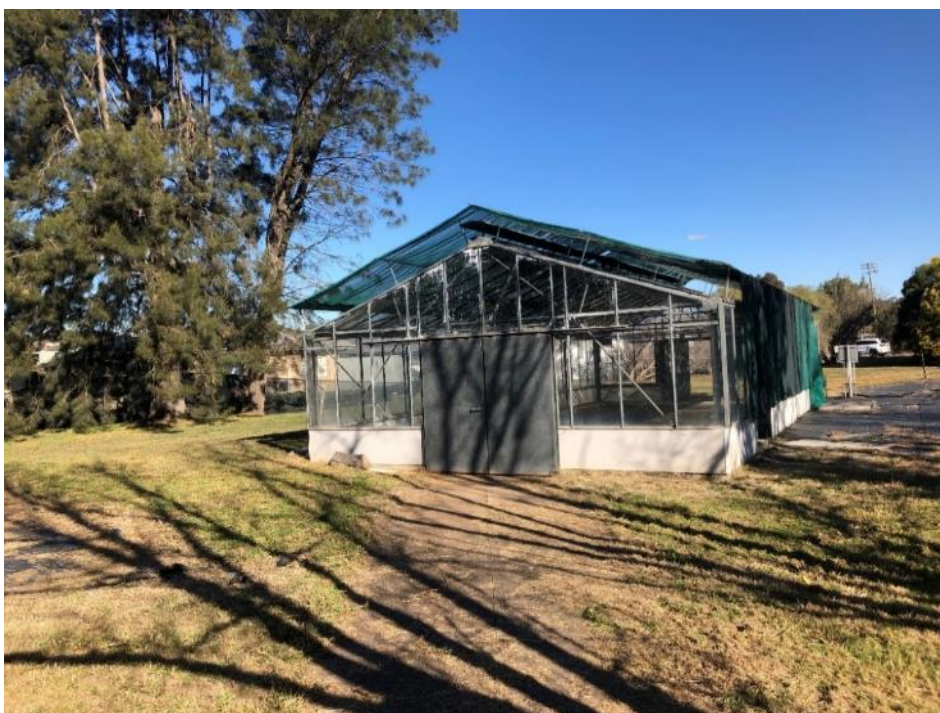
Photograph 66: Glasshouse.
