PRELIMINARY SITE INVESTIGATION AT 505 WILSON STREET EVELEIGH TRANSPORT FOR NSW

29 JULY 2022
122040_VAR1
VERSION 1

Preliminary site investigation at 505 Wilson Street, Eveleigh, NSW

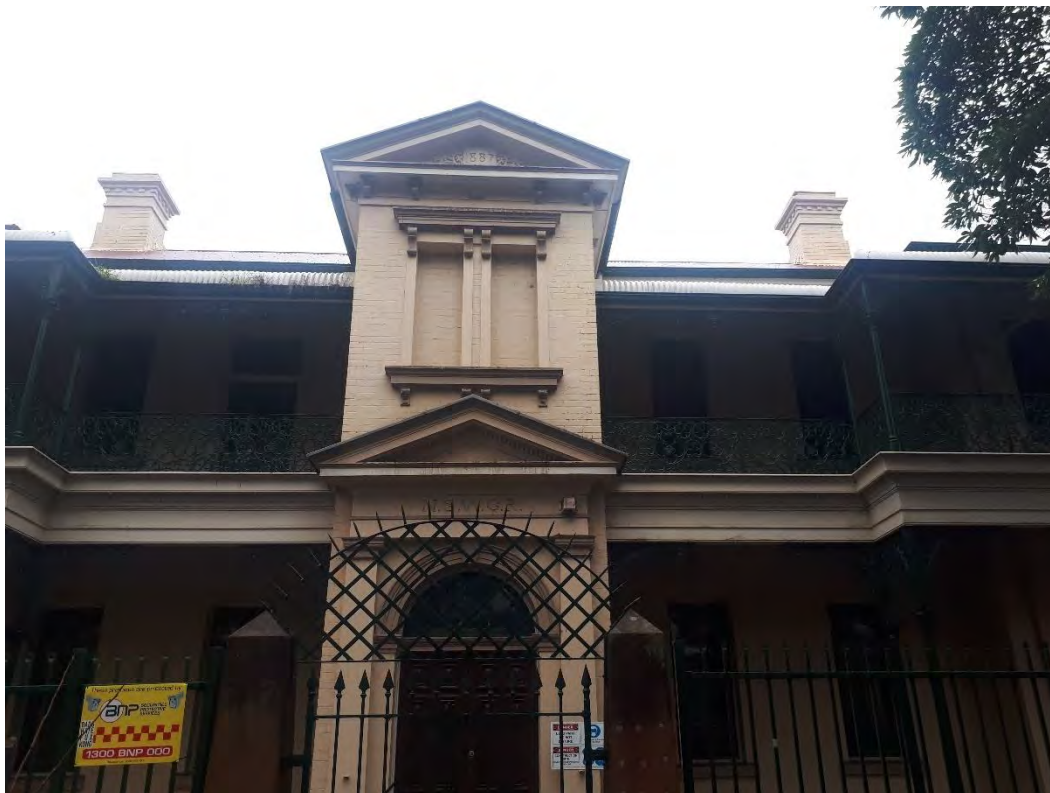
Photo Plate 1: Front of CME building. Photo taken from Wilson Street.

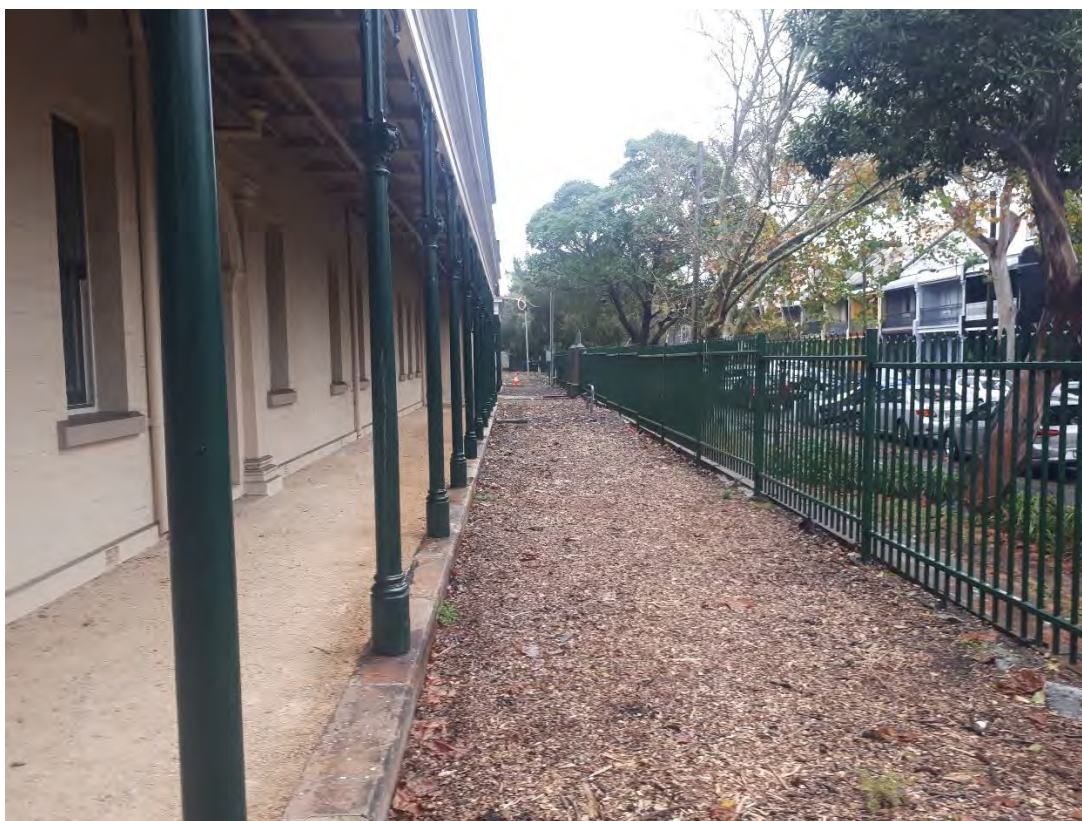
Photo Plate 3: BH 1, 2 & 3 were positioned along this strip at the front of CME building. Wilson street seen on the right of the image.

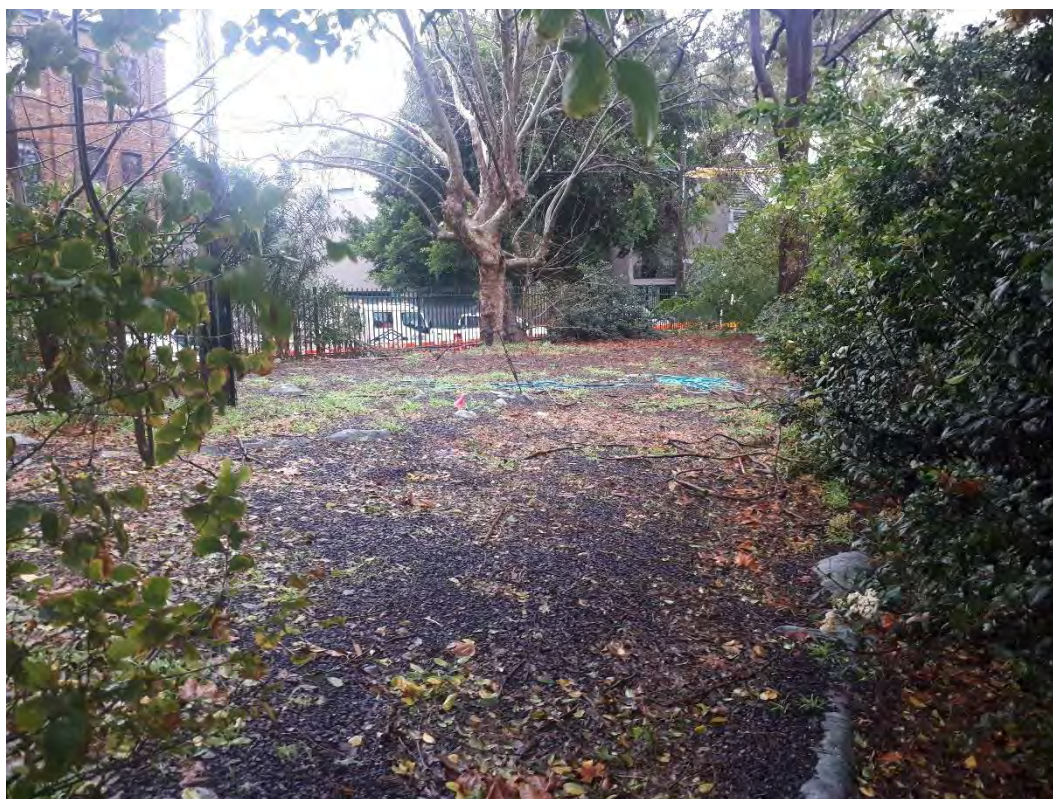
Photo Plate 4: Leaf, mulch and light grass covered area on eastern side of CME building. BH4 located here at pink flag seen in photo.

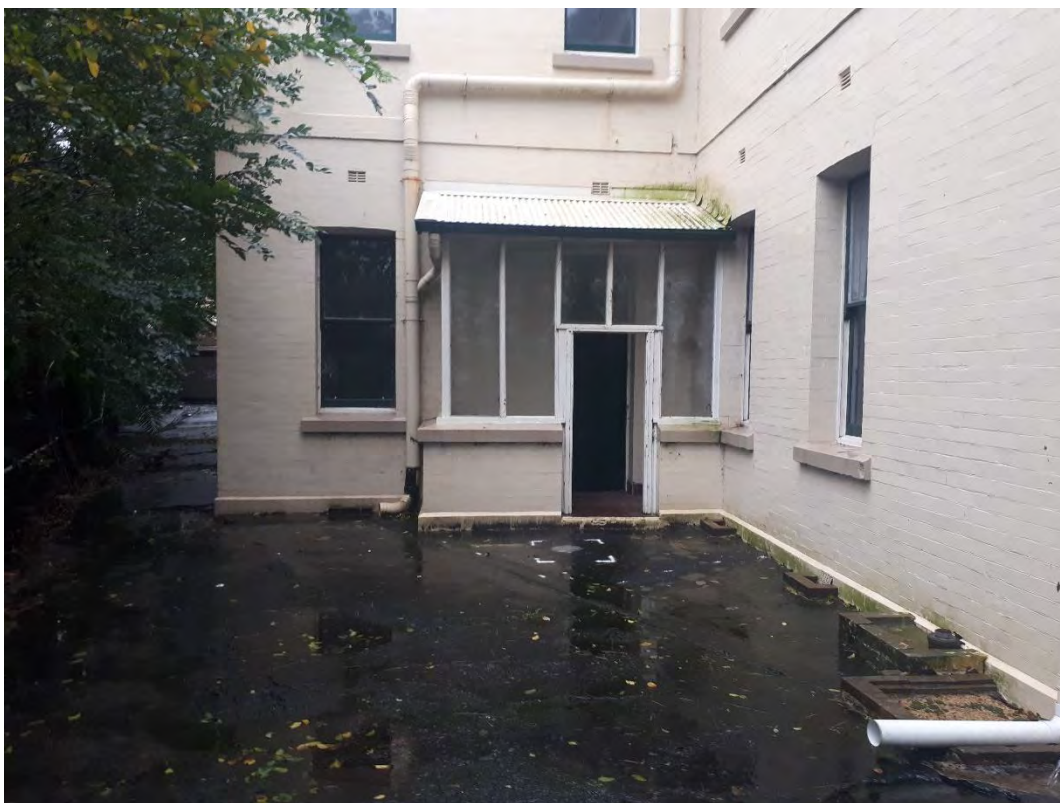
Photo Plate 5: Asphalt covered area behind the BME building. White service locator paint indicating position of BH5.

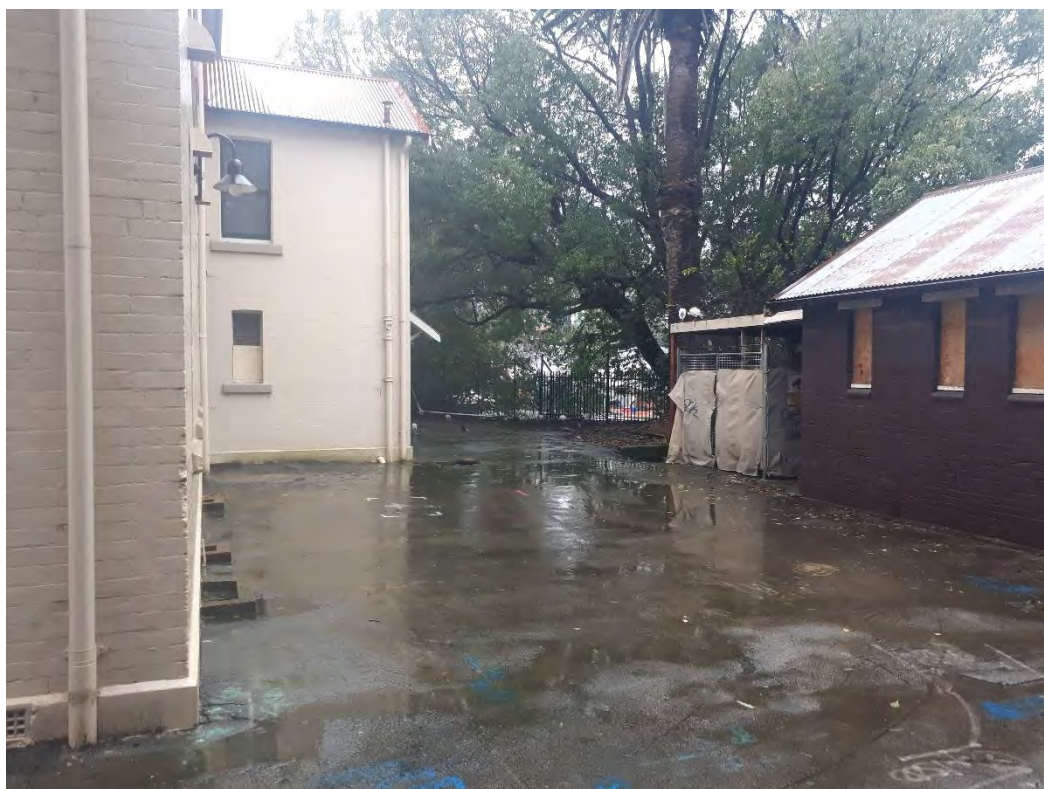
Photo Plate 6: Asphalt covered area behind the BME building. White service locator paint indicating position of BH6.

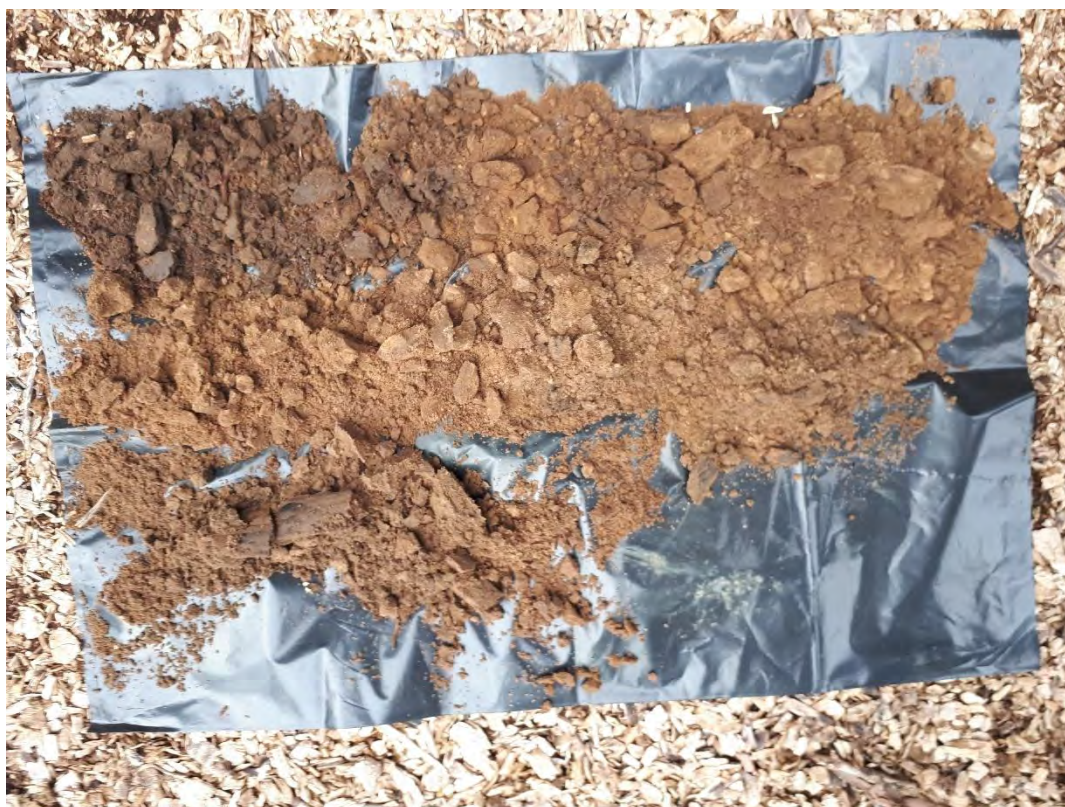
Photo Plate 12: Representative material of BH3

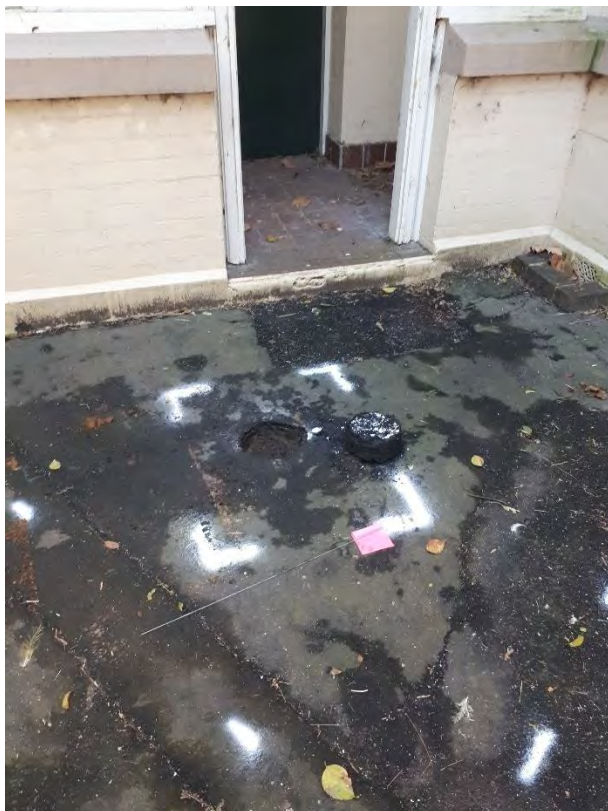
Photo Plate 17: Asphalt core of BH5 removed for soil material to be hand augured

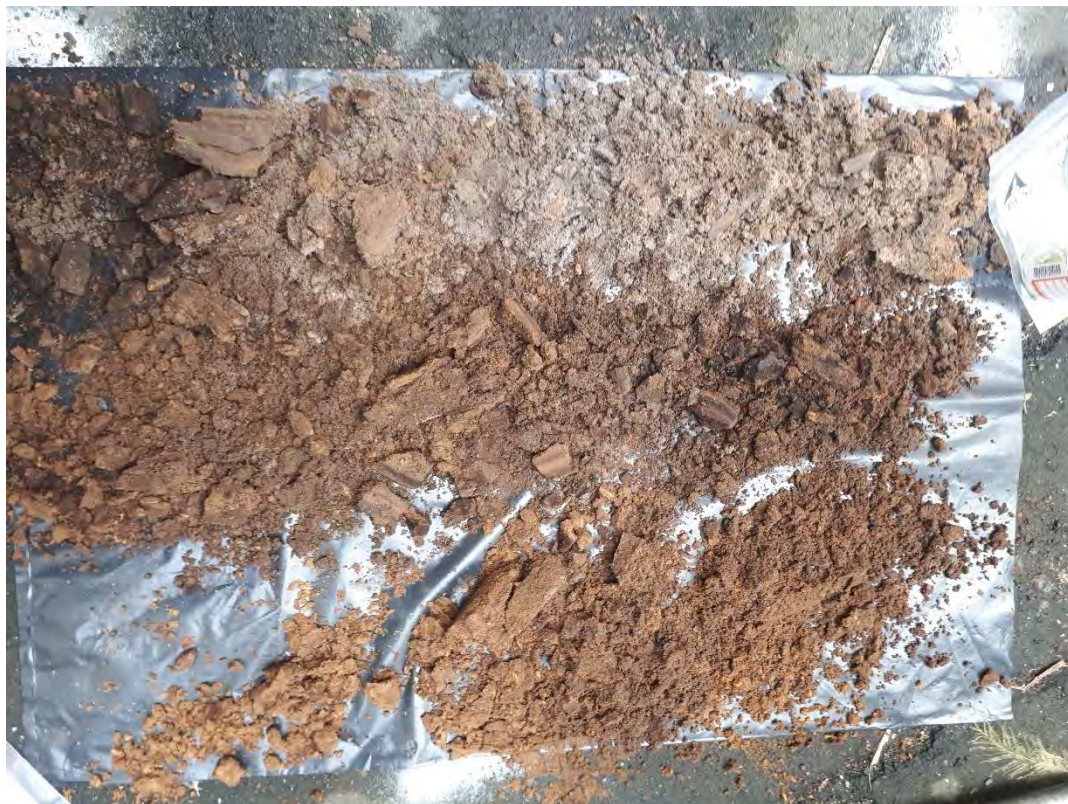
Photo Plate 18: Representative material of BH5

STRATIGRAPHY	GRAPHIC LOG	Depth (metres)	Sample Depth	Sample ID	Moisture Content	Comments
FILL: Asphalt hardstand.

FILL: Loose, dry black SAND with inclusions of fine angular igneous gravels (2%), angular sandstone gravels (2%) and red clay clods (2%).		0.2

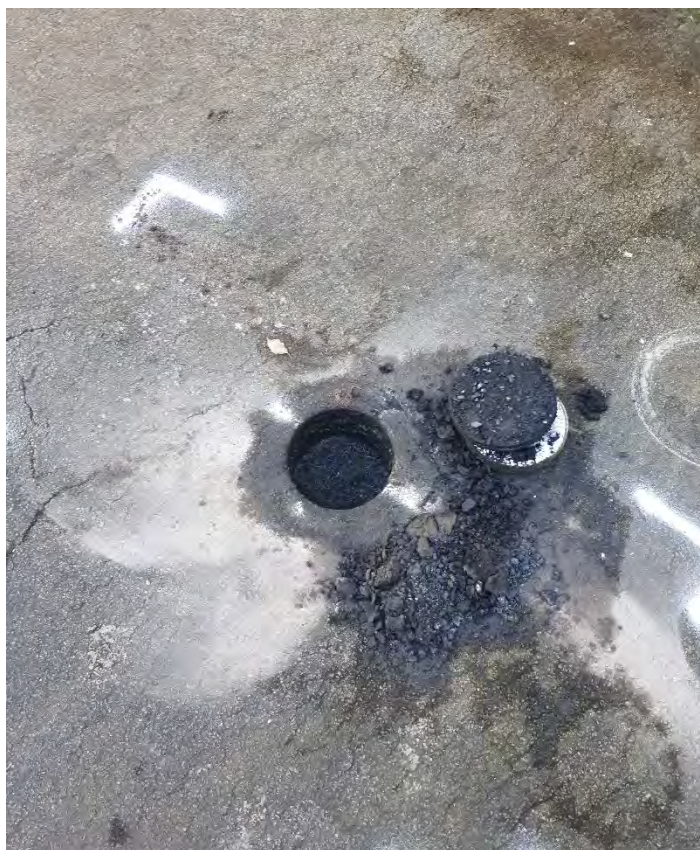
Photo Plate 19: Asphalt core of BH6 removed for soil material to be hand augured

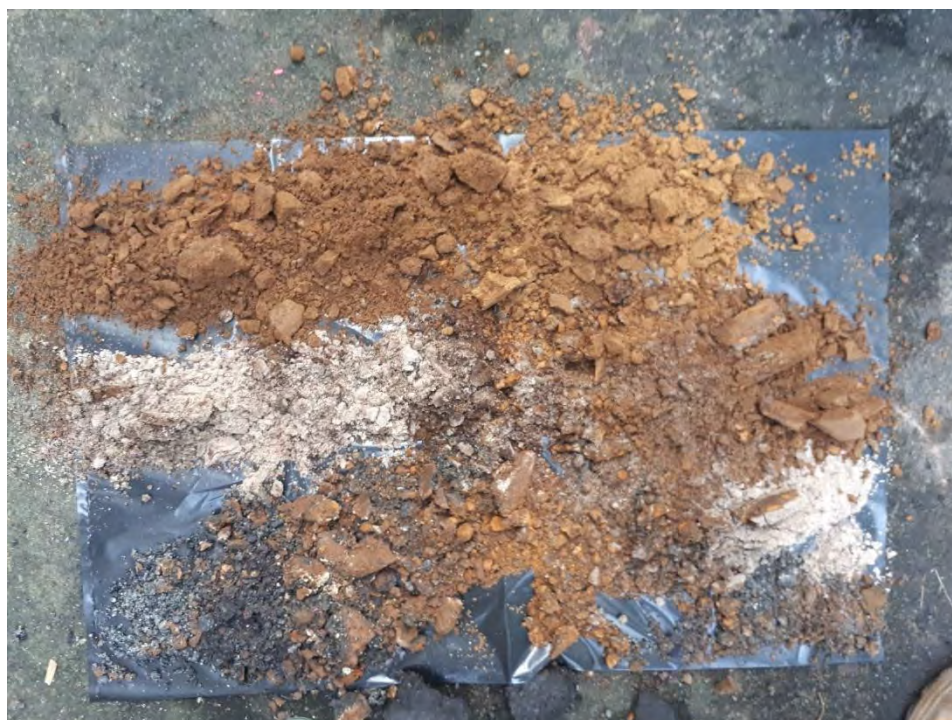
Photo Plate 20: Representative material of BH6
