## PRE-CONSTRUCTION DILAPIDATION REPORT

### Bluescope Proposed Entry Crossover

### 55 Templar Rd, Erskine Park NSW

**Reference:** CO8332.11-02.rpt

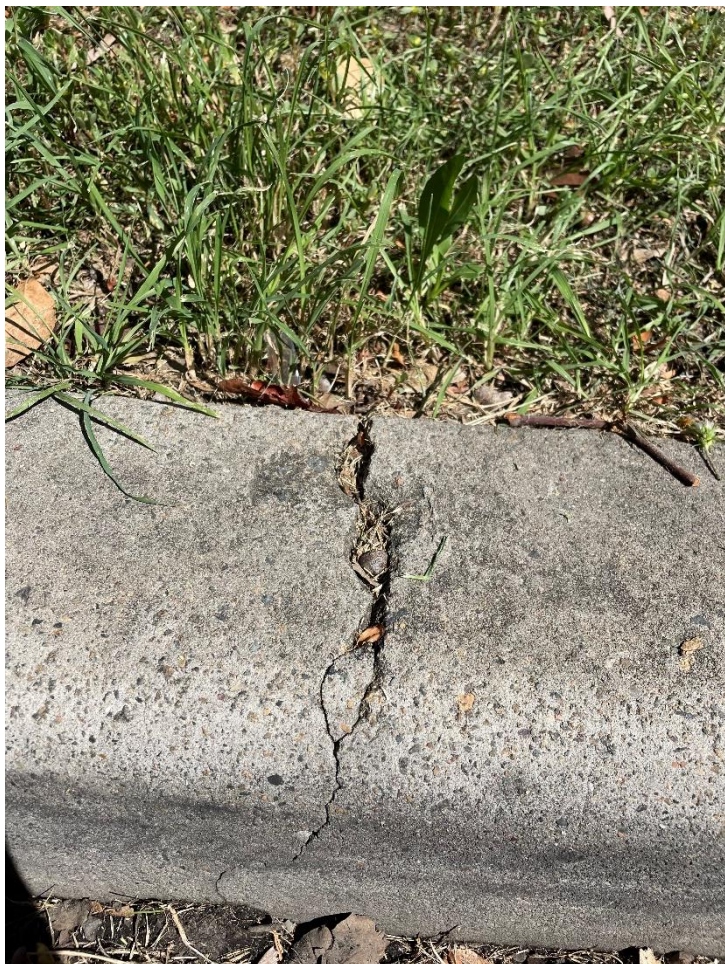
**PHOTO 3**

| ITEM | Pre-Construction Dilapidation Inspection<br>6 March 2023 | PHOTO |
|---|---|---|
| 1.1.3 | Fretting and cracking to kerb measured to be approx. 0.8mm wide. | <b>3-4</b> |

Fretting and cracking to  
kerb measured to be  
approx. 0.8mm wide.

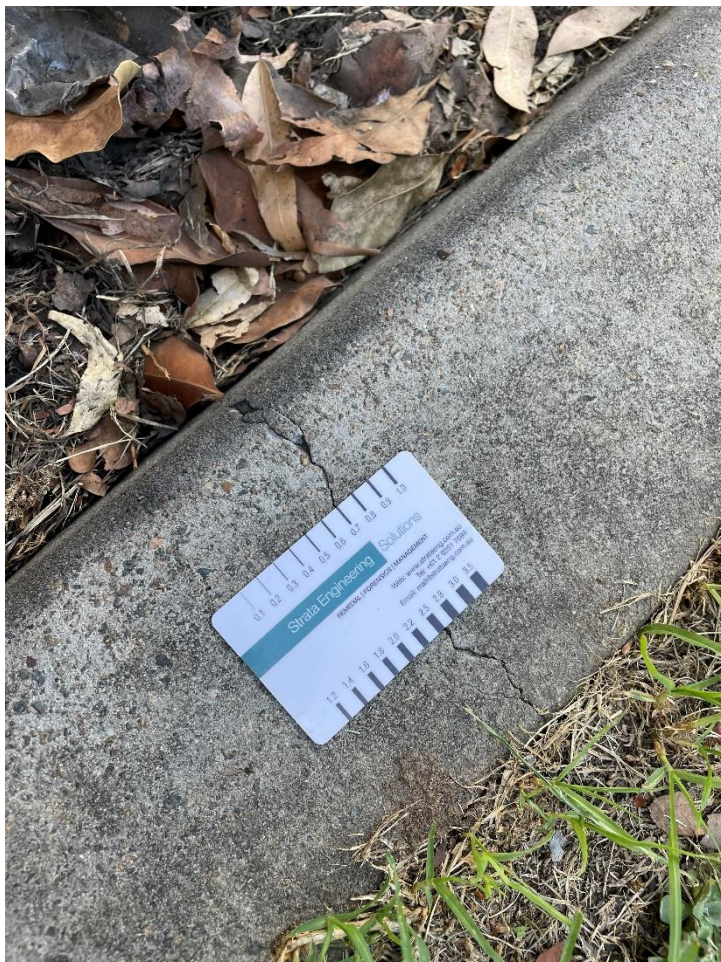
**PHOTO 7**

| ITEM | Pre-Construction Dilapidation Inspection<br>6 March 2023 | PHOTO |
|---|---|---|
| 1.1.6 | Cracking to kerb measured to be approx. 0.7mm wide. | <b>7</b> |

Cracking to kerb measured  
to be approx. 0.7mm wide.

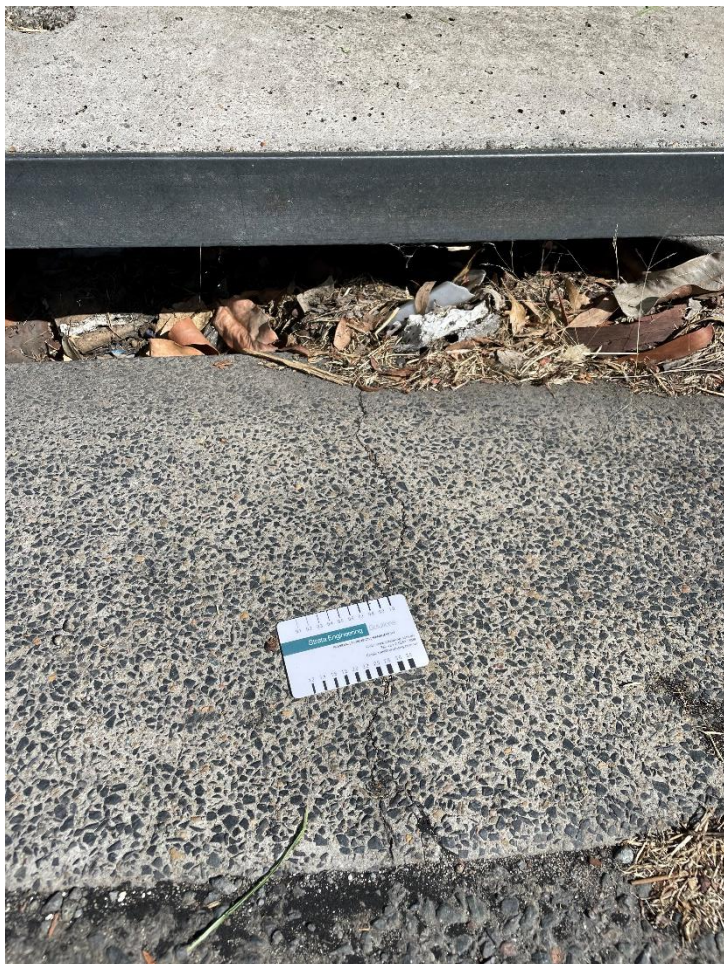
**PHOTO 9**

| ITEM | Pre-Construction Dilapidation Inspection<br>6 March 2023 | PHOTO |
|---|---|---|
| 1.1.8 | Cracking adjacent drainage opening measured to be approx. 1.0mm wide. | <b>9</b> |

Cracking adjacent drainage opening measured to be approx. 1.0mm wide.

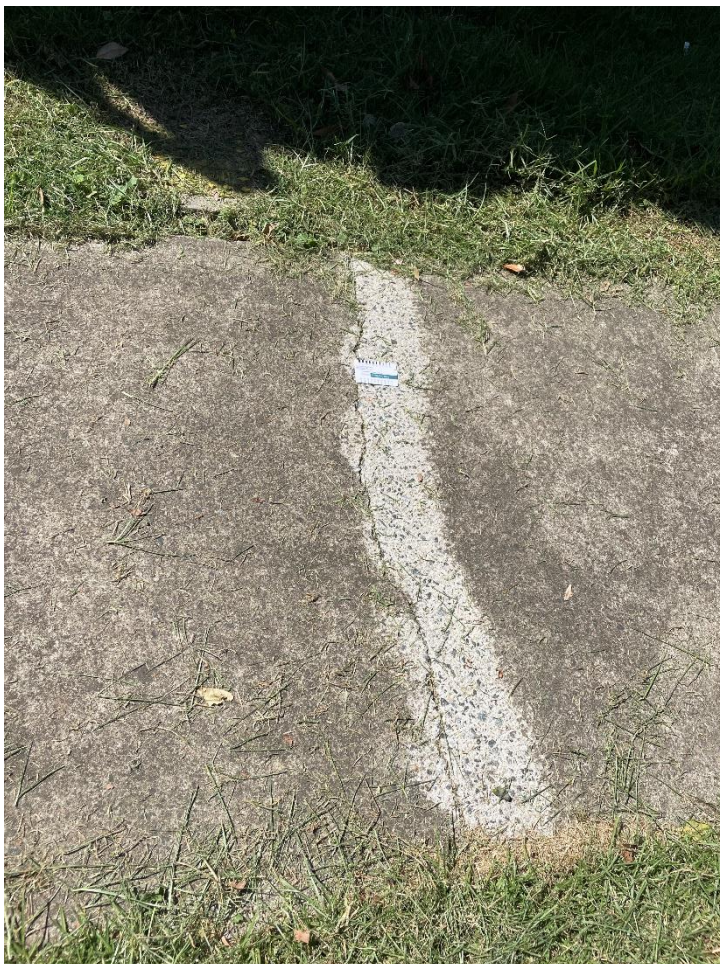
**PHOTO 12**

| ITEM | Pre-Construction Dilapidation Inspection<br>6 March 2023 | PHOTO |
|---|---|---|
| 1.2.2 | Cracking to path measured to be approx. 3.5mm wide. | <b>12-13</b> |

Cracking to path measured to be approx. 3.5mm wide.

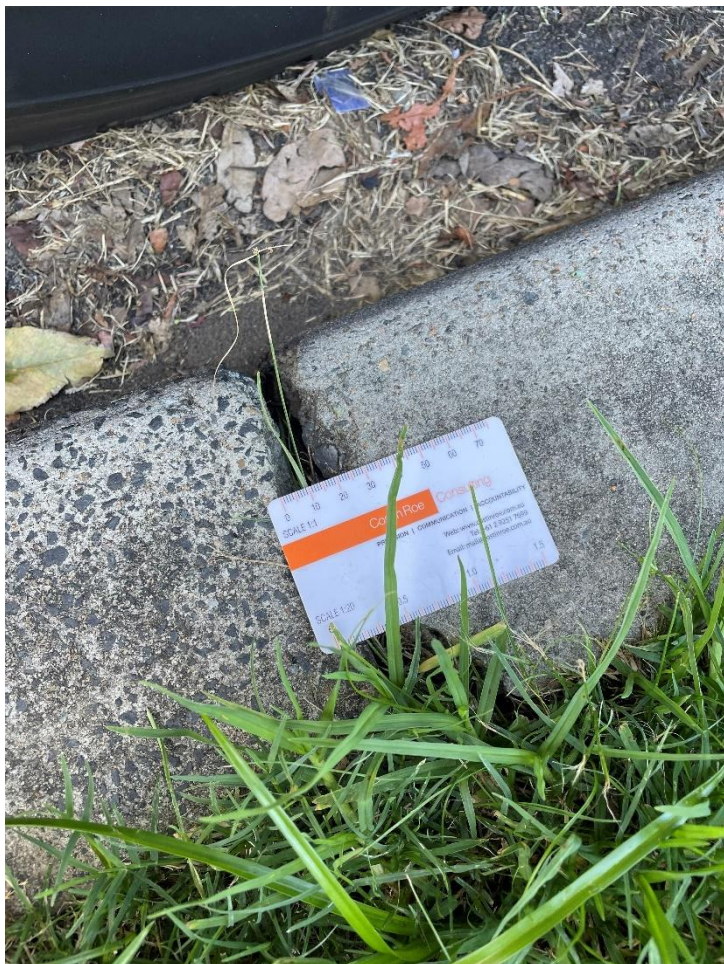
**PHOTO 17**

Separation to kerb  
measured to be approx.  
15mm wide.

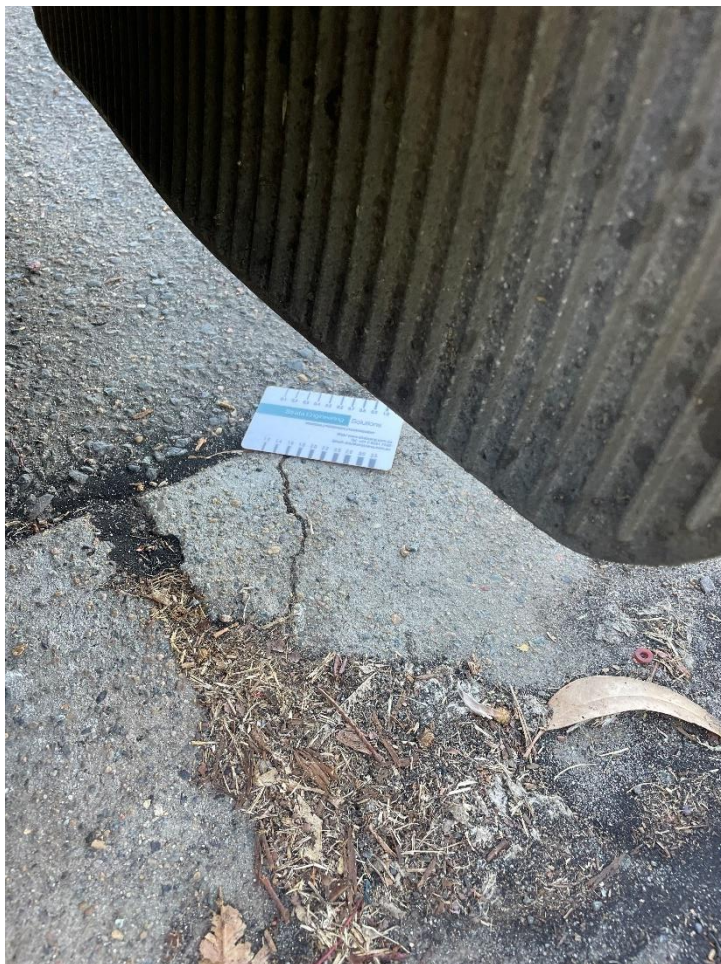
**PHOTO 19**

| ITEM | Pre-Construction Dilapidation Inspection<br>6 March 2023 | PHOTO |
|---|---|---|
| 1.2.7 | Cracking adjacent kerb measured to be approx. 1.2mm wide. | <b>19</b> |

Cracking adjacent kerb  
measured to be approx.  
1.2mm wide.

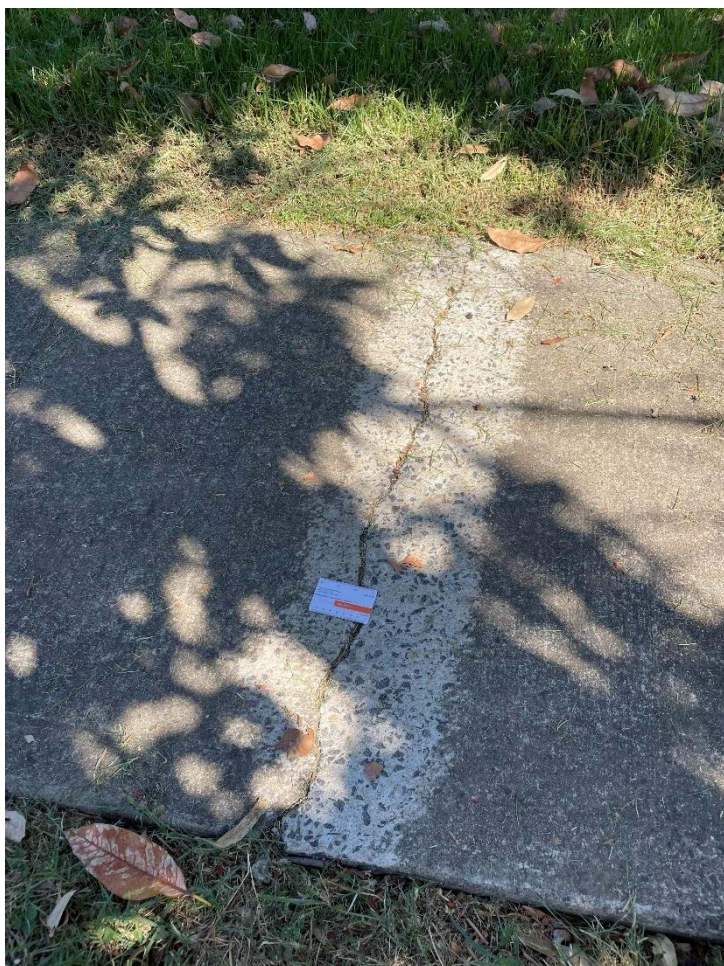
**PHOTO 24**

| 1.3.2 | Cracking to path measured to be approx. 10mm wide. | 24-25 |

Cracking to path measured to be approx. 10mm wide.

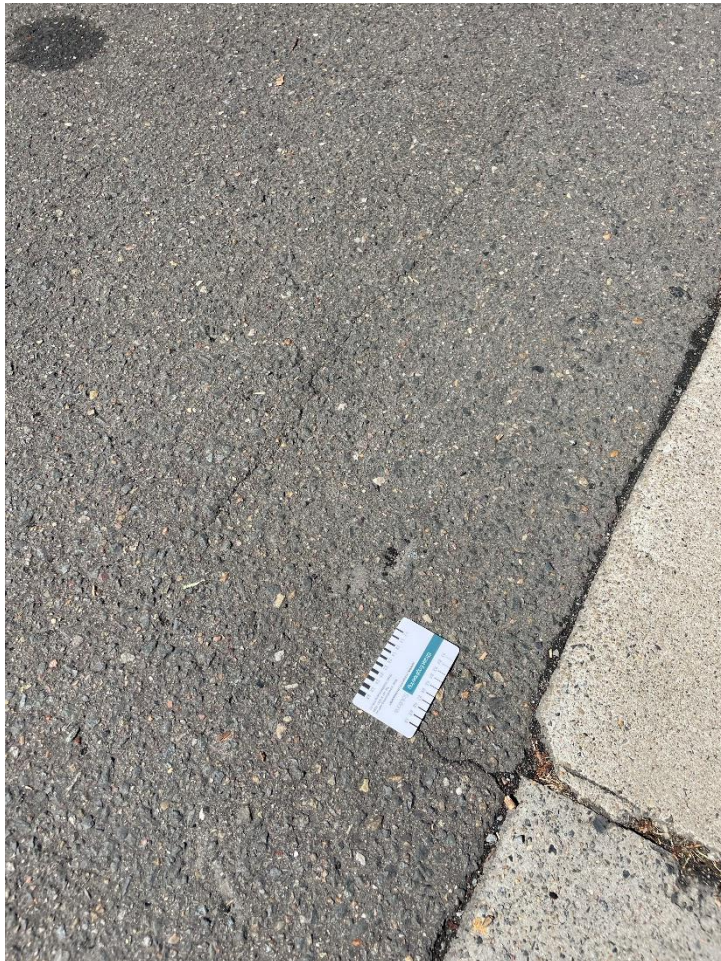
**PHOTO 29**

| 1.3.6 | Cracking to road measured to be approx. 1.0mm wide. | 29-30 |

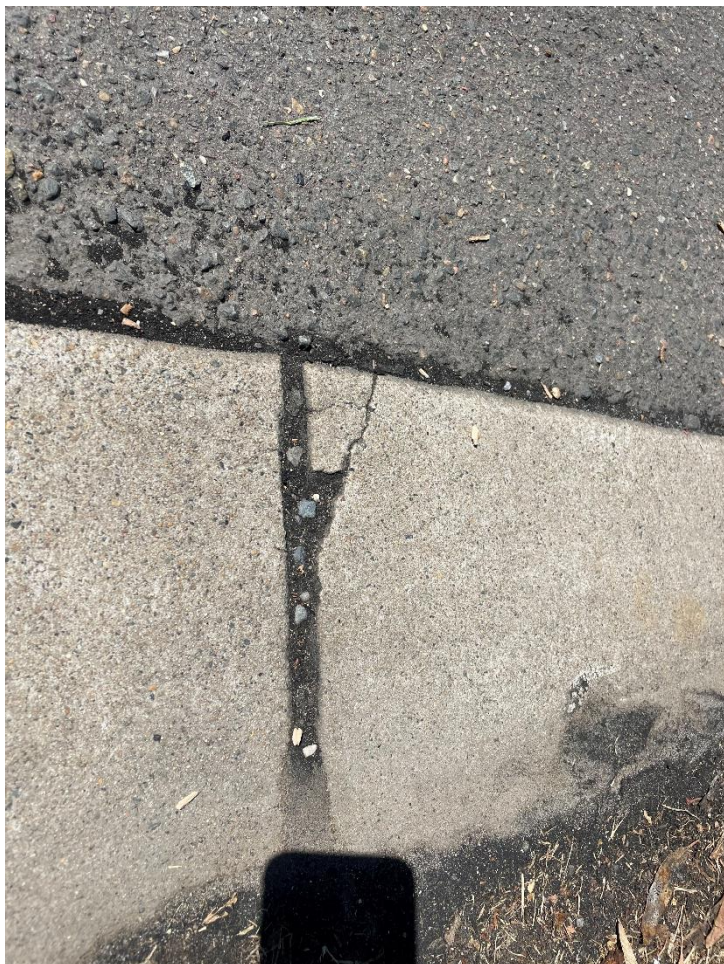
**PHOTO 33**

| 1.4.3 | Fretting and cracking adjacent kerb measured to be approx. 1.2mm | 33-34 |

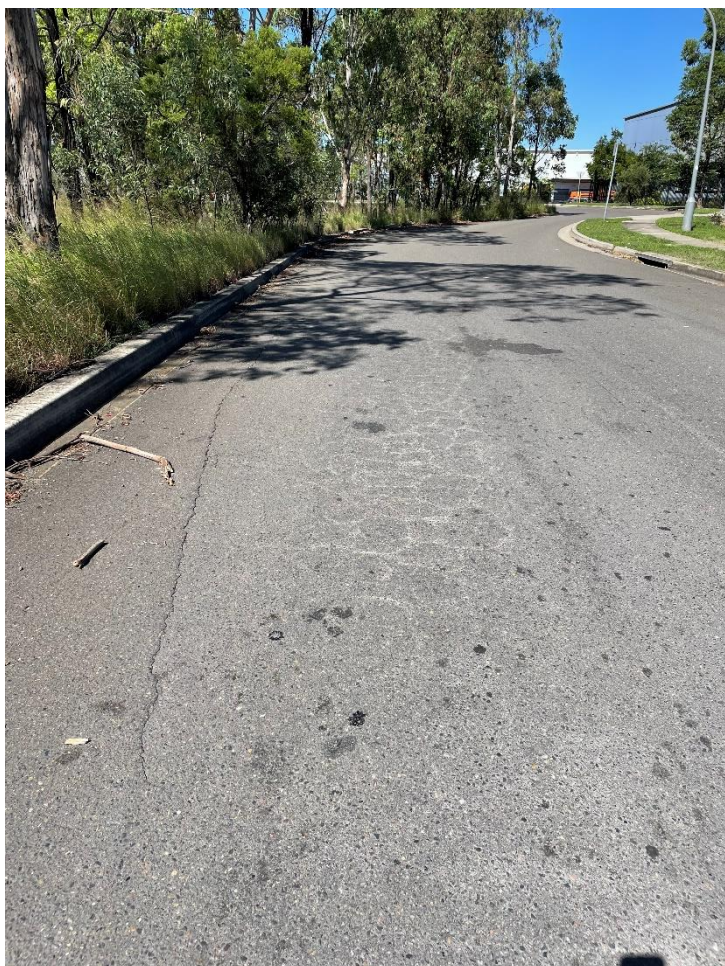
**PHOTO 38**

| 1.4.7 | Alligator cracking to road observed. | 38 |

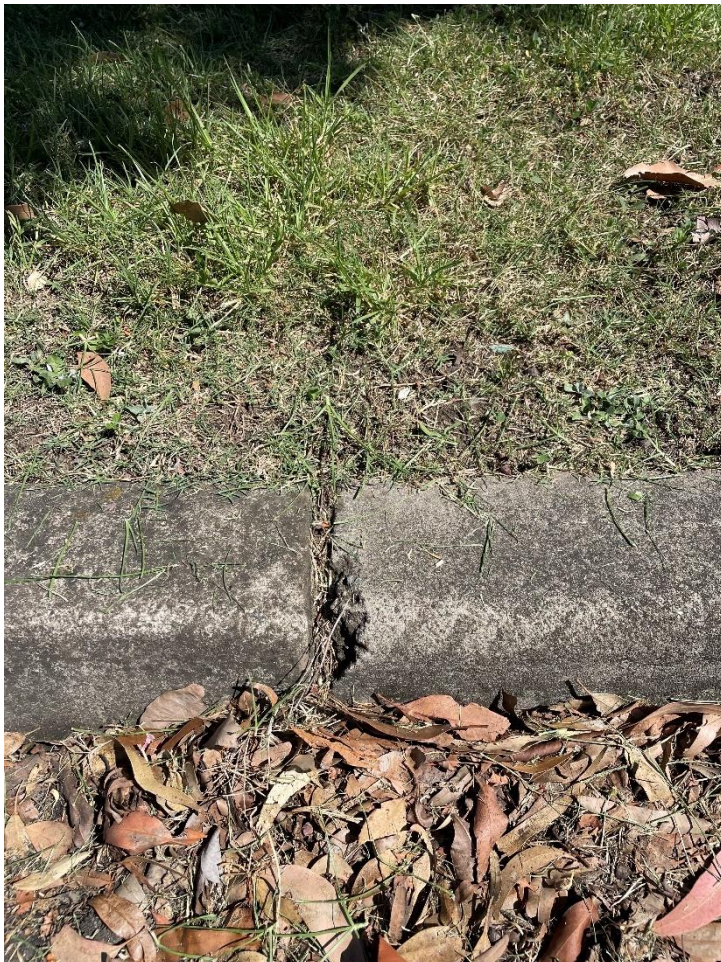
**PHOTO 42**

| 1.5.3 | Fretting to kerb observed. | 42 |

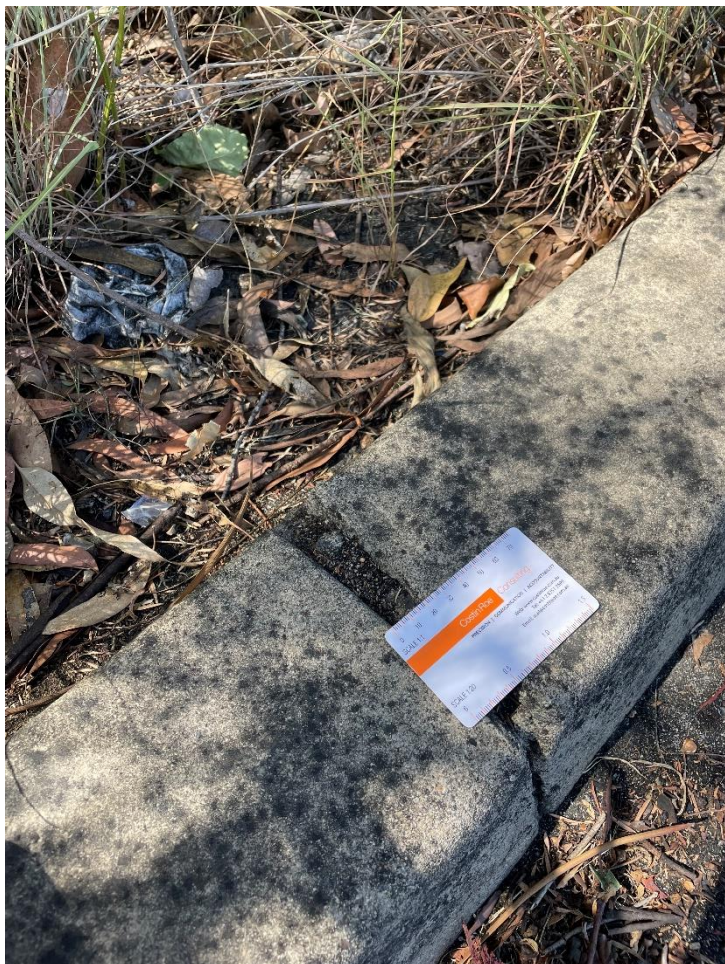
**PHOTO 45**

Separation to kerb  
measured to be approx.  
18mm wide.

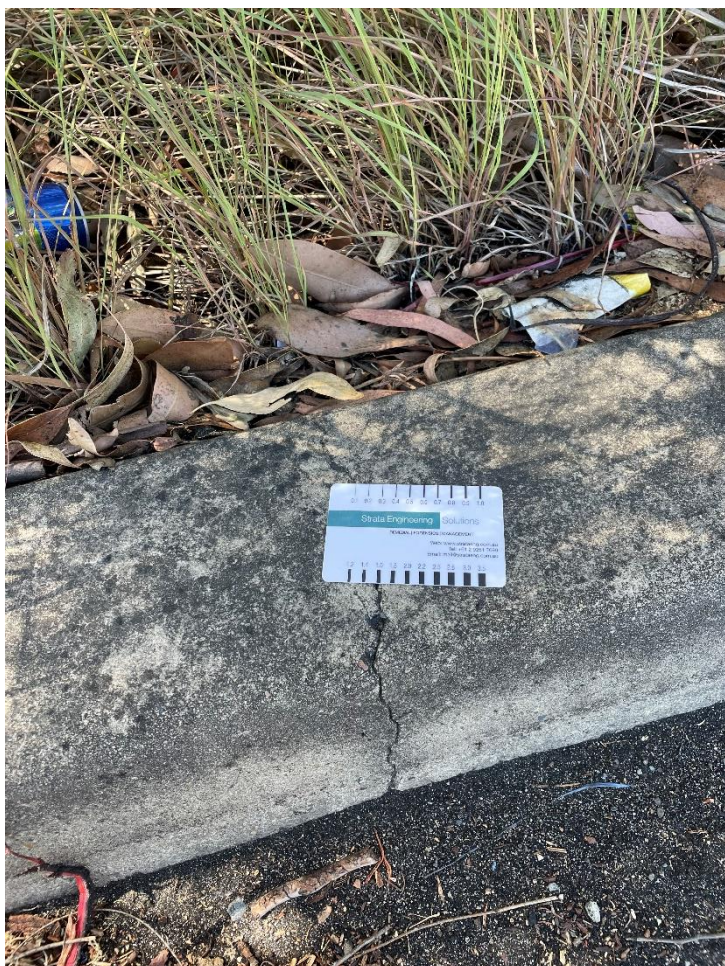
**PHOTO 46**

| 1.5.7 | Cracking to kerb measured to be approx. 1.6mm wide. | 46 |

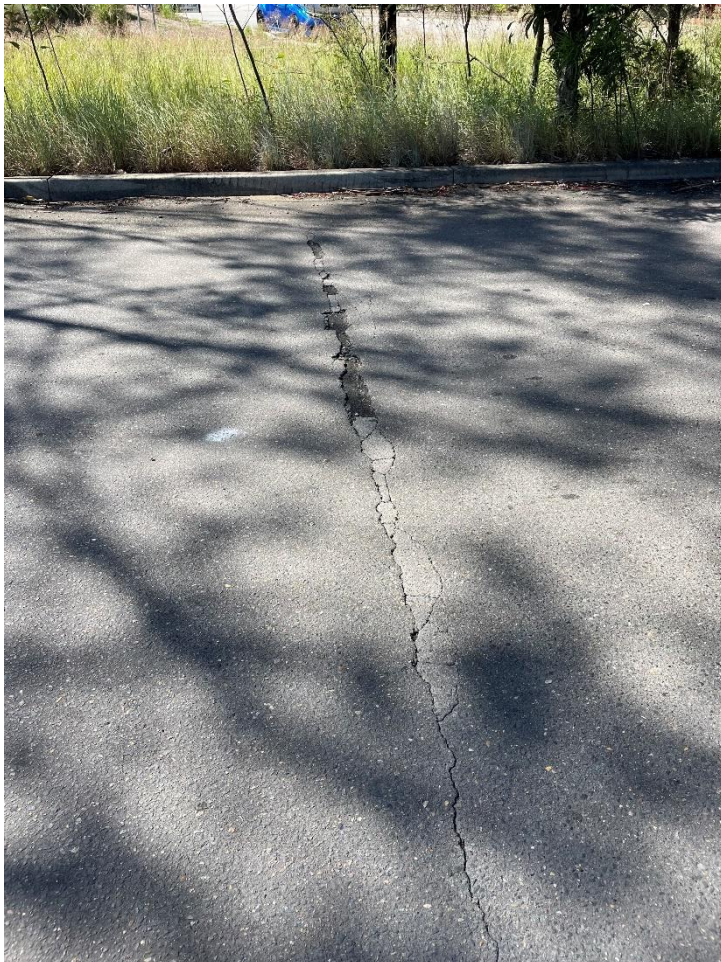
**PHOTO 50**

| 1.5.11 | Cracking and fretting to road observed. | 50-51 |

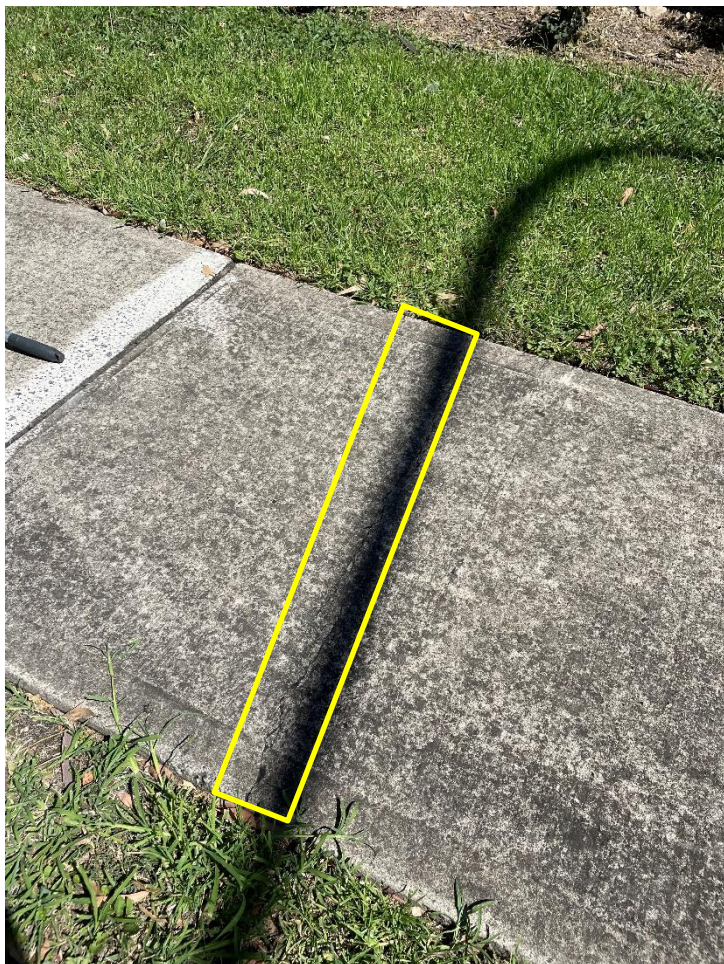
**PHOTO 53**

| 1.6.2 | Cracking to path measured to be approx. 1.8mm wide. | 53-54 |

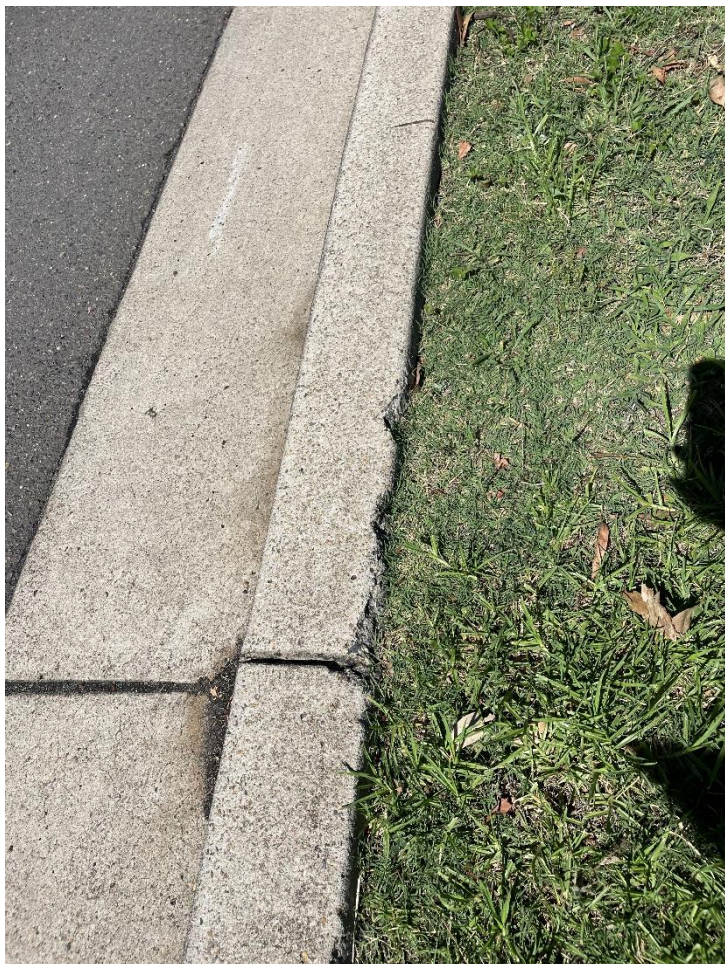
**PHOTO 57**

| 1.6.4 | Fretting to kerb observed. | 57 |

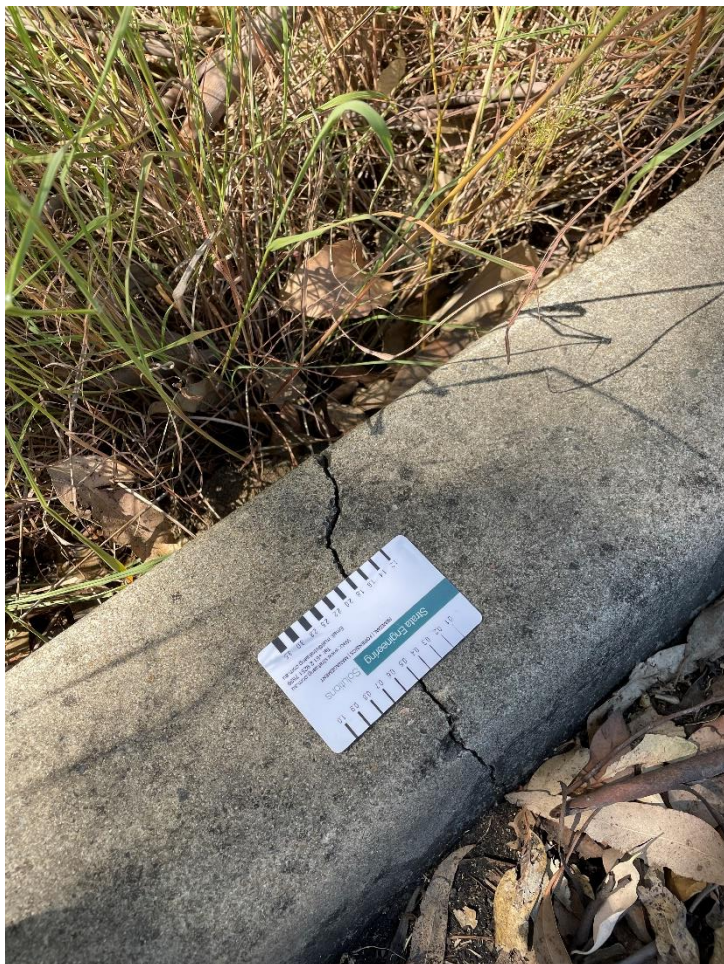
**PHOTO 61**

| 1.6.6 | Cracking to kerb measured to be approx. 1.8mm wide. | 61 |

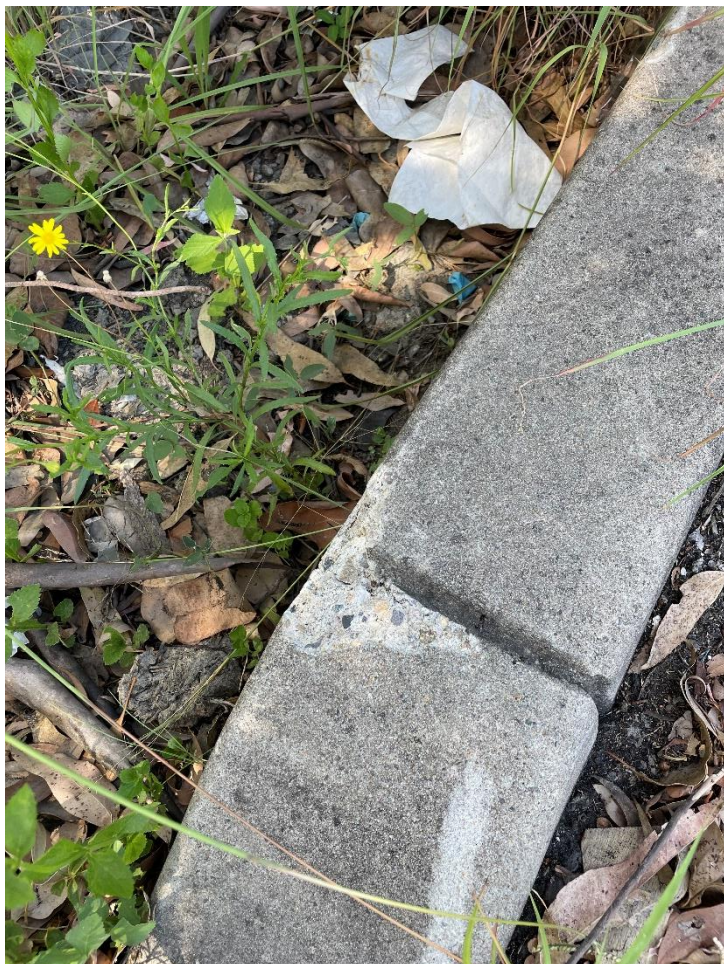
**PHOTO 63**

| 1.6.8 | Fretting to kerb observed. | 63 |

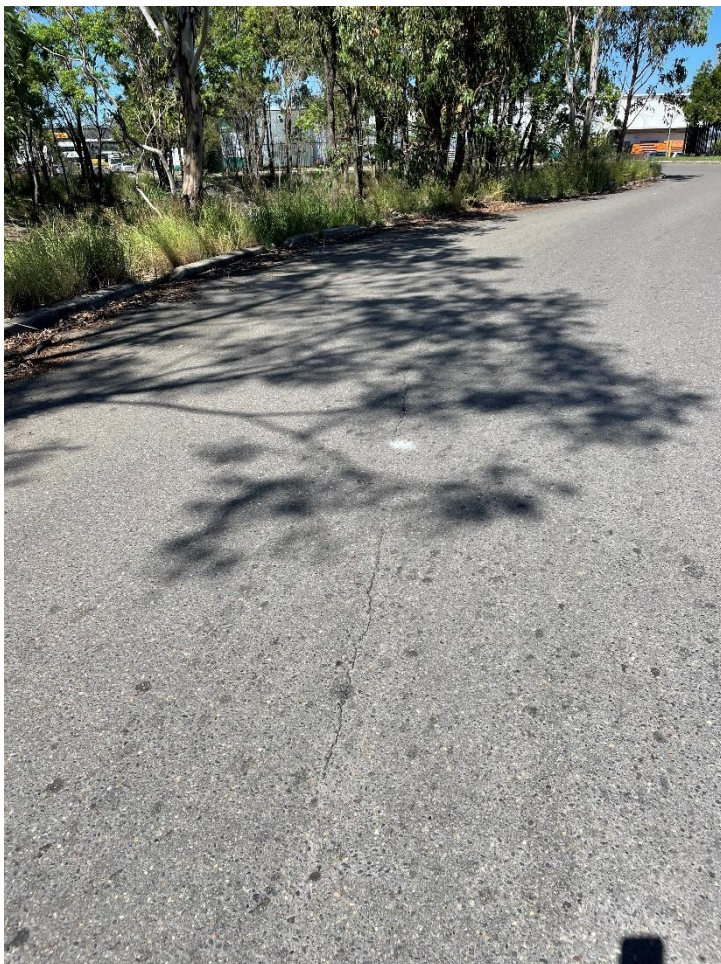
**PHOTO 66**

| 1.6.11 | Cracking to road measured to be approx. 3.5mm wide. | 66-68 |

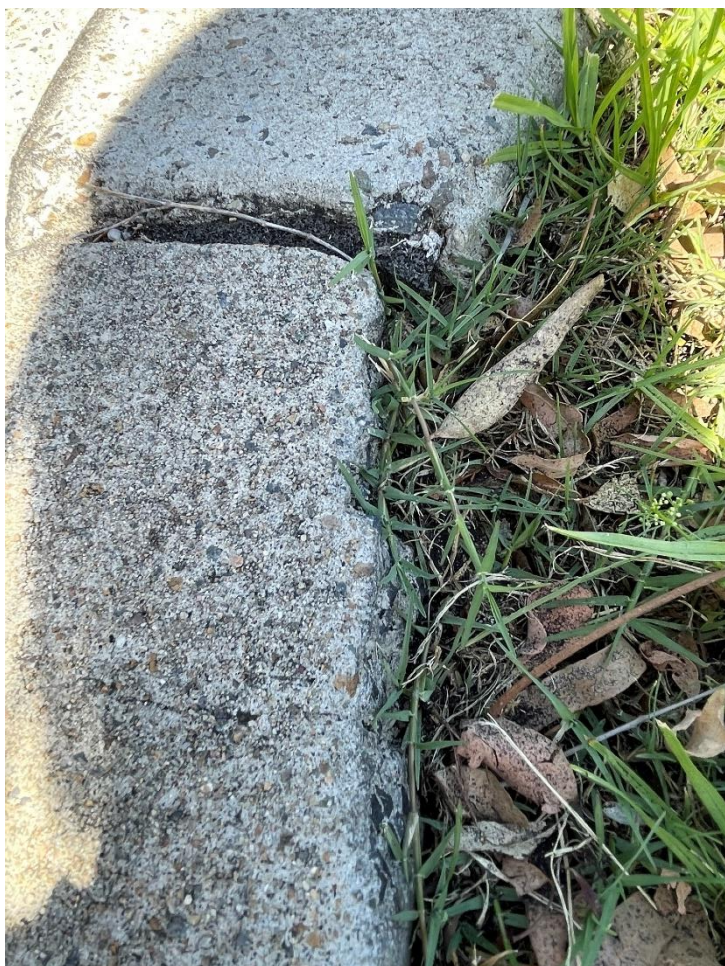
**PHOTO 70**

| 1.7.2 | Fretting to kerb observed. | 70 |

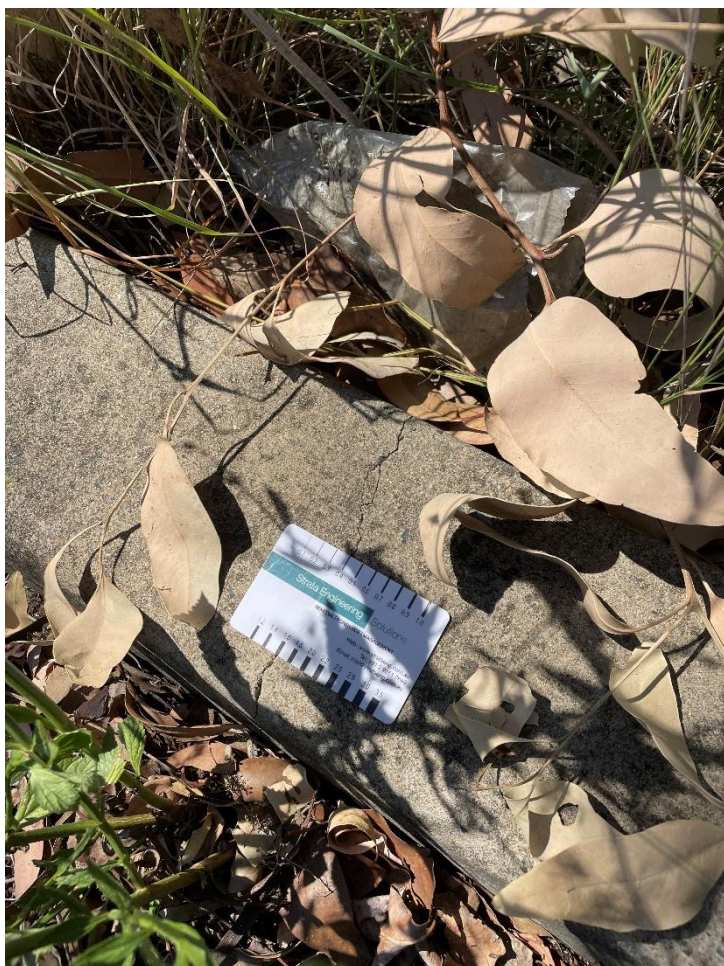
**PHOTO 72**

| 1.7.4 | Cracking to kerb measured to be approx. 0.4mm wide. | 72 |

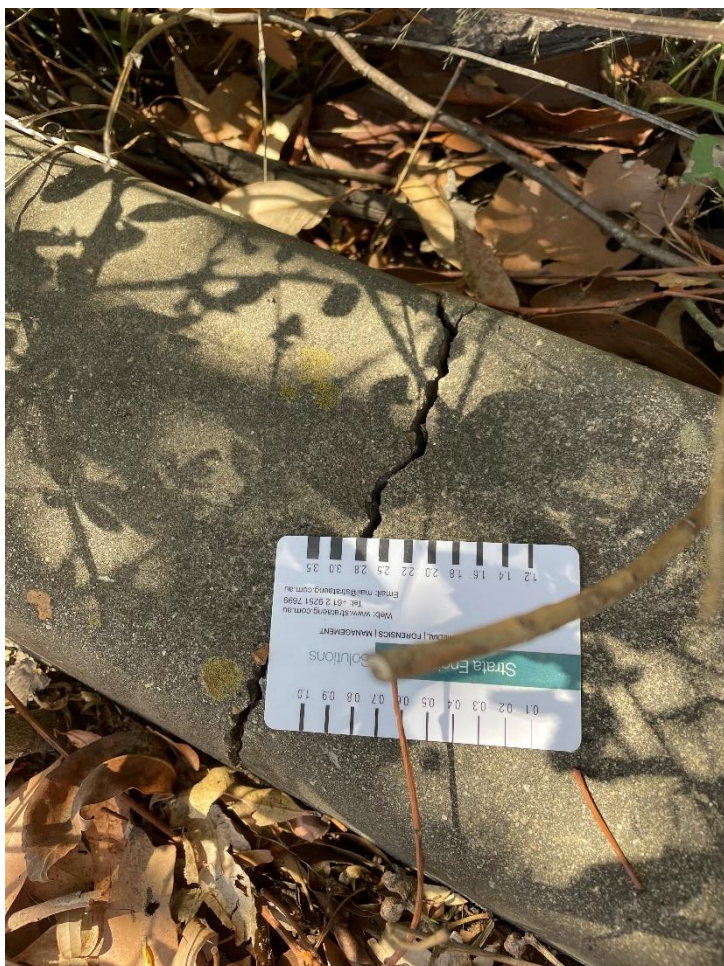
**PHOTO 74**

| 1.7.6 | Cracking to kerb measured to be approx. 2.8mm wide. | 74 |

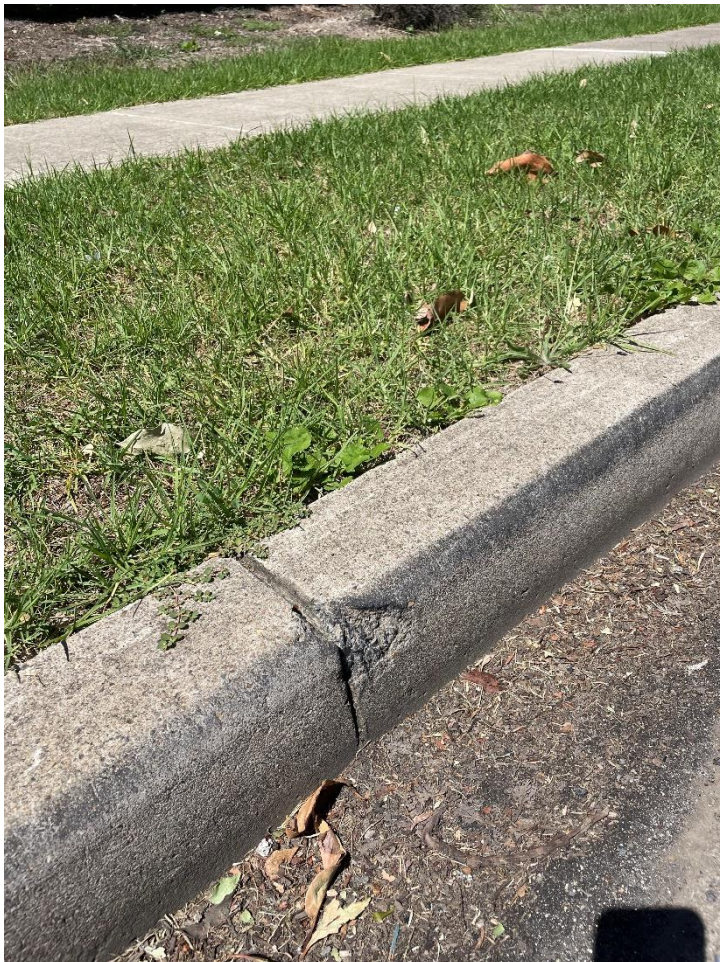
**PHOTO 3**

Fretting to kerb observed.

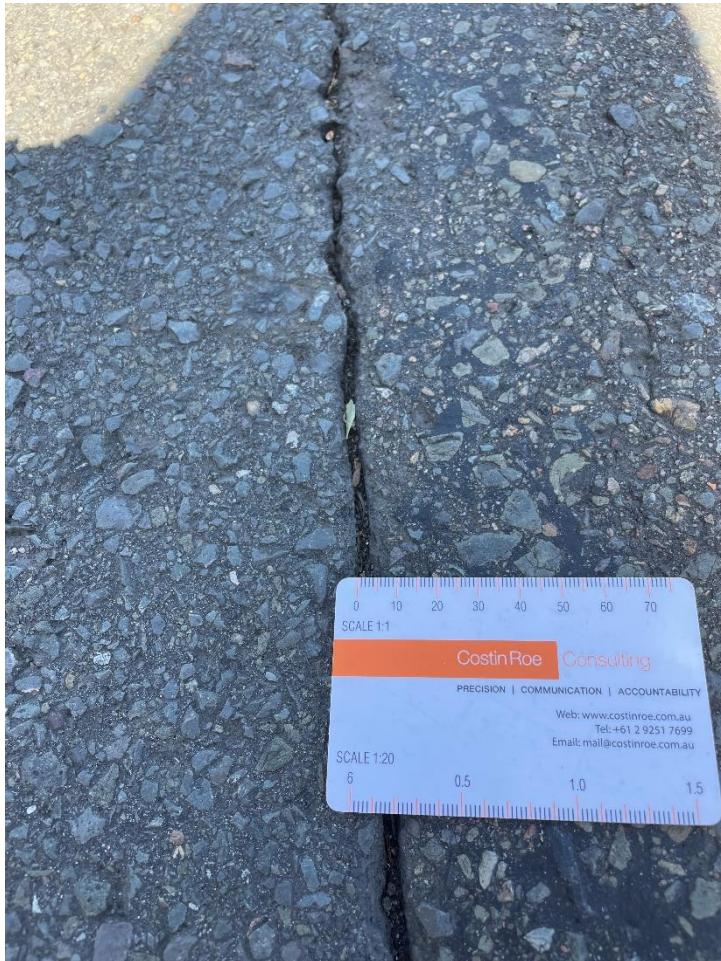
**PHOTO 6**

Cracking to road measured to be approx. 4mm wide.

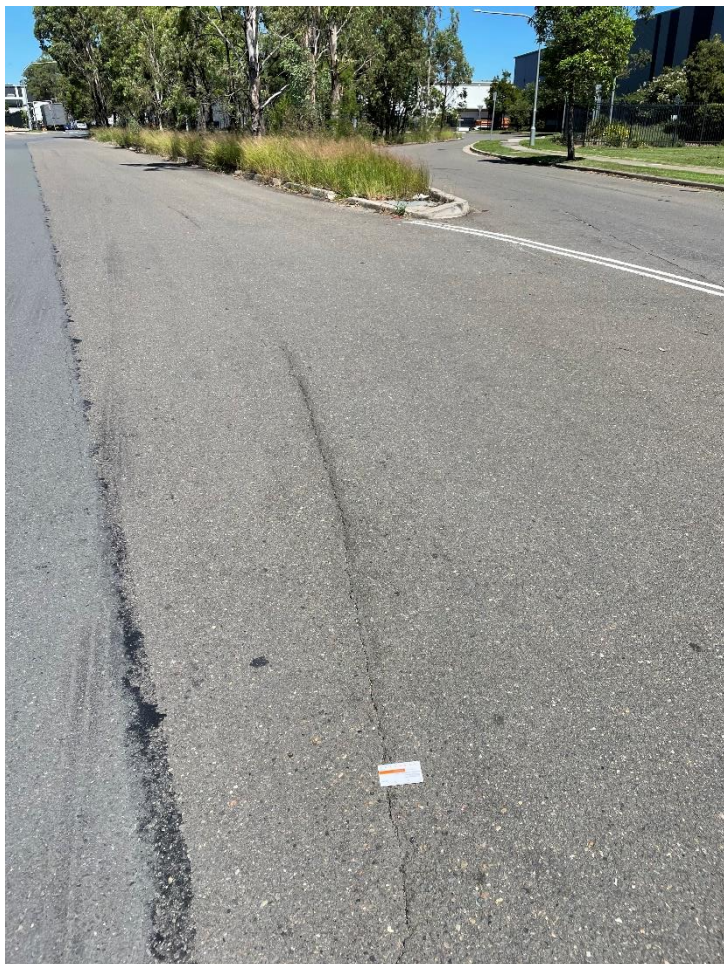
**PHOTO 15**

Cracking to road measured  
to be approx. 15mm wide.

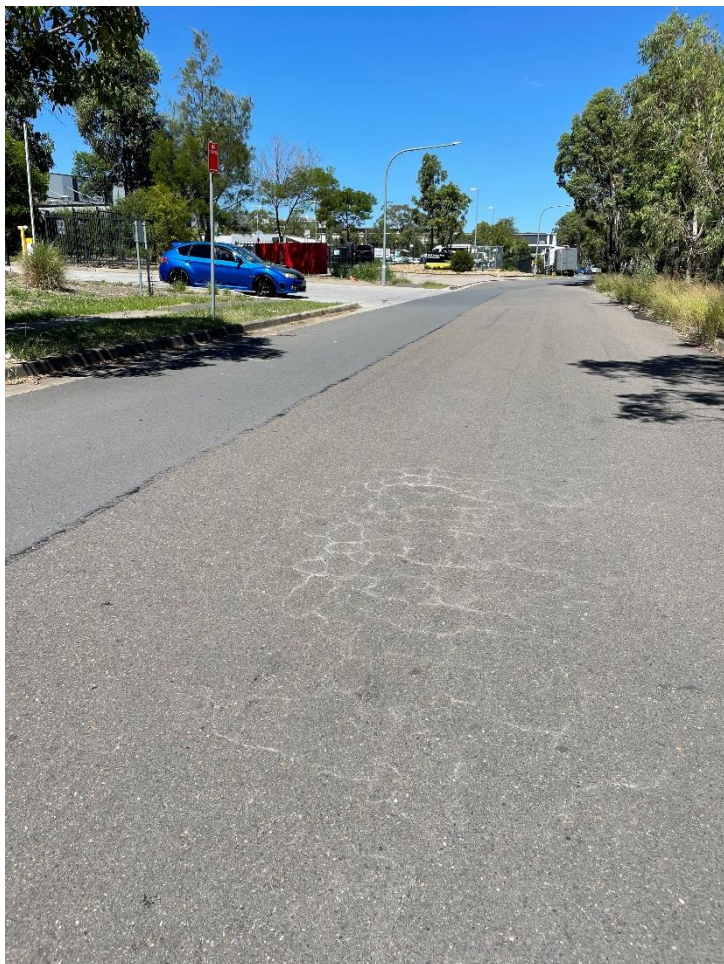
**PHOTO 23**

Alligator cracking to road  
observed.

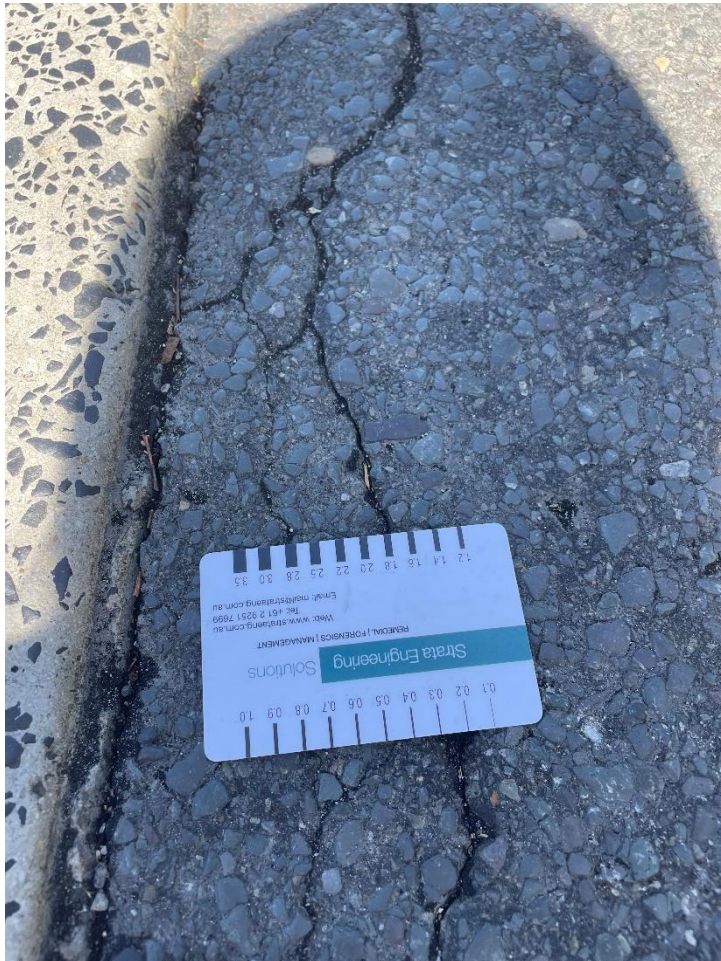
**PHOTO 50**

| 2.6.7 | Cracking to road measured to be approx. 1.8mm wide. | <b>50-51</b> |

Cracking to road measured to be approx. 1.8mm wide.

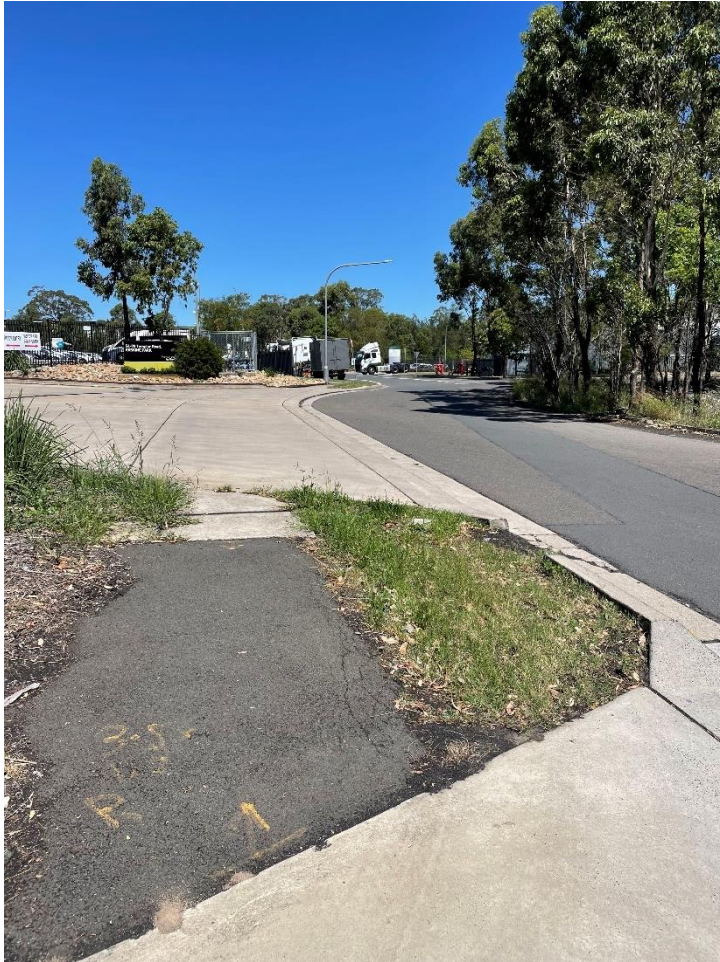
| 2.6.9 | Cracking to road measured to be approx. 11mm wide. | <b>53-54</b> |

Cracking to road measured  
to be approx. 11mm wide.

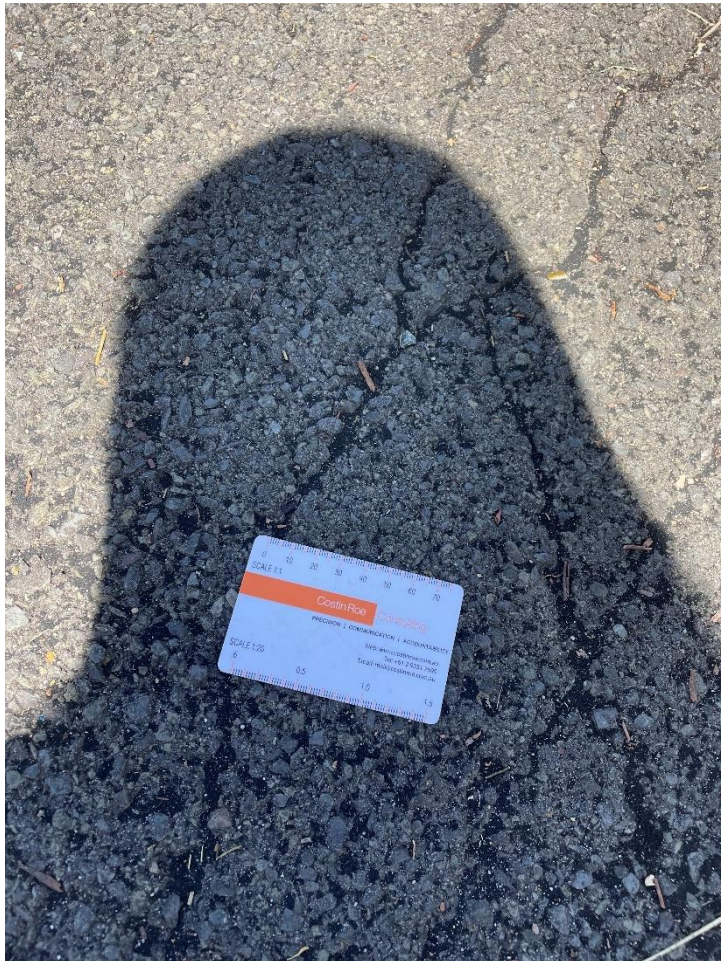
**PHOTO 56**

| 2.7.2 | Cracking to path measured to be approx. 8mm wide. | <b>56-57</b> |

Cracking to path measured to be approx. 8mm wide.

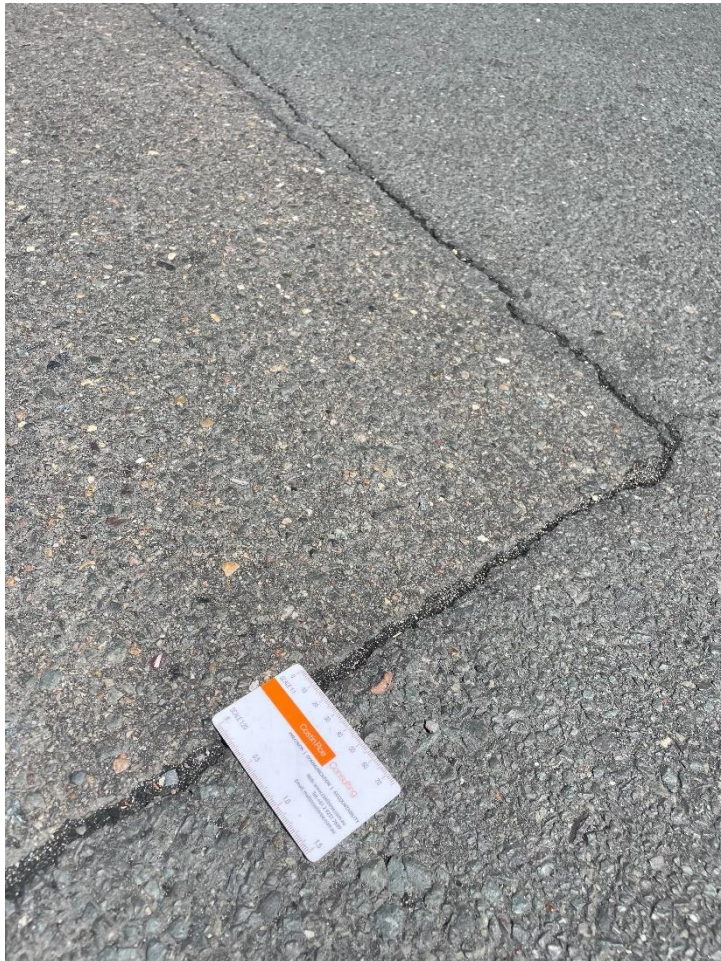
**PHOTO 62**

| 2.7.7 | Cracking to road measured to be approx. 17mm wide. | <b>62-63</b> |

Cracking to road measured to be approx. 17mm wide.
