## DILAPIDATION REPORT

10 EASTERN CREEK DRIVE EASTERN CREEK, NSW, 2766

THURSDAY, 22 FEBRUARY 2024

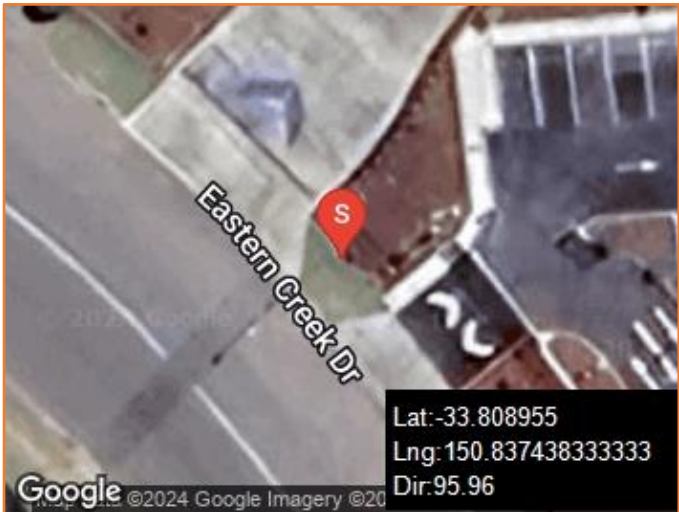
Figure 2: Good - General condition of service pit.

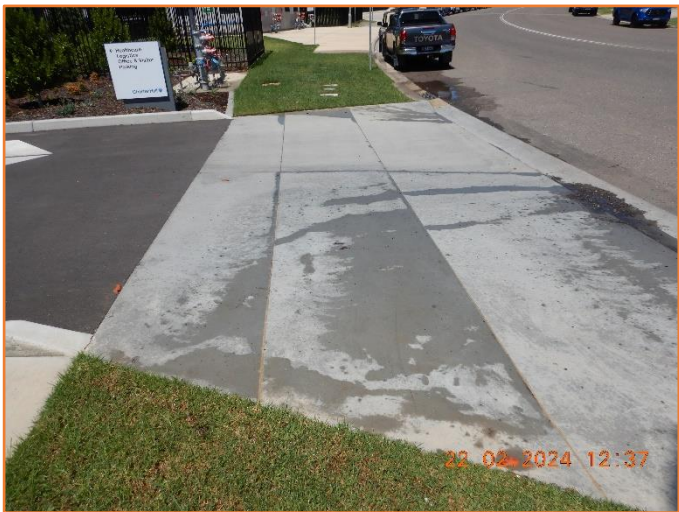
Figure 3: Reasonable - General condition of driveway crossover.

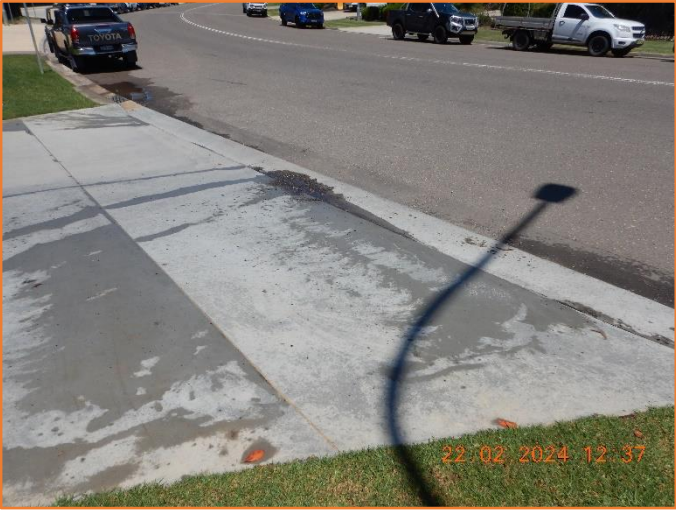
Figure 4: Reasonable - General condition of driveway crossover.

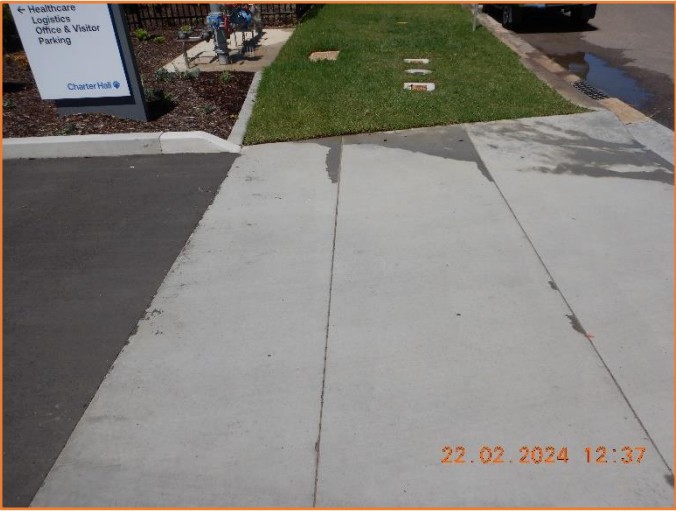
Figure 5: Reasonable - General condition of driveway crossover.

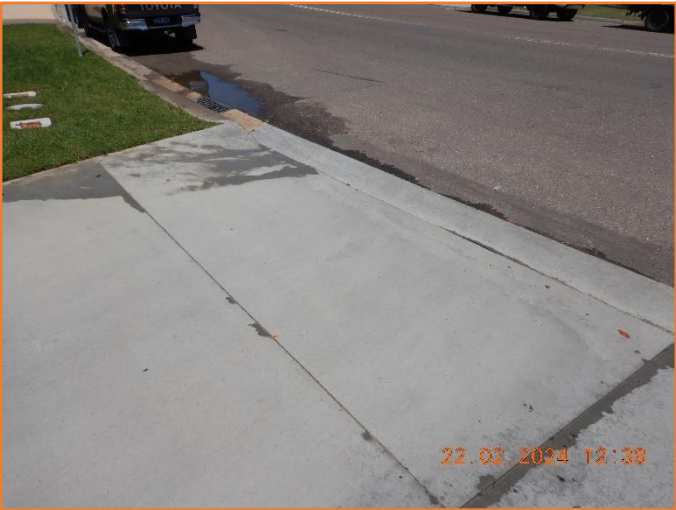
Figure 6: Reasonable - General condition of driveway crossover.

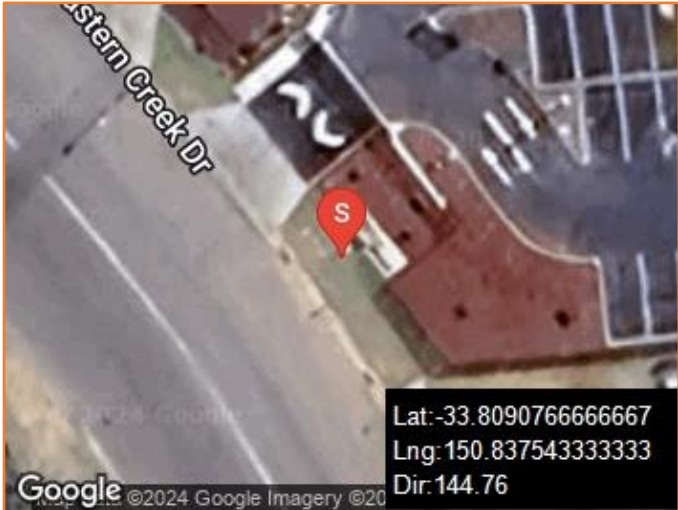
Figure 10: Reasonable - General condition of footpath.

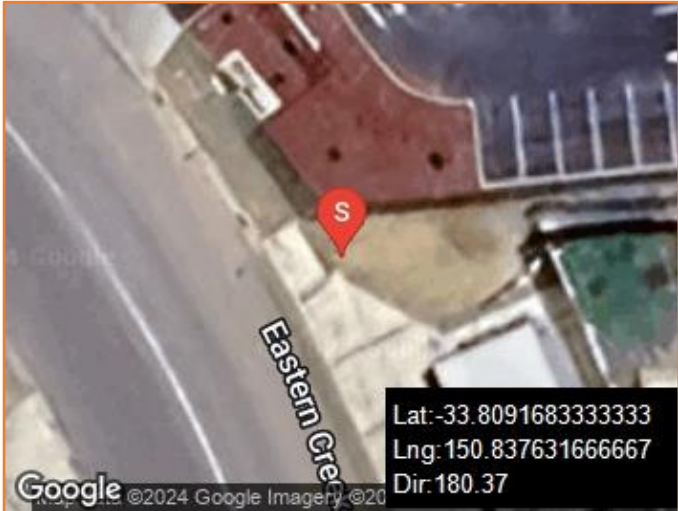
Figure 15: Good - General condition of footpath and service pits.

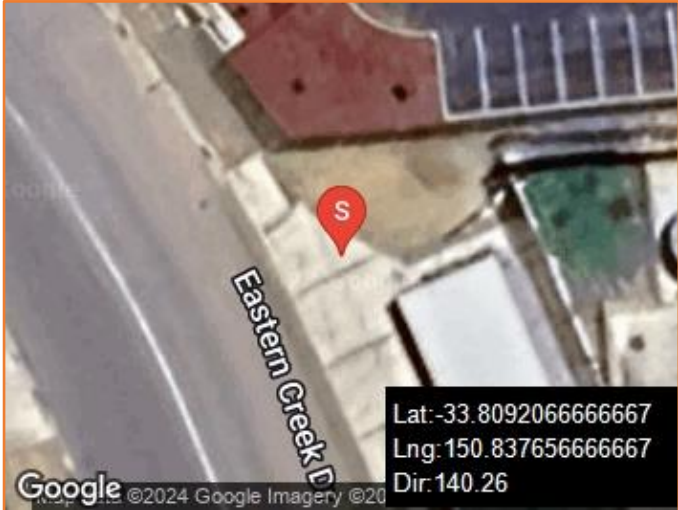
Figure 17: Reasonable - General condition of footpath.

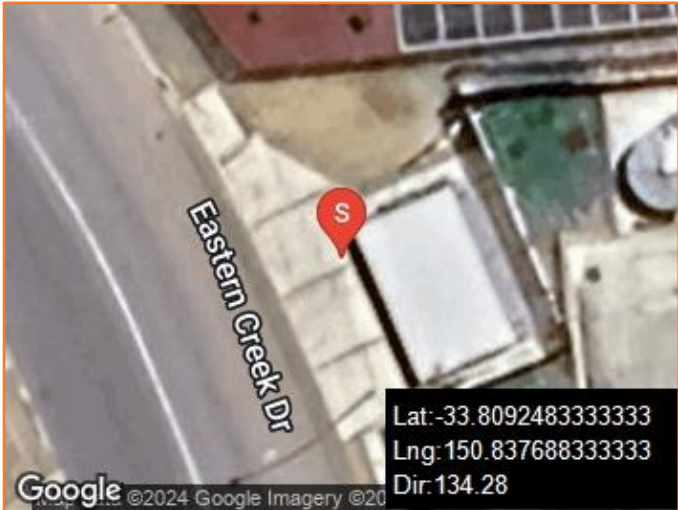
Figure 19: Reasonable - General condition of footpath.

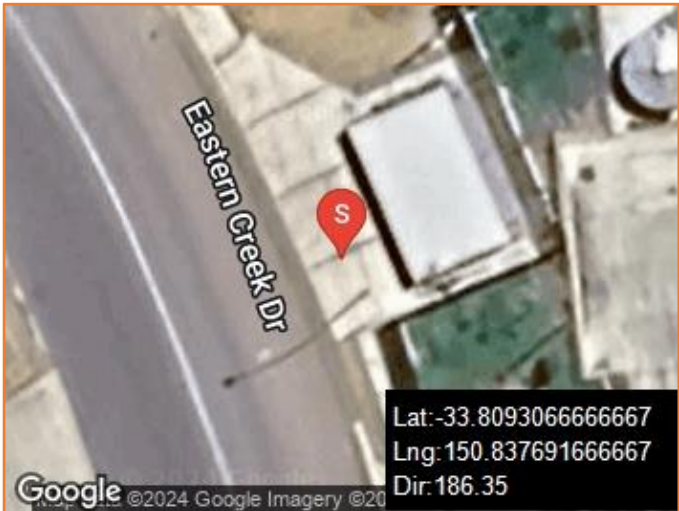
Figure 24: Reasonable - General condition of footpath.

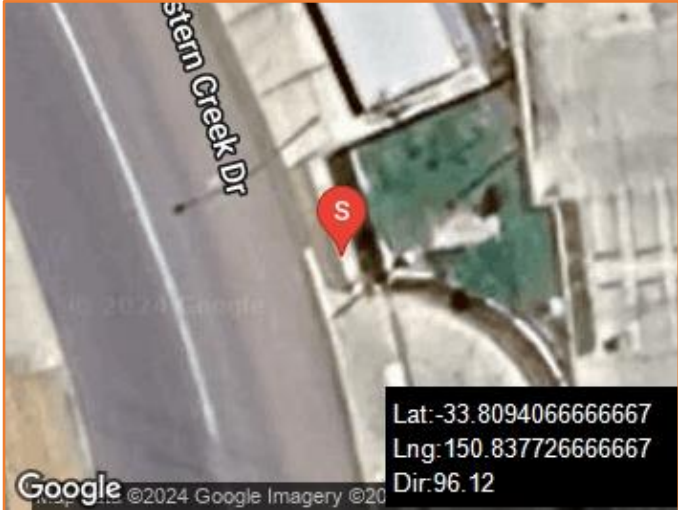
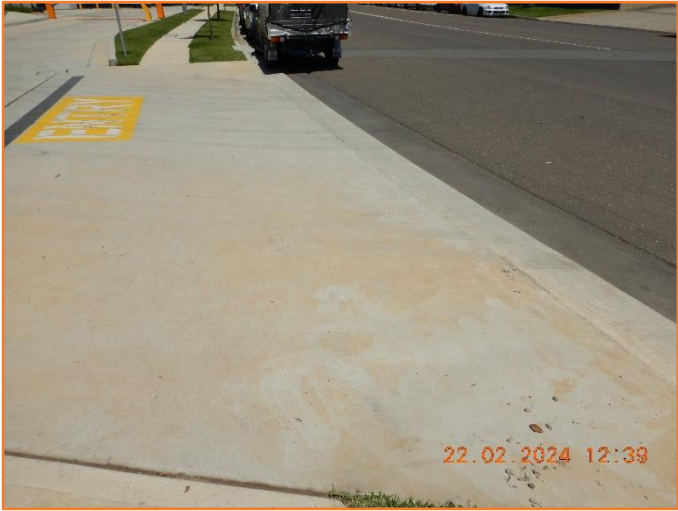
Figure 26: Reasonable - General condition of driveway crossover.

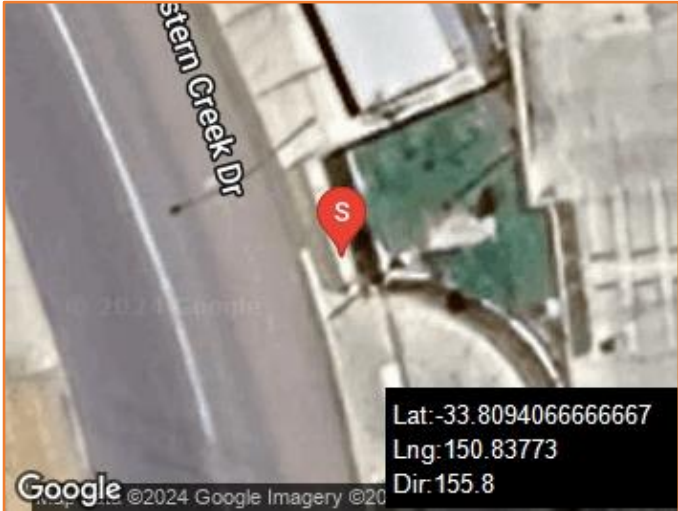
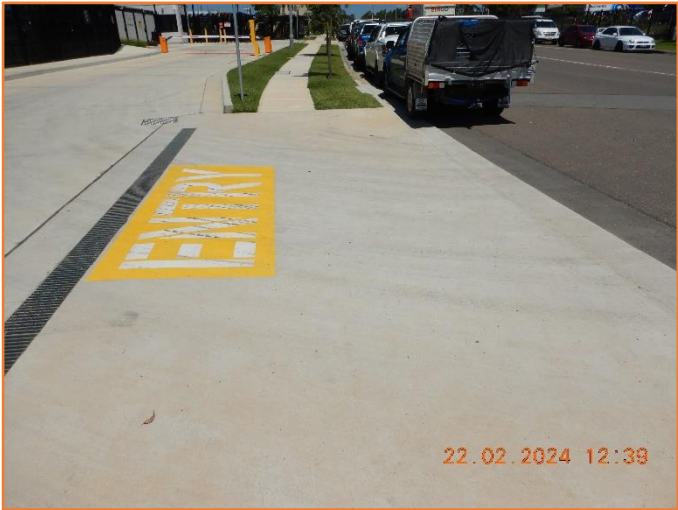
Figure 27: Reasonable - General condition of driveway crossover.

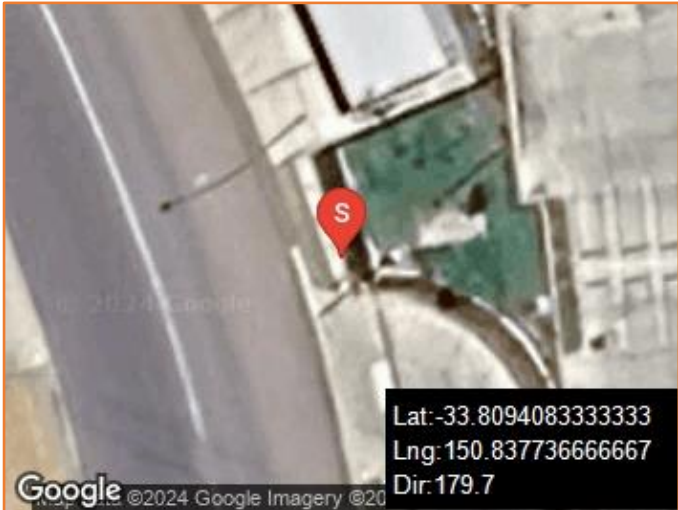
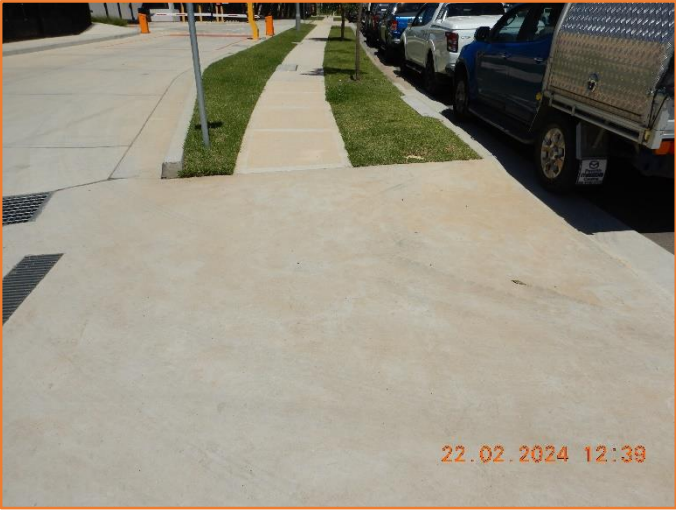
Figure 28: Reasonable - General condition of driveway crossover.

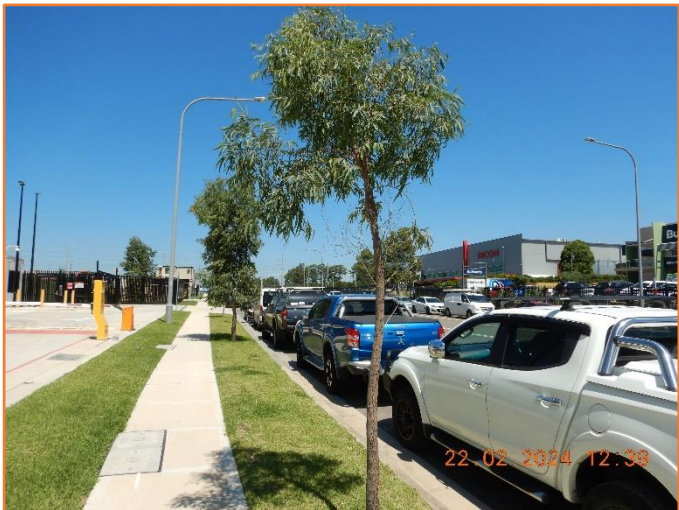
Figure 33: Good - General condition of street planting.

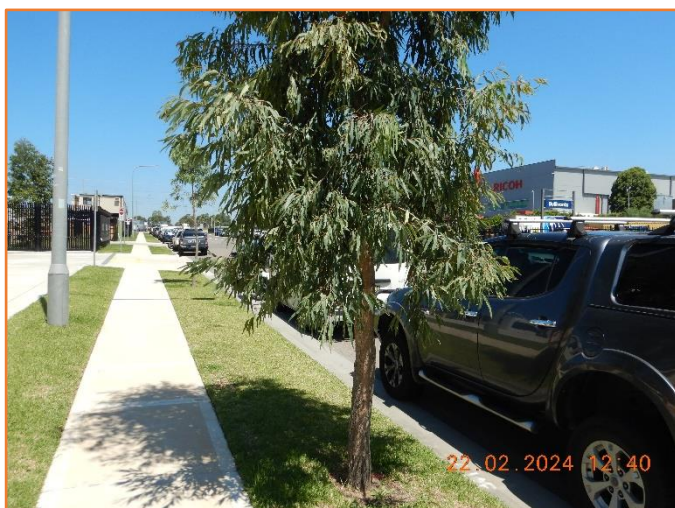
Figure 39: Good - General condition of street planting.

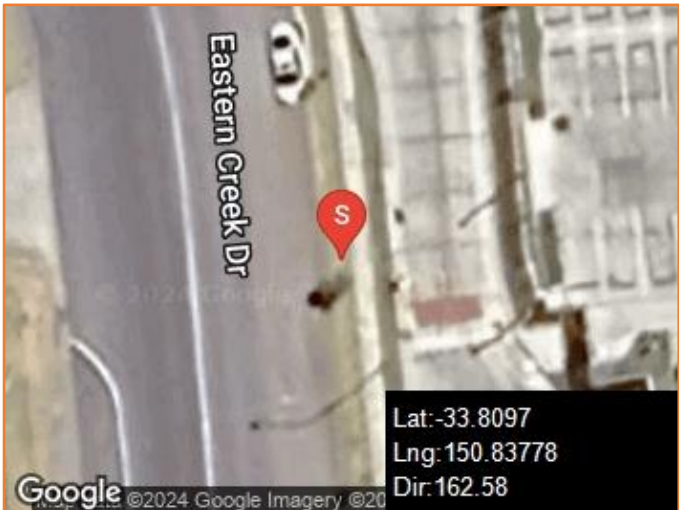
Figure 43: Good - General condition of footpath.

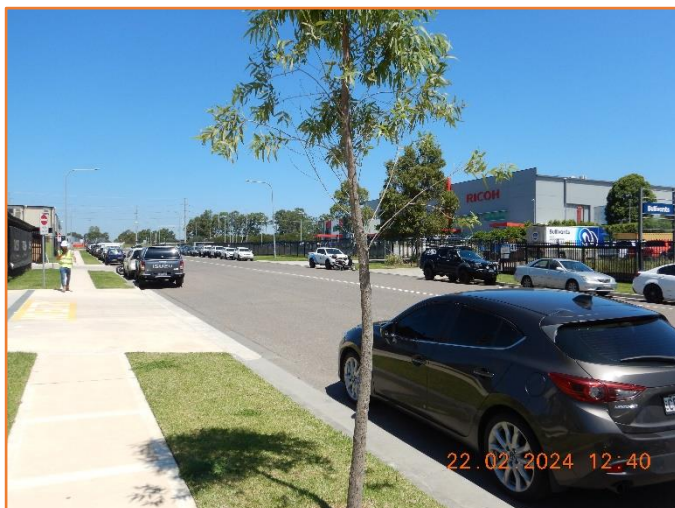
Figure 44: Good - General condition of street planting.

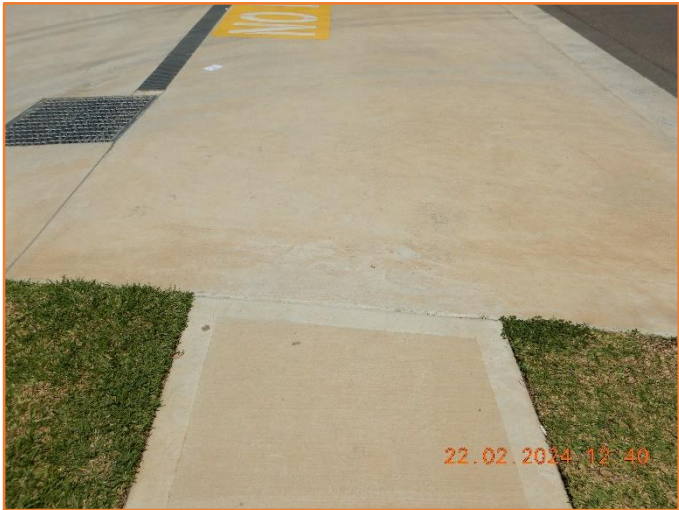
Figure 46: Reasonable - General condition of driveway crossover.

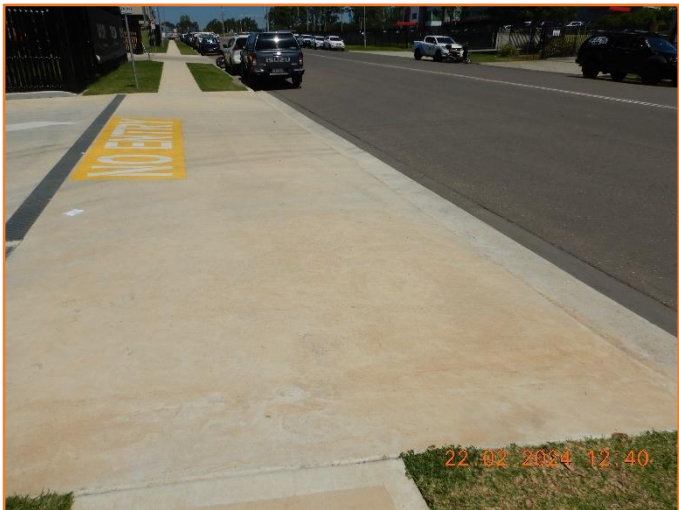
Figure 48: Reasonable - General condition of driveway crossover.

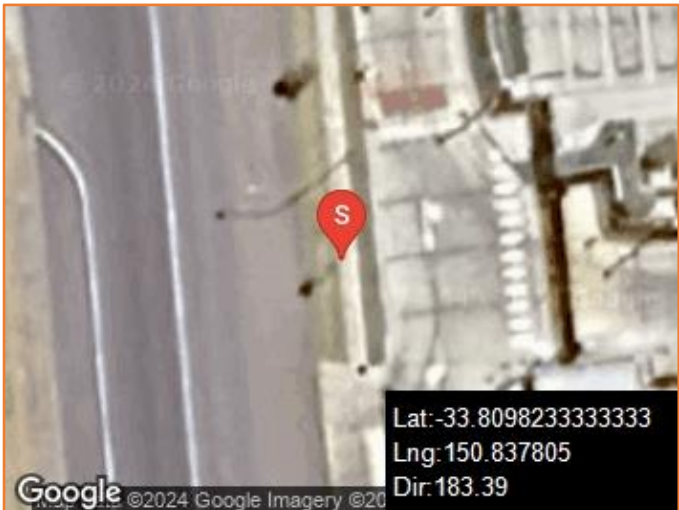
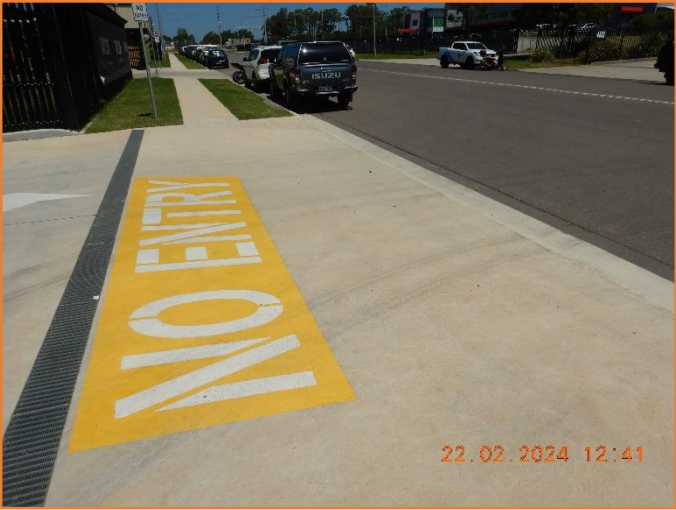
Figure 49: Reasonable - General condition of driveway crossover.

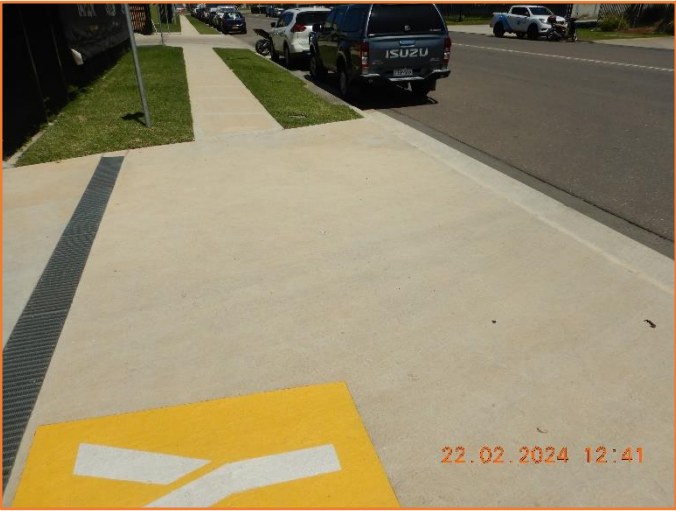
Figure 50: Reasonable - General condition of driveway crossover.

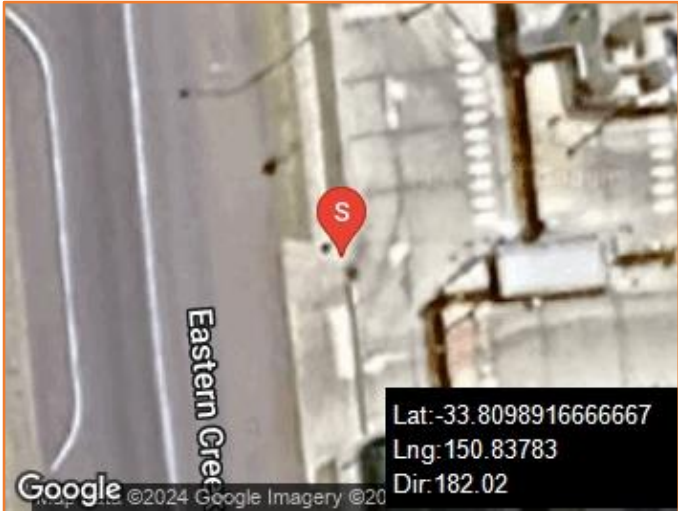
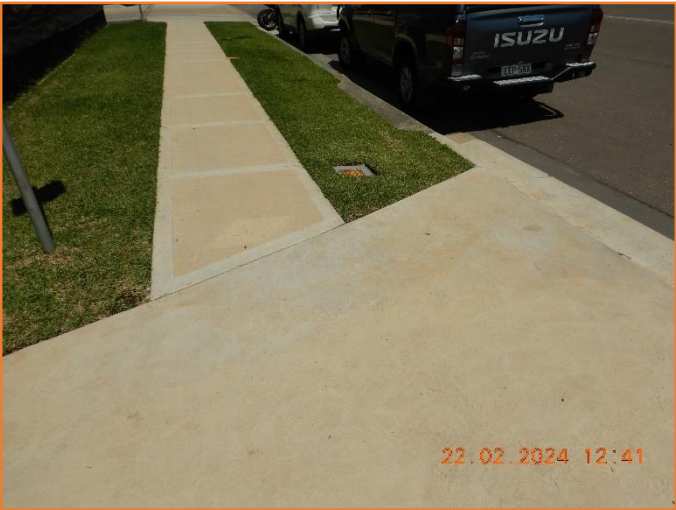
Figure 51: Reasonable - General condition of driveway crossover.

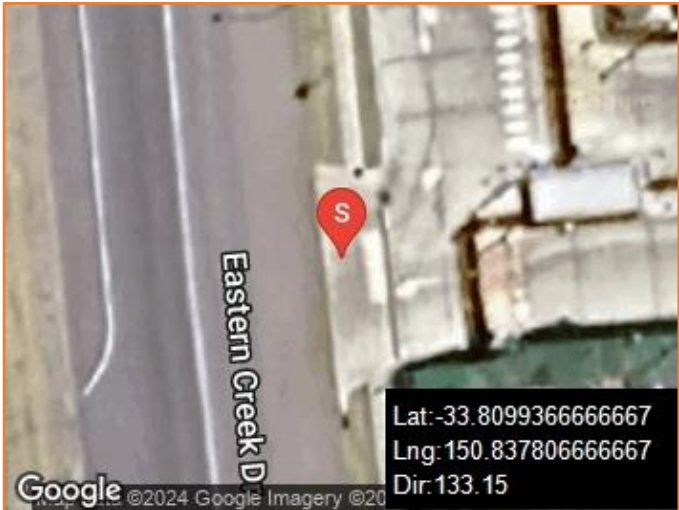
Figure 53: Good - General condition of footpath.

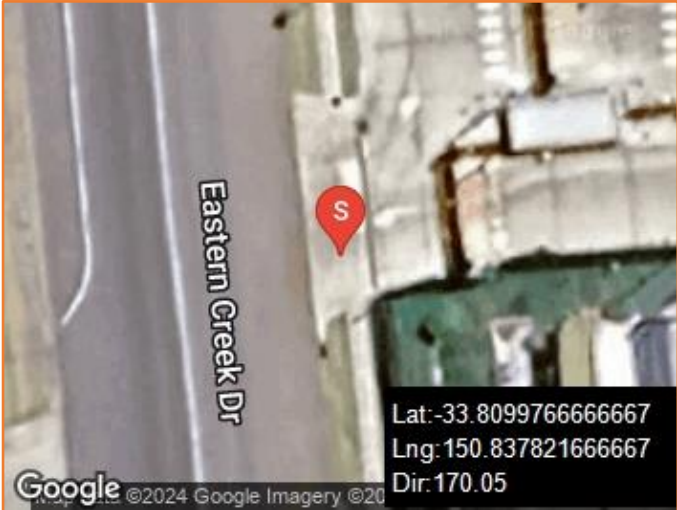
Figure 56: Good - General condition of footpath.

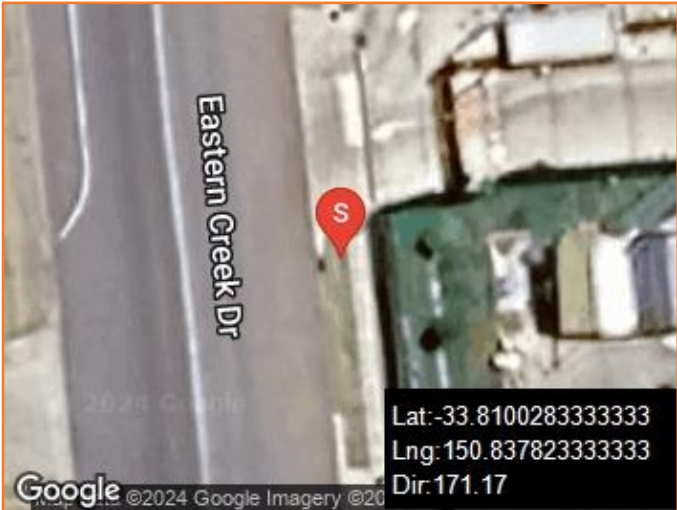
Figure 58: Good - General condition of footpath.

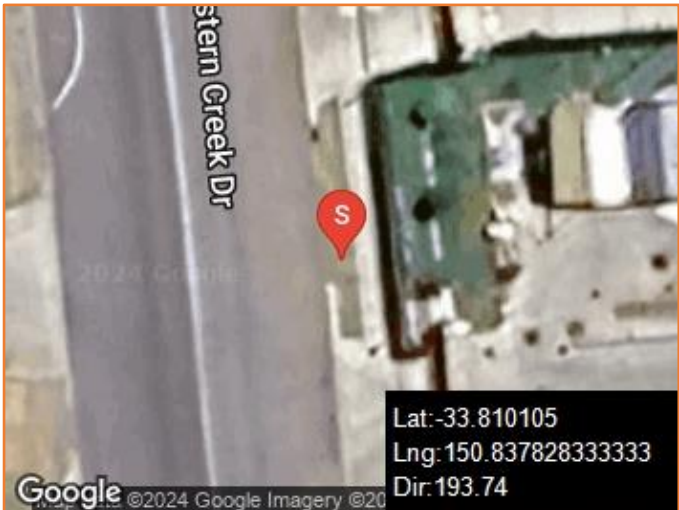
Figure 61: Good - General condition of traffic signage.

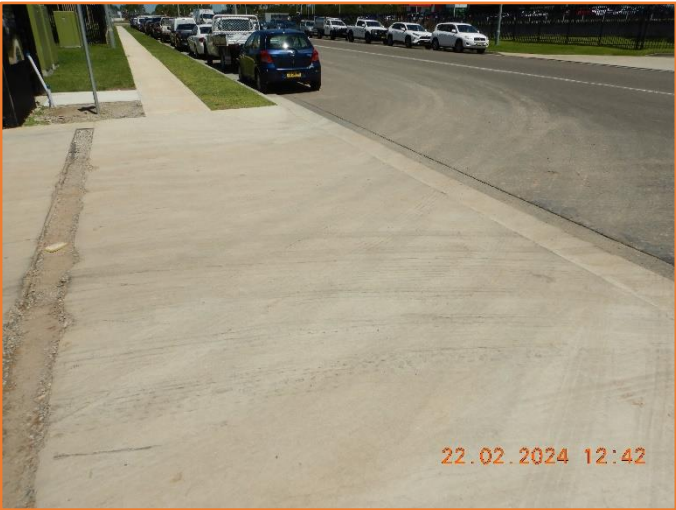
Figure 63: Reasonable - General condition of driveway crossover.

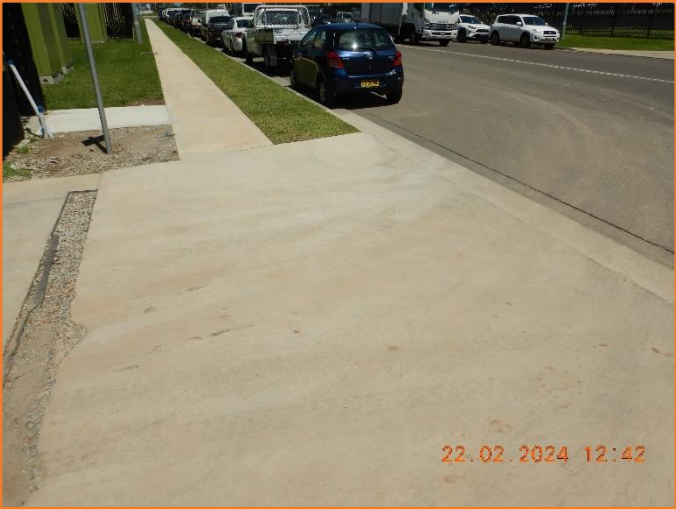
Figure 64: Reasonable - General condition of driveway crossover.

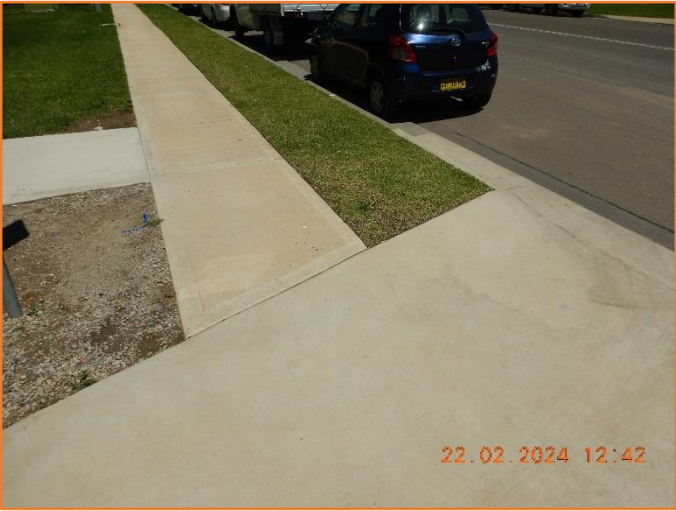
Figure 65: Reasonable - General condition of driveway crossover.

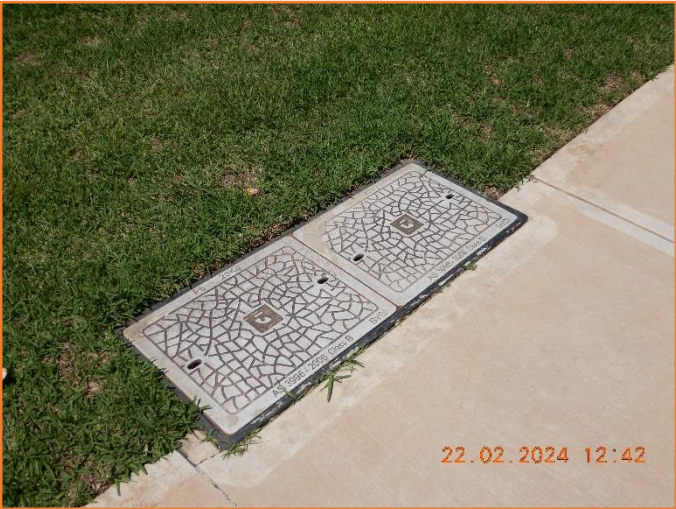
Figure 74: Reasonable - General condition of service pit. Moderate cracking observed.

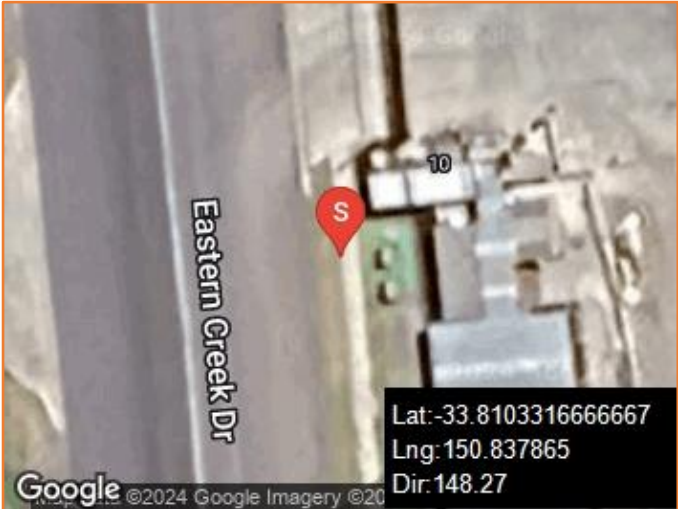
Figure 75: Good - General condition of footpath.

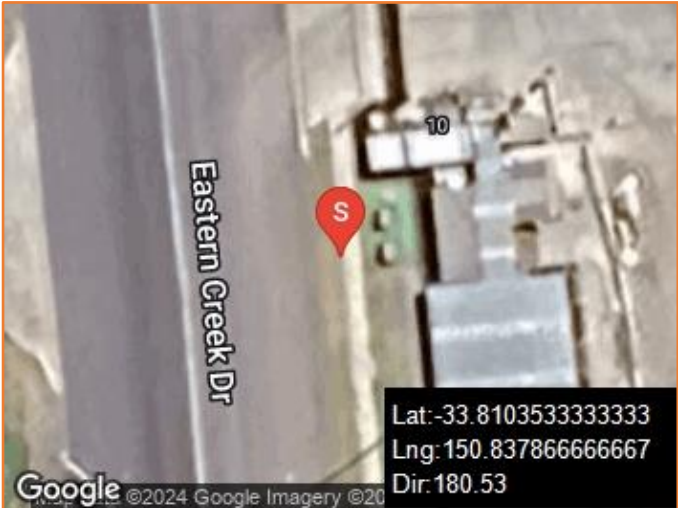
Figure 76: Good - General condition of monopole assembly.

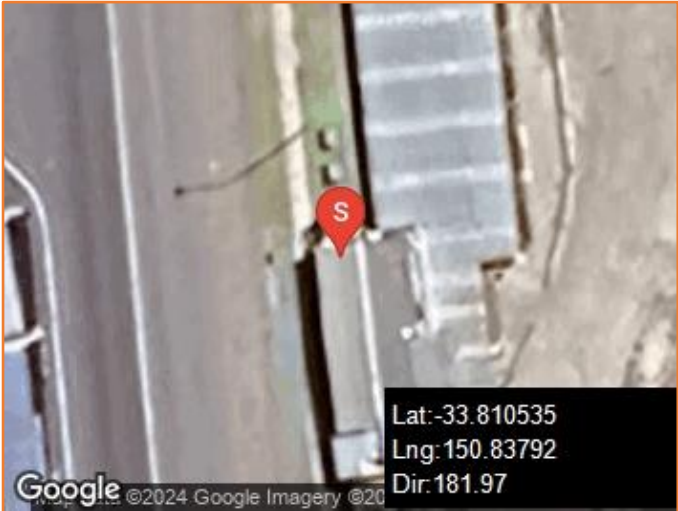
Figure 84: Good - General condition of footpath.

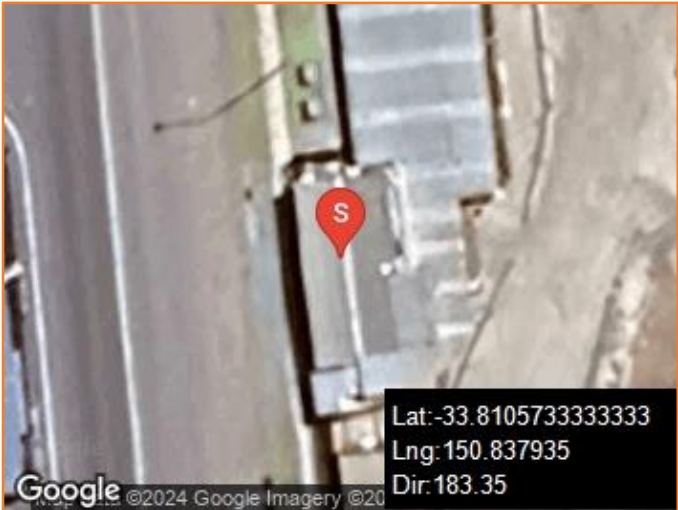
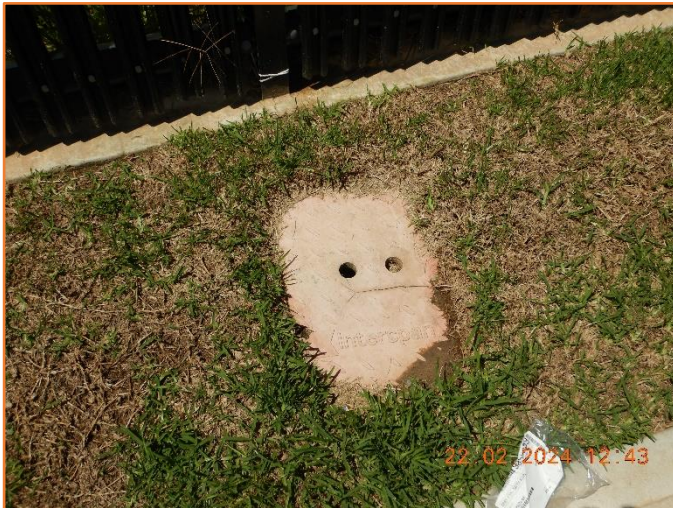
Figure 85: Reasonable - General condition of service pit. Moderate cracking observed.

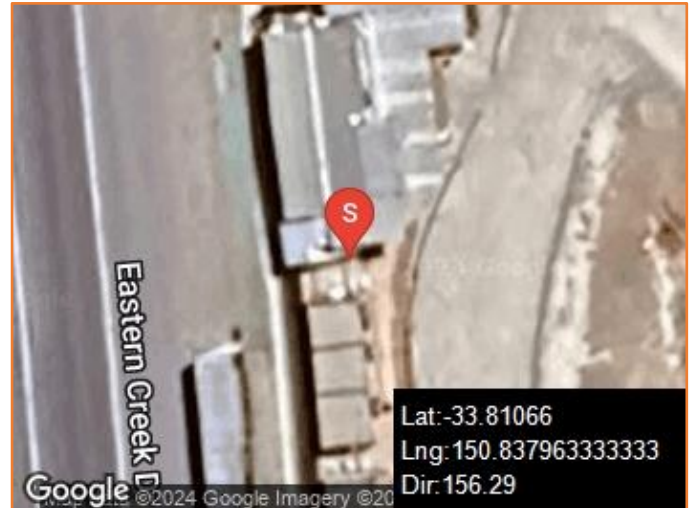
Figure 86: Good - General condition of footpath.

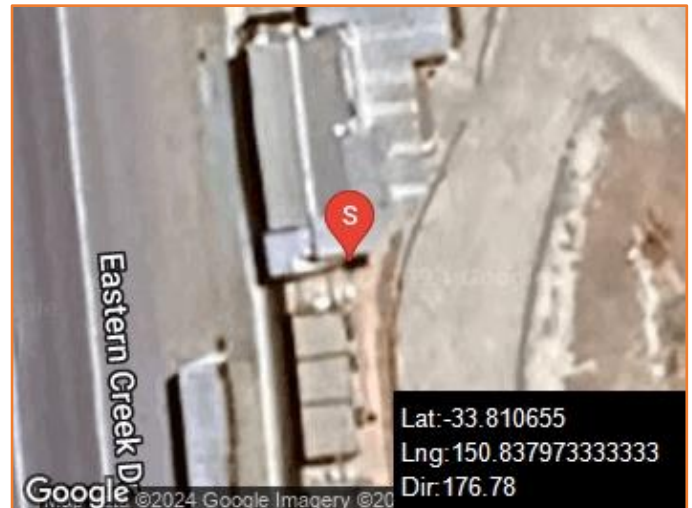
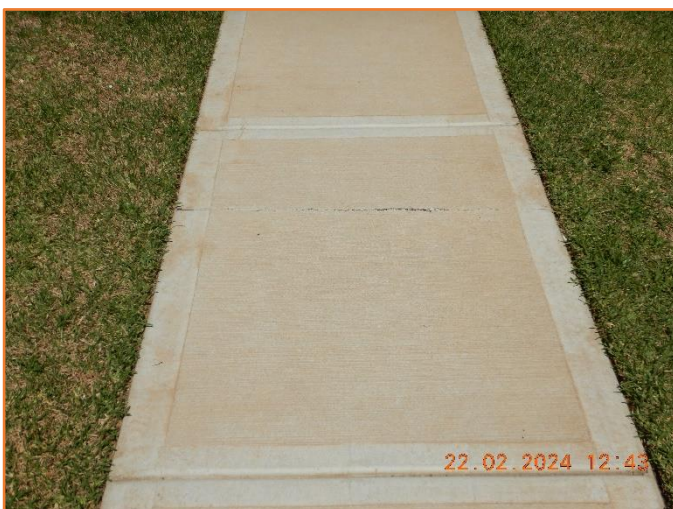
Figure 87: Reasonable - General condition of footpath. Moderate cracking observed.

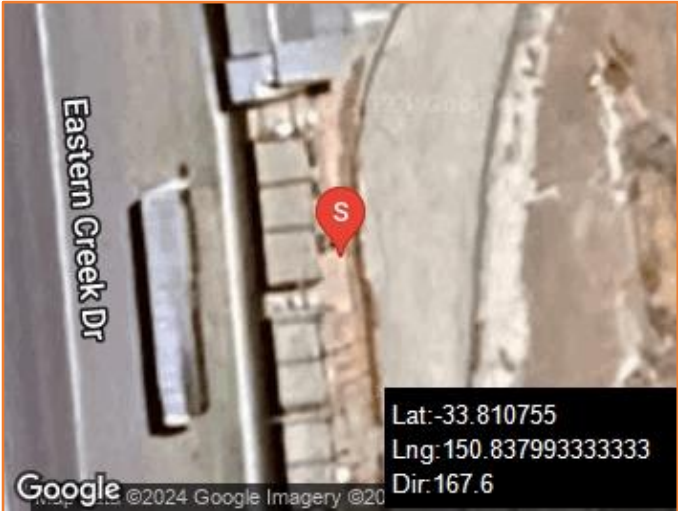
Figure 89: Good - General condition of footpath.

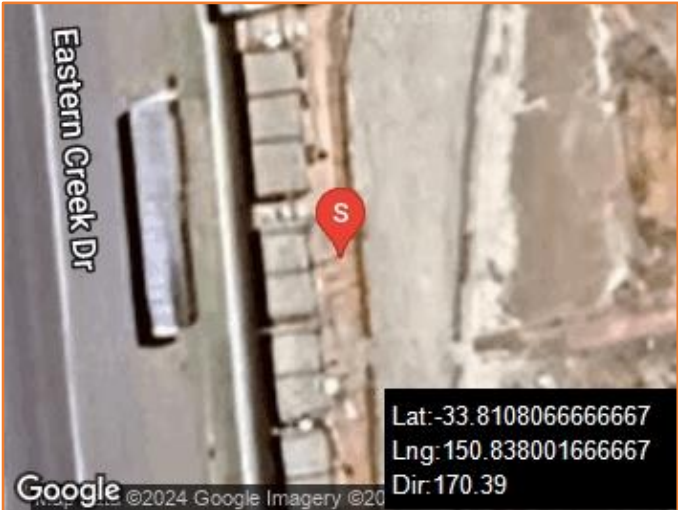
Figure 90: Good - General condition of footpath.

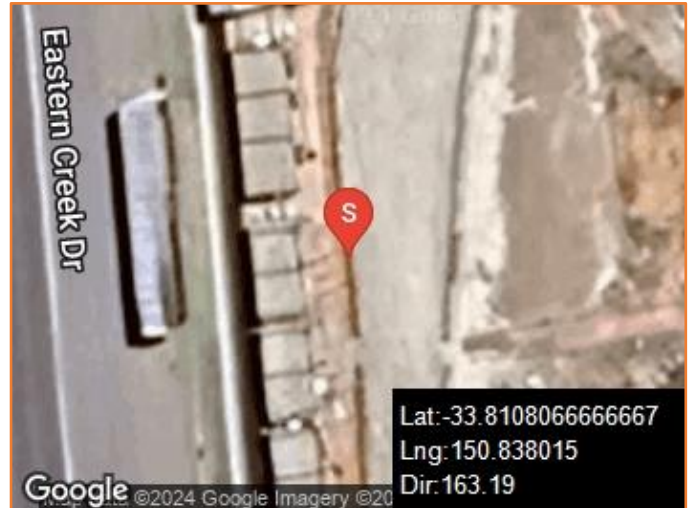
Figure 91: Good - General condition of service pit.

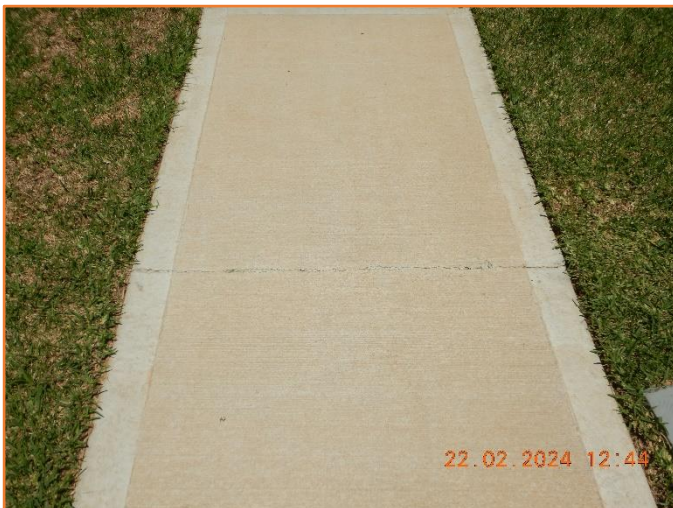
Figure 92: Reasonable - General condition of footpath. Minor hairline cracking observed.

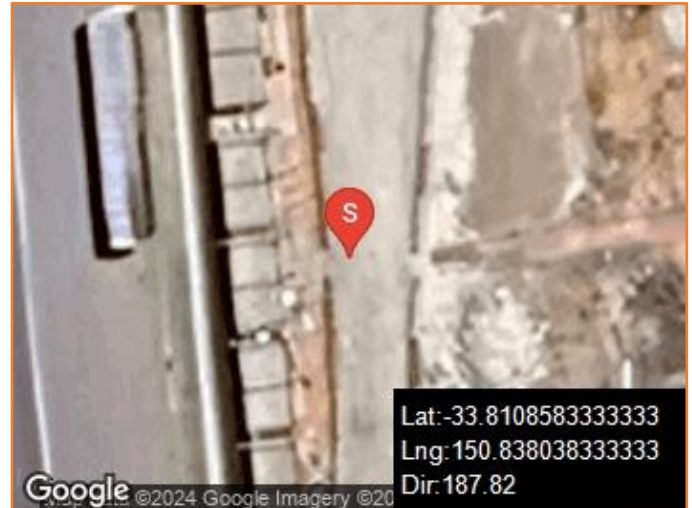
Figure 94: Good - General condition of footpath.

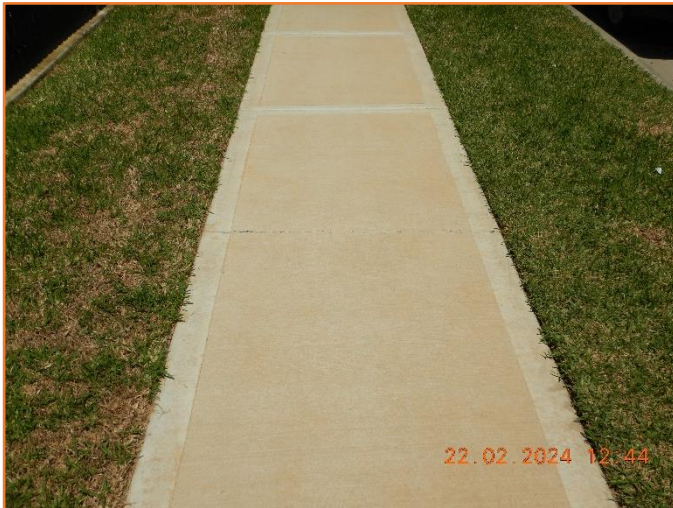
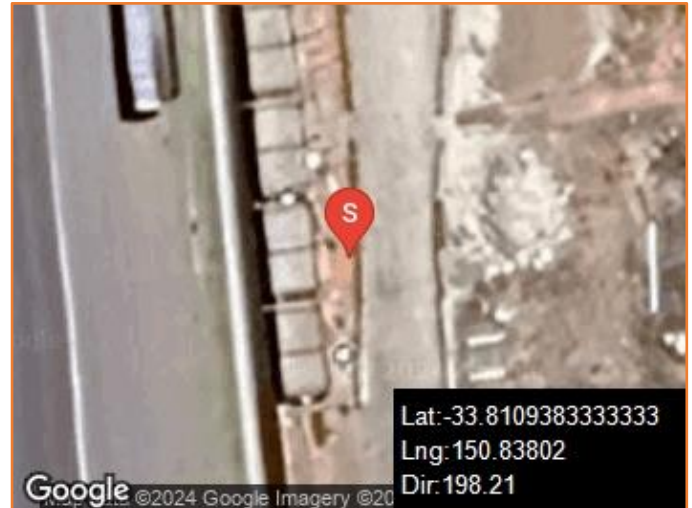
Figure 97: Reasonable - General condition of footpath. Moderate cracking observed.

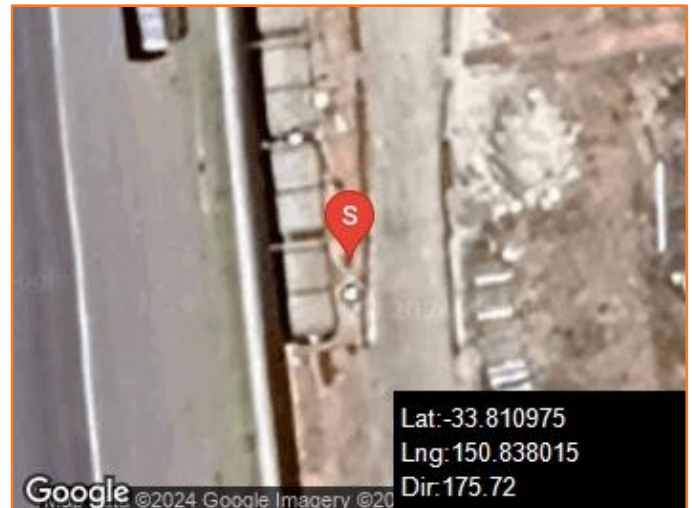
Figure 98: Good - General condition of footpath.

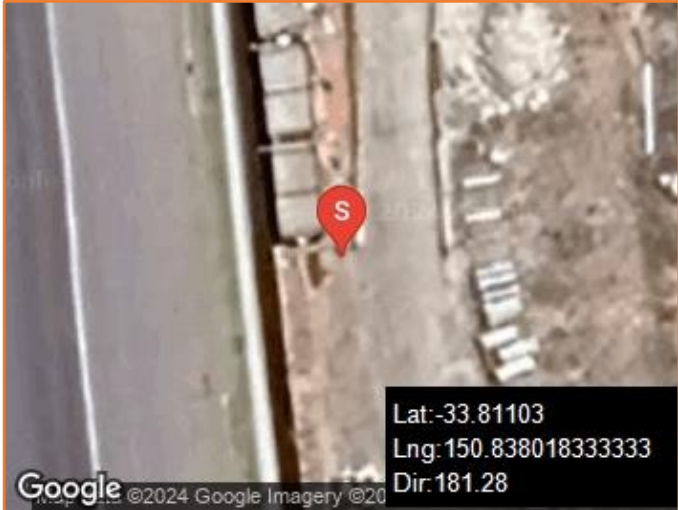
Figure 100: Good - General condition of footpath.

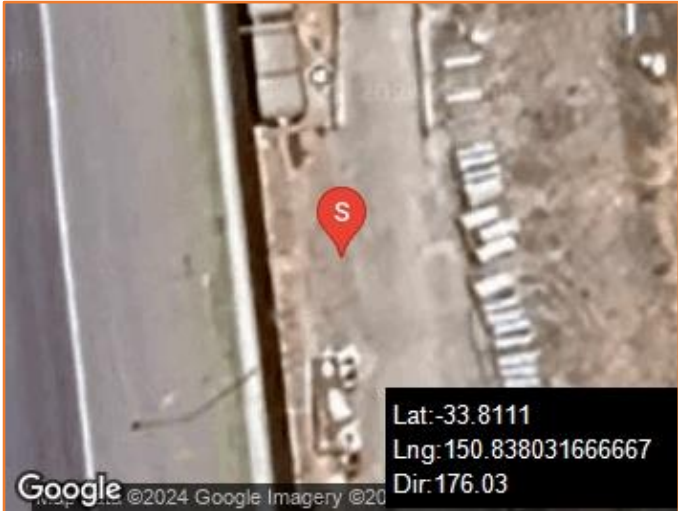
Figure 101: Good - General condition of footpath.

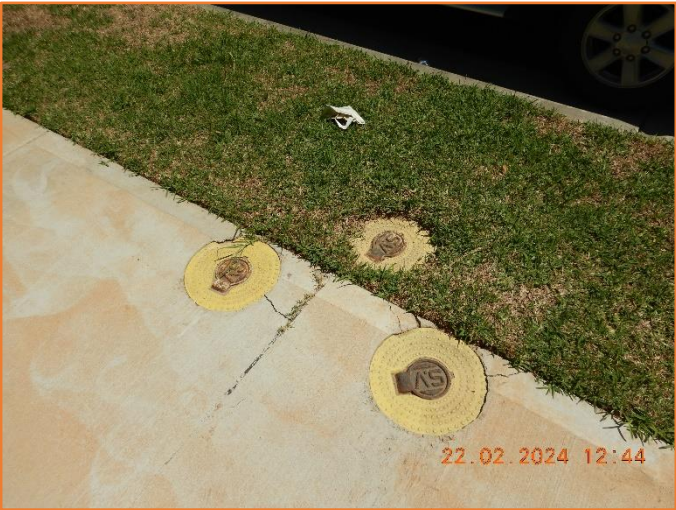
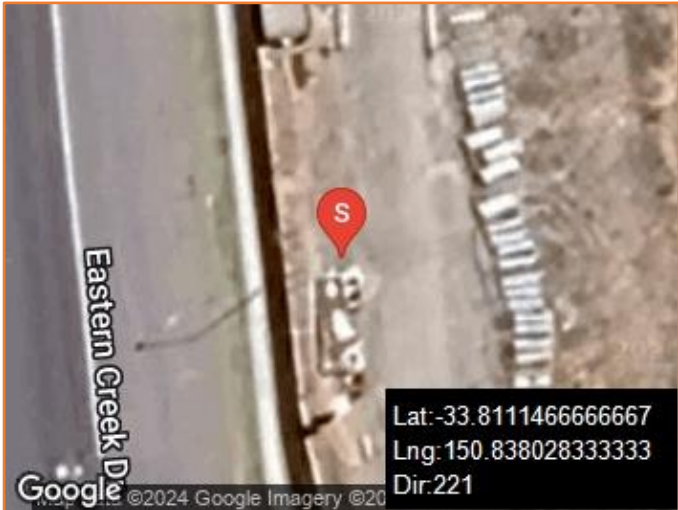
Figure 102: Reasonable - General condition of service pits. Moderate cracking observed.

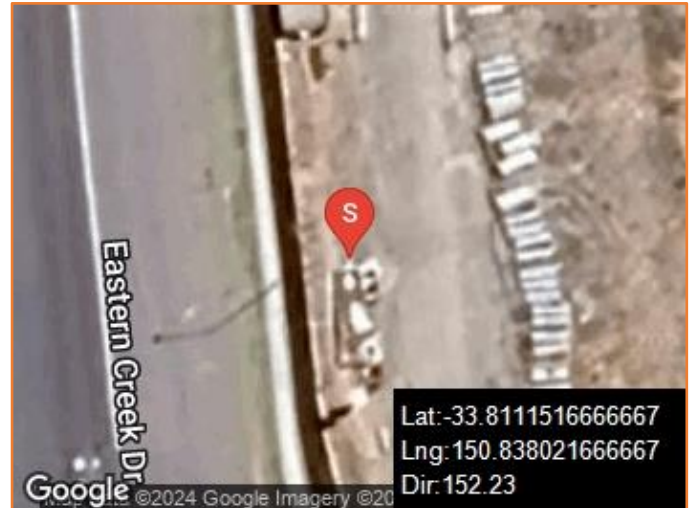
Figure 103: Good - General condition of monopole assembly.

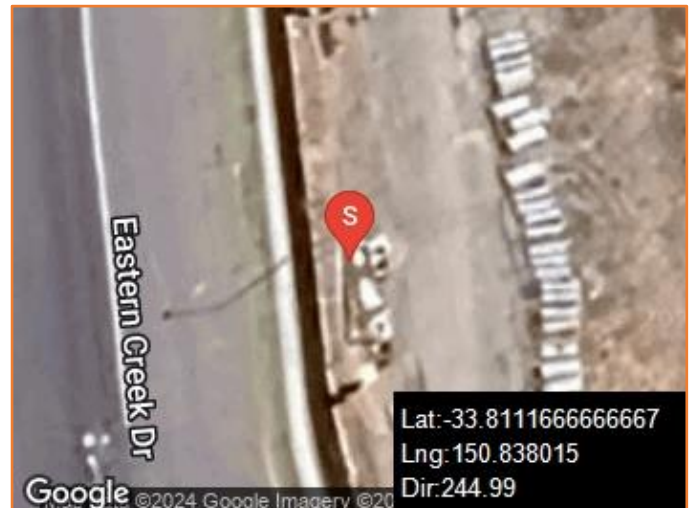
Figure 104: Good - General condition of footpath.

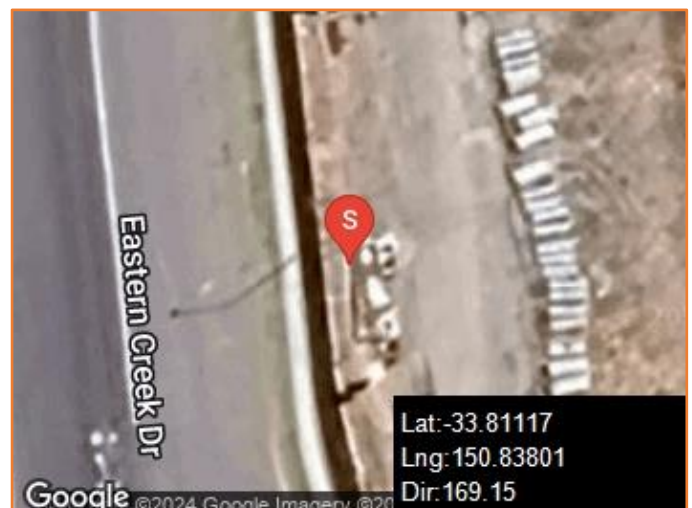
Figure 105: Reasonable - General condition of traffic signage. Moderate corrosion observed.

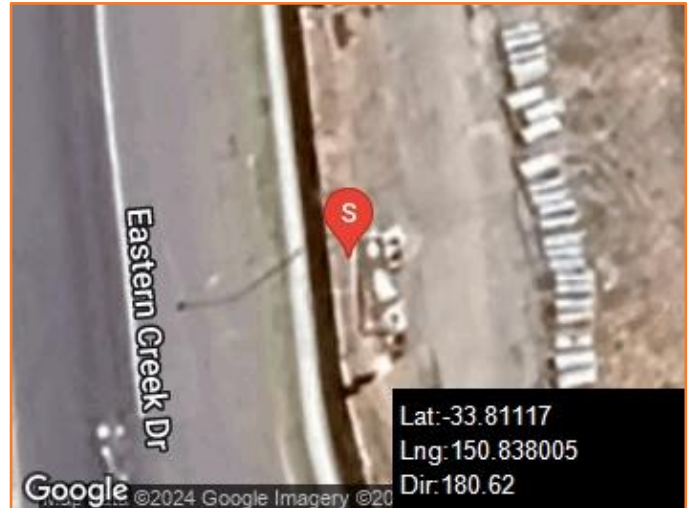
Figure 106: Good - General condition of footpath.

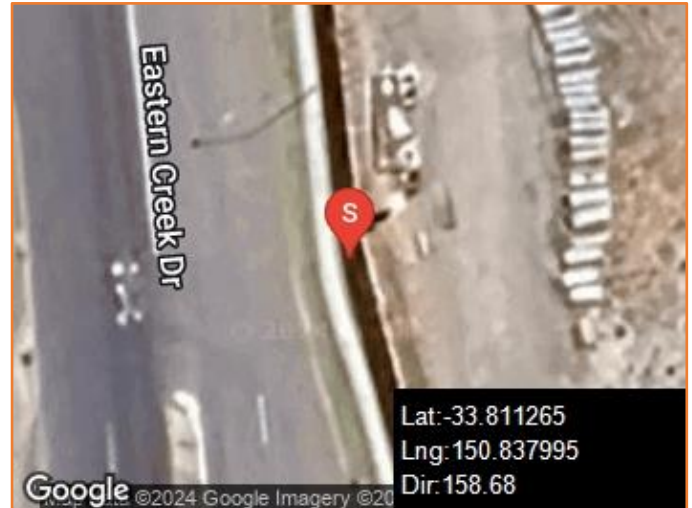
Figure 109: Good - General condition of footpath.

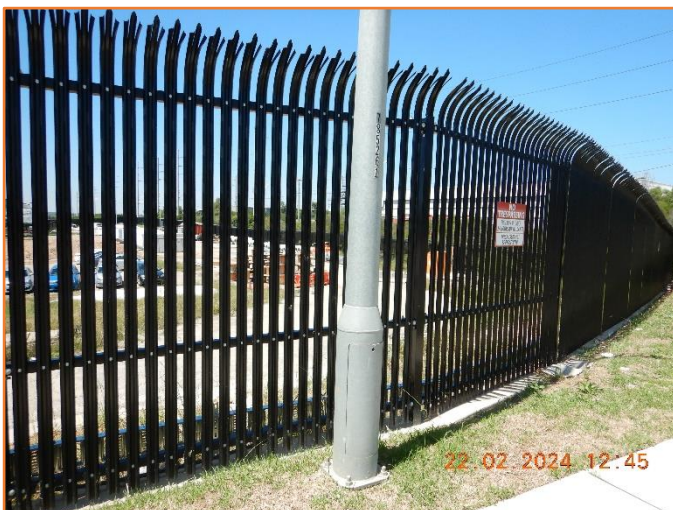
Figure 116: monopole assembly.

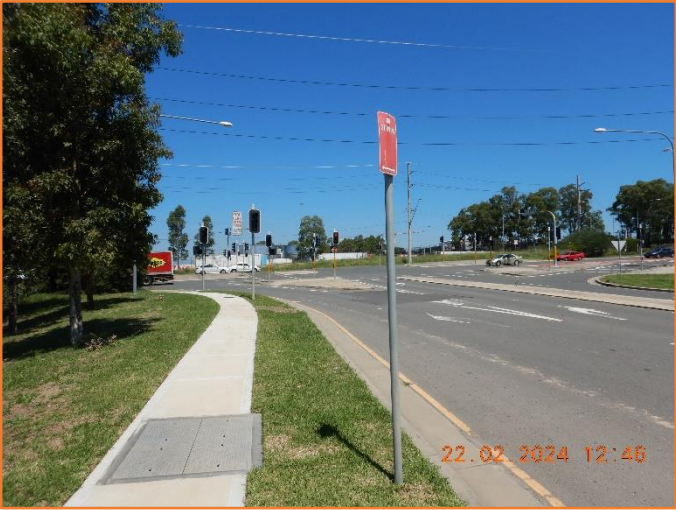
Figure 118: Reasonable - General condition of traffic signage. Minor rotation observed.

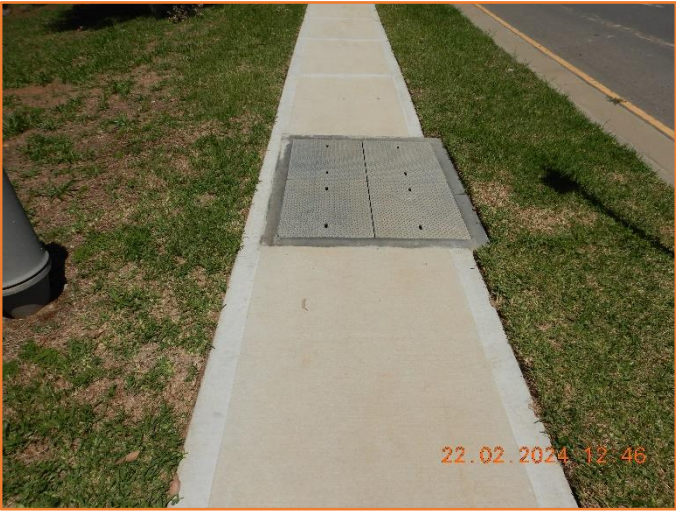
Figure 120: Reasonable - General condition of footpath and service pit.

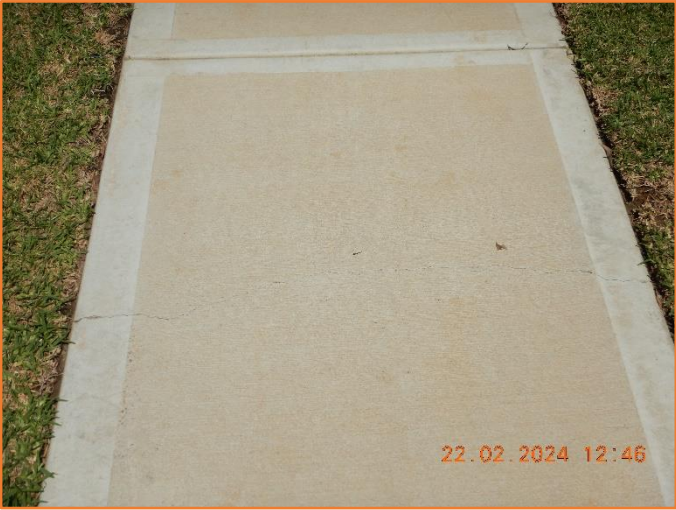
Figure 121: Reasonable - General condition of footpath. Moderate hairline cracking observed.
