## DILAPIDATION REPORT

10 EASTERN CREEK DRIVE EASTERN CREEK, NSW, 2766

THURSDAY, 22 FEBRUARY 2024

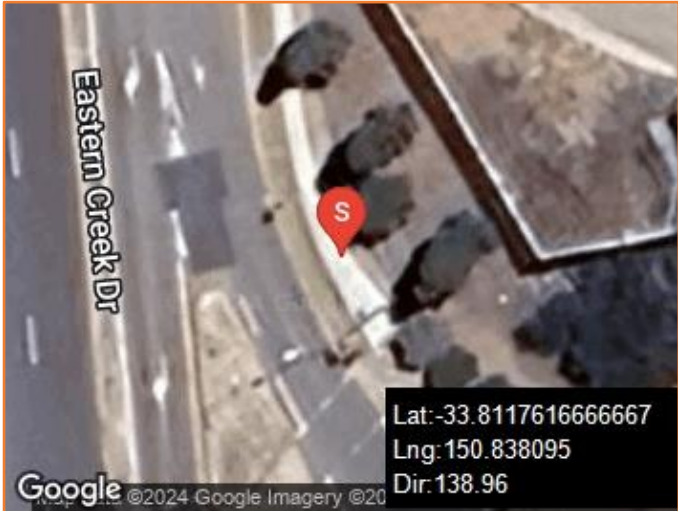
Figure 132: Reasonable - General condition of footpath.

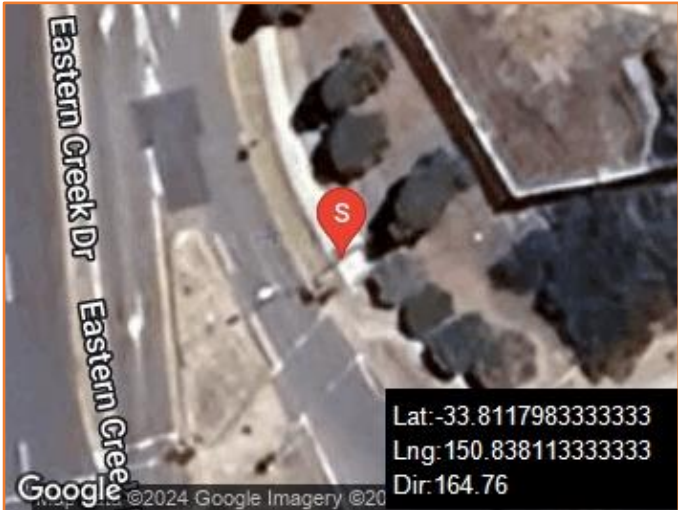
Figure 133: Reasonable - General condition of footpath.

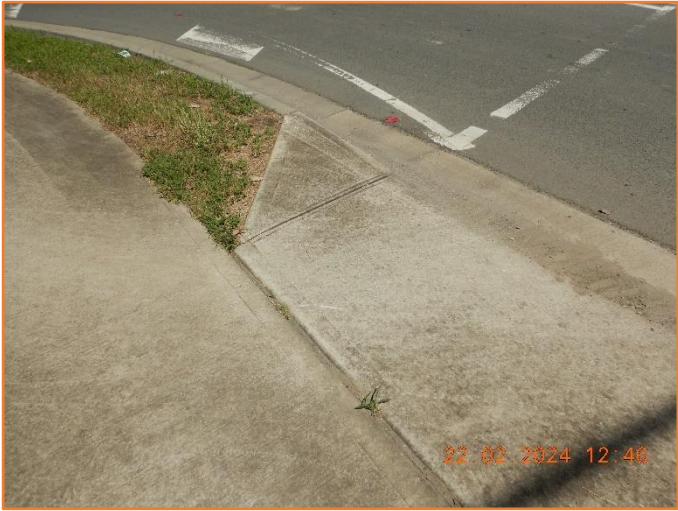
Figure 134: Reasonable - General condition of footpath and pram ramp.

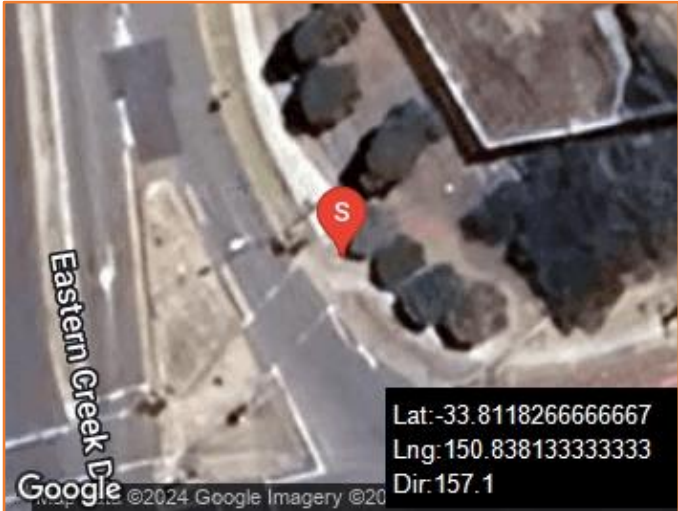
Figure 135: Reasonable - General condition of footpath.

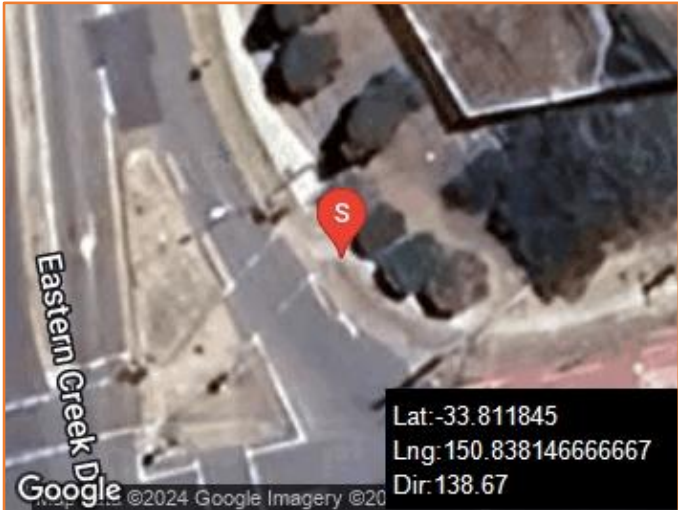
Figure 136: Reasonable - General condition of flexible pavement.

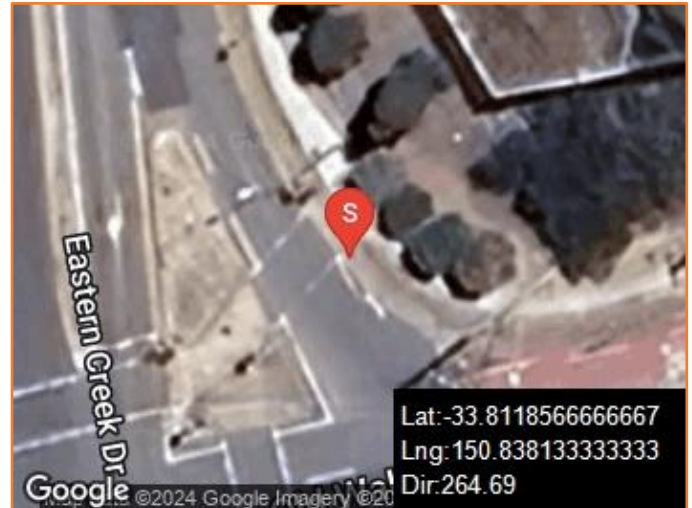
Figure 137: Reasonable - General condition of flexible pavement.

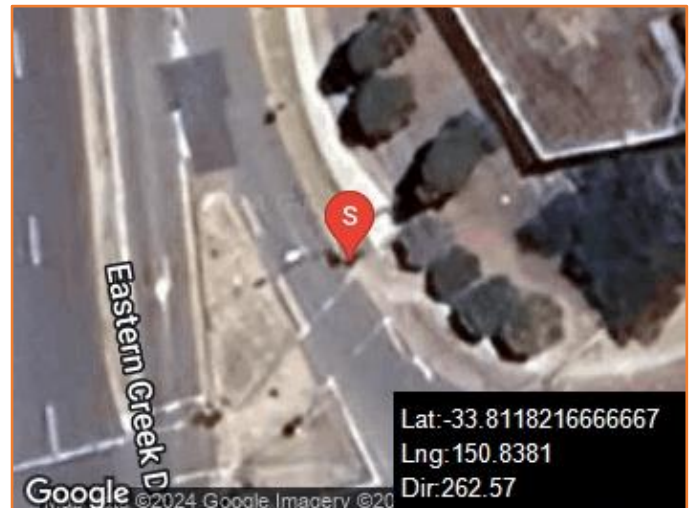
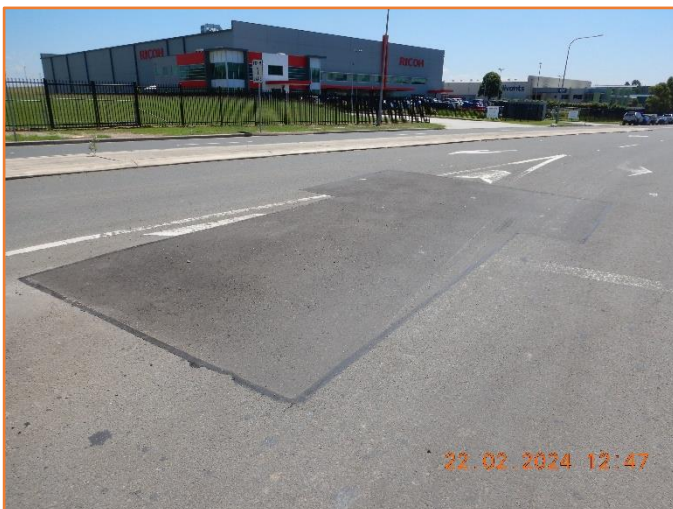
Figure 138: Reasonable - General condition of flexible pavement. Previous repair observed.

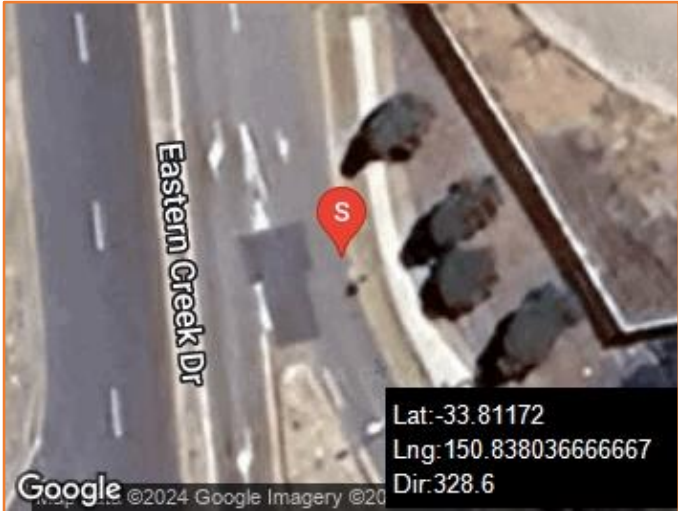
Figure 141: Reasonable - General condition of flexible pavement.

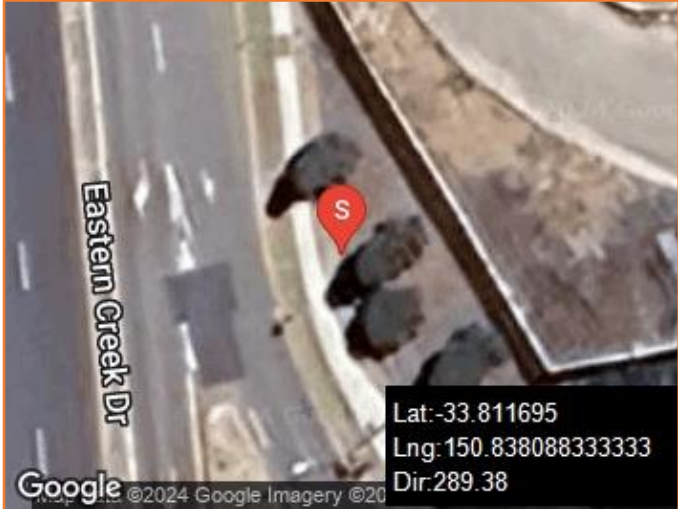
Figure 142: Reasonable - General condition of flexible pavement.

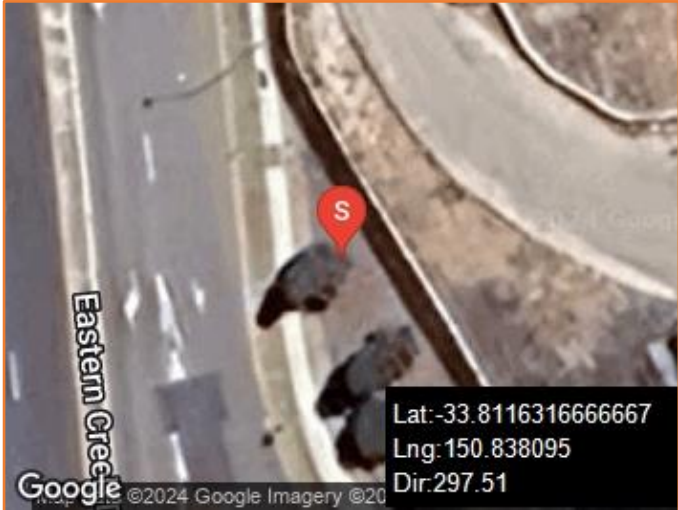
Figure 143: Reasonable - General condition of flexible pavement.

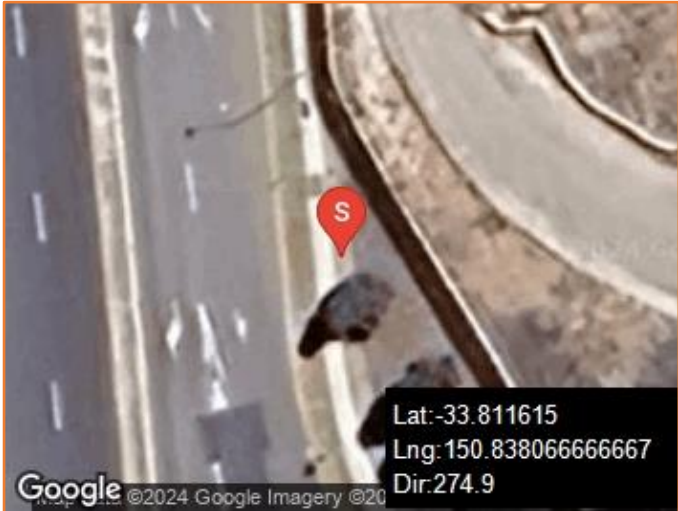
Figure 144: Reasonable - General condition of flexible pavement.

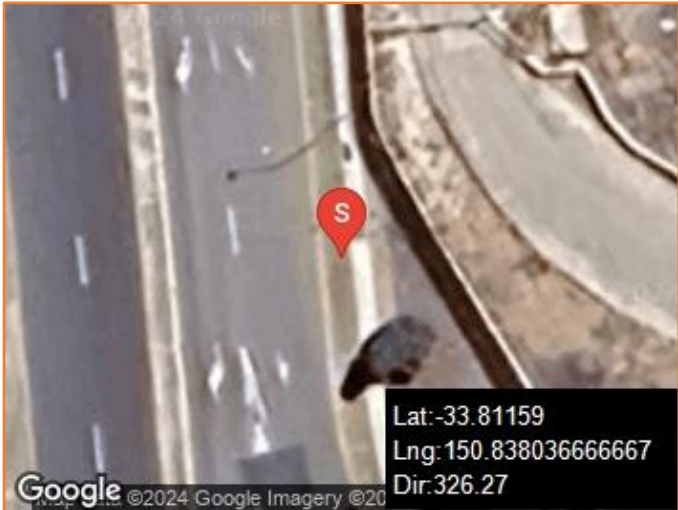
Figure 145: Reasonable - General condition of flexible pavement.

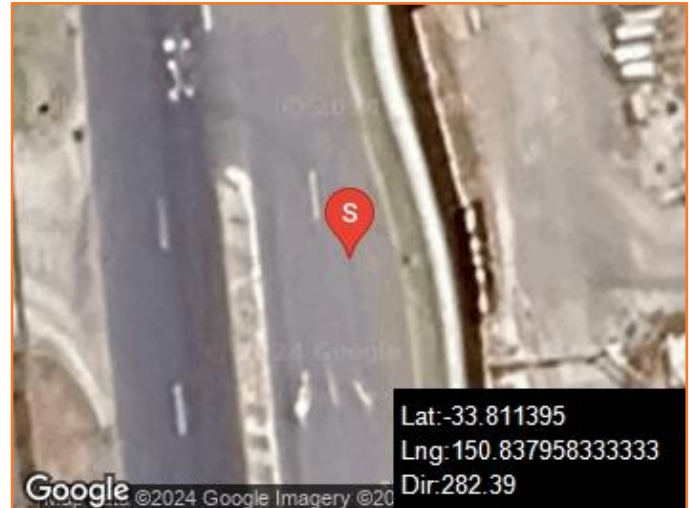
Figure 152: Reasonable - General condition of flexible pavement.  
 Moderate alligator cracking observed.

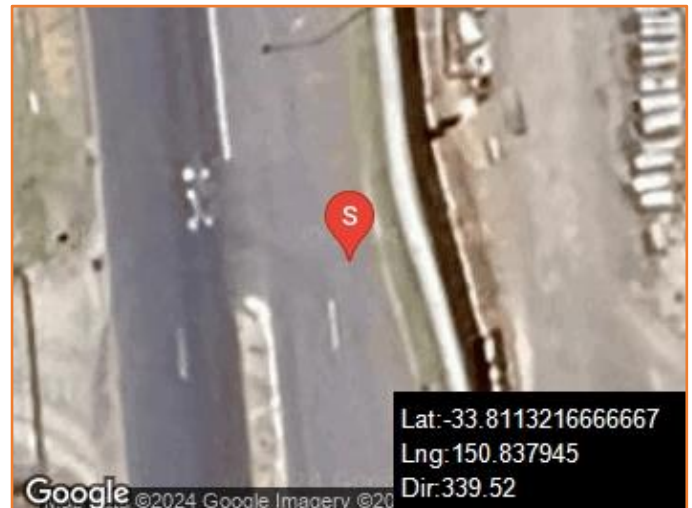
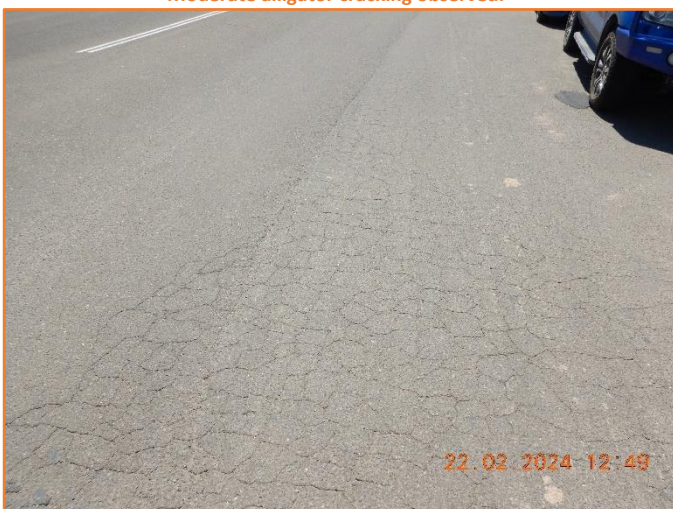
Figure 153: Reasonable - General condition of flexible pavement.  
 Moderate alligator cracking observed.

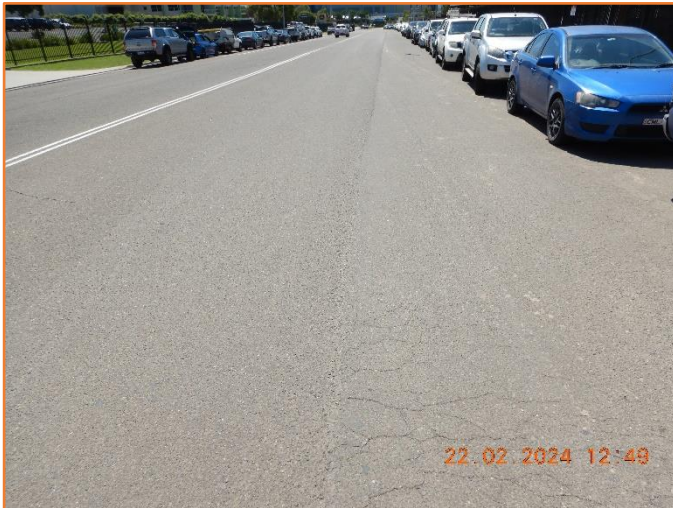
Figure 154: Reasonable - General condition of flexible pavement.  
Moderate alligator cracking observed.

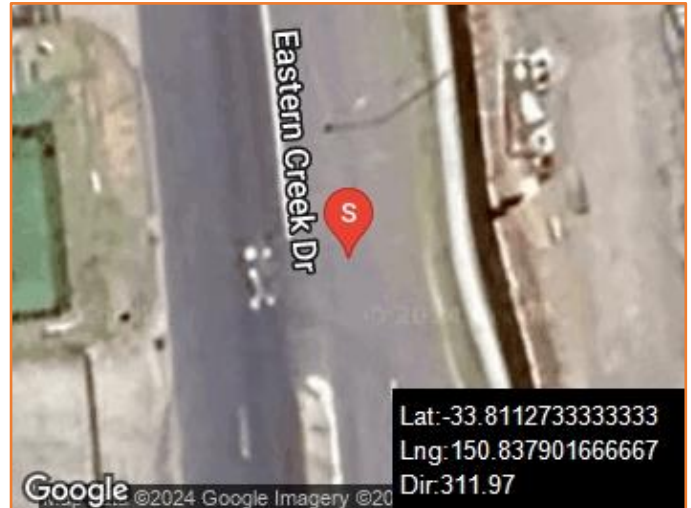
Figure 155: Reasonable - General condition of flexible pavement.

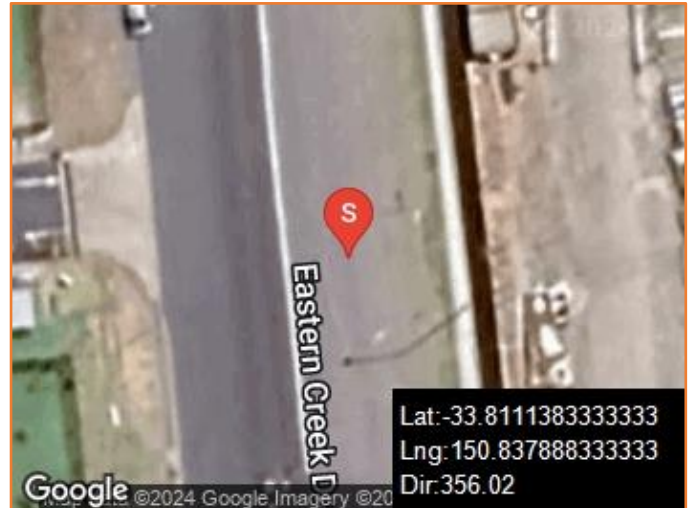
Figure 158: Reasonable - General condition of flexible pavement.

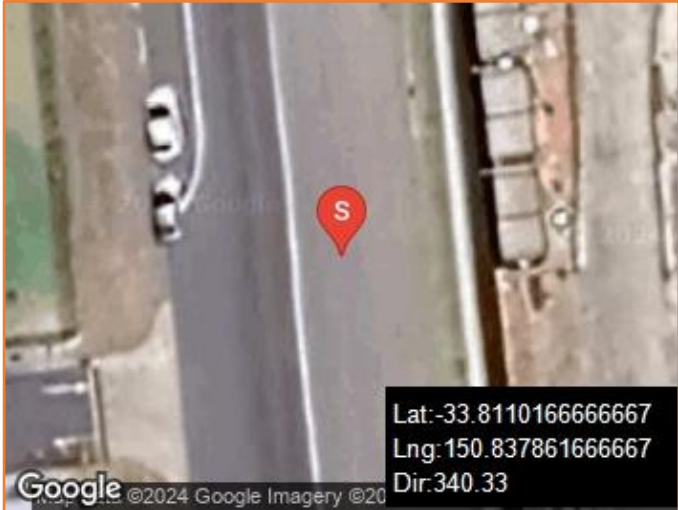
Figure 161: Reasonable - General condition of flexible pavement.

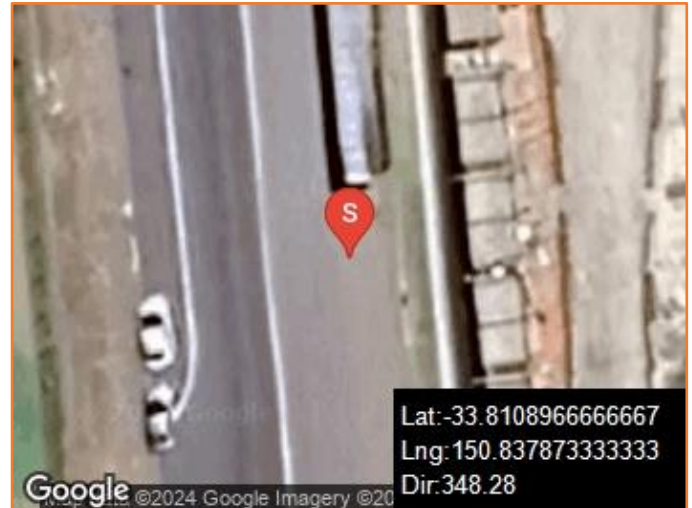
Figure 164: Reasonable - General condition of flexible pavement.

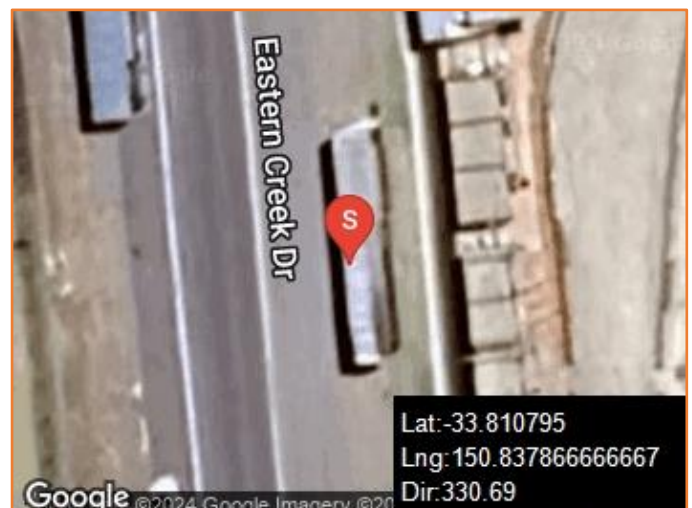
Figure 166: Reasonable - General condition of flexible pavement.

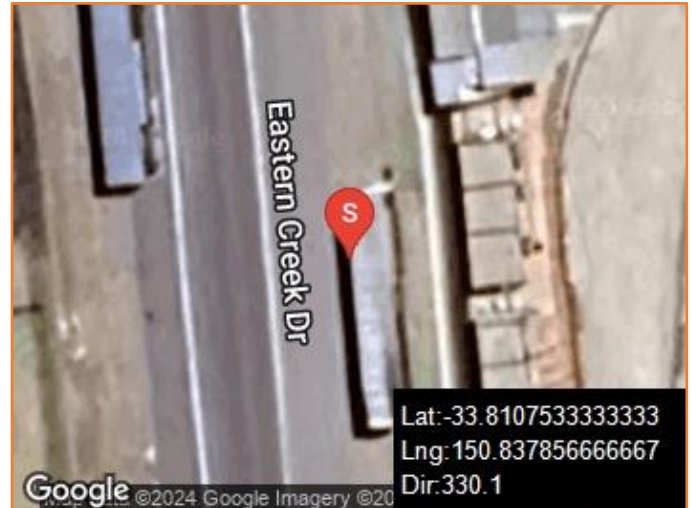
Figure 167: Reasonable - General condition of flexible pavement.

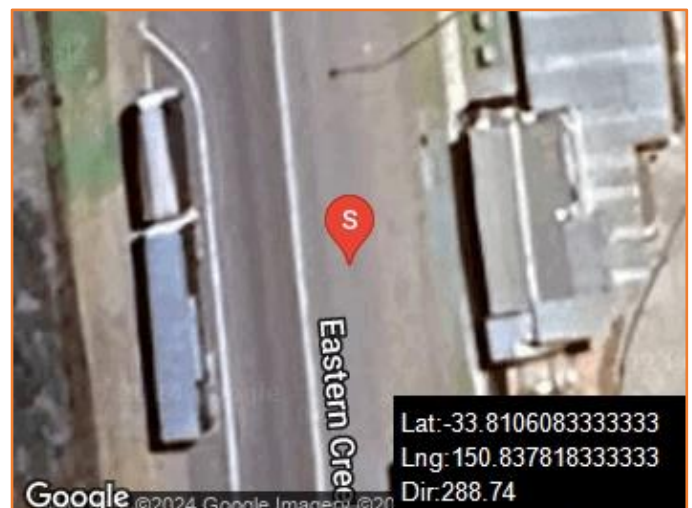
Figure 169: Reasonable - General condition of flexible pavement.

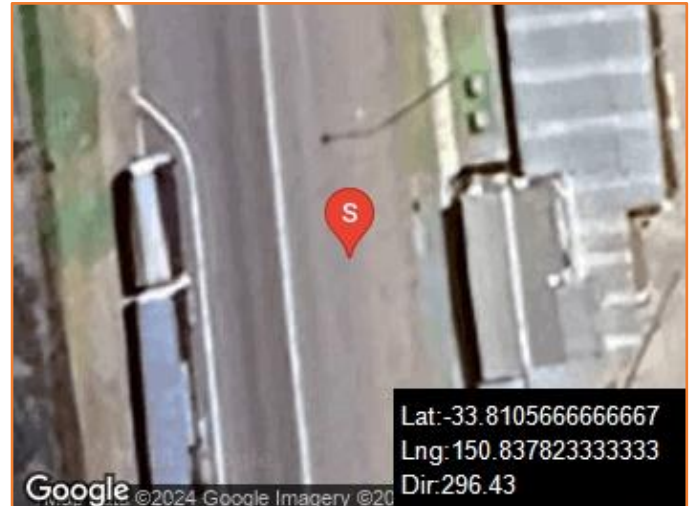
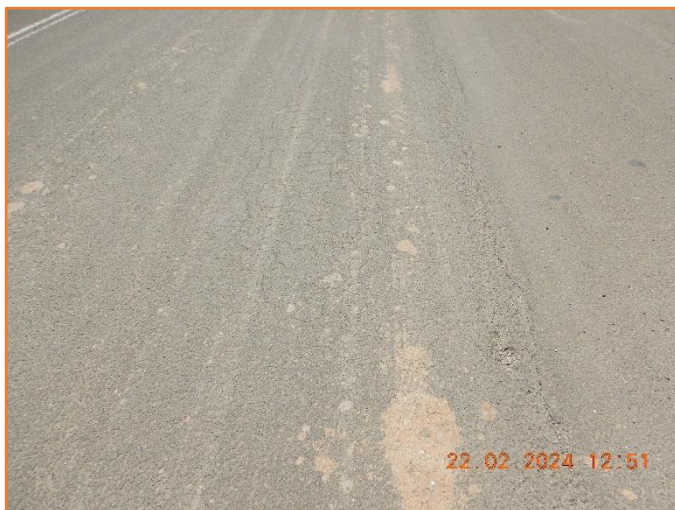
Figure 170: Reasonable - General condition of flexible pavement.  
Moderate alligator cracking observed.

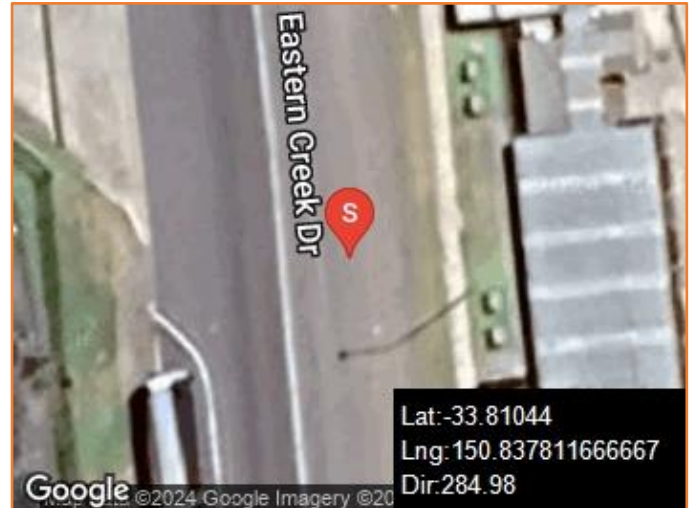
Figure 173: Reasonable - General condition of flexible pavement.

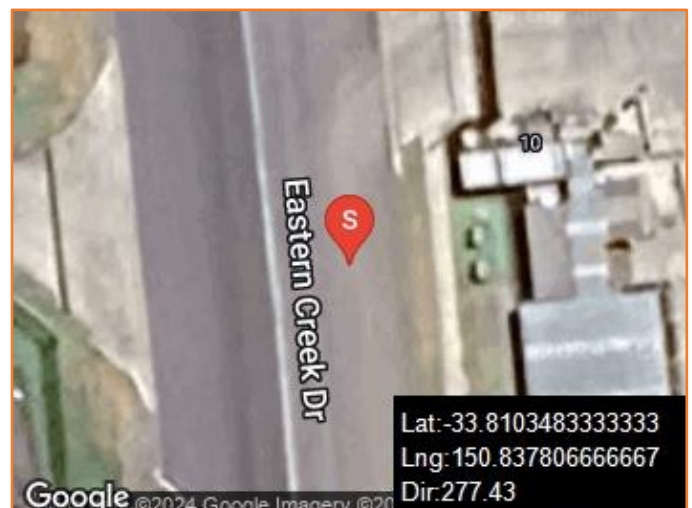
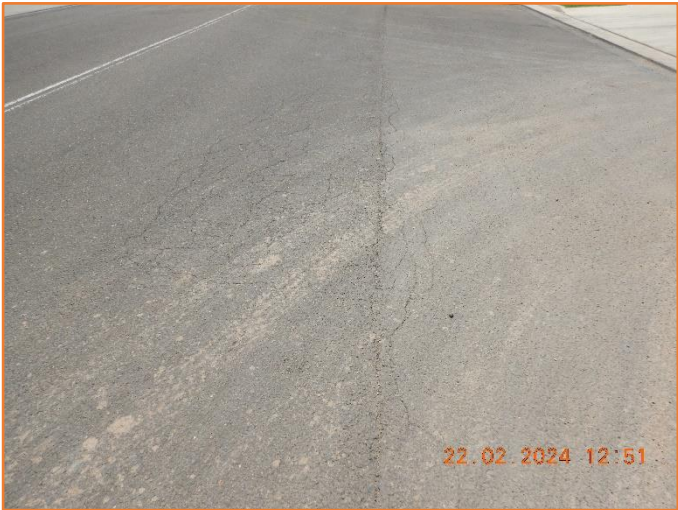
Figure 175: Reasonable - General condition of flexible pavement.  
Moderate alligator cracking observed.

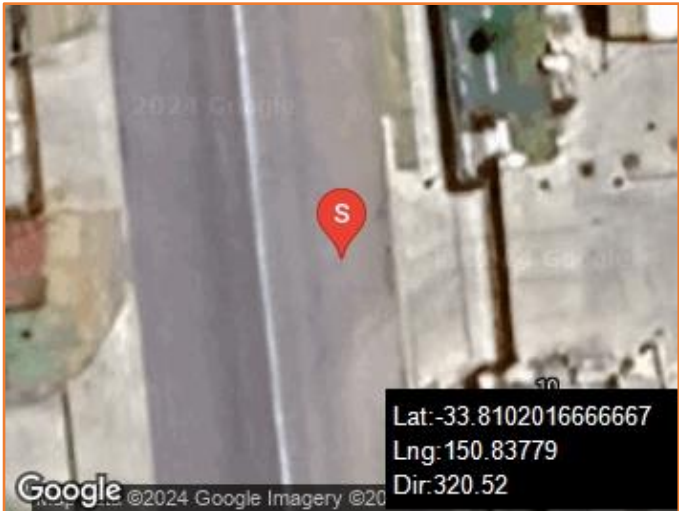
Figure 179: Reasonable - General condition of flexible pavement.  
Moderate alligator cracking observed.

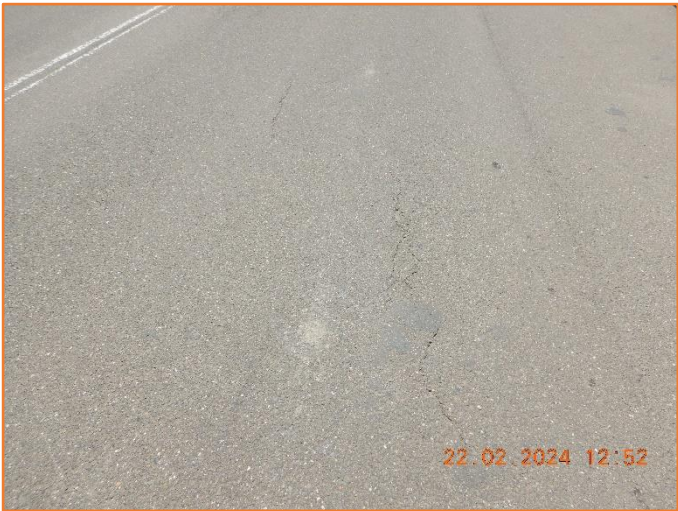
Figure 182: Reasonable - General condition of flexible pavement. Minor cracking observed.

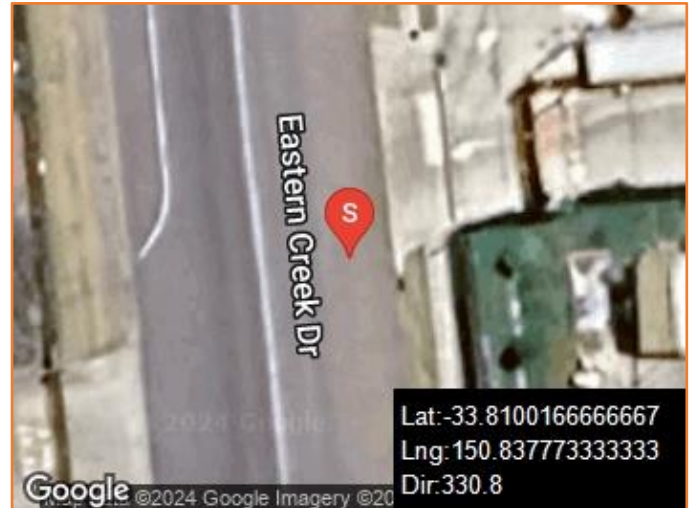
Figure 187: Reasonable - General condition of flexible pavement.

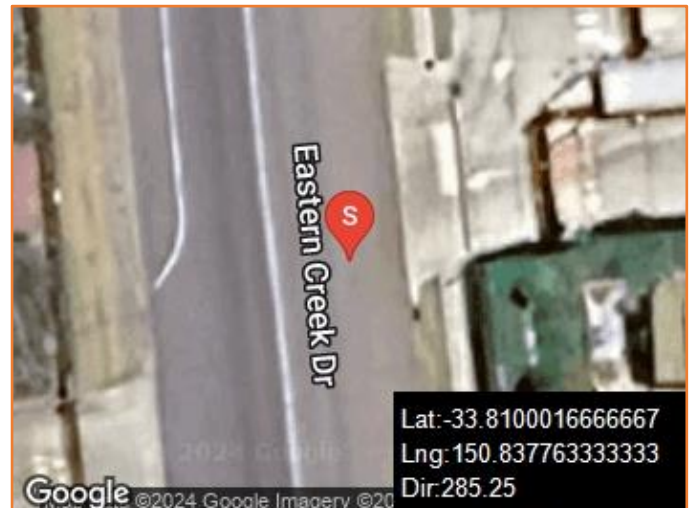
Figure 188: Reasonable - General condition of flexible pavement.

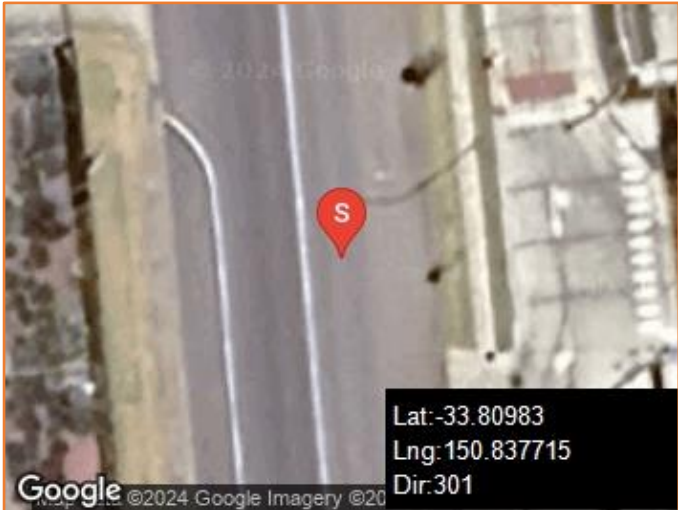
Figure 192: Reasonable - General condition of flexible pavement.

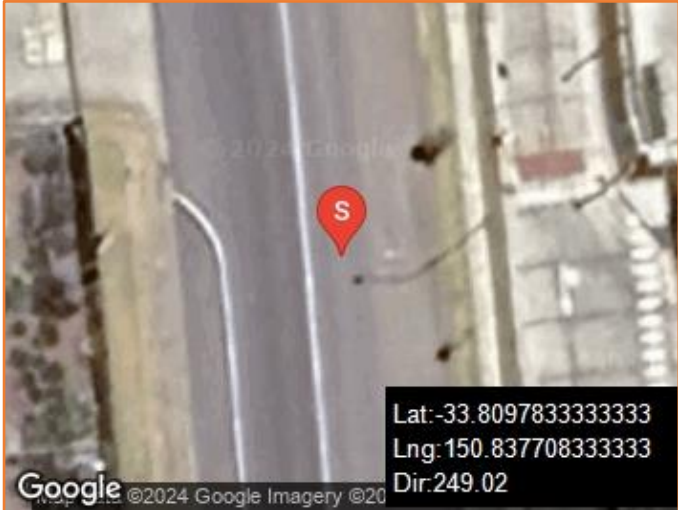
Figure 193: Reasonable - General condition of flexible pavement.

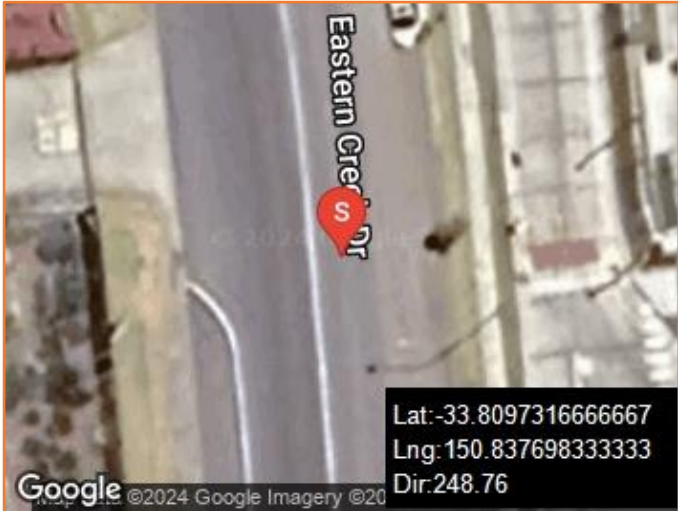
Figure 194: Reasonable - General condition of flexible pavement.

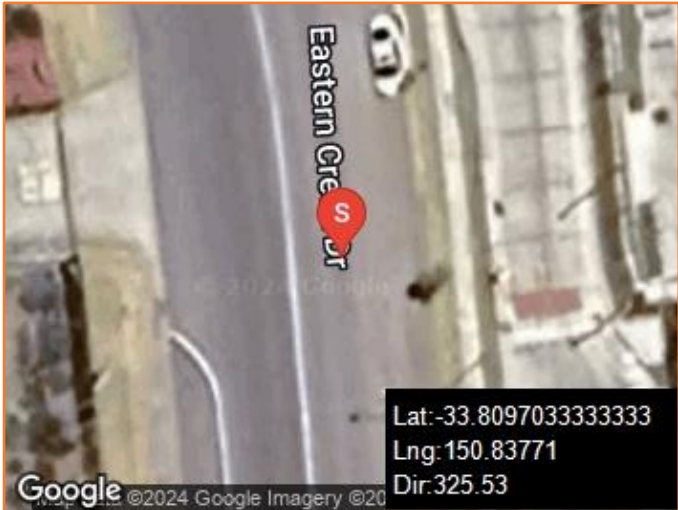
Figure 195: Reasonable - General condition of flexible pavement.

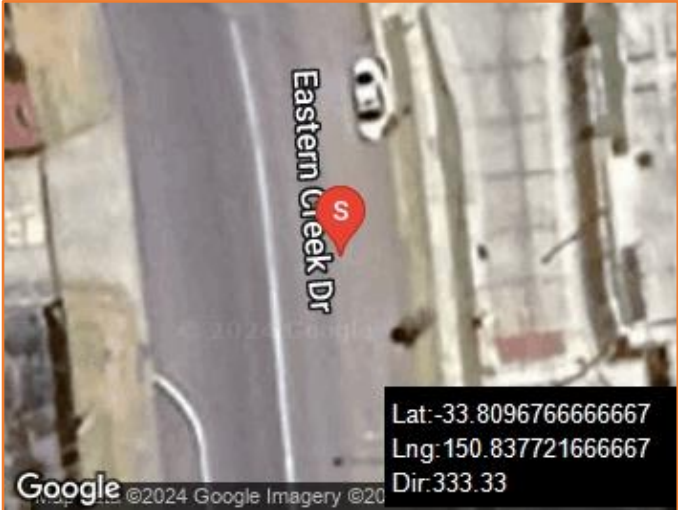
Figure 196: Reasonable - General condition of flexible pavement.

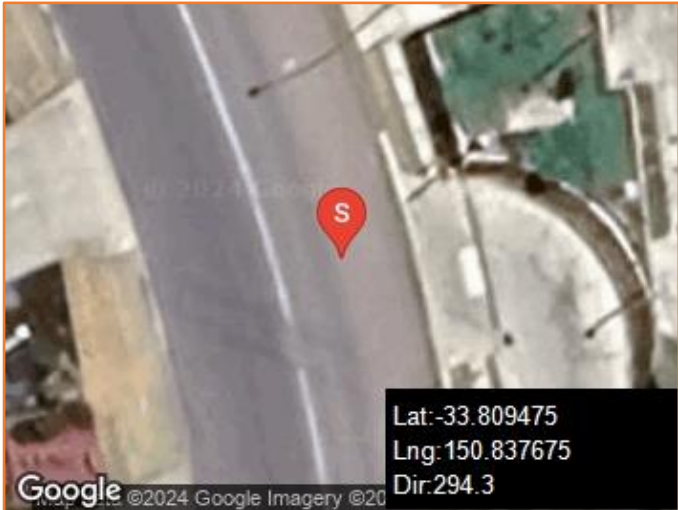
Figure 201: Reasonable - General condition of flexible pavement.

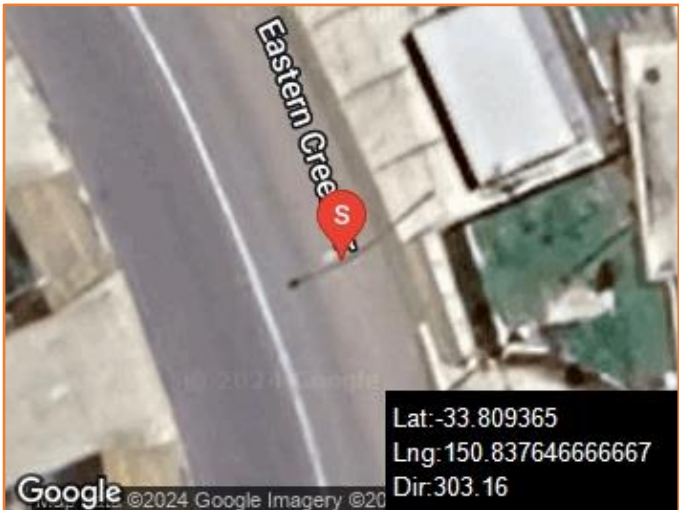
Figure 204: Reasonable - General condition of flexible pavement.

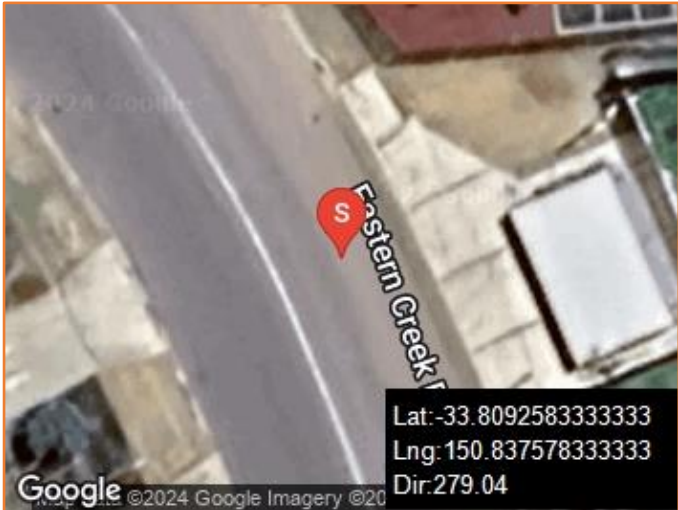
Figure 207: Reasonable - General condition of flexible pavement.

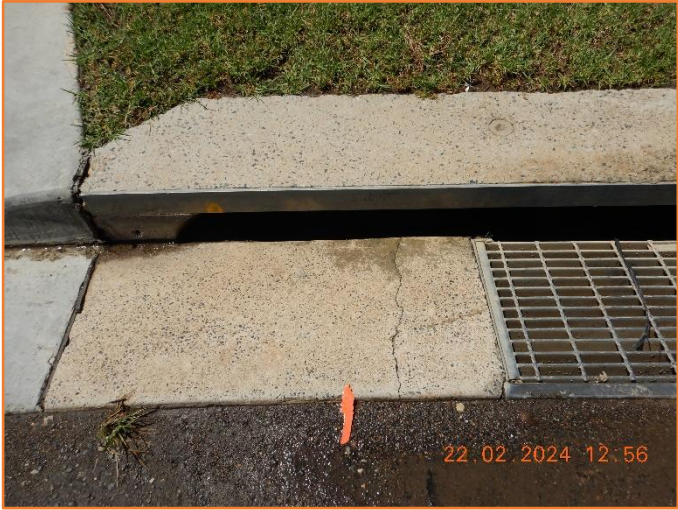
Figure 220: Reasonable - General condition of kerb inlet pit. Minor cracking observed.

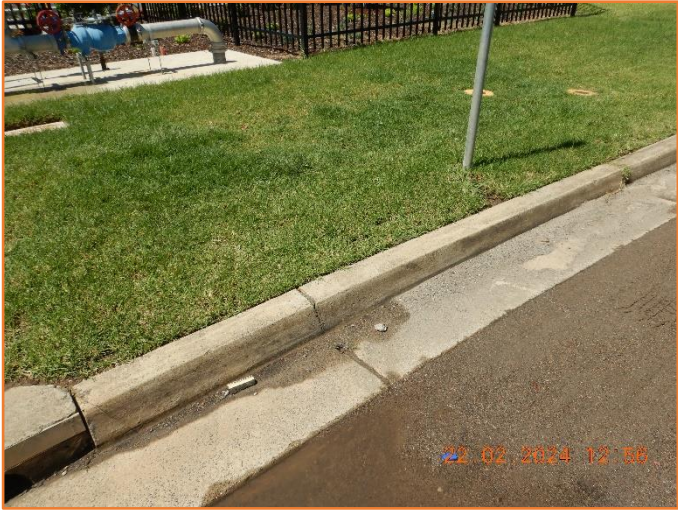
Figure 221: Reasonable - General condition of kerb and gutter.

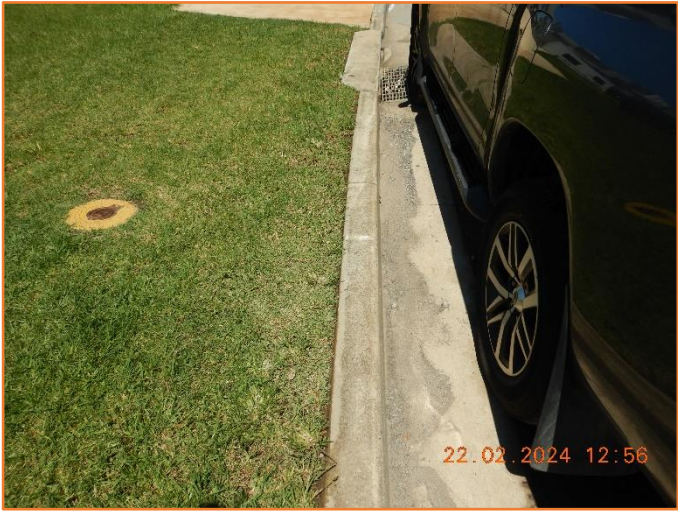
Figure 222: Reasonable - General condition of kerb and gutter.

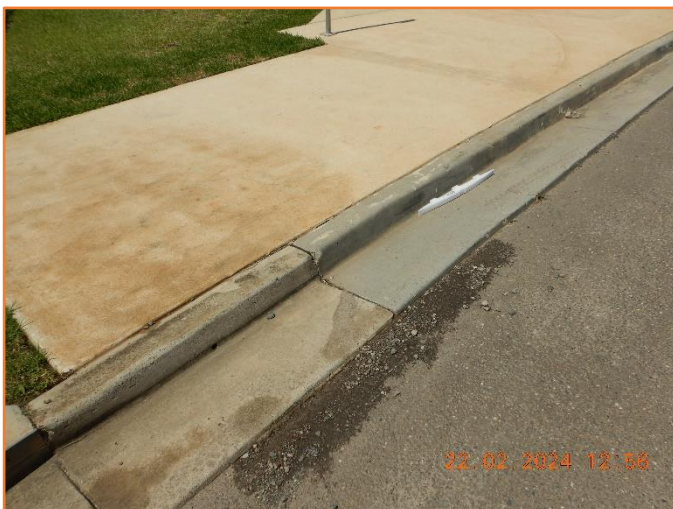
Figure 225: Reasonable - General condition of kerb and gutter.

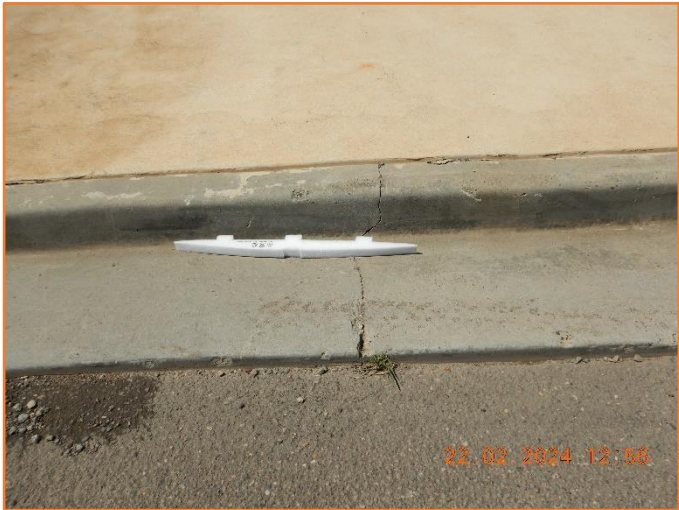
Figure 226: Reasonable - General condition of kerb and gutter. Moderate cracking observed.

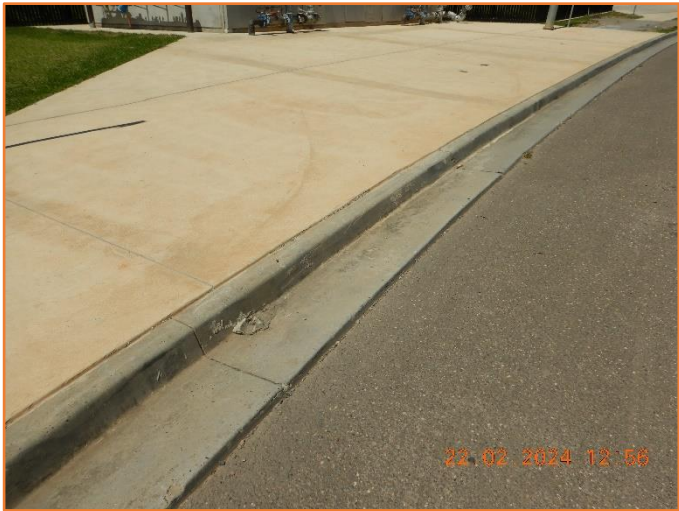
Figure 227: Reasonable - General condition of kerb and gutter.

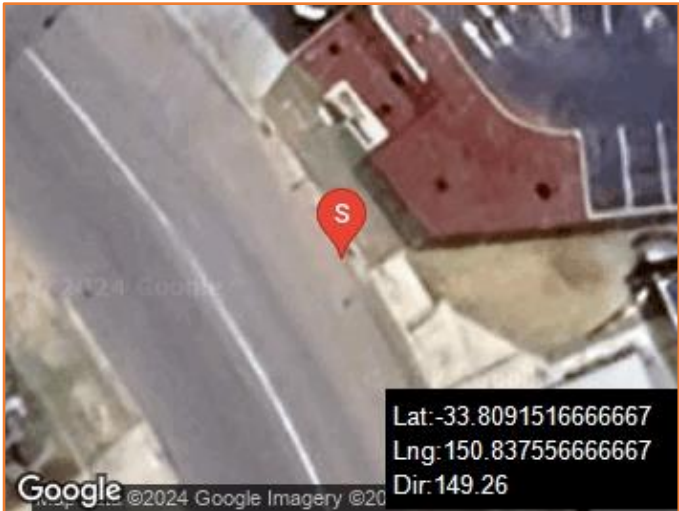
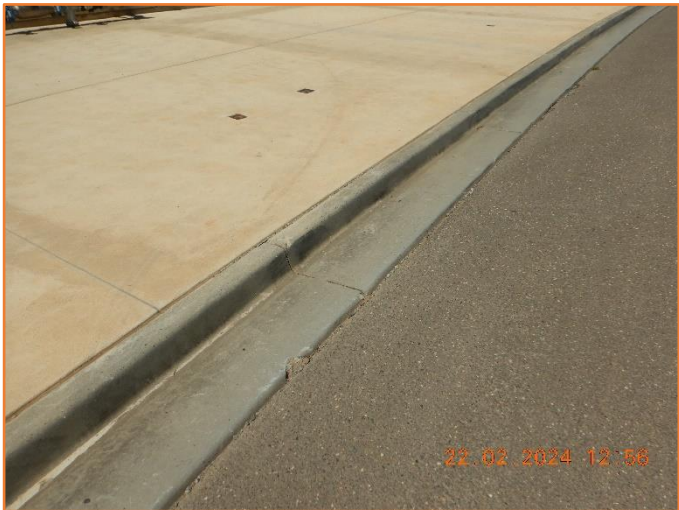
Figure 228: Reasonable - General condition of kerb and gutter.

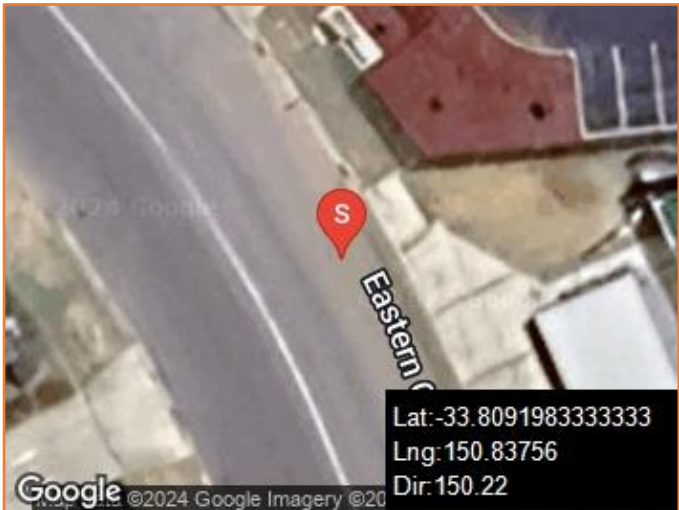
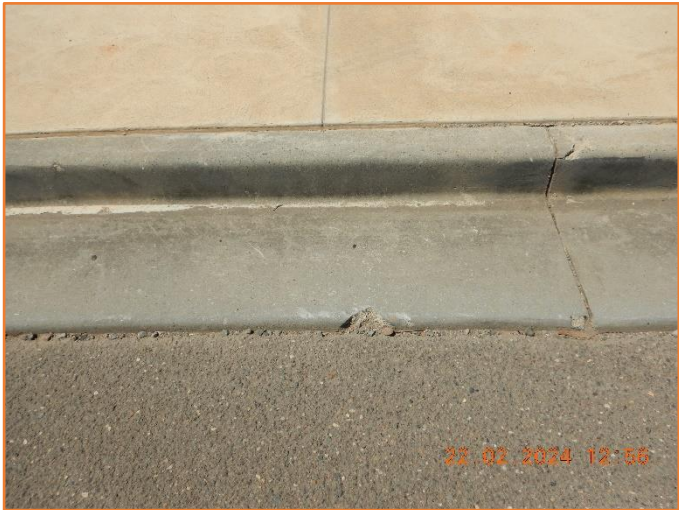
Figure 229: Reasonable - General condition of kerb and gutter. Minor spalling observed.

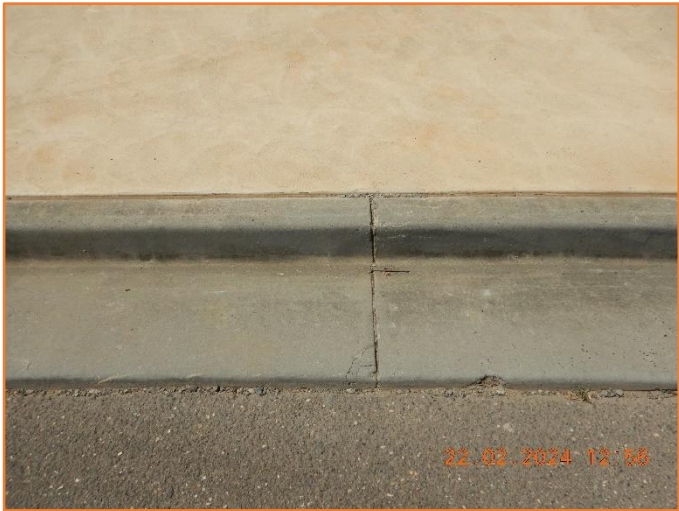
Figure 230: Reasonable - General condition of kerb and gutter. Minor hairline cracking observed.

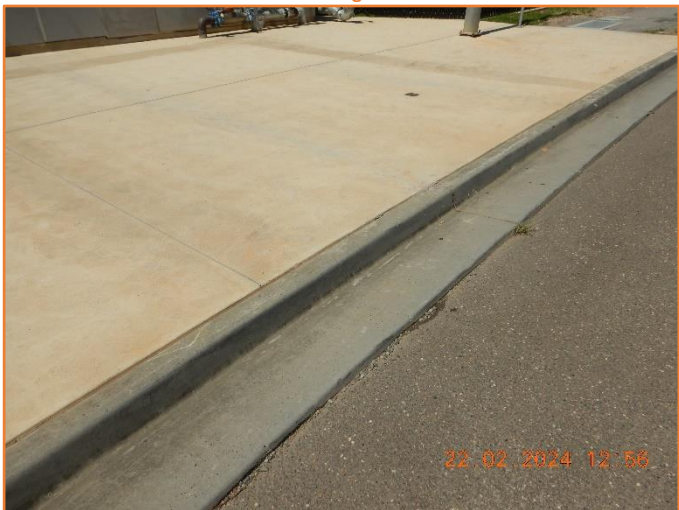
Figure 231: Reasonable - General condition of kerb and gutter.

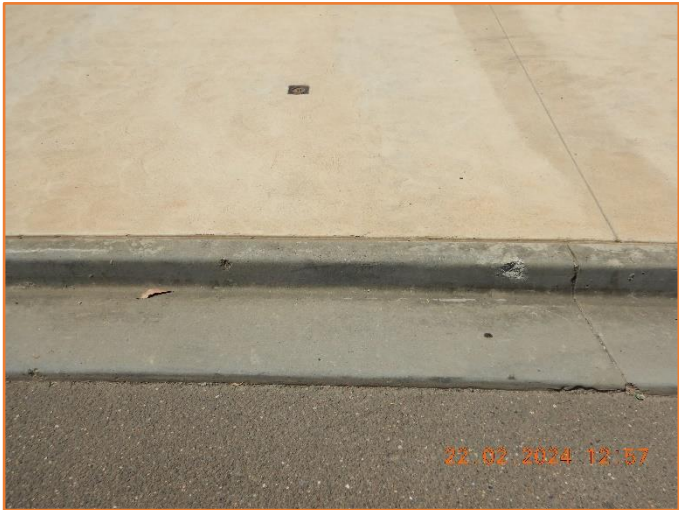
Figure 232: Reasonable - General condition of kerb and gutter. Minor spalling observed.

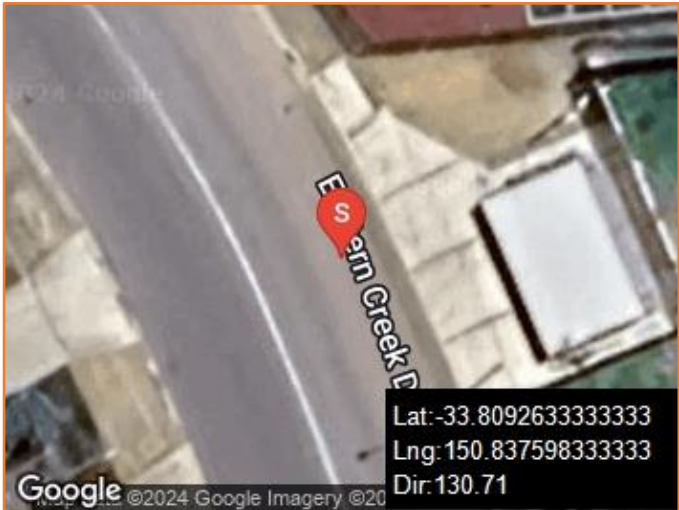
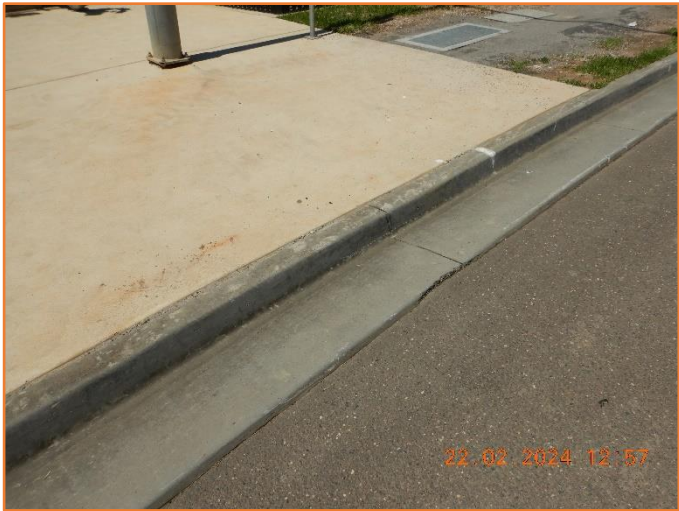
Figure 233: Reasonable - General condition of kerb and gutter.

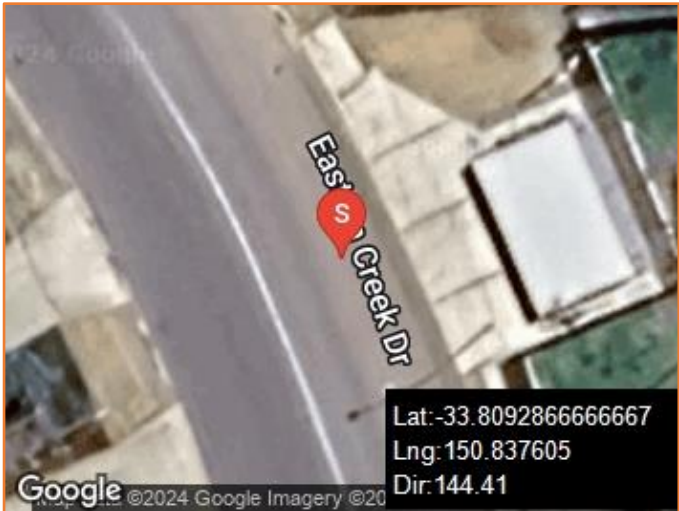
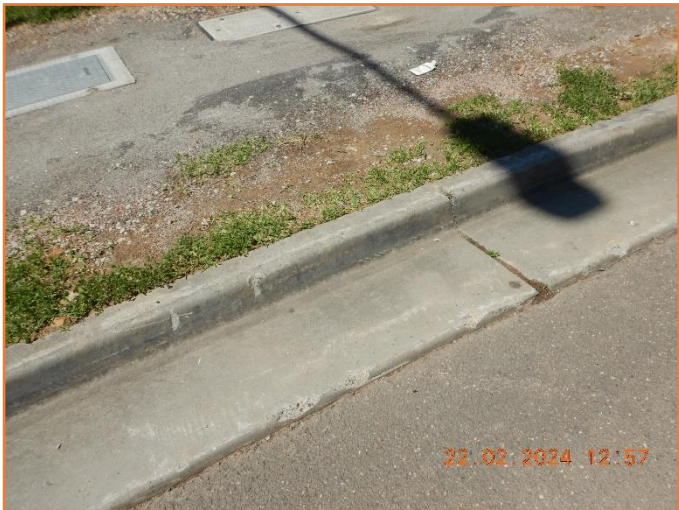
Figure 234: Reasonable - General condition of kerb and gutter.

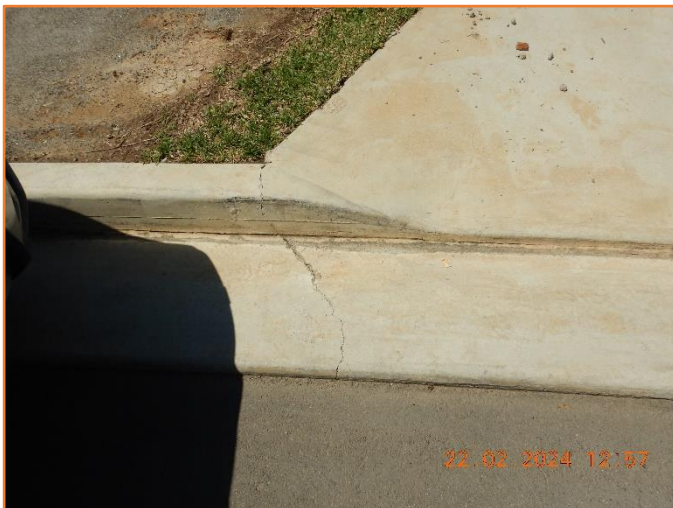
Figure 236: Reasonable - General condition of driveway splay. Moderate hairline cracking observed.

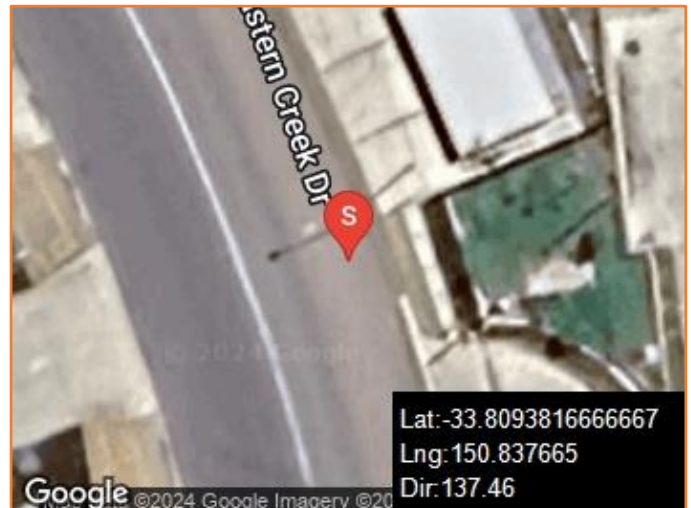
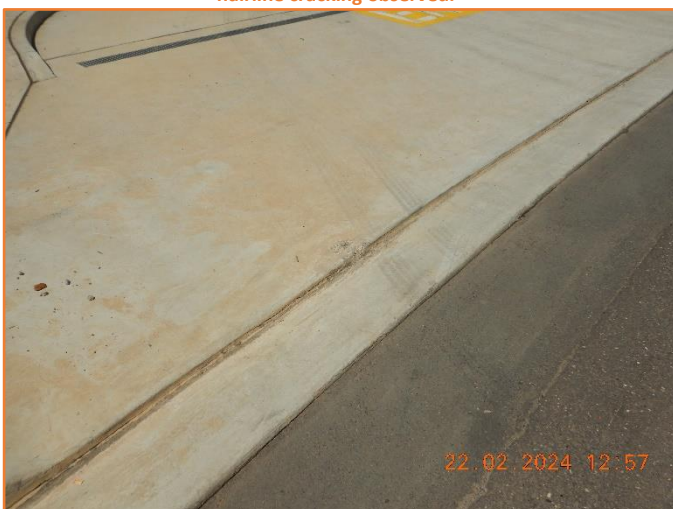
Figure 237: Reasonable - General condition of driveway layback. Minor spalling observed.

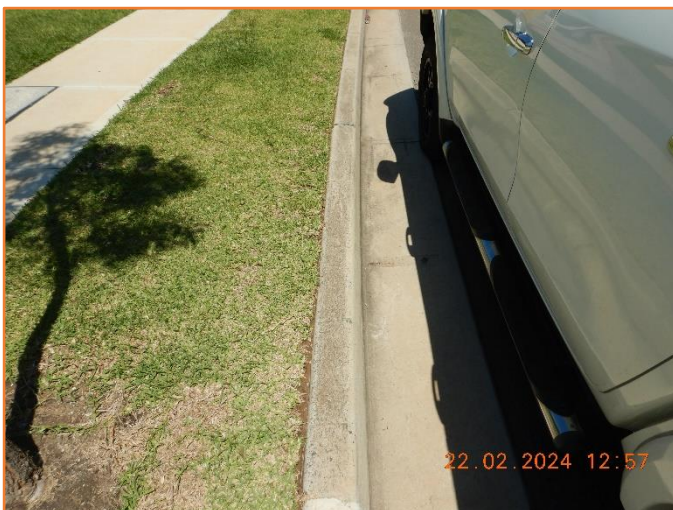
Figure 242: Reasonable - General condition of kerb and gutter.

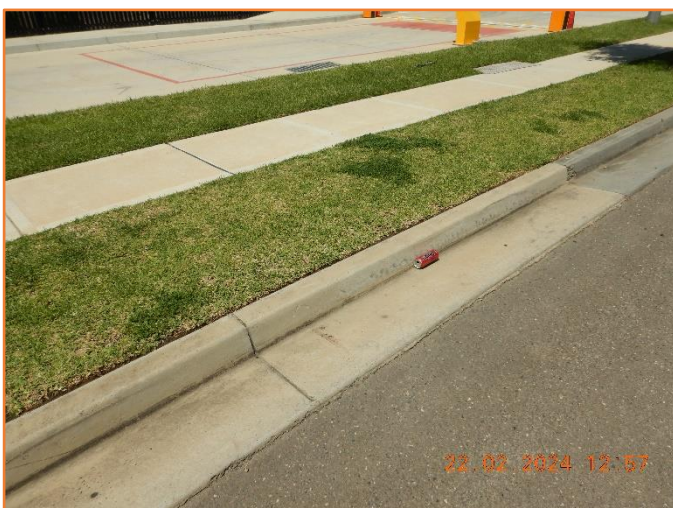
Figure 243: Reasonable - General condition of kerb and gutter.
