## DILAPIDATION REPORT

10 EASTERN CREEK DRIVE EASTERN CREEK, NSW, 2766

THURSDAY, 22 FEBRUARY 2024

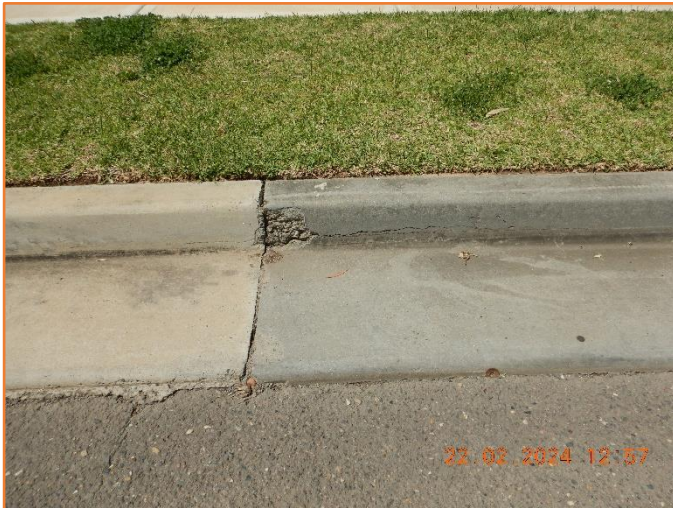
Figure 244: Poor - General condition of kerb and gutter. Moderate cracking and loss of material observed.

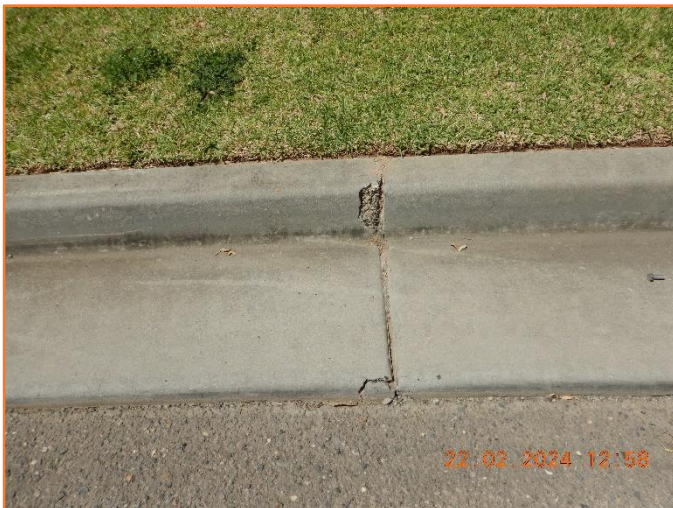
Figure 245: Reasonable - General condition of kerb and gutter. Minor spalling observed.

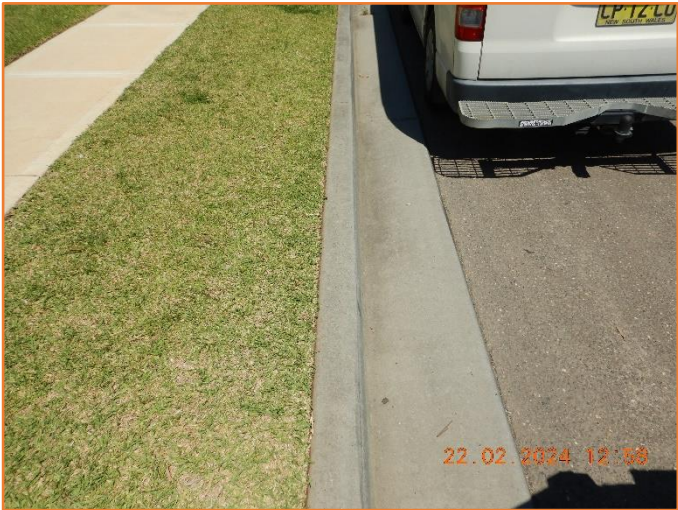
Figure 247: Reasonable - General condition of kerb and gutter.

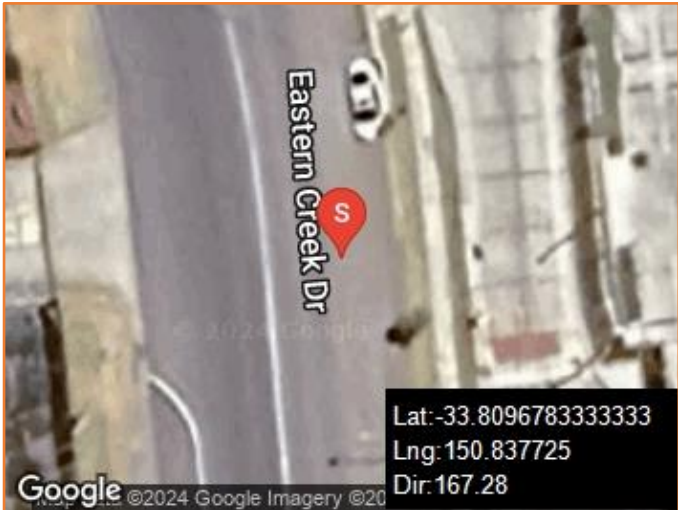
Figure 248: Reasonable - General condition of kerb and gutter.

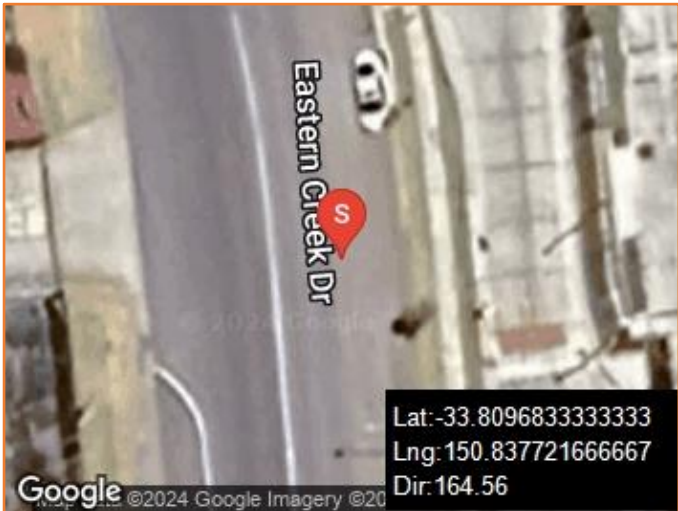
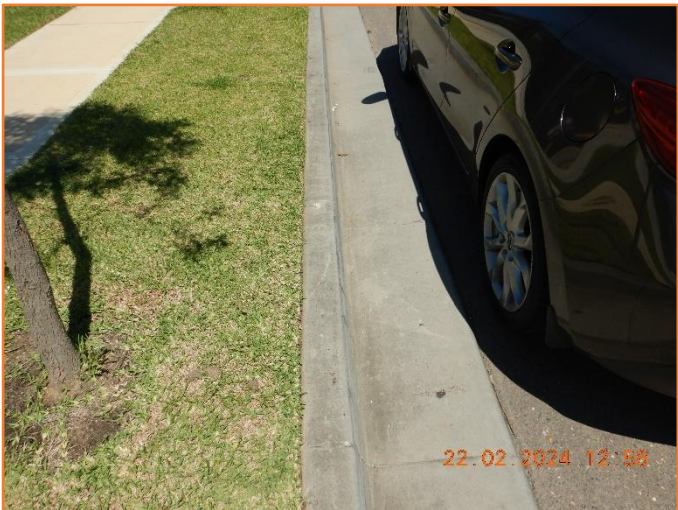
Figure 249: Reasonable - General condition of kerb and gutter.

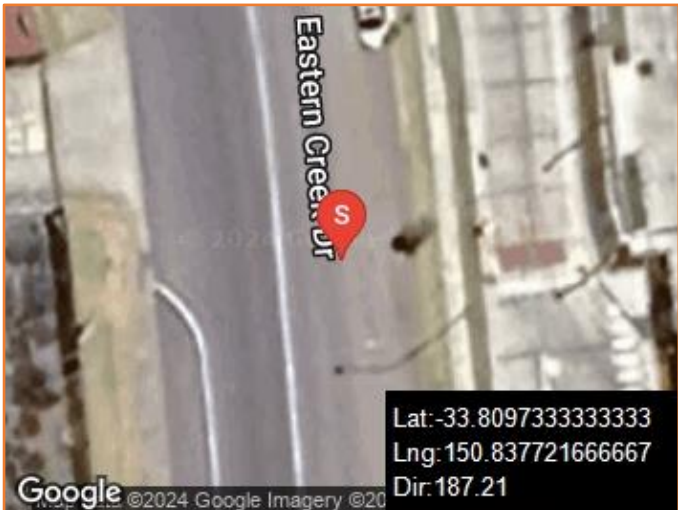
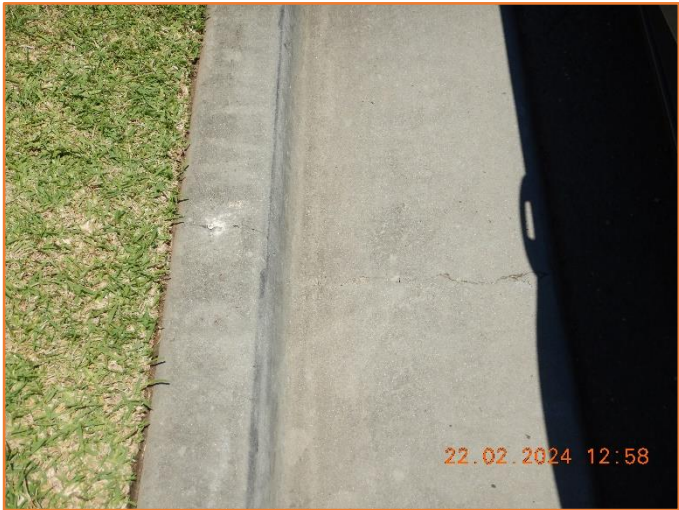
Figure 250: Reasonable - General condition of kerb and gutter. Minor cracking observed.

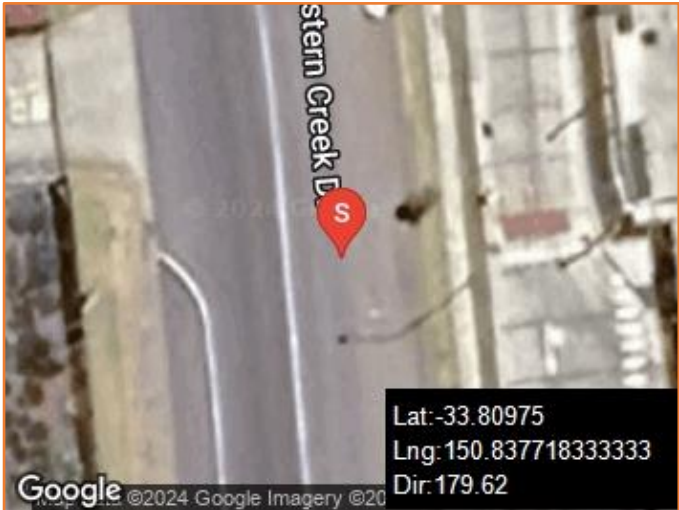
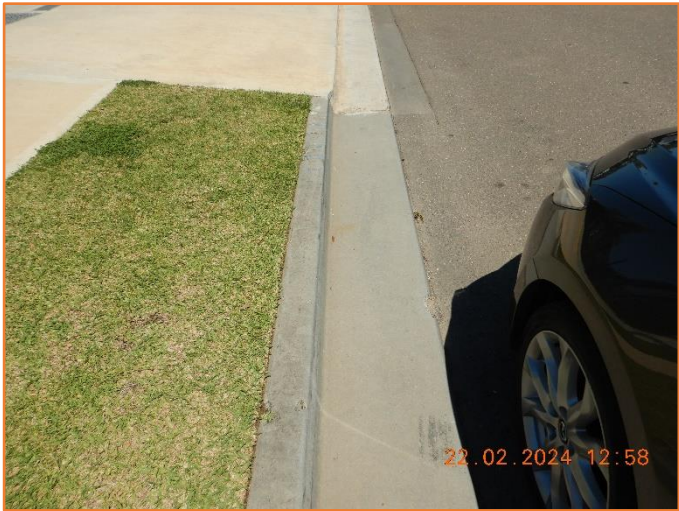
Figure 251: Reasonable - General condition of kerb and gutter.

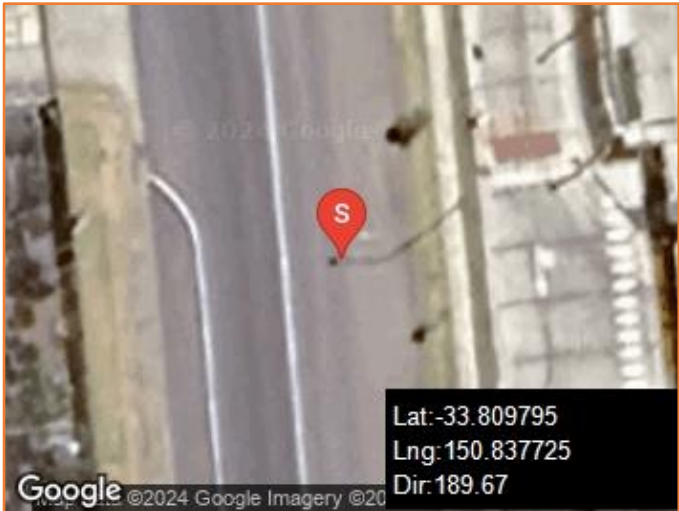
Figure 252: Reasonable - General condition of driveway splay.

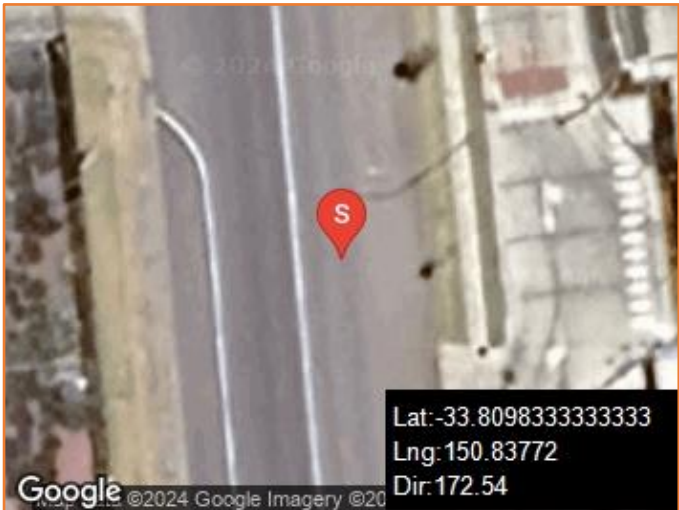
Figure 253: Reasonable - General condition of driveway layback.

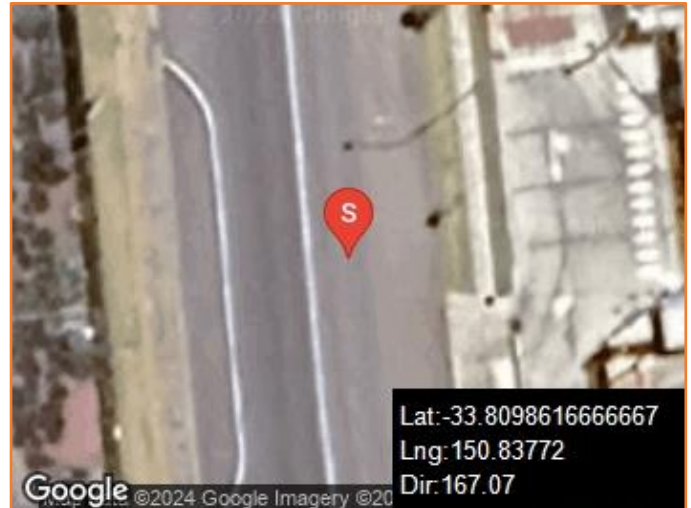
Figure 254: Reasonable - General condition of driveway splay. Moderate cracking observed.

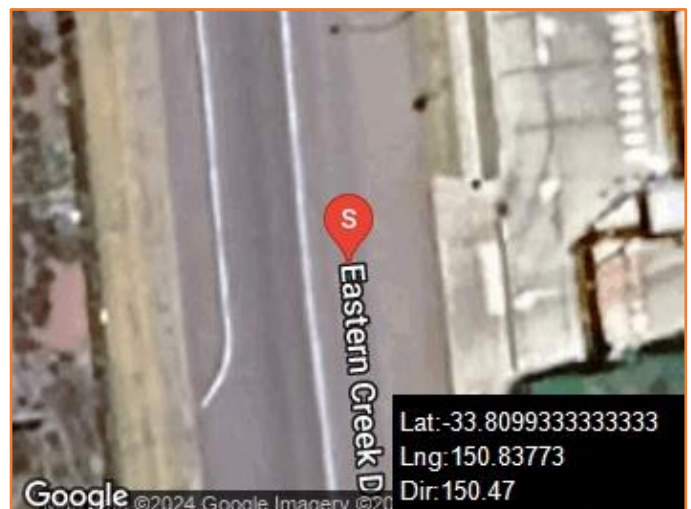
Figure 256: Reasonable - General condition of kerb inlet pit.

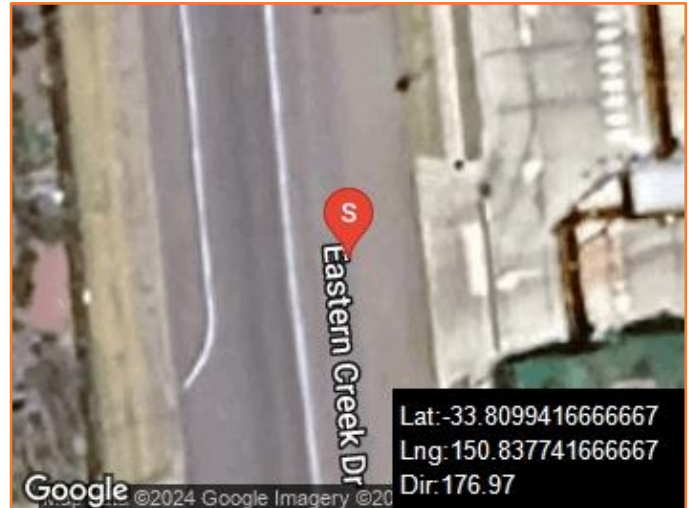
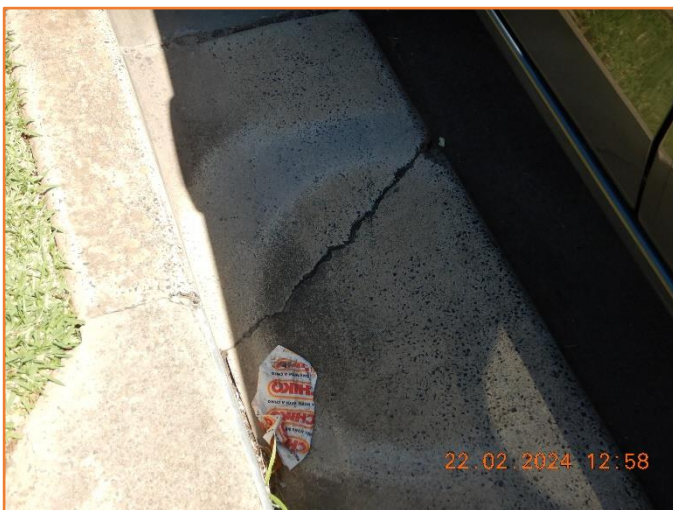
Figure 257: Reasonable - General condition of kerb inlet pit. Moderate cracking observed.

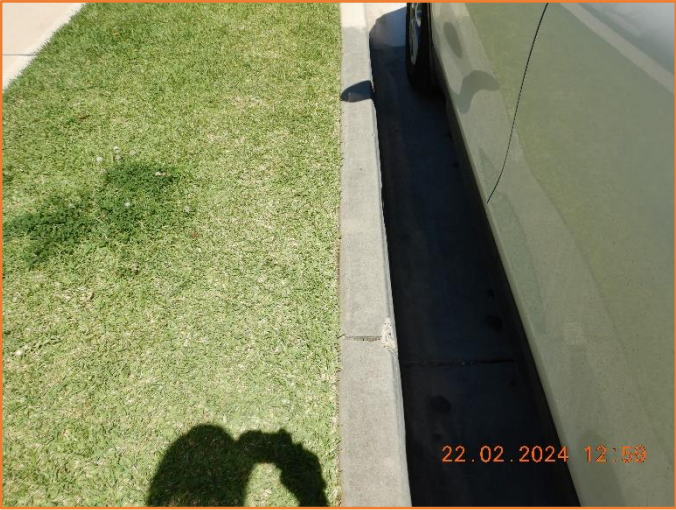
Figure 259: Reasonable - General condition of kerb and gutter.

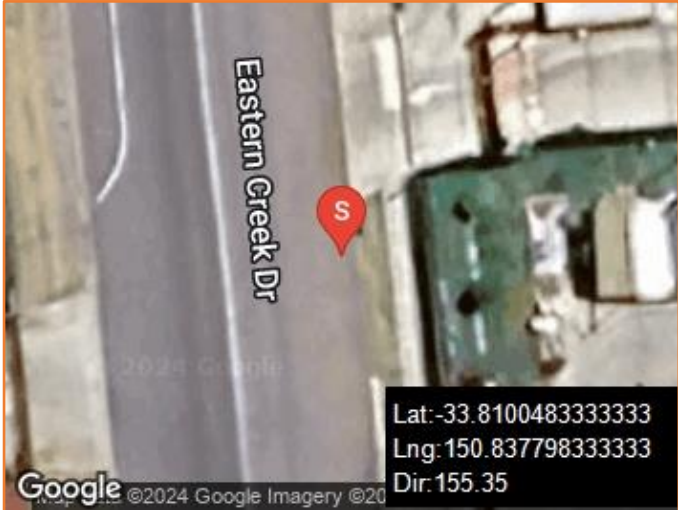
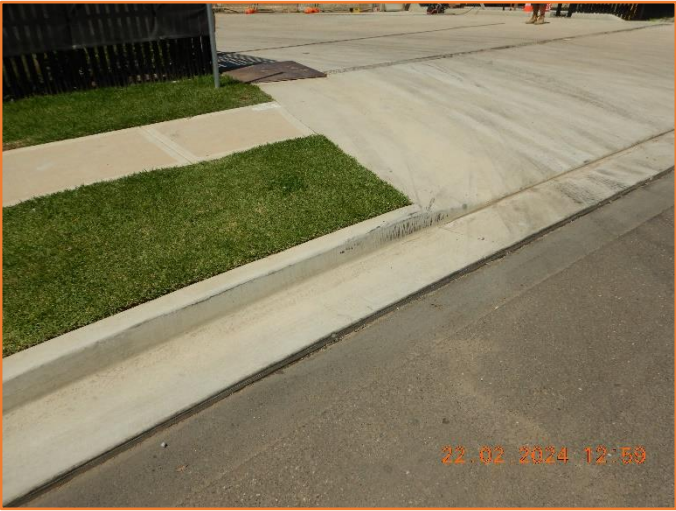
Figure 260: Reasonable - General condition of kerb and gutter.

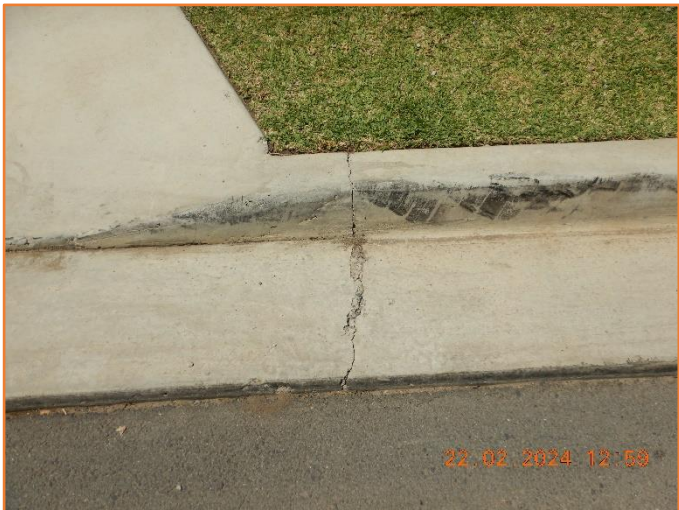
Figure 264: Reasonable - General condition of driveway splay. Moderate hairline cracking observed.

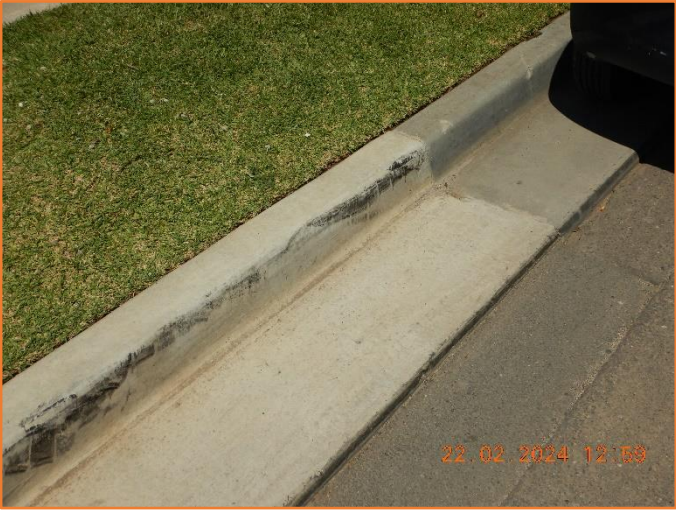
Figure 265: Reasonable - General condition of kerb and gutter.

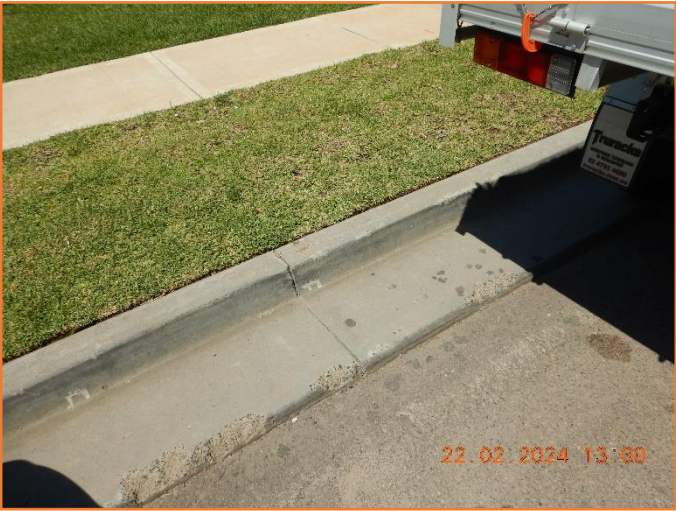
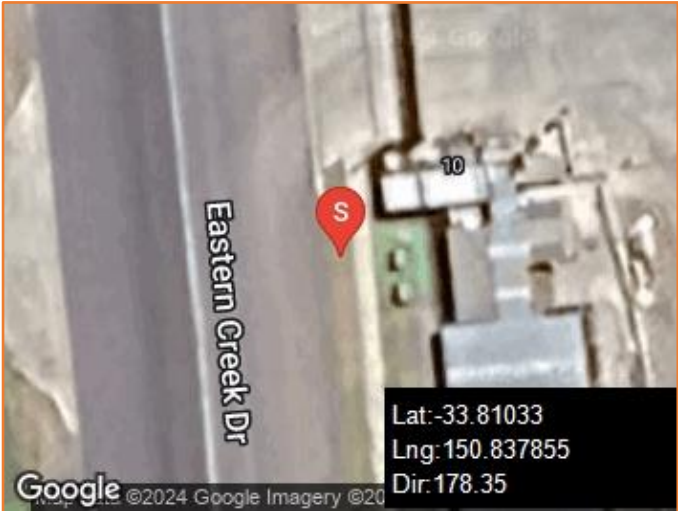
Figure 267: Reasonable - General condition of kerb and gutter.

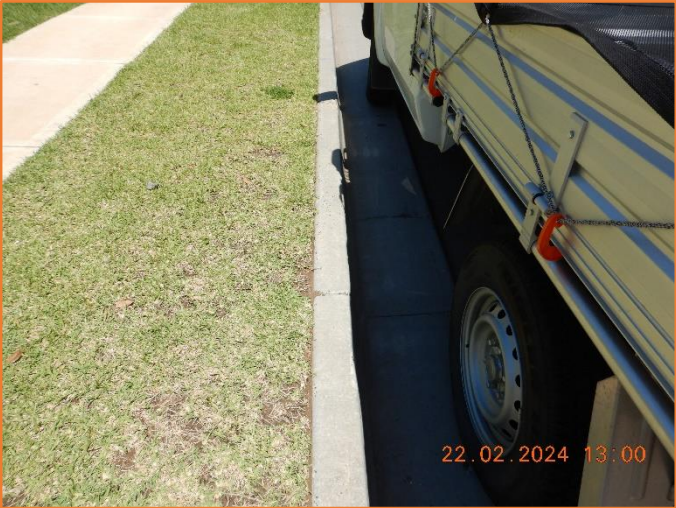
Figure 268: Reasonable - General condition of kerb and gutter.

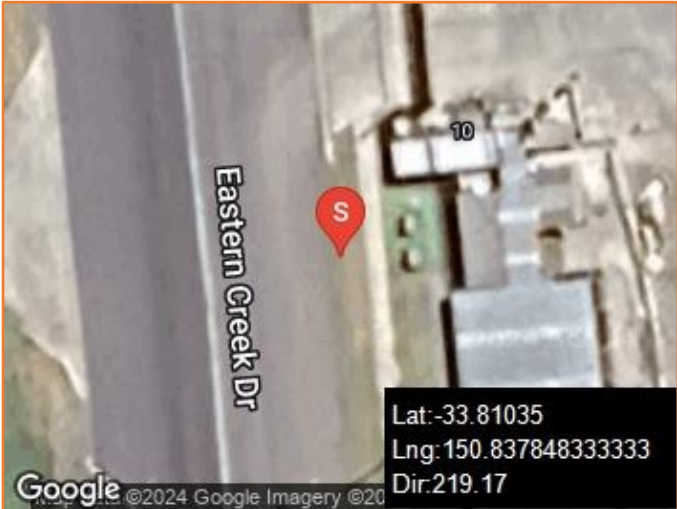
Figure 269: Reasonable - General condition of kerb and gutter. Moderate cracking observed.

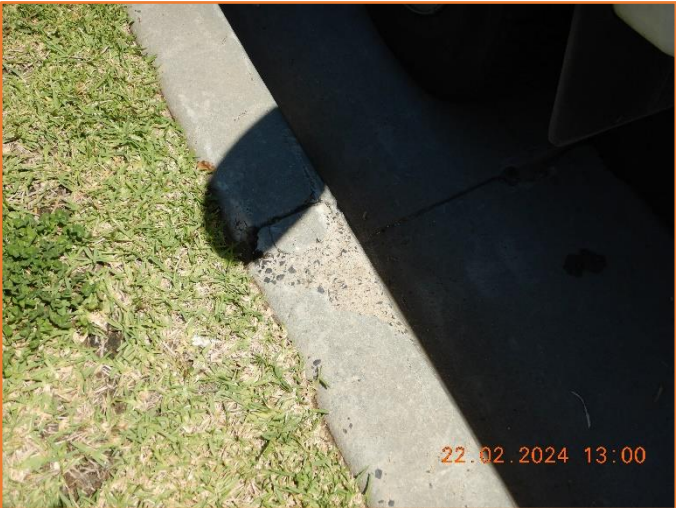
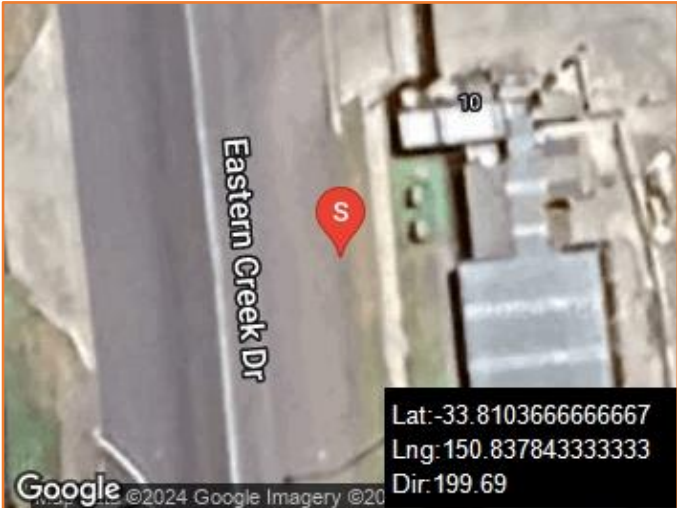
Figure 270: Reasonable - General condition of kerb and gutter. Moderate spalling observed.

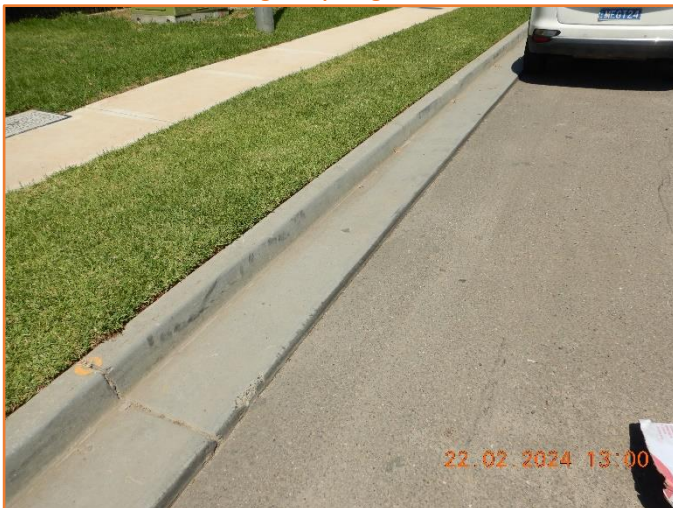
Figure 272: Reasonable - General condition of kerb and gutter.

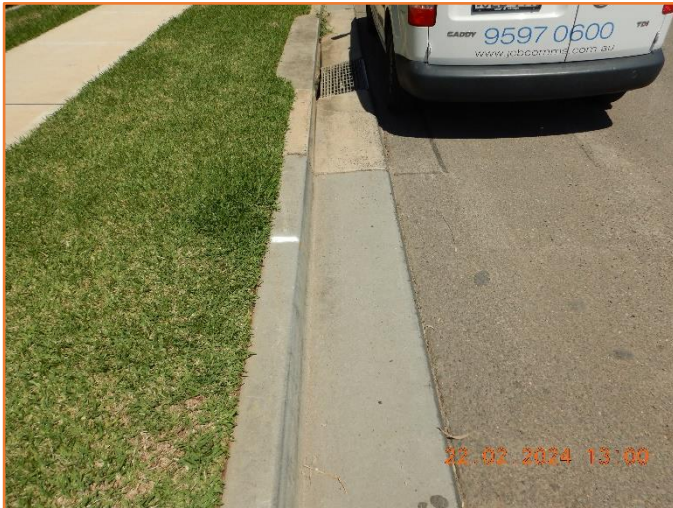
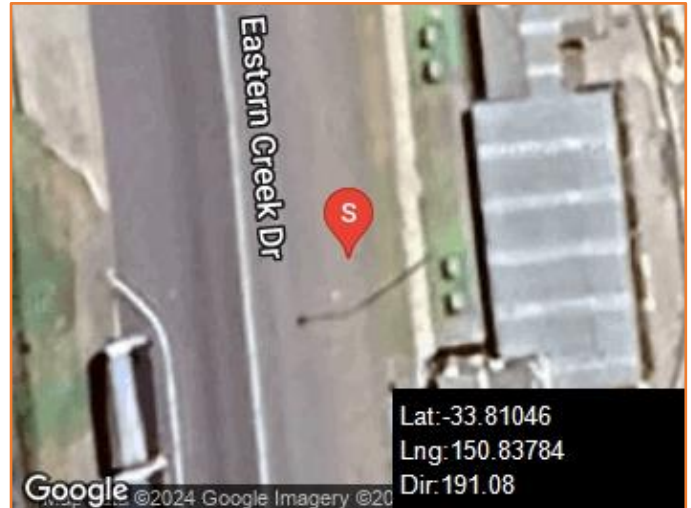
Figure 274: Reasonable - General condition of kerb and gutter.

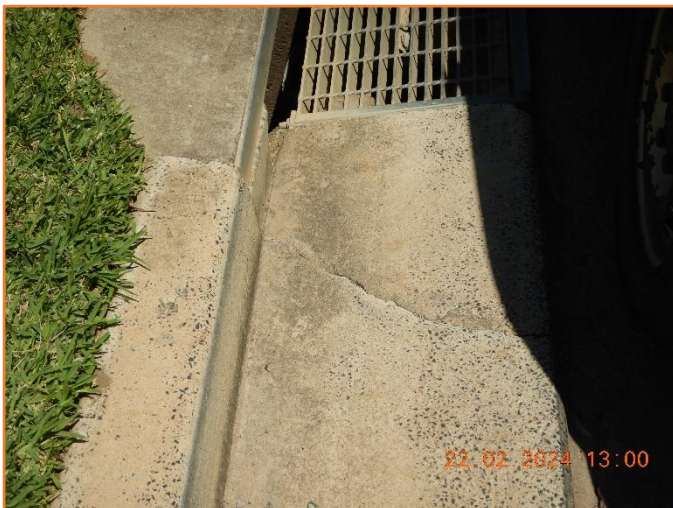
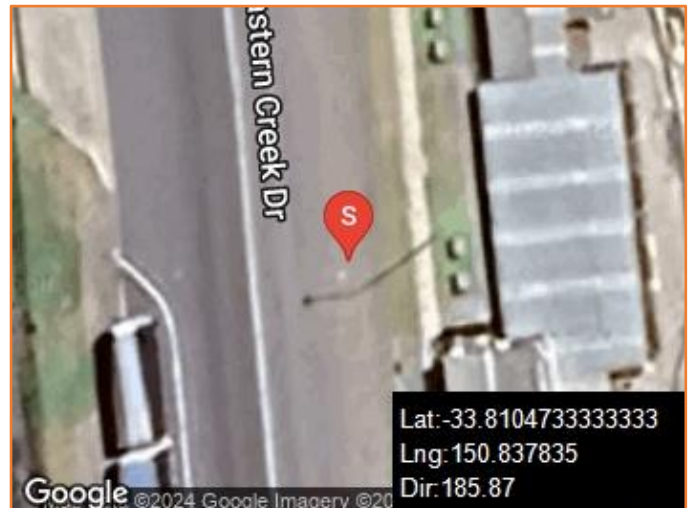
Figure 275: Reasonable - General condition of kerb inlet pit. Moderate cracking observed.

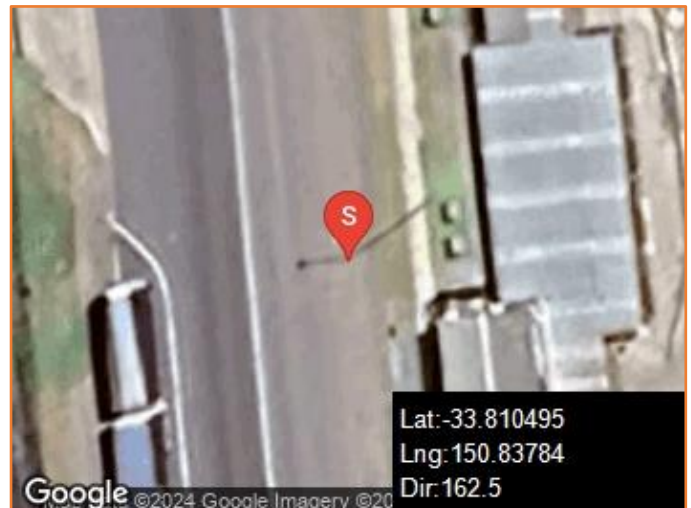
Figure 276: Reasonable - General condition of kerb inlet pit.

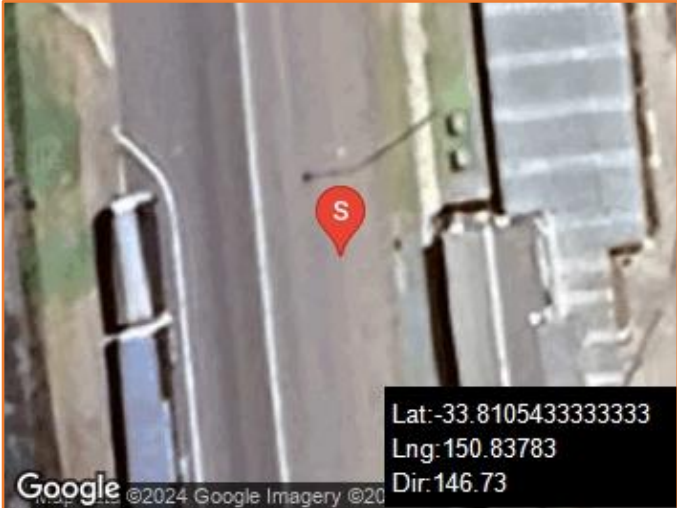
Figure 277: Reasonable - General condition of kerb inlet pit. Moderate cracking observed.

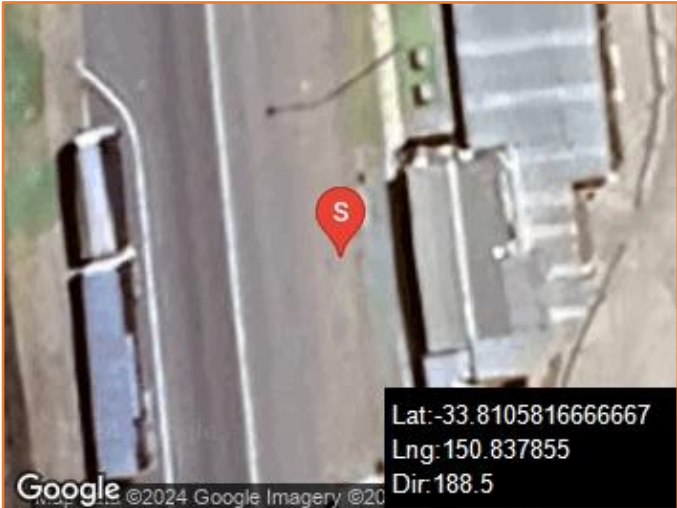
Figure 279: Reasonable - General condition of kerb and gutter. Minor spalling observed.

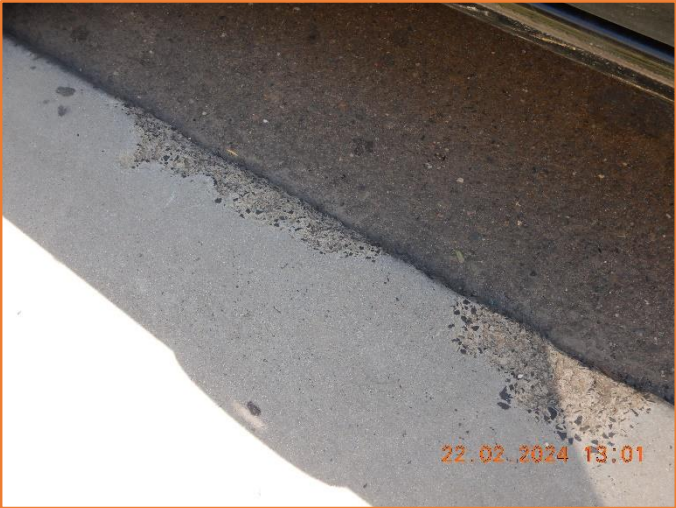
Figure 280: Reasonable - General condition of kerb and gutter. Minor spalling observed.

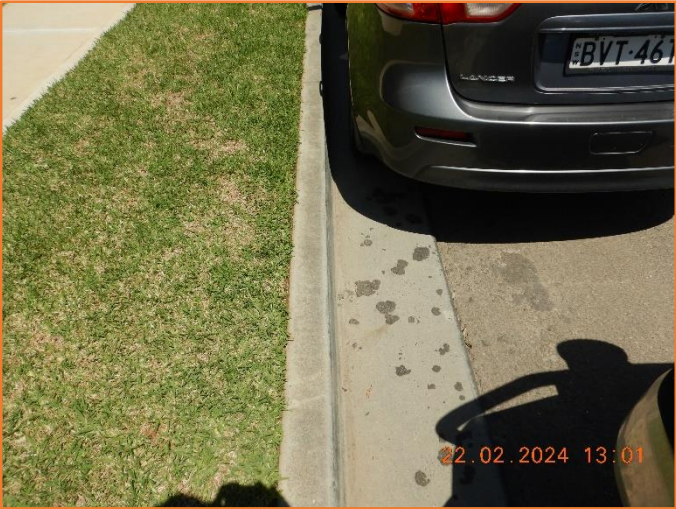
Figure 281: Reasonable - General condition of kerb and gutter.

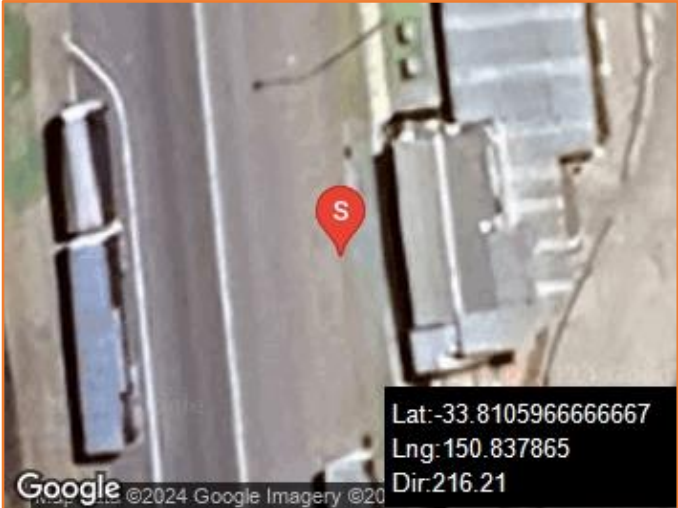
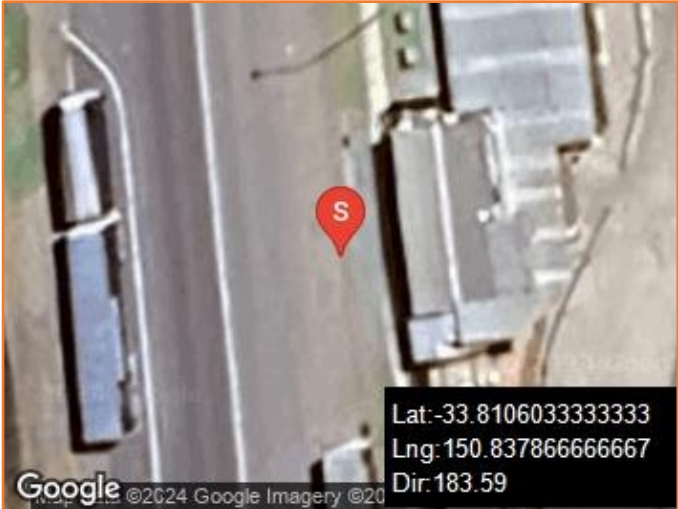
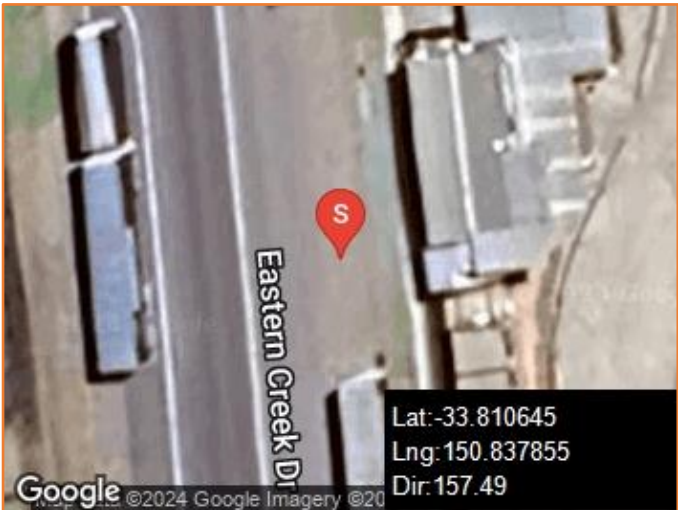
Figure 283: Reasonable - General condition of kerb and gutter.

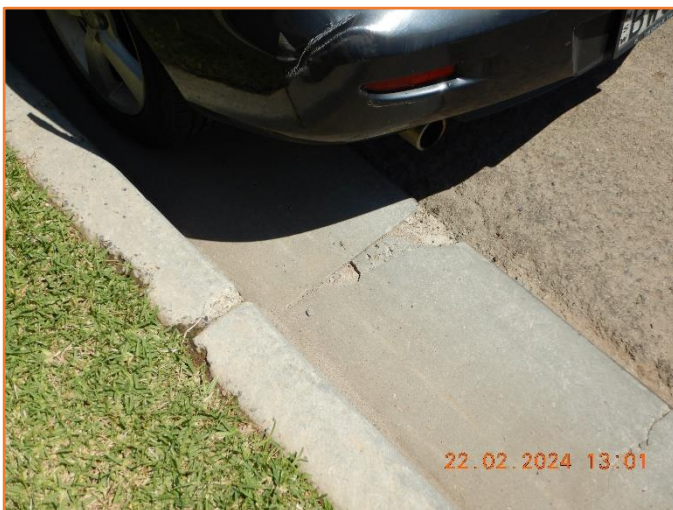
Figure 284: Reasonable - General condition of kerb and gutter. Minor spalling observed.

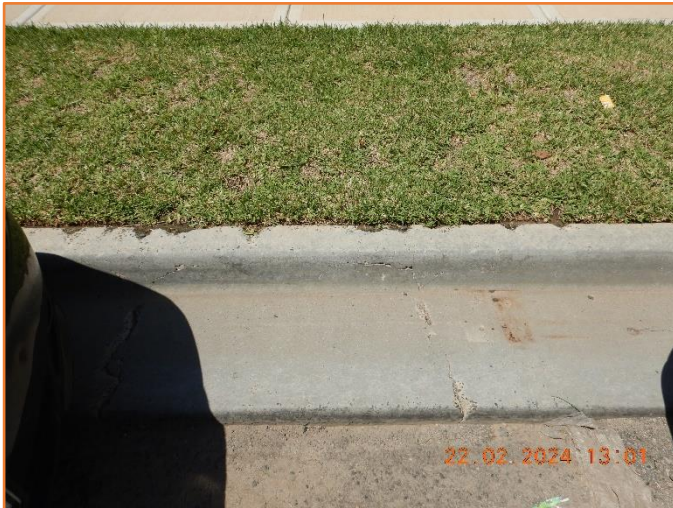
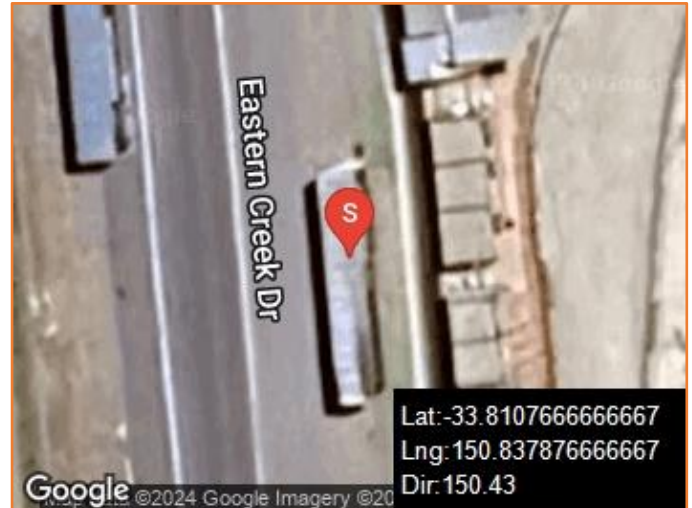
Figure 286: Reasonable - General condition of kerb and gutter. Moderate cracking observed.

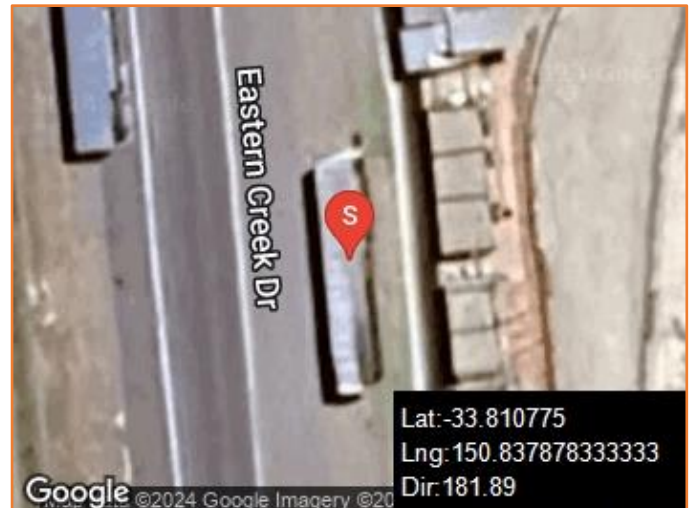
Figure 287: Reasonable - General condition of kerb and gutter.

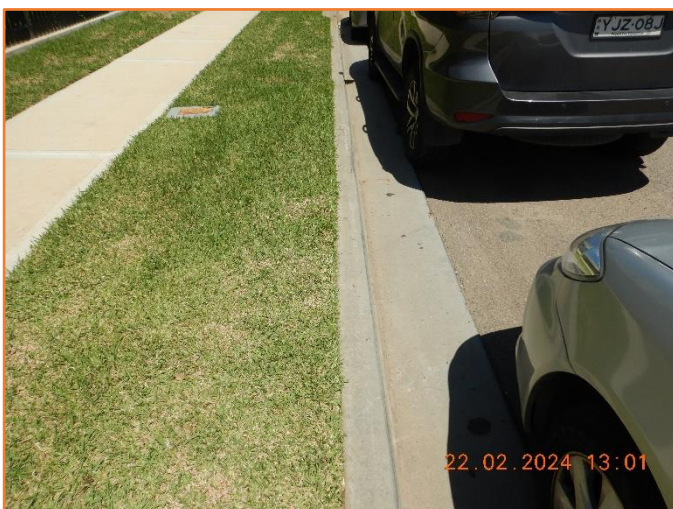
Figure 288: Reasonable - General condition of kerb and gutter.

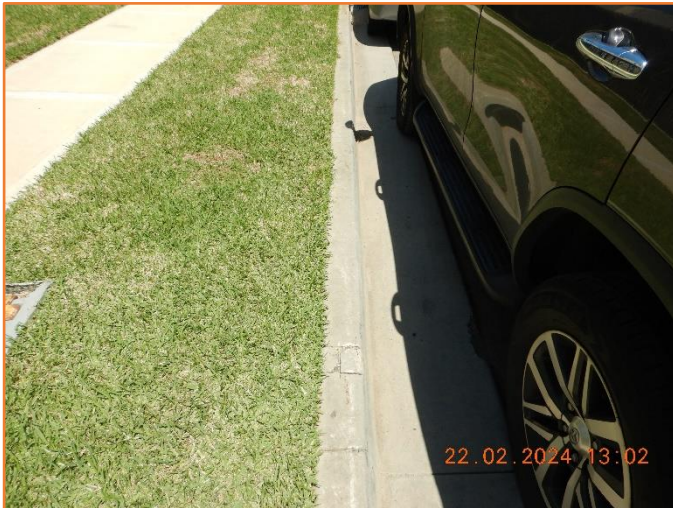
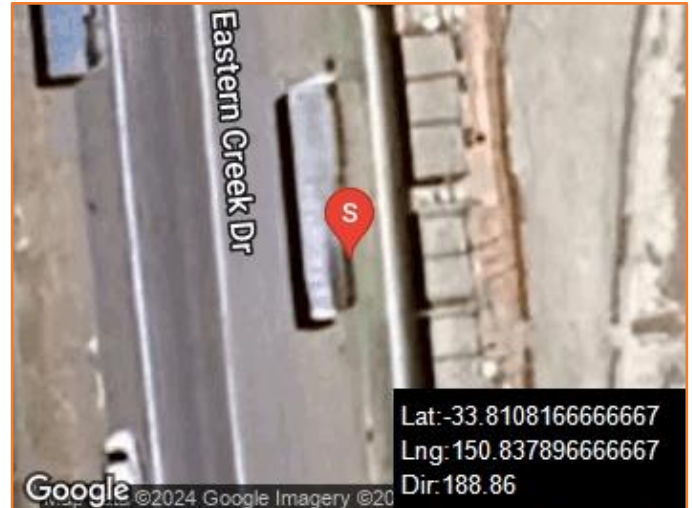
Figure 289: Reasonable - General condition of kerb and gutter.

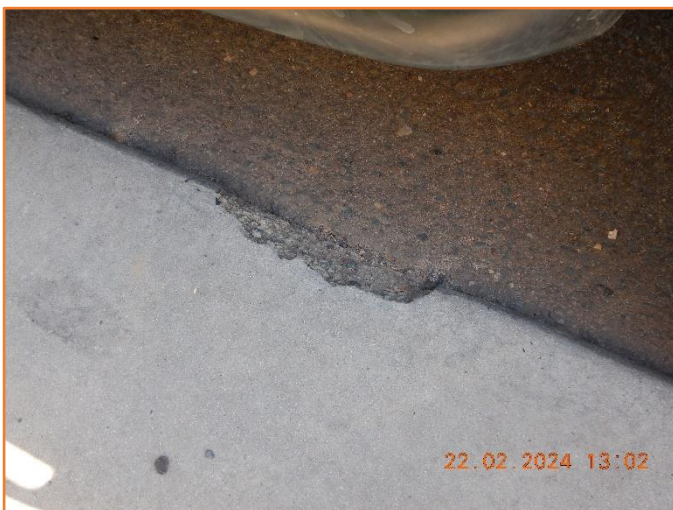
Figure 290: Reasonable - General condition of kerb and gutter. Minor spalling observed.

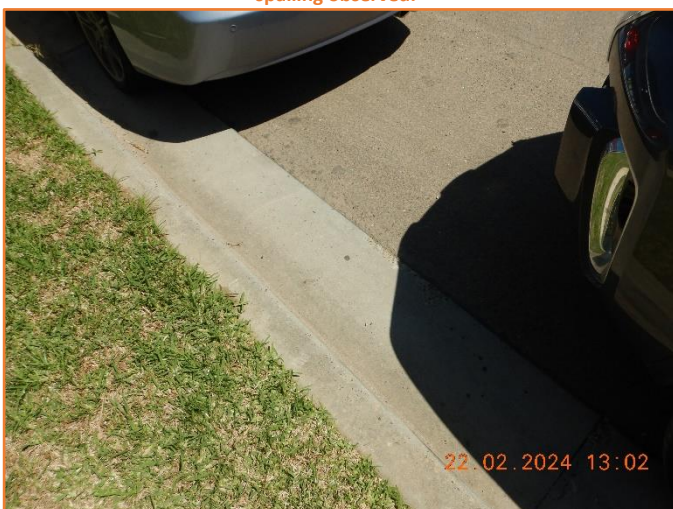
Figure 291: Reasonable - General condition of kerb and gutter.

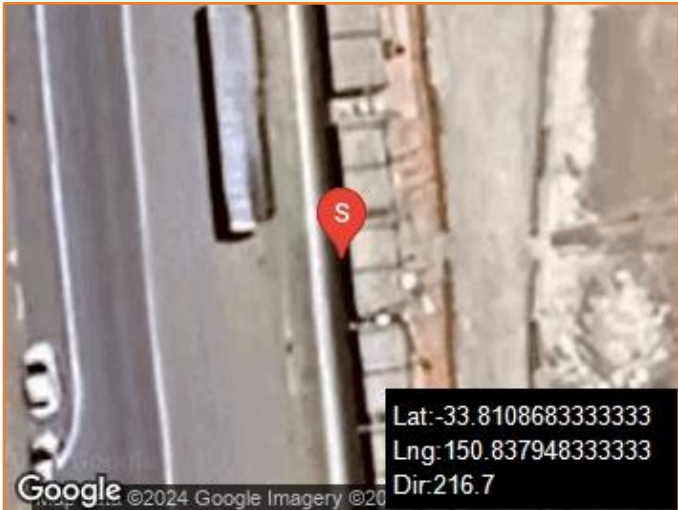
Figure 292: Reasonable - General condition of kerb inlet pit.

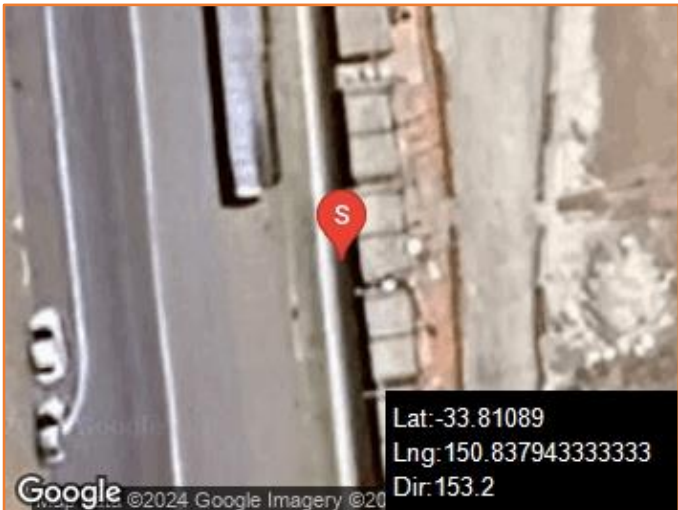
Figure 294: Reasonable - General condition of kerb and gutter.

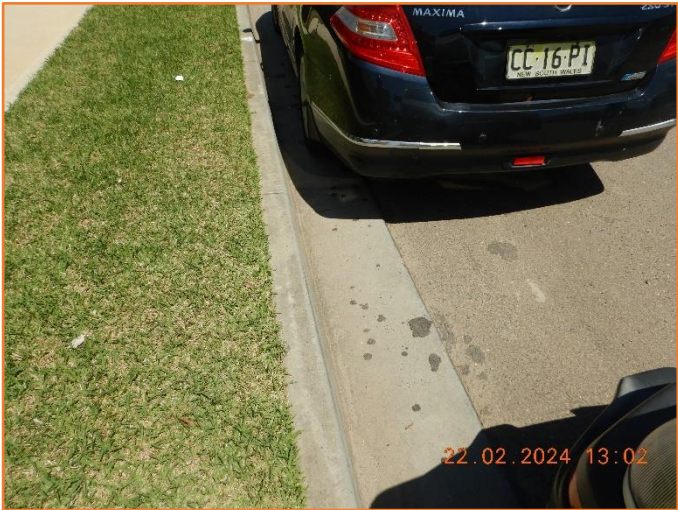
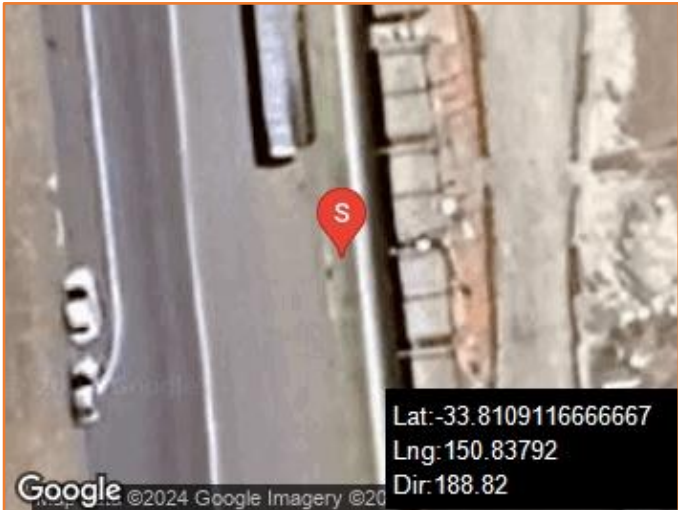
Figure 295: Reasonable - General condition of kerb and gutter.

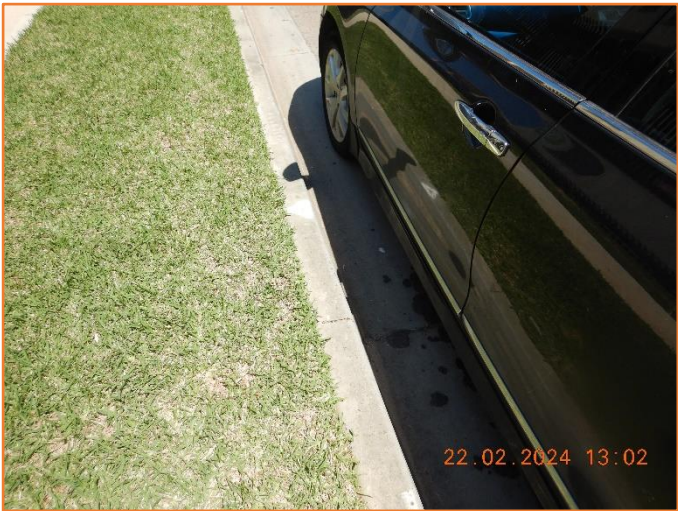
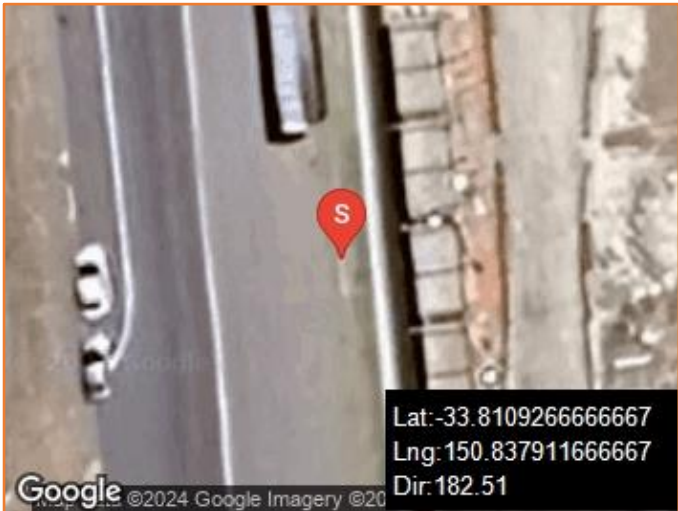
Figure 296: Reasonable - General condition of kerb and gutter.

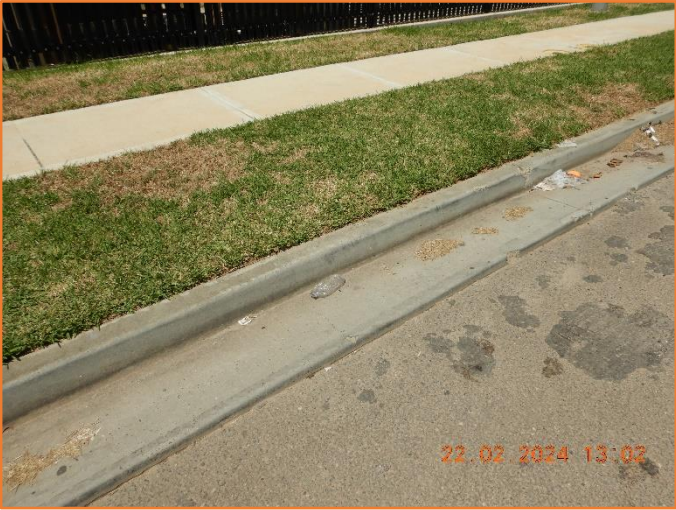
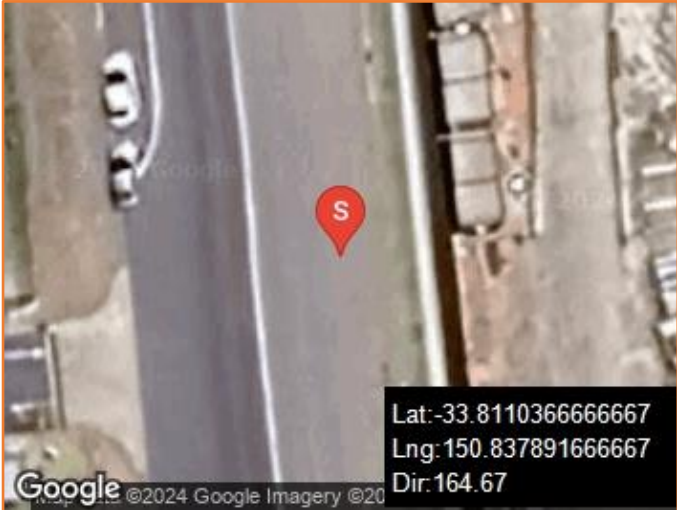
Figure 298: Reasonable - General condition of kerb and gutter.

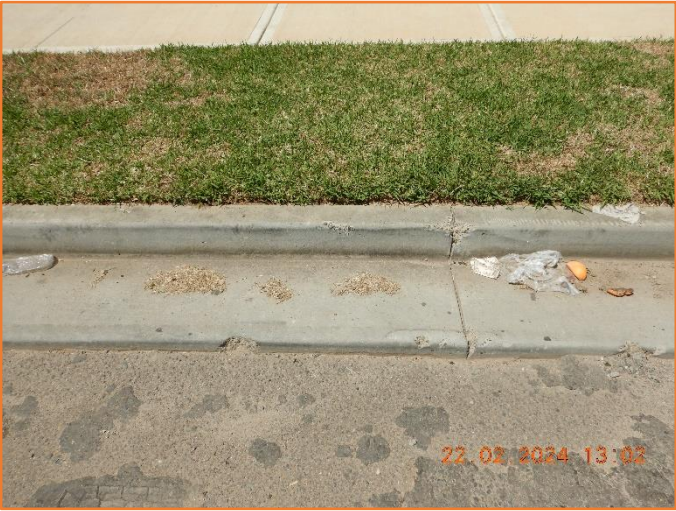
Figure 299: Reasonable - General condition of kerb and gutter. Moderate spalling observed.

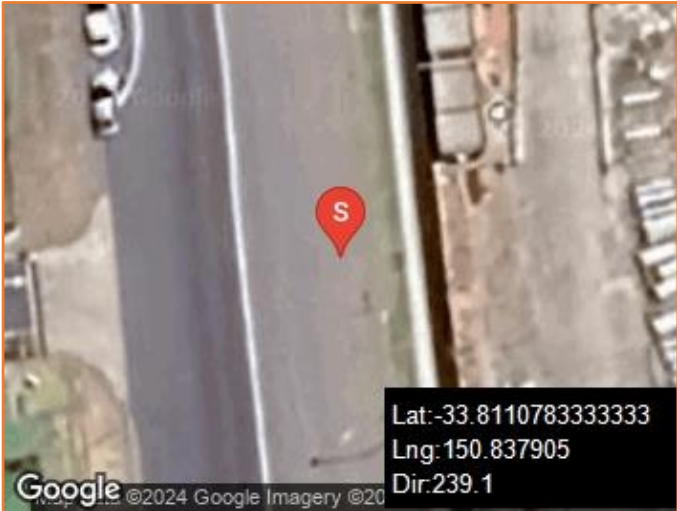
Figure 300: Reasonable - General condition of kerb and gutter.

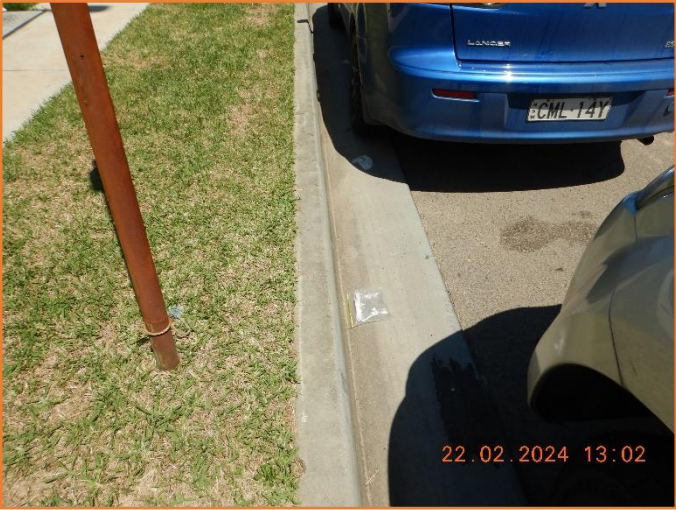
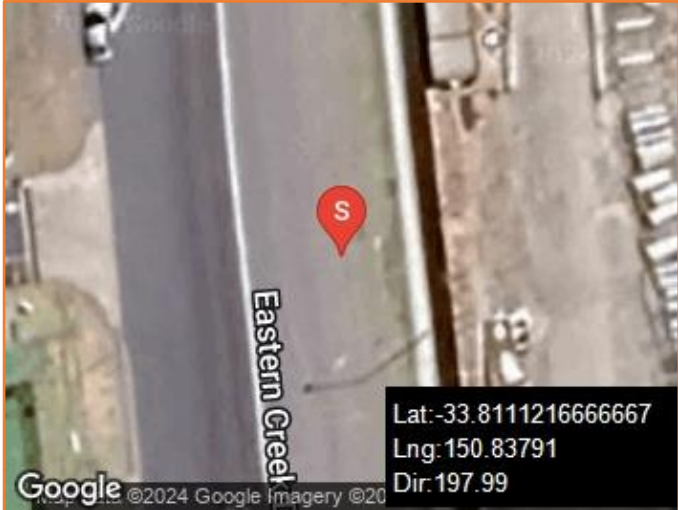
Figure 301: Reasonable - General condition of kerb and gutter.

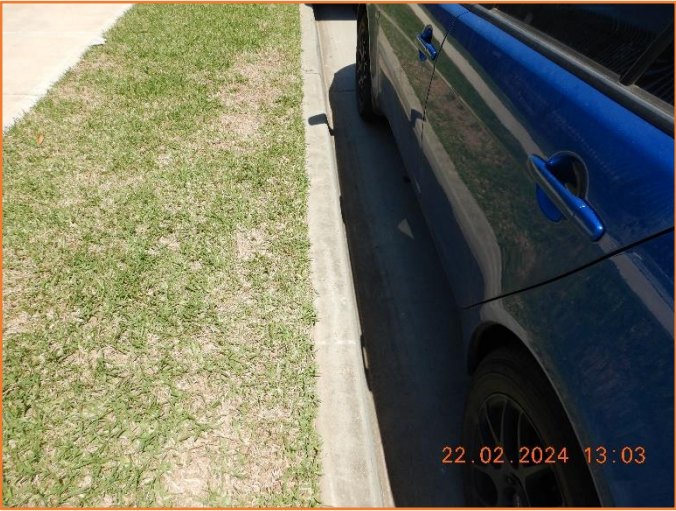
Figure 302: Reasonable - General condition of kerb and gutter.

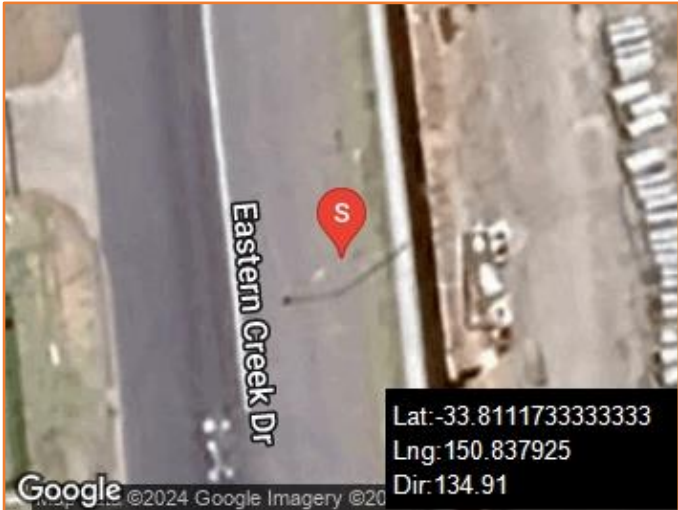
Figure 303: Reasonable - General condition of kerb and gutter.

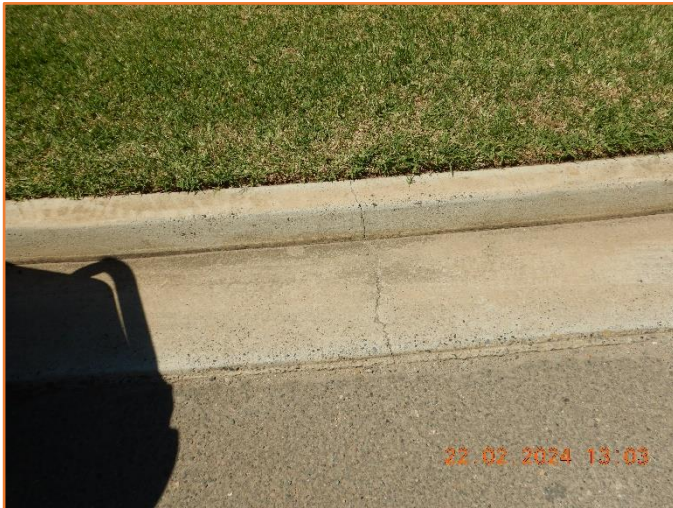
Figure 304: Reasonable - General condition of kerb and gutter. Moderate hairline cracking observed.
