## DILAPIDATION REPORT

10 EASTERN CREEK DRIVE EASTERN CREEK, NSW, 2766

THURSDAY, 22 FEBRUARY 2024

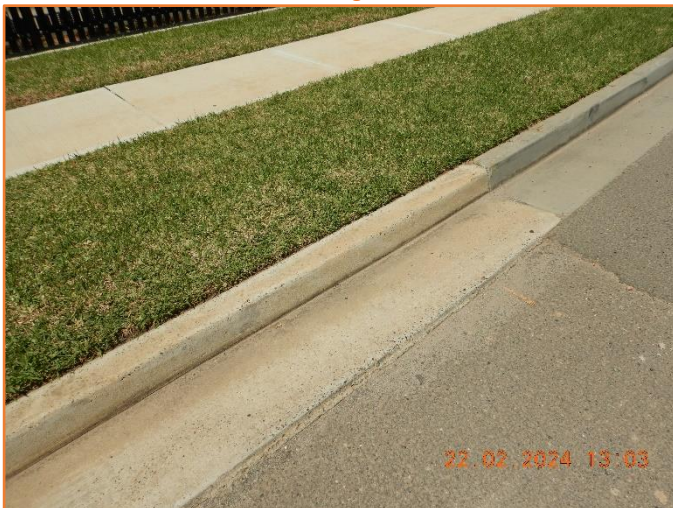
Figure 305: Reasonable - General condition of kerb and gutter.

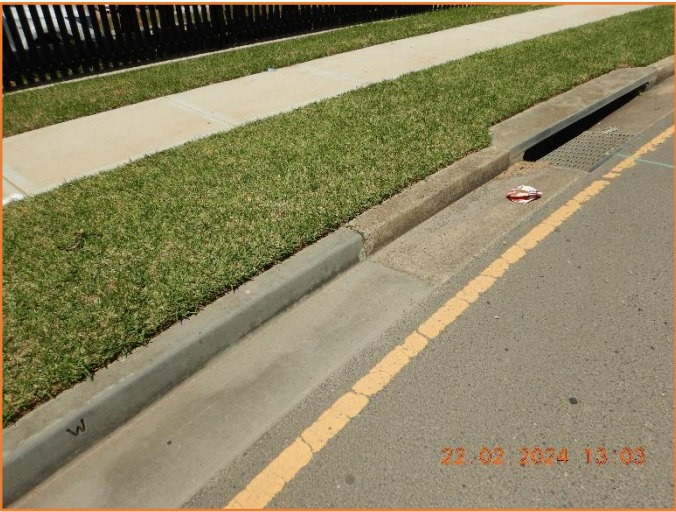
Figure 307: Reasonable - General condition of kerb and gutter.

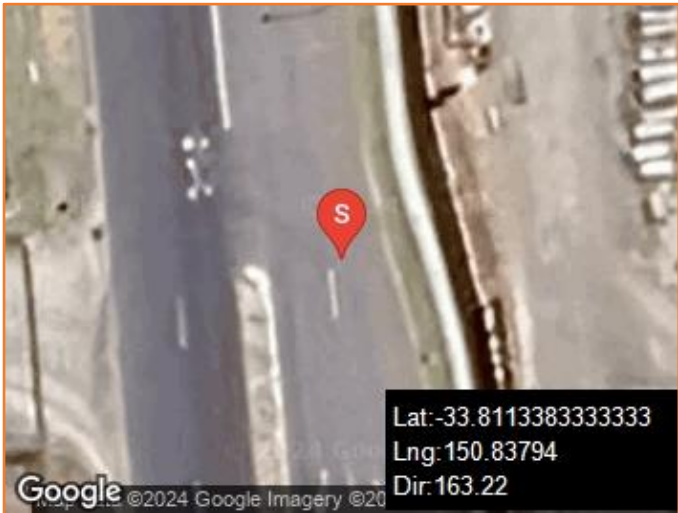
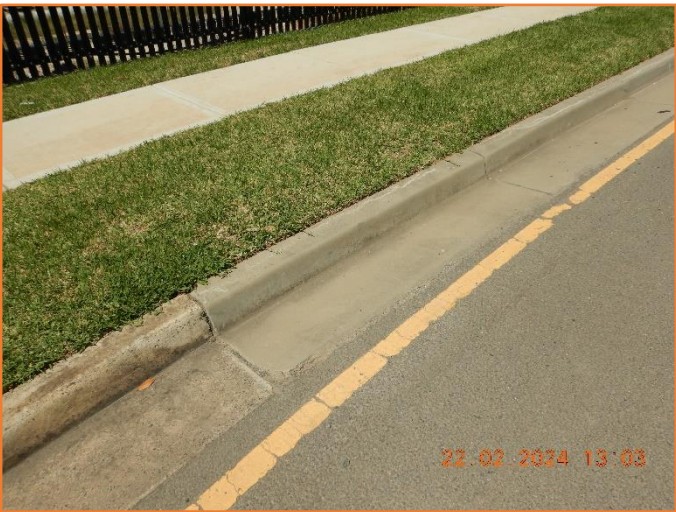
Figure 309: Reasonable - General condition of kerb and gutter.

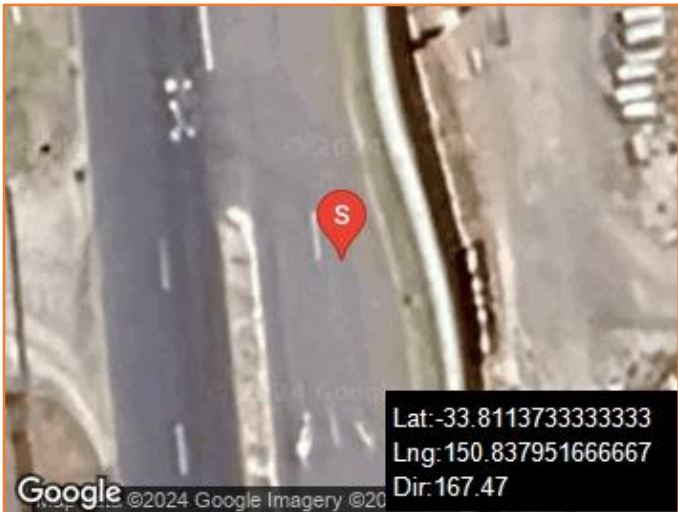
Figure 310: Reasonable - General condition of kerb and gutter.

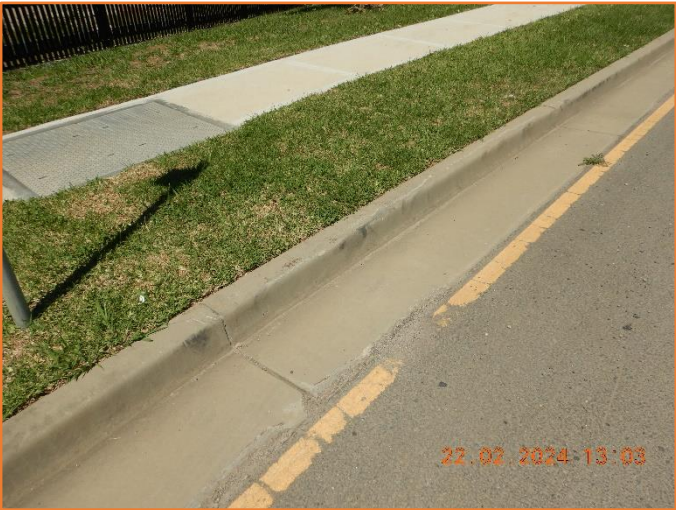
Figure 312: Reasonable - General condition of kerb and gutter.

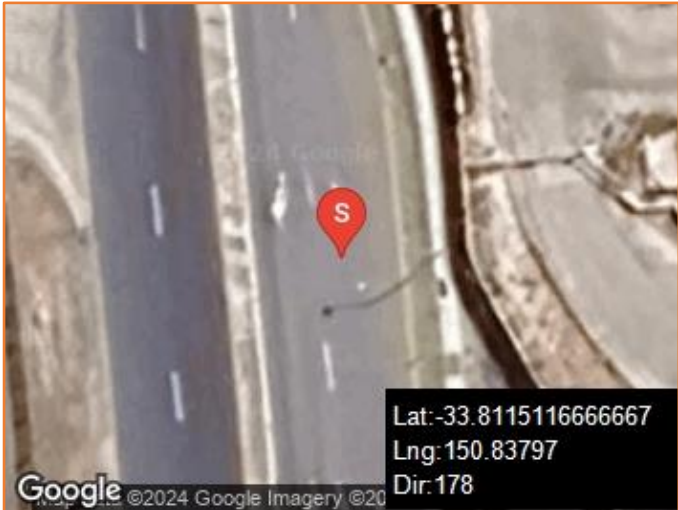
Figure 313: Reasonable - General condition of kerb and gutter.

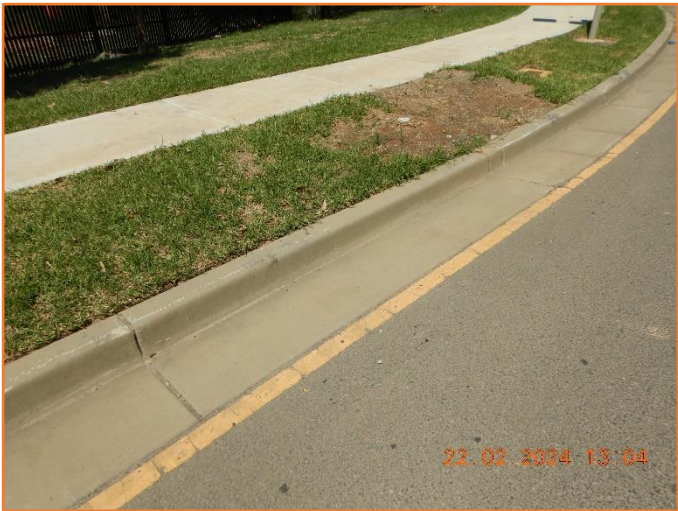
Figure 314: Reasonable - General condition of kerb and gutter.

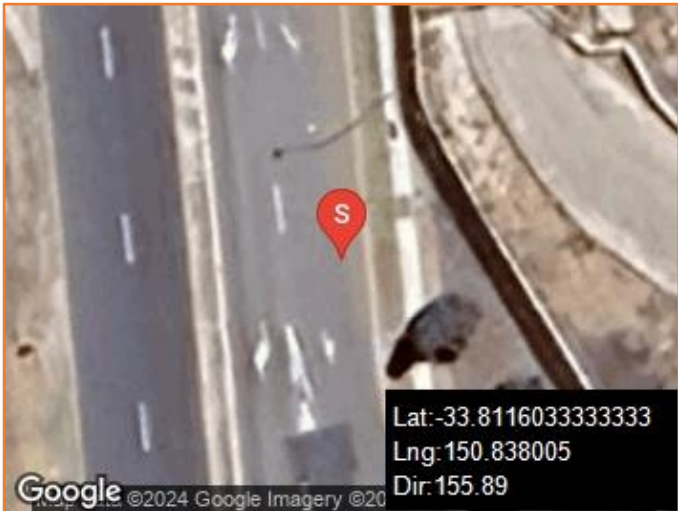
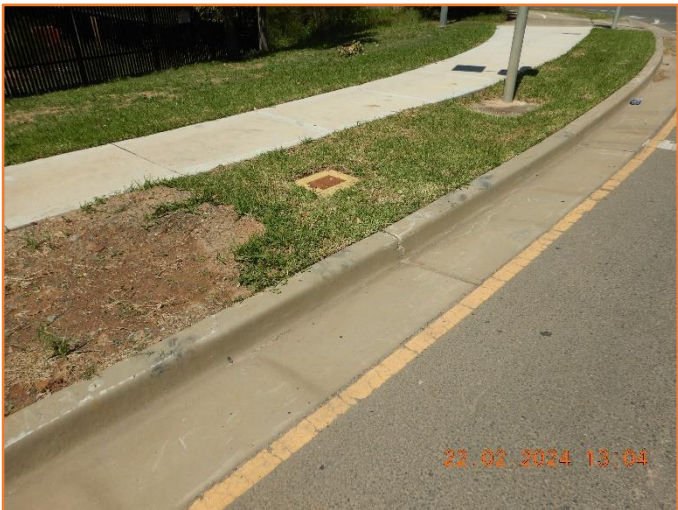
Figure 315: Reasonable - General condition of kerb and gutter.

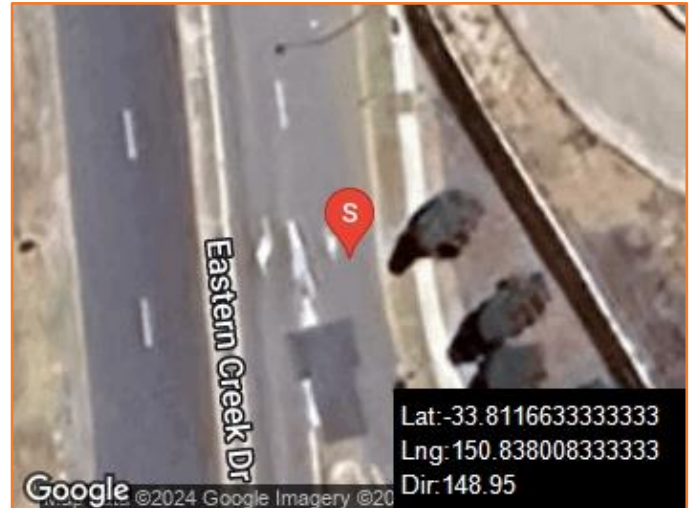
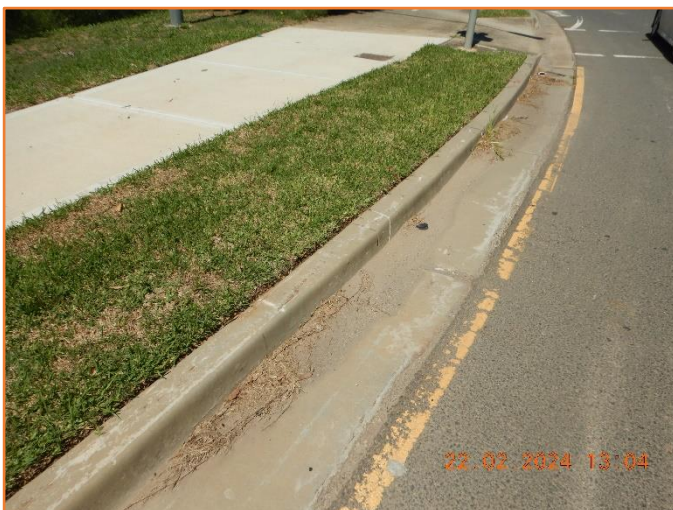
Figure 317: Reasonable - General condition of kerb and gutter.

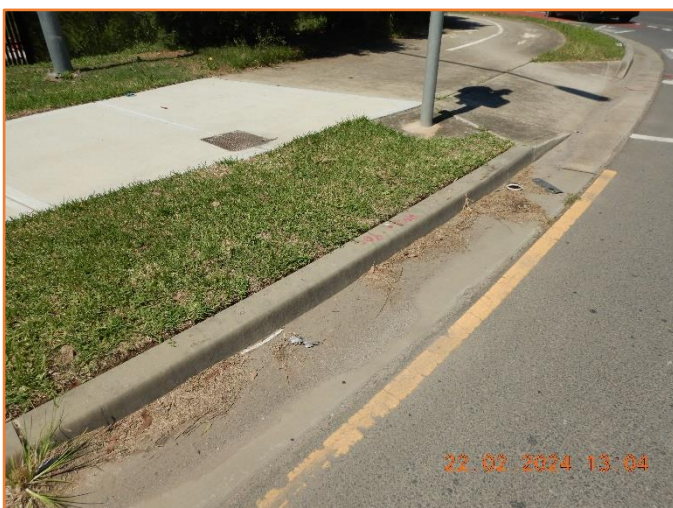
Figure 318: Reasonable - General condition of kerb and gutter.

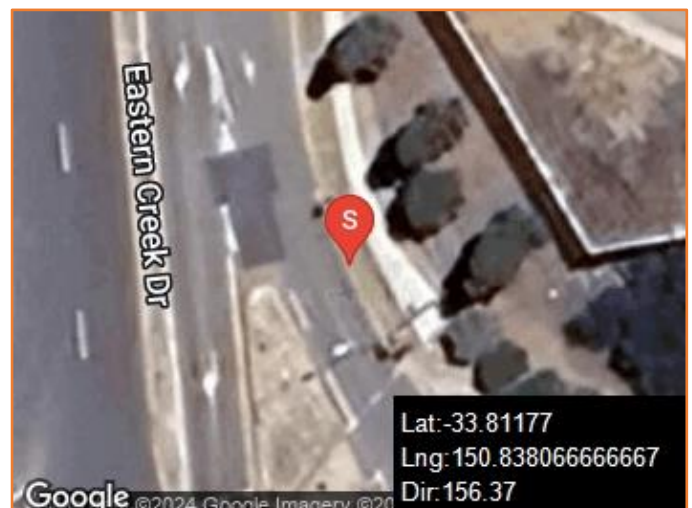
Figure 319: Reasonable - General condition of pram ramp.

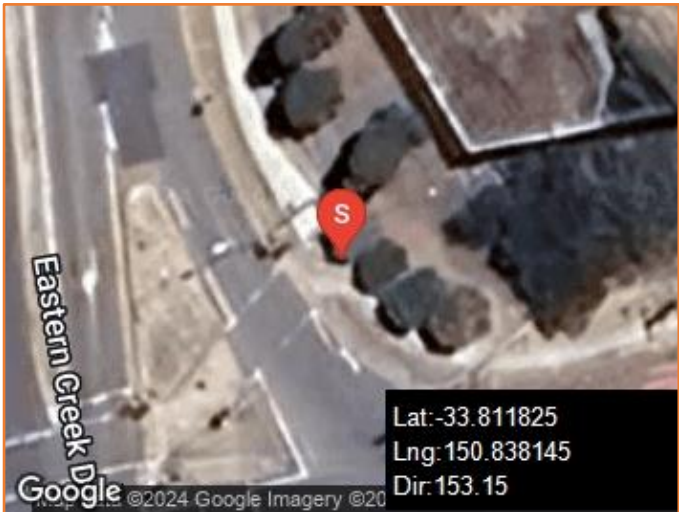
Figure 321: Good - General condition of traffic signage.

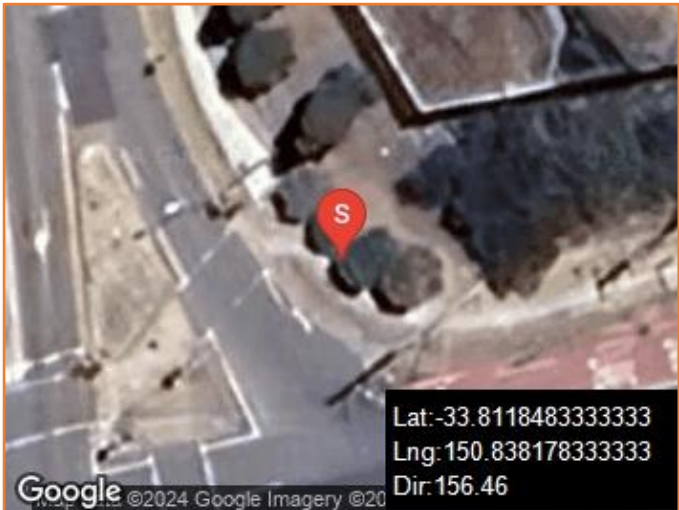
Figure 322: Reasonable - General condition of footpath.

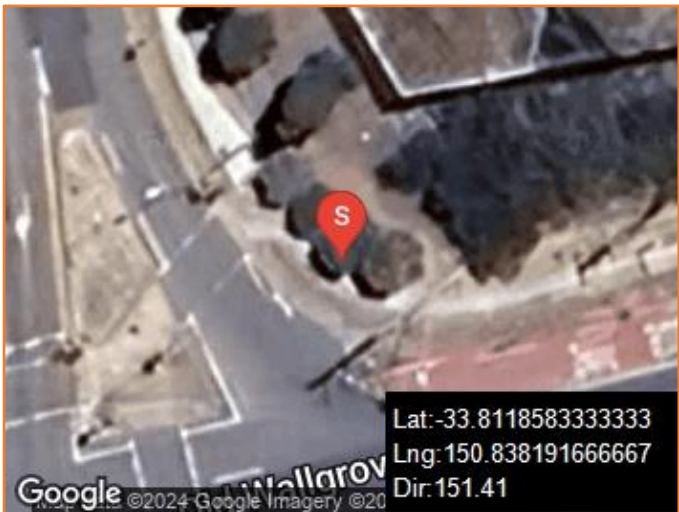
Figure 323: Reasonable - General condition of footpath.

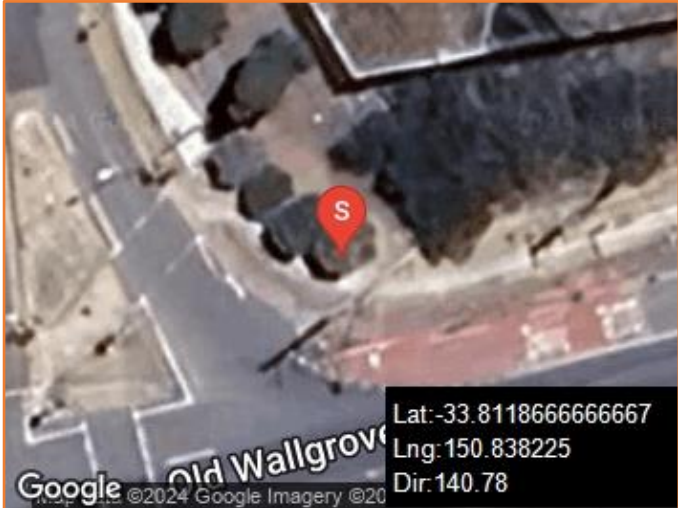
Figure 324: Good - General condition of monopole assembly.

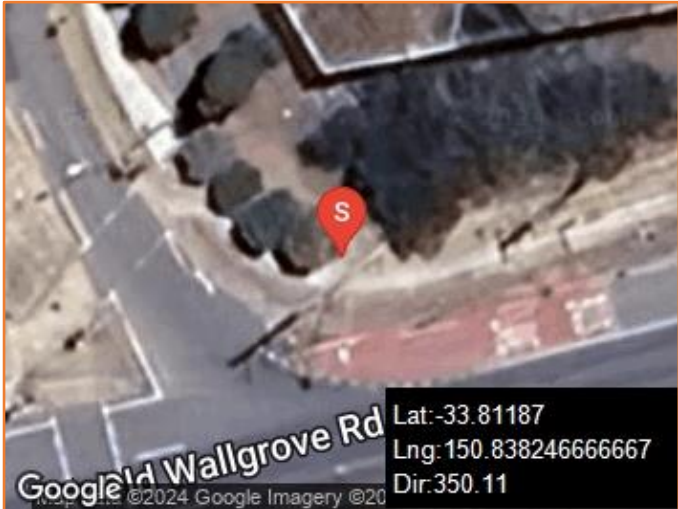
Figure 325: Reasonable - General condition of footpath.

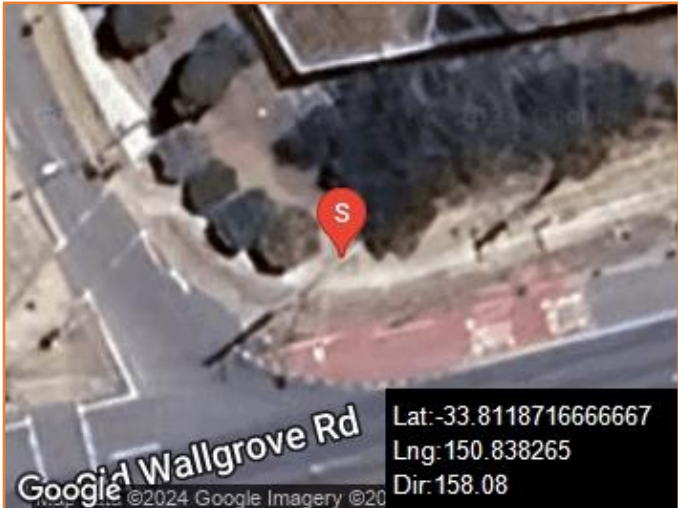
Figure 326: Good - General condition of traffic signage.

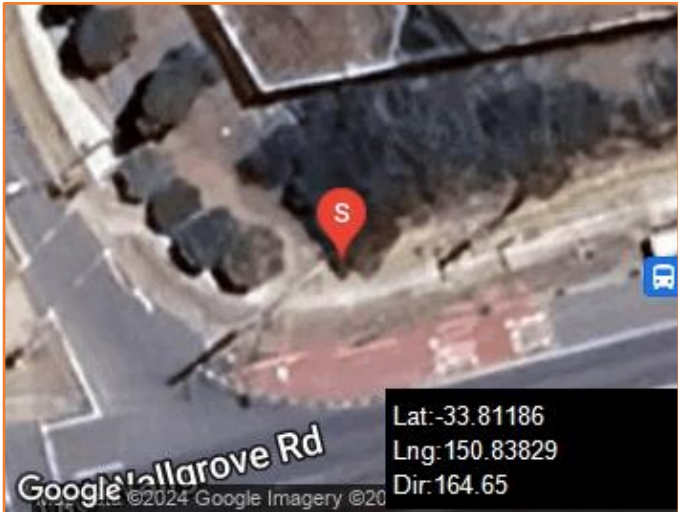
Figure 327: Reasonable - General condition of footpath and service pit.

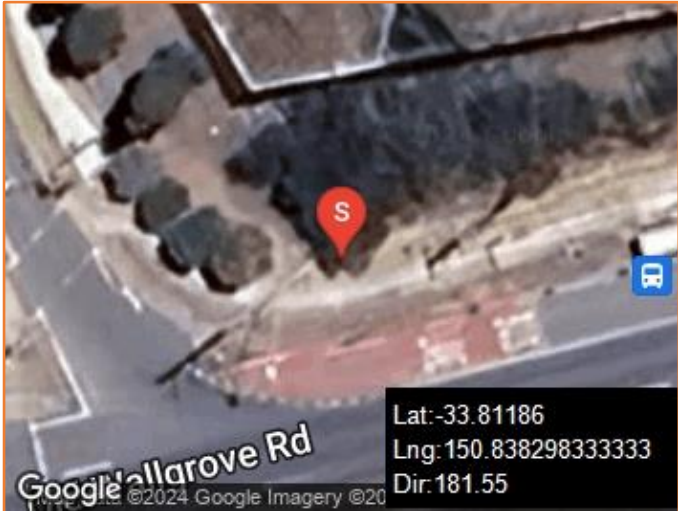
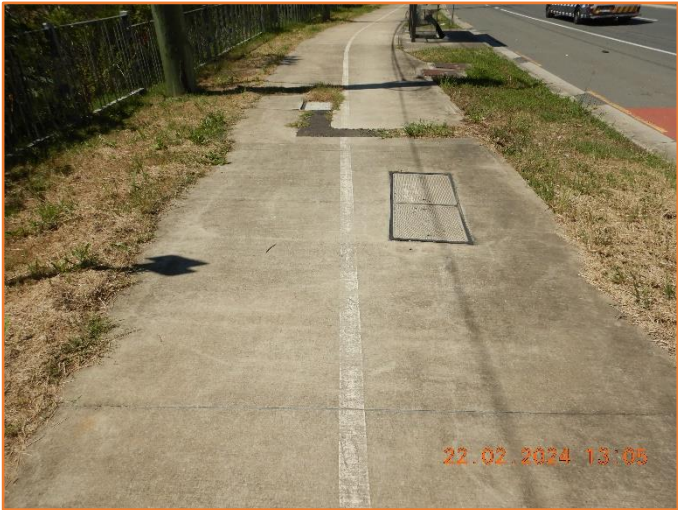
Figure 328: Reasonable - General condition of footpath and service pit.

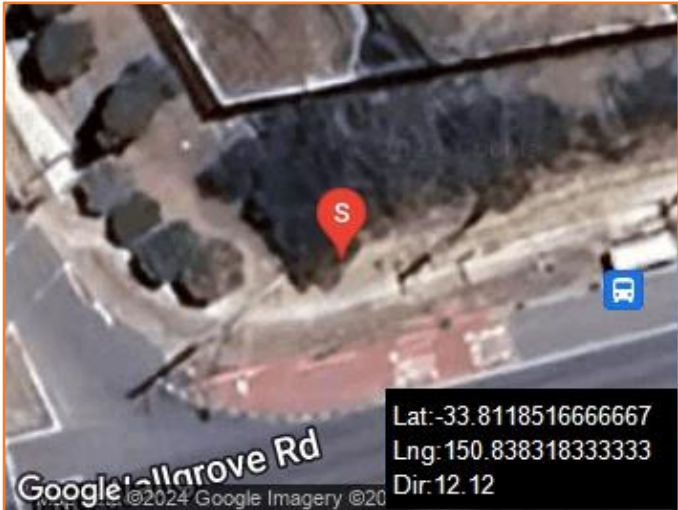
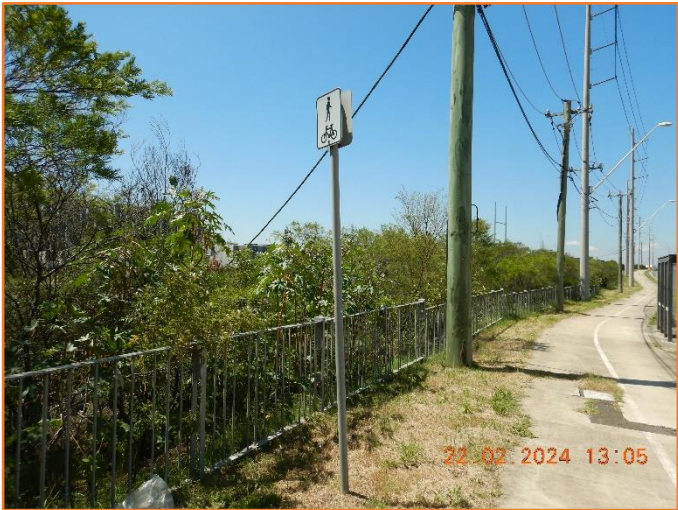
Figure 329: Reasonable - General condition of signage. Moderate rotation observed.

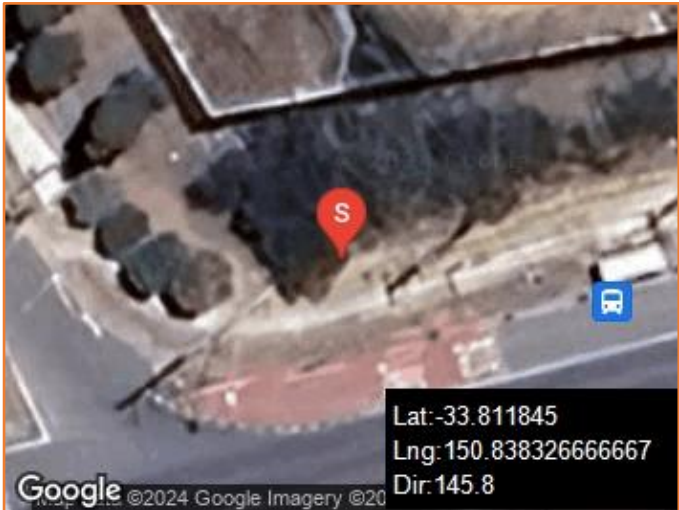
Figure 330: Reasonable - General condition of footpath and service pit.

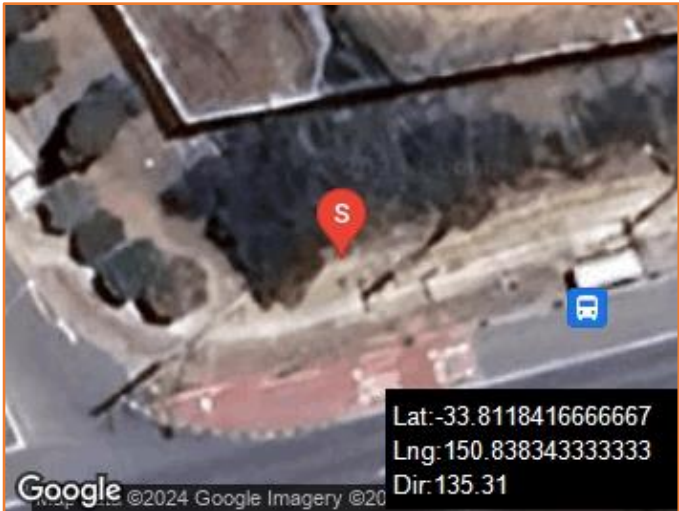
Figure 331: Poor - General condition of footpath. Previous repair works observed.

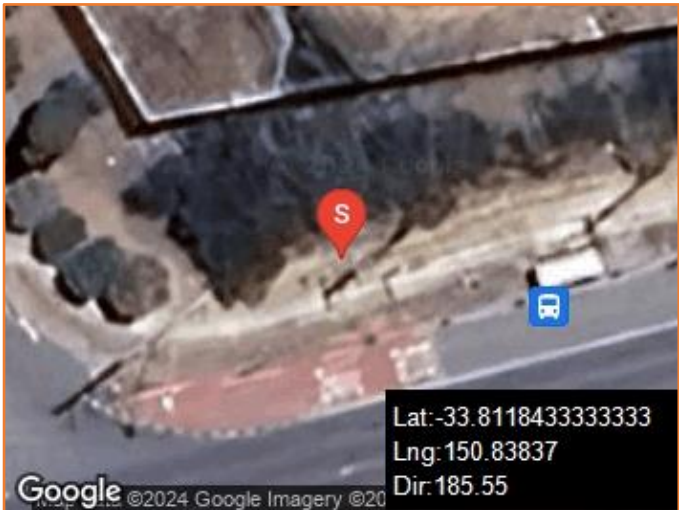
Figure 332: Reasonable - General condition of monopole assembly.

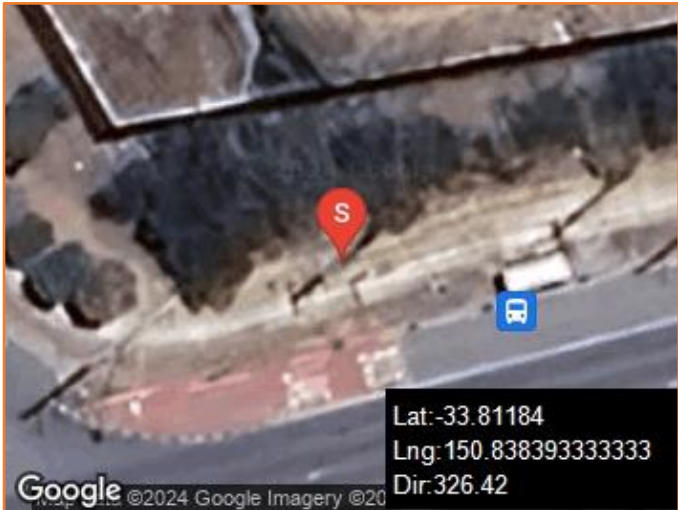
Figure 333: Poor - General condition of footpath and service pit. Moderate cracking observed.

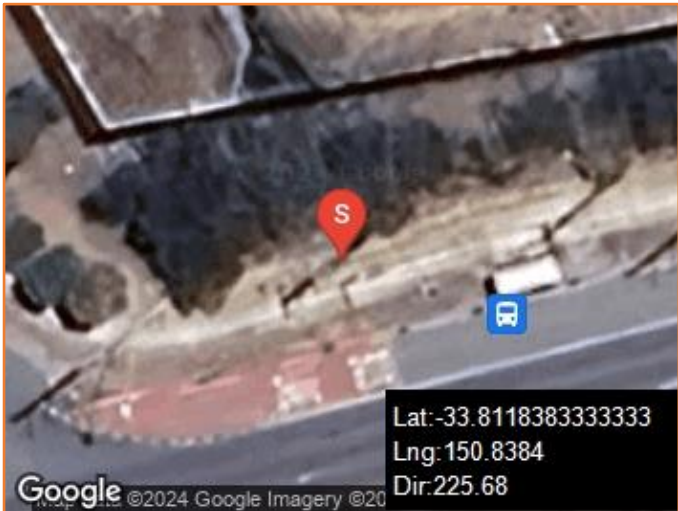
Figure 334: Reasonable - General condition of service pit.

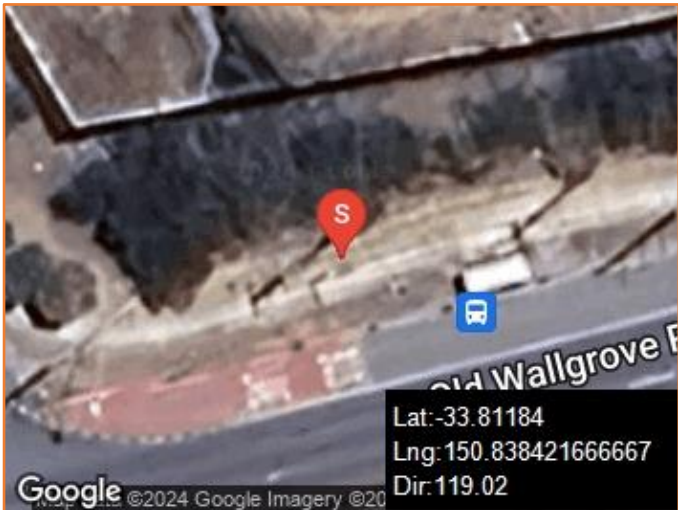
Figure 335: Reasonable - General condition of footpath.

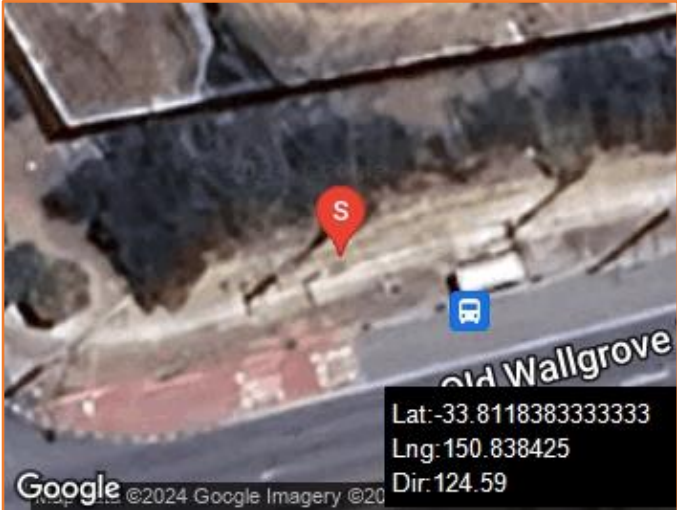
Figure 336: Reasonable - General condition of footpath.

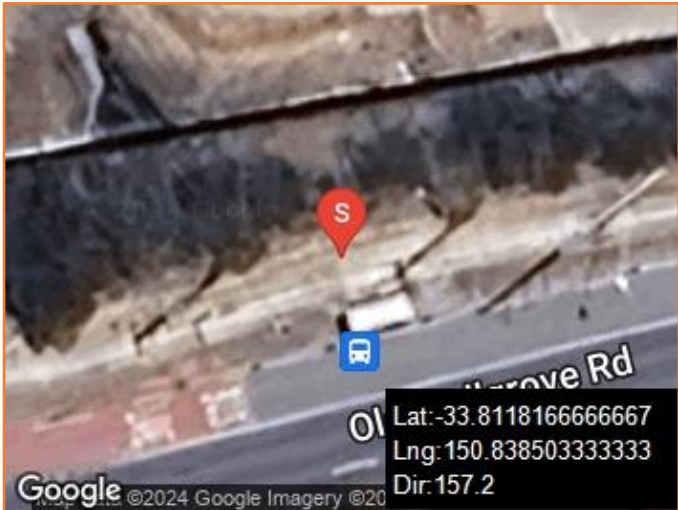
Figure 339: Reasonable - General condition of footpath.

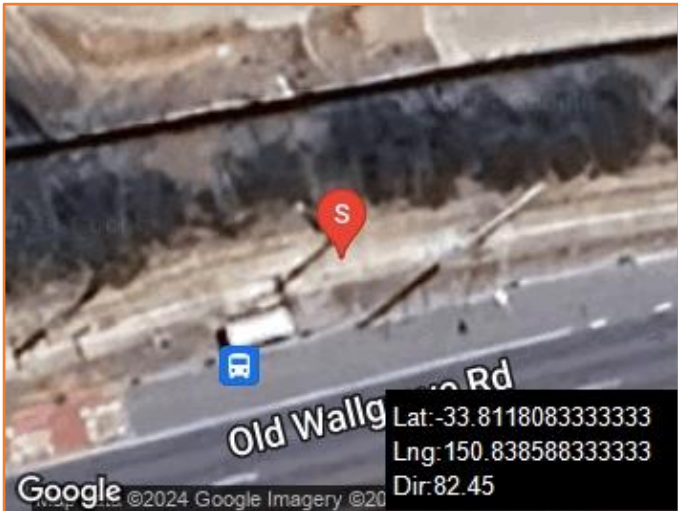
Figure 340: Reasonable - General condition of monopole assembly.

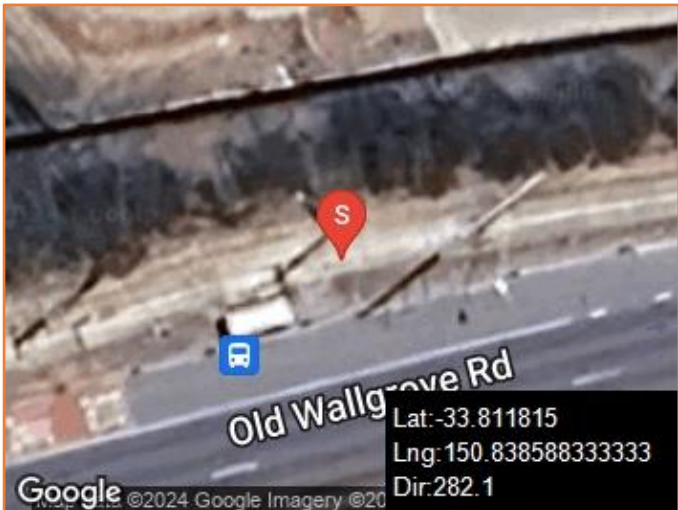
Figure 341: Reasonable - General condition of footpath.

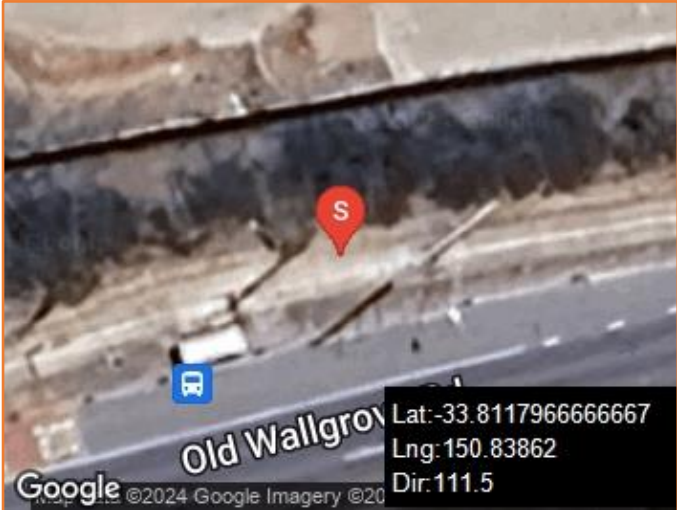
Figure 342: Reasonable - General condition of footpath.

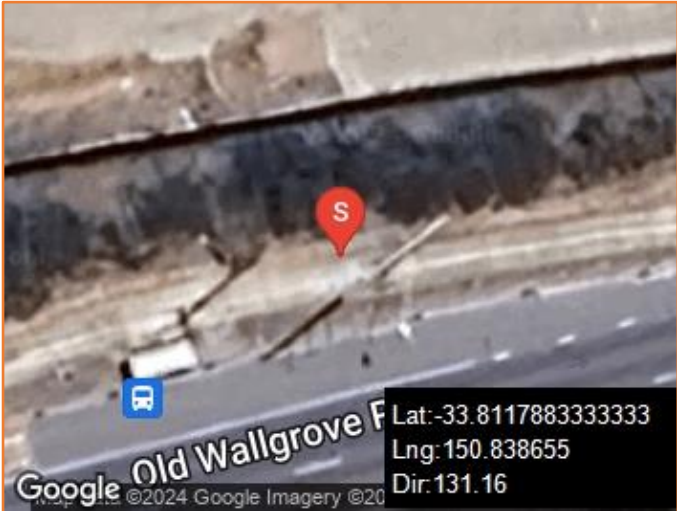
Figure 343: Good - General condition of monopole assembly.

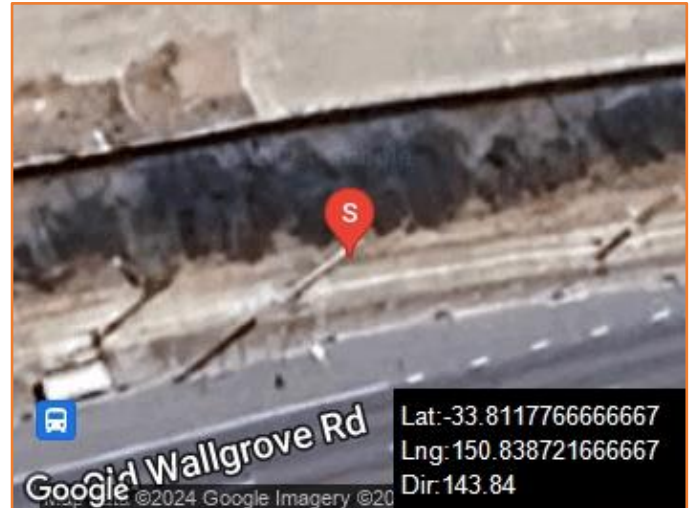
Figure 345: Reasonable - General condition of footpath.

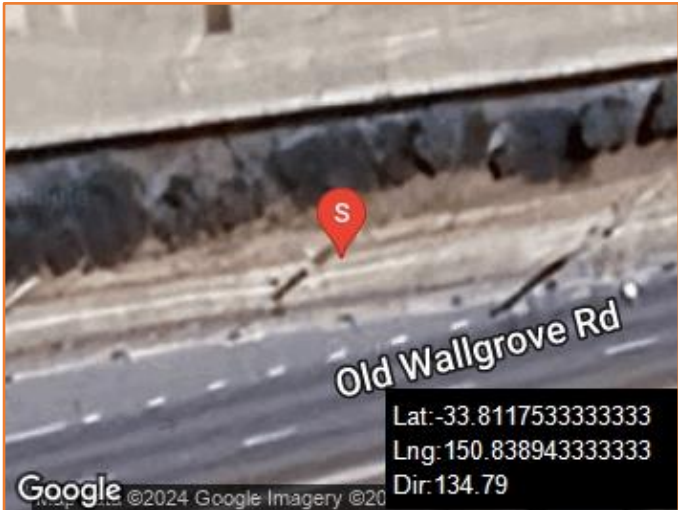
Figure 348: Reasonable - General condition of monopole assembly.

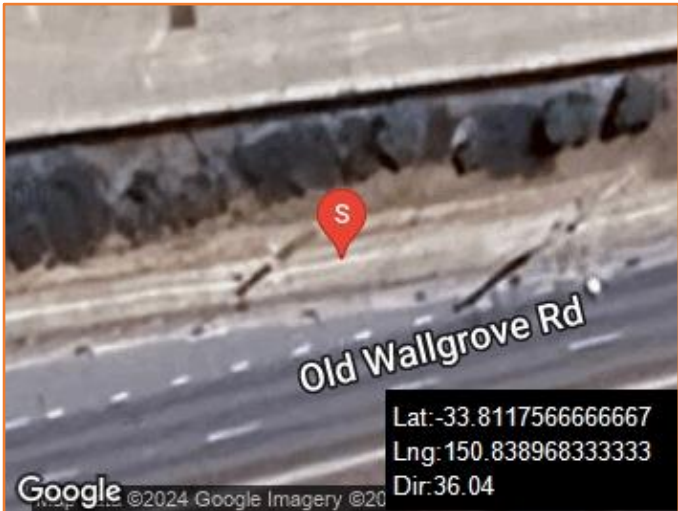
Figure 349: Reasonable - General condition of footpath.

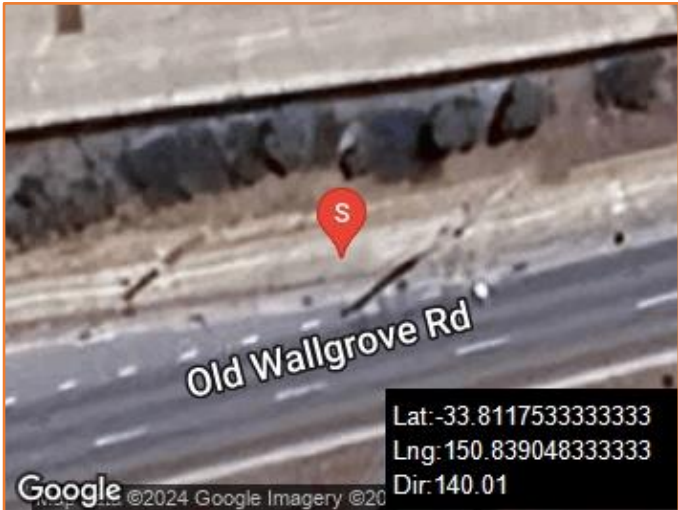
Figure 351: Reasonable - General condition of service pit.

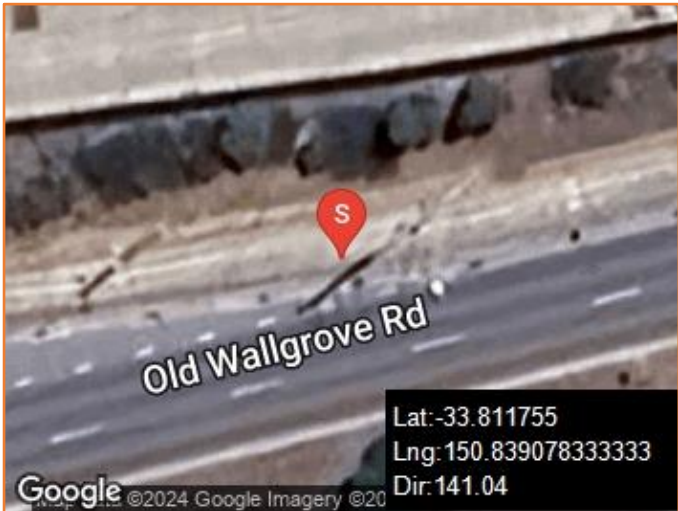
Figure 352: Reasonable - General condition of footpath.

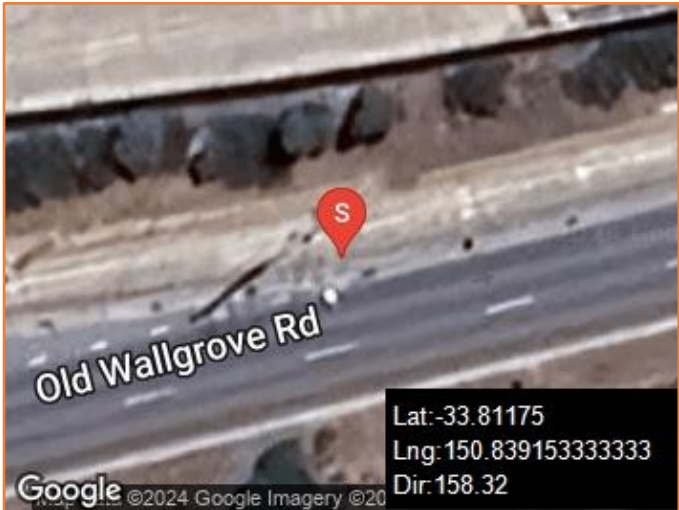
Figure 354: Reasonable - General condition of footpath.

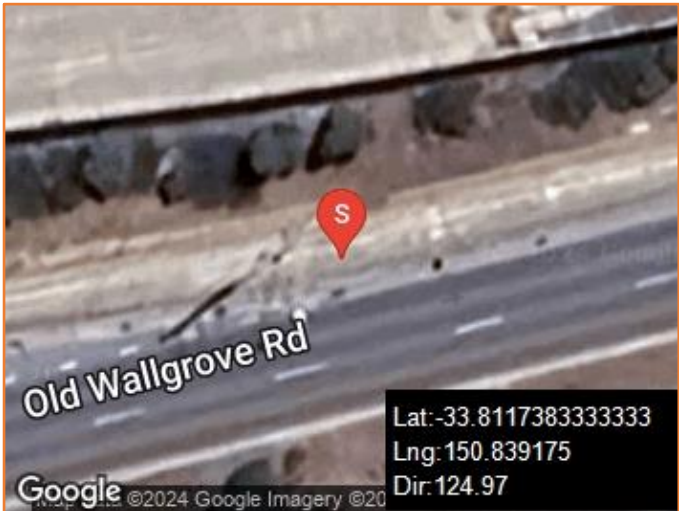
Figure 355: Good - General condition of traffic signage.

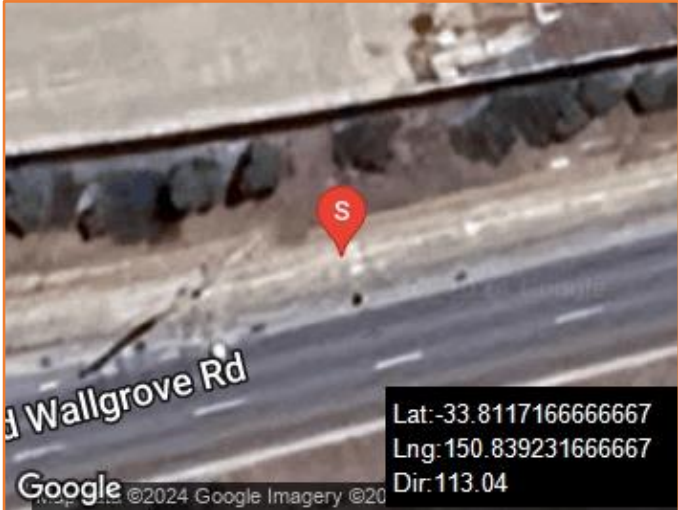
Figure 357: Reasonable - General condition of footpath.

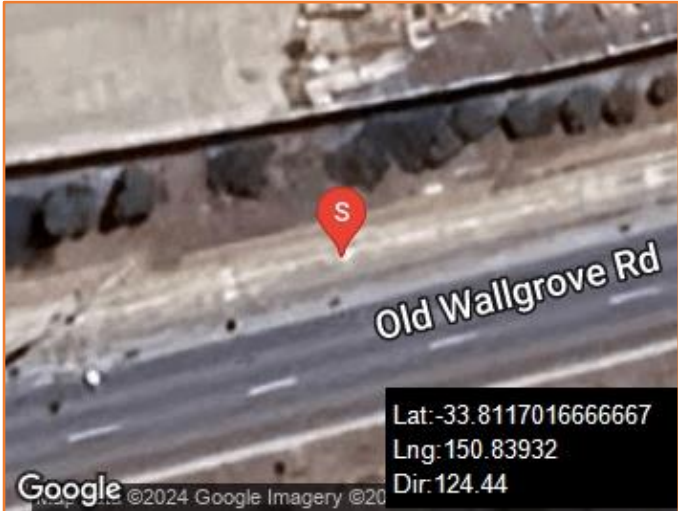
Figure 358: Reasonable - General condition of footpath.

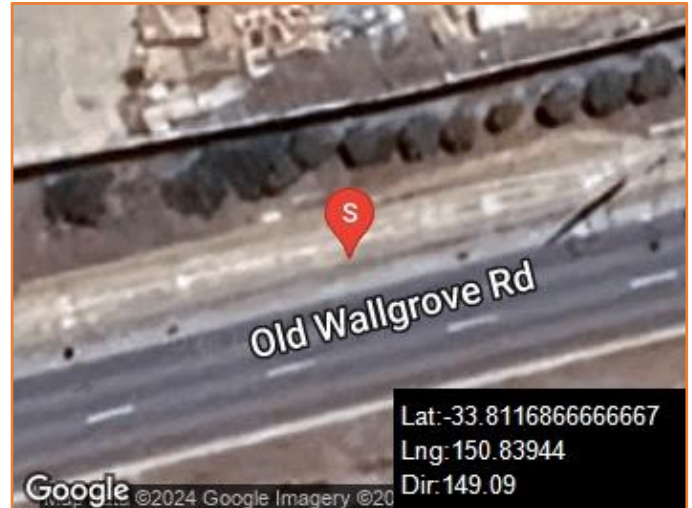
Figure 360: Reasonable - General condition of footpath.

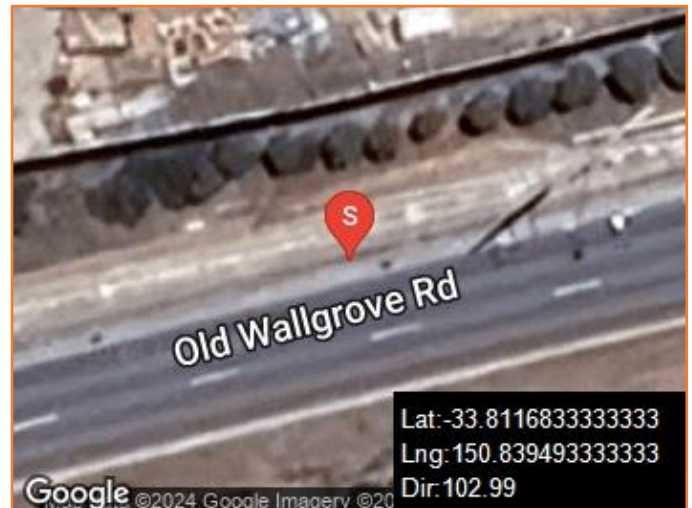
Figure 361: Reasonable - General condition of footpath.

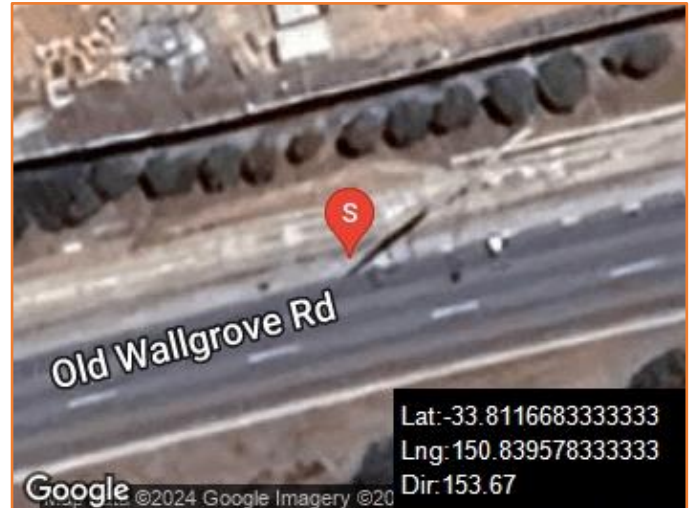
Figure 363: Reasonable - General condition of footpath.

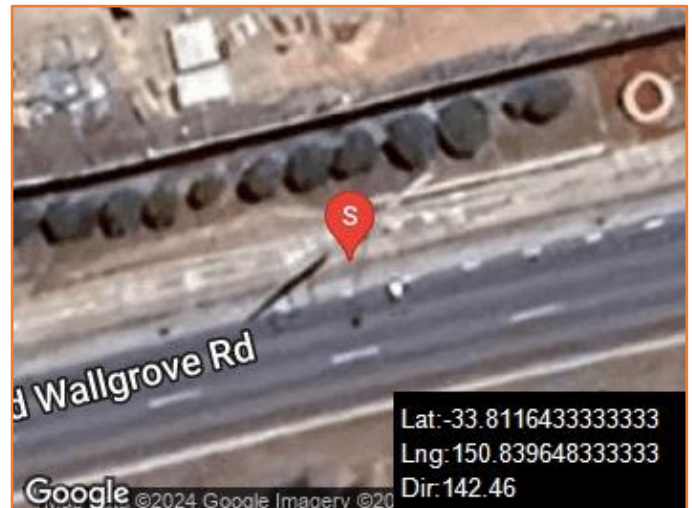
Figure 364: Reasonable - General condition of service pit.

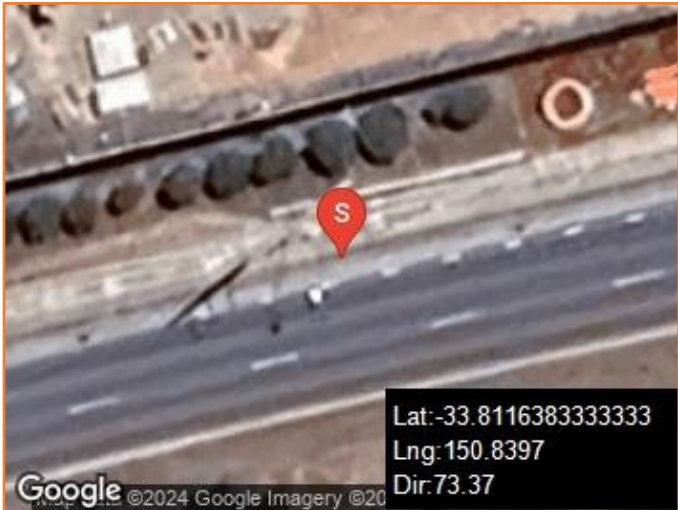
Figure 366: Reasonable - General condition of footpath.

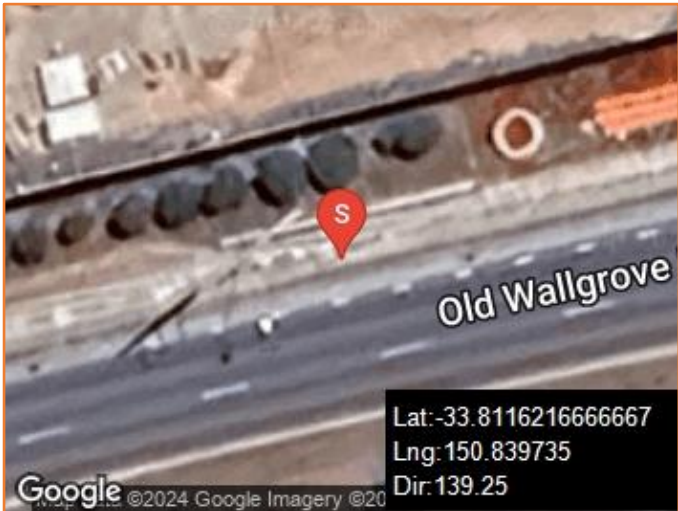
Figure 367: Reasonable - General condition of footpath.

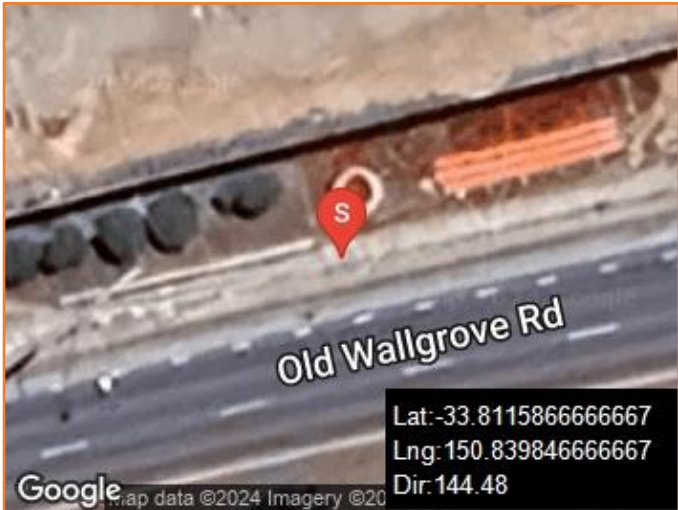
Figure 369: Reasonable - General condition of footpath.

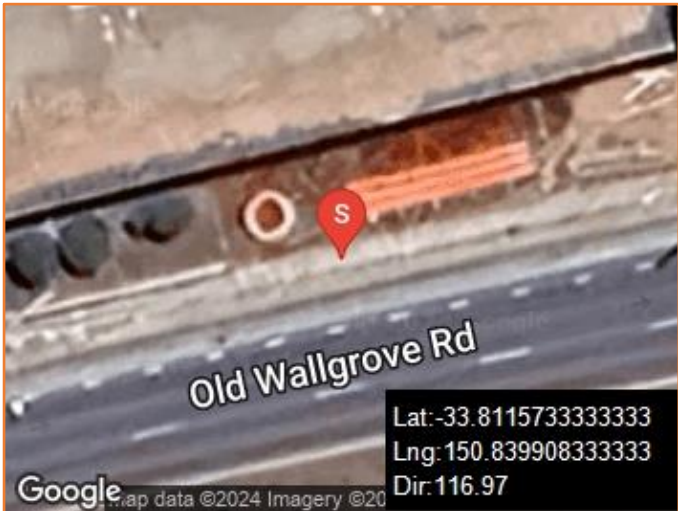
Figure 370: Good - General condition of monopole assembly.

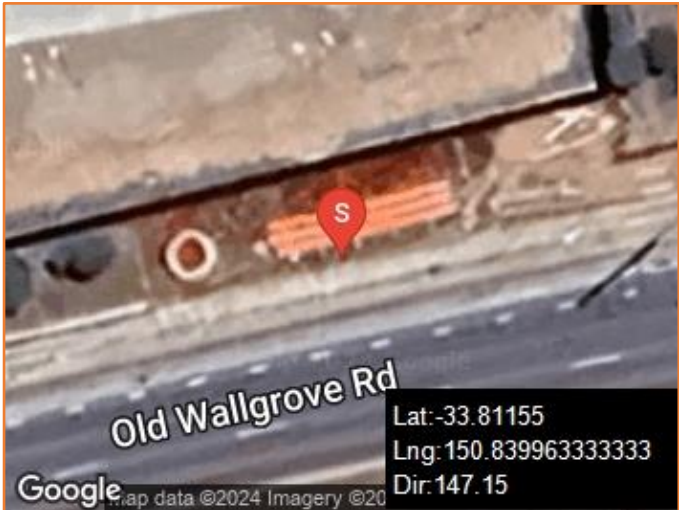
Figure 372: Poor - General condition of service pit. Moderate vertical displacement observed.

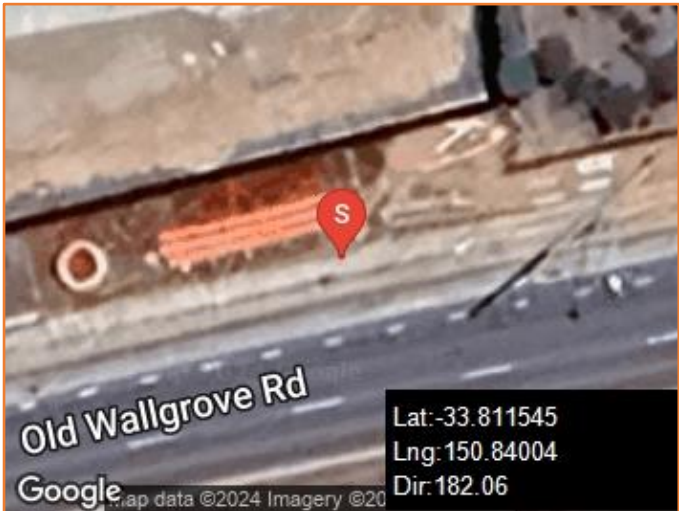
Figure 373: Reasonable - General condition of footpath.

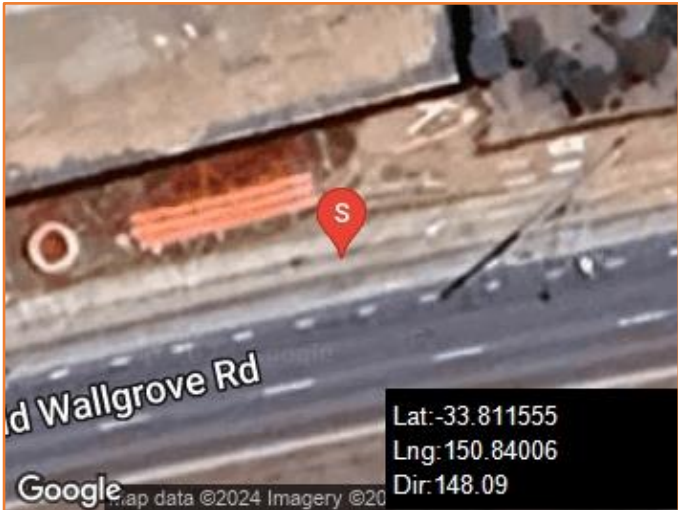
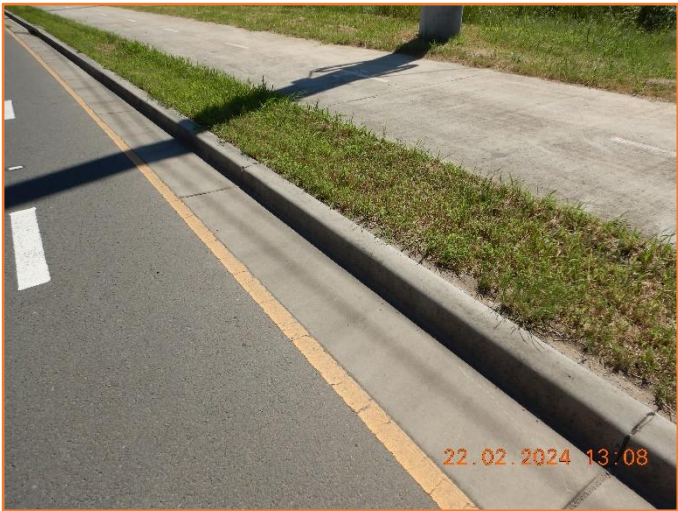
Figure 375: Reasonable - General condition of kerb and gutter.

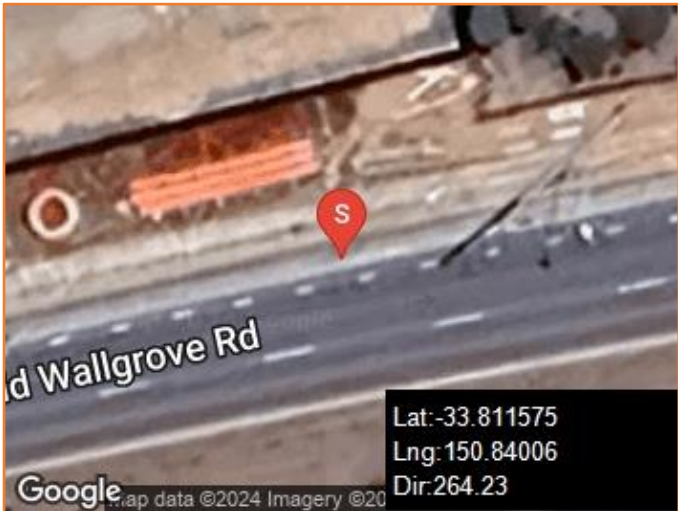
Figure 376: Reasonable - General condition of kerb and gutter.

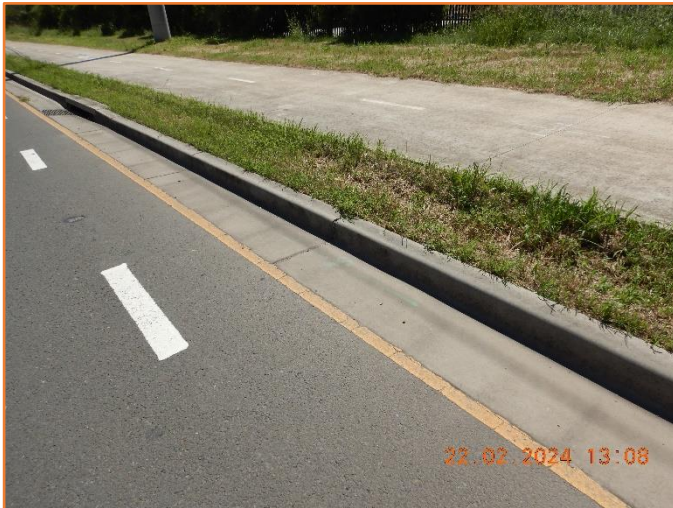
Figure 377: Reasonable - General condition of kerb and gutter.

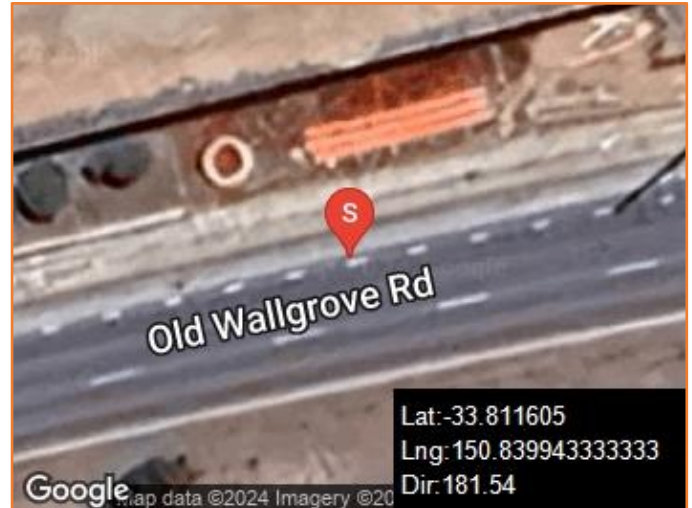
Figure 378: Reasonable - General condition of kerb and gutter.

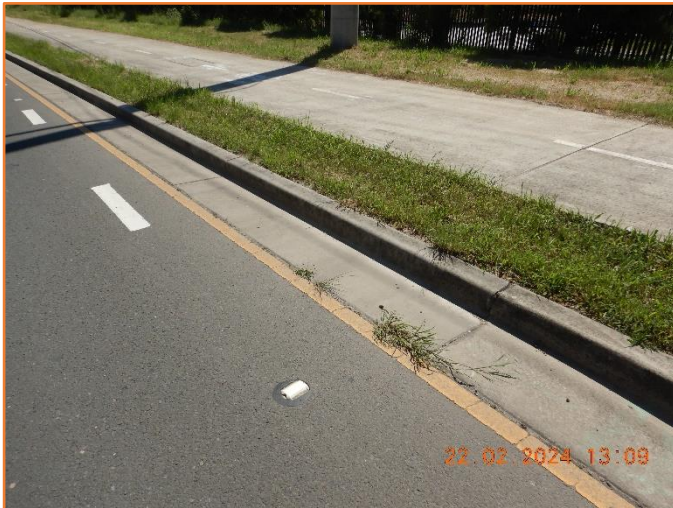
Figure 380: Reasonable - General condition of kerb and gutter.

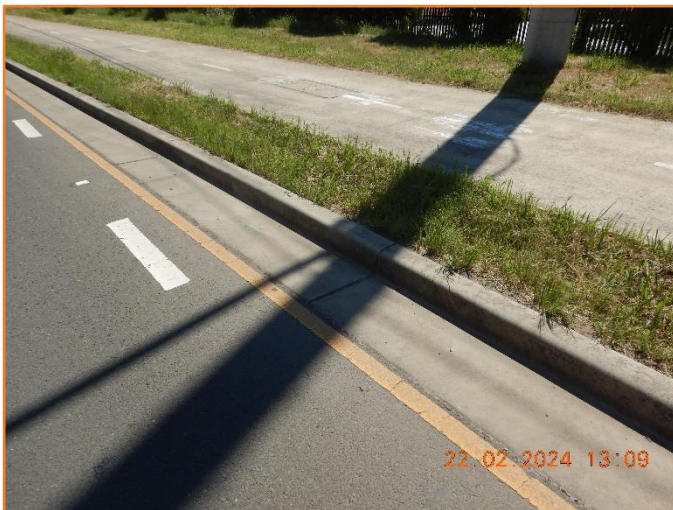
Figure 381: Reasonable - General condition of kerb and gutter.

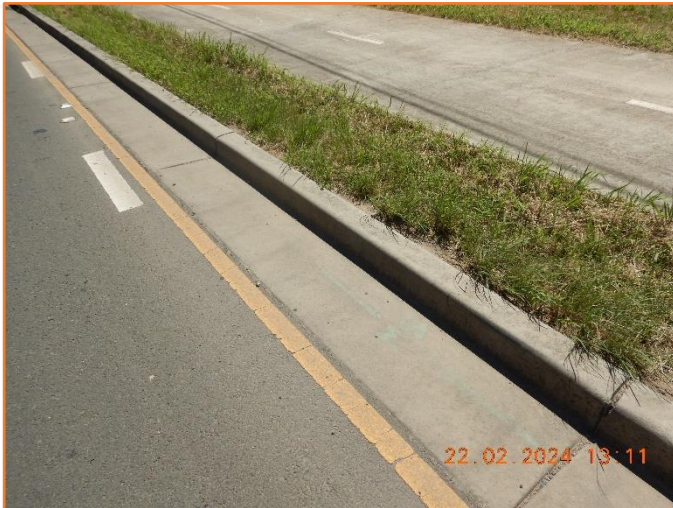
Figure 383: Reasonable - General condition of kerb and gutter.
