## DILAPIDATION REPORT

10 EASTERN CREEK DRIVE EASTERN CREEK, NSW, 2766

THURSDAY, 22 FEBRUARY 2024

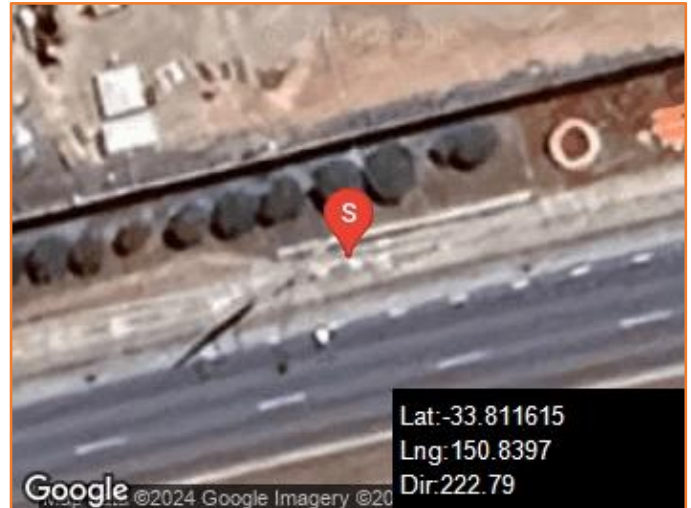
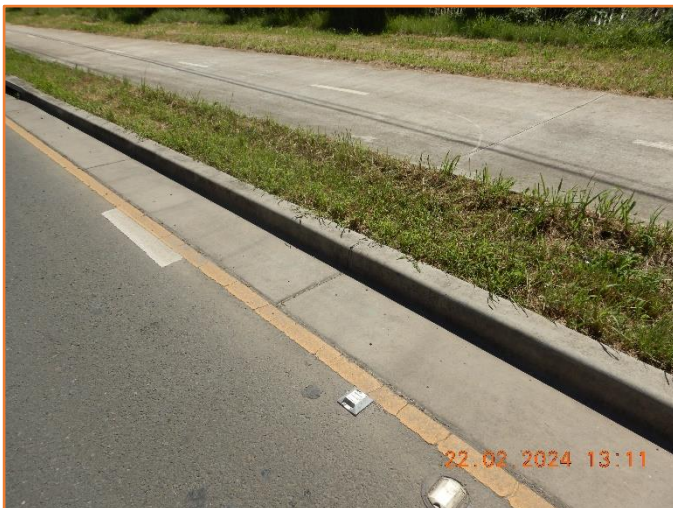
Figure 384: Reasonable - General condition of kerb and gutter.

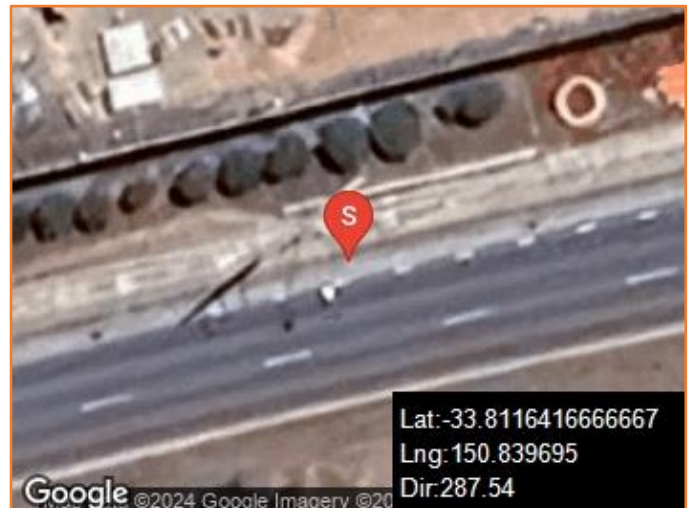
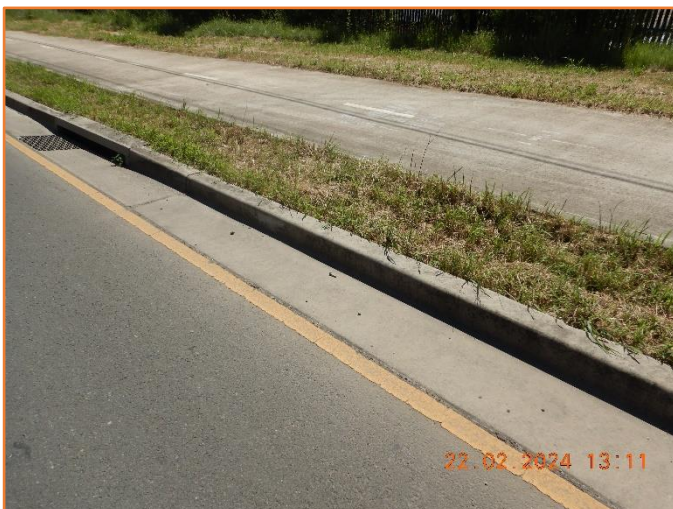
Figure 385: Reasonable - General condition of kerb and gutter.

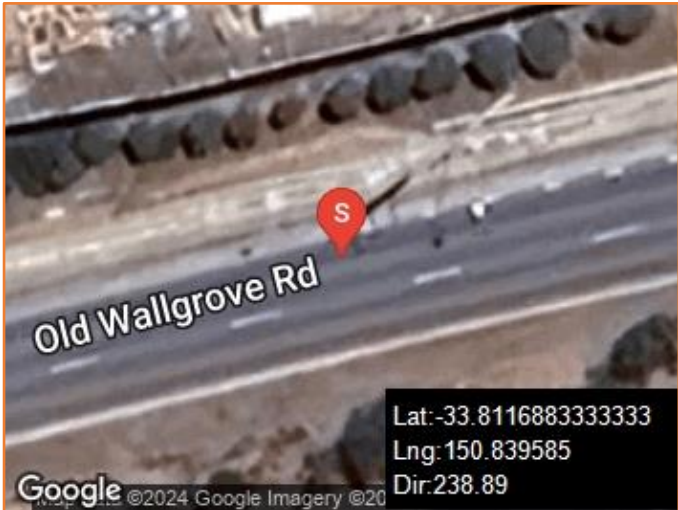
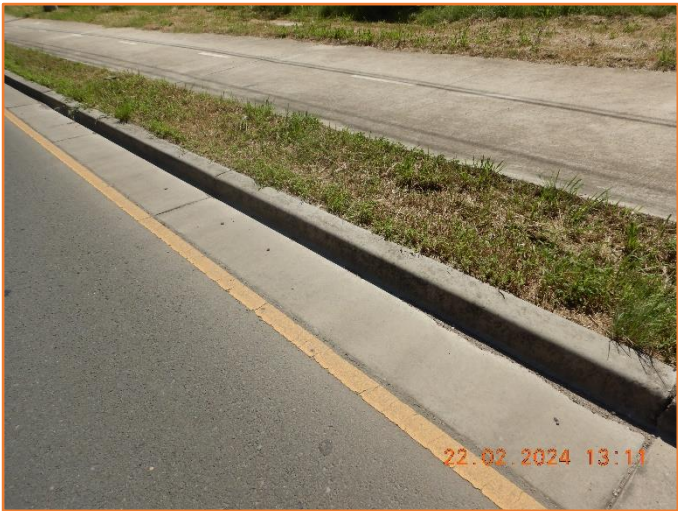
Figure 387: Reasonable - General condition of kerb and gutter.

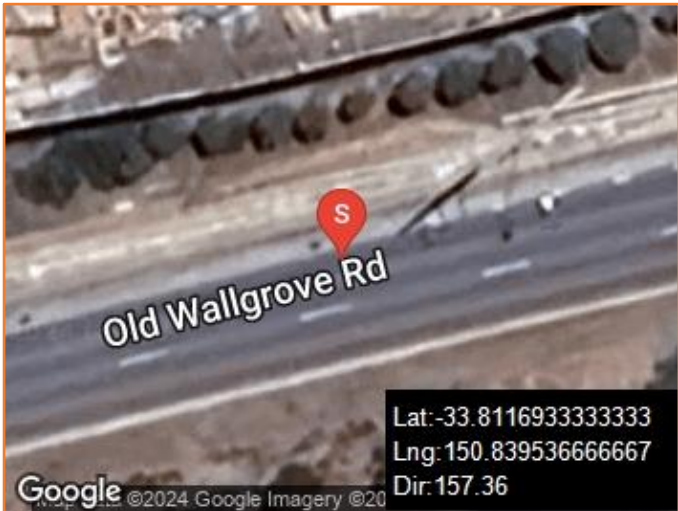
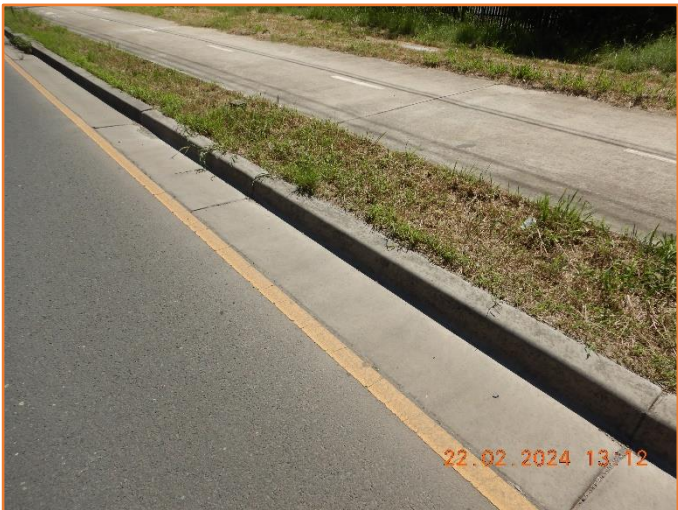
Figure 388: Reasonable - General condition of kerb and gutter.

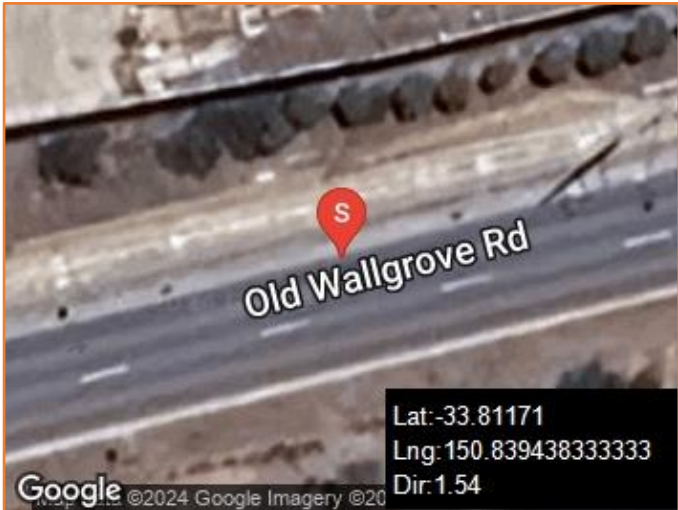
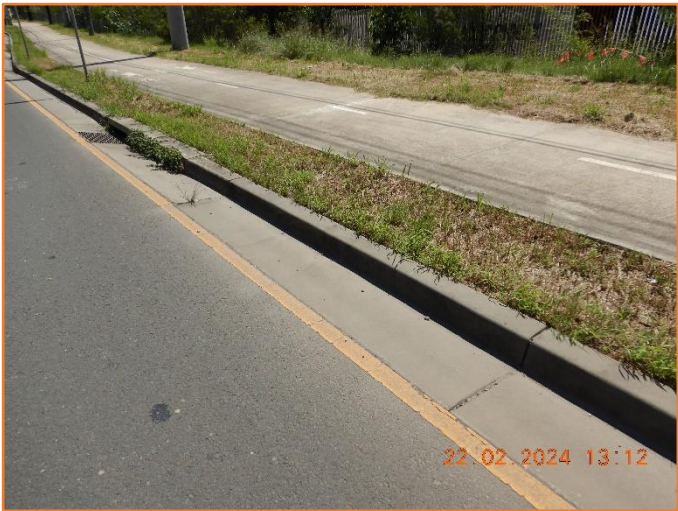
Figure 390: Reasonable - General condition of kerb and gutter.

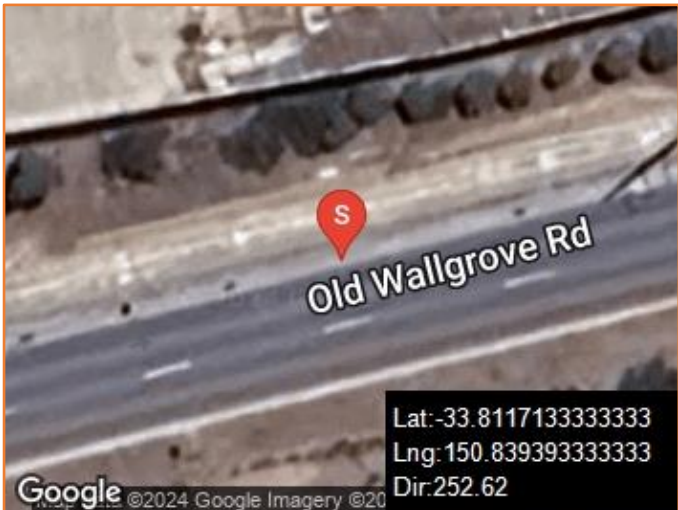
Figure 391: Reasonable - General condition of kerb inlet pit.

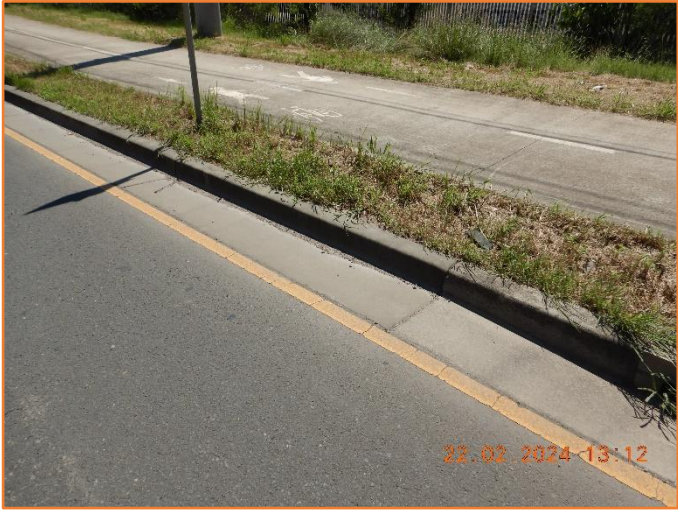
Figure 392: Reasonable - General condition of kerb and gutter.

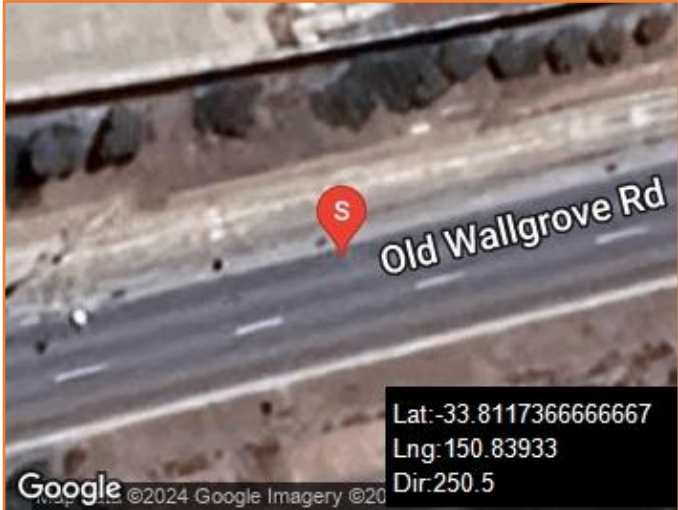
Figure 393: Reasonable - General condition of kerb and gutter.

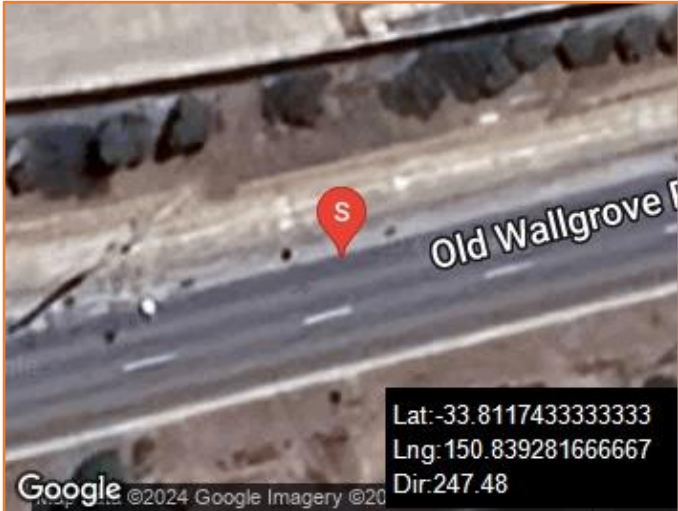
Figure 394: Reasonable - General condition of kerb inlet pit.

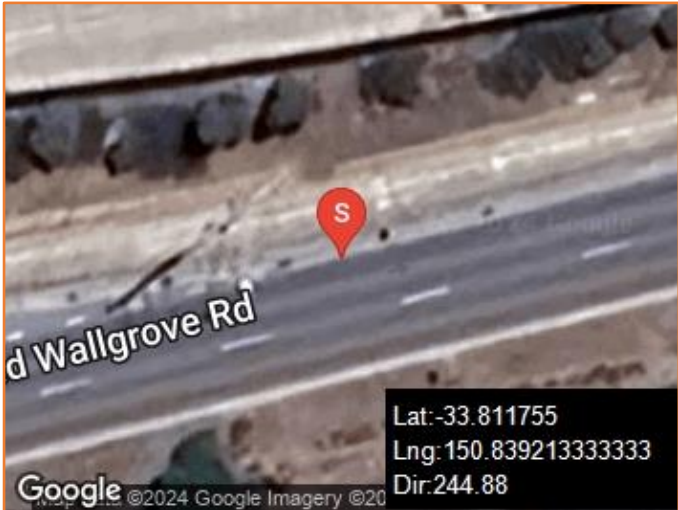
Figure 395: Reasonable - General condition of kerb and gutter.

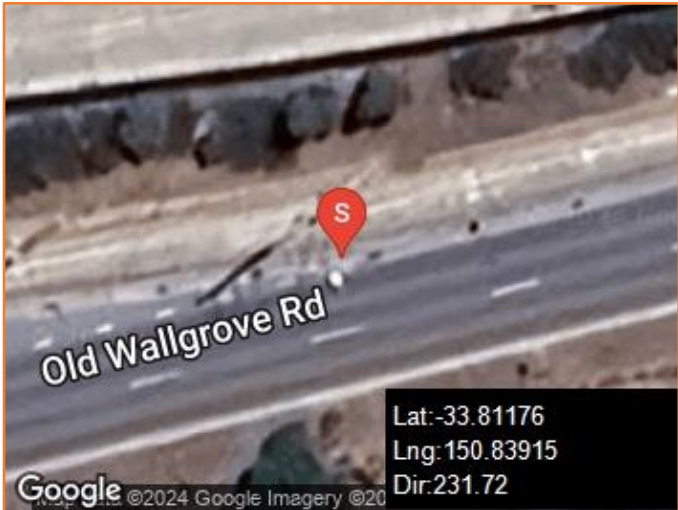
Figure 396: Reasonable - General condition of kerb inlet pit.

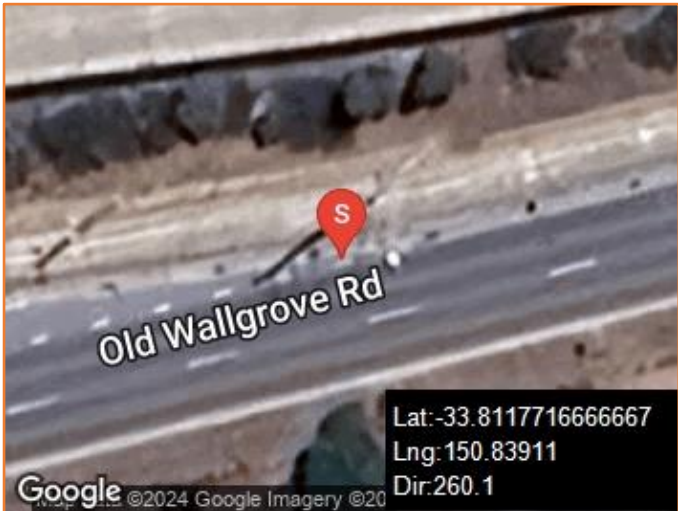
Figure 397: Reasonable - General condition of kerb and gutter.

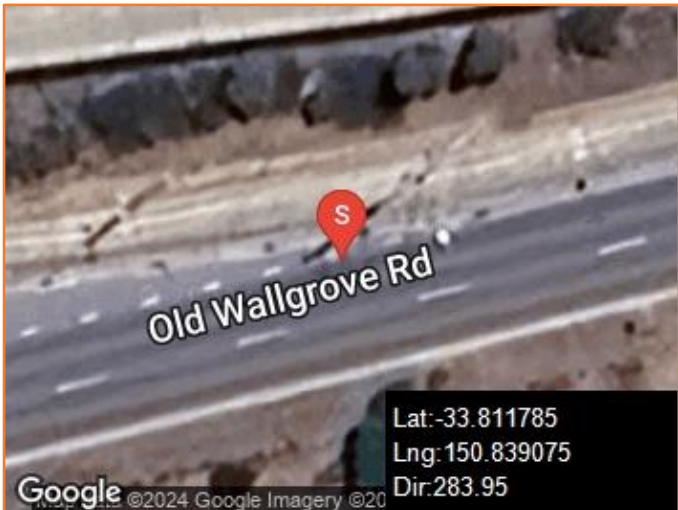
Figure 398: Reasonable - General condition of kerb inlet pit.

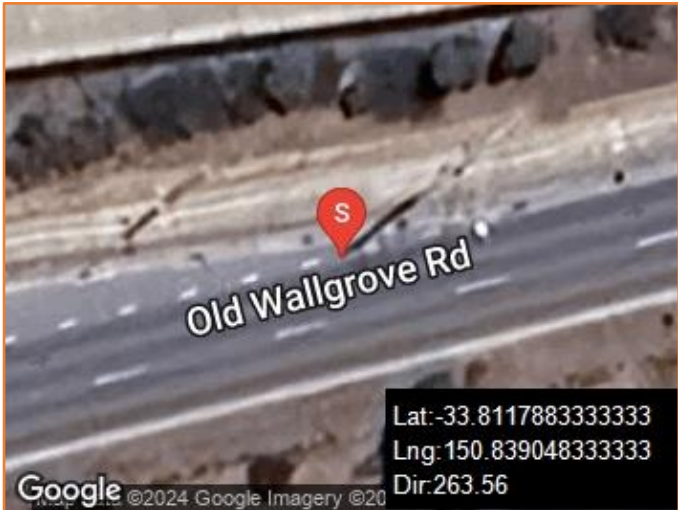
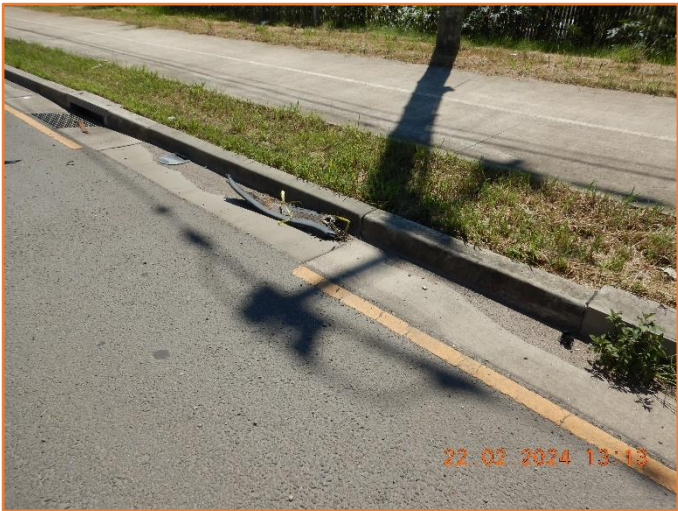
Figure 399: Reasonable - General condition of kerb and gutter.

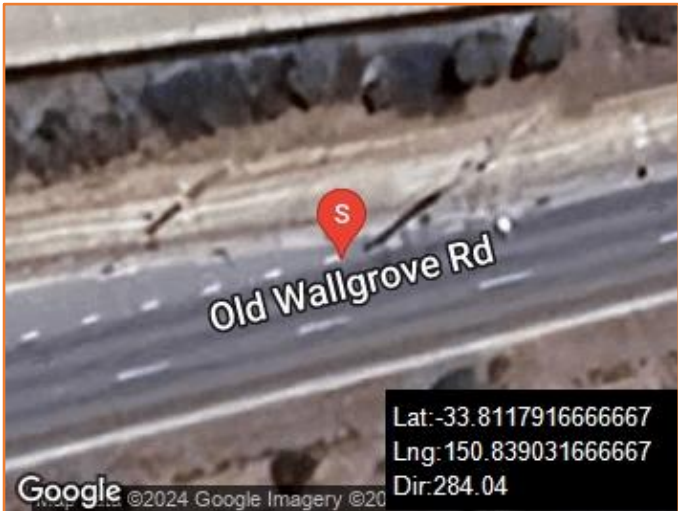
Figure 400: Reasonable - General condition of kerb and gutter and kerb inlet pit.

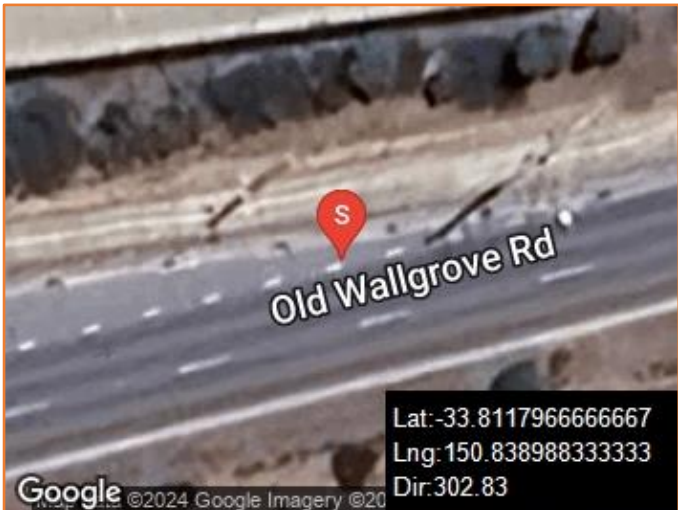
Figure 401: Reasonable - General condition of kerb and gutter.

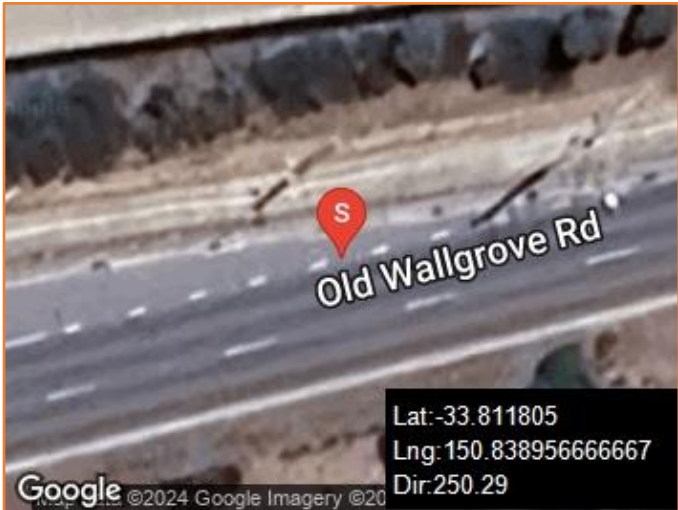
Figure 402: Reasonable - General condition of kerb and gutter and kerb inlet pit.

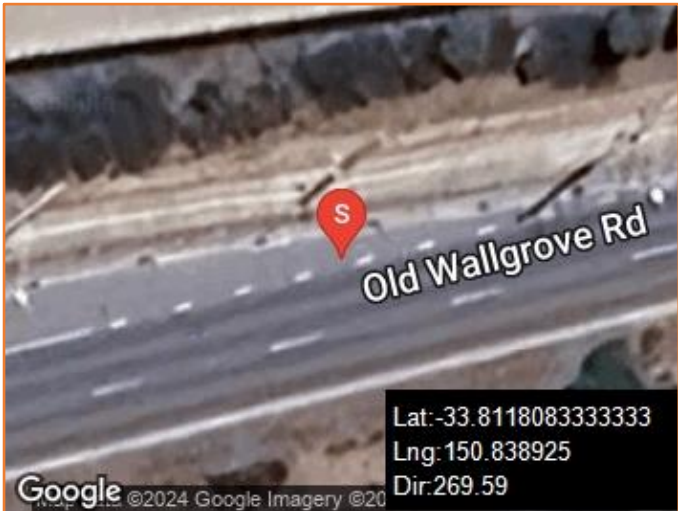
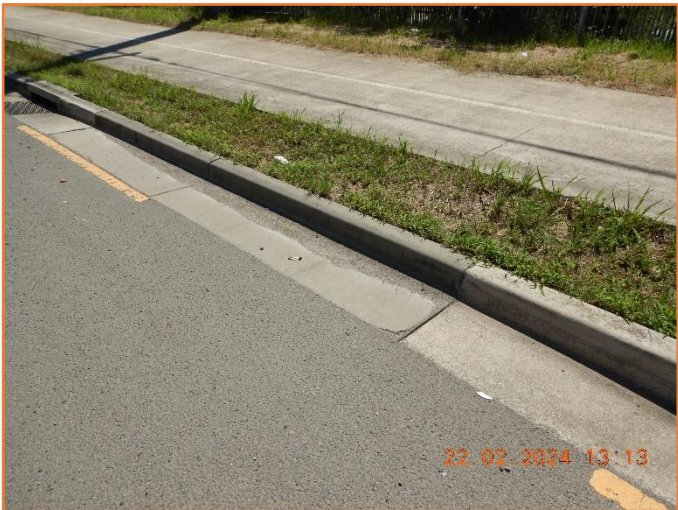
Figure 403: Reasonable - General condition of kerb and gutter.

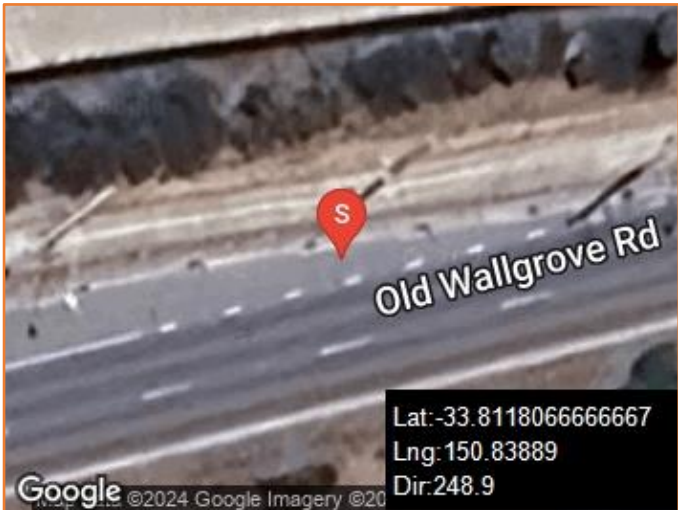
Figure 404: Reasonable - General condition of kerb and gutter and kerb inlet pit.

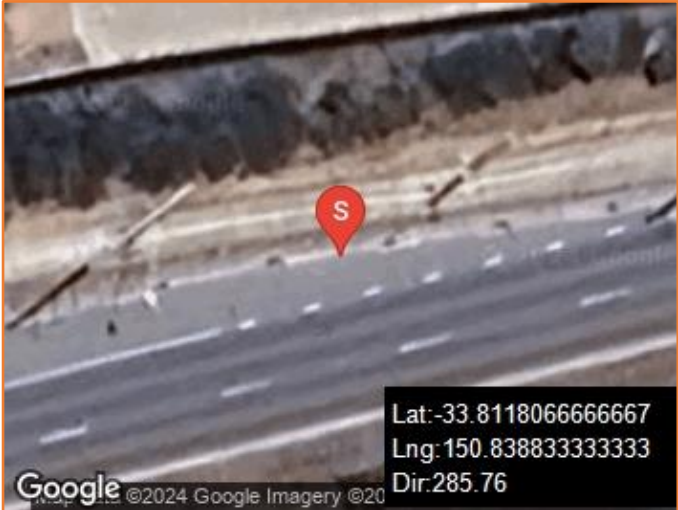
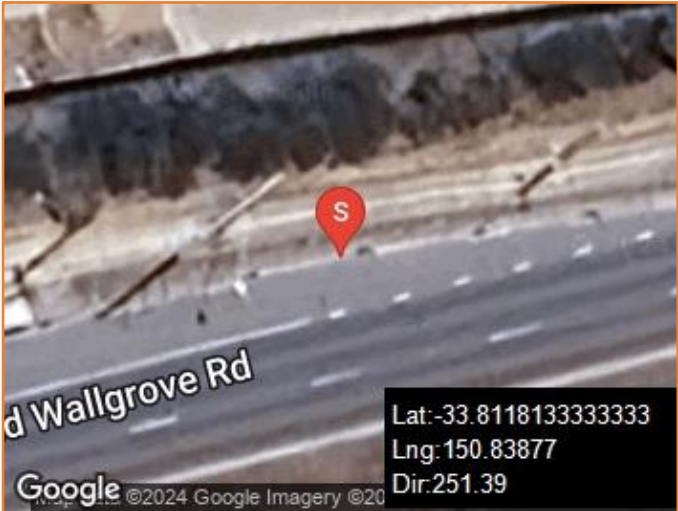
Figure 407: Reasonable - General condition of kerb inlet pit.

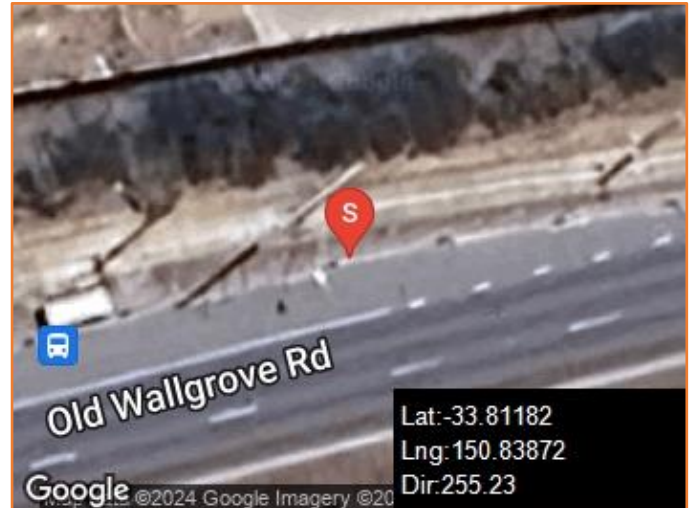
Figure 408: Reasonable - General condition of kerb and gutter.

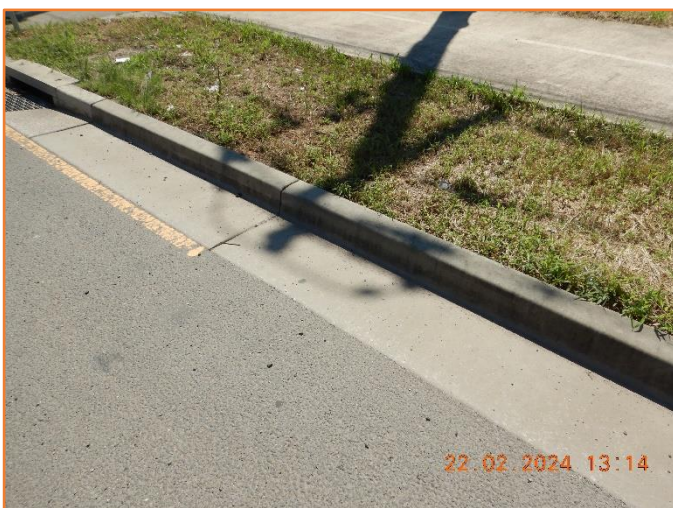
Figure 409: Reasonable - General condition of kerb and gutter.

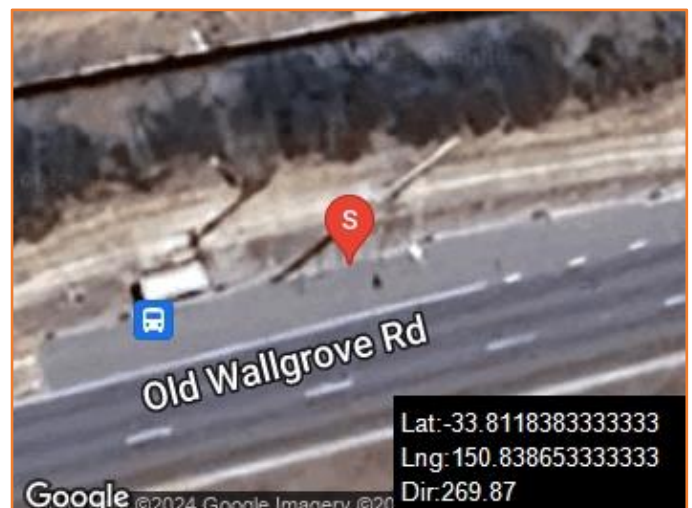
Figure 410: Reasonable - General condition of kerb inlet pit.

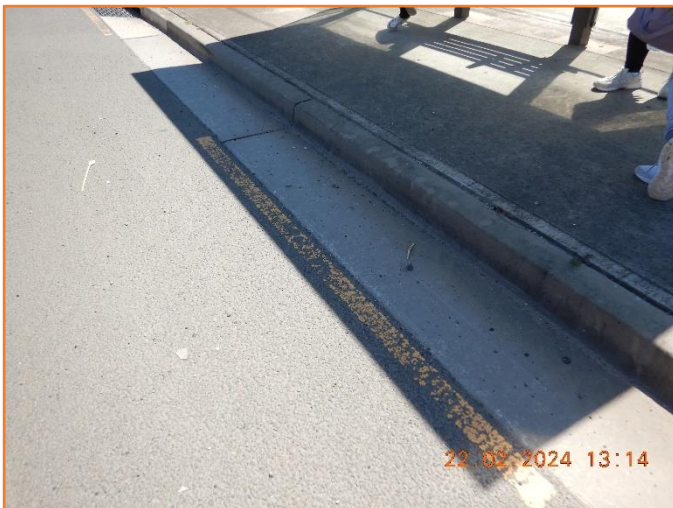
Figure 411: Reasonable - General condition of kerb and gutter.

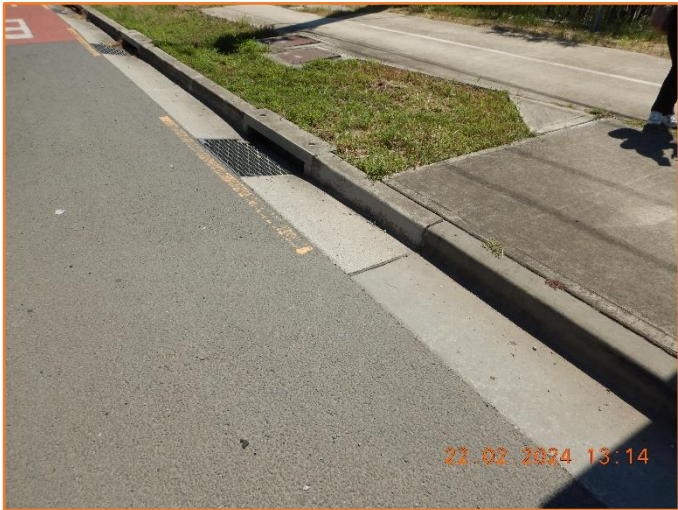
Figure 416: Reasonable - General condition of kerb and gutter.

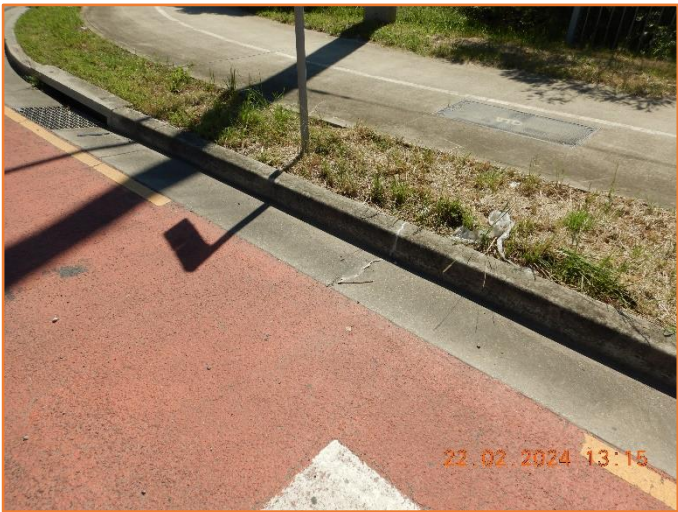
Figure 421: Reasonable - General condition of kerb and gutter.

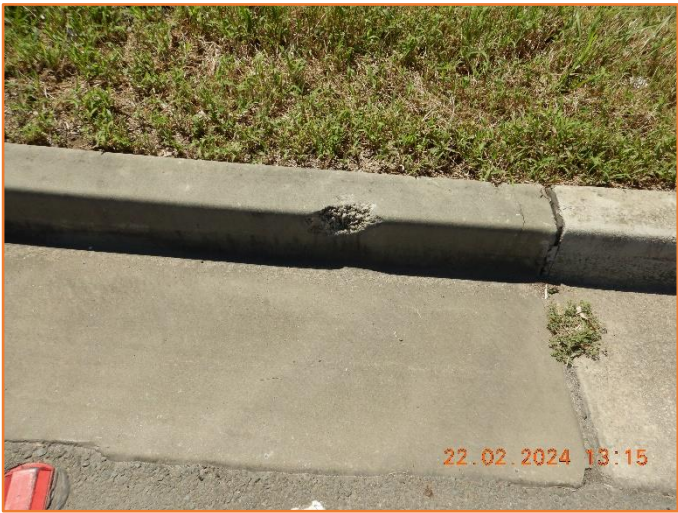
Figure 424: Reasonable - General condition of kerb and gutter. Moderate spalling observed.

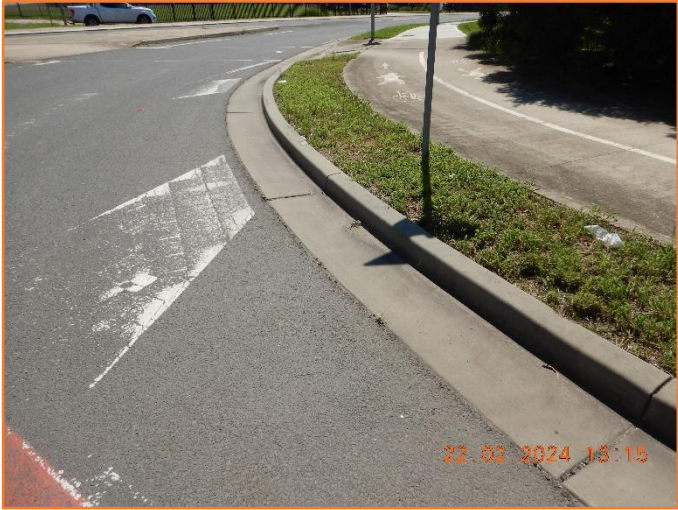
Figure 425: Reasonable - General condition of kerb and gutter.

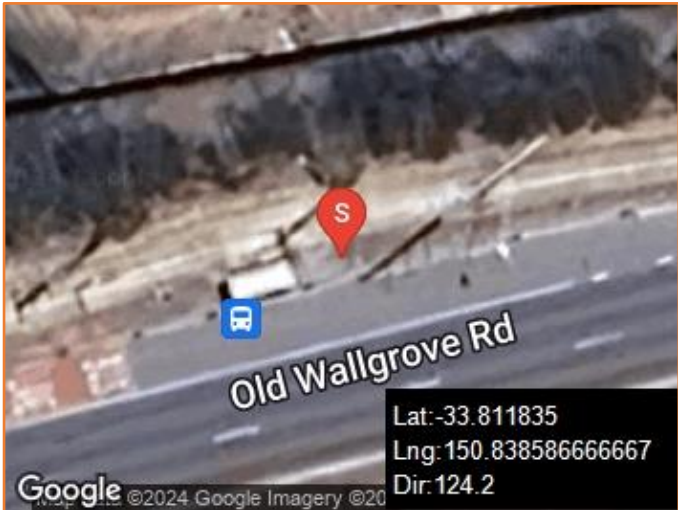
Figure 434: Reasonable - General condition of flexible pavement.

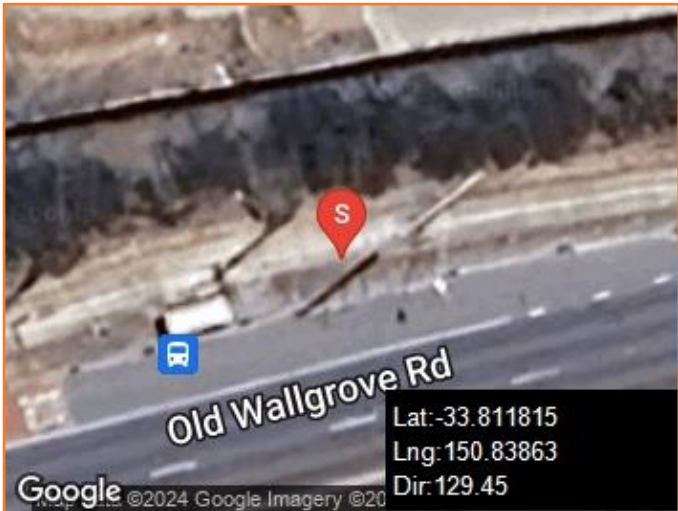
Figure 435: Reasonable - General condition of flexible pavement.

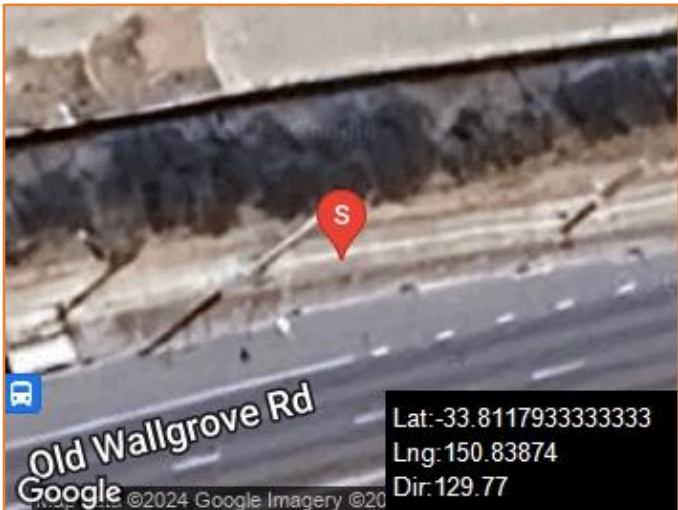
Figure 436: Reasonable - General condition of flexible pavement.

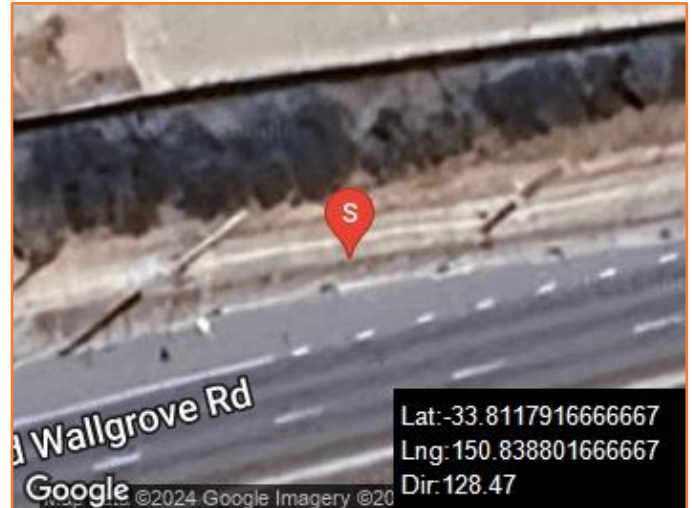
Figure 437: Reasonable - General condition of flexible pavement.

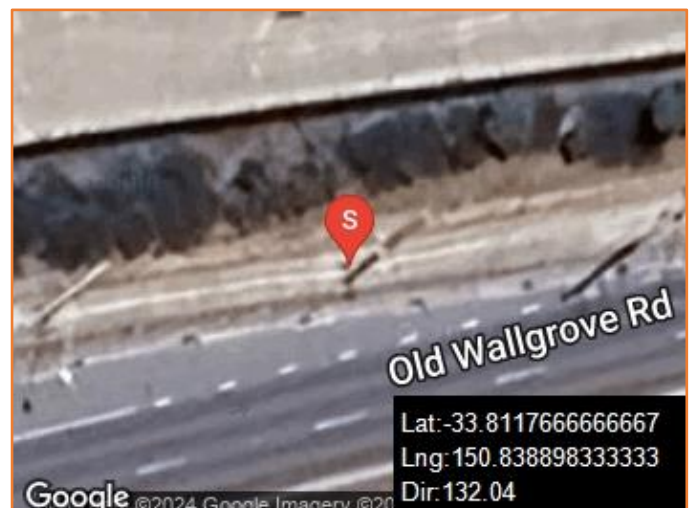
Figure 439: Reasonable - General condition of flexible pavement.

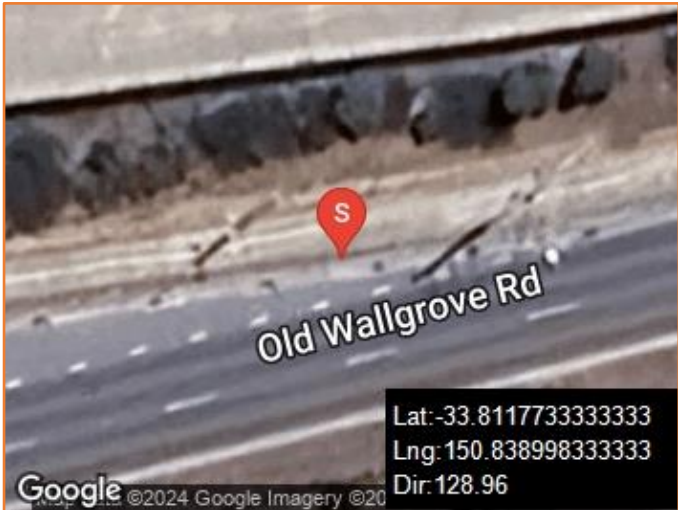
Figure 440: Reasonable - General condition of flexible pavement.

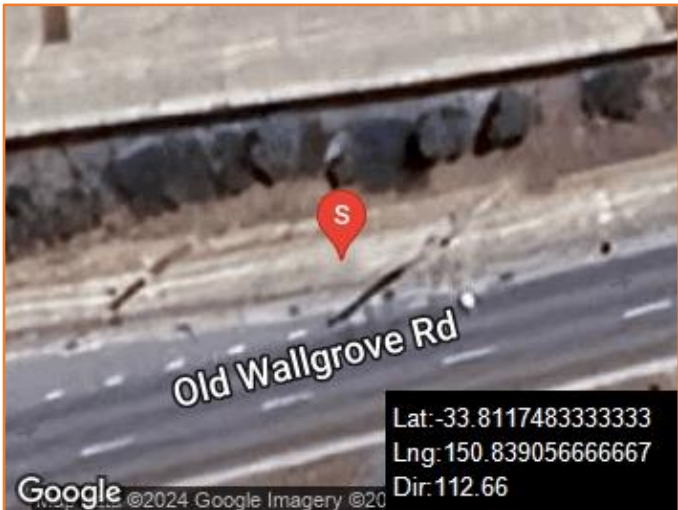
Figure 442: Reasonable - General condition of flexible pavement.

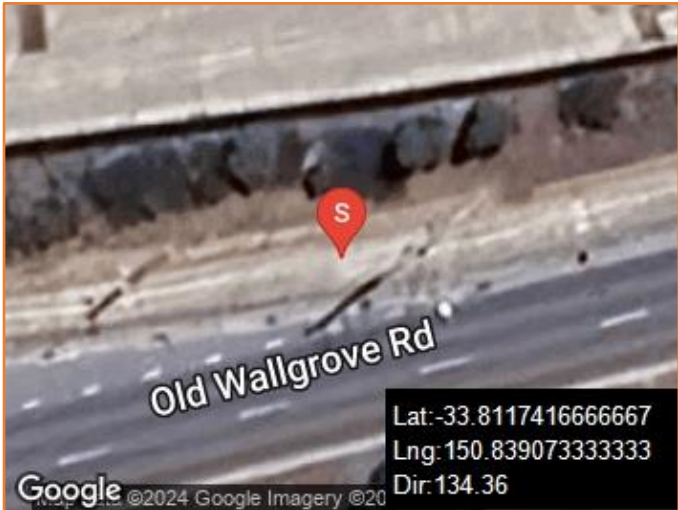
Figure 443: Reasonable - General condition of flexible pavement.

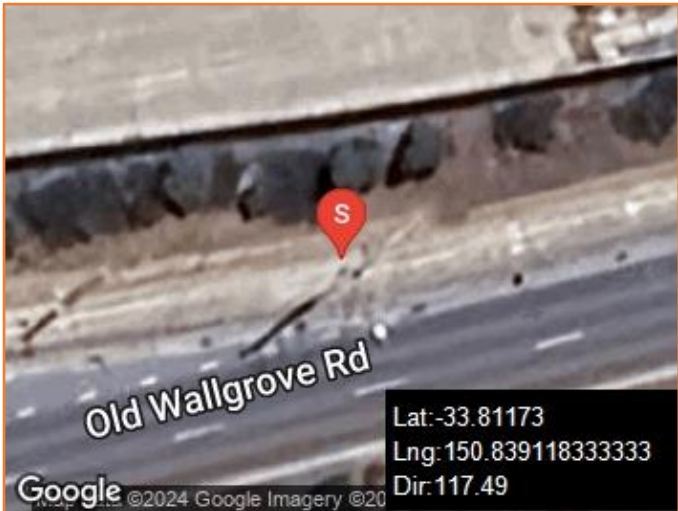
Figure 444: Reasonable - General condition of flexible pavement.

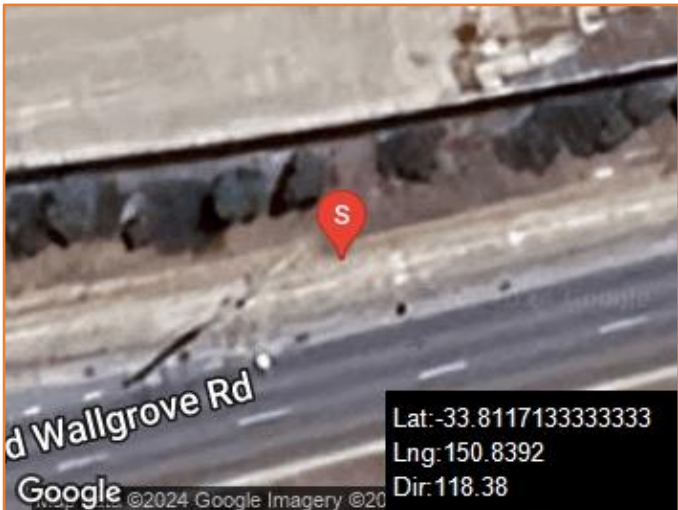
Figure 445: Reasonable - General condition of flexible pavement.

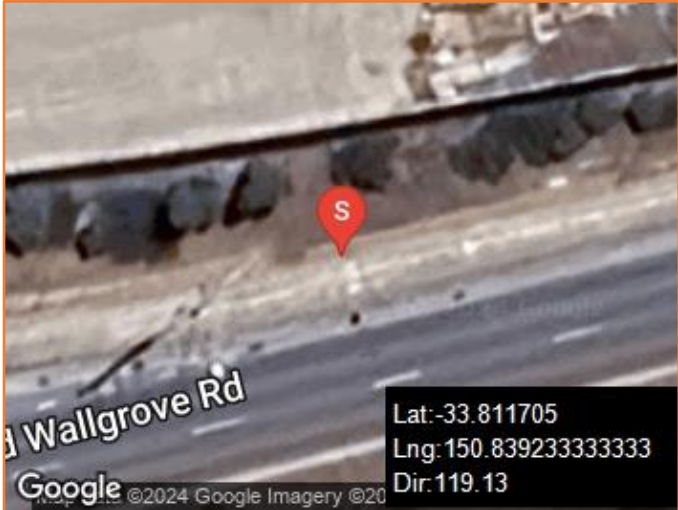
Figure 446: Reasonable - General condition of flexible pavement.

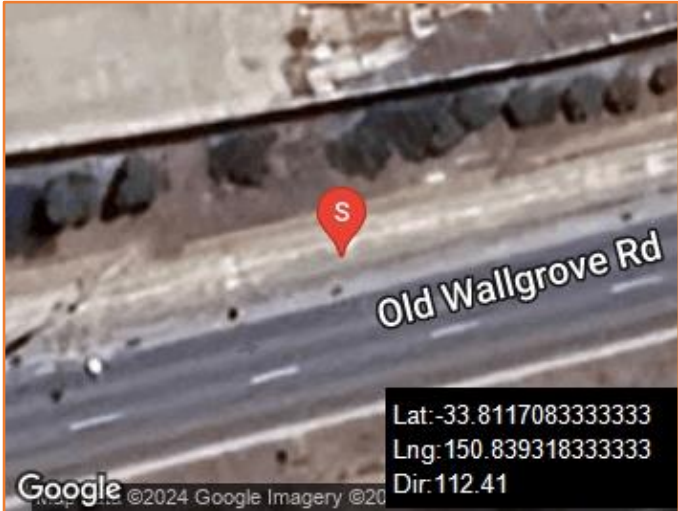
Figure 447: Reasonable - General condition of flexible pavement.

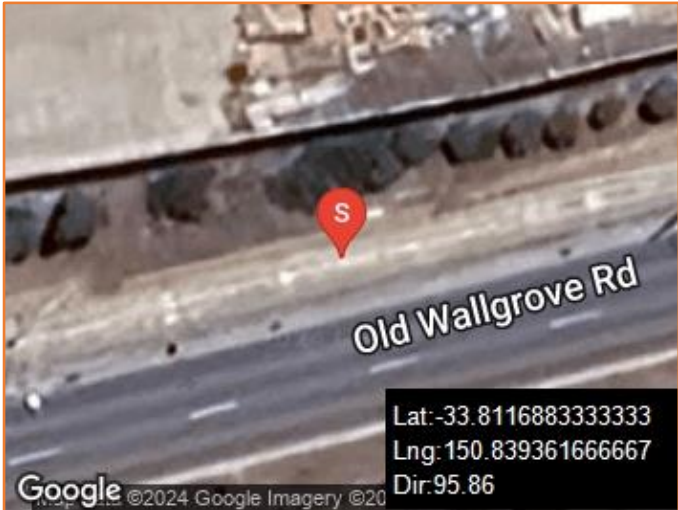
Figure 448: Reasonable - General condition of flexible pavement.

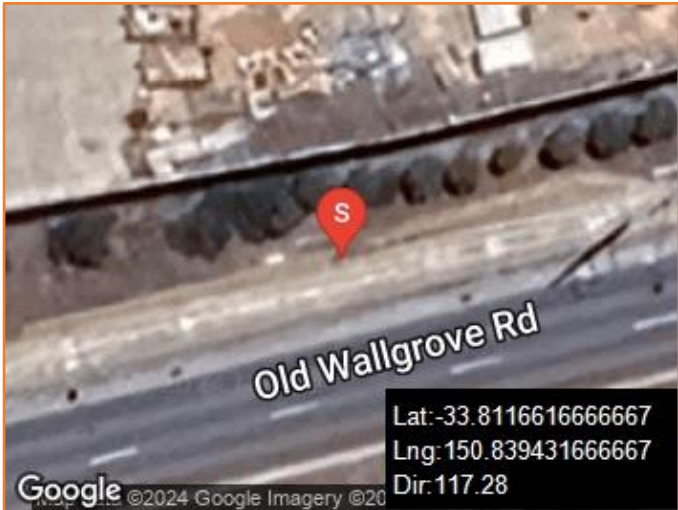
Figure 449: Reasonable - General condition of flexible pavement.

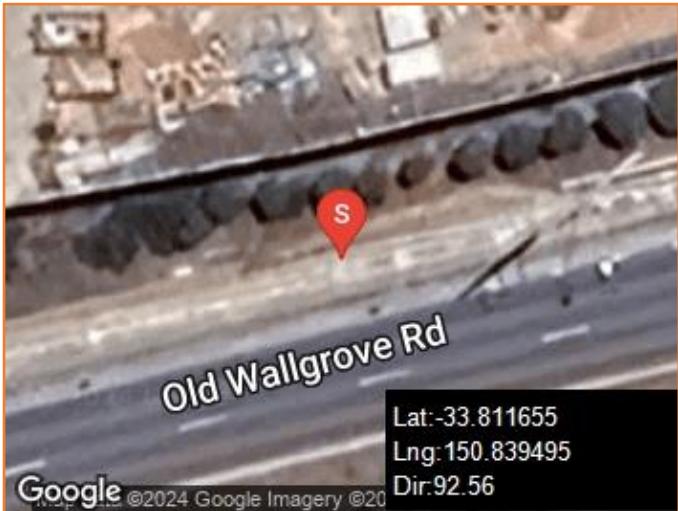
Figure 450: Reasonable - General condition of flexible pavement.

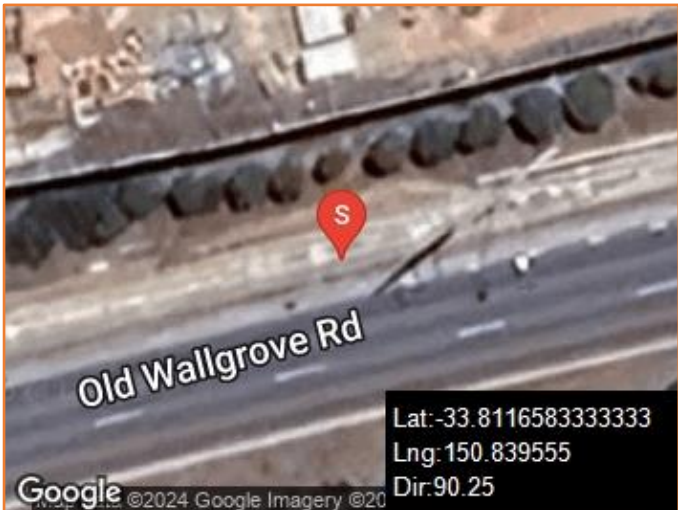
Figure 451: Reasonable - General condition of flexible pavement.

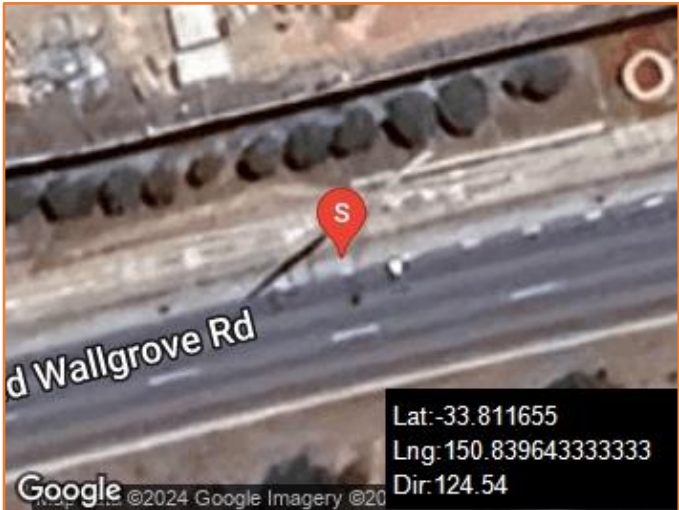
Figure 453: Reasonable - General condition of flexible pavement.

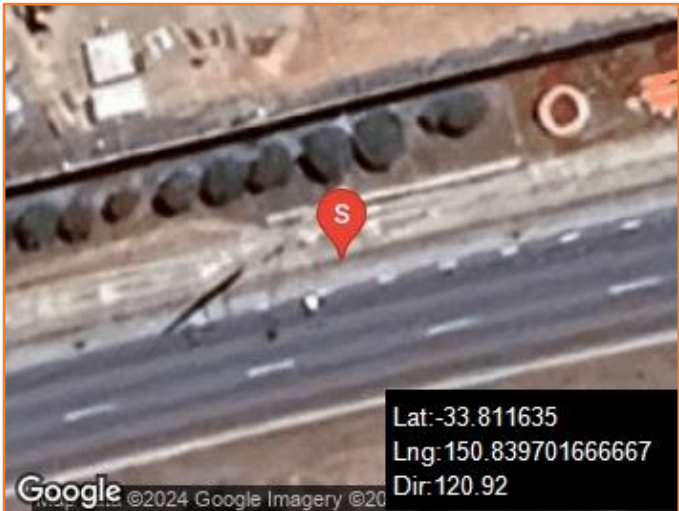
Figure 454: Reasonable - General condition of flexible pavement.

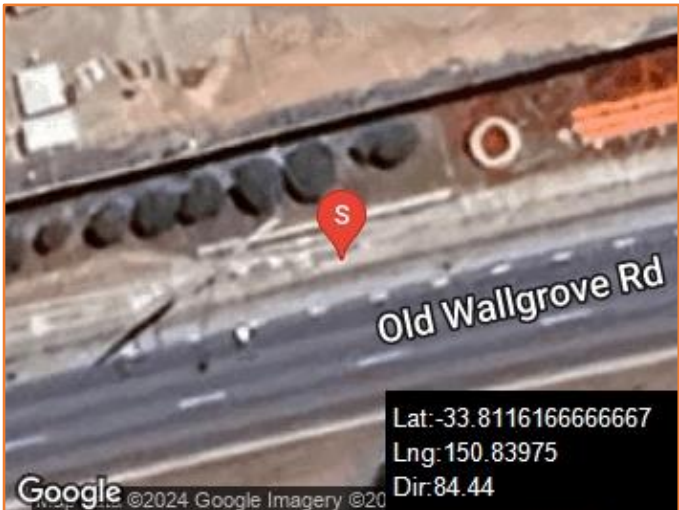
Figure 455: Reasonable - General condition of flexible pavement.

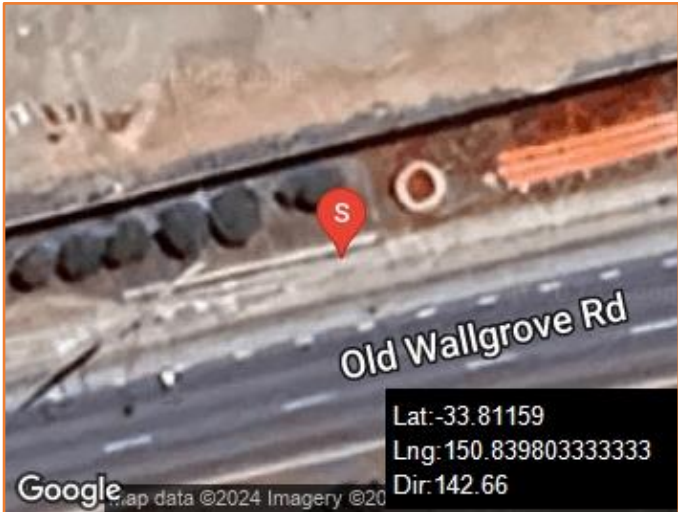
Figure 456: Reasonable - General condition of flexible pavement.

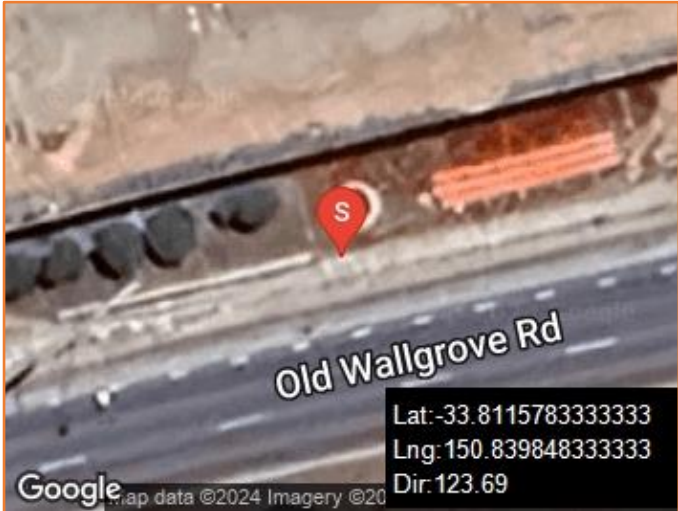
Figure 457: Reasonable - General condition of flexible pavement.

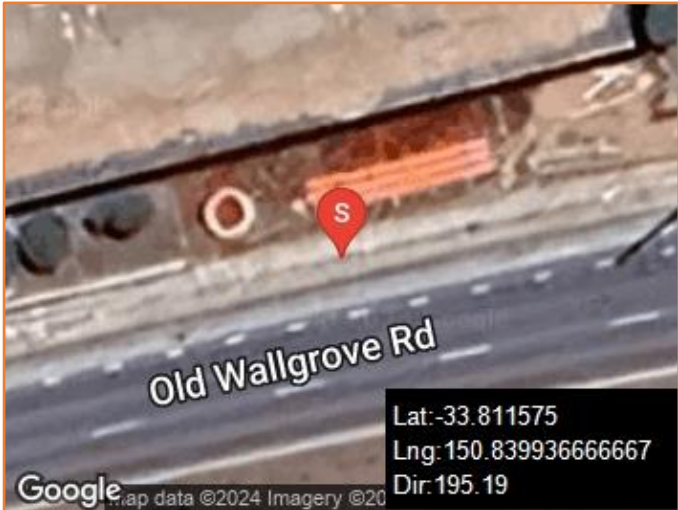
Figure 458: Reasonable - General condition of flexible pavement.
