**Re. SSD-65490715 Central Park Bradfield City Centre - Post Approval Document Submission  
Condition C11 – Dilapidation Report**

# Dilapidation Inspection Report

Council Assets – 215 Badgerys Creek Rd, Bradfield NSW 2556

W03125.CA.DLP

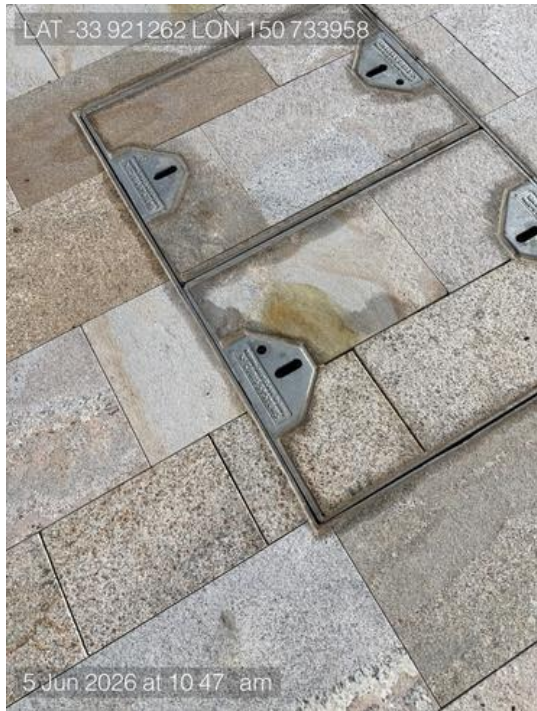
Photo 588

Staining to pavers

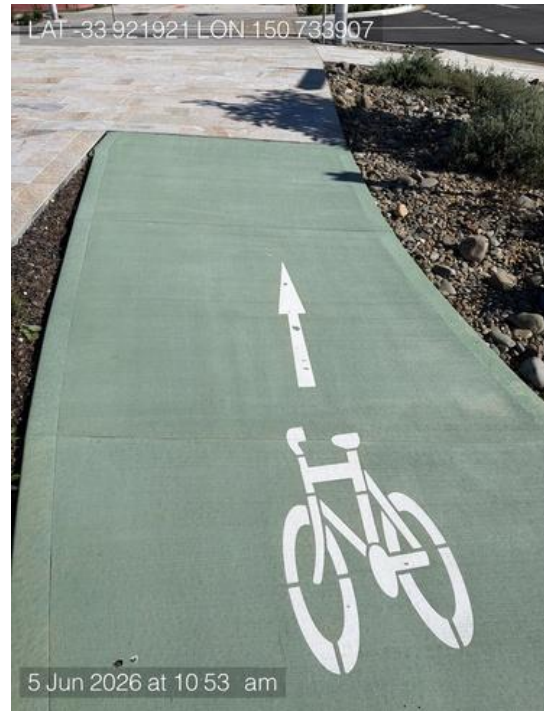
Photo 637

Worn paint to arrow

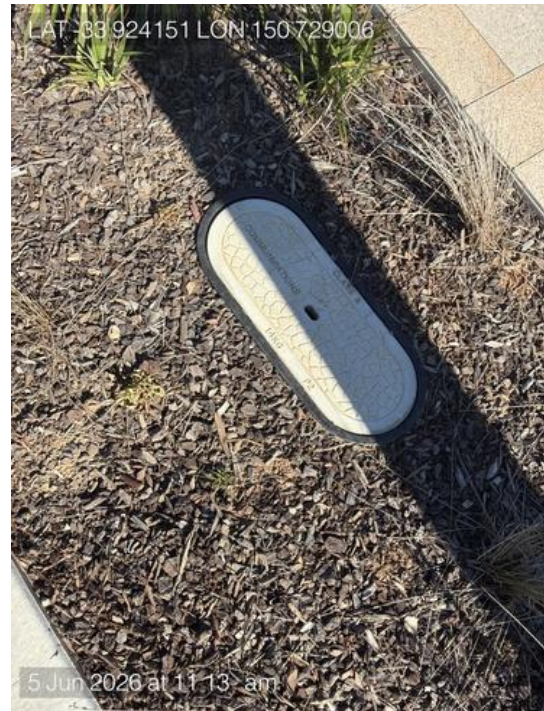
Photo 685

Cracking to lid

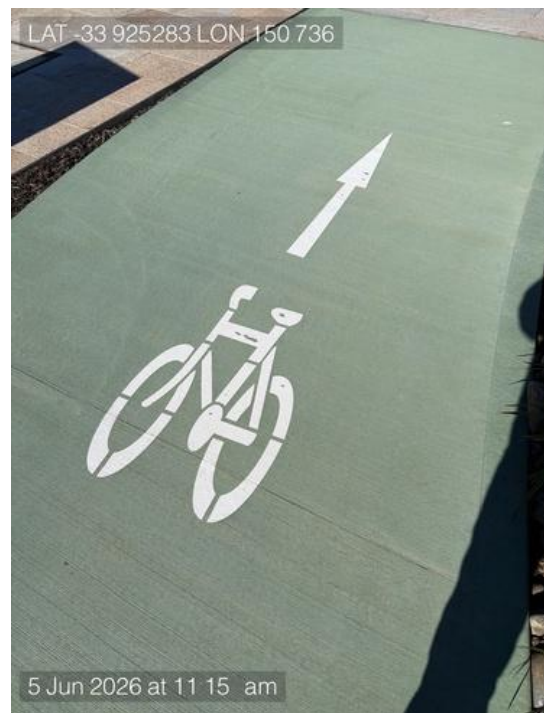
Photo 687

Worn paint to bike lane markings
