# **PRE-CONSTRUCTION CONDITION SURVEY (DILAPIDATION REPORT)**

**REPORT NUMBER:** S26211301 - 001

**PROJECT:** 6 Halifax Street, Macquarie Park NSW 2113

**INSPECTION DATE:** 17<sup>th</sup> April 2026

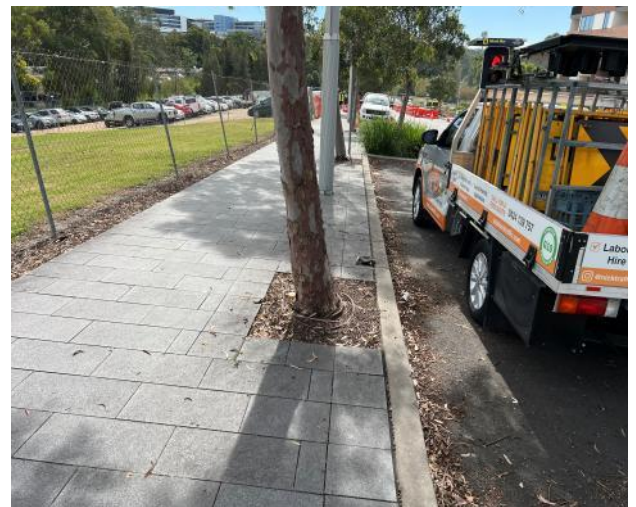
Figure 22 – General view of tree on council footpath.

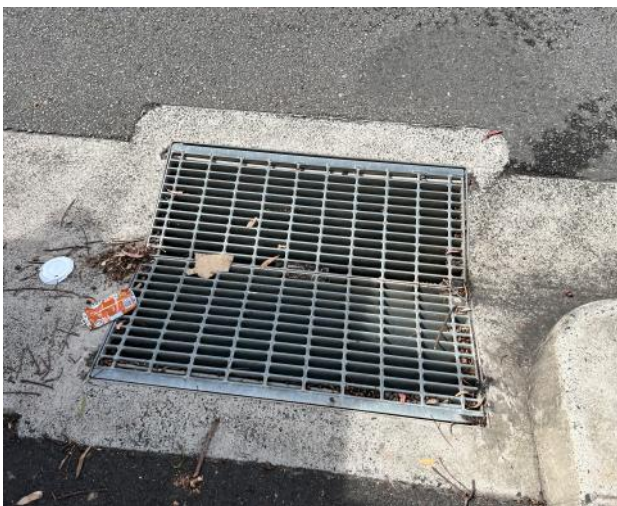
Figure 23 – Stormwater pit.

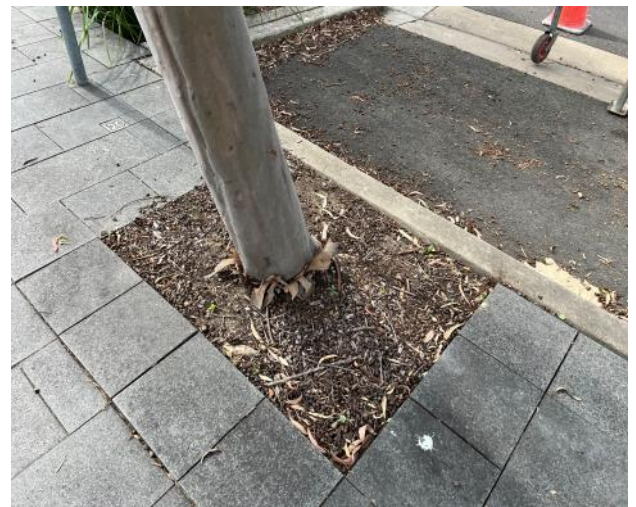
Figure 28 – Tree base.

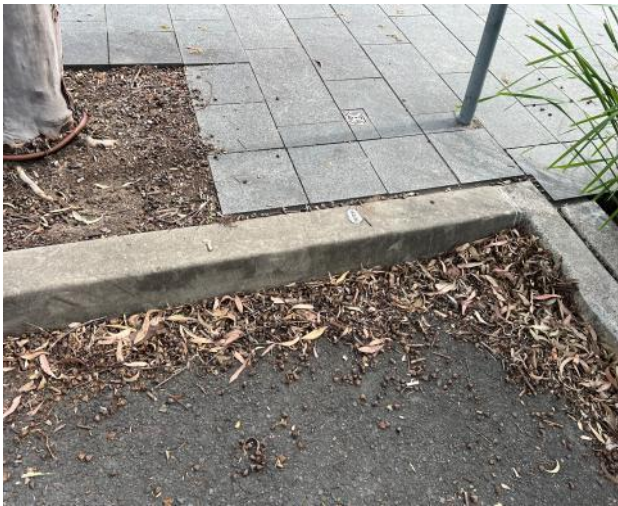
Figure 31 – kerb on council land.

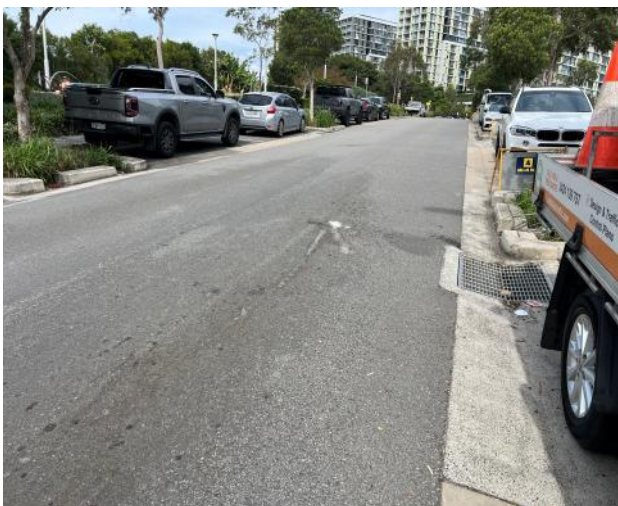
Figure 35 – General view of council road.

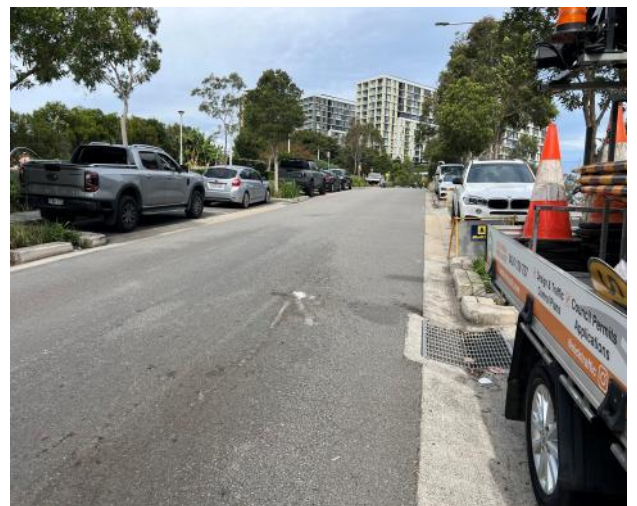
Figure 36 – General view of council road.

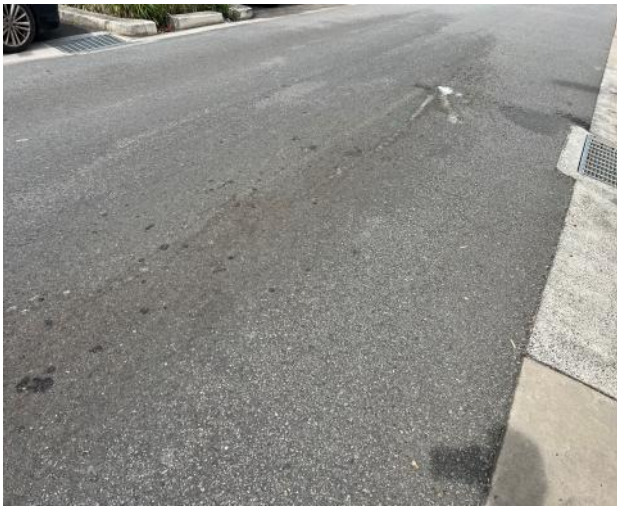
Figure 37 – General view of council road.

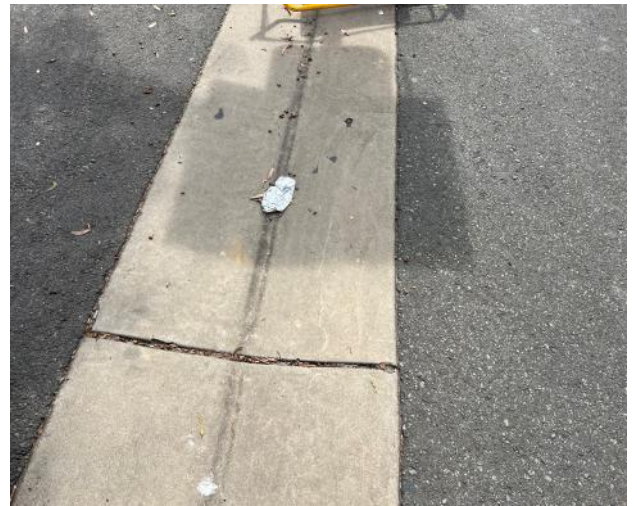
Figure 38 – Gutter.

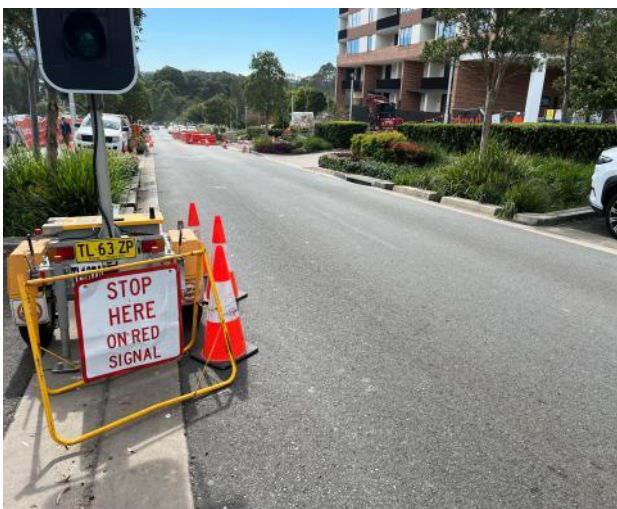
Figure 39 – General view of council road.

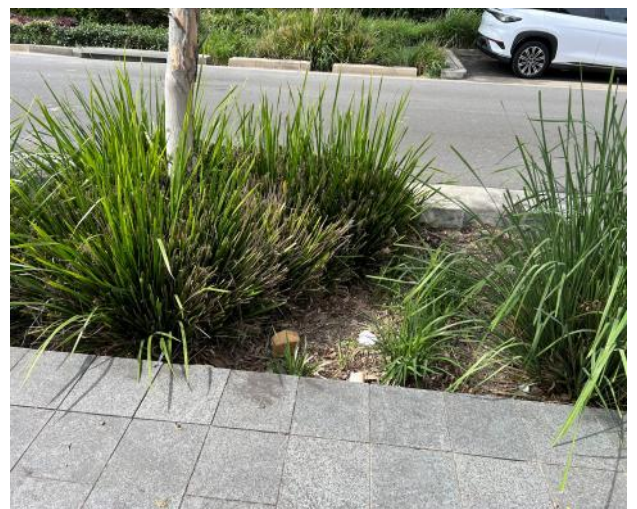
Figure 40 – General view of nature strip.

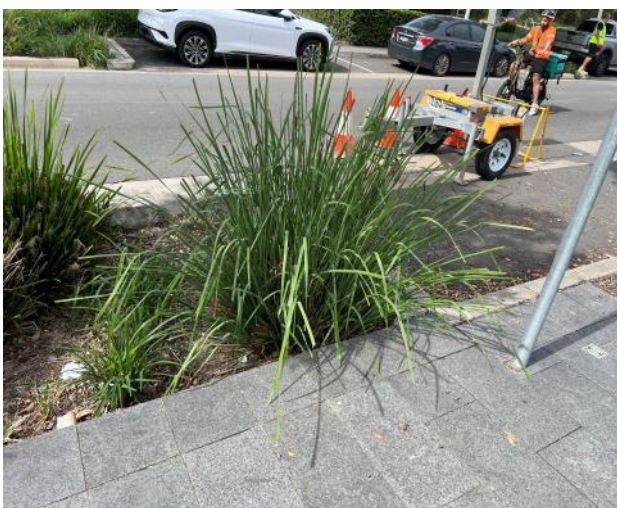
Figure 41 – Council nature strip.

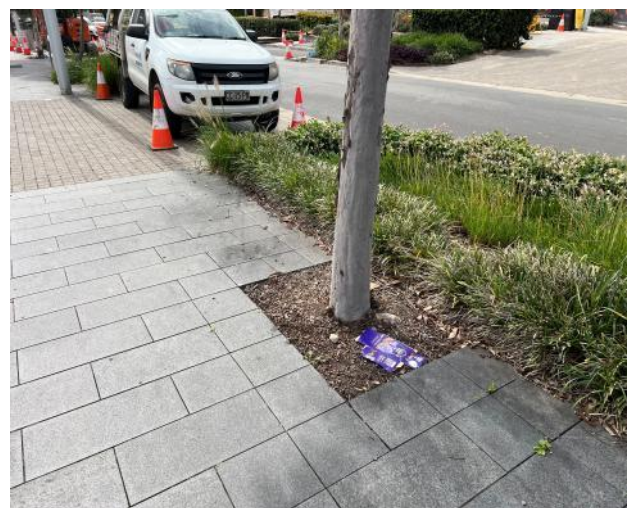
Figure 42 – Tree.

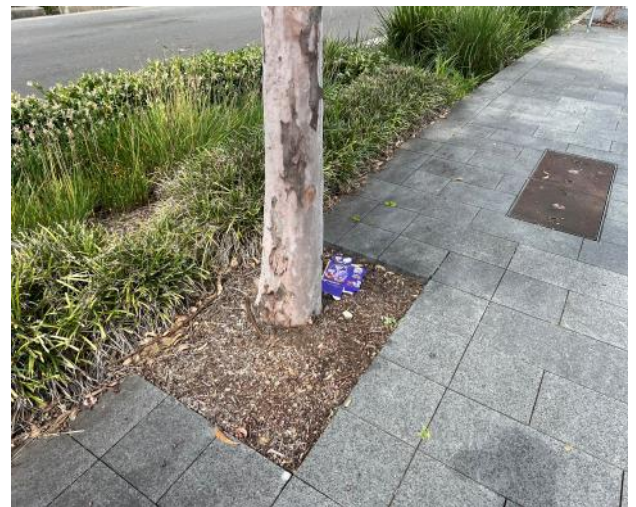
Figure 46 – Tree on council land.

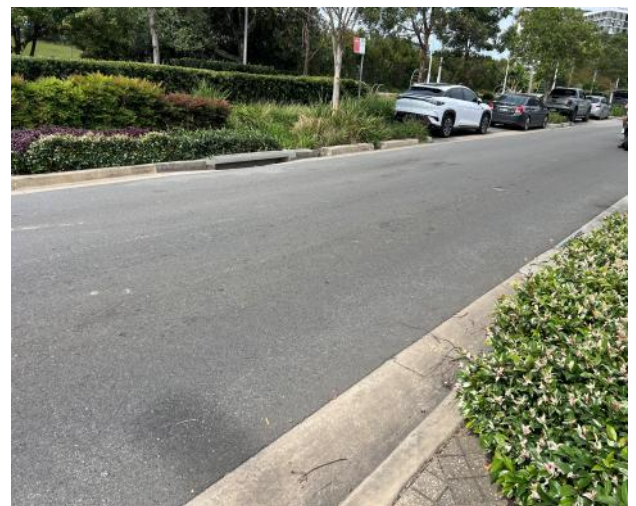
Figure 48 – General view of council road.

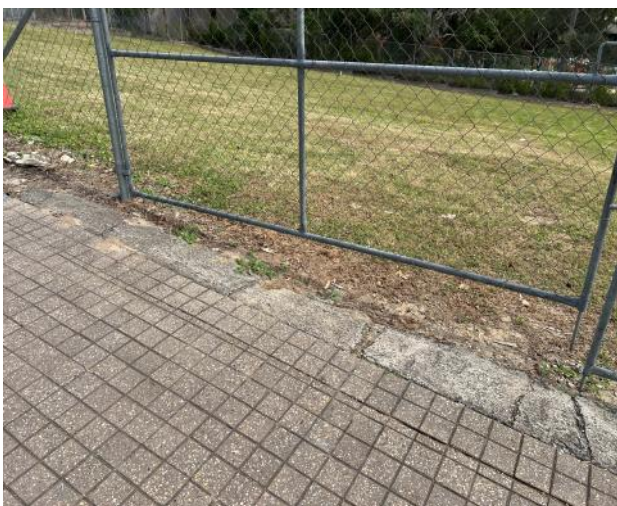
Figure 59 – General view of boundary fence.

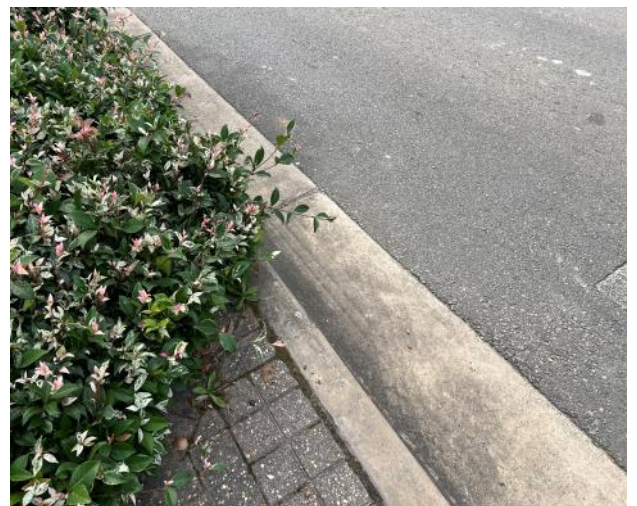
Figure 66 – Kerb and gutter.

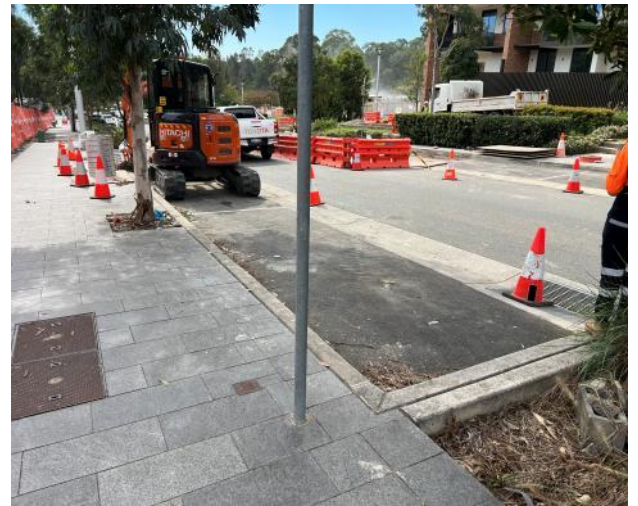
Figure 68 – General view of council footpath and road pavement.

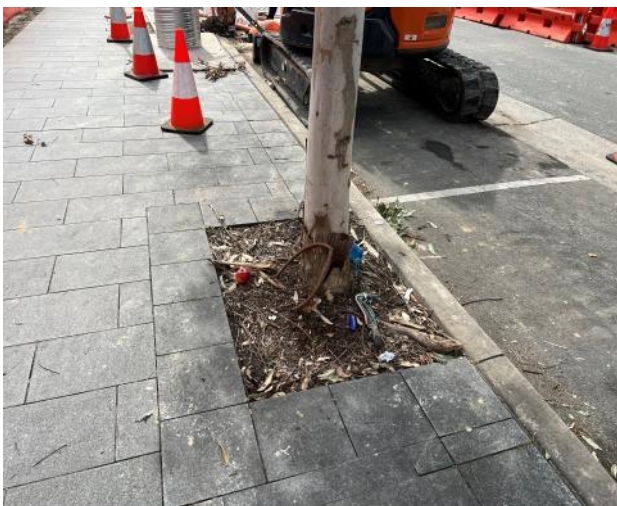
Figure 77 – Tree pit.

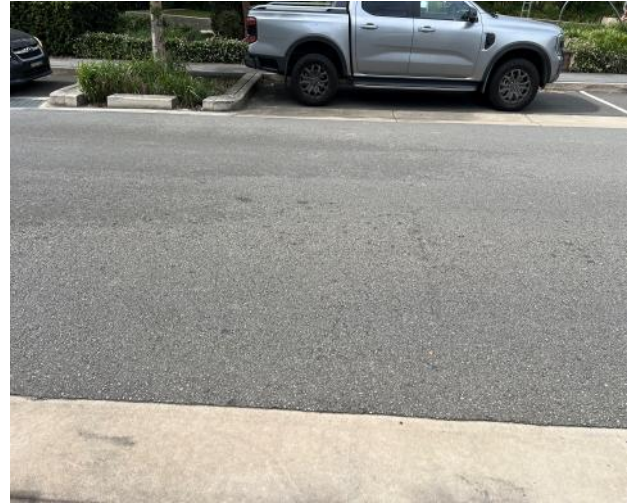
Figure 86 – General view of council road.

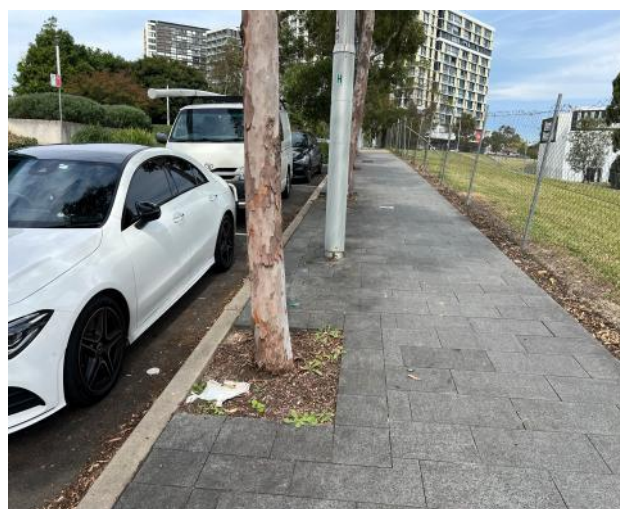
Figure 94 – General view of tree on council land.

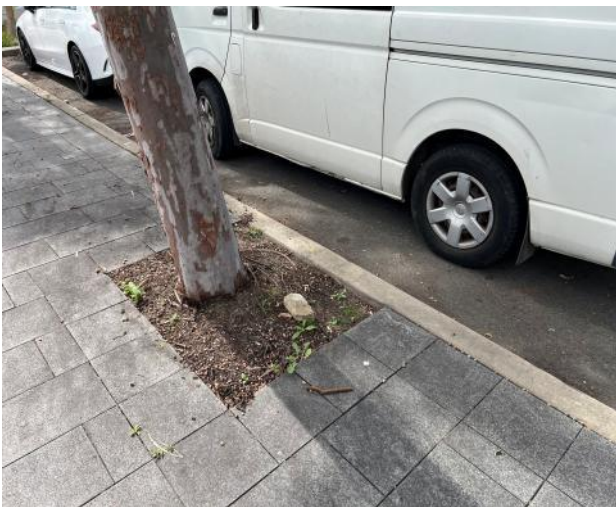
Figure 105 – Tree on council land.

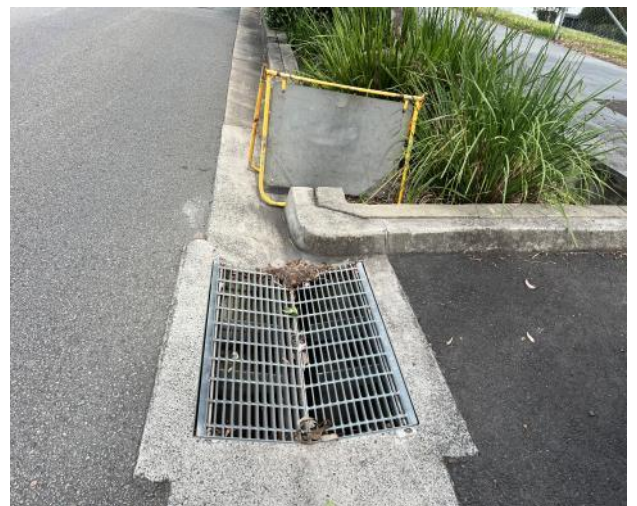
Figure 114 – Stormwater pit.

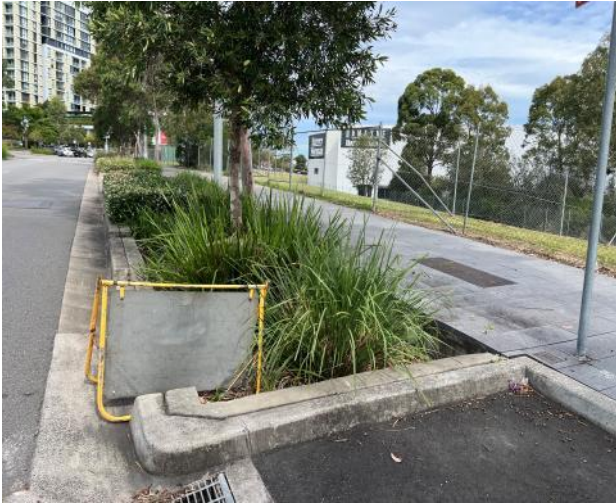
Figure 115 – Nature strip on council land.

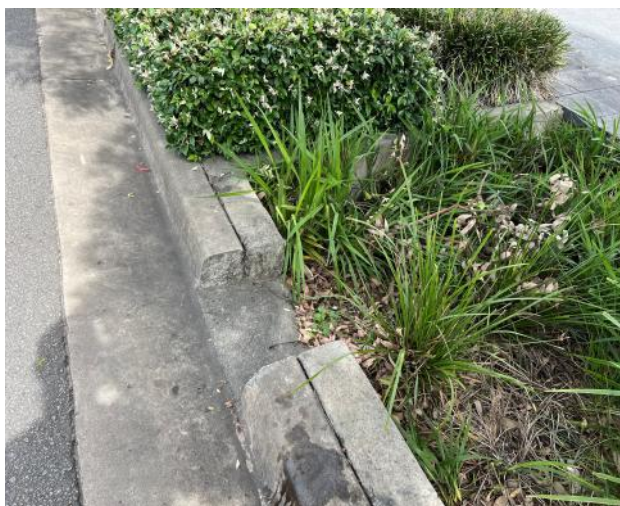
Figure 121 – kerb and nature strip.

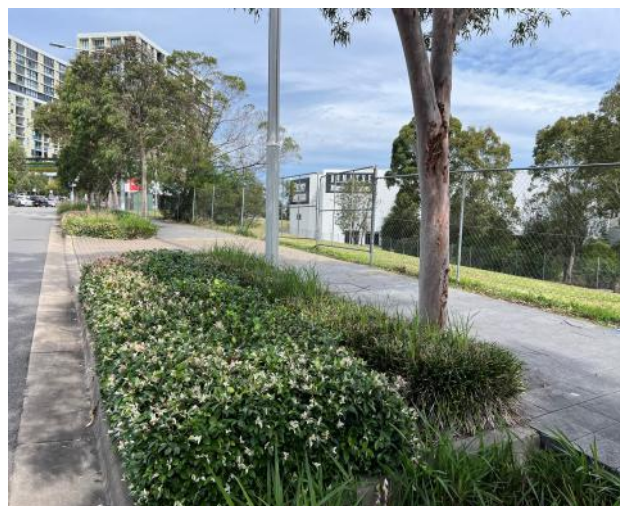
Figure 122 – General view of nature strip.

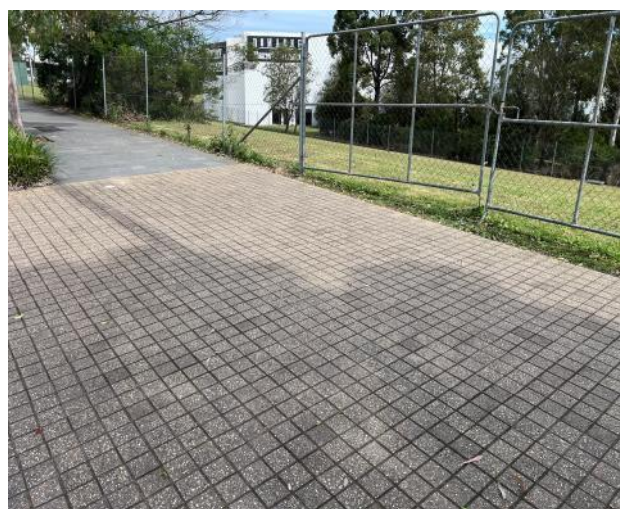
Figure 124 – Council footpath.
