391-423 PACIFIC HIGHWAY, CROWSNEST NSW 2065

PRE-DILAPIDATION REPORT

DEICORP PTY LTD

Job No. 240325.4

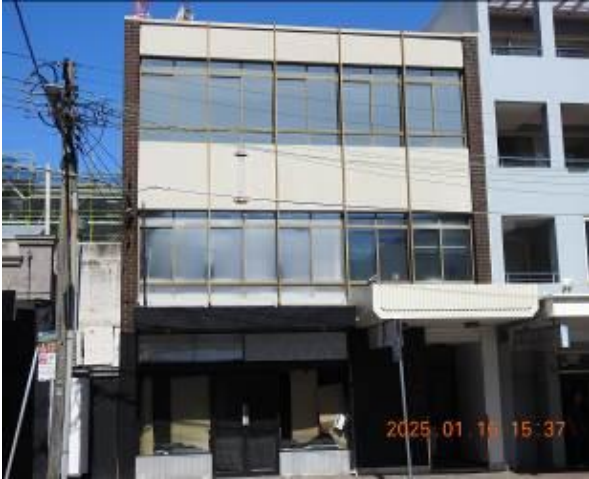
Figure 1 – The following image displays the general condition of 11-15 Alexander Street

The property located at 11-15 Alexander Street, is the neighbouring property to our client's site. It was photographed and visually inspected prior to any construction works on the subject site and was found to be in a reasonable condition. The building serves as a Restaurant.

The exterior of the building was in a reasonable condition. The building was inspected externally only as visible from footpath since the building was under construction internally during the time of inspection.

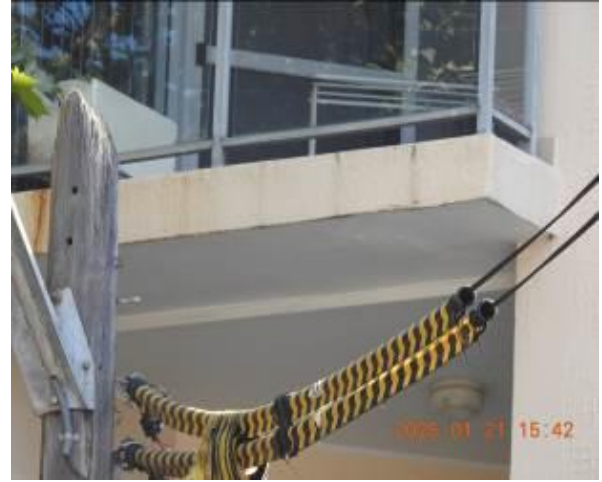
Figure 119 - General condition of external wall

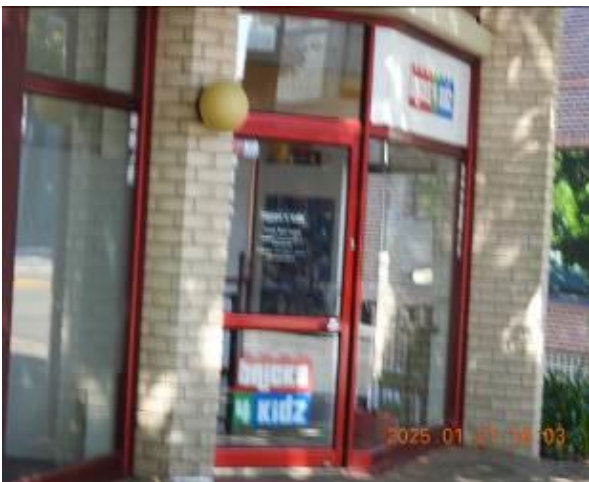
Figure 253 - General condition of external wall

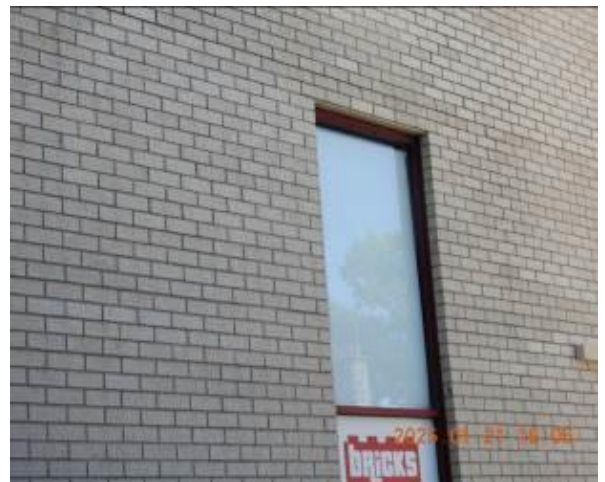
Figure 284 - General condition of external wall
