Pre-Construction Dilapidation Survey of 25-27 Leeds St, Rhodes -  
Roads and Council Assets - Leeds St

| MAJ-20240111-DS-REP-001-1C-R01 | | Complete |

RE: 25-27 LEEDS STREET, RHODES  
PRE-CONSTRUCTION DILAPIDATION SURVEY OF ROADS AND COUNCIL ASSETS – LEEDS STREET

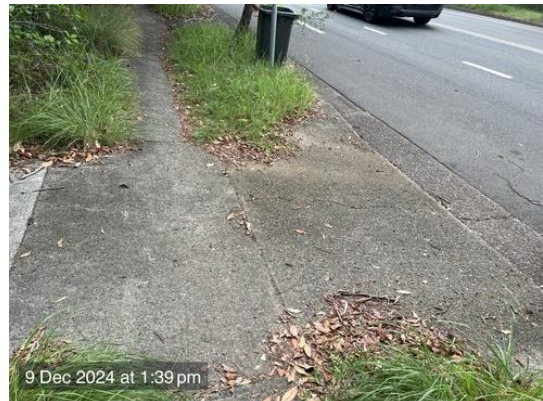
Photo 163

Crack

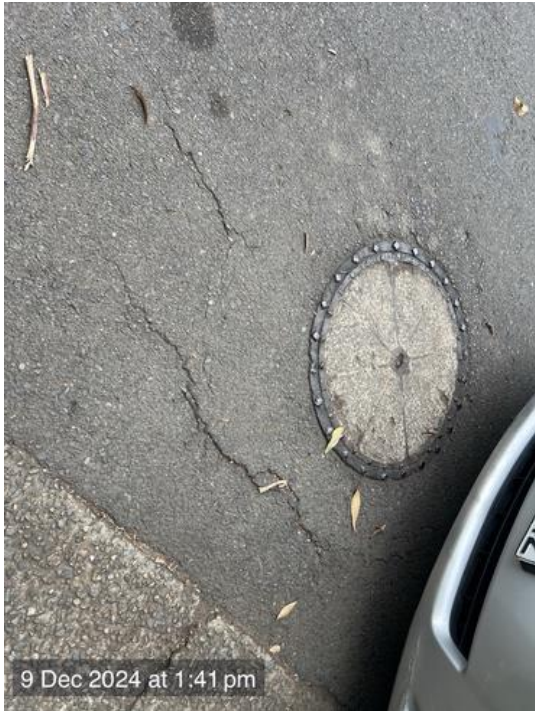
Photo 166

Number of cracks

Average length of crack 1 (mm)

Width of crack 1

Average length of crack 2 (mm)

Width of crack 2

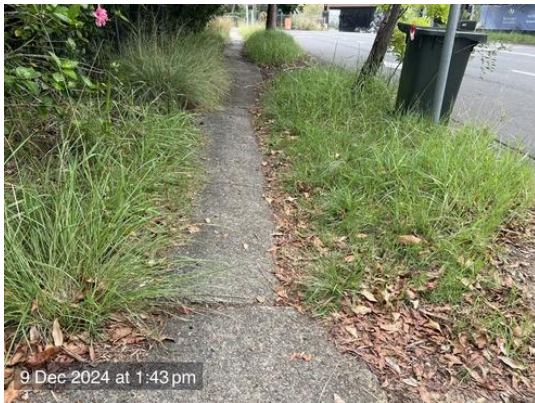
Photo 168

General views/conditions

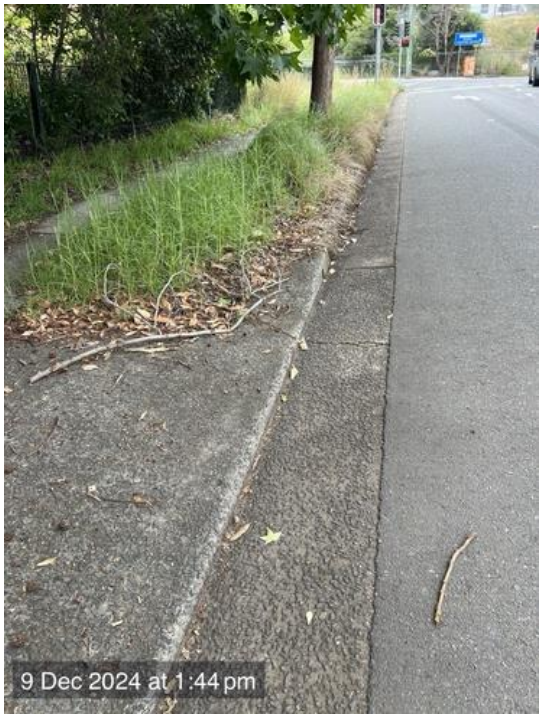
Photo 170

General views/conditions

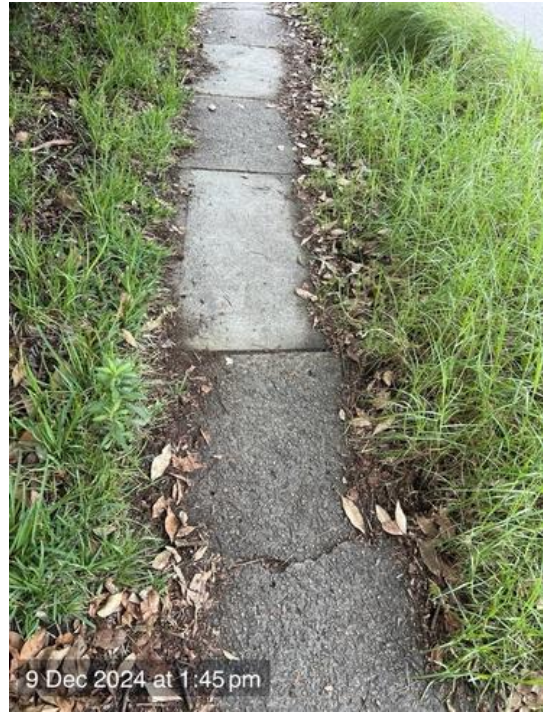
Photo 175

Crack

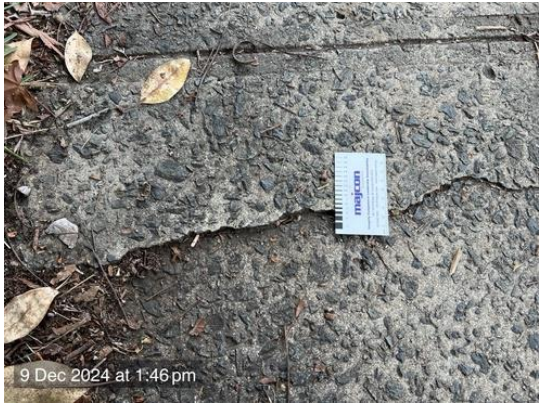
Photo 178

Type of Photo Crack

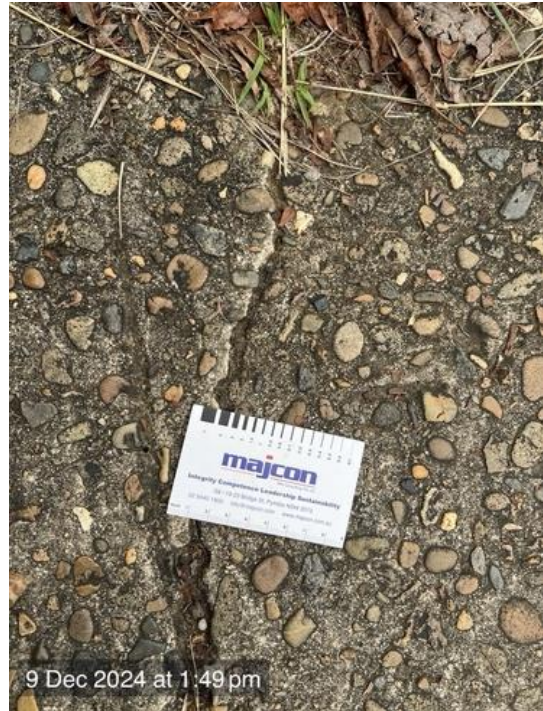
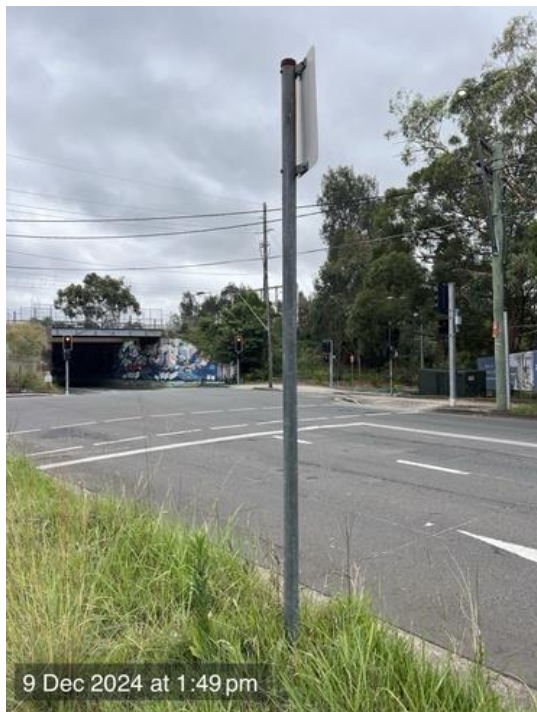
| Type of Photo | Crack | | | | | |
| Number of cracks | 1 | | | | | |
| Average length of crack (mm) | 300 | | | | | |
| Width of Crack | Category 4; 4.0 < α < 10.0 mm | | | | | |

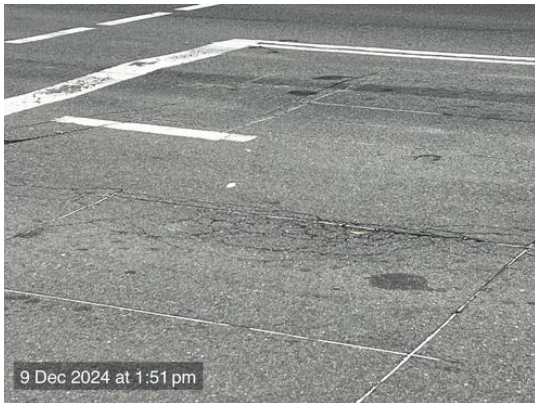
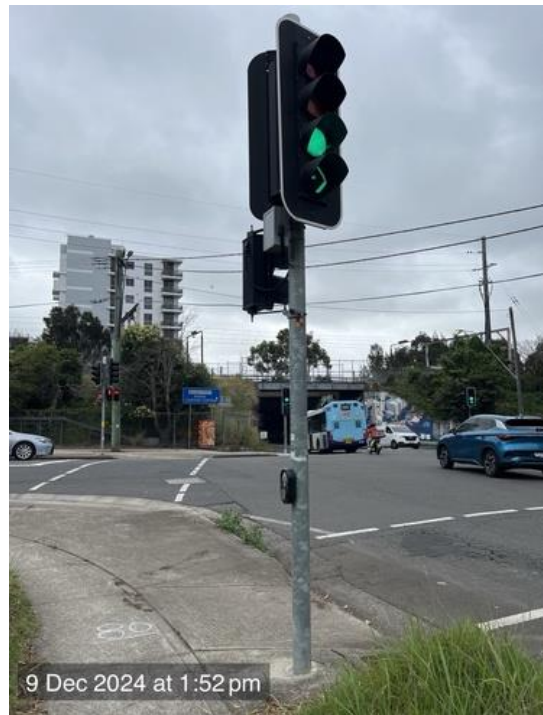
| Type of Photo | Crack |

| Number of cracks | Map Cracking |
| Average length of cracks (mm) | 1000 |
| Width of Cracks | Category 4; 4.0 < α < 10.0 mm |

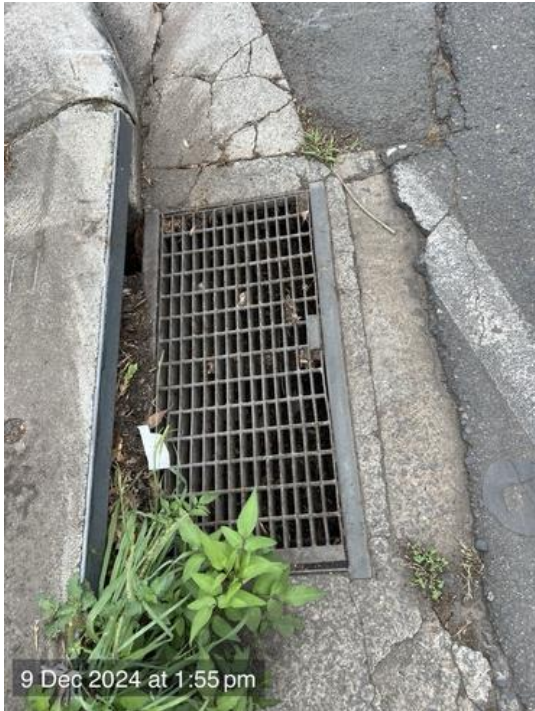
Photo 206

Crack

Number of cracks

Map Cracking

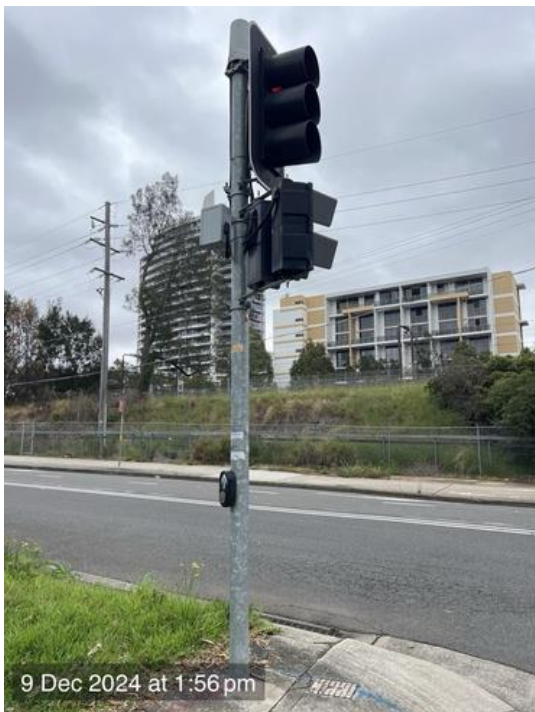
Photo 208

Damage

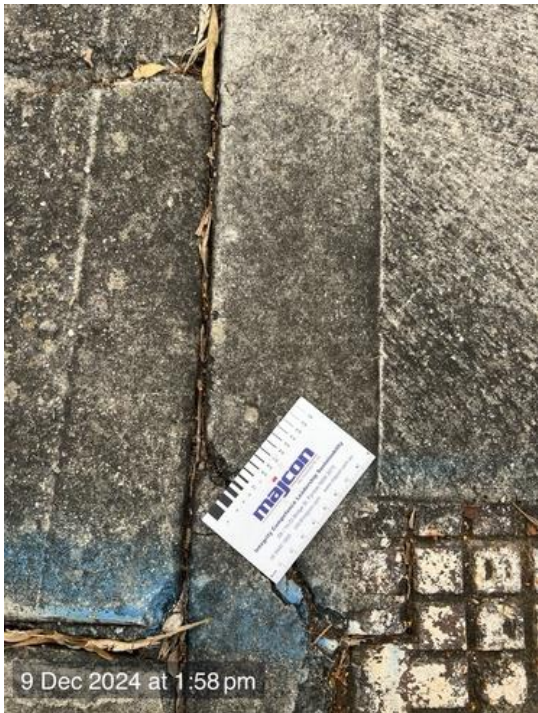
Photo 214

Crack

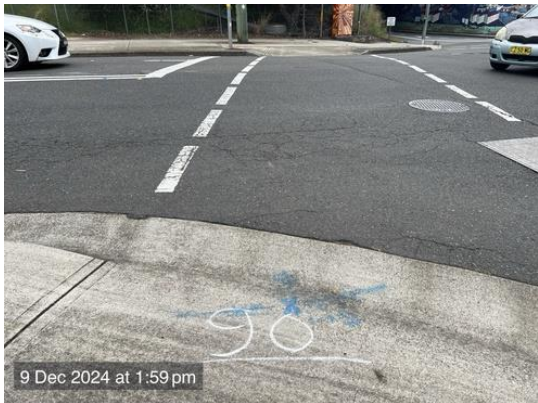
Photo 217

### Number of cracks

### Average length of crack (mm)

### Width of crack

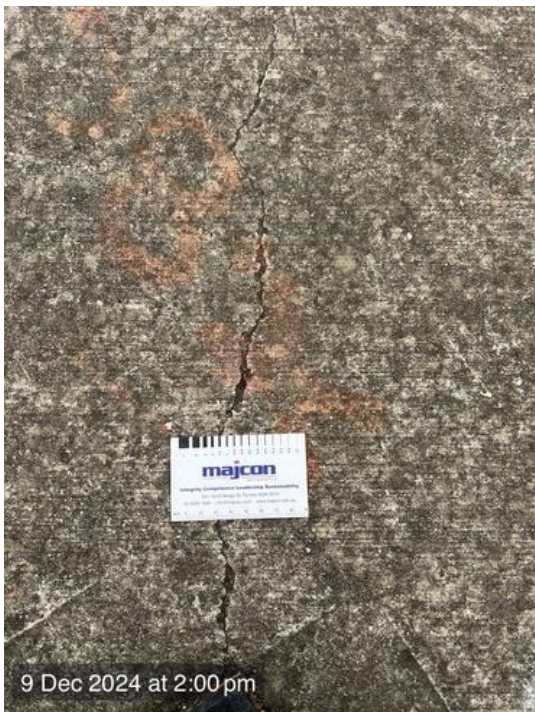
Photo 224

Crack

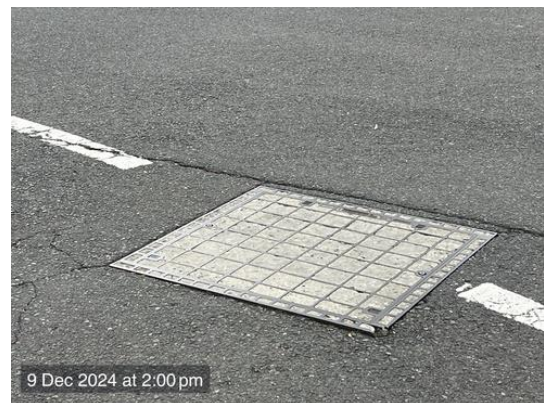
Photo 225

| Number of cracks | 1 |
| Average length of crack (mm) | 1200 |
| Width of Crack | Category 2; $1.0 < \alpha < 2.0$ mm |

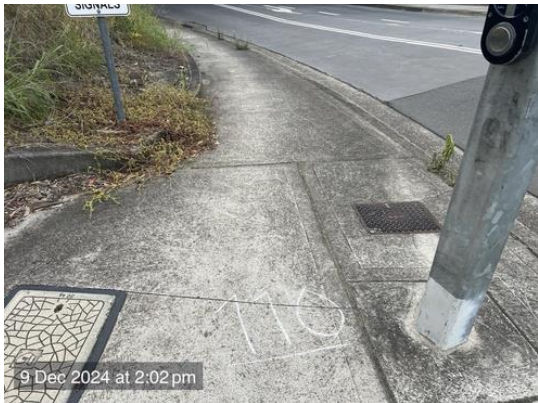
Photo 228

Type of Photo Crack

| Number of cracks | Map Cracking |
| Average length of cracks (mm) | 1000 |
| Width of Cracks | Category 4; $4.0 < \alpha < 10.0$ mm |

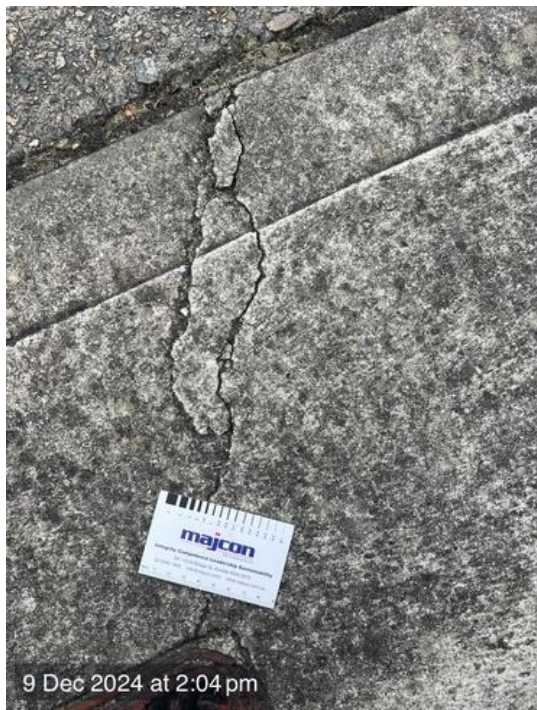
Photo 238

Crack

| Number of cracks | 2 | |
| Average length of crack 1 (mm) | 500 | |
| Width of crack 1 | Category 3; $2.0 < \alpha < 4.0$ mm | |
| Average length of crack 2 (mm) | 400 | |
| Width of crack 2 | Category 3; $2.0 < \alpha < 4.0$ mm | |
