## 20240111 25-27 Leeds Street, Rhodes - Pre-Demolition Dilapidation Survey of External Elevations and Common Areas at 21 Leeds Street, Rhodes

MAJ-20240111-DS-REP-001-2D-R01

Re: 25-27 LEEDS STREET, RHODES  
PRE-CONSTRUCTION DILAPIDATION SURVEY OF EXTERNAL ELEVATIONS AND COMMON AREAS  
AT 21 LEEDS STREET, RHODES

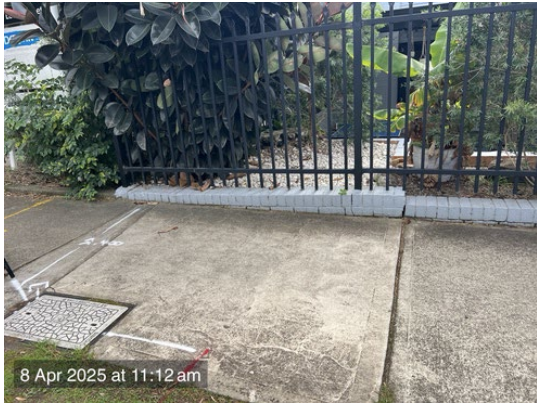
Photo 52

- i. Cracks on external brick wall (Example photos 49-52 - Category 1)
- ii. Typical cracks on coffee shop entry area floor (Example photos 94 – Category 1; photos 69, 85-90 – Category 2; photo 118 – Category 3)
- iii. Movement of floor slab (Example photo 72)
- iv. Movement at planter box (Example photo 77)

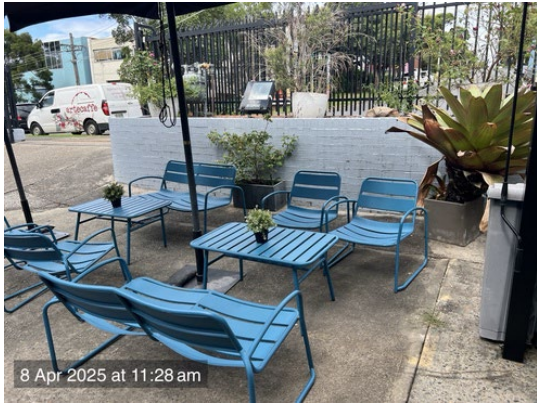
Photo 78

| Details | Stain on planter box |
| Type of Stain | Water |

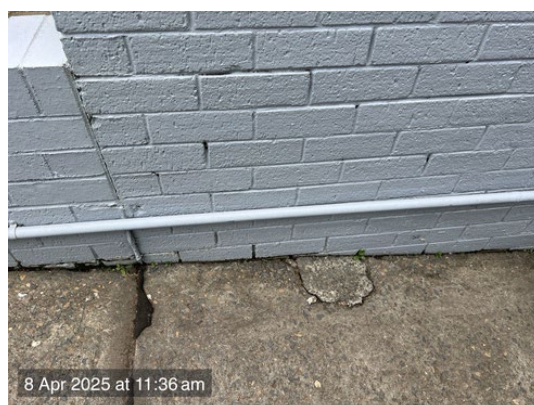
Photo 95

| Damage on the external floor | |

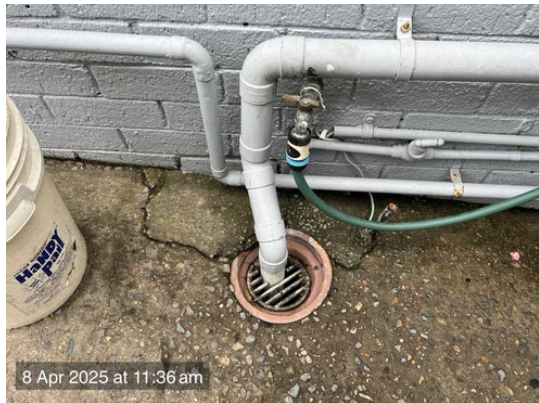
Photo 96

| Damage on driveway | |

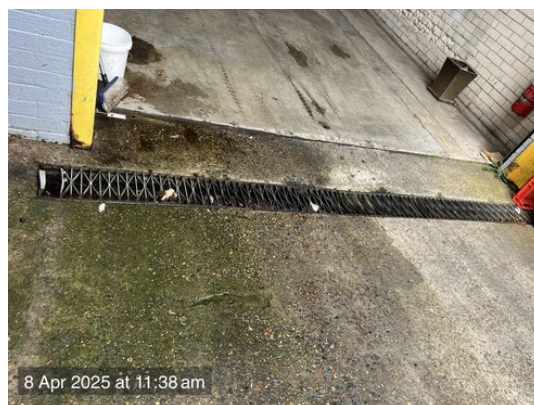
Photo 99

| Number of Cracks | 1 |
| Average Length of Crack | 3000 mm |
| Width of Crack | Category 2; $1.0 < a < 2.0$ mm |

Cracks on driveway

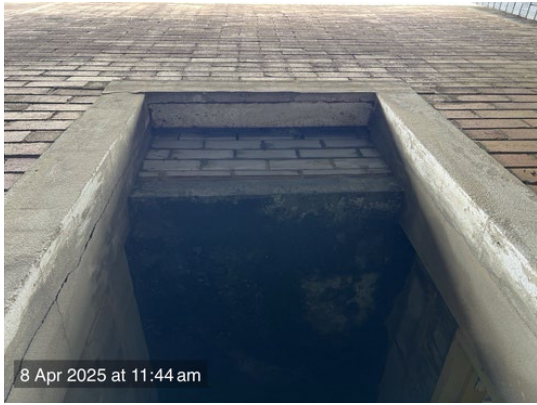
Photo 112

| Number of Cracks | 2 |
| Average Length of Crack 1 | 4000 mm |
| Width of Crack 1 | Category 2; $1.0 < a < 2.0$ mm |
| Average Length of Crack 2 | 4000 mm |
| Width of Crack 2 | Category 1; $0.3 < a < 1.0$ mm |
| Other Details | Cracks on architrave render |

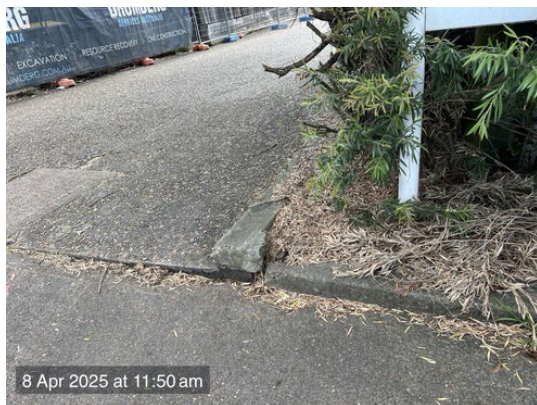
Photo 122

| Width of Crack | Category 3; 2.0 < a < 4.0 mm | | | |
| Other Details | Cracks on common driveway | | | |

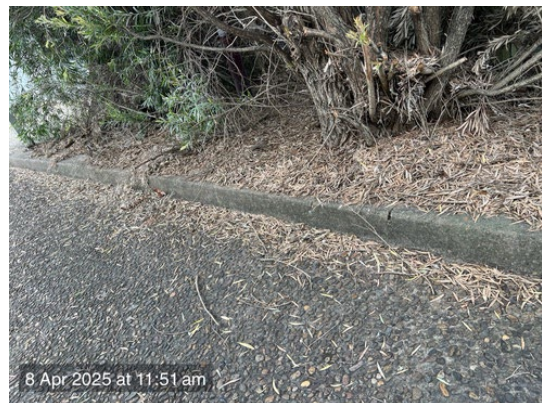
Photo 125

| Number of Cracks | Typical | | | |
| Average Length of Crack | 200 mm | | | |
| Width of Crack | Category 1; 0.3 < a < 1.0 mm | | | |
| Other Details | Typical cracks on kerb | | | |

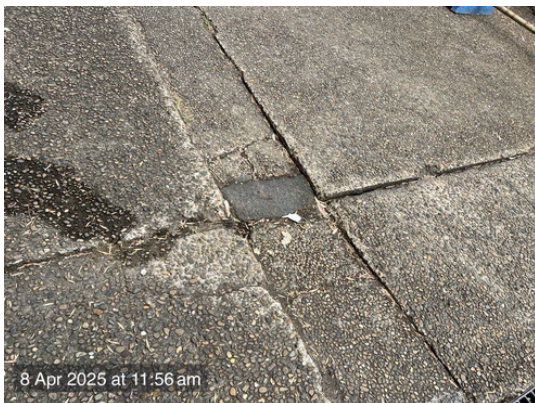
Photo 138

| Type of Photo | Damage |
| Other Details | Damage on common driveway |
