## 20240111 25-27 Leeds Street, Rhodes - Pre-Demolition Dilapidation Survey of External Elevations and Carpark Area at 23 Leeds Street, Rhodes

MAJ-20240111-DS-REP-001-1E-R01

RE: 25-27 LEEDS STREET, RHODES  
PRE-DEMOLITION DILAPIDATION SURVEY OF EXTERNAL ELEVATIONS AND CARPARK AREA AT  
23 LEEDS TREET, RHODES

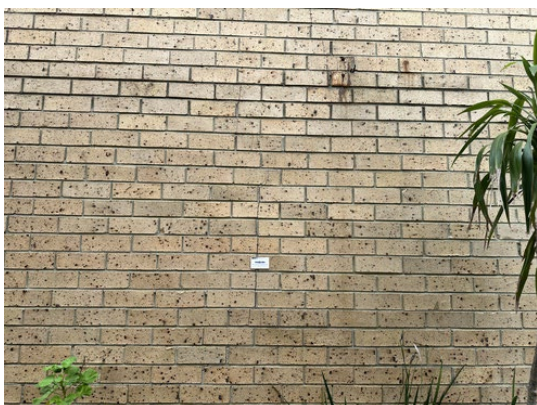
Photo 13

Crack

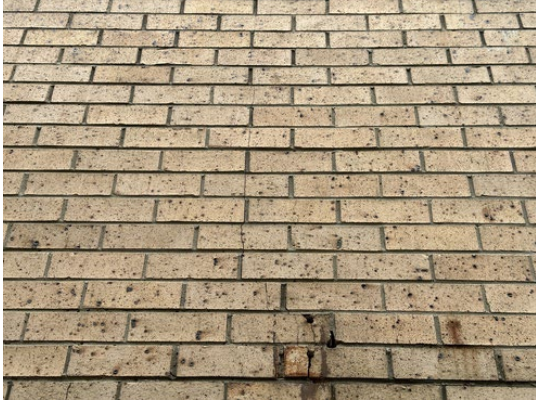
Photo 15

Crack

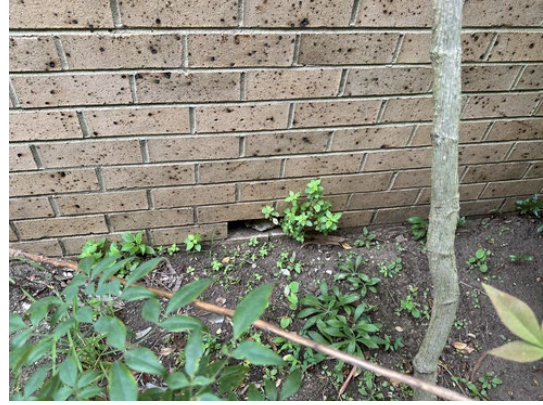
Photo 30

| Details | Missing a piece of brick on the wall |

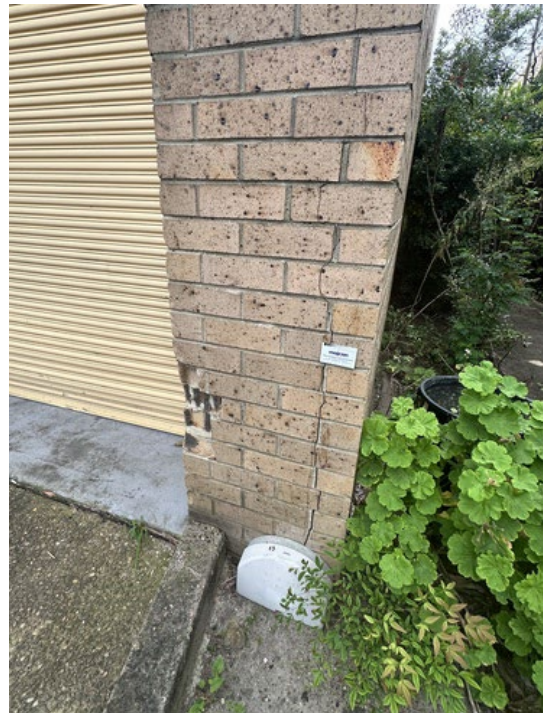
Photo 34

Crack

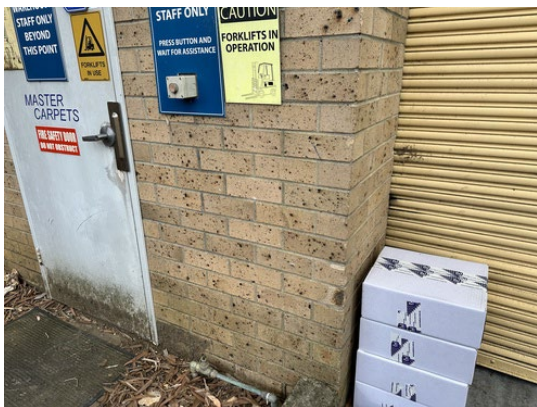
Photo 41

Damage

Damage to brick wall

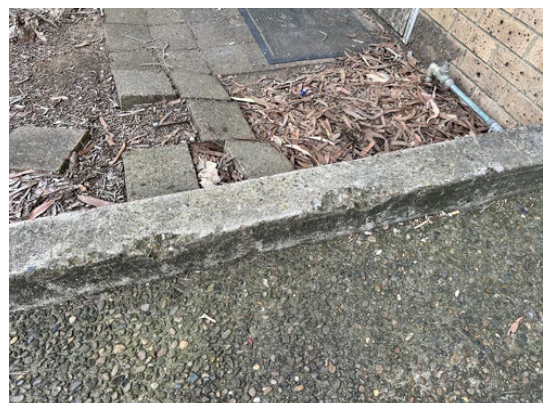
Photo 65

| Other Details | Damage to kerb |

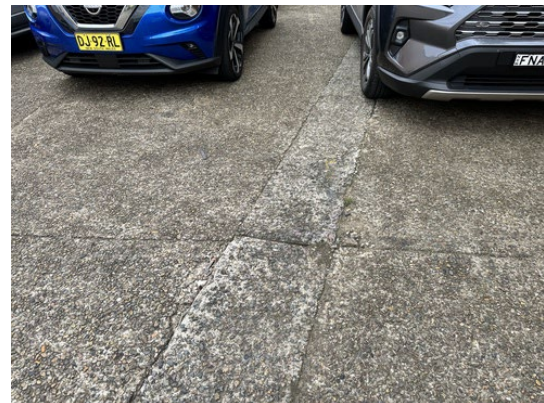
Photo 69

| Other Details | Damage paver bricks |

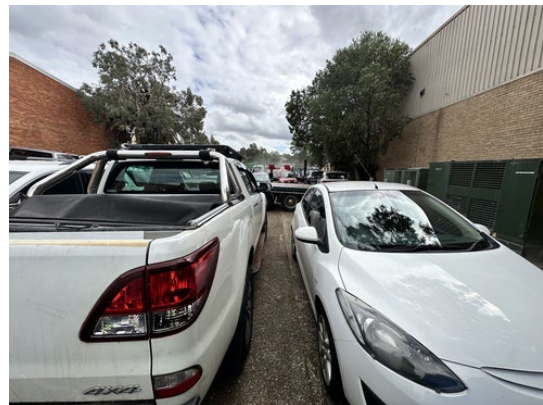
Photo 81

| Other Details | Crack and damage to kerb and driveway slab |

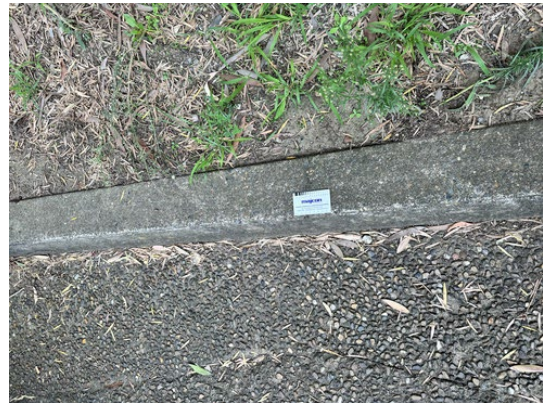
Photo 97

Typical crack to driveway slab

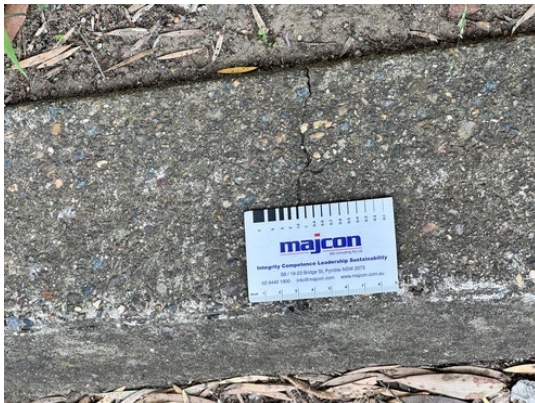
Photo 98

| Number of Cracks | 1 |
| Average Length of Crack | 250 mm |
| Width of Crack | Category 2; $1.0 < a < 2.0$ mm |
| Other Details | Crack to kerb |

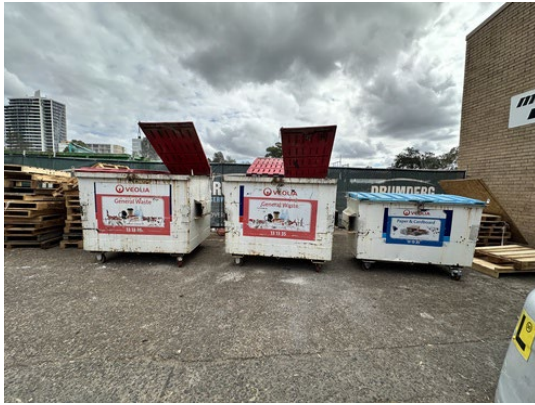
Photo 114

Typical crack to driveway slab

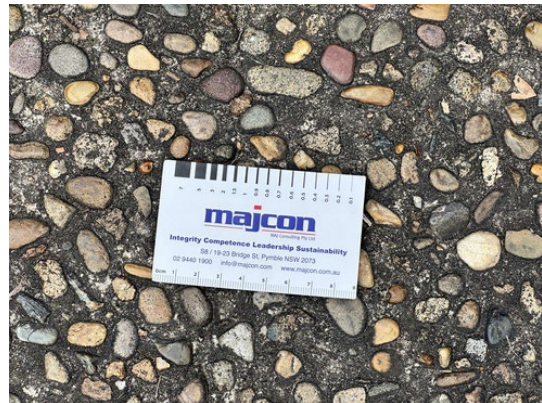
Photo 139

Crack to driveway slab

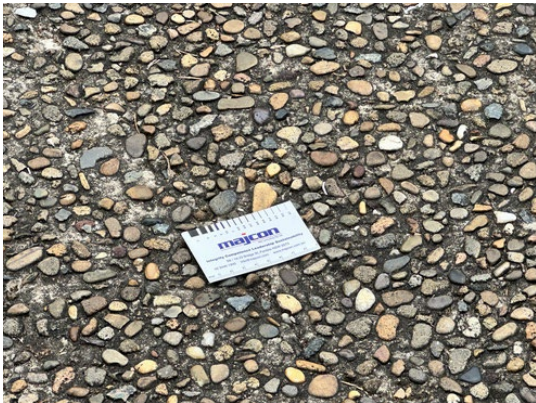
Photo 144

Typical cracks to driveway slab
