# **Pre-Dilapidation Report**

**19 GEORGE STREET**

**REAR BUILDING (UNITS 20-29)**

Project Reference: 20250047.19G.3

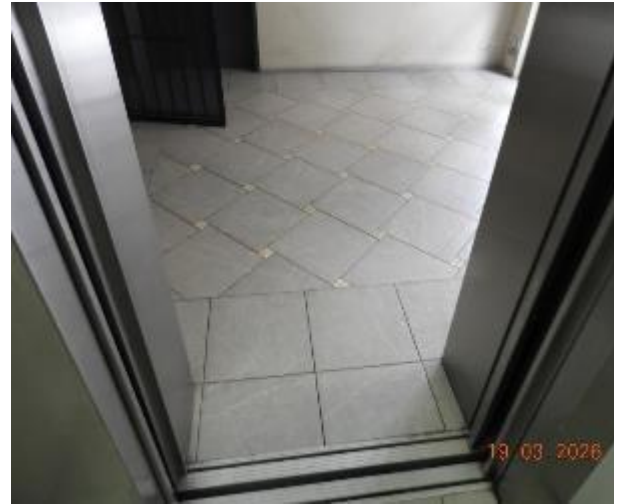
Figure 2 - General condition of level 1 common area floor tiles

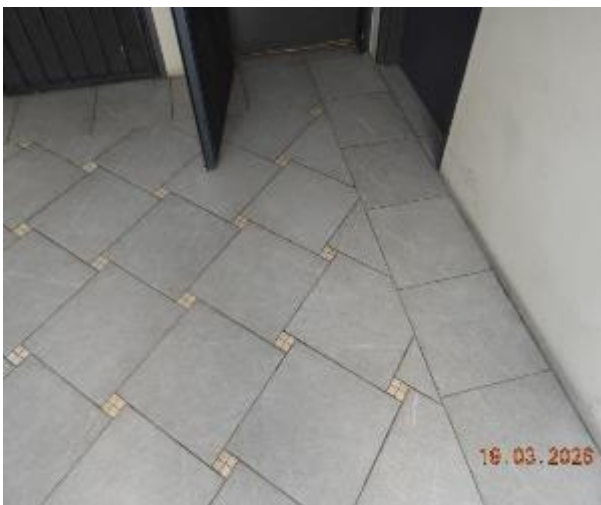
Figure 5 - General condition of level 1 common area floor tiles

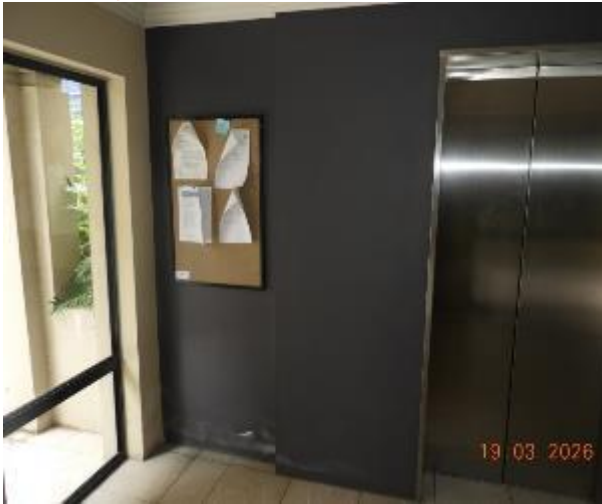
Figure 7 - General condition of level 1 common area internal wall

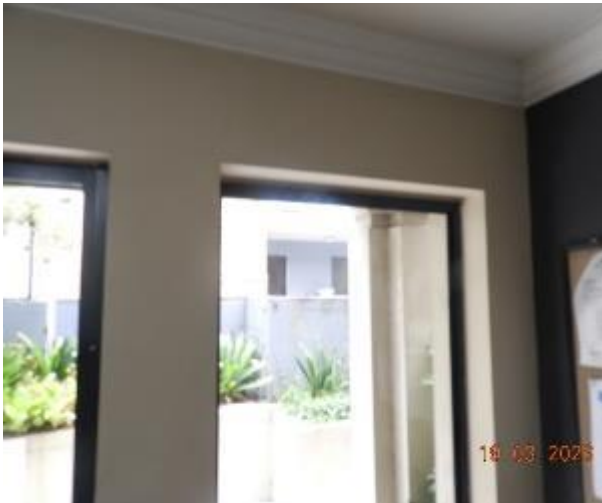
Figure 9 - General condition of level 1 common area internal wall

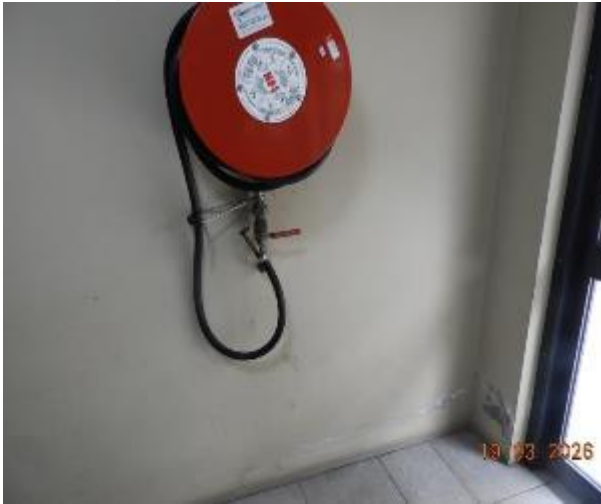
Figure 13 - General condition of level 1 common area internal wall

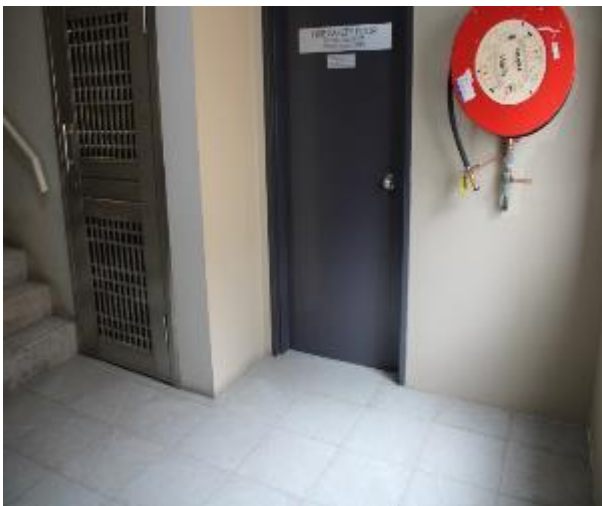
Figure 99 - General condition of level 4 common area internal wall

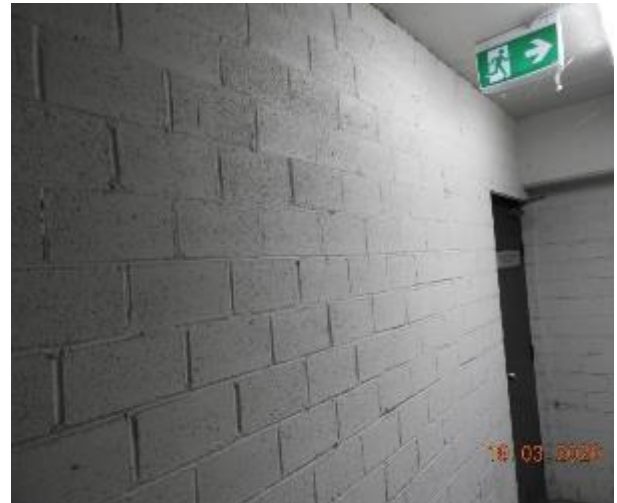
Figure 182 - General condition of B2 to Level 1 fire stairs internal wall

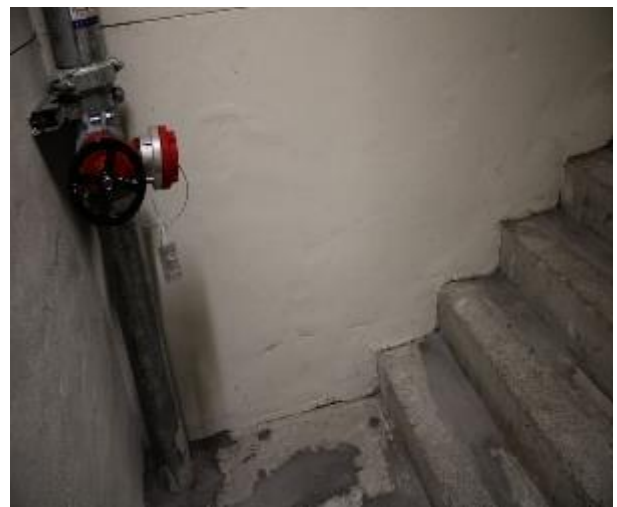
Figure 308 - General condition of level 5 to basement B2 fire stairs internal wall

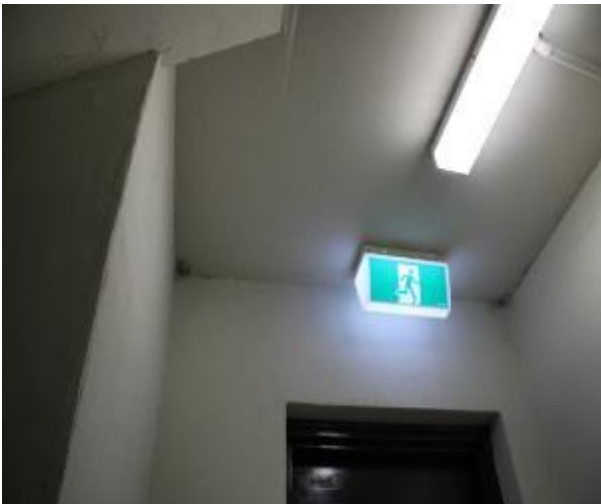
Figure 431 - General condition of level 5 to basement B2 fire stairs underside stairs

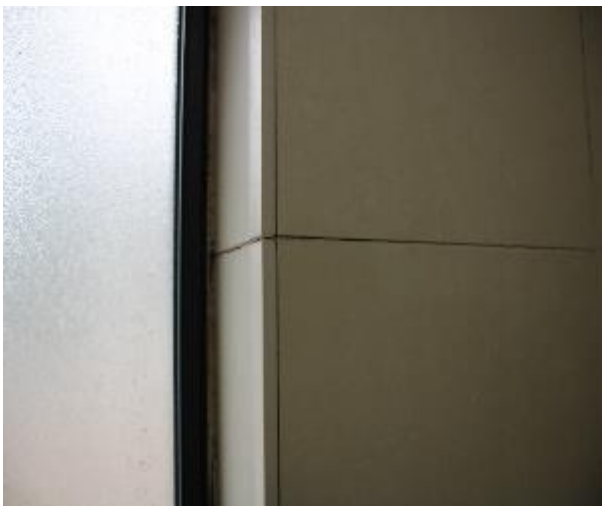
Figure 606 - Crack propagation through bathroom 1 internal wall

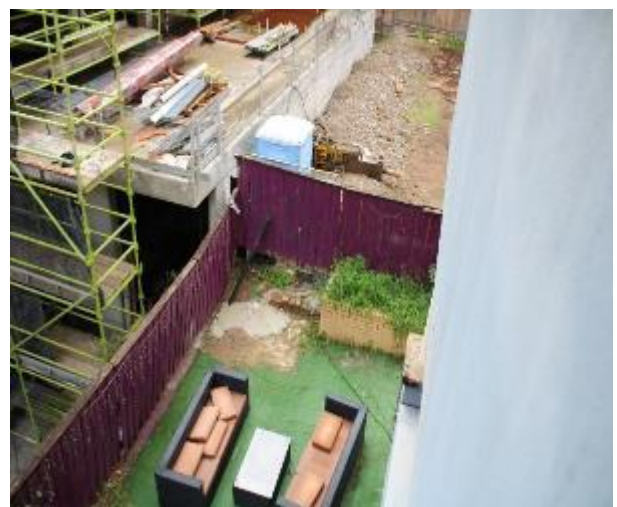
Figure 959 - General condition of boundary fence as seen from Unit 24 balcony

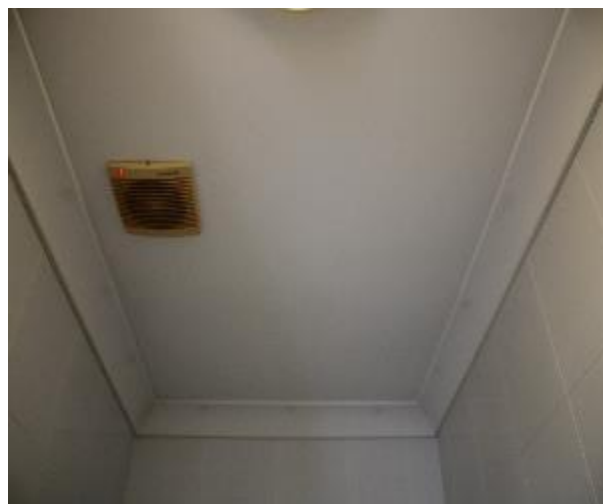
Figure 1505 - General condition of ensuite bathroom ceiling

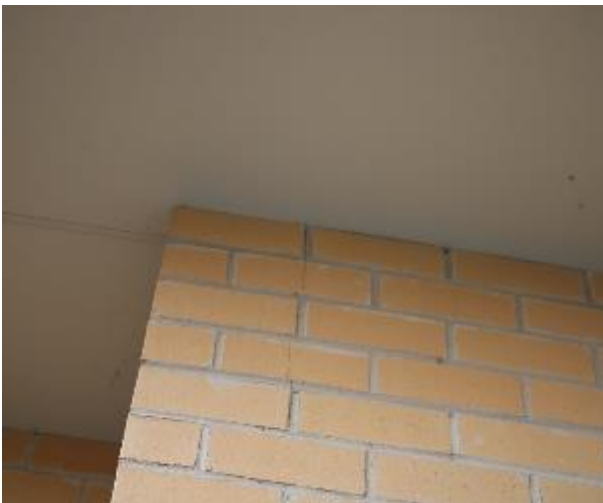
Figure 1596 - Crack propagation through external wall
