# **Pre-Dilapidation Report**

**19 GEORGE STREET**

**FRONT BUILDING (UNITS 1-19)**

Project Reference: 20250047.19G.2

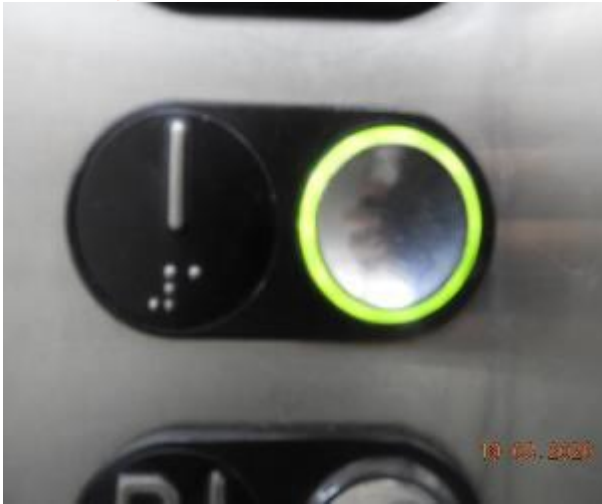
Figure 1 - The following images display the condition of Level 1 Common Area

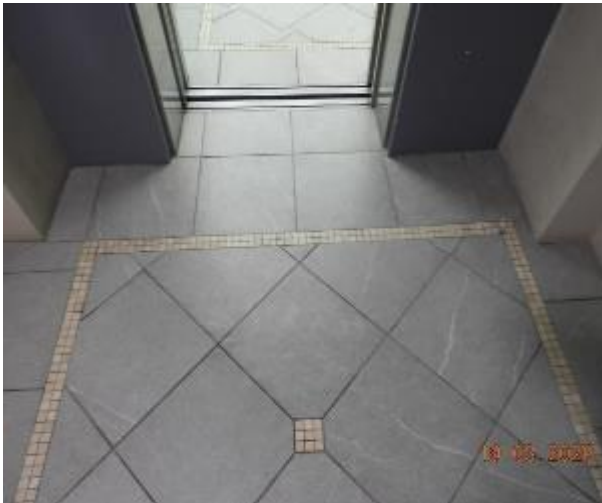
Figure 3 - General condition of level 1 common area floor tiles

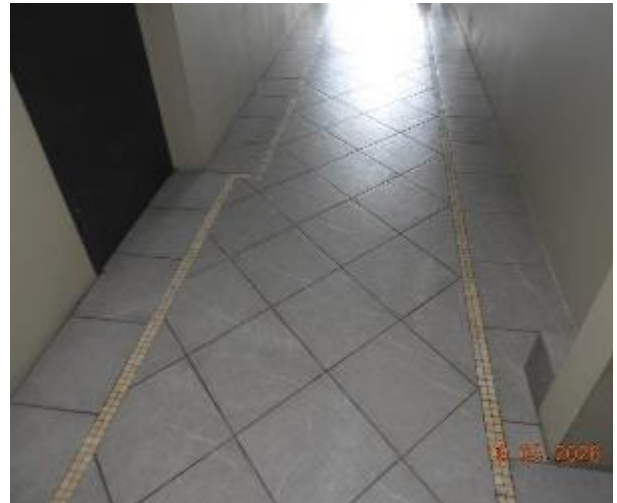
Figure 4 - General condition of level 1 common area floor tiles

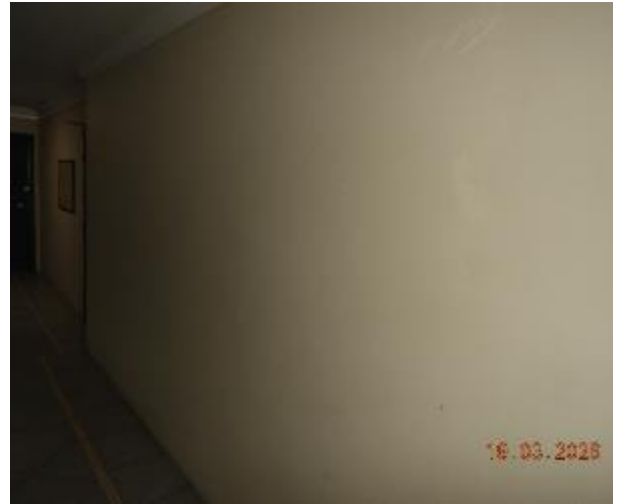
Figure 8 - General condition of level 1 common area internal wall

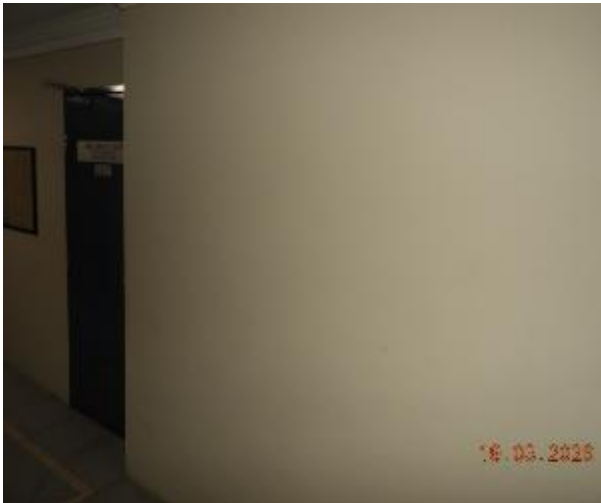
Figure 15 - General condition of level 1 common area internal wall

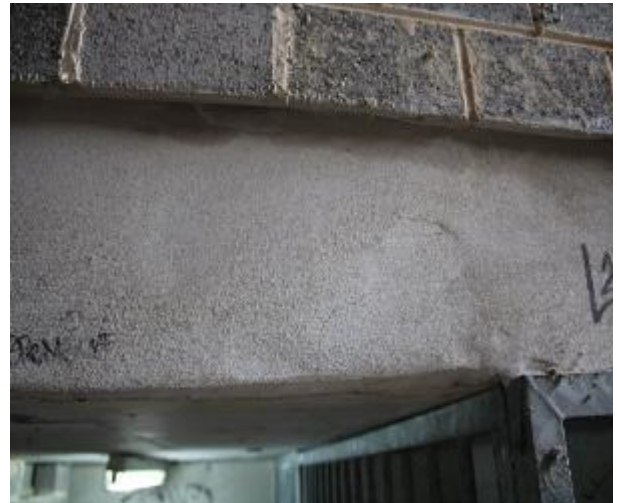
Figure 272 - Crack propagation through fire stairs underside slab

The fire stairs from Basement B2 to Level 1 were inspected and determined to be in reasonable condition. There were cases of cracking through the internal walls, underside stairs, and underside slab.

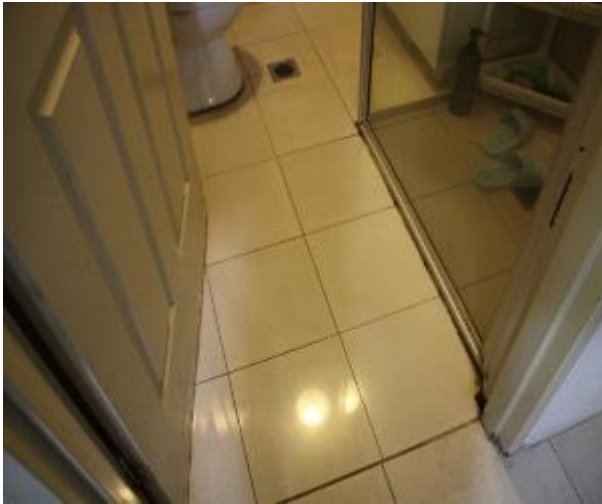
Figure 557 - General condition of bathroom 1 floor tiles

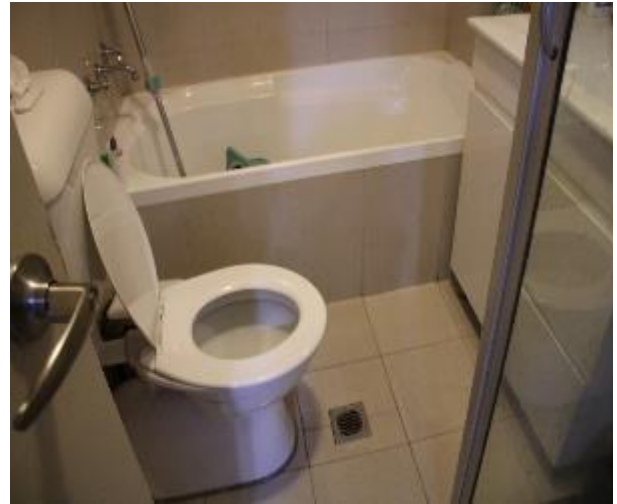
Figure 558 - General condition of bathroom 1 floor tiles

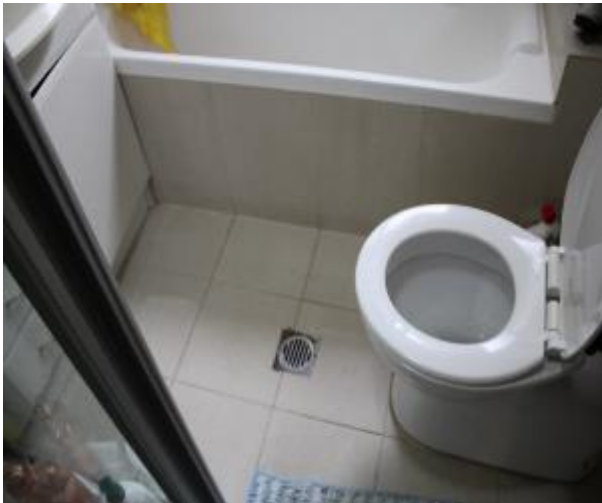
Figure 692 - General condition of bathroom 1 floor tiles

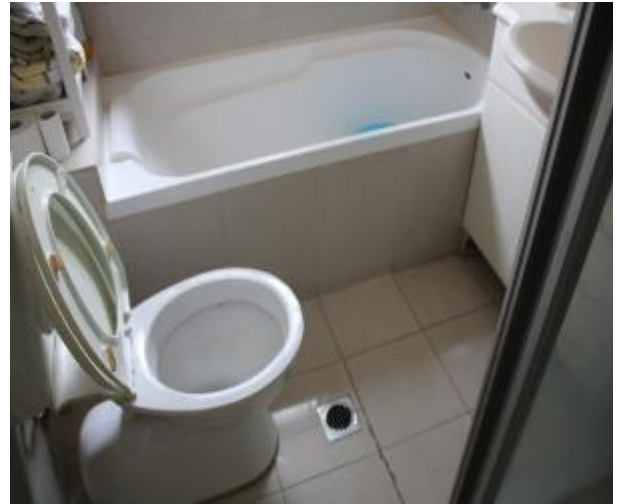
Figure 775 - General condition of bathroom 1 floor tiles

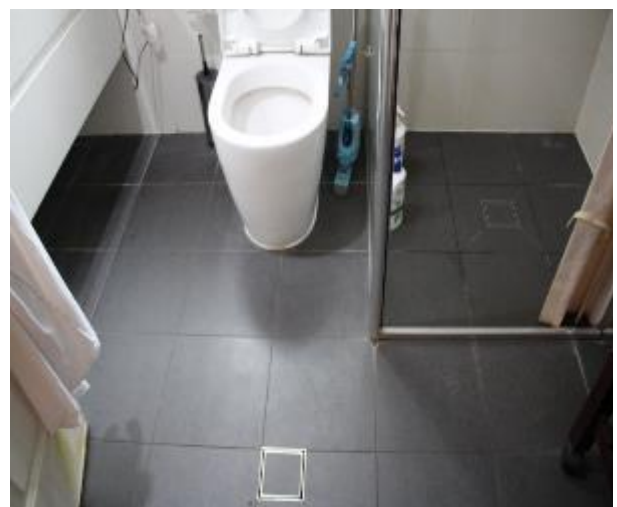
Figure 881 - General condition of bathroom 1 floor tiles

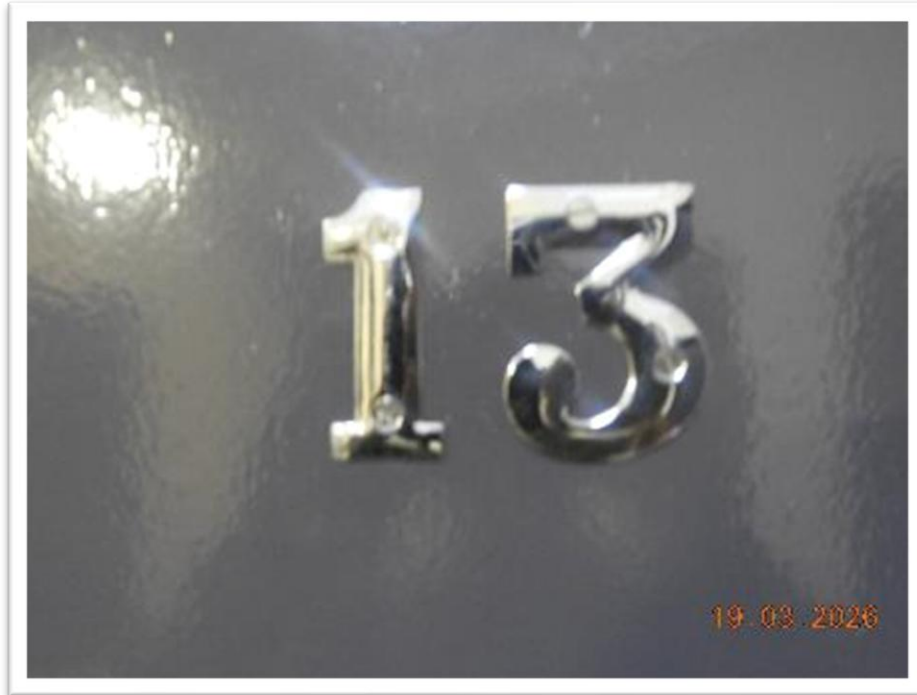
(xiii) Unit 13

It is important to note that Unit 13 was unattended at the time of this inspection, and hence no comment can be made on the pre-existing condition of the unit.

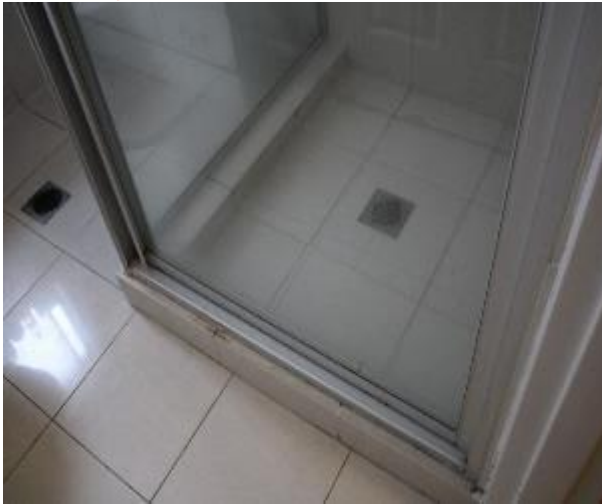
Figure 1157 - General condition of bathroom 1 floor tiles

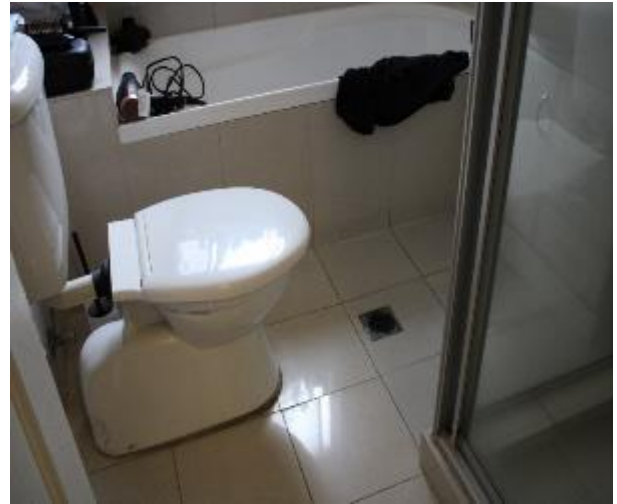
Figure 1158 - General condition of bathroom 1 floor tiles

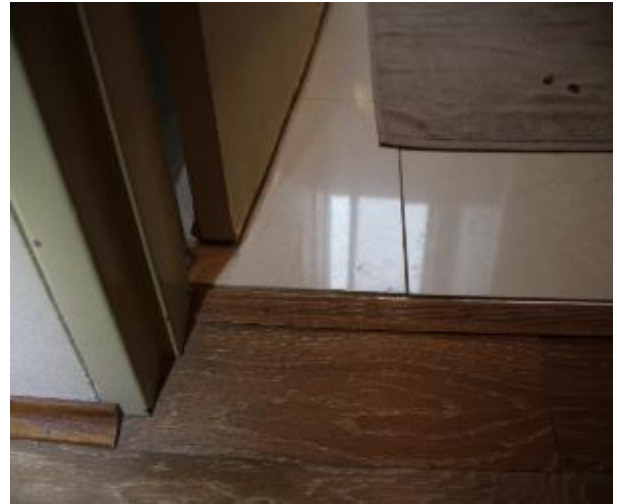
Figure 1340 - Displacement evident through corridor flooring

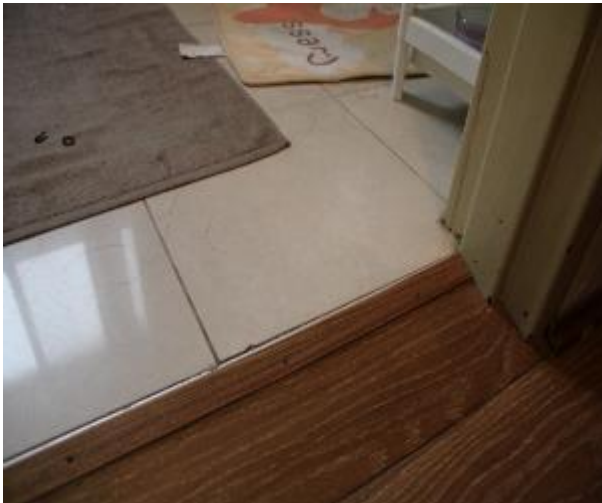
Figure 1341 - General condition of bathroom 1 floor tiles

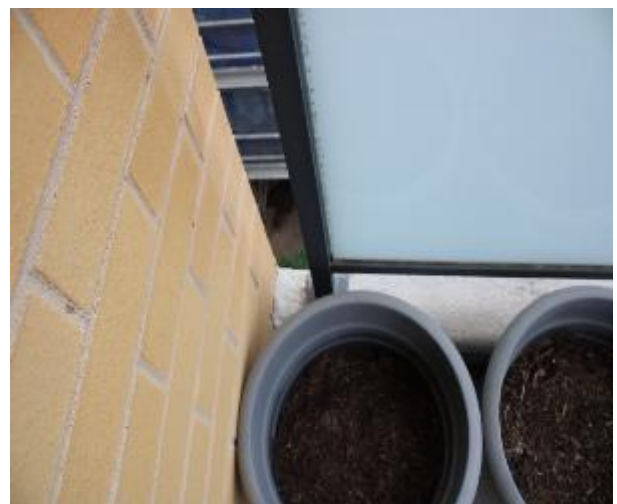
Figure 1434 - General condition of balcony floor tiles

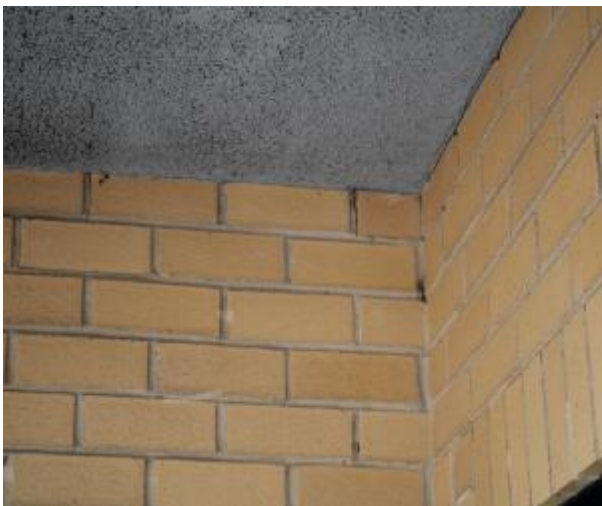
Figure 1449 - Crack propagation through balcony underside slab

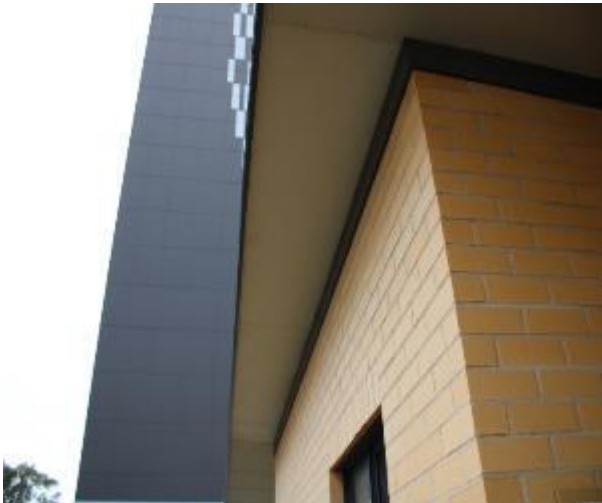
Figure 1531 - General condition of balcony underside slab

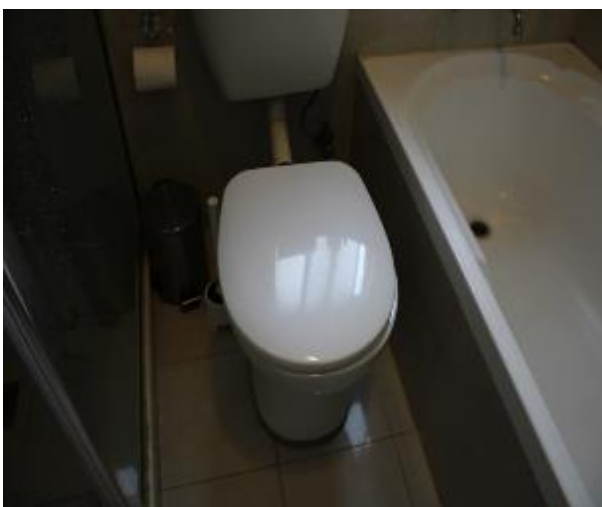
Figure 1581 - General condition of bathroom 1 floor tiles
