# **PRE-DILAPIDATION REPORT**

**COUNCIL ASSETS**

**21 GEORGE STREET,  
BURWOOD, NSW 2134**

PROJECT REFERENCE: 20250047.CA.1  
17/04/2026

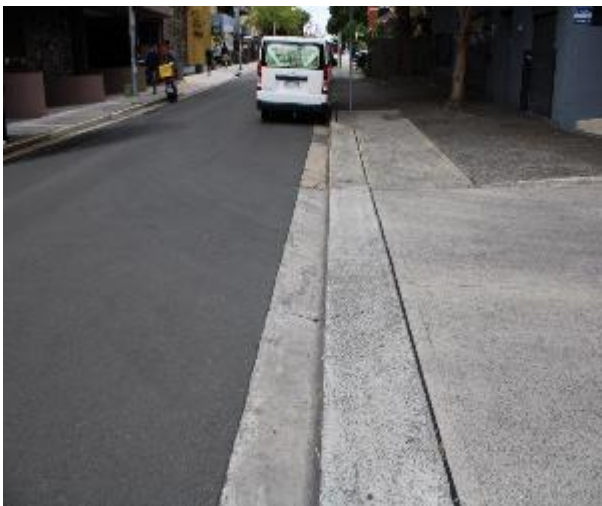
Figure 291 - General condition of driveway layback and gutter heading East

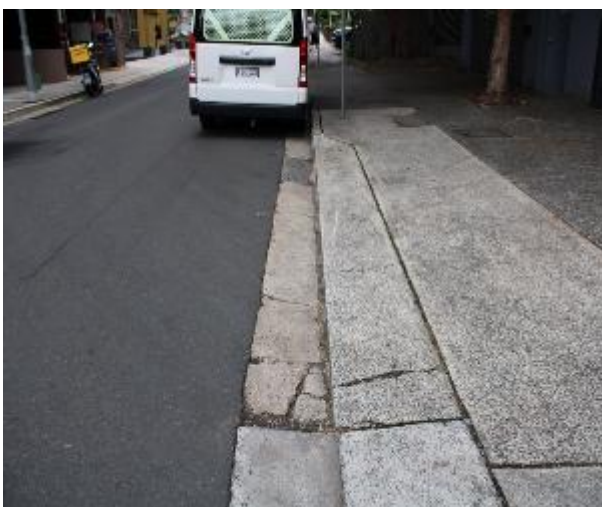
Figure 293 - General condition of driveway layback and gutter heading East

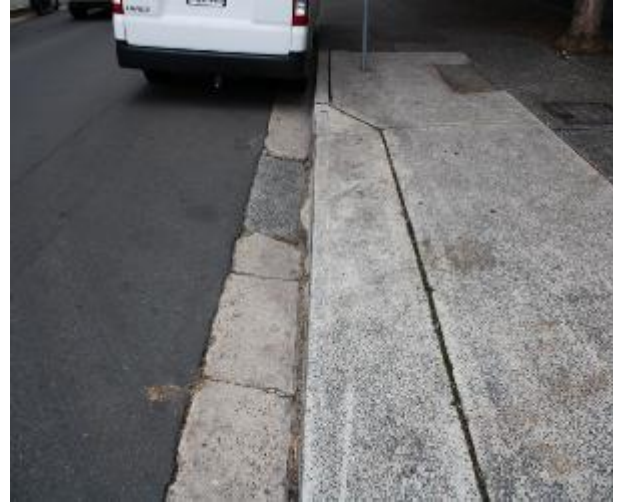
Figure 296 - General condition of driveway layback and gutter heading East

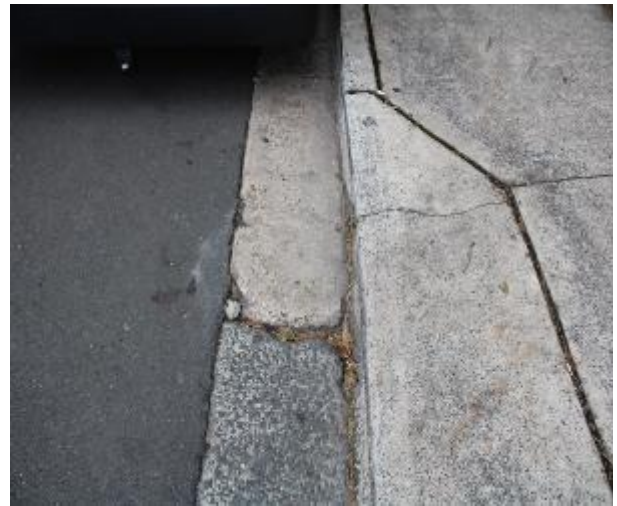
Figure 298 - General condition of driveway layback and gutter heading East

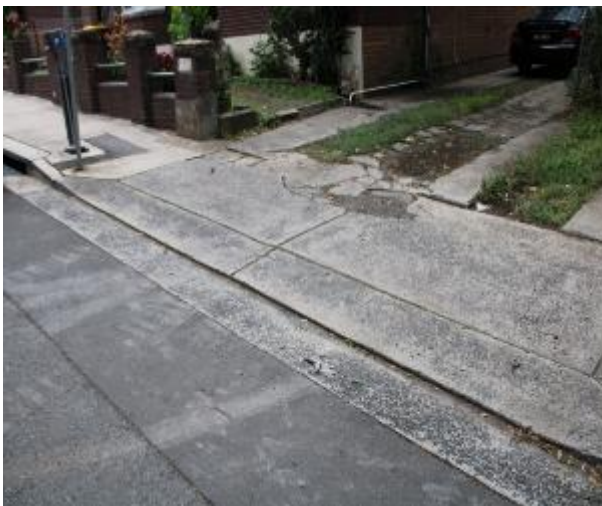
Figure 315 - General condition of driveway layback and gutter heading East

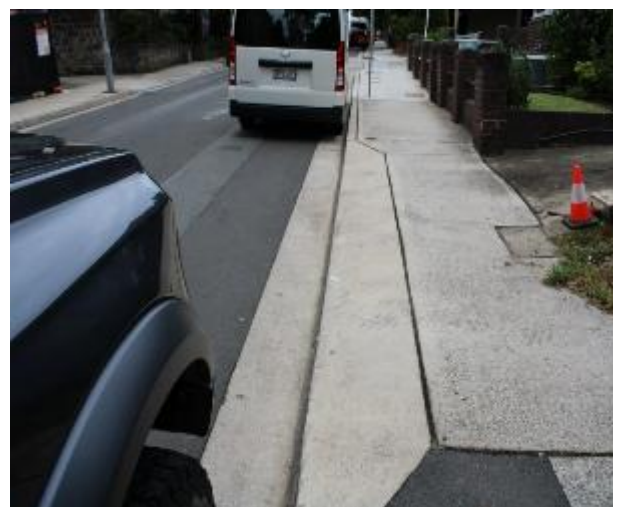
Figure 324 - General condition of driveway layback and gutter heading East

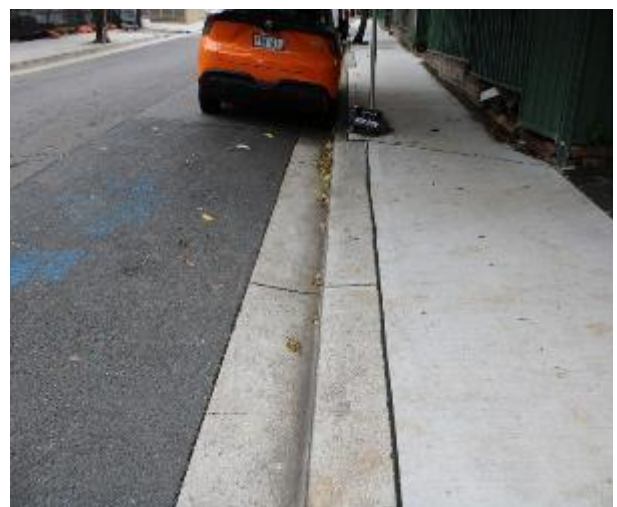
Figure 342 - General condition of driveway layback and gutter heading East

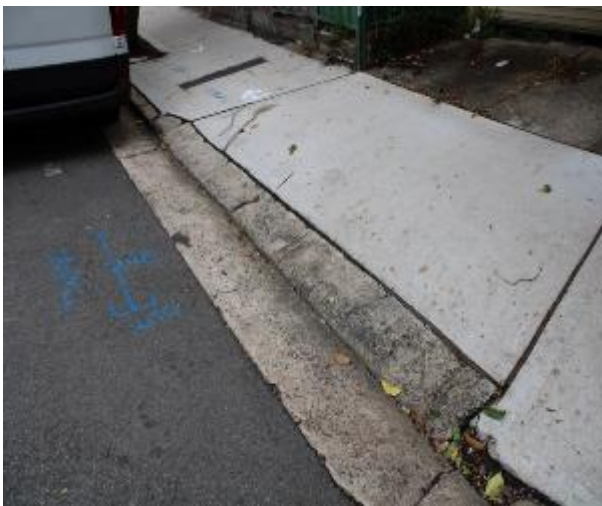
Figure 351 - General condition of driveway layback and gutter heading East

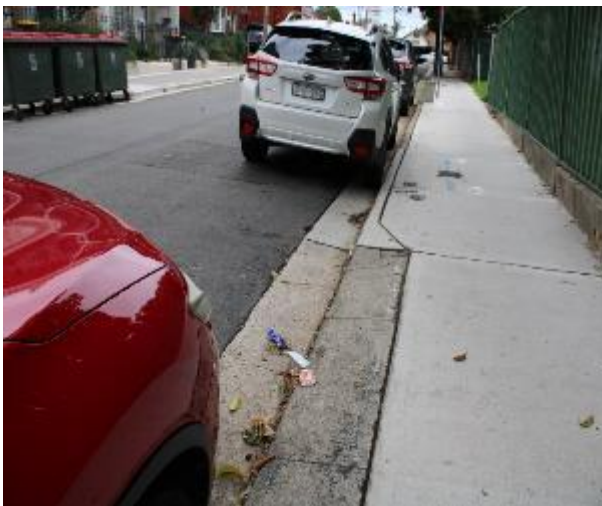
Figure 363 - General condition of driveway layback and gutter heading East

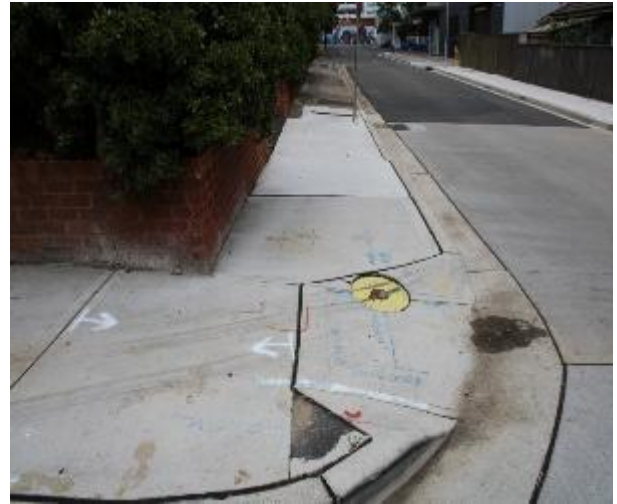
Figure 398 - General condition of footpath pavement heading South

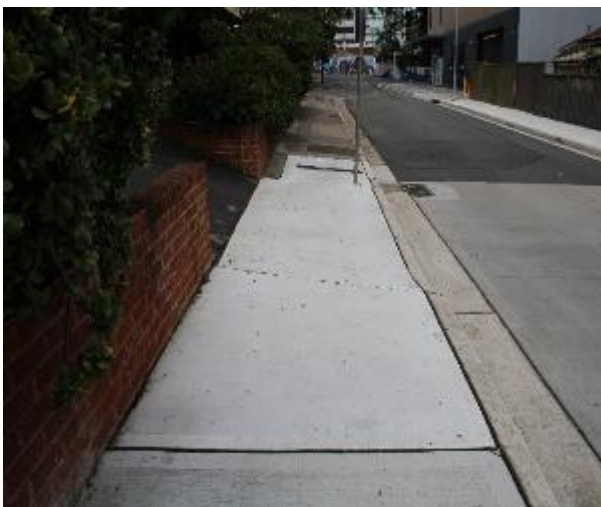
Figure 401 - General condition of footpath pavement heading South

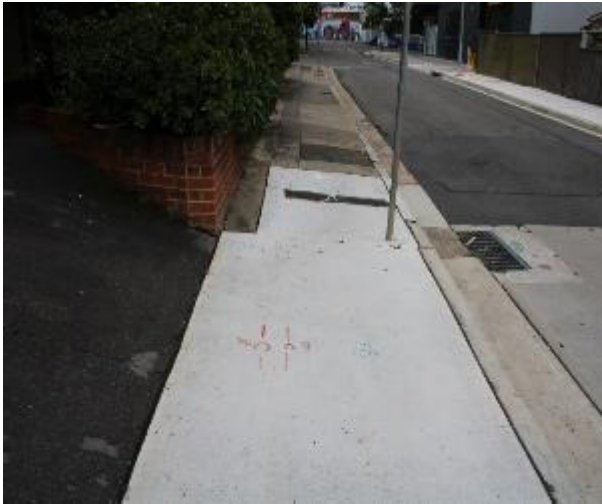
Figure 403 - General condition of footpath pavement heading South

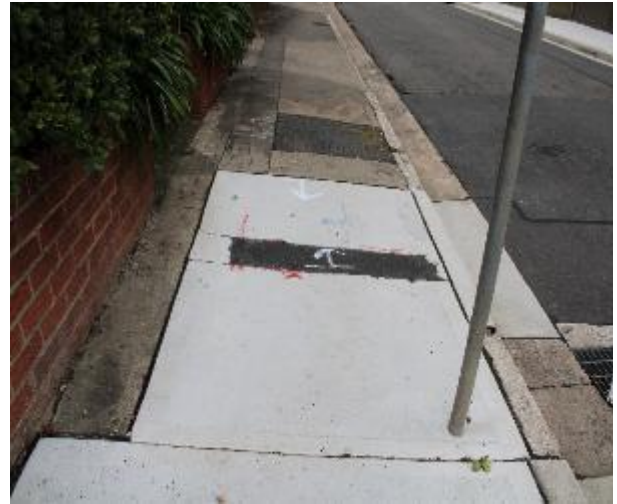
Figure 404 - General condition of footpath pavement heading South

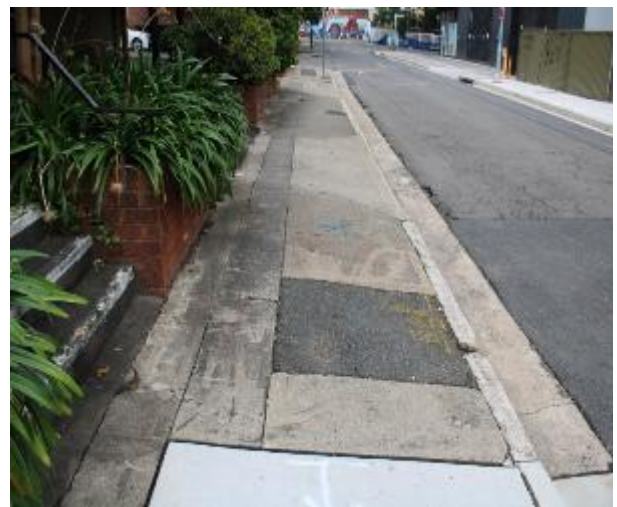
Figure 408 - General condition of footpath pavement heading South

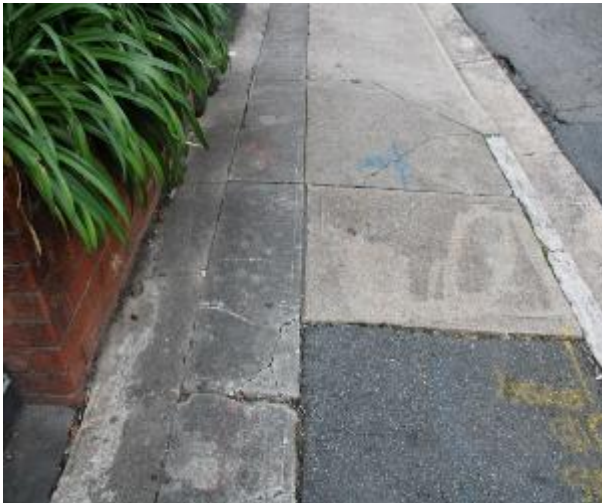
Figure 411 - General condition of footpath pavement heading South

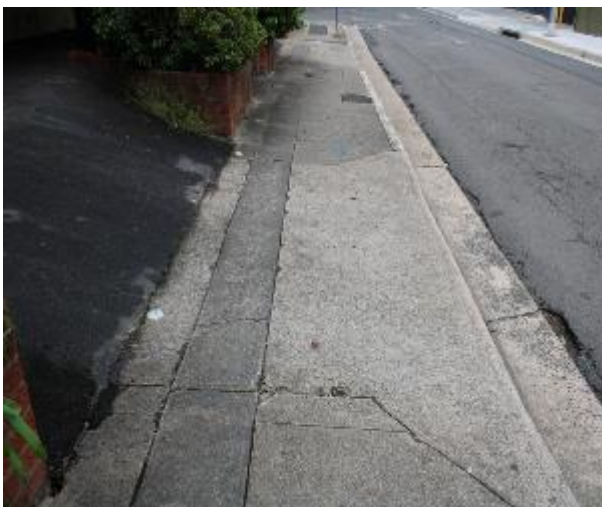
Figure 413 - General condition of footpath pavement heading South

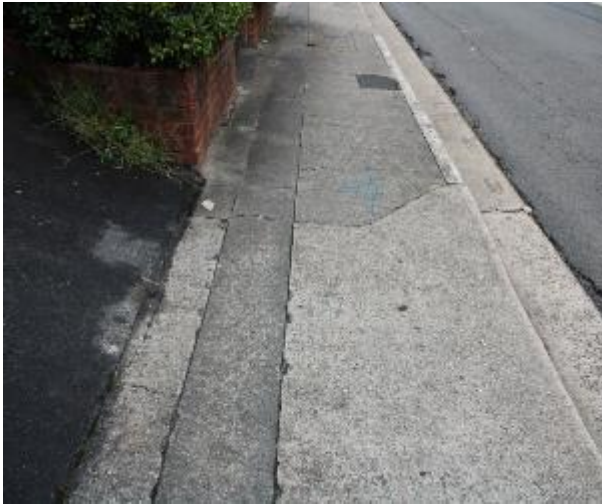
Figure 415 - General condition of footpath pavement heading South

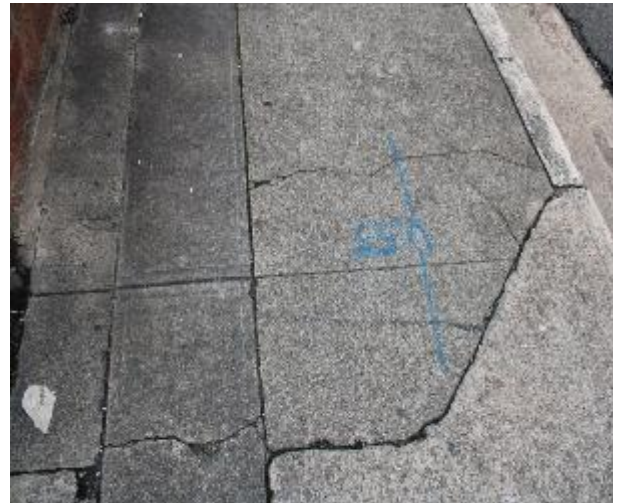
Figure 418 - General condition of footpath pavement heading South

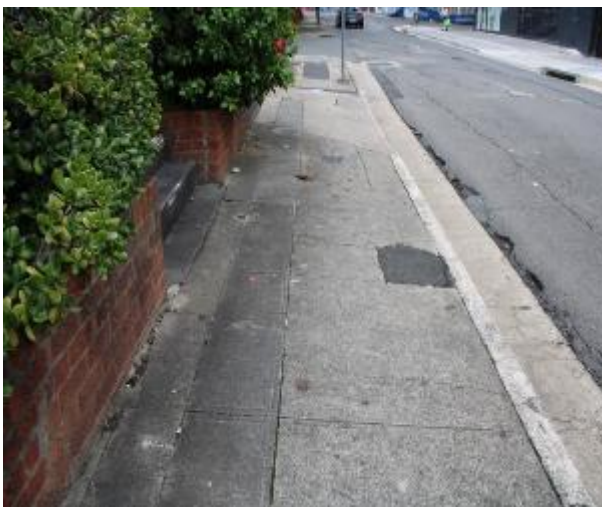
Figure 419 - General condition of footpath pavement heading South

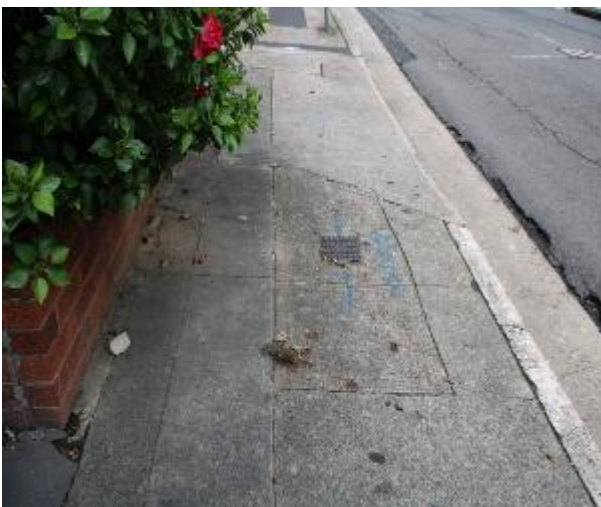
Figure 425 - General condition of footpath pavement heading South

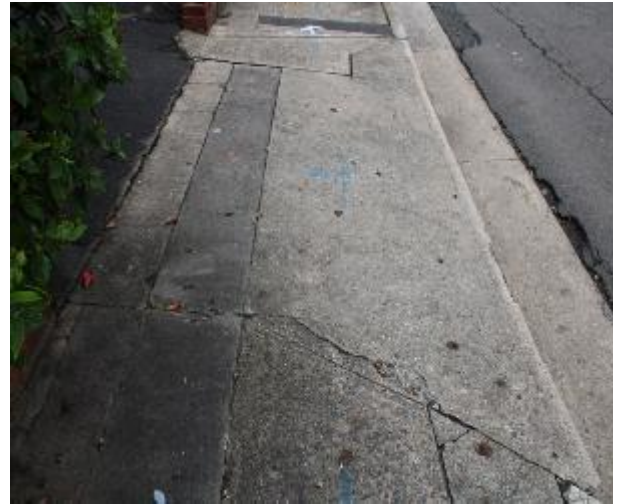
Figure 428 - General condition of footpath pavement heading South

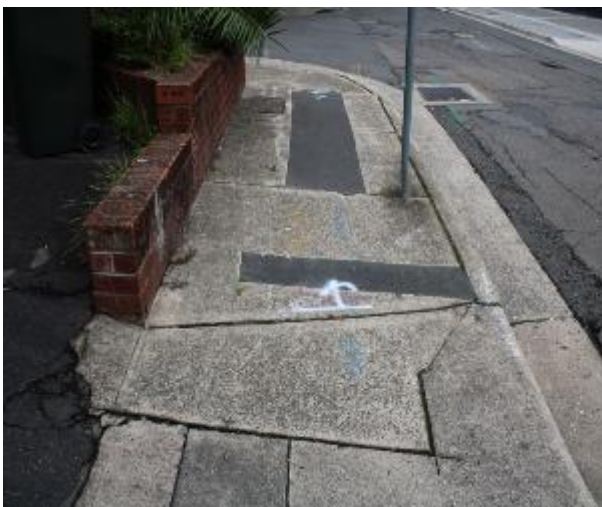
Figure 431 - General condition of footpath pavement heading South

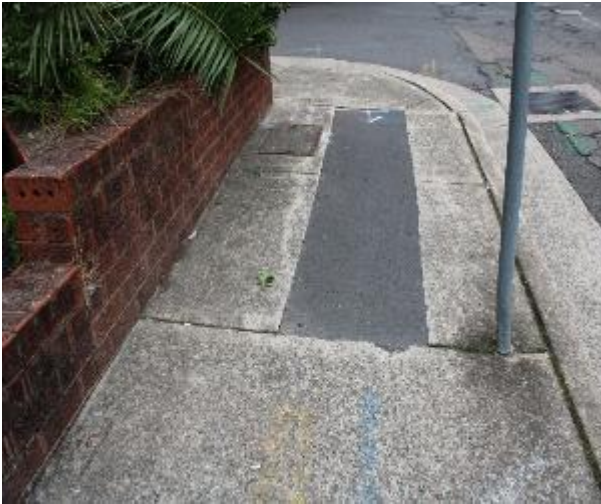
Figure 433 - General condition of footpath pavement heading South

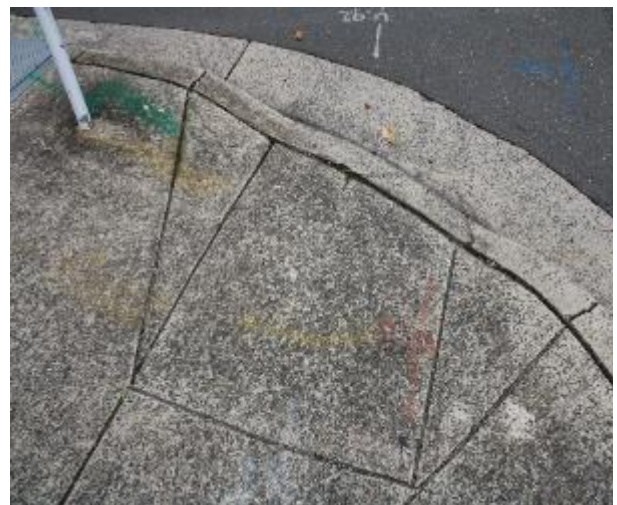
Figure 438 - General condition of footpath pavement heading South

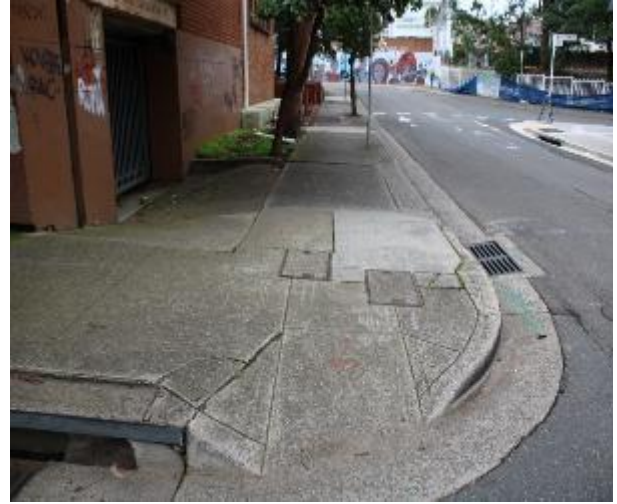
Figure 440 - General condition of footpath pavement heading South

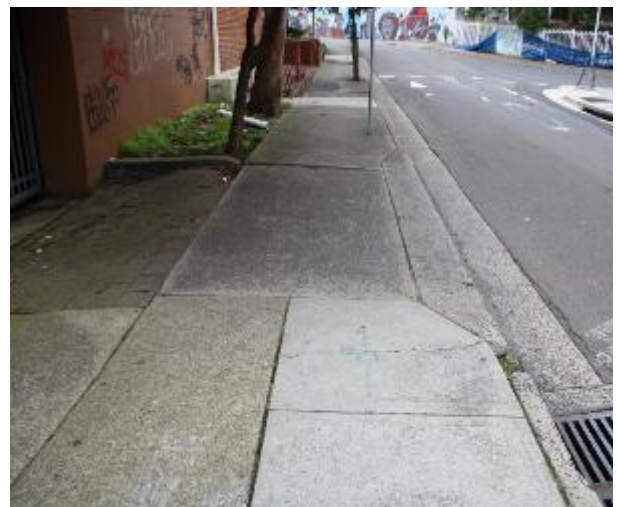
Figure 444 - General condition of footpath pavement heading South

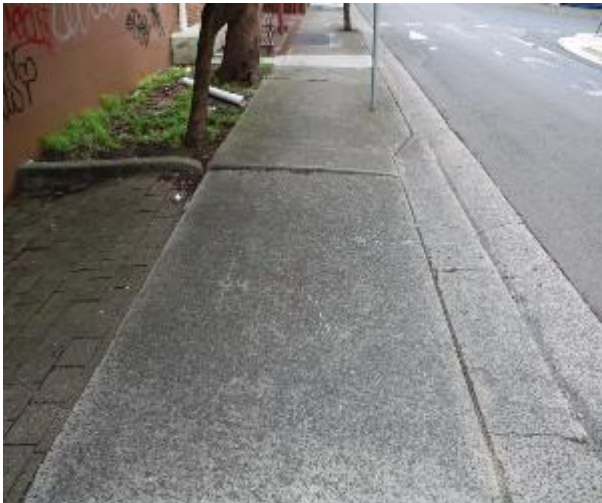
Figure 447 - General condition of footpath pavement heading South

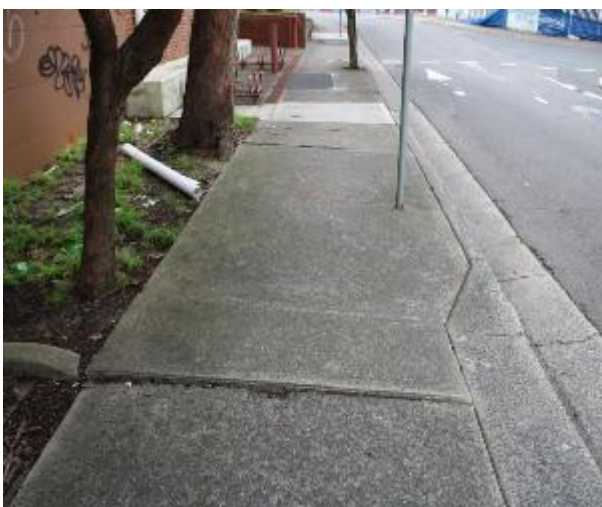
Figure 449 - General condition of footpath pavement heading South

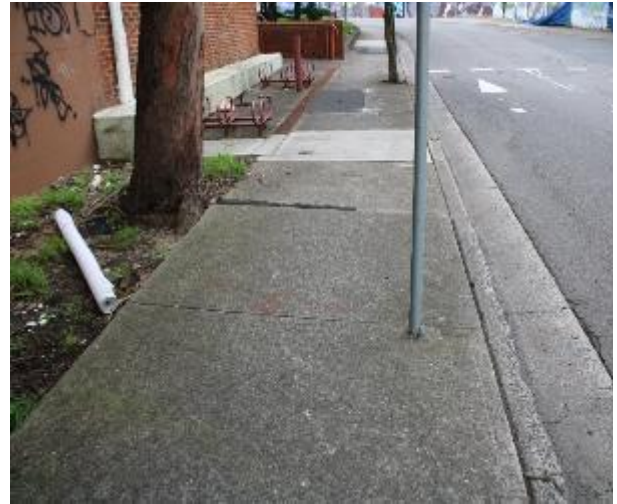
Figure 452 - General condition of footpath pavement heading South

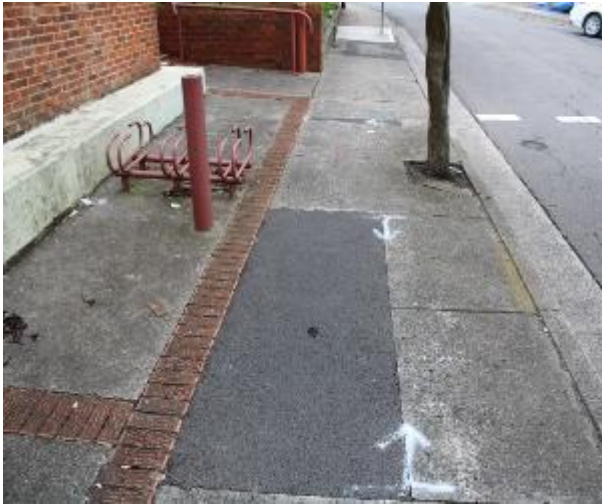
Figure 456 - Crack propagation through footpath pavement heading South

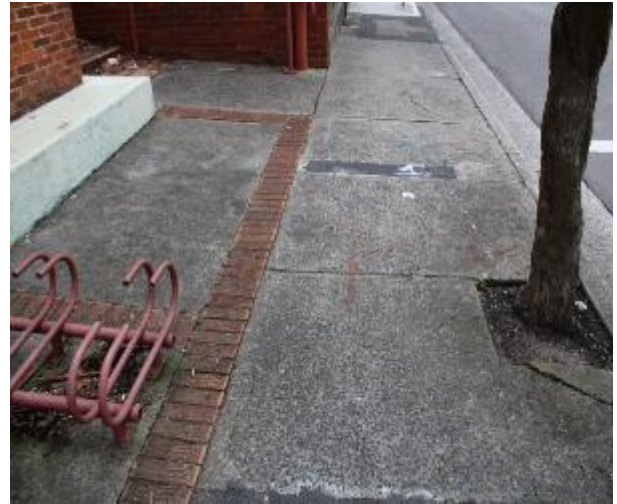
Figure 457 - General condition of footpath pavement heading South

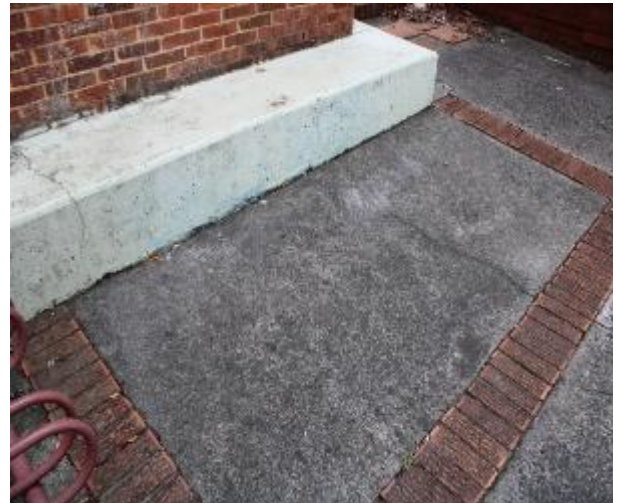
Figure 459 - Crack propagation through footpath pavement heading South

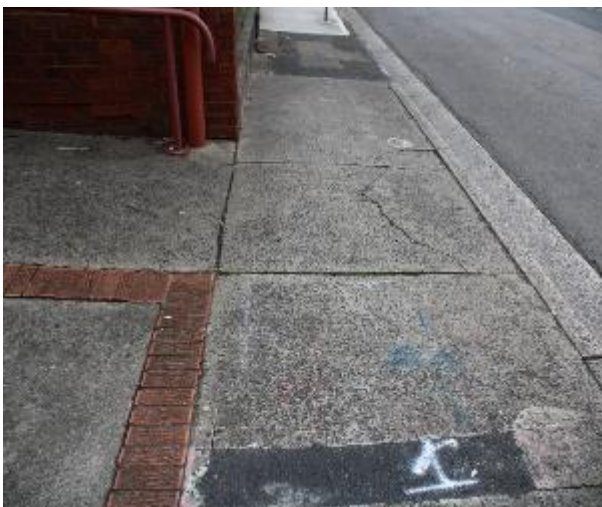
Figure 460 - General condition of footpath pavement heading South

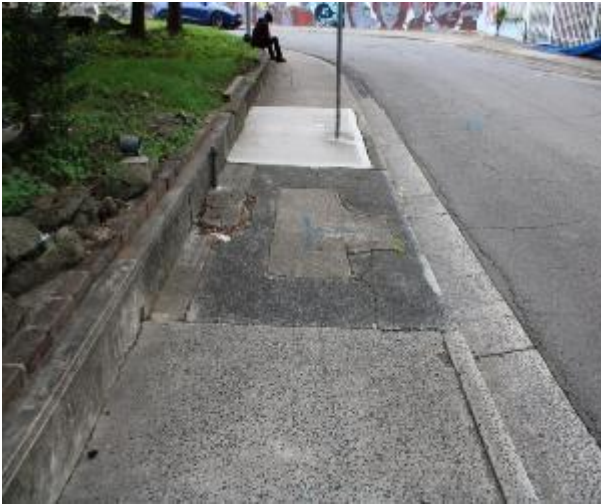
Figure 462 - Crack propagation through footpath pavement heading South

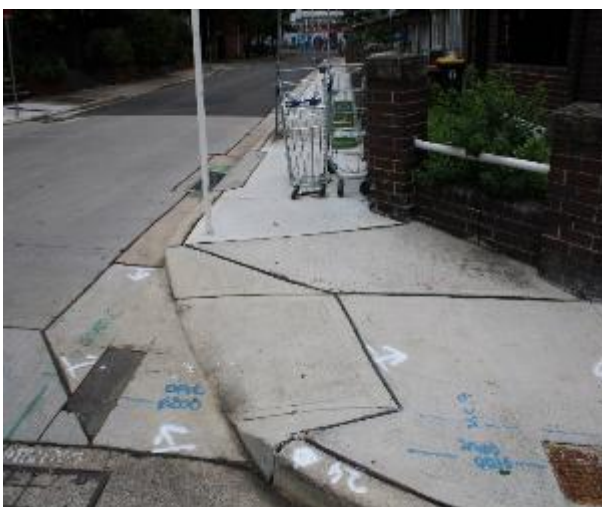
Figure 508 - General condition of kerb and gutter heading North

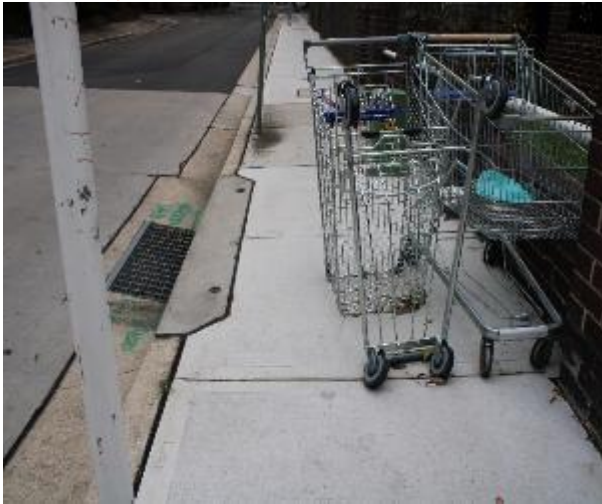
Figure 510 - Crack propagation through footpath pavement heading South

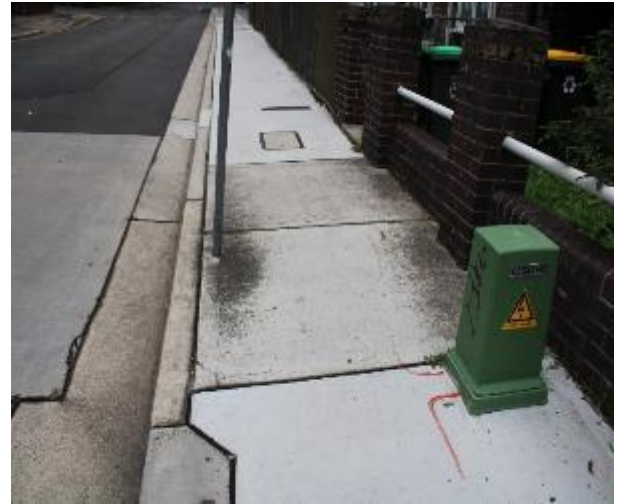
Figure 511 - General condition of footpath pavement heading South

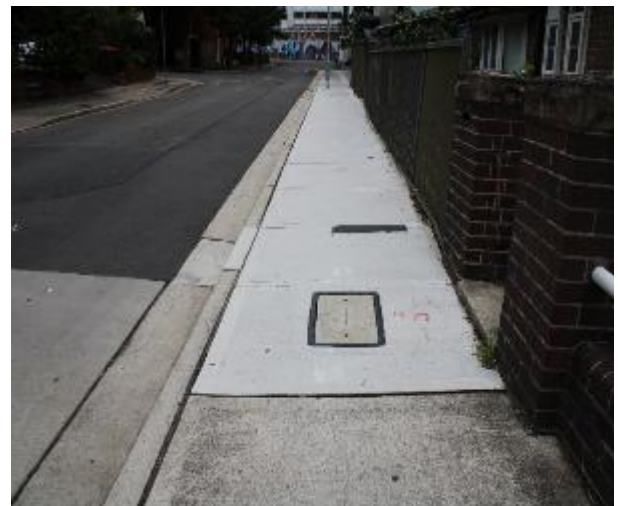
Figure 513 - Crack propagation through footpath pavement heading South

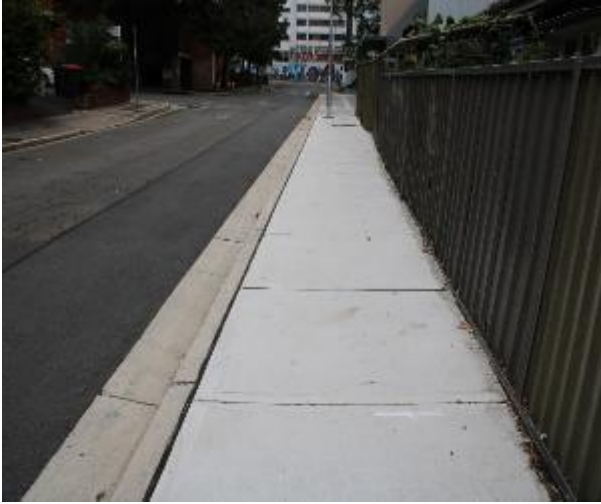
Figure 516 - Patchwork evident through footpath pavement heading South

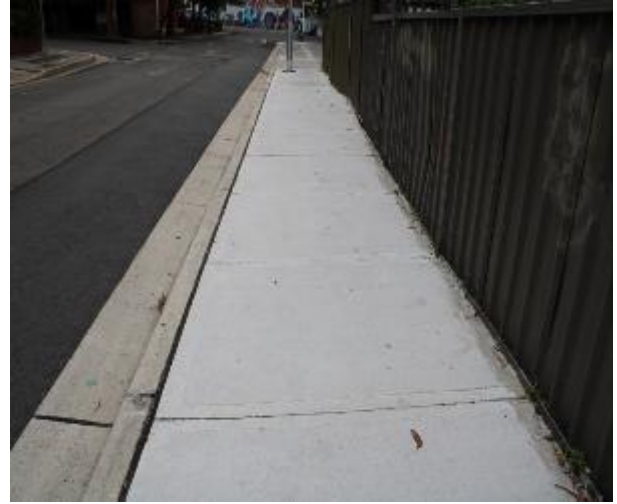
Figure 517 - General condition of footpath pavement heading South

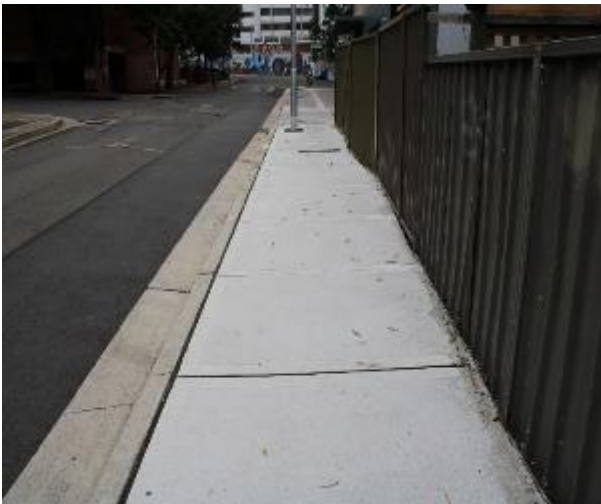
Figure 518 - General condition of footpath pavement heading South

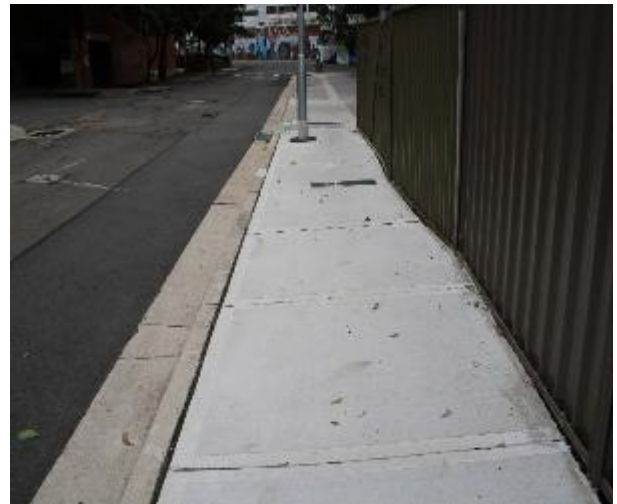
Figure 519 - General condition of footpath pavement heading South

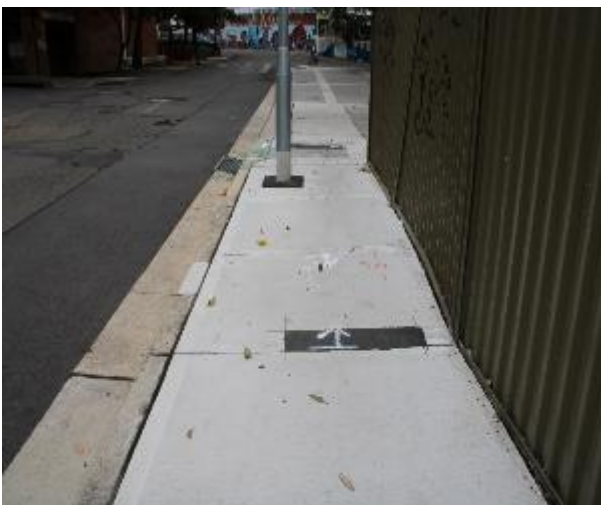
Figure 520 - General condition of footpath pavement heading South

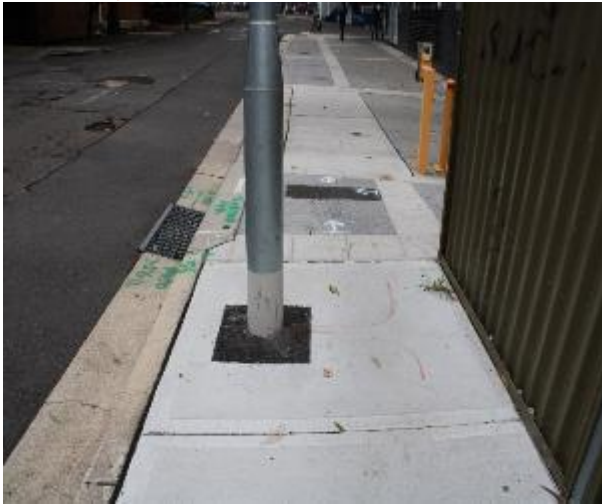
Figure 522 - Patchwork evident through footpath pavement heading South

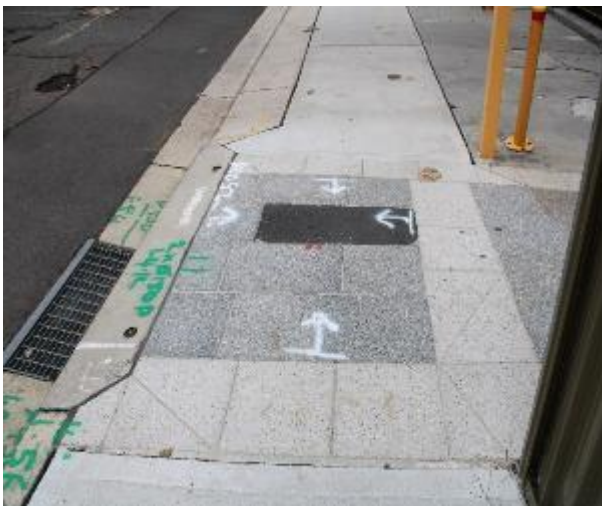
Figure 524 - Crack propagation through footpath pavement heading South

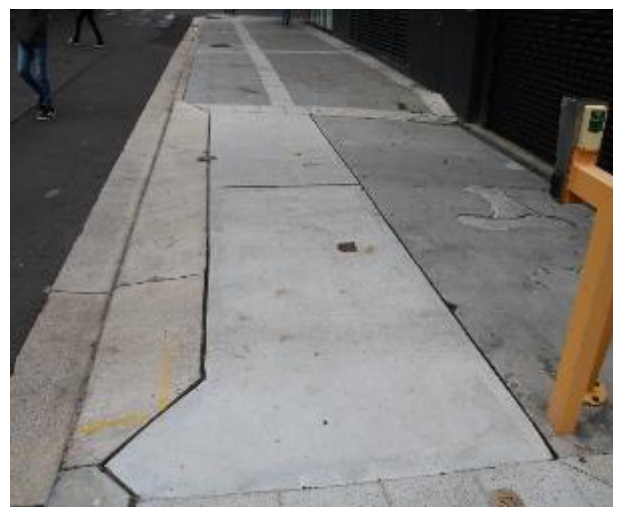
Figure 527 - General condition of footpath pavers heading South

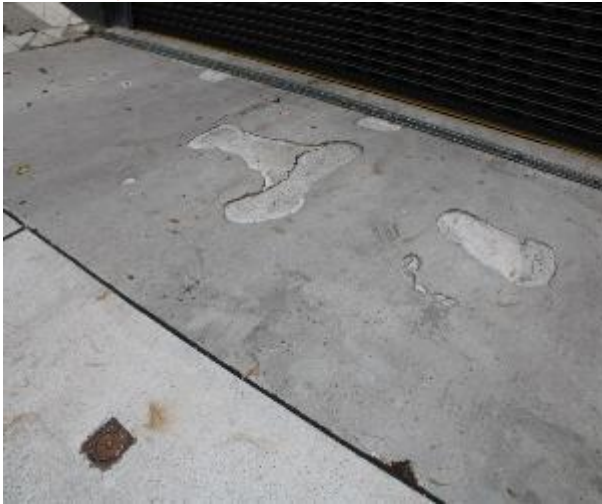
Figure 528 - General condition of footpath pavement heading South

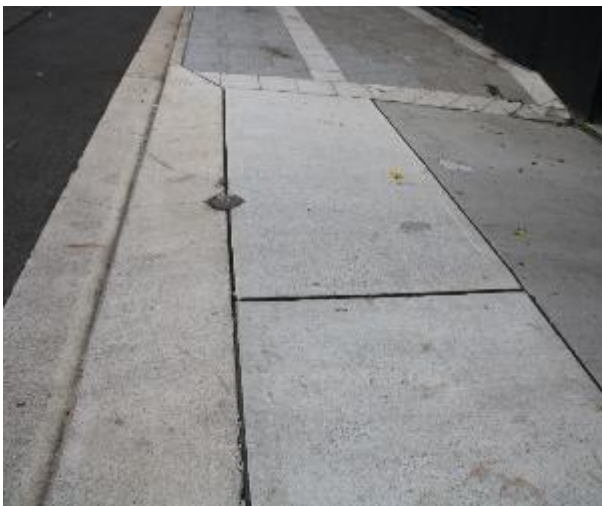
Figure 530 - Loss of material through footpath pavement heading South
