# Hazardous Material Report

**Burrah Park, 1953-2109 Elizabeth Drive,  
Badgerys Creek**

26 September 2024

**Our Ref:** 30206389-R02-Burrah Park-HazMat

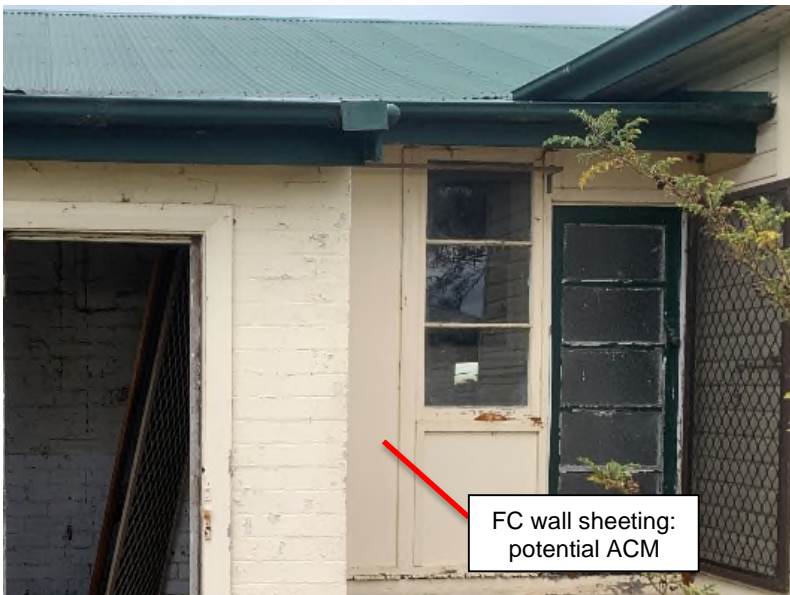
FC wall sheeting:  
potential ACM**Print 3***Unoccupied house*

View of the central northeast entrance showing FC wall sheeting.

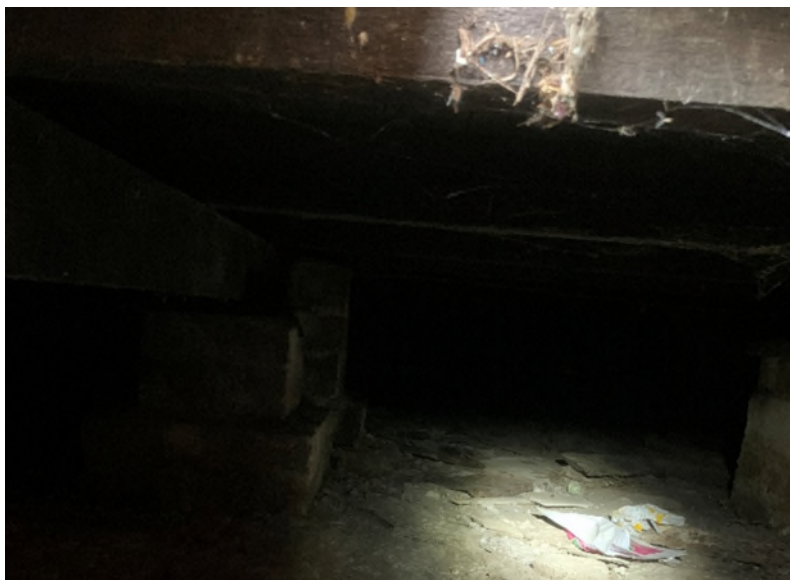
**Print 9***Unoccupied house*

View of the underside of the house at the northern entry showing brick pier construction and general rubbish under structure.

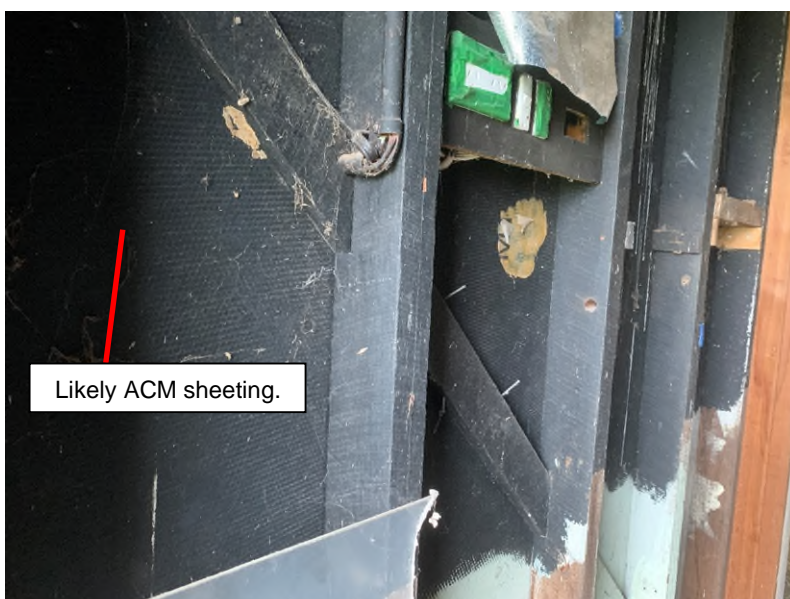
**Print 23b**

Wall sheeting behind wall tiles is likely ACM along northern wall (back of wall visible in Print 23b)

Likely ACM wall in eastern entrance room, behind tiled, northern wall in laundry.

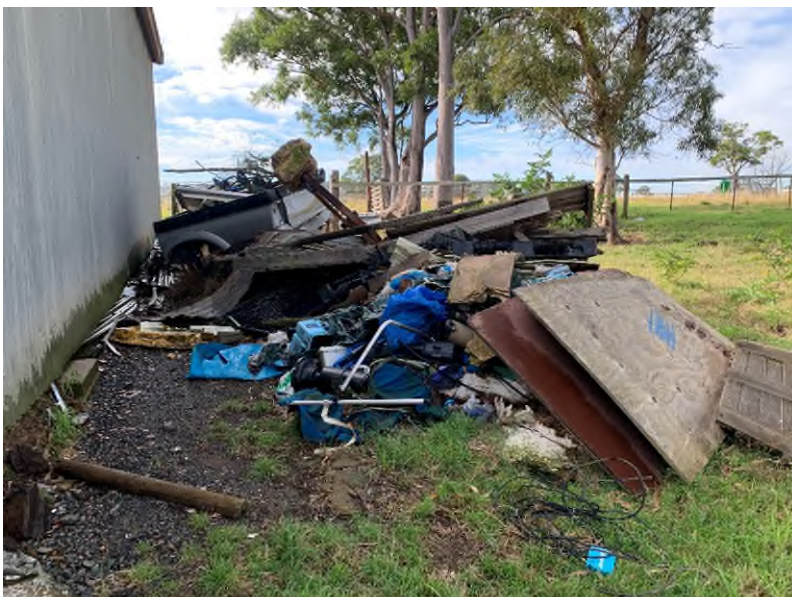
**Print 32***Shed 1 Stockpile*

Stockpiled mixed waste and household items along the southeastern wall of stockyard shed 1.

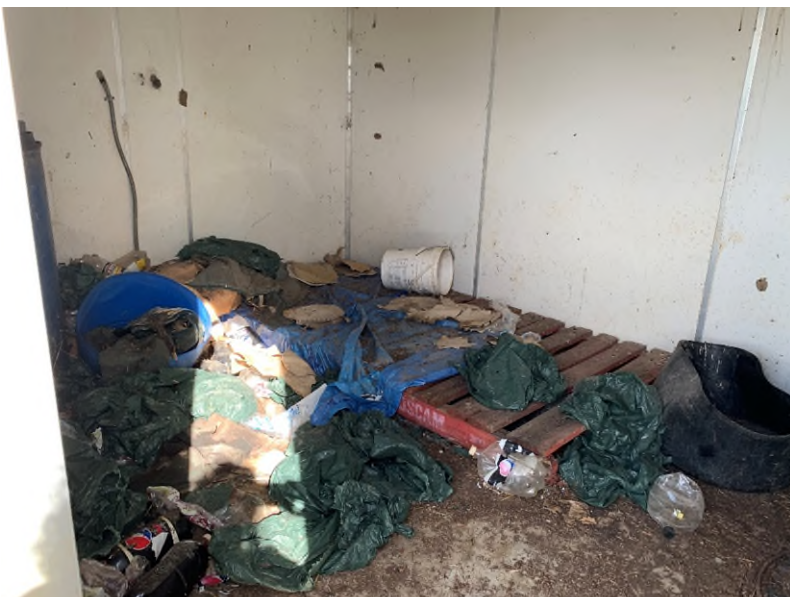
**Print 43***Cool Room*

Building	Room/Area	Description	Print No.	Sample Collected	Hazardous Material Present
Shed 2	Stockpile 2	Stockpile of mixed building material and rubble including fragments of FC sheeting (potential ACM), located along the southwestern wall of the shed.	40	No	Potential ACM
Shed 3	Walls, roof and floor	Timber frame with metal walls, metal roof and concrete slab floor construction.	41, 42	No	Not identified
Cool room	Walls, roof and floor	Insulated panel walls and ceiling, concrete floor and timber framed metal roof.	43, 44	No	Not identified

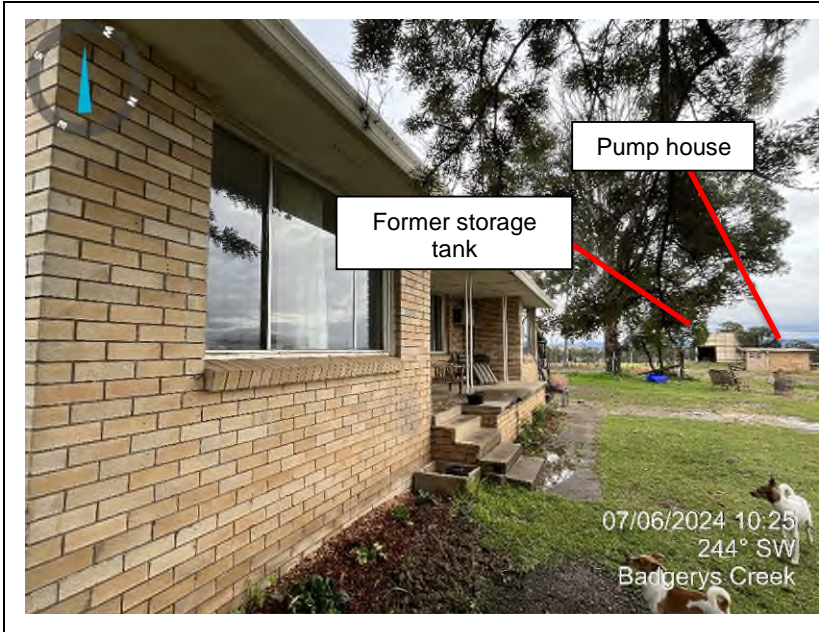
**Print 45**

Building	Room/Area	Description	Print No.	Sample Collected	Hazardous Material Present
Tenanted house	External roof and soffits	Tile roof construction with metal gutters and timber fascia. FC soffit sheeting (visually verified ACM).	45 – 47	No	Visually verified ACM
Tenanted house	External walls	Brick wall construction with FC sheeting (visually verified ACM) for gable walls.	45 – 47	No	Visually verified ACM
Tenanted house	Windows	Aluminium windows with aluminium frames.	45, 47	No	Not identified
Tenanted house	Hay store	Timber frame and metal roof construction lean to semi-detached from main house.	48	No	Not identified

View of the tenanted house along the northern façade, with the pump house and former storage tank at rear.

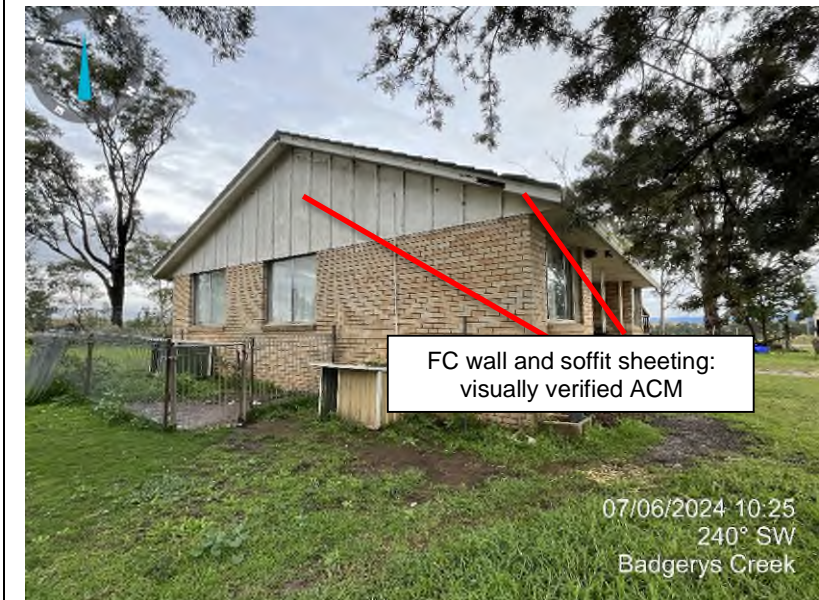
**Print 46**

View of the tenanted house from the northeast.

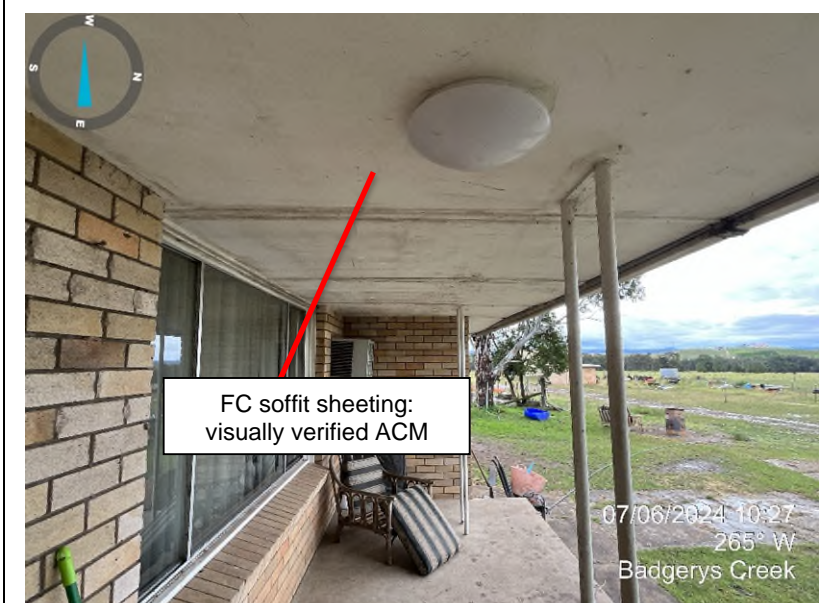
**Print 47**

View of the entrance porch.

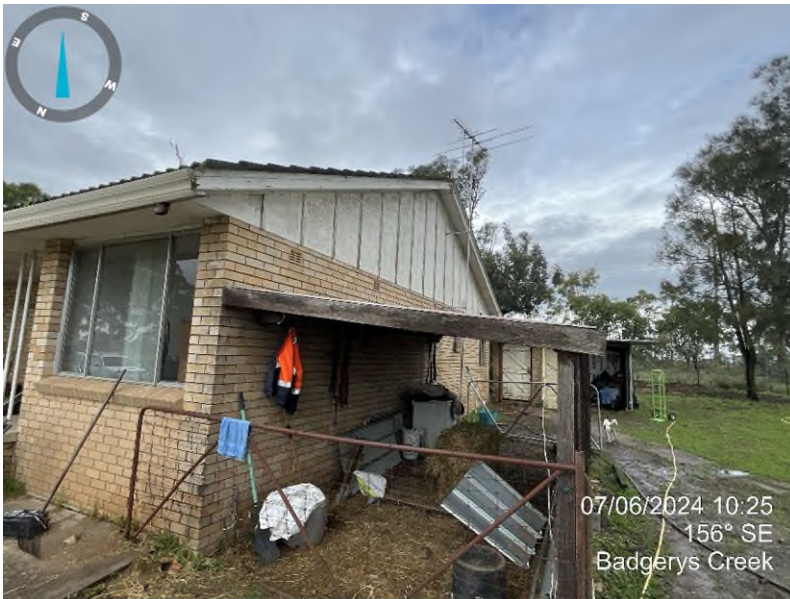
**Print 48***Tenanted house*

View along the western façade showing the adjoining hay store.

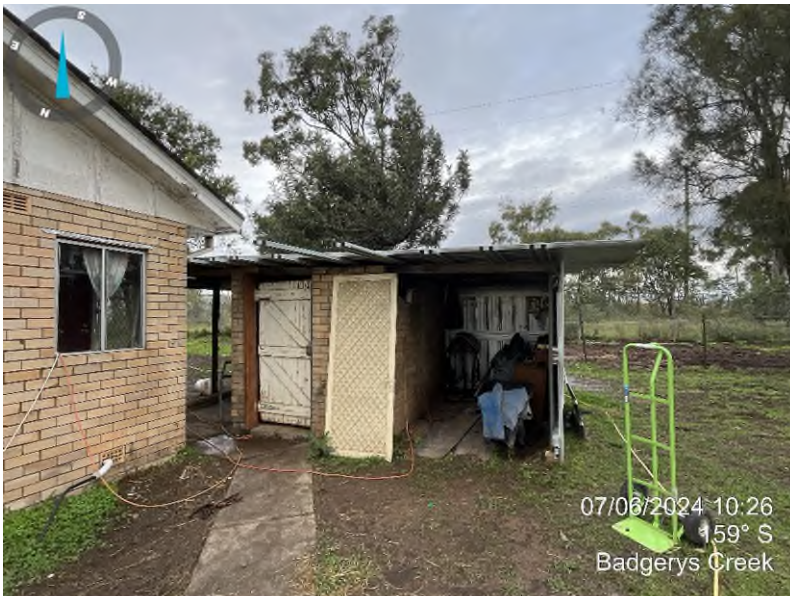
**Print 49***Tenanted house*

Building	Room/Area	Description	Print No.	Sample Collected	Hazardous Material Present
Tenanted house	Detached storage shed	Unlined brick walls with timber framed metal roof and concrete slab floor construction.	49, 50	No	Not identified
Tenanted house	Living spaces and bedrooms	Plasterboard walls, ceiling and cornices with floating timber floor construction.	51 – 54	No	Visually verified non-ACM
Tenanted house	Eastern Corridor area	FC wall sheeting near bathroom.	52	No	Visually verified ACM
Tenanted house	Kitchen	Plasterboard walls, ceiling and cornices with floating timber floor construction.	55 – 58	No	Not identified
Tenanted house	Storage room	FC wall and ceiling sheeting (potential ACM) with floating timber floor and concrete floor construction.	59	No	Likely ACM
Tenanted house	Sunroom	FC walls and ceiling with timber floor.	60 – 61	No	Likely ACM
Tenanted house	Light fittings	Combination of downlights, incandescent globes and fluorescent light fittings identified (e.g. storage room) considered unlikely to contain PCBs.	55 – 64	No	Not identified

Semi-detached storage shed at the southwest corner of the main house.

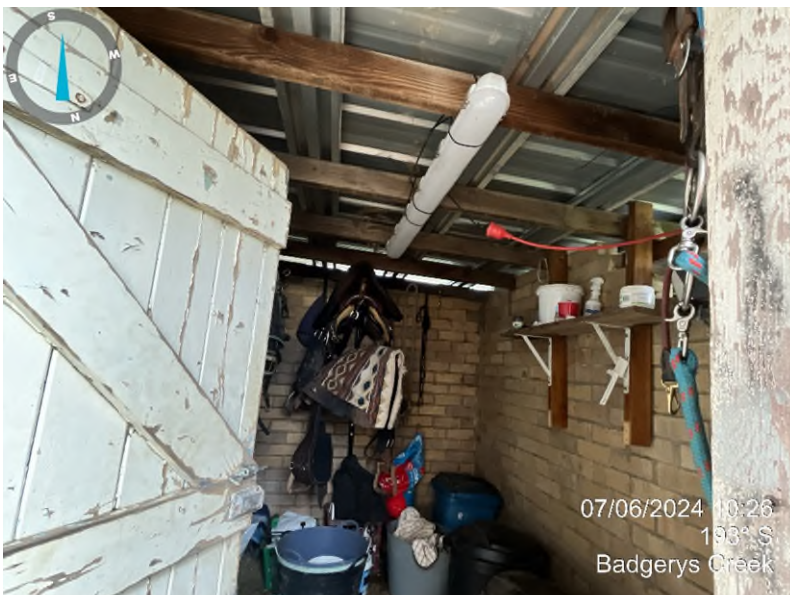
**Print 50***Tenanted house*

Internal view of the semi-detached storage shed.

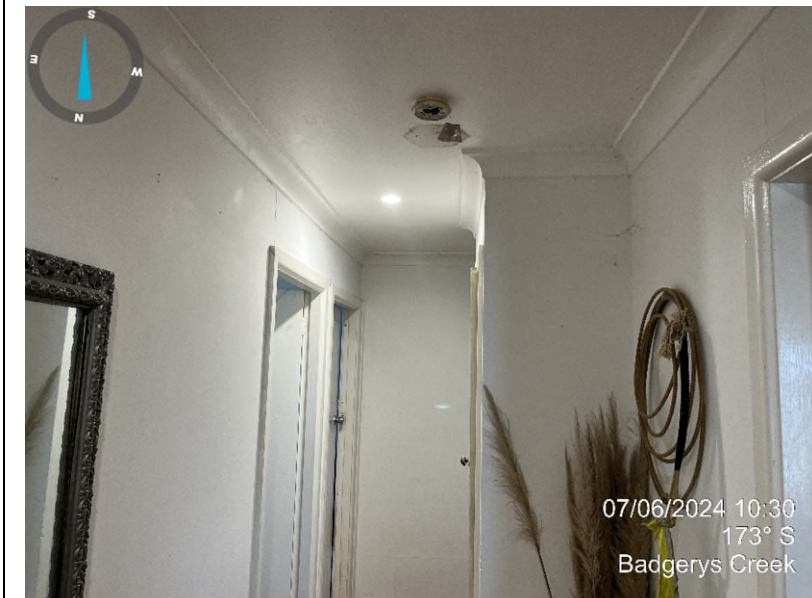
**Print 52**

Eastern corridor area

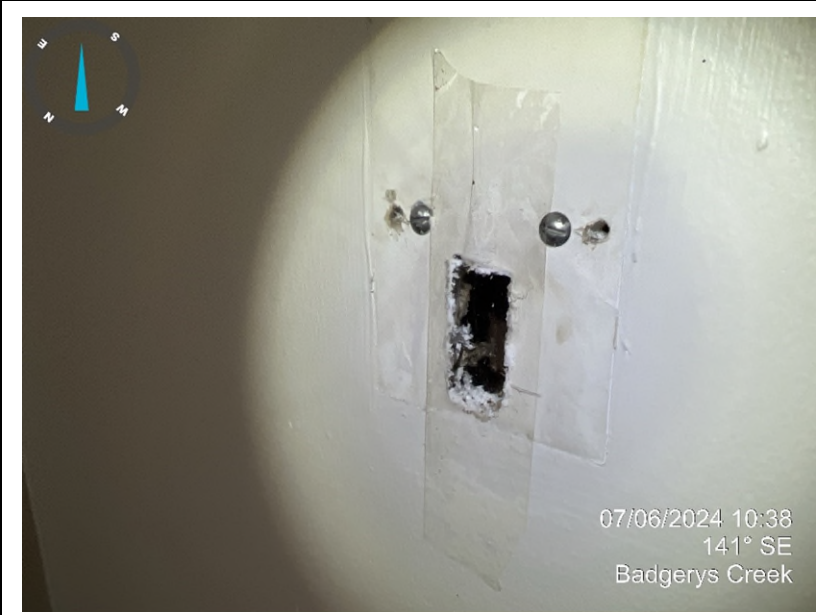
**Print 54**

Exposed internal wall structure showing plasterboard composition.

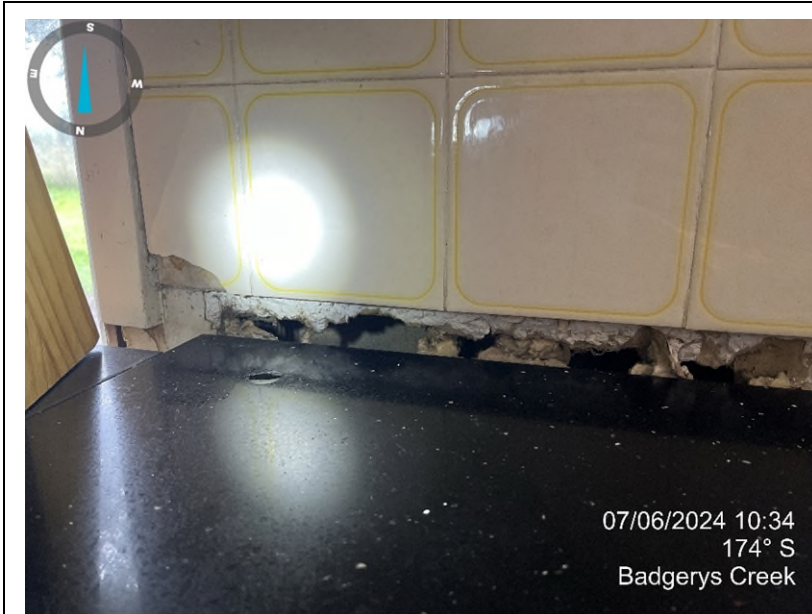
**Print 57**

*Kitchen tiles fixed to plasterboard wall sheeting.*

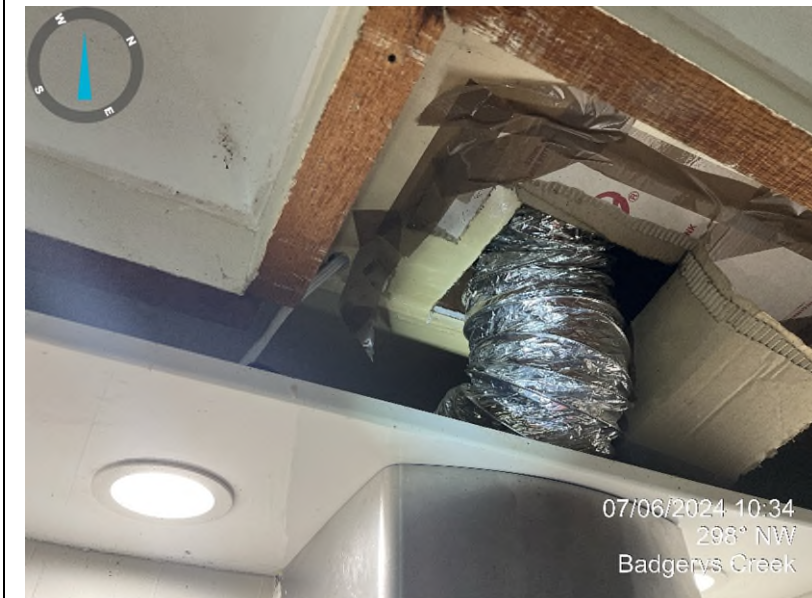
**Print 58**

*Kitchen false ceiling and original ceiling - plasterboard*

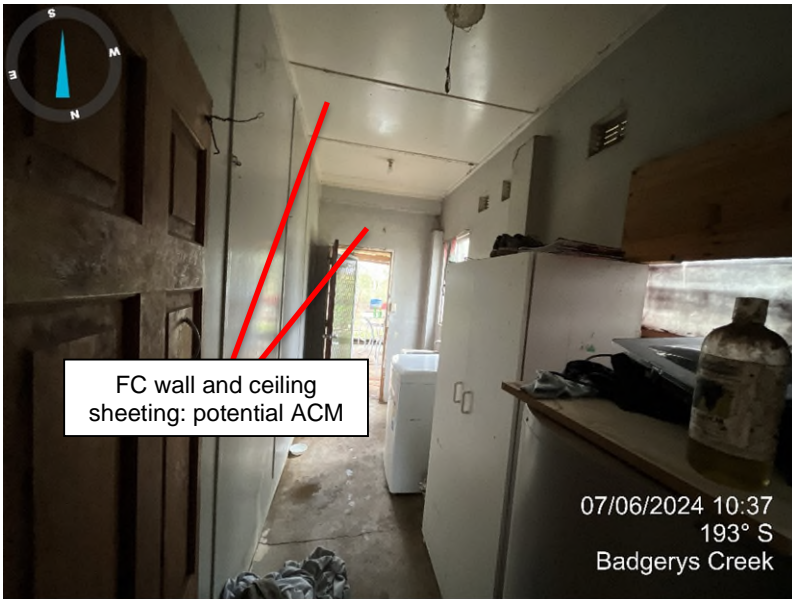
**Print 63**

View of the laundry area looking toward the rear door.

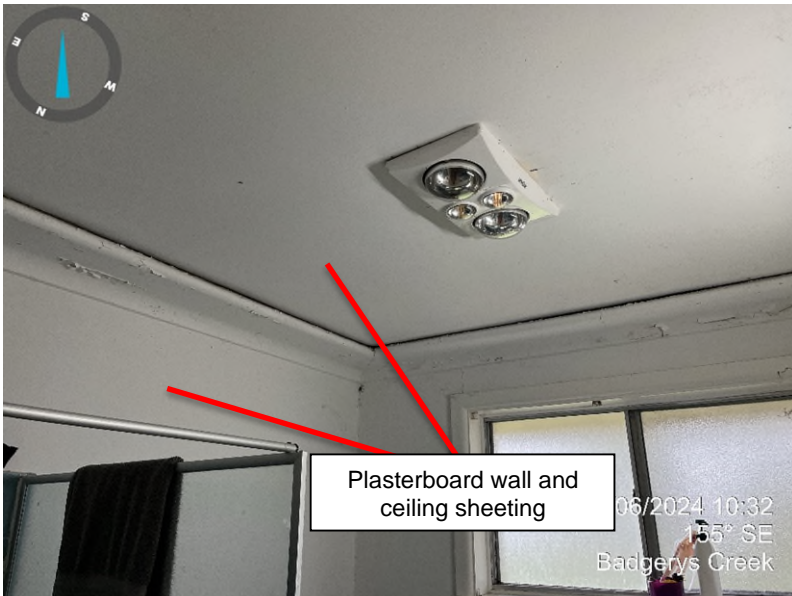
**Print 64**

View of the bathroom.

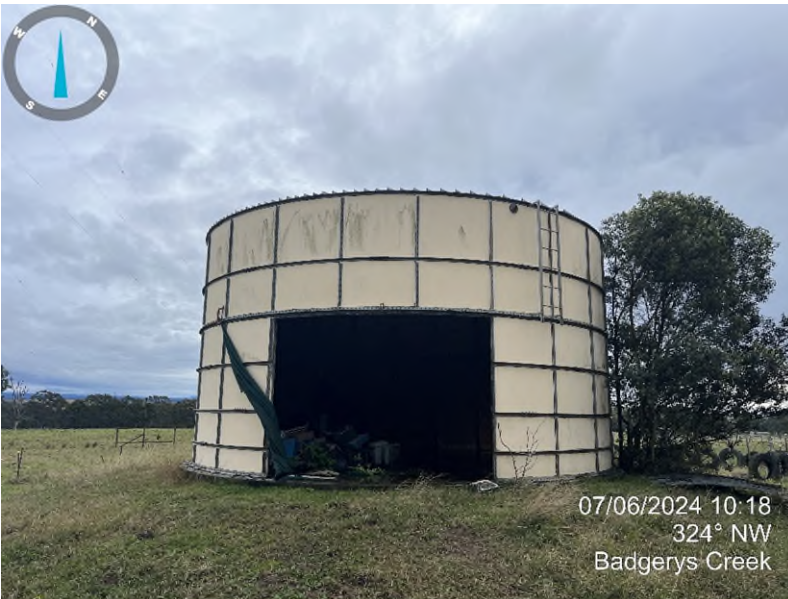
**Print 69***Former Storage Tank*

Building	Room/Area	Description	Print No.	Sample Collected	Hazardous Material Present
Former storage tank	Wall and roof	Metal wall frame and sheet construction with metal roof on concrete slab.	69-70	No	Not identified

View of the former storage tank from the southeast.

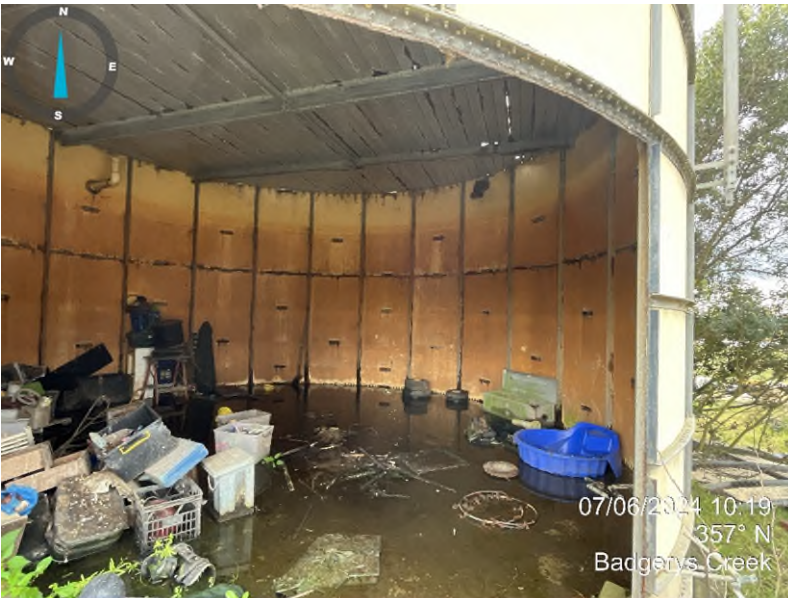
**Print 70***Former Storage Tank*

Internal view of the former storage tank, currently used for mixed storage and experi water ingress.

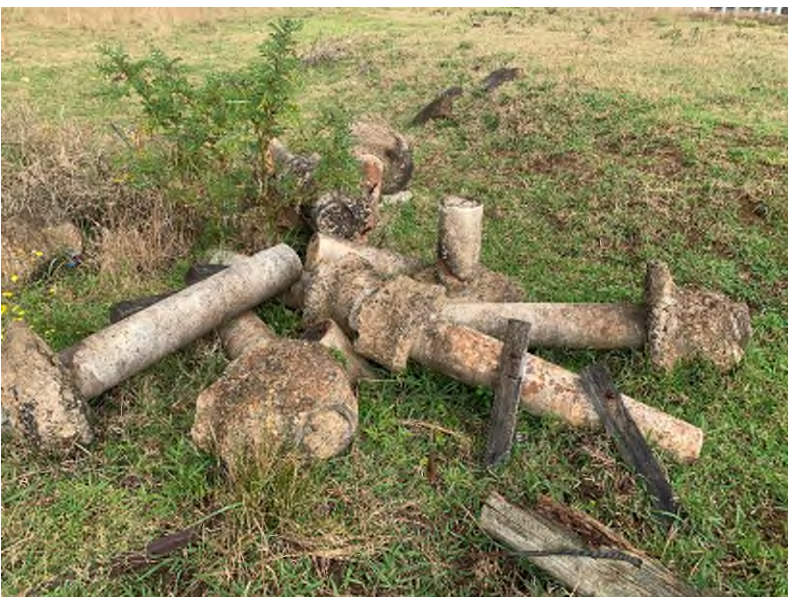
**Print 71***Potential ACM pipe stockpile*

Feature	Area	Description	Print No.	Sample Collected	Hazardous Material Present
ACM pipe stockpile	NA	Stockpile of ACM pipes infilled with concrete.	71	No	Likely ACM
Pump house 1	Wall and floors	Timber structure with unlined metal walls and concrete slab floor construction.	72-73	No	Not identified
Pump house 1	Switchboards	Two switchboards with potential Zelemite backing boards (known ACM).	73-74	No	Likely ACM
Pump house 2	Wall, roof and floors	Timber structure with unlined metal roof, metal walls and concrete slab floor construction.	75-76	No	Not identified
Pump house 2	Switchboard	Switchboard with potential Zelemite backing board (known ACM).	76	No	Likely ACM

Stockpiled ACM pipes infilled with concrete.
