## Appendix 32:

## Public Infrastructure – Maclaurin Parade, Roseville

**PROJECT NUMBER. V260255**

Project Address: 2-4 Larkin Street & 1,3,5 Pockley Avenue, Roseville

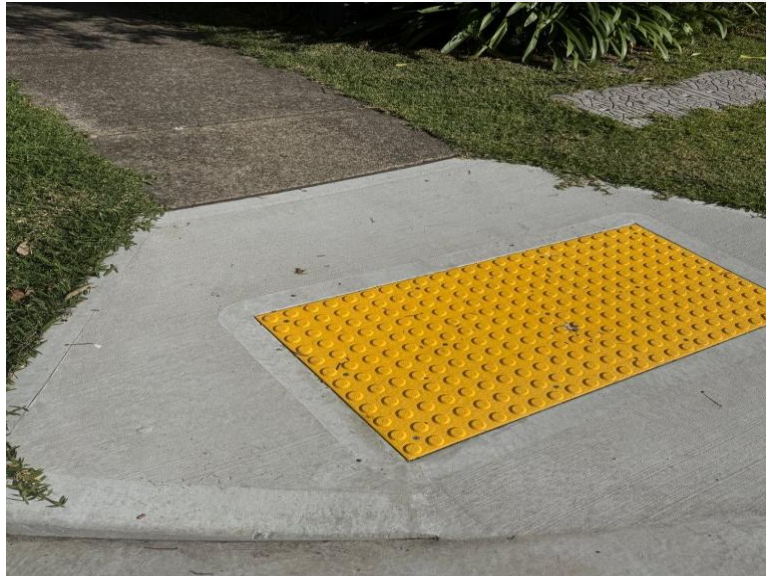
*Figure 1*

General condition of the Council pram ramp

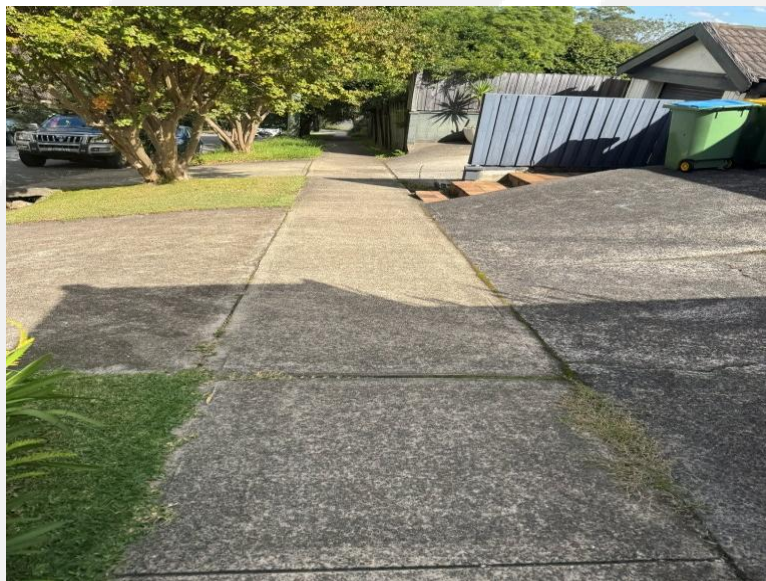
*Figure 6*

General condition along the Council concrete pathway

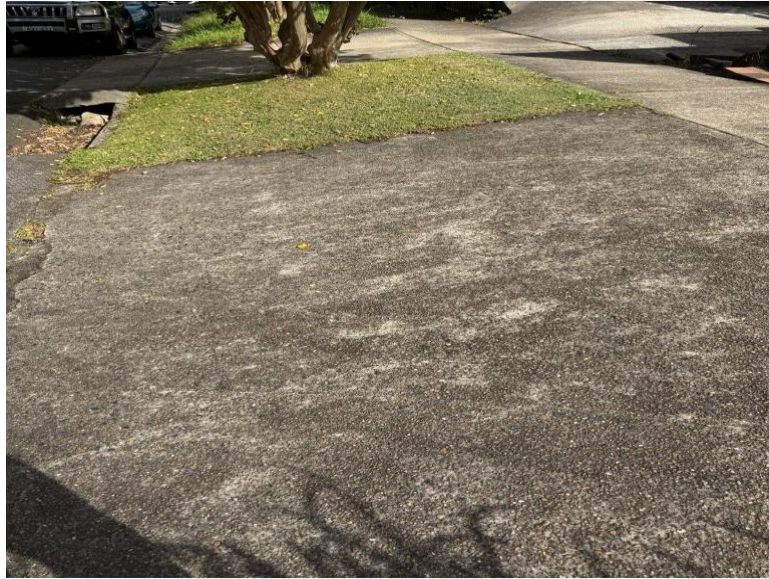
*Figure 7*

General condition along the Council vehicle crossing

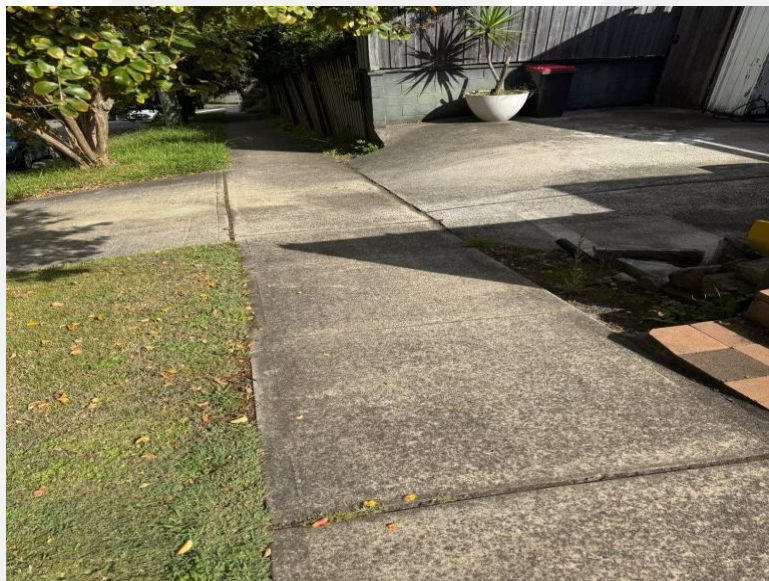
*Figure 8*

General condition along the Council concrete pathway

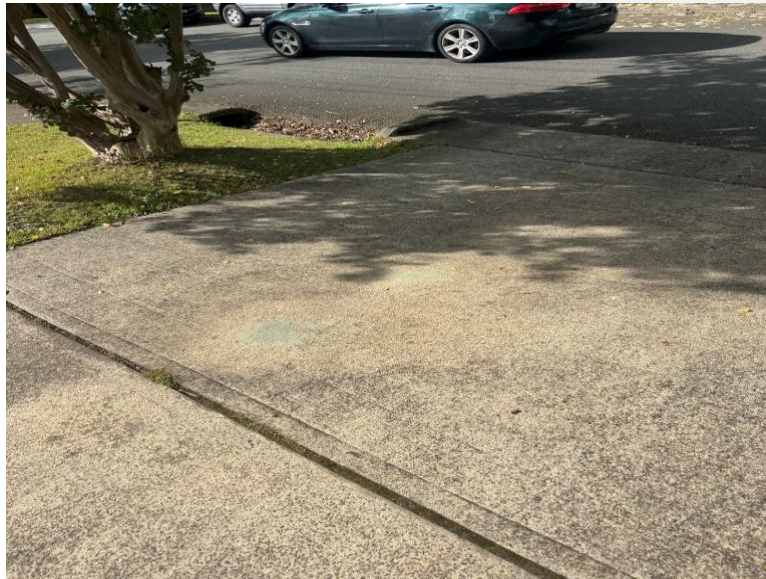
*Figure 9*

General condition along the Council vehicle crossing

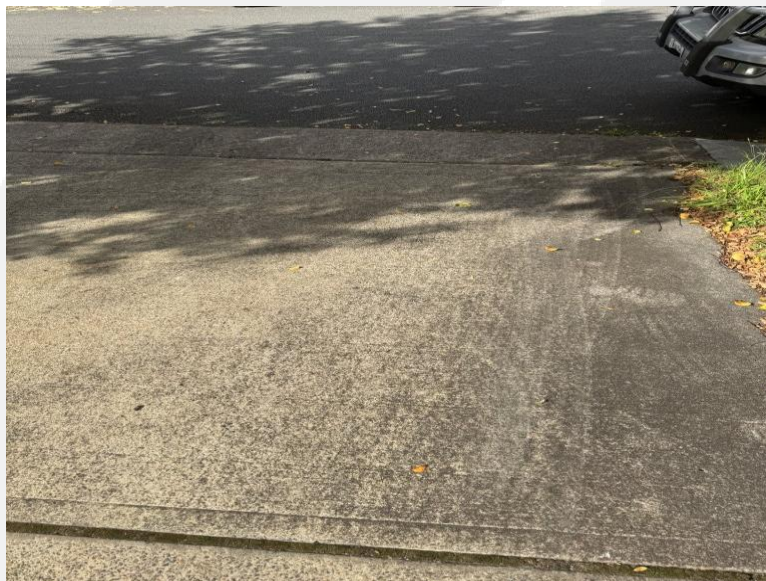
*Figure 10*

General condition along the Council vehicle crossing

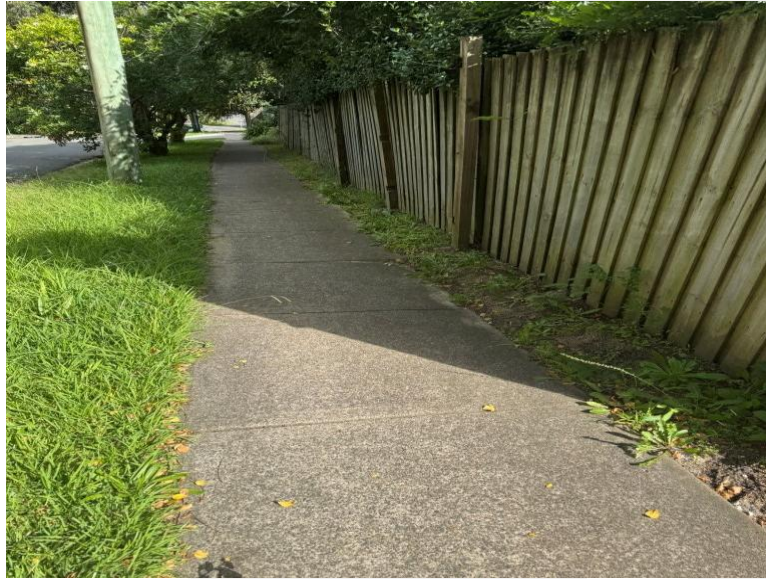
*Figure 11*

General condition along the Council concrete pathway

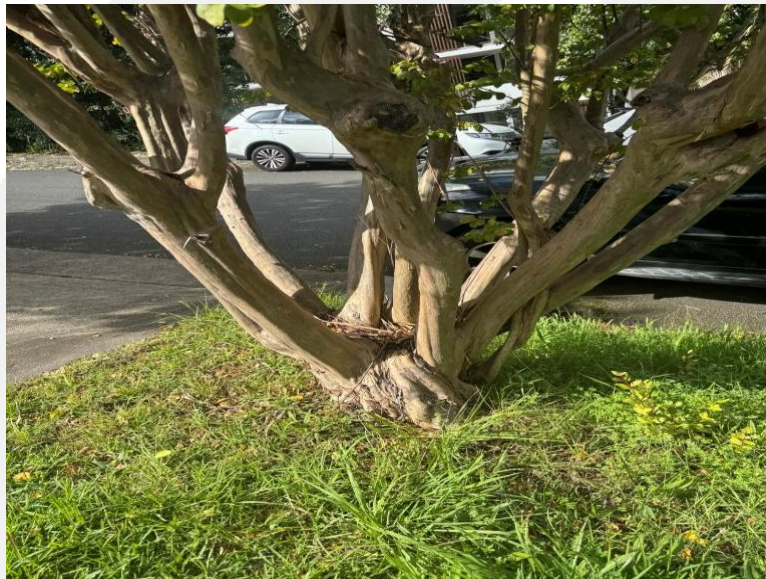
*Figure 12*

General condition of the Council existing tree base

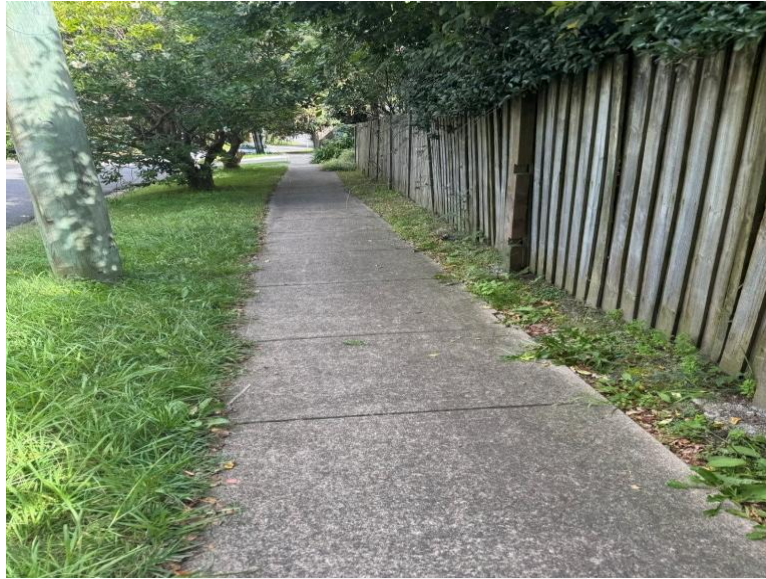
*Figure 13*

General condition along the Council concrete pathway

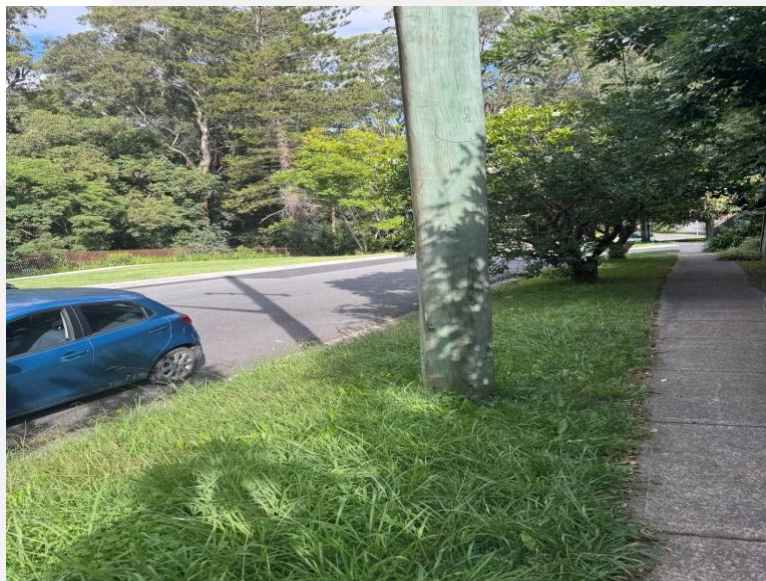
*Figure 14*

General condition of the Council utility post

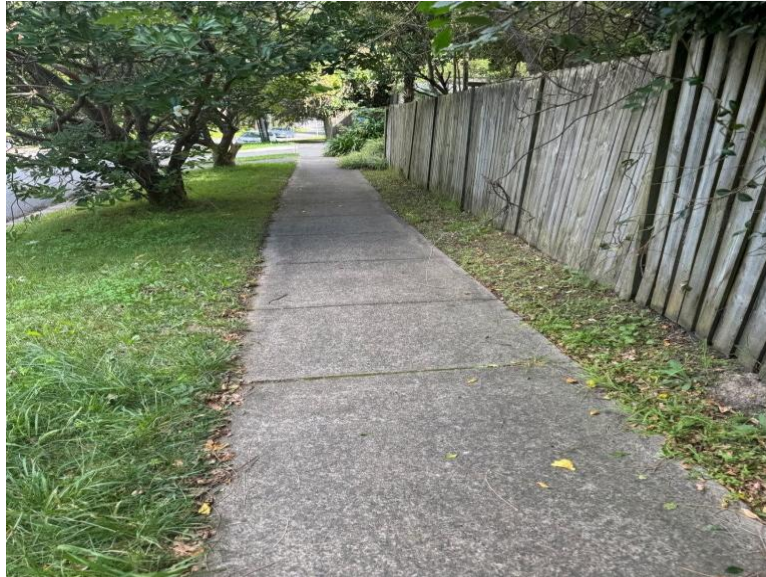
*Figure 15*

General condition along the Council concrete pathway

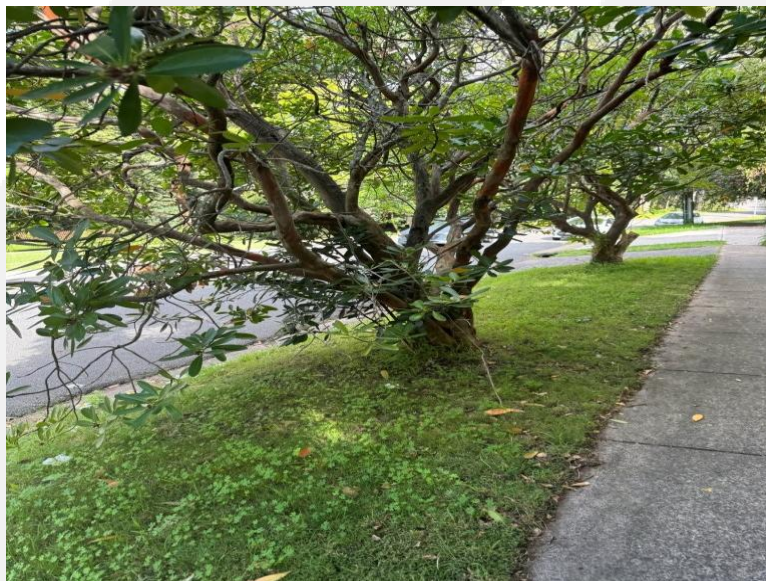
*Figure 16*

General condition of the Council existing tree base

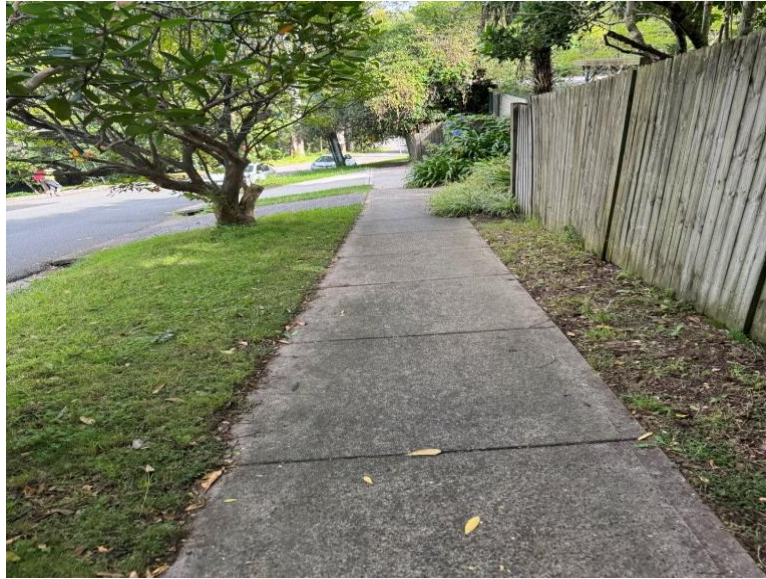
*Figure 17*

General condition along the Council concrete pathway

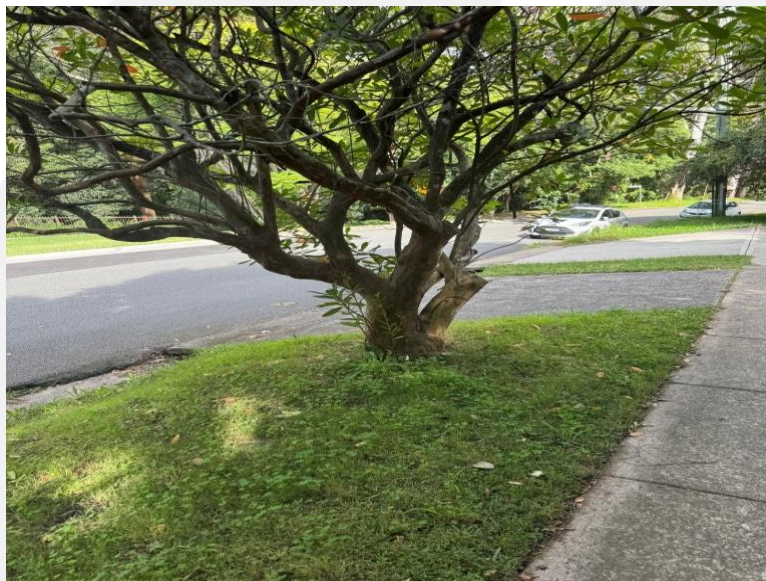
*Figure 18*

General condition of the Council existing tree base

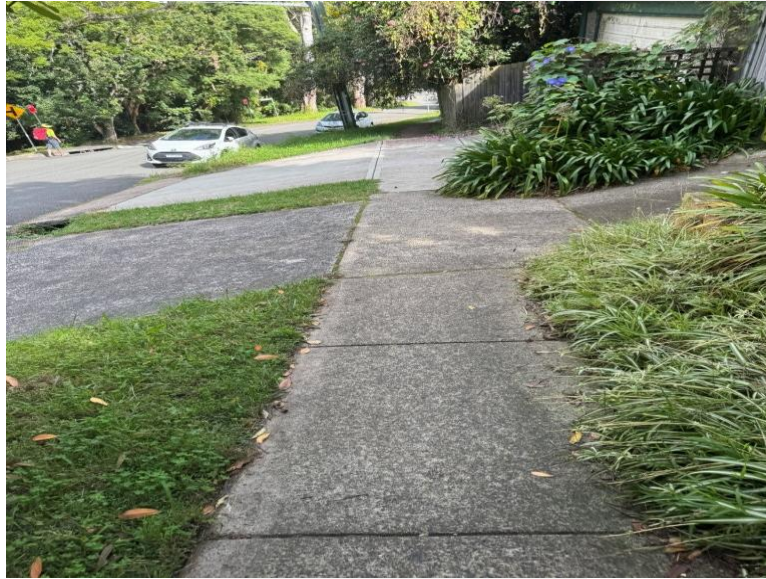
*Figure 19*

General condition along the Council concrete pathway

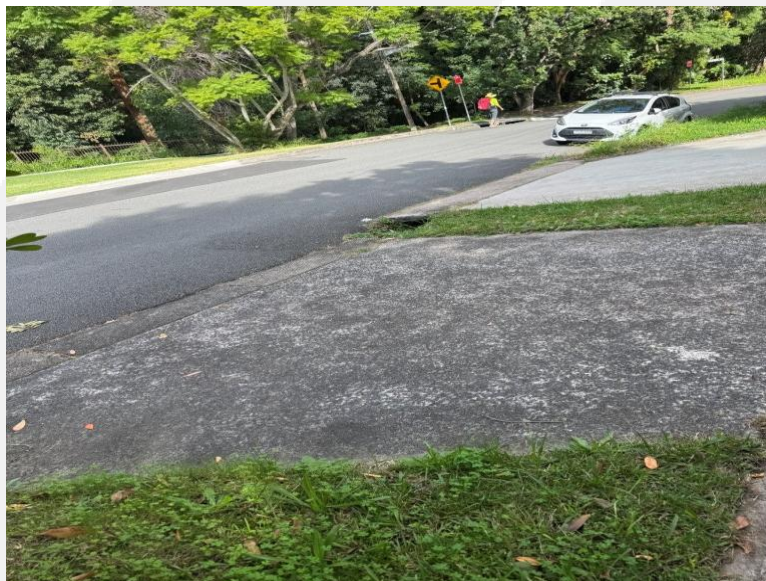
*Figure 20*

General condition along the Council vehicle crossing

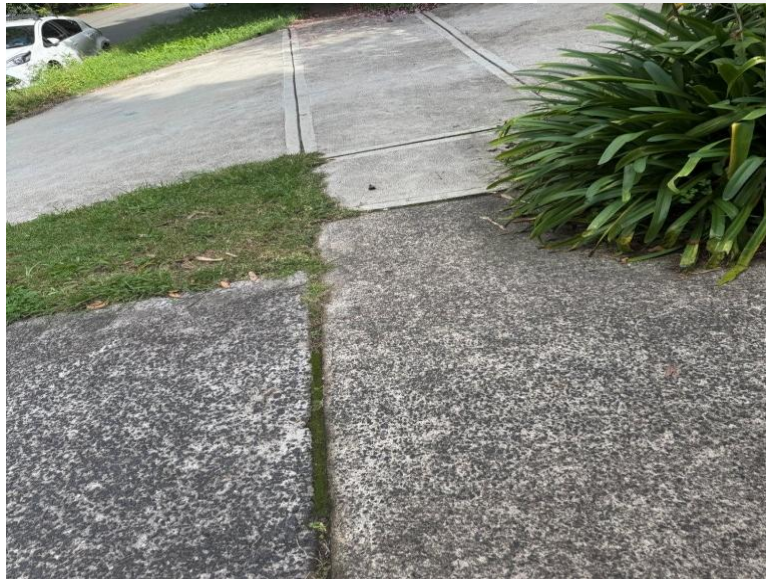
*Figure 21*

General condition along the Council concrete pathway

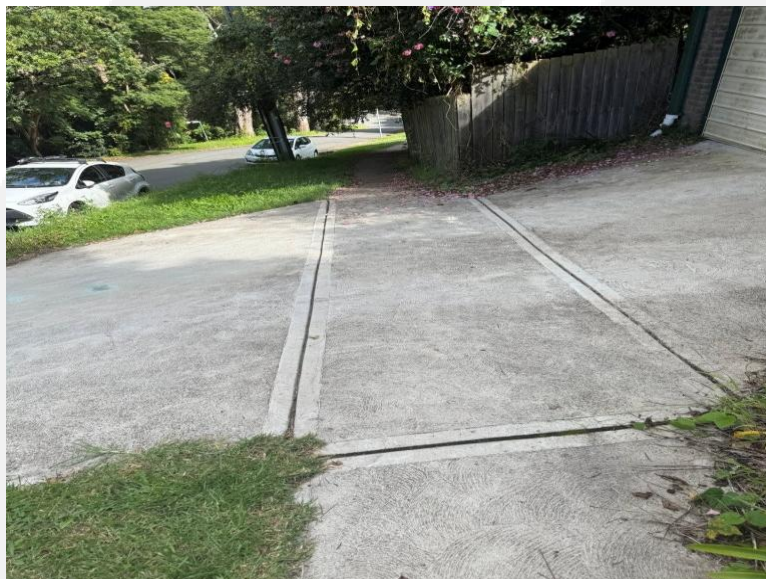
*Figure 22*

General condition along the Council vehicle crossing

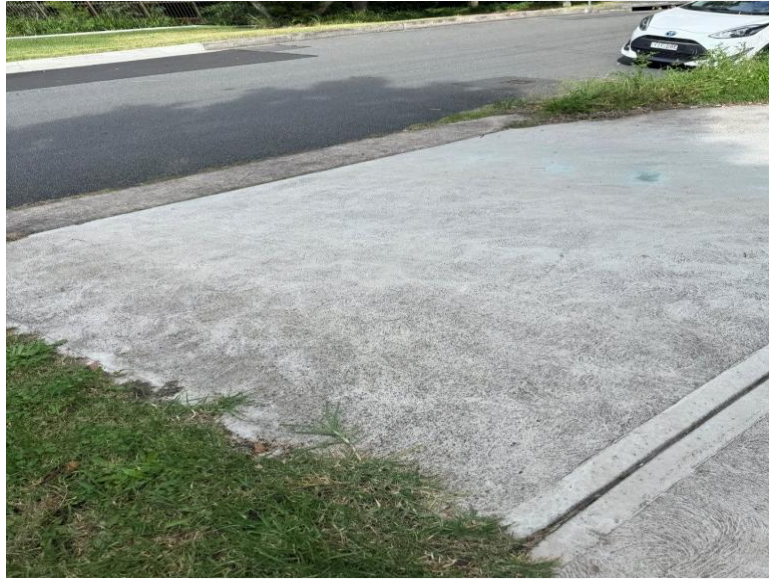
*Figure 23*

General condition along the Council vehicle crossing

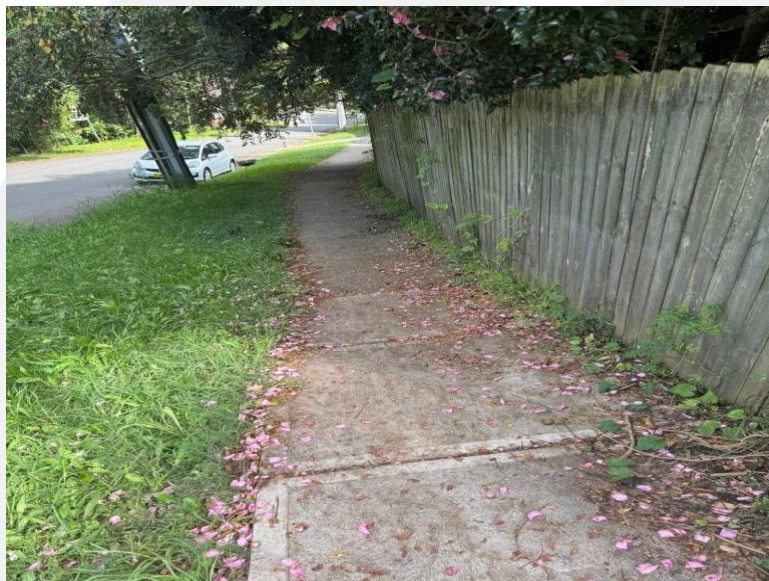
*Figure 24*

General condition along the Council concrete pathway

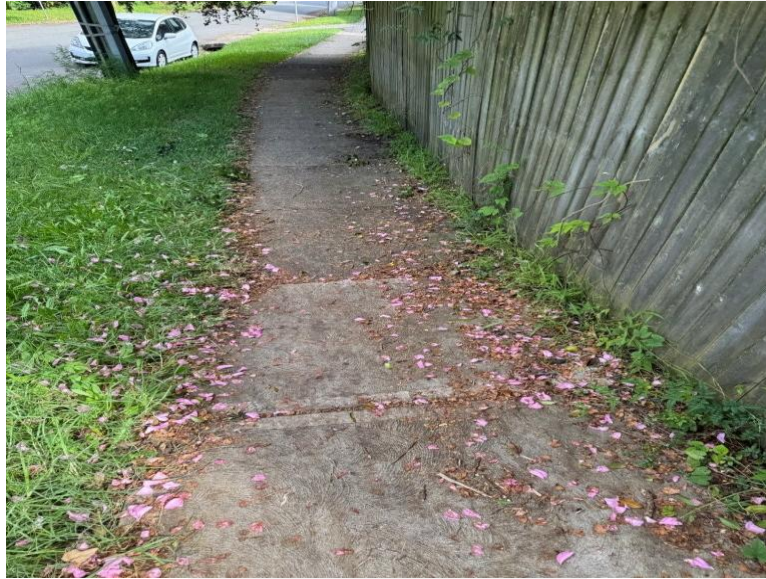
*Figure 25*

General condition along the Council concrete pathway

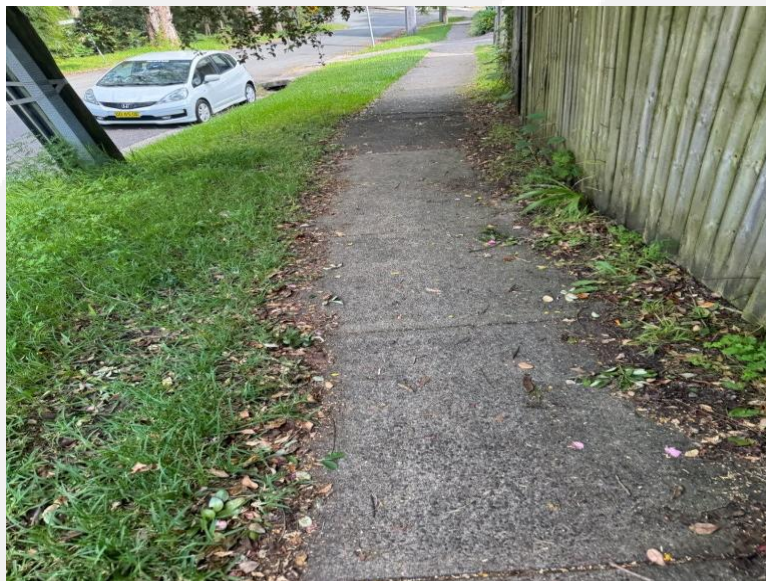
*Figure 26*

General condition along the Council concrete pathway

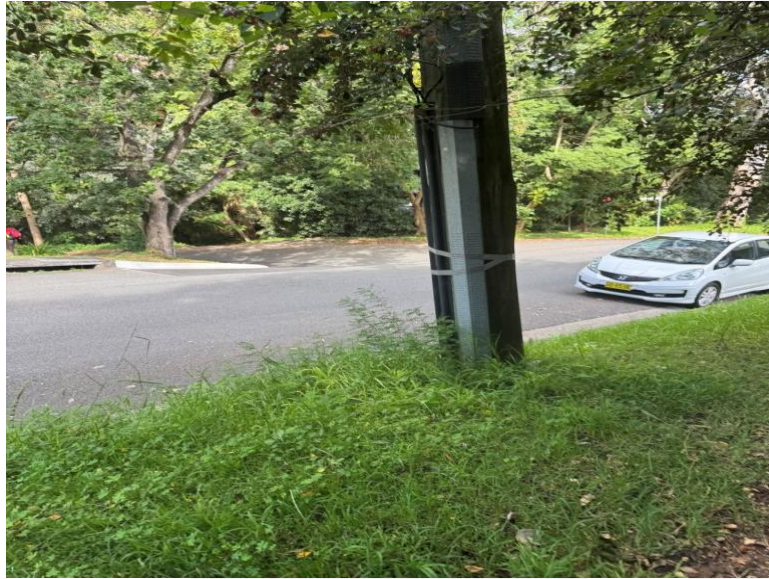
*Figure 27*

General condition of the Council utility post

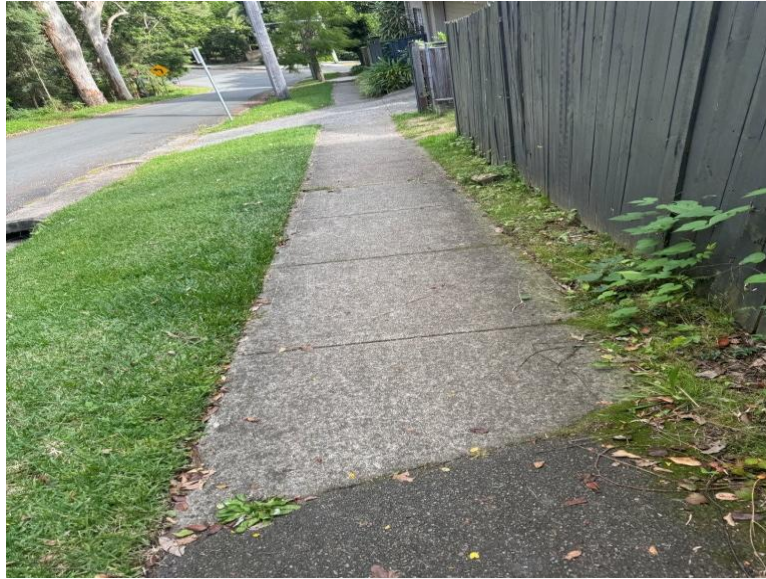
*Figure 29*

General condition along the Council concrete pathway

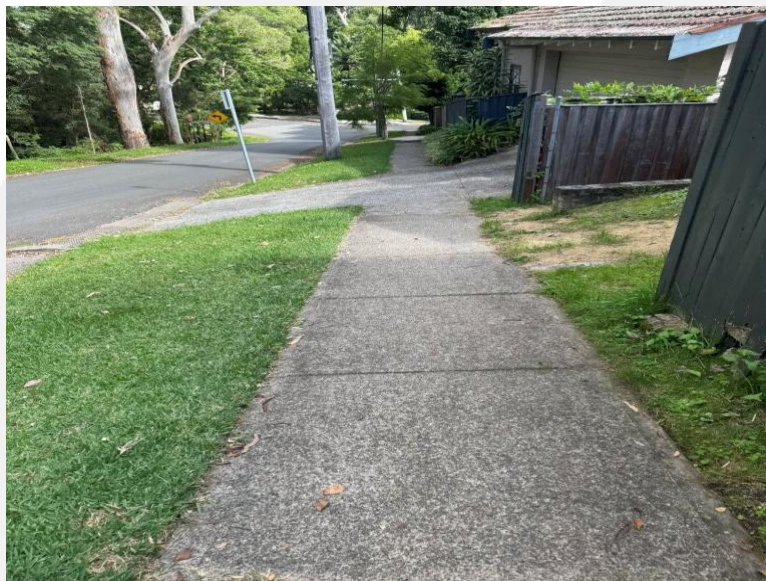
*Figure 30*

General condition along the Council concrete pathway

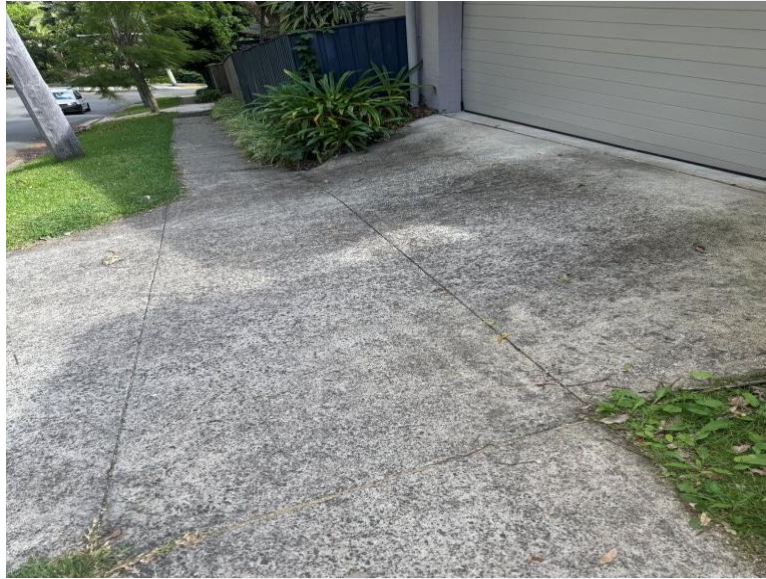
*Figure 31*

General condition along the Council vehicle crossing

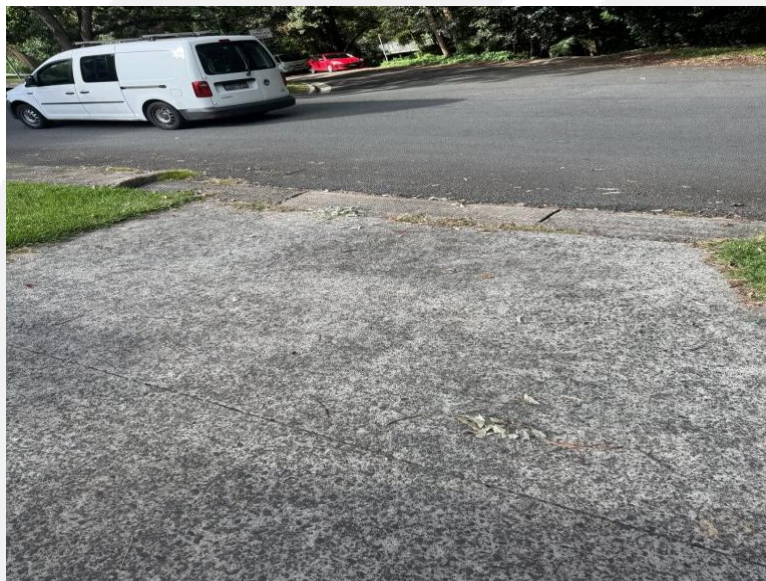
*Figure 32*

General condition along the Council vehicle crossing

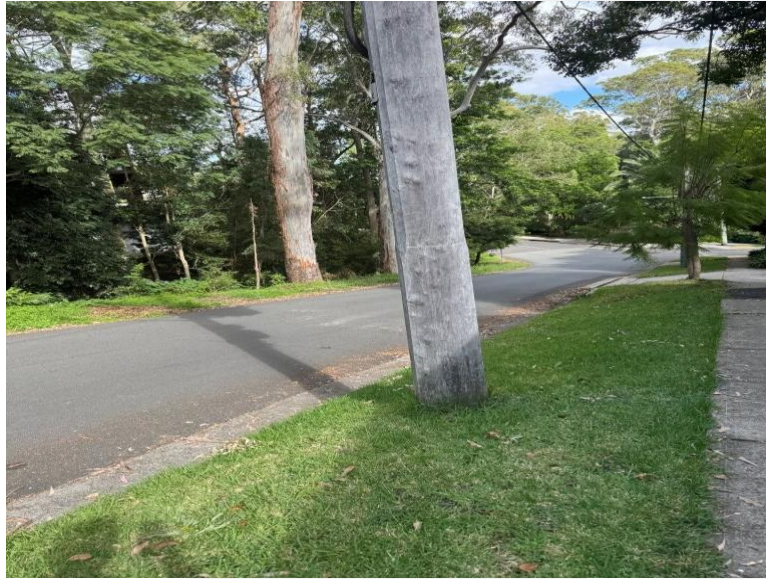
*Figure 33*

General condition of the Council utility post

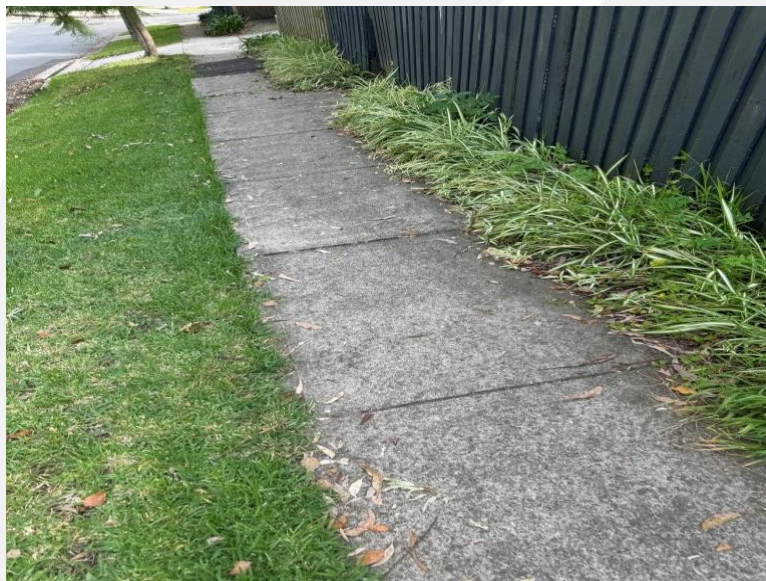
*Figure 34*

General condition along the Council concrete pathway

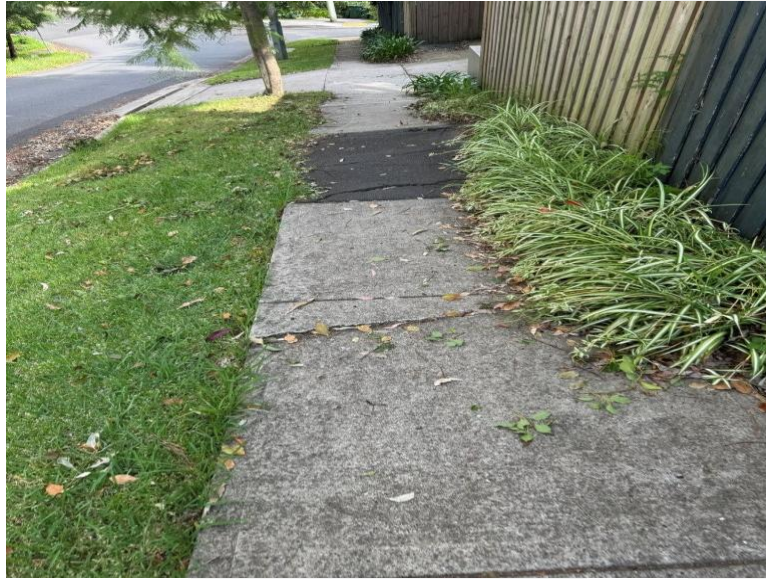
*Figure 35*

General condition along the Council concrete pathway

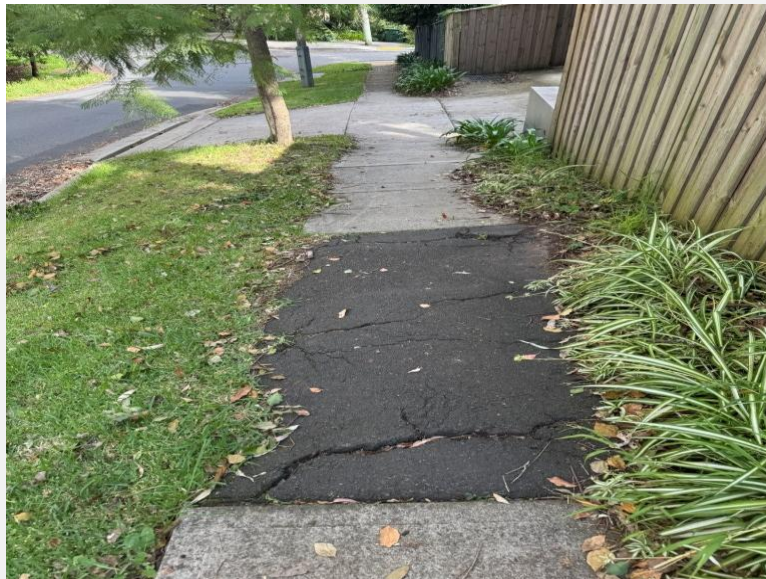
*Figure 36*

Cracking found along the Council bitumen pathway

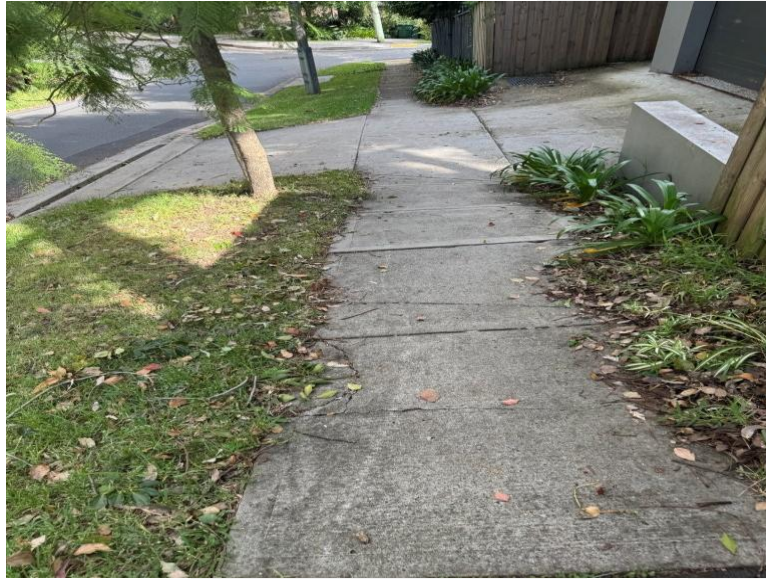
*Figure 37*

General condition along the Council concrete pathway

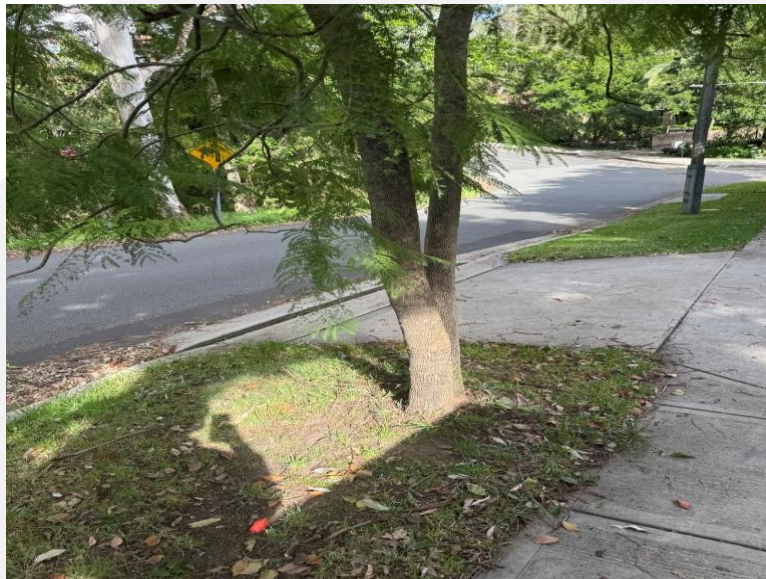
*Figure 38*

General condition of the Council existing tree base

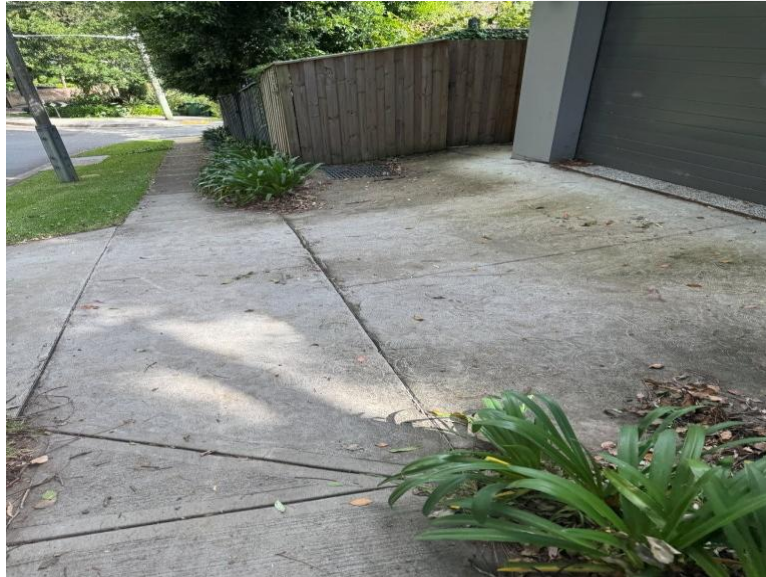
*Figure 39*

General condition along the Council vehicle crossing

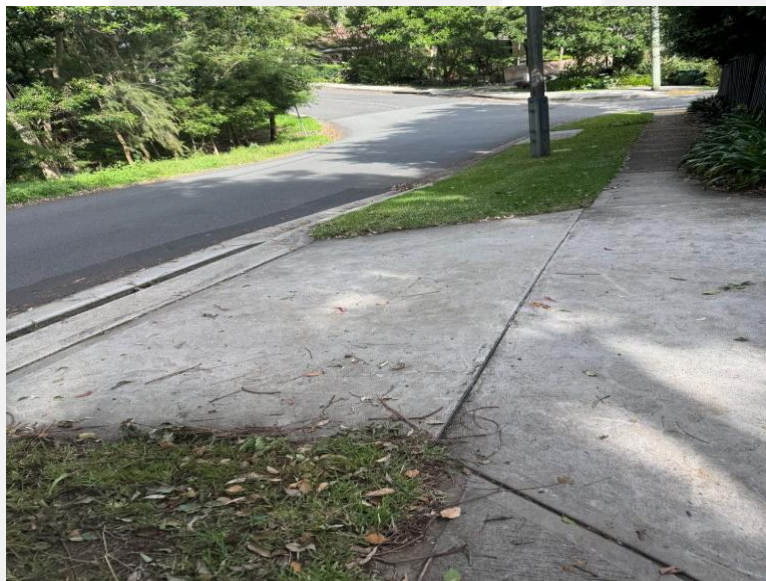
*Figure 40*

General condition along the Council vehicle crossing

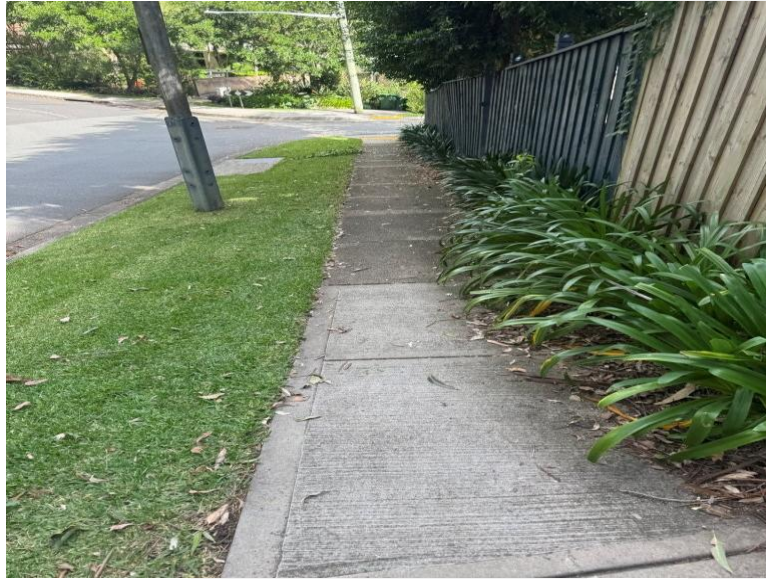
*Figure 41*

General condition along the Council concrete pathway

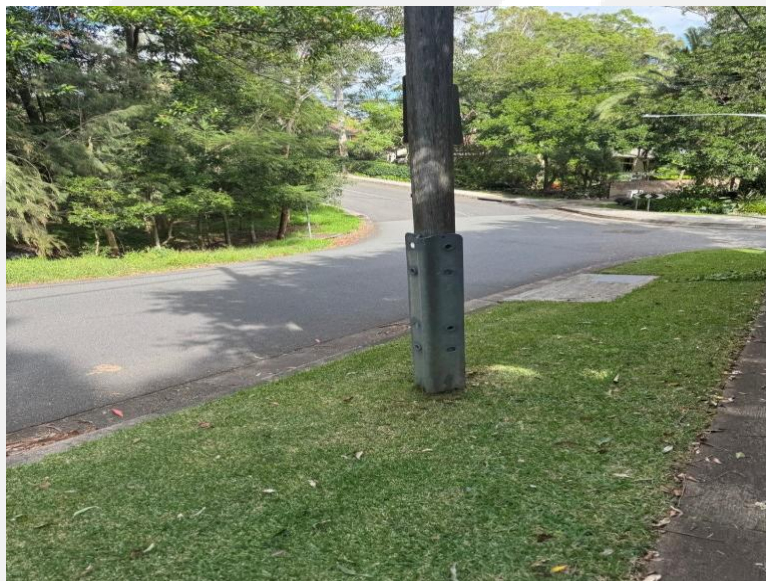
*Figure 42*

General condition of the Council utility post

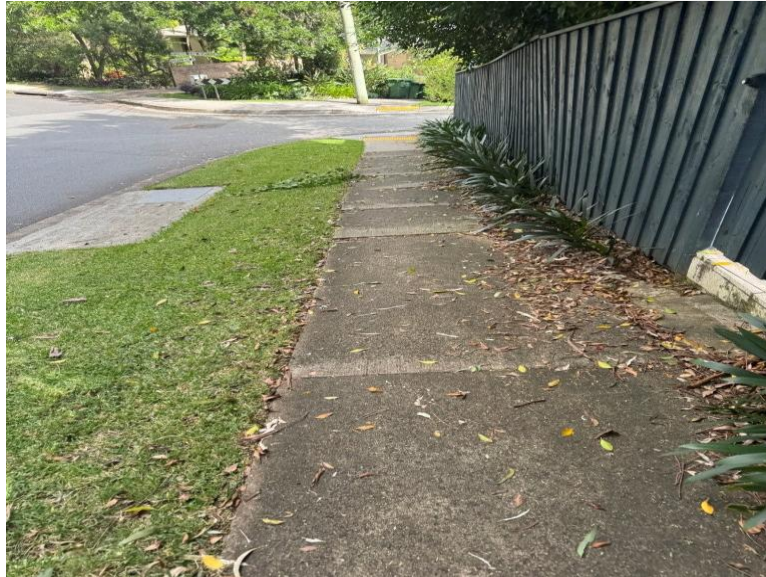
*Figure 43*

General condition along the Council concrete pathway

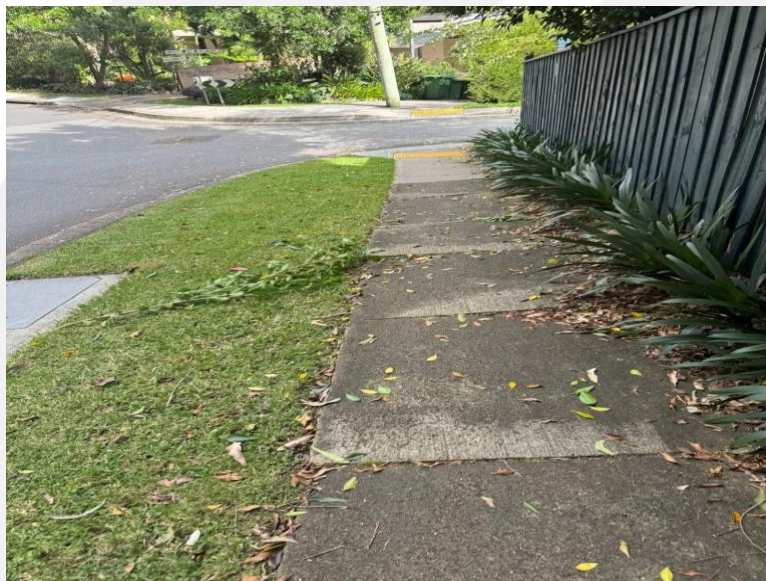
*Figure 44*

General condition along the Council concrete pathway

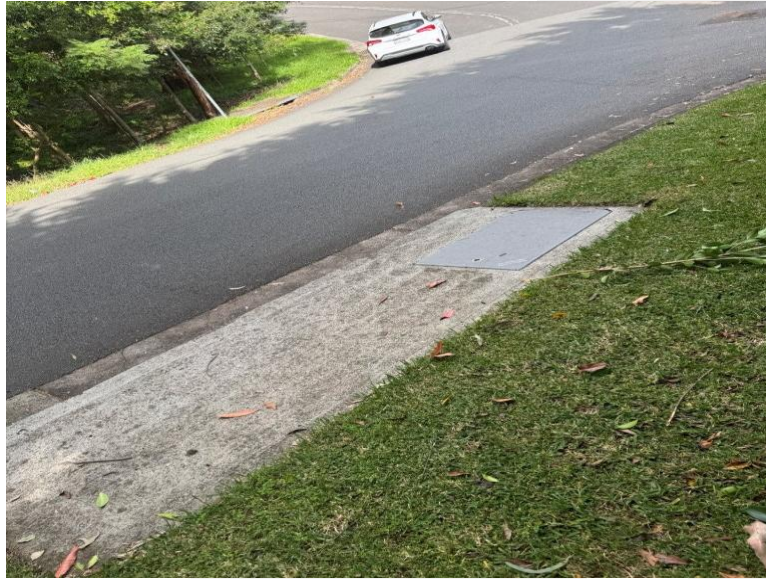
*Figure 45*

General condition along the Council concrete pathway

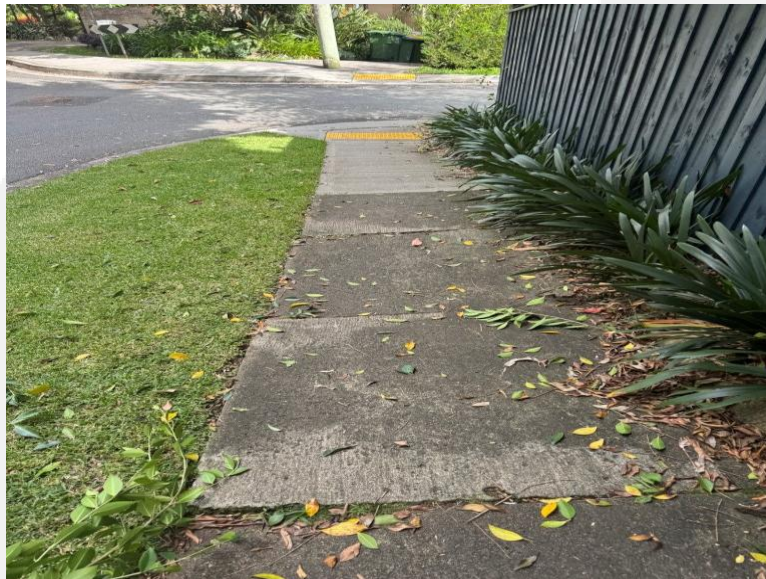
*Figure 46*

General condition along the Council concrete pathway

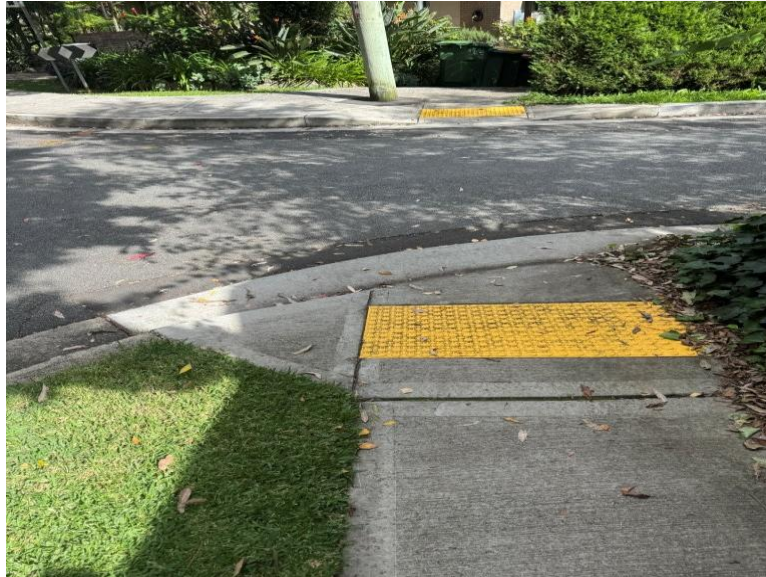
*Figure 47*

General condition along the Council concrete pathway

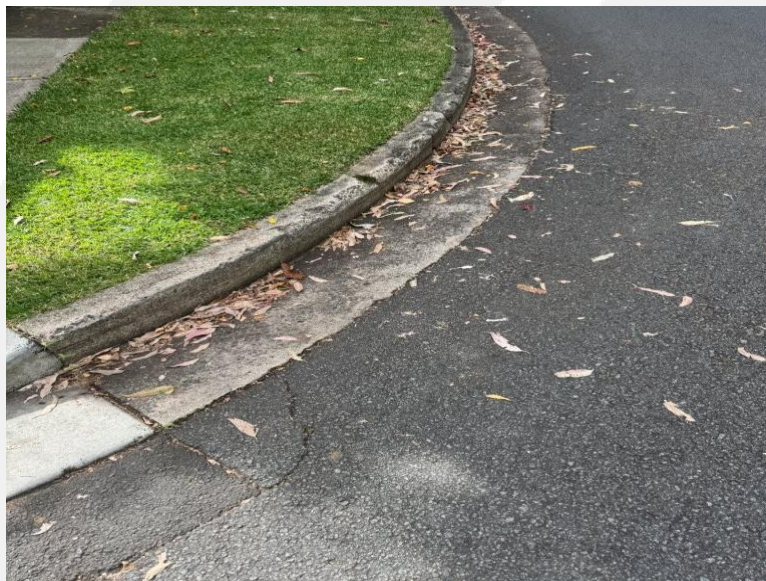
*Figure 48*

General condition along the Council concrete kerb and gutter

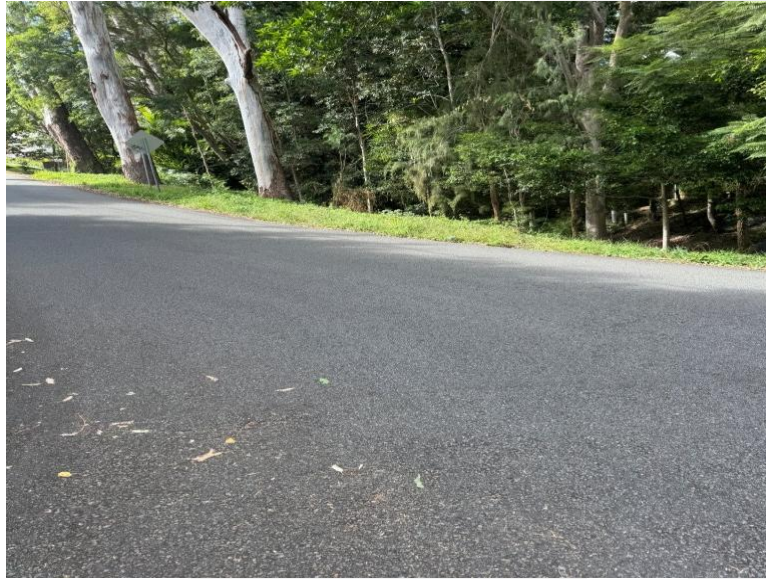
*Figure 49*

General condition along the Council bitumen road

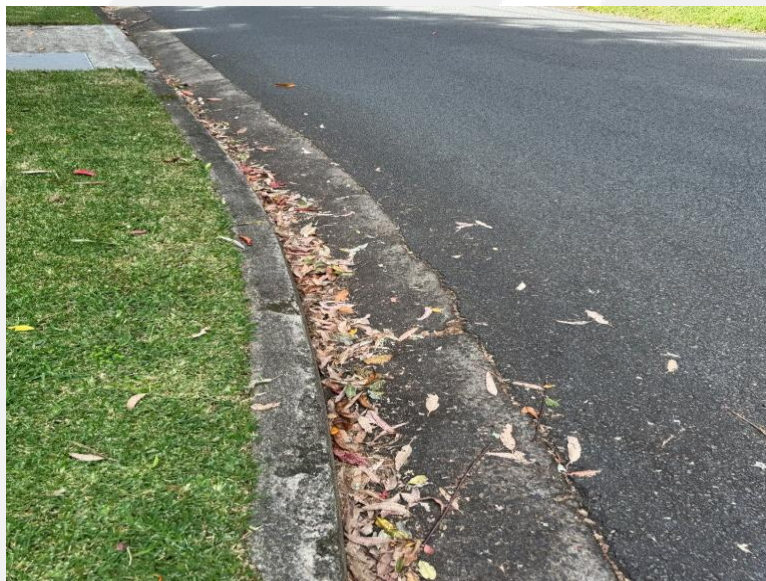
*Figure 50*

General condition along the Council concrete kerb and gutter

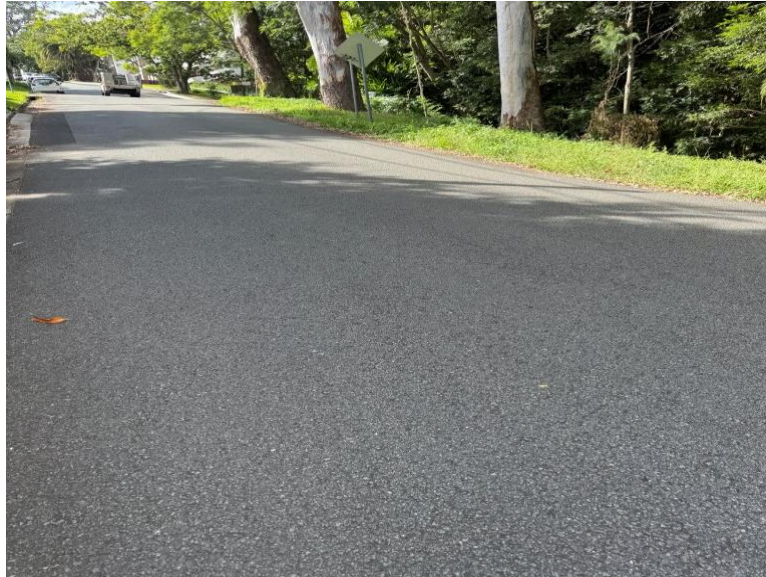
*Figure 51*

General condition along the Council bitumen road

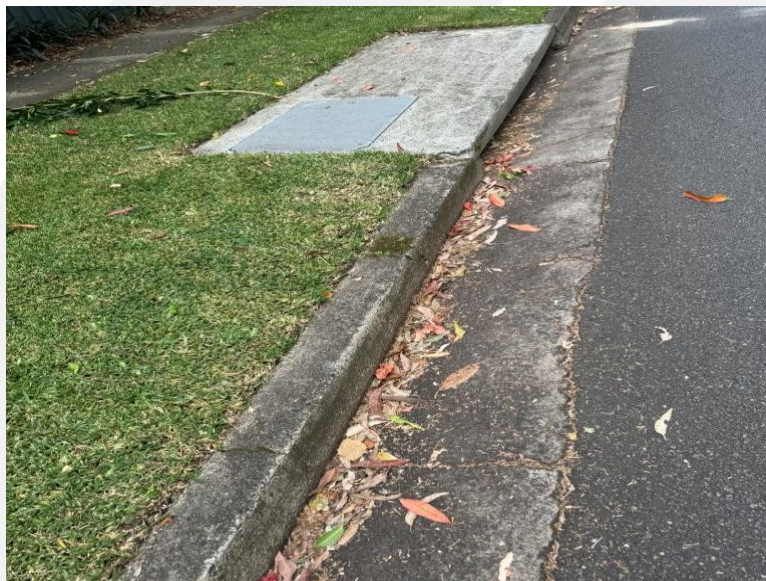
*Figure 52*

General condition along the Council concrete kerb and gutter

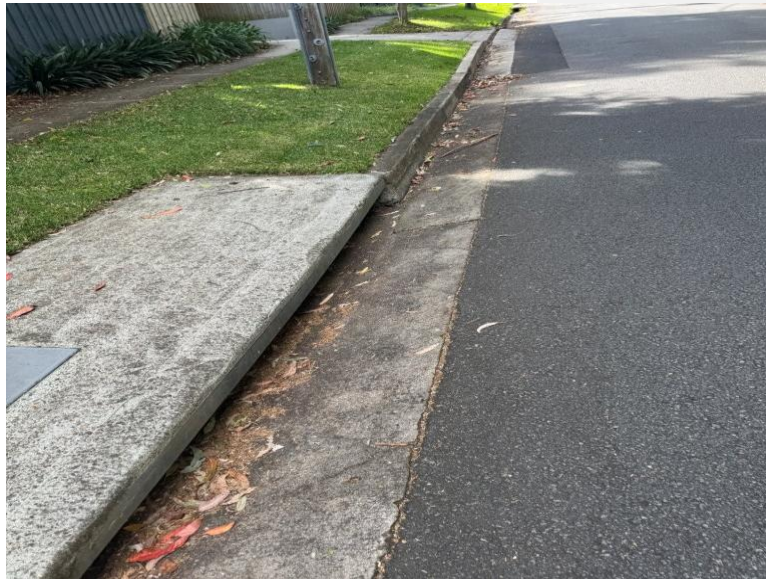
*Figure 53*

General condition along the Council concrete lintel

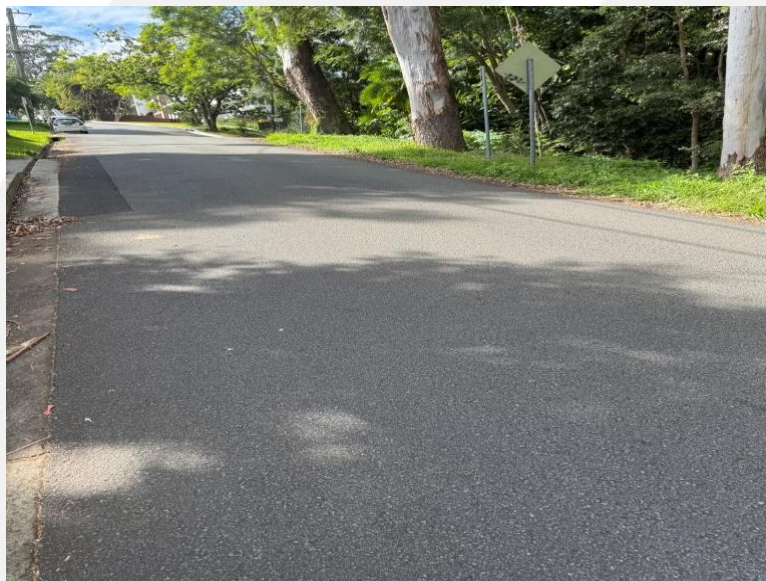
*Figure 54*

General condition along the Council bitumen road

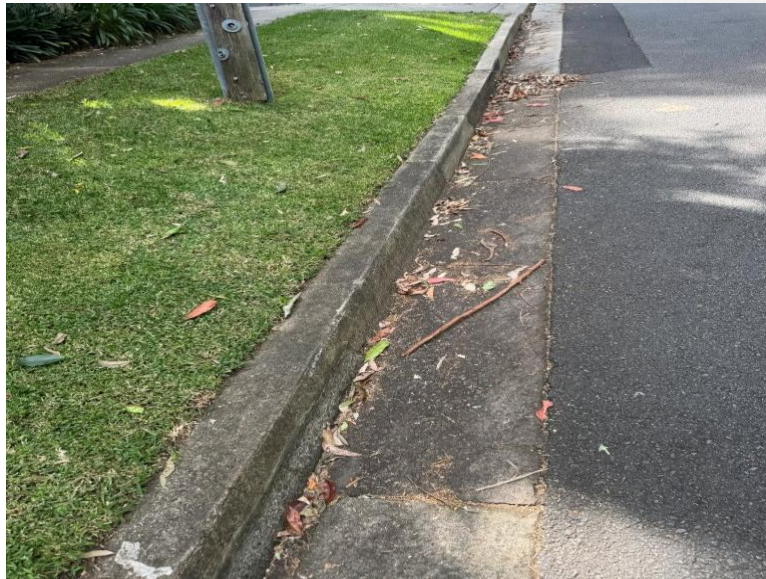
*Figure 55*

General condition along the Council concrete kerb and gutter
