## Appendix 32:

## Public Infrastructure – Maclaurin Parade, Roseville

**PROJECT NUMBER. V260255**

Project Address: 2-4 Larkin Street & 1,3,5 Pockley Avenue, Roseville

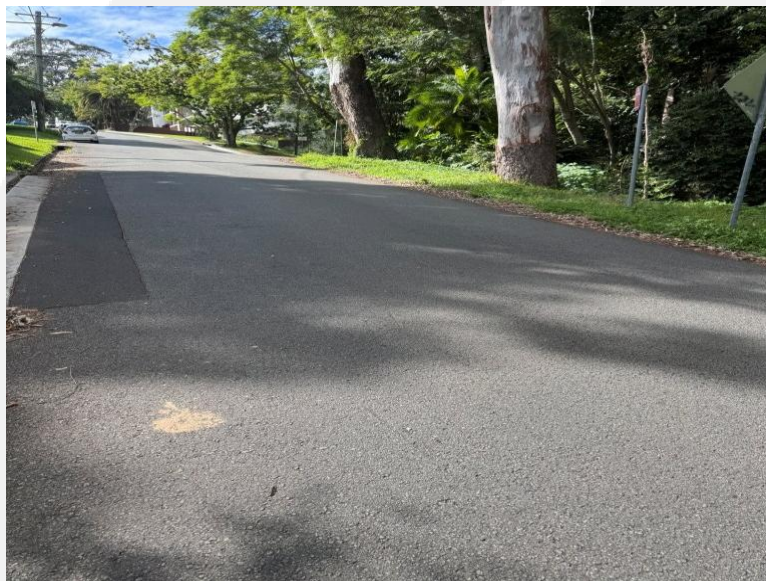
*Figure 56*

General condition along the Council bitumen road

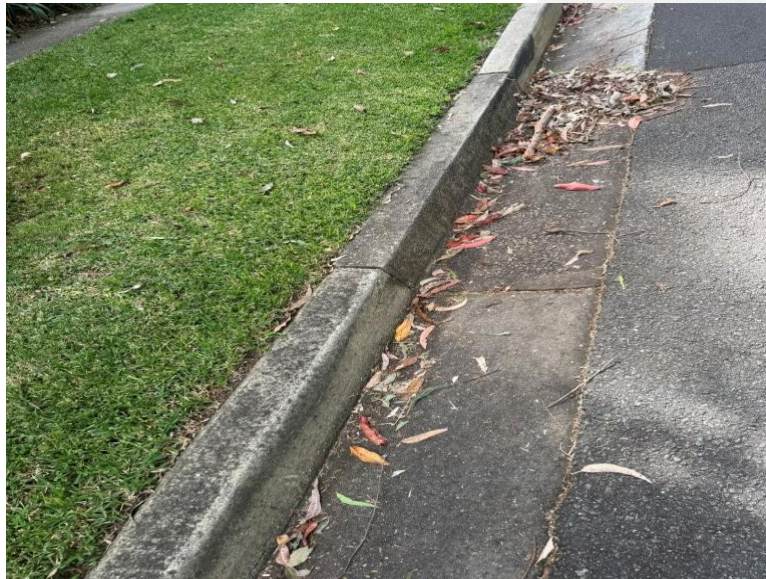
*Figure 57*

General condition along the Council concrete kerb and gutter

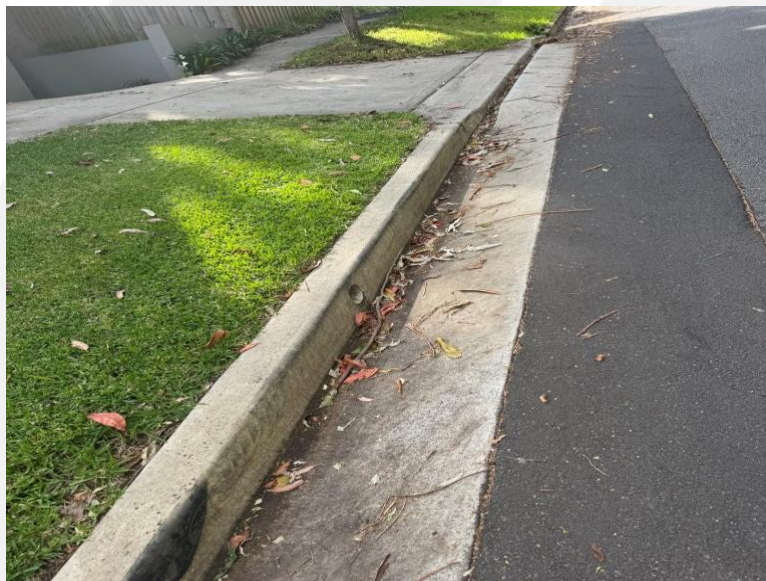
*Figure 58*

General condition along the Council concrete kerb and gutter

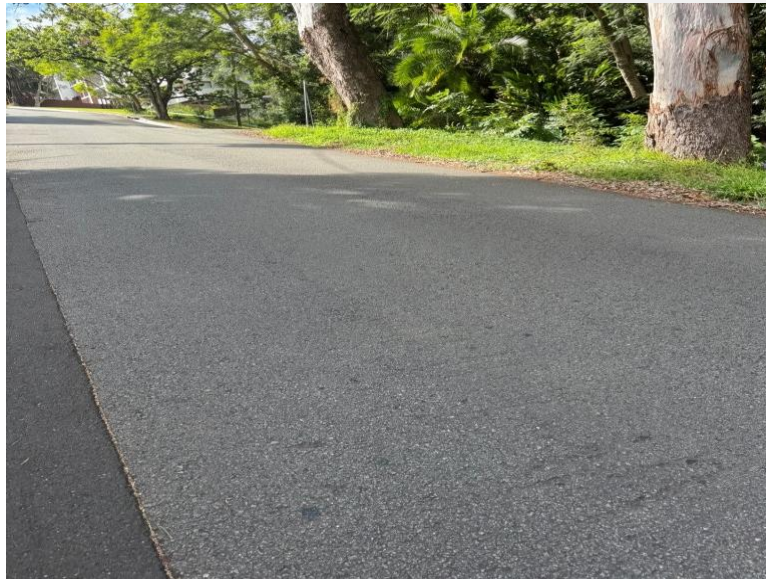
*Figure 59*

General condition along the Council bitumen road

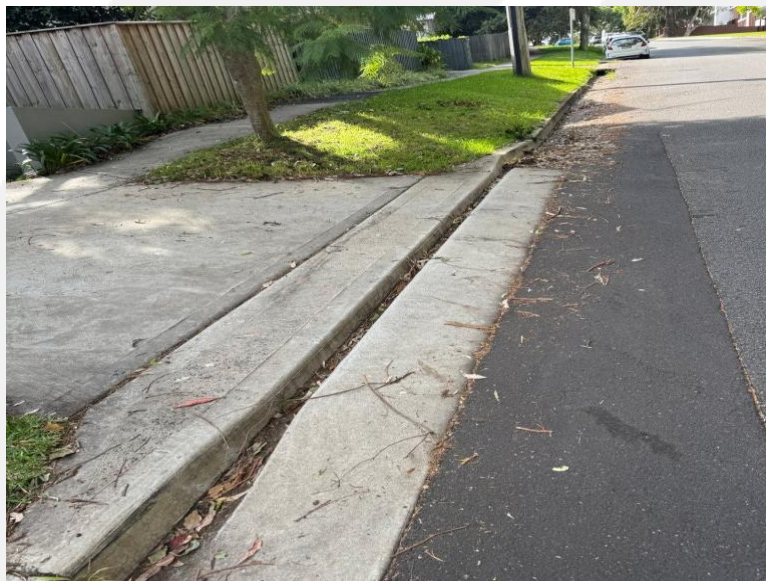
*Figure 60*

General condition along the Council concrete layback and gutter

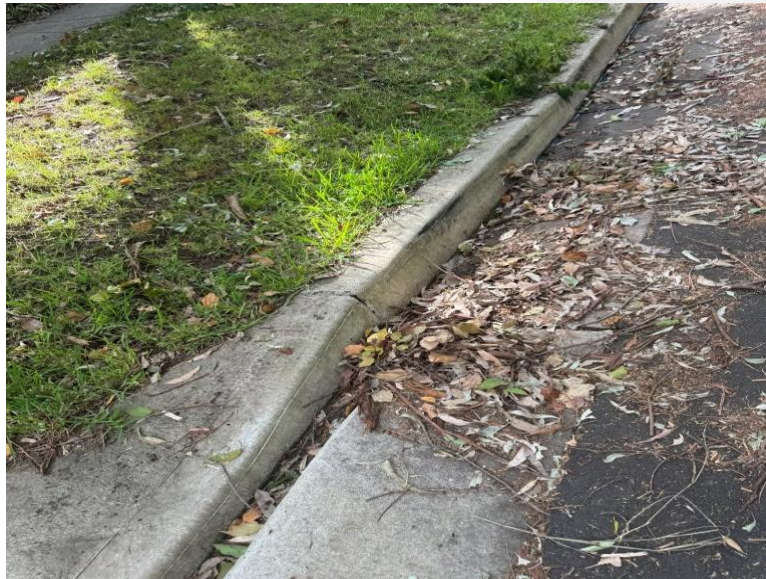
*Figure 61*

General condition along the Council concrete kerb and gutter

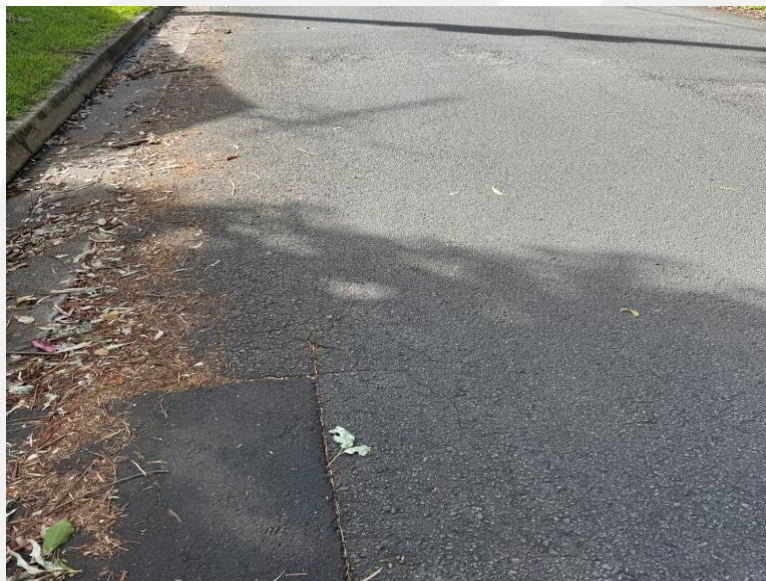
*Figure 62*

General condition along the Council bitumen road

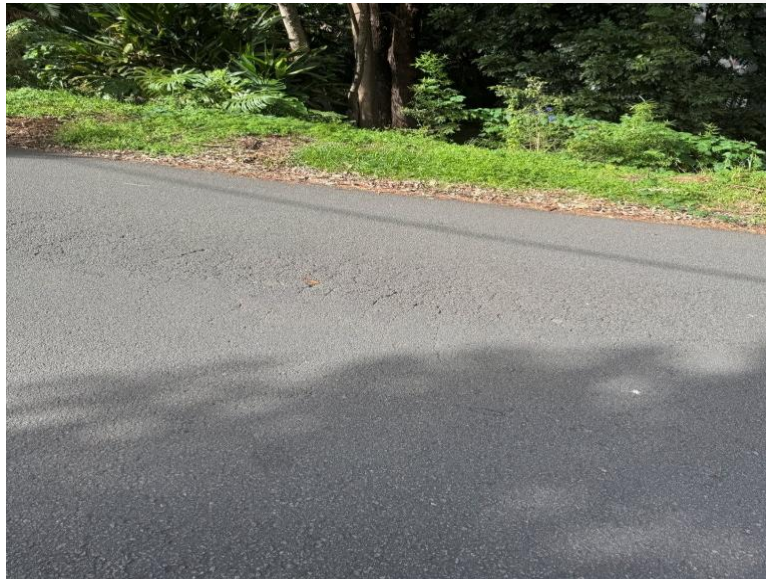
*Figure 63*

General condition along the Council bitumen road

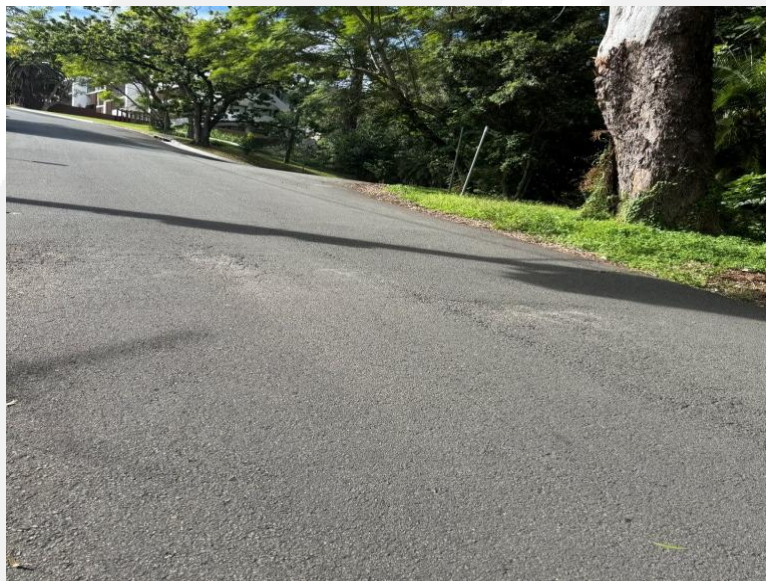
*Figure 64*

General condition along the Council bitumen road

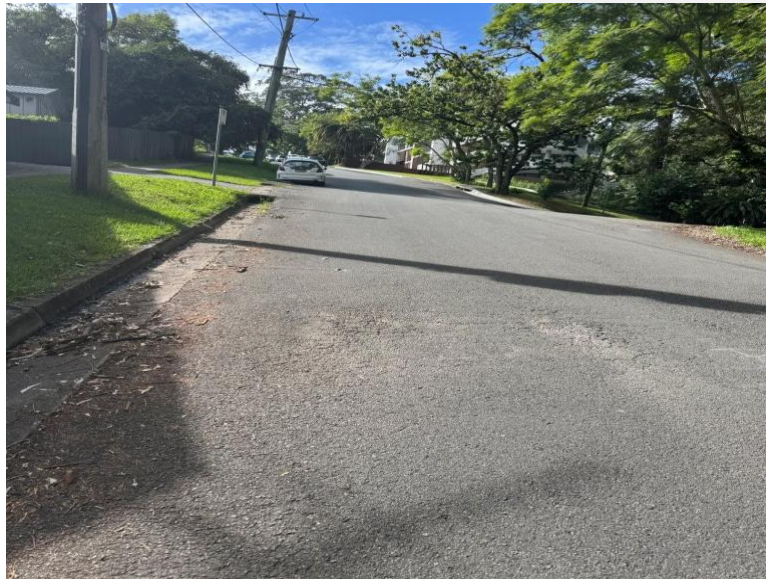
*Figure 65*

General condition along the Council bitumen road

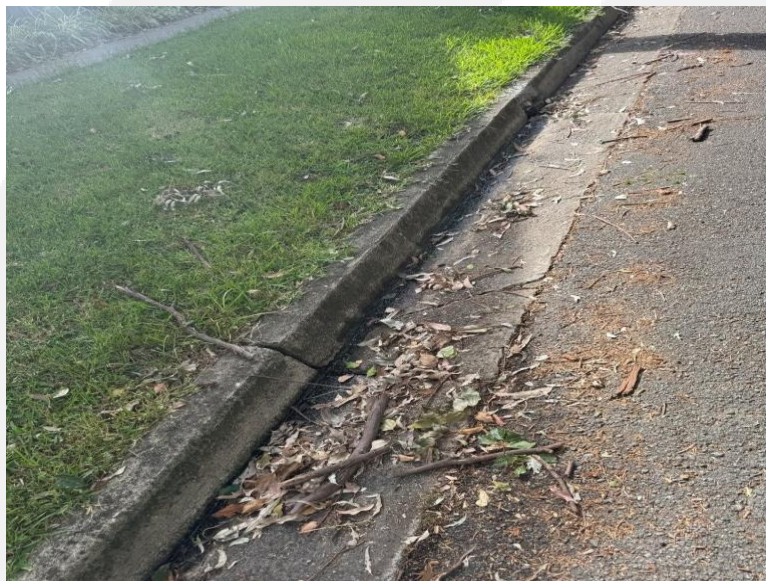
*Figure 66*

General condition along the Council concrete kerb and gutter

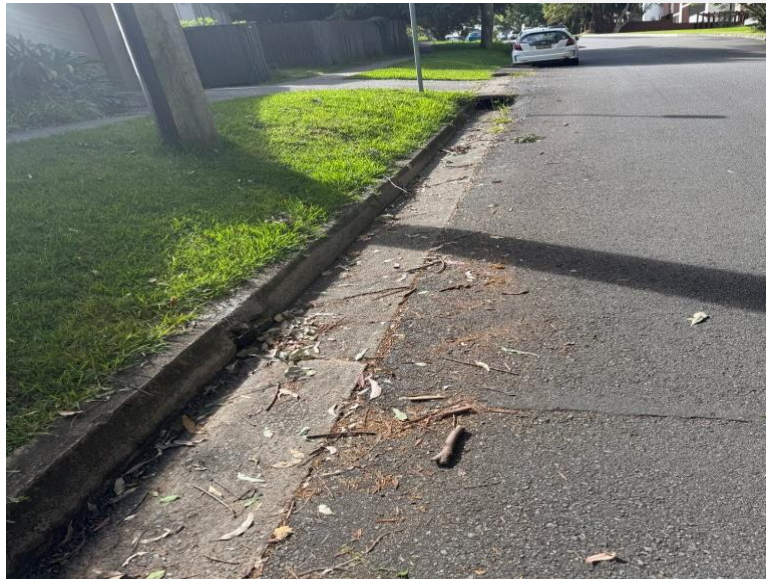
*Figure 67*

General condition along the Council concrete kerb and gutter

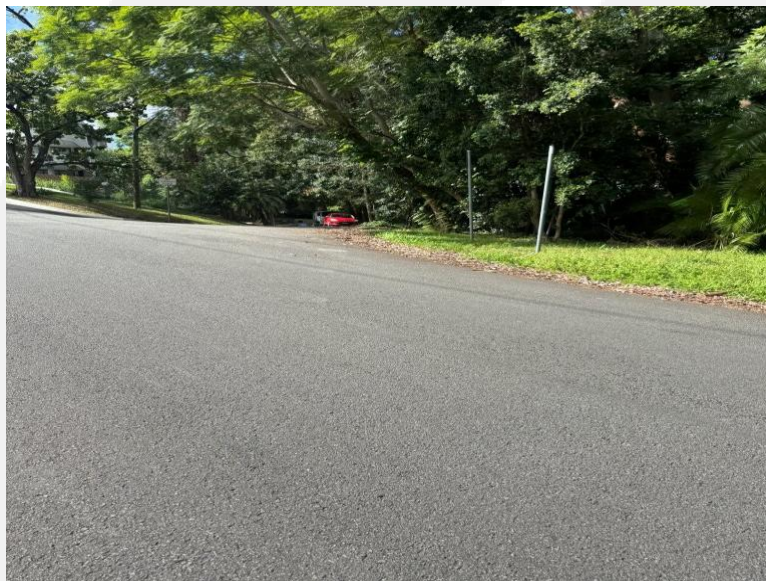
*Figure 68*

General condition along the Council bitumen road

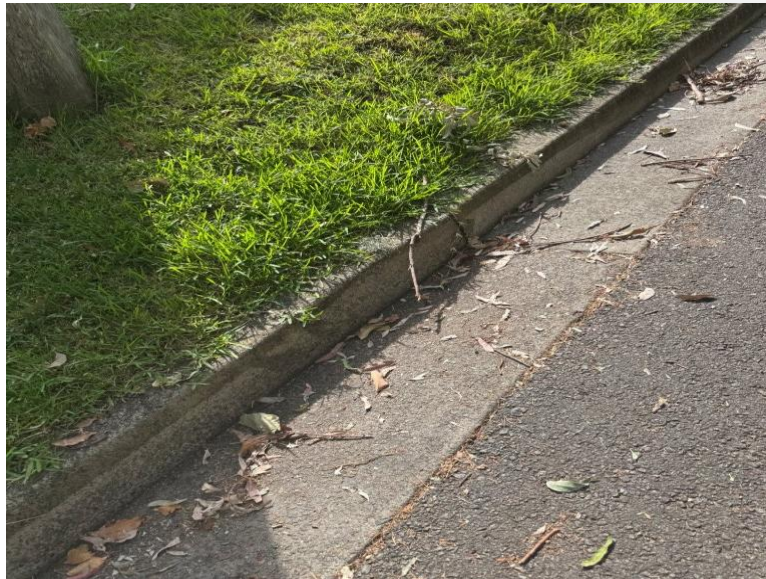
*Figure 69*

General condition along the Council concrete kerb and gutter

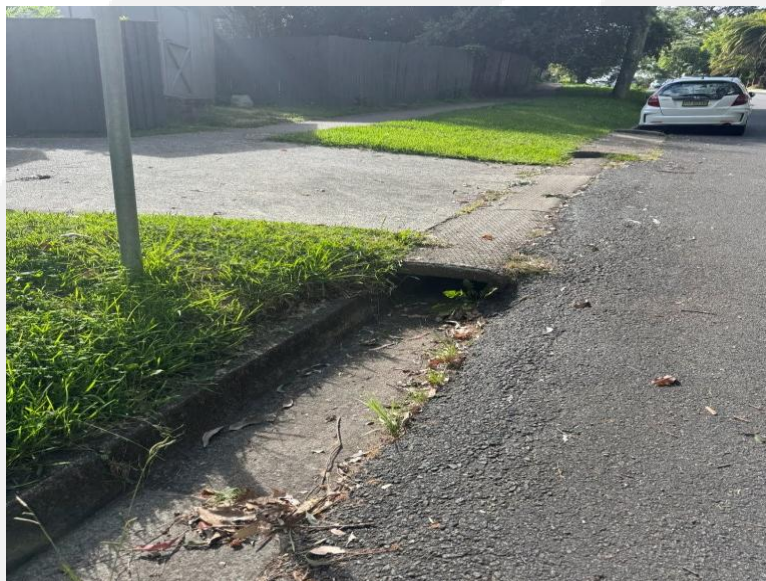
*Figure 70*

General condition along the Council concrete kerb and gutter

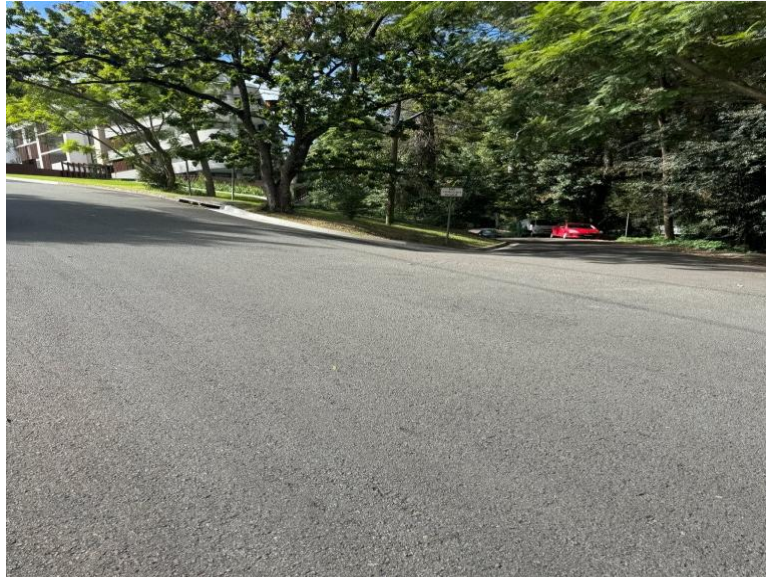
*Figure 71*

General condition along the Council bitumen road

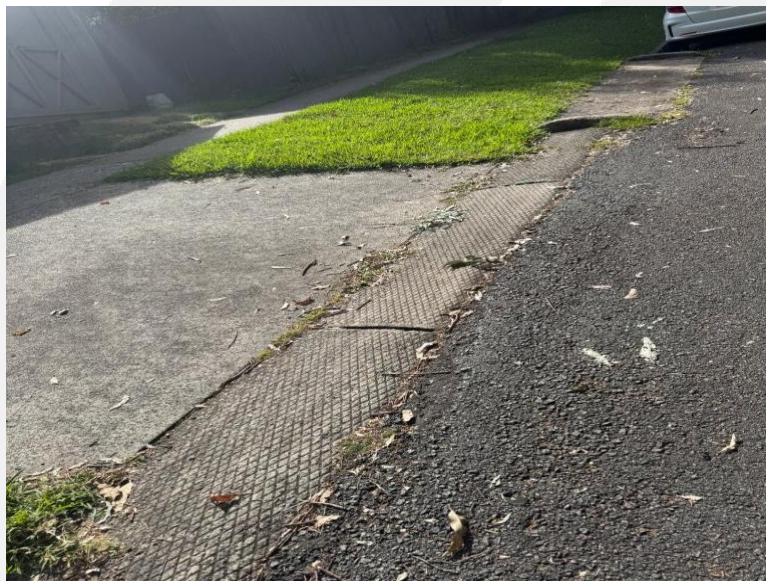
*Figure 72*

General condition along the Council concrete layback and gutter

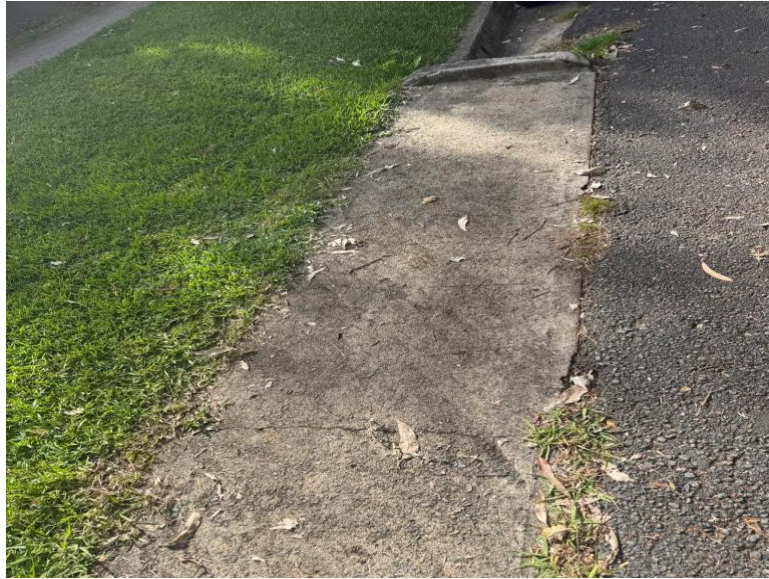
*Figure 73*

General condition along the Council concrete layback and gutter

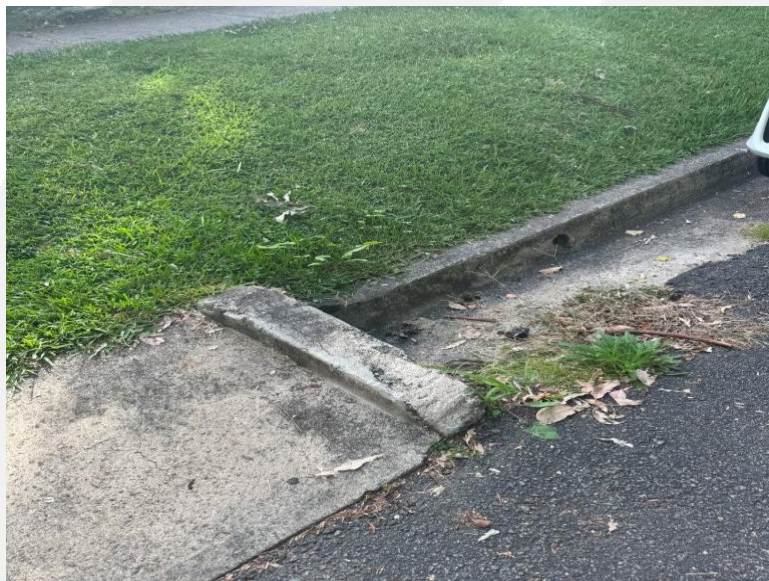
*Figure 74*

General condition along the Council concrete layback and gutter

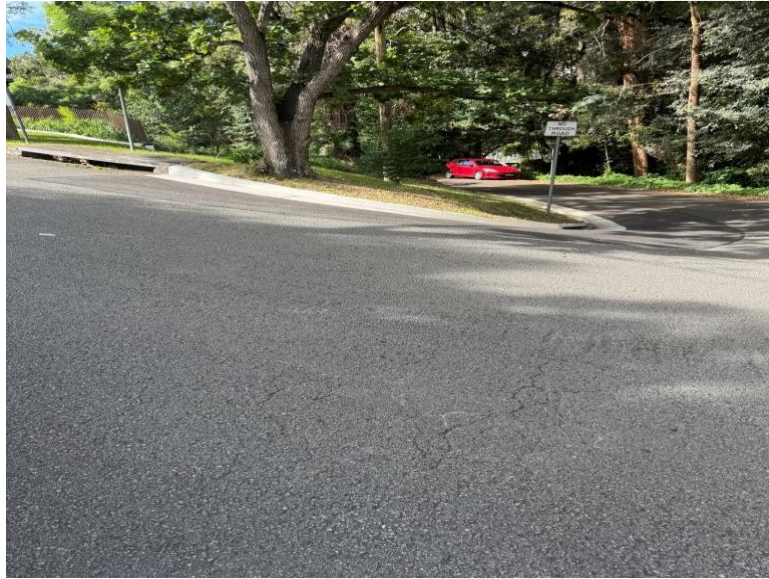
*Figure 75*

General condition along the Council bitumen road

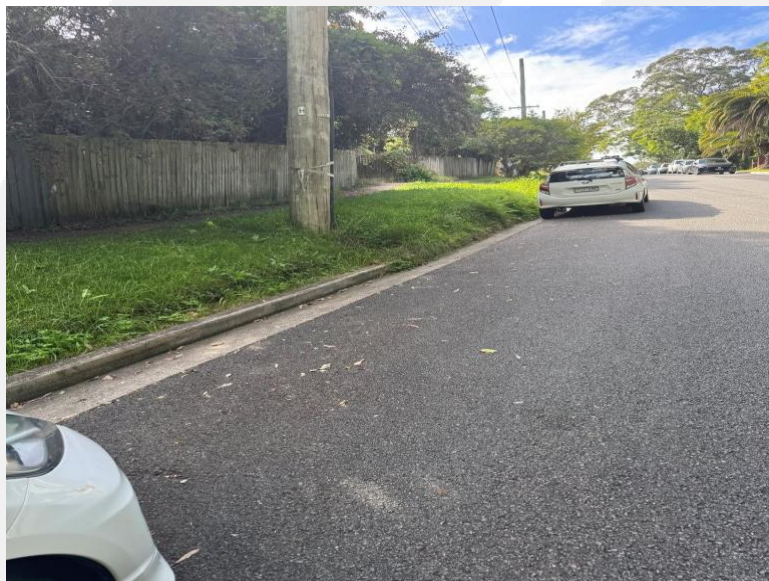
*Figure 76*

General condition along the Council bitumen road

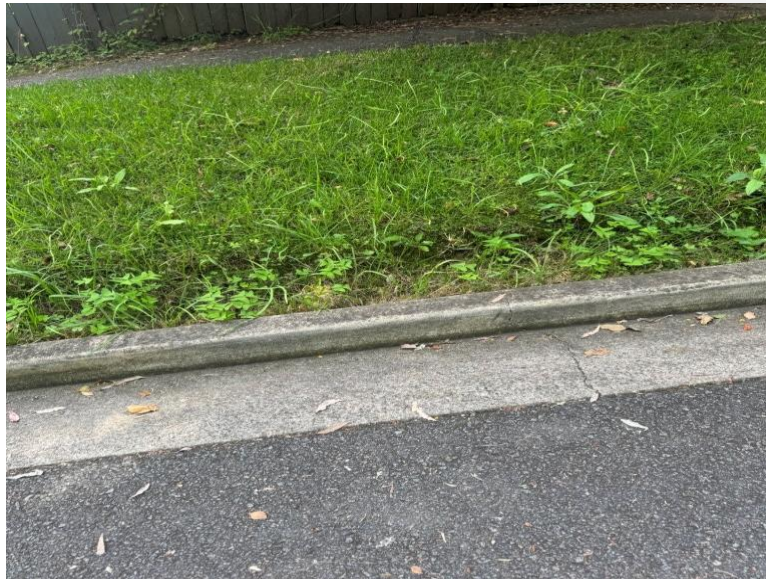
*Figure 77*

General condition along the Council concrete kerb and gutter

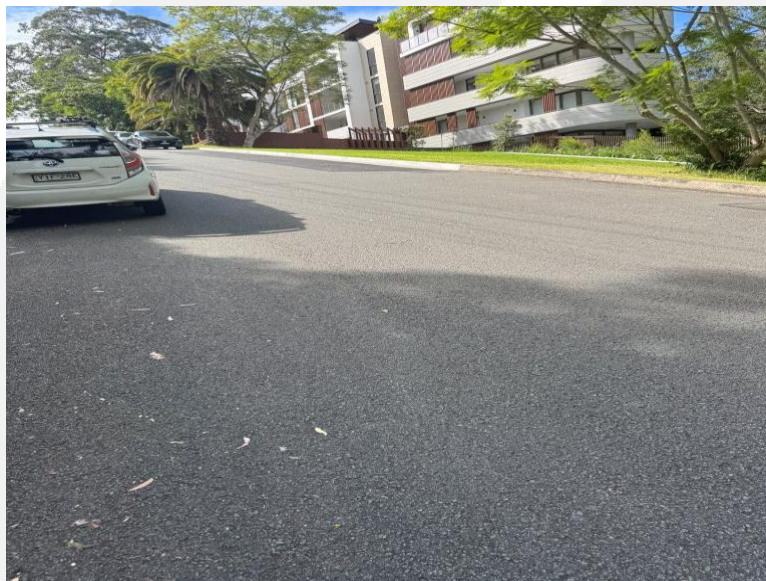
*Figure 78*

General condition along the Council bitumen road

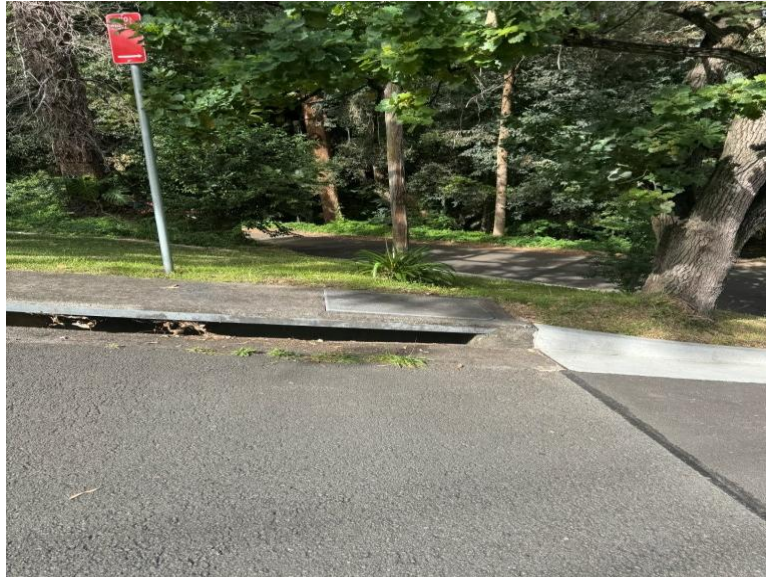
*Figure 79*

General condition along the Council bitumen road

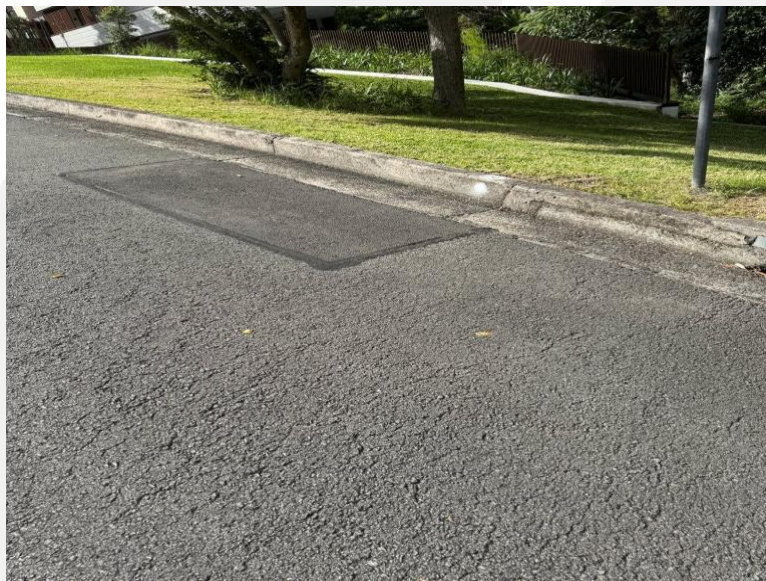
*Figure 80*

General condition along the Council bitumen road

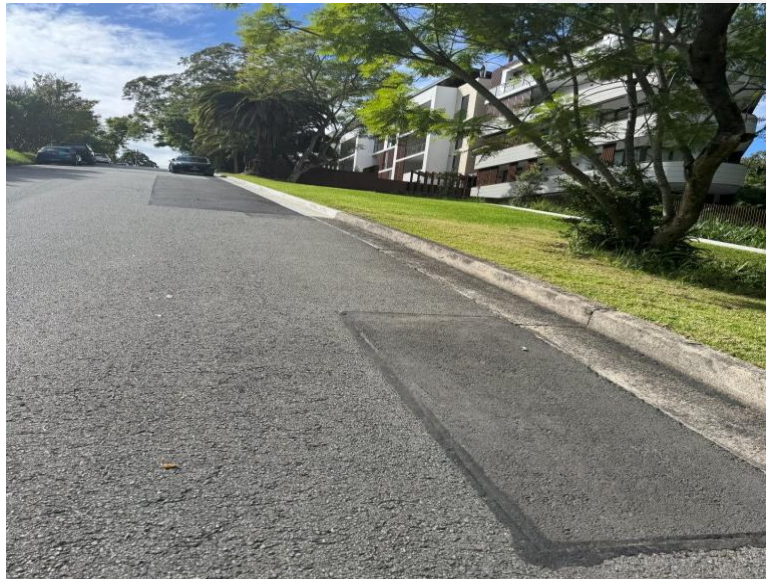
*Figure 81*

General condition along the Council bitumen road

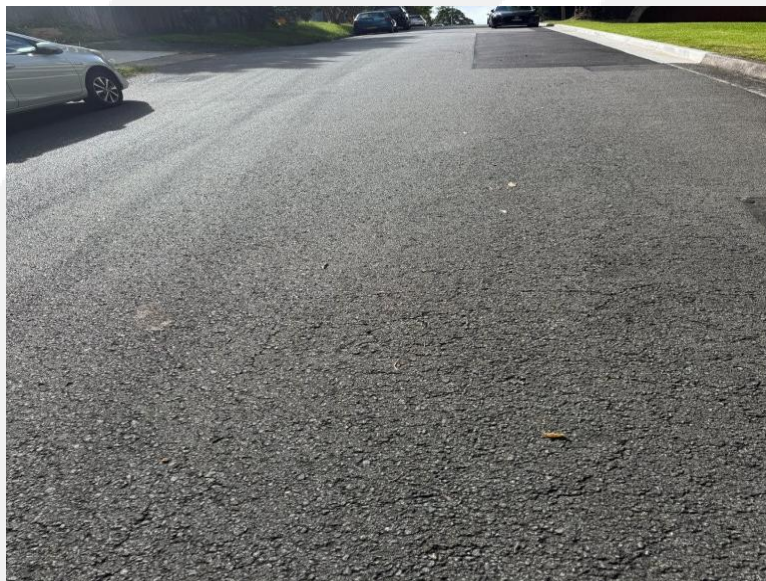
*Figure 82*

General condition along the Council bitumen road

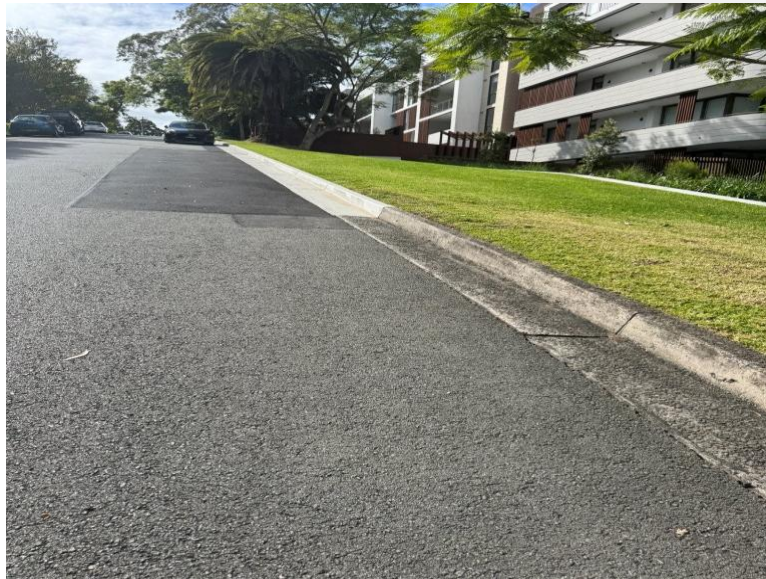
*Figure 83*

General condition along the Council bitumen road

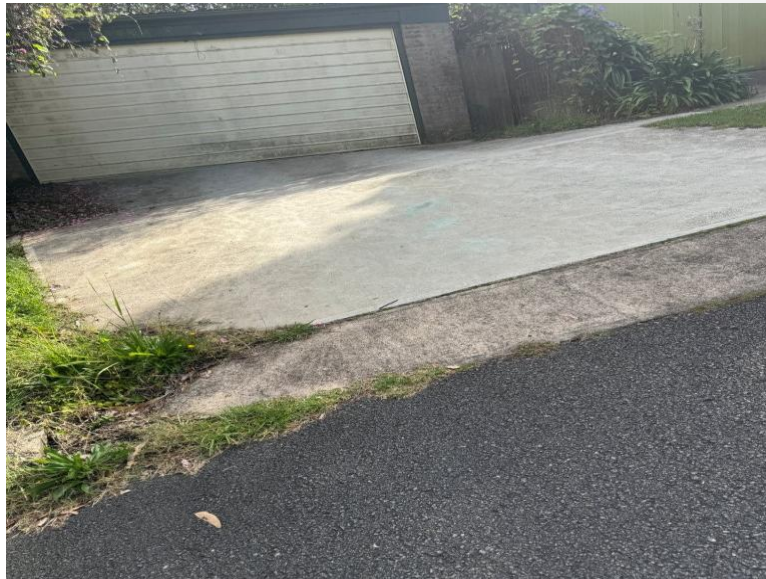
*Figure 84*

General condition along the Council bitumen road

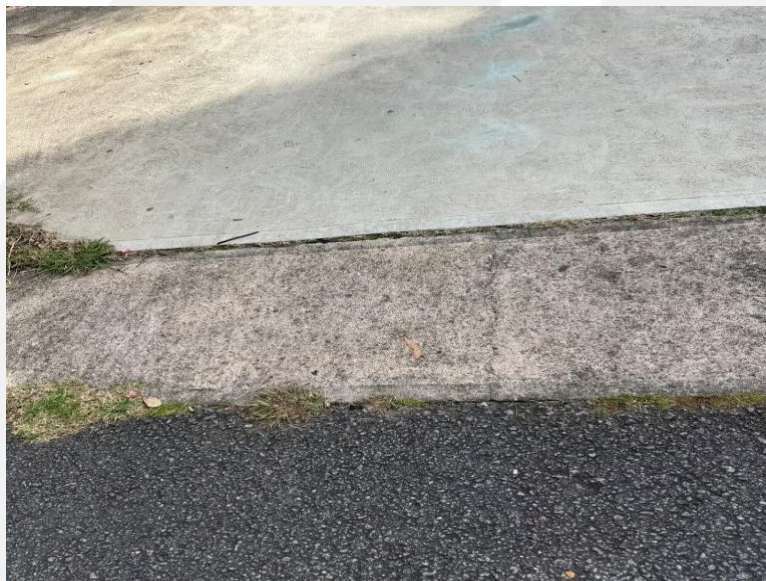
*Figure 85*

General condition along the Council concrete layback and gutter

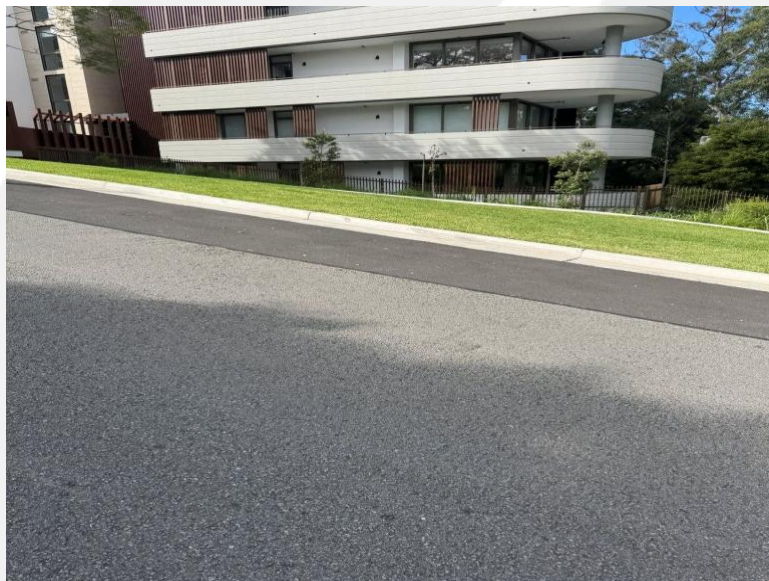
*Figure 87*

General condition along the Council concrete layback and gutter

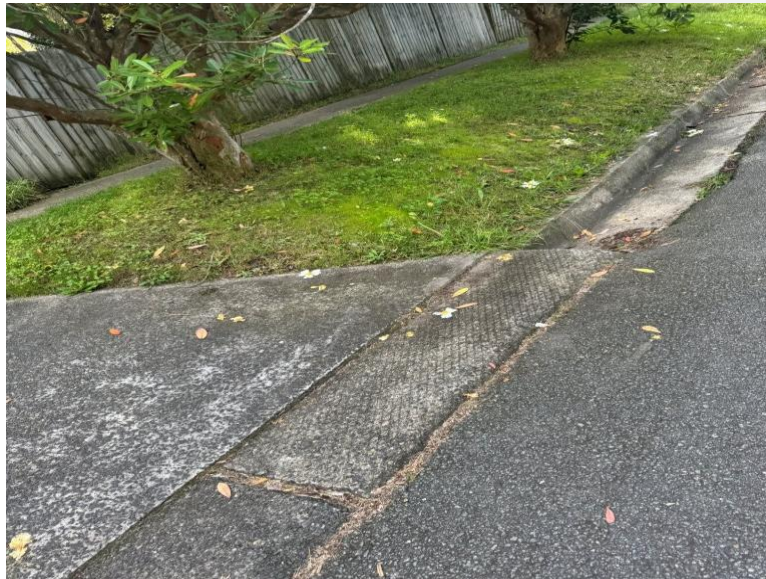
*Figure 88*

General condition along the Council bitumen road

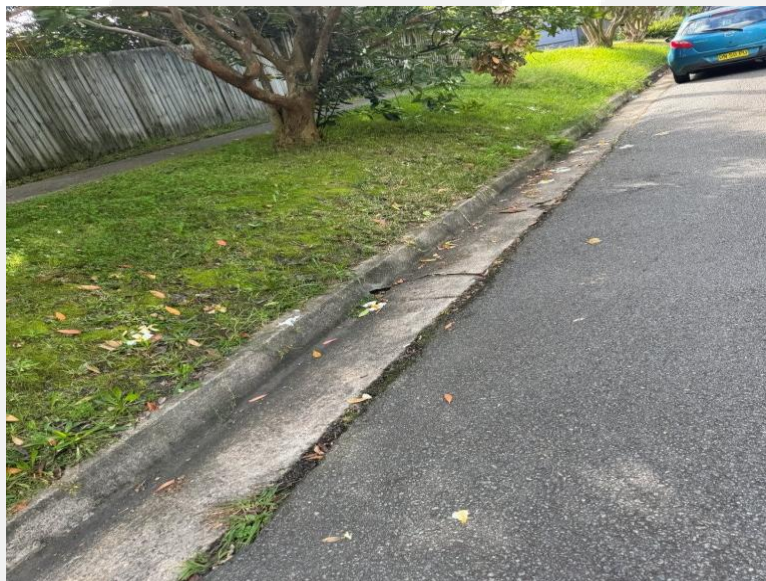
*Figure 89*

General condition along the Council concrete layback and gutter

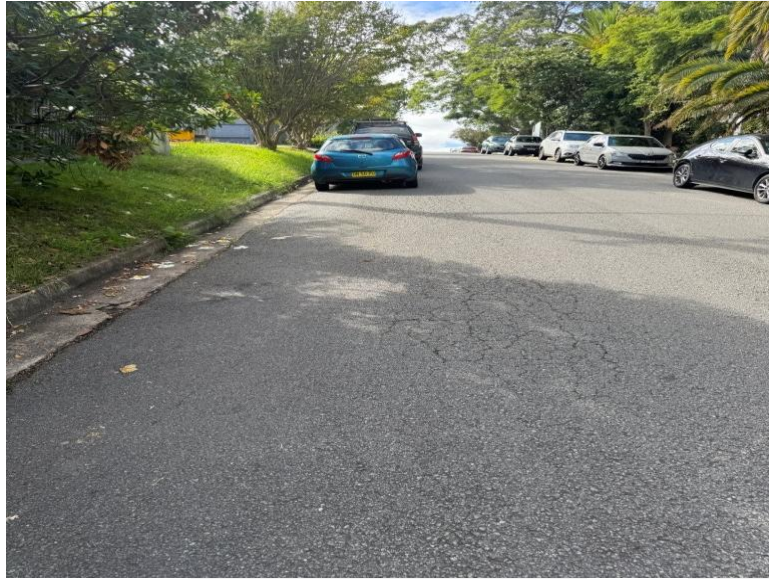
*Figure 90*

General condition along the Council concrete kerb and gutter

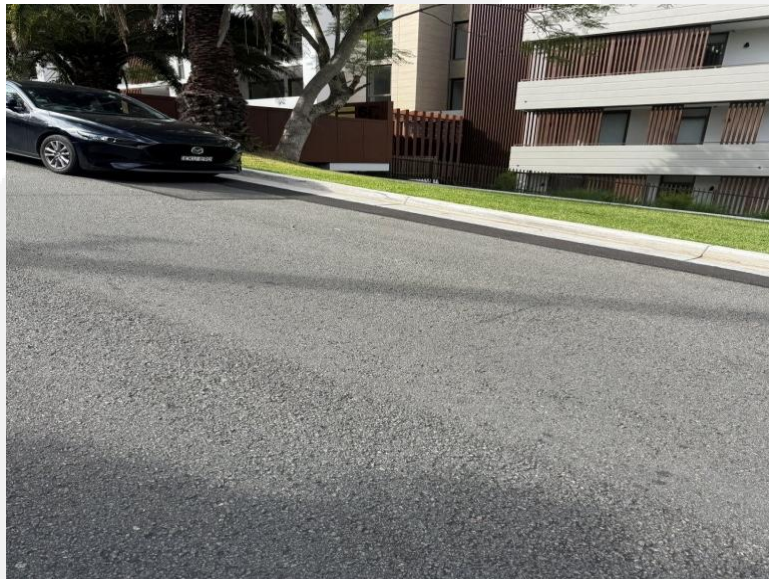
*Figure 91*

General condition along the Council bitumen road

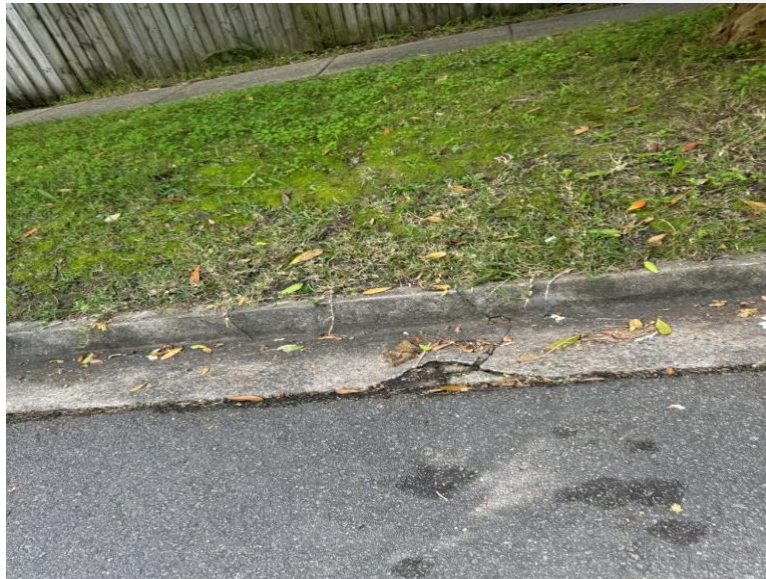
*Figure 92*

General condition along the Council bitumen road

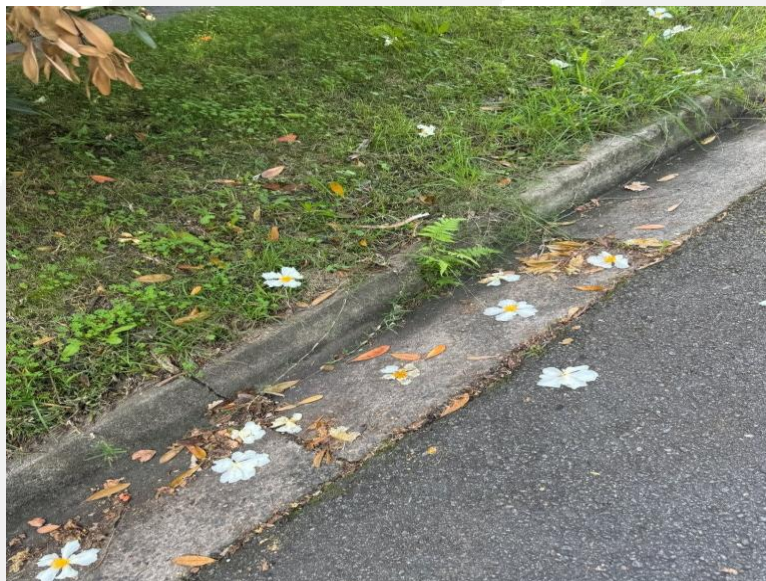
*Figure 93*

General condition along the Council concrete kerb and gutter

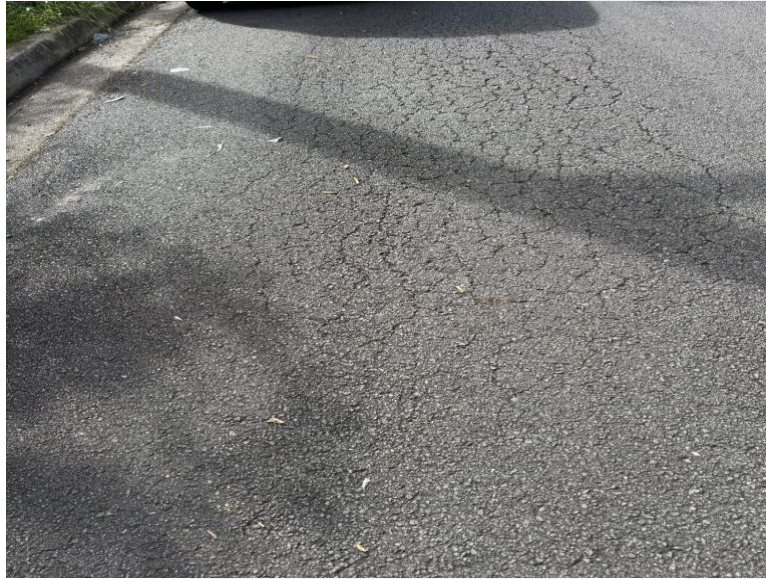
*Figure 94*

General condition along the Council concrete kerb and gutter

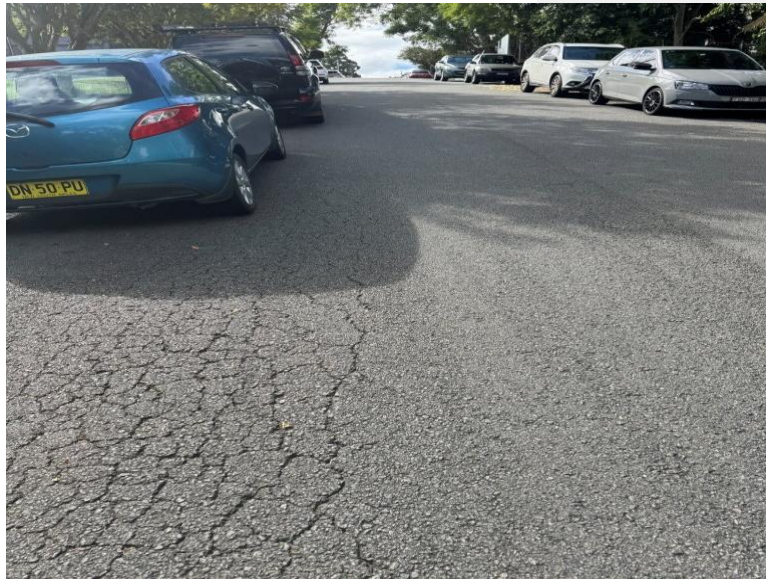
*Figure 96*

General condition along the Council bitumen road

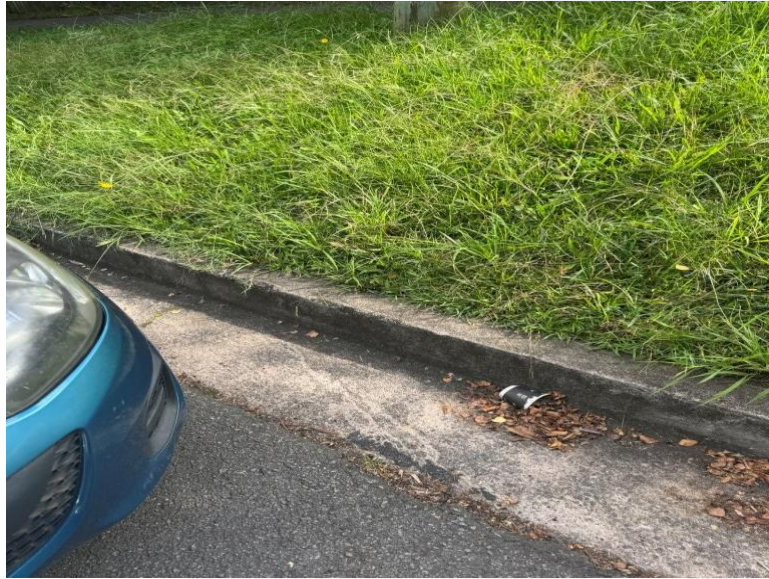
*Figure 98*

General condition along the Council bitumen road

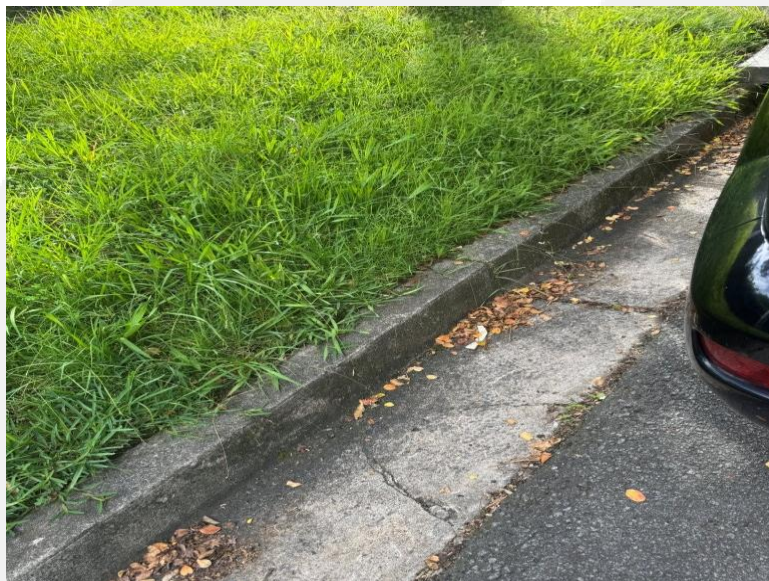
*Figure 99*

General condition along the Council concrete kerb and gutter

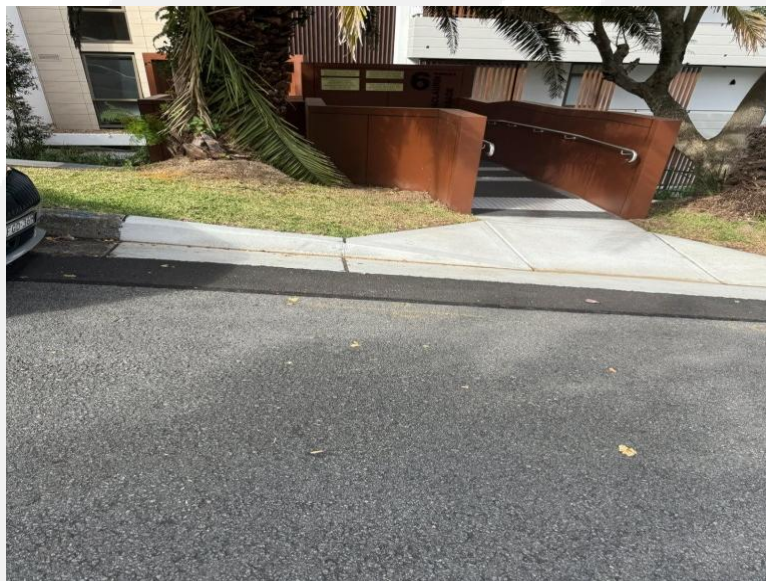
*Figure 101*

General condition along the Council bitumen road

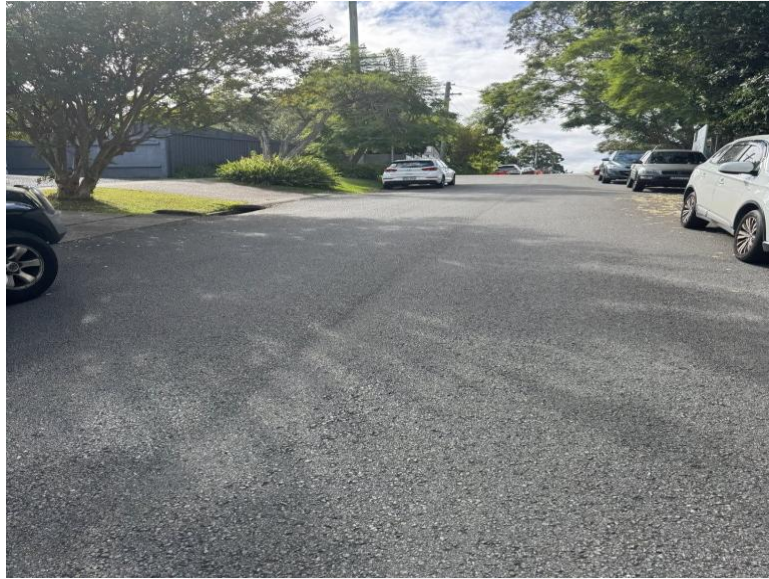
*Figure 102*

General condition along the Council bitumen road

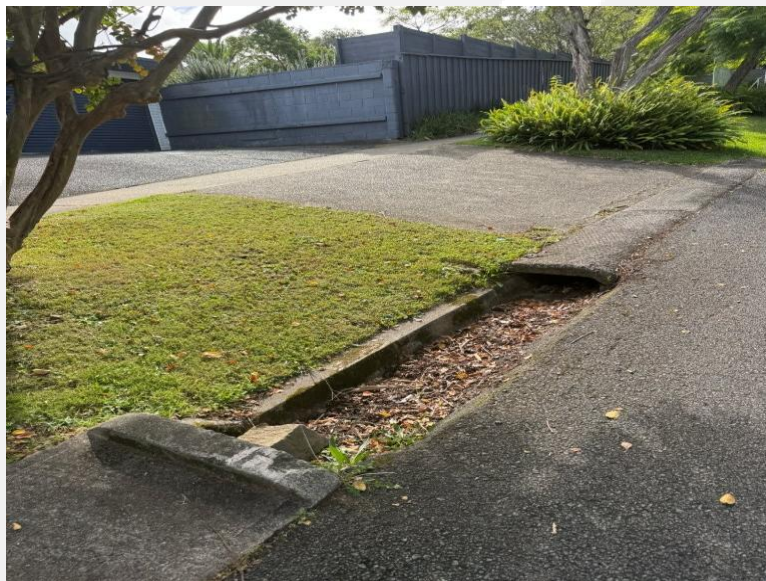
*Figure 105*

General condition along the Council concrete layback and gutter

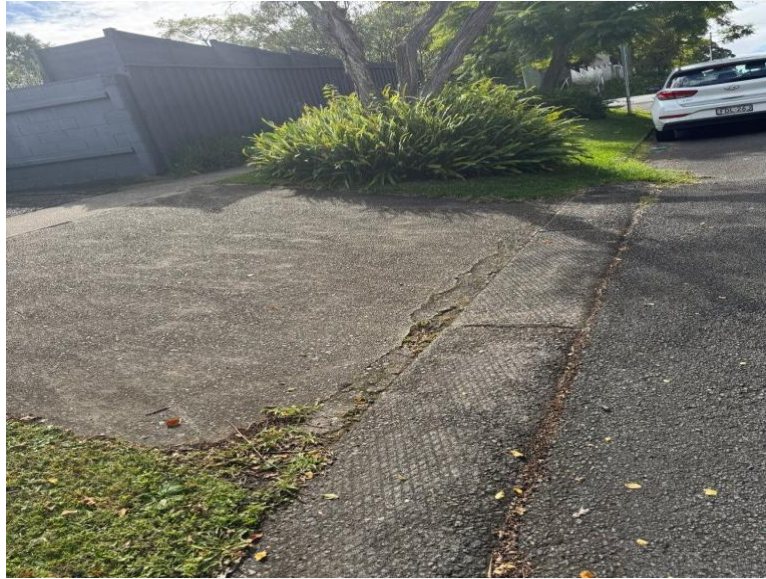
*Figure 106*

General condition along the Council concrete kerb and gutter

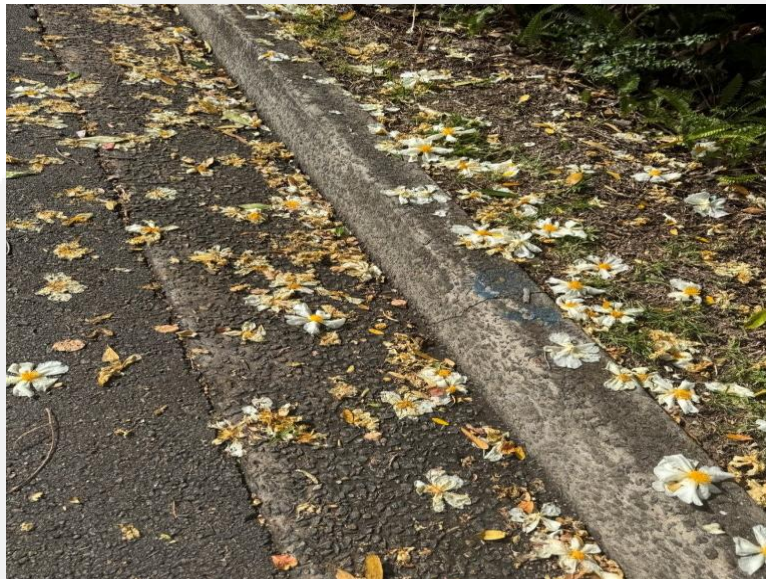
*Figure 107*

General condition along the Council concrete layback and gutter

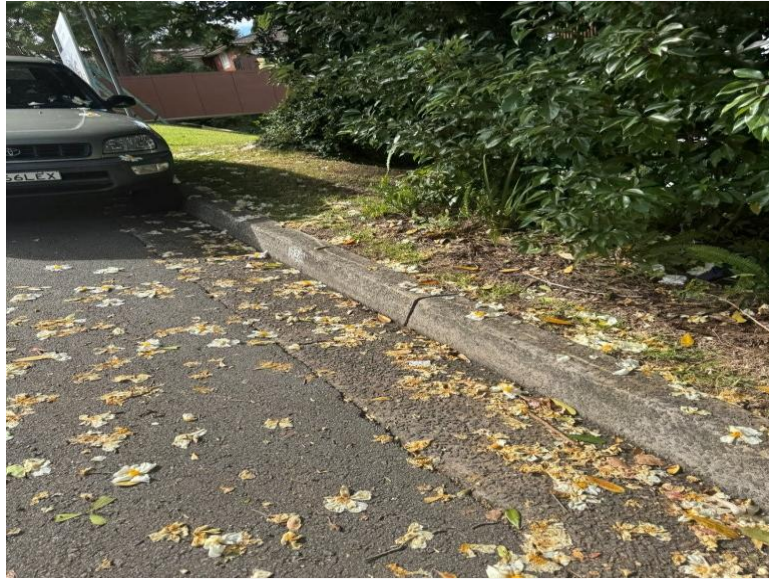
*Figure 108*

General condition along the Council concrete kerb and gutter

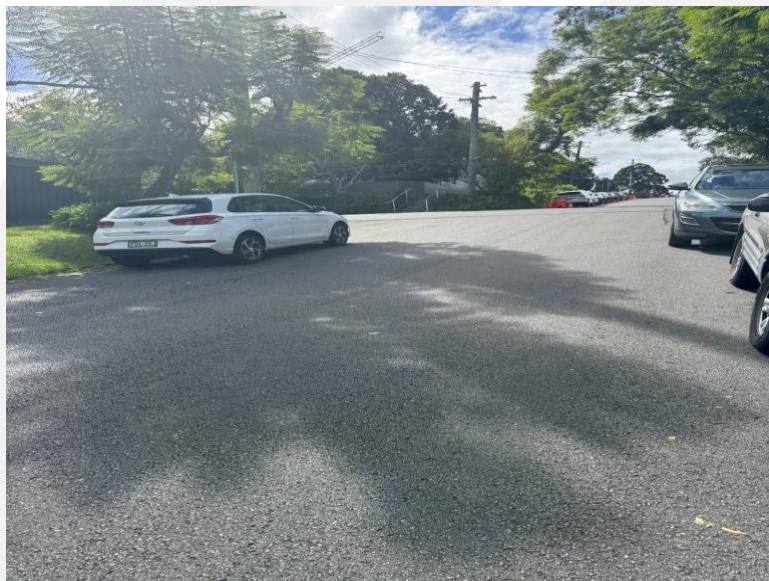
*Figure 109*

General condition along the Council concrete kerb and gutter

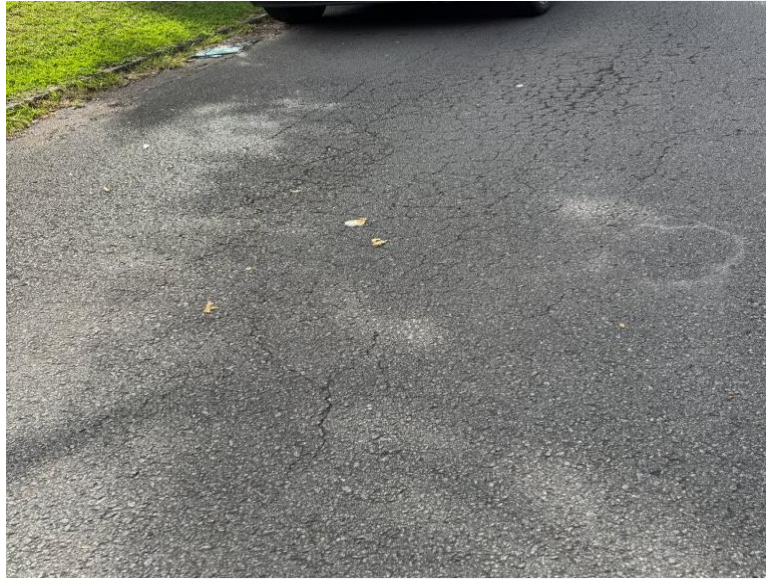
*Figure 110*

General condition along the Council bitumen road

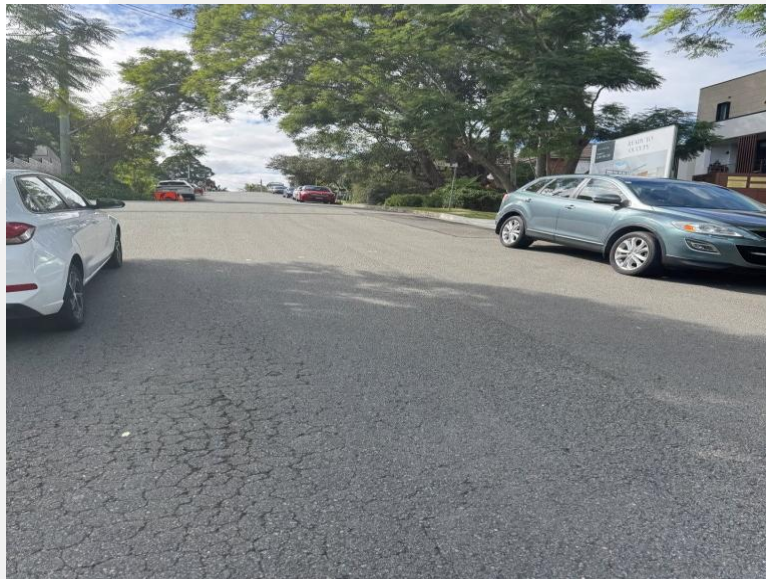
*Figure 111*

Cracking found along the Council bitumen road
