## Appendix 32:

## Public Infrastructure – Maclaurin Parade, Roseville

**PROJECT NUMBER. V260255**

Project Address: 2-4 Larkin Street & 1,3,5 Pockley Avenue, Roseville

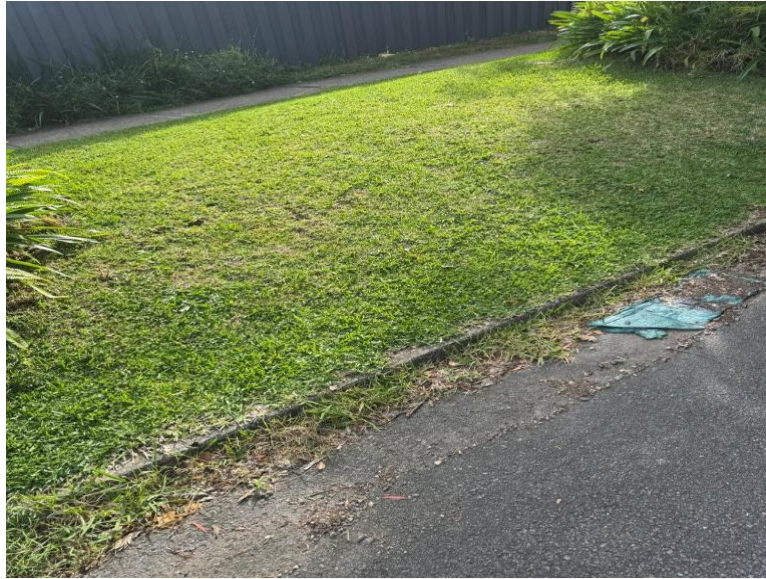
*Figure 112*

Cracking found along the Council bitumen road

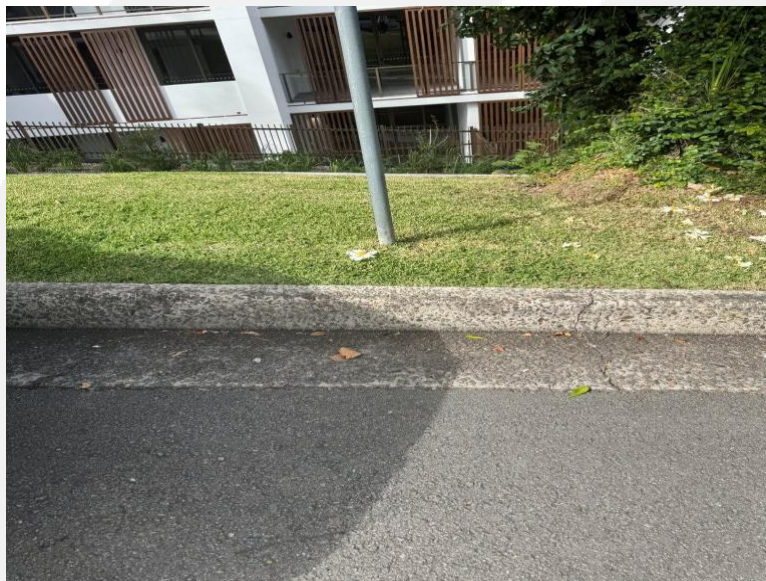
*Figure 113*

General condition along the Council concrete kerb and gutter

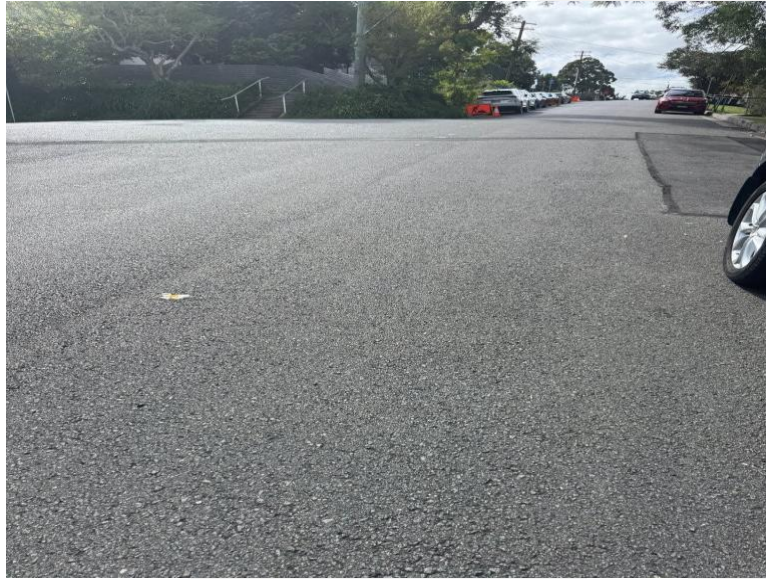
*Figure 114*

General condition along the Council concrete kerb and gutter

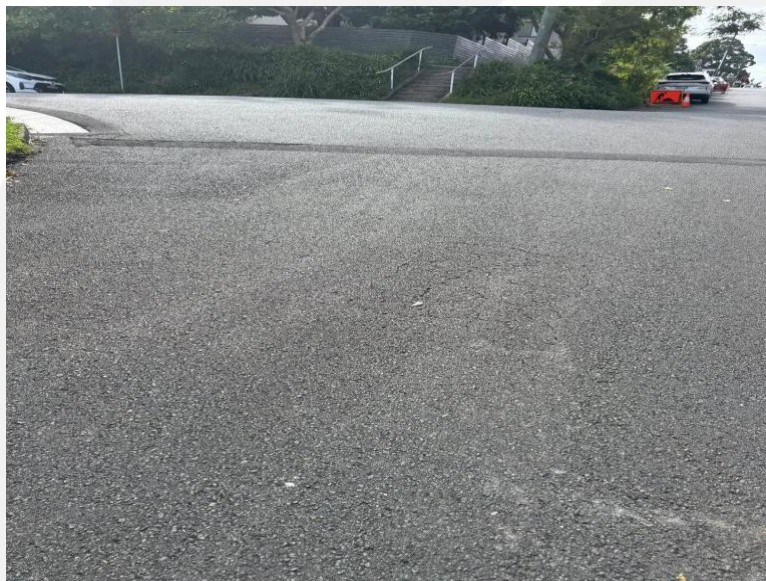
*Figure 115*

General condition along the Council bitumen road
