# **DILAPIDATION REPORT**

**For Property At  
3A Valley Rd,  
Lindfield, NSW 2070**

**For Development At  
59-63 Trafalgar Ave & 1A-1B Valley Rd,  
Lindfield, NSW 2070**

**Ref: 26009-DR-001-R1-3A Valley Rd  
Date: 25.05.2026**

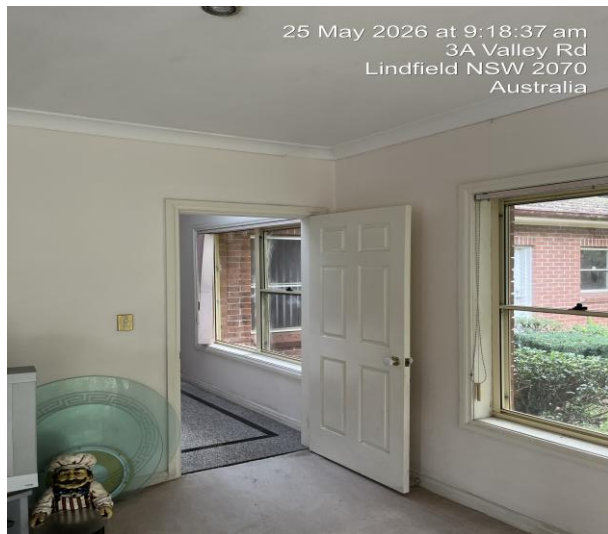
Photo 1 – General view

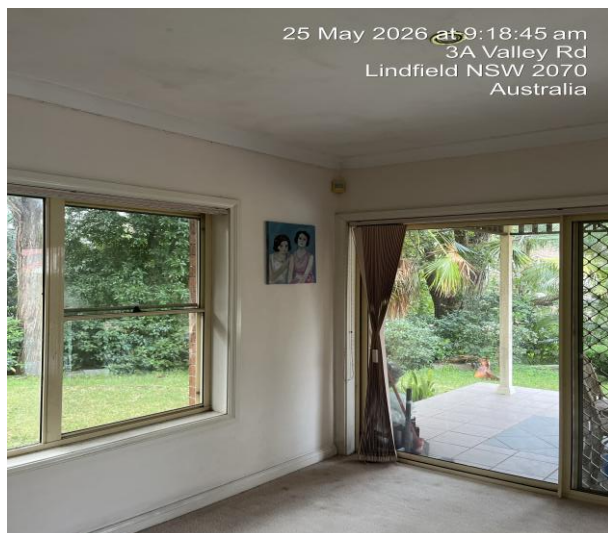
Photo 3 – General view

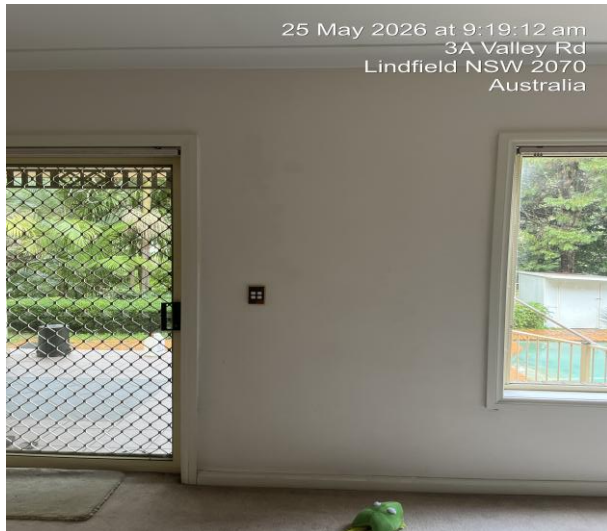
Photo 7 – General view

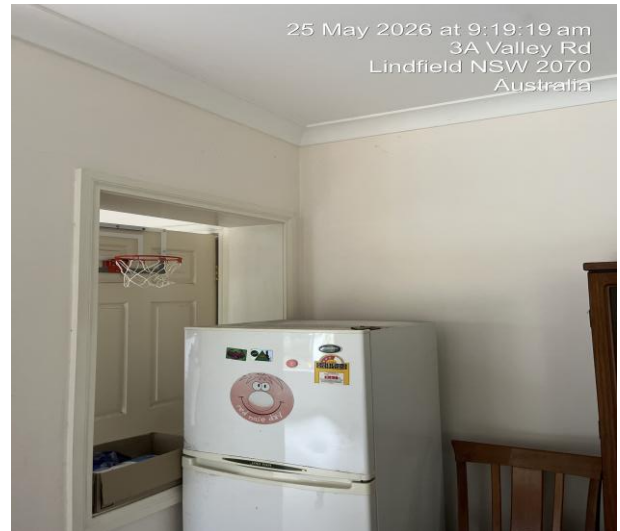
Photo 8 – General view

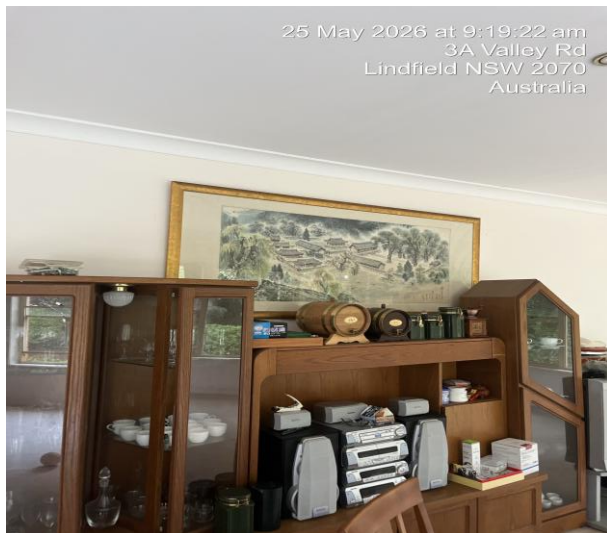
Photo 9 – General view

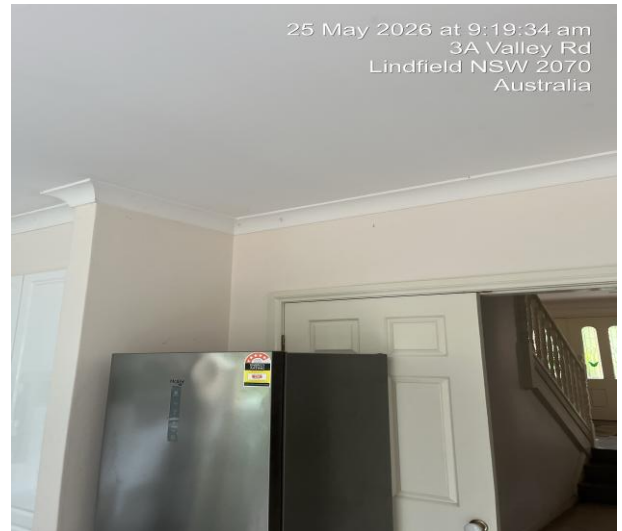
Photo 14 - General view

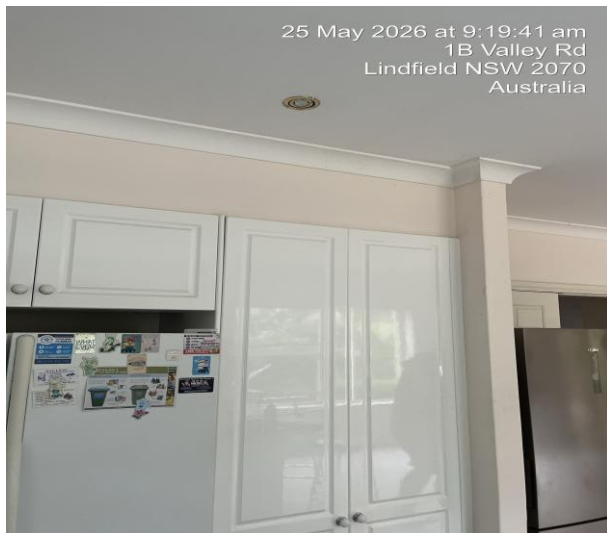
Photo 15 - General view

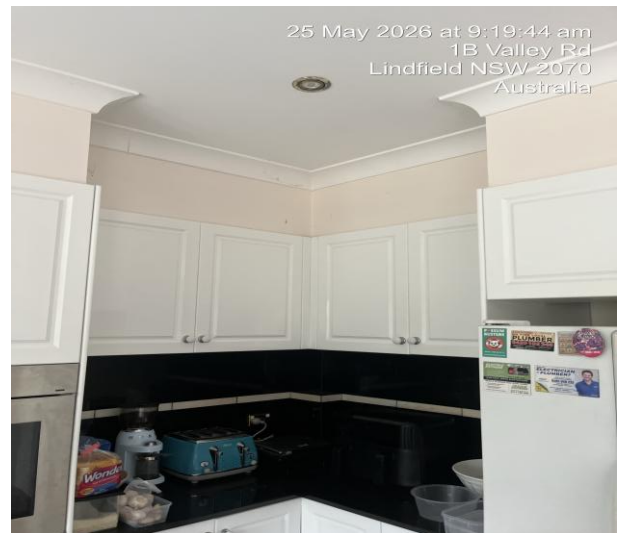
Photo 16 – General view

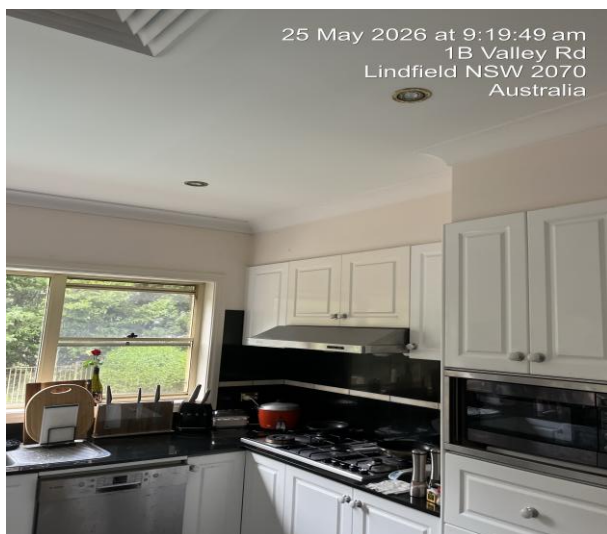
Photo 17 - General view

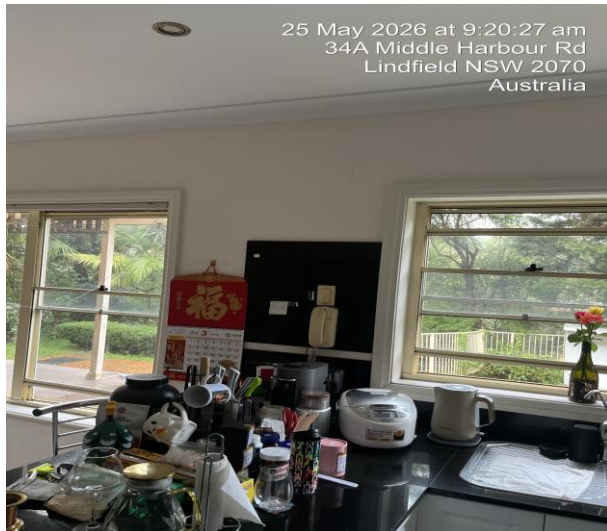
Photo 19 – General view

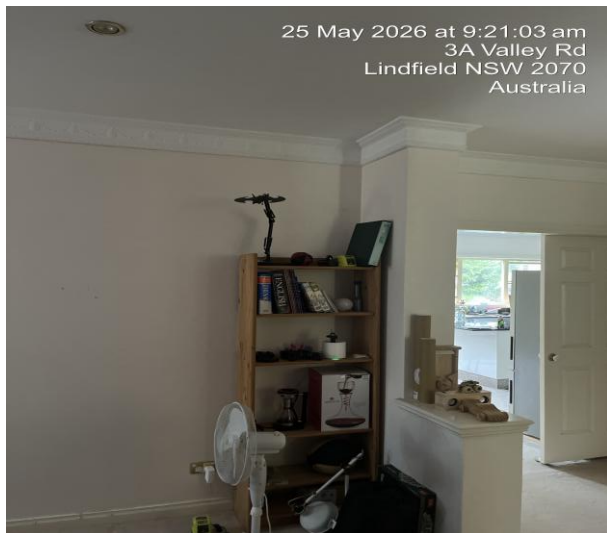
Photo 21 - General view

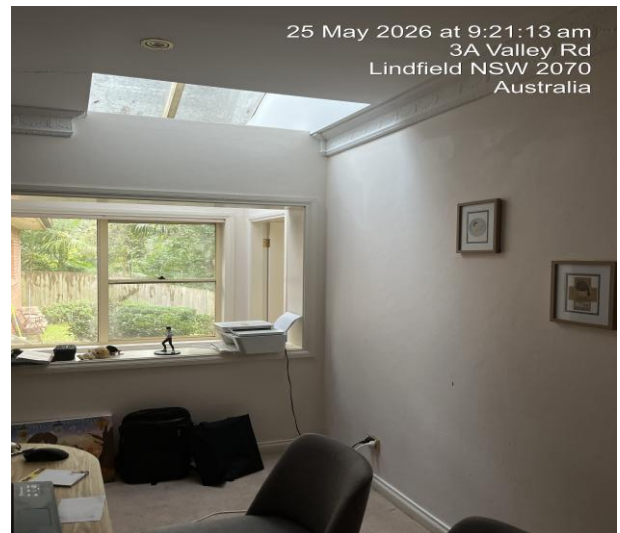
Photo 22 – General view

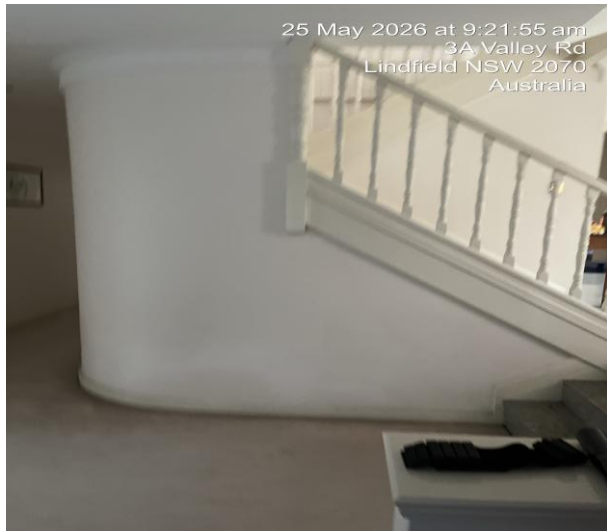
Photo 25 – General view

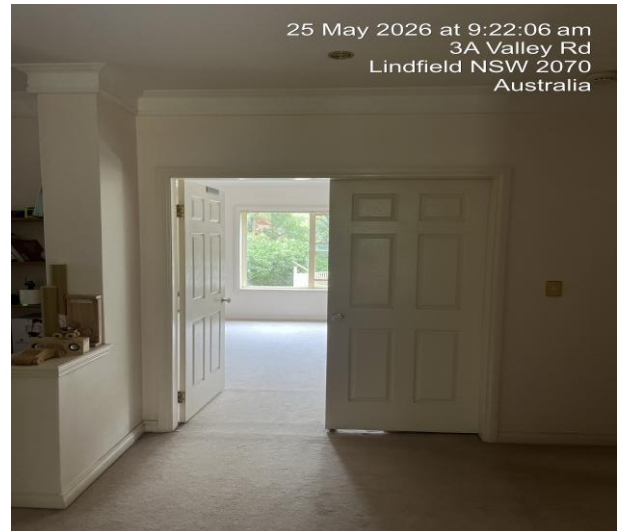
Photo 26 – General view

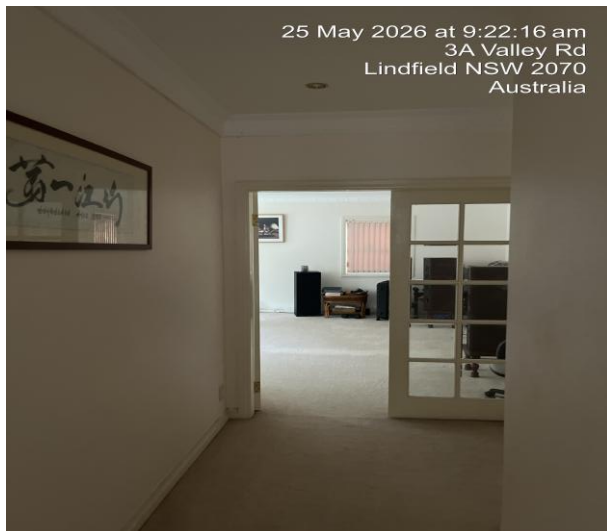
Photo 27 – General view

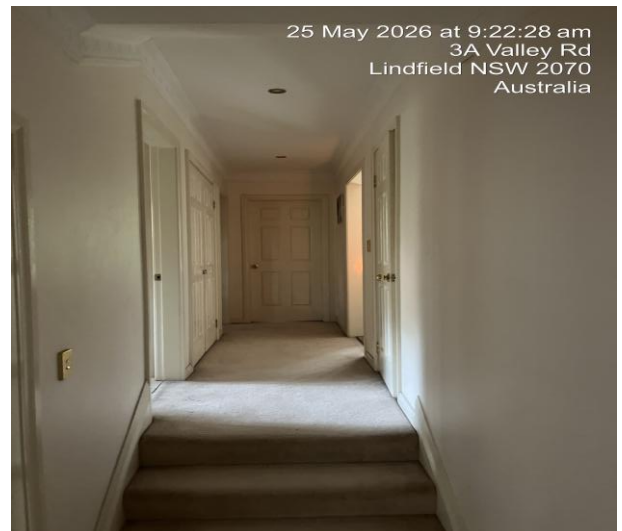
Photo 28 - General view

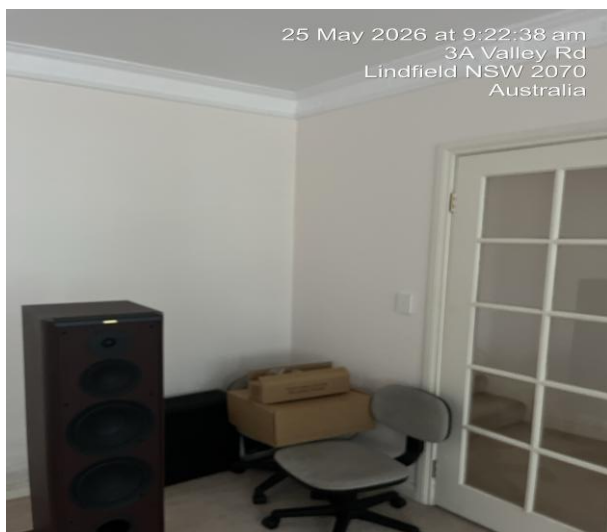
Photo 29 - General view

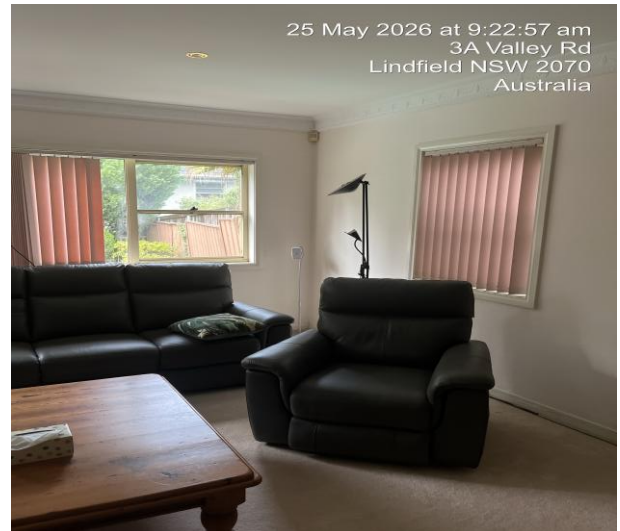
Photo 32 – General view

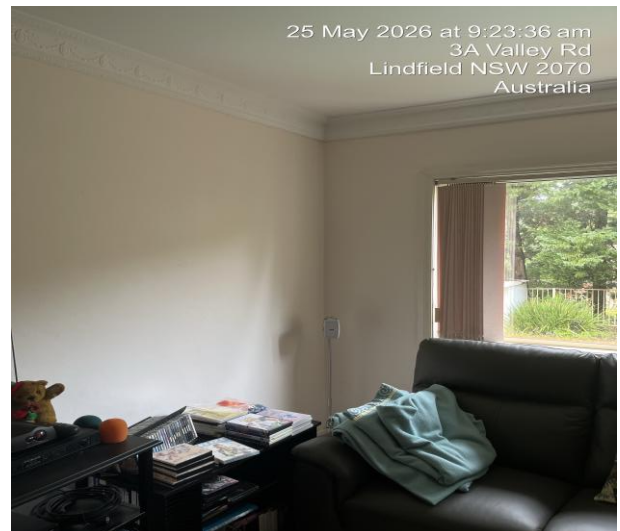
Photo 34 - General view

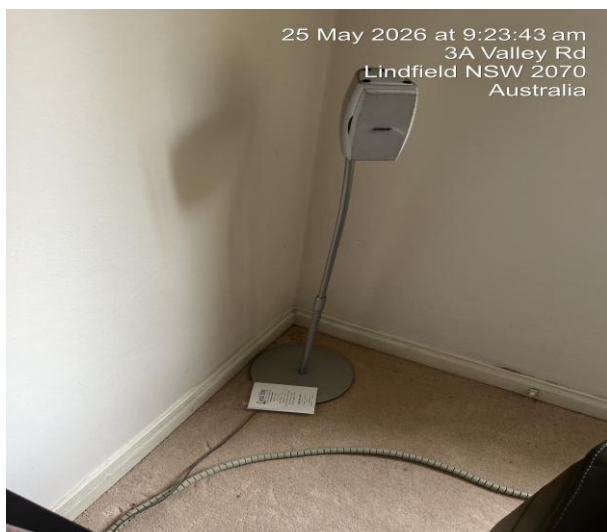
Photo 35 - General view

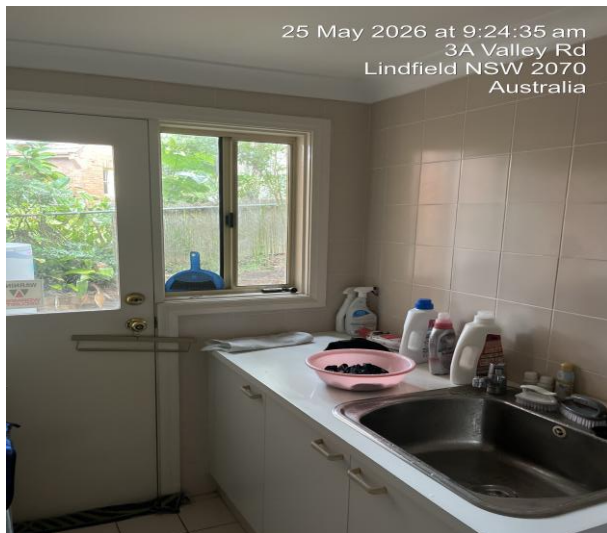
Photo 39 – General view

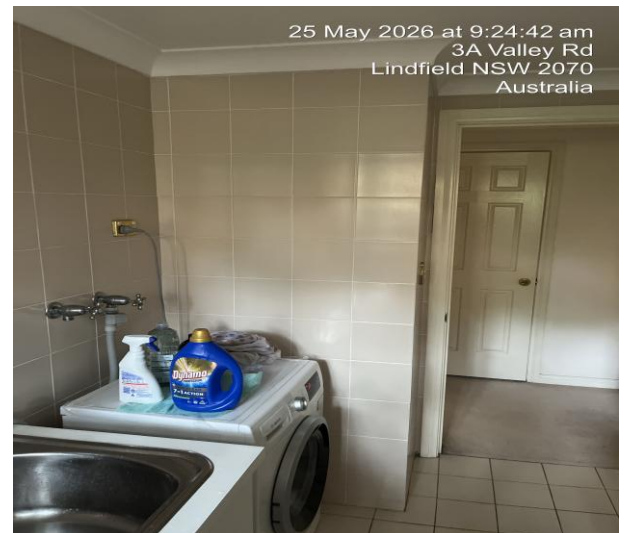
Photo 40 - General view

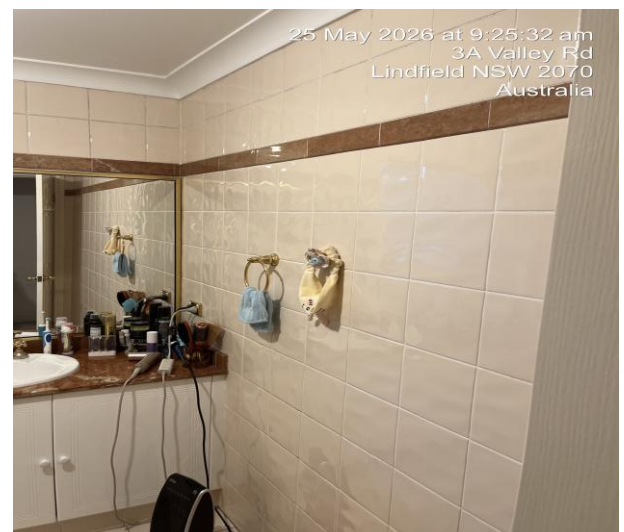
Photo 42 – General view

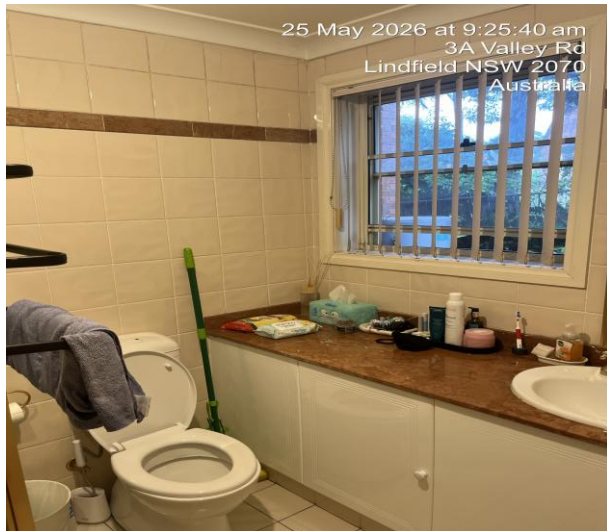
Photo 43 – General view

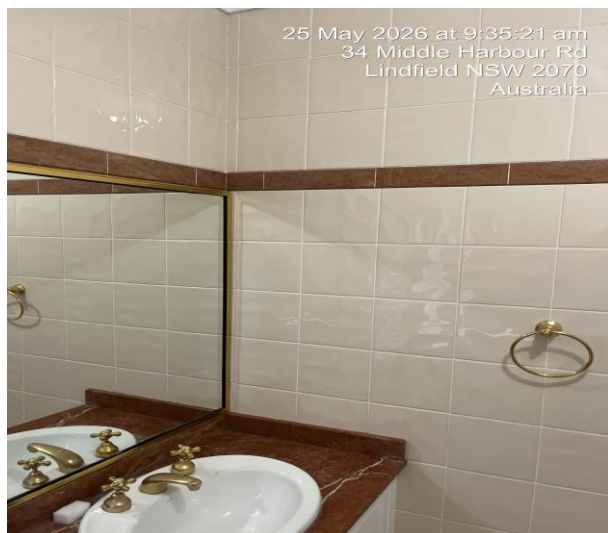
Photo 93 – General view

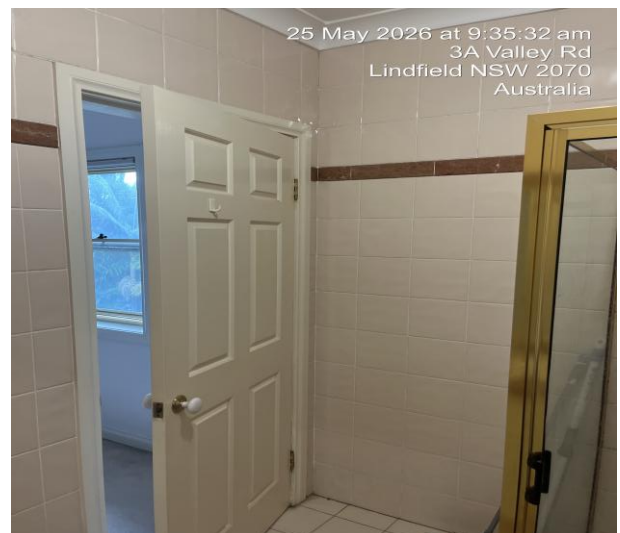
Photo 94 - General view

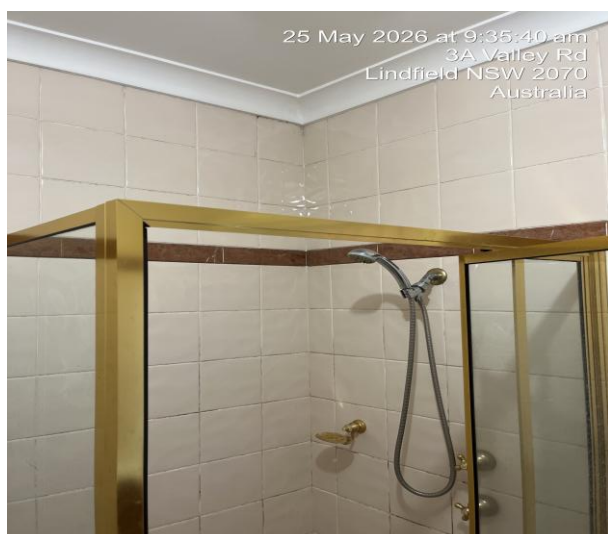
Photo 95 – General view

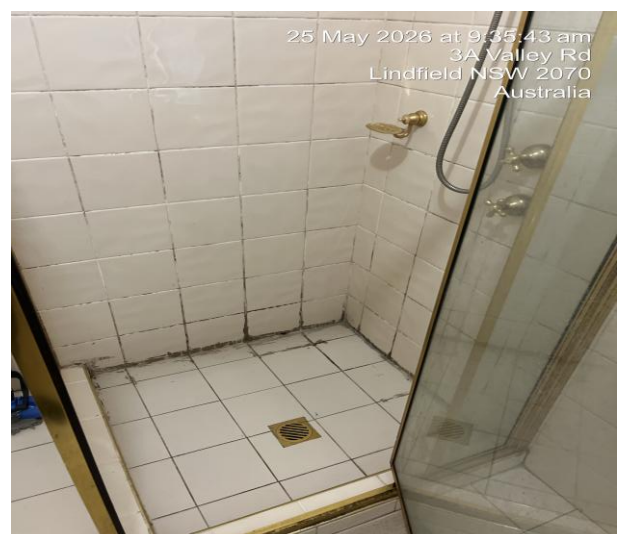
Photo 96 – General view

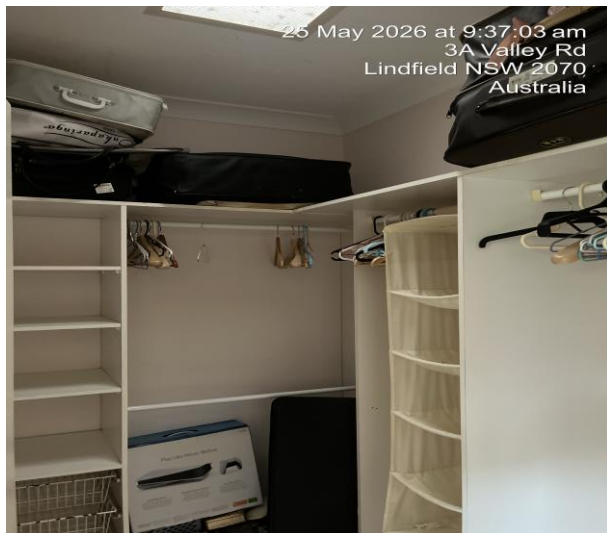
Photo 99 – General view

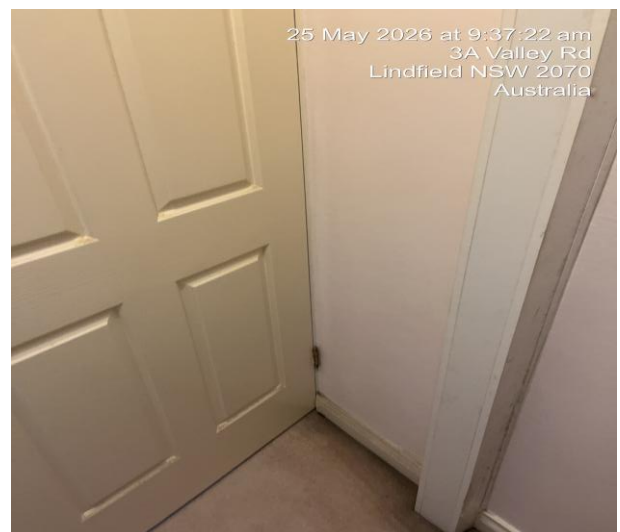
Photo 102 – General view

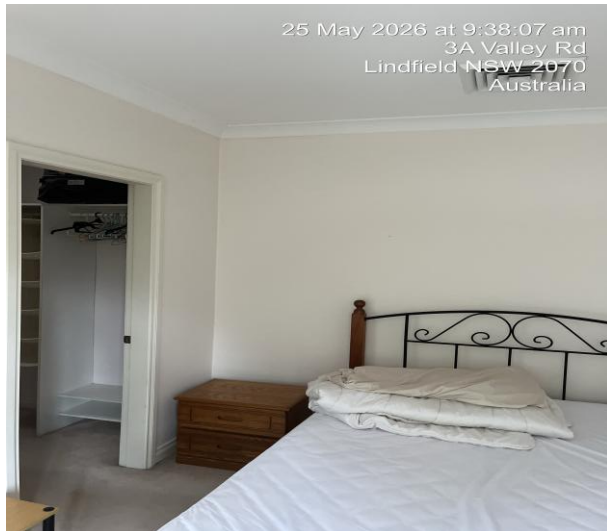
Photo 103 – General view

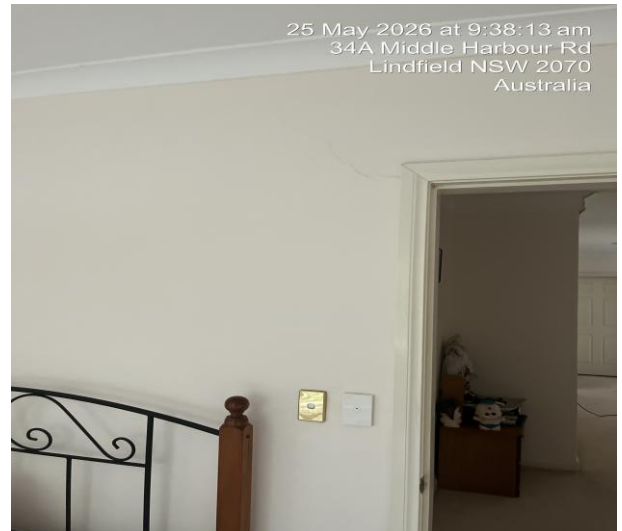
Photo 104 – General view

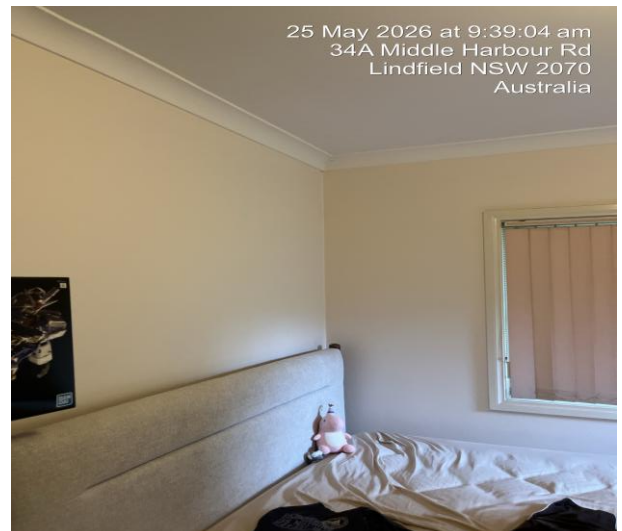
Photo 106 - General view

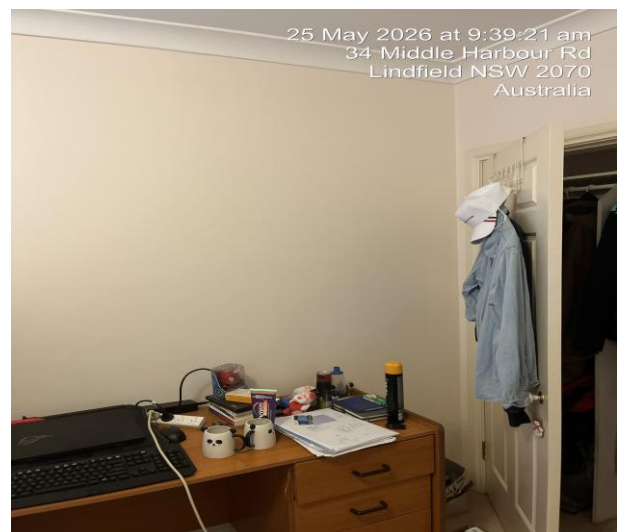
Photo 108 – General view

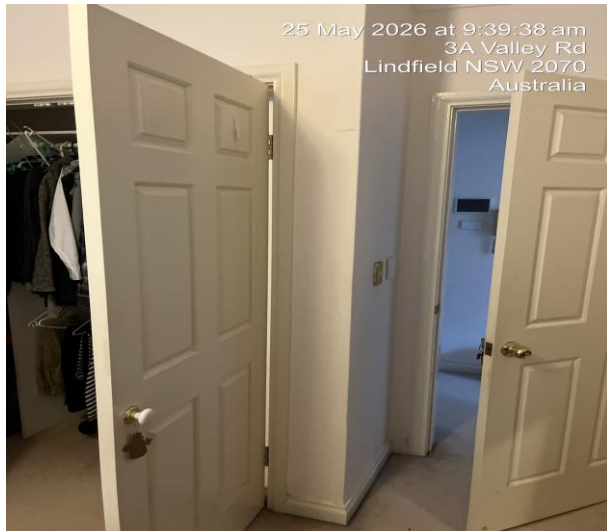
Photo 109 – General view

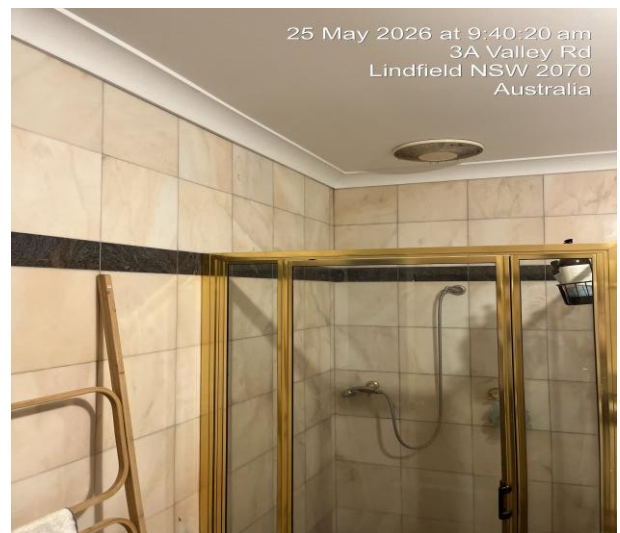
Photo 112 - General view

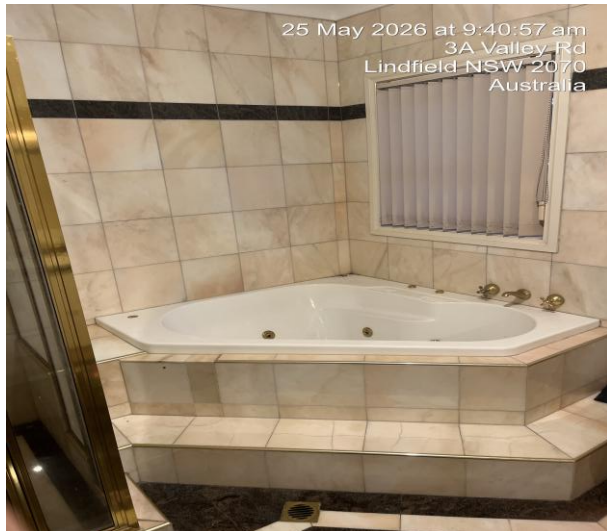
Photo 115 – General view

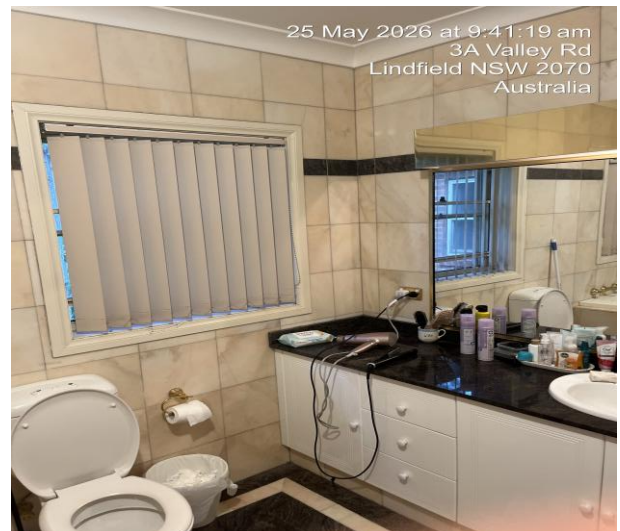
Photo 118 - General view

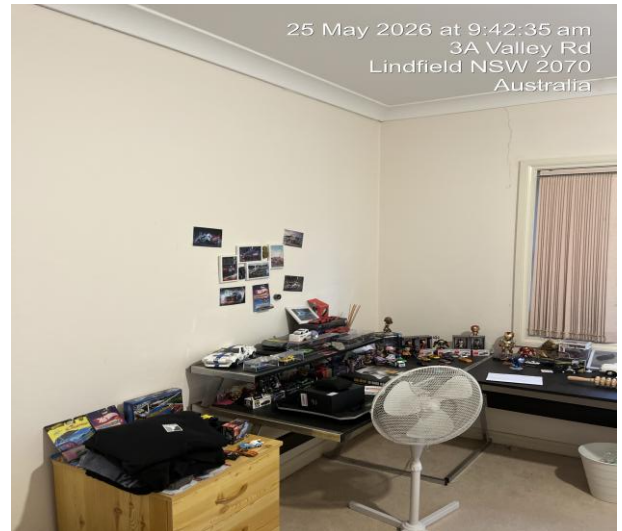
Photo 122 – General view

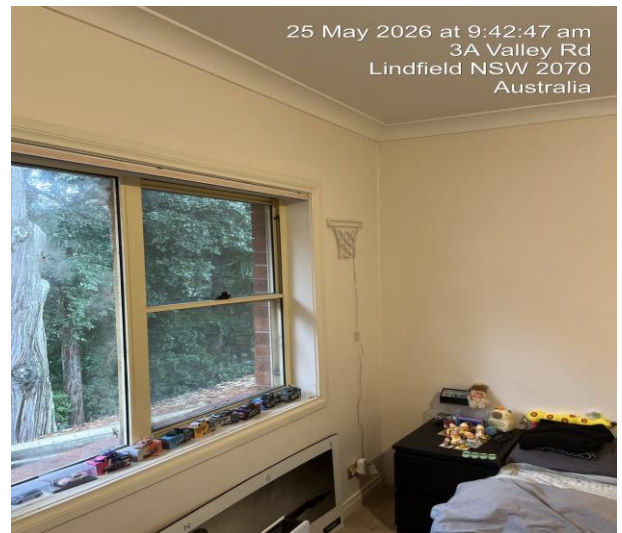
Photo 124 - General view

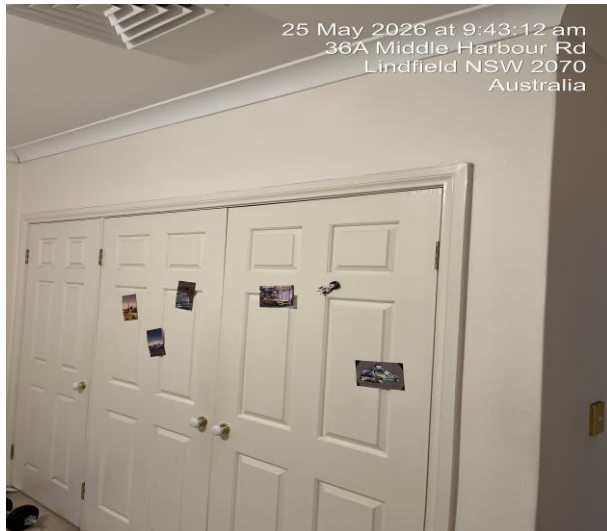
Photo 127 – General view

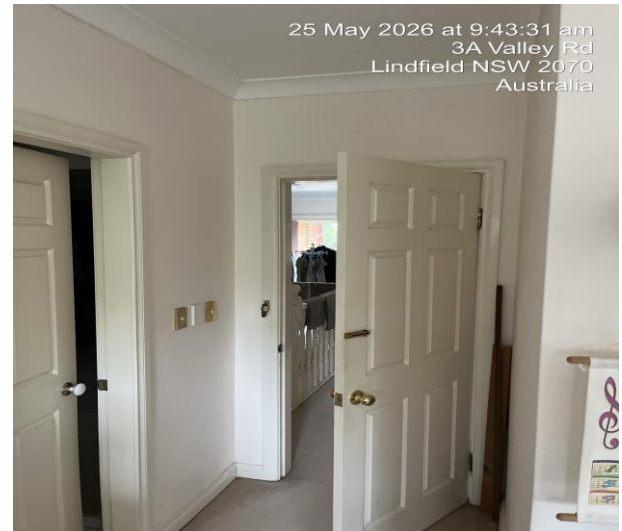
Photo 128 – General view

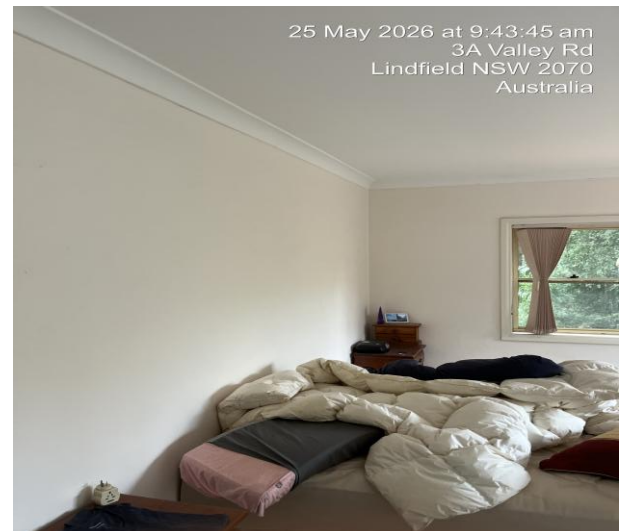
Photo 130 - General view

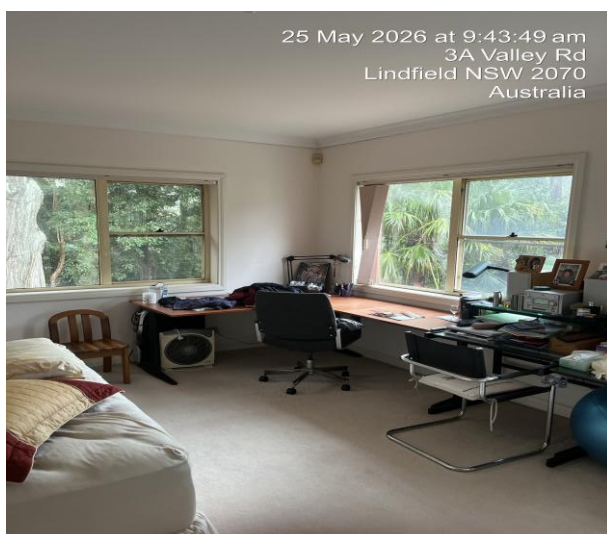
Photo 131 – General view

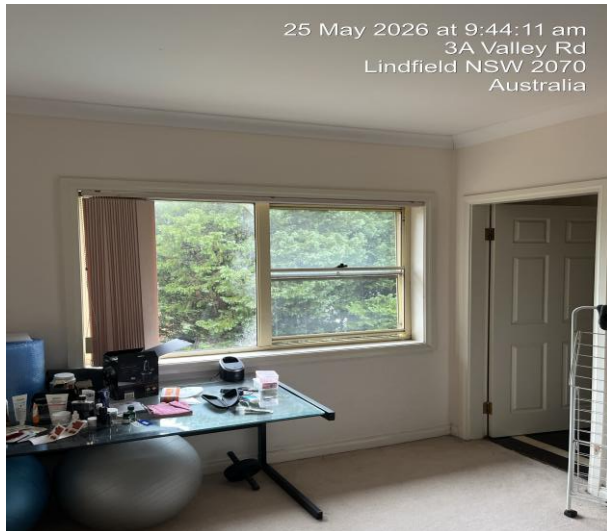
Photo 133 – General view

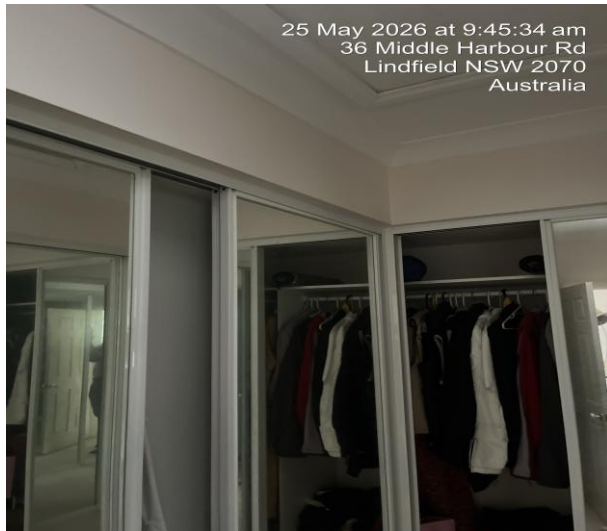
Photo 138 – Cracking observed to ceiling

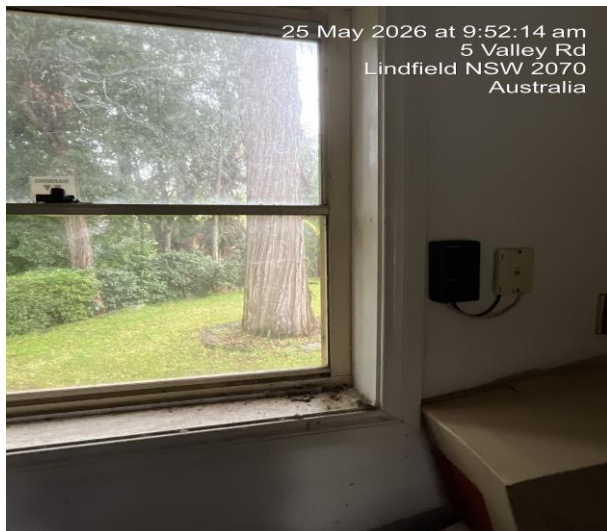
Photo 152 – Cracking observed to coving

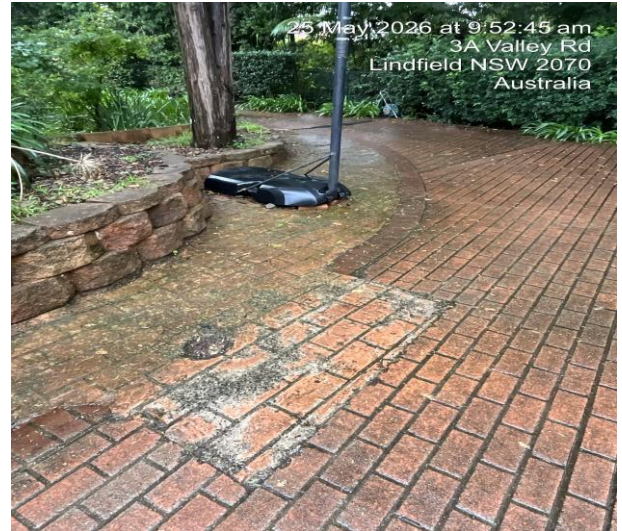
Photo 157 – Cracking observed to paver

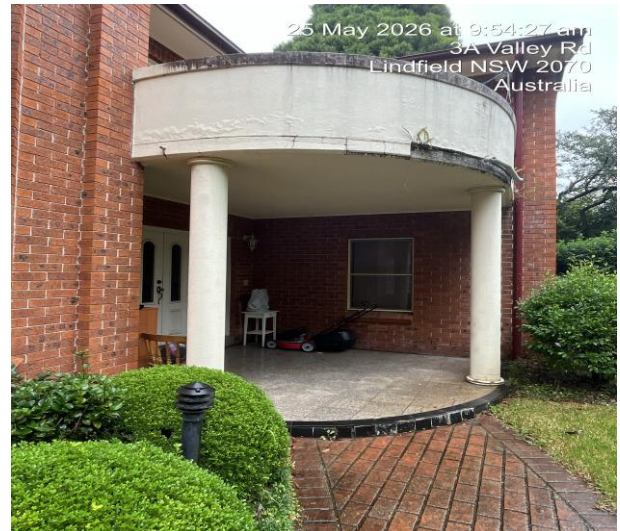
Photo 163 – Mold growth observed to tiling

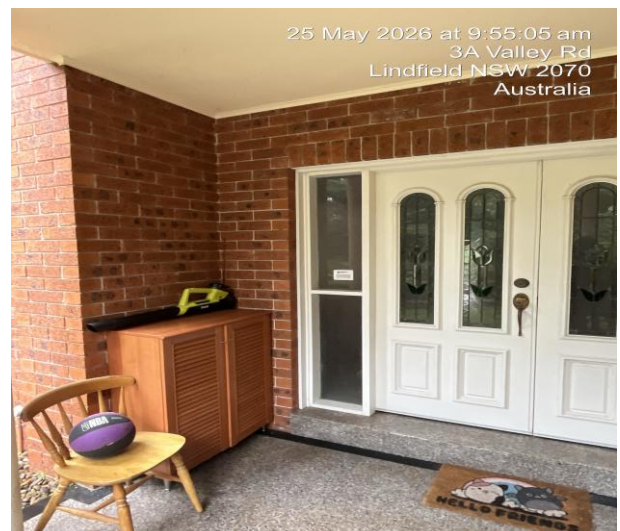
Photo 167 – Cracking and dislodgement observed to tiling

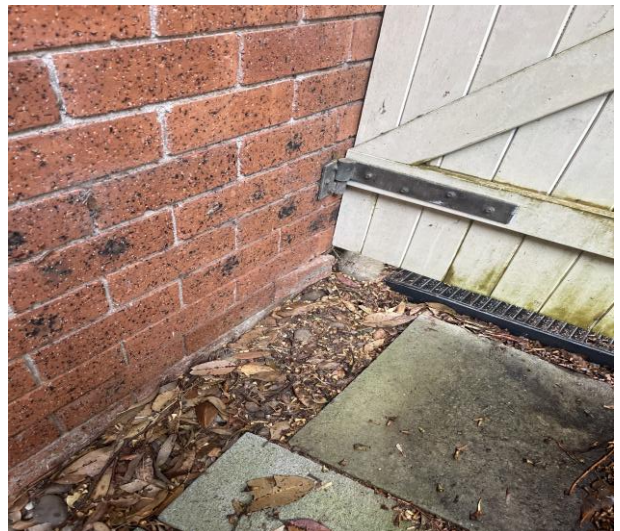
Photo 214 – Dislodged brick observed

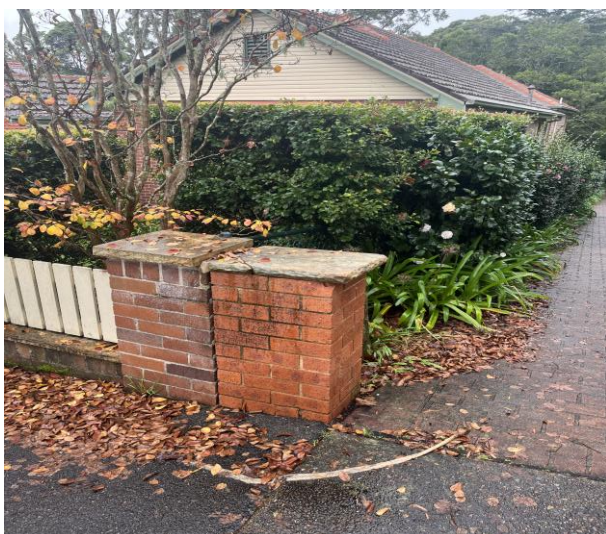
Photo 222 – Cracking observed to stone

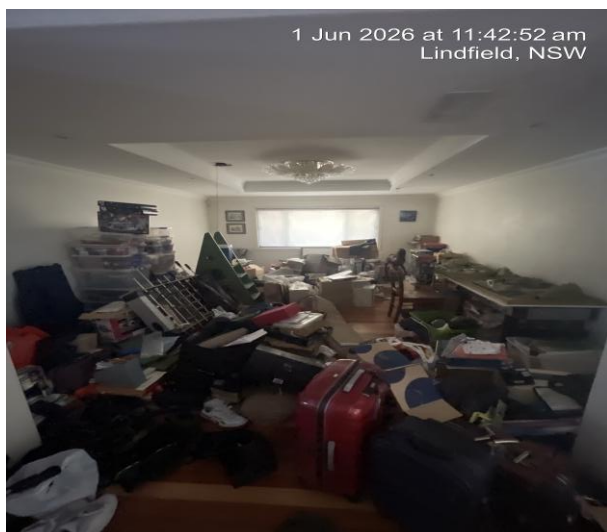
Photo 35 - General view

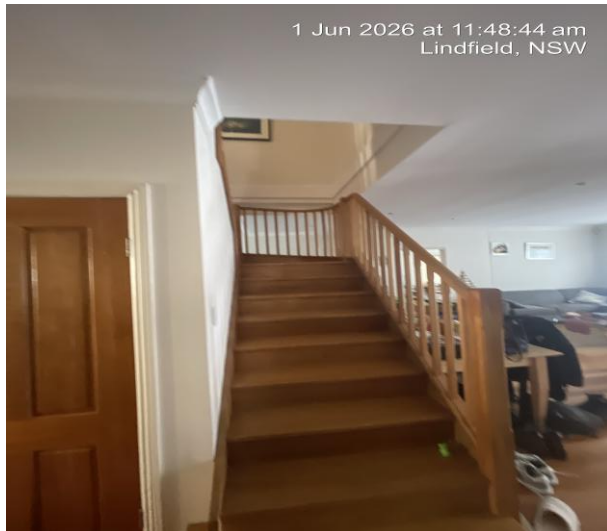
Photo 73 – General view

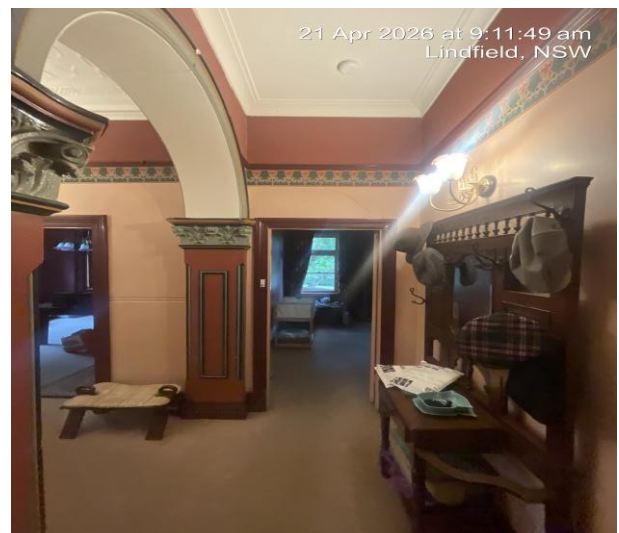
Photo 21 - Cracking observed to archway

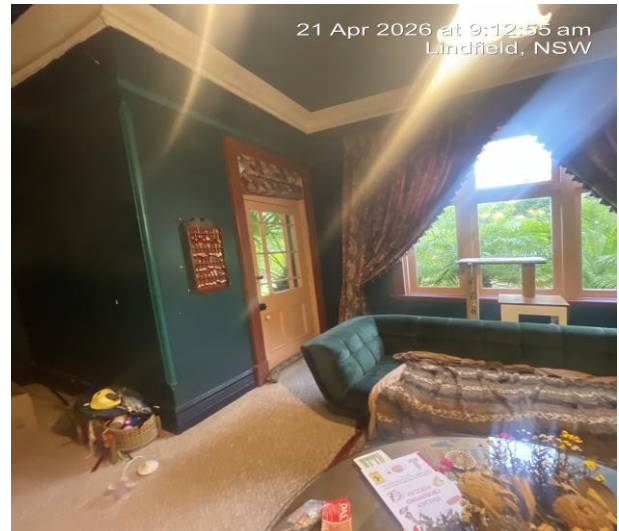
Photo 31 – Cracking observed to wall

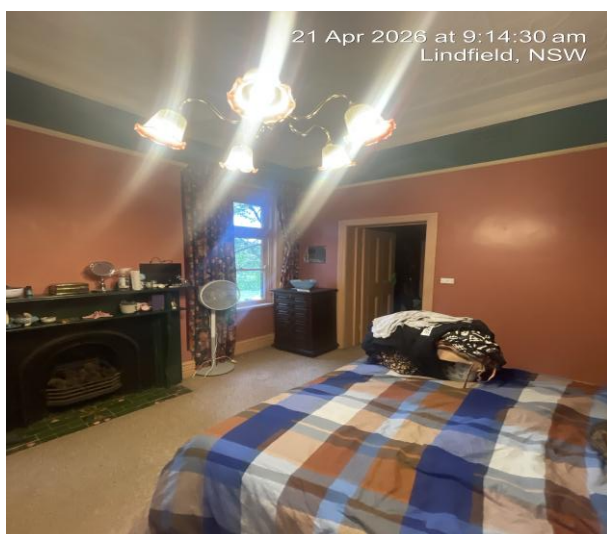
Photo 40 - Cracking observed to wall and coving

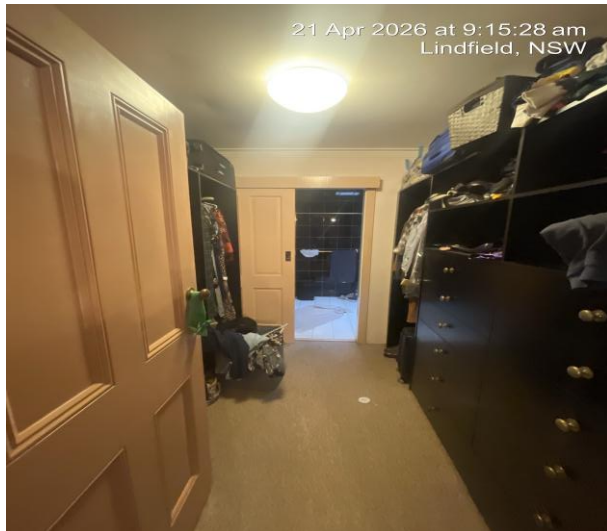
Photo 48 - Cracking observed to wall

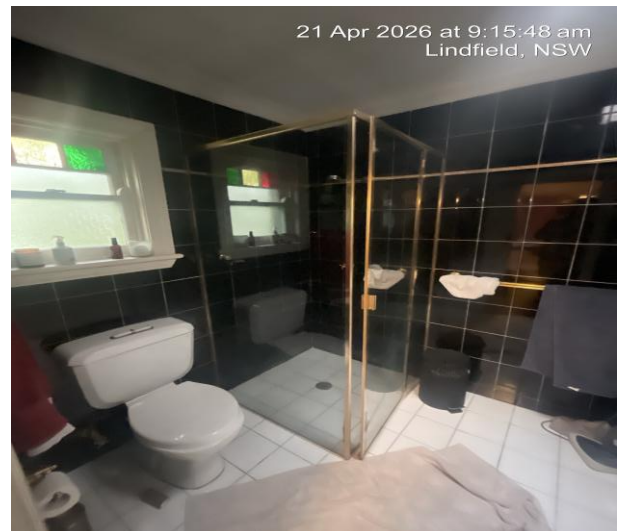
Photo 51 - Cracking observed to wall

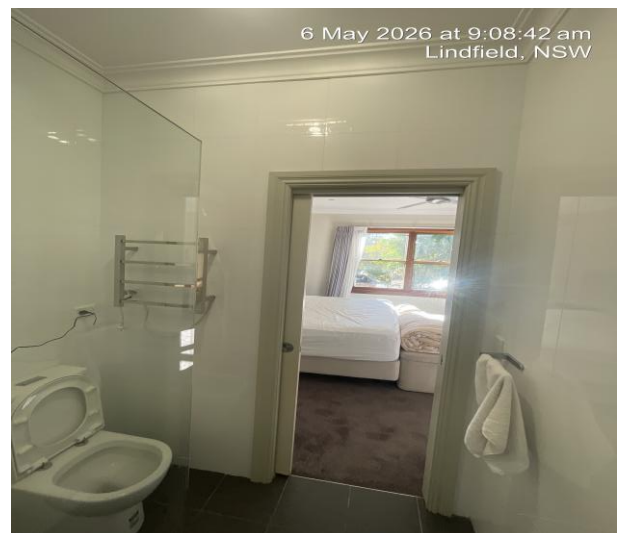
Photo 16 – General view

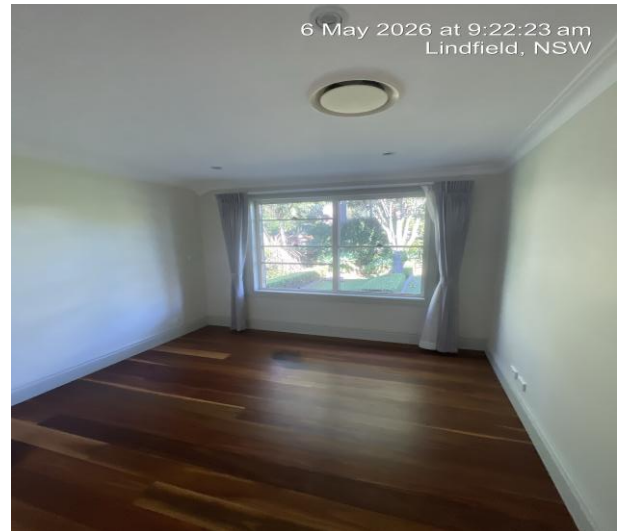
Photo 79 – Movement observed to skirting

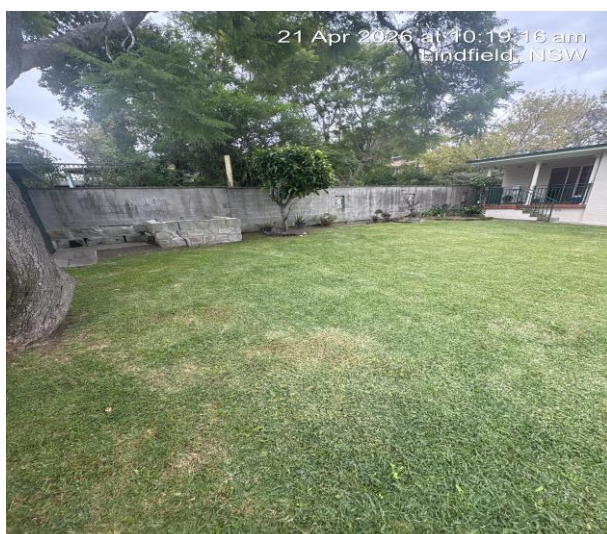
Photo 70 – Cracking observed to stone

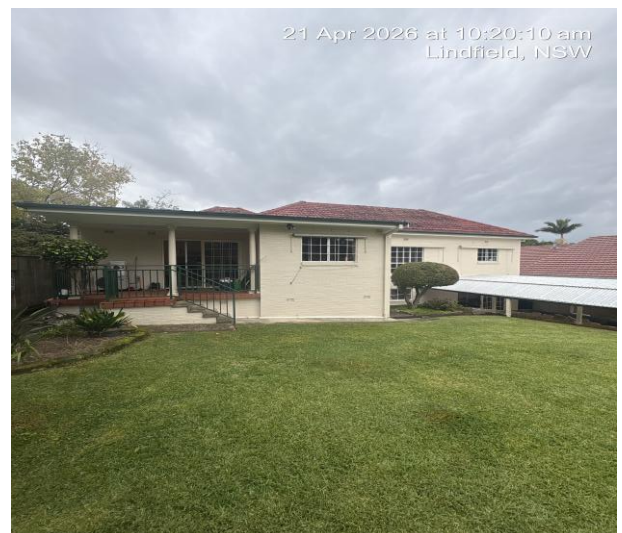
Photo 75 – Cracking observed to mortar

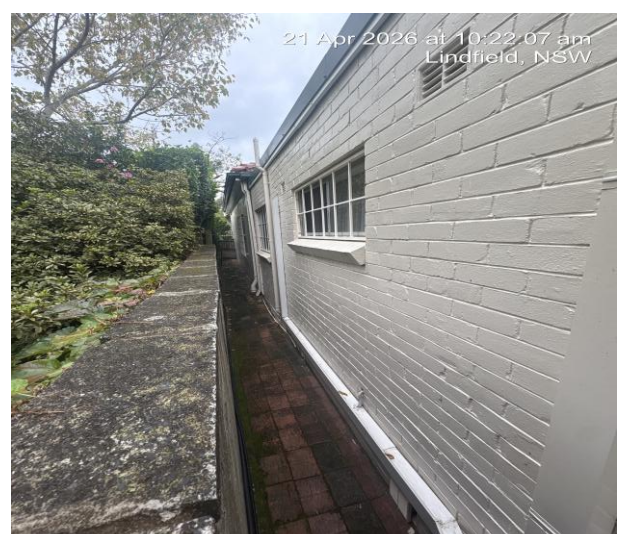
Photo 77 – Cracking observed to wall/floor junction

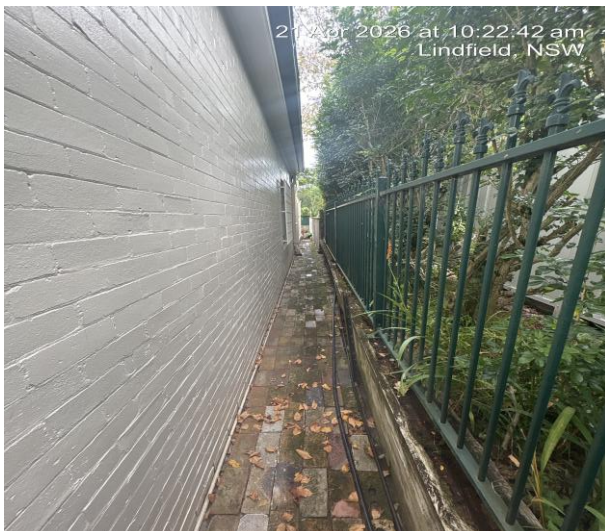
Photo 80 – Cracking observed to mortar

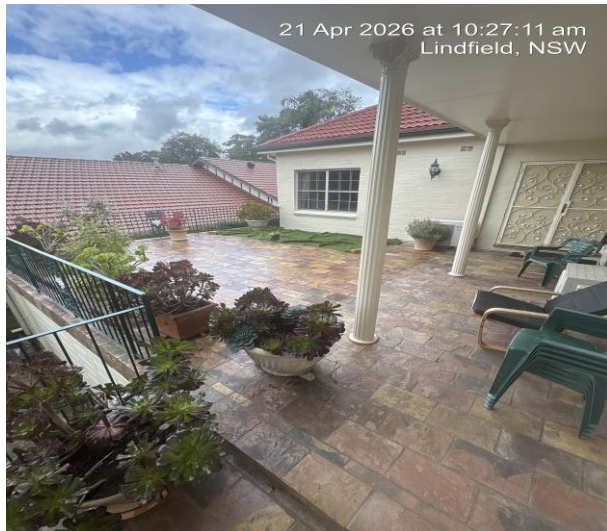
Photo 84 – Cracking observed to mortar

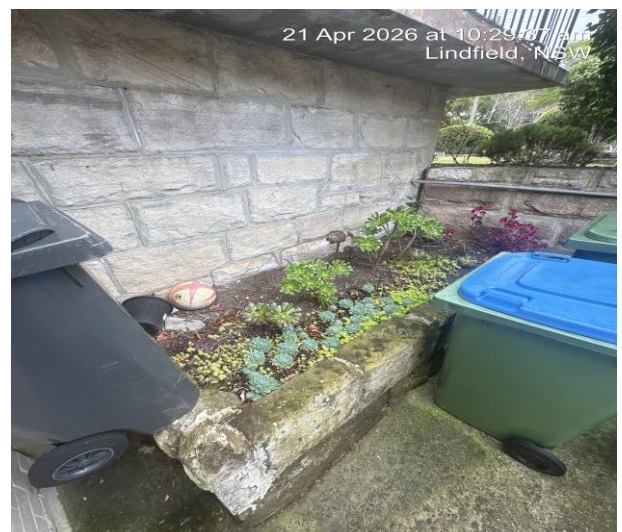
Photo 95 – Cracking observed to mortar

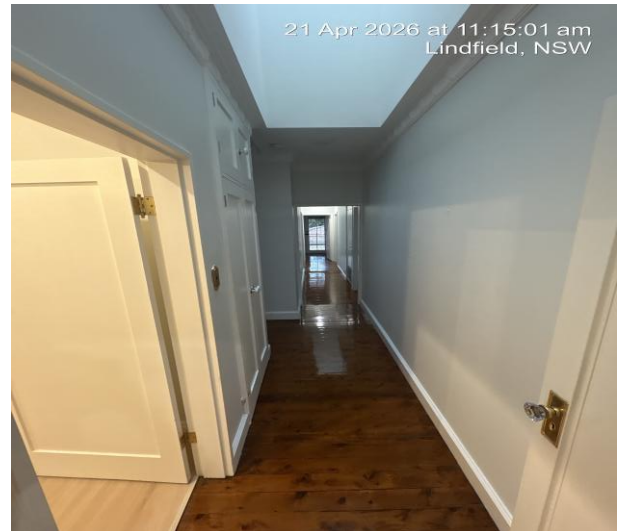
Photo 25 – Cracking observed to wall

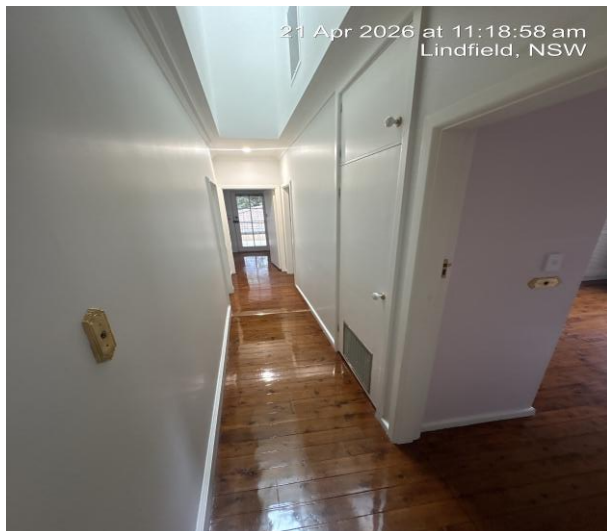
Photo 38 – Cracking observed to ceiling
