# **DILAPIDATION REPORT**

**For Property At  
3A Valley Rd,  
Lindfield, NSW 2070**

**For Development At  
59-63 Trafalgar Ave & 1A-1B Valley Rd,  
Lindfield, NSW 2070**

**Ref: 26009-DR-001-R1-3A Valley Rd  
Date: 25.05.2026**

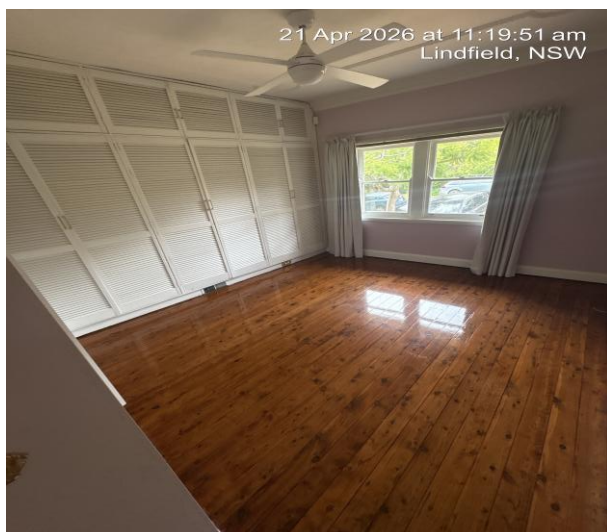
Photo 40 – Cracking observed to ceiling

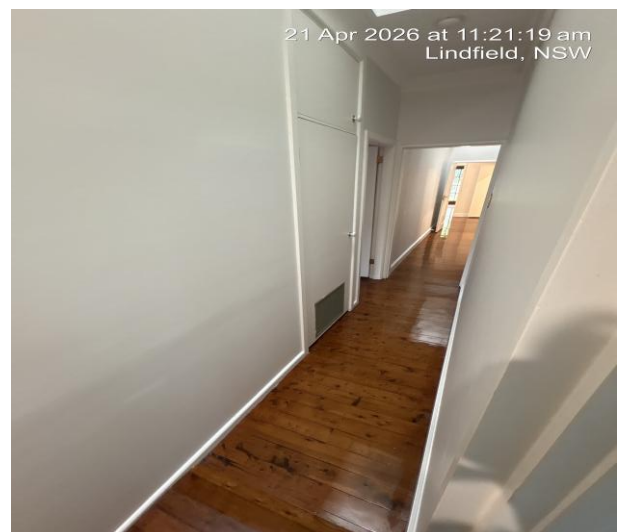
Photo 47 – Cracking observed to coving

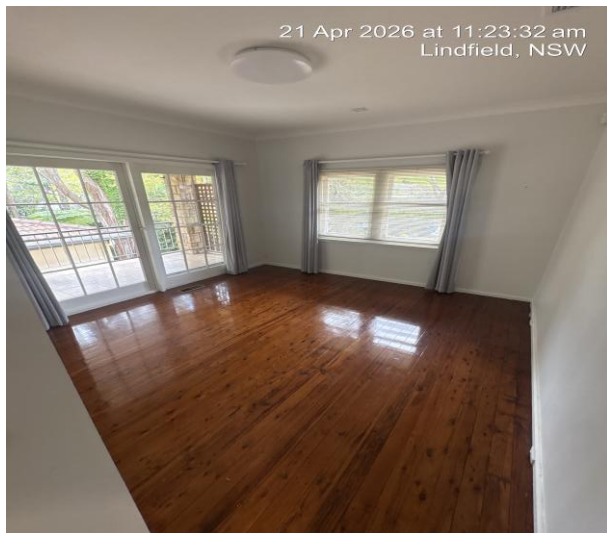
Photo 56 – Cracking observed to coving and ceiling

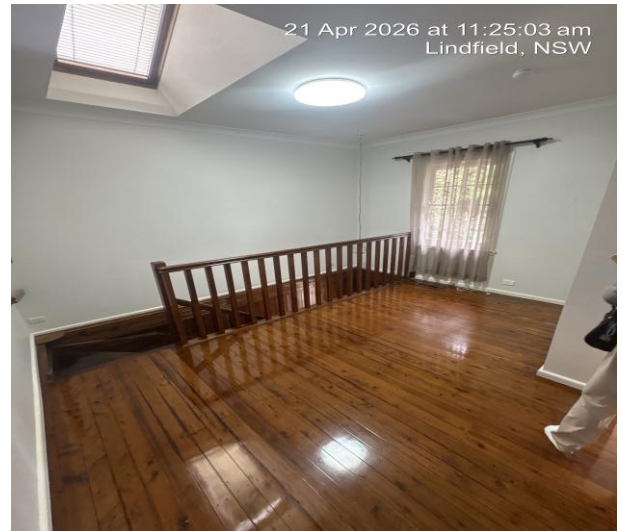
Photo 61 – Vertical cracking observed to wall and coving

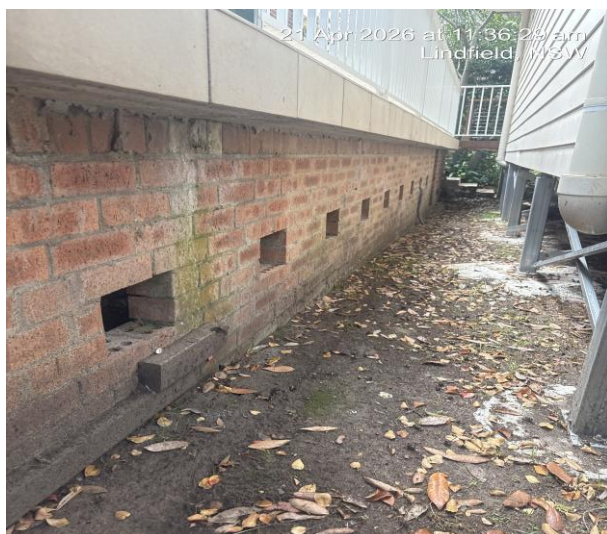
Photo 94 – Cracking observed to mortar

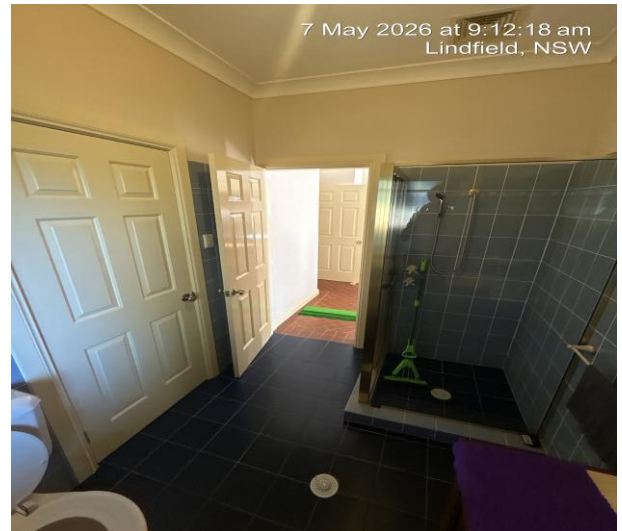
Photo 39 – Cracking observed to wall
