96-104 Carlingford Road, Epping NSW 2121

Epping West Public School

DILAPIDATION REPORT

7<sup>th</sup> September 2021

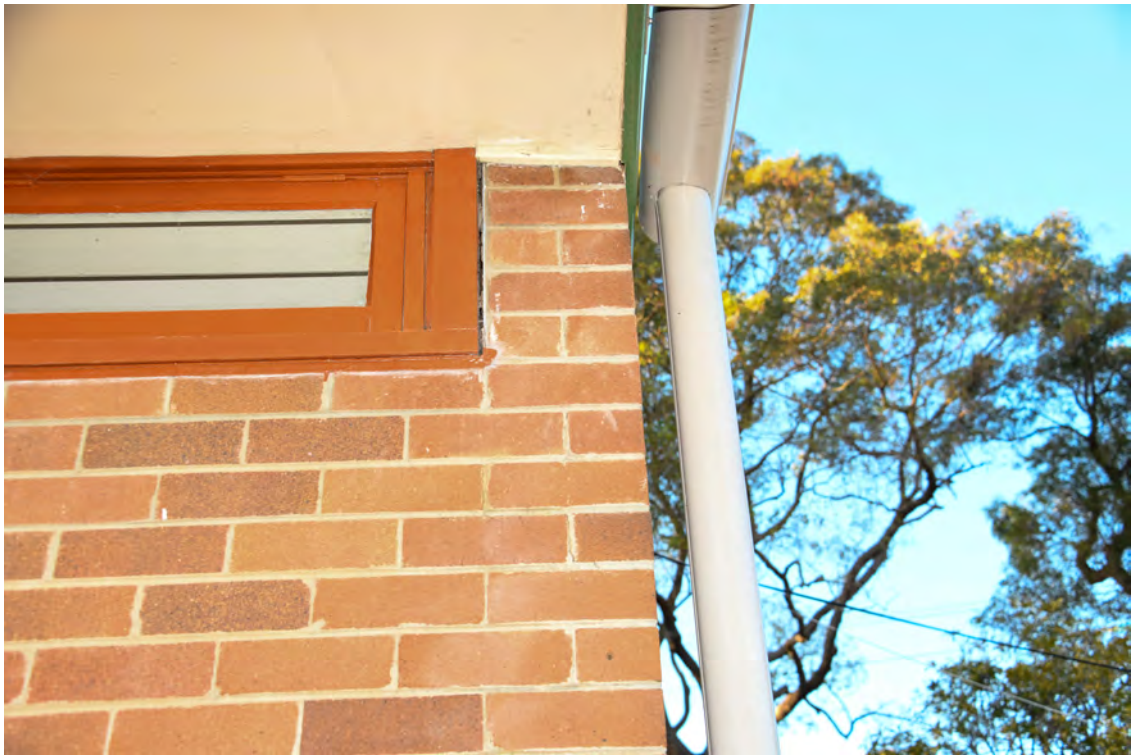
PRO\_0005.jpg

Block H. Northern elevation. Heading east. Gap between the brickwork and the window framing.

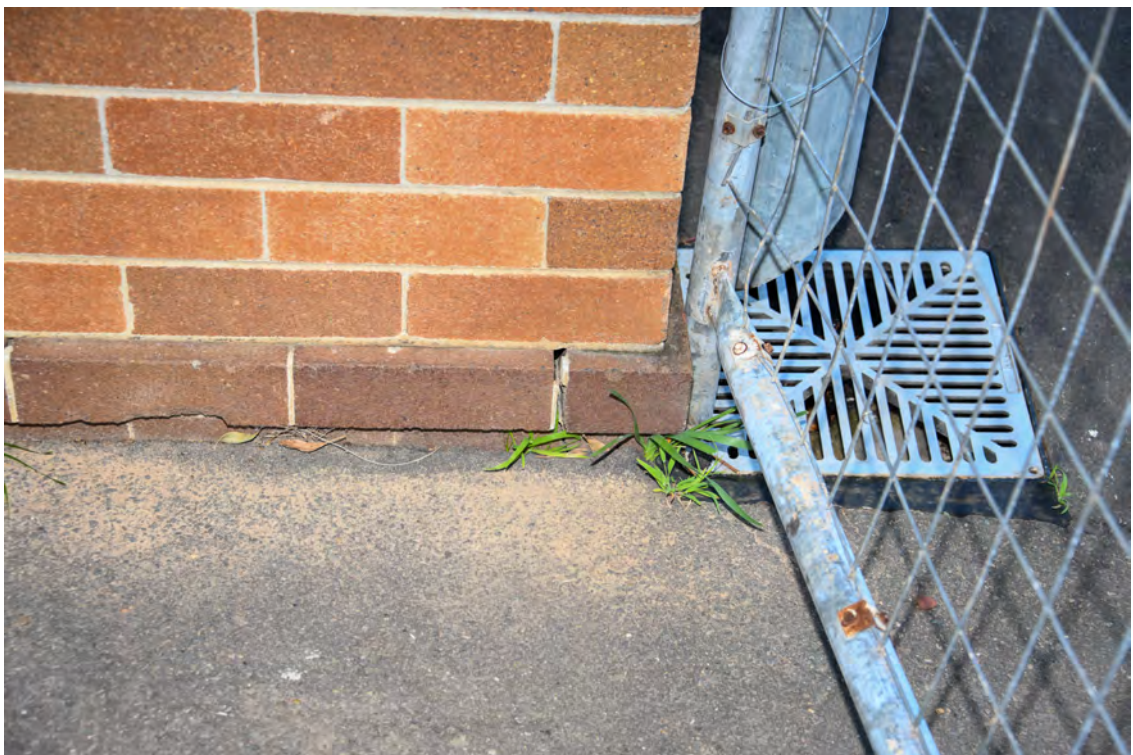
PRO\_0006.jpg

Block H. Northern elevation. Heading east. Movement to the brick on the lower brick course.

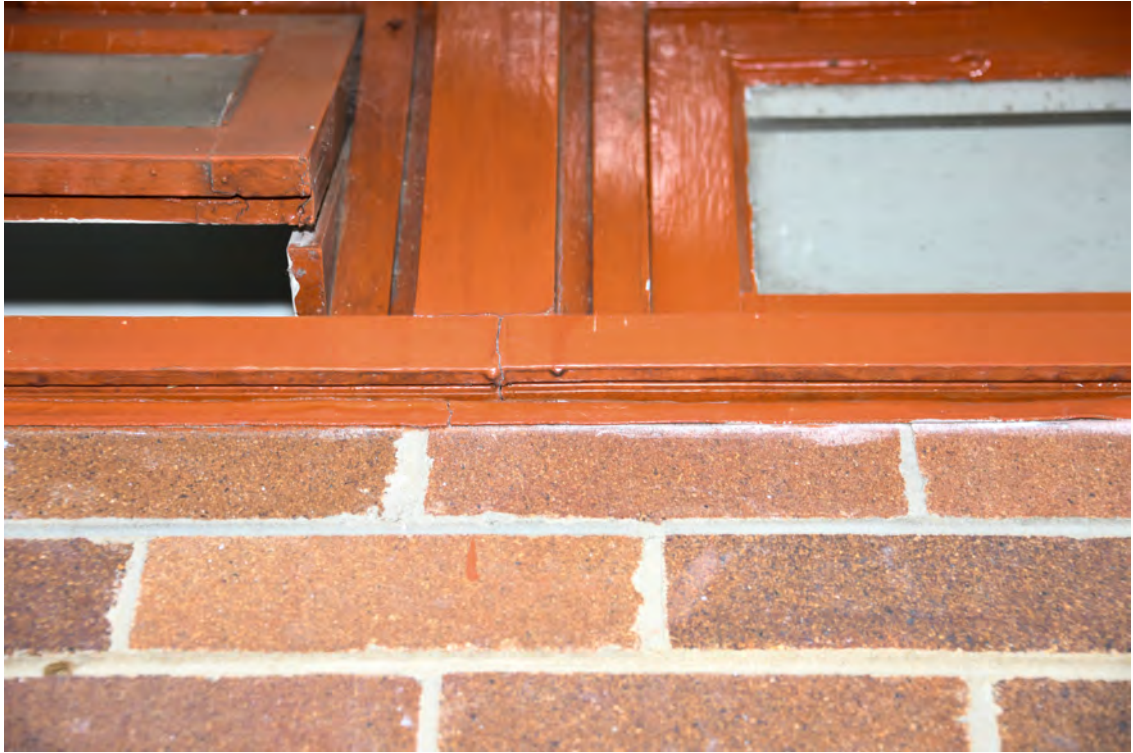
PRO\_0009.jpg

Block H. Northern elevation. Heading east. Movement in window framing.

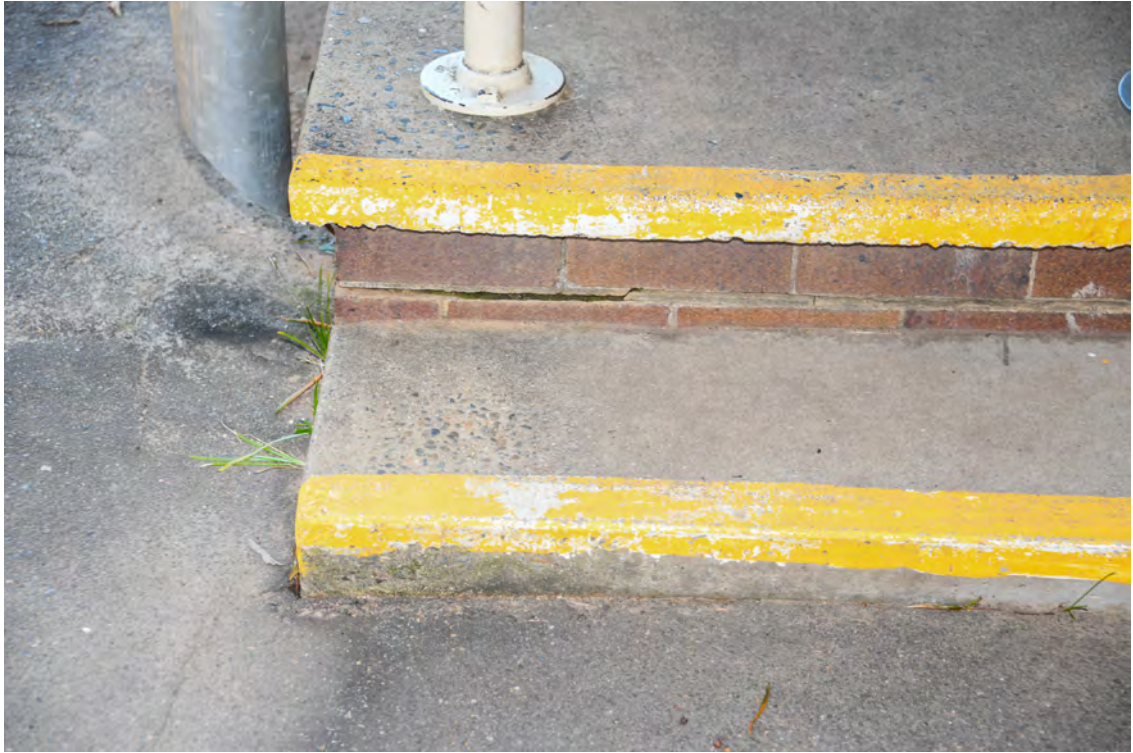
PRO\_0011.jpg

Block H. Northern elevation. Heading east. Eastern set of doors. Movement to the brick tread.

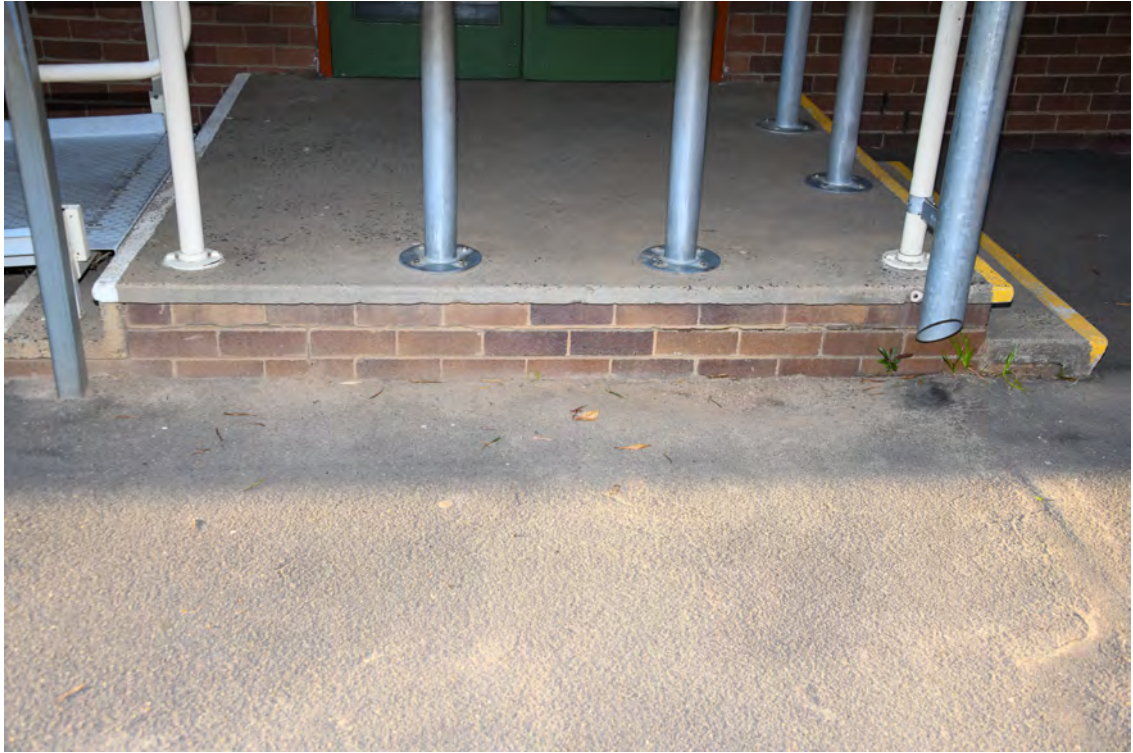
PRO\_0013.jpg

Block H. Northern elevation. Western stairs. Movement to the brickwork.

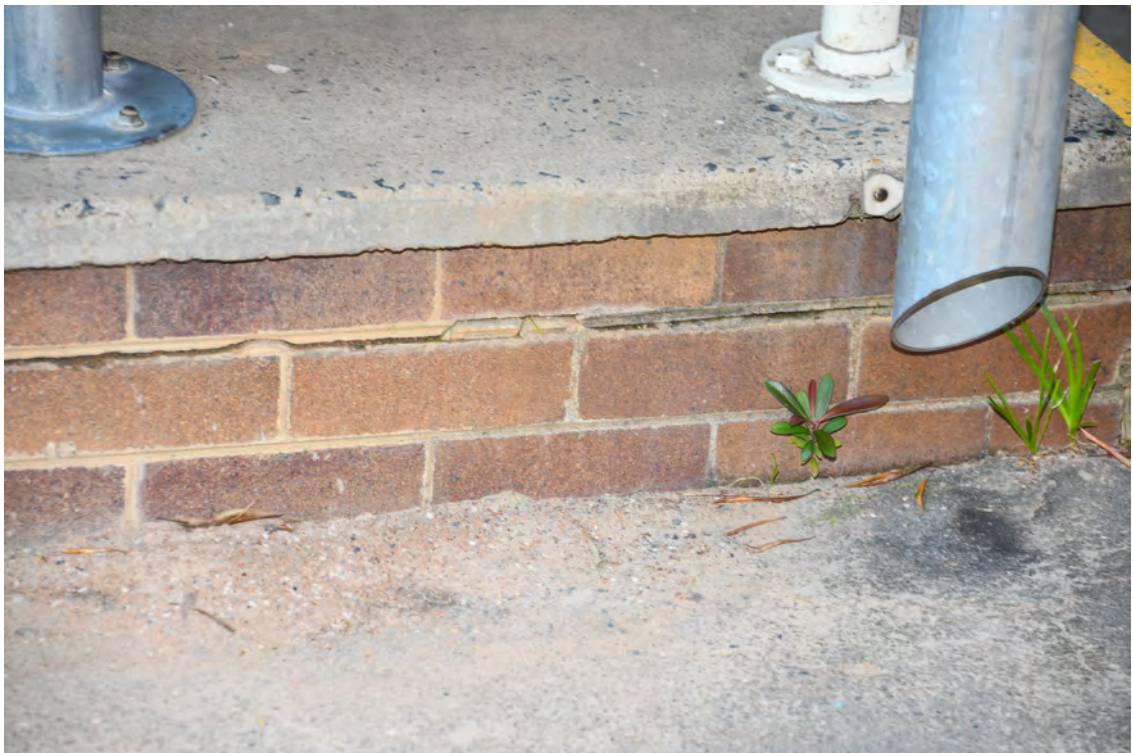
PRO\_0014.jpg

Block H. Northern elevation. Western stairs. Movement to the brickwork.

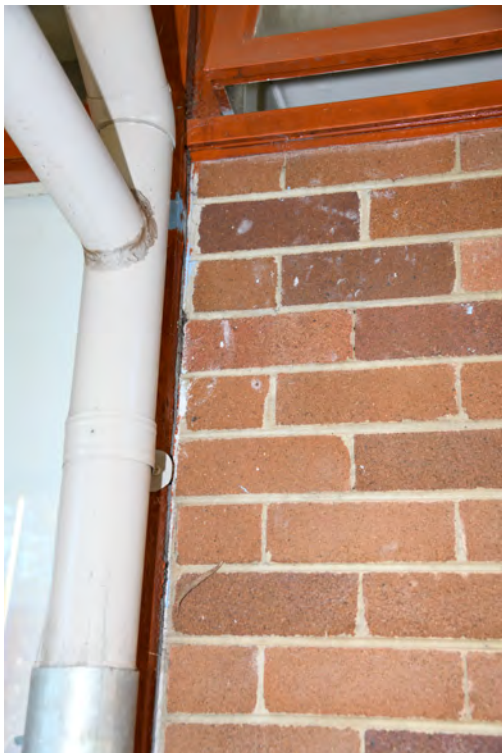
PRO\_0018.jpg

Block H. Northern elevation. Western end. Heading east. Control joint in the brickwork.

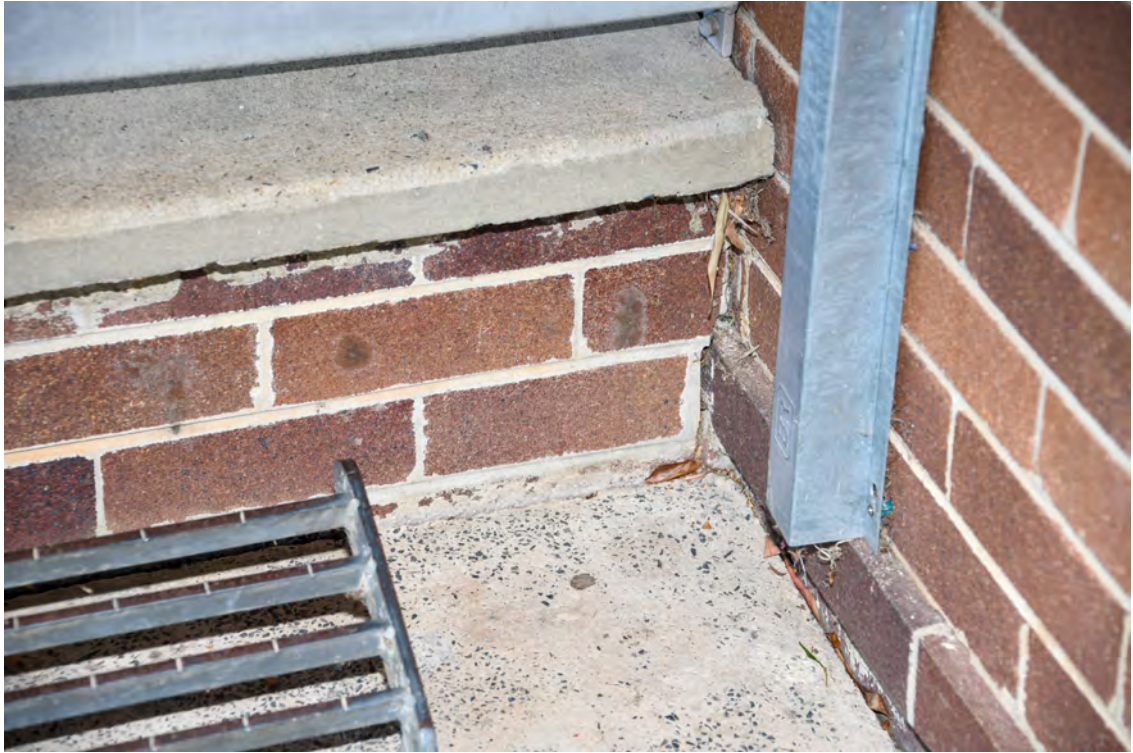
PRO\_0035.jpg

Block H. Northern elevation. Eastern entry. Movement to the brickwork.

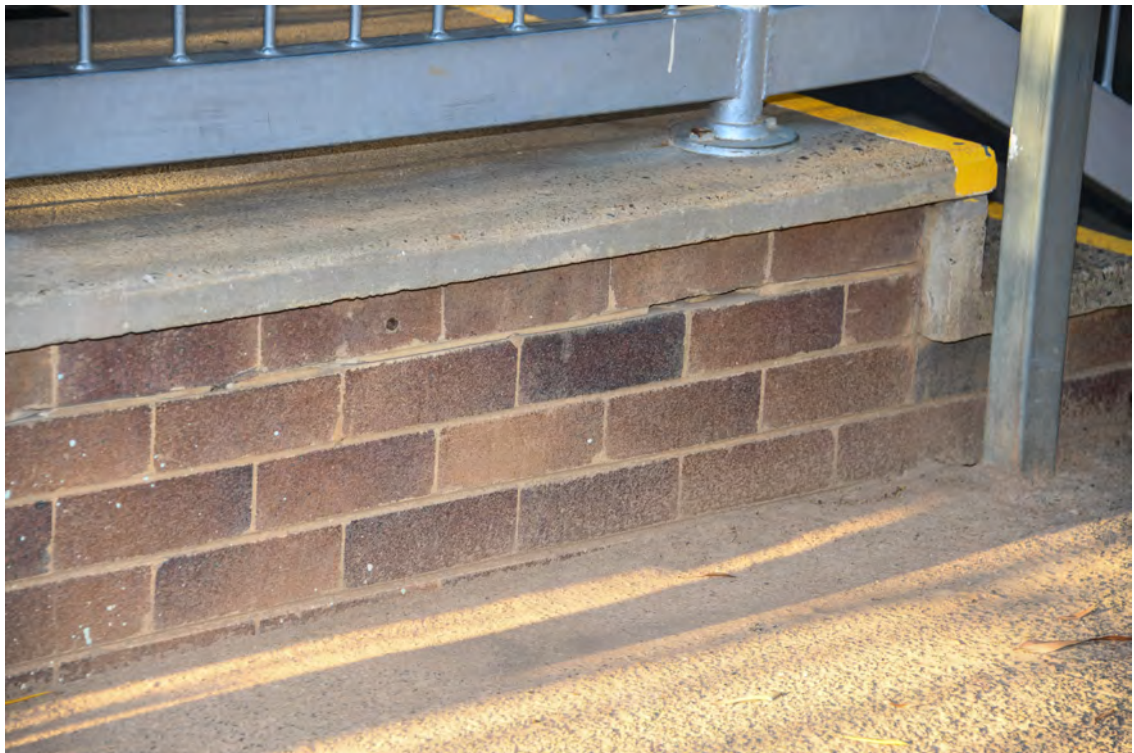
PRO\_0040.jpg

Block H. Northern elevation. Eastern entry. Eroded mortar beds.

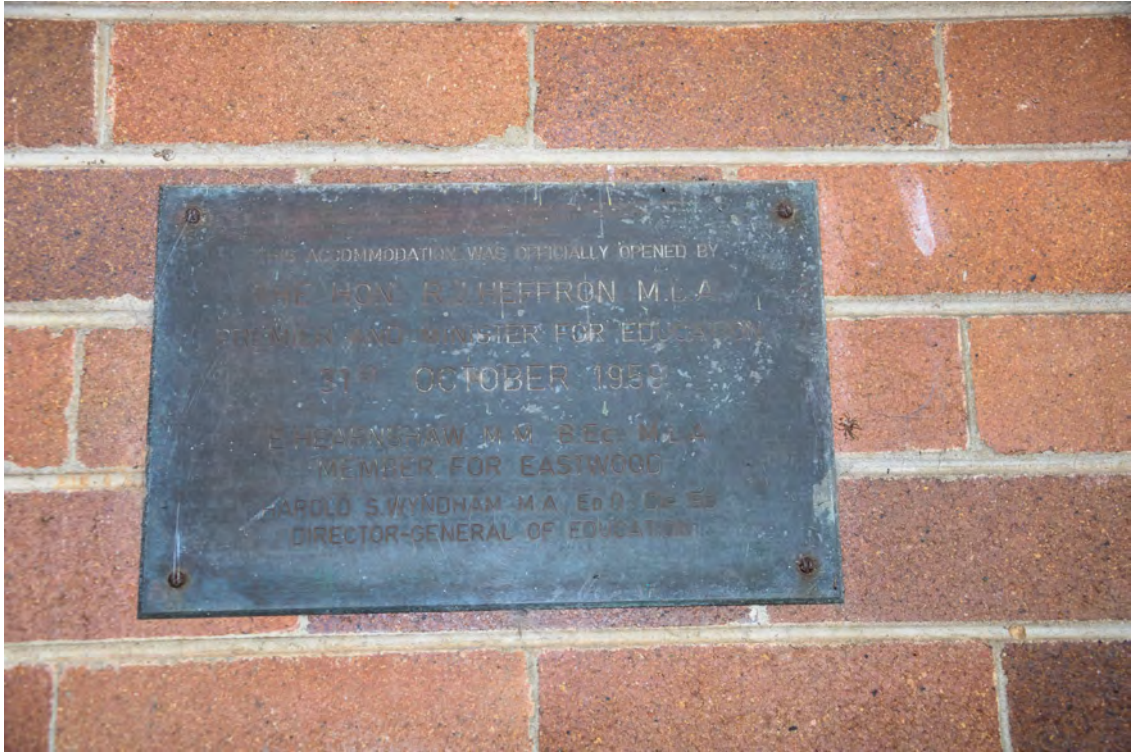
PRO\_0055.jpg

Block H. Southern elevation fronting Carlingford Road. Heading west. Eastern building entry. Cracked concrete landing.

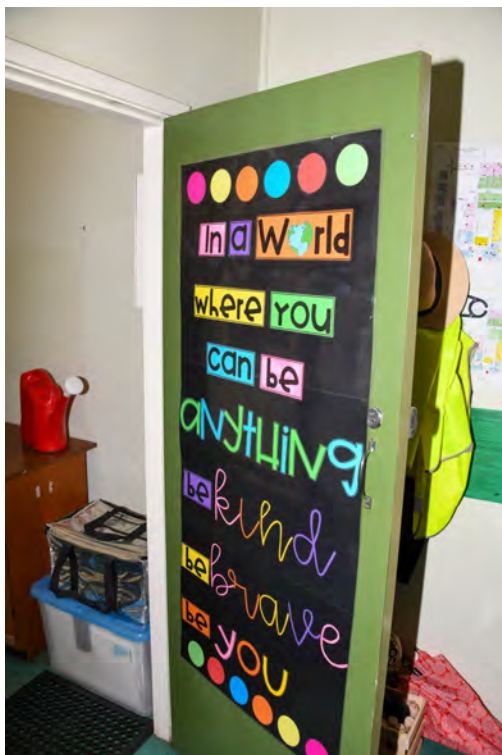
PRO\_0479.jpg

Block H. Interior. Eastern end. Foyer. Eastern face. Crack stemming out from the doorway.

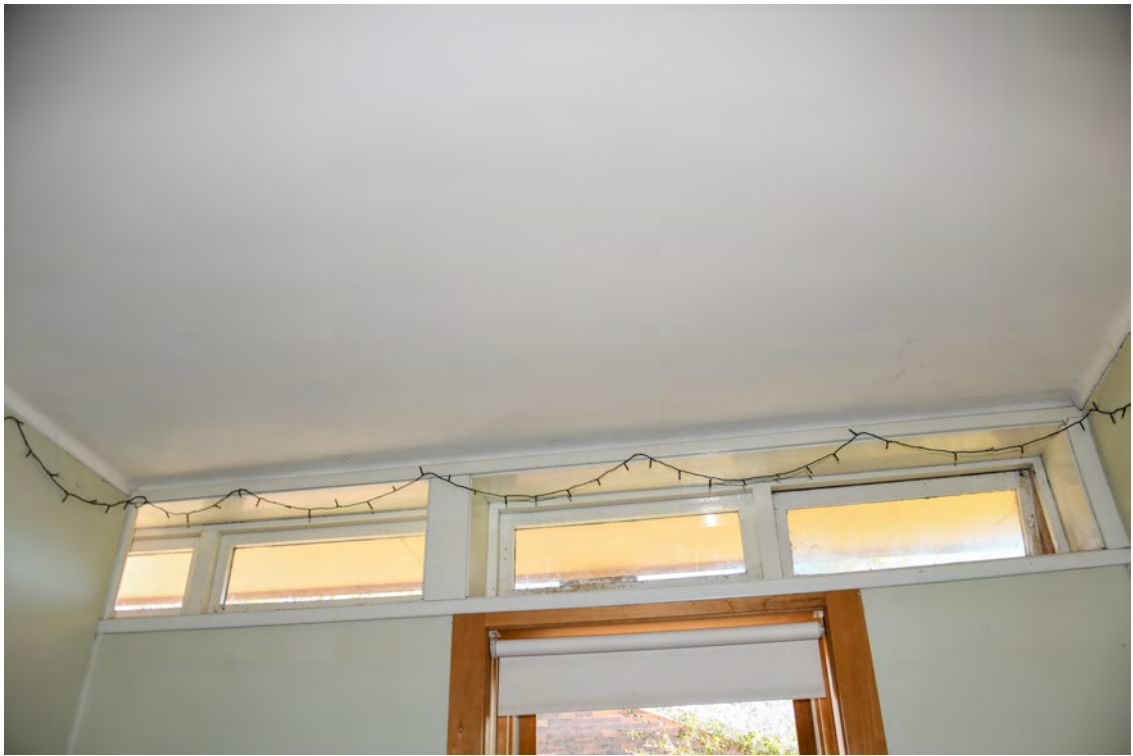
PRO\_0492.jpg

Block H. Interior. Eastern room. Room K6F. Western face. Cracked cladding.

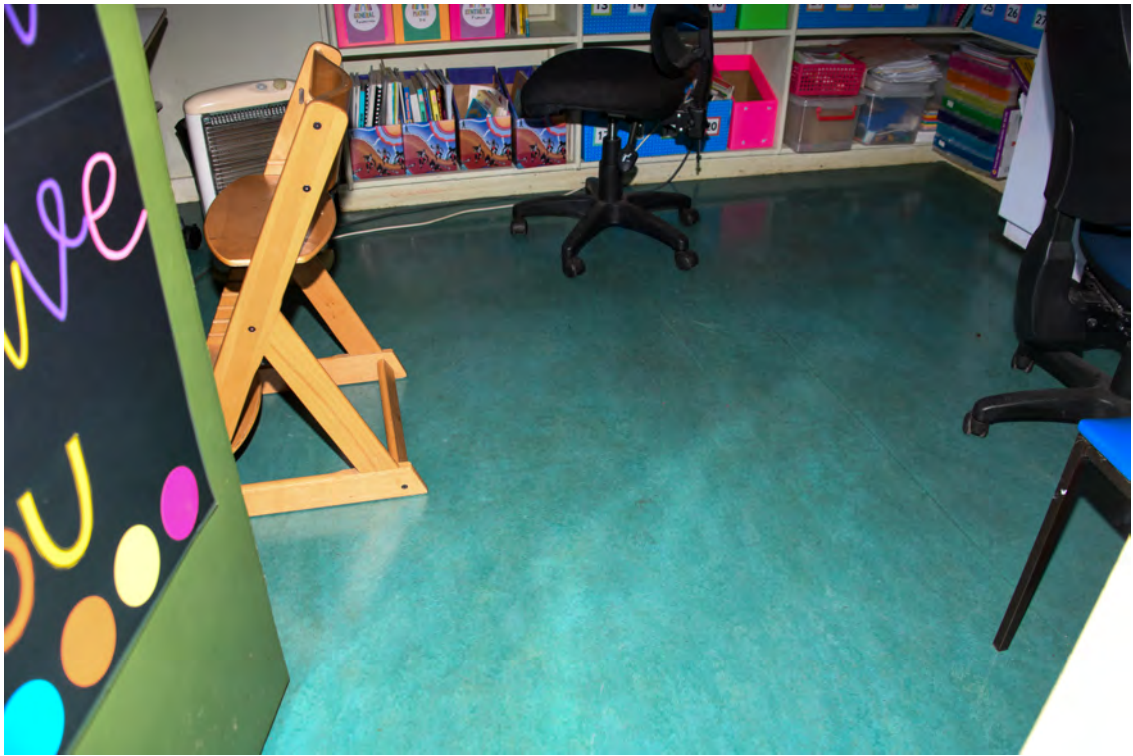
PRO\_0494.jpg

Block H. Interior. Eastern room. Room K6F. Storeroom.

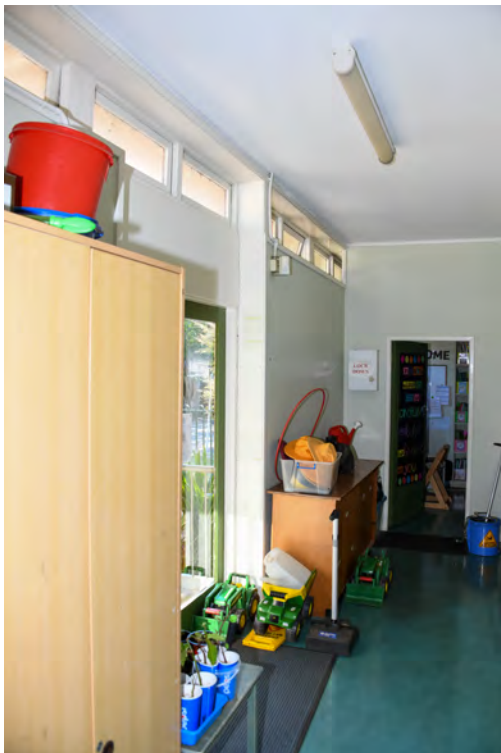
PRO\_0495.jpg

Block H. Interior. Eastern end. Foyer. Northern face. Facing east.

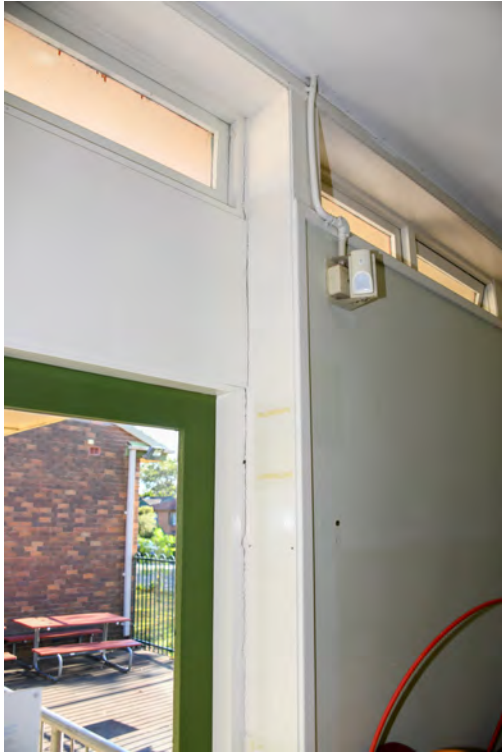
PRO\_0496.jpg

Block H. Interior. Eastern end. Foyer. Northern face. Facing east.

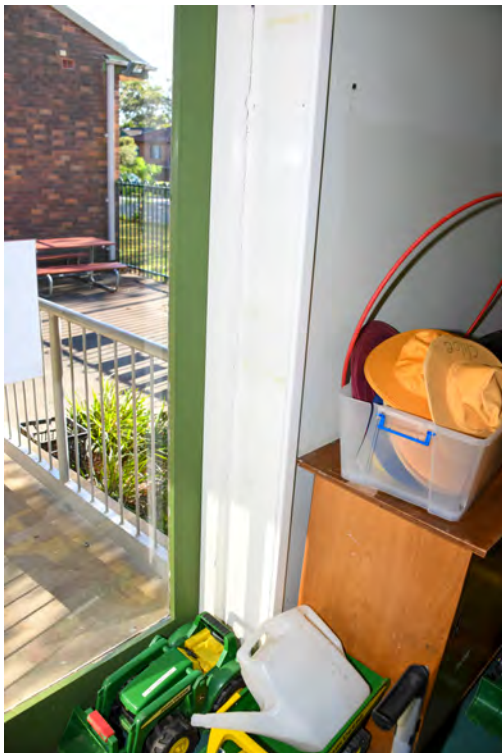
PRO\_0497.jpg

Block H. Interior. Eastern end. Foyer. Northern face. Facing east.

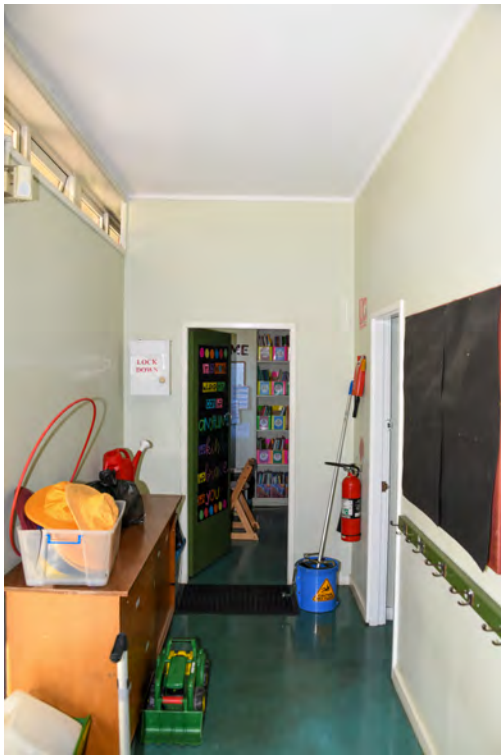
PRO\_0498.jpg

Block H. Interior. Eastern end. Foyer. Eastern face.

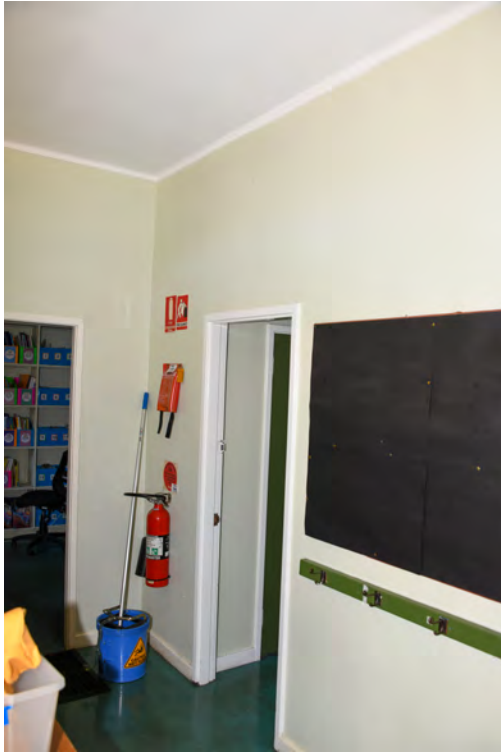
PRO\_0500.jpg

Block H. Interior. Eastern end. Foyer. Eastern end of the southern face.

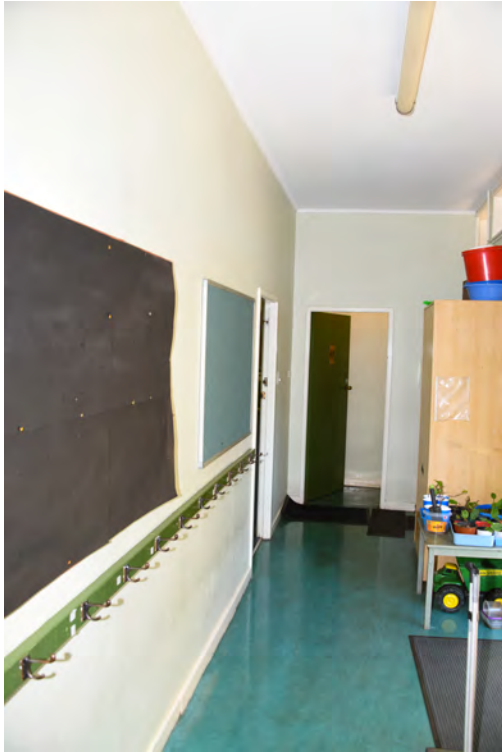
PRO\_0502.jpg

Block H. Interior. Eastern end. Foyer. Southern face. Facing west.

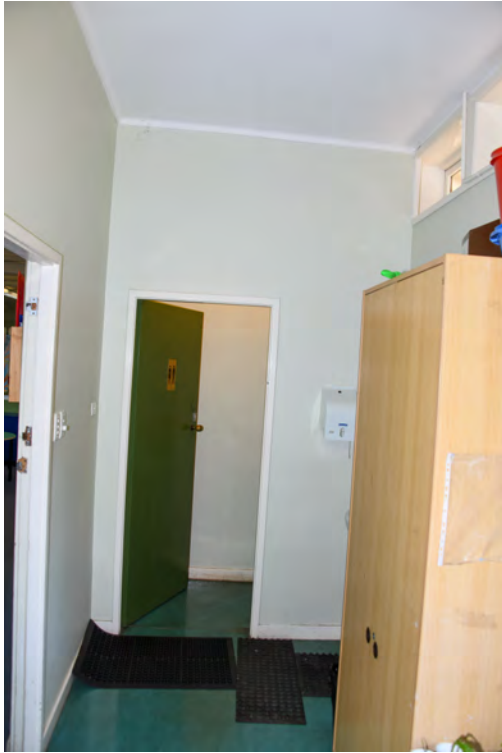
PRO\_0504.jpg

Block H. Interior. Eastern end. Foyer. Western face.

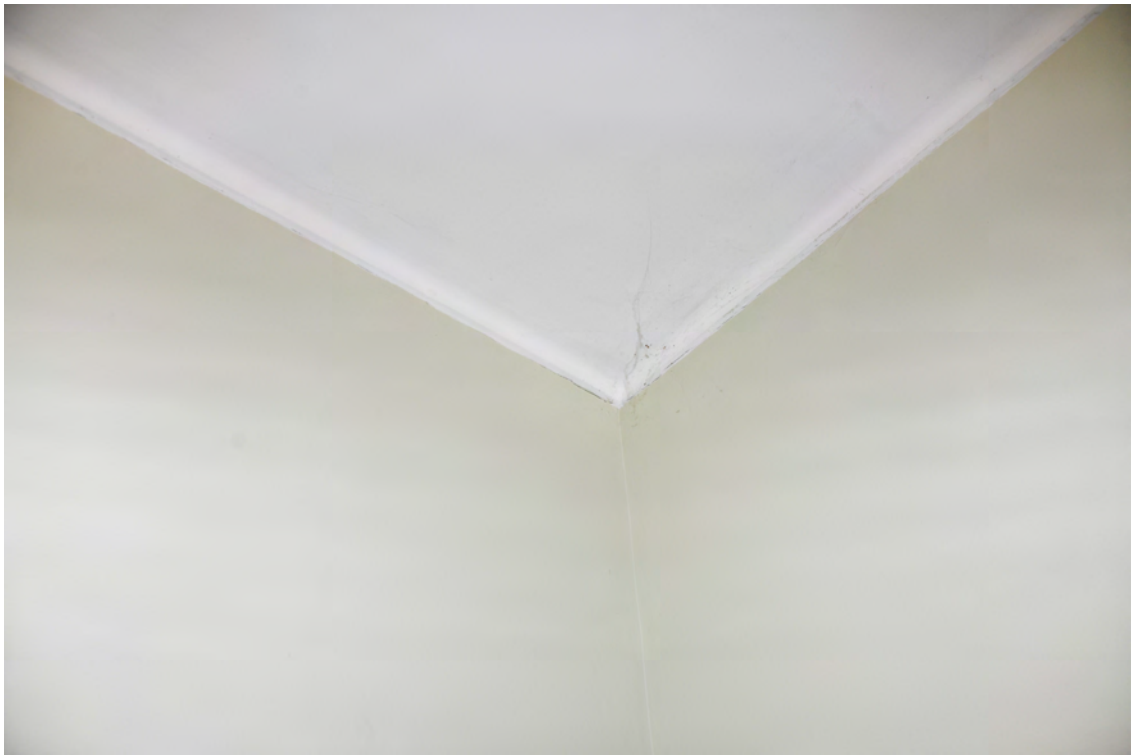
PRO\_0506.jpg

Block H. Interior. Eastern end. Foyer. South-western corner.

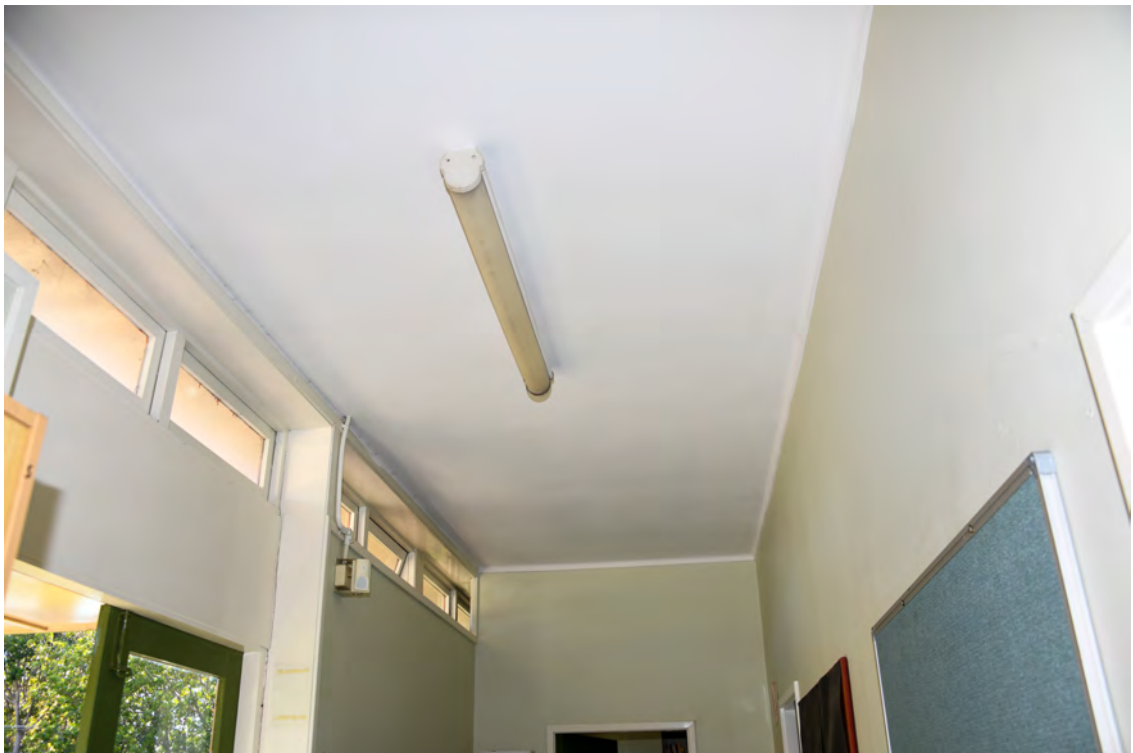
PRO\_0507.jpg

Block H. Interior. Eastern end. Foyer. Facing east to the ceiling.

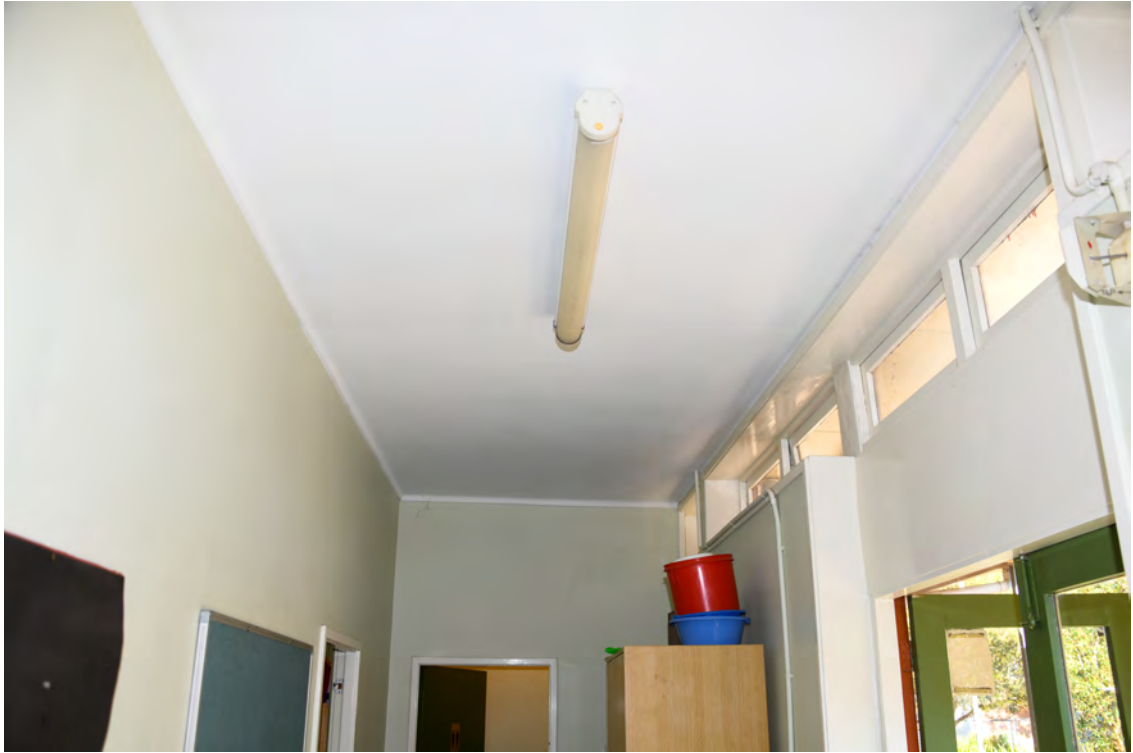
PRO\_0508.jpg

Block H. Interior. Eastern end. Foyer. Facing west to the ceiling.

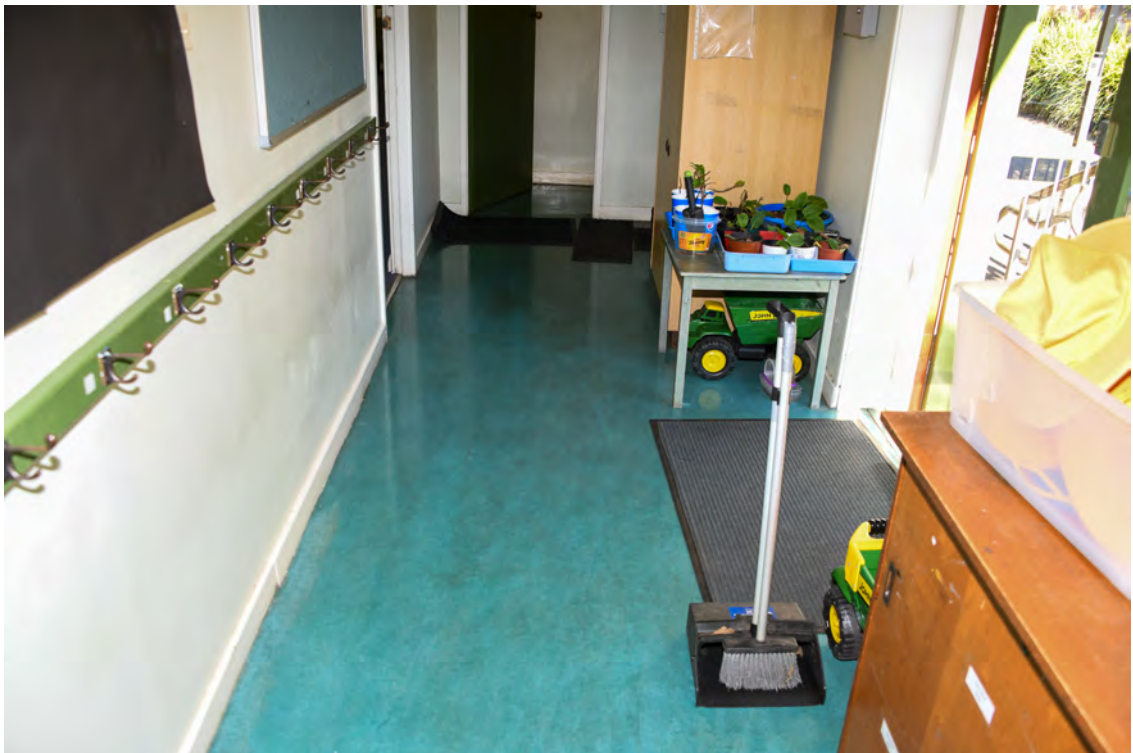
PRO\_0509.jpg

Block H. Interior. Eastern end. Foyer. Facing west to the flooring.

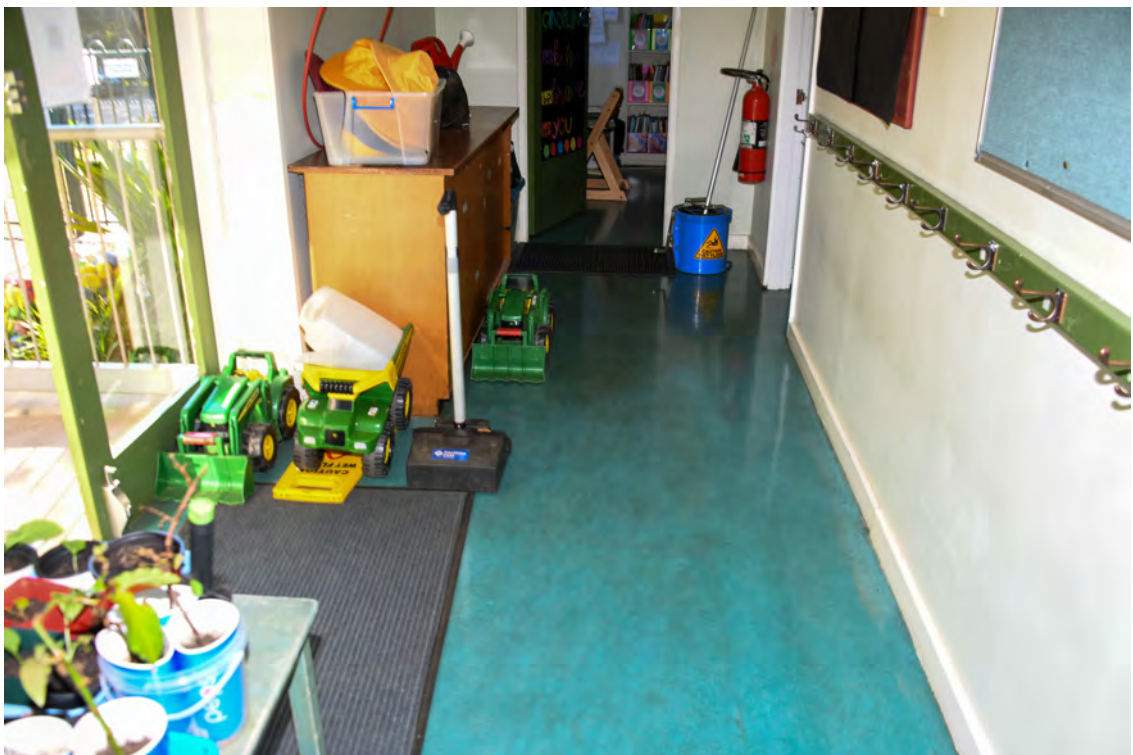
PRO\_0511.jpg

Block H. Interior. Eastern end. Foyer. Eastern end of the flooring.

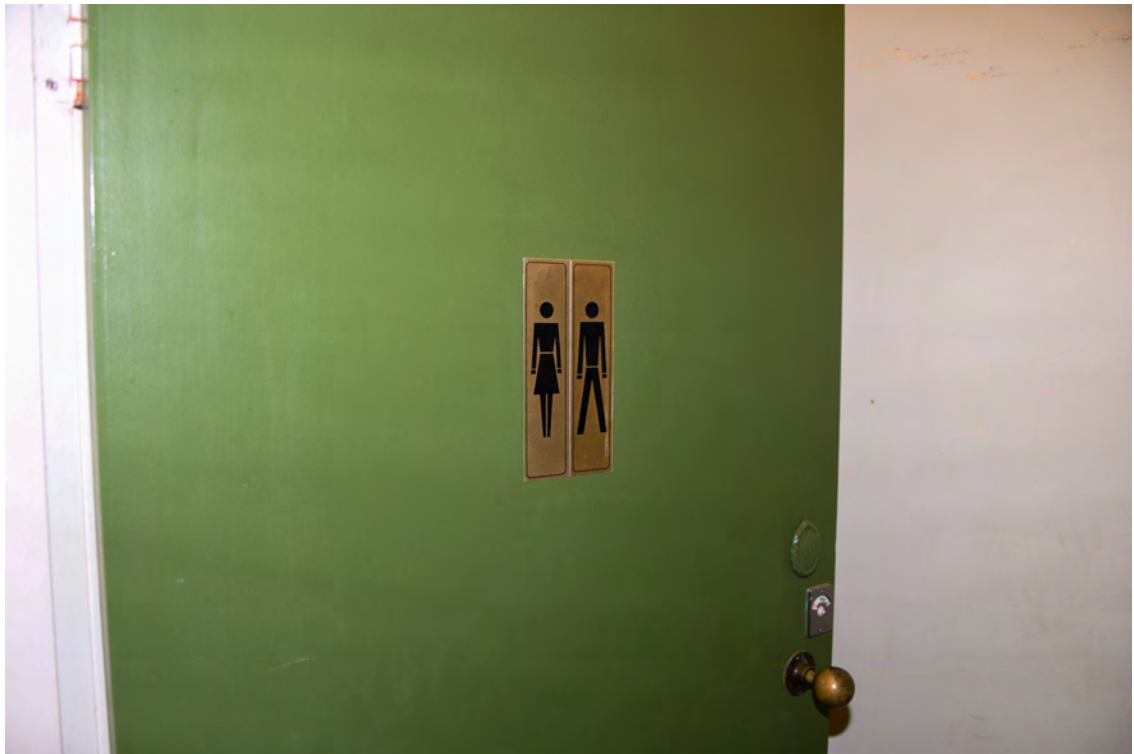
PRO\_0512.jpg

Block H. Interior. Eastern end. Foyer. Amenities.

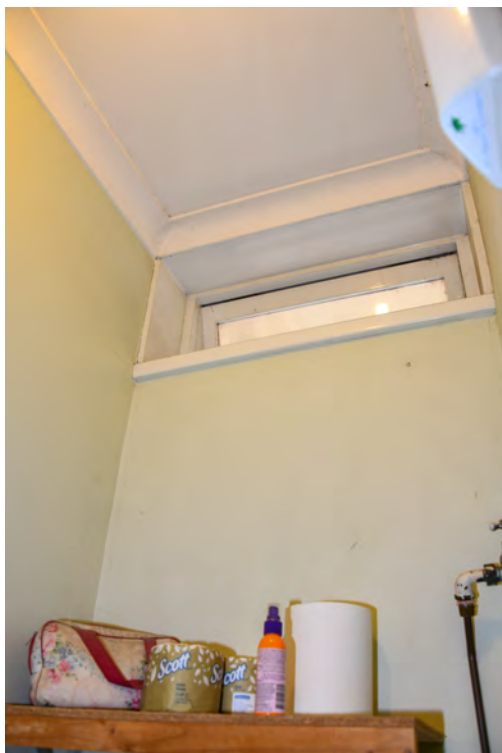
PRO\_0513.jpg

Block H. Interior. Eastern end. Foyer. Amenities.

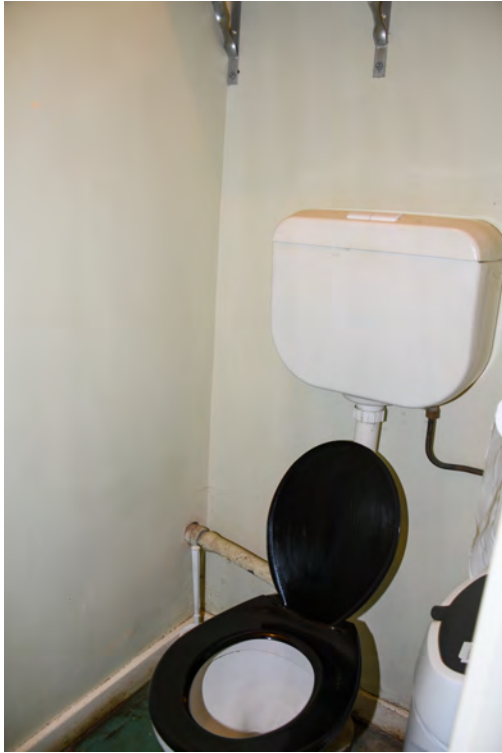
PRO\_0514.jpg

Block H. Interior. Eastern end. Foyer. Amenities.

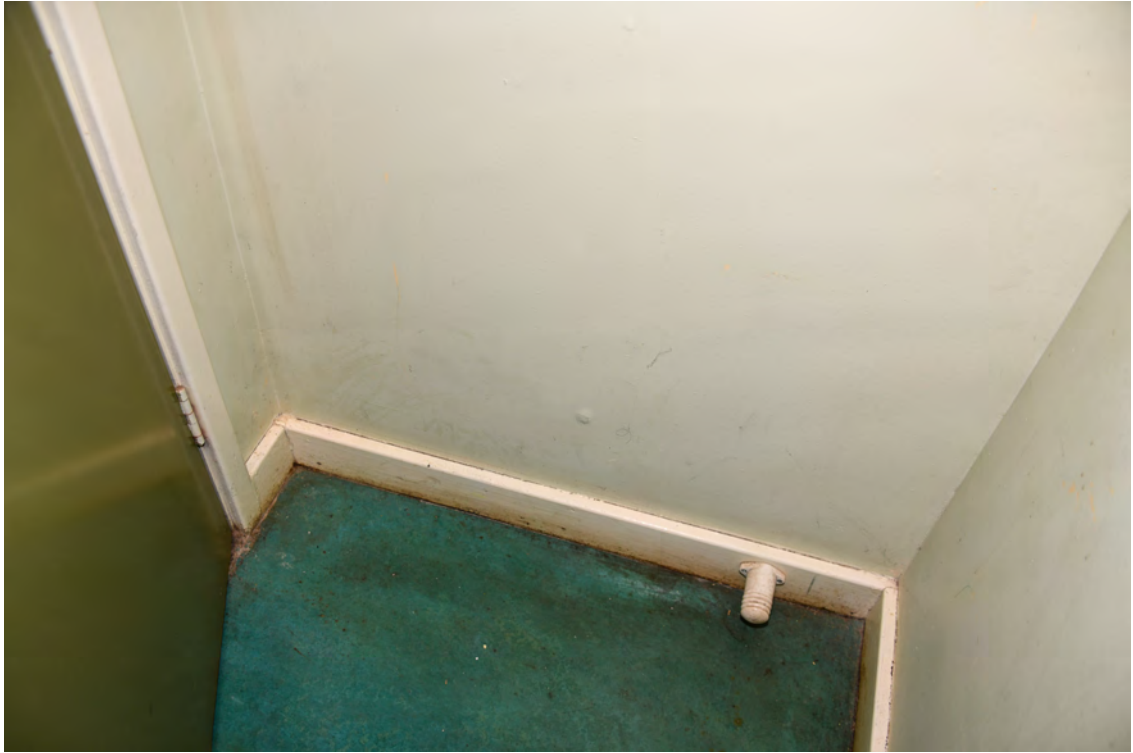
PRO\_0516.jpg

Block H. Interior. Eastern end. Foyer. Amenities. Southern face.

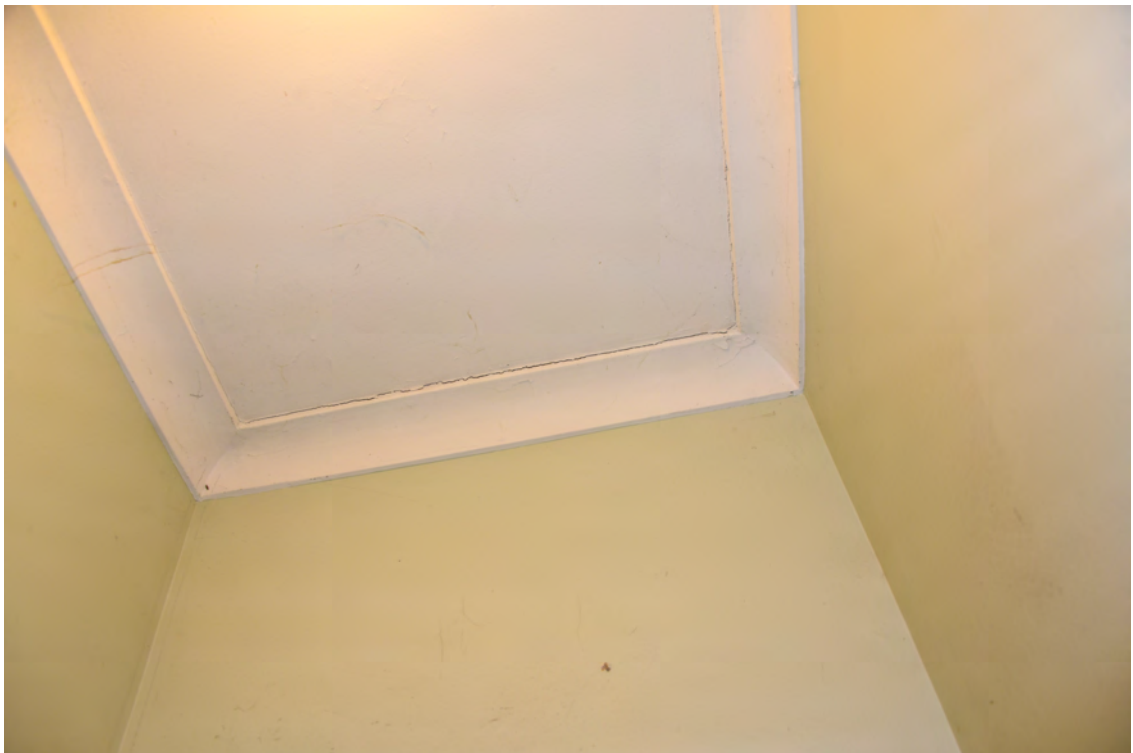
PRO\_0517.jpg

Block H. Interior. Eastern end. Foyer. Amenities. Southern end of the ceiling.

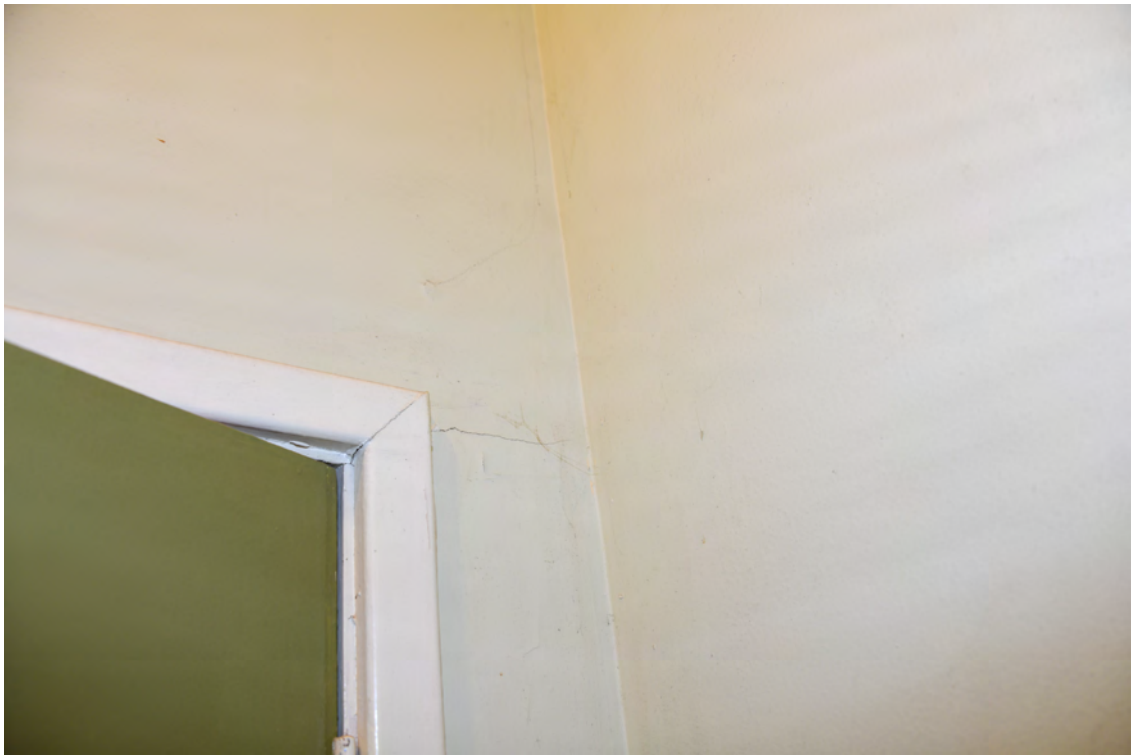
PRO\_0518.jpg

Block H. Interior. Eastern end. Foyer. Amenities. Eastern face.

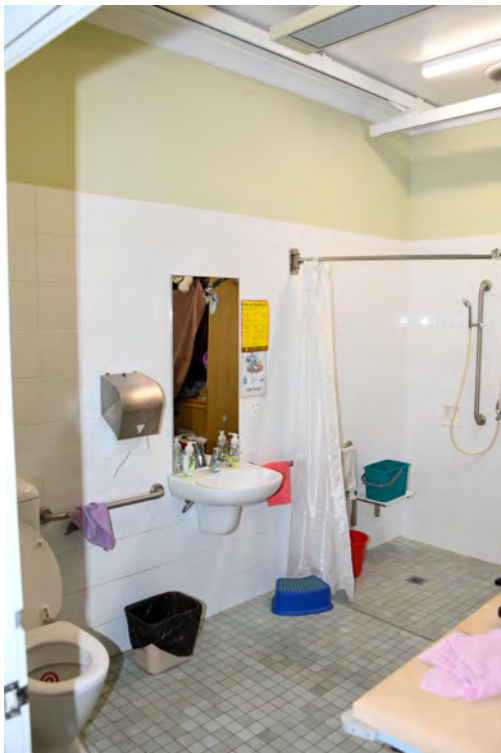
PRO\_0519.jpg

Block H. Interior. Amenities. North-eastern corner.

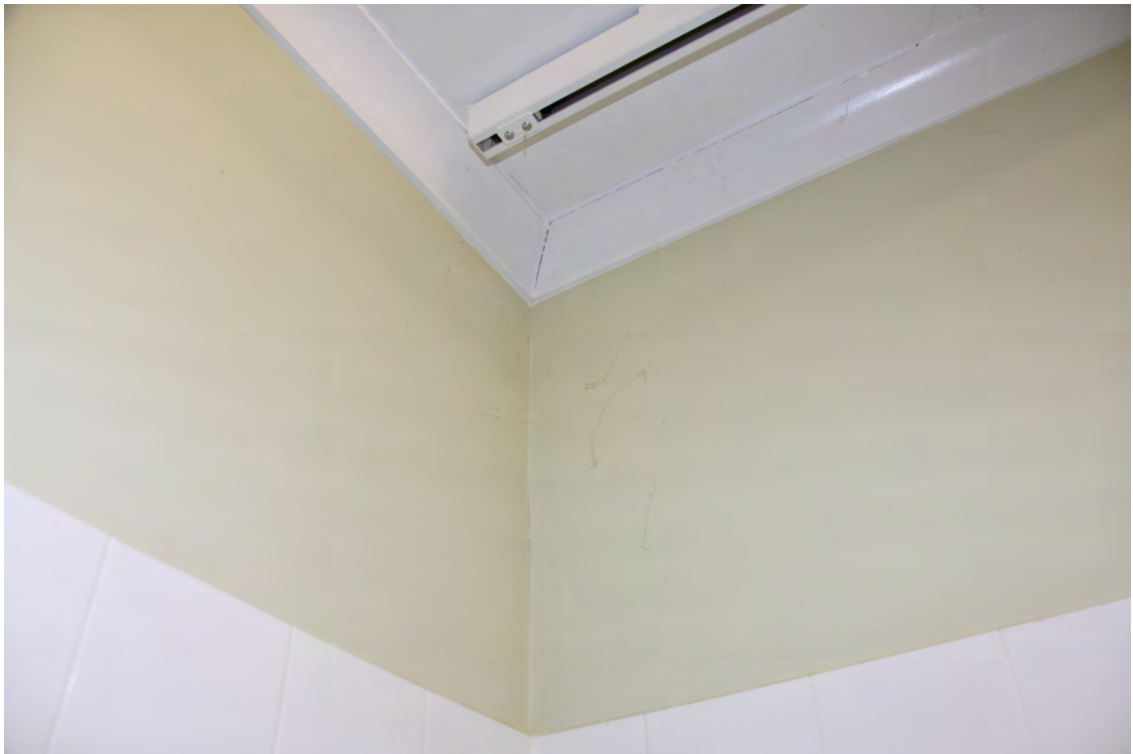
PRO\_0520.jpg

Block H. Interior. Amenities. North-eastern corner.
