96-104 Carlingford Road, Epping NSW 2121

Epping West Public School

DILAPIDATION REPORT

7<sup>th</sup> September 2021

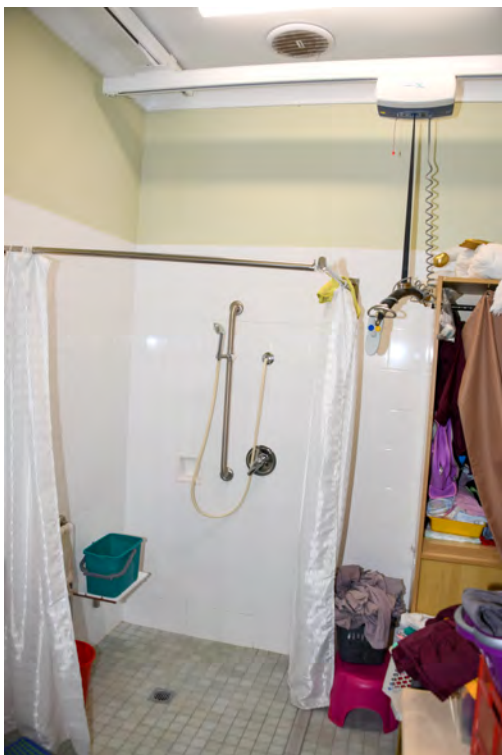
PRO\_0521.jpg

Block H. Interior. Amenities. Eastern face.

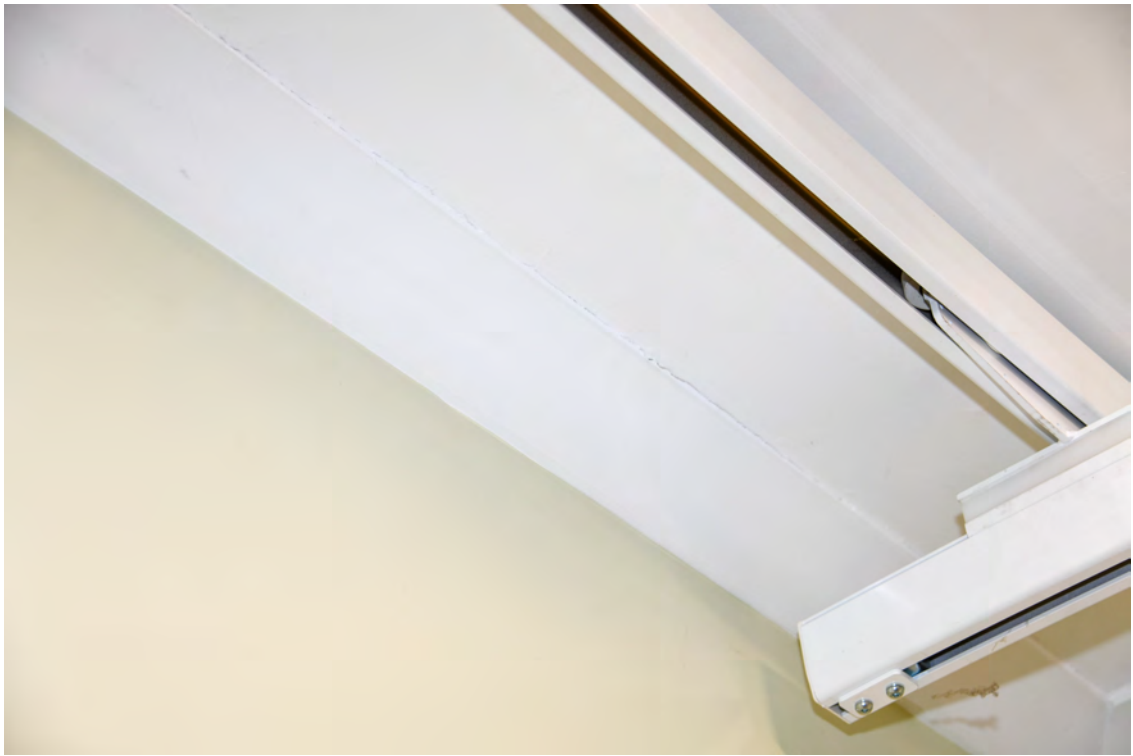
PRO\_0522.jpg

Block H. Interior. Amenities. Eastern face. Cornice.

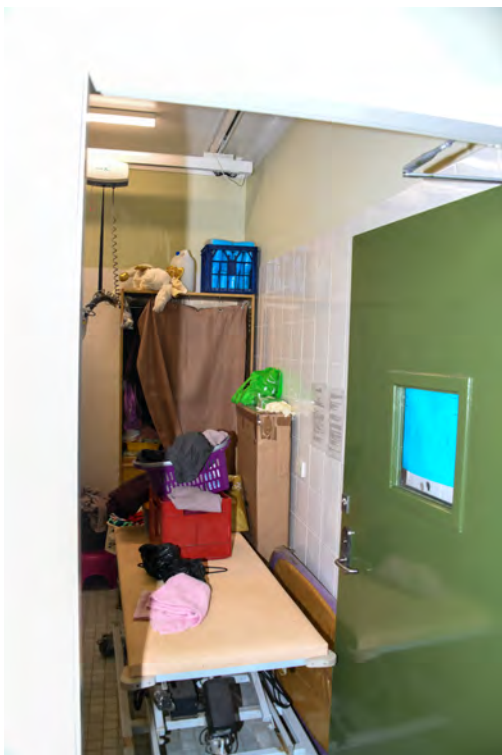
PRO\_0523.jpg

Block H. Interior. Amenities. Facing east from the doorway.

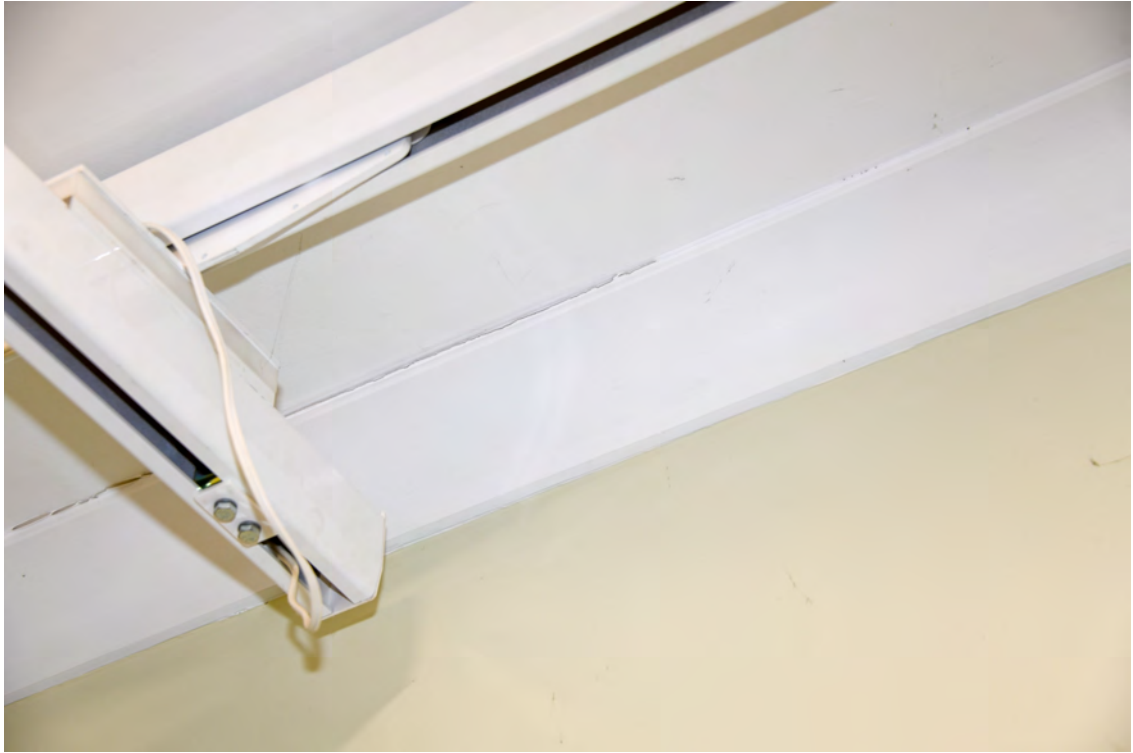
PRO\_0524.jpg

Block H. Interior. Amenities. Movement to the cornice.

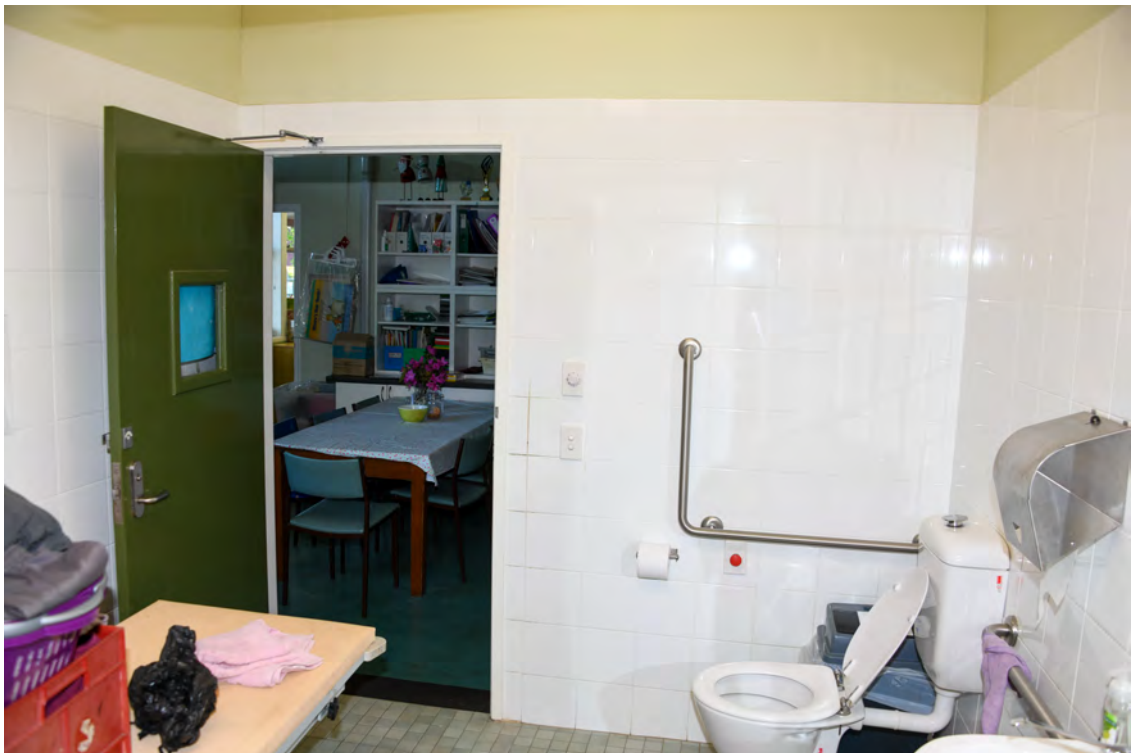
PRO\_0525.jpg

Block H. Interior. Amenities. Western face.

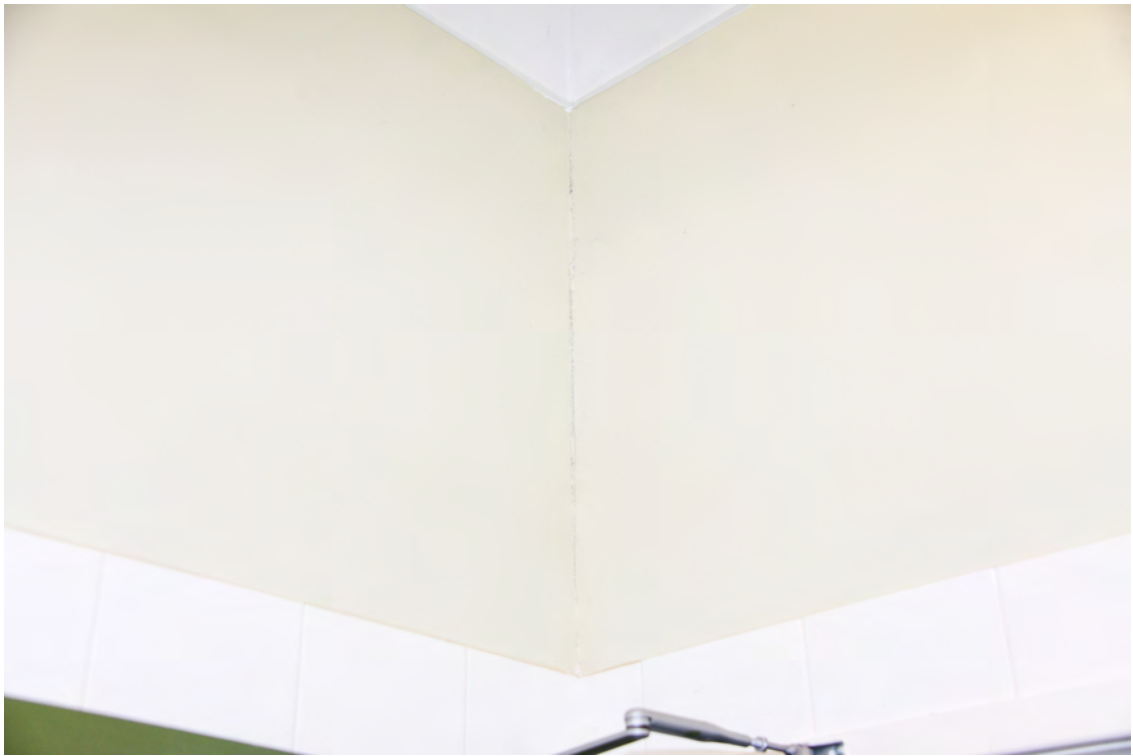
PRO\_0526.jpg

Block H. Interior. Amenities. South-western corner.

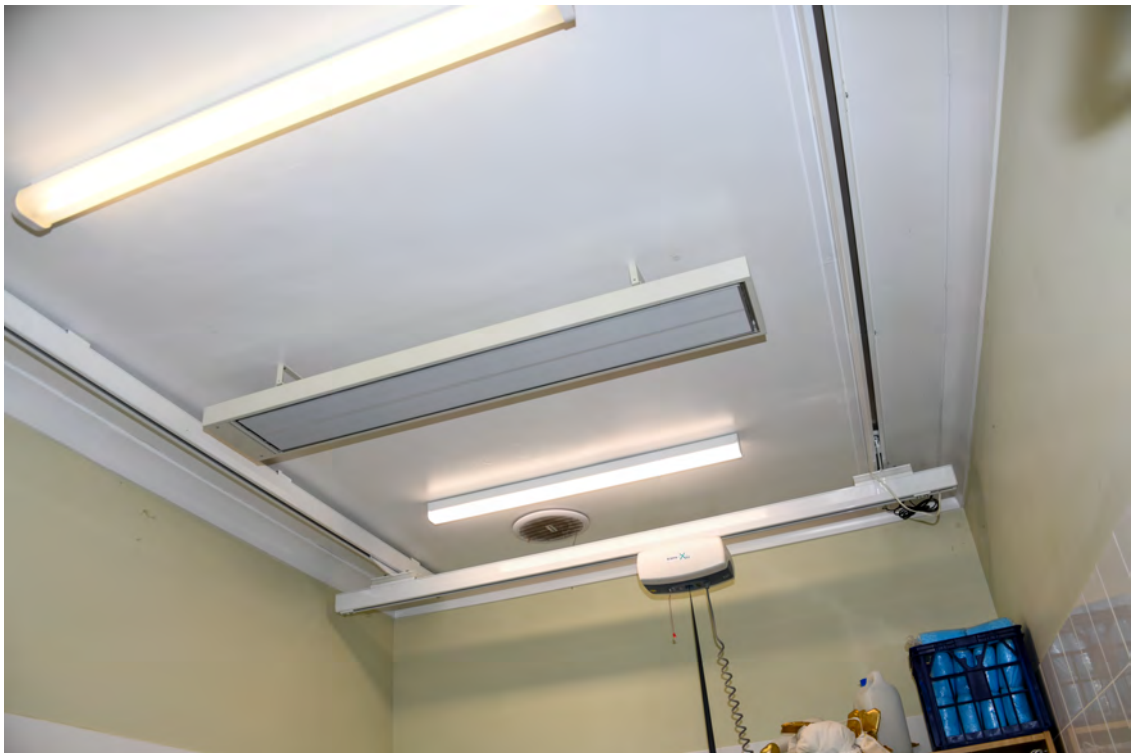
PRO\_0527.jpg

Block H. Interior. Amenities. Facing east to the ceiling.

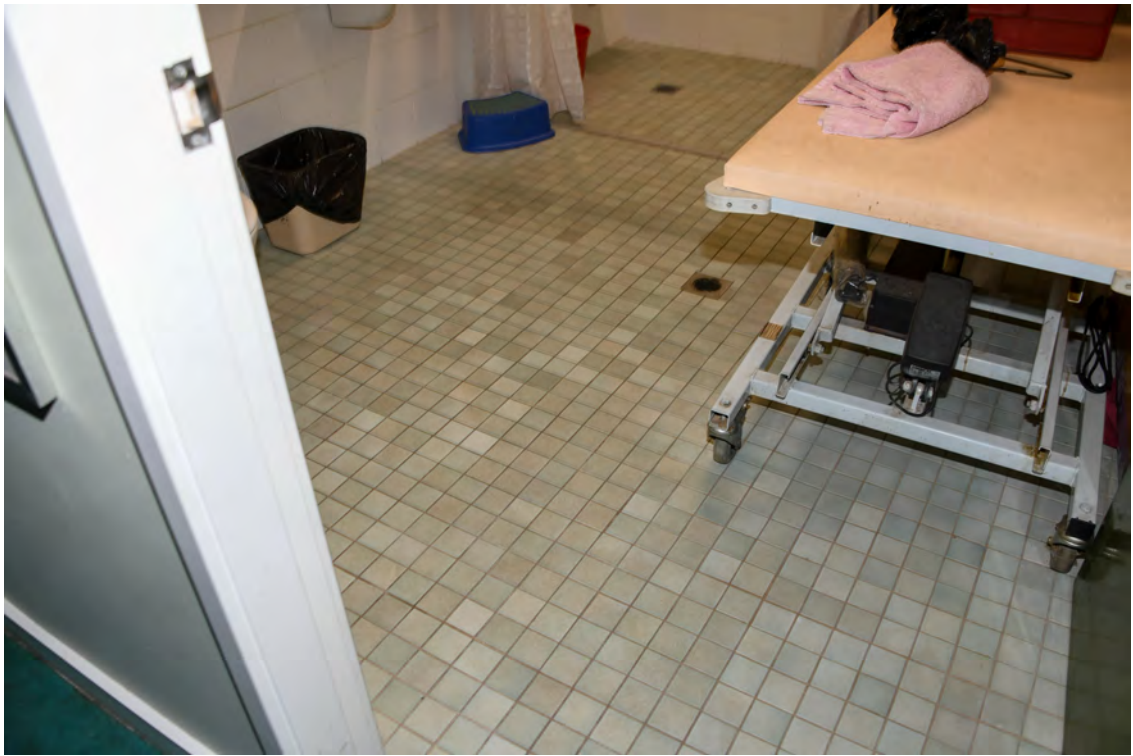
PRO\_0528.jpg

Block H. Interior. Amenities. Facing east to the floor tiles.

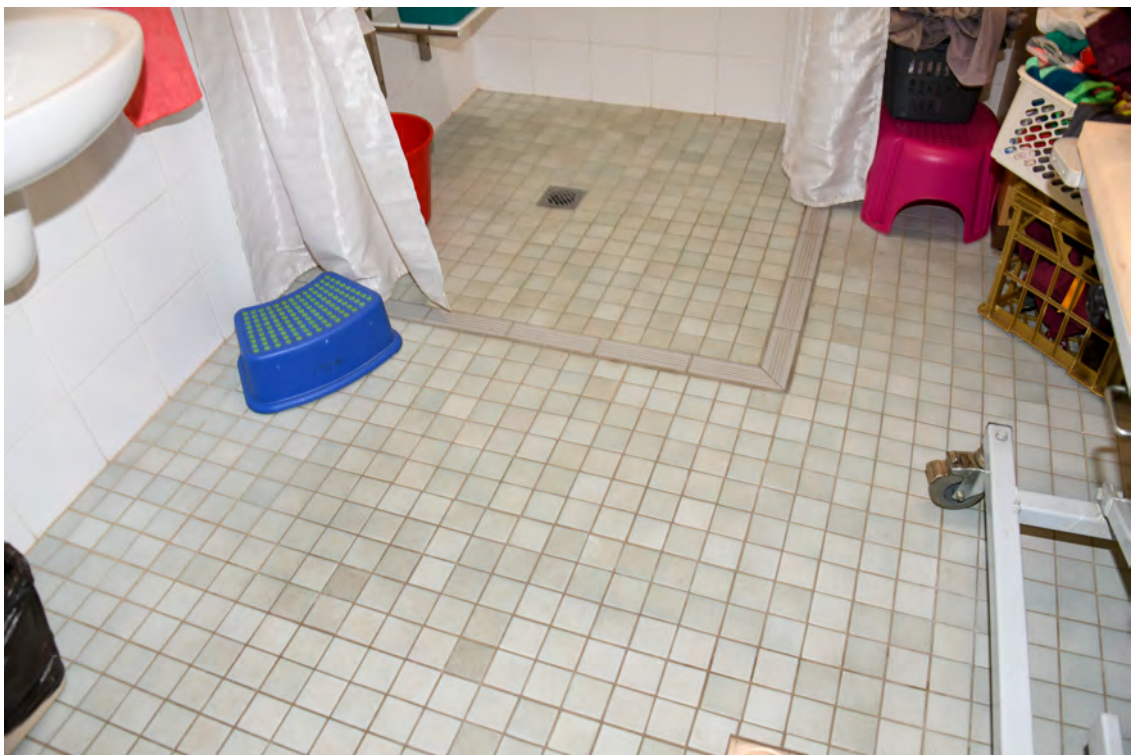
PRO\_0529.jpg

Block H. Interior. Amenities. Facing east to the floor tiles.

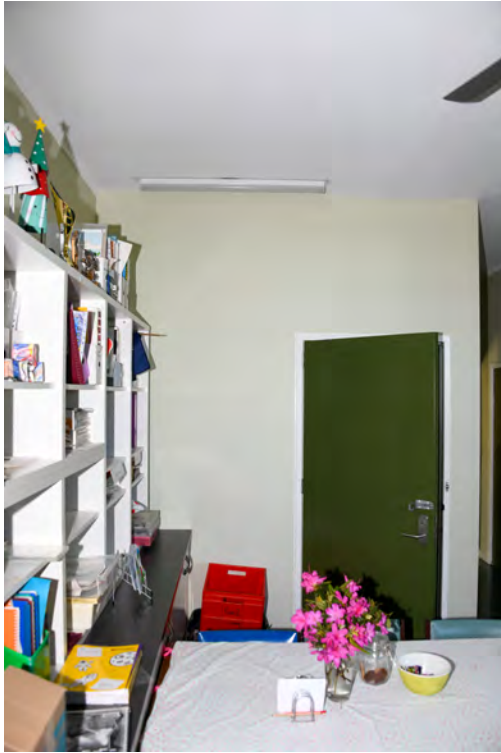
PRO\_0530.jpg

Block H. Interior. Staff room. Northern face. Western end.

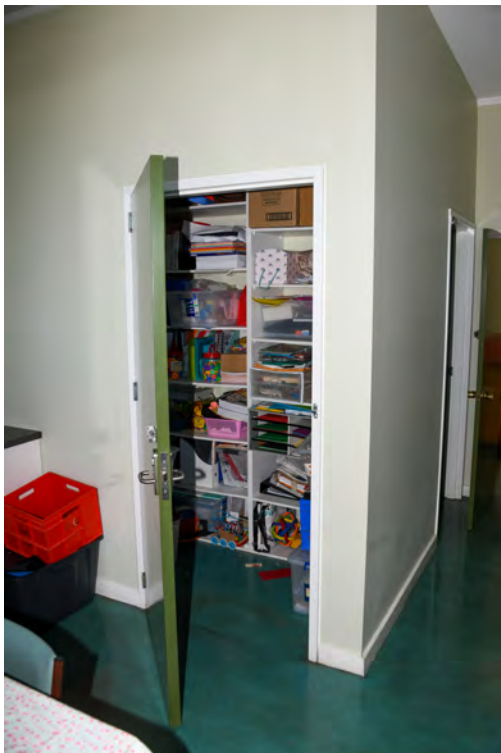
PRO\_0531.jpg

Block H. Interior. Staff room. Northern face. Western end.

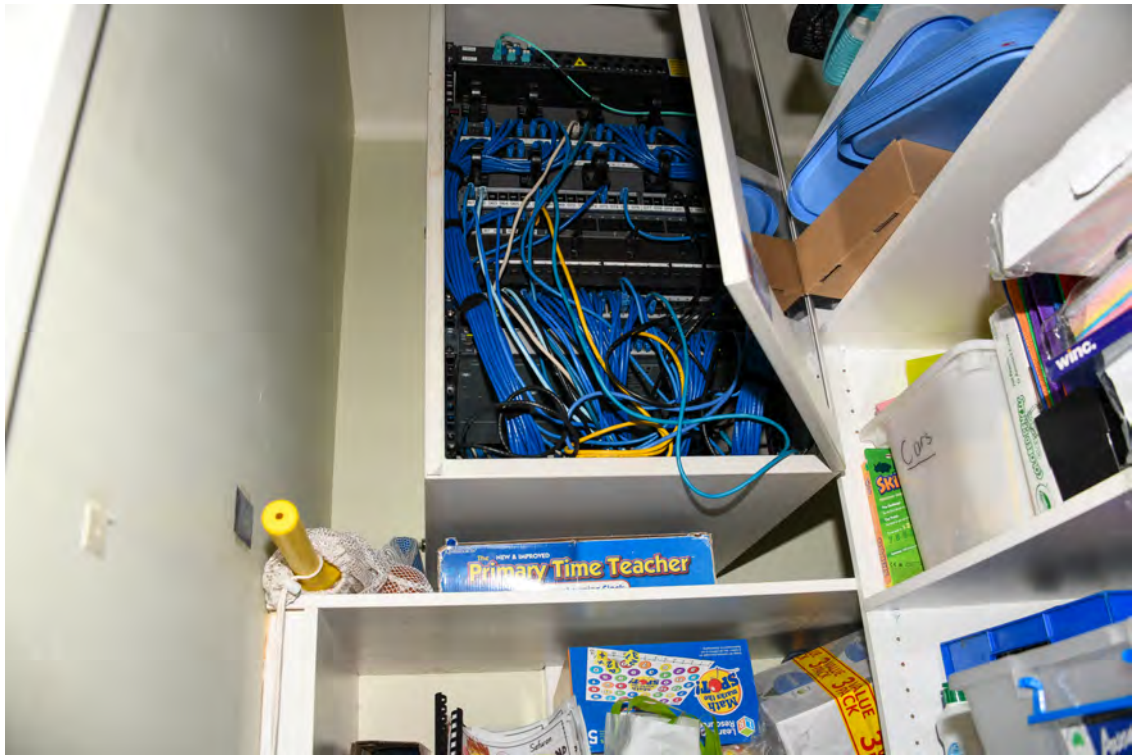
PRO\_0532.jpg

Block H. Interior. Staff room. Room in the north-western corner.

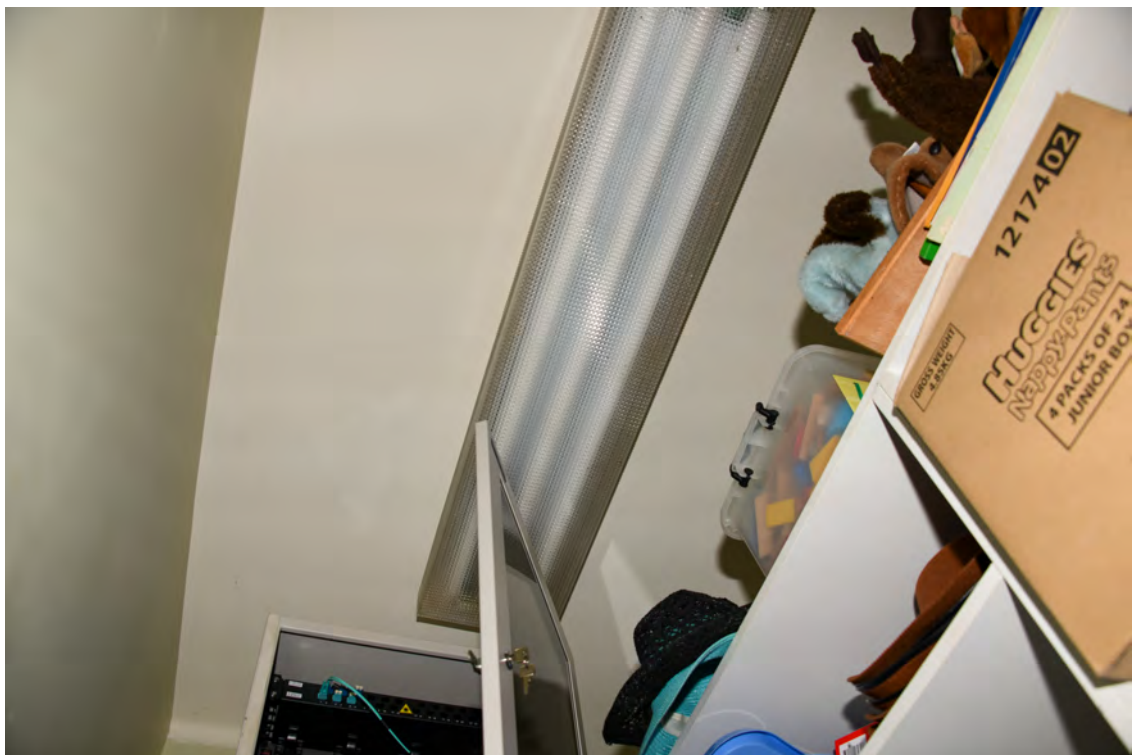
PRO\_0533.jpg

Block H. Interior. Staff room. Room in the north-western corner.

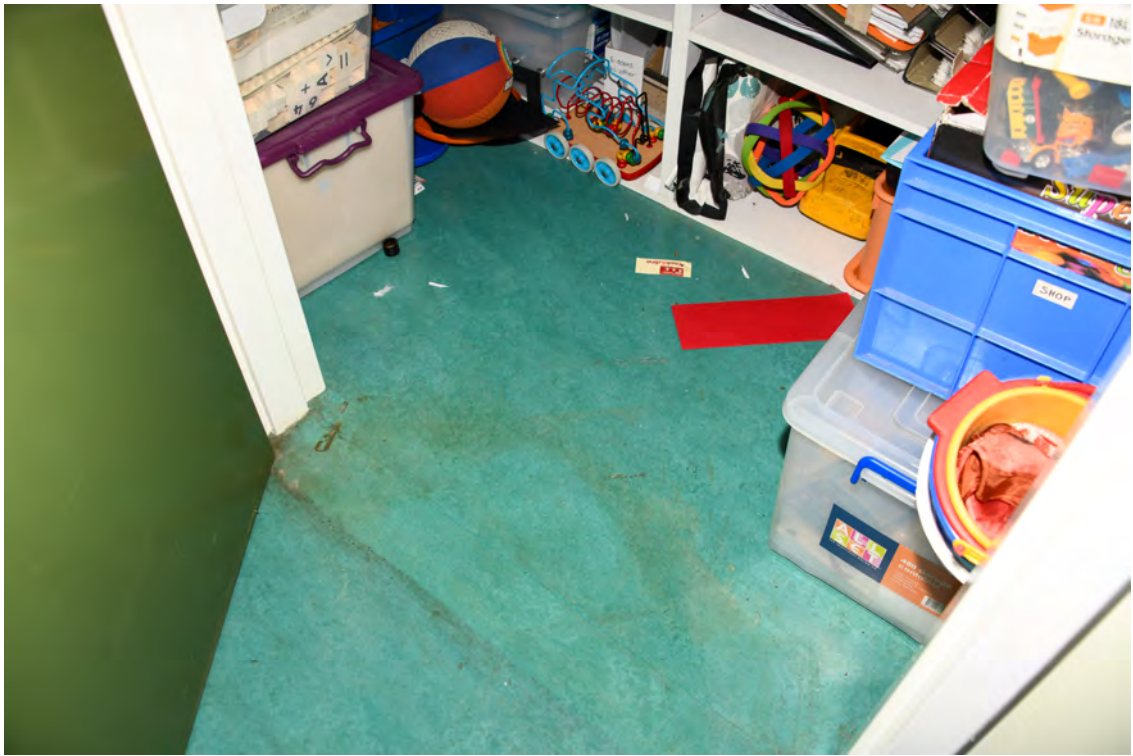
PRO\_0534.jpg

Block H. Interior. Staff room. Room in the north-western corner.

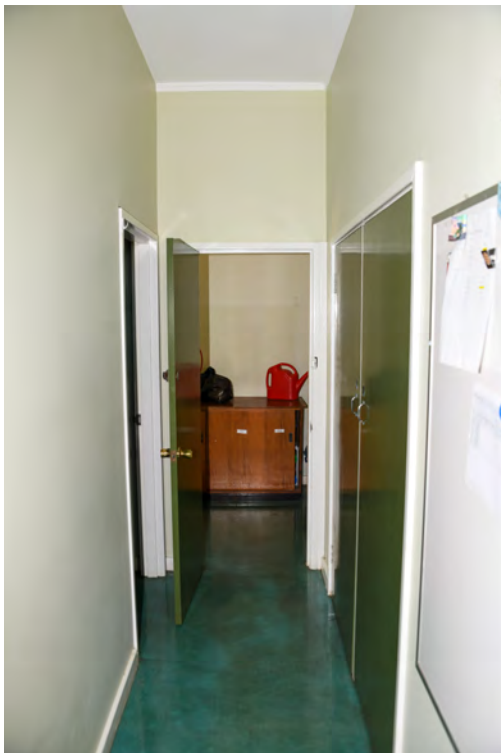
PRO\_0535.jpg

Block H. Interior. Staff room. Northern end. Corridor.

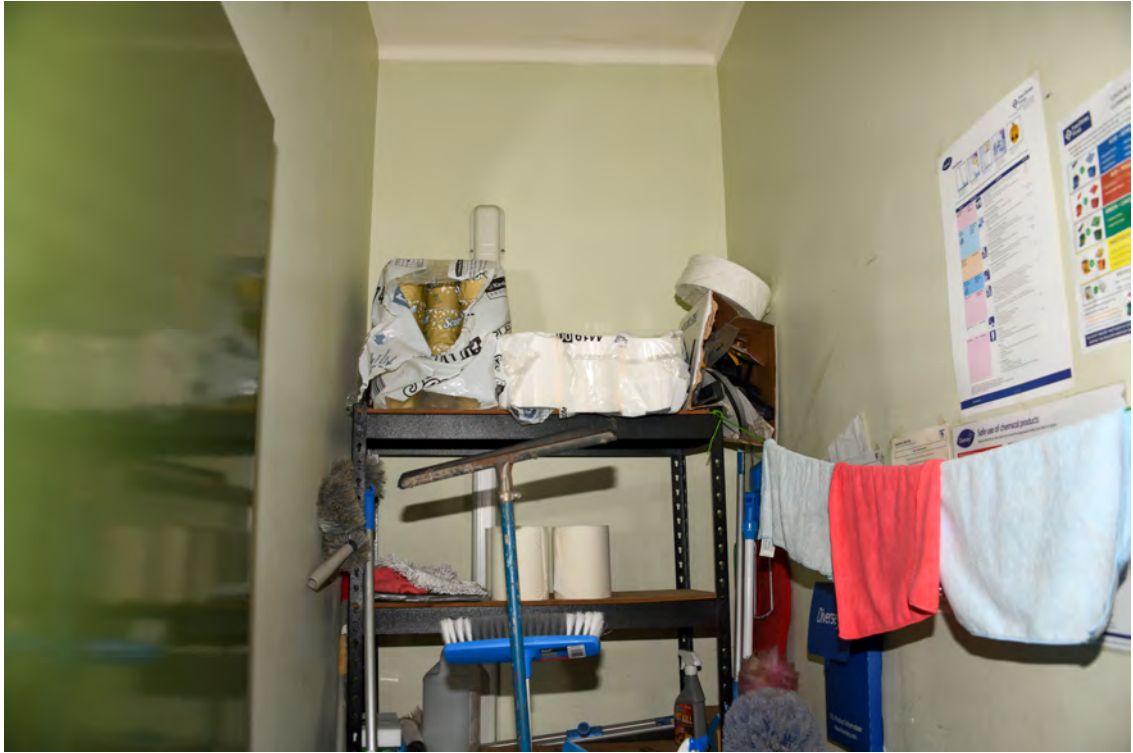
PRO\_0536.jpg

Block H. Interior. Staff room. Northern end. Cleaners room.

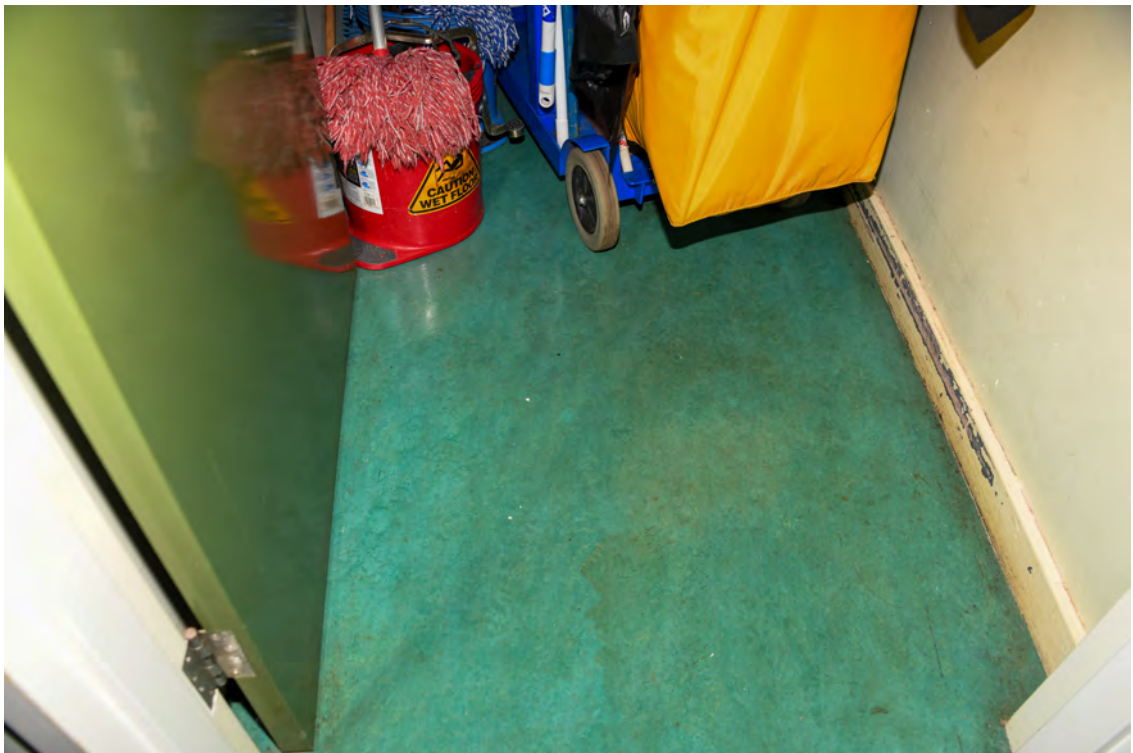
PRO\_0537.jpg

Block H. Interior. Staff room. Northern end. Cleaners room. Flooring.

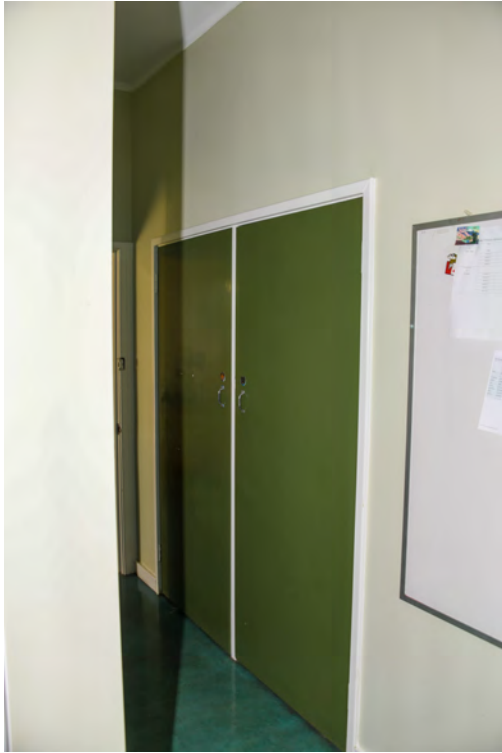
PRO\_0538.jpg

Block H. Interior. Staff room. Northern end. Corridor. Eastern face.

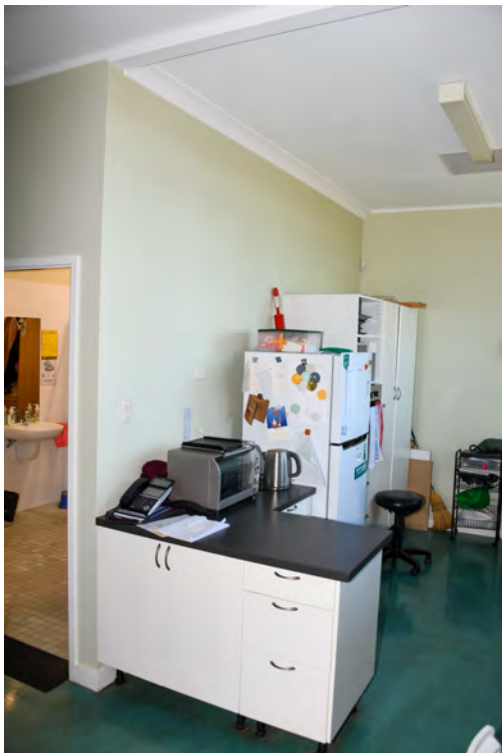
PRO\_0539.jpg

Block H. Interior. Staff room / Kitchen. Northern face. Eastern end.

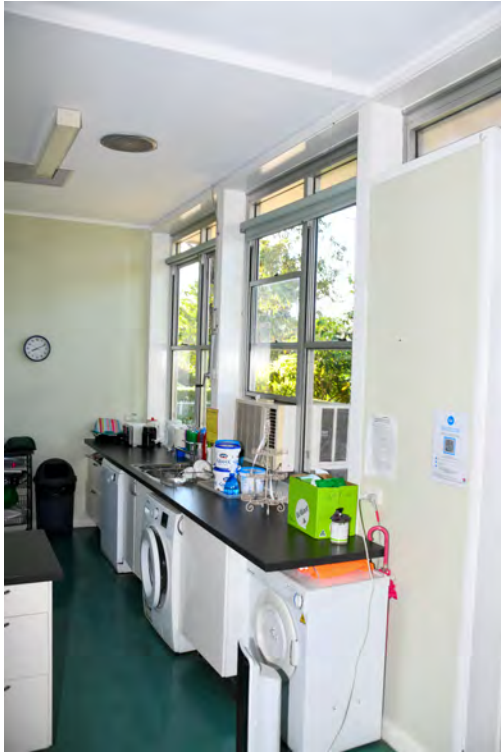
PRO\_0540.jpg

Block H. Interior. Staff room / Kitchen. Southern face.

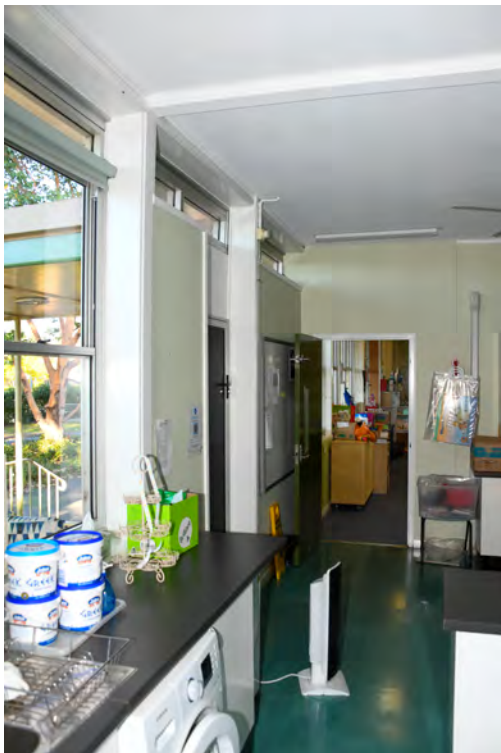
PRO\_0541.jpg

Block H. Interior. Staff room. Southern face.

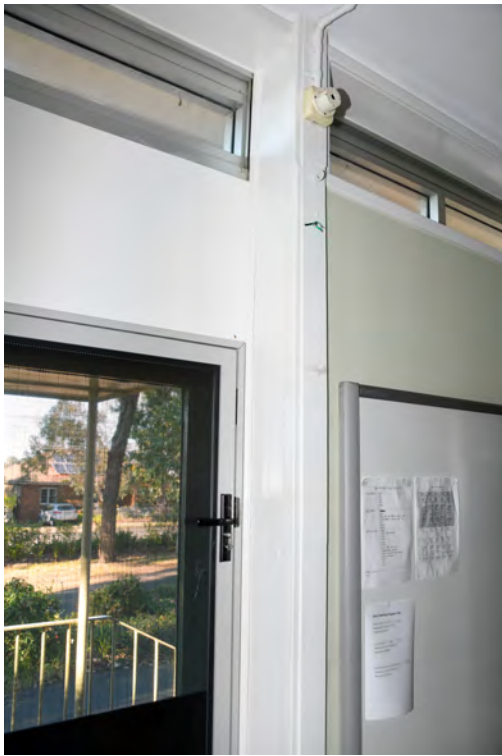
PRO\_0542.jpg

Block H. Interior. Staff room. Southern face.

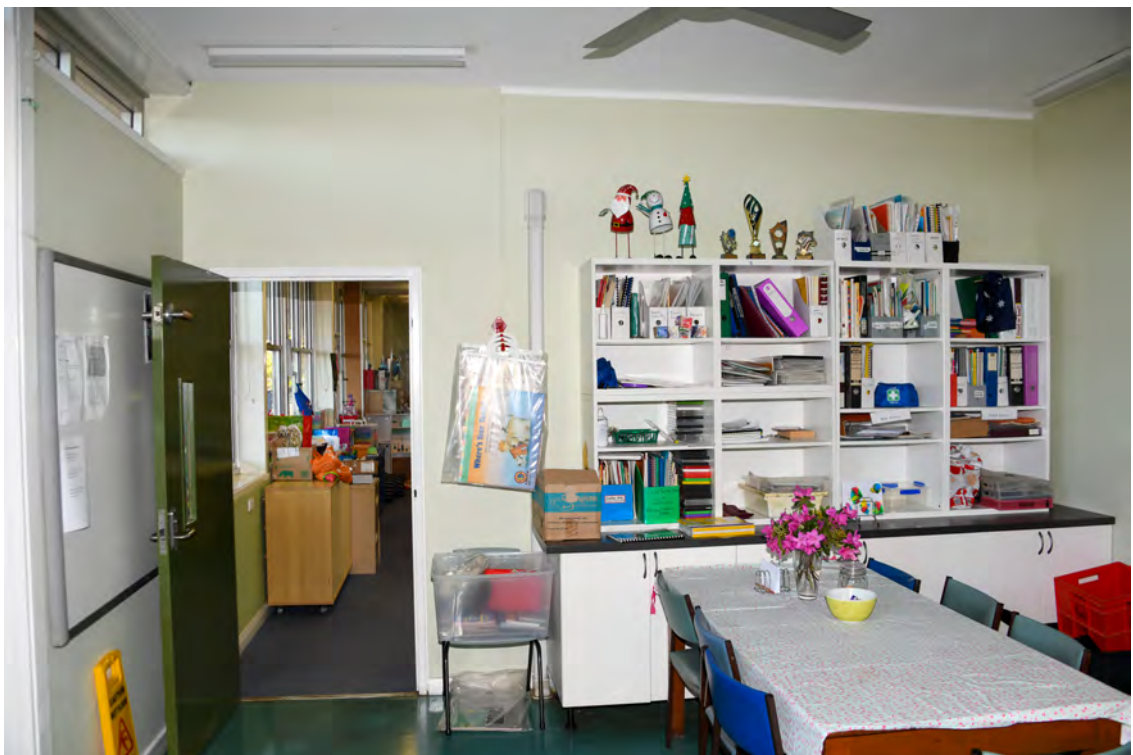
PRO\_0543.jpg

Block H. Interior. Staff room. Western face.

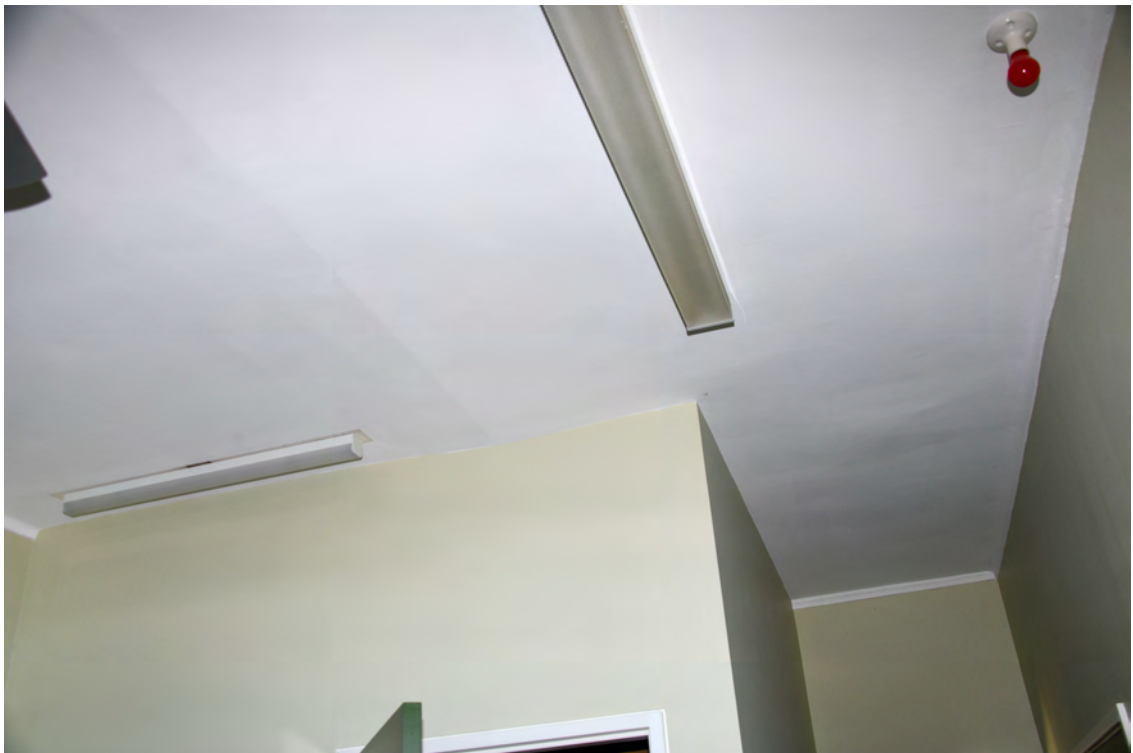
PRO\_0545.jpg

Block H. Interior. Staff room. Northern end of the ceiling.

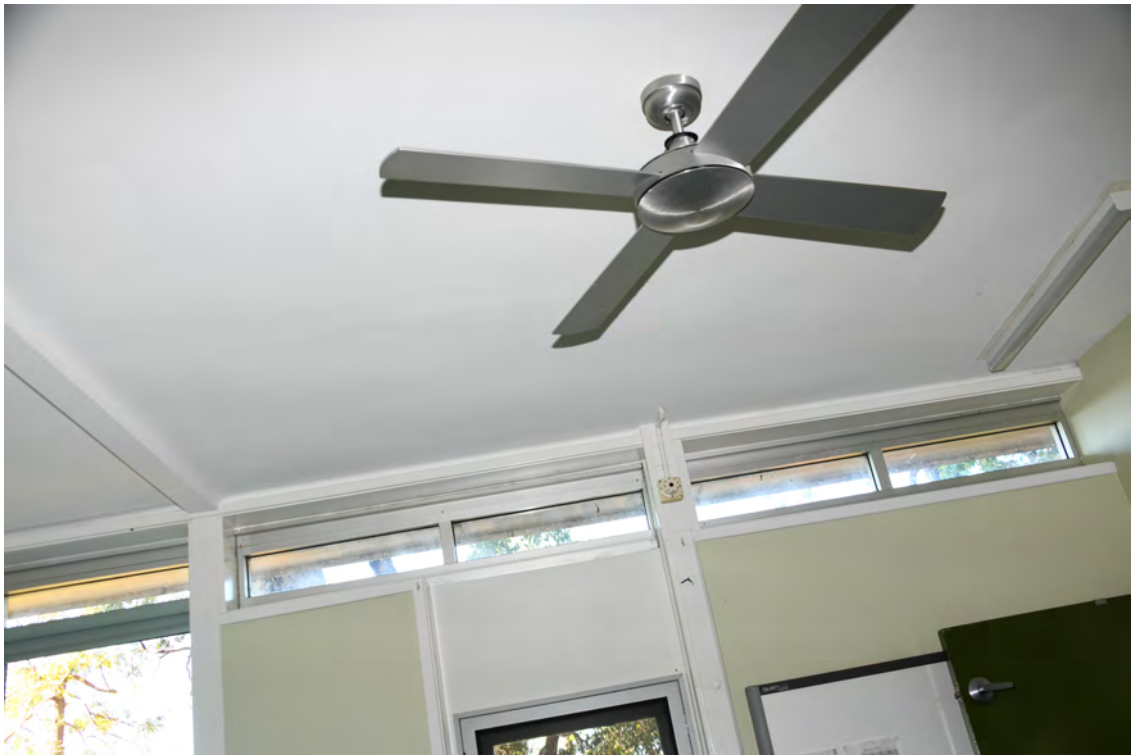
PRO\_0546.jpg

Block H. Interior. Staff room. Southern end of the ceiling.

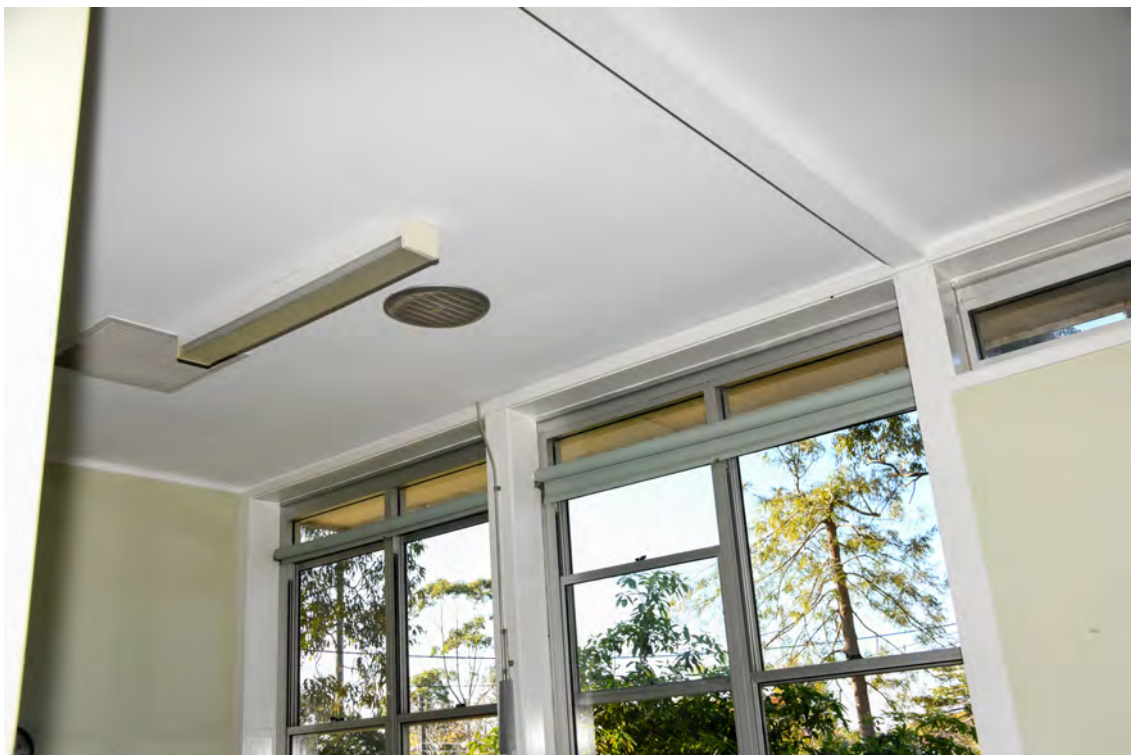
PRO\_0547.jpg

Block H. Interior. Staff room. Kitchen. South-eastern corner of the ceiling.

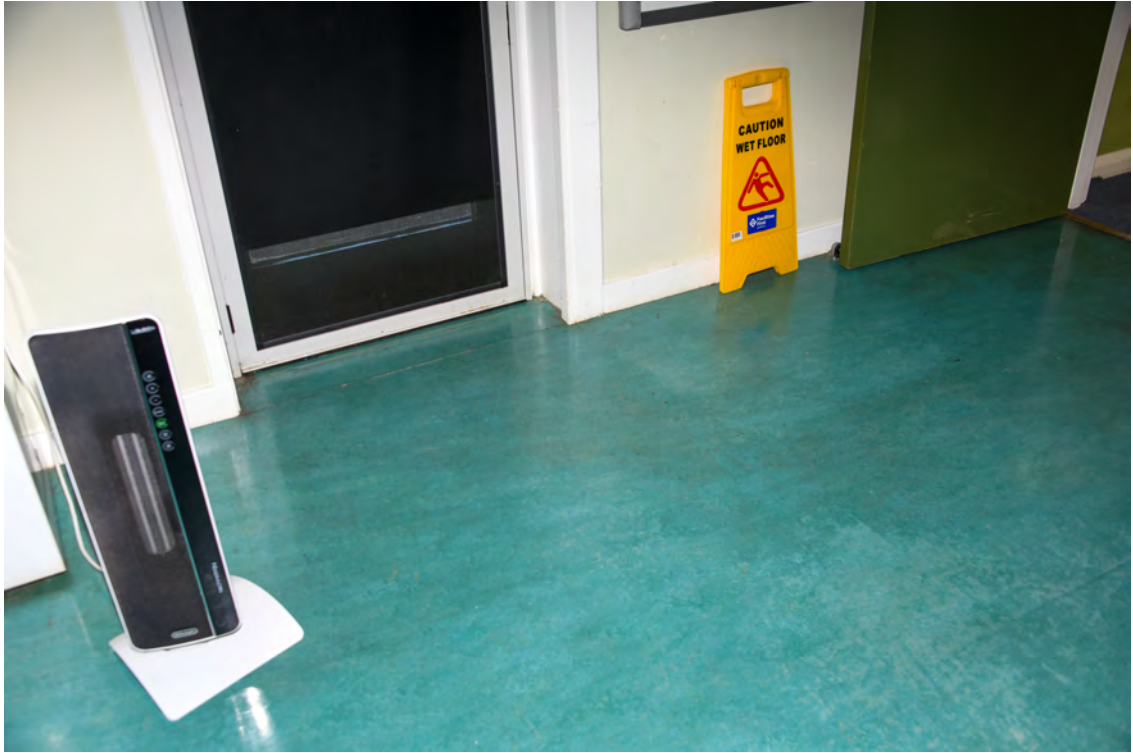
PRO\_0548.jpg

Block H. Interior. Staff room. Southern end of the flooring.

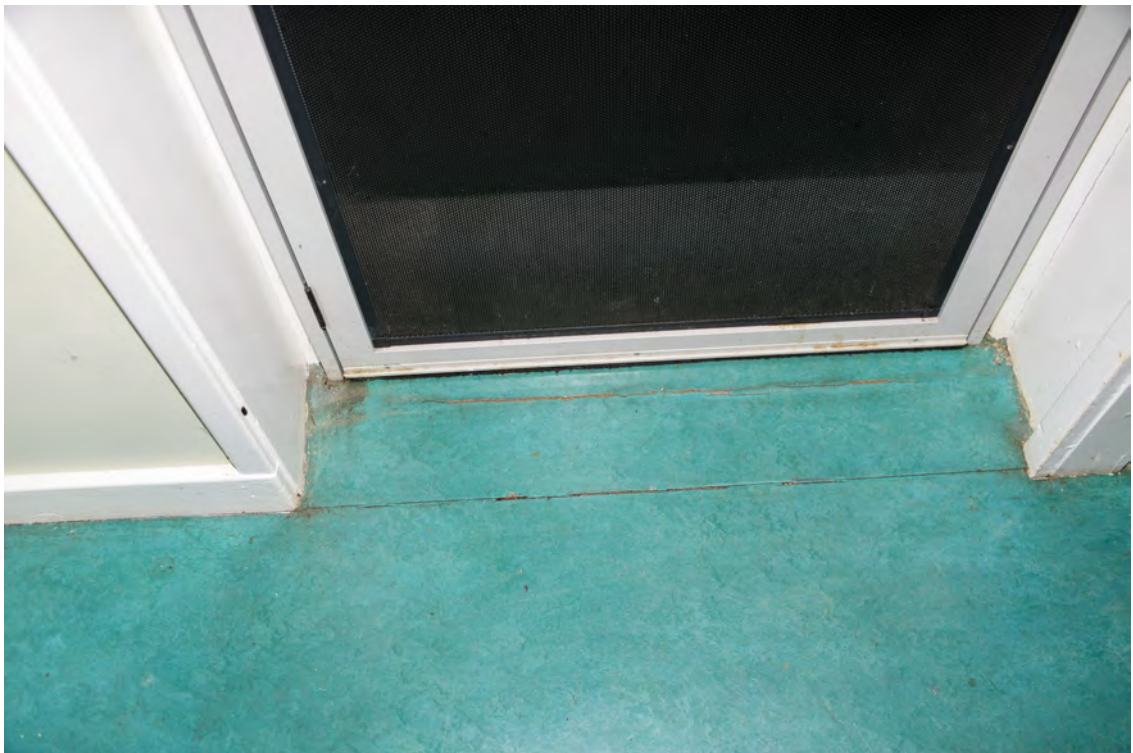
PRO\_0549.jpg

Block H. Interior. Staff room. Southern end of the flooring.

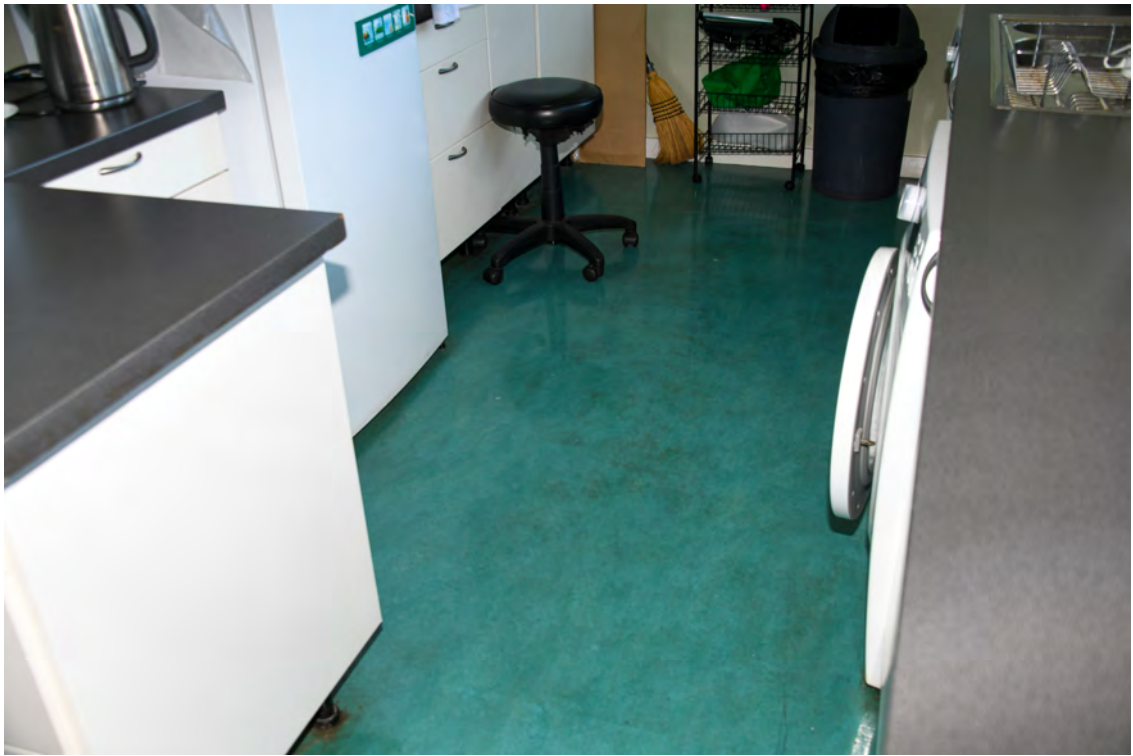
PRO\_0550.jpg

Block H. Interior. Staff room. Eastern end of the flooring.

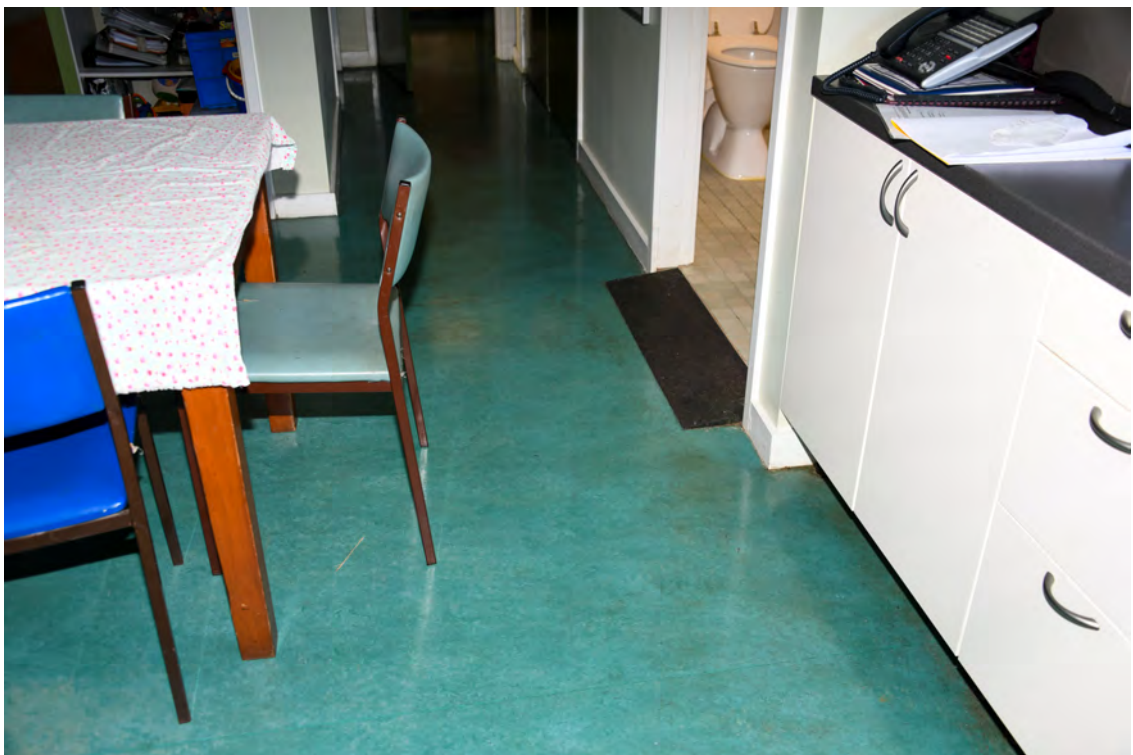
PRO\_0551.jpg

Block H. Interior. Staff room. Northern end of the flooring.

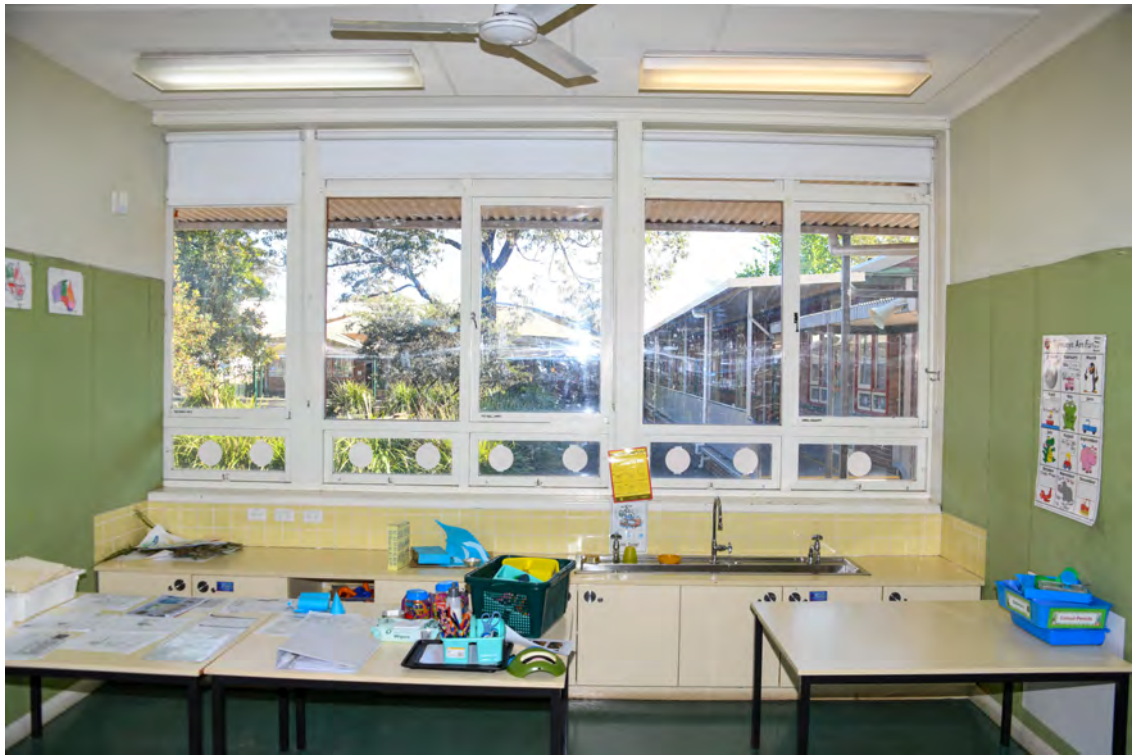
PRO\_0554.jpg

Block H. Interior. Room HR0031. Northern face. Western end.

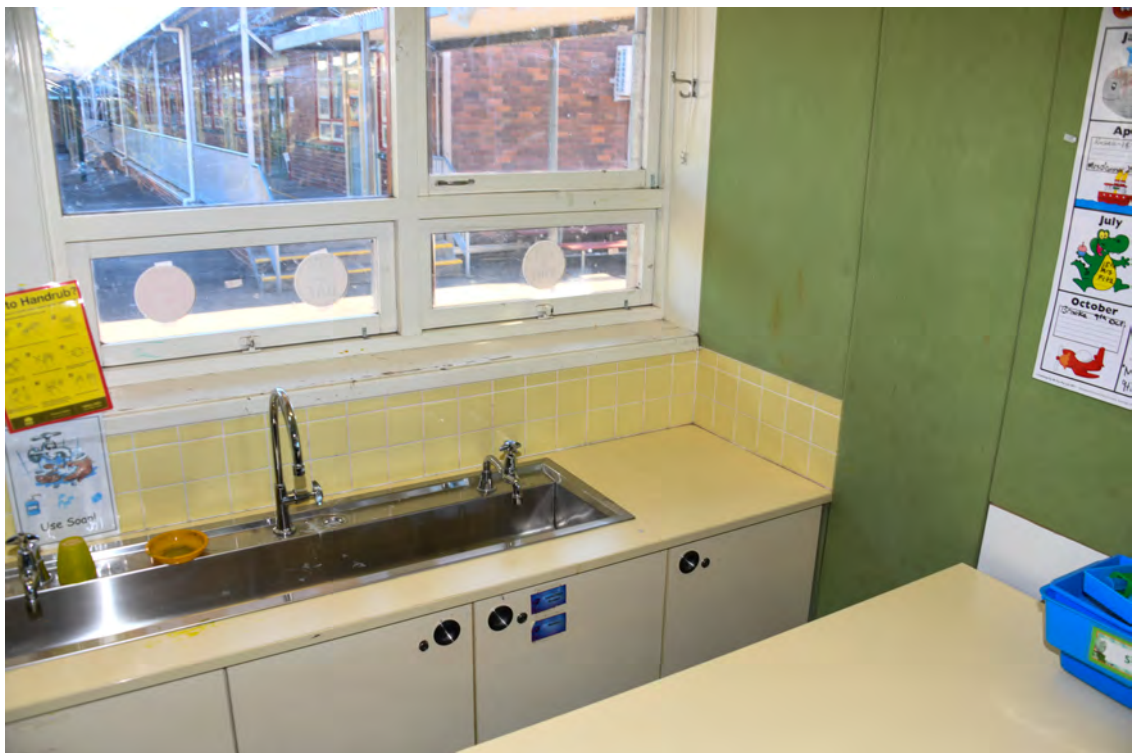
PRO\_0555.jpg

Block H. Interior. Room HR0031. Northern face. Western end.
