96-104 Carlingford Road, Epping NSW 2121

Epping West Public School

DILAPIDATION REPORT

7<sup>th</sup> September 2021

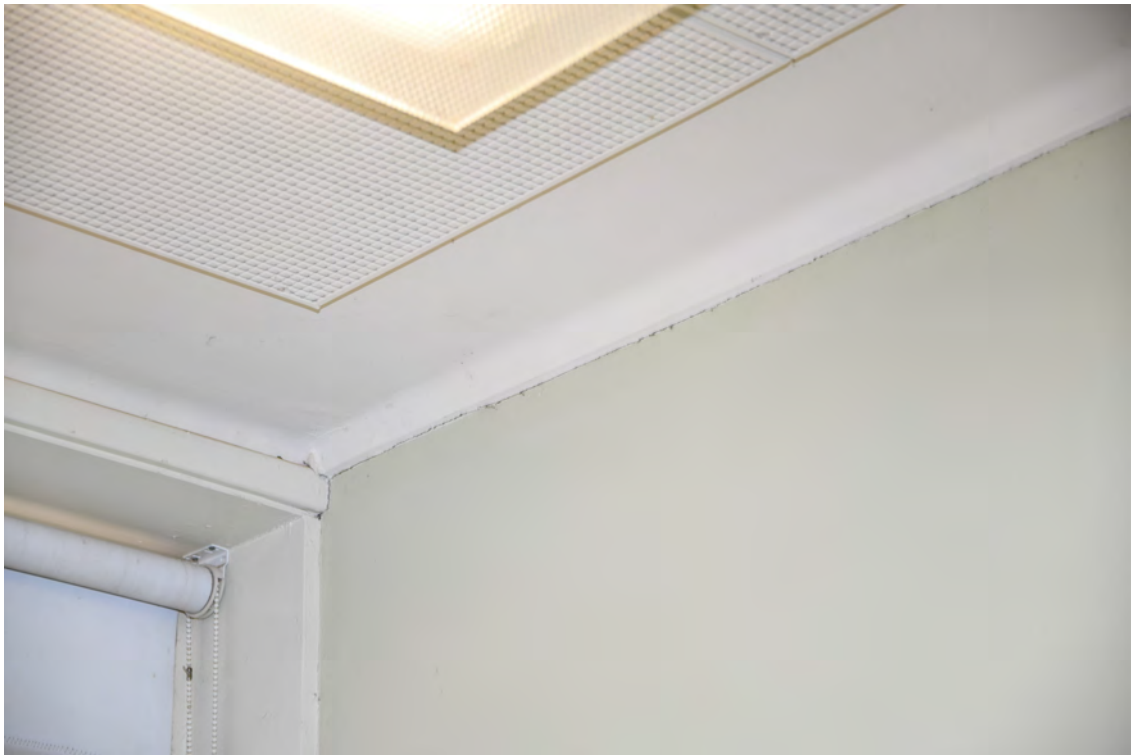
PRO\_0556.jpg

Block H. Interior. Room HR0031. Northern face. Western end. Cornice.

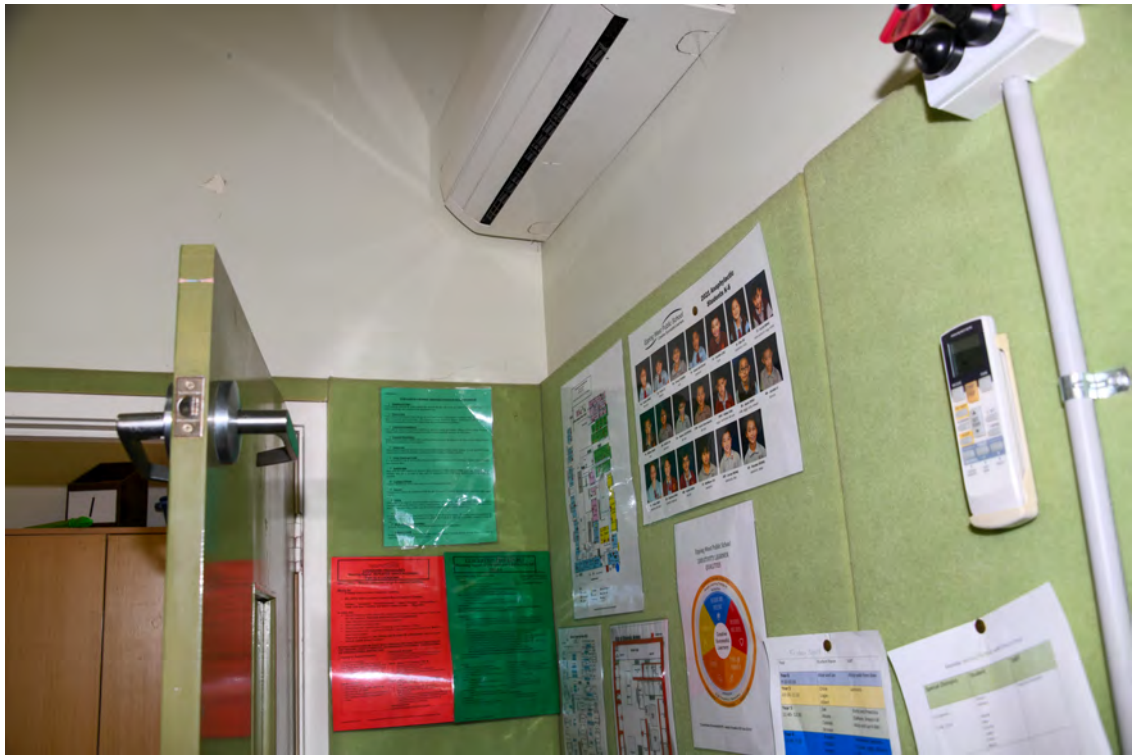
PRO\_0560.jpg

Block H. Interior. Room HR0031. Eastern face. Northern end.

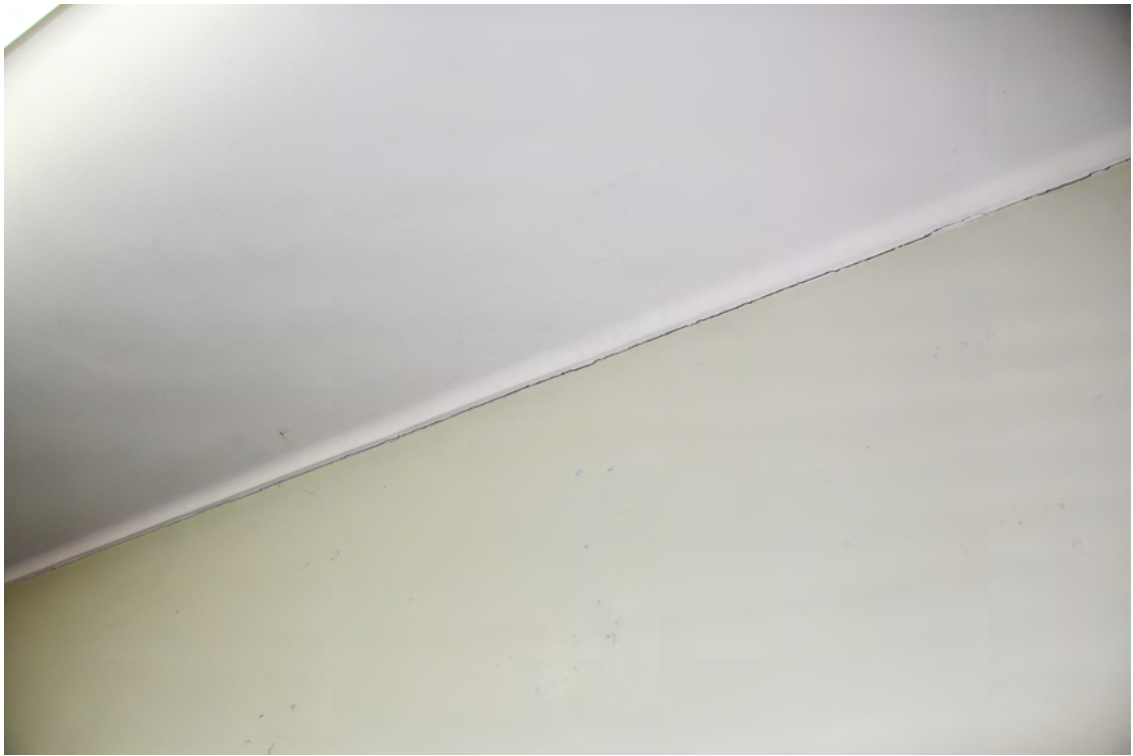
PRO\_0562.jpg

Block H. Interior. Room HR0031. Eastern face. Cornice.

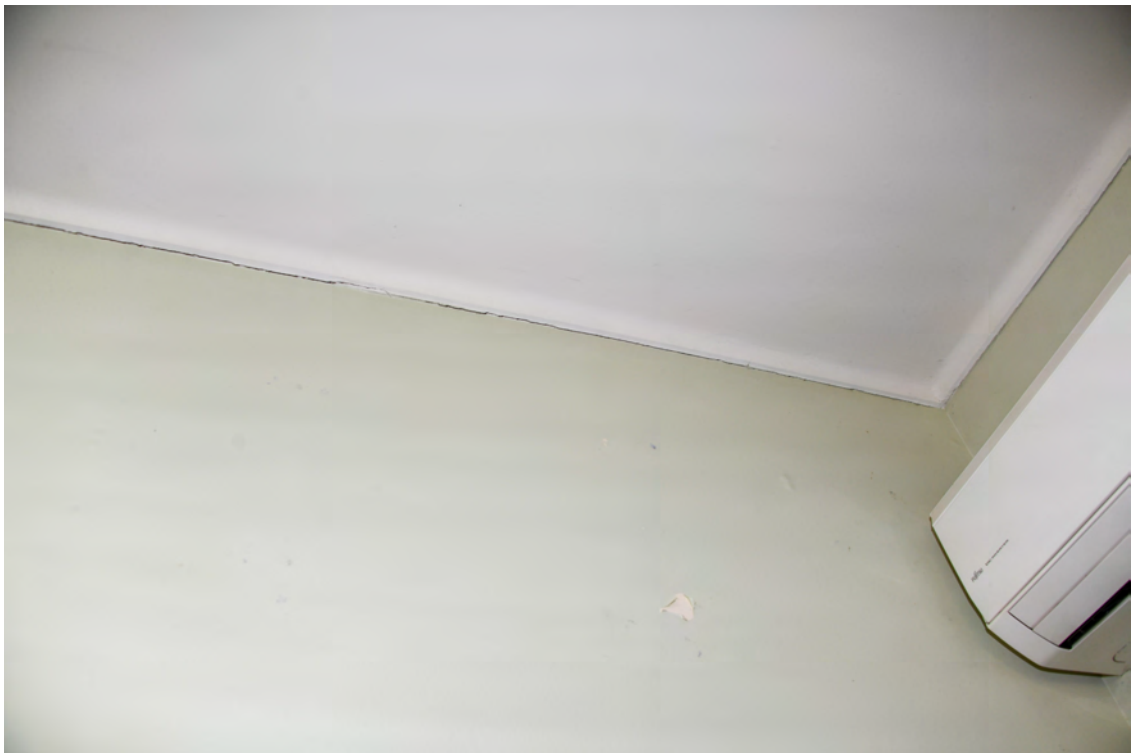
PRO\_0563.jpg

Block H. Interior. Room HR0031. Eastern face. Cornice.

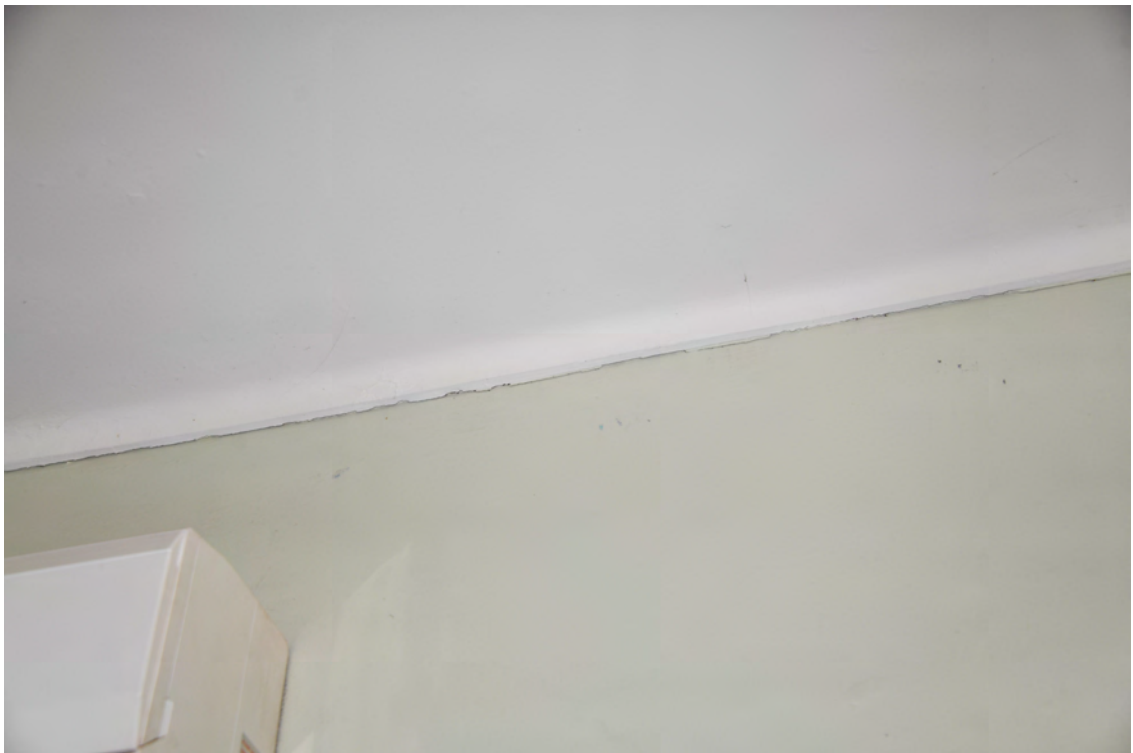
PRO\_0565.jpg

Block H. Interior. Room HR0031. Eastern face. Cornice.

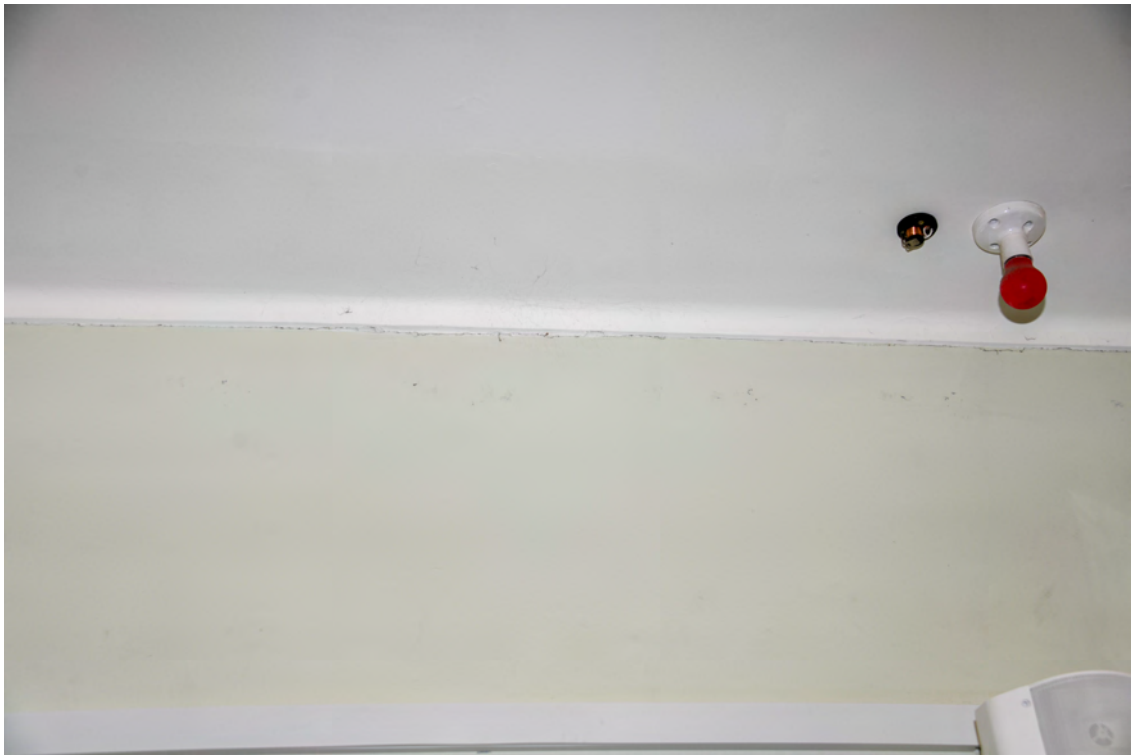
PRO\_0566.jpg

Block H. Interior. Room HR0031. Eastern face. Cornice.

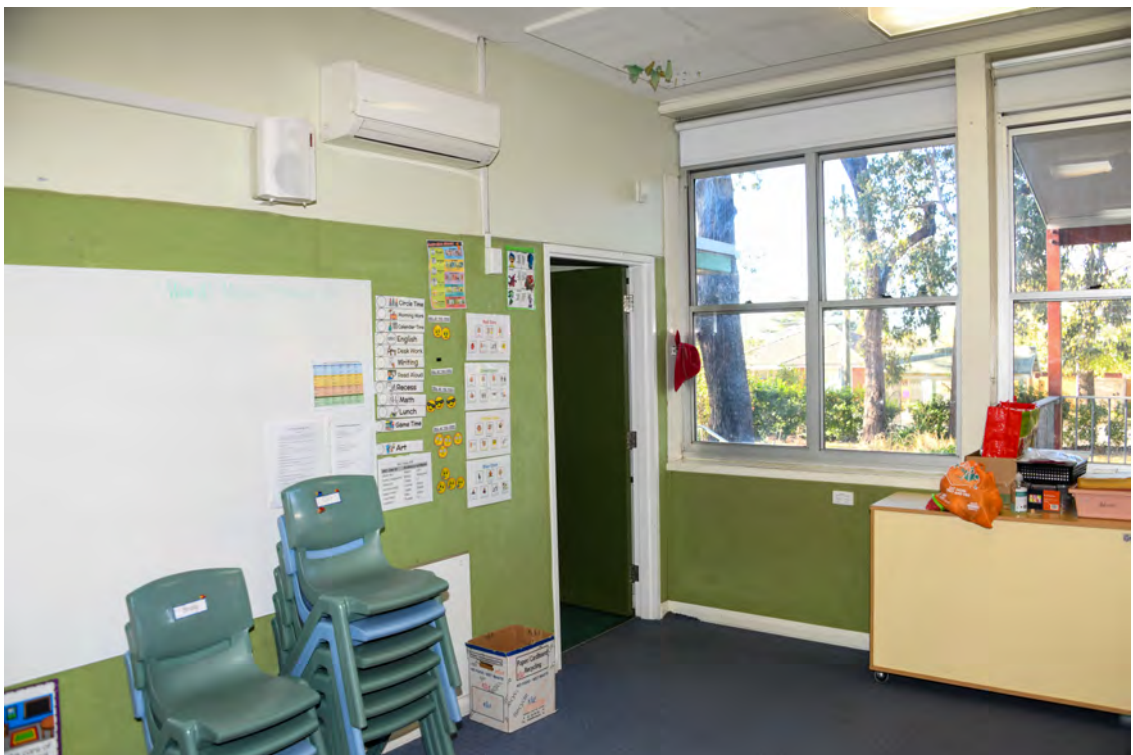
PRO\_0567.jpg

Block H. Interior. Room HR0031. Eastern face. Southern end.

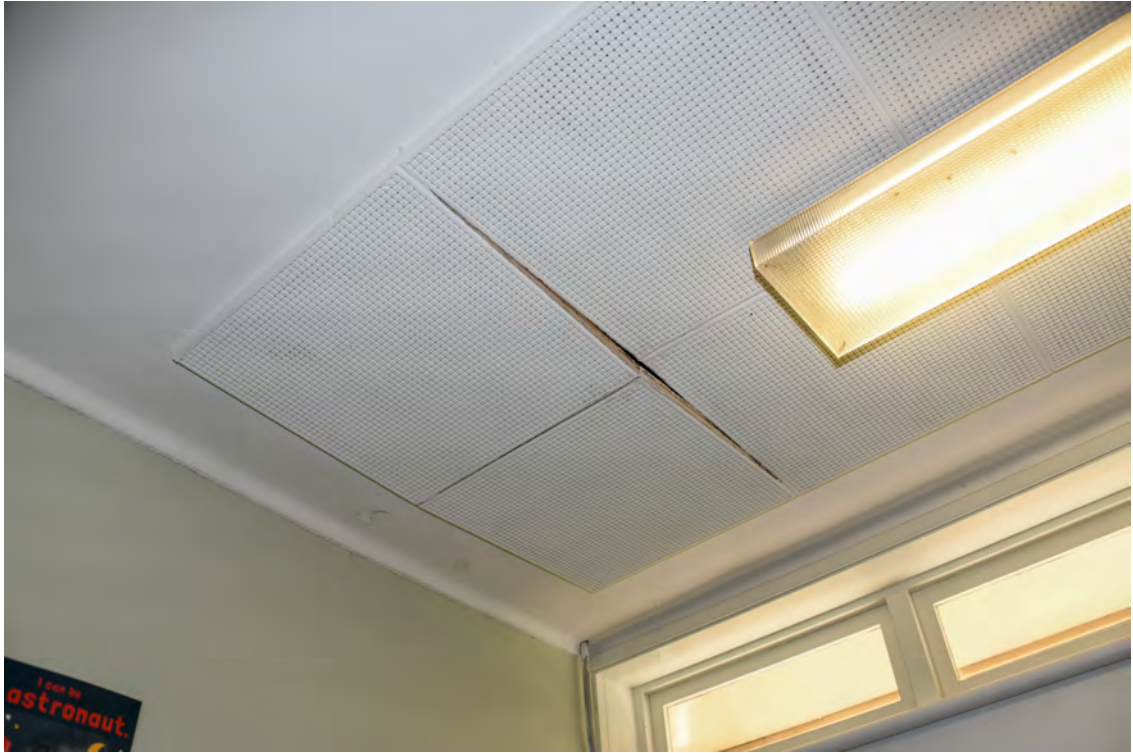
PRO\_0613.jpg

Block H. Interior. Room HR0027. Ceiling. Movement to the ceiling tiles in the north-western corner of the room.

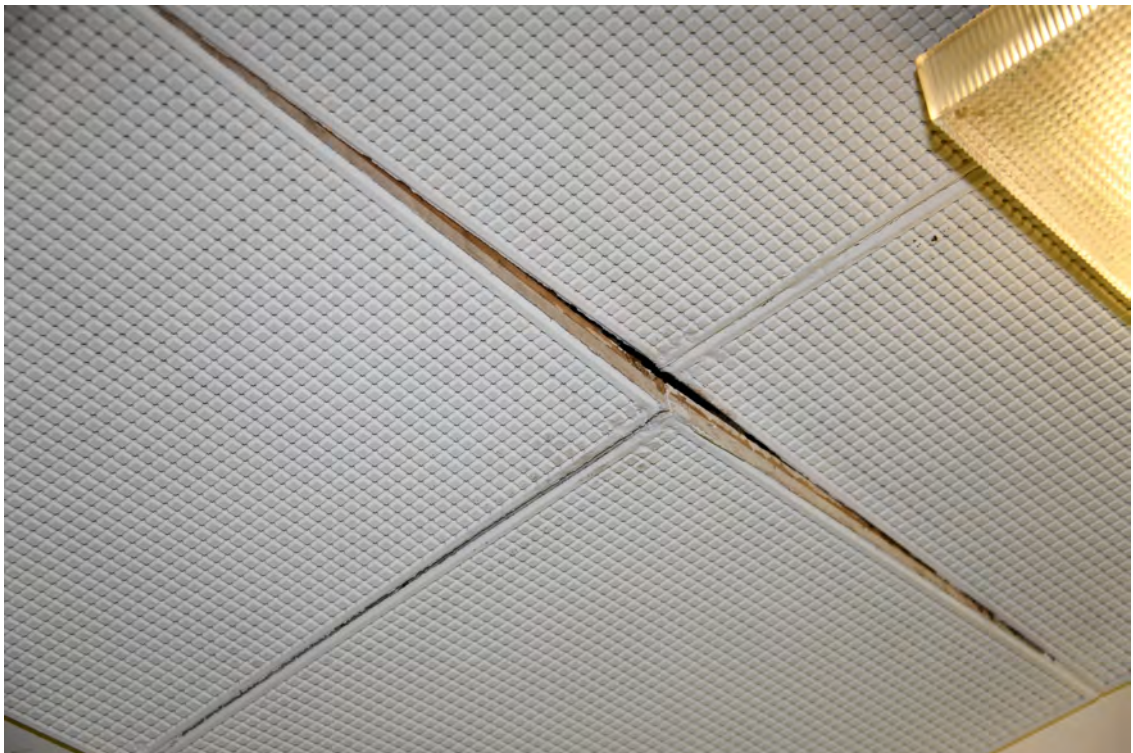
PRO\_0614.jpg

Block H. Interior. Room HR0027. Ceiling. Movement to the ceiling tiles in the north-western corner of the room.

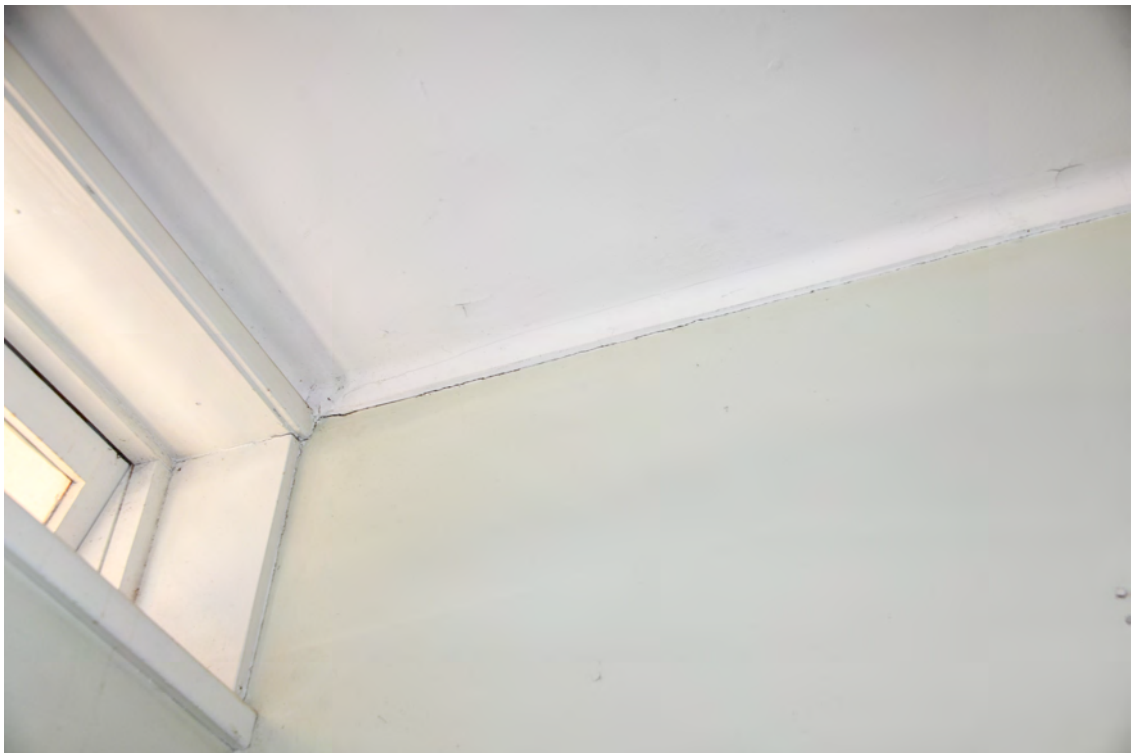
PRO\_0625.jpg

Block H. Interior. Foyer. Eastern face. Northern end.

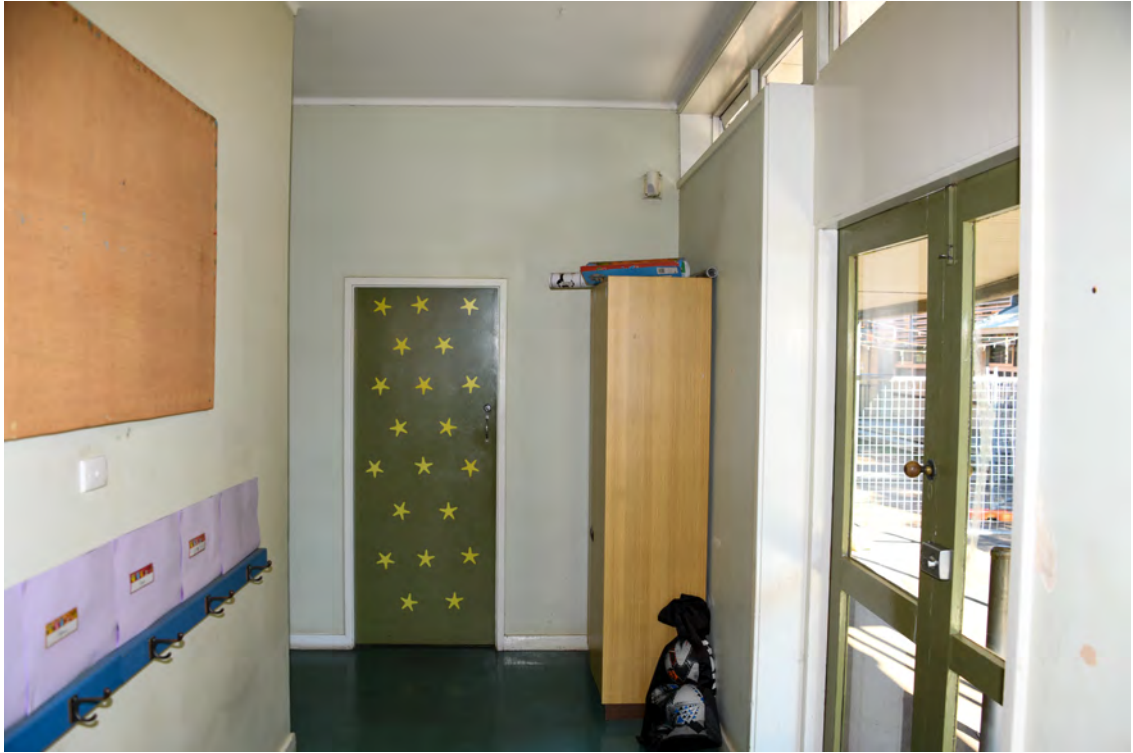
PRO\_0628.jpg

Block H. Interior. Foyer. Western face.

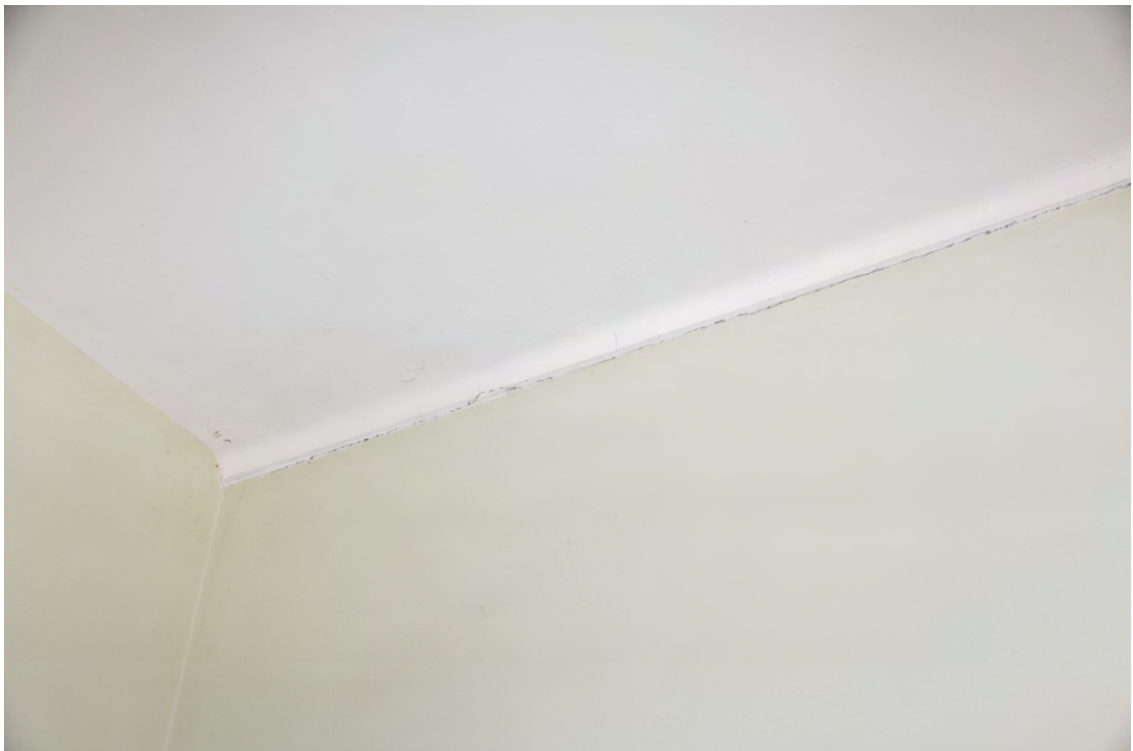
PRO\_0629.jpg

Block H. Interior. Foyer. Western face. Cornice.

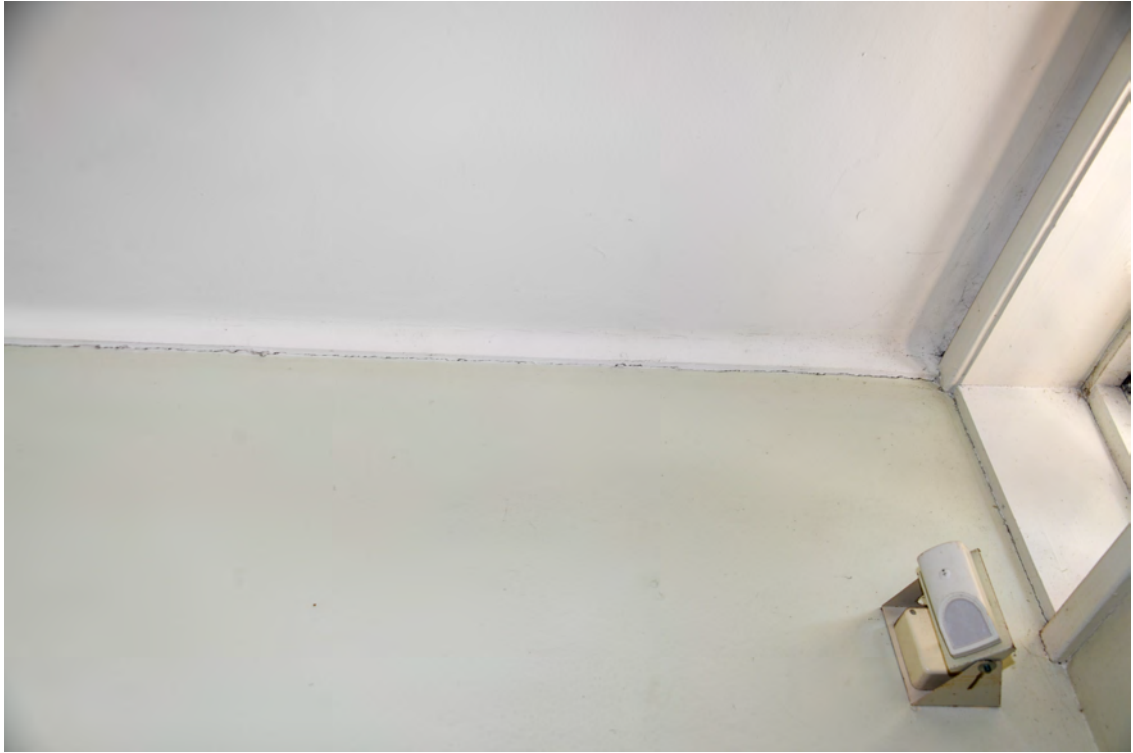
PRO\_0630.jpg

Block H. Interior. Foyer. Western face. Cornice.

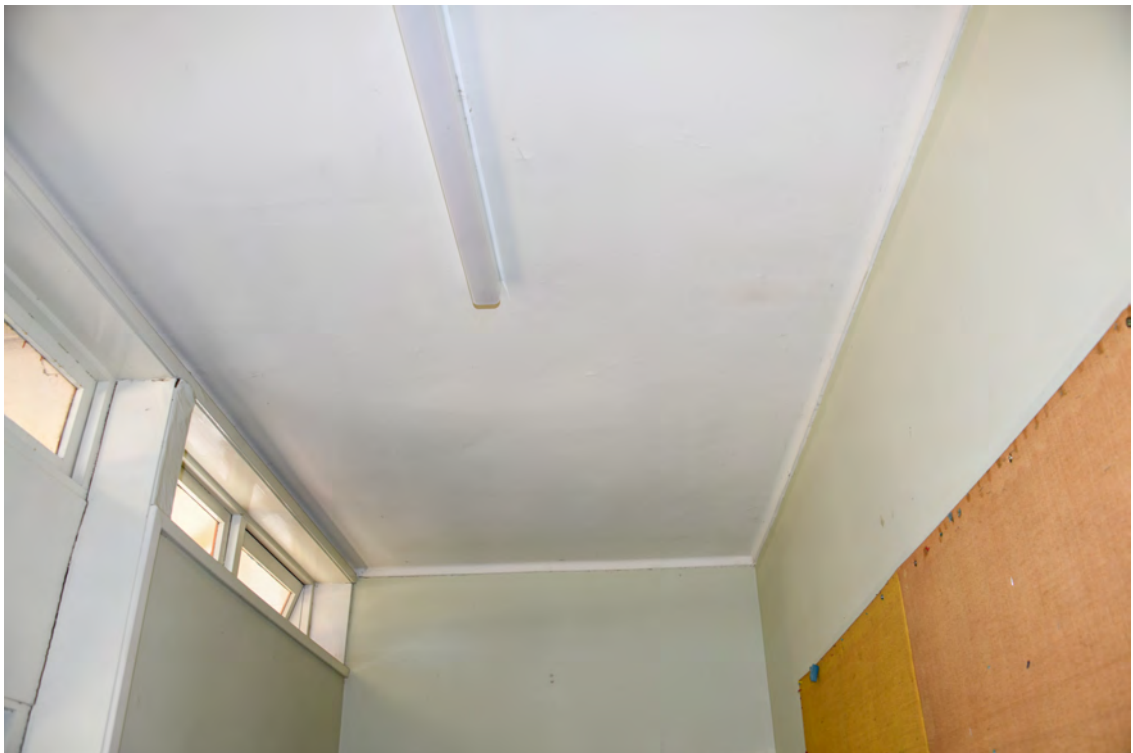
PRO\_0631.jpg

Block H. Interior. Foyer. Eastern end of the ceiling.

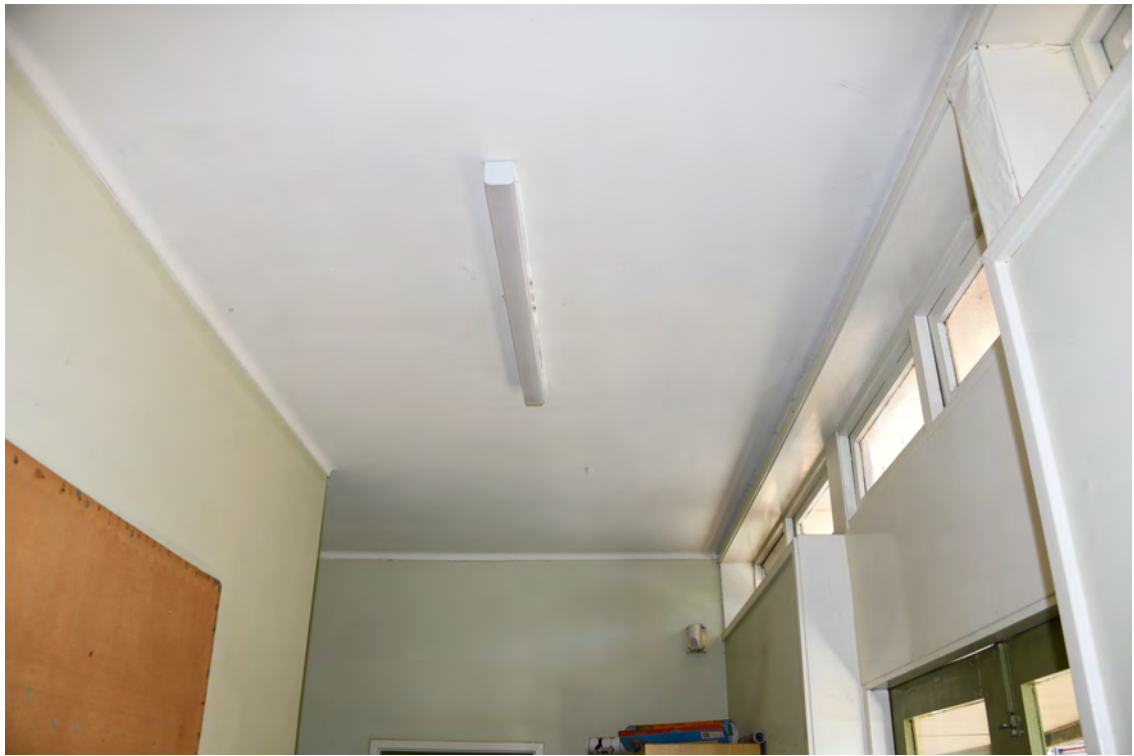
PRO\_0632.jpg

Block H. Interior. Foyer. Western end of the ceiling.

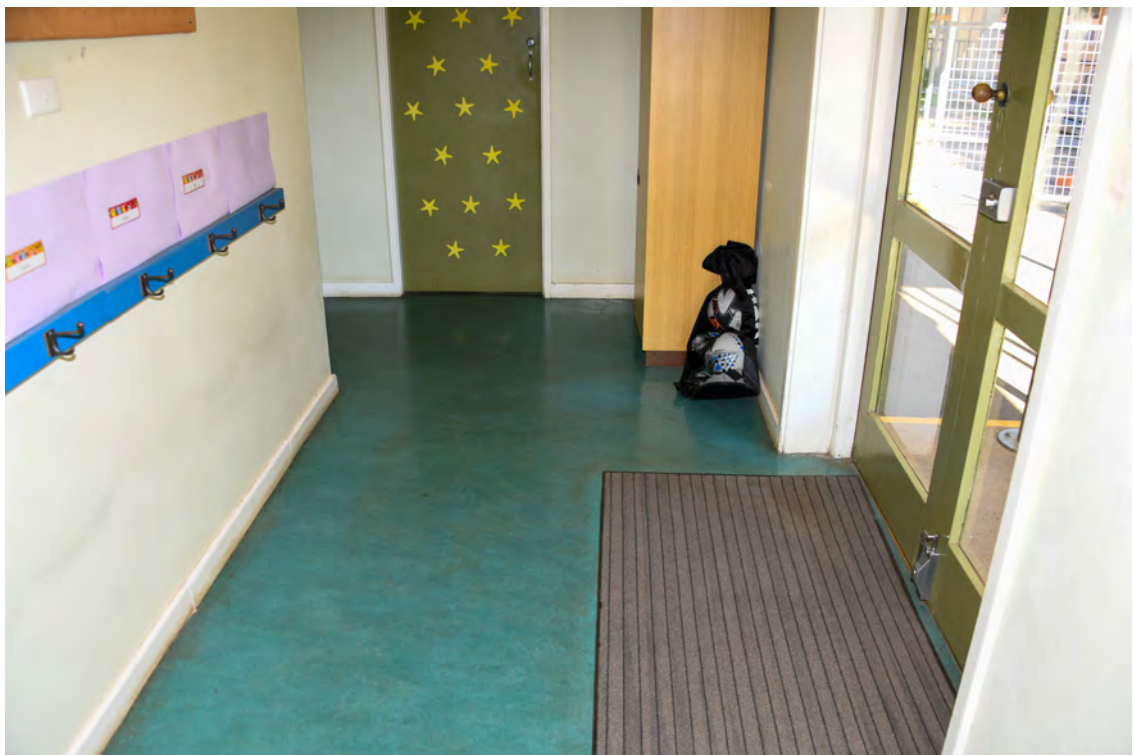
PRO\_0633.jpg

Block H. Interior. Foyer. Western end of the flooring.

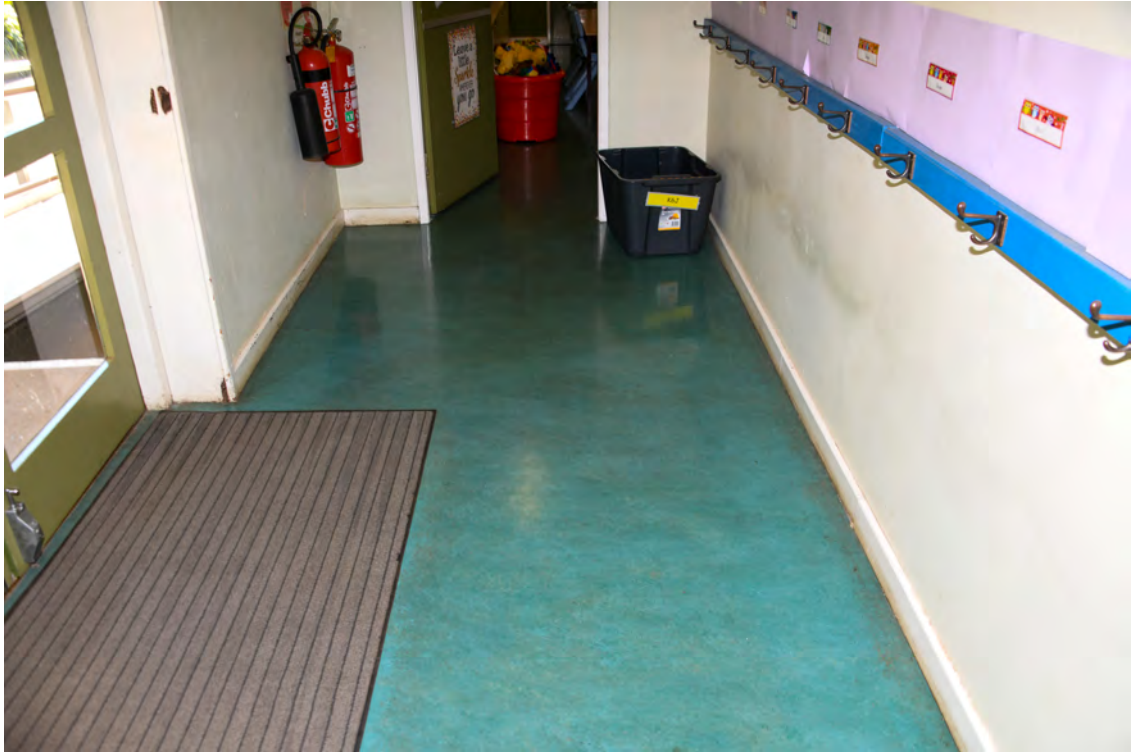
PRO\_0634.jpg

Block H. Interior. Foyer. Eastern end of the flooring.

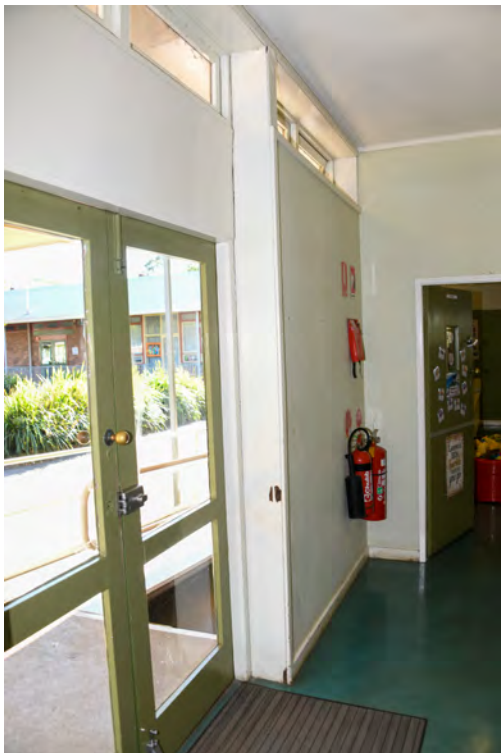
PRO\_0635.jpg

Block H. Interior. Foyer. Eastern end of the northern face.

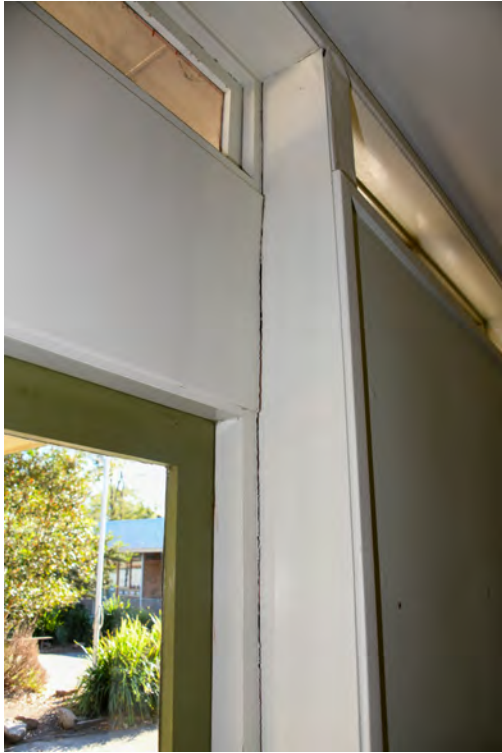
PRO\_0636.jpg

Block H. Interior. Foyer. Northern face. Eastern reveal to the doorway.

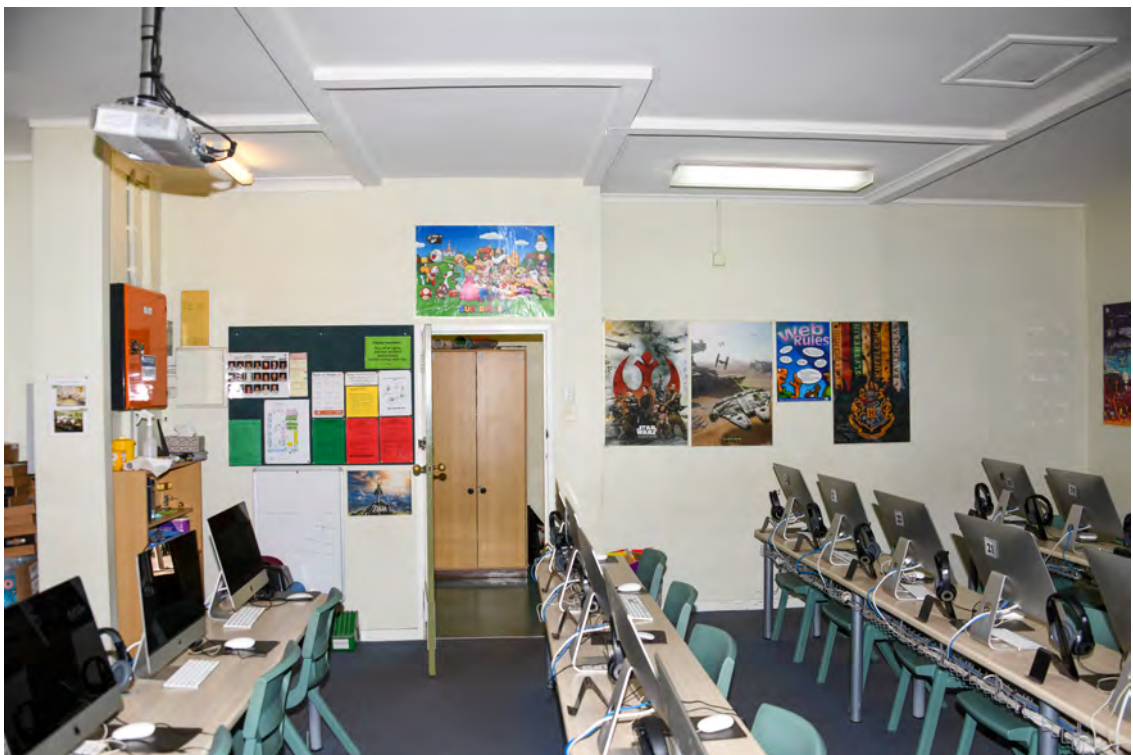
PRO\_0639.jpg

Block H. Interior. Computer room. Northern face.

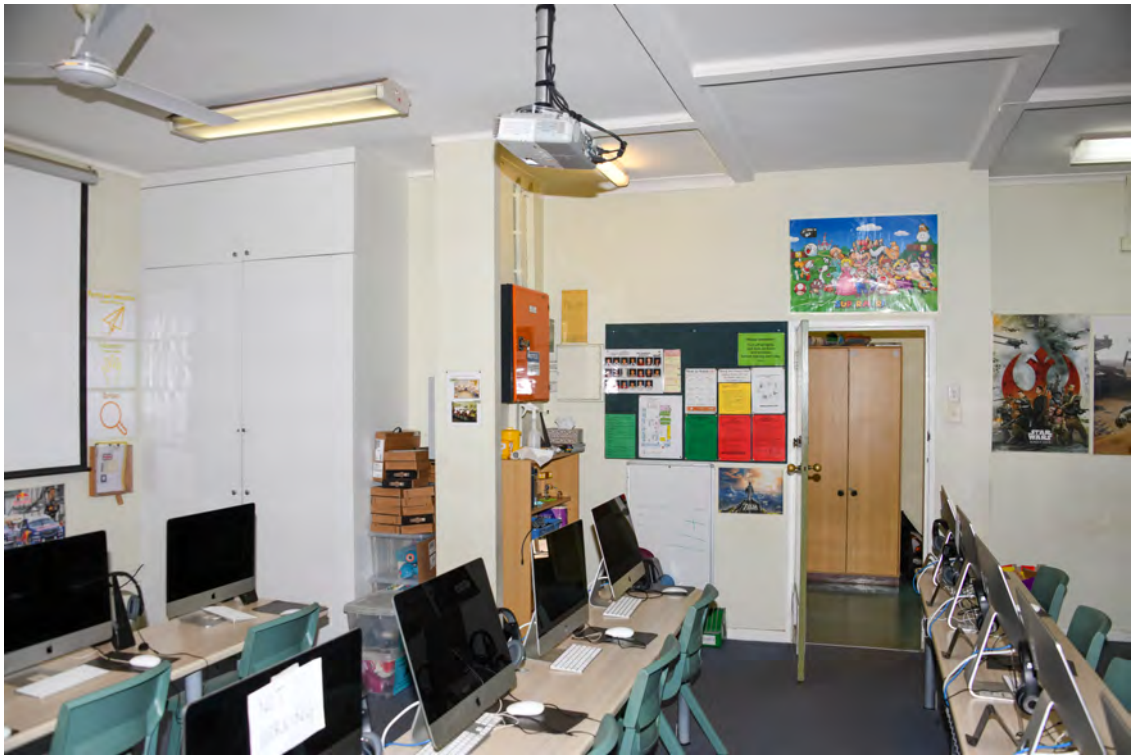
PRO\_0640.jpg

Block H. Interior. Computer room. Northern face.

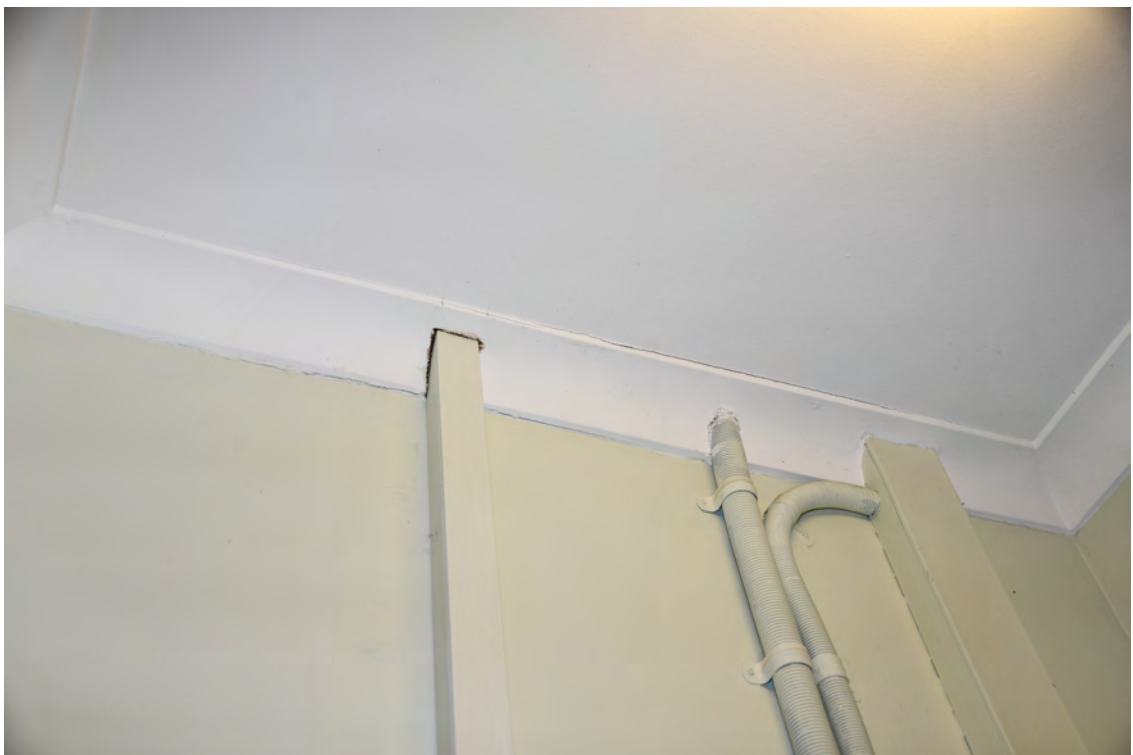
PRO\_0641.jpg

Block H. Interior. Computer room. Northern face.

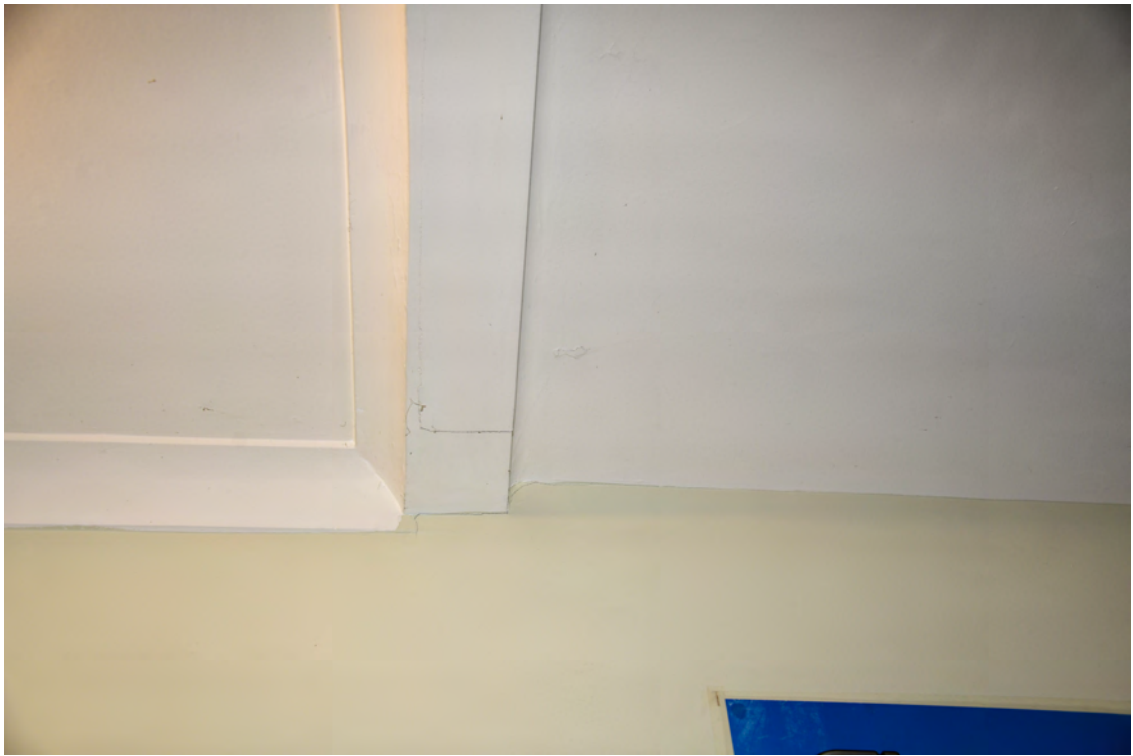
PRO\_0642.jpg

Block H. Interior. Computer room. Northern face.

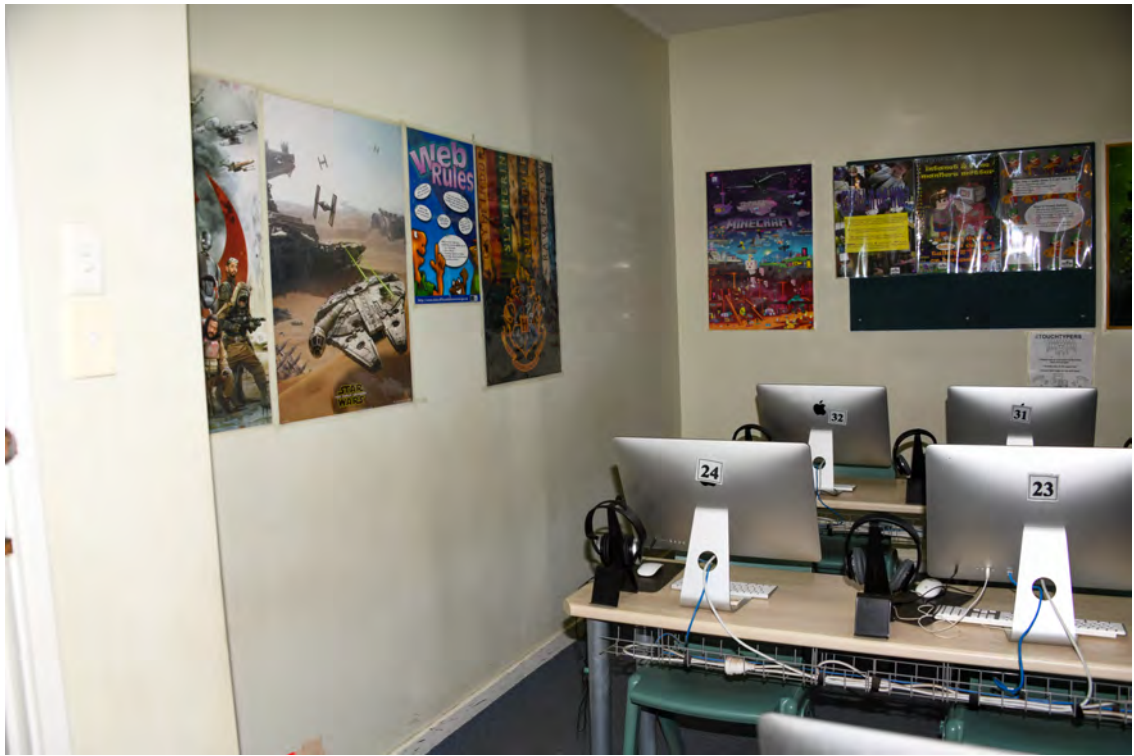
PRO\_0644.jpg

Block H. Interior. Computer room. Northern face. Eastern end.

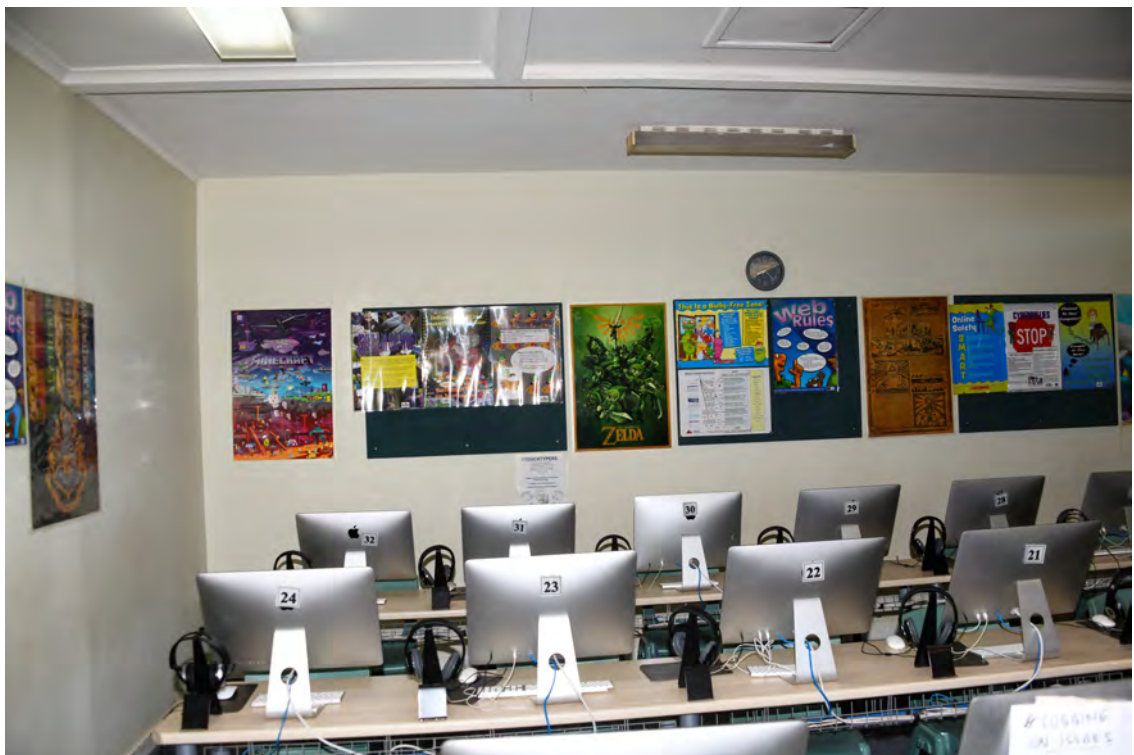
PRO\_0645.jpg

Block H. Interior. Computer room. Eastern face.

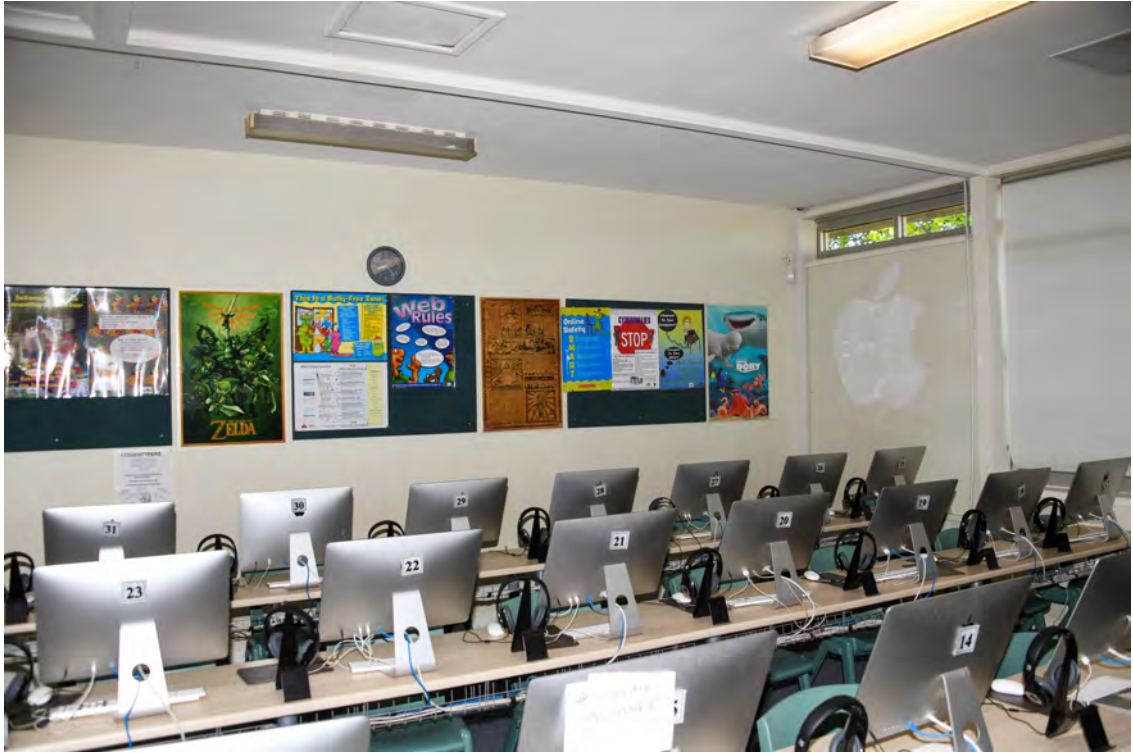
PRO\_0646.jpg

Block H. Interior. Computer room. Eastern face.

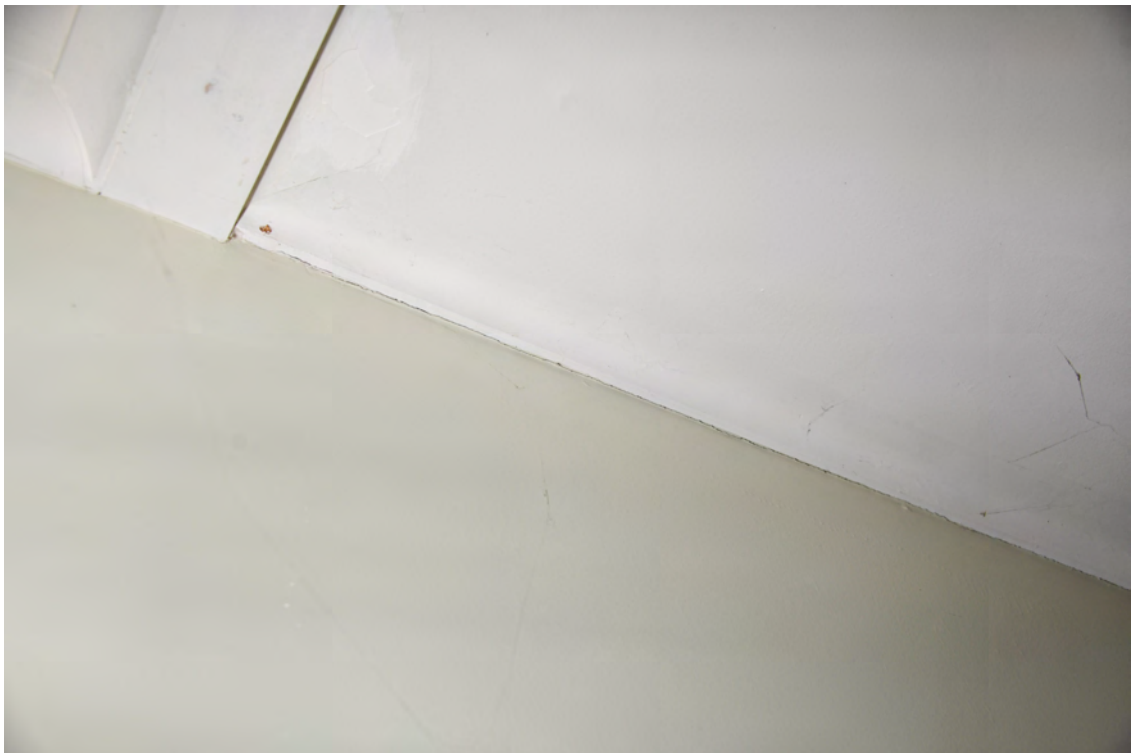
PRO\_0647.jpg

Block H. Interior. Computer room. Eastern face.
