96-104 Carlingford Road, Epping NSW 2121

Epping West Public School

DILAPIDATION REPORT

7<sup>th</sup> September 2021

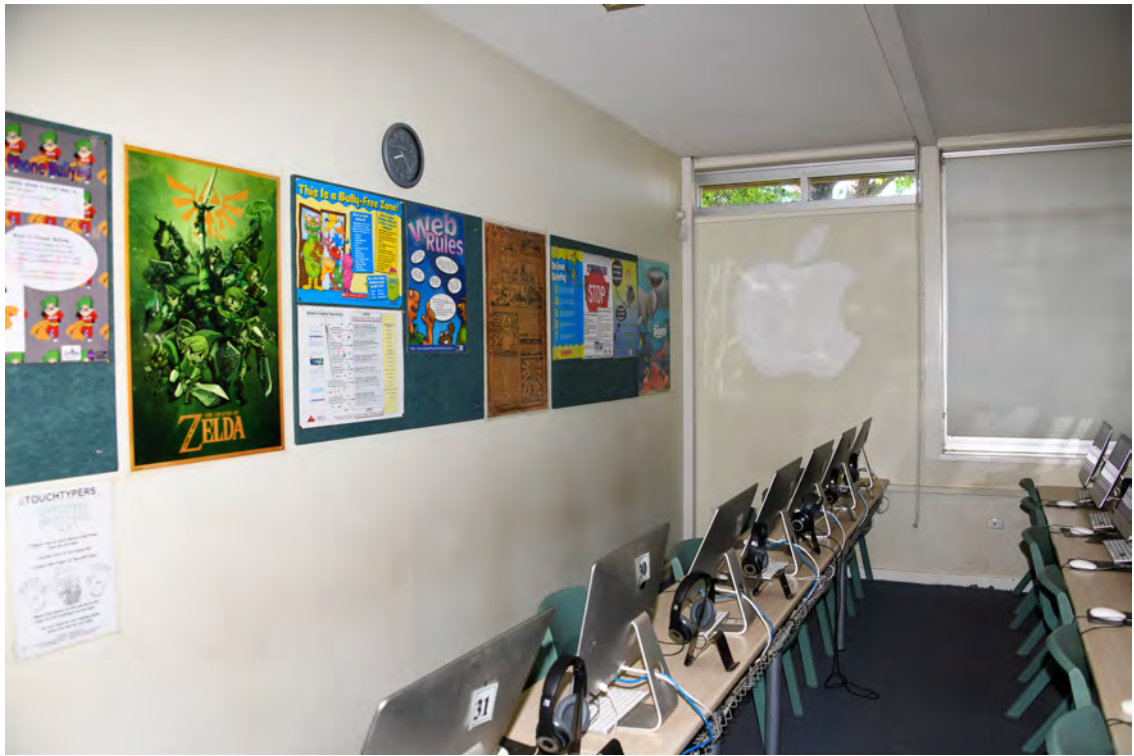
PRO\_0648.jpg

Block H. Interior. Computer room. Eastern face. Southern end.

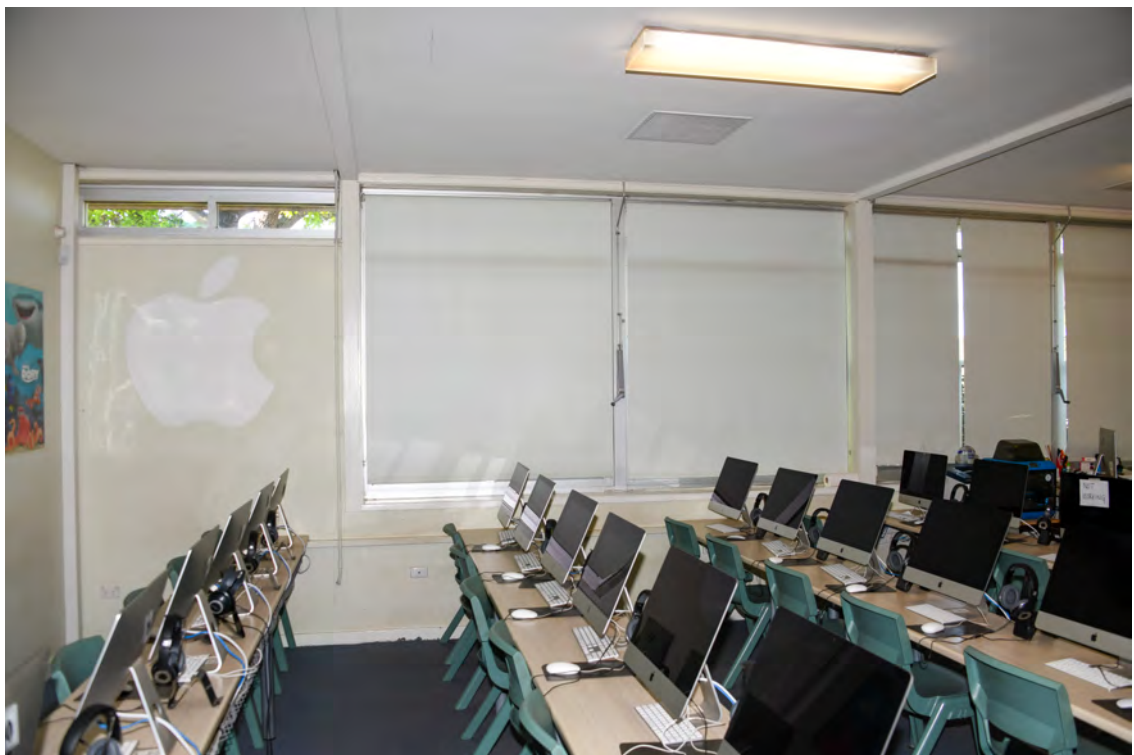
PRO\_0649.jpg

Block H. Interior. Computer room. Southern face.

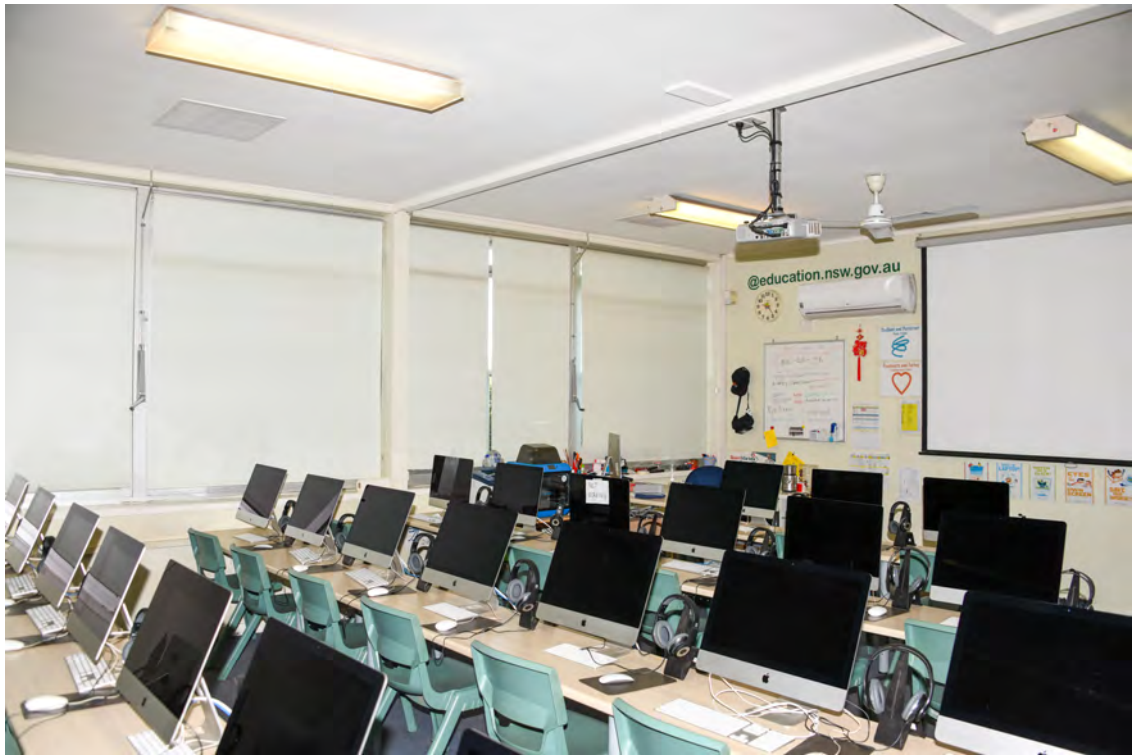
PRO\_0650.jpg

Block H. Interior. Computer room. Southern face.

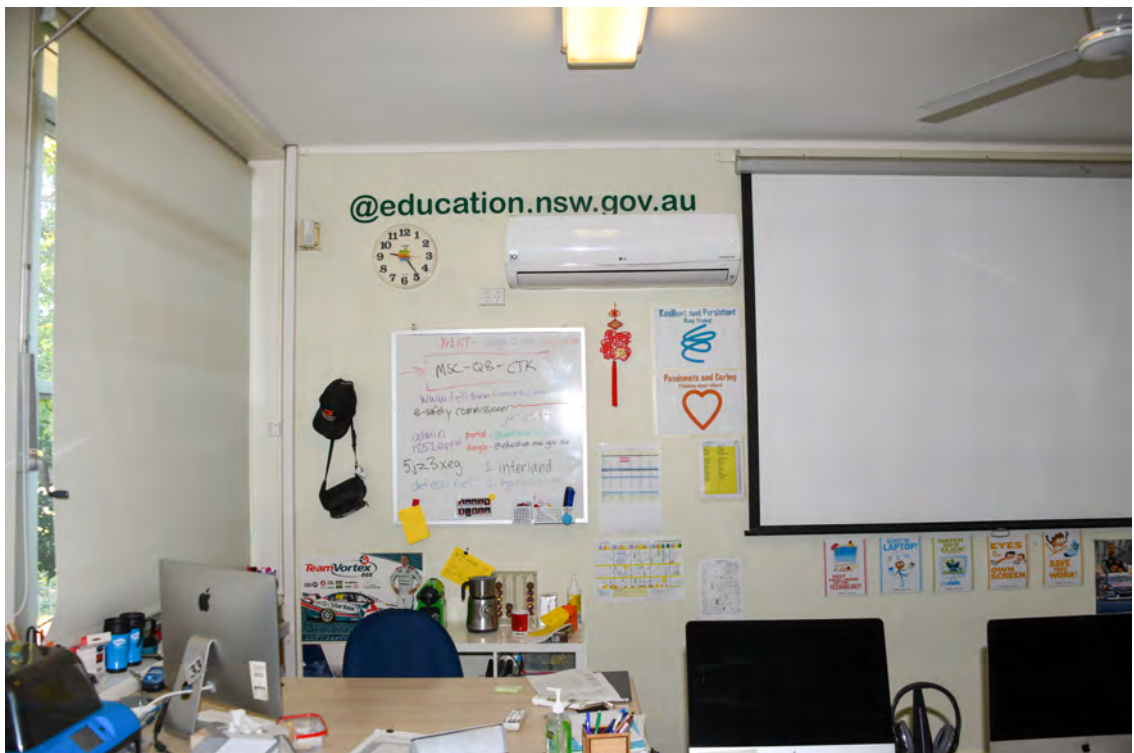
PRO\_0651.jpg

Block H. Interior. Computer room. Western face.

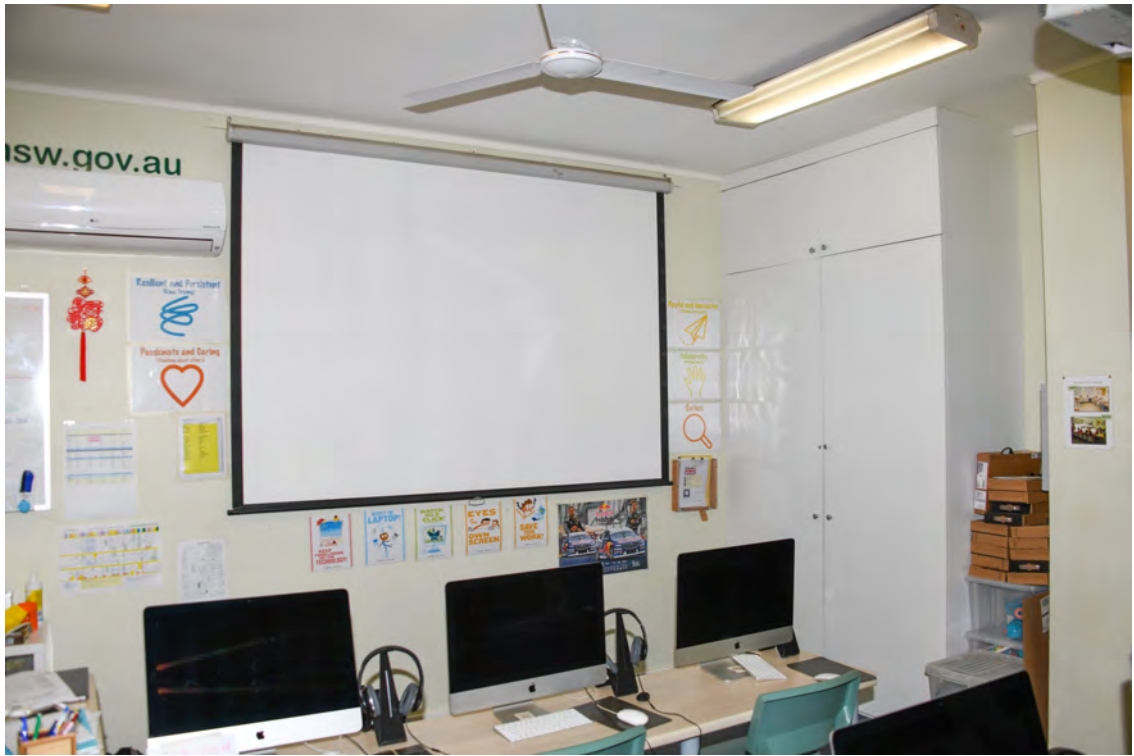
PRO\_0652.jpg

Block H. Interior. Computer room. Western face.

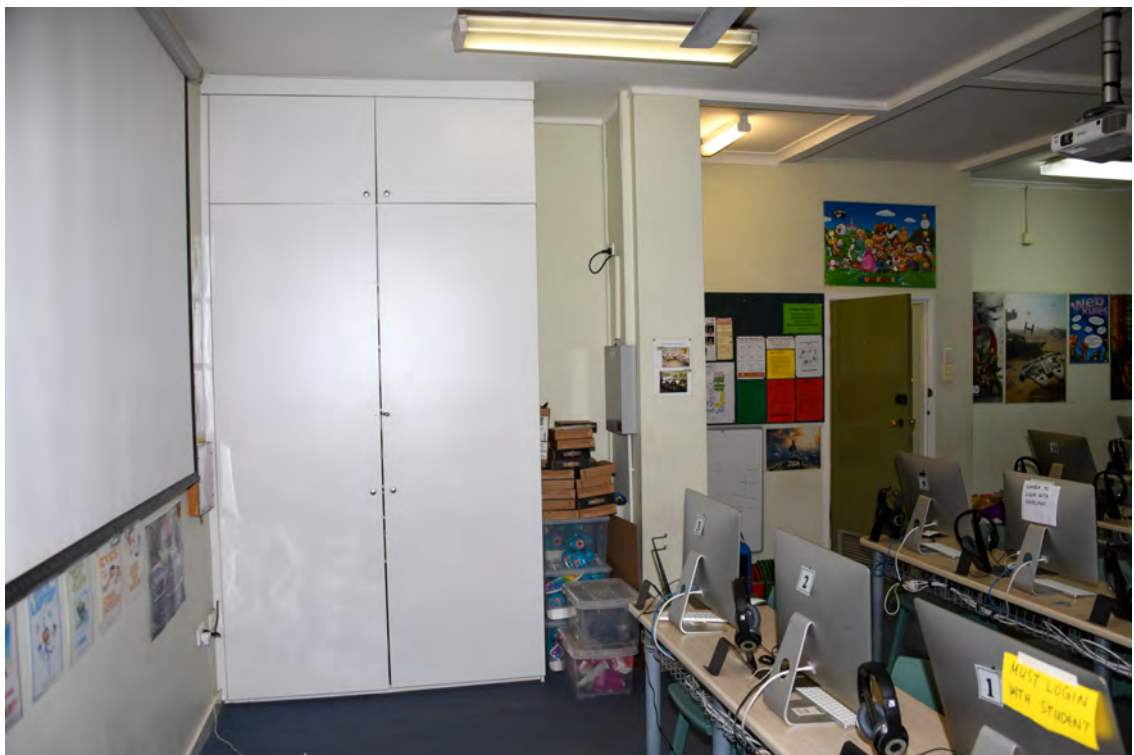
PRO\_0653.jpg

Block H. Interior. Computer room. North-western corner.

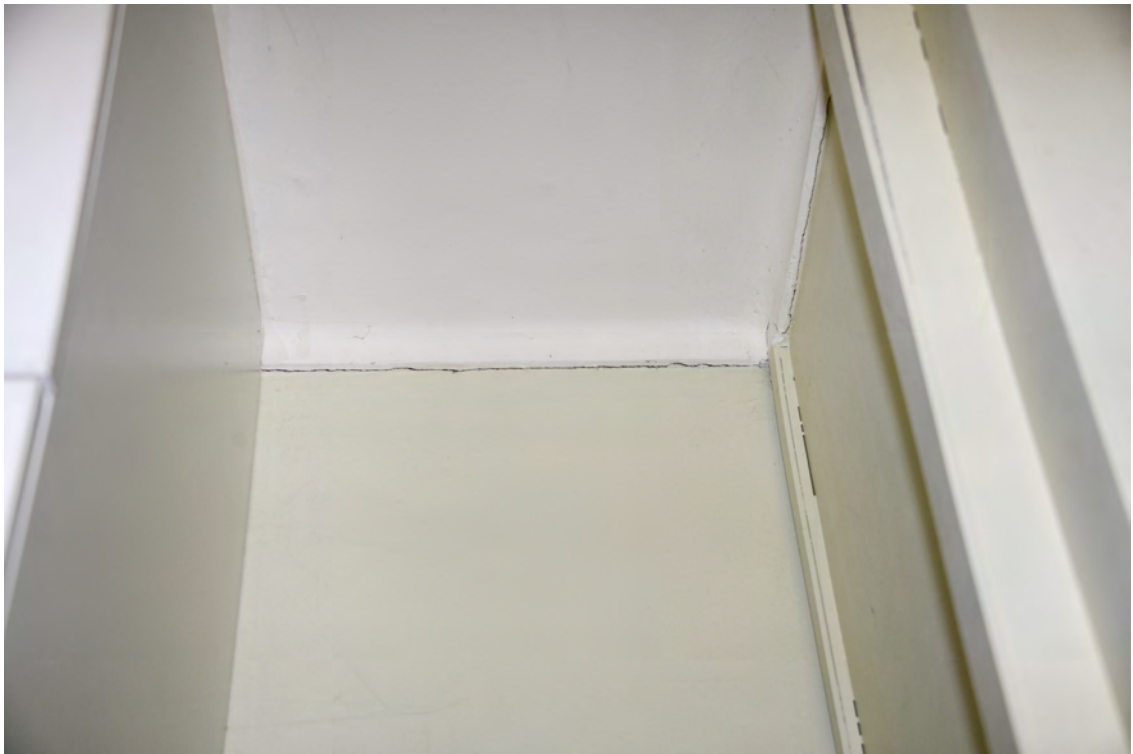
PRO\_0654.jpg

Block H. Interior. Computer room. North-western corner. Cornice.

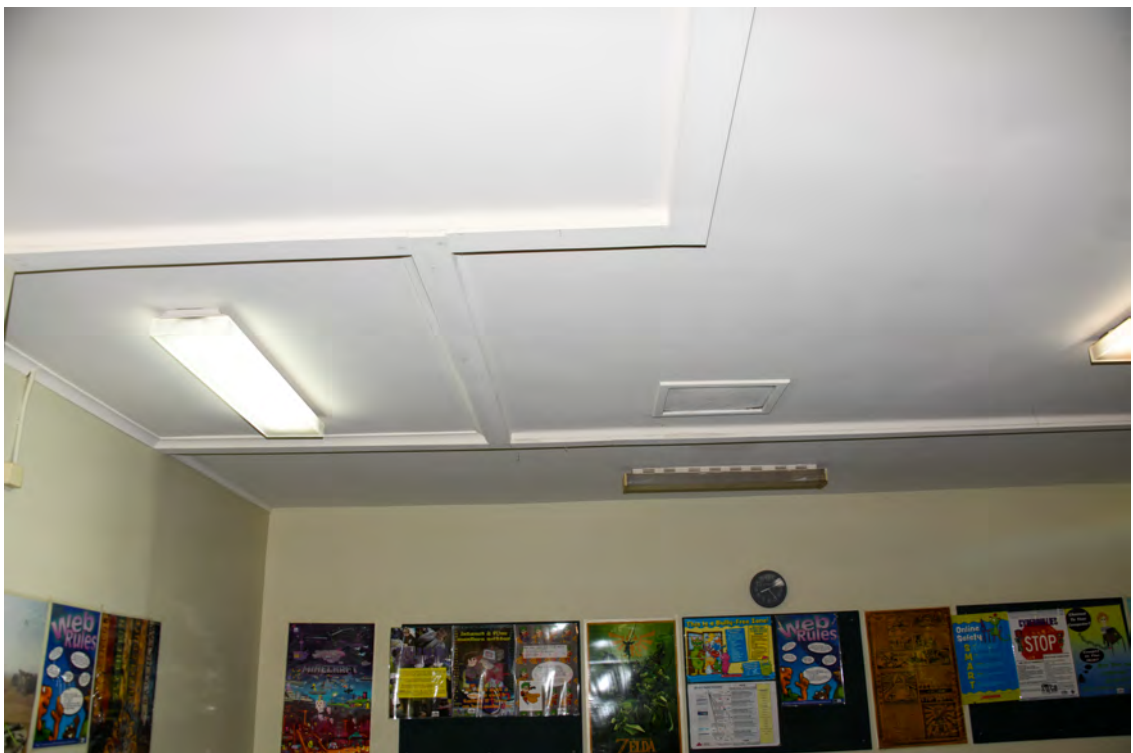
PRO\_0655.jpg

Block H. Interior. Computer room. Ceiling.

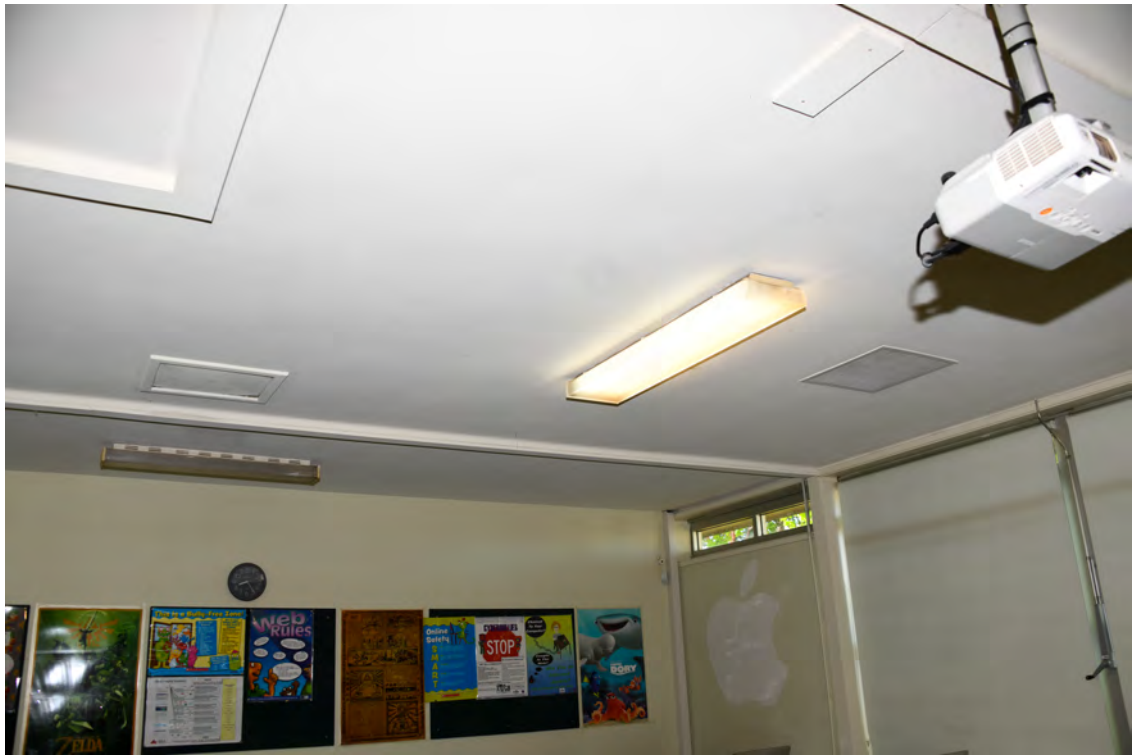
PRO\_0656.jpg

Block H. Interior. Computer room. Ceiling.

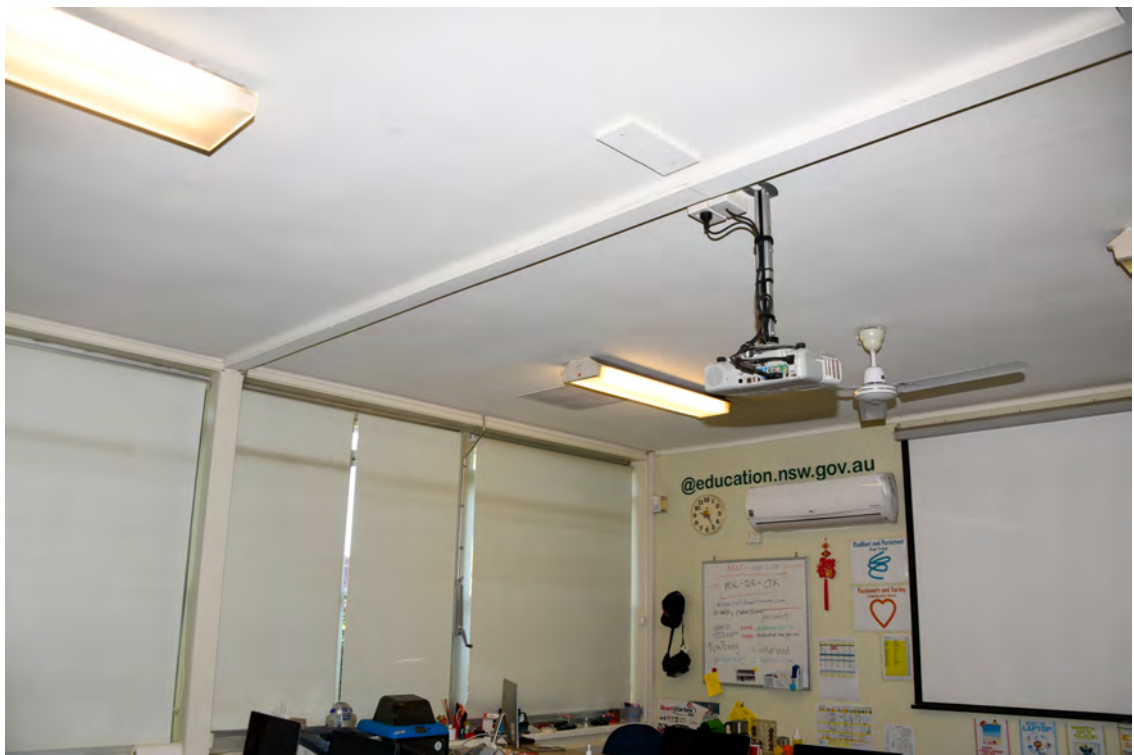
PRO\_0657.jpg

Block H. Interior. Computer room. Ceiling.

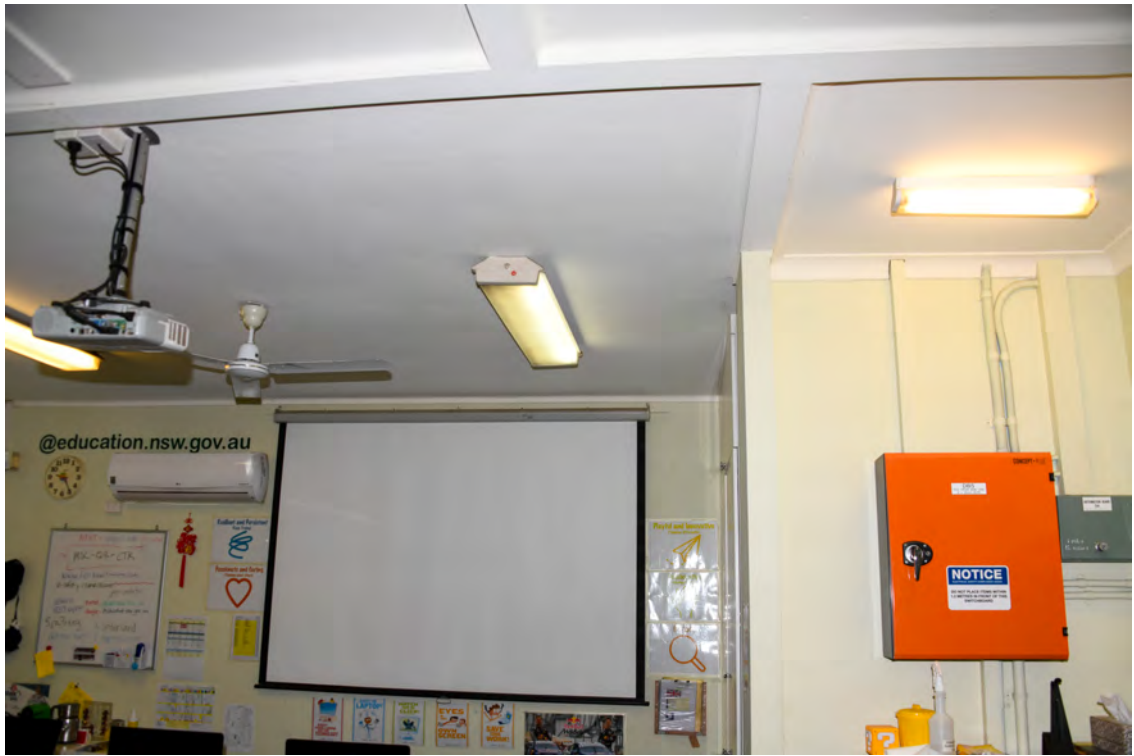
PRO\_0658.jpg

Block H. Interior. Computer room. Ceiling. Western side.

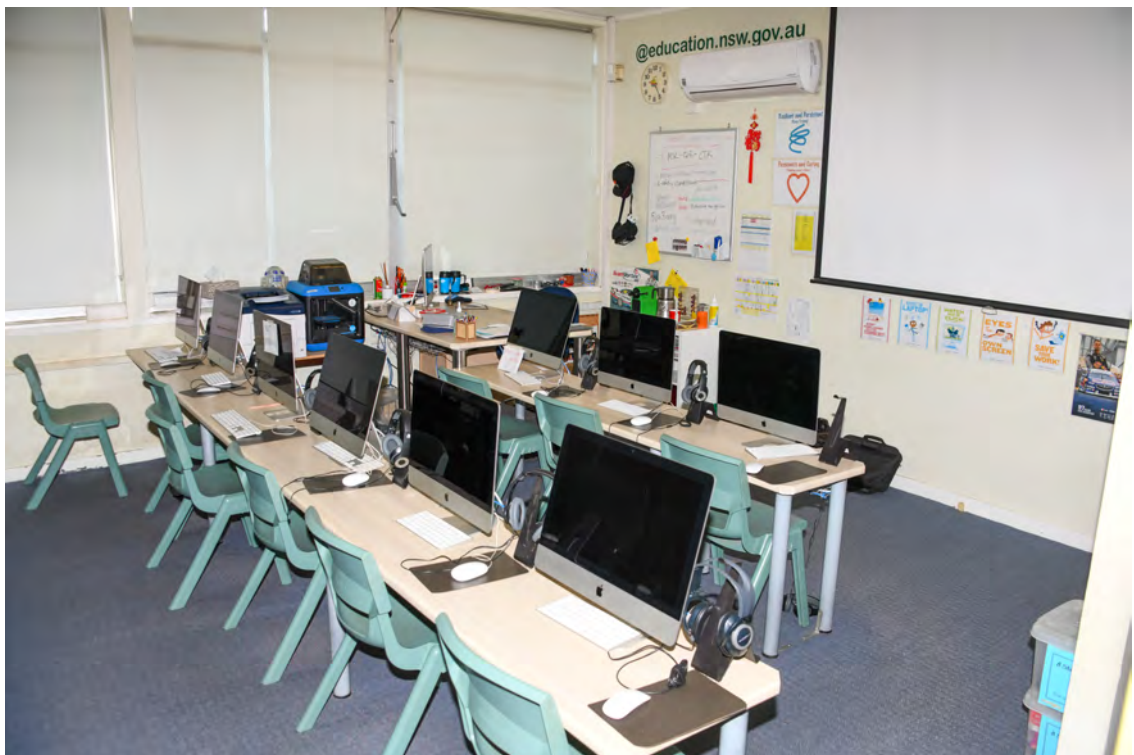
PRO\_0659.jpg

Block H. Interior. Computer room. Western side.

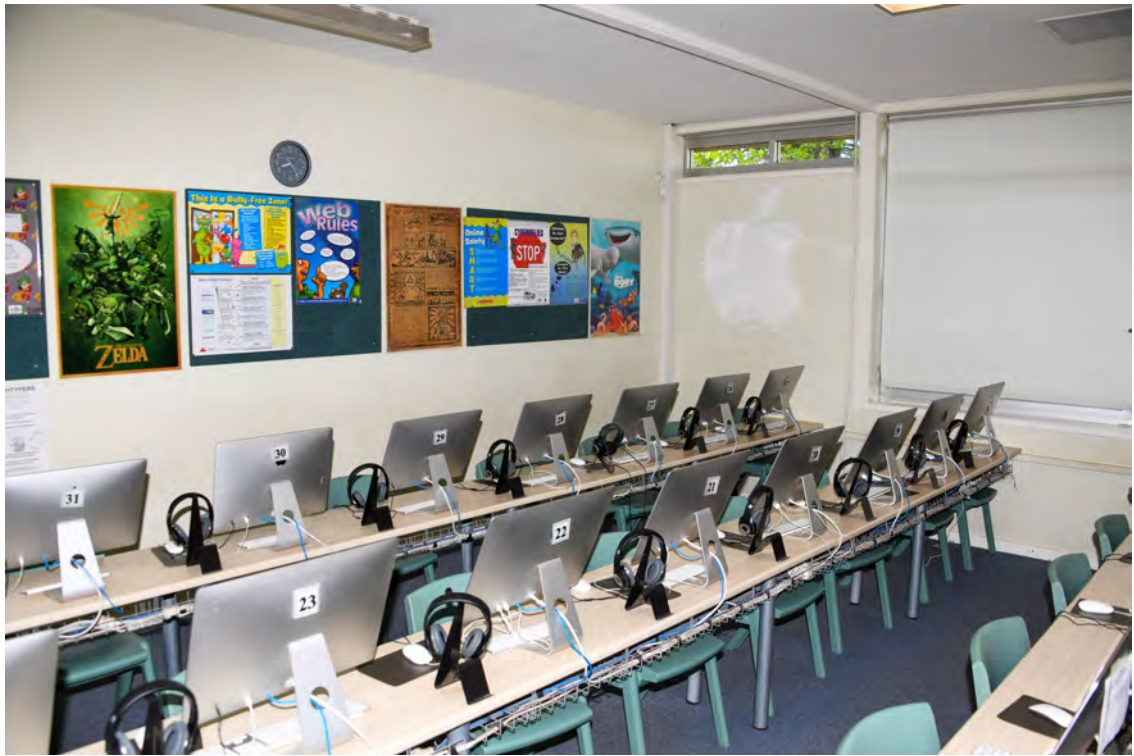
PRO\_0660.jpg

Block H. Interior. Computer room. South-eastern corner.

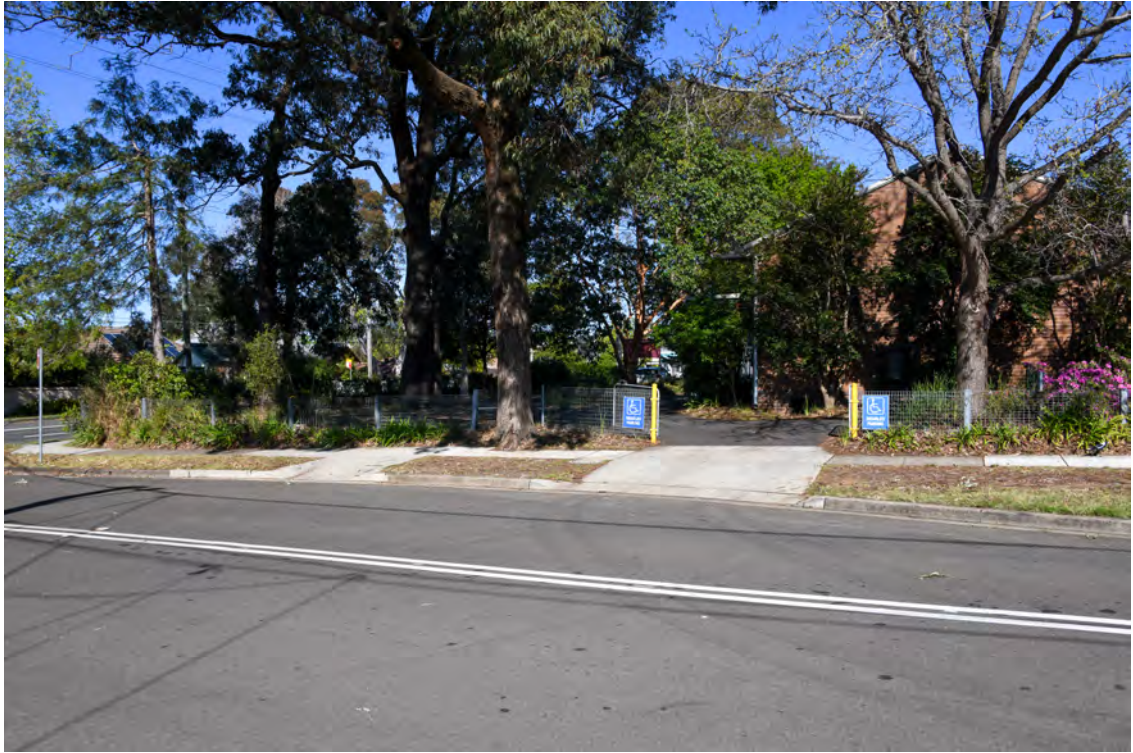
PRO\_1013.jpg

Block H. South-eastern corner of the school. Ward Street. Facing west to the crossover to the ring-road on the southern side of Block H.

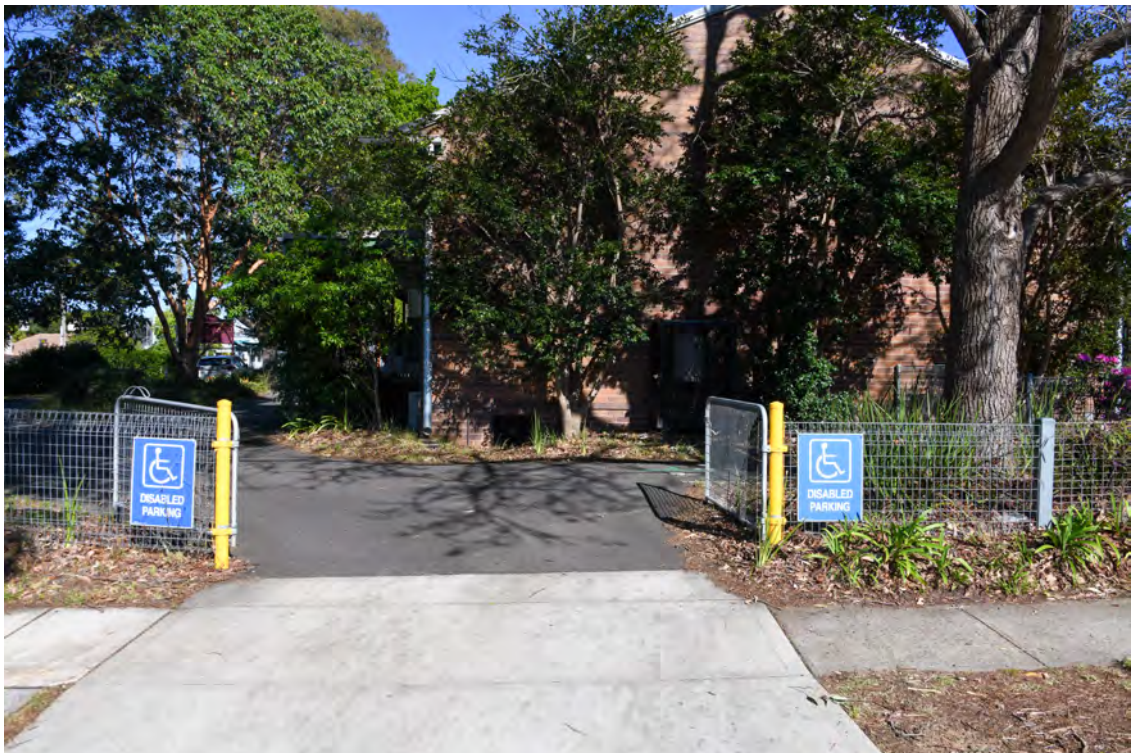
PRO\_1014.jpg

Block H. South-eastern corner of the school. Ward Street. Facing west to the crossover to the ring-road on the southern side of Block H.

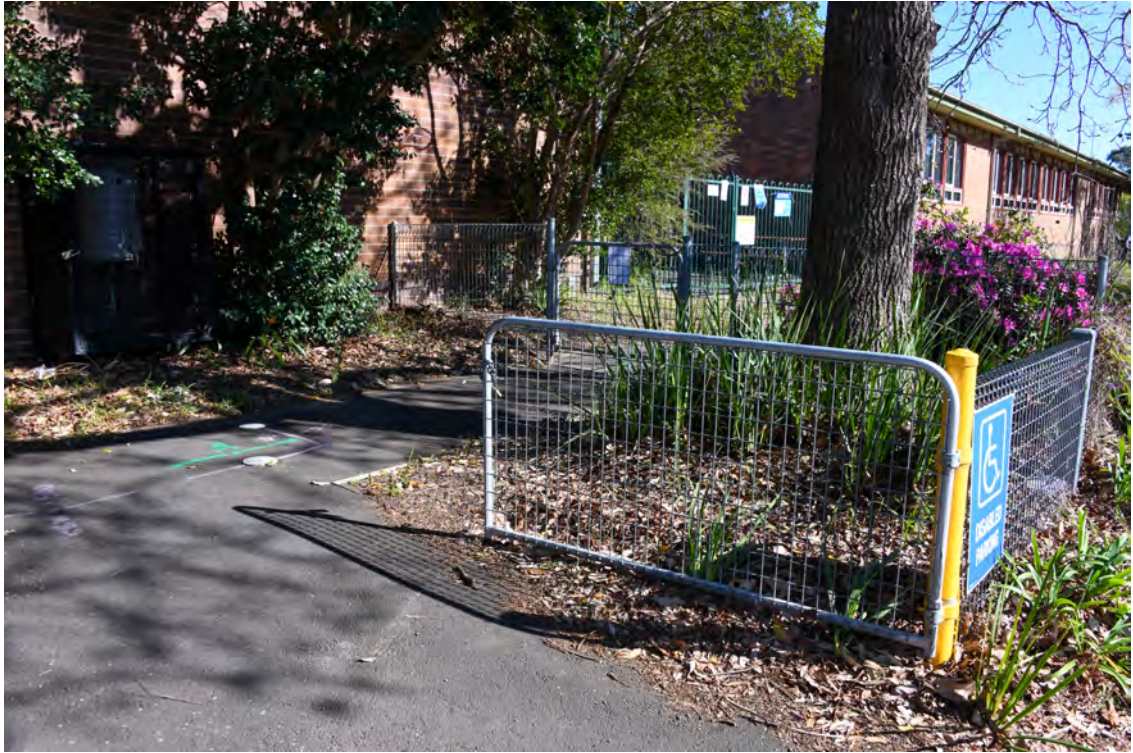
PRO\_1015.jpg

Block H. South-eastern corner of the school. Crossover to the ring-road on the southern side of Block H. Gates fronting Ward Street.

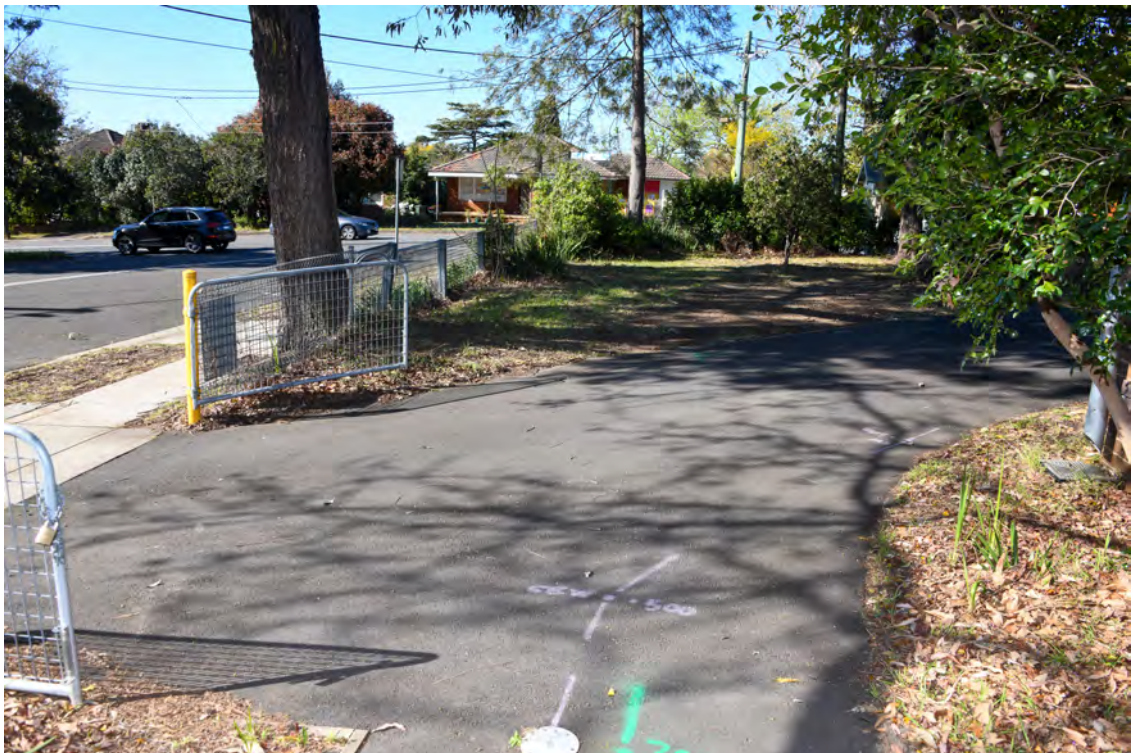
PRO\_1016.jpg

Block H. South-eastern corner of the school. Ring-road on the southern side of Block H. Area fronting Ward Street.

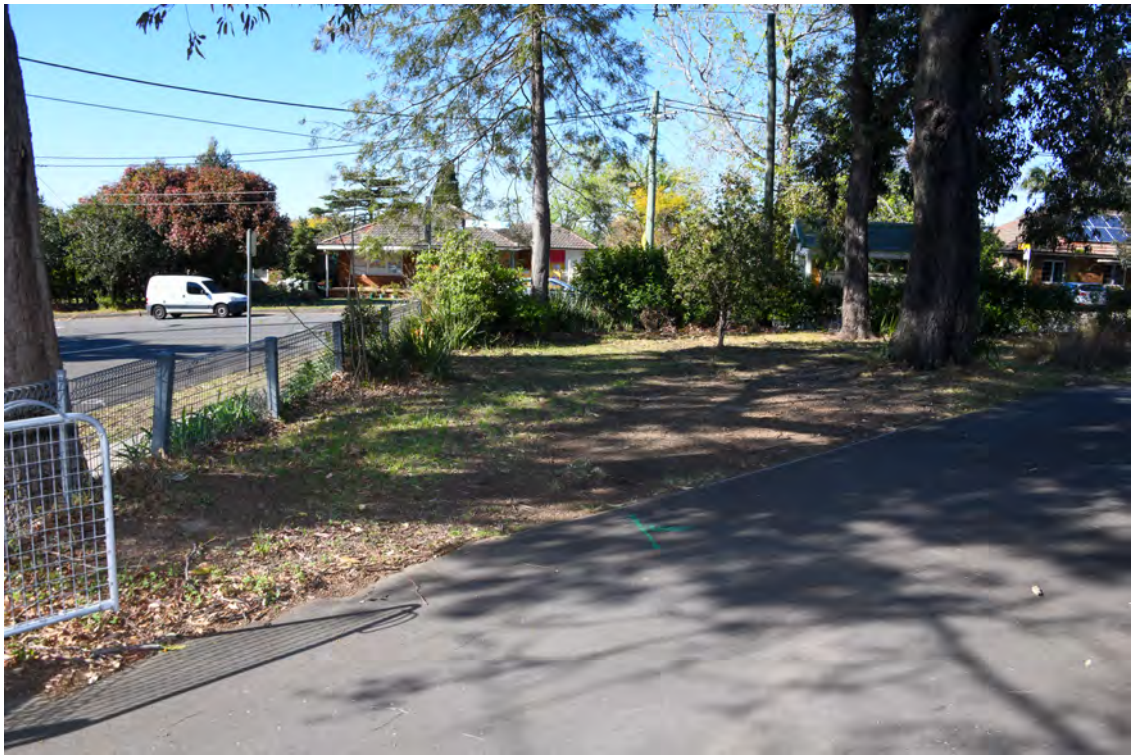
PRO\_1017.jpg

Block H. South-eastern corner of the school. Ring-road on the southern side of Block H. Area fronting Ward Street.

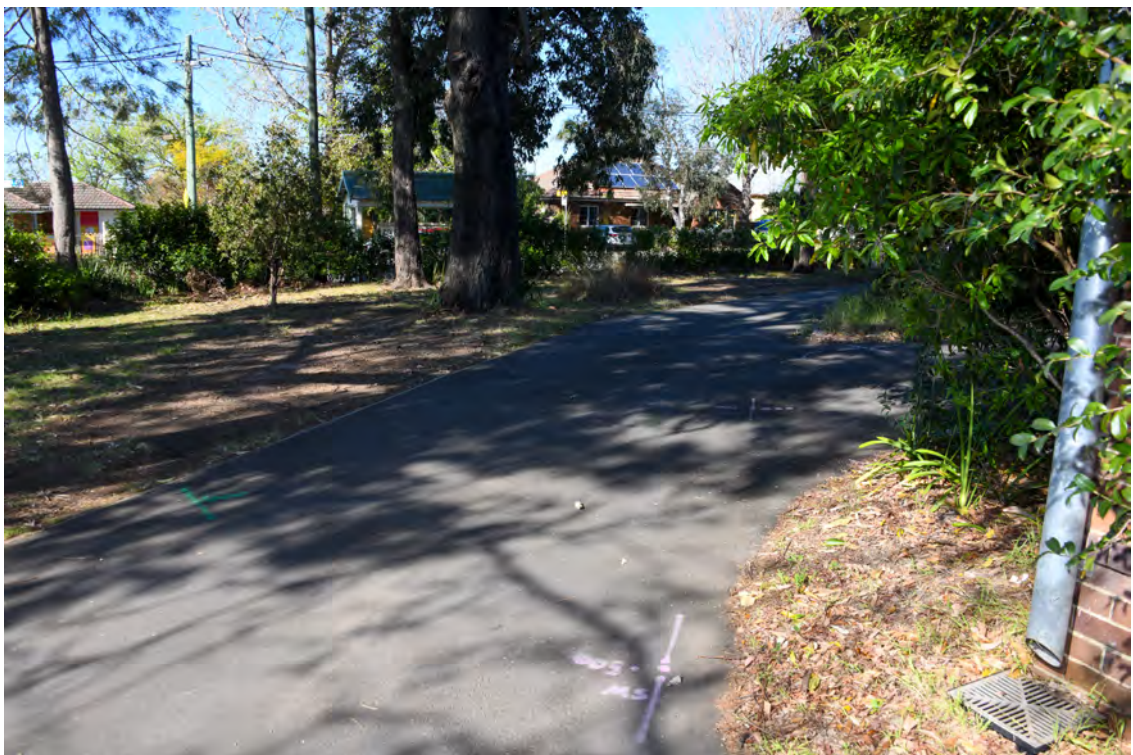
PRO\_1018.jpg

Block H. South-eastern corner of the school. Ring-road on the southern side of Block H. Heading west.

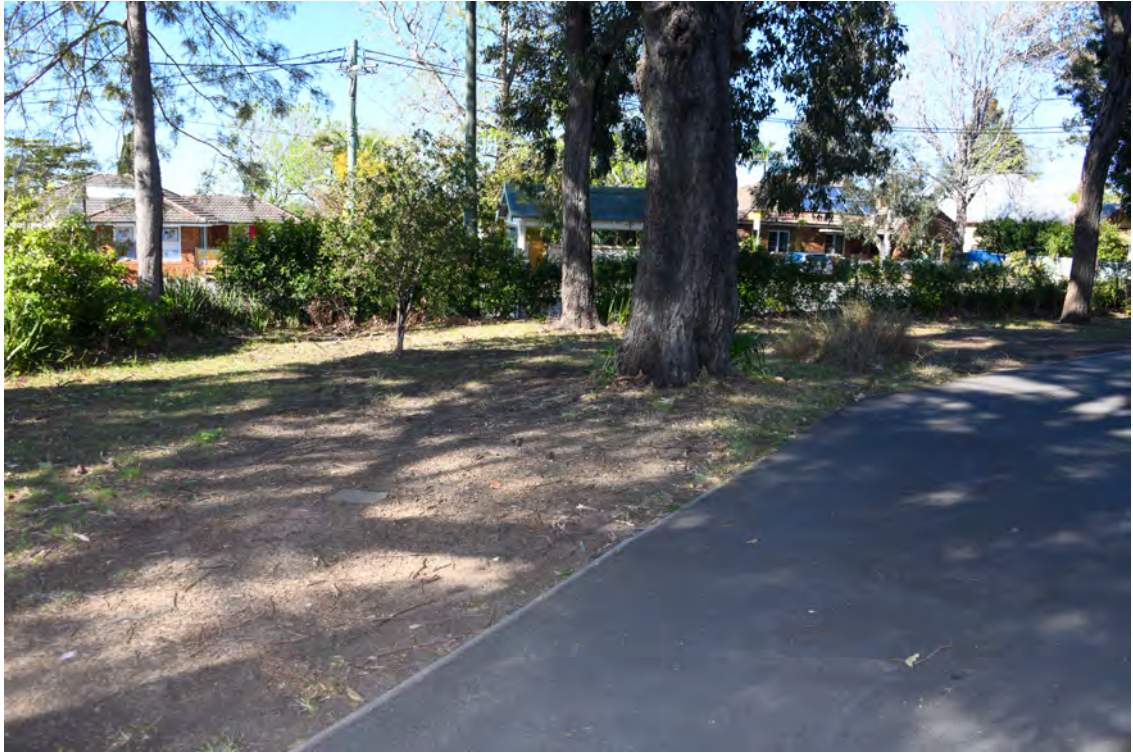
PRO\_1019.jpg

Block H. South-eastern corner of the school. Ring-road on the southern side of Block H. Heading west.

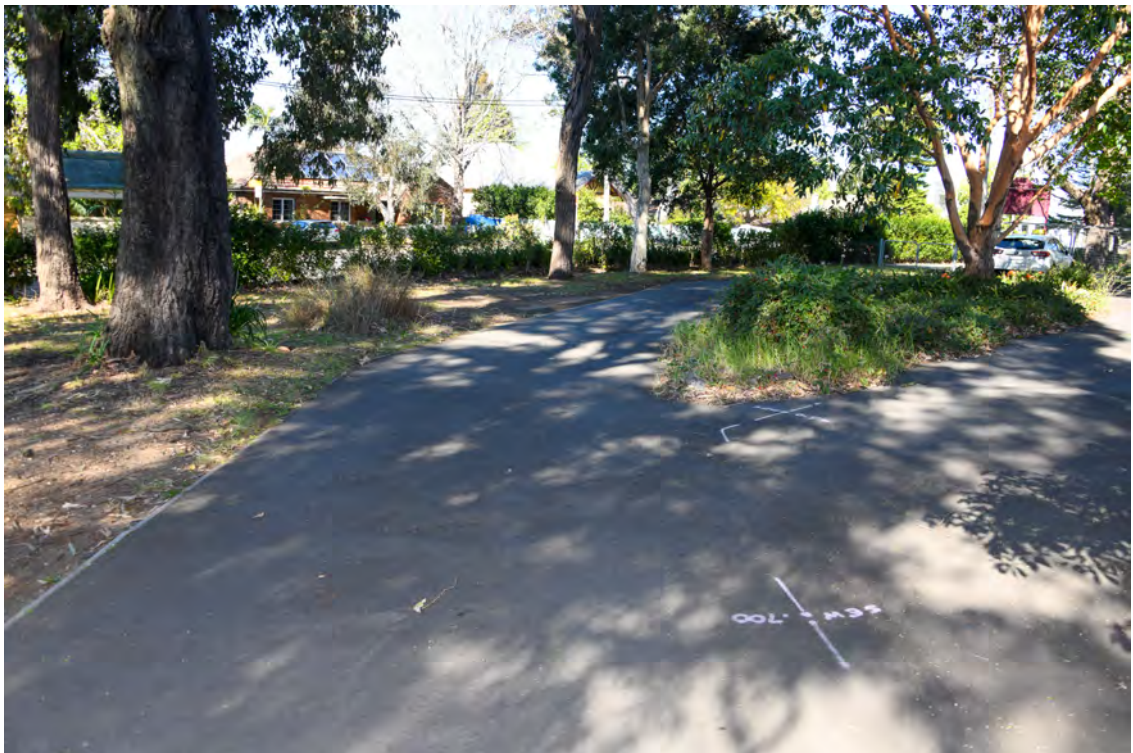
PRO\_1020.jpg

Block H. South-eastern corner of the school. Ring-road on the southern side of Block H. Heading west.

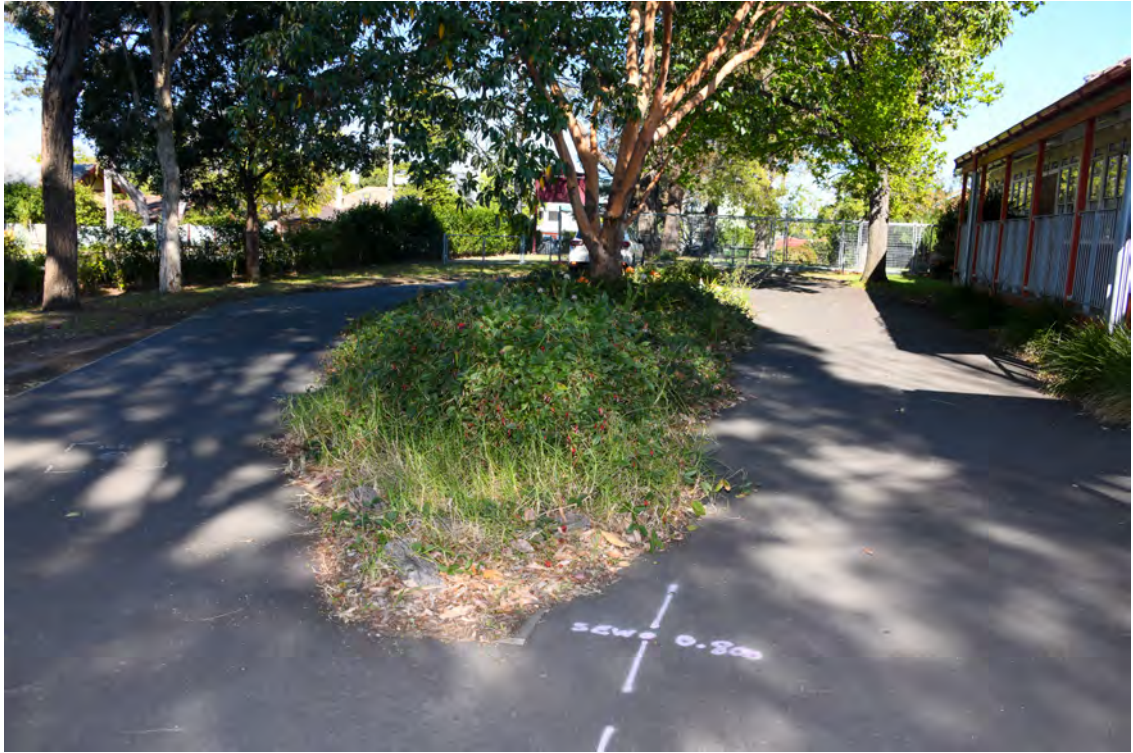
PRO\_1021.jpg

Block H. South-eastern corner of the school. Ring-road on the southern side of Block H. Heading west.

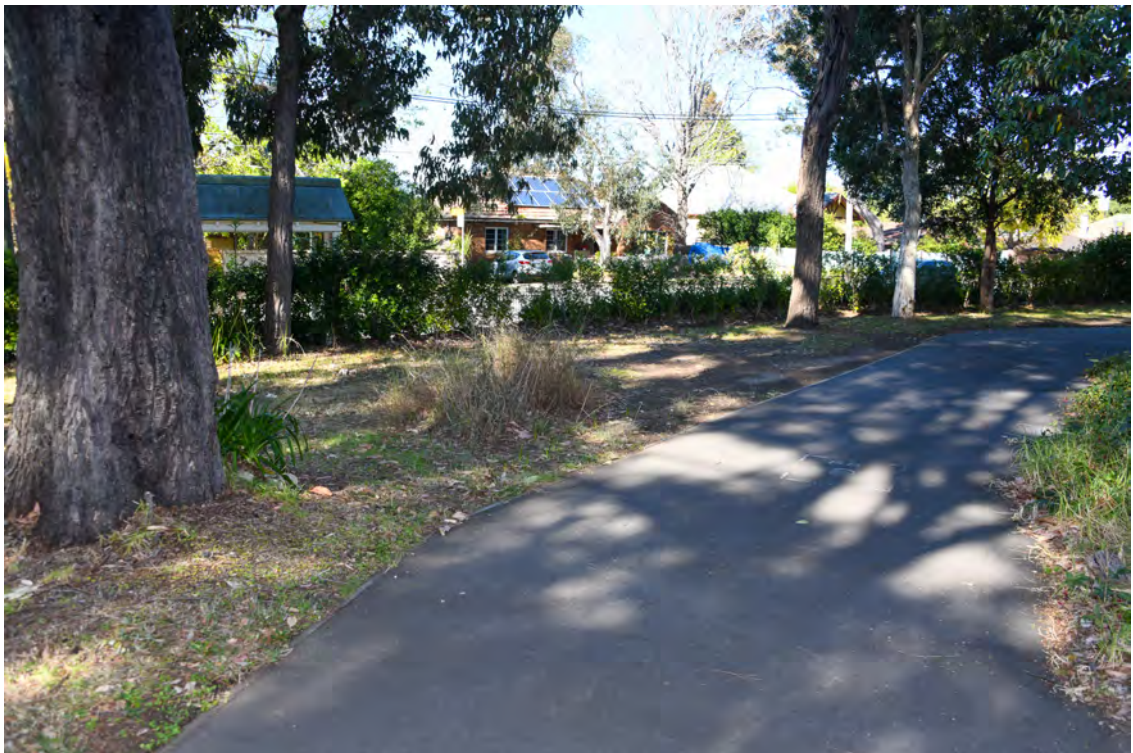
PRO\_1022.jpg

Block H. South-eastern corner of the school. Ring-road on the southern side of Block H. Heading west.

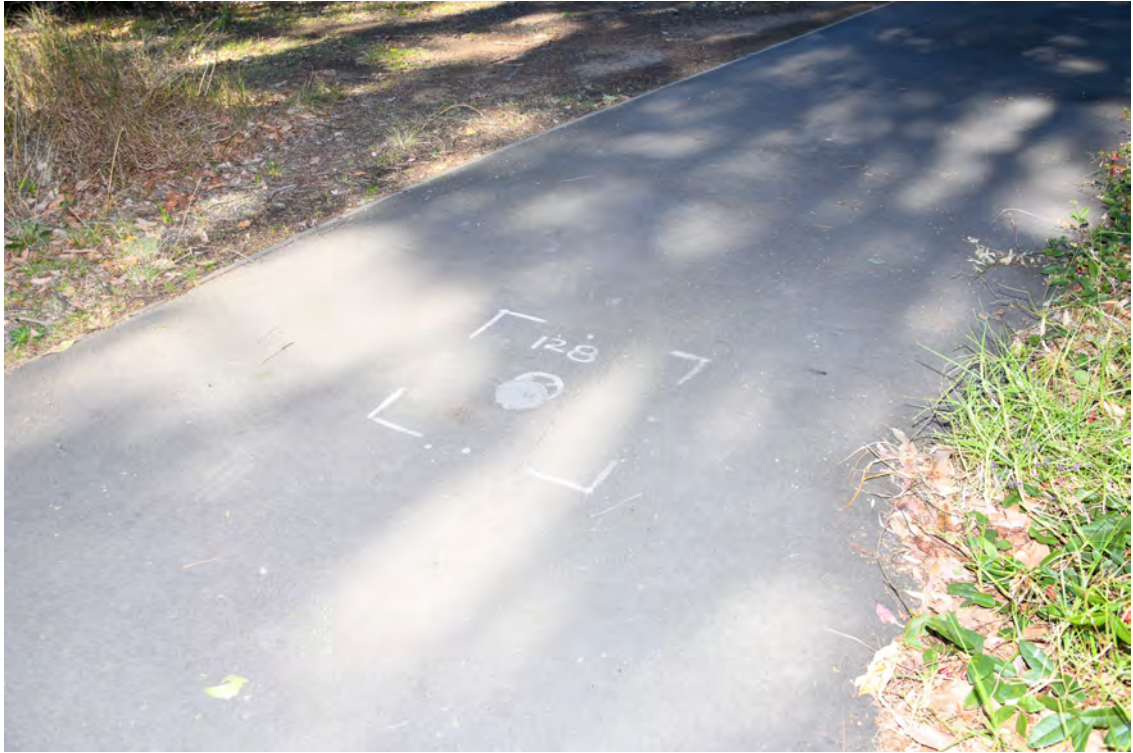
PRO\_1023.jpg

Block H. South-eastern corner of the school. Ring-road on the southern side of Block H. Heading west.

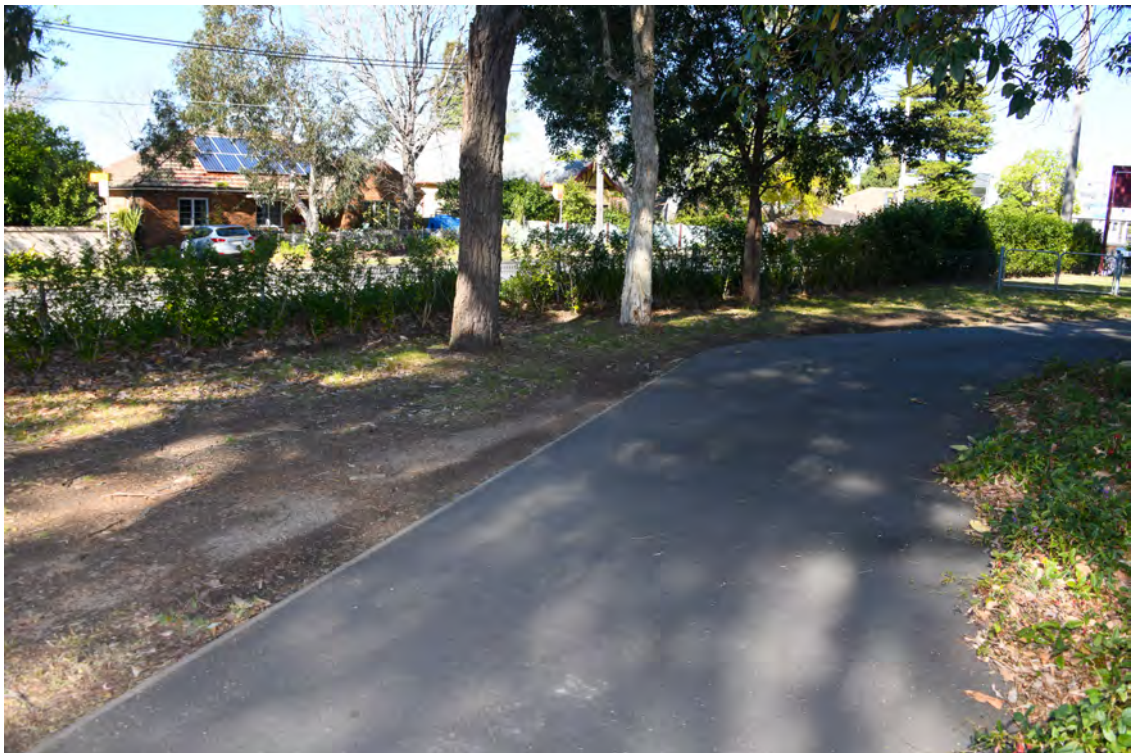
PRO\_1024.jpg

Block H. South-eastern corner of the school. Ring-road on the southern side of Block H. Heading west.

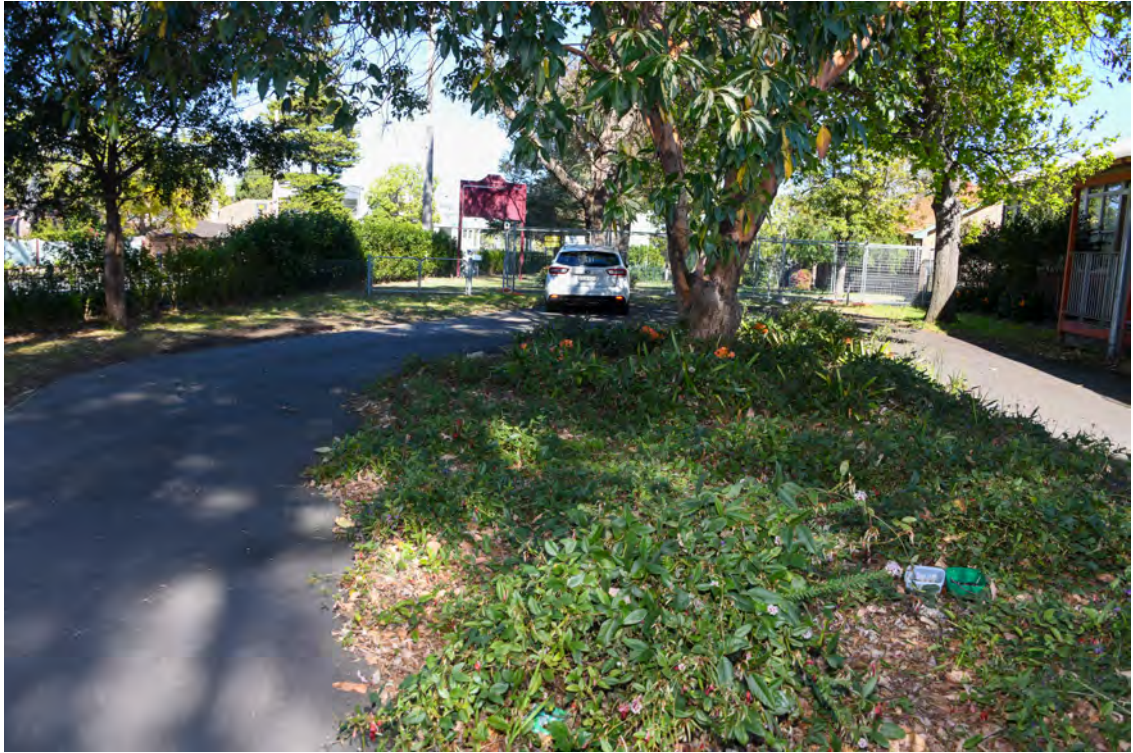
PRO\_1025.jpg

Block H. South-eastern corner of the school. Ring-road on the southern side of Block H. Heading west.
