96-104 Carlingford Road, Epping NSW 2121

Epping West Public School

DILAPIDATION REPORT

7<sup>th</sup> September 2021

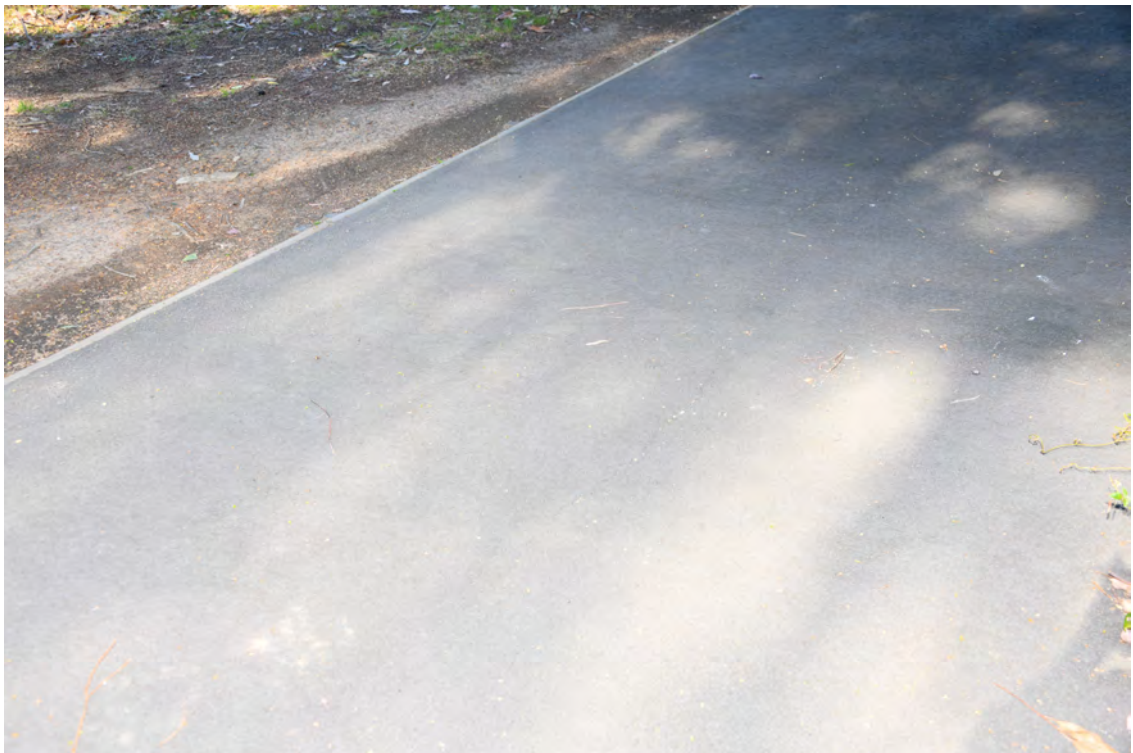
PRO\_1026.jpg

Block H. South-eastern corner of the school. Ring-road on the southern side of Block H. Heading west.

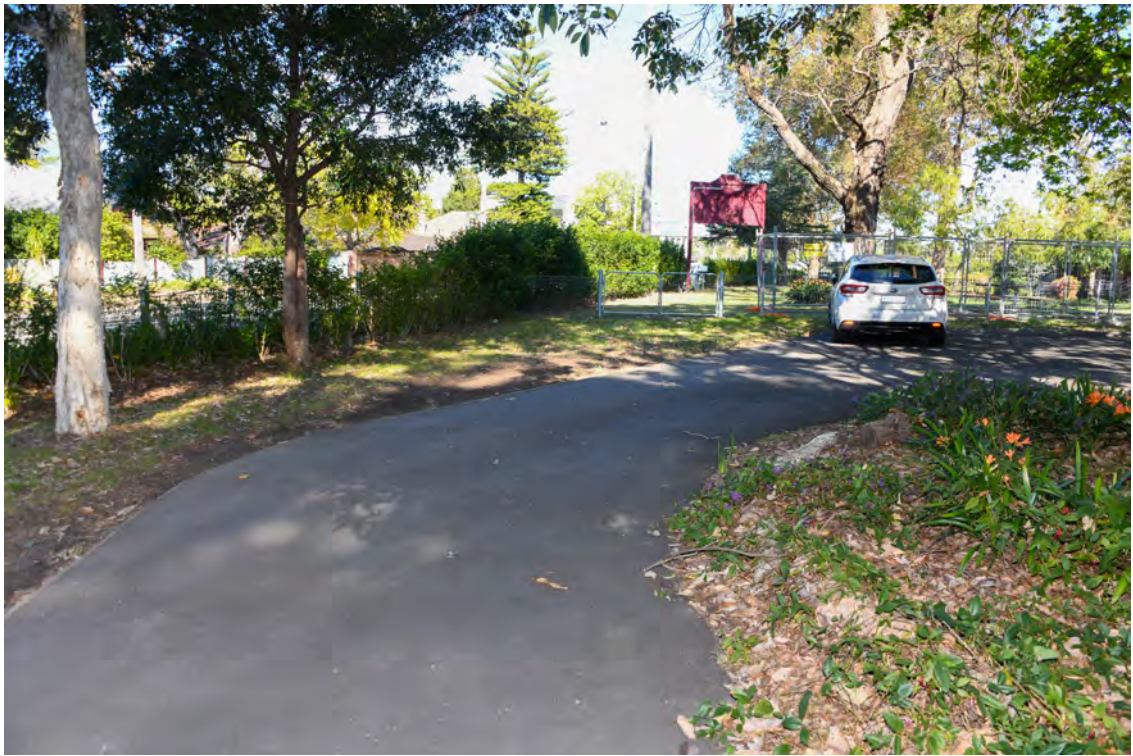
PRO\_1027.jpg

Block H. South-eastern corner of the school. Ring-road on the southern side of Block H. Heading west.

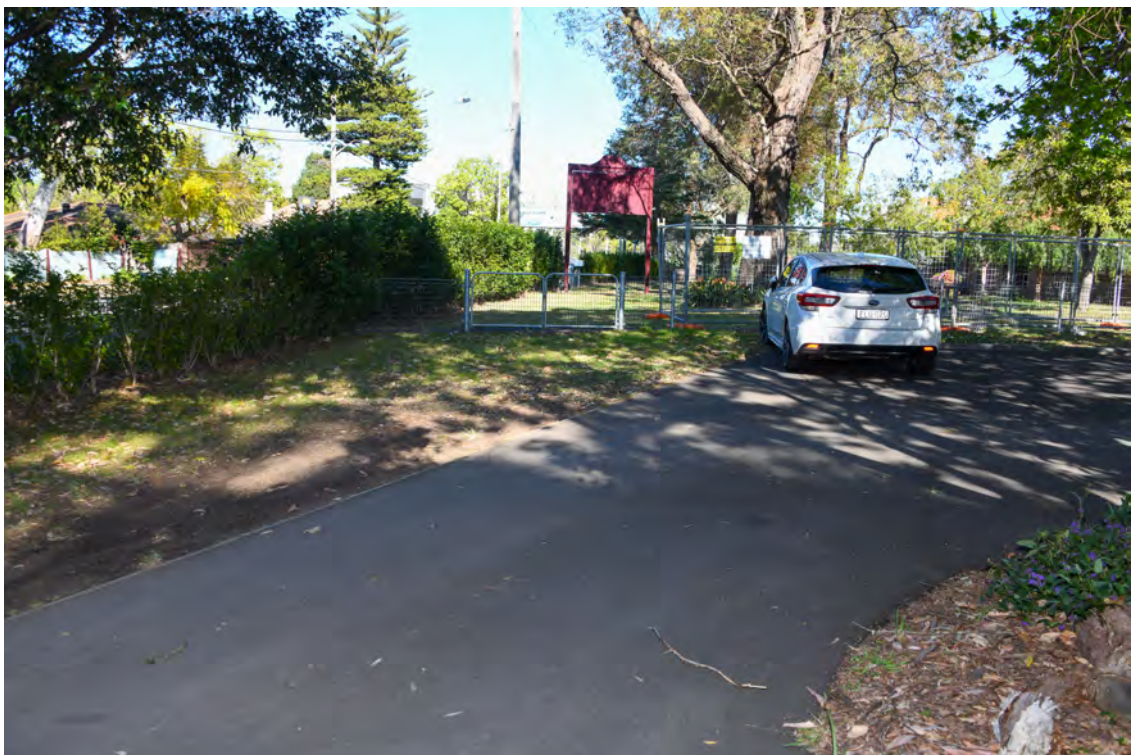
PRO\_1028.jpg

Block H. South-eastern corner of the school. Ring-road on the southern side of Block H. Heading west.

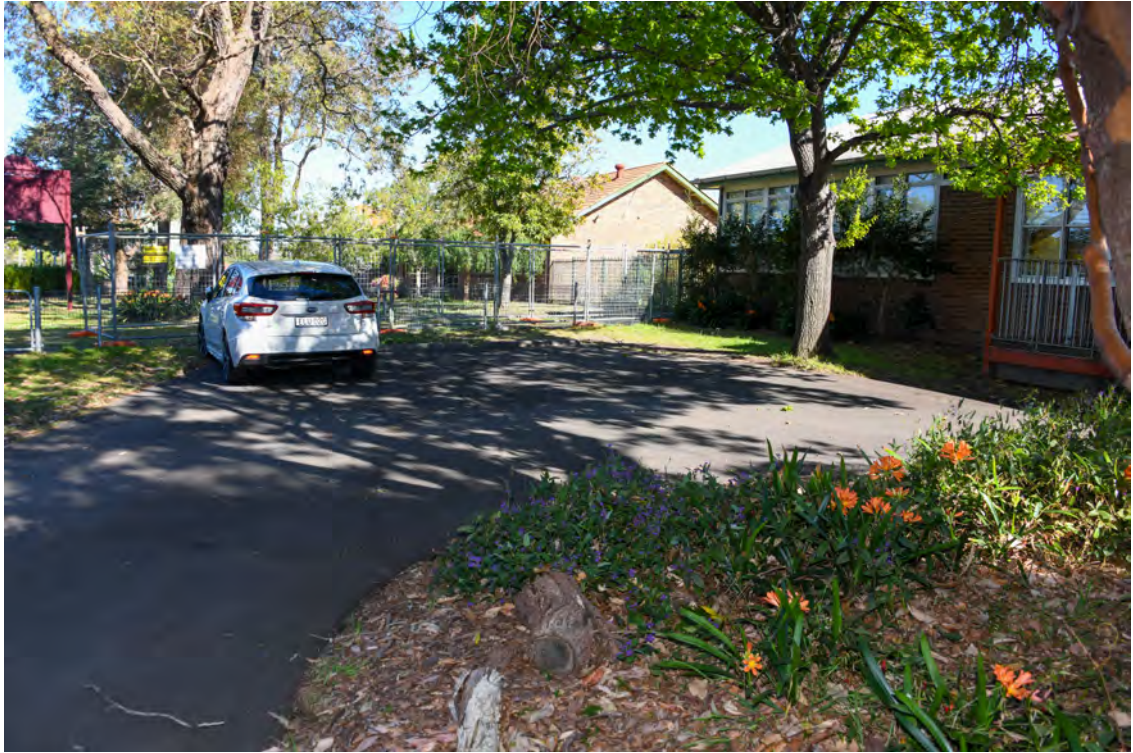
PRO\_1029.jpg

Block H. South-eastern corner of the school. Ring-road on the southern side of Block H. Heading west.

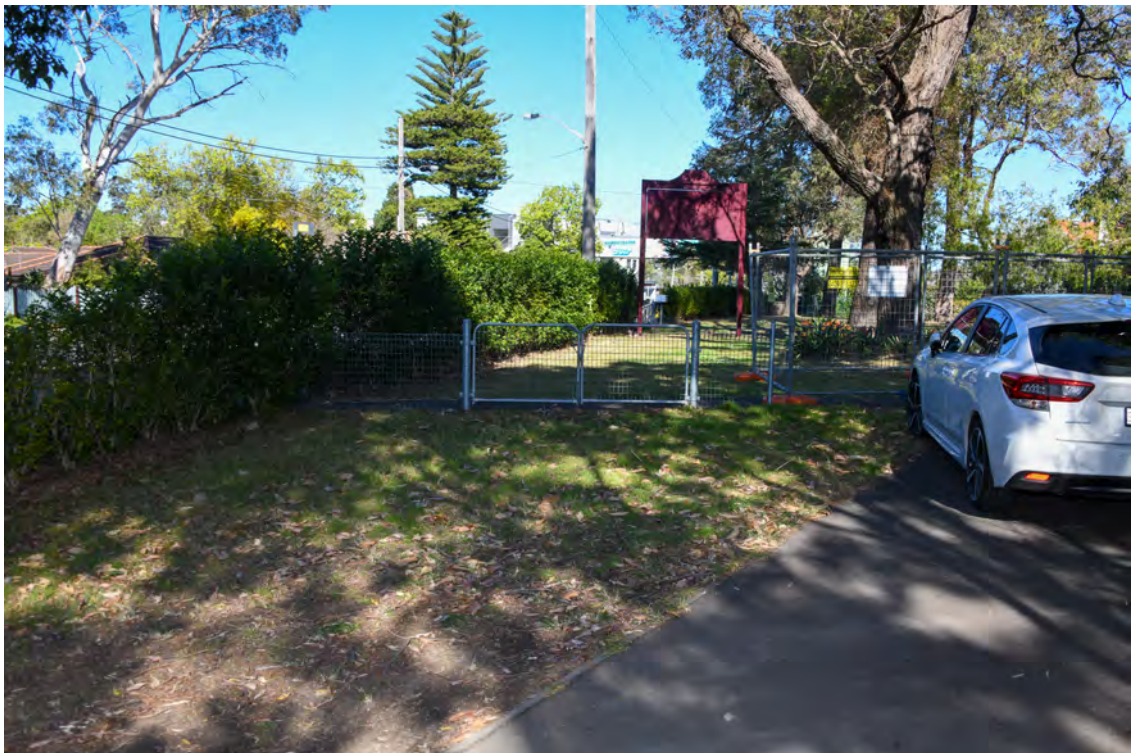
PRO\_1030.jpg

Block H. South-eastern corner of the school. Ring-road on the southern side of Block H. Heading west.

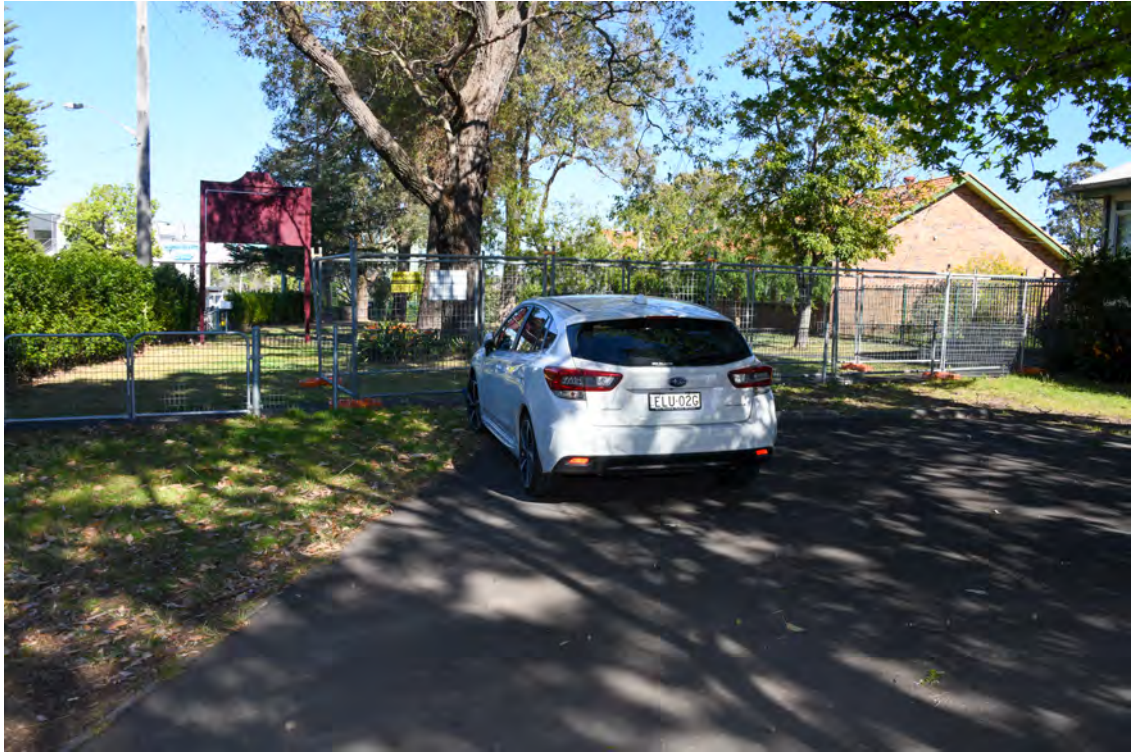
PRO\_1031.jpg

Block H. South-eastern corner of the school. Ring-road on the southern side of Block H. Heading west.

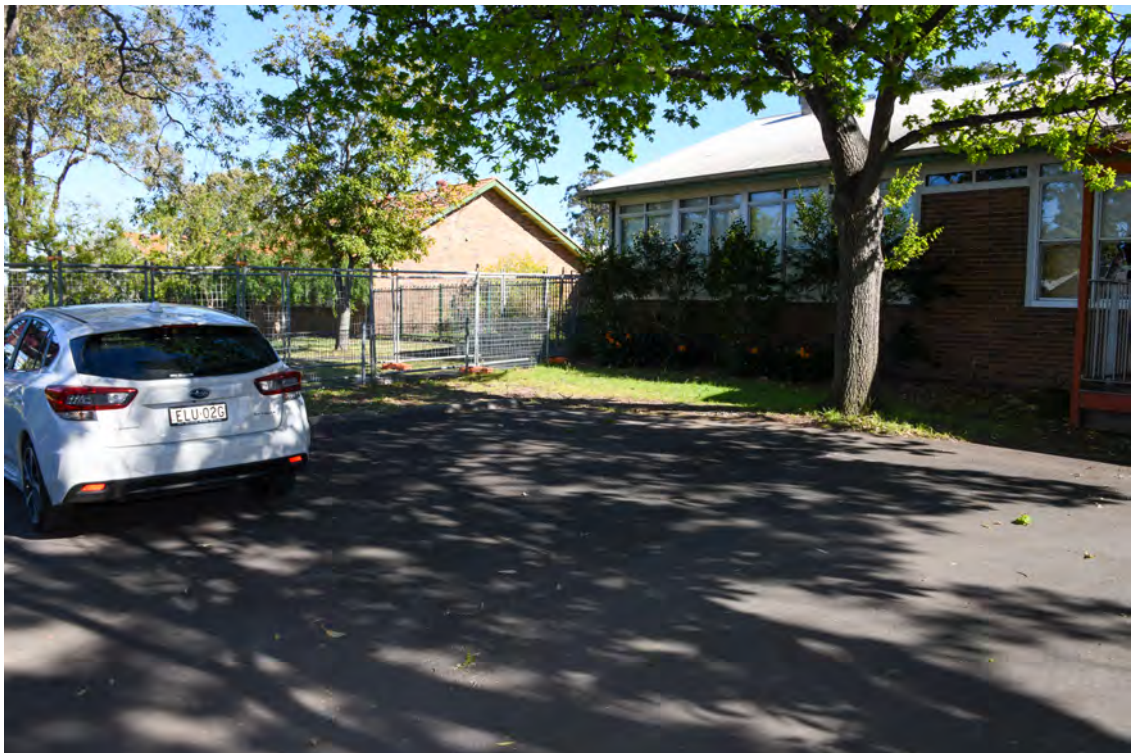
PRO\_1032.jpg

Block H. South-eastern corner of the school. Ring-road on the southern side of Block H. Heading north-west.

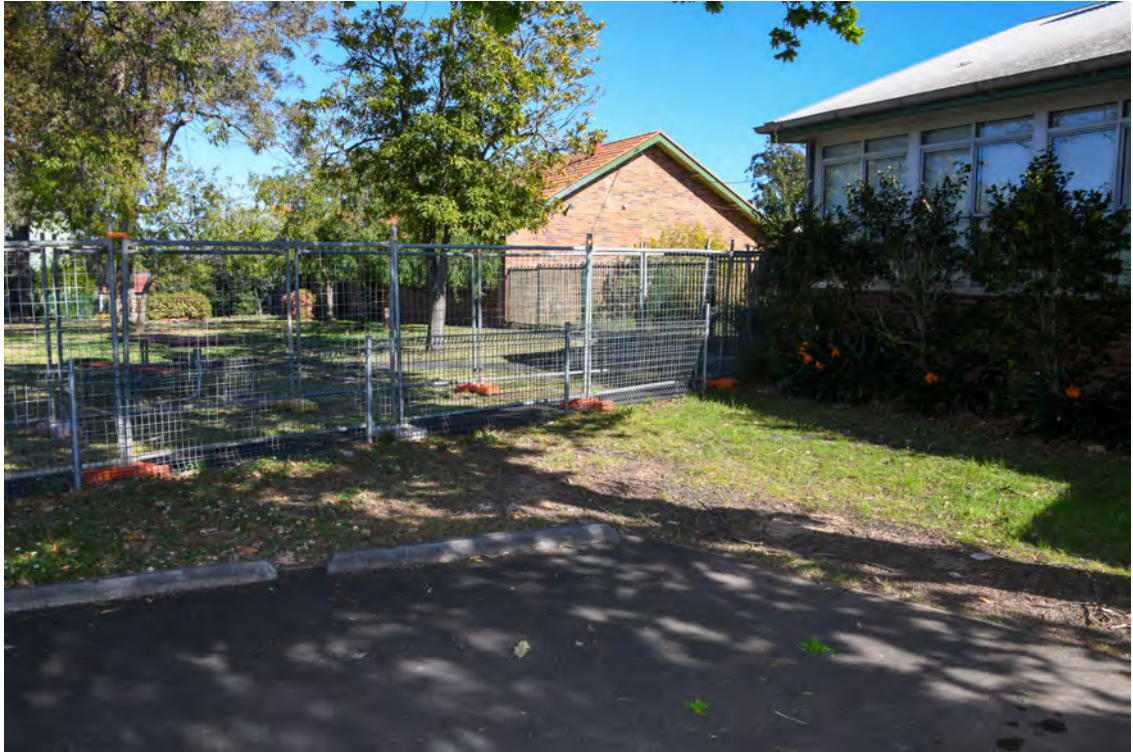
PRO\_1033.jpg

Block H. South-eastern corner of the school. Ring-road on the southern side of Block H. Heading north-west.

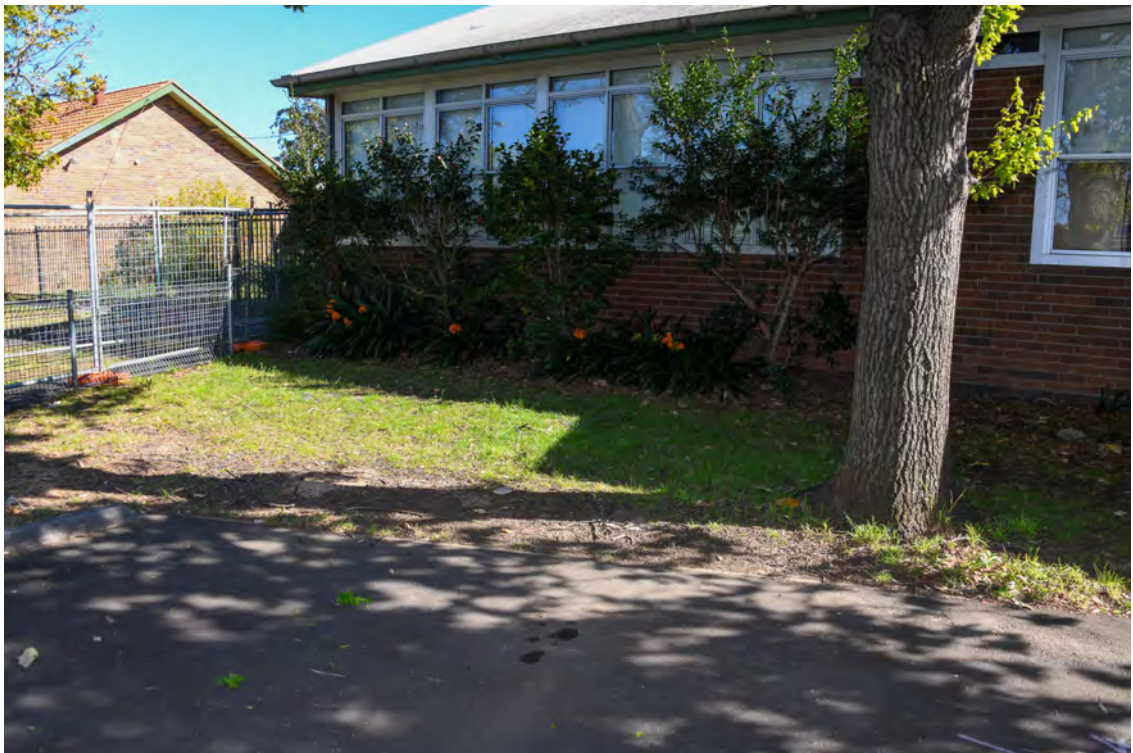
PRO\_1034.jpg

Block H. South-eastern corner of the school. Ring-road on the southern side of Block H. Heading north-west.

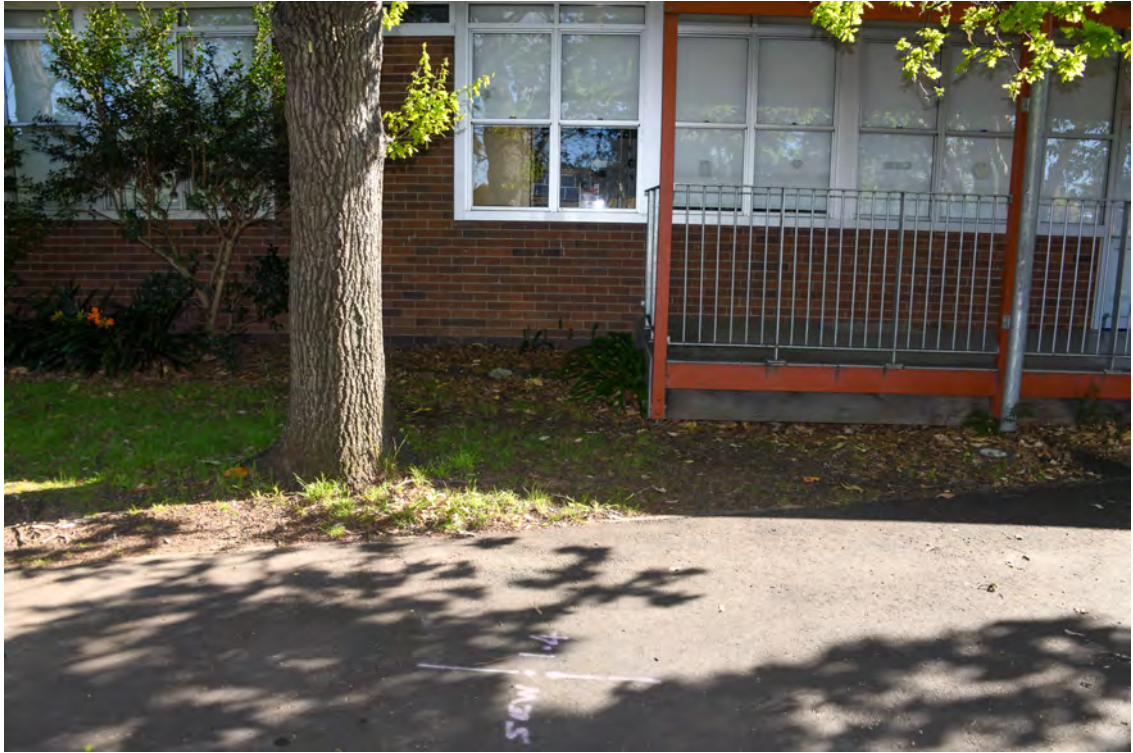
PRO\_1035.jpg

Block H. South-eastern corner of the school. Ring-road on the southern side of Block H. Heading north.

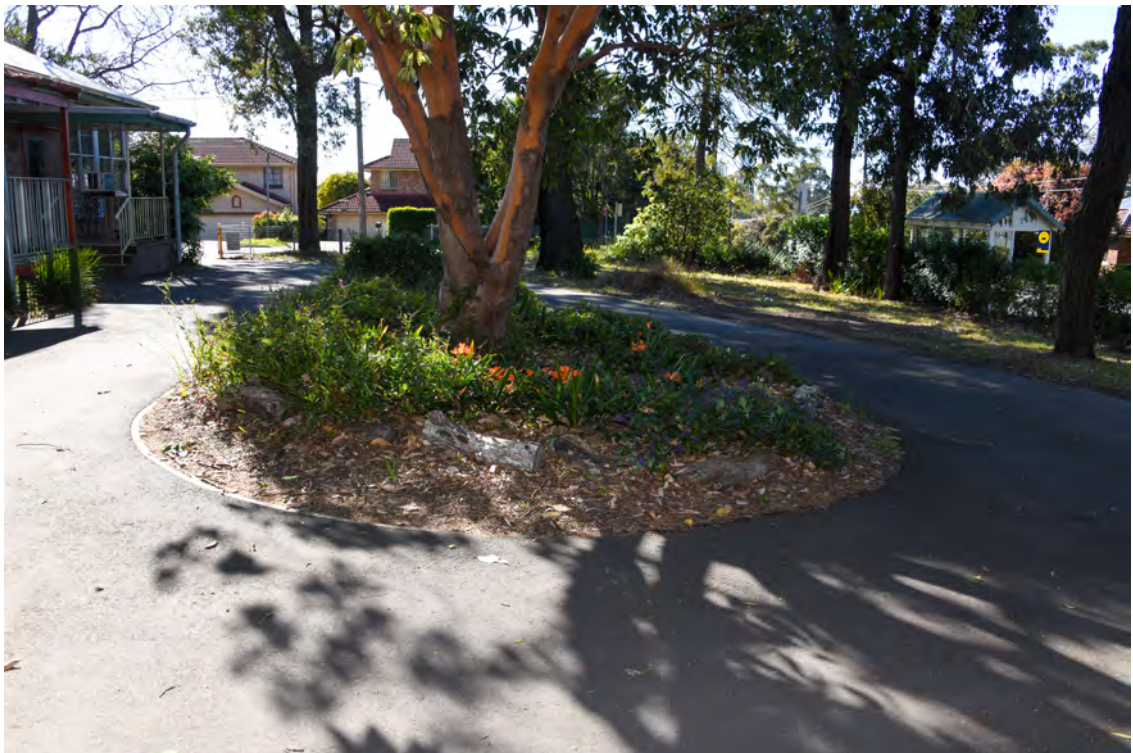
PRO\_1036.jpg

Block H. South-eastern corner of the school. Ring-road on the southern side of Block H. Heading east.

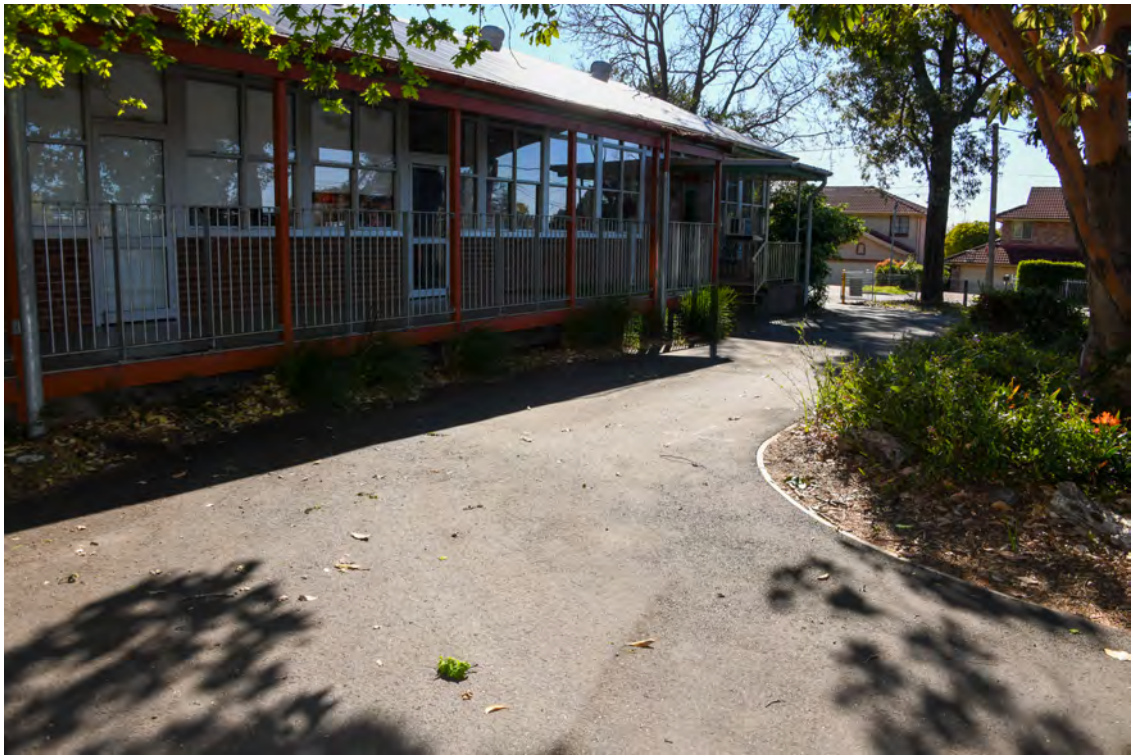
PRO\_1037.jpg

Block H. South-eastern corner of the school. Ring-road on the southern side of Block H. Heading east.

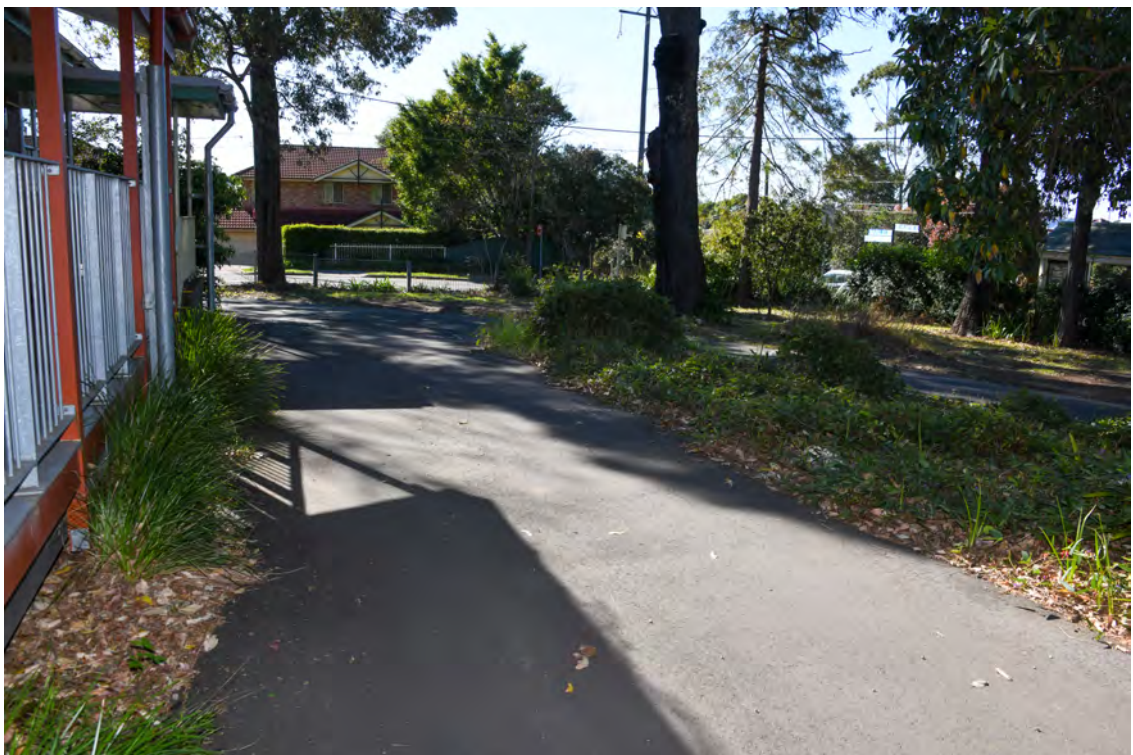
PRO\_1038.jpg

Block H. South-eastern corner of the school. Ring-road on the southern side of Block H. Heading east.

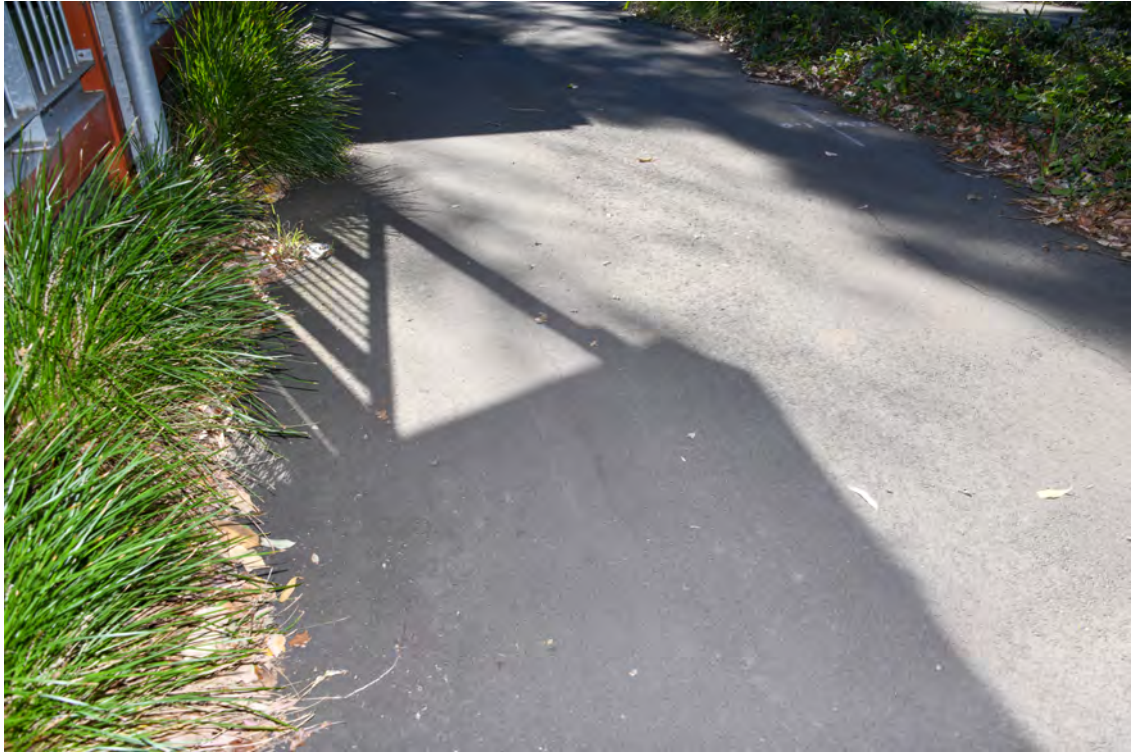
PRO\_1039.jpg

Block H. South-eastern corner of the school. Ring-road on the southern side of Block H. Heading east.

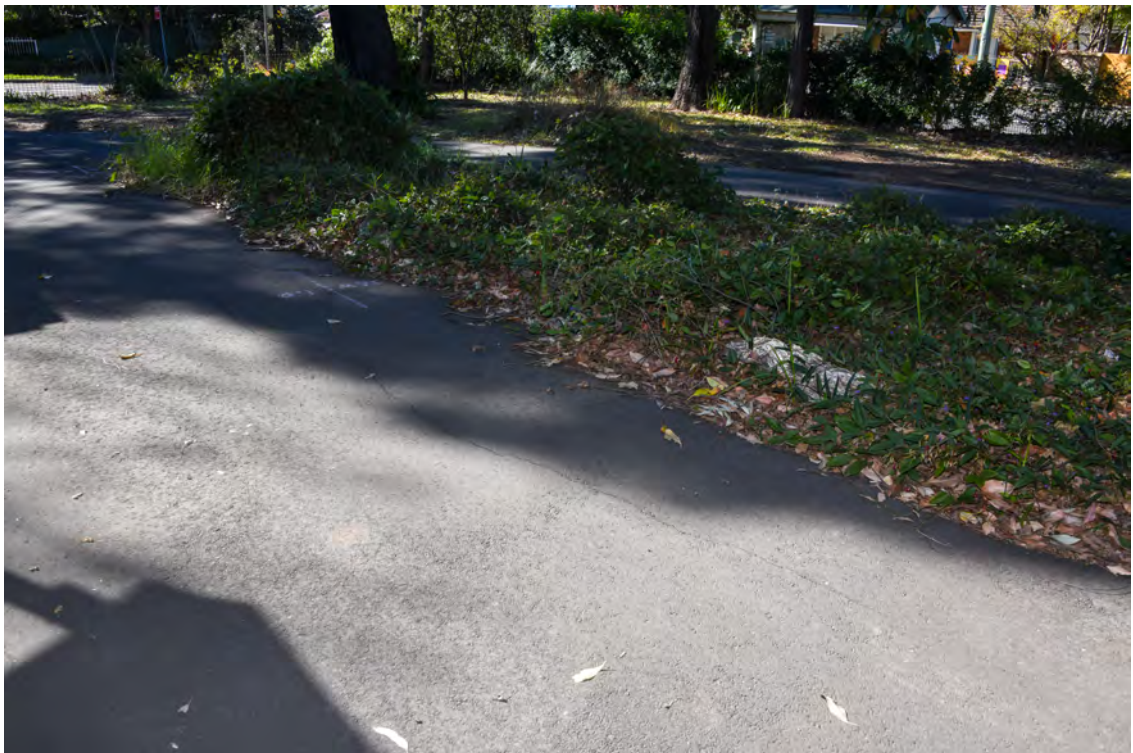
PRO\_1040.jpg

Block H. South-eastern corner of the school. Ring-road on the southern side of Block H. Heading east.

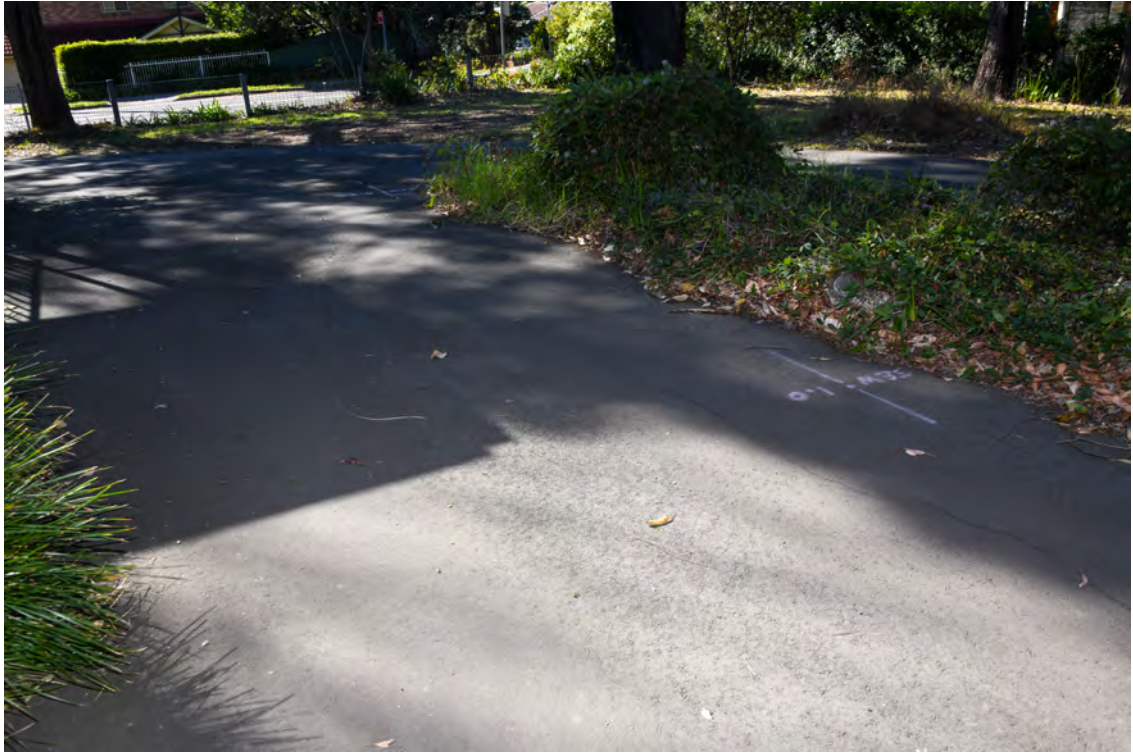
PRO\_1041.jpg

Block H. South-eastern corner of the school. Ring-road on the southern side of Block H. Heading east.

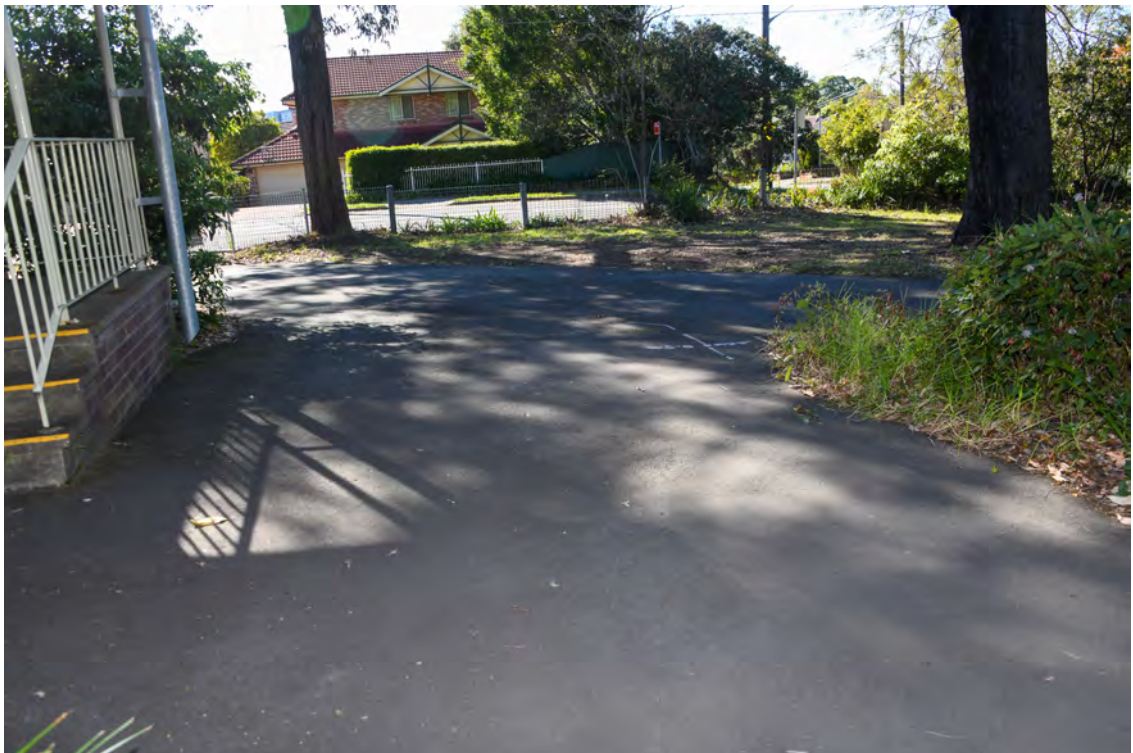
PRO\_1042.jpg

Block H. South-eastern corner of the school. Ring-road on the southern side of Block H. Heading east.

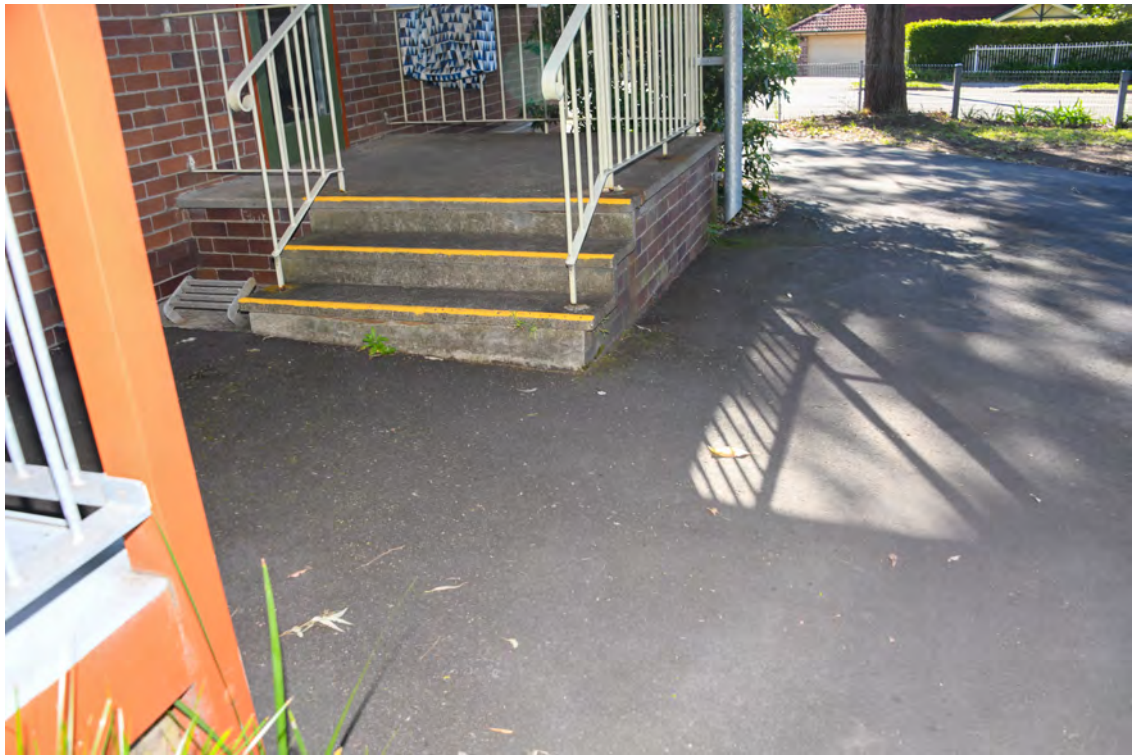
PRO\_1043.jpg

Block H. South-eastern corner of the school. Ring-road on the southern side of Block H. Heading east.

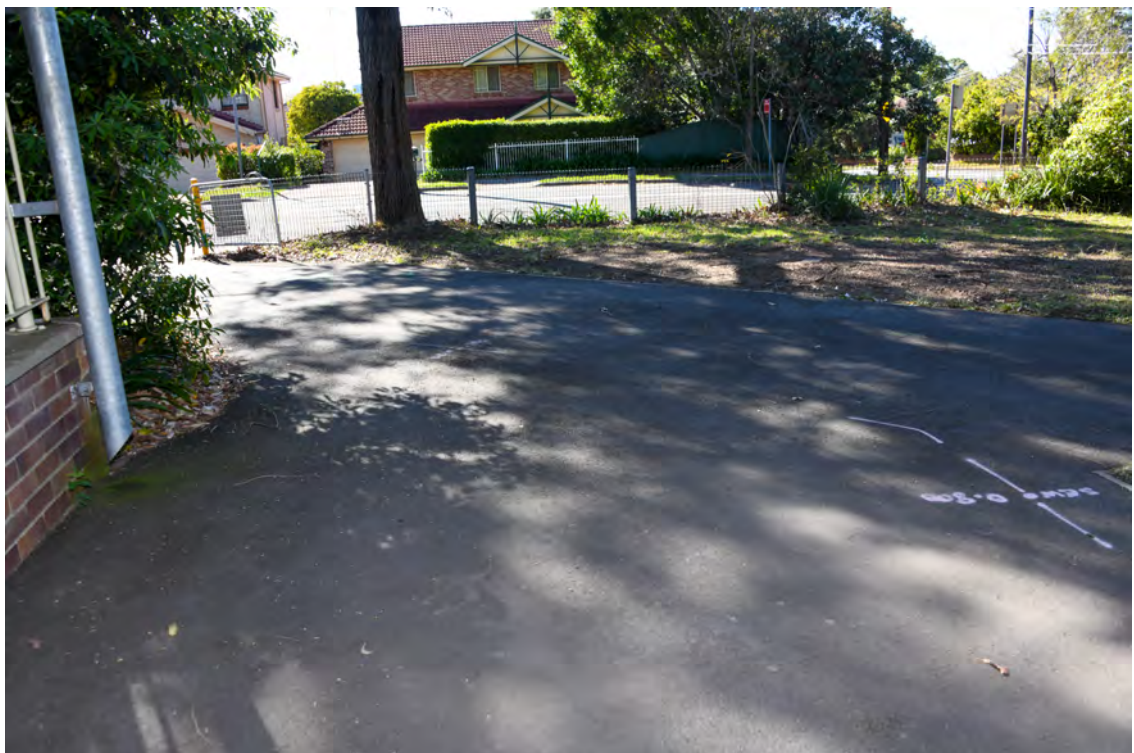
PRO\_1044.jpg

Block H. South-eastern corner of the school. Ring-road on the southern side of Block H. Heading east.

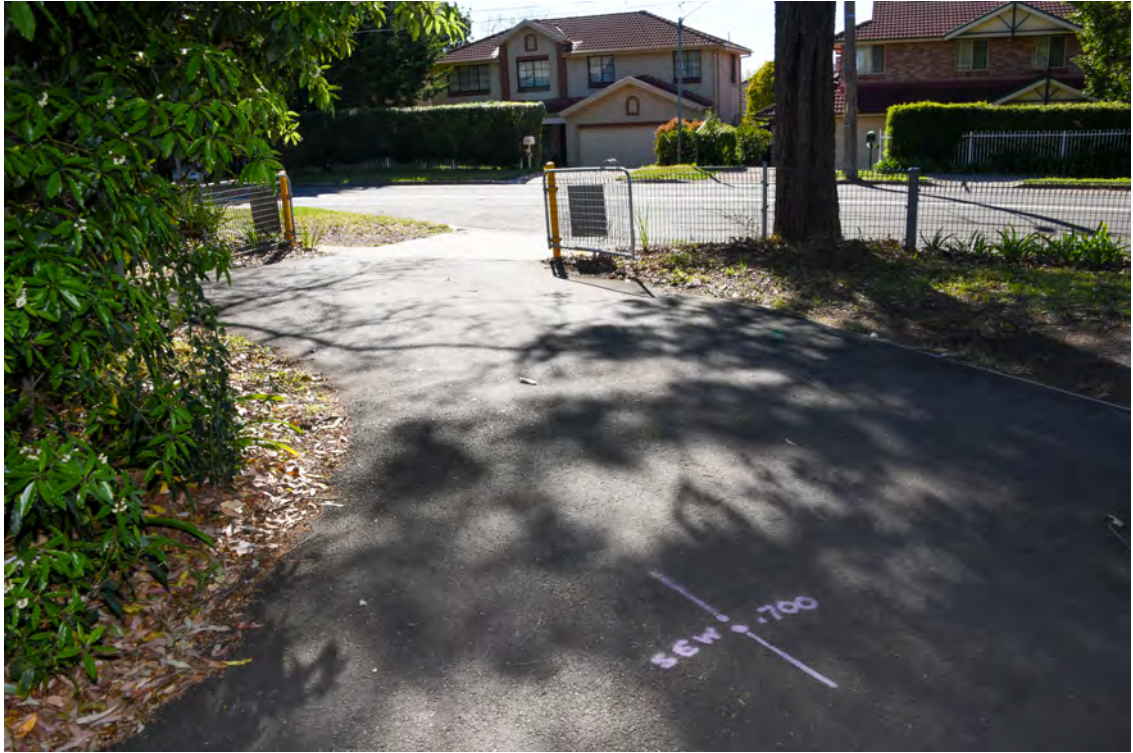
PRO\_1045.jpg

Block H. South-eastern corner of the school. Ring-road on the southern side of Block H. Heading east.

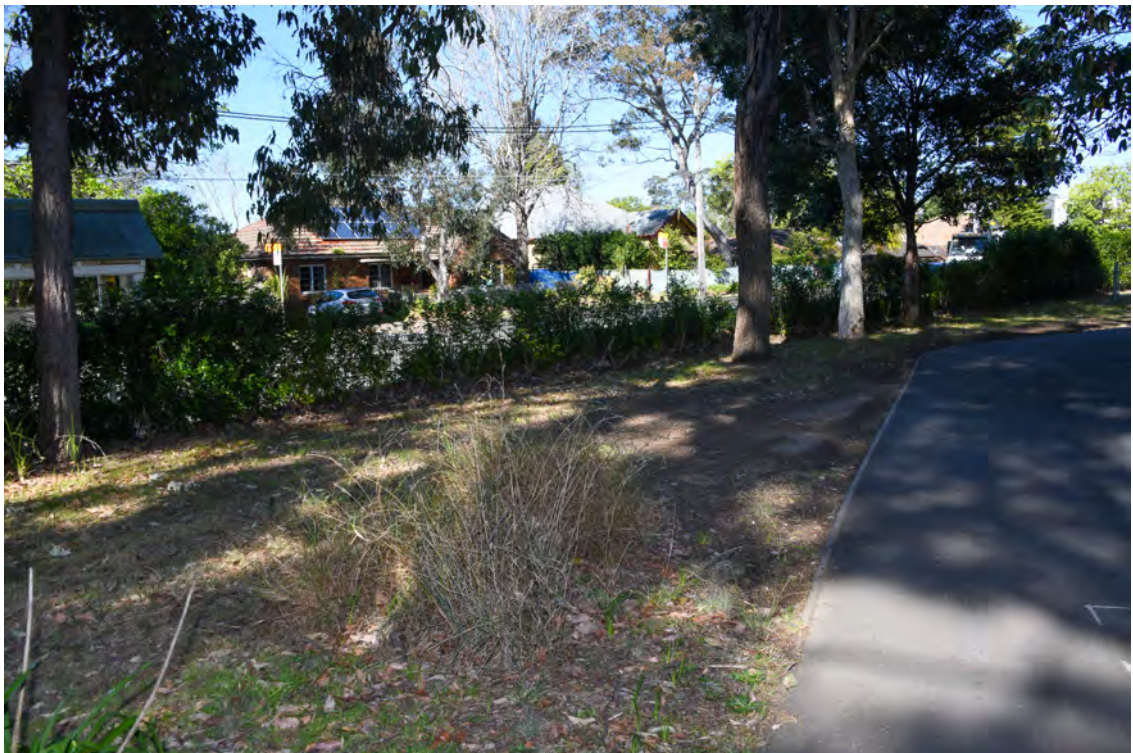
PRO\_1046.jpg

Block H. South-eastern corner of the school. Ring-road on the southern side of Block H. Heading west.

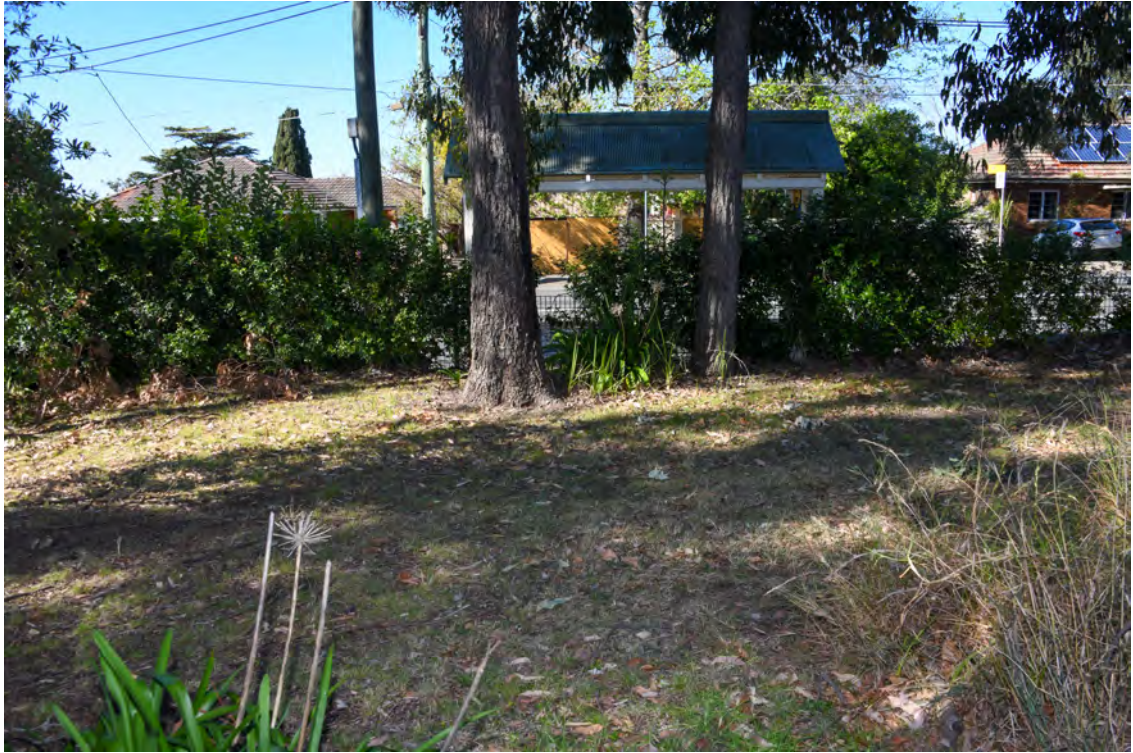
PRO\_1047.jpg

Block H. South-eastern corner of the school. Ring-road on the southern side of Block H. Heading south.

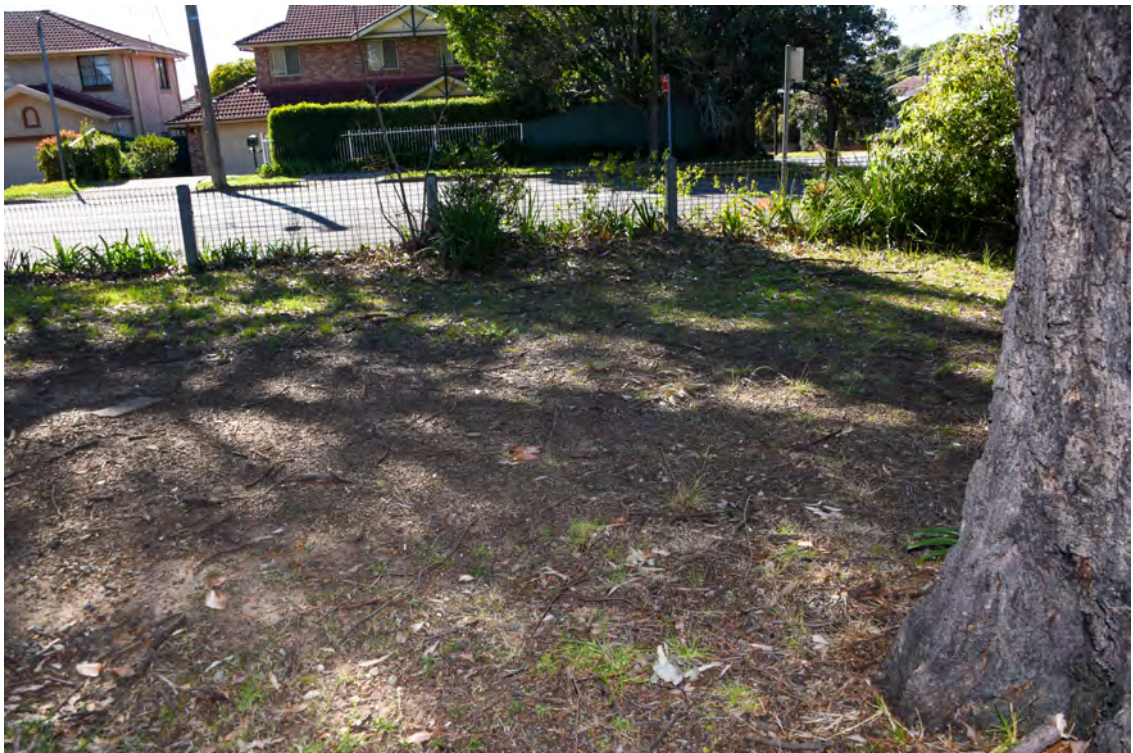
PRO\_1048.jpg

Block H. South-eastern corner of the school. Ring-road on the southern side of Block H. Heading east.

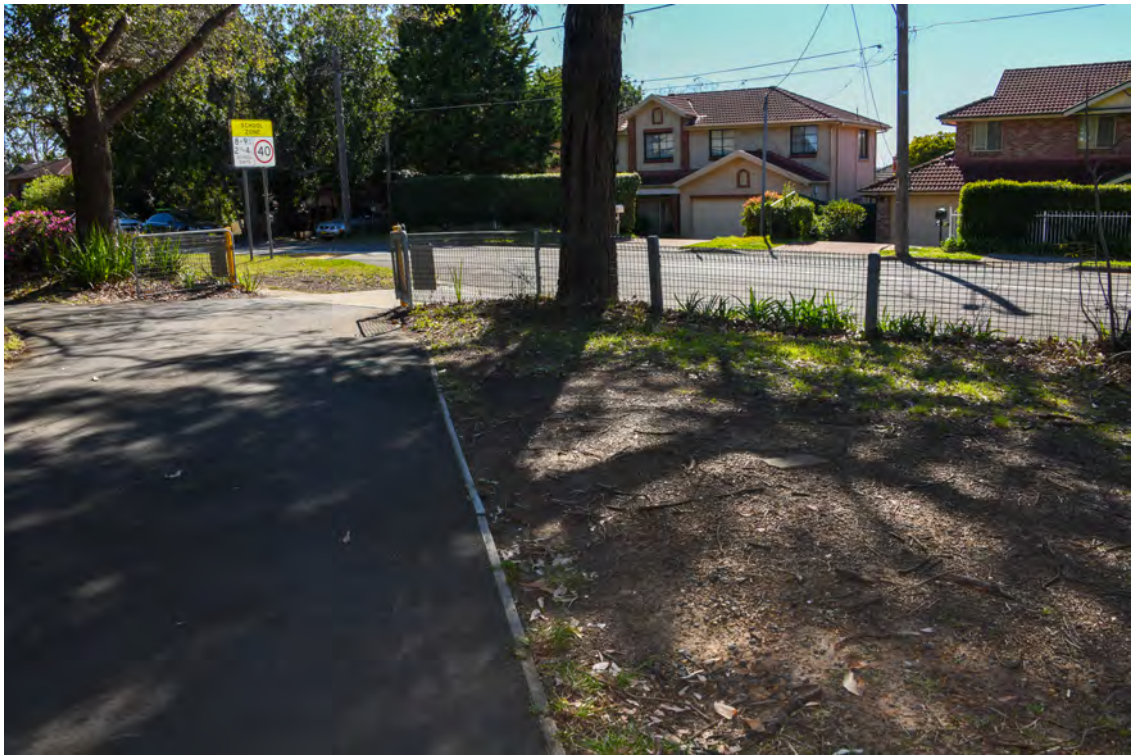
PRO\_1049.jpg

Block H. South-eastern corner of the school. Ring-road on the southern side of Block H. Heading north-east.

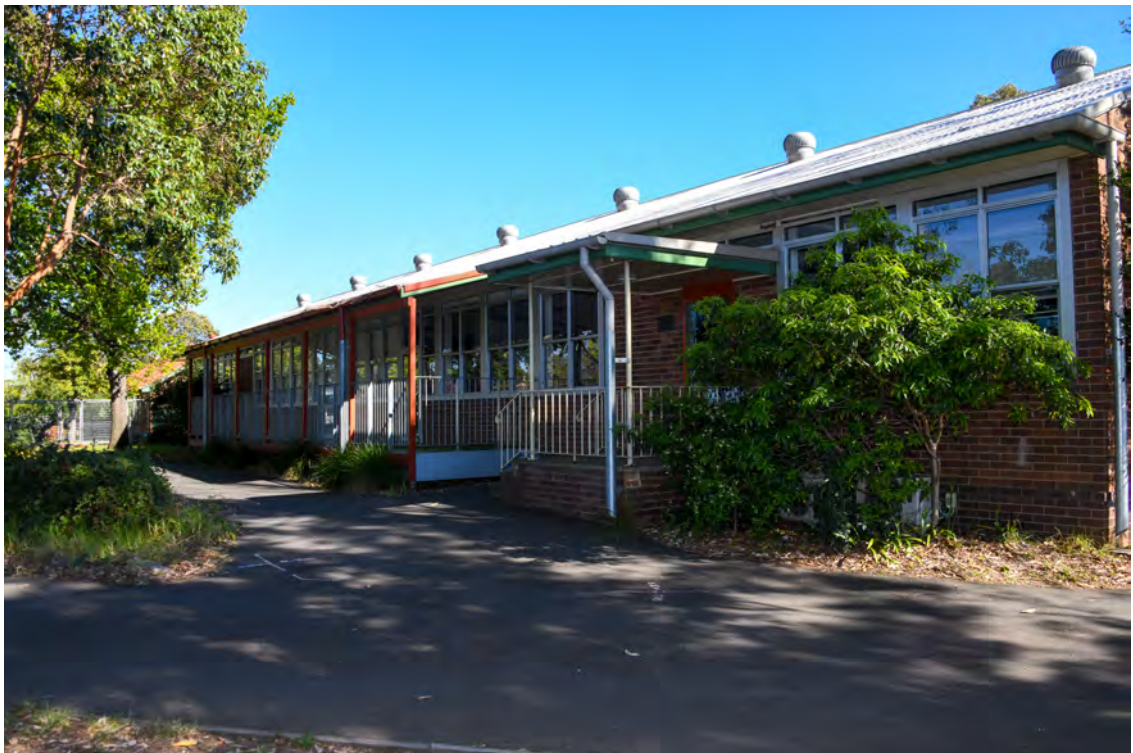
PRO\_1050.jpg

Block H. Southern elevation.

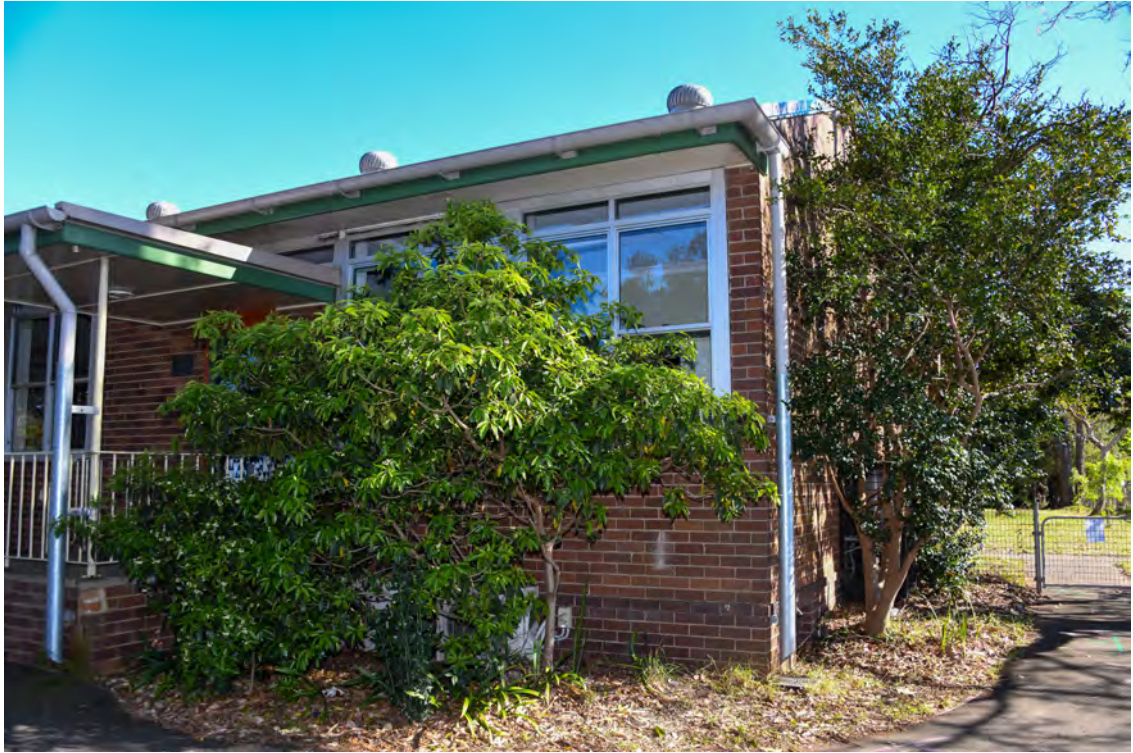
PRO\_1051.jpg

Block H. Southern elevation. Eastern end.
